Type of Incident	Fingers caught in nip points of an etching press
Date Occurred	18 th April 2005
WHAT HAPPENED	<p>A student sustained crushing injuries to the tips of two of her fingers when they got caught between the moving table of an etching press and a revolving roller.</p> <p>At the time of the incident the press was manually operated by turning the large wheel which caused the table to move horizontally over the guiding roller. The torque is such that it takes considerable movement of the wheel to move the table forward.</p> <p>There was a similar guiding roller on the opposite side of the etching press.</p> <p>The space between the table and roller is the unguarded nip point.</p>
<p>The Press BEFORE</p>

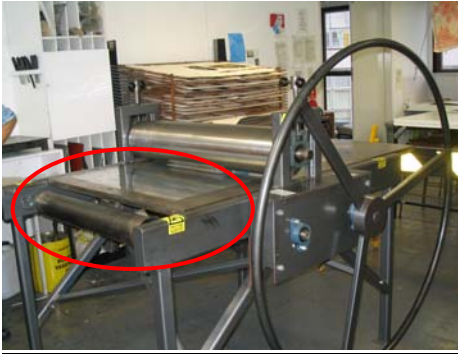
WERE THERE ANY INJURIES	The tips of two fingers were crushed
Most Likely Cause	The etching press had unguarded nip points
Corrective Action	<ul style="list-style-type: none"> • The Engineering solution involved removing the bottom guiding rollers of the large press and replacing them with guarded roller bearings. In addition a locking device has been fitted to the Operating Wheel. • All users (staff or students) are now required to produce evidence of competency in order to gain access to the press. • The SOP was updated to reflect these latest engineering and authorisation controls. • Risk Assessments were conducted for each of the other presses in the area with engineering controls implemented via a staged approach.
