Safety Alert March 2023

Subject: Water Pump Fire

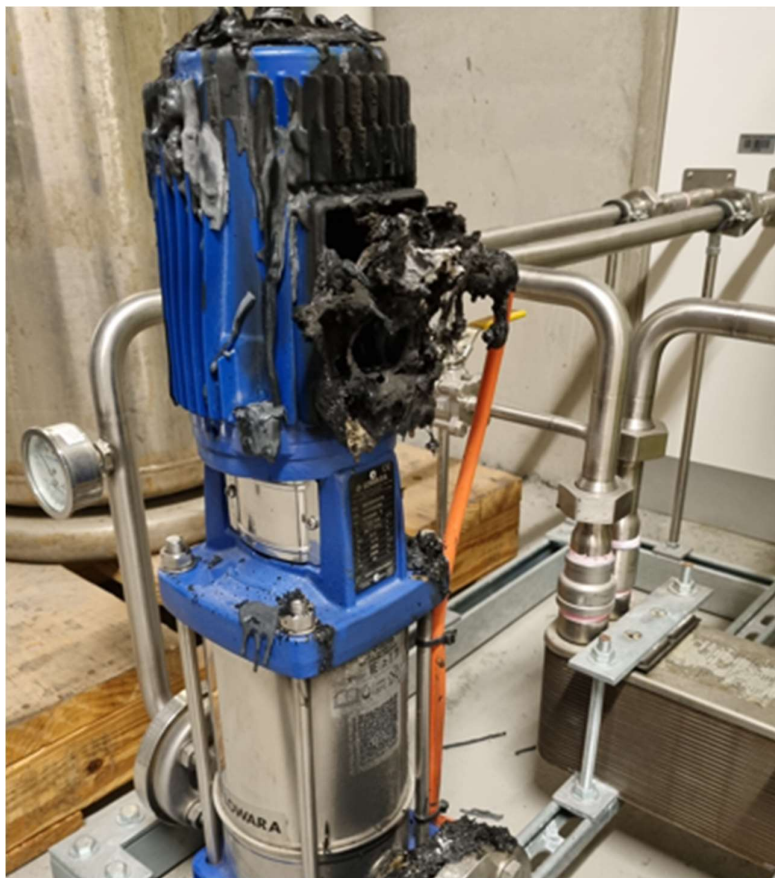
A person was using an arc melter in a laboratory that was connected to a water pump in an adjacent service corridor. The water pump provides cooling water for several devices in the lab. The person had switched on the water pump prior to using the equipment in the laboratory but had forgotten to switch it off at the conclusion of their work. Several days later after operating continuously, the pump caught fire causing the building to be evacuated.

- The pump was running for approximately 5 days continuously prior to the fire starting
- The location of the fire was identified by two Wormald technicians who were working close by and attended the building fire indication panel when they heard the fire alarm sounding

- Estate Management arranged for a third-party review of the damaged water pump to determine the probable cause of failure
 - The review of the damaged pump indicated that the probable cause of failure was the motor run capacitor breaking down, eventually causing the motor to stop rotating, leading to the generation of heat resulting in the plastic components heating to the point of combustion

- The third party has recommended that the motor/pump be fitted to a starter/controller that has an overload protection circuit to suit the motor operating parameters, and incorporating a water flow switch to prevent the unit from operating with no water flow through the system

- **What should we do now?**
 - Conduct a condition check on all water pumps, particularly ones of this make/model
 - Implement the modifications to the equipment recommended above

- As an interim control, implement local processes to ensure the water pumps are not run for extended timeframes. This could include daily equipment checks or fitting timer switches
