Physical modelling of complex overtopping flows at Ōhau Point, Kaikōura and development of mitigation measures

Francois Flocard¹, Mathieu Deiber¹, Tom S. Shand^{2,3}, Matt, J. Blacka¹, Patrick Knook^{2,3}, Steve Proctor³

¹ Water Research Laboratory, School of Civil and Environmental Engineering, UNSW Sydney, Manly Vale, Australia. f.flocard@wrl.unsw.edu.au

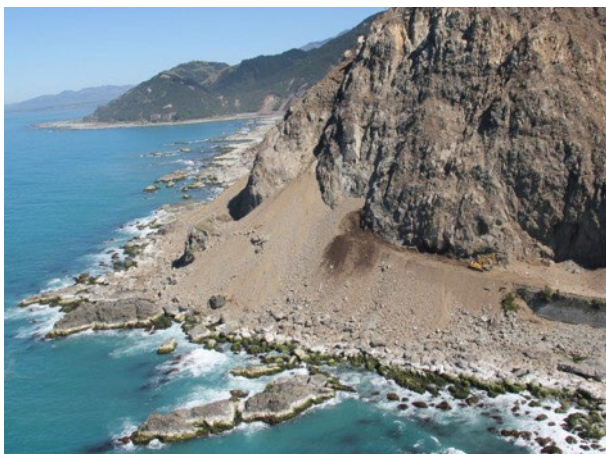
Ōhau Point was the location one of the largest and most challenging landslides, with more than 160,000 cubic meters of rock falling from the surrounding cliffs and inundating the road and rail corridors (Figure 1). The extent of the landslide resulted the new road alignment being shifted seaward and lower than the previous location. The road is supported by a near vertical seawall,

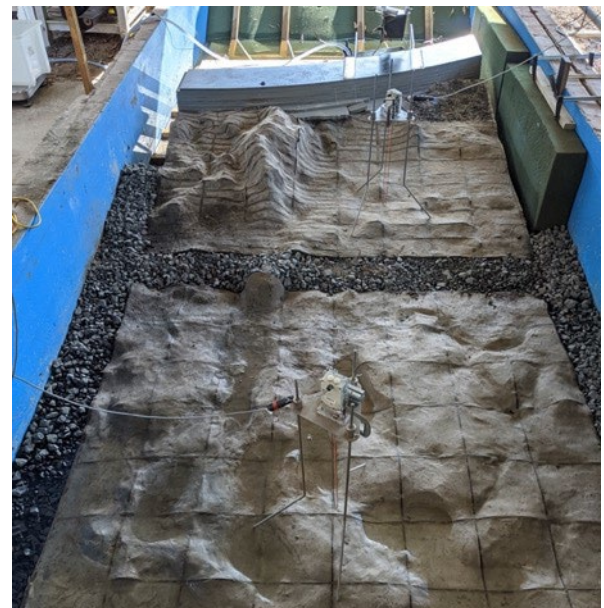
Figure 7 Overview of completed nearshore model bathymetry zones and seawall

Specific attention was given to emergent elements such as larger rocks located immediately off the seawall toe as well as the existing concrete slabs, by using detailed elevation information from recently captured LiDAR and onsite photography.

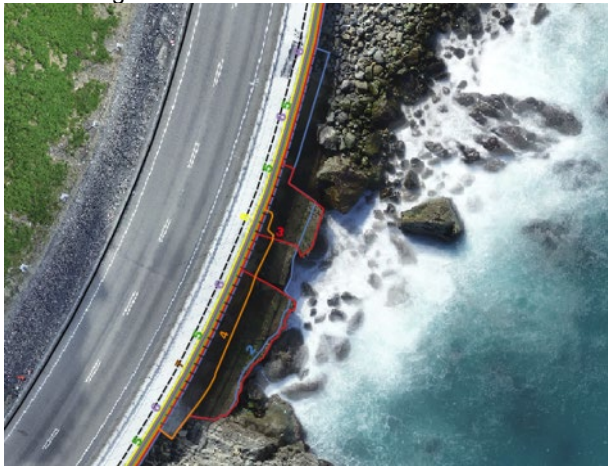
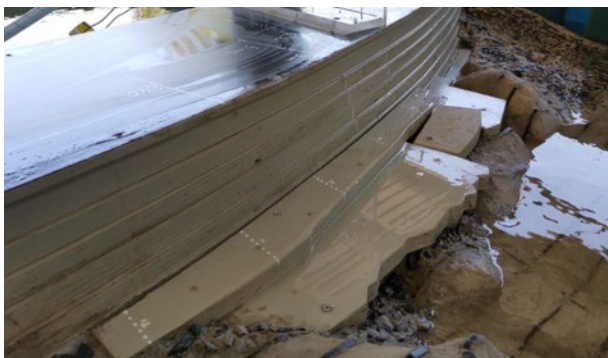
Figure 8 Overview of completed nearshore model bathymetry zones and seawall

Critical elements such as the step offset between each layer and the top recurve were included to ensure accurate modelling of overtopping processes when waves impact the seawall.

The model of the seawall was assembled within the flume and integrated within the nearshore bathymetry area prior to the final pour and shaping of the bathymetry capping, allowing for a seamless

bathymetry surface extending right up to the seawall face. The modelled concrete slabs at the toe of the seawall were secured in place over the bathymetry with localised infill based on review of the provided hi-resolution aerial photography and DEM.

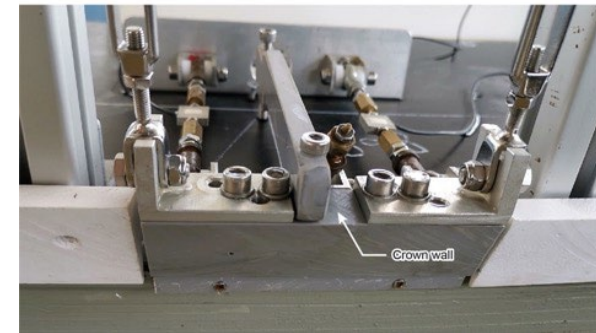
The horizontal wave loads on the crown wall were measured using load cells. Two load cells were mounted on a rigid frame at the rear of a 5 m long section (prototype scale) of the crown wall. Forces were measured using Futek LSB210 submersible load cells due to ongoing overtopping of the structure (Figure 10).

Figure 10 Crown wall section with load cells

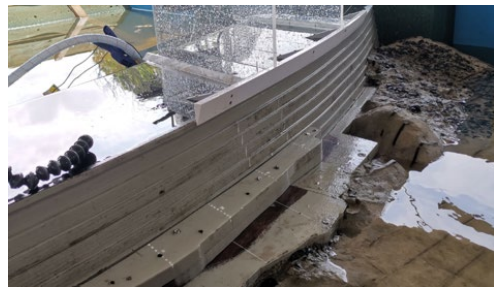
The physical modelling considered a range of configurations including the existing format of the site and three remediation options to mitigate the overtopping hazard. The first upgrade option was to remove part of the mass concrete slabs located at the toe of the existing concrete seawall.

The second upgrade option considered the installation of a crown wall along the crest of the wall in area affected by overtopping. The third upgrade option consisted of the placement of concrete armour units (Hanbars) in front of the existing seawall to form a toe berm.

(a) Crown wall and concrete slab removed (partially)

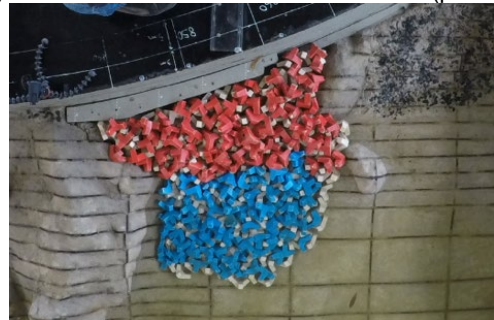
(b) Configuration 5 - 6.5 T Hanbars

A total of 9 Hanbar armour unit stability tests were undertaken for three (3) different armouring configurations, which consisted of 6.5 T (310 units), 10 T (240 units) and a mix of 20 T (35) and 10 T (180) Hanbar units, placed in front of the existing seawall and extending seaward to the -4.0 m NZVD2016 bathymetric contour.

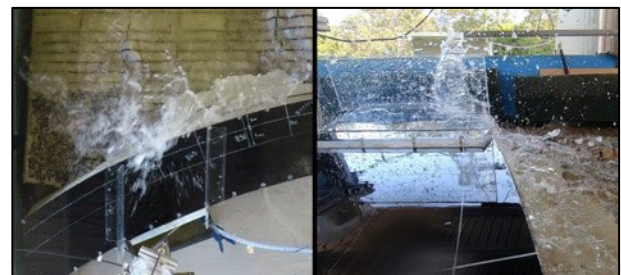
Review of the overhead video footage clearly showed that a direct consequence of the interactions between the incoming waves and the complex nearshore bathymetry resulted in focused impulsive jets of water overtopping the crest of the wall in a highly 3D form. These localised overtopping jets were of variable width, predominantly between 5 and 10 metres.

Figure 12 Examples of highly 3D wave overtopping

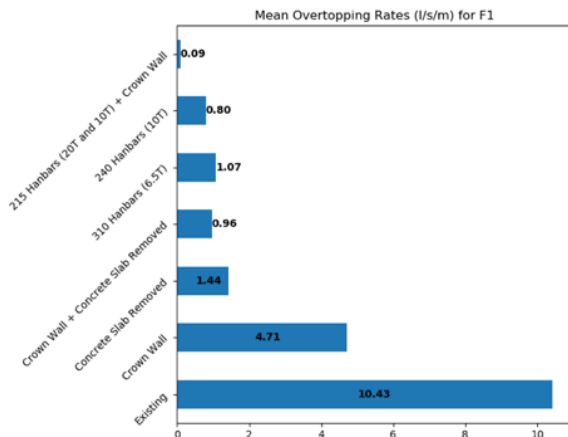
Overtopping volumes were reduced by 50% with the installation of the crown wall (10 L/s/m down to less than 5 L/s/m at prototype scale). Interestingly, the physical model showed that removing sections of the concrete slabs located in front of the seawall also significantly reduced overtopping by 75% to 85%. This was attributed to the slabs acting as a ramp to direct the wave up the seawall as well as reducing the effective freeboard above the wave impact level.

Figure 14 Mean overtopping rates for F1

Further reduction of overtopping volumes was observed with the partial removal of the concrete slabs combined with the installation of a crown wall or the placement of model units representing 10T or 6.5T Hanbar units, with average overtopping volumes around 1 L/s/m (prototype scale) for a 100 year ARI storm for the present day water levels.

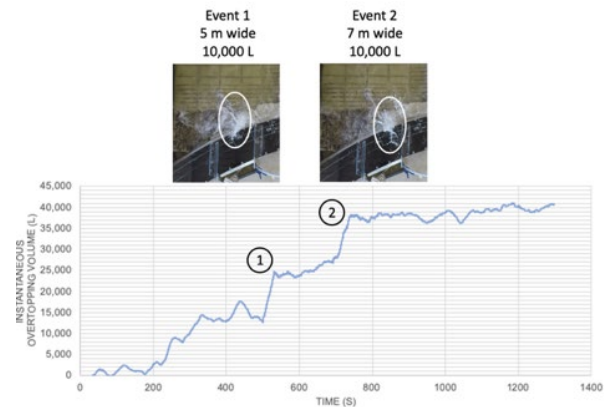
Figure 15 Time series of overtopping volumes for existing condition

Note that two overtopping events (i.e. Events 1 and 2) accounted for nearly 50% of the total volume measured. Review of these two events indicates that the overtopping jet width was between 5 and 10 m, albeit at different locations along the crest.

The consequence of averaging overtopping over the 20 m (prototype scale) width can be further volumes during flume testing. depicts the evolution

illustrated by looking at instantaneous overtopping of total overtopping volumes captured by the catch tray during a short duration test for the existing seawall configuration.

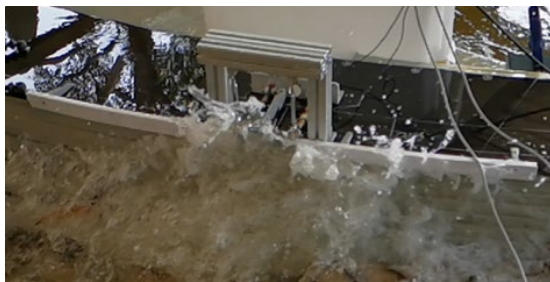
Tests were performed to measure the wave loads on the seawall crown wall for two model configurations (with and without the concrete slab at the toe of the existing seawall). Wave loads were measured on a 5 m long crown wall section (prototype scale) centred on chainage 860 m, which was at the location considered to experience peak overtopping intensity. An example of a wave hitting the crown wall section attached to the load cells is shown in Figure 17.

Figure 17 Wave hitting the crown wall during Test F1 (without concrete slab)

Wave loads on the proposed crown wall were assessed for the 100 year storm event (present day sea level). Maximum instantaneous peak horizontal wave loads of approximately 100 kN/m (prototype scale) were observed for the tested design. While the measured data is considered to provide a reasonable estimate of the magnitude of wave impact loads on the crown wall, it is important to consider that the results contain some inherent scale effects such as altered air entrainment at this scale.

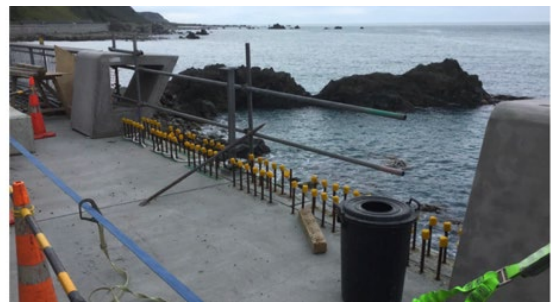
Removal of the concrete slabs was trialed but could not be achieved. A concrete crown wall was designed informed by the results of the physical modelling and construction on site finalised in late 2020.

Figure 18 Construction of new crown wall
