The use of Trigger Action Response Plans to mitigate wave overtopping hazard on coastal infrastructure

Tom Shand^{1,2,3}, Peter Quilter^{1,2}, Patrick Knook^{1,2}, Richard Reinen-Hamill^{1,2} and Francois Flocard⁴

¹ Tonkin + Taylor Ltd., Auckland, NEW ZEALAND email: tshand@tonkintaylor.co.nz

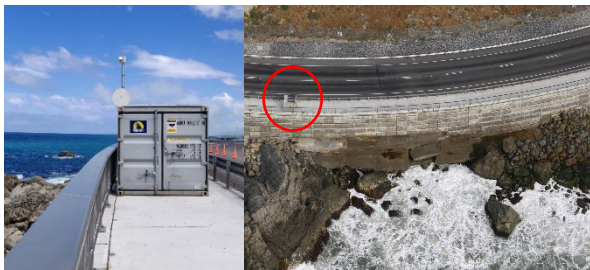
Figure 5 Camera installed at Ōhau Point (circled)

A fixed point camera was established overlooking the critical overtopping point at Ōhau Point (Figure 5). The camera captures images at 1 second intervals for the first 20 minutes of each hour. The imagery is intended to provide a record of when overtopping occurs and its extent.

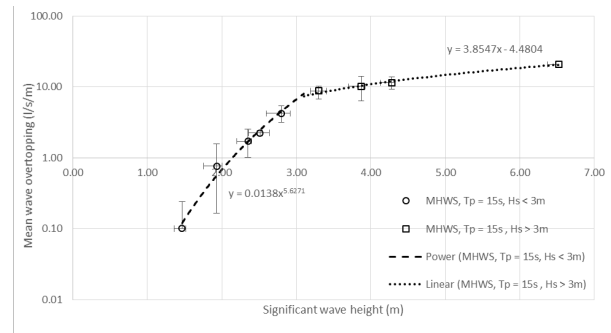
Figure 8 Example of measured mean overtopping rate for a range of wave heights during a MHWs water level.

Wave overtopping was measured during a range of wave heights (1.5 – 4m), wave periods (11-17s) and water levels (MSL to MHWS + 0.5m) to characterise the overtopping flows during a range of potential conditions (i.e Figure 8) and assist in deriving wave height and water level-based trigger levels. Additionally, testing of extreme conditions under current and future sea levels was undertaken to assist in developing engineering options for mitigation.

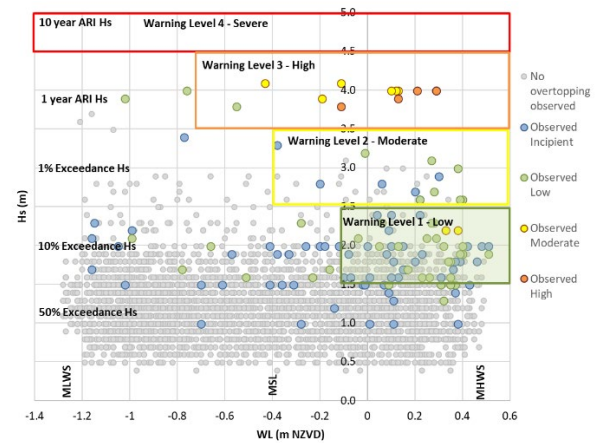
Figure 10 Observed overtopping events as a function of nowcast Hs and WL. Incipient events are levels of overtopping below the criteria for low level. Coloured boxes represent the initial TARP threshold criteria

Figure 10 shows the level of overtopping observed over a 10-month record compared to the initial TARP thresholds. Cases where no overtopping was observed are also identified along with ‘incipient’ overtopping where minor spray may occur but doesn’t meet the low threshold. From results, it is evident that overtopping could from time to occur at lower wave height and water level thresholds than initially defined but also that no overtopping could occur at higher thresholds. There are likely to be a range of explanations for this including: inaccurate nowcast information (though comparisons against wave buoy and water level gauge data show similar scatter); additional factors such as wave period and direction; groupiness unaccounted for in the spectral wave characteristics; limitations in observing overtopping due to the camera shortcoming described above and/or user error in designating overtopping level.

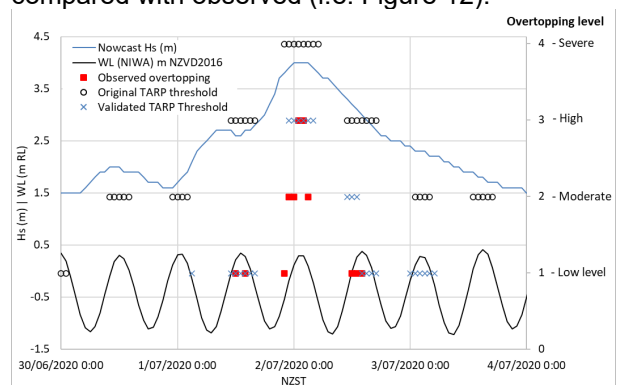
Figure 11 Predicted overtopping levels based on wave height and water level using the initial and the validated criteria compared observed levels.

On this basis, the warning thresholds were slightly revised, particularly for the lower thresholds with the low level threshold increasing to Hs = 2m and moderate level to Hs = 3m. The ‘initial’ TARP was then updated to produce a ‘validated’ TARP. In undertaking this validation, it was found to be important to identify the conditions when overtopping was not occurring as well as when it was and also to only consider conditions occurring when accurate image data was available. Figure 11 shows an example of an event with the initial and validated criteria used to predict overtopping level compared with observed (i.e. Figure 12).

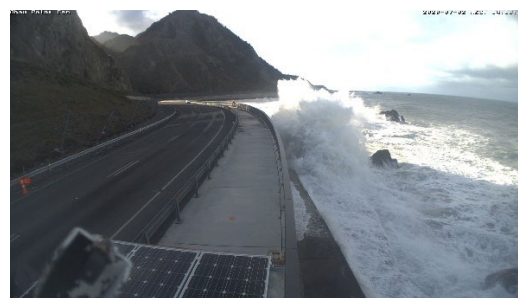
Figure 12 Example of low level overtopping identified at 2pm on 2/7/20

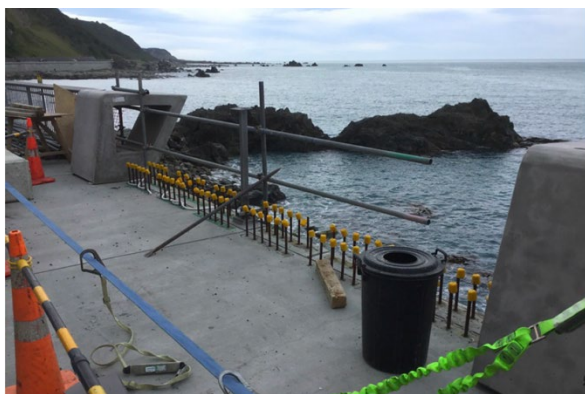
Figure 13 Installation of a crown wall at Ohau Point

A 1.2m high crown wall was selected as the preferred option (Figure 13). This was found during physical modelling to reduce overtopping to around 40% of the existing situation and allowed wave height thresholds for TARP triggers to be increased by around 0.5m. This change reduced the frequency of a required response by around 50% resulting in significant potential cost savings over the project life as well as improving safety and resilience of the infrastructure.

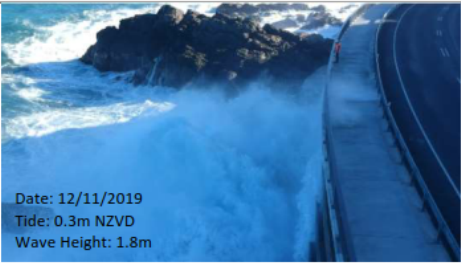
<p>Date: 12/11/2019 Tide: 0.3m NZVD Wave Height: 1.8m</p>	<ul style="list-style-type: none"> Spray onto capping beam and may reach edge of road Overtopping occurs infrequently (<20min between events) Uncomfortable but not dangerous for aware pedestrians/cyclists. No major risk to traffic though potentially distracting at high speed 	<ul style="list-style-type: none"> NOC aware Deploy wave warning signage at discretion
<ul style="list-style-type: none"> Level 2 <p>Occurrence: Average ~once/2 months (though action could be required on consecutive high tides)</p>	<ul style="list-style-type: none"> Wave height 3.0 – 4.0m 3 hours either side of high tide 	Moderate ($q_{\text{mean}} = 1 \text{ l/s/m}$)

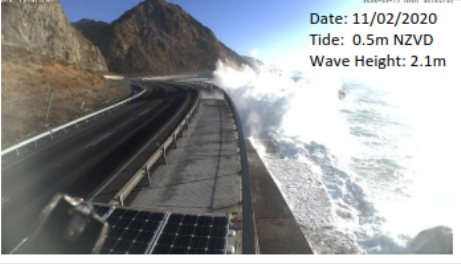
<p>Date: 11/02/2020 Tide: 0.5m NZVD Wave Height: 2.1m</p>	<ul style="list-style-type: none"> Whitewater splashing over capping beam and onto road. Some sheet flow (<50mm depth) over road Occurs semi-frequently (10-20min between overtopping events) May be dangerous to pedestrians/cyclists. May be distracting to drivers and dangerous at high speed 	<ul style="list-style-type: none"> Deploy wave warning signage to alert drivers Restrict access to shoulder Speed reduction to 50 km/hr

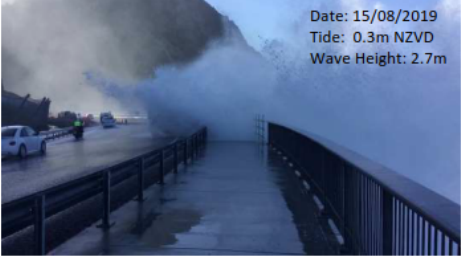
<p>Date: 15/08/2019 Tide: 0.3m NZVD Wave Height: 2.7m</p>	<ul style="list-style-type: none"> Significant whitewater across road. Sheet flow up to 100mm depth. Occurs frequently (5-10 min between overtopping events) Dangerous to pedestrians/cyclists. Dangerous to drivers at any speed 	<ul style="list-style-type: none"> Deploy wave warning signage Close the shoulder Speed Reduction 30km/h Single Lane Operation – using northbound lane Stop / Go Stop / Stop at Peak tide
<ul style="list-style-type: none"> Level 4 <p>Occurrence: Average ~once/10 years</p>	<ul style="list-style-type: none"> Wave height Threshold > 5m All tides 	Severe ($q_{\text{mean}} > 10 \text{ l/s/m}$)	<p><i>Scenario not yet observed post-seawall construction</i></p>

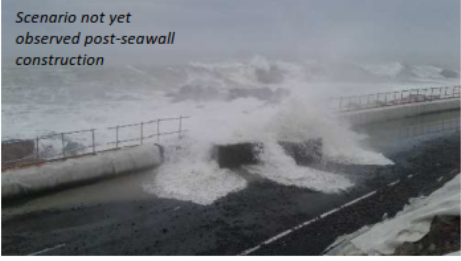
<ul style="list-style-type: none"> Significant greenwater over road (flows likely >0.3m depth) Occurs very frequently (<5 min between overtopping events) Extremely dangerous for pedestrians/cyclists Extremely dangerous for vehicles Likely some damage to road or fixtures 	<ul style="list-style-type: none"> Deploy wave warning signage Close road / shoulder Use single lane Stop / Go operation during low tides, using northbound lane. With Stop / Stop as required.
