Management and Protection of Indigenous and Cultural Foreshore Assets in NSW Australia

James T Carley¹, Ian R Coghlan¹, Chris D Drummond¹ and Michael Thomas²

¹ Water Research Laboratory, School of Civil and Environmental Engineering, UNSW Sydney, Australia
email: james.carley@unsw.edu.au

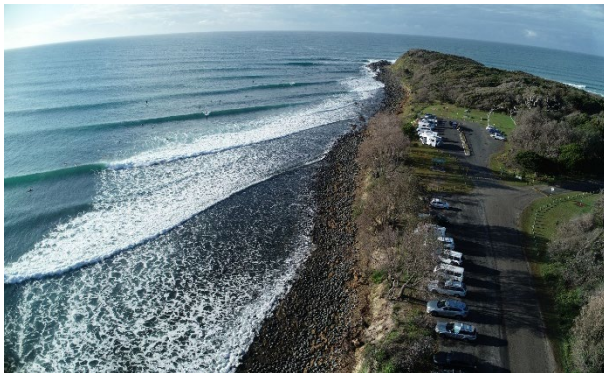
Figure 2 Foreshore and embankment looking east at Saltwater Point, with right hand point break (Chris Drummond)

The foreshore is mostly composed of loose rounded hard igneous cobbles, with some embedded in an underlying conglomerate of soft, erodible siltstone (Figure 2, Figure 3).

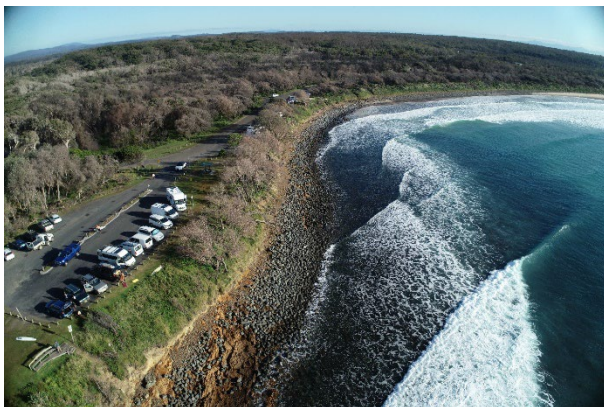
Figure 3 Foreshore and embankment looking west at Saltwater Point, with right hand point break (Chris Drummond)

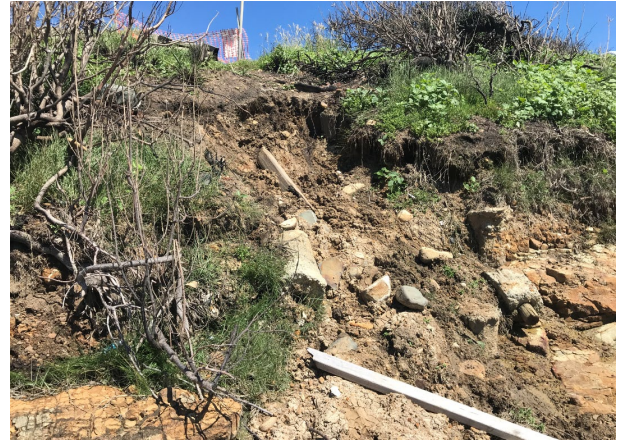
Figure 4 Eroding embankment unearthing artefacts

Reference [2] notes that the embankment has been eroding/receding, particularly as a result of large ocean storm events from the north-east to east such as those of June 2016 and February 2020. This erosion has unearthed indigenous artefacts such as stone tools (Figure 4).

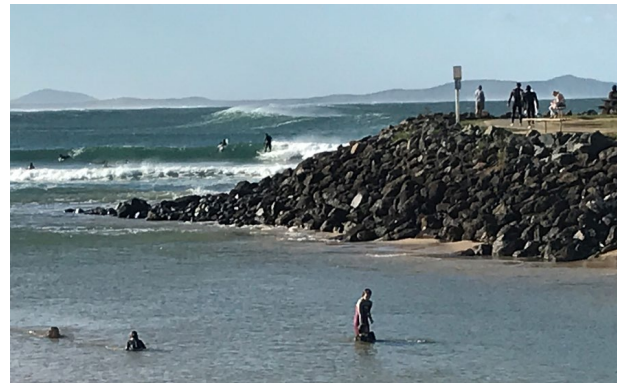
Figure 6 Angular and rounded rock enhancement of existing cobble foreshore at Crescent Head NSW. Note adjacent surf break (James Carley)

Following consultation between NPWS staff and traditional owners, stakeholders elected to pursue a hybrid large armour rock and cobbles/pebbles, similar to that used at the iconic surf break, Crescent Head (Figure 6, Figure 7).

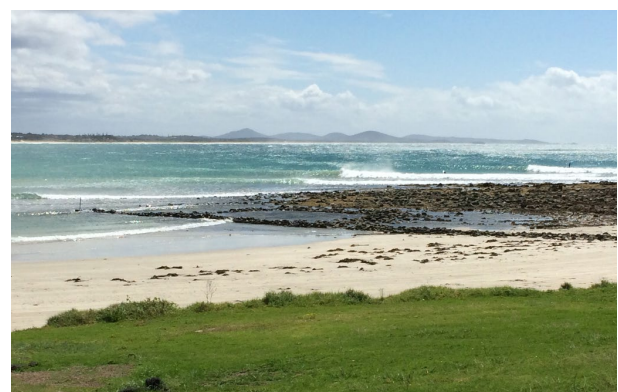
Figure 16 Foreshore and fish trap at Arrawarra Headland, 2015. Note adjacent right hand point break (James Carley)

This fish trap coexists with a renowned right hand surfing point break (Figure 16, Figure 17), and is also arguably the oldest evident coastal structure in NSW. They are an important component of cultural tourism in the area.

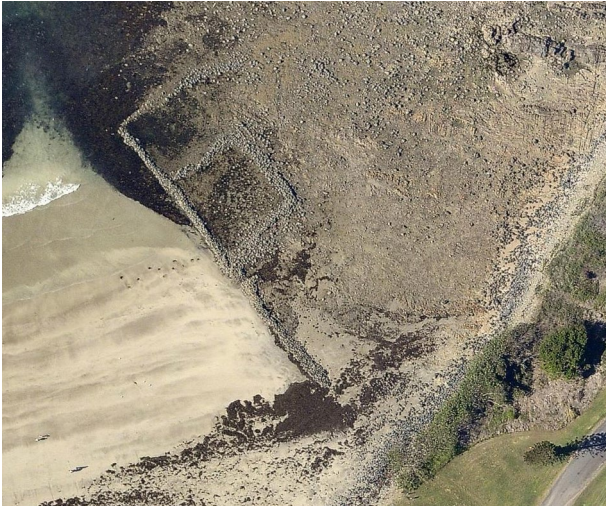
Figure 17 Nearmap image of fish trap at Arrawarra Headland, 21/12/2013. Estimated to be approximately 1000 years old. Rebuilt in 2006

Reference [6] stated that these are thought to be approximately 1000 years old. They were restored under the supervision of Garby elders over 3 years from 2006.
