## Everlasting Swamp Hydrodynamic Modelling Study

WRL TR 2017/02 | March 2019

Water Research Laboratory  
University of New South Wales  
School of Civil and Environmental Engineering

WRL Technical Report 2017/02

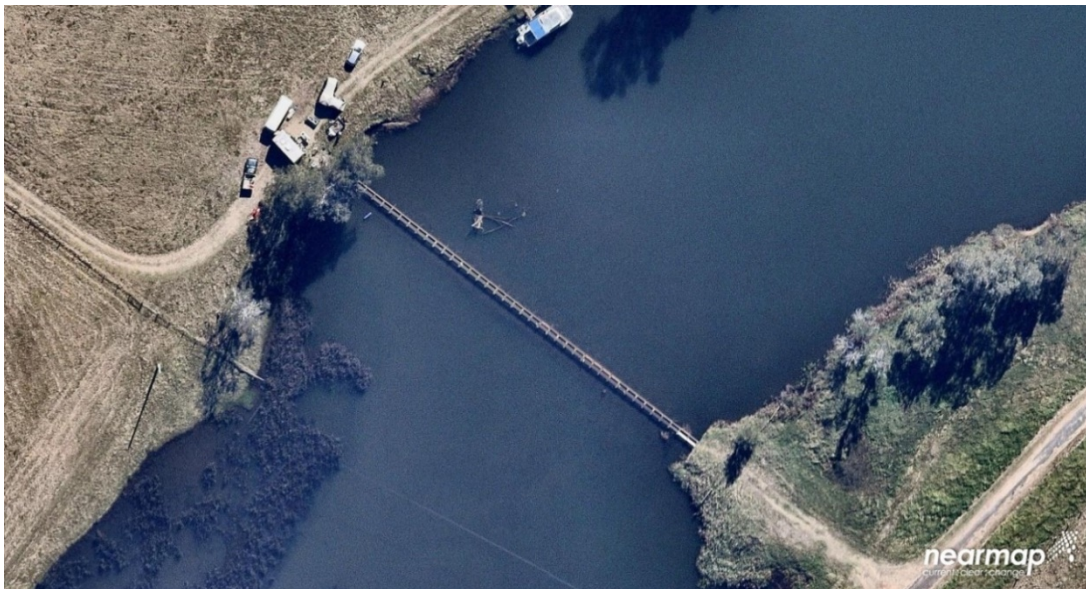
**Figure 2.4: Aerial View of Sportsmans Creek Weir**

In 2000, an investigation was commissioned into the structural integrity and condition of the weir. The investigation concluded that the weir was structurally sound, including for most severe flood loadings, and would remain so for another 20 years (McElroy, 2000). The study also found that due to ongoing degradation, the weir was highly leaky with up to 23% of tidal flows at high tide penetrating upstream of the weir, or an average of 11.5% of the full range of flows. In addition, several large flooding events (e.g. 2001, 2008, 2011, 2013) since the 2000 assessment have resulted in significant damage to the weir structure and the floodgate flaps. Ongoing concerns have been raised by the SCDU about the cost of maintenance of the weir and the potential litigation risks without continued maintenance. The current condition of the weir (as of 8 February 2017) is shown in Figure 2.5. Further information on the weir, including a detailed review of its hydrologic impacts to wetland inundation and risk management was completed by Gordos (2012).

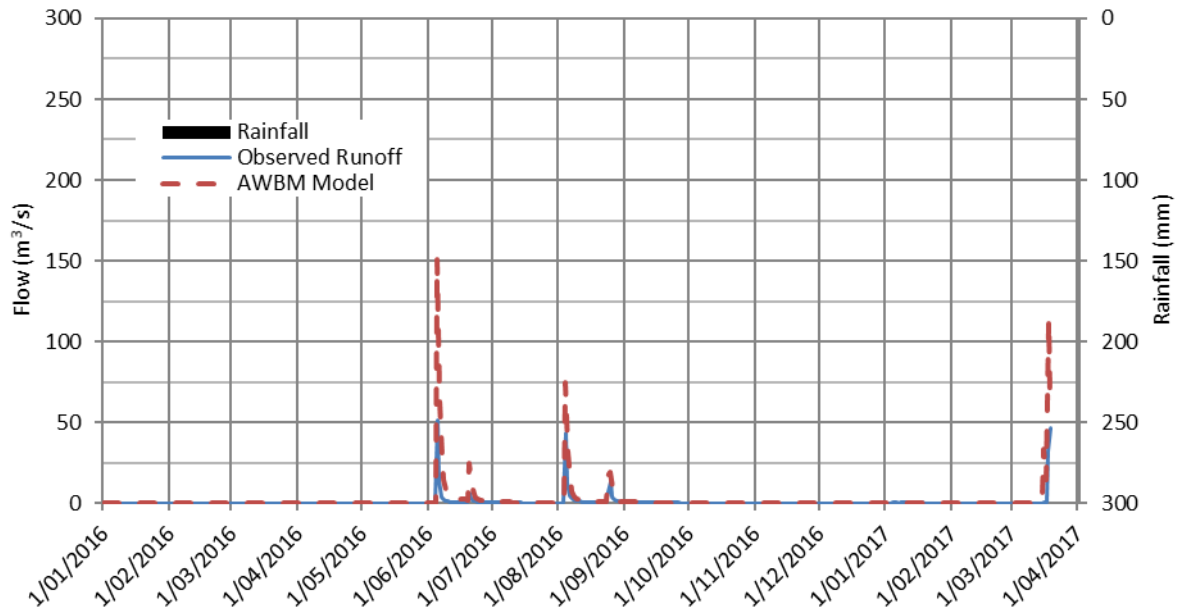
**Figure D.7: Predicted and Observed Runoff for the Catchment Area Upstream of the NOW Gauging Location at Sportsmans Gurrang**

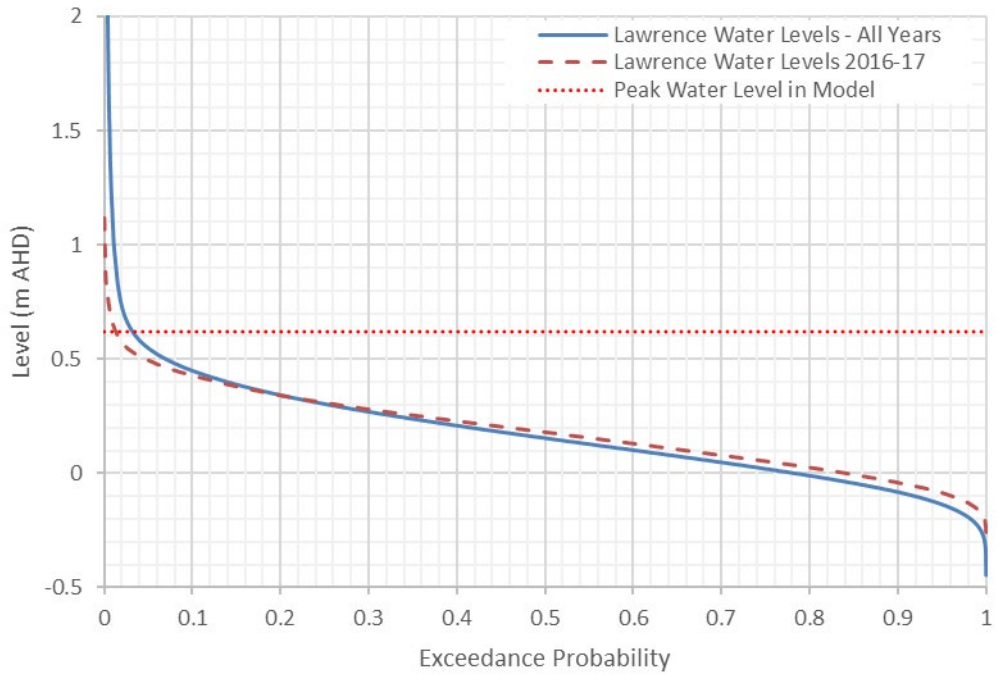
**Figure D.8: Exceedance Probability of Water Levels at Lawrence Tide Gauge**
