Crookhaven River floodgate tidal flushing assessment

By D S Rayner

WRL TR 2020/19, May 2021

UNSW
Water Research
Laboratory

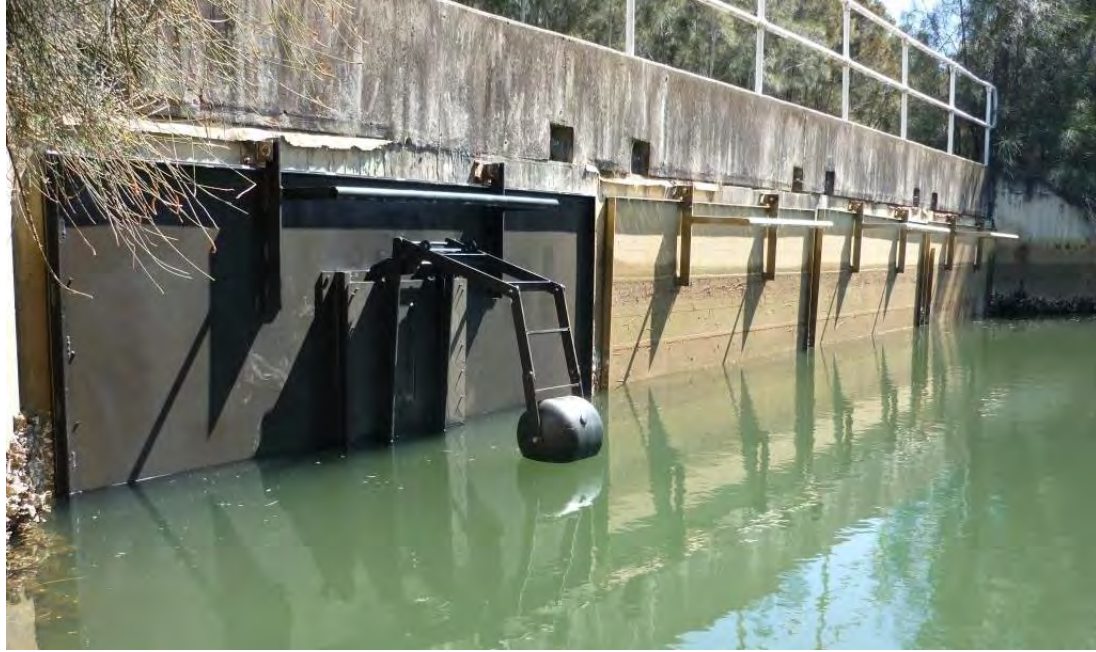
Figure ES.1: Example of a buoyancy controlled auto-tidal floodgate installed on a similar structure (Photo: S. Nichols/DPI)

Auto-tidal floodgates operate by allowing a controlled volume of tidal water to flow upstream of the floodgate structure until a set water level cut-off is reached; whereby the rising tide actuates the float trigger and closes the gate. When the downstream water level is below the tidal cut-off level, the float lowers and the gate is opened, allowing for tidal flushing. The cut-off level for closing the gate can be easily adjusted and managed to provide the required tidal flushing and ensure no impacts to upstream floodplain land.

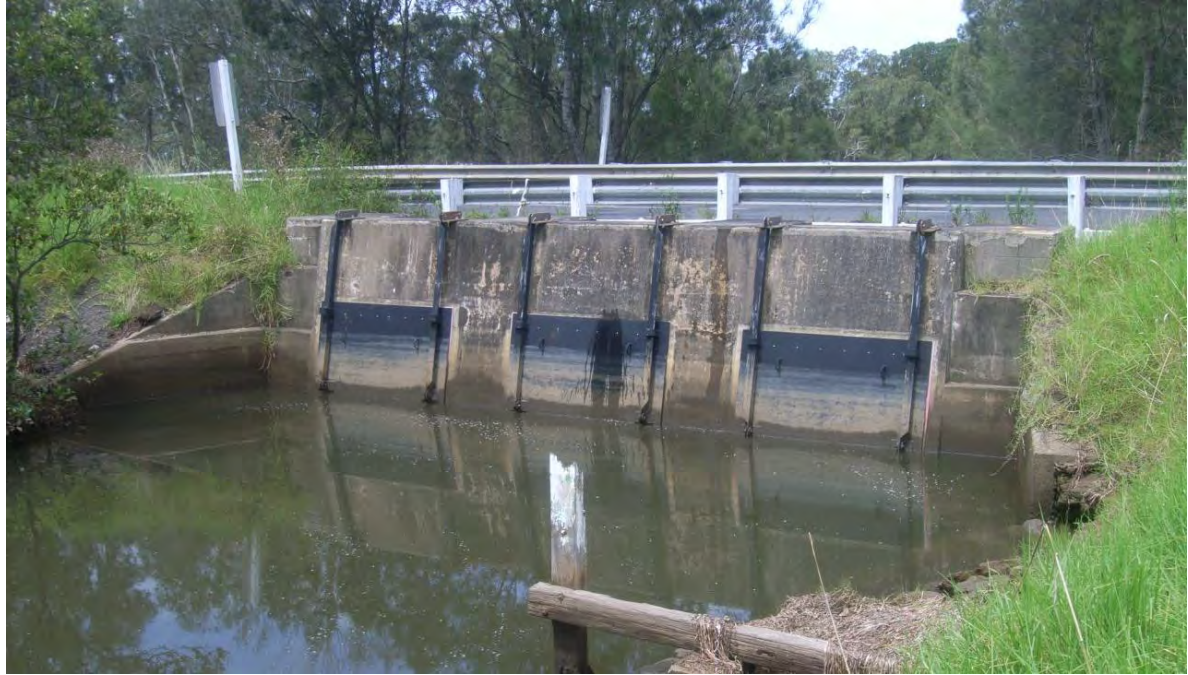
Figure 2-1: P10G1 Crookhaven River floodgates at Culburra Rd (Photo: S. Nichols/DPI)

Structures were inspected and surveyed during July 2020. Flood mitigation structures P10G1 and P7G1 were observed to be in good condition. The private landholder floodgate was observed to be in poor-to-average condition. No floodgates were observed on the culverts beneath Springbank Road, and the culverts do not protrude beyond the rock rubble headwall.

Structure	Type	Number of pipes/cells	Invert (m AHD)	Headwall Level (m AHD)	Dimensions (m)	Responsibility
P10G1	Floodgate	3	-0.5	2.23	1.7 (w) x 1.8 (h)	Council
P7G1	Floodgate	4	-0.95	1.50	2.3 (w) x 1.55 (h)	Council
Landholder	Floodgate	1	-0.75	1.00	1.2 (dia)	Landholder
Springbank Rd	Open Culvert	4	-0.8	1.10	0.9 (dia)	Council

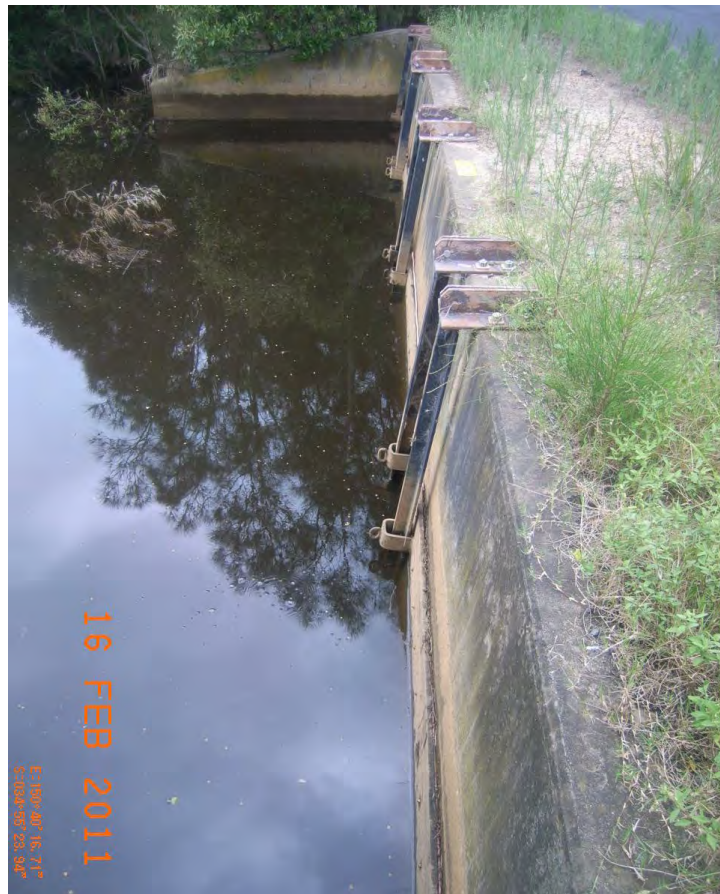
Figure 2-2: P7G1 floodgates at Mayfield Rd (Photo: Shoalhaven City Council)

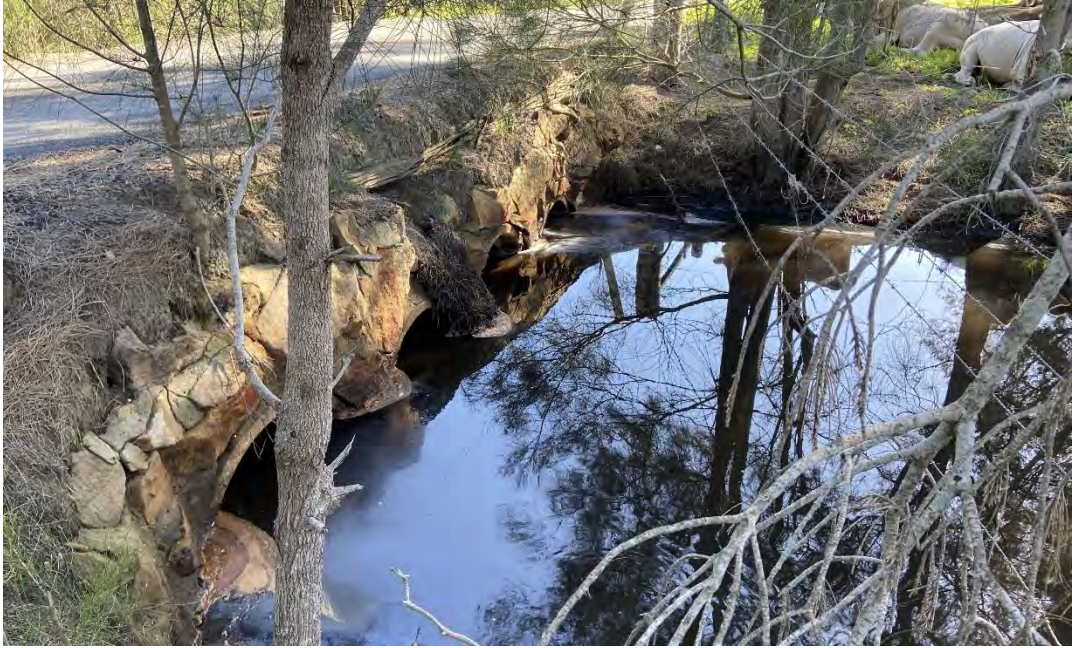
Figure 2-3: Culverts beneath Springbank Rd (Photo: Shoalhaven City Council)

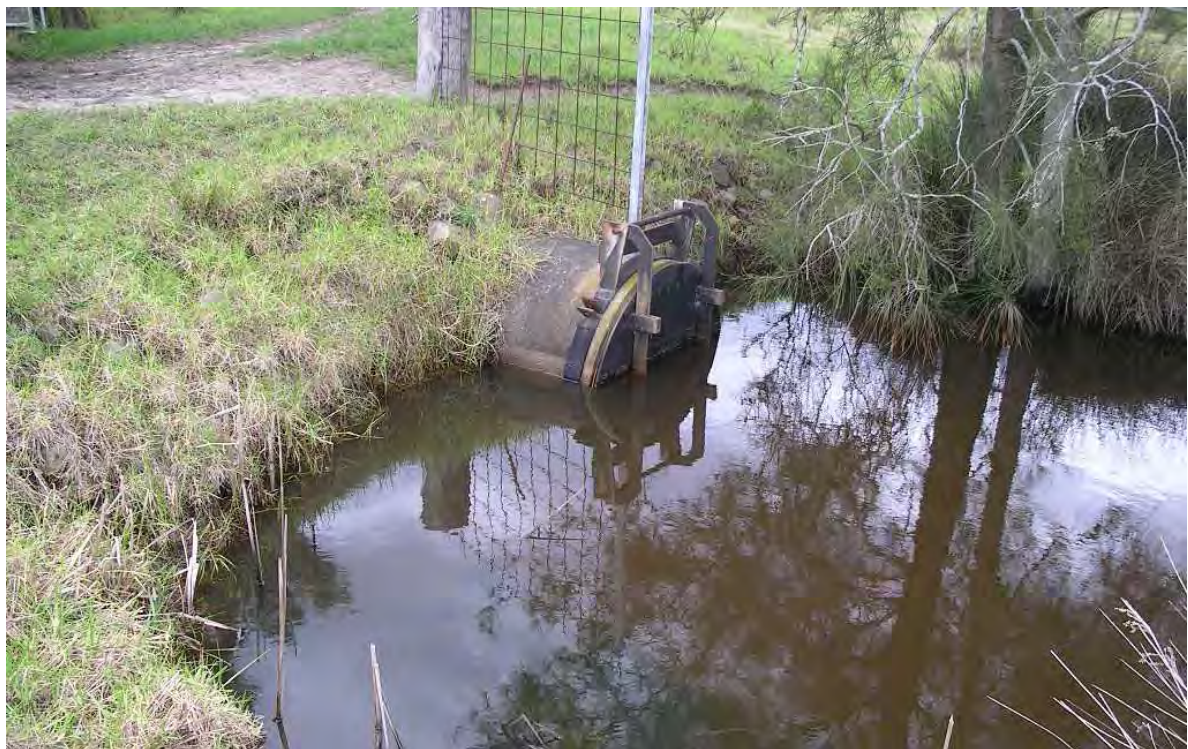
Figure 2-4: Private structure on side drain (Photo: S. Nichols/DPI)

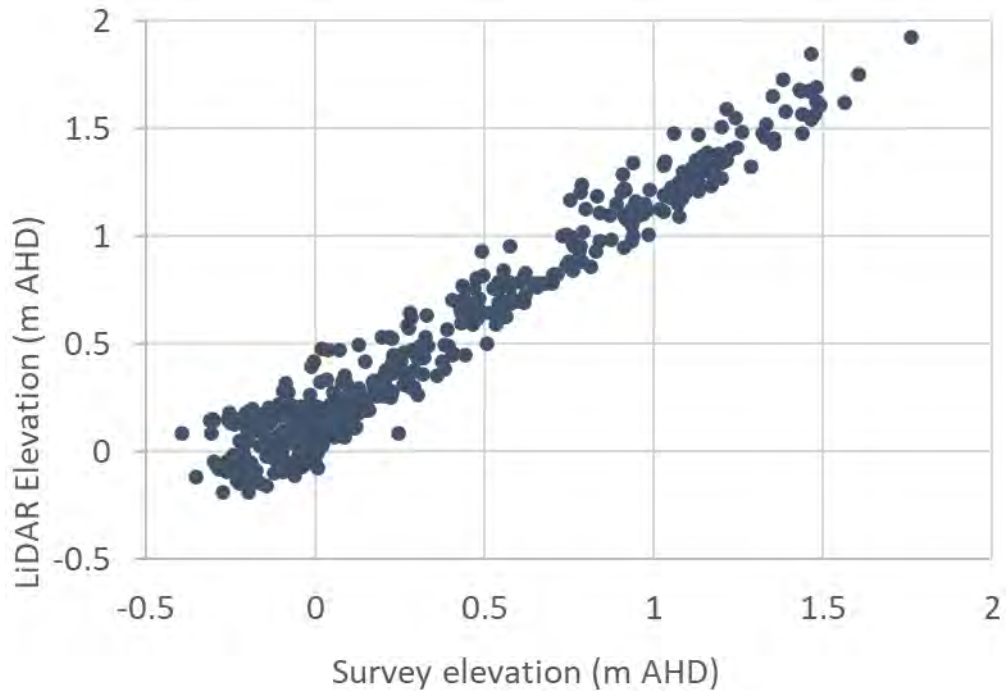
The ground survey data was collected across the site where access and GPS signal permitted. Collected RTK GPS survey data was compared to the LiDAR data where the datapoints coincided to assess the accuracy of the LiDAR DEM across the site at different elevations (Figure 3-3). The LiDAR data was generally higher for all elevations, which was not unexpected for low-lying coastal floodplain environments, as it confirmed that dense ground cover (e.g. pasture grasses) influenced the remote sensing LiDAR survey data values.

Figure 3-3: Comparison of surveyed points with LiDAR topography

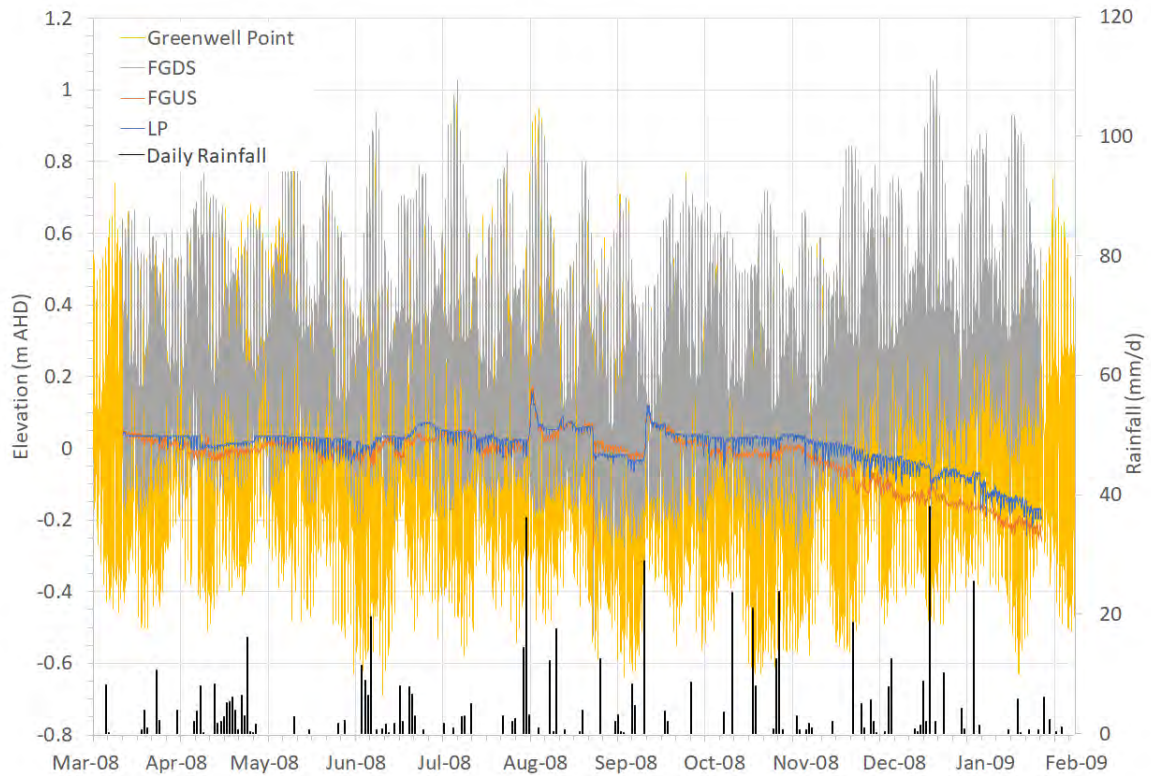
Analysis of water levels upstream of the gates measured during 2008 shows that elevated water levels following rainfall events drain efficiently through the floodgates. Periods of elevated average

water levels in the lower Crookhaven River do not appear to have a significant impact on average water levels upstream of the floodgates. The DPI (2009) dataset does indicate a change in measurement from November 2008 onwards. Comparison of water levels immediately upstream of the P10G1 floodgates with those measured 1.5 km upstream shows minimal differences in observed water levels, indicating efficient drainage of the system. Measured water levels are noted to deviate from the long-term trend after November 2008.

Figure 3-6: Water levels during 2008 (DPI, 2009)

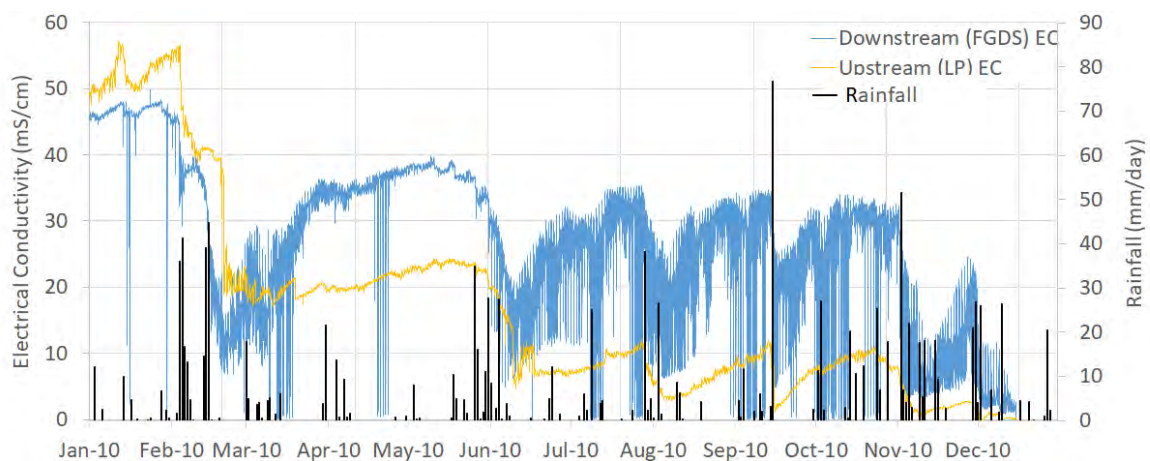
DPI (2009) collected electric conductivity (EC) data upstream and downstream of the Culburra Road floodgates during 2010. Electrical conductivity is a proxy for salinity. Note that the EC of ocean water is approximately 55 mS/cm. Measured EC data indicates that the floodgate flaps were leaking during or prior to the 2010 monitoring period, with elevated upstream EC levels measured. The data indicates that the Crookhaven River experiences elevated salinity during dry to average rainfall periods. This is due to the relatively close proximity of the site to the ocean entrance.

Figure 3-7: Electrical conductivity either side of P10G1 floodgates during 2010 (DPI, 2009)

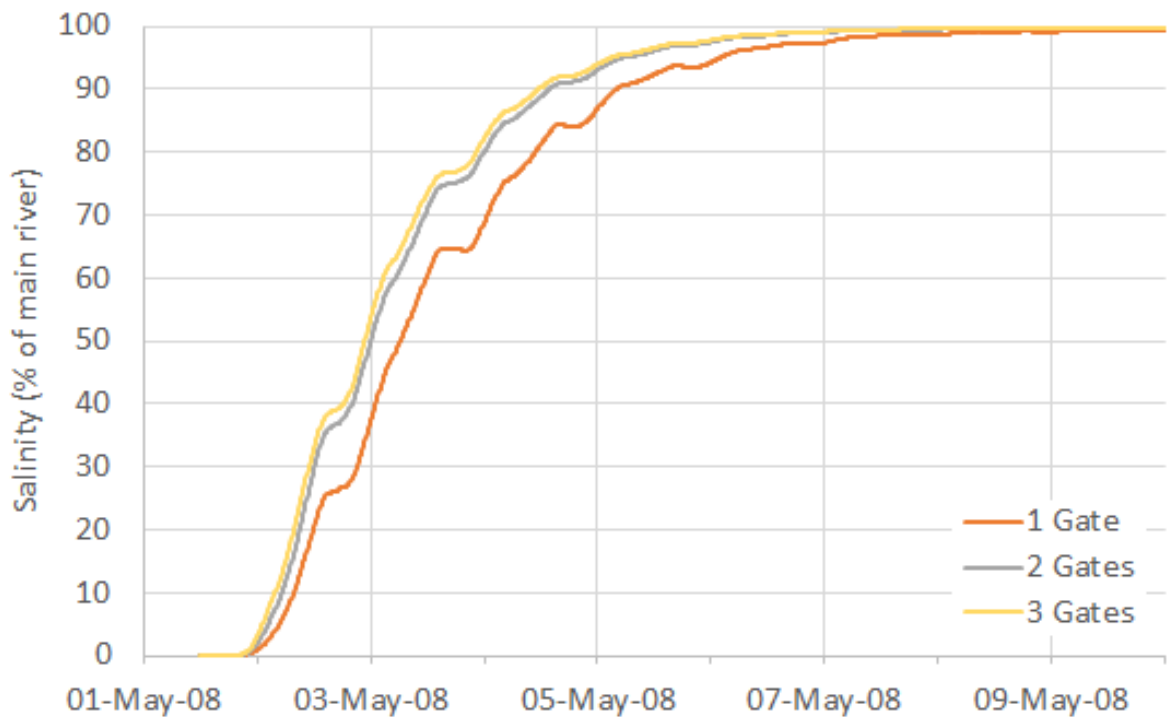
When assessing salinity (Figure 4-8), all floodgate configurations are estimated to provide significant flushing of the waterway with 100% flushing predicted to occur within 10 days. Note that this assumes dry conditions with zero freshwater inflows. In reality, catchment runoff and groundwater inflow as well as salinity flushing dynamics in the wider Crookhaven River estuary will all influence actual day-to-day salinity levels.

Figure 4-8: Salinity levels (compared to Crookhaven River salinity) near Saltwater Swamp (Location 2) with different auto-tidal floodgate configurations with a +0.1 m AHD tidal cut-off level

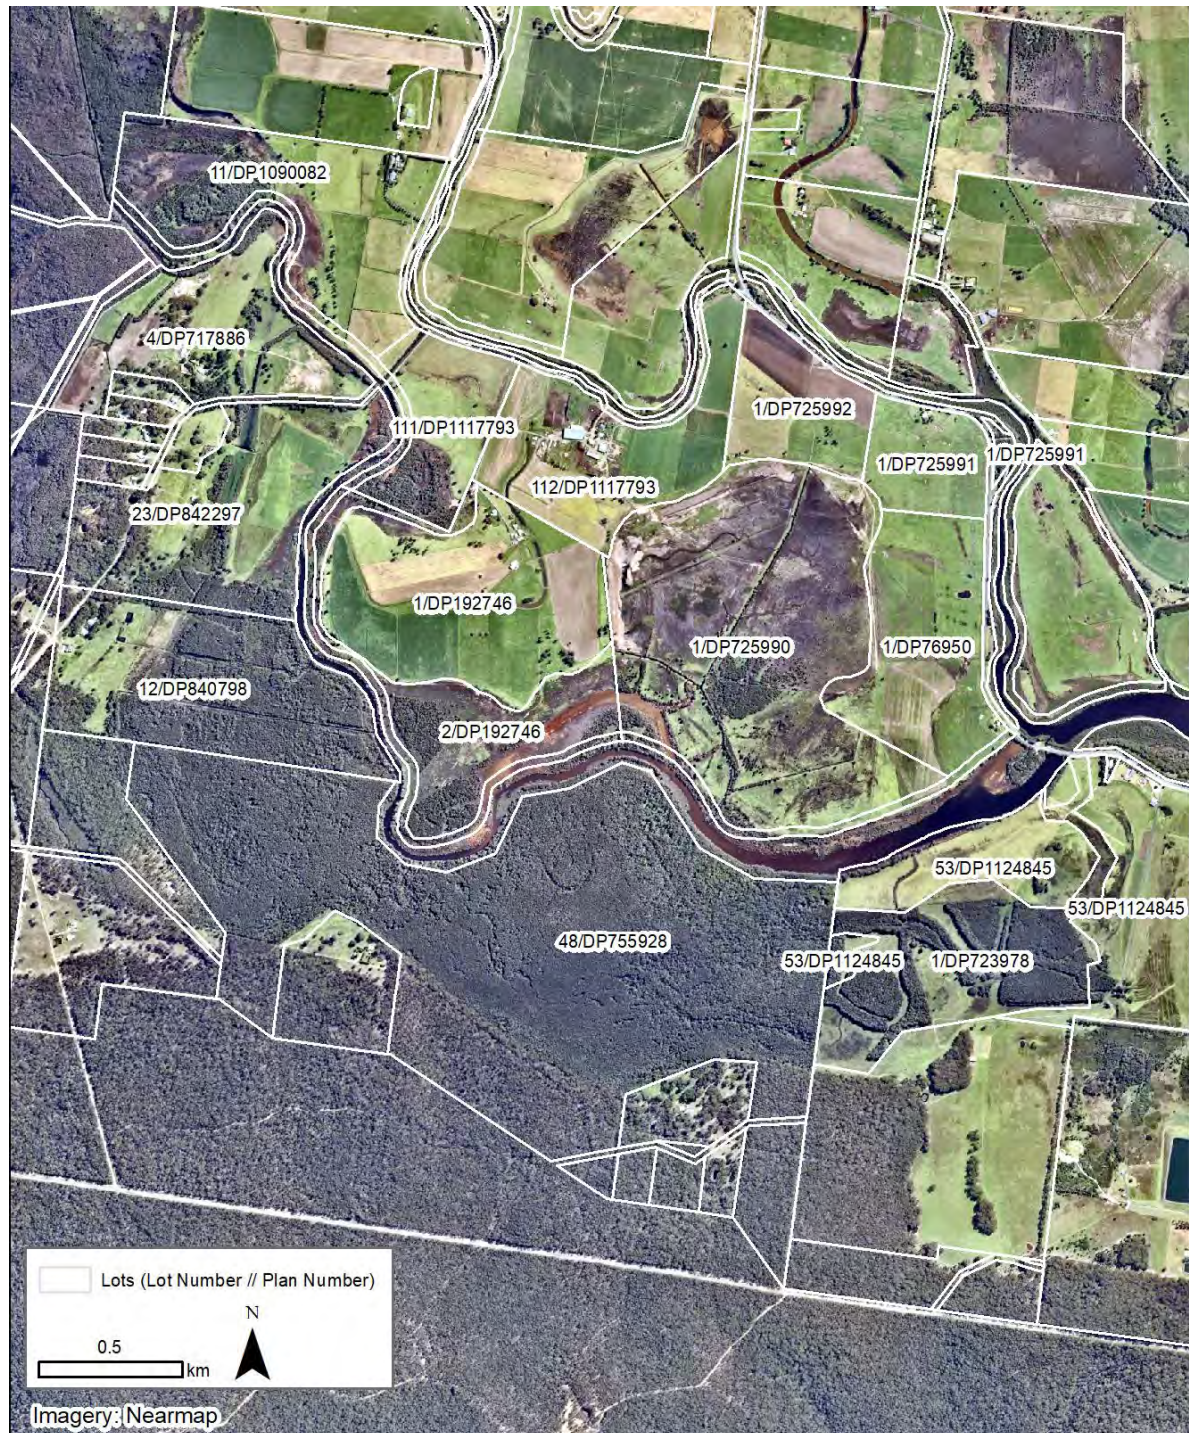
Figure E.1: Overview of property boundary extents and lot and plan numbers

Detailed mapping of floodplain elevations upstream of Culburra Road is presented in Appendix E on a property scale at a 10 cm vertical resolution.
