# Manly Lagoon: Review of environmental processes

WRL TR 2021/23, May 2023

By T A Tucker, D S Rayner and A J Harrison

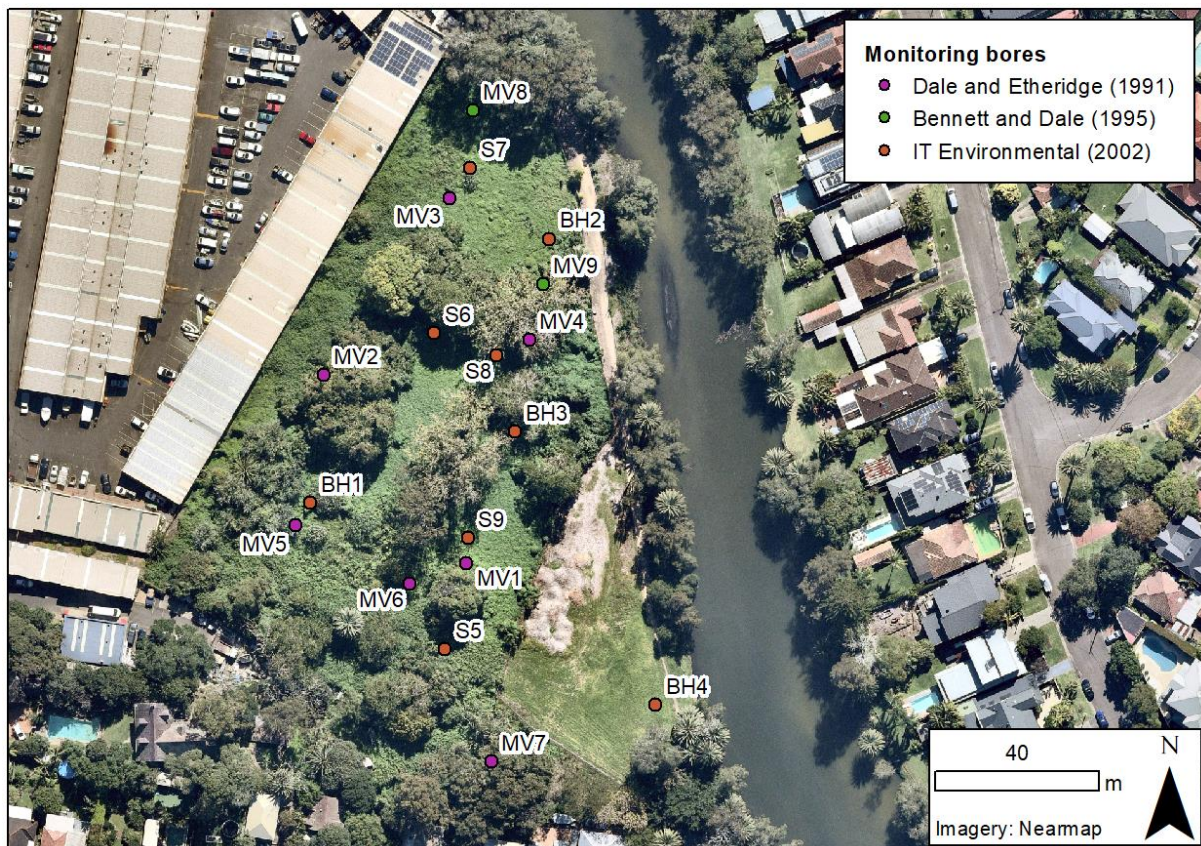
In 2008, Parsons Brinkerhoff (2008a; 2008b) reviewed the groundwater monitoring completed at the site over the previous decade for the development of a groundwater management plan and a remedial action plan. Upon reviewing the monitoring data they concluded that the primary contaminants of concern for the site are heavy metals (zinc, copper, cadmium and lead), PAHs, total petroleum hydrocarbons (TPHs), and ammonia. Of these they noted that zinc was consistently at higher concentrations than guideline values. Review of groundwater flow by Parsons Brinkerhoff (2008a; 2008b) found that there is a hydraulic gradient of approximately 0.005 m across the site with the groundwater flowing in an easterly to north-easterly direction.

**A.2: Historic monitoring bores at the Addiscombe Road remediation site**

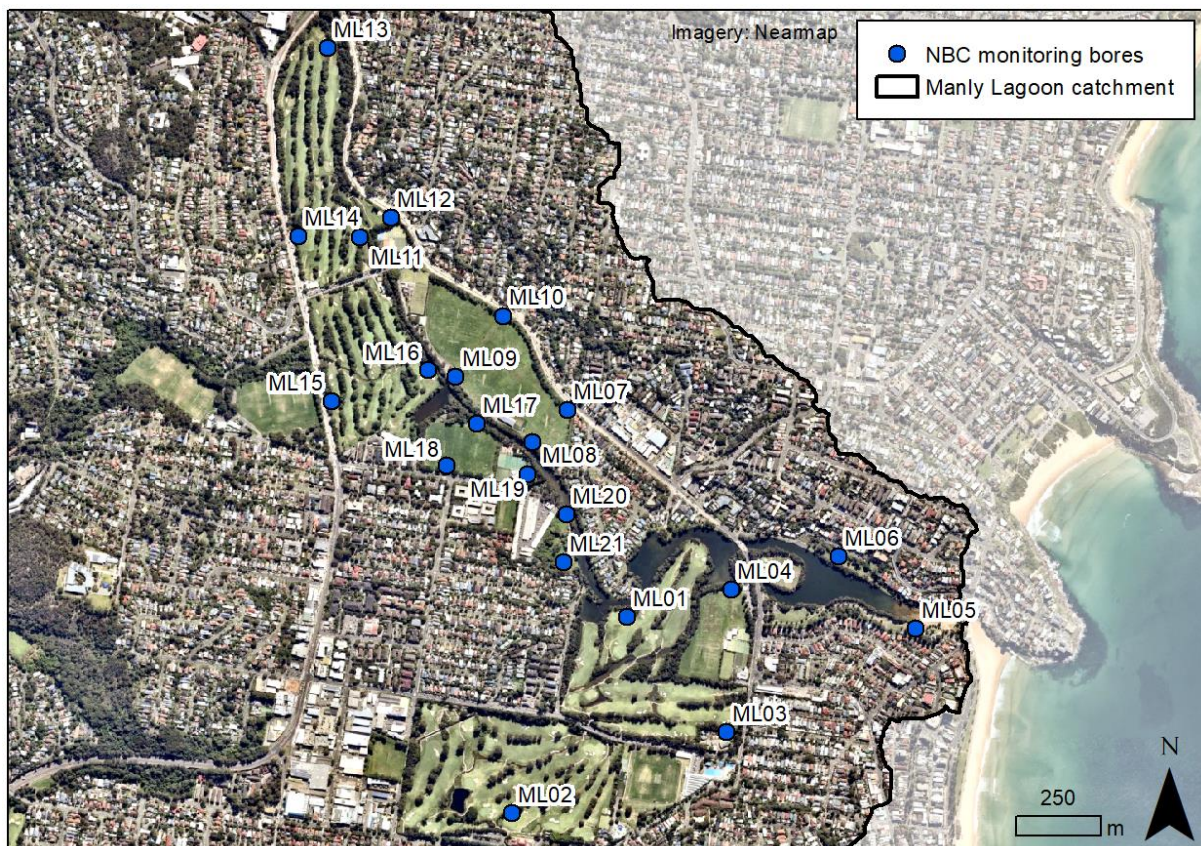
Other bores in the Manly Lagoon catchment include 21 monitoring bores constructed by Northern Beaches Council in March 2017 for the purpose of measuring groundwater quality and levels (Figure A.2). The 21 monitoring bores were constructed by Northern Beaches Council off the back of radon experiments completed in July 2016 which identified that there was an interaction between the groundwater and surface water of Manly Lagoon. Since their construction in 2017, the bores have been monitored for water quality in June 2018, March 2019, and August 2021, as well as for continuous water levels from June 2018 until July 2020.

**A.3: Monitoring bores including 21 constructed by Northern Beaches Council (NBC) in 2017**

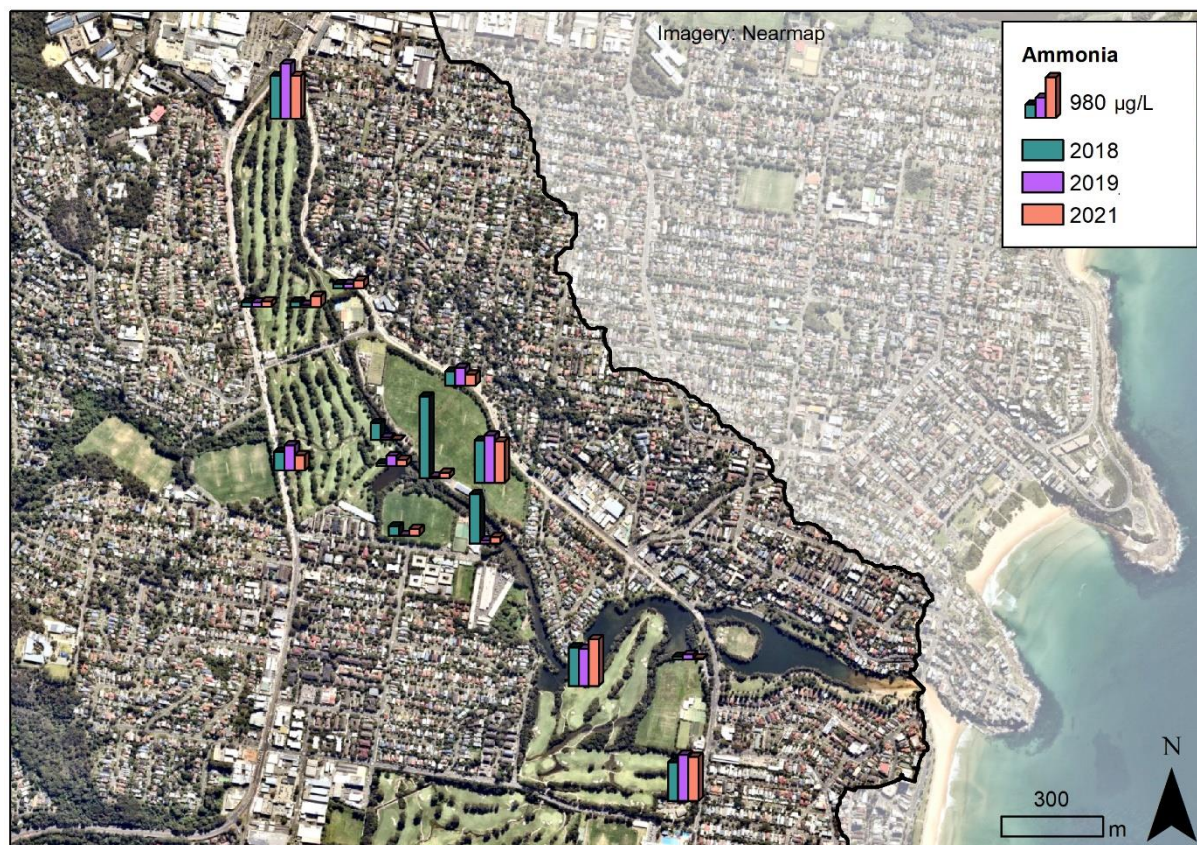
Ammonia, total filtered nitrogen and total filtered phosphorus were measured during the 2018 (dry weather), 2019 (wet weather) and 2021 (dry weather) sampling programs. A comparison between the sampling events is shown in Figure A.4, Figure A.5 and Figure A.6. Note that measurements of analytes across the site were extremely variable. Despite this, on both monitoring occasions, nutrient samples at all bores were observed above the ANZECC and ARMCANZ (2000) guideline values for aquatic ecosystems.

**A.4: Comparison of ammonia sampled at Manly Lagoon**

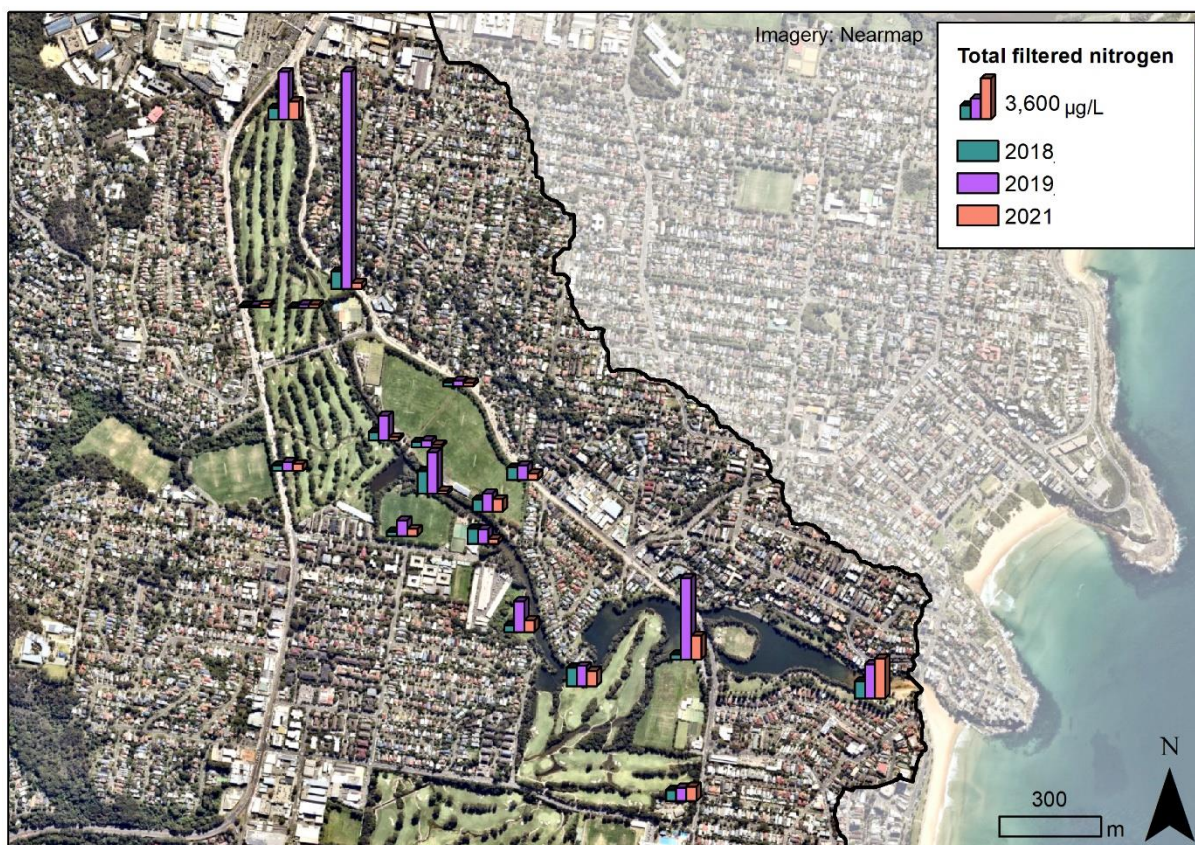
**A.5: Comparison of total filtered nitrogen sampled at Manly Lagoon**

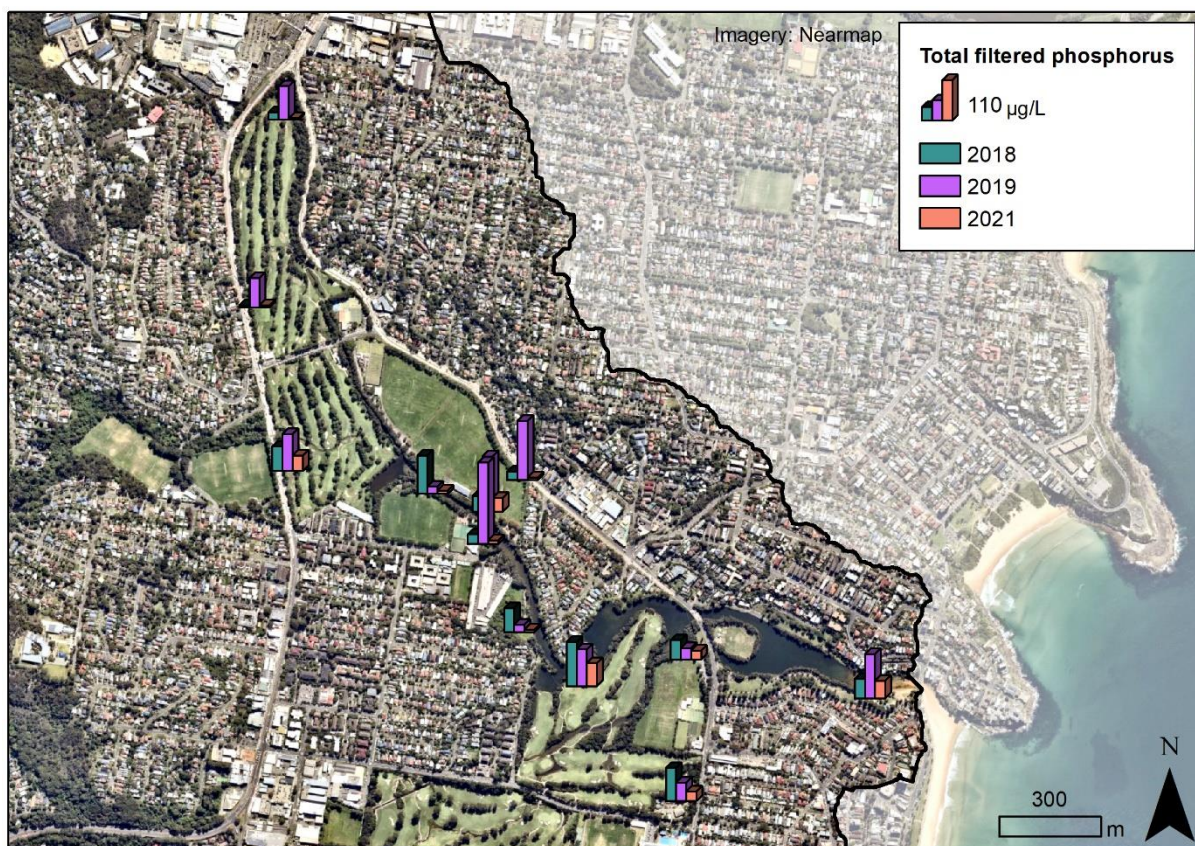
**A.6: Comparison of total filtered phosphorus sampled at Manly Lagoon**

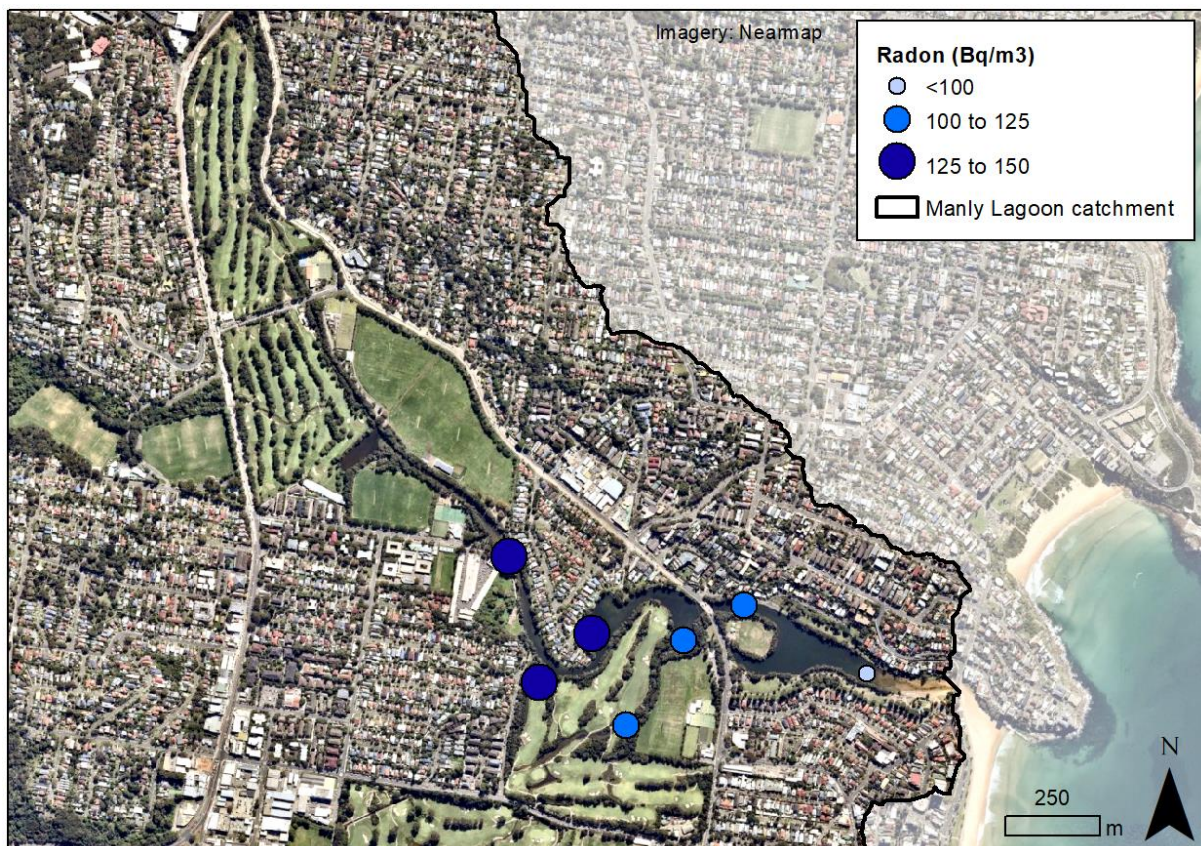
Radon measurements observed at different locations across the lagoon on 26 July 2016 are presented in Figure A.8. This clearly shows that there is a greater influence of groundwater in the lagoon further from its entrance with the ocean. It is likely this is caused from flushing at the entrance with ocean water which has a low radon concentration.

**A.8: Radon measurements across Manly Lagoon on 26 July 2016**

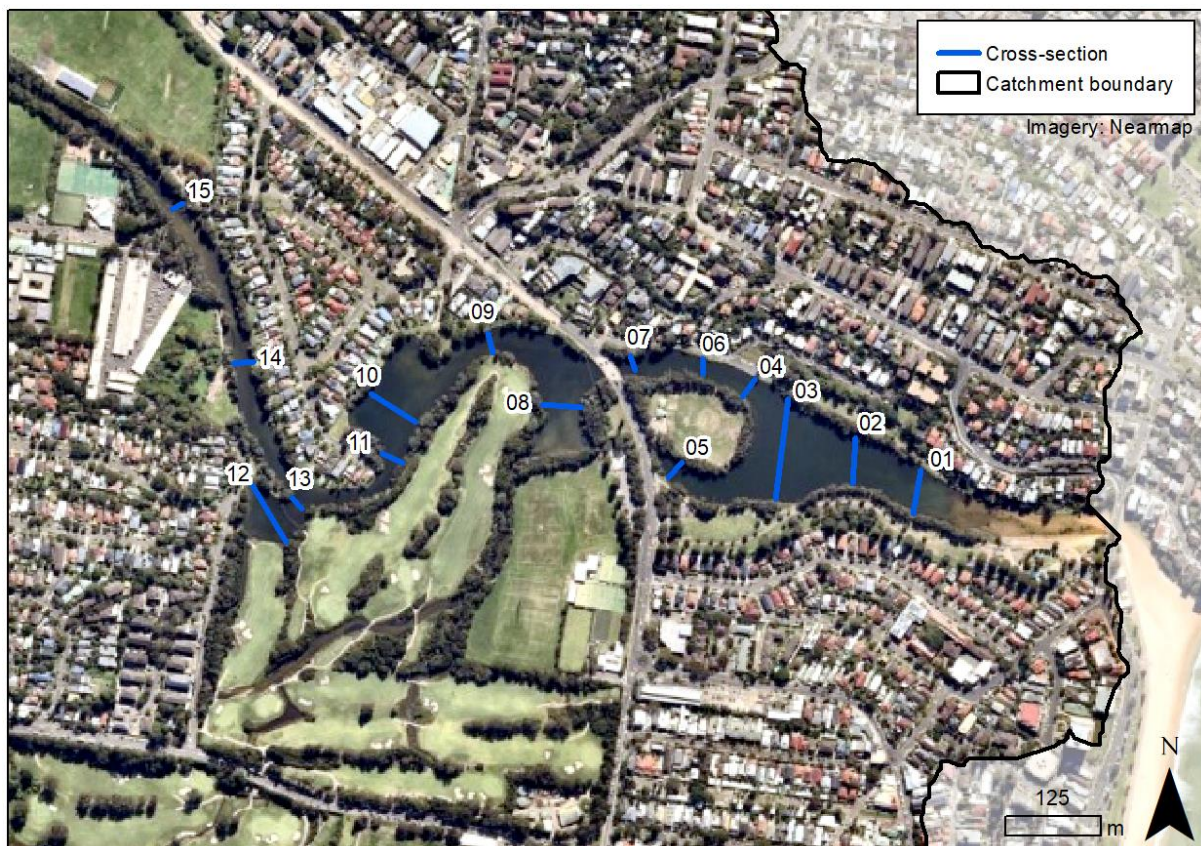
Bathymetry measured in 2011 has also been compared to recent measurements taken in 2017 by Harrison and Rayner (2019). Figure A.16 shows the cross-section locations where bathymetry data has been compared and Figure A.17 shows the comparisons between the two datasets. Note, measurements were gathered using an echosounder which can only take measurements underwater so the banks of the lagoon are not shown in Figure A.17.

**A.16: Location of cross-sections where 2011 and 2017 data was compared**
