Assessing the impact of sewage overflows on oyster harvest areas: Nambucca River estuary technical summary

WRL TR 2023/19, May 2025

By M Mason, A J Harrison, Y Doherty and B M Miller

UNSW
Water Research
Laboratory

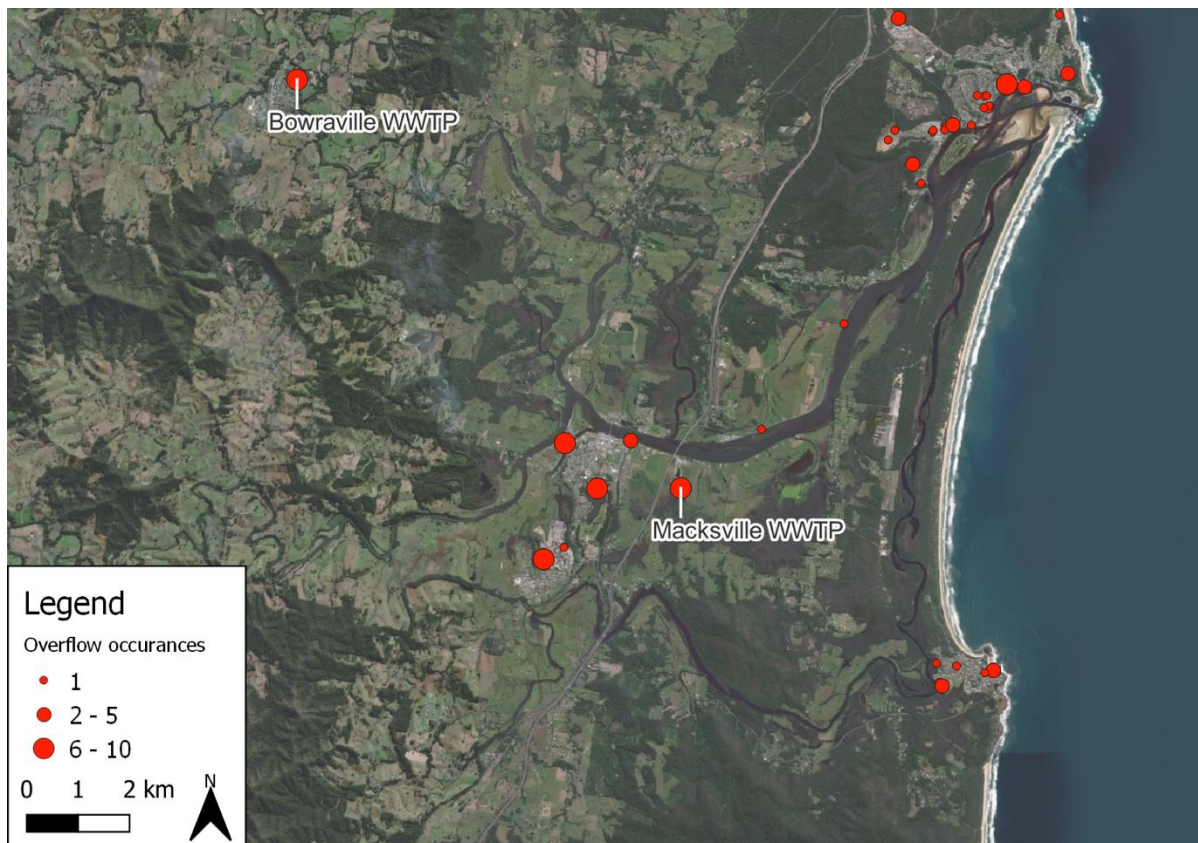
Figure 2-3 Locations of reported sewage overflows on the Nambucca River

Nambucca Valley Council (NVC) is the agency responsible for wastewater treatment and sewage management in the catchment surrounding the Nambucca River estuary. The sewerage system is comprised of a reticulation network of pipes and sewage pumping stations (SPS), in addition to wastewater treatment plants (WWTPs) at Bowraville and Macksville. When sewage overflows occur, NVC is required to notify NSW Food Authority so that appropriate decisions can be made on whether harvest area closures are necessary. Information on sewage overflows between 2016 and 2023 has been provided by the NSW Food Authority and reported overflow locations are shown in Figure 2-3. More information on sewage overflows and why they occur is provided in WRL TR2023/32 Section 2.5.

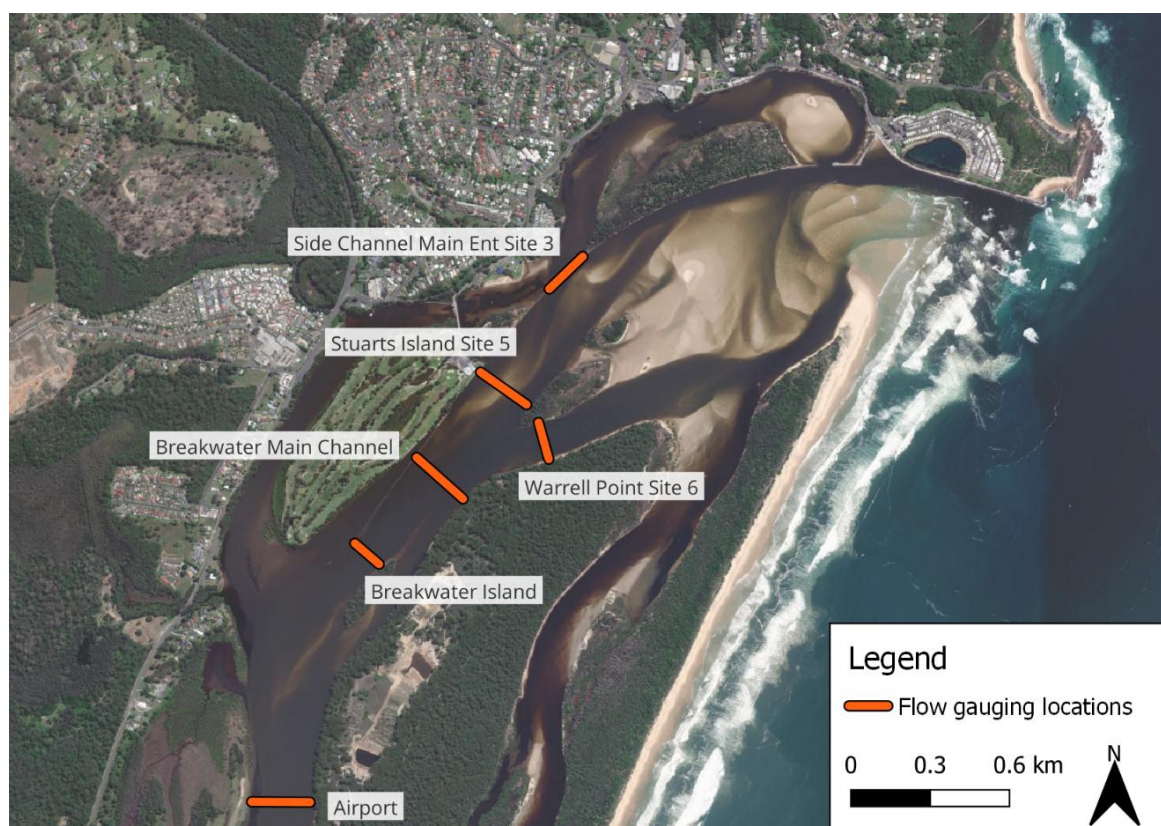
Figure 3-4 Tidal flow gauging locations from 2023 fieldwork

Flow was measured using a boat mounted SonTek RiverSurveyor M9 ADCP at four targeted locations across a range of ebb and flood tidal stages. More information on methods used for tidal gauging can be found in WRL TR2023/32 Section 4.2. Flow measurements in the Nambucca River estuary are summarised in Table 3-1, with locations shown in Figure 3-4. For a table of tidal gauging measurements refer to Appendix A2, and for plots of tidal flows refer to Appendix B1.7.

Location	Location label*	27 August # transects	28 August # transects	29 August # transects
Side Channel Main Entrance Site 3	A	2	-	1
Stuarts Island Site 5	B	4	-	4
Warrell Point Site 6	C	4	-	6
Breakwater Main Channel	I	21	-	19
Breakwater Island	J	6	-	11
Airport	K	11	20	11

* Location labels correspond to locations shown in Figure 2-1.

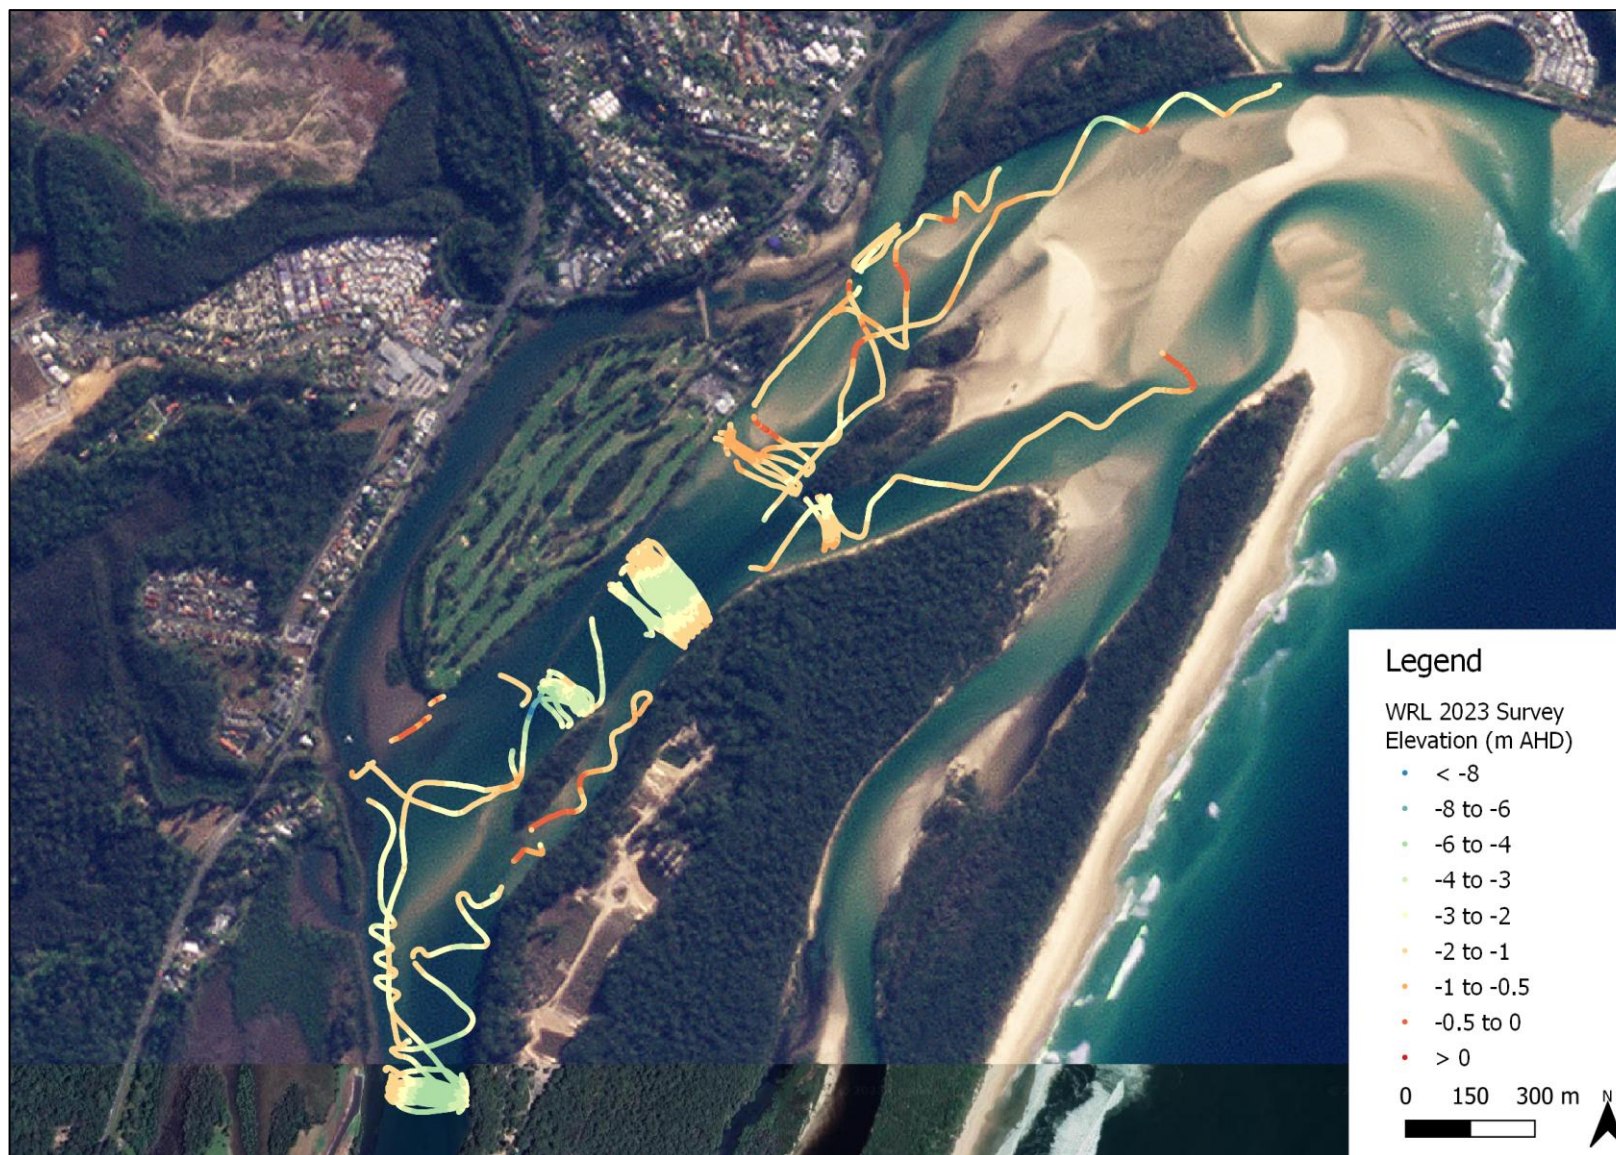
Figure 3-5 Bathymetry collected during 2023 fieldwork

During the ADCP data collection campaign, an RTK-GPS unit collected vertical position data to an accuracy of 10 cm. By pairing depth soundings and elevation data, bathymetry was captured for all flow gauging locations (refer to WRL TR2023/32 Section 4.3 for details on methods used for bathymetric surveys). Bathymetry data for all locations is shown in Figure 3-5, and the change between the 2018 LiDAR data and field captured bathymetry is shown in Figure 3-6, highlighting the dynamic nature of this area. As noted in Section 2.5, the bathymetry of the entrance and lower estuary is extremely variable and a change of greater than 1 m has been experienced in many locations. The state of the entrance during fieldwork differs from the 2009 or 2018 bathymetries in that the south and north channel have separate outlets to the ocean, rather than both joining to form one channel which runs along the northern training wall. NearMap imagery shows this southern outlet developed sometime between 6 June and 18 July 2022.

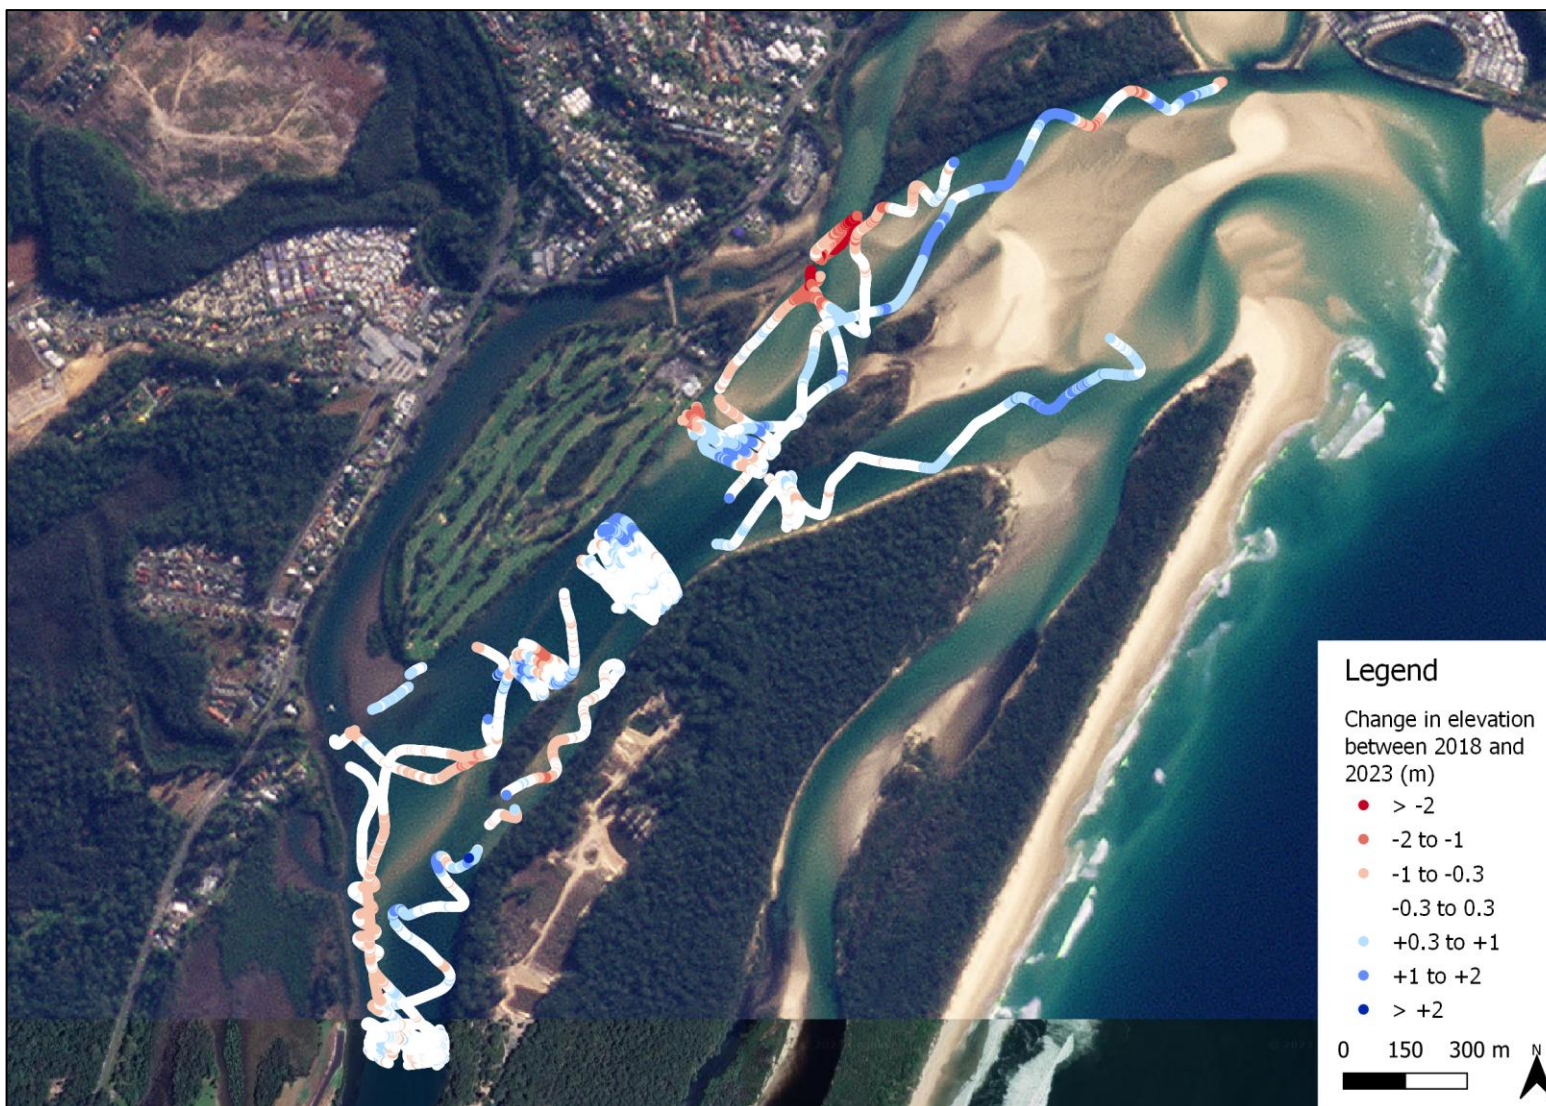
Figure 3-6 Change between 2018 LiDAR and 2023 fieldwork bathymetry. Red represents erosion and blue represents accretion

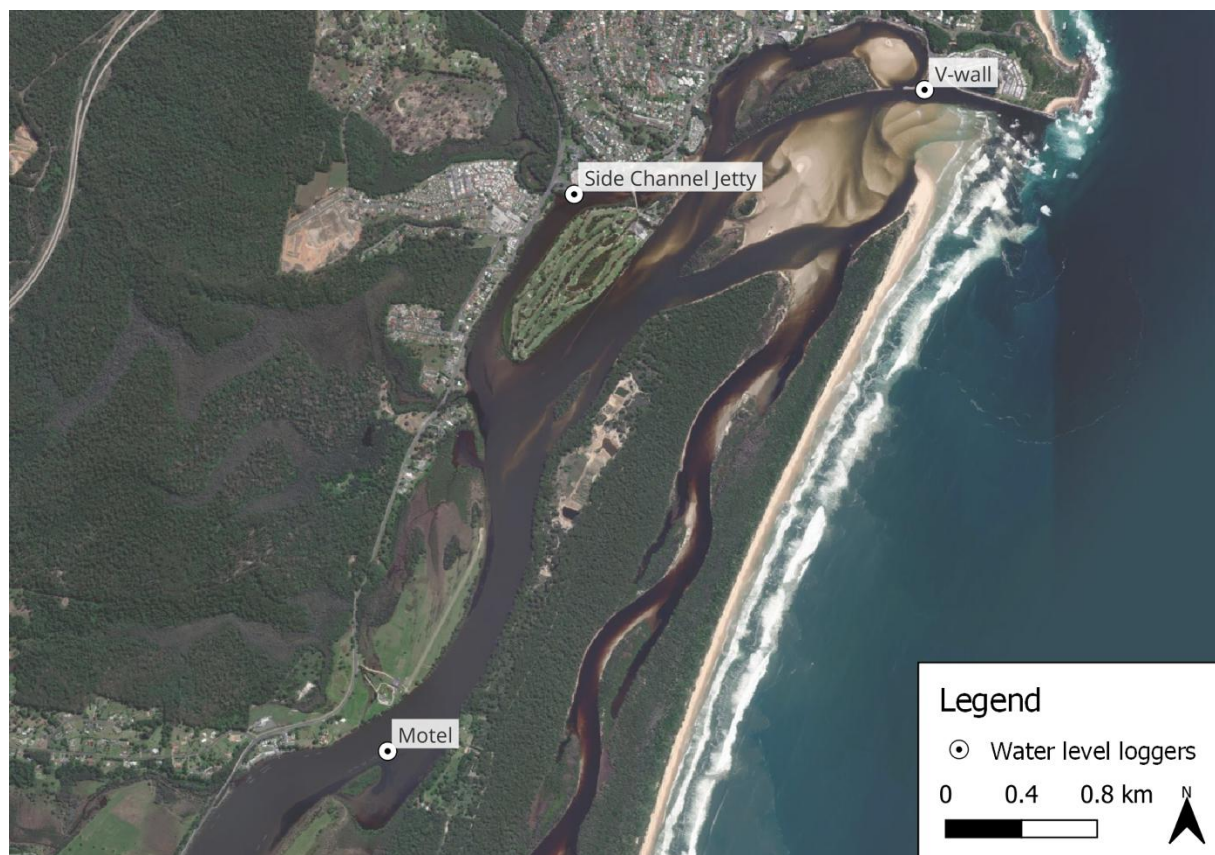
Figure 3-12 Location of water level monitoring during 2023 fieldwork

To supplement the water level data available from the five long term MHL water level gauges on the Nambucca River estuary, three water level loggers were installed during the 2023 fieldwork: at the “V-wall” near the entrance, in the side channel behind Stuarts Island and near the location of Motel Site 9 gauging during the 1999 MHL campaign. (refer to Figure 3-12). Plots of collected water level data can be seen alongside model results in Appendix B1.8.

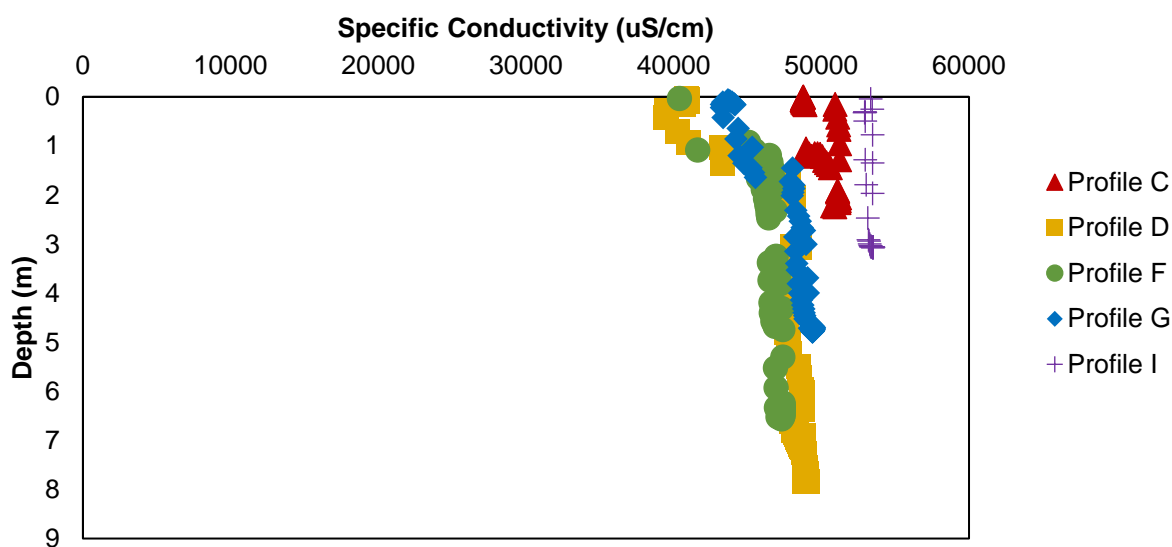
To measure saline intrusion, conductivity profiles were taken during the fieldwork campaign with a Sontek EXO3, as detailed in WRL TR2023/32 Section 4.7. Conductivity profiles were recorded in various locations on the second day of field monitoring, mainly on the incoming tide. These profiles provide insight into whether there is density (salinity) stratification in the water column (water increases in density and salinity throughout the water column). Weak salinity stratification (defined as a difference of more than 5,000 $\mu\text{S}/\text{cm}$ across the water column) was observed upstream of the airport on the incoming tide. Unfortunately, no measurements were taken in this section of the river on the outgoing tide, although it is suspected that strong stratification occurs on this tide, as described in Section 4.7.2. Figure 3-13 shows the timing of conductivity profiles, while Figure 3-15 shows locations and Figure 3-14 plots some sample profiles for both stratified and unstratified locations.

Figure 3-14 Conductivity profiles at select locations labelled with letters corresponding to timing on Figure 3-13

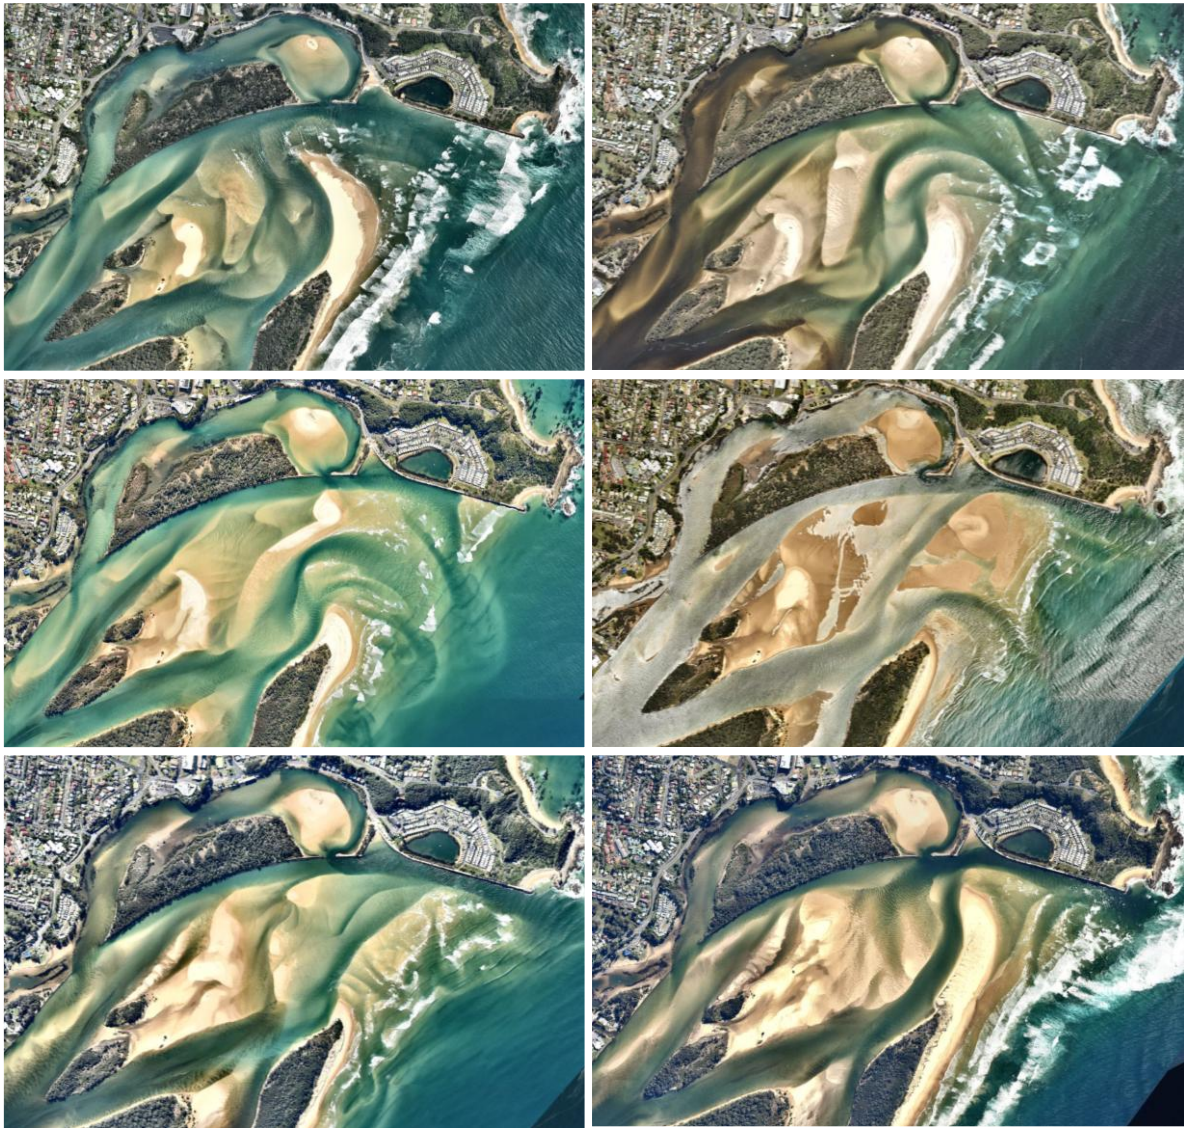
Figure 5-11 Examples of different Nambucca entrance states (4/10/2024, 9/4/2024, 6/7/2023, 19/11/2022, 8/6/2022 and 4/7/2021) from NearMap imagery

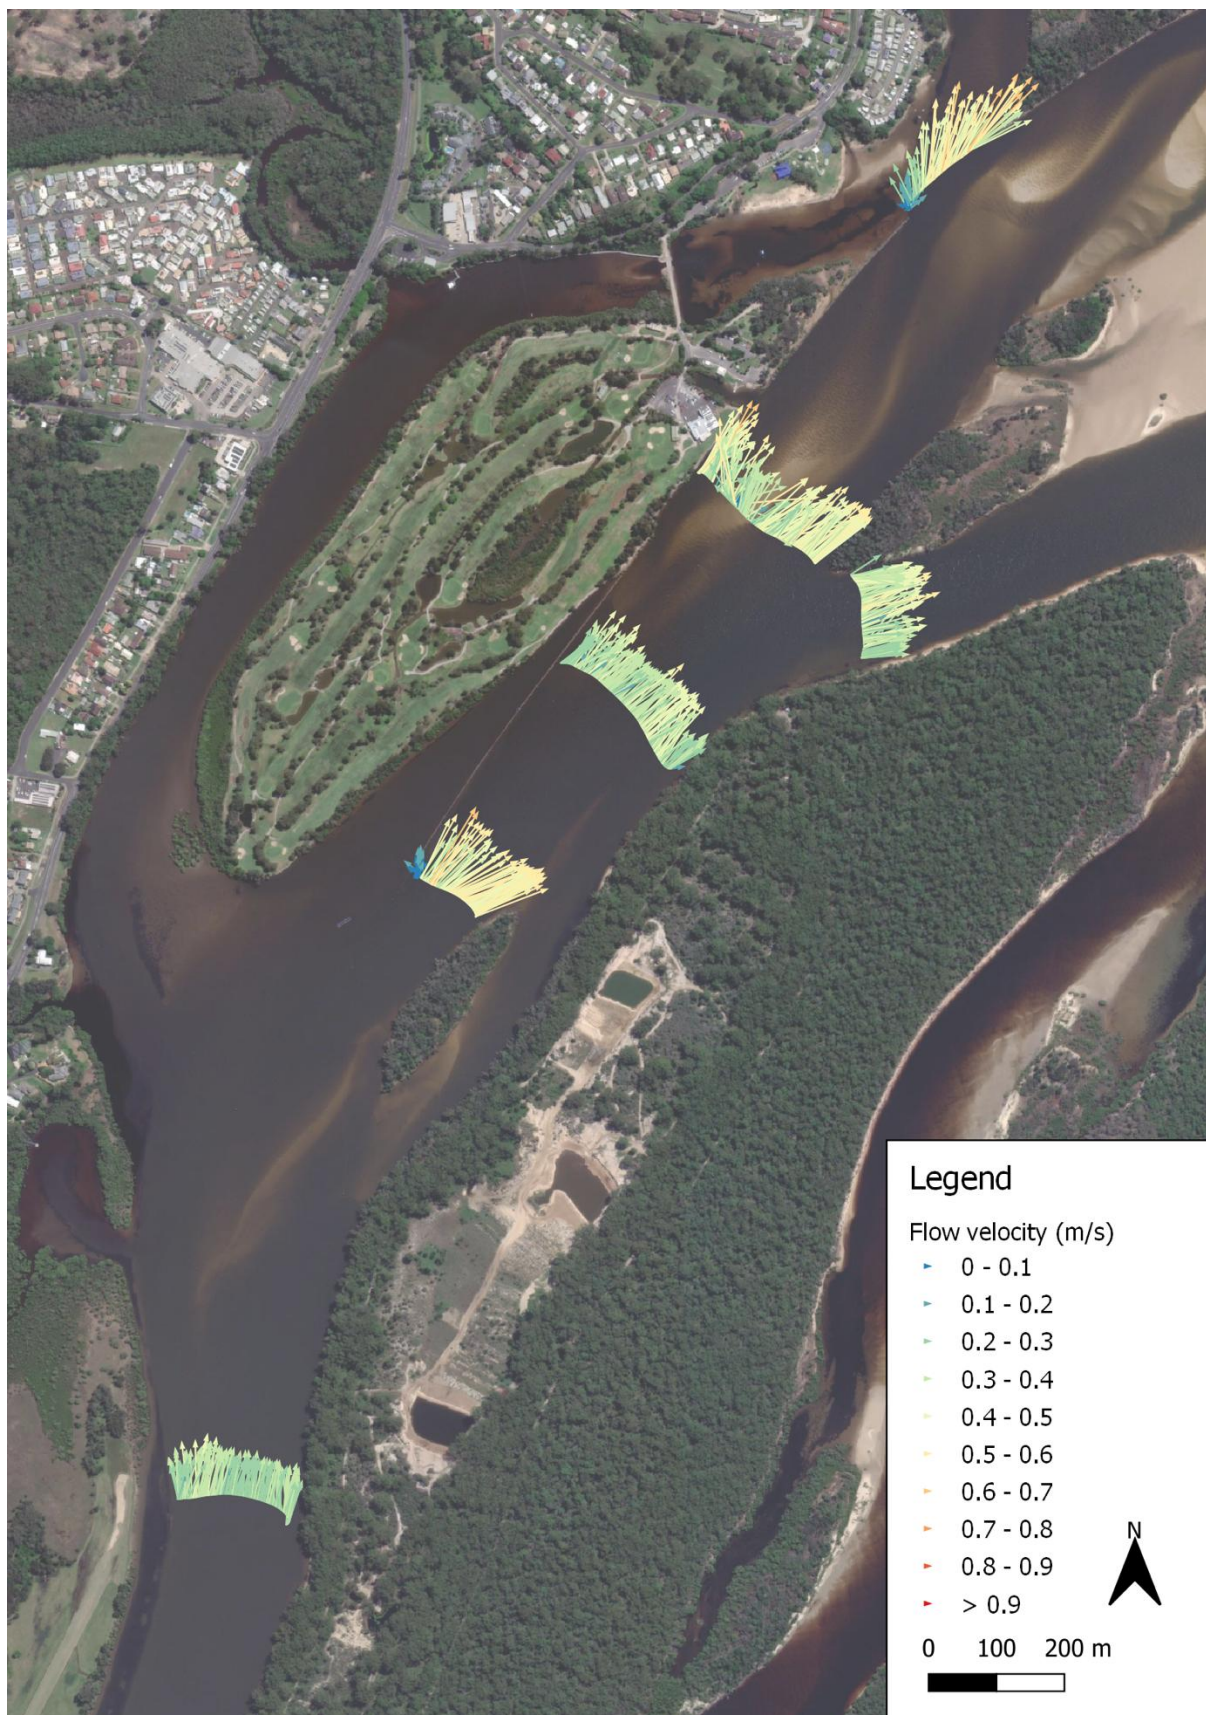
Figure A-7 Ebb tide channel flow distribution

In addition to measuring total flow, ADCP data collected along each transect was used to understand flow and velocity distributions across the channel. Refer to Appendix A3 for figures of ebb and flood channel velocity distribution for all gauging transects.
