# Assessing the impact of sewage overflows on oyster harvest areas: Camden Haven River estuary technical summary

WRL TR 2023/20, May 2025

By Y Doherty, M Mason, A J Harrison and B M Miller

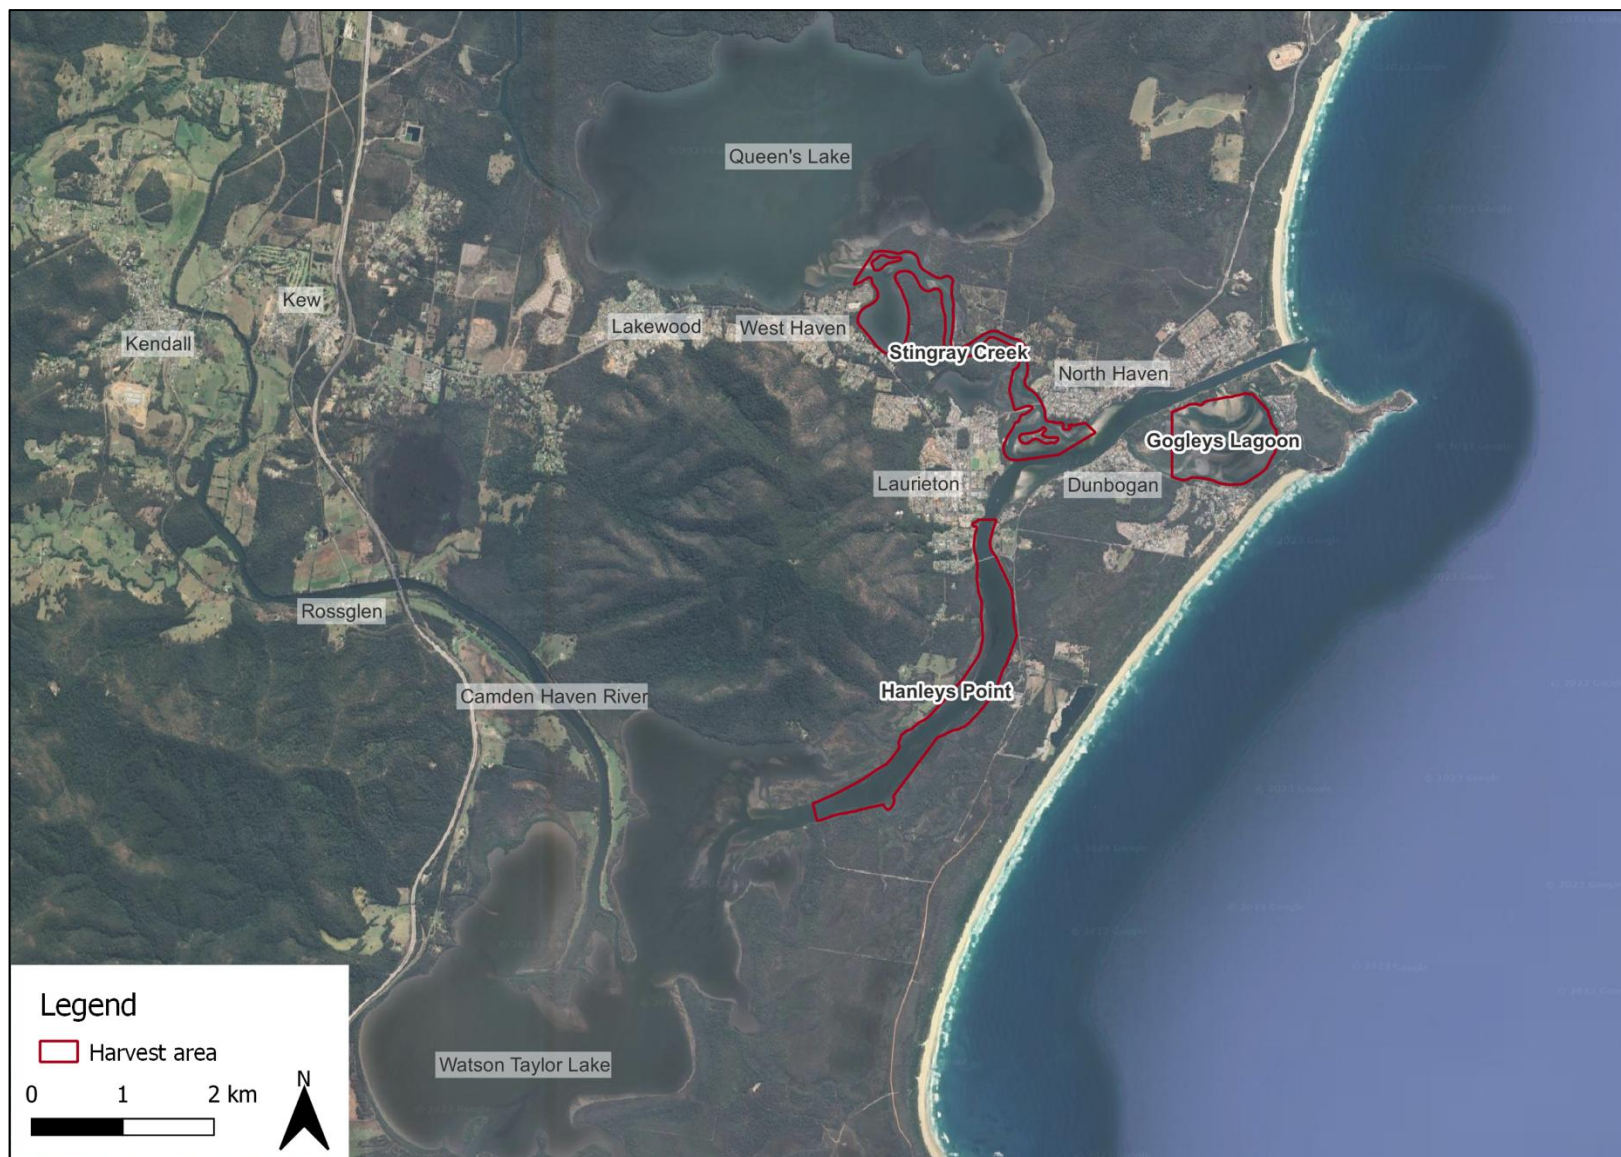
**Figure 1-1 Oyster harvest areas on the Camden Haven River**

The Camden Haven estuary is a coastal river in NSW, Australia, located 285 km north of Sydney and 25 km south of Port Macquarie. Major towns in the area include Laurieton, North Haven, Dunbogan, Kendall, and Kew. The estuary is comprised of two lake systems. Queens Lake to the north, which is connected to Camden Haven Inlet via Stingray Creek, and Watson Taylors Lake which drains directly through the Camden Haven River. The estuary has a catchment of approximately 720 km<sup>2</sup> with a waterway area of 28 km<sup>2</sup> (MHL, 1997). The tidal extent of the Camden Haven River is 25 km upstream of the estuary entrance. To the north, tidal influence extends 16 km inland from the ocean, passing through Queens Lake and into Herons Creek. The tidal prism of the estuary on a spring tide in 1997 was  $7.6 \times 10^6$  m<sup>3</sup> (MHL, 1997). The entrance to Camden Haven Inlet was artificially trained in the early 1900s, with the breakwater at the heads last extended in 1973 (MHL, 1997). The estuary has three oyster harvest areas, Gogleys Lagoon, Stingray Creek, and Hanleys Point, shown in Figure 1-1.

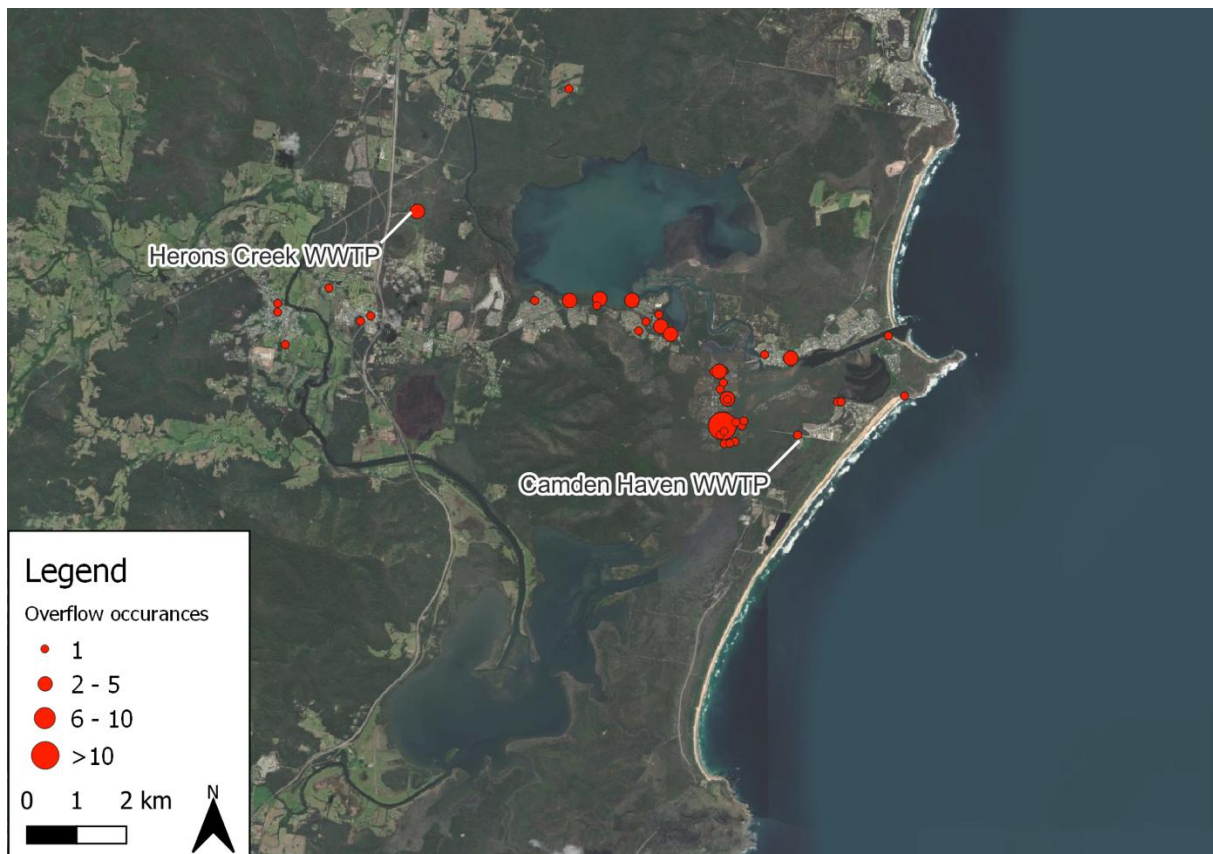
**Figure 2-3 Locations of reported sewage overflows on the Camden Haven River**

Port Macquarie Hastings Council (PMHC) is the agency responsible for wastewater treatment and sewage management in the catchment surrounding the Camden Haven estuary. The sewerage system is comprised of a reticulation network of pipes and sewage pumping stations (SPS), in addition to wastewater treatment plants (WWTPs) at Camden Haven and Herons Creek. When sewage overflows occur, PMHC is required to notify NSW Food Authority so that appropriate decisions can be made on whether harvest area closures are necessary. Information on sewage overflows between 2016 and 2023 has been provided by the NSW Food Authority and reported overflow locations are shown in Figure 2-3. More information on sewage overflows and why they occur is provided in WRL TR2023/32 Section 2.5.

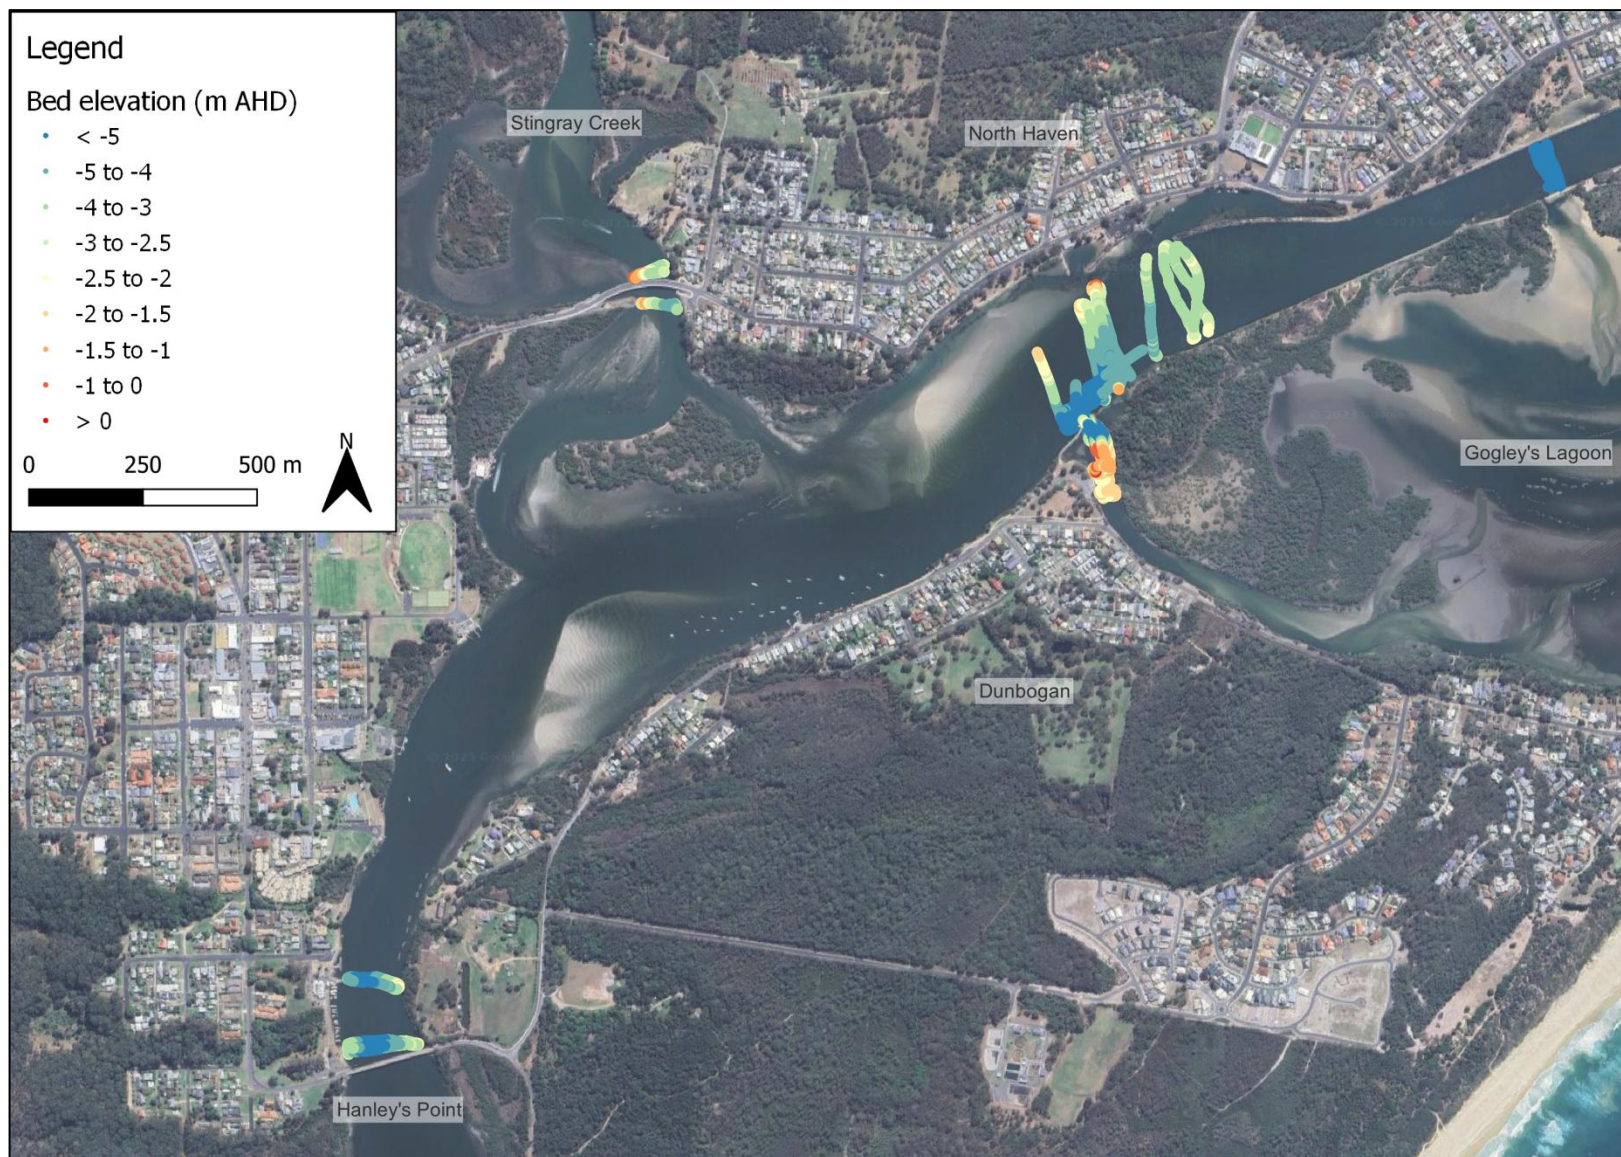
**Figure 3-5 Bathymetry collected during 2023 fieldwork**

During the ADCP data collection campaign, an RTK-GPS unit collected vertical position data to an accuracy of 10 cm. By pairing depth soundings and elevation data, bathymetry was captured for all flow gauging locations (refer to WRL TR2023/32 Section 4.3 for details on methods used for bathymetric surveys). In addition to gauging sites, additional bathymetry was collected at the western entrance to Gogleys Lagoon to gather depth information where gaps in the existing bathymetry datasets (outlined in Section 2.5) had been identified. Bathymetry data for all locations is shown in Figure 3-5, and change between the 2018 LiDAR data and field captured bathymetry is shown in Figure 3-6.

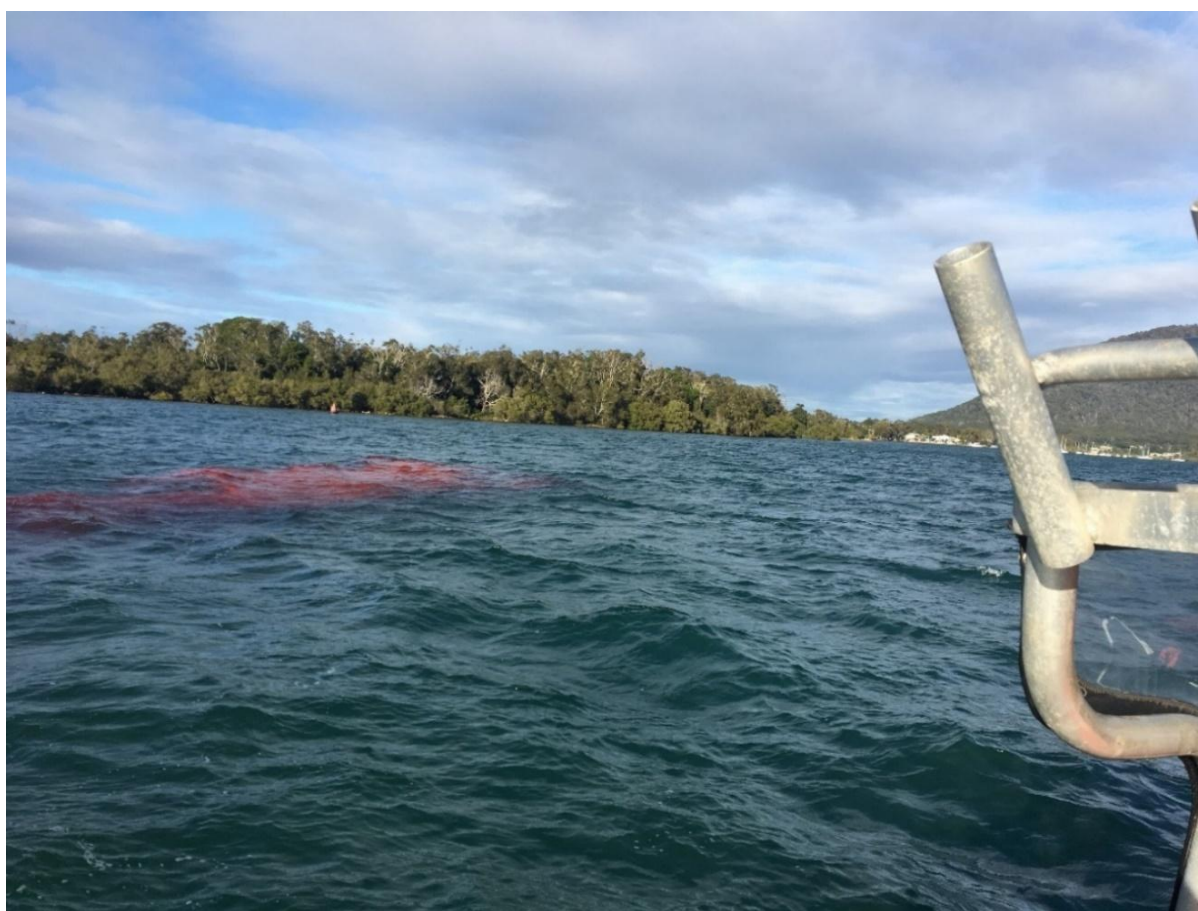
**Figure 3-8 North Haven Dye release after 5 minutes**

Initially the plume moved upstream quickly towards Laurieton without significant lateral spreading (plume stayed within 30 to 40 m in width), however rapid decreases in peak concentrations were observed (refer to Figure 3-8). As the plume continued upstream, significant longitudinal spreading was observed and after 20 minutes (offshore of the entrance to Gogleys Lagoon), the visible plume was approximately 200 x 50 m. As the plume had not spread to the southern bank by this point, no obvious dye was noted entering Gogleys Lagoon. Past Gogleys Lagoon entrance, the plume continued spreading and by 30 minutes measured 280 x 55 m.

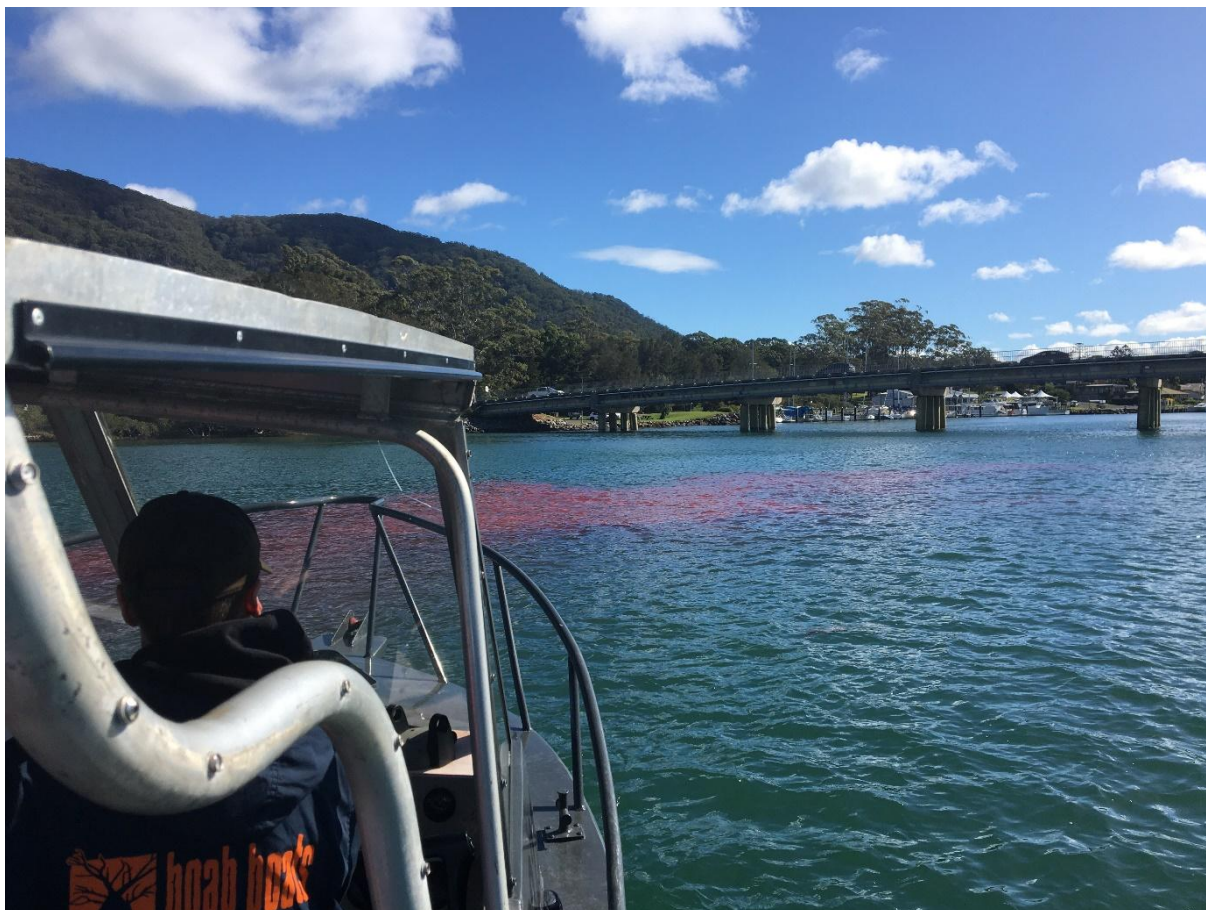
**Figure 3-10 Dye release 2 after 3 minutes**

Upon release, the plume spread rapidly in the longitudinal direction and after 3 minutes measured 30 x 10 m, and 60 x 20 m after 6 minutes. As the front edge of the plume passed the bridge (9 minutes after release) additional mixing was observed as the plume was dispersed by pylon eddies and vortices (Figure 3-11). This mixing resulted in additional dilution and elongation of the plume (140 x 20 m after 14 minutes).

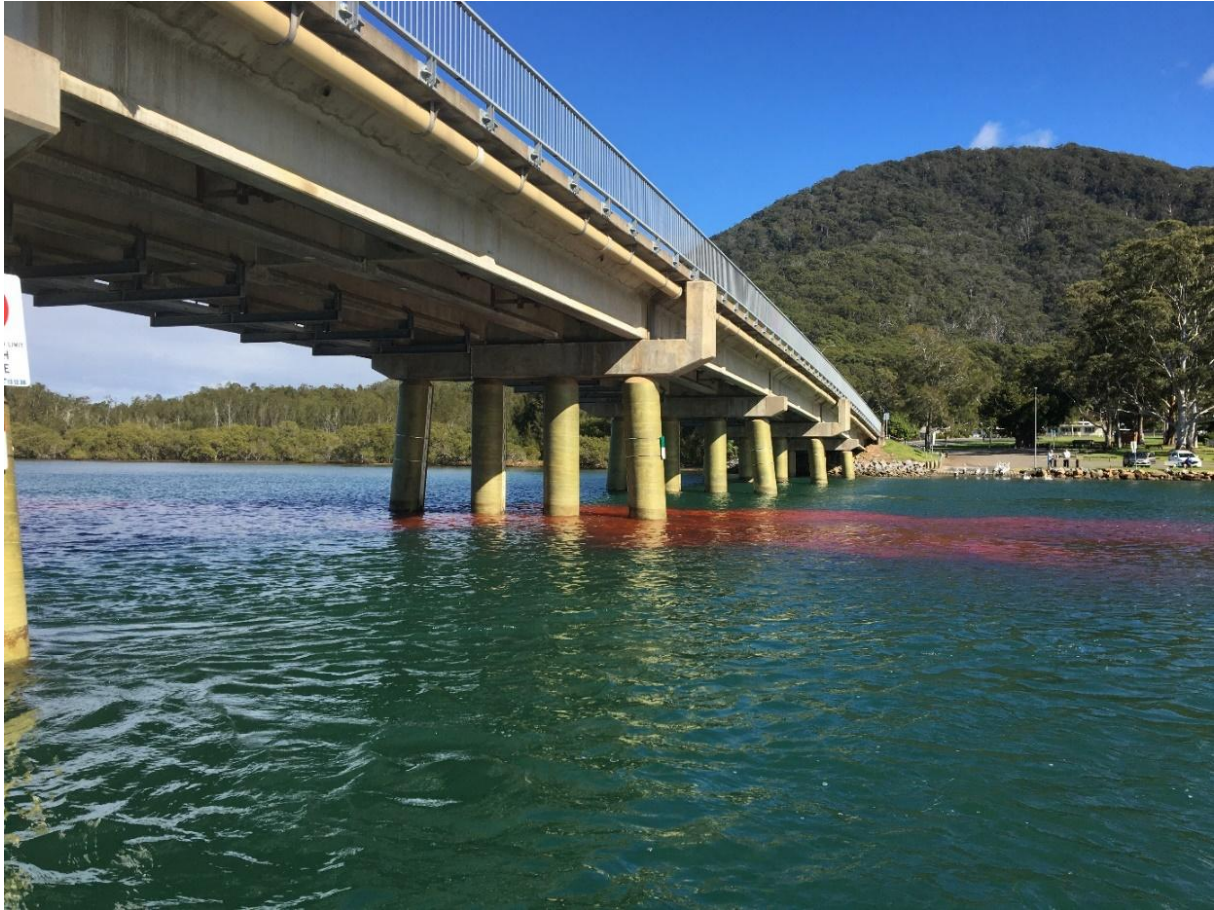
**Figure 3-11 Dye release 2 mixing around bridge pylons 9 minutes after release**

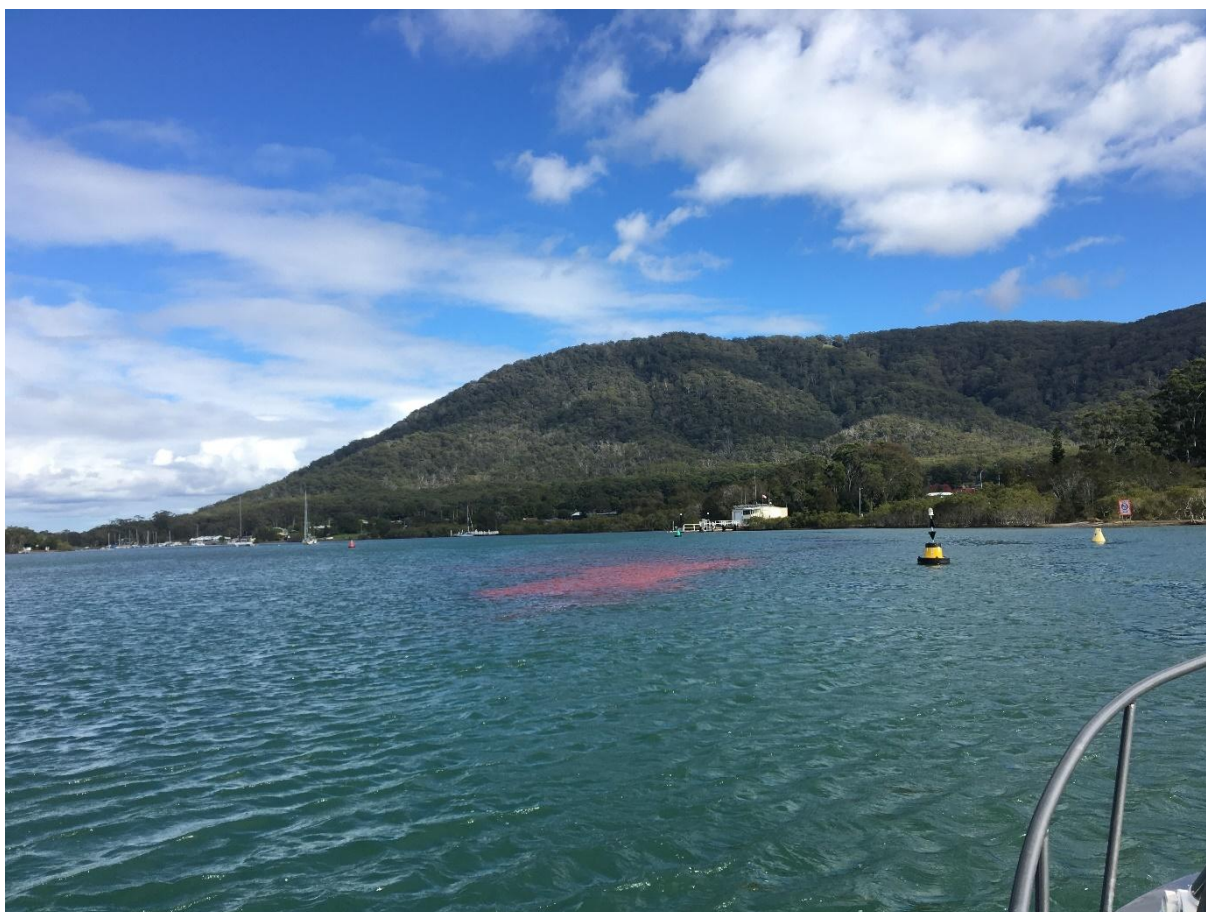
**Figure 3-13 Dye release 3 prior to mixing with Stingray Creek after 10 minutes**

Similar to release 2, longitudinal spreading was greater than lateral spreading and after 7 minutes, the plume was approximately 50 x 30 m (refer to Figure 3-13). As the plume reached the inside bend of the shallow bar at Camden Point, the plume spread longitudinally before mixing and diluting at the convergence with Stingray Creek. Immediately downstream of this junction, the plume had spread to cover the main deep channel width and measured 80 x 110 m. Offshore of Dunbogan Marina, the plume visually began to disperse and the plume edge was no longer clearly distinguishable. The plume was tracked in a dispersed state covering the main channel width for another 750 m downstream to the entrance of Gogleys Lagoon until recordings were stopped at 12.14pm.

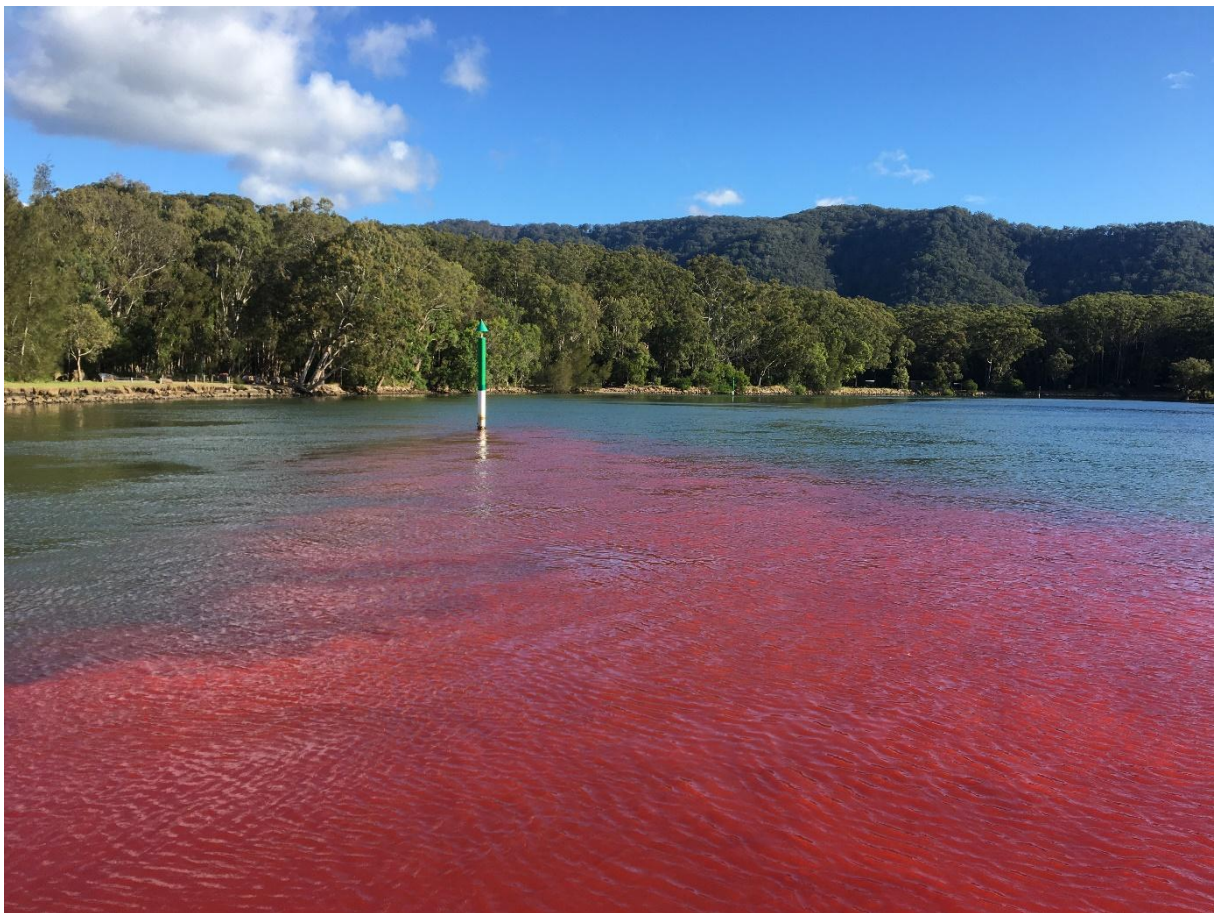
**Figure 3-15 Dye release 4 spreading as flow transitions from right bank to left bank**

After the initial dye release, significant longitudinal spreading was observed and at 4 minutes, the plume measured approximately 30 x 4 m (Figure 3-15). As the plume moved downstream, flow transitioned across the channel from the right bank to left bank resulting in significant spreading. After the plume had rounded the first bend and reached the straight (14 minutes), the plume visually covered two thirds of the channel width with dimensions of 35 x 100 m. Around the second bend, further mixing increased dilution and the plume edge was no longer visually discernible.

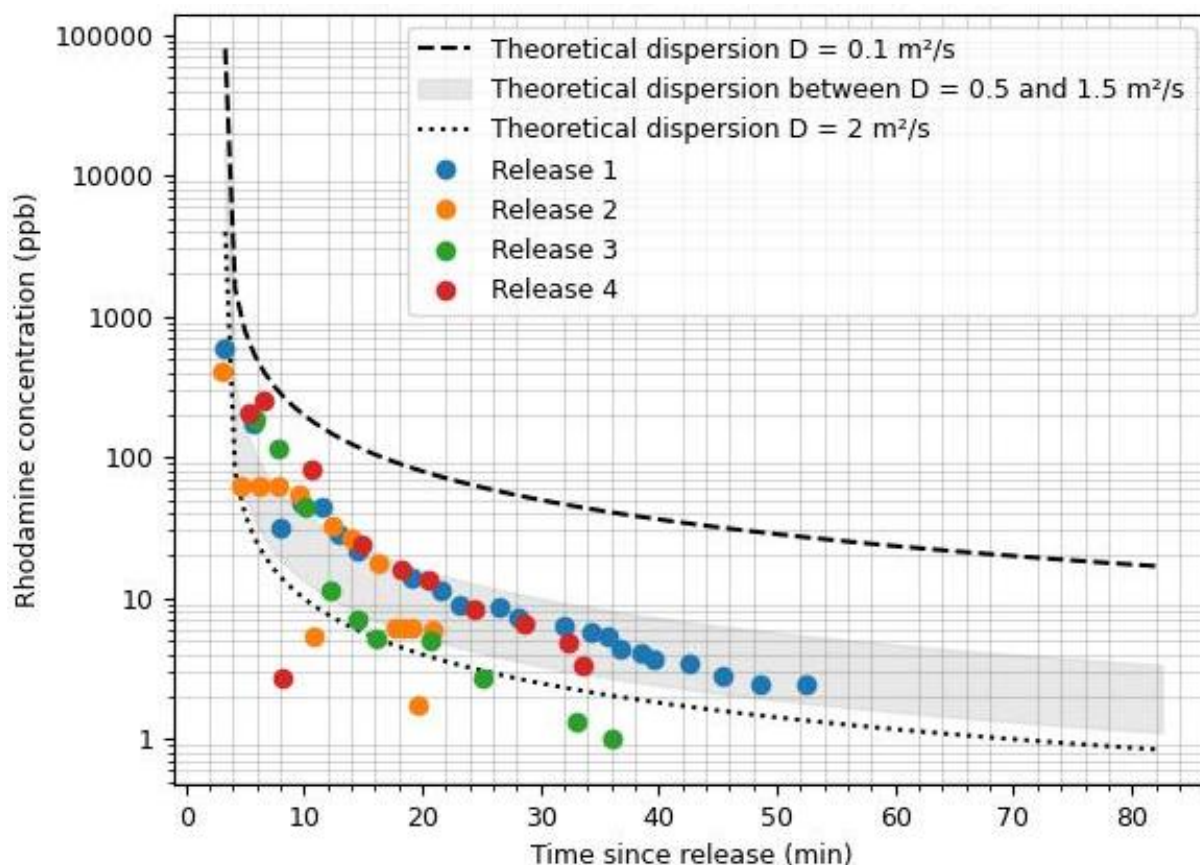
**Figure 3-17 Peak concentration of select transects plotted against theoretical dispersion**

Field dye experiments were used to obtain estimates of plume spreading dispersion rates in the Camden Haven River, using the methods described in WRL TR2023/32 Section 7.3. During each dye release, transects were taken across the plume to capture the plume width and peak concentration at a point in time. From the set of all transects, a subset of representative peak concentrations was compared to theoretical estimates of maximum plume concentrations over time. This is shown in Figure 3-17.

Measurements of field dispersion across the state for this project showed dispersion was spatially and temporally variable typically between  $D = 0.1$  and  $2 \text{ m}^2/\text{s}$ , with the most common range being  $0.5$  to  $1.5 \text{ m}^2/\text{s}$ , which was consistent in Camden Haven. When comparing the observed peak observations to theoretical dispersion, most field dispersion values fall within  $D = 0.1$  and  $2 \text{ m}^2/\text{s}$ , with dye release 1, 2 and 4 largely within  $D = 0.5$  to  $1.5 \text{ m}^2/\text{s}$ . For release 3, the high dispersion values of  $>2 \text{ m}^2/\text{s}$  may be attributed to the rapid mixing of the plume shortly after release as the plume reached the junction with Stingray Creek (refer to Section 3.5.3).

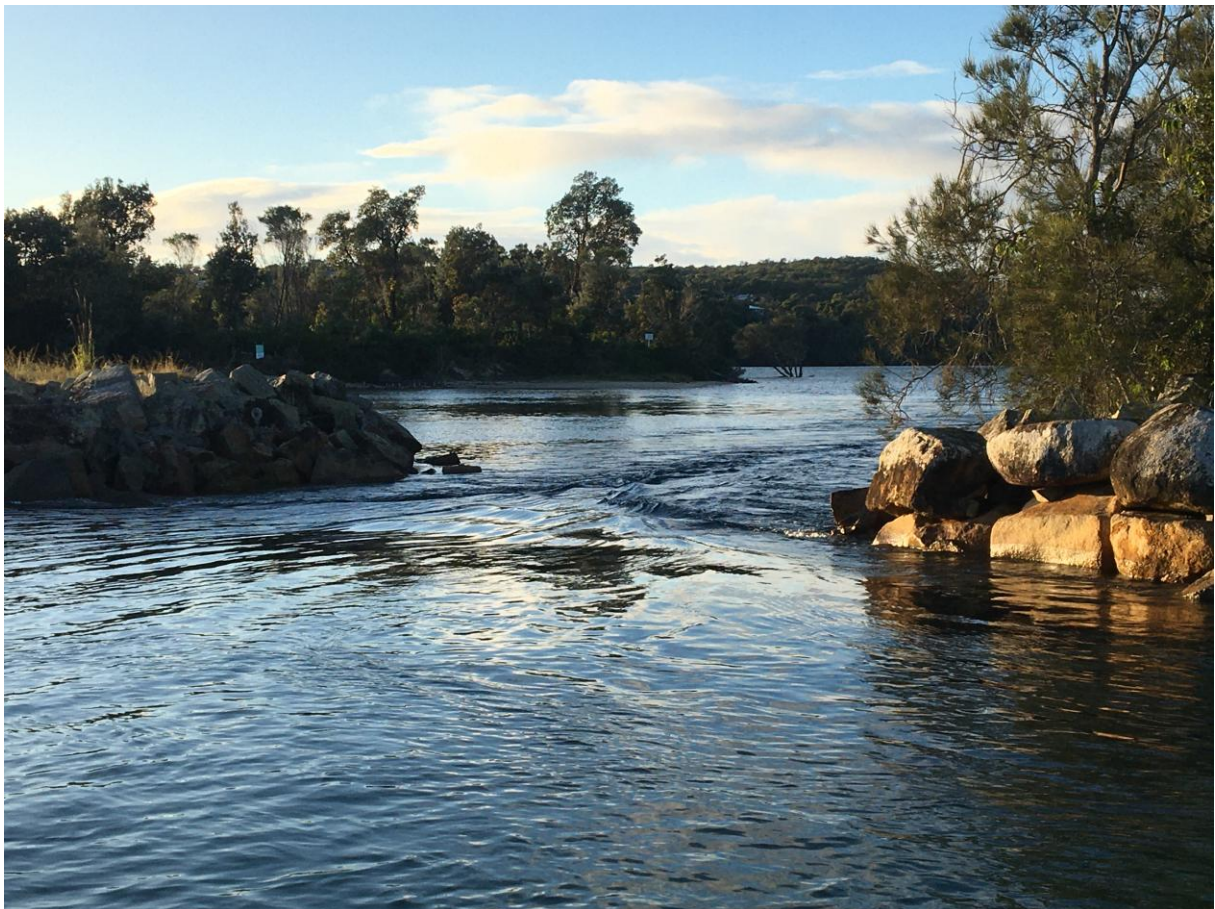
**Figure 3-19 Gogleys Lagoon eastern entrance weir at mid tide**

The eastern entrance weir to Gogleys Lagoon was observed on several occasions during the field campaign. In the middle of the entrance channel the weir is around low tide level and due to fast velocities it was unable to be surveyed using the ADCP or RTK-GPS. The weir was only observed during mid-tides (refer to Figure 3-19), so an estimation of water depth was made by observing the water level from the North Haven water level gauge. The estimate of the crest elevation at this location is between -0.3 to -0.6 m AHD. The weir is comprised of large rock armour units with diameters ranging from 50 cm to 1 m and as a result, the weir is porous and allows some flow even when the crest is exposed.

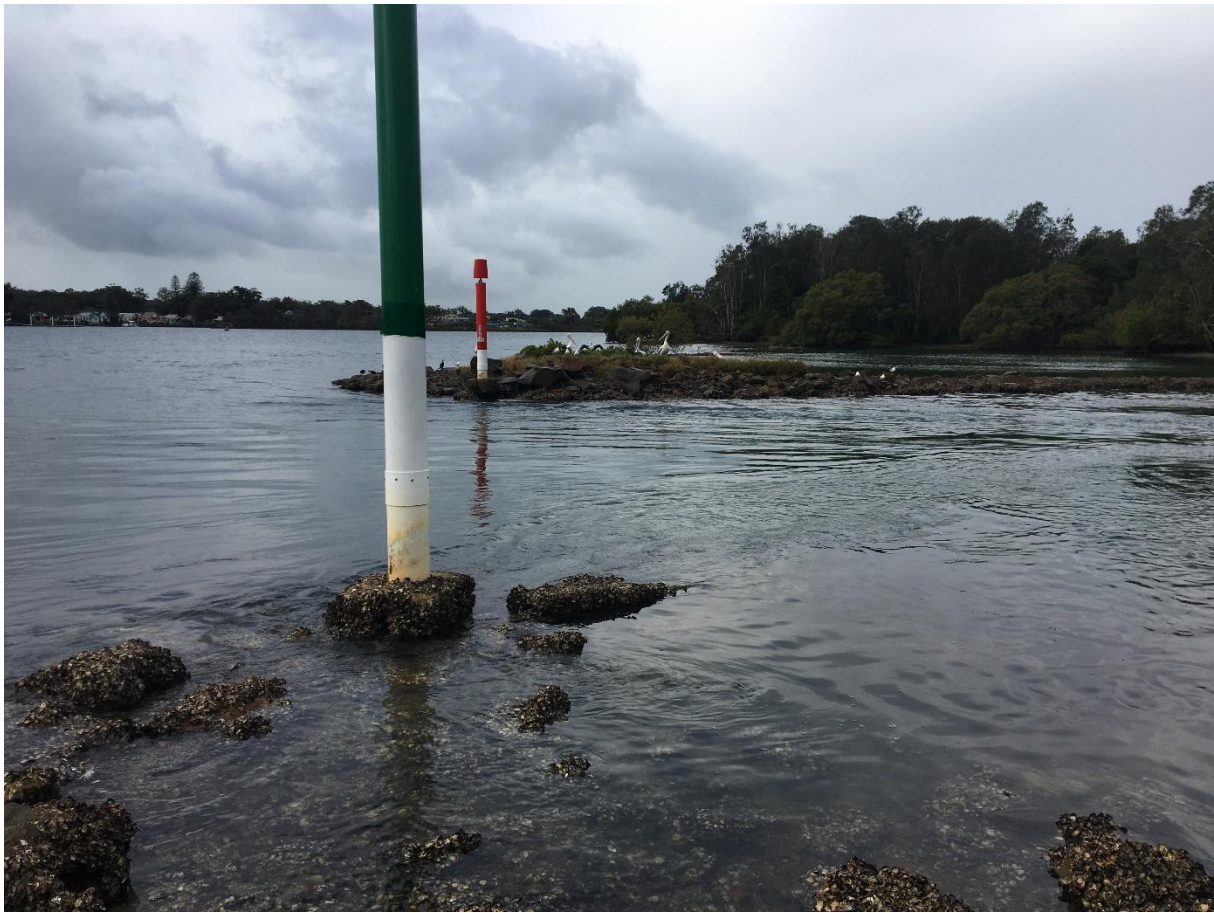
**Figure 3-20 Gogleys Lagoon western entrance at mid tide**

The western entrance to Gogleys Lagoon is a deeper channel, approximately -3.5 m AHD, and the bathymetry of this entrance was thoroughly surveyed, as discussed in Section 3.4. The western entrance at mid tide is shown in Figure 3-20.

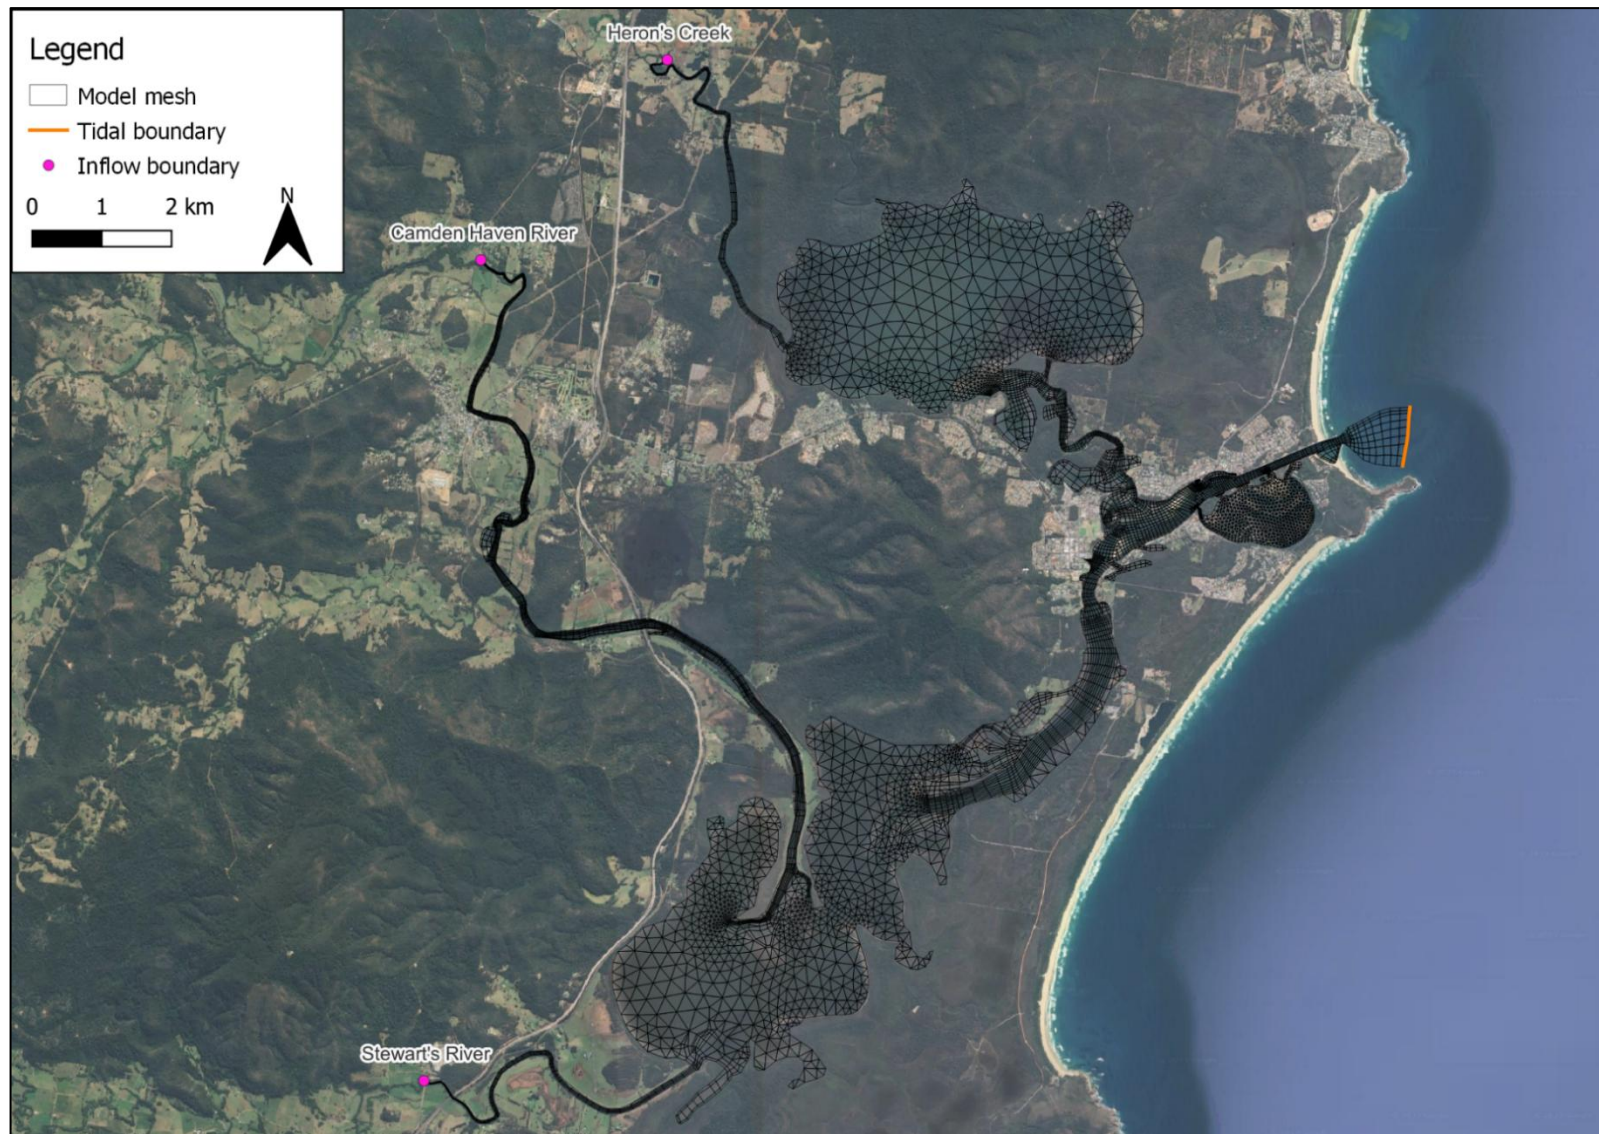
**Figure 4-2 RMA model mesh showing boundary condition locations**

The model domain extends from approximately 1 km offshore of the ocean entrance of the Camden Haven Inlet, to the tidal limits of the estuary and its major tributaries (refer to Figure 4-2). The model mesh consists of over 28,000 nodes and 10,000 two dimensional elements varying in size from 4 m<sup>2</sup> to over 35,000 m<sup>2</sup>. A two-dimensional, depth averaged model mesh was chosen for Camden Haven, where advective transport is largely driven by tidal and riverine flow (not wind), near-depth averaged vertical velocity profiles were observed. A discussion on the impact of model dimensionality is provided in WRL TR2023/32 Section 6.2.2.

The model includes three upstream catchment flow boundaries, shown in Figure 4-2 and discussed in Section 2.3. A tidal elevation boundary was included in the model offshore of the Camden Haven Inlet heads (refer to Figure 4-2). This modelled water level boundary was based on observed tidal elevation data collected by MHL at Crowdy Head (station number 208470 prior to 2013, and 208471 from 2013). This data was then smoothed to remove signal noise to increase model stability. For modelling water quality scenarios, all boundaries (upstream and ocean) were set to a constant constituent concentration of zero (e.g. no pollutant inflows from these boundaries).

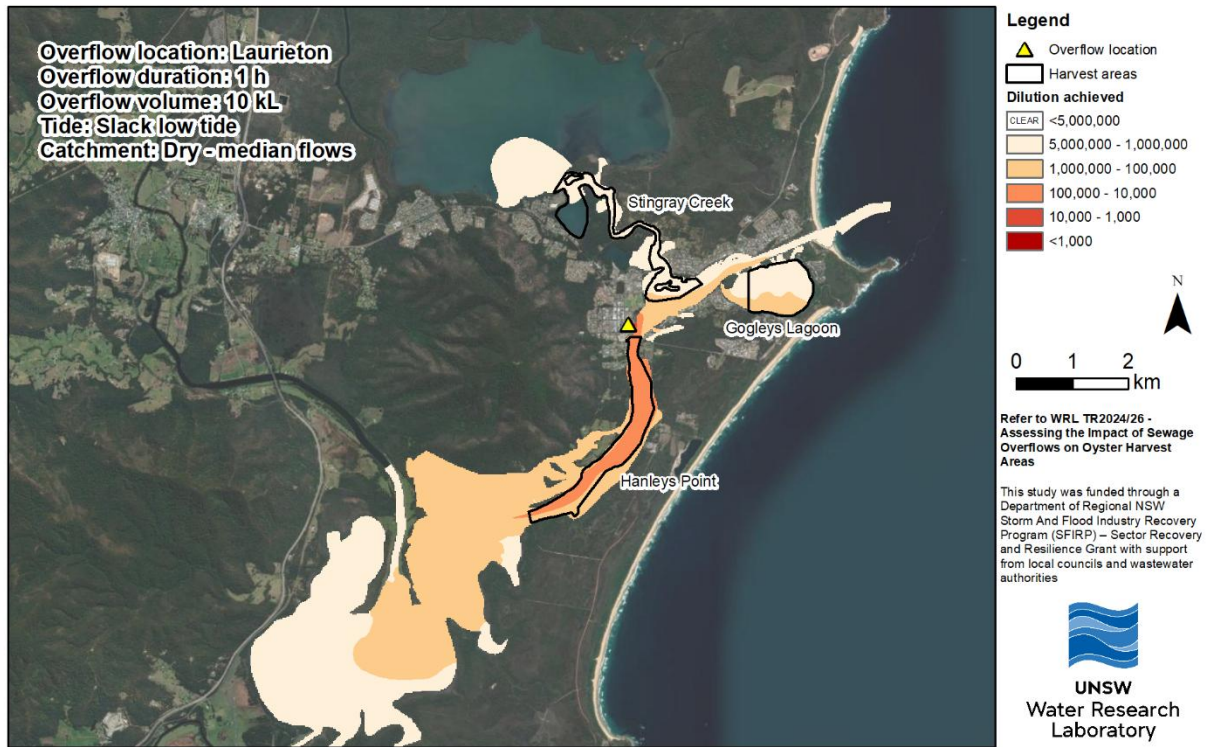
**Figure 5-2 Example of a 1-hour overflow at Laurieton during median inflow conditions\***

\*Result figures present the minimum dilution (i.e. maximum concentration) observed at each point during the entire scenario period (21 days).

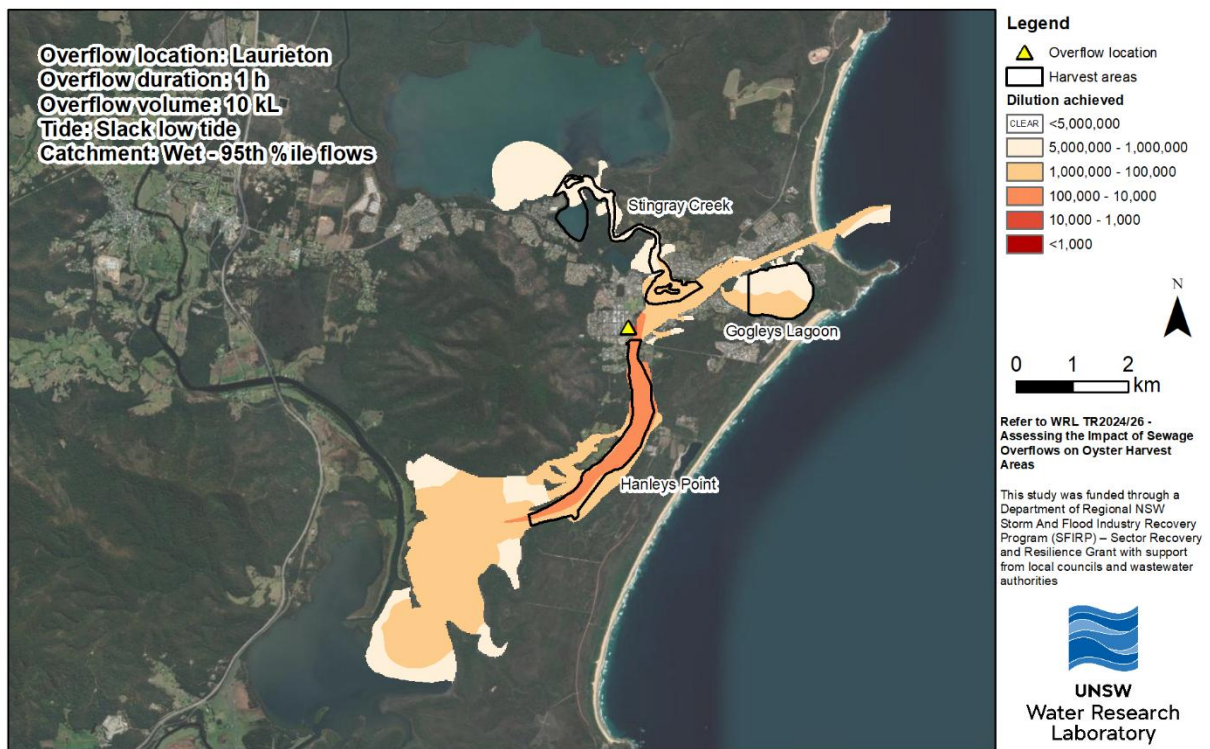
**Figure 5-3 Example of a 1-hour overflow at Laurieton during wet (95<sup>th</sup> percentile) inflow conditions\***

\*Result figures present the minimum dilution (i.e. maximum concentration) observed at each point during the entire scenario period (21 days).

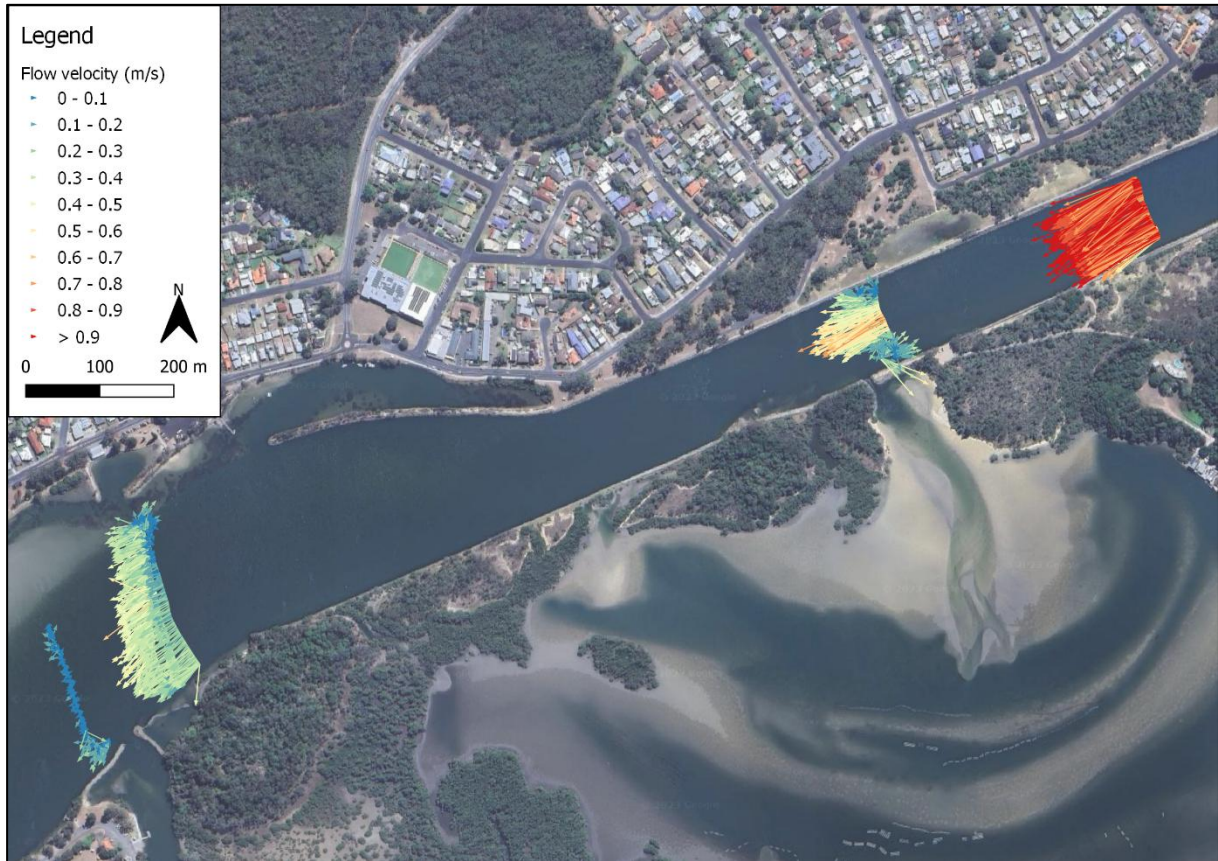
**Figure A-5 Incoming channel flow distribution at North Haven**

The below figures summarise velocity distribution results from the 2023 field campaign. For more information, refer to Section 3.3. Note that all measurements are at a different stage of the tidal cycle so the magnitude of flow will vary. The primary purpose is to illustrate flow distribution across the channel.
