Assessing the impact of sewage overflows on oyster harvest areas: Pambula Lake estuary technical summary

WRL TR 2023/27, May 2025

By Y Doherty, M Mason, A J Harrison and B M Miller

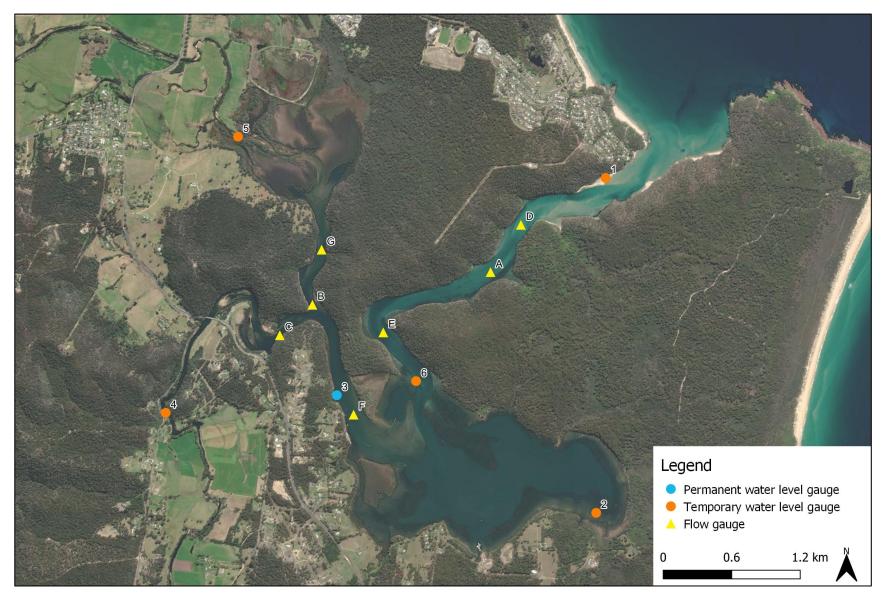
Figure 2-1 Water level and tidal flow gauging locations

^{*} Location labels correspond to locations shown in Figure 2-1.

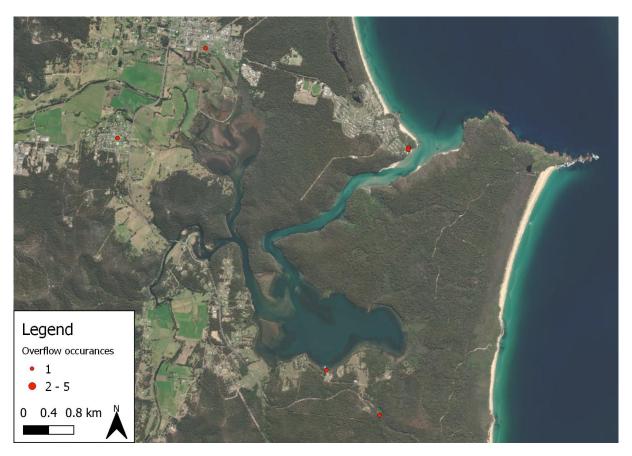
Figure 2-3 Locations of reported sewage overflows in Pambula Lake estuary

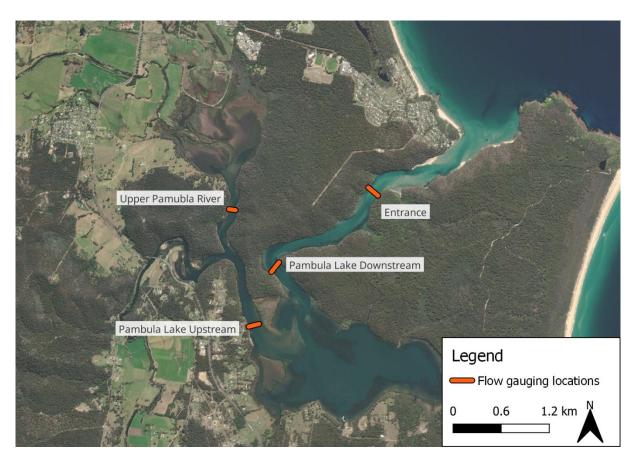
Figure 3-4 Tidal flow gauging locations from 2023 fieldwork

Flow was measured using a boat mounted SonTek RiverSurveyor M9 ADCP at four locations across a range of ebb and flood tidal stages. More information on methods used for tidal gauging can be found in WRL TR2023/32 Section 4.2. Flow measurements in Pambula Lake are summarised in Table 3-1, with locations shown in Figure 3-4. For a table of tidal gauging measurements refer to Appendix A2, and for plots of tidal flows refer to Appendix A3 and A4.

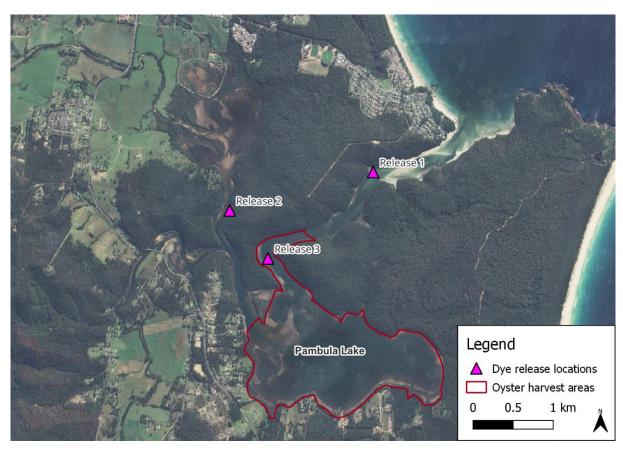
Figure 3-7 Rhodamine WT dye release locations

Dye release 1 was released on the northern bank of the main channel 1.5 km upstream of the estuary entrance (see Figure 3-7 and Figure 3-10). This release was completed to understand transport rates in the entrance channel and to determine pollutant dispersion rates. The release occurred on an incoming tide, approximately 1 hour before peak inflow at the Pambula Lake Downstream transect. Dye was released around 8.00am and tracked for 1 hour 20 minutes. Figure 3-9 shows the observed dye concentrations over the period of monitoring, with the maximum plume concentration along select transects highlighted.

Dye release 2 was conducted in the deepest part of the channel in Upper Pambula River, approximately 500 m upstream of the confluence with Yowaka River (see Figure 3-7 and Figure 3-10). The aim of this release was to observe plume velocity and dispersion in the slow moving Upper Pambula River. For this release, 250 mL of dye was released instead of the usual 500 mL due to low anticipated dispersion and advection. The release was timed to coincide with the anticipated peak outflow at the location and was tracked for 1 hour 5 minutes from 11.50am. Figure 3-11 shows the observed dye concentrations over the period of monitoring, with the maximum plume concentration along select transects highlighted.

Dye release 3 was completed mid-channel at Tea Tree Point approximately 1 km downstream of Pambula Lake (see Figure 3-7 and Figure 3-12). This release was completed to understand transport rates in the entrance channel and to determine pollutant dispersion rates. The release occurred on an outgoing tide, approximately 30 minutes after estimated peak outflow at the release location. Dye was released around 1.45pm and was tracked for 1 hour 15 minutes. Figure 3-13 shows the observed dye concentrations over the period of monitoring, with the maximum plume concentration along select transects highlighted.

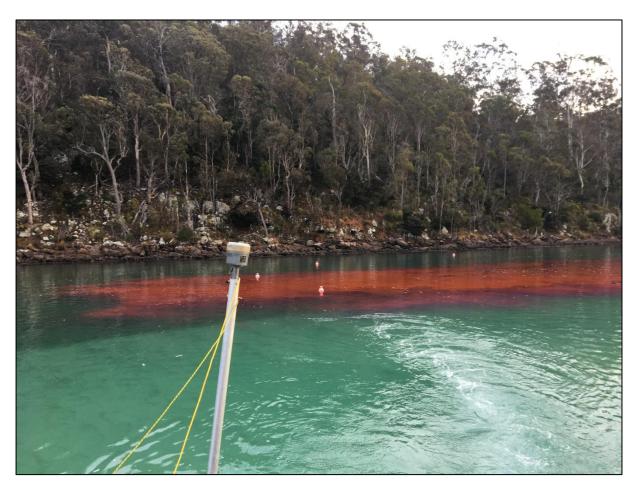
Figure 3-8 Dye release 1 after 5 minutes

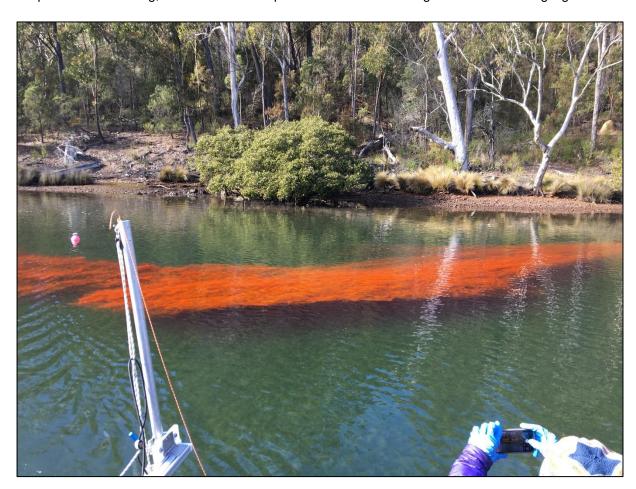
Figure 3-10 Dye release 2 after 10 minutes

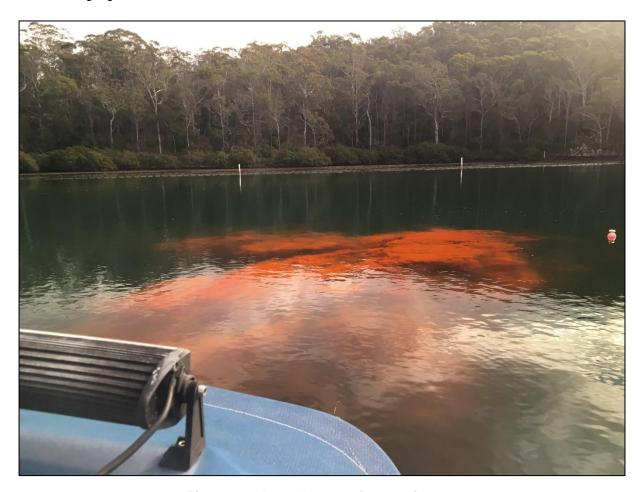
Figure 3-12 Dye release 3 after 10 minutes

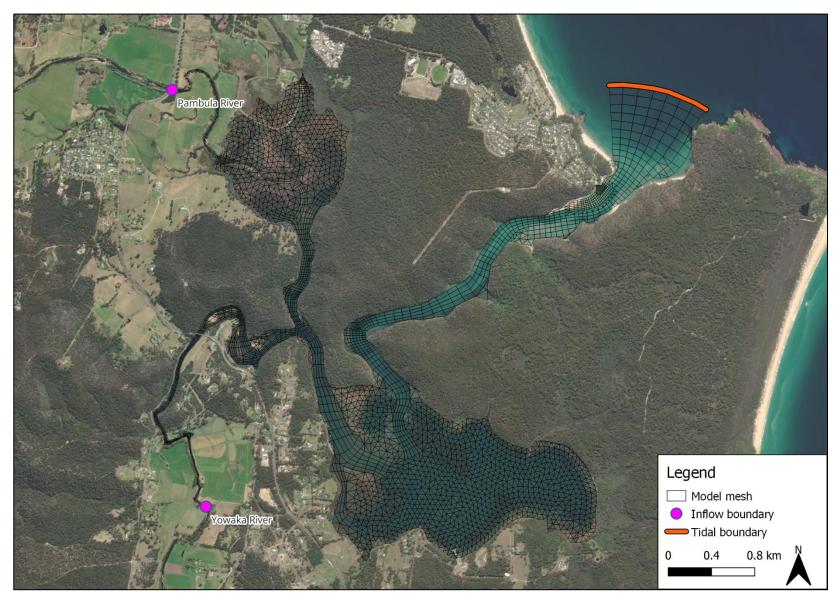
Figure 4-2 RMA model mesh showing boundary condition locations

The model includes two upstream catchment flow boundaries, shown in Figure 4-2 and discussed in Section 2.3. A tidal elevation boundary was included in the model offshore of the Pambula River entrance (refer to Figure 4-2). This modelled water level boundary was based on observed tidal elevation data collected by MHL at Eden (station number 220470). This data was then smoothed to remove signal noise to increase model stability. For modelling water quality scenarios, all boundaries (upstream and ocean) were set to a constant constituent concentration of zero (e.g. no pollutant inflows from these boundaries).

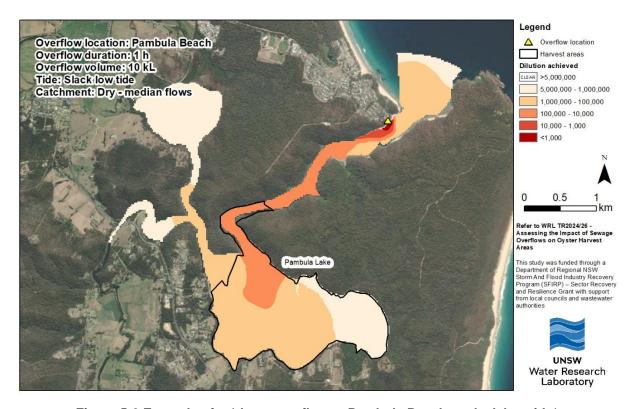
Figure 5-2 Example of a 1 hour overflow at Pambula Beach at slack low tide*

^{*}Result figures present the minimum dilution (i.e. maximum concentration) observed at each point during the entire scenario period (21 days).

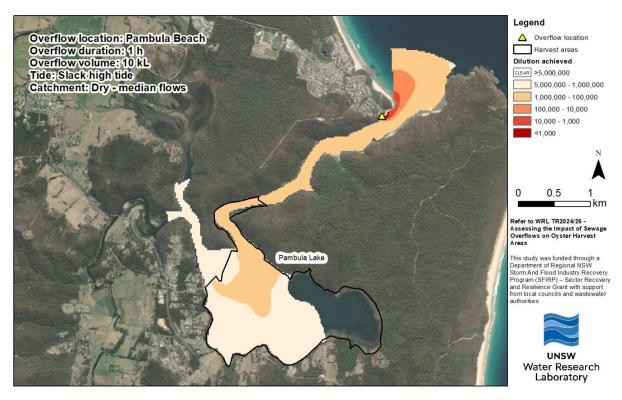
Figure 5-3 Example of a 1 hour overflow at Pambula Beach at slack high tide*

^{*}Result figures present the minimum dilution (i.e. maximum concentration) observed at each point during the entire scenario period (21 days).

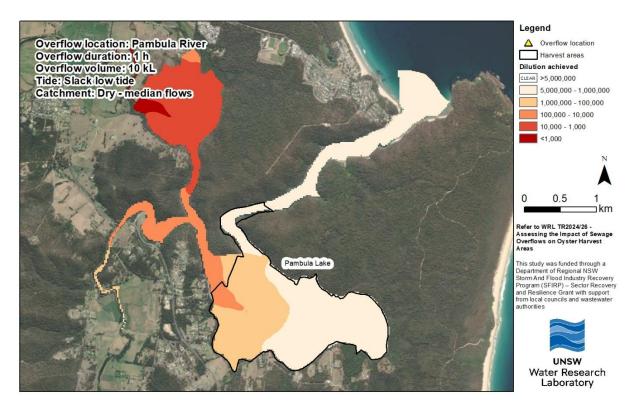
Figure 5-4 Example of a 1 hour overflow at Pambula River during median inflow conditions*

*Result figures present the minimum dilution (i.e. maximum concentration) observed at each point during the entire scenario period (21 days).

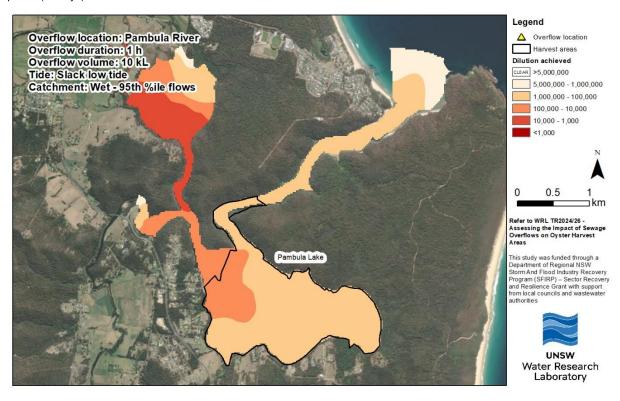
Figure 5-5 Example of a 1 hour overflow at Pambula Beach during 95th percentile inflow conditions*

^{*}Result figures present the minimum dilution (i.e. maximum concentration) observed at each point during the entire scenario period (21 days).

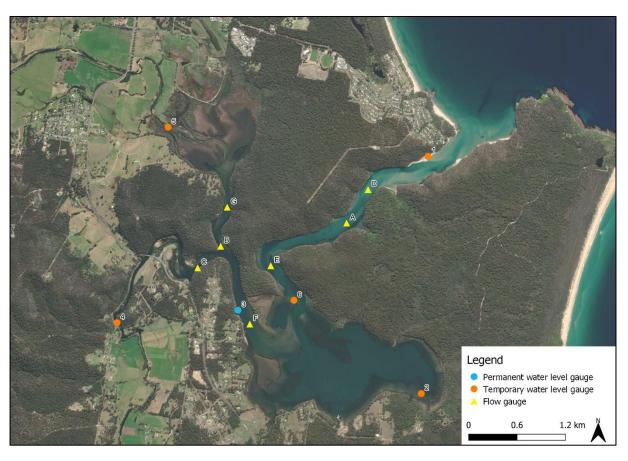
Figure B-1 Water level and tidal flow gauging locations
