Safety Alert April 2021

Use of Hydrothermal

Autoclaves The Incident

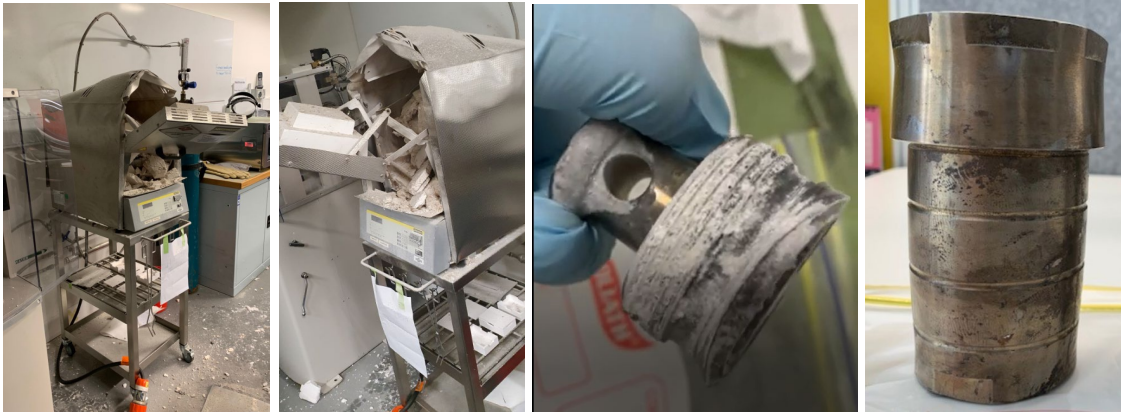
In a recent incident a Hydrothermal Autoclave Vessel (HAV) was exposed to temperatures higher than intended in the experimental design (at approximately 550 °C; intended was 180 °C). The hydrothermal autoclave was operating well outside the temperature specifications of the unit when it failed. The over-temperature resulted in the HAV threaded cap ejecting from the collar and causing significant damage to the furnace and the surrounding area, and injury.

- All users are to ensure that heating devices (ovens) are appropriate to the experimental needs. They should be selected to ensure that if programming of thermostats fail, or human error in their setting, that the temperatures will not result in vessel failure. That is, the design capability of the vessels should be greater than that of the oven. Furnaces with capability of very high temperature should not be used with Hydrothermal Autoclaves.

- Vessels are to be supplied with documentation for their use, including operational specifications, appropriate maintenance, and inspection requirements, and limitations for use (such as Teflon capsules are to be replaced every 20 uses).

- Vessels are to be provided with certification to AS/NZ standards, or relevant manufacturers certifications.
- Safe work procedures are to be updated to minimise human factors and to provide increased risk management (such as implementation of increased supervision or restriction of personnel into spaces where equipment is being used for higher risk activities, and appropriate shielding).

- Implementation of inspections and maintenance registers.
