# **ROLLOVER CRASHWORTHINESS TEST RESULTS**

## **REPORT 3**

**Professor Raphael Grzebieta,  
Adjunct Associate Professor George Rechnitzer,  
Dr. Andrew McIntosh**

**TRANSPORT AND ROAD SAFETY (TARS)  
University of New South Wales  
Sydney, Australia**

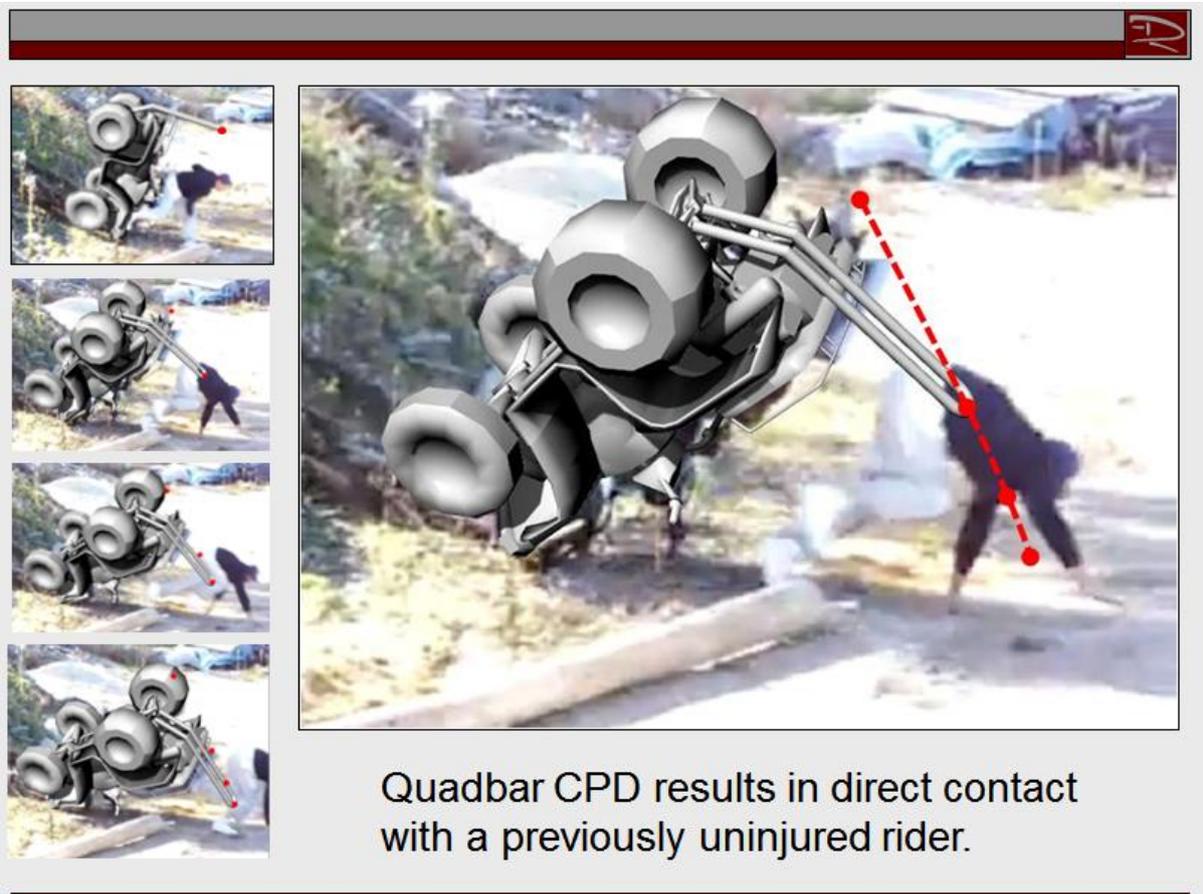
Figure 3: Van Ee et al. (2012) demonstrate how a Quad bike can roll laterally over a rider without causing any injury. The rider stood up and walked away from the incident.

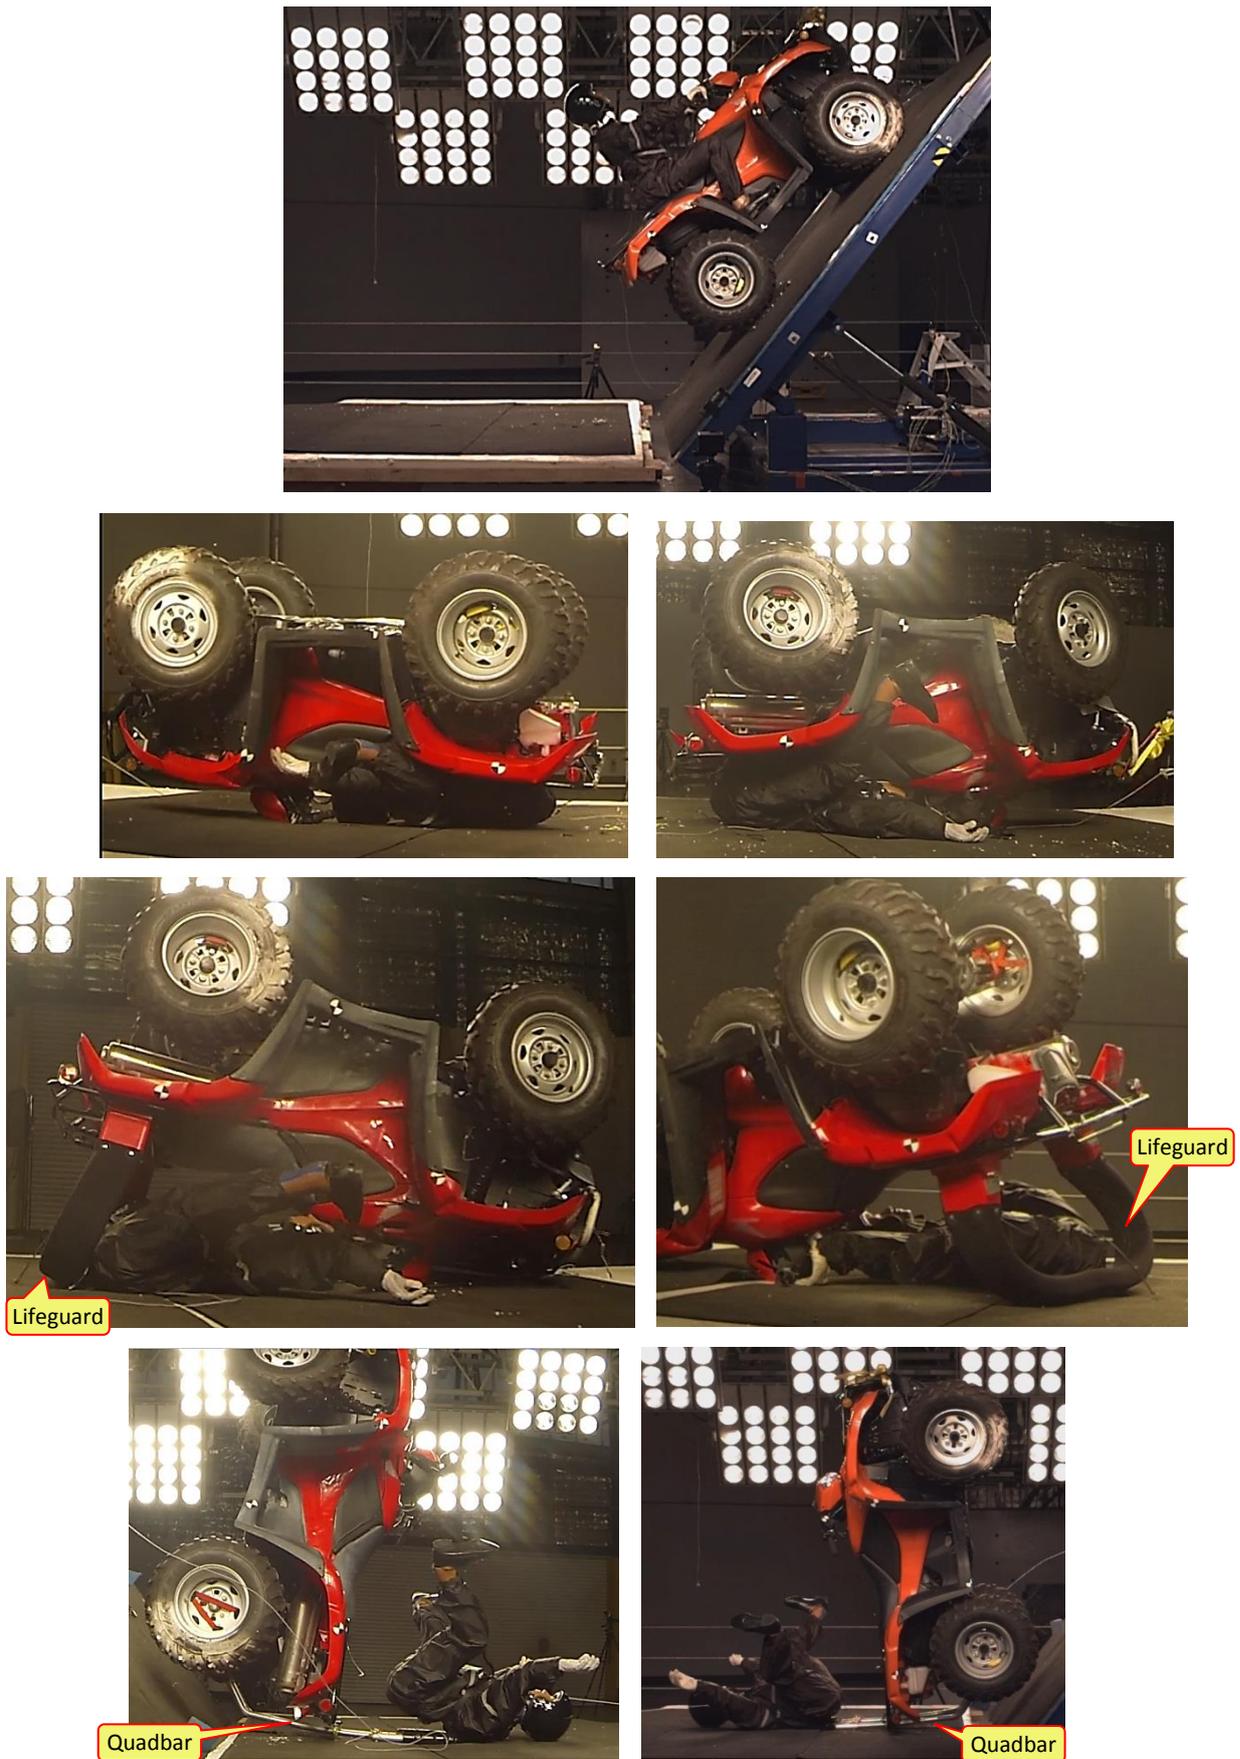
Figure 10: Quad Tests: Rearward pitch: Top – setup; 2<sup>nd</sup> row – baseline; 3<sup>rd</sup> row – Lifeguard; 4<sup>th</sup> row – Quadbar.

However, with the Lifeguard, a concern regarding the rearward pitch test was noted. The MATD was found to fall into the hollow part of the Lifeguard as shown in Figure 11a. The belted flexible part of the device distorted such that the MATD's lumbar spine contacted the upper edge of the distorted belt portion of the device. The belt then straightened out to the position shown in Figure 10 (frames in 3<sup>rd</sup> row) and the Quad bike subsequently rolled away off the MATD.

The Authors are concerned that this distortion in rearward pitch would present a serious hazard to a rider involved in such an incident particularly if the belt impinged on the rider's spine (as it did in this test) and if the Quad bike fell from a higher initial height as in the exploratory tests, i.e. 1,500 mm from the 'lowered' edge of the tilt table. The device would need to be redesigned to ensure this would not occur. Moreover, if for example netting were used to prevent such rearward ingress of the rider, the rider's head would be further forward as is evident in Figure 11a). This in turn would position the rider's head such that it would be directly under the front handle bars of the vehicle as it rotates downward towards the rider. This again would present a potential hazard.

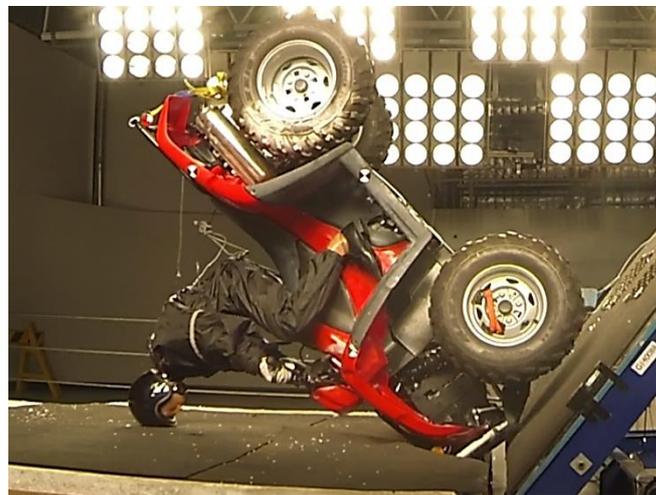
b) Forward pitch demonstrating how rider can receive serious cervical spine injury. MATD neck was fractured twice during testing.

Figure 11: Quad Tests – Rearward and Forward Pitch, including with Lifeguard OPD.

In all three lateral roll Honda TRX500 Quad bike tests the first point of contact with the ground was the MATD head. The worst case in terms of injury is the forward pitch test as is clearly evident in Figure 11b. In this case the MATD neck was broken in "half". The MATD neck also fractured in the exploratory tests albeit in the first side rollover test.

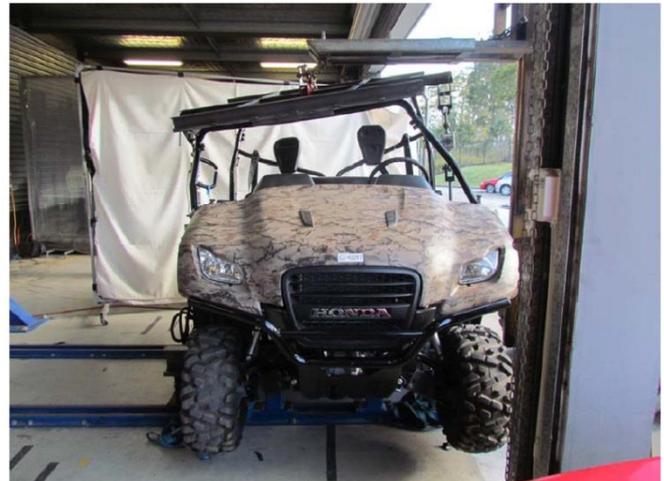
*Vertical loading reaches 88% of ANSI/ROHVA 1-  
2011 requirements after which test was stopped.*

**Figure 14: Honda Big Red loaded laterally and then vertically.  
Note failure of ROPS under vertical load in bottom frame**

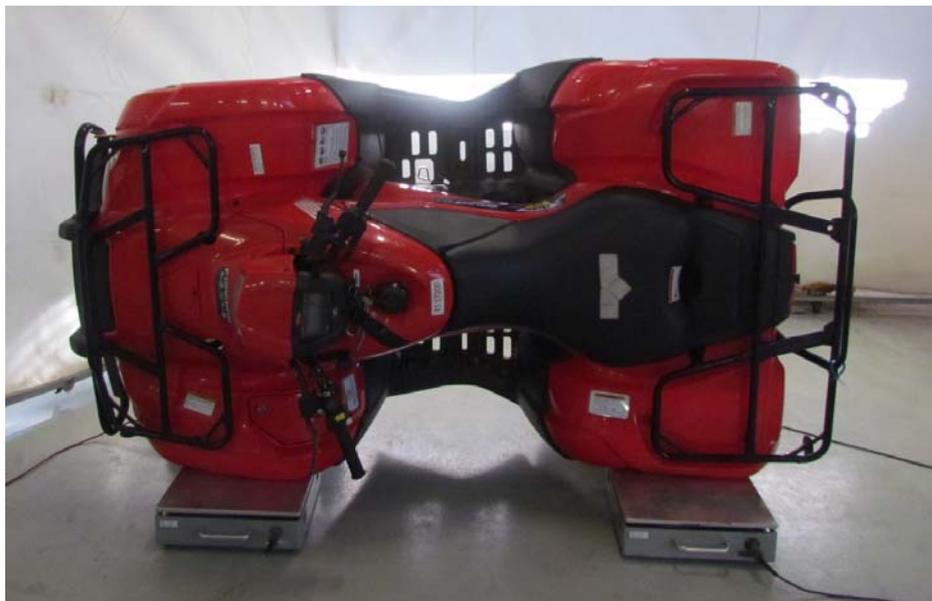
Figure 1 – Quad bike ground contact force test in progress

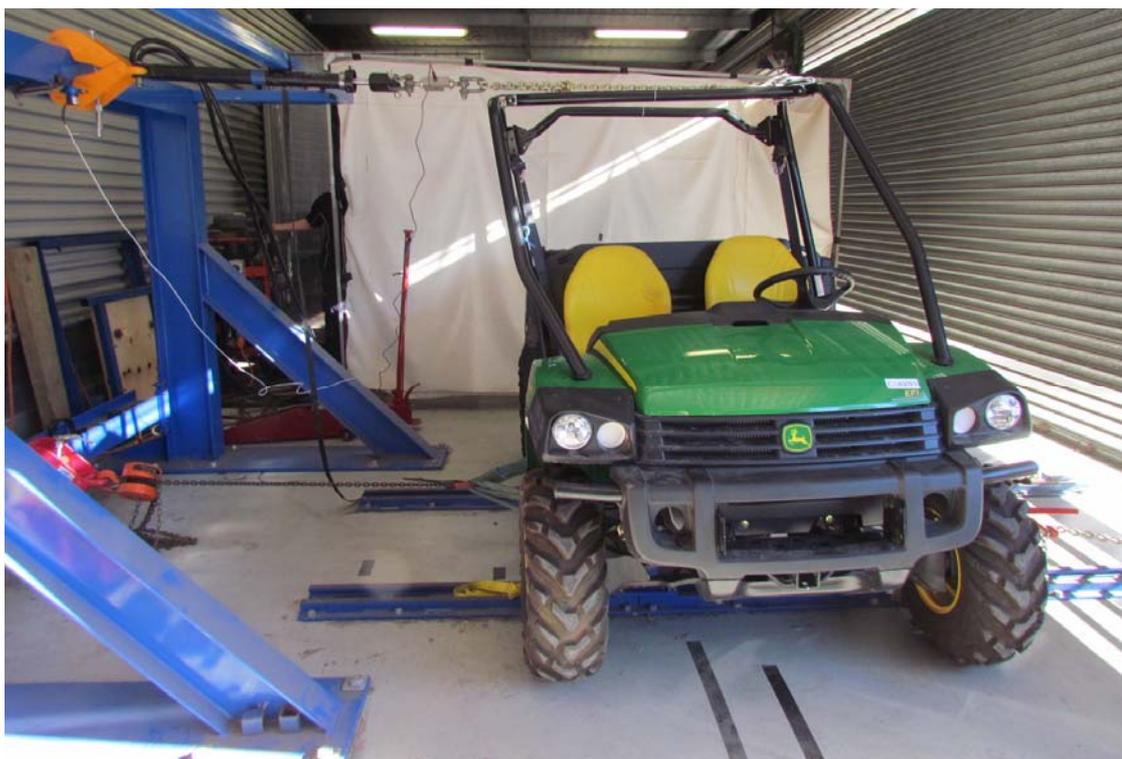
Figure 3 – SSV Roll-Over Protective Structure (ROPS) lateral pull test in progress

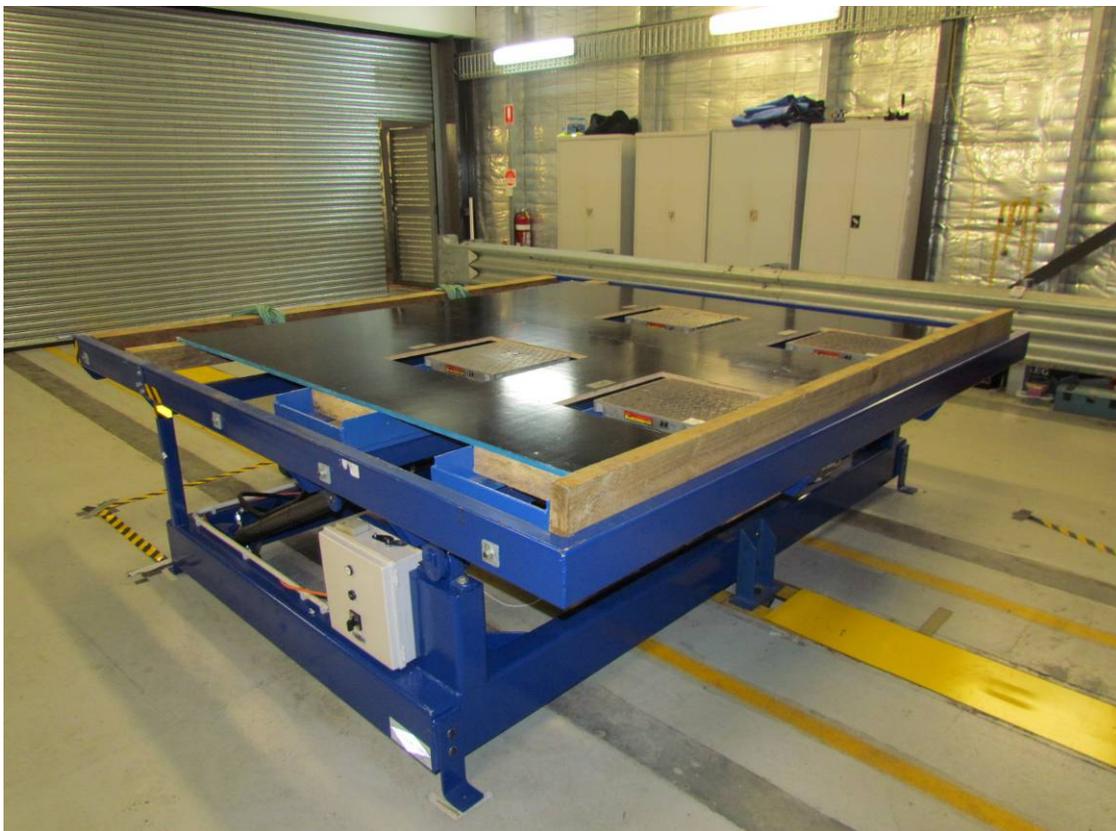
Tilt table (lowered, horizontal position)

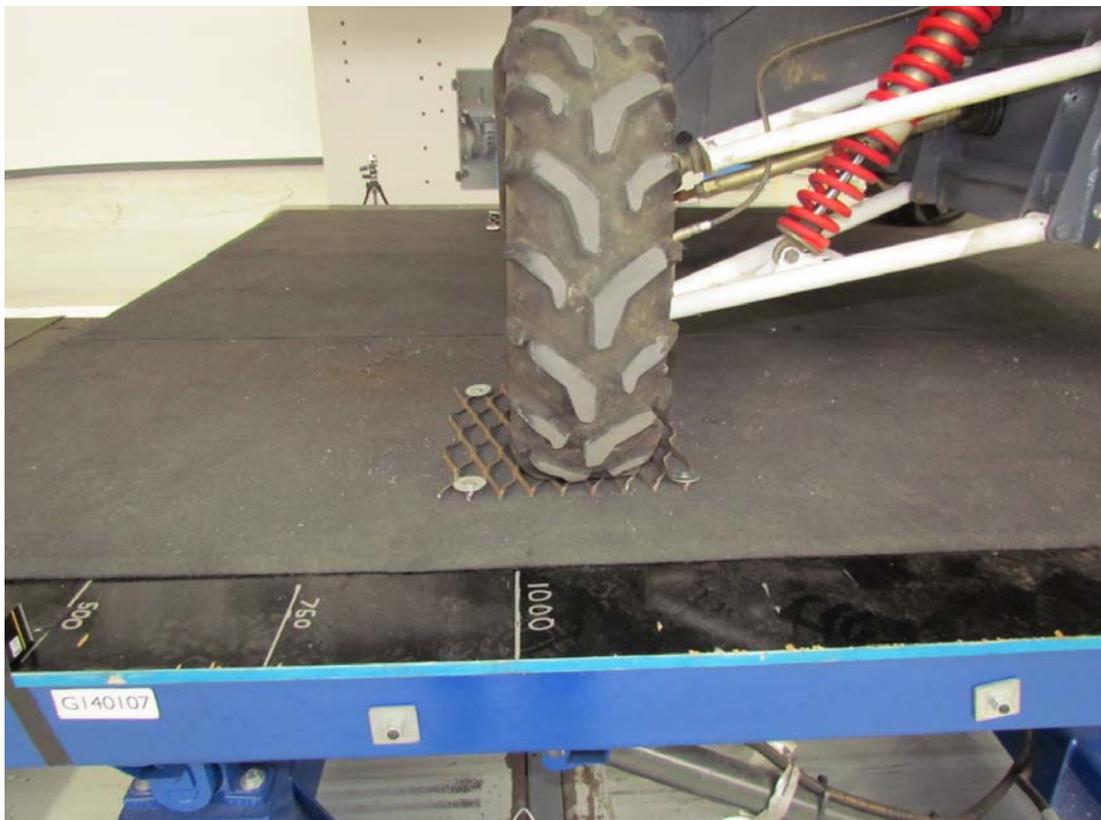
Tilt table top surface with expanded mesh anti-slip plates located under vehicle tyres

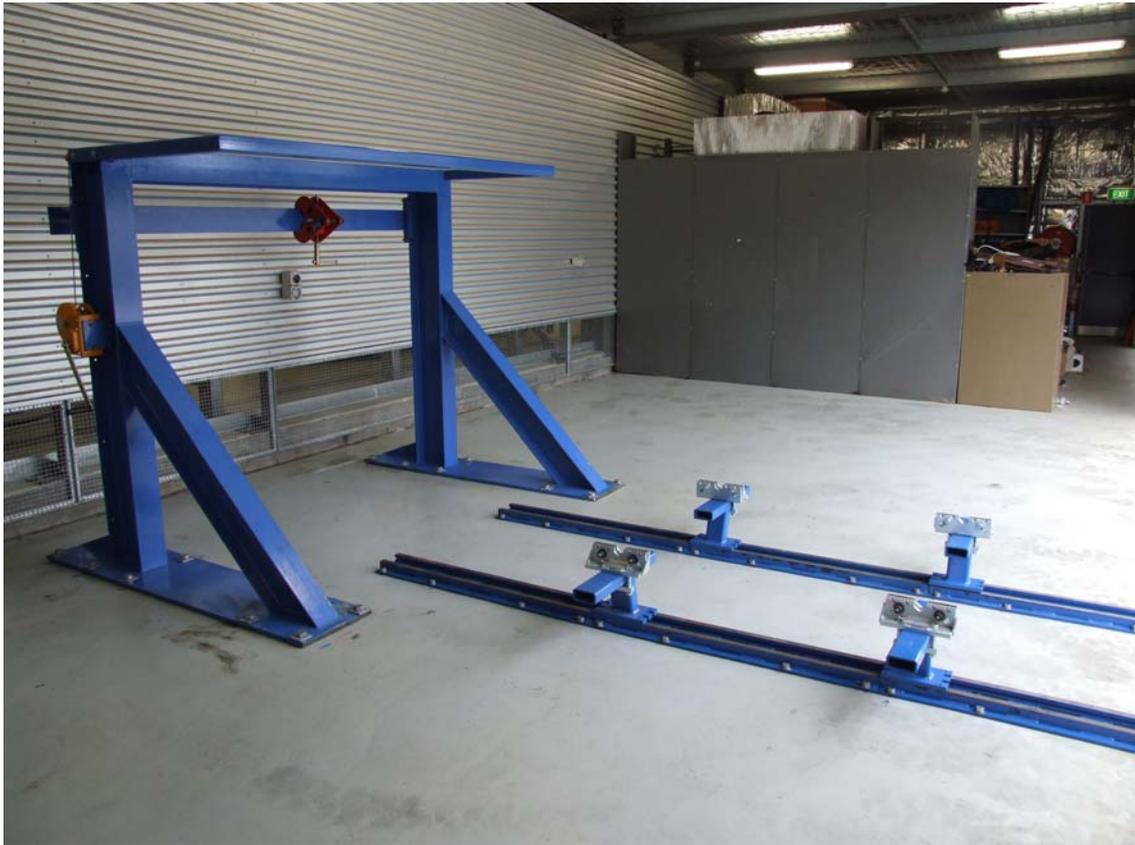
Roll-Over Protective Structure rigid steel test fixture, rails and adjustable vehicle mounting stands (lateral and longitudinal tests)

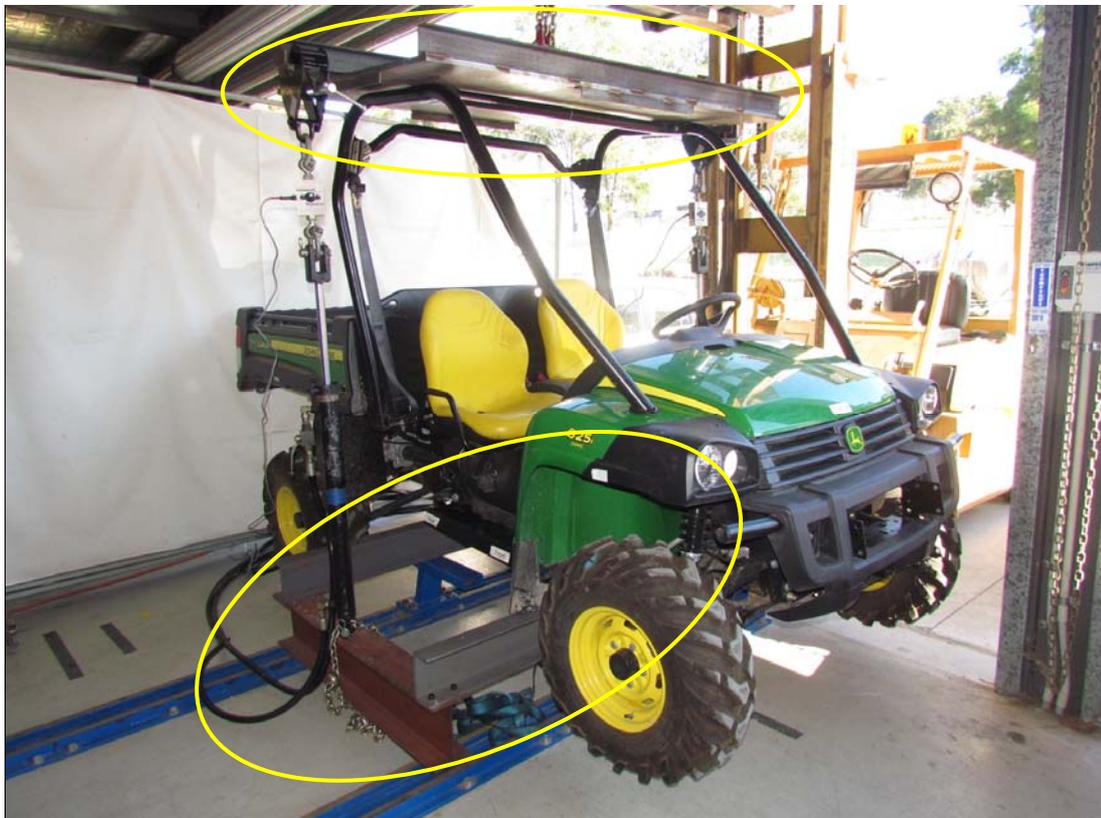
Roll Over Protective Structure vertical test steel frame (under vehicle) and load plate (on top of ROPS)

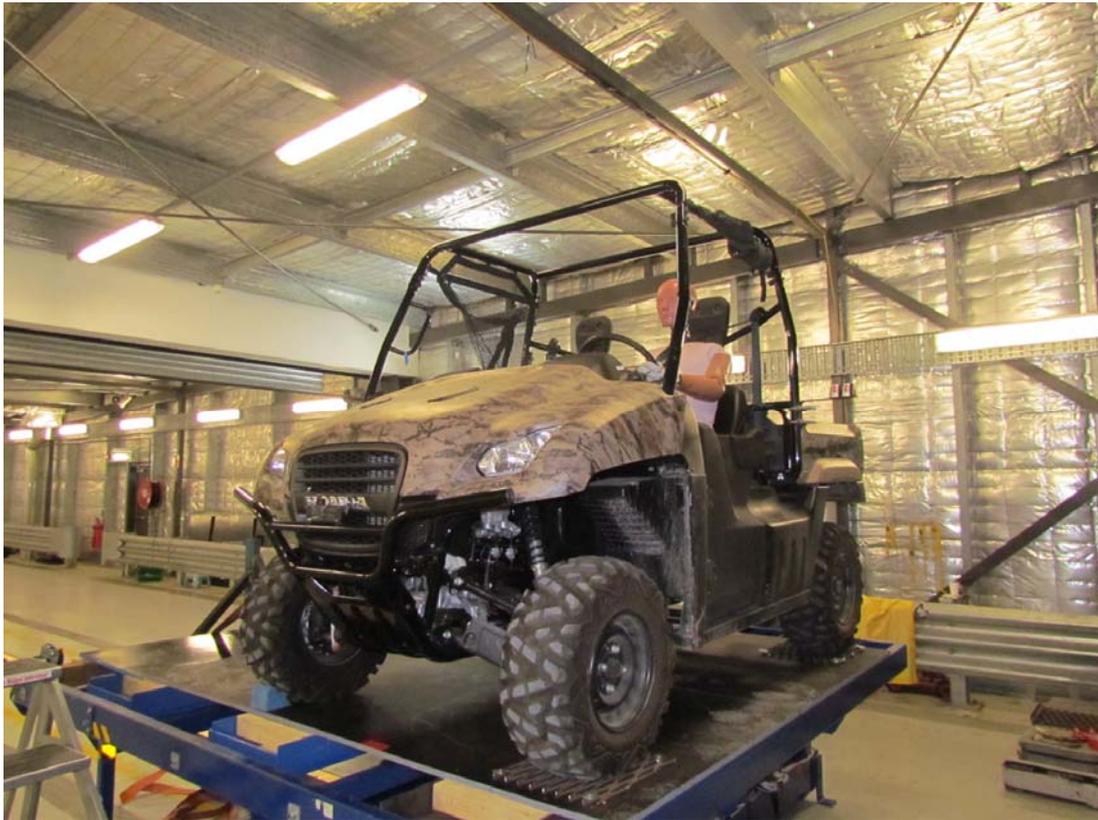
Side by Side Vehicle occupant retention – typical vehicle setup on tilt table

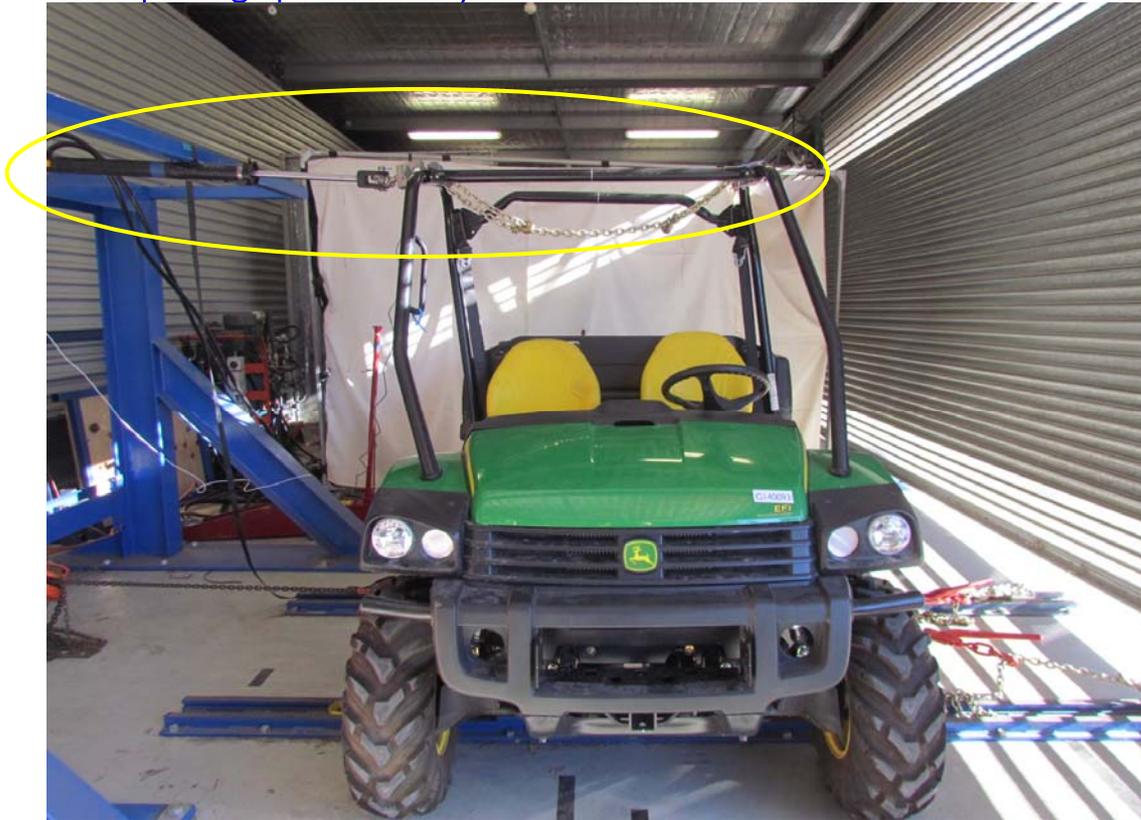
ROPS test – Lateral pull typical setup. Vehicle secured to mounting stands. Hydraulic cylinder, load cell & chain secured between Rigid test fixture and vehicle ROPS

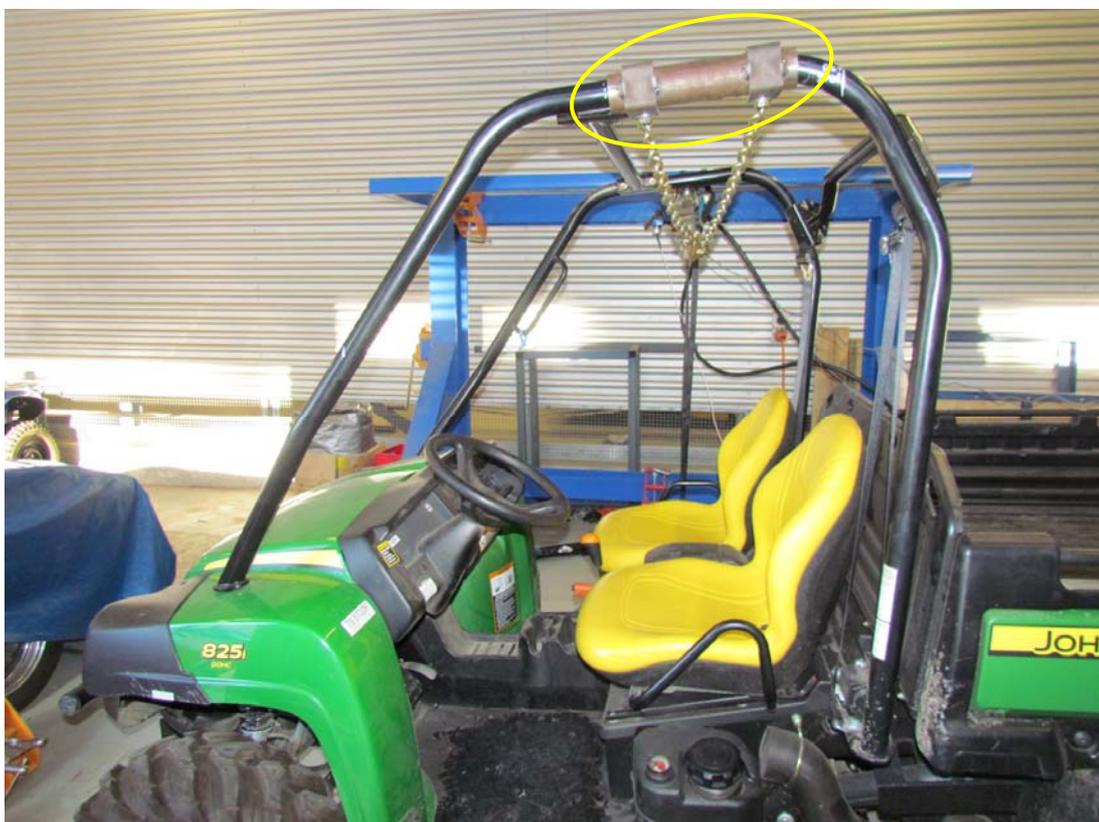
ROPS test – Lateral pull typical setup, Load Distribution Device (LDD)

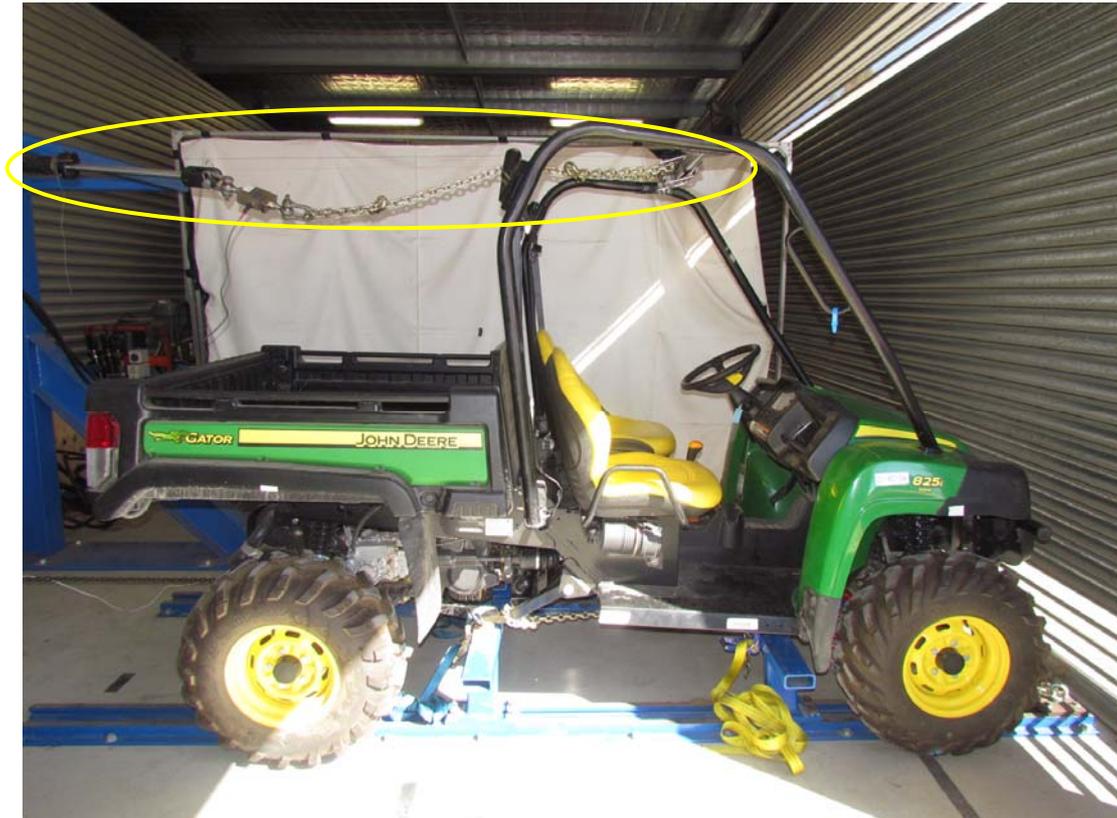
ROPS test – Longitudinal pull typical setup. Vehicle secured to mounting stands. Hydraulic cylinder, load cell & chain secured between Rigid test fixture and vehicle ROPS

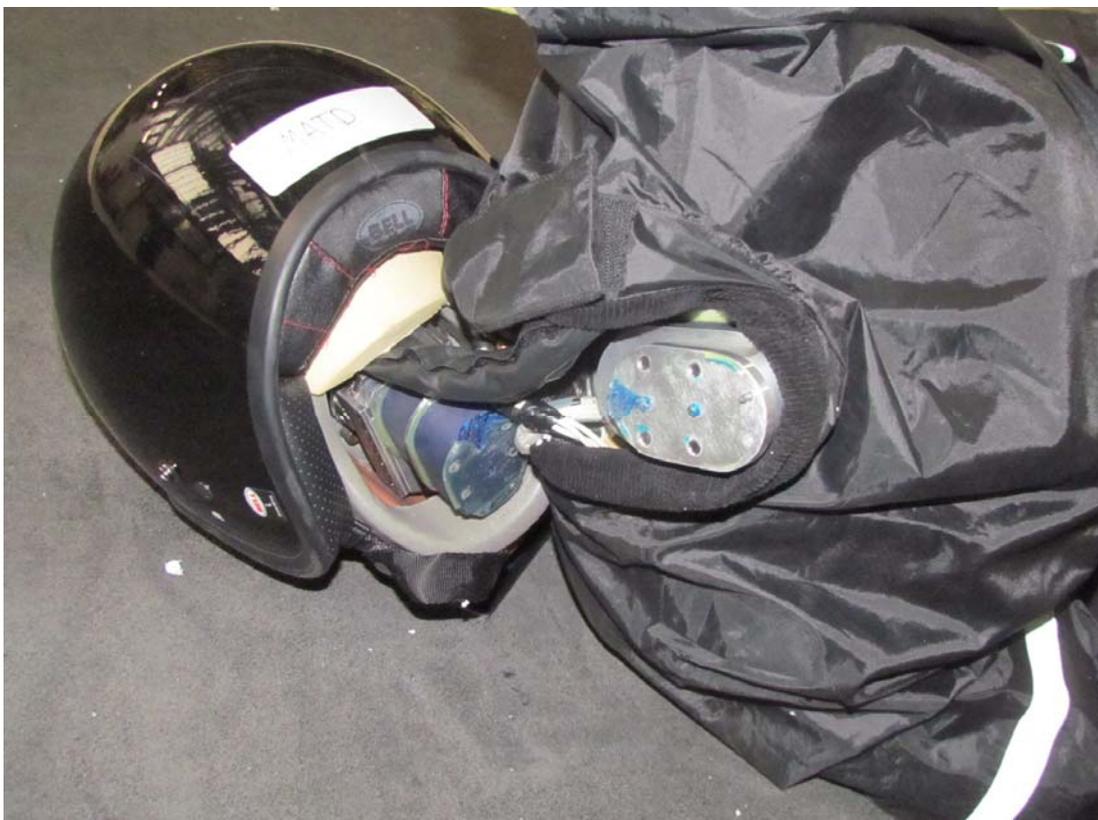
Vehicle and occupant rollover – Test GI40082, damage to MATD neck

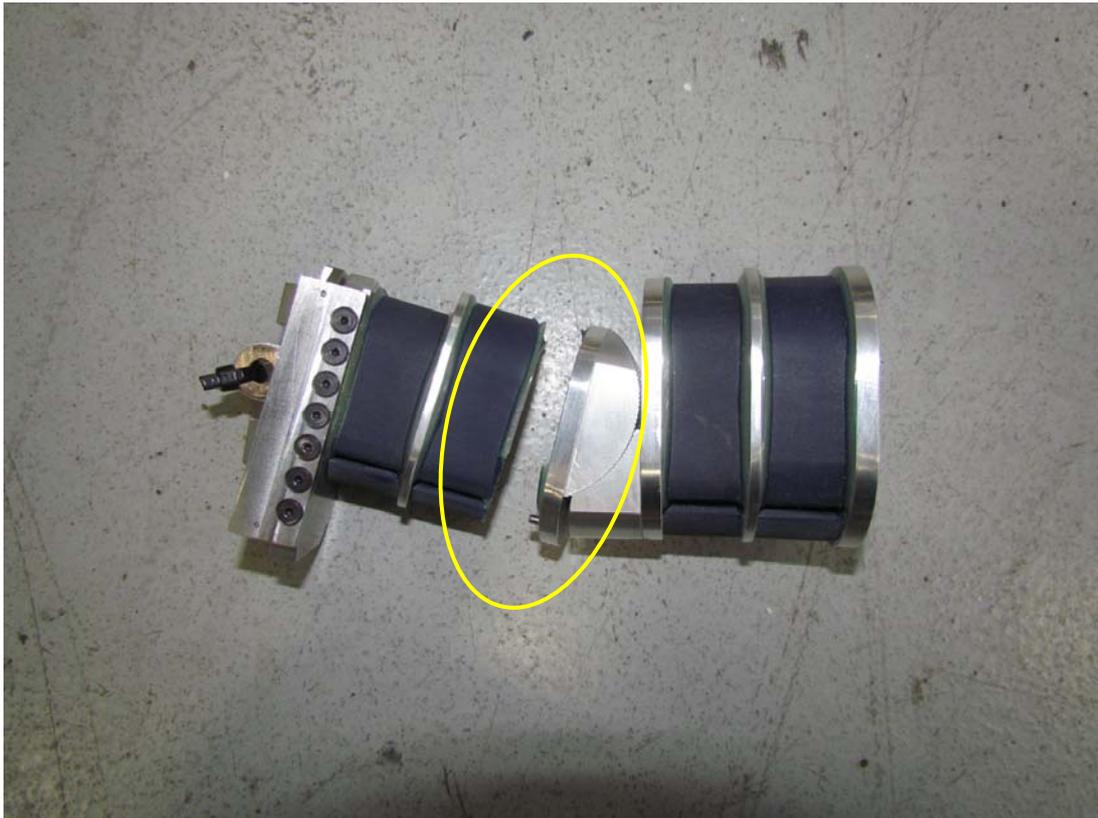
Vehicle and occupant rollover – Test GI40082, damage to MATD neck

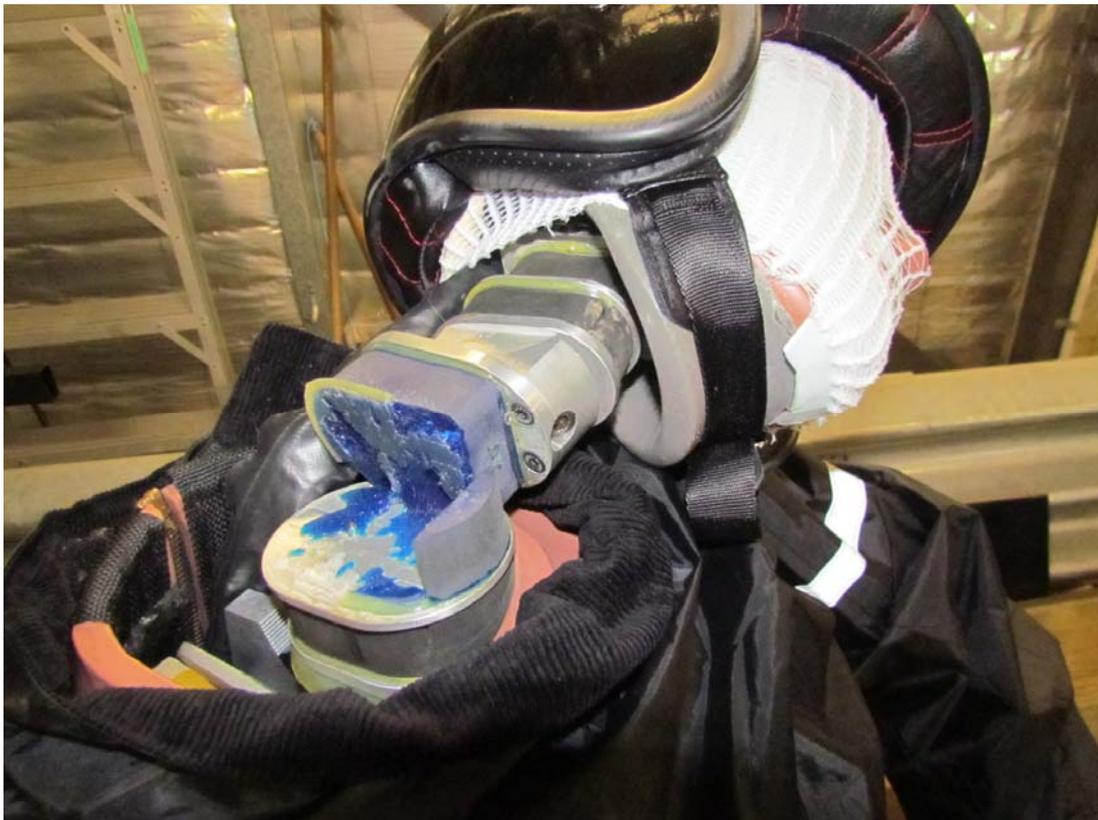
Vehicle and occupant rollover – Test latroll\_00, damage to MATD neck

It should be noted that on the first forward pitch test in the nine configuration test series, and in the first lateral rollover test in the exploratory test series, the MATD neck was mechanically fractured without a corresponding injury recorded. This mechanical fracture can occur because the MATD does not have a lateral shoulder stop for the neck<sup>11</sup>.

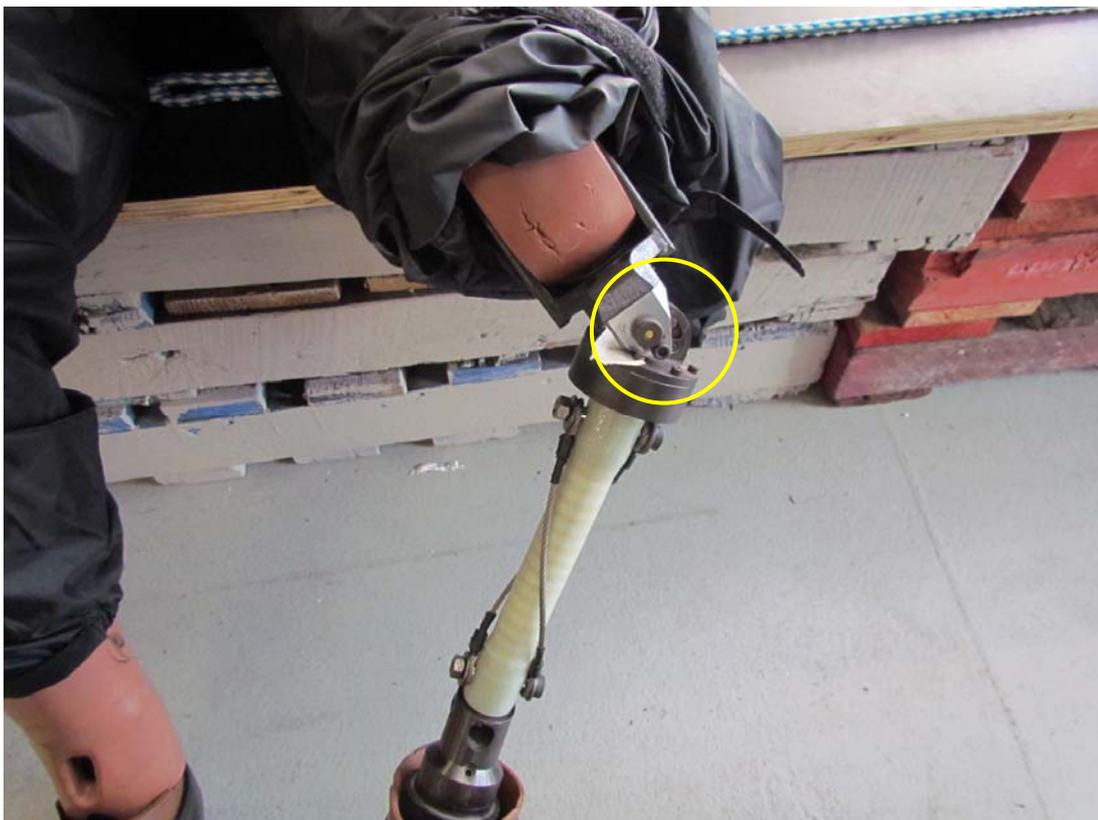
Vehicle and occupant rollover – Test latroll\_01, damage to MATD left knee varus valgus shear pin
