Blacksmiths Beach surf amenity assessment

WRL TR 2020/14, April 2020

UNSW
Water Research
Laboratory

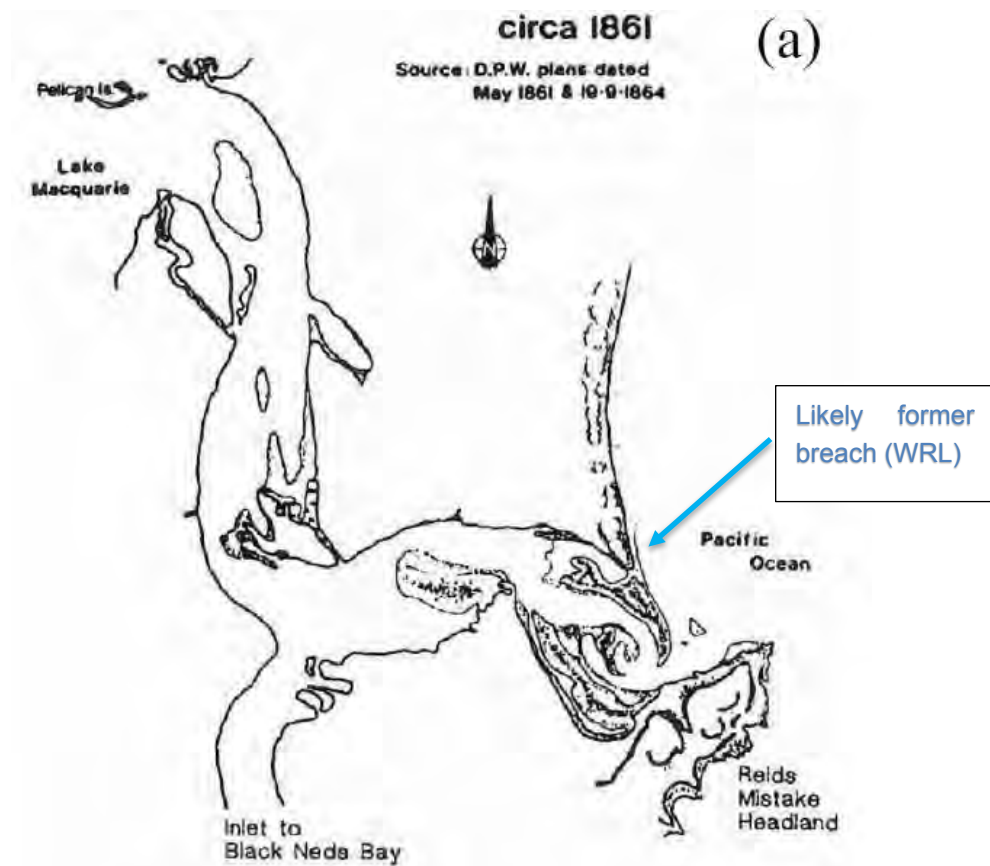
Figure 3.5 Previous potential breach at Blacksmiths (PWD survey 1861)

The geology of Blacksmiths Beach is shown in Figure 3.3. While the peninsula is now sufficiently wide to prevent a breach from oceanic erosion over the next 50 years, it is highly likely that it has been breached at some point in the past, prior to the training walls fixing the entrance in its present location. This spit breach and regrowth cycle is shown in Figure 3.4 and a likely breach site in 1861 is shown in Figure 3.5.

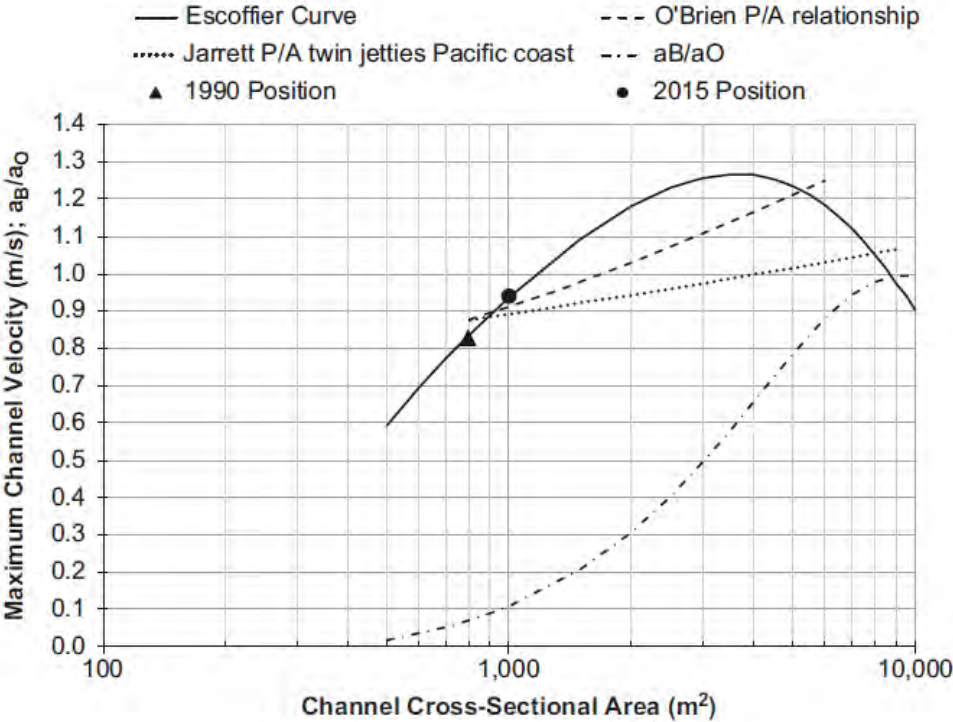
Figure 3.7 Escoffier diagram for Lake Macquarie (Nielsen and Gordon, 2017)

Analysis by Nielsen and Gordon (2015, 2017) estimated that Swansea Channel will continue to scour and deepen for another 350 to 600 years before stabilising to a new equilibrium (Figure 3.7). This new equilibrium is estimated to involve a channel cross sectional area of three to six times the present channel shape. With the bank armouring effectively limiting an expansion in width of the channel, this additional equilibrium area can only be gained through an increase in the depth to the channel bed.

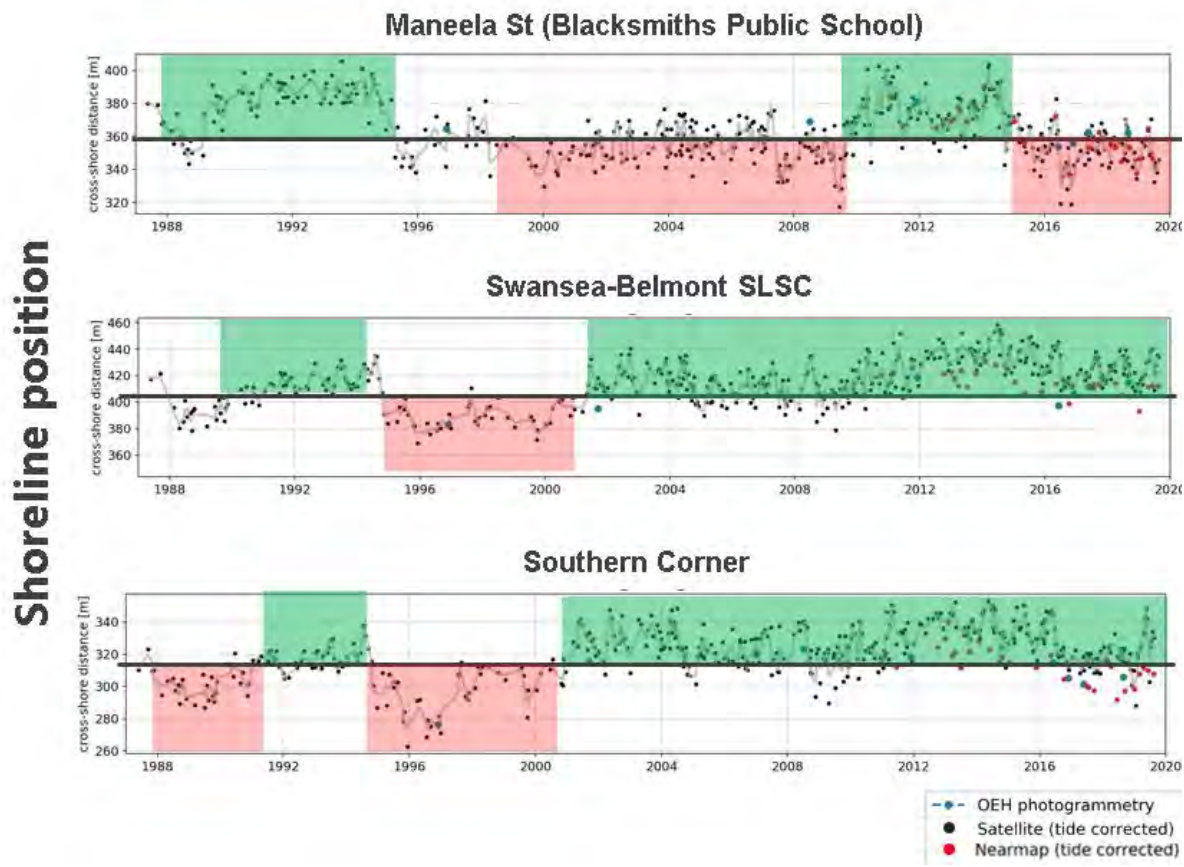
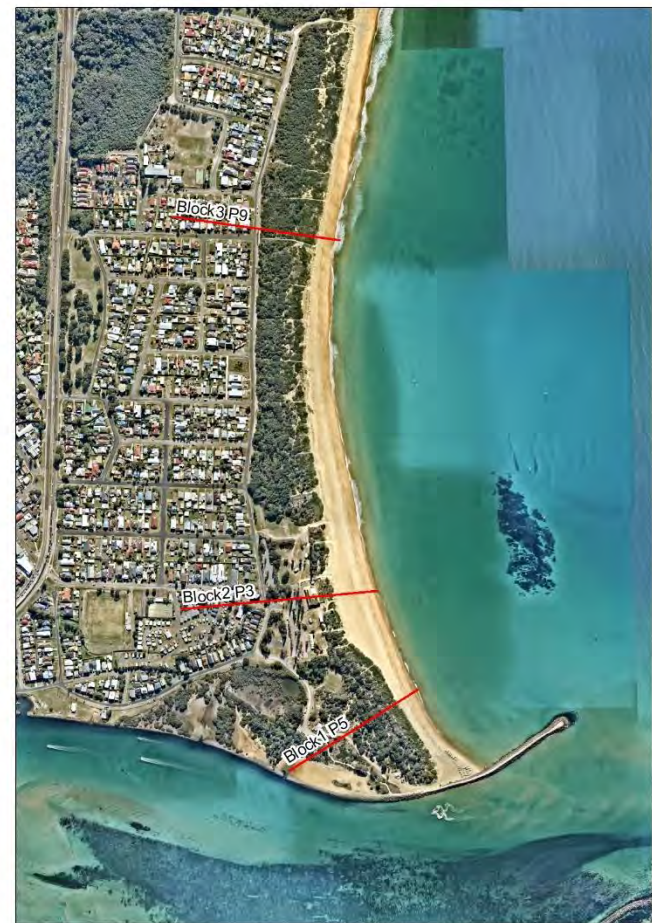
Figure 3.10 Beach width at three transects

Shoreline position for three transects was calculated using images from satellites and aerial photos from 1988 (Figure 3.10). This data was corrected for the tide at the time of the image before shorelines were extracted.

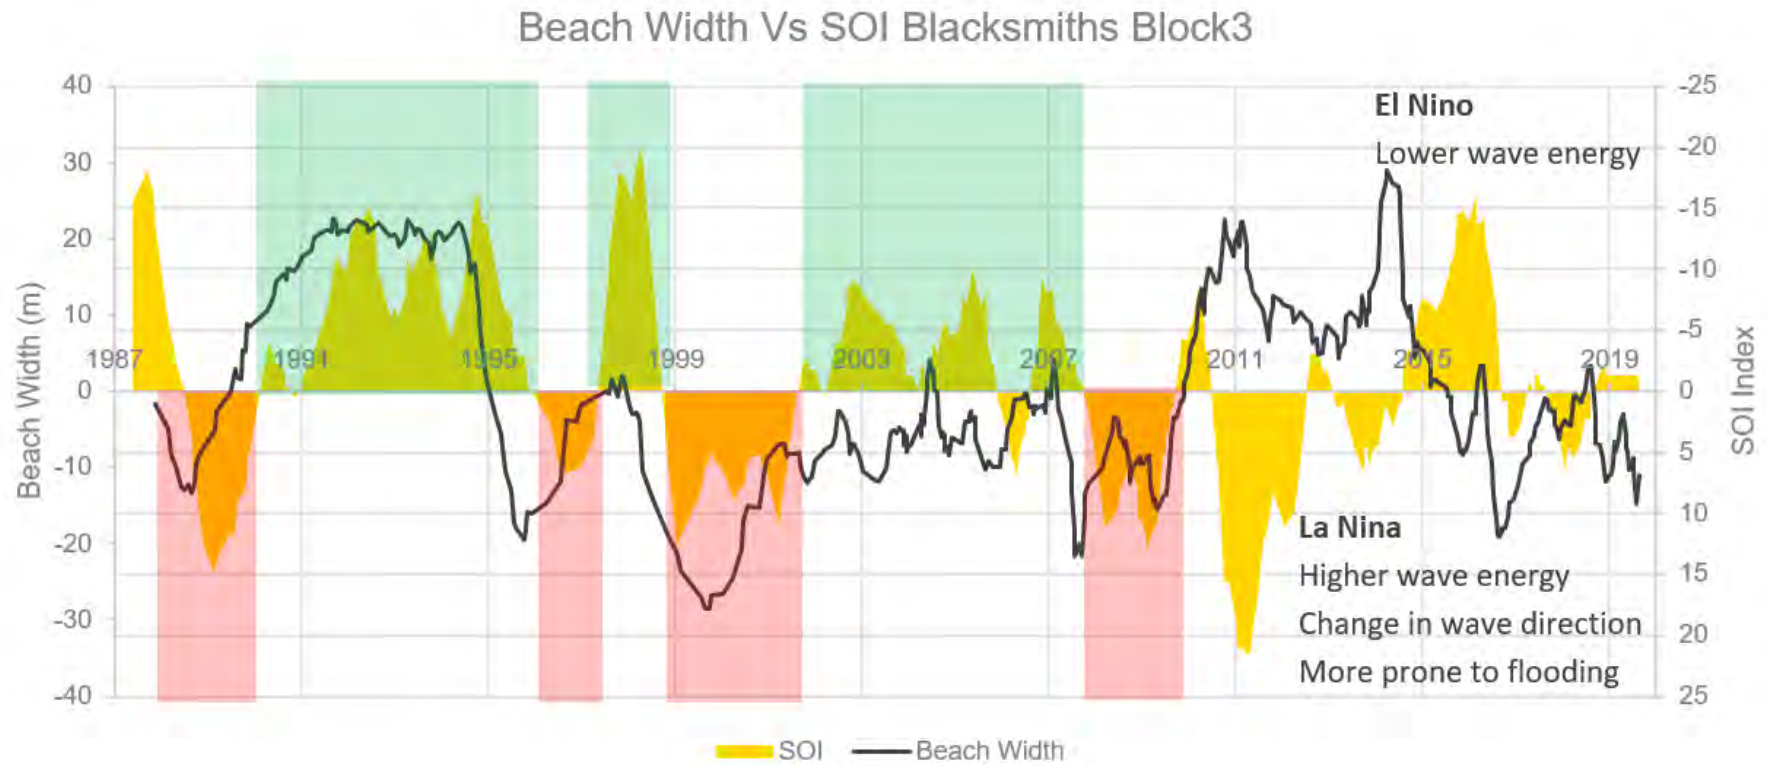
Figure 3.11 Plot of beach width at Blacksmiths SLSC versus SOI

There is no strong long term trend, but several medium term cycles are evident. These appear to have some correlation with climate indices such as ENSO (El Niño-southern oscillation), (Figure 3.11), in a similar manner to that observed at other locations in NSW in Harley et al., (2015).

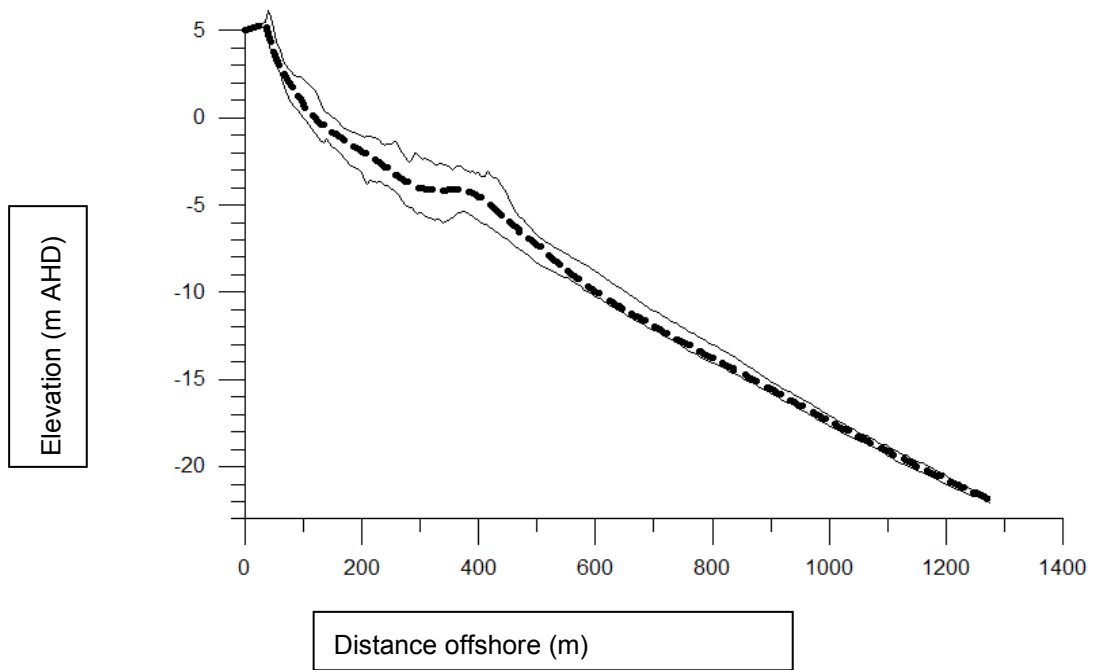
Figure 4.1 Envelope of surveyed (ETA63) profiles of Surfers Paradise (1976 to 1997)

- Cross shore profile slope and depth – this affects wave breaking intensity, and may result in a shore break only, or reforms, and sometimes wave reflections/backwash. The cross shore profile is also somewhat attuned to specific wave conditions (height and period). The only comprehensive measurements of this in Australia are on the Gold Coast, with the change there shown in Figure 4.1.

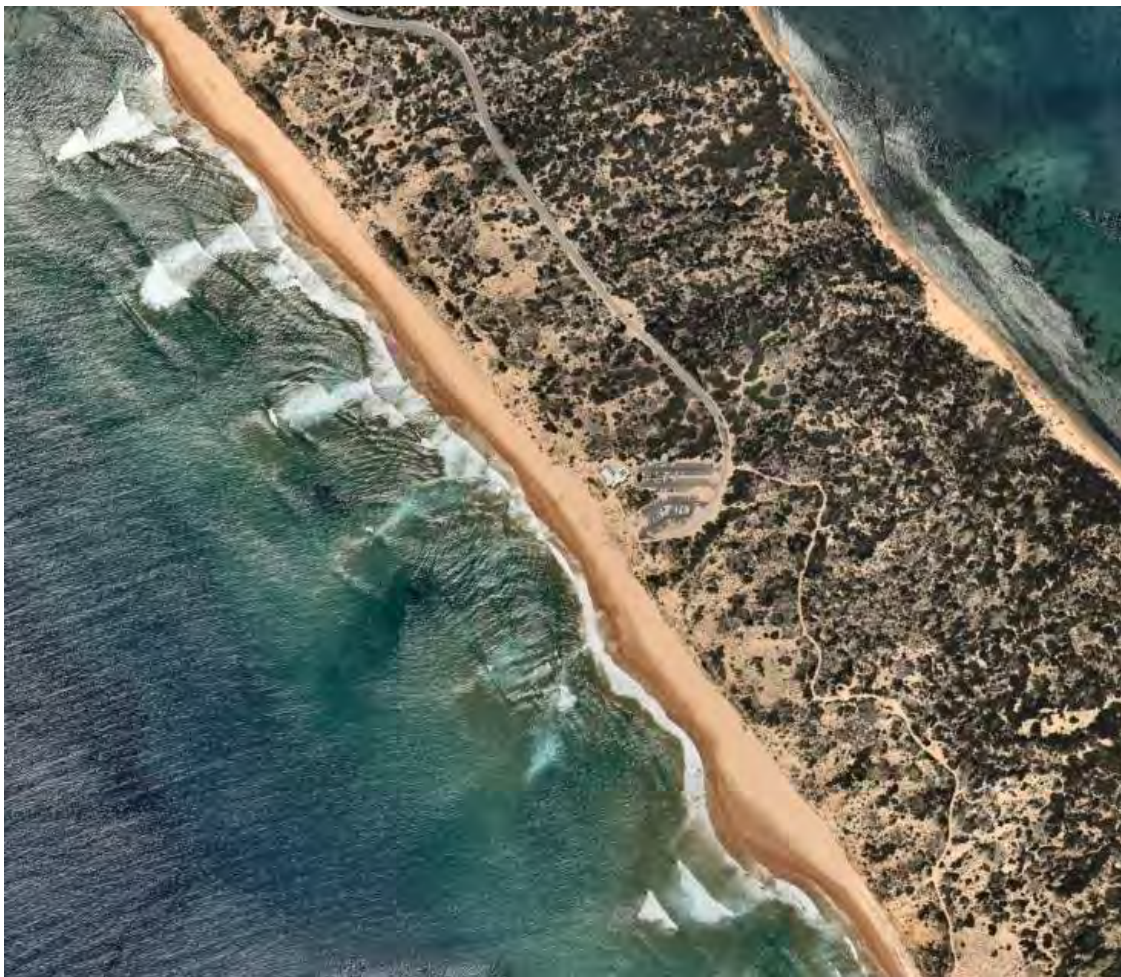
Note: Transverse Bar and Rip as described in Short and Wright (1984), Source: Nearmap

Figure 4.2 Example of renowned three dimensional beach break – Woolamai VIC

- Three dimensionality - peeling of waves, which is influenced by multiple factors:
 - “Banks” – the three dimensionality of the seabed (Figure 4.2);
 - Offshore features such as sand shoals, reefs and islands (e.g. the sand shoals offshore from Duranbah on the Gold Coast, and similar features offshore from Blacksmiths);

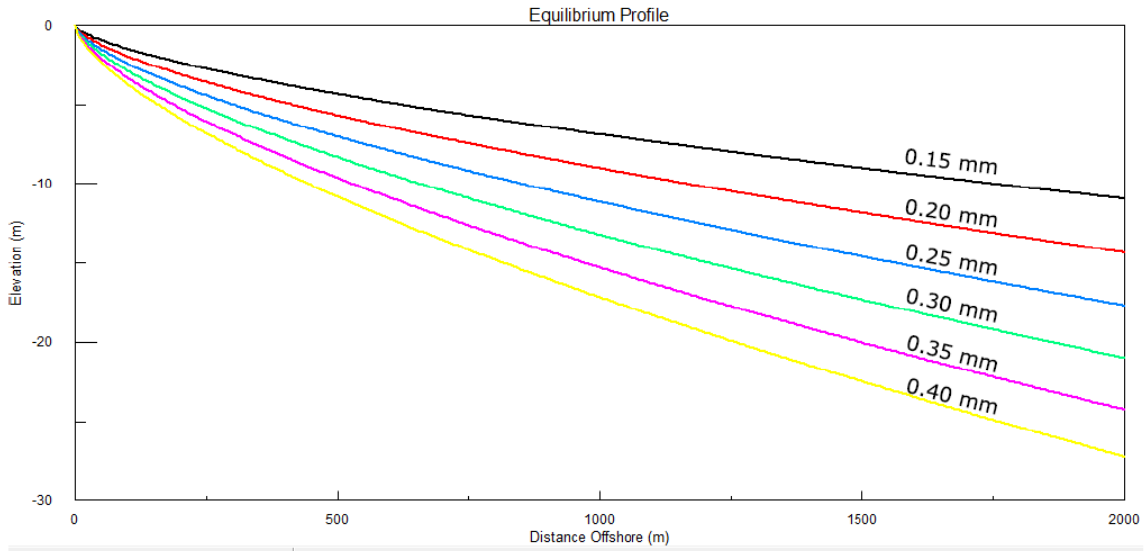
Figure 4.4 Equilibrium beach profile for various sand grain sizes

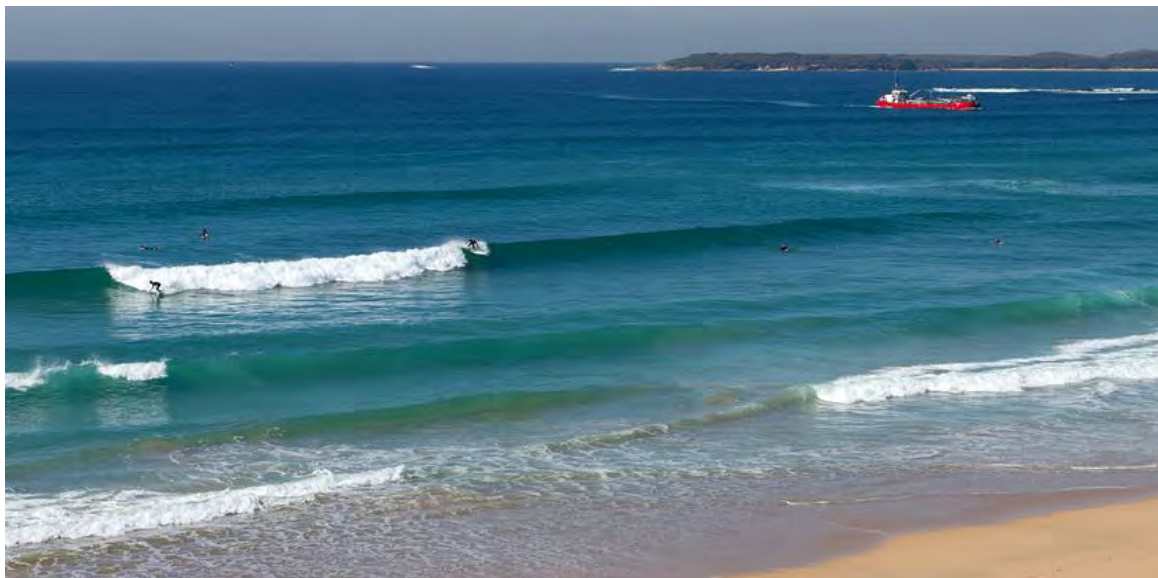
Figure 5.4 Dredger Faucon travelling from Port Hacking to North Cronulla

The works were undertaken from June to September 2012. The *Faucon*, a Gold Coast based trailing suction hopper dredger can be seen transporting sand in Figure 5.4. The surf from a good day (Tuesday 14 August 2012 - prior to completion) is shown in Figure 5.5. Pitt (2012) reported that the best month was August 2012, and that the sand slug had a positive impact on surf quality from July to October 2012, a life exceeding 4 months.

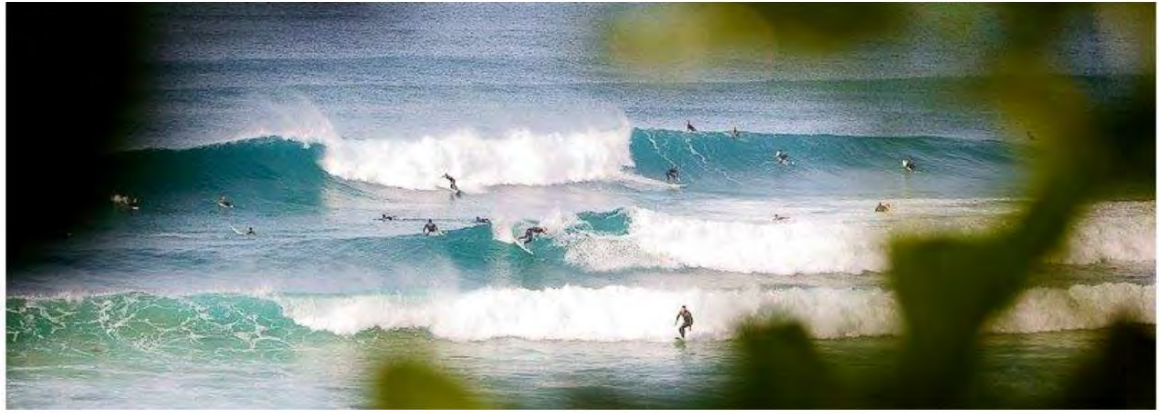
Image 1. *Slug-Fest!* Tuesday 14th August 2012, North Cronulla, fantastic wave breaking patterns in the lee of the temporary sand slug feature, plenty of peaks. Set, peeling left and right, local surfers called it a 'Slug-Fest'. Photo, One Shut Eye

Figure 5.5 High quality surf on Cronulla sand slug

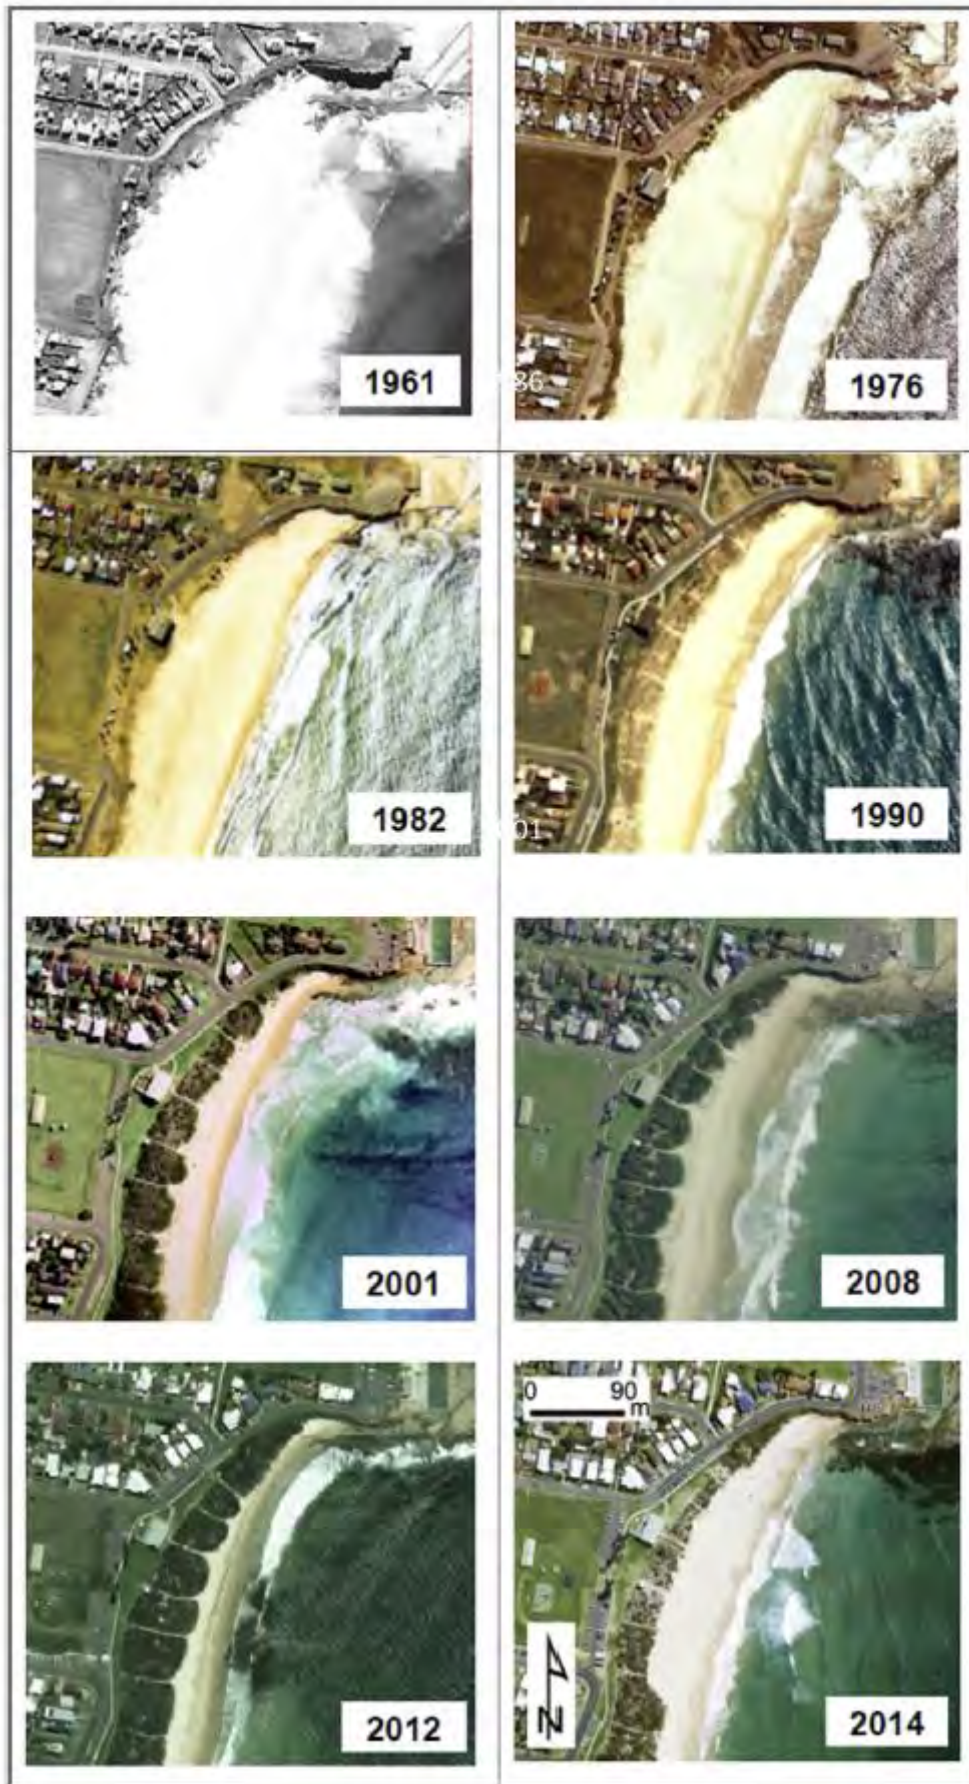
Figure 5.6 Aerial photos of Woonona vegetation change (Gangaiya et al., 2017)

As described below, a targeted dune vegetation program was undertaken in 1986, with dune vegetation changes shown in Figure 5.6. The earliest aerial photo dates to 1948, and the extent of dune vegetation prior to this is unknown. During the preparation of a coastal zone management plan (CZMP), community concerns were raised regarding excessive dune height, scarping, sightlines for lifeguards and surf life savers and public amenity.

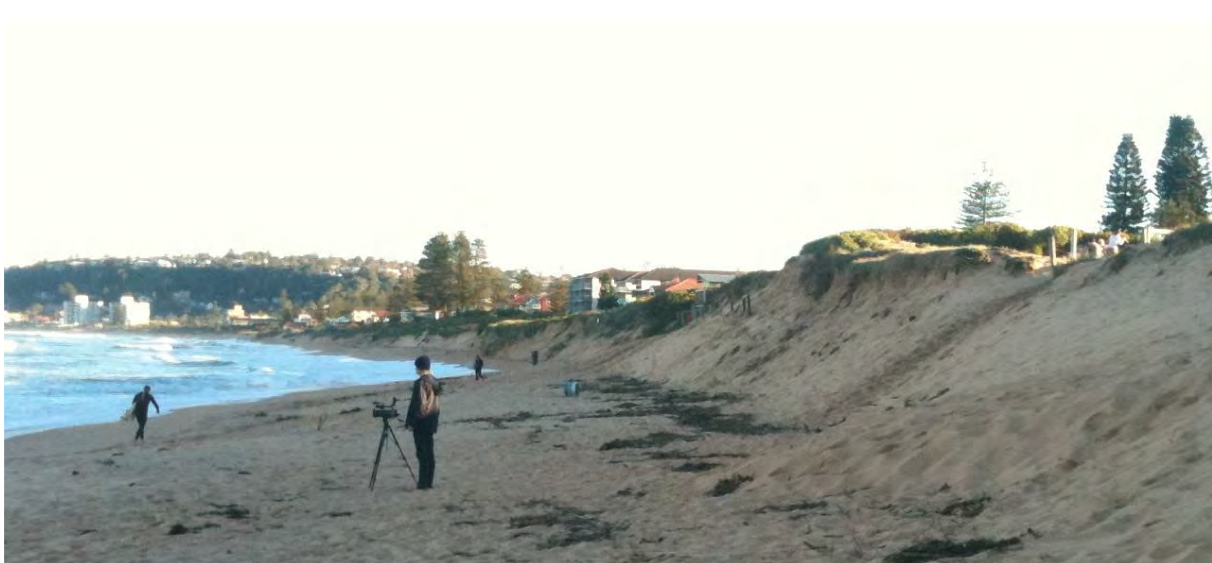
Figure 5.7 Steep dune at North Narrabeen, July 2013 (James Carley)

- Sightlines were no longer available between North Narrabeen SLSC clubhouse and the most dangerous areas of the beach – the lagoon mouth, due to sand and/or vegetation growth. This prevented the casual after hours surveillance by life savers using their clubhouse which underpins many rescues.
- The surf could not be seen from the car park and surrounding public spaces, noting that this is a World Surfing Reserve.
- The dune face was dangerously steep (Figure 5.7).
- The steepness and size of the dune was adversely affecting surf quality.

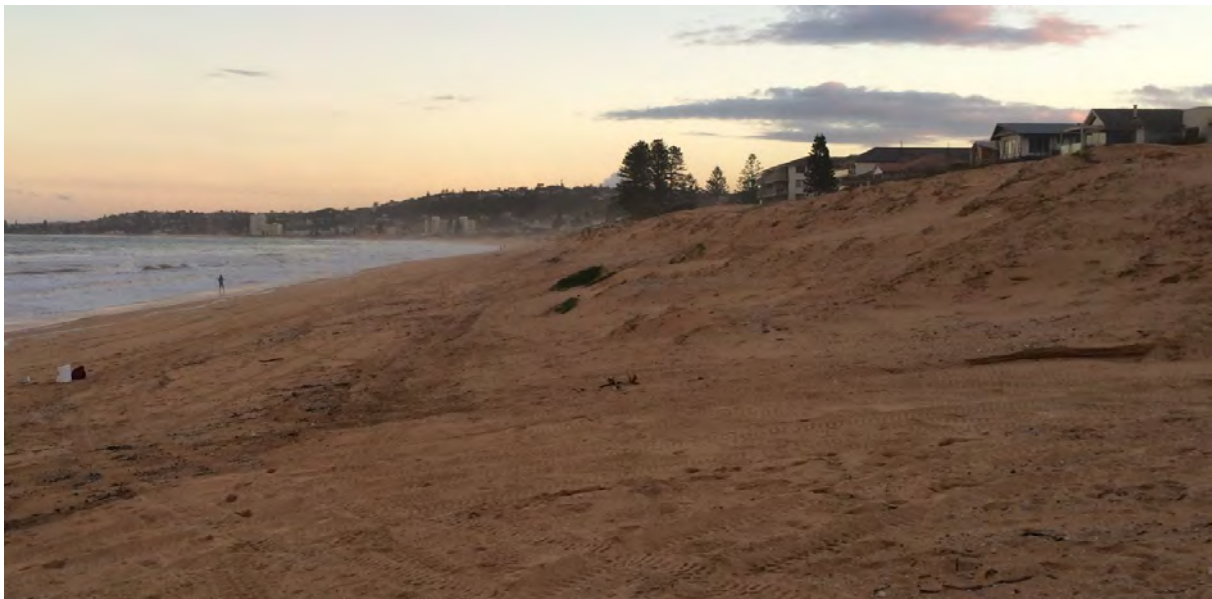
Figure 5.10 Reshaped dune, April 2015 (James Carley)

The steep seaward face was reduced (Figure 5.10) and sightlines between the SLSC clubhouse and danger areas of the beach have now been restored, as have those for viewing the surf from the car park and surrounding public spaces. Surfrider Foundation Australia (2013) had listed North Narrabeen on their list of endangered waves, and expected that the dune alterations would improve the surf quality.

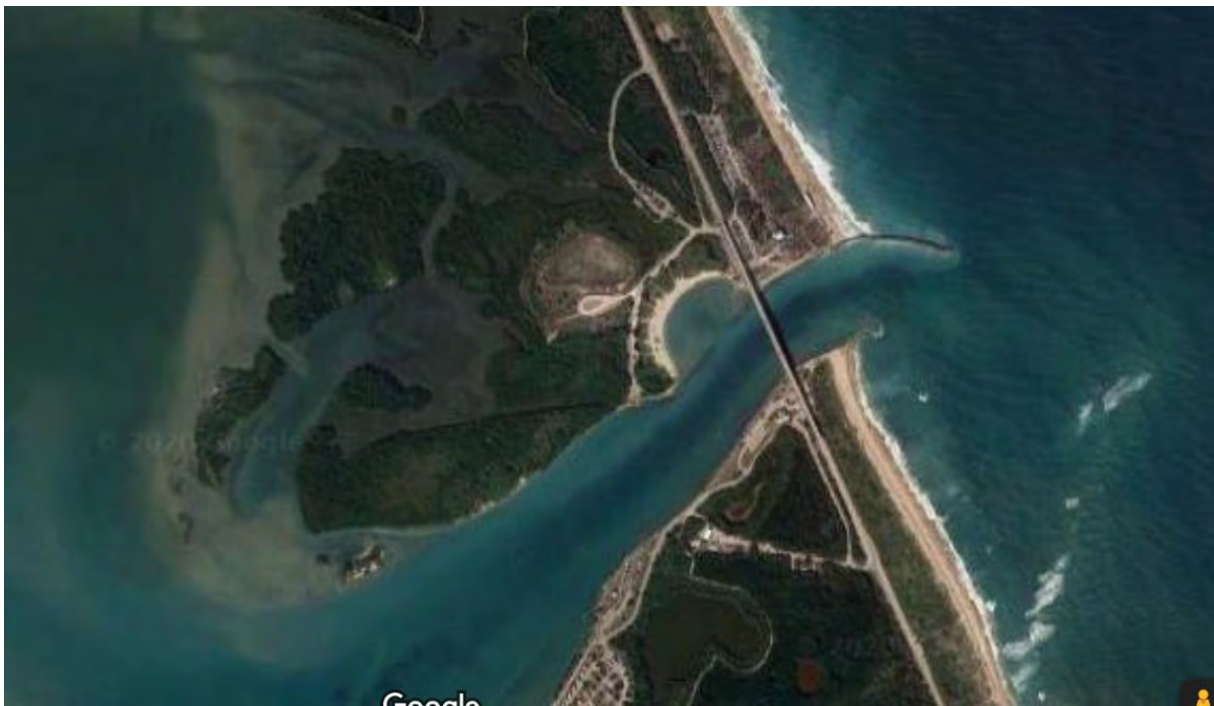
Note curved northern breakwater

Figure 5.12 Sebastian Inlet, Florida USA (Google)

WRL engineers do not have first hand knowledge of Sebastian Inlet, Florida USA (Figure 5.12), but are aware of changes to surf conditions there through various surfing media.

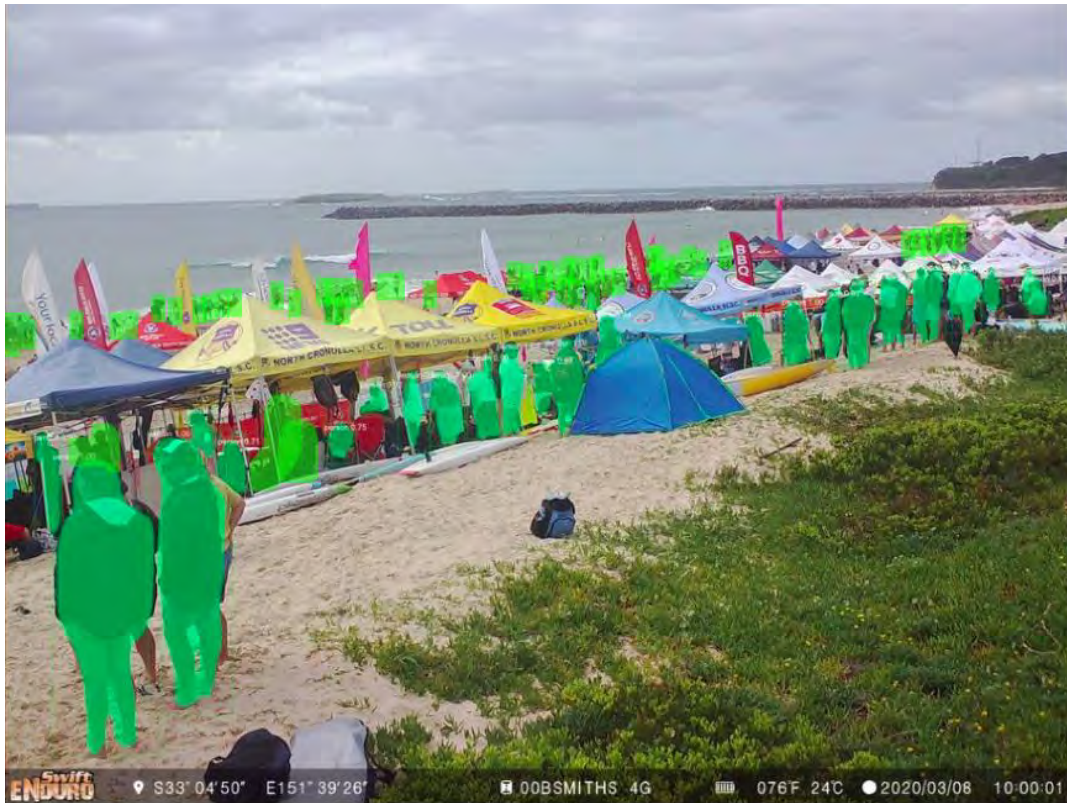
Figure 7.3 December 21 – busiest day between November 10, 2019 and March 19, 2020 at Blacksmiths Beach

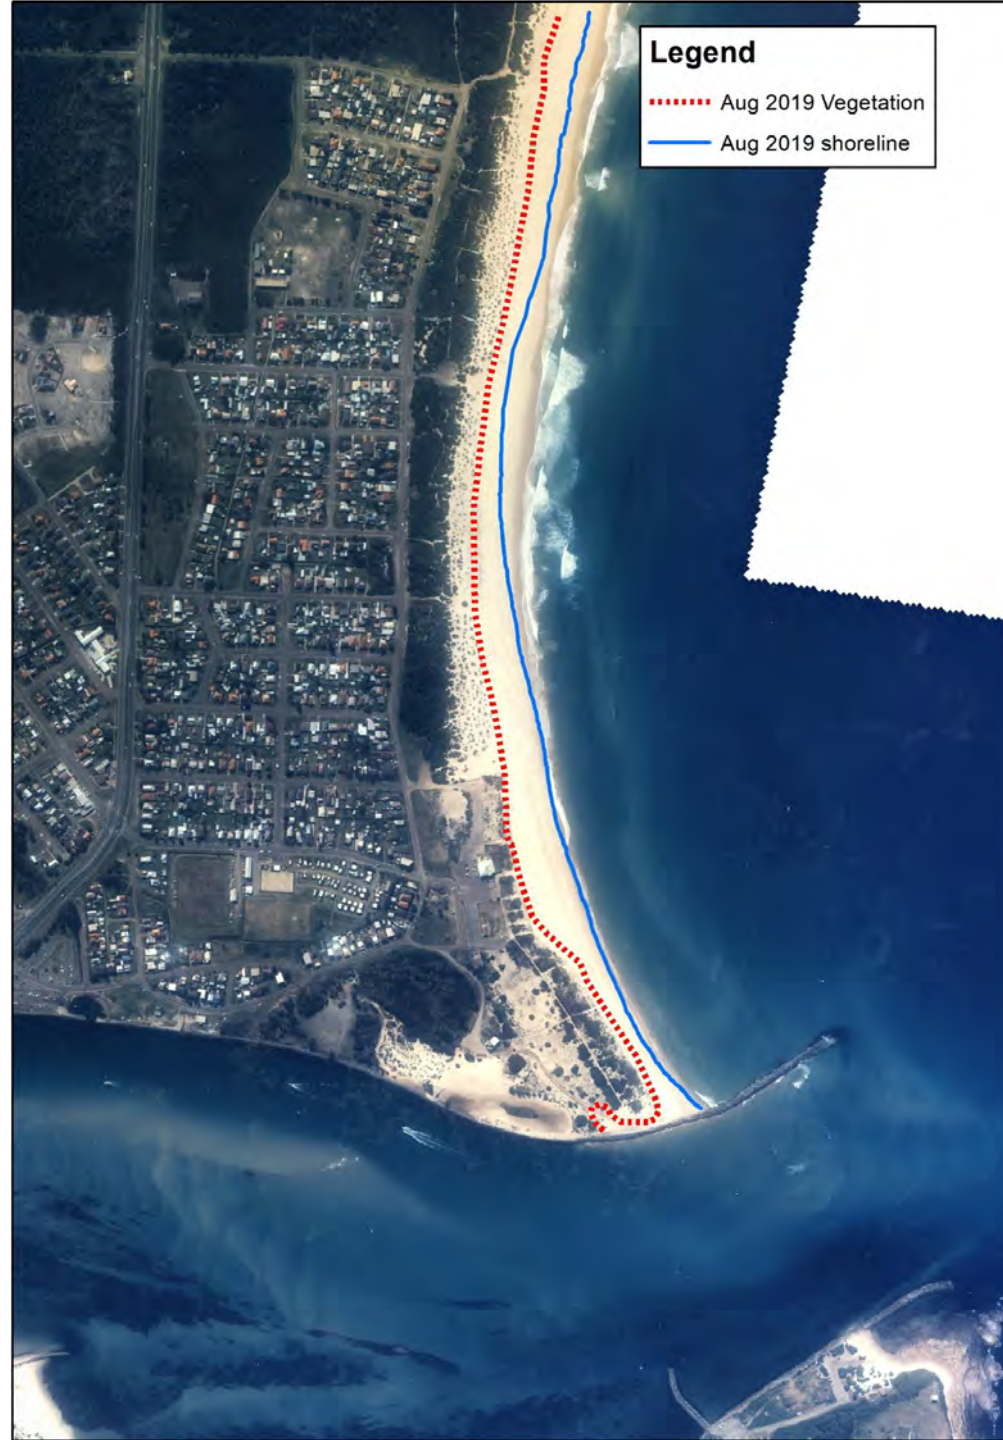
1991

- Revegetation of southern end of beach
- Breakwater is the same as in 1940

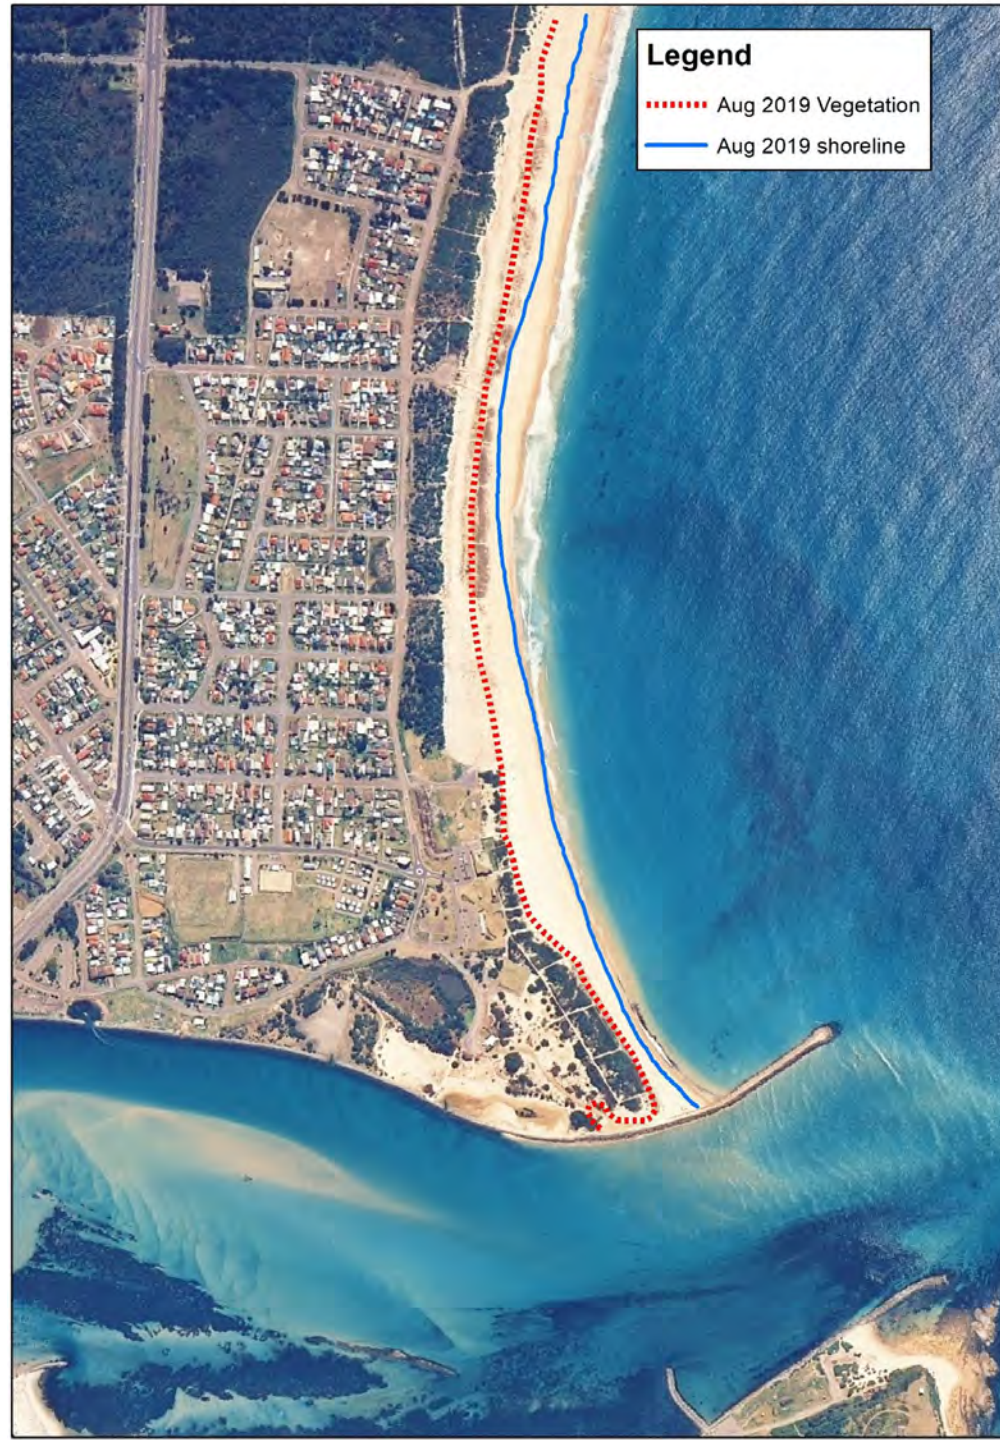
- Breakwater upgrade sometime between 1991 and 1994

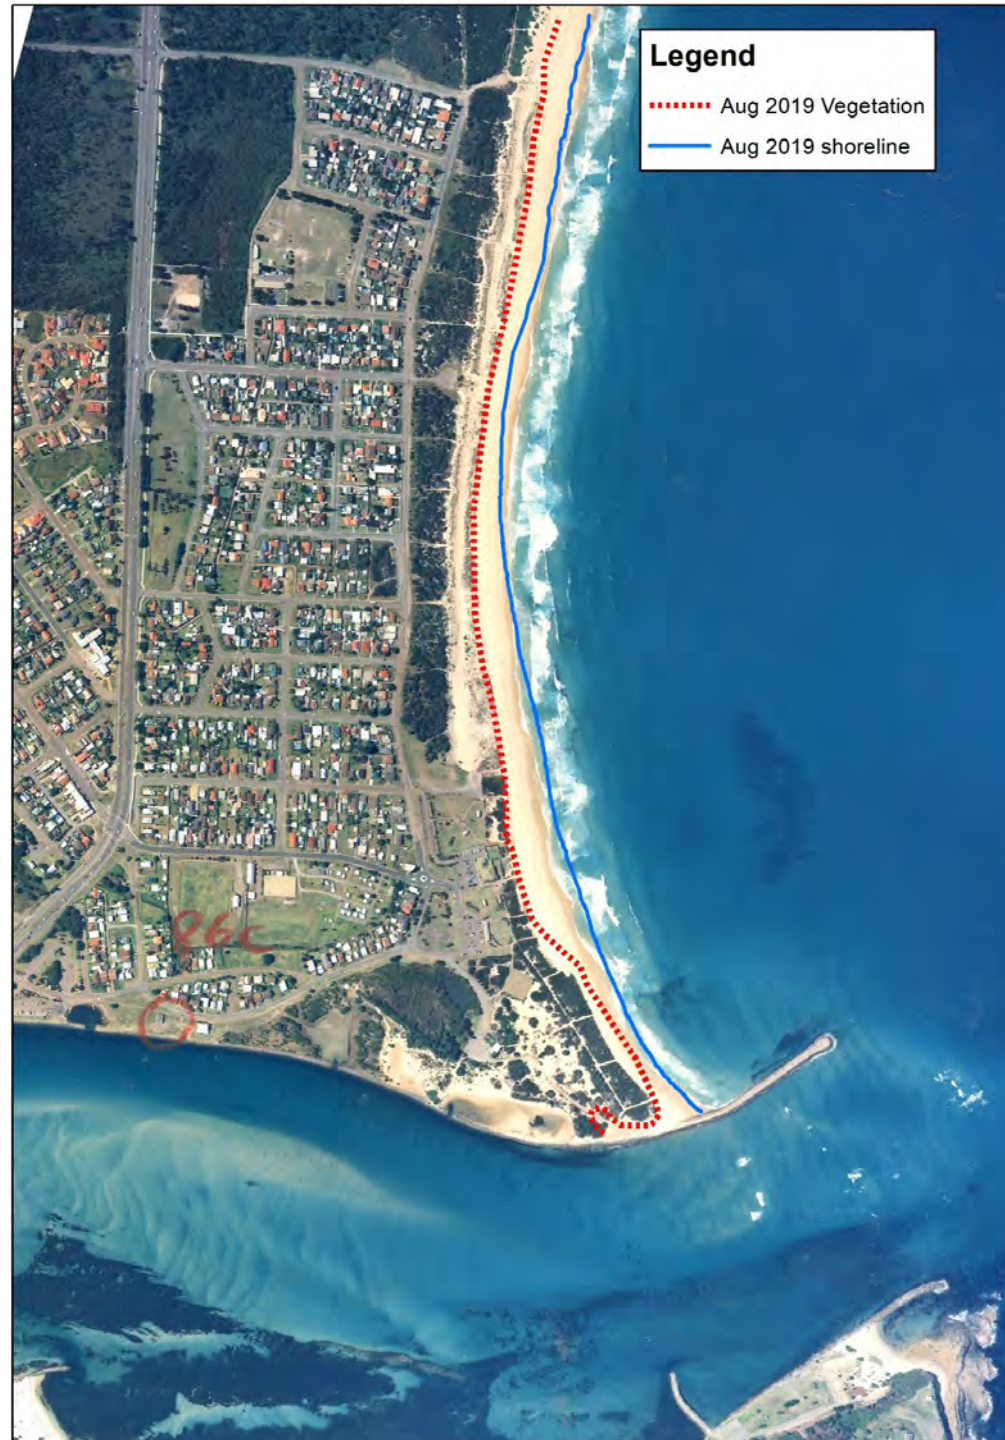
1996

- Beach erosion

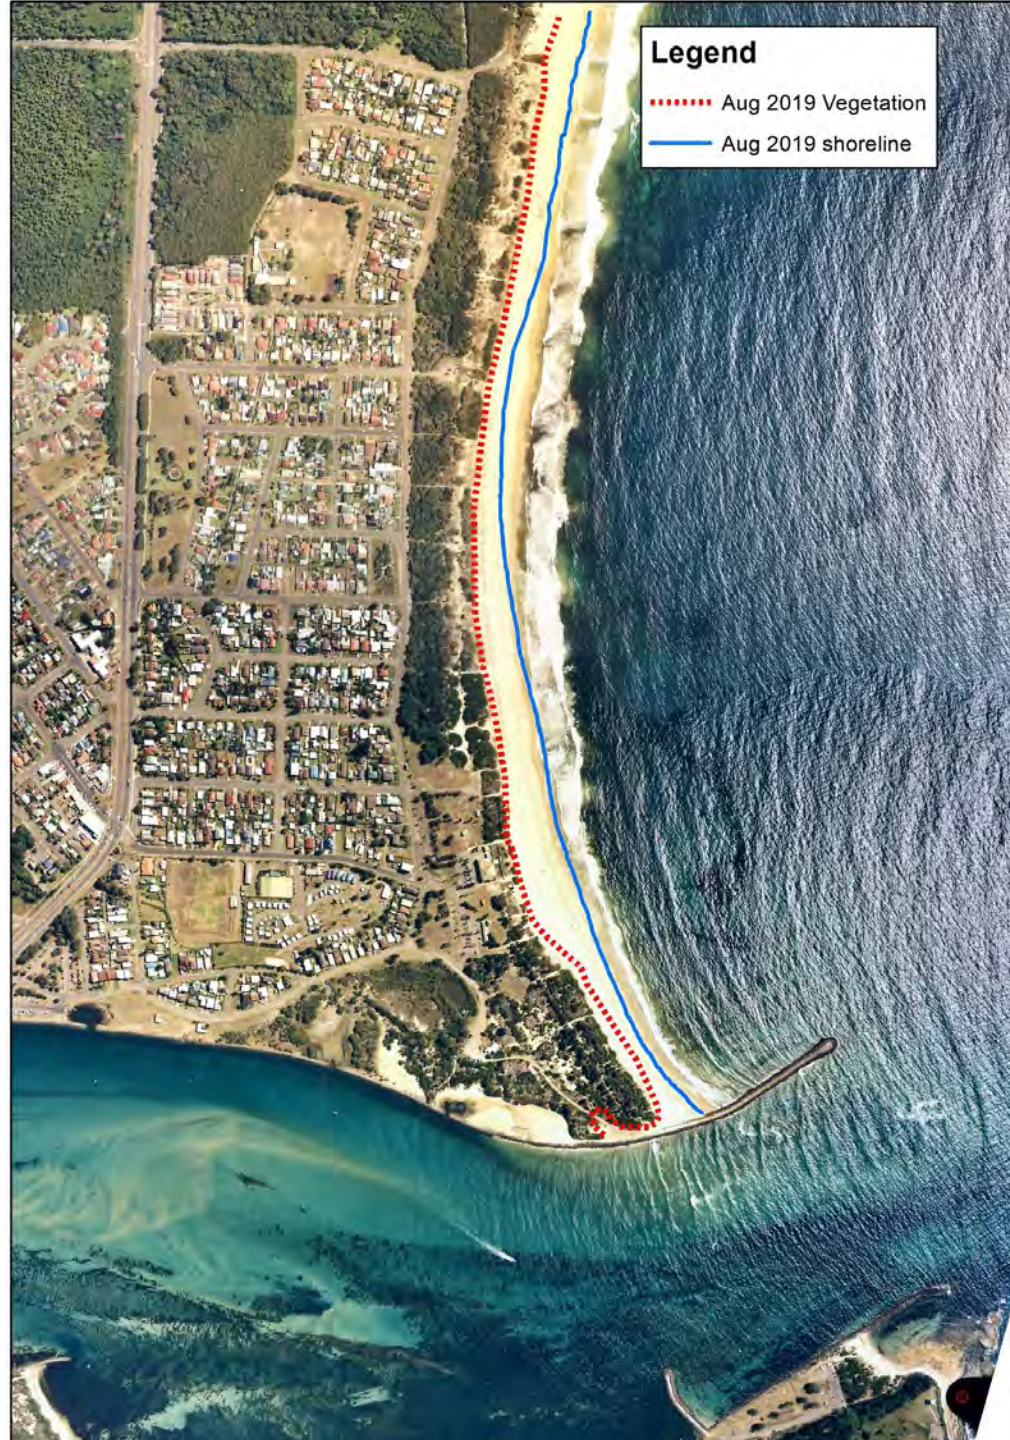
2006

- Sediment accretion since 1999

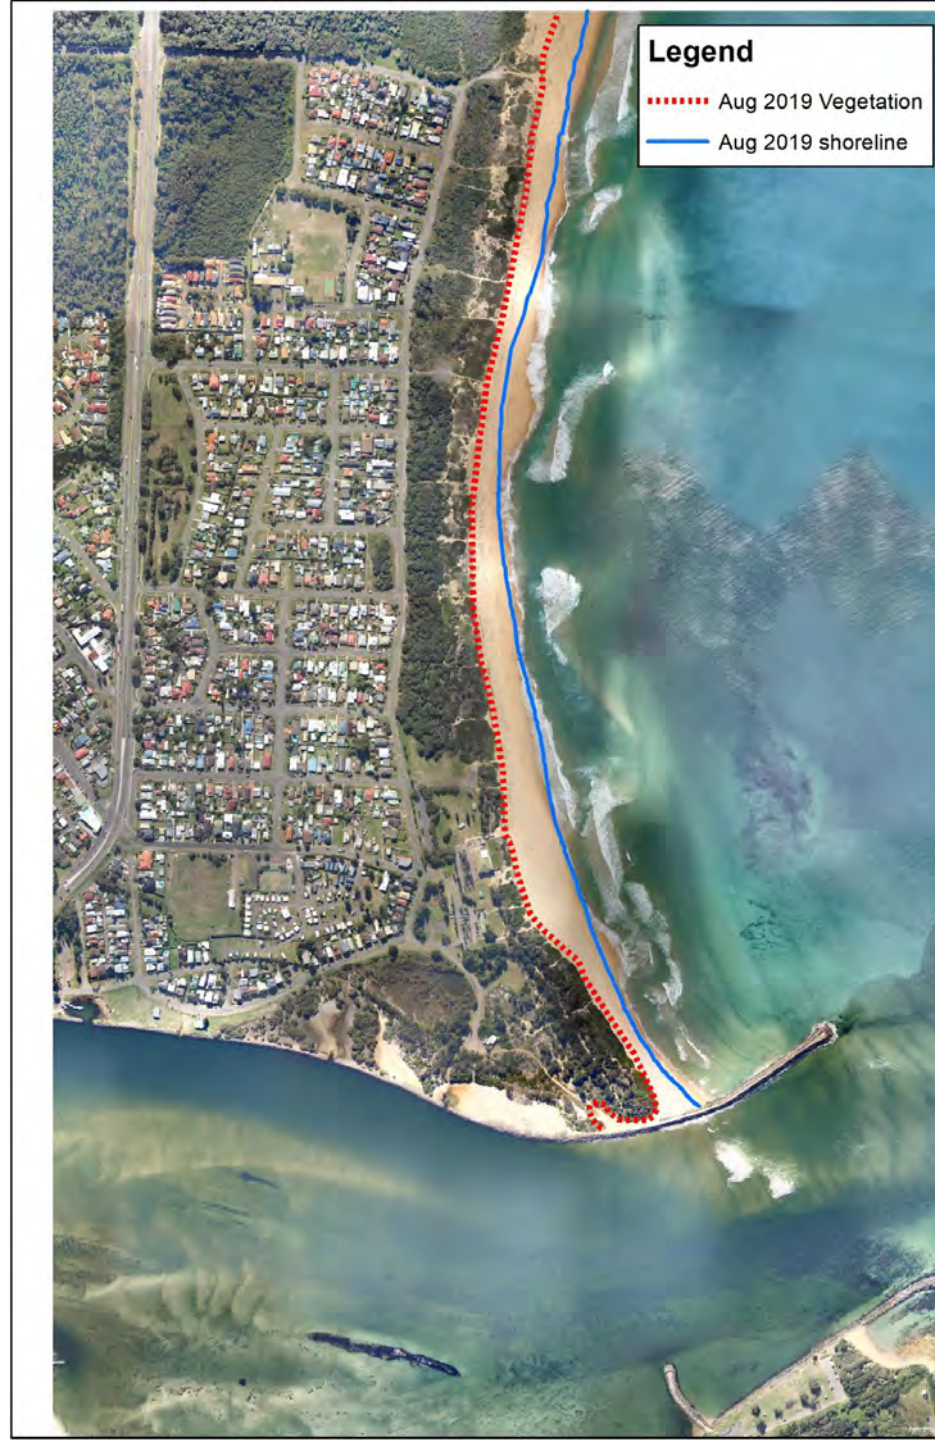
2013

- Sandbar morphology at times – waves breaking out far from shore and at different angles in these conditions

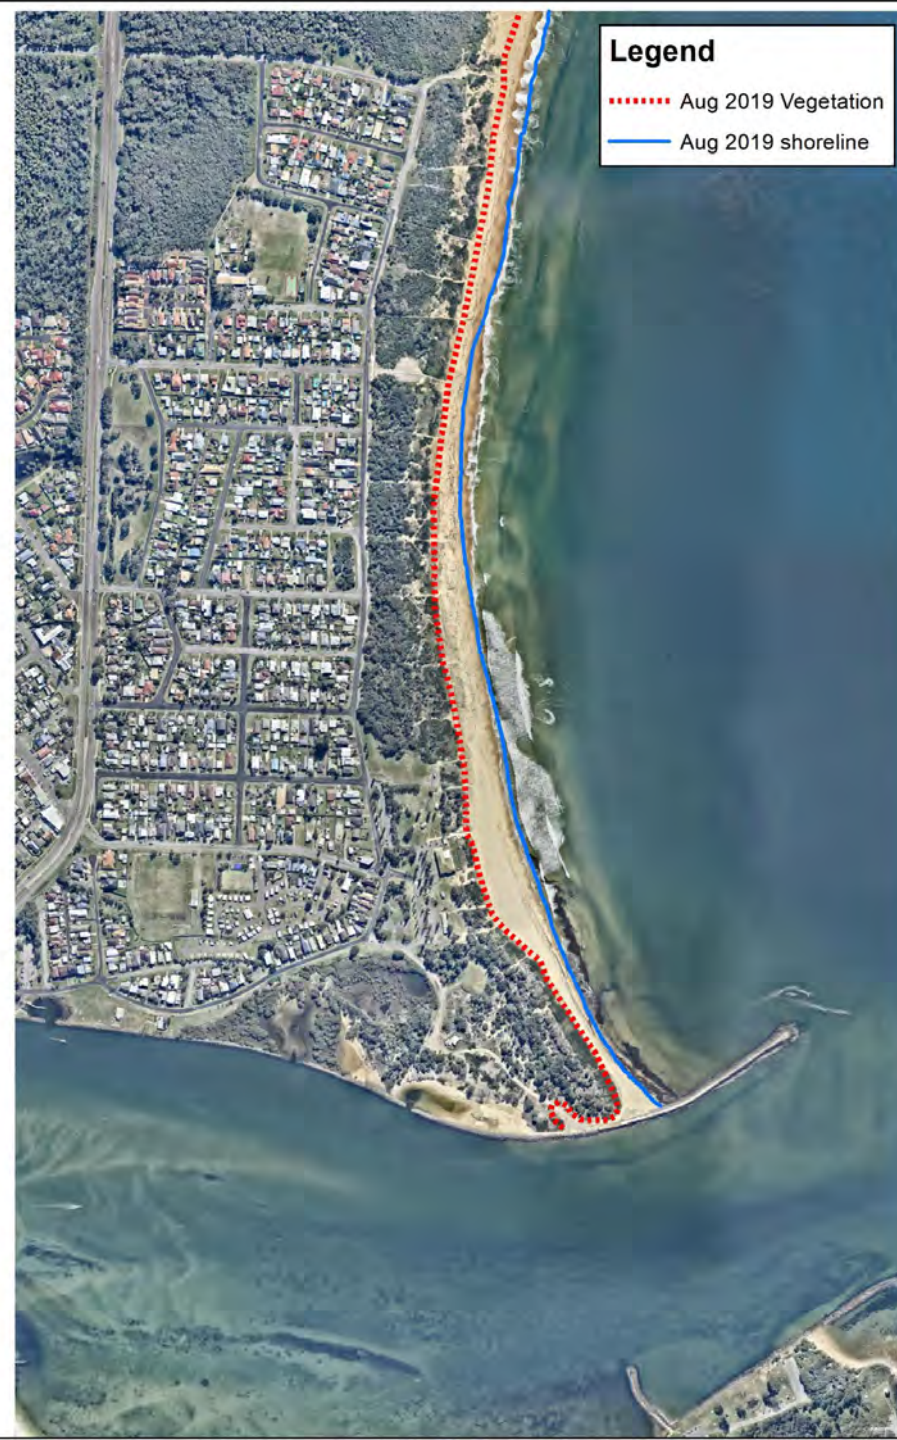
2015

- Breakwater upgrade – same length and width since 1994, just 1m higher and concrete path
