Blacksmiths Beach surf amenity assessment

WRL TR 2020/14, April 2020

UNSW
Water Research
Laboratory

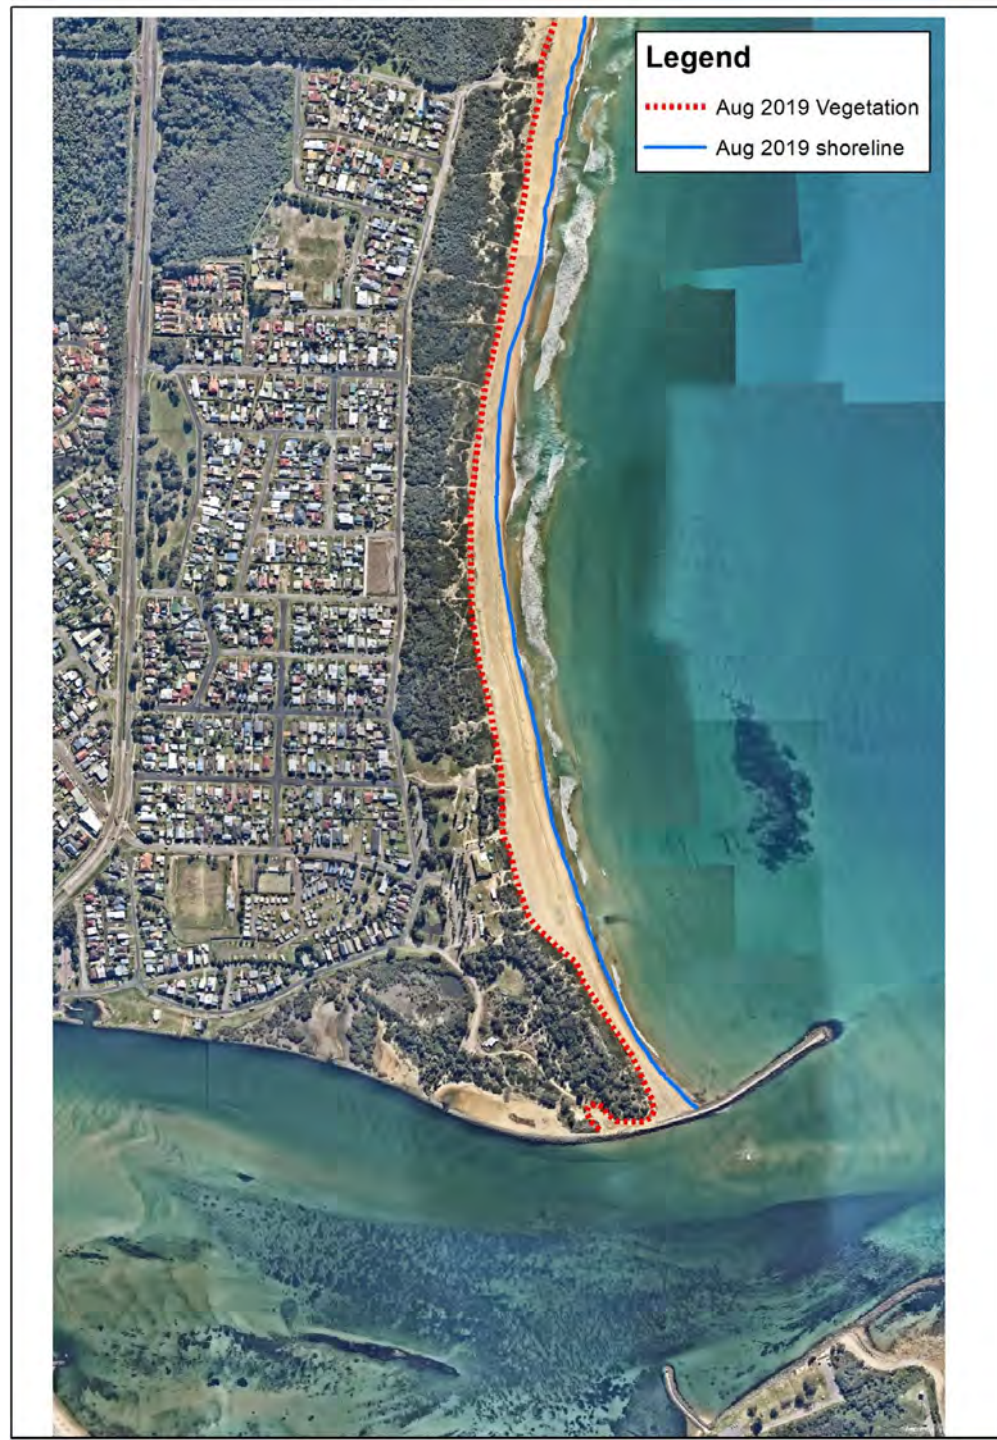
2017

- Sandbar morphology at times
