## Eurobodalla Coastal Hazard Assessment

WRL Technical Report 2017/09  
October 2017

By I R Coghlan, J T Carley, A J Harrison, D Howe, A D Short,  
J E Ruprecht, F Flocard and P F Rahman

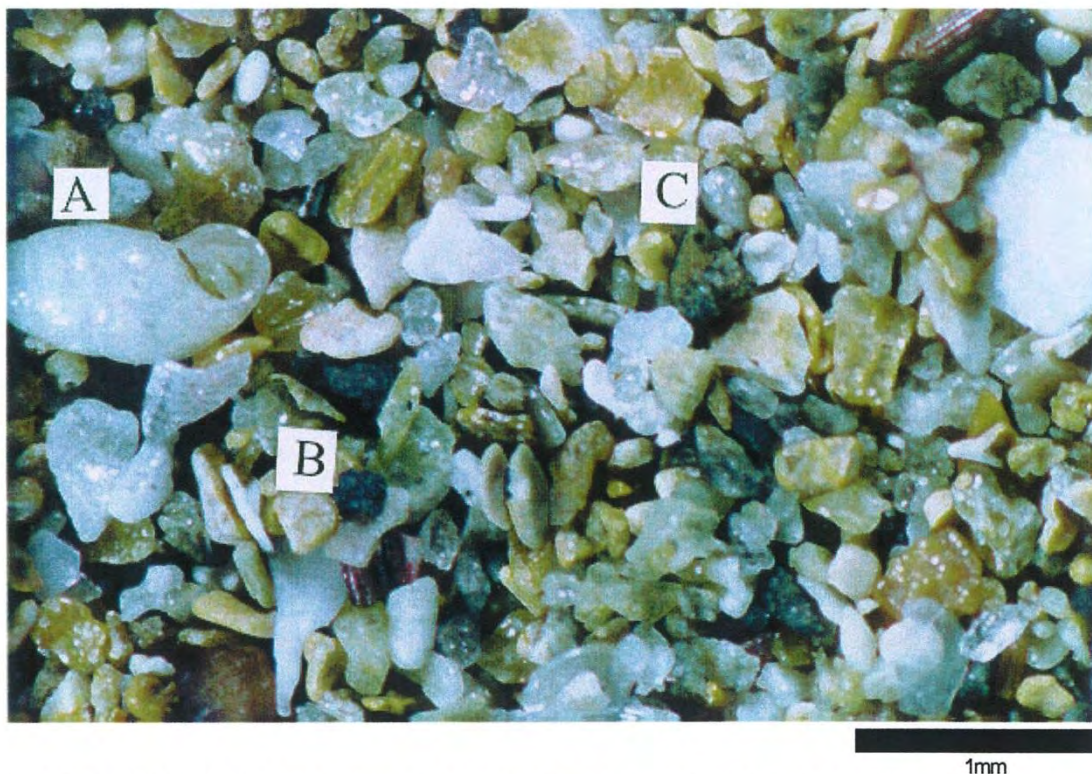
**Figure 2-1: Photomicrograph of a sand sample from the western end of Long Beach identifying carbonate sand (A) and marine quartz (C) (Source: WBM Oceanics, 2000)**

Shelly quartzose beach sand with coarse dark lithic grains and predominantly marine quartz. Carbonate fraction consists of abraded mollusc fragments, whole gastropods (A), sponge spicules, echinoderms and foraminifera. Photomicrograph shows (B) lithic fragment and (C) marine quartz.

During field inspection Campaign 3, WRL collected additional sand samples to test for carbonate content. The dried sediment samples were treated with hydrochloric acid to determine the percentage carbonate content (Table 2-3). These values generally compared well with previous analysis from the Australian Beach Safety And Management Program database (ABSAMP, 2009). This work was undertaken to inform the development of the conceptual sediment transport models (Section ) and particularly to identify the exact location of the significant sediment change between Bengello Beach (marine quartz) and Broulee Beach (carbonate sand), and beaches to the north. Carbonate sand, which is generally fragments of shell material, is derived from the rocks and sea floor immediately adjacent to a beach and supplied onto it in an ongoing fashion. The lithic-quartz sand is derived from both the Clyde and Moruya River fluvial sands, as well as inner shelf sands transported landwards during the sea level transgression. An example photograph, taken using the aid of a microscope, of a sand sample from the western end of Long Beach by WBM Oceanics (2000) clearly shows a mix of carbonate sand and marine quartz (Figure 2-1).

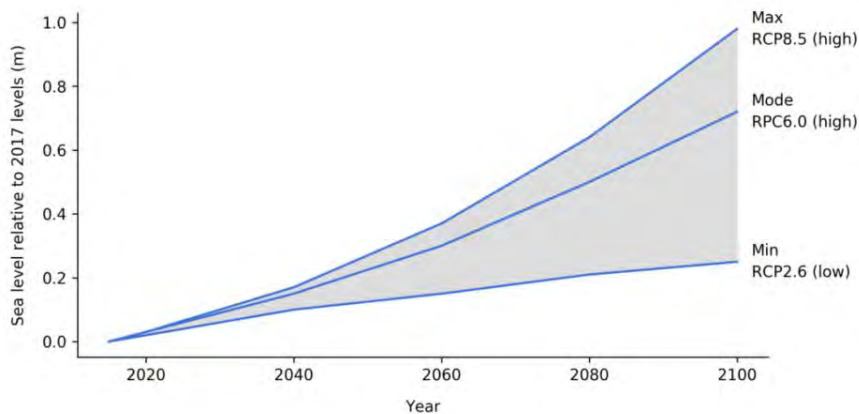
Sea level rise was considered to be uniform across all beaches, with the value in 2100 ranging from 0.24 m to 0.97 m, relative to the 2017 MSL (Figure 6-3). The modal sea level rise trajectory follows ESC's sea level rise policy and planning framework (RCP 6.0, upper bound – Whitehead & Associates, 2014). The minimum and maximum sea level rise trajectories were established to cover the full range of IPCC projections (IPCC, 2013 and 2014), namely, to locally adjusted projections of RCP 2.6 (lower bound) and RCP 8.5 (upper bound), respectively.

**Figure 6-3: Sea level rise input values (Whitehead & Associates, 2014)**

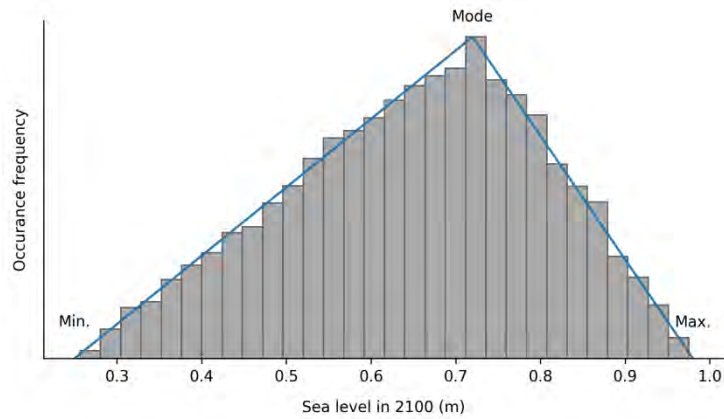
Random values for sea level rise, Bruun factor, and underlying shoreline movement were simulated using triangular distributions (Figure 6-4), with the values from Table 6-1.

**Figure 6-4: Triangular probability density function of sea level rise in 2100**

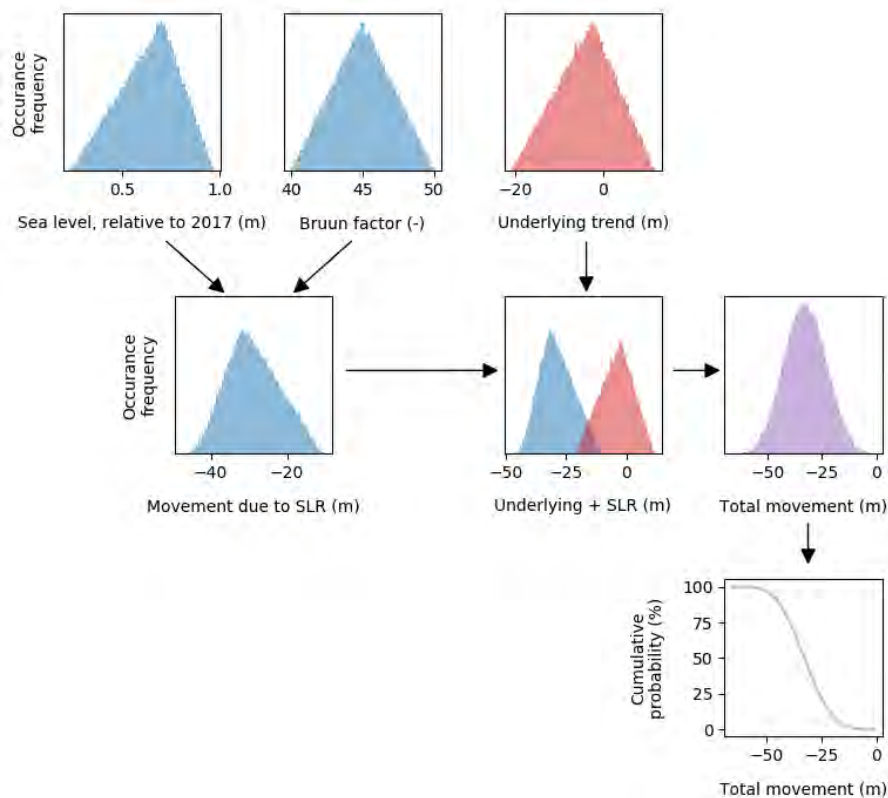
The values for these variables were combined to give a total shoreline movement for each beach. Because the values were combined in a random order with 1,000,000 iterations, the probability density function for the total shoreline movement resembles a Gaussian distribution, rather than a triangular distribution (Figure 6-5). For example, this means that the larger sea levels were only combined with the larger Bruun factors for a small number iterations.

**Figure 6-5: Methodology for combining random values to estimate shoreline movement**

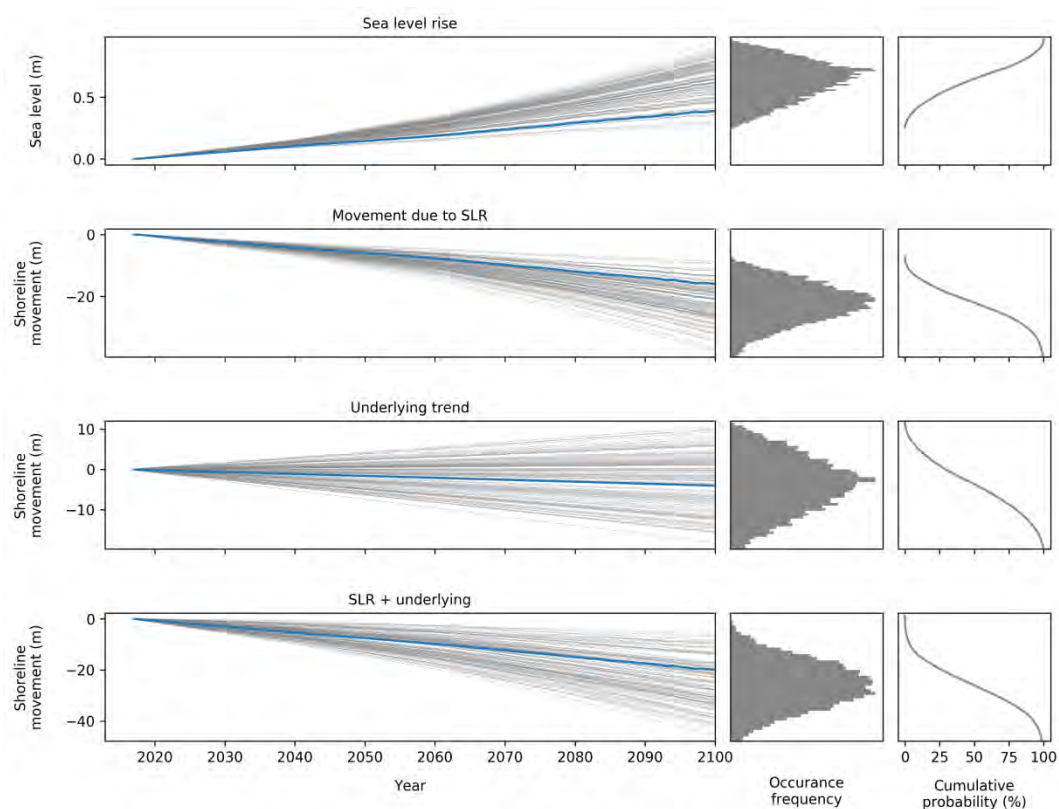
A set of 1,000,000 Monte-Carlo simulations were completed by randomly combining a constant Bruun factor, a discrete underlying shoreline movement rate, and a time-varying sea level rise trajectory, to create 1,000,000 different possible time series (Figure 6-6).

Note: Blue lines represent the shoreline trajectory for a single probabilistic model result.  
Left panels only show the first 100 simulations to minimise clutter.

**Figure 6-6: Simulated trajectories for sea level rise and underlying shoreline movement**

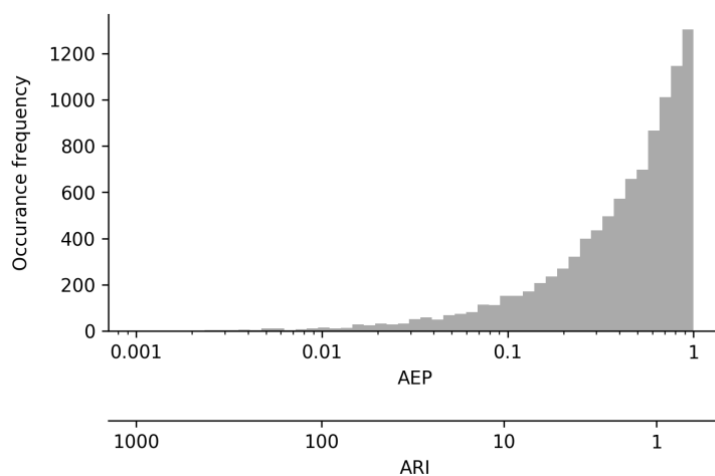
Storm demand probabilities for each year were calculated using a uniform distribution of AEP values along an interval between 0 and 1 (Figure 6-7).

**Figure 6-7: Uniform distribution of AEP values for generating storm demand volumes**

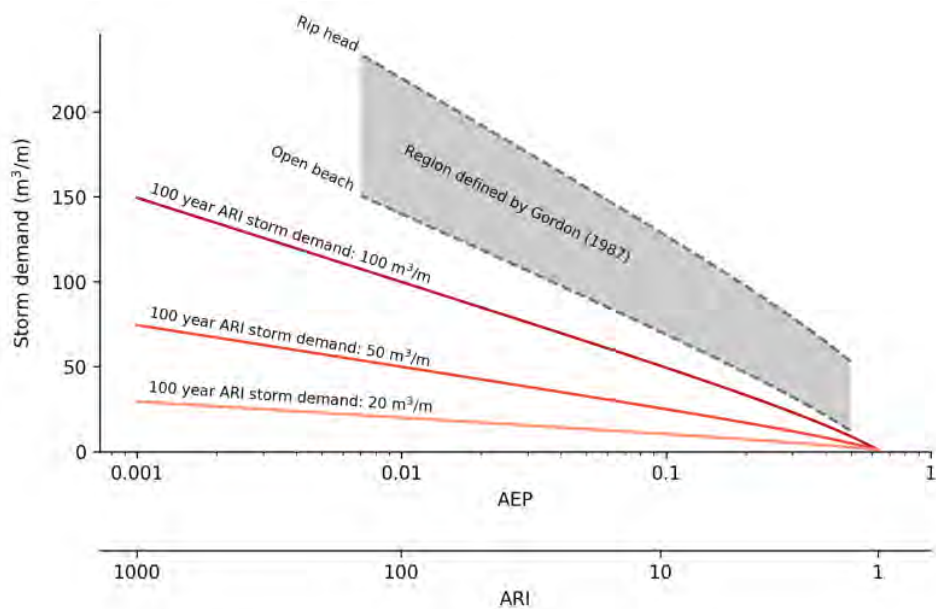
The AEP values were converted to erosion volumes using the method described in Gordon (1987), based on the individual reference 100 year ARI storm demand volume for each beach. The Gordon method is only defined for 100 year ARI storm demand volumes between 140 m<sup>3</sup>/m and 220 m<sup>3</sup>/m. Many of the beaches in this study are somewhat sheltered, and have lower storm demand volumes. The defining equations Gordon (1987) were modified for these somewhat sheltered beaches to ensure that the storm demand was always greater than zero (Figure 6-8, Table 6-3).

**Figure 6-8: Storm demand volumes for exposed beaches in NSW (after Gordon, 1987)**

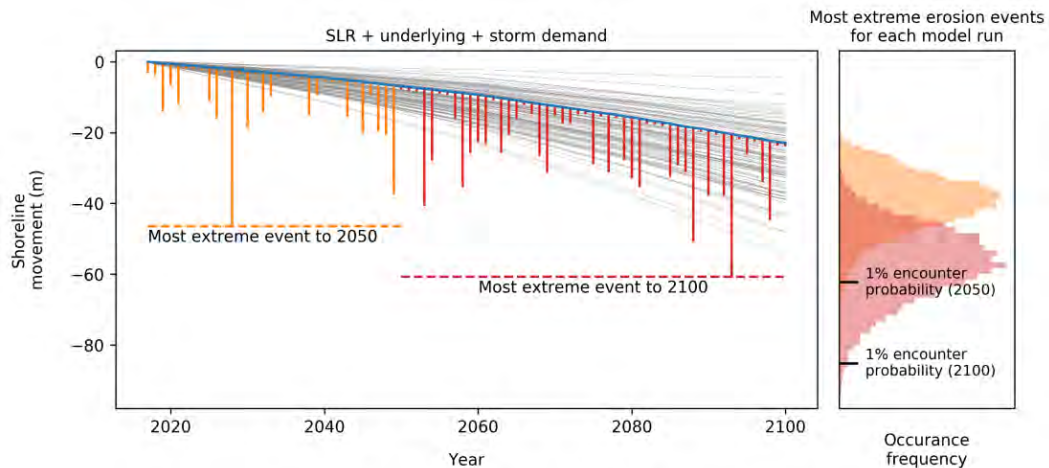
The storm demand volumes were converted to horizontal erosion distances to the back of the ZRFC (Figure 6-2), based on the photogrammetry records for each beach profile. The storm demand was calculated separately for each Monte-Carlo simulation, and was combined with sea level rise, and underlying trend to calculate a receded shoreline position for each year. Each beach was allowed to recover from any storm-driven erosion at the beginning of the year. The most extreme erosion event was identified for all of the different planning periods in each simulation, and the erosion hazard lines were calculated from these events, for each encounter probability (Figure 6-9).

Note: Orange and red bars represent storm demand erosion for a single probabilistic simulation result.

Left panel only shows the first 100 simulations to minimise clutter.

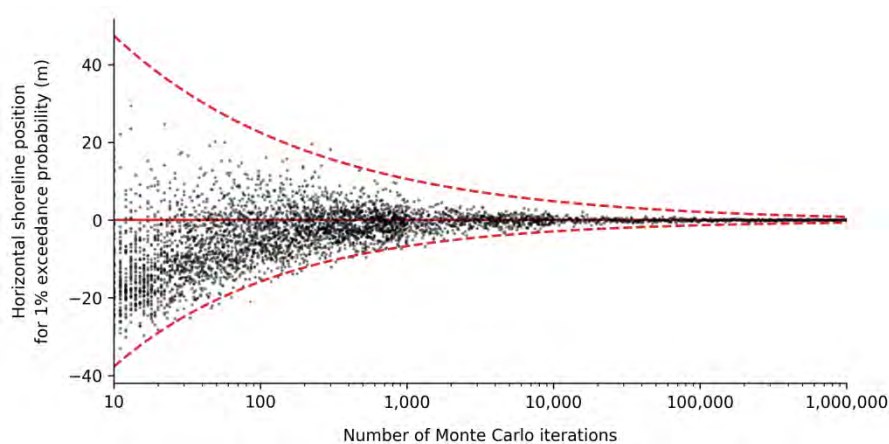
A total of 1,000,000 runs were used for the Monte-Carlo simulation. The sensitivity of this number of runs was tested, and the scatter in the simulated shoreline position was found to be less than 1 m (Figure 6-10).

Note: Each dot shows unique simulation result for the same beach profile.

**Figure 6-10: Sensitivity of Monte-Carlo simulation**

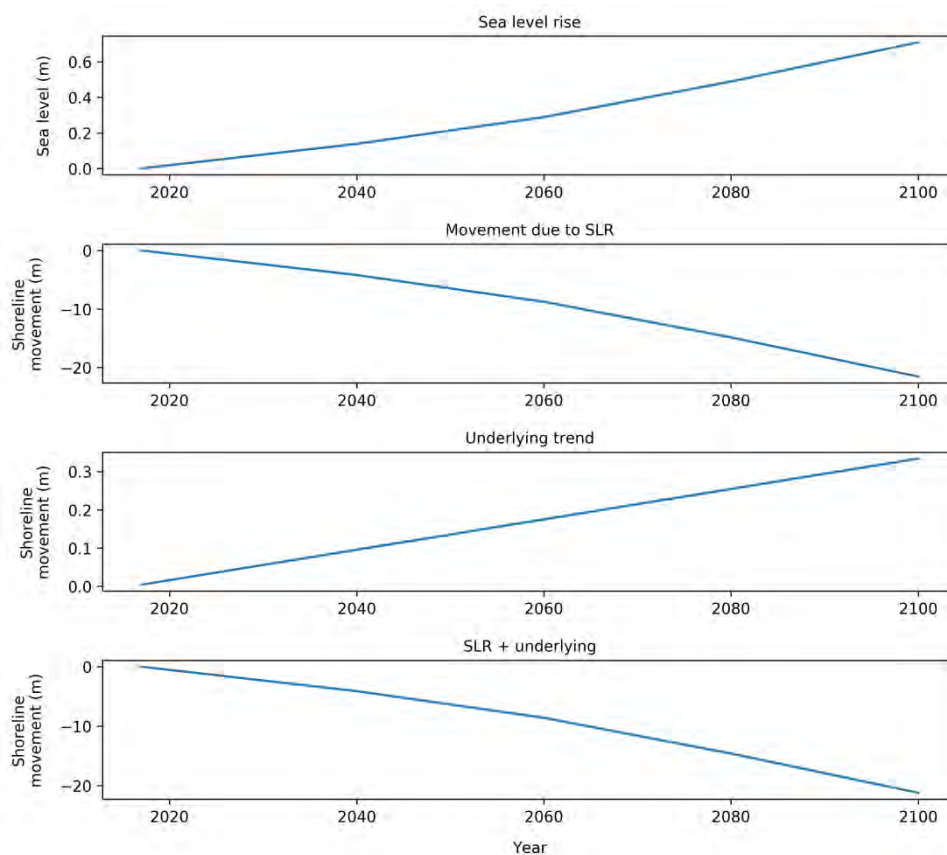
The methodology for the deterministic assessment was similar to that of the probabilistic assessment, but a single value for each parameter was adopted, rather than a range (Table 6-4). This deterministic approach resulted in a single shoreline movement trajectory for each profile (Figure 6-11). The shoreline movement only due to Bruun recession at each beach and for each planning period is tabulated in Table 6-5. A single 100 year ARI storm demand volume was adopted for each beach (Figure 6-12).

**Figure 6-11: Calculated deterministic trajectories for sea level rise and underlying recession**

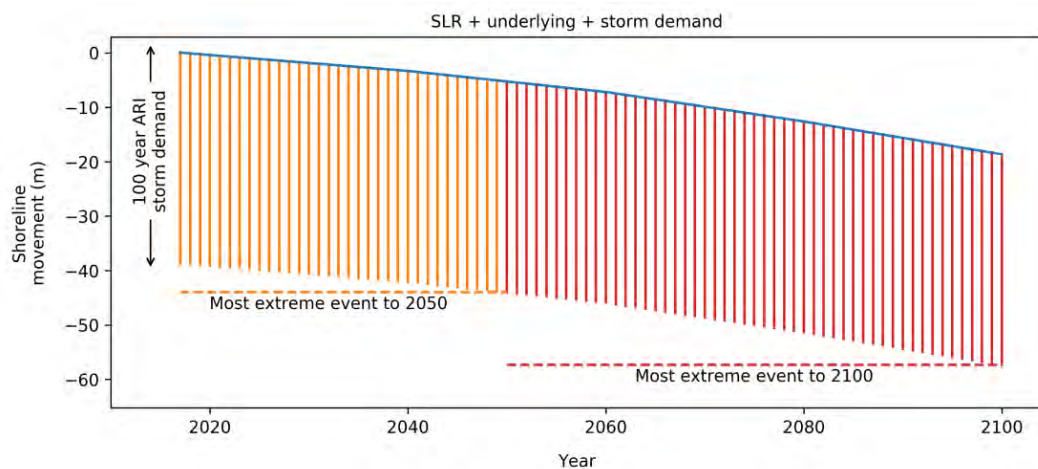
**Figure 6-12: 100 year ARI storm demand superimposed on deterministic shoreline movement**

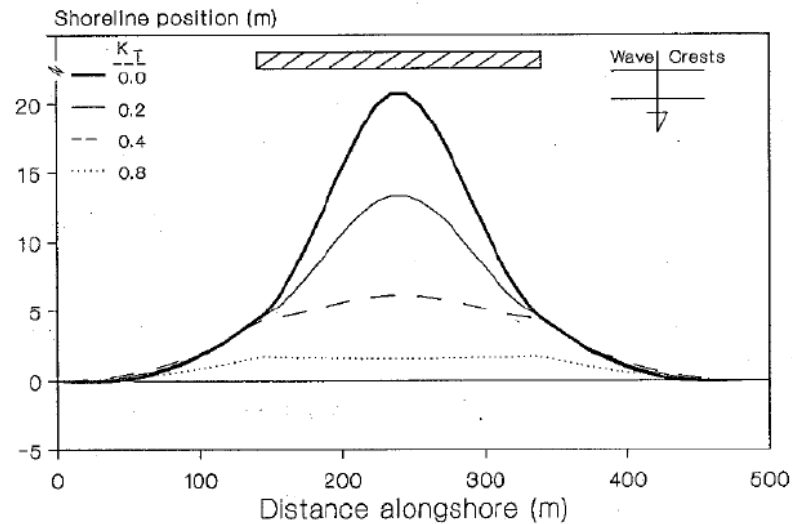
**Figure 6-13: Effect of Wave Transmission ( $K_T$ ) over a reef on the extent of a salient (Source: Hanson et al., 1990)**

At Tomakin Cove only, a “potential salient loss region” notation was included on the erosion/recession maps. This has been mapped qualitatively following consideration of the present day (2017) beach planform and the landward penetration of the erosion/recession hazard lines at the centre of the cove. The rock/reef at the southern end of the cove presently influences the beach planform, and particularly controls the sand salient feature directly in its lee. While it is outside the scope of works to quantify in this study, at some quantum of future sea level rise, this rock/reef will have reduced control over the southern beach planform causing the loss of the coastal area composing the salient. As a result, the shoreline could potentially move landward of the erosion/recession hazard lines in this region. The effect of sea level rise (directly related to wave transmission over a reef) on the salient extent is shown in Figure 6-13. Figure 6-14 also provides an example of the loss of a salient/tombolo controlled by rock reef/island at Woody Bay. While salient loss at Woody Bay was related to reduced sediment supply (rather than sea level rise), it illustrates the dramatic change in planform that may occur with this coastal hazard.

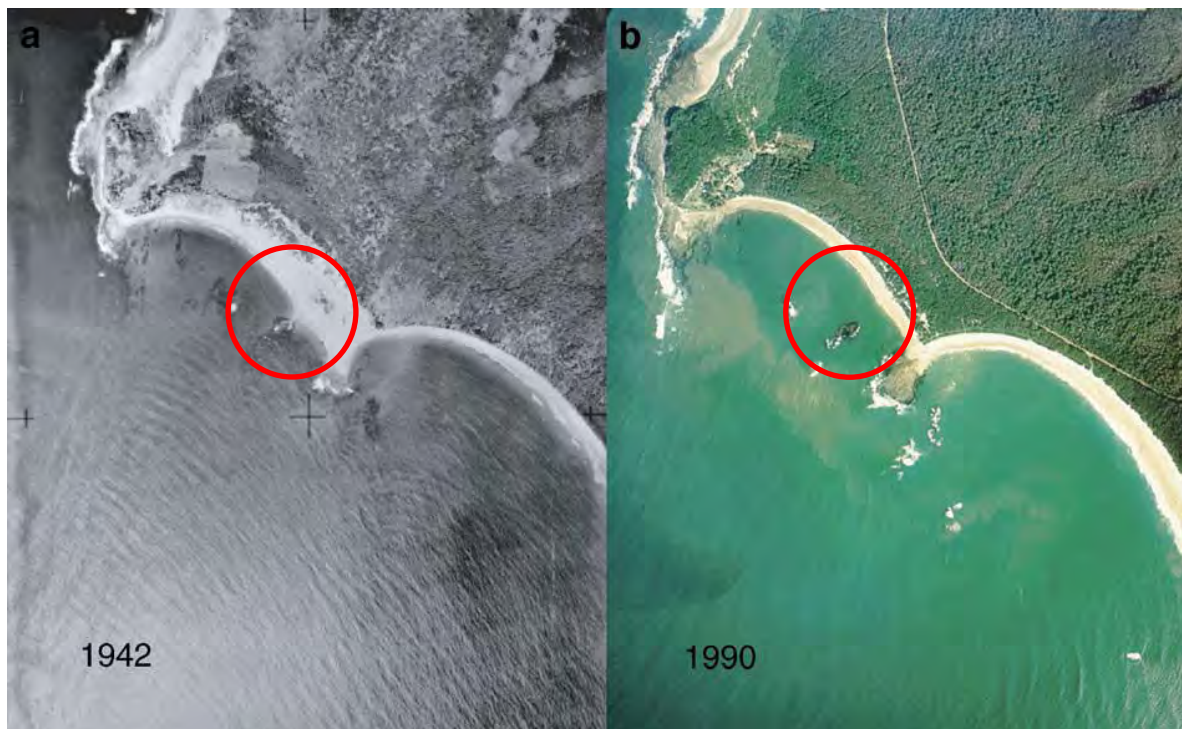
**Figure 6-14: Aerial photographs taken in (a) 1942 and (b) 1990 at Woody Bay, NSW illustrates an example of salient loss. (Source: Goodwin et al., 2006)**

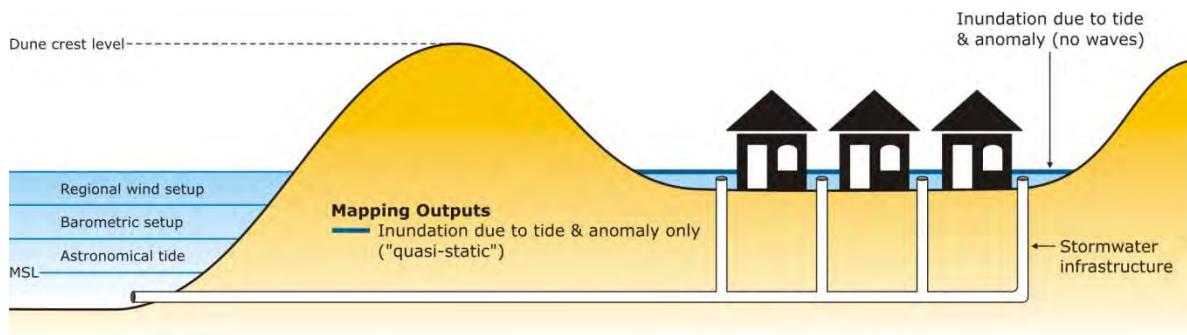
Tidal inundation is the extent to which the land around the coastline is inundated by regular tide events without any further allowance for additional elevated components (storm surge, river flooding, wave setup or wave runup). It represents the level of nuisance flooding inundation that can be expected in low-lying coastal areas from tidal events. Tidal inundation is presented for the High High Water Solstices Springs (HHWSS) water level and the 63% AEP (1 year ARI) water levels (astronomical tide and anomaly but excluding wave effects - Figure 7-1) for present day (2017), 2050, 2065 and 2100 projected conditions.

- The influence of additional local wind setup on tidal inundation may also require assessment.
- Where coastal entrances are located in the vicinity of beaches being assessed, the influence of fresh water flooding coincident with tidal inundation may also require assessment.

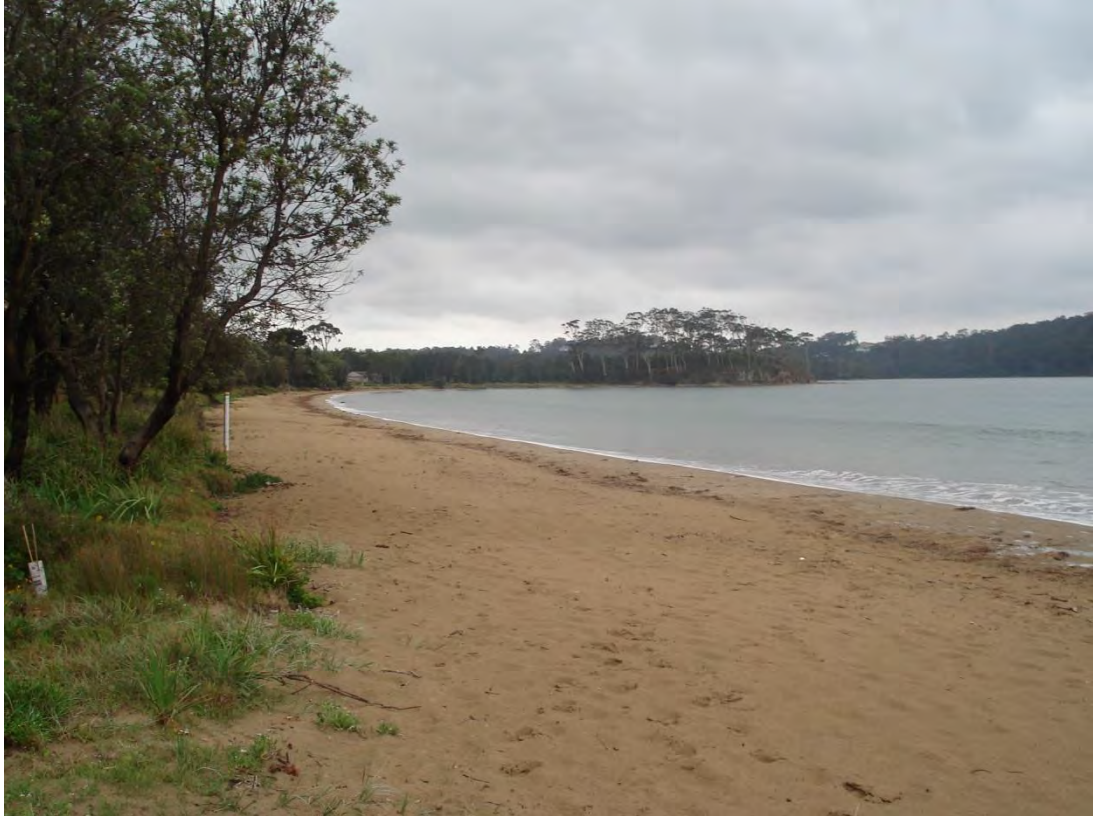
In support of a report prepared by Watson and Frazer (2009), Mr Norman Lenehan of ESC photographed a large spring tide event on 12 January 2009. The water level peaked at 1.00 m AHD at 9:00 (AEDST) at the Princess Jetty tide gauge in Batemans Bay and coincided with relatively calm wave conditions. Example photographs at, or close to, this water level (which is higher than HHWSS but lower than the 1 year ARI water level) are shown for several locations within Batemans Bay in Figure 7-2, Figure 7-3, Figure 7-4 and Figure 7-5.

**Figure 7-2: Surfside Beach (east): 1.0 m AHD Water Level - 12 January, 2009 (ESC, 2009)**

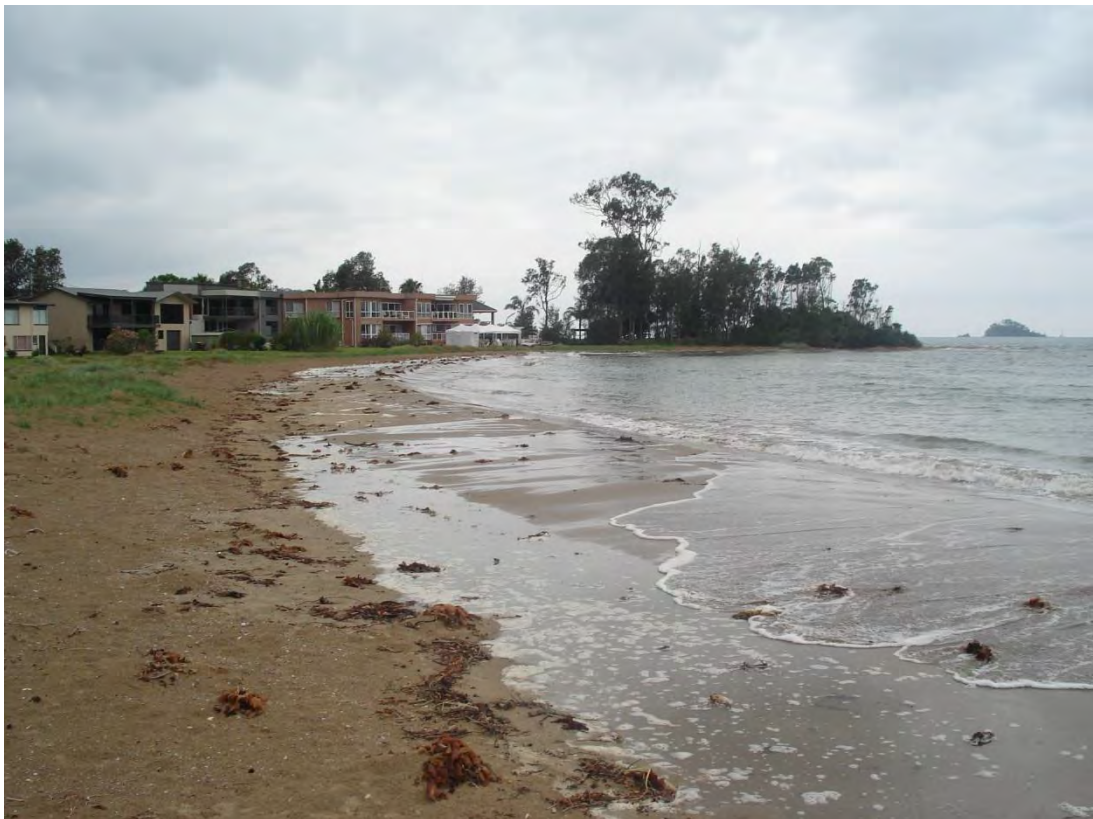
**Figure 7-3: Surfside Beach (west): 1.0 m AHD Water Level - 12 January, 2009 (ESC, 2009)**

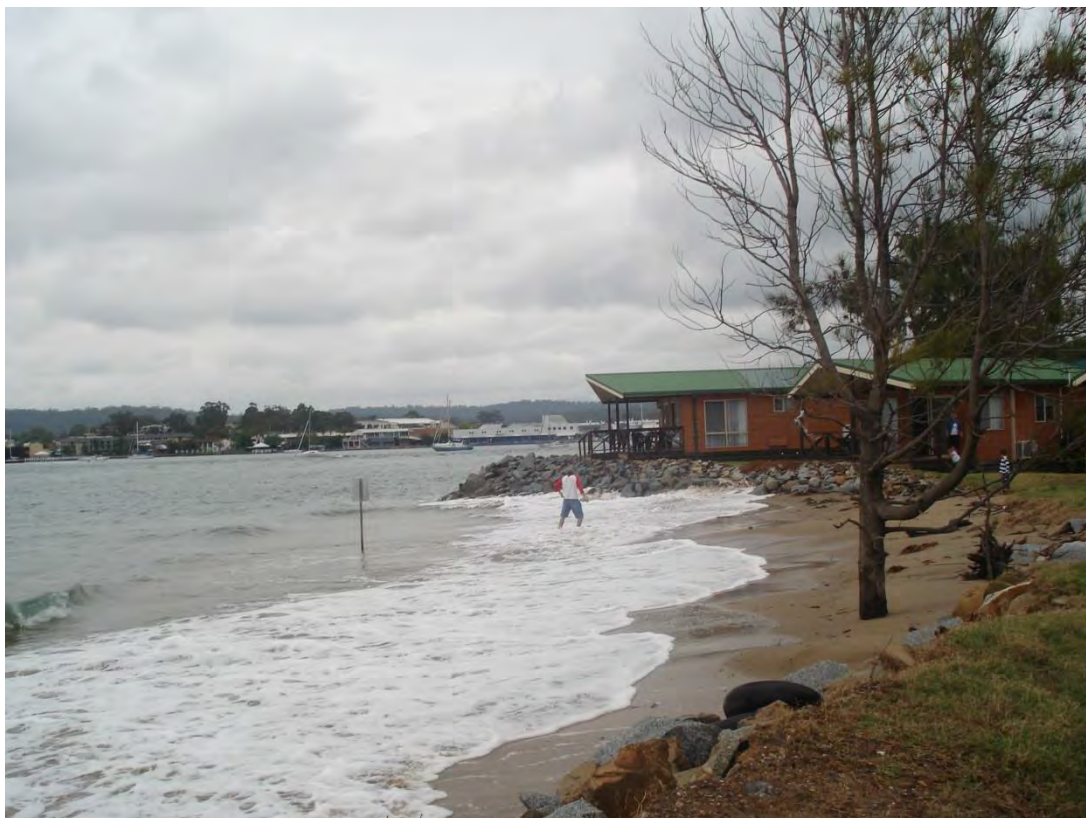
**Figure 7-4: Wharf Road: 1.0 m AHD Water Level - 12 January, 2009 (ESC, 2009)**

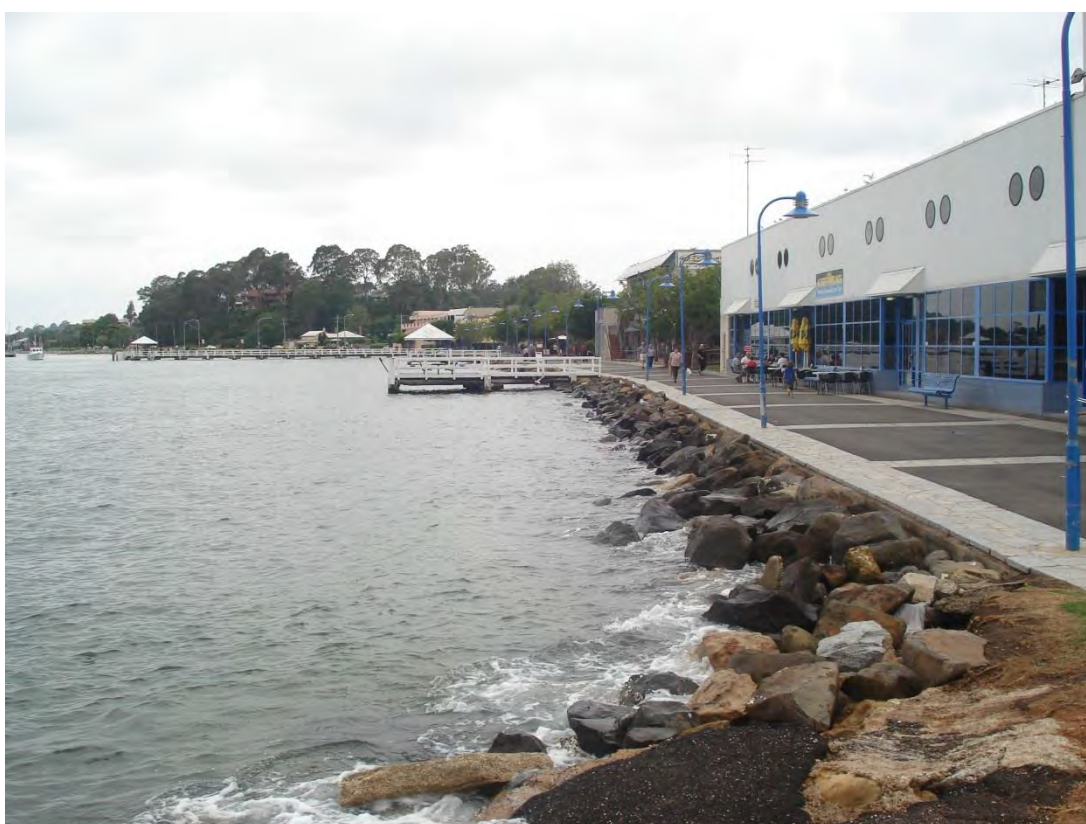
**Figure 7-5: Central Business District: 1.0 m AHD Water Level - 12 January, 2009 (ESC, 2009)**

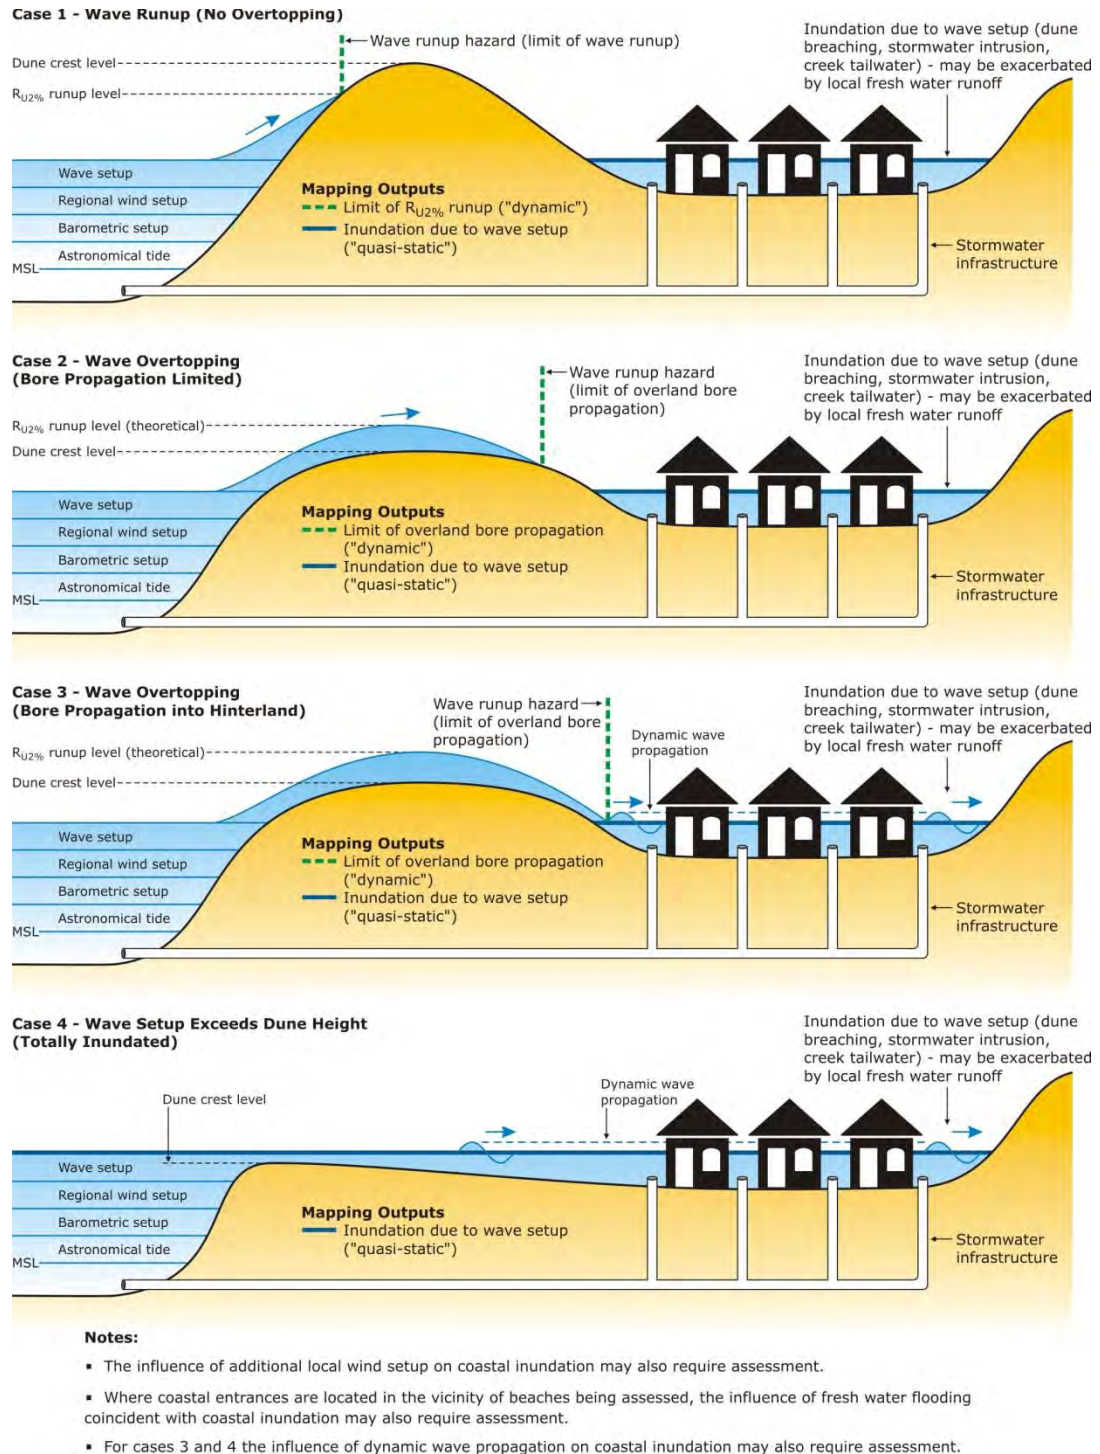
Coastal inundation is the flooding of coastal areas by ocean waters and is typically caused by elevated water levels combined with extreme waves impacting the coast. Figure 8-1 diagrammatically represents the different components contributing to coastal inundation.

Figure 8-1: Components of Coastal Inundation

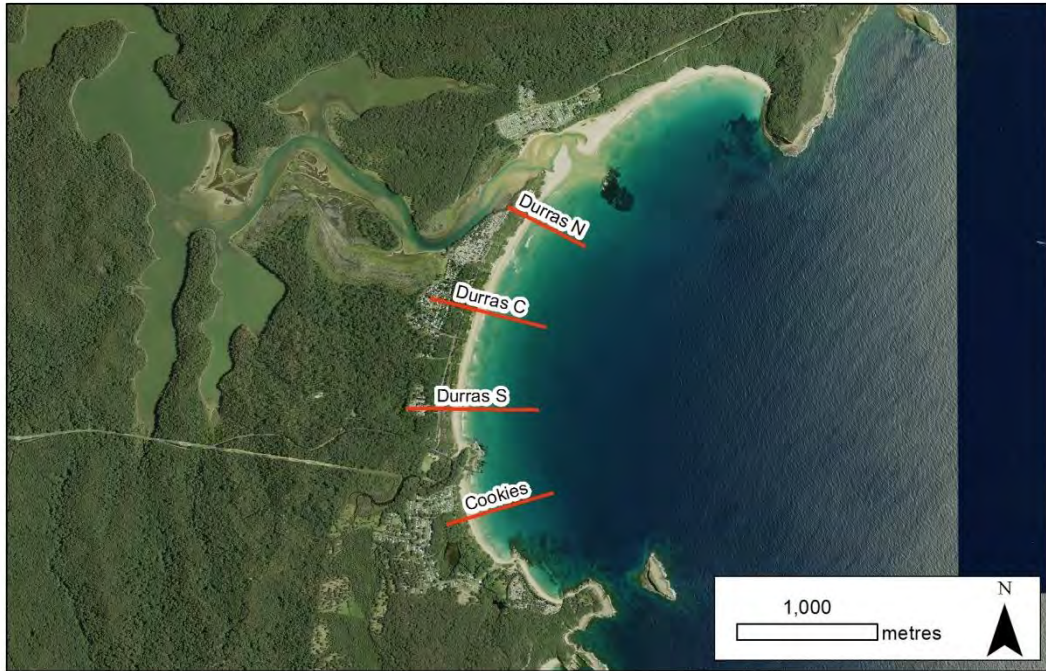
**Figure 8-2: SBEACH profiles - northern area**

These wave heights, along with the corresponding peak spectral periods, were applied as a boundary condition to the Dally, Dean and Dalrymple (1984) two-dimensional surf zone model, implemented using the numerical modelling software SBEACH (Version 4.03). At each of the 35 profiles, topographic (LiDAR) and bathymetric data (nearshore bathymetric surveys and Australian Hydrographic Service bathymetry) were extracted as an input to the SBEACH model. The resultant water level was then extracted to determine the wave setup at each profile, an example of which is shown in Figure 8-5 for 1% AEP conditions at Malua Bay.

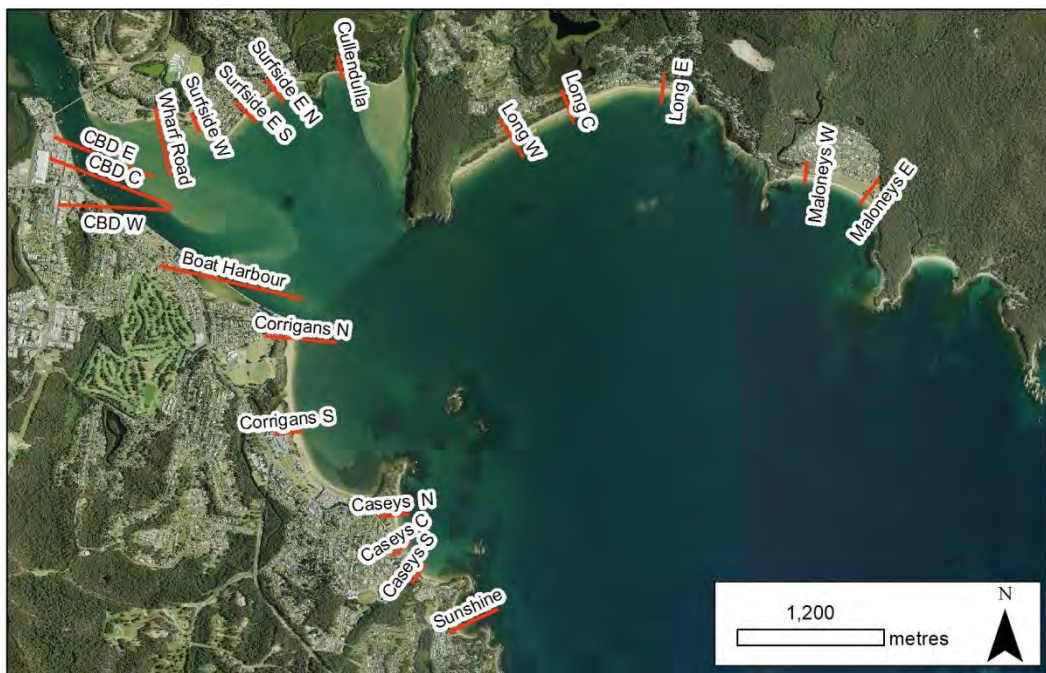
**Figure 8-3: SBEACH profiles - inner Batemans Bay**

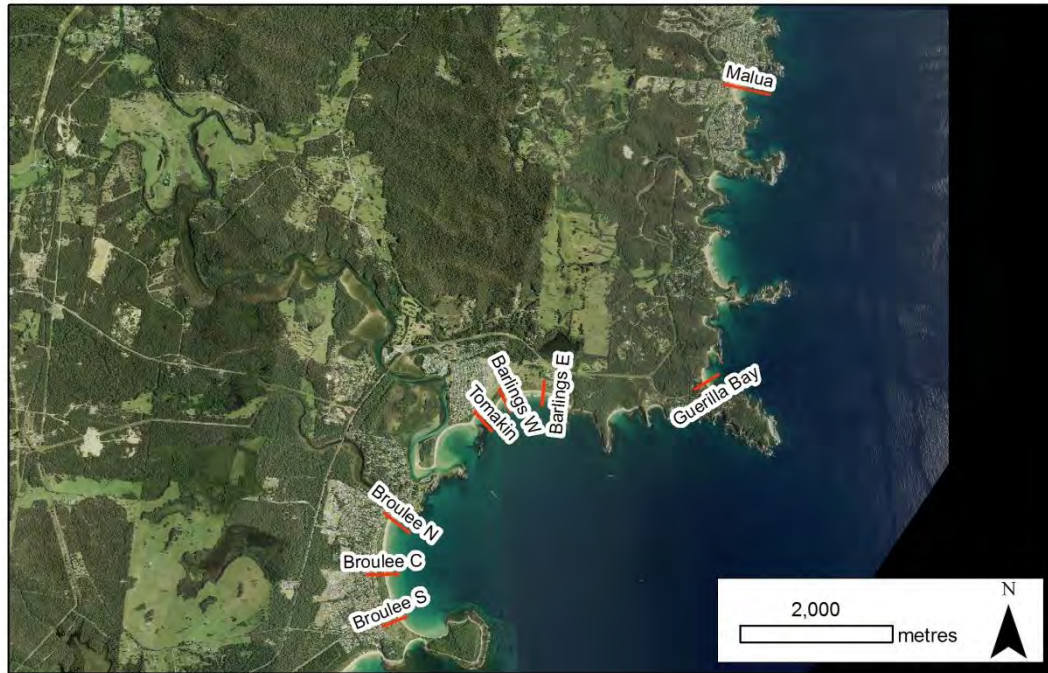
**Figure 8-4: SBEACH profiles - southern area**

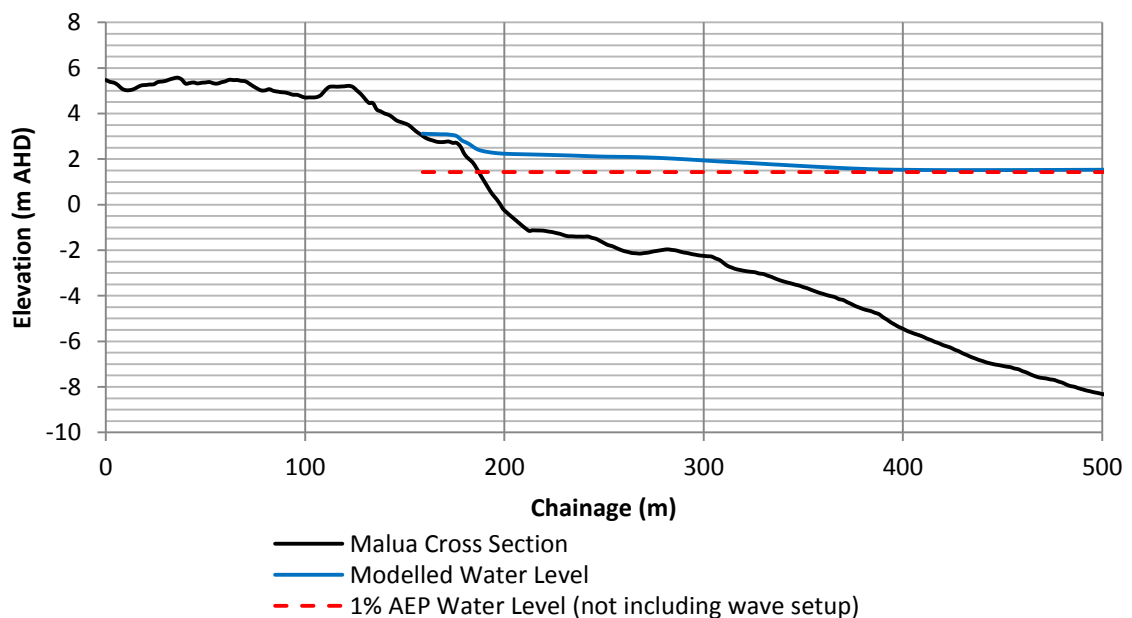
**Figure 8-5: Example of SBEACH wave setup modelling at Malua Bay**

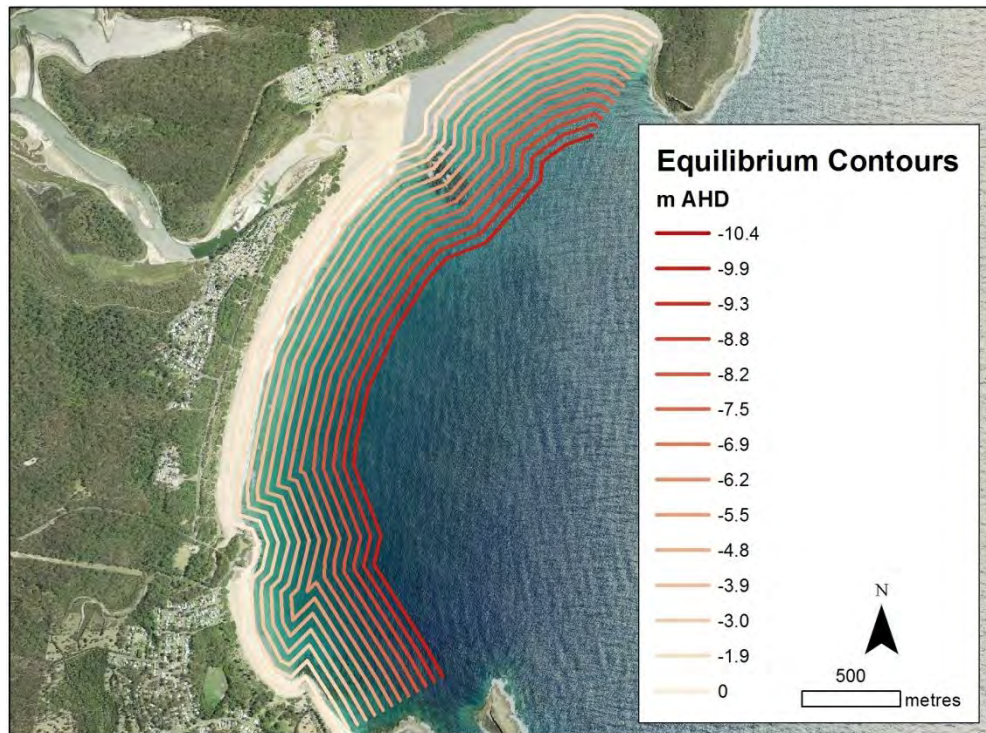
At Durras Beach and Cookies Beach, there was no available nearshore bathymetric surveys. The AHS bathymetric data in this area has contours starting at -15 m AHD, but very little available information closer to the shore. To fill the nearshore region, contours based on a Dean Equilibrium Profile (Dean, 1977) was assumed based on the measured grain size of 0.37 mm, shown in Figure 8-6. This equilibrium profile information was used as required for the bathymetry portion of the Durras Beach and Cookies Beach profiles.

**Figure 8-6: Dean equilibrium contours for Durras Beach and Cookies Beach**

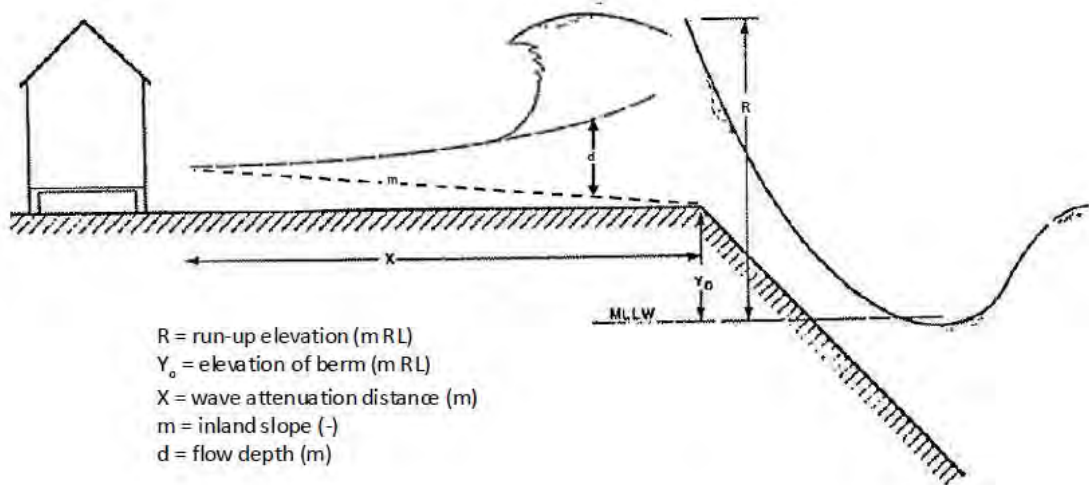
If the wave runup level does not exceed the crest of the dune or seawall, mapping the extent of wave runup is a simple exercise. However, if the runup level exceeds the crest, the wave will propagate inland to a certain extent until gravitational and frictional forces prevent further landward attenuation. The landward propagation of the bore is dependent on the runup elevation, the crest elevation and the backshore slope, shown in Figure 8-7. Bore propagation distance has been calculated based on Equation 8.9, modified from FEMA (2005).

**Figure 8-7: Bore propagation (Source: Tonkin & Taylor, 2016b and Cox and Machemehl, 1986)**

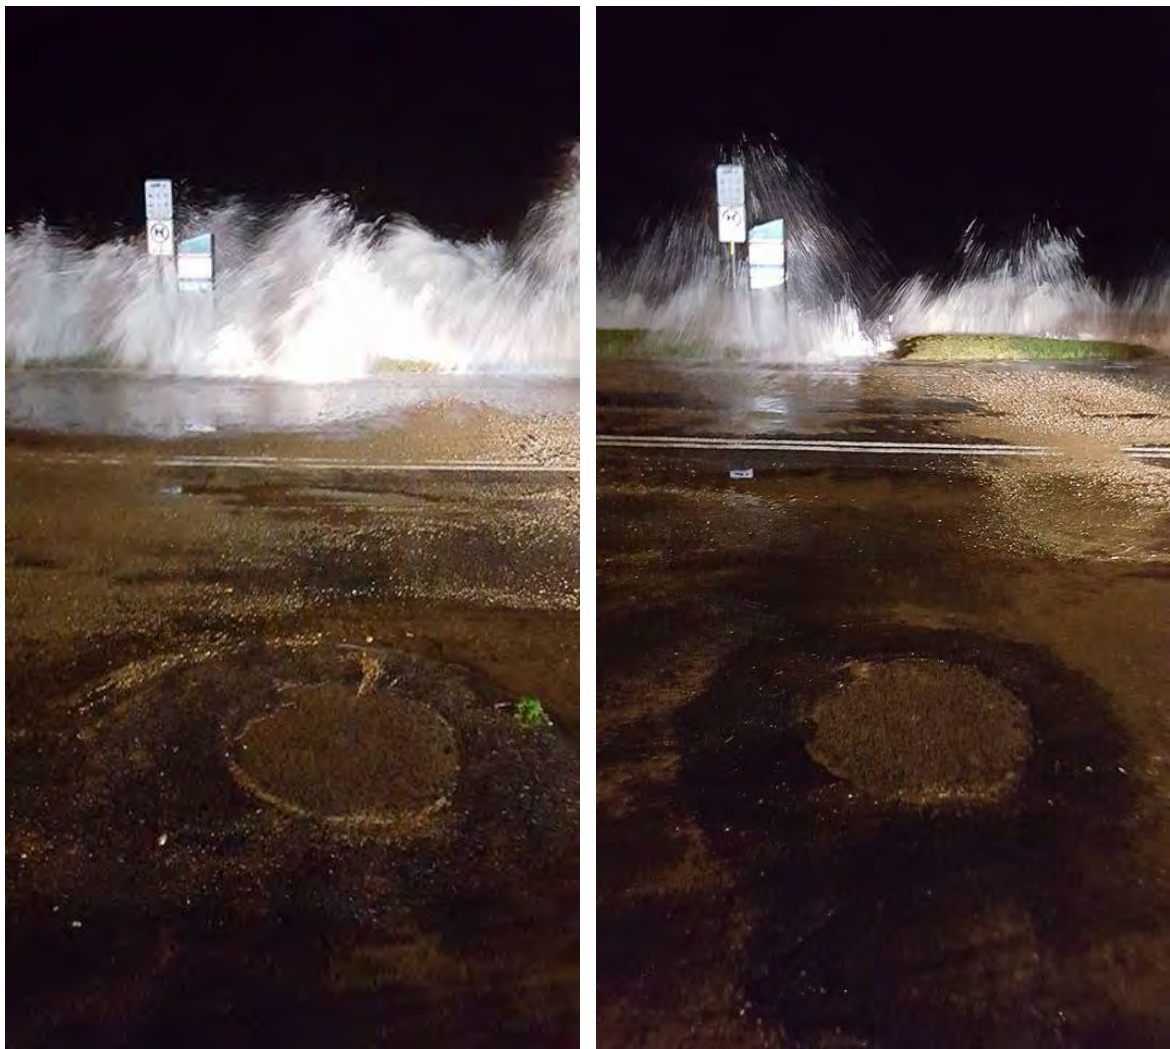
During a site inspection at Caseys Beach on 15 June 2016, WRL observed and surveyed the debris line after the East Coast Low event of June 5<sup>th</sup>-6<sup>th</sup> 2016 which caused significant overtopping of the northern section of seawall at Caseys Beach. Photos of the overtopping captured at the intersection of Batehaven and Beach Roads are shown in Figure 8-8). The most severe overtopping was within the area extending from approximately 50 m to the north of John Street to 140 m to the south of John Street, where overtopping wash completely crossed Beach Road and progressed into the front yards of the private properties in this area (Figure 8-9). Runup debris lines were surveyed by WRL in the front yard of the property at 382 Beach Road (Figure 8-10) and the observed approximate runup extent at 378 Beach Road was also surveyed during the seawall inspection for this project. It is difficult to precisely quantify the average recurrence interval of that runup and overtopping event, but WRL estimates it to be in the order of 15 – 25 years based on historical inundation damage (Blacka and Coghlan, 2016). This runup extent has therefore been used to calibrate the bore propagation methodology at this site, by adjusting the inland slope factor (A) in Equation 1.11 (Figure 8-11).

**Figure 8-8: Overtopping at Intersection of Batehaven and Beach Road, 6/6/2016 10:00 pm  
(Source: Facebook)**
