## Eurobodalla Coastal Hazard Assessment

WRL Technical Report 2017/09  
October 2017

By I R Coghlan, J T Carley, A J Harrison, D Howe, A D Short,  
J E Ruprecht, F Flocard and P F Rahman

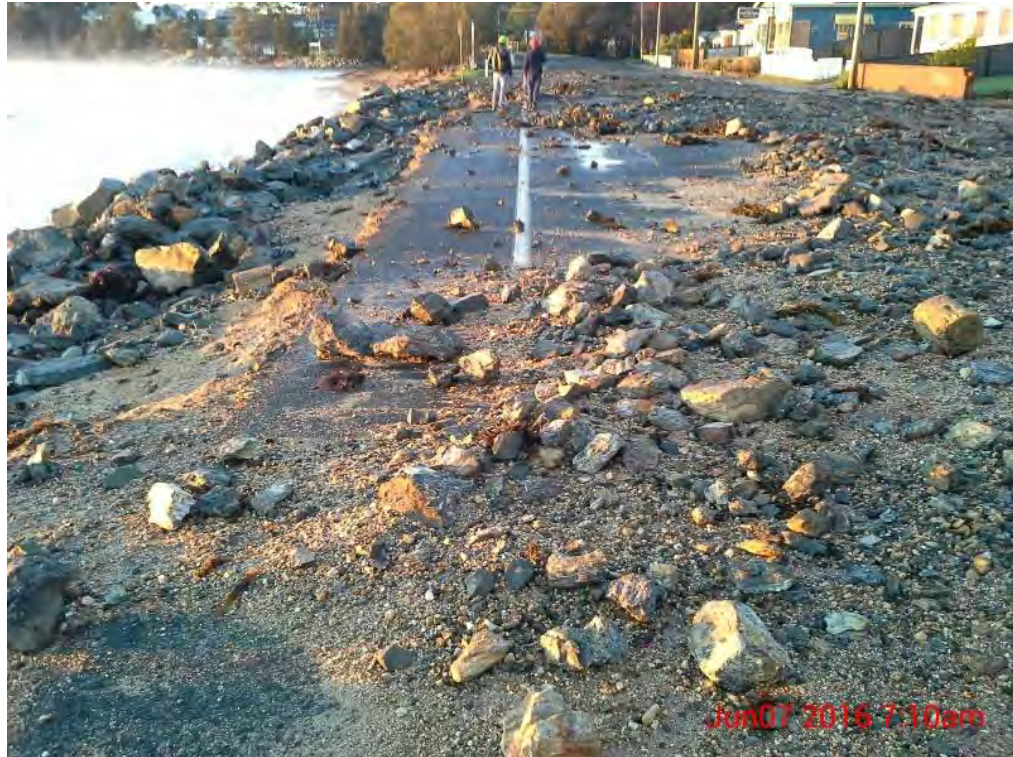
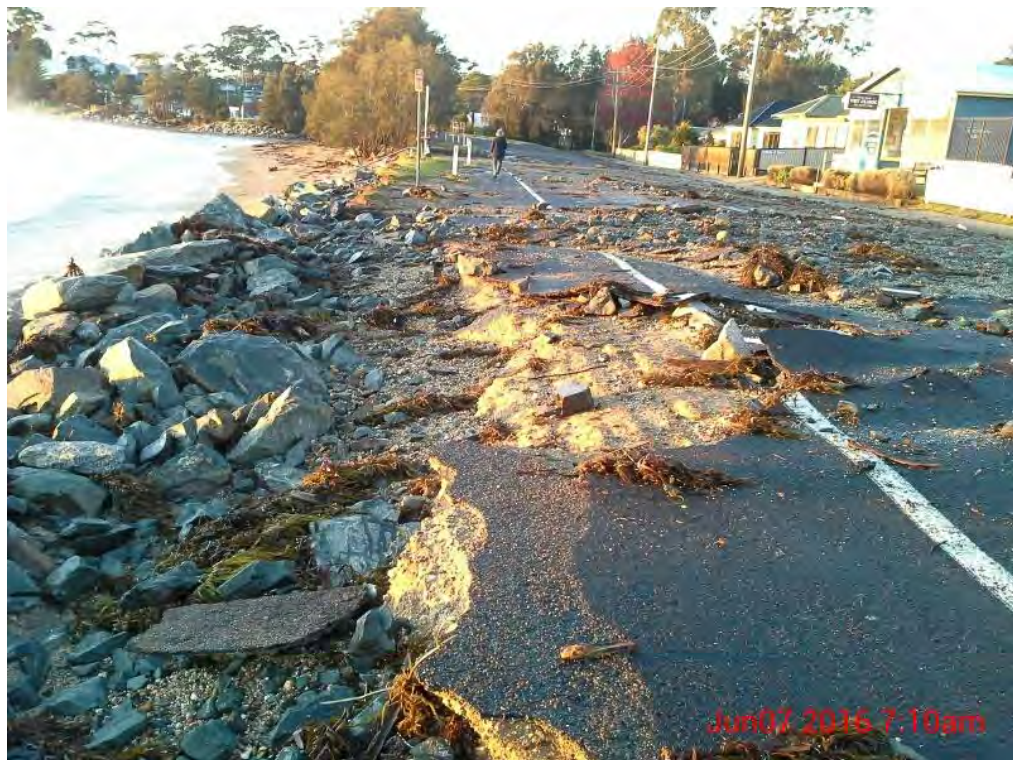
**Figure 8-9: Post June 2016 Storm Damage to South of John Street (ESC, 2016)**

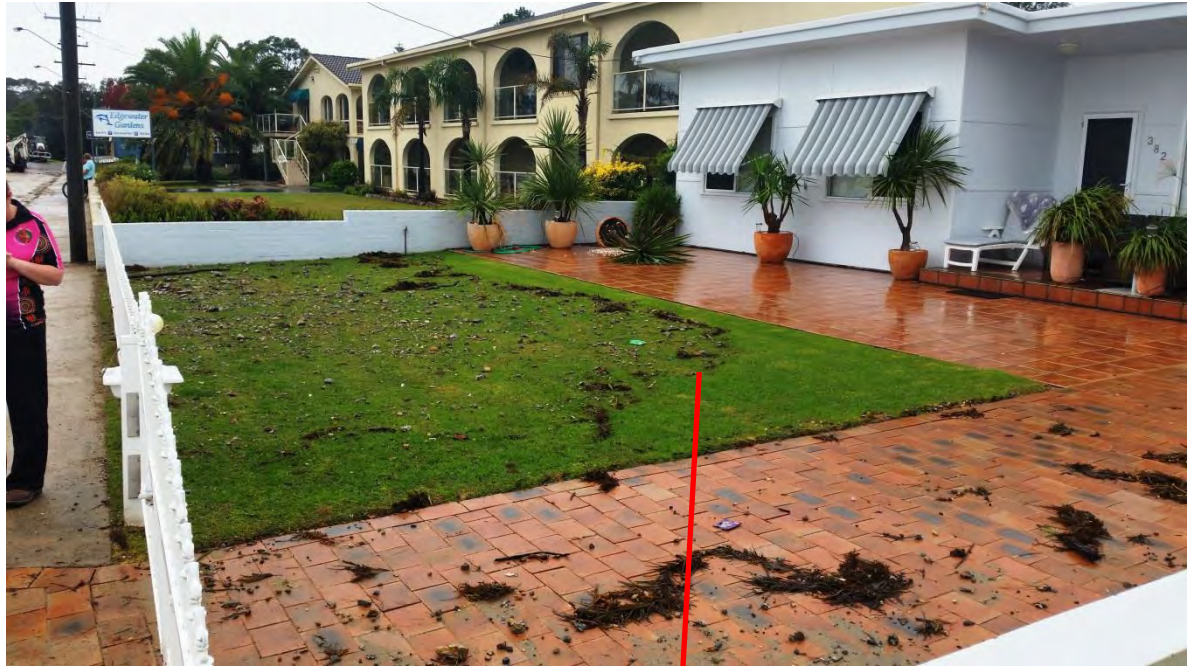
During a site inspection at Caseys Beach on 15 June 2016, WRL observed and surveyed the debris line after the East Coast Low event of June 5<sup>th</sup>-6<sup>th</sup> 2016 which caused significant overtopping of the northern section of seawall at Caseys Beach. Photos of the overtopping captured at the intersection of Batehaven and Beach Roads are shown in Figure 8-8). The most severe overtopping was within the area extending from approximately 50 m to the north of John Street to 140 m to the south of John Street, where overtopping wash completely crossed Beach Road and progressed into the front yards of the private properties in this area (Figure 8-9). Runup debris lines were surveyed by WRL in the front yard of the property at 382 Beach Road (Figure 8-10) and the observed approximate runup extent at 378 Beach Road was also surveyed during the seawall inspection for this project. It is difficult to precisely quantify the average recurrence interval of that runup and overtopping event, but WRL estimates it to be in the order of 15 – 25 years based on historical inundation damage (Blacka and Coghlan, 2016). This runup extent has therefore been used to calibrate the bore propagation methodology at this site, by adjusting the inland slope factor (A) in Equation 1.11 (Figure 8-11).

**Figure 8-10: Runup Debris Line surveyed by WRL in the front yard of 382 Beach Road (ESC, 2016)**

- Observed debris line: 5.5 m AHD
- Calculated Mase  $R_{\max}$ : 5.5 m AHD
- Calculated Mase  $R_{2\%}$ : 4.9 m AHD

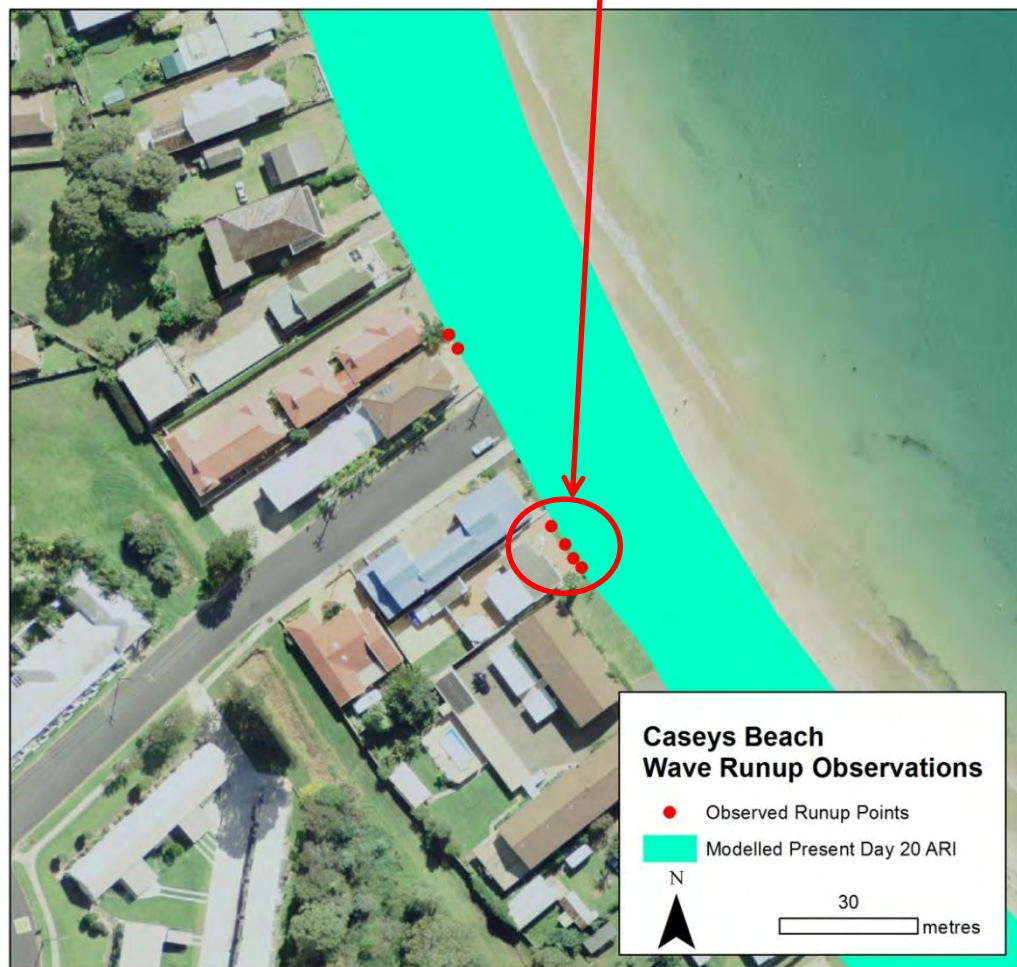
**Figure 8-11: Calibration of bore propagation methodology for Caseys Beach**

By adjusting the inland slope factor to 1.5, the modelled 20 year ARI wave runup extent agreed well with the observed runup extent. Therefore, an inland slope factor of 1.5 has been adopted at Caseys Beach behind the seawalls. Without observed runup at other locations, the inland slope factor was kept as 1.

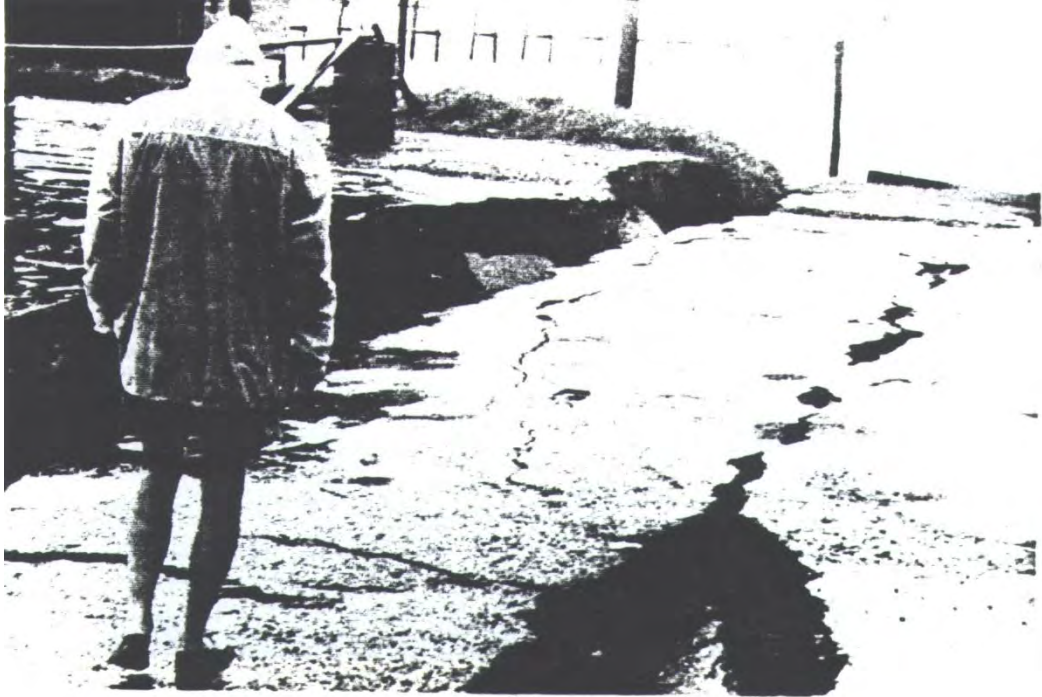
**Figure 8-12: Soldiers Club, Beach Road, CBD, 29-30 August 1963 (NSW PWD, 1989)**

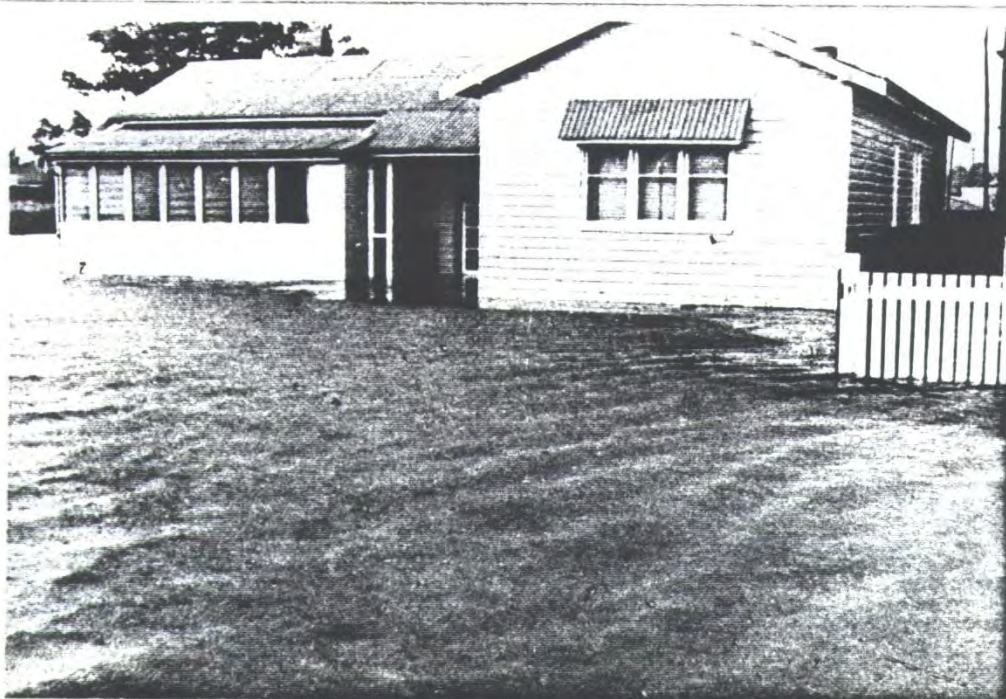
**Figure 8-13: Corner of Bavarde Avenue and Golf Links Drive (Hanging Rock) 29-30 August 1963 (NSW PWD, 1989)**

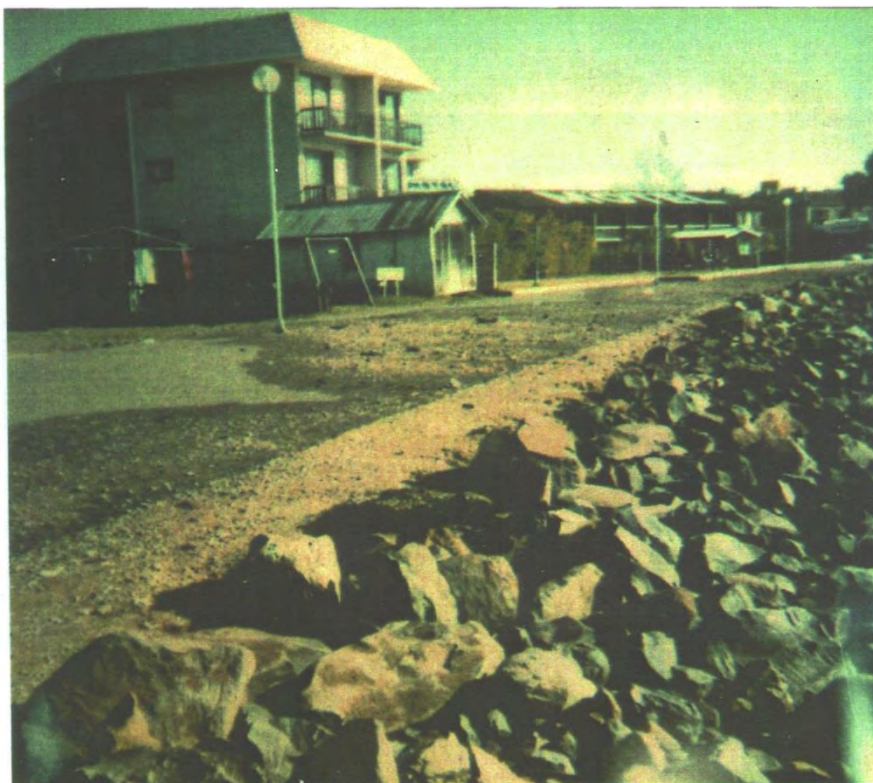
**Figure 8-14: Mariners on the Waterfront, CBD, 1 July 1984 (NSW PWD, 1989)**

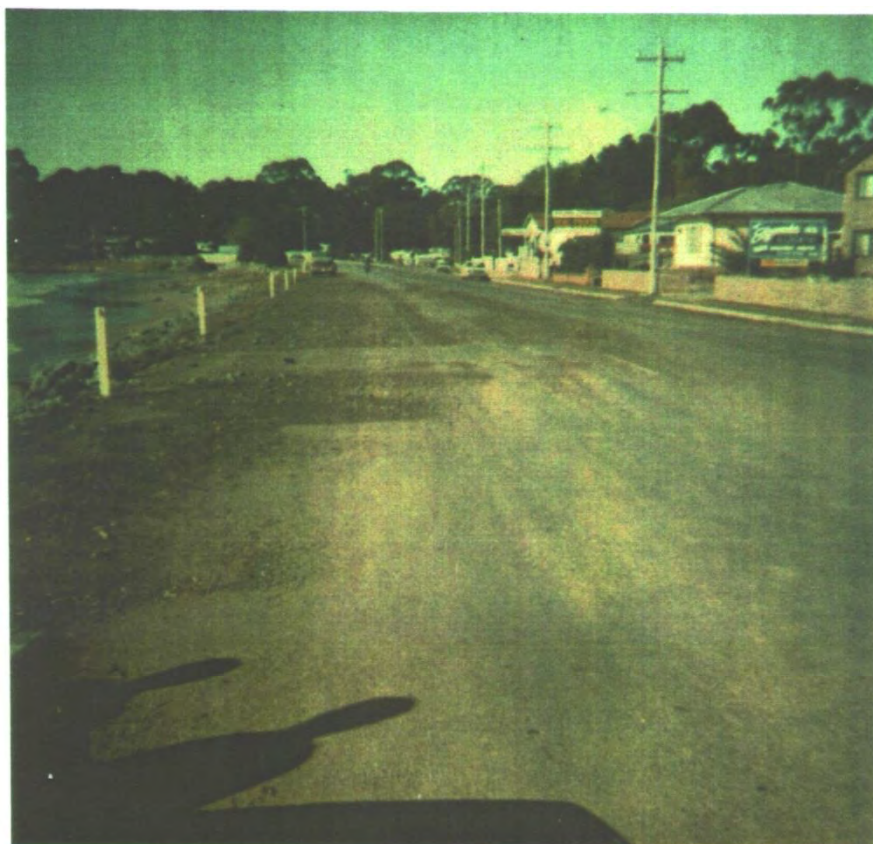
**Figure 8-15: Overtopping of Caseys Beach Seawall 1 July 1984 (NSW PWD, 1989)**

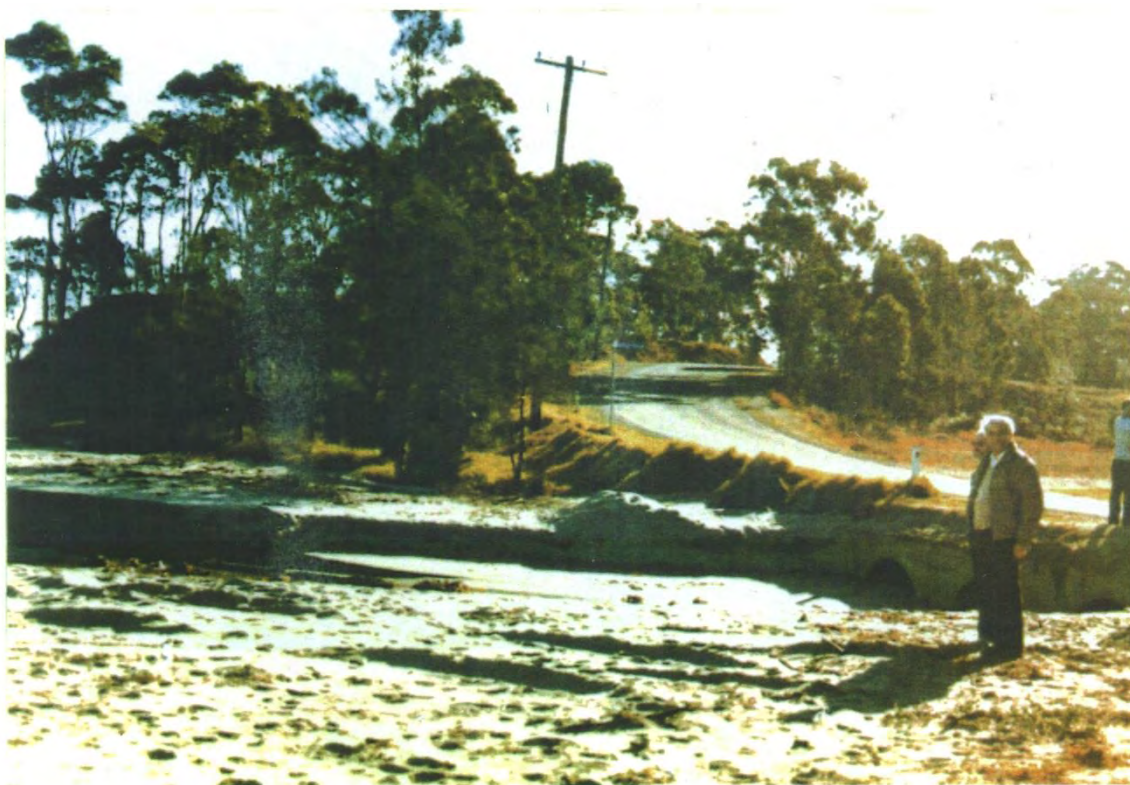
**Figure 8-16: Overtopping of Myamba Parade at Surfside Beach (west) 13 August 1986  
(NSW PWD, 1989)**

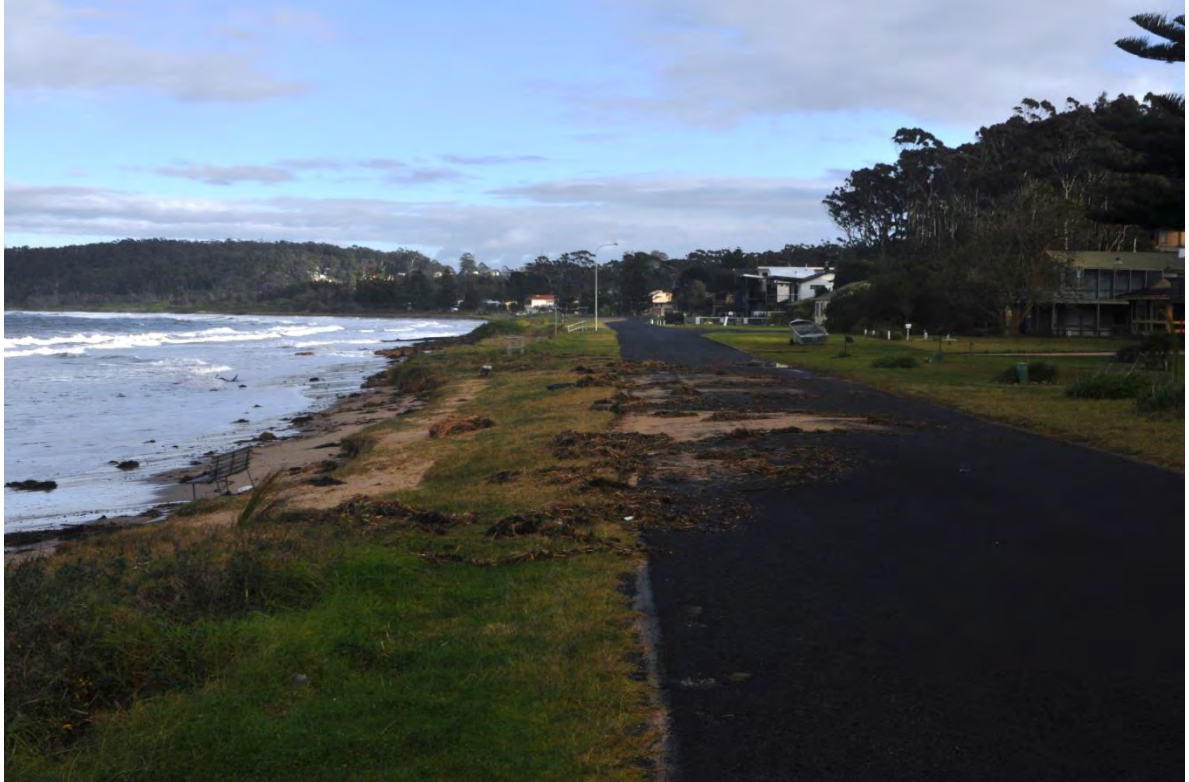
**Figure 8-17: Overtopping of Bay Road, Long Beach, 6 June 2012 (Mr Lindsay Usher)**

On 4-6 June 2012, a severe storm with offshore significant wave heights of 6 m (typical  $T_p = 13$  s, south-easterly wave direction, maximum water level 1.3 m AHD) had a large impact upon beaches within Batemans Bay. A series of photos, collated by ESC, documenting the extent of coastal inundation are reproduced in Figure 8-17 through Figure 8-28.

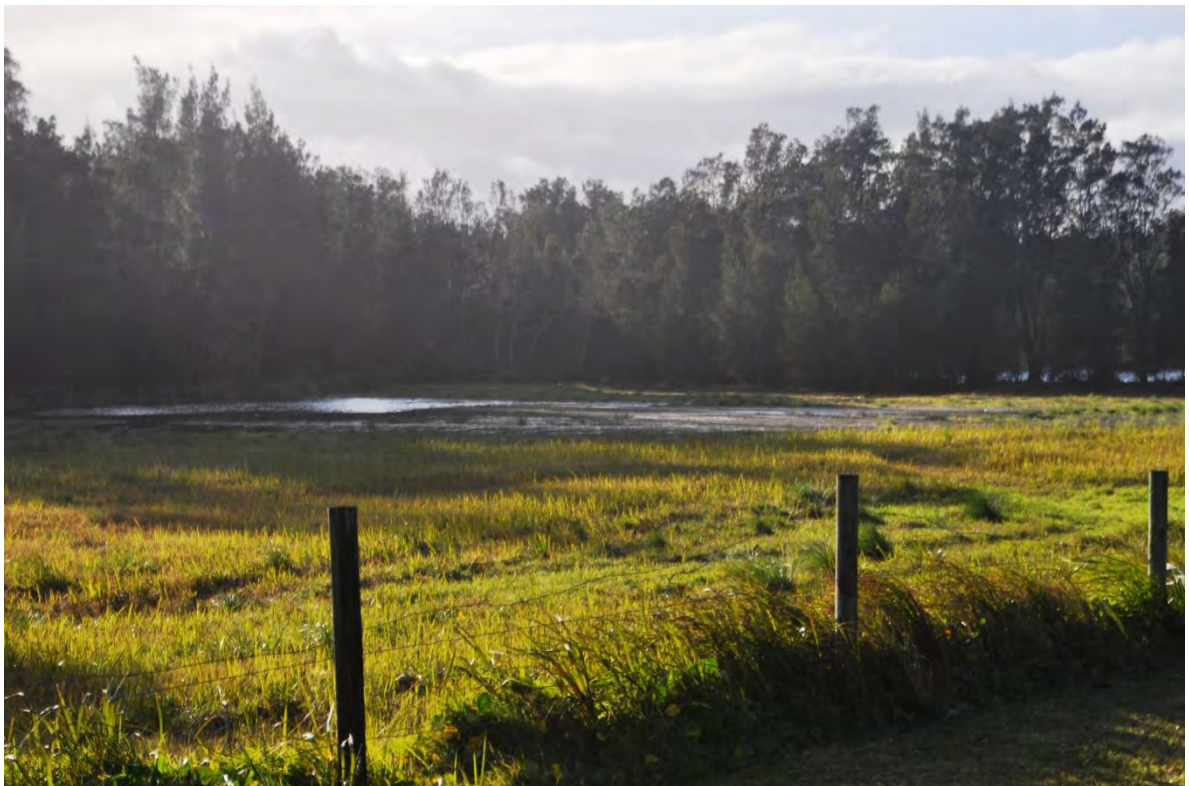
**Figure 8-18: Backshore Inundation at Cullendulla Beach, 6 June 2012 (Mr Lindsay Usher)**

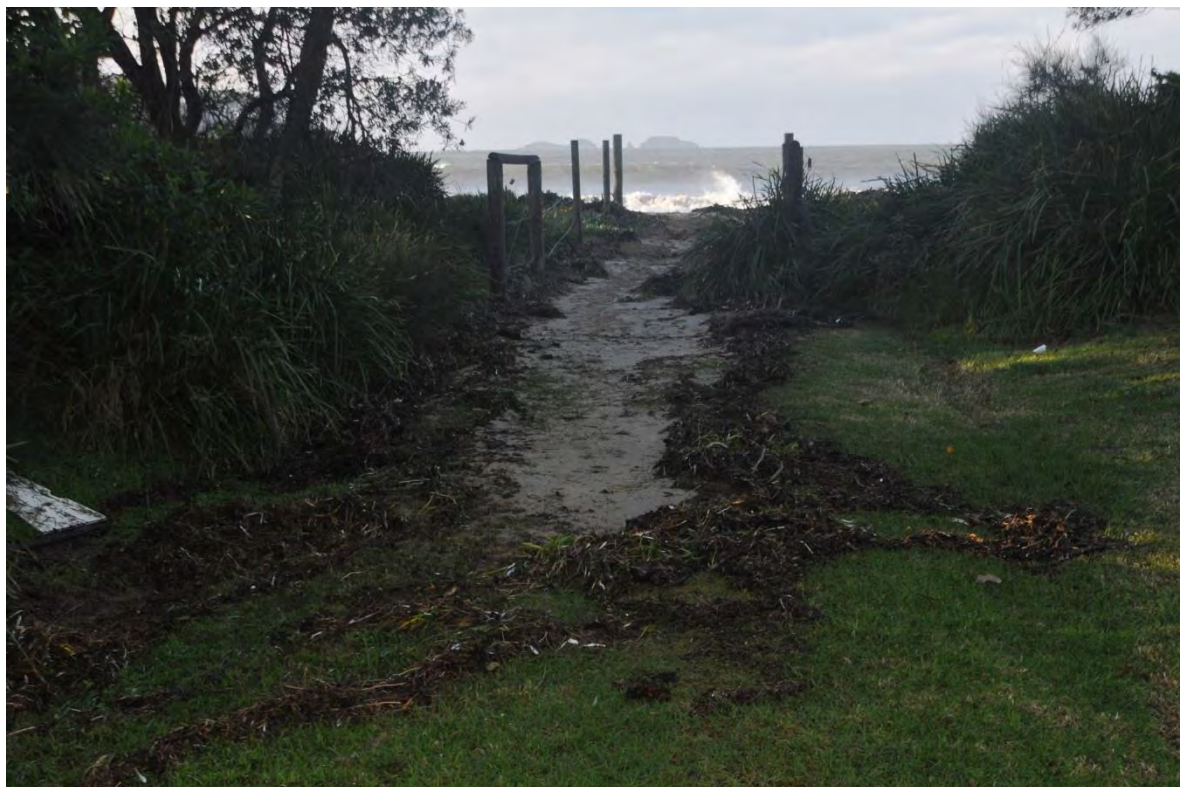
**Figure 8-19: Inundation Debris Line at Surfside Beach (East), 6 June 2012 (Mr Lindsay Usher)**

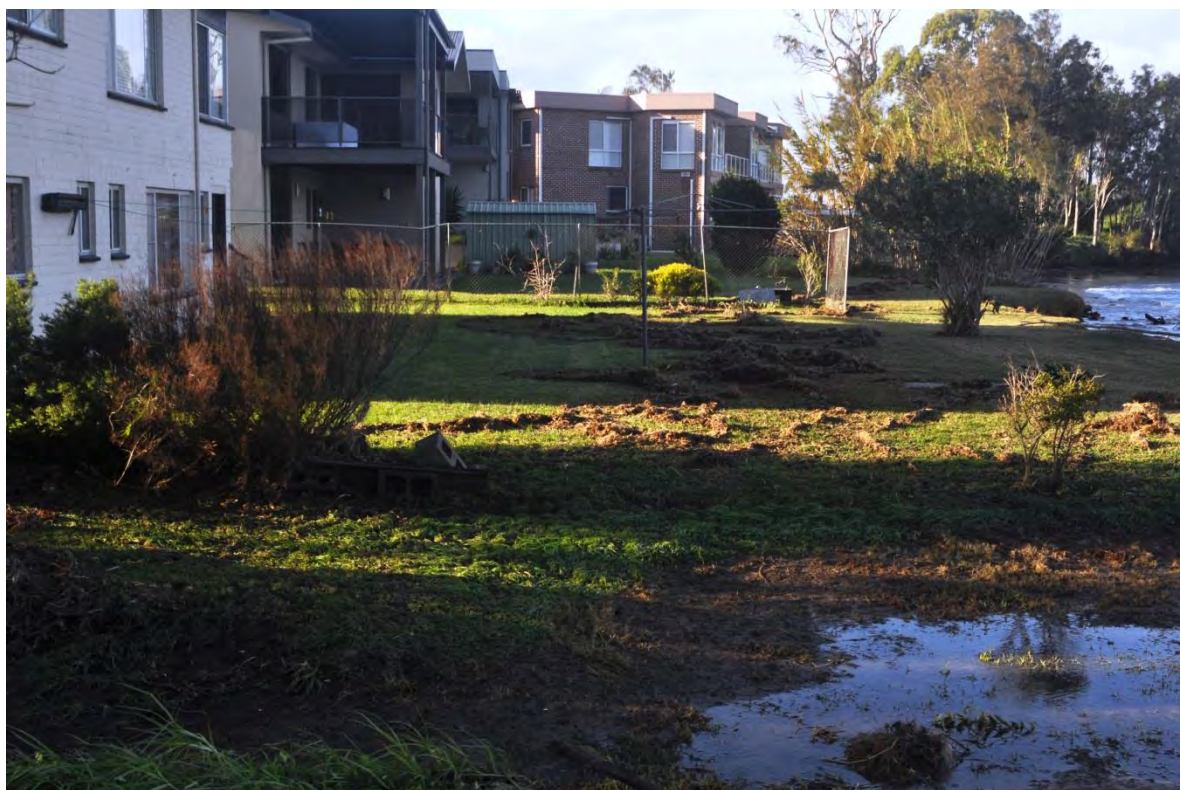
**Figure 8-20: Inundation Debris Line at Surfside Beach (West), 6 June 2012 (Mr Lindsay Usher)**

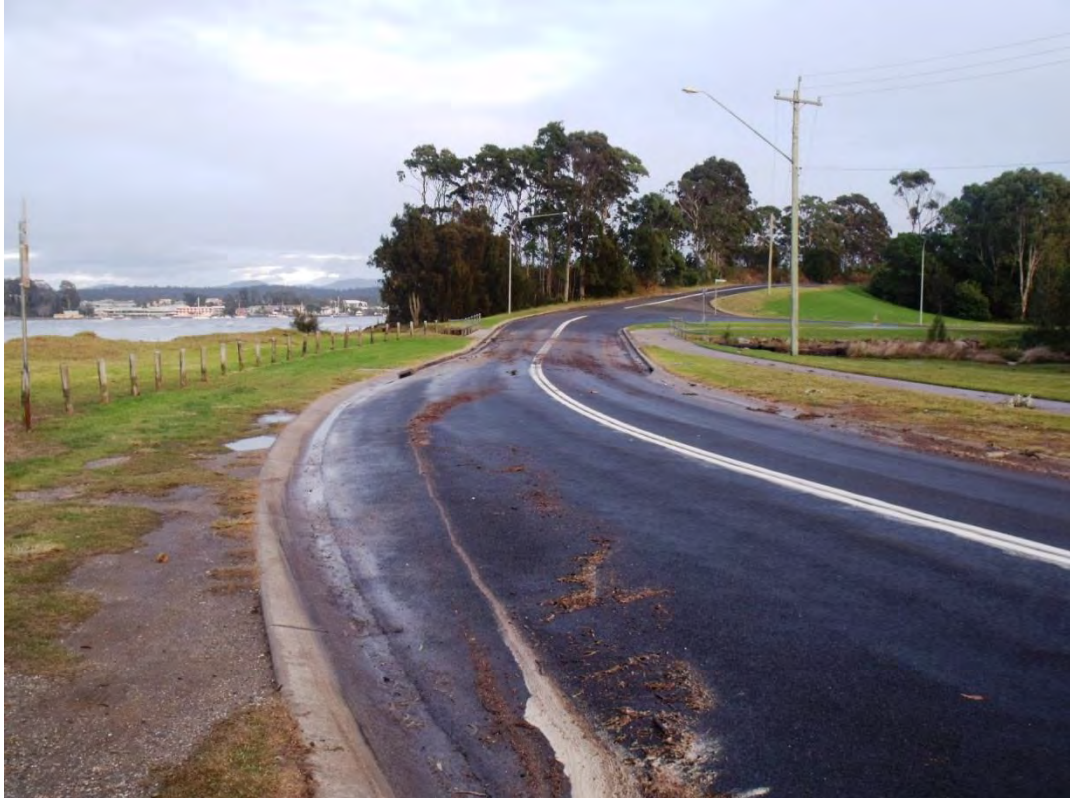
**Figure 8-21: Overtopping of Myamba Parade at Surfside Beach (West), 6 June 2012 (Mr Dick Crompton)**

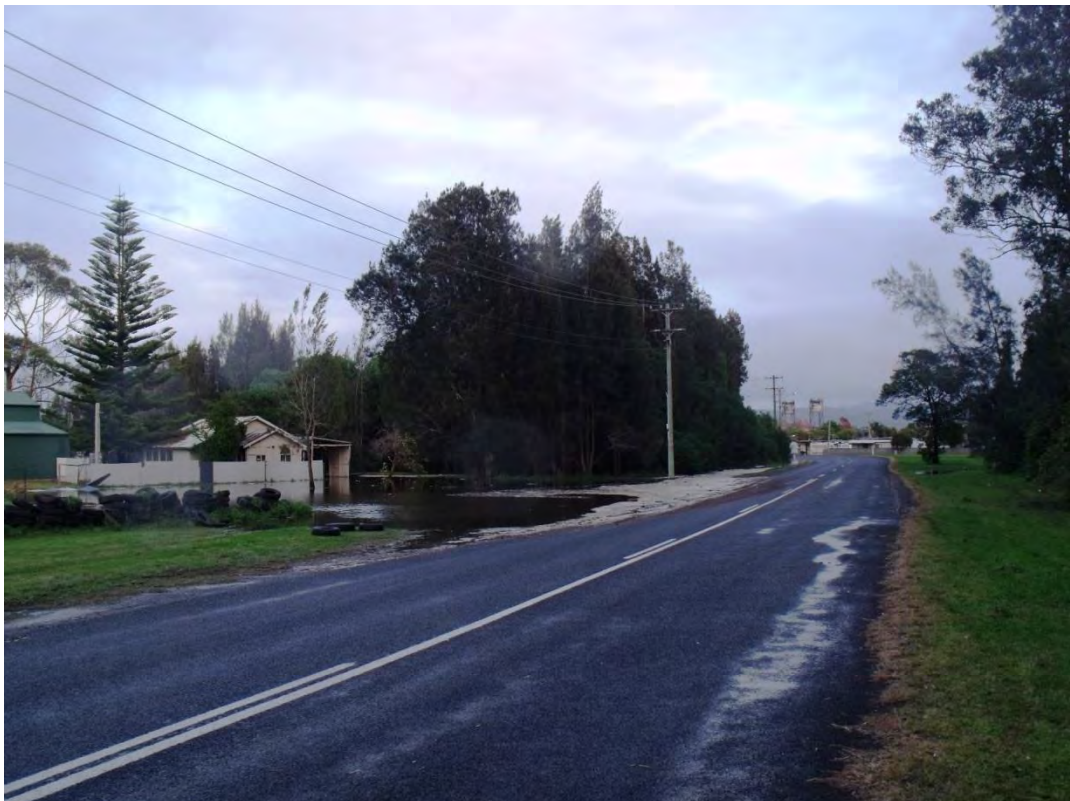
**Figure 8-22: Inundation at Wharf Road (1 of 3), 6 June 2012 (Mr Dick Crompton)**

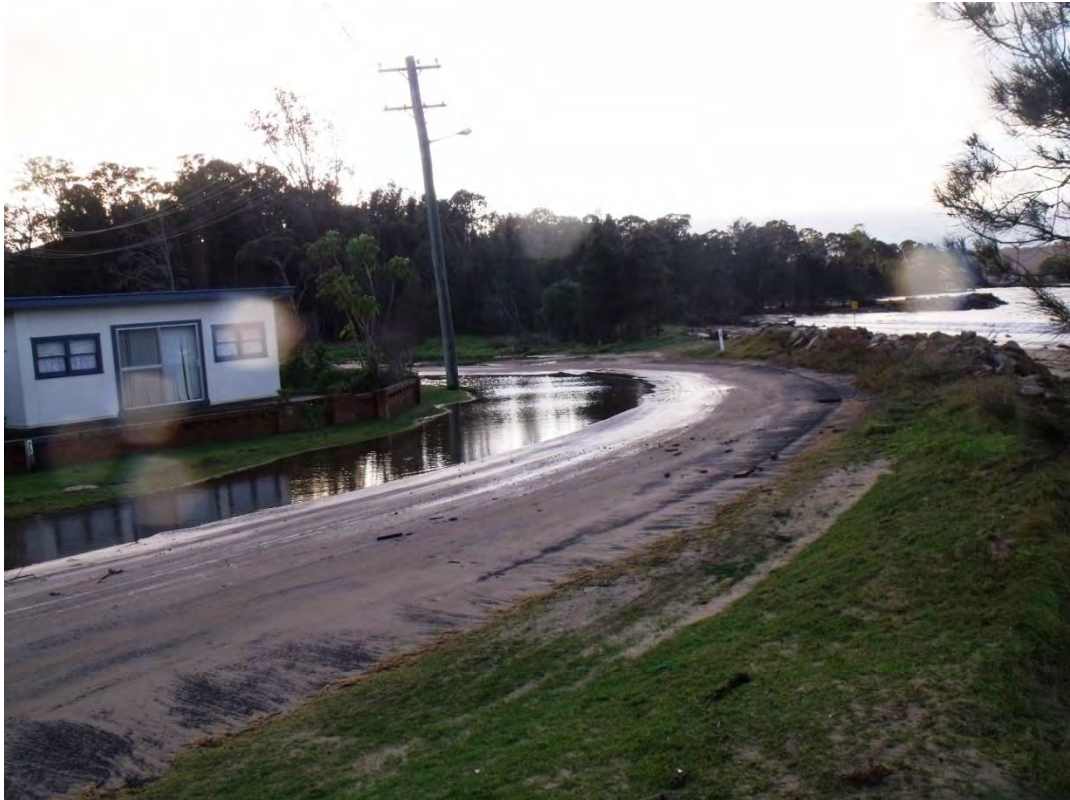
**Figure 8-23: Inundation at Wharf Road (2 of 3), 6 June 2012 (Mr Dick Crompton)**

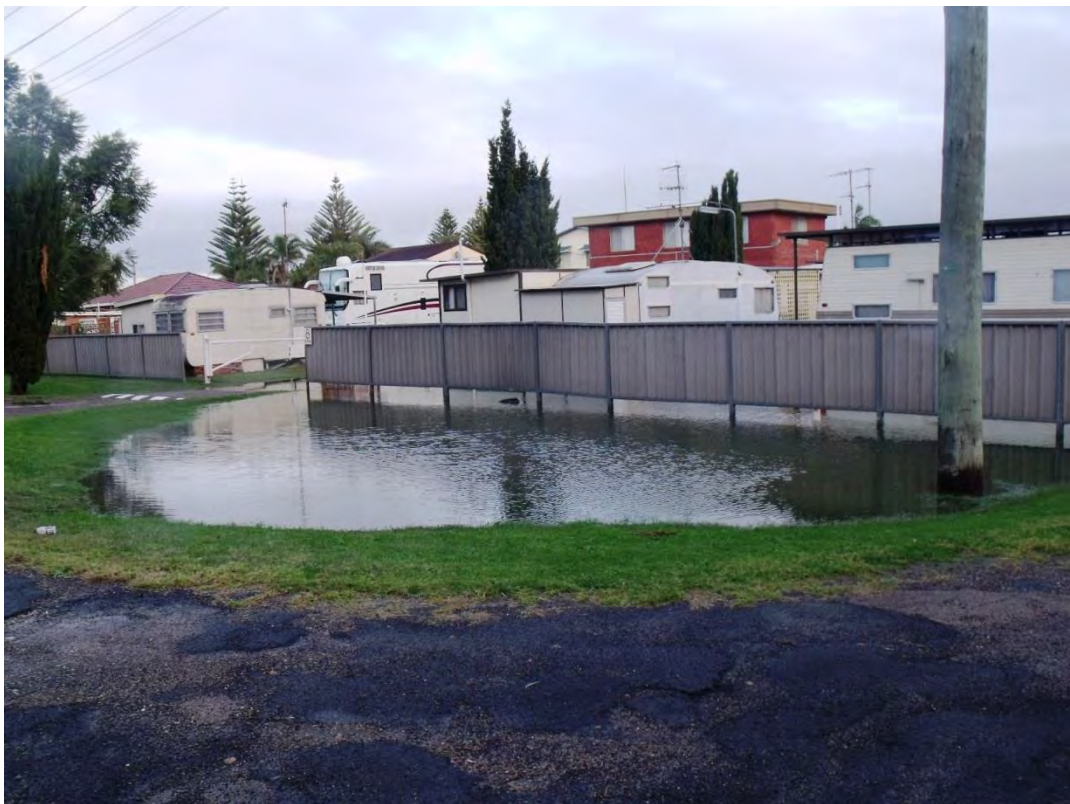
**Figure 8-24: Inundation at Wharf Road (3 of 3), 6 June 2012 (Mr Dick Crompton)**

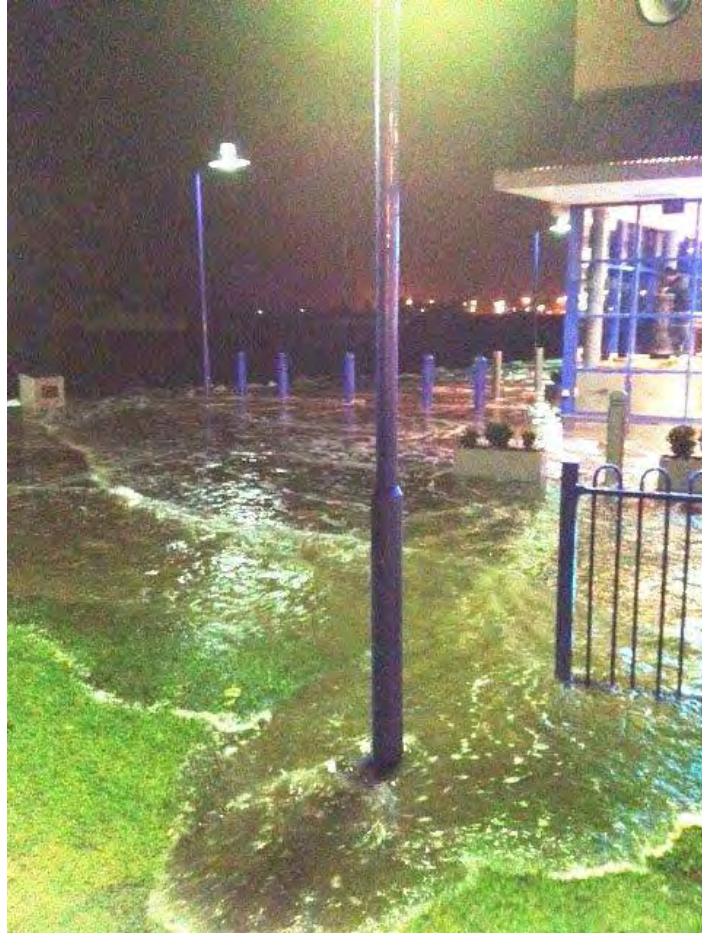
**Figure 8-25: Inundation at CBD near Starfish Deli, 6 June 2012 (Mr Mark Swadling)**

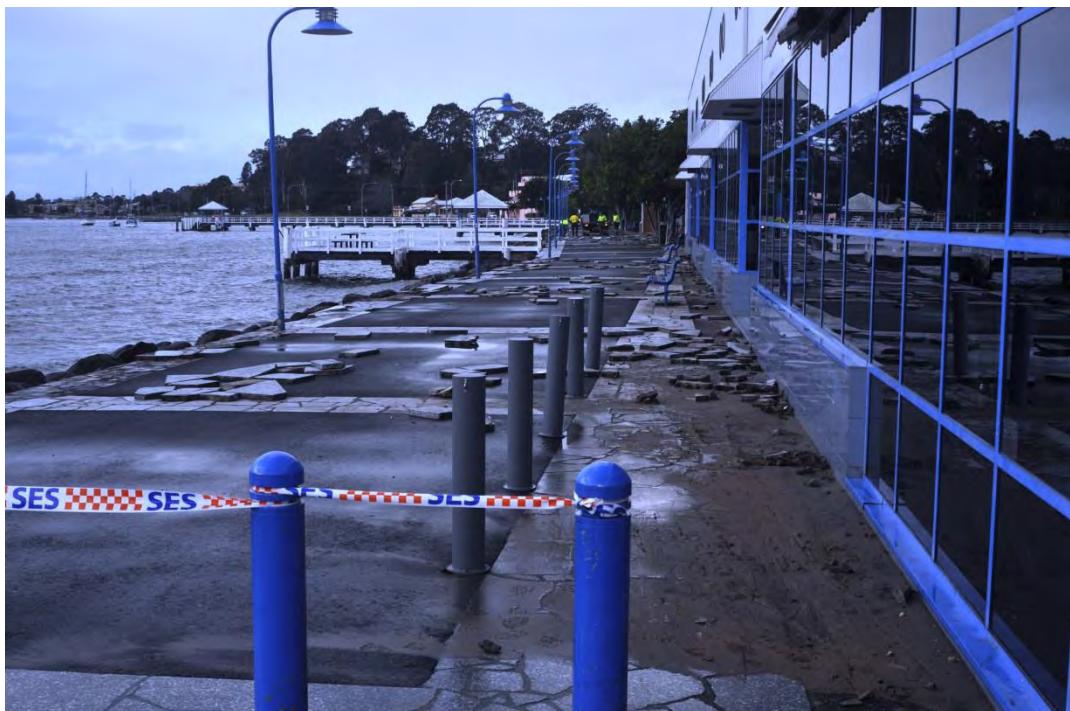
**Figure 8-26: Inundation Damage to CBD Foreshore, 6 June 2012 (Mr Lindsay Usher)**

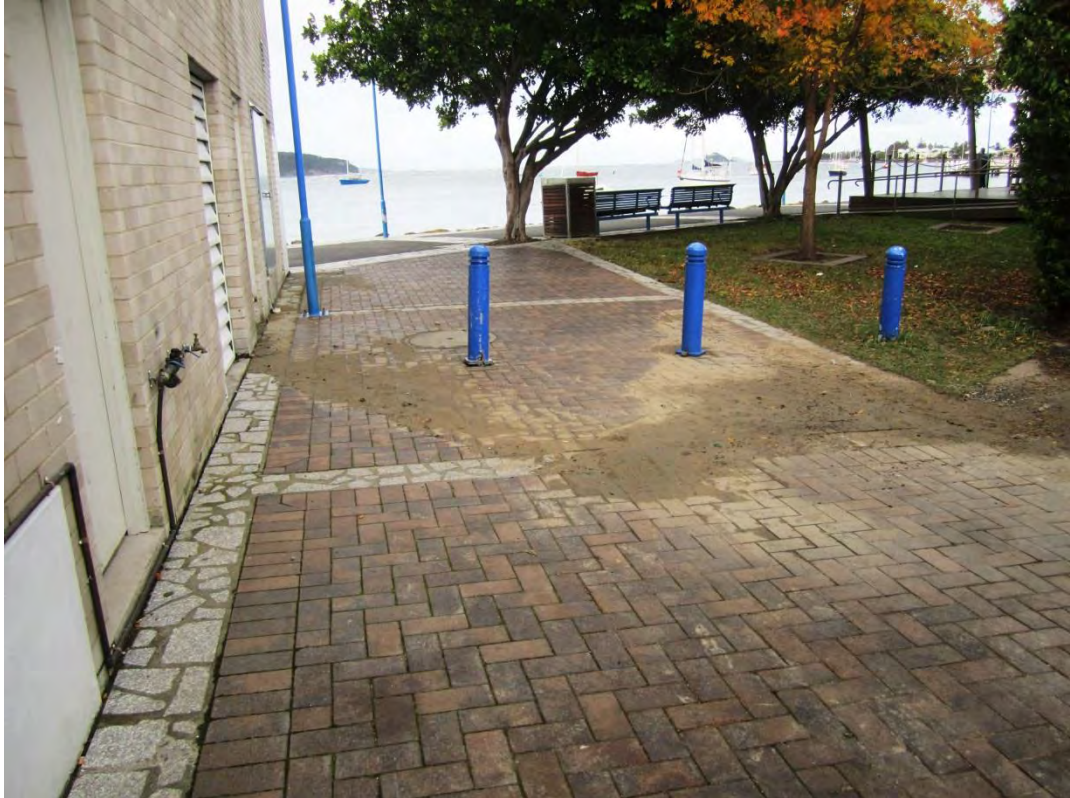
**Figure 8-27: Overtopping Extents at CBD, 7 June 2012 (Mr Norman Lenehan)**

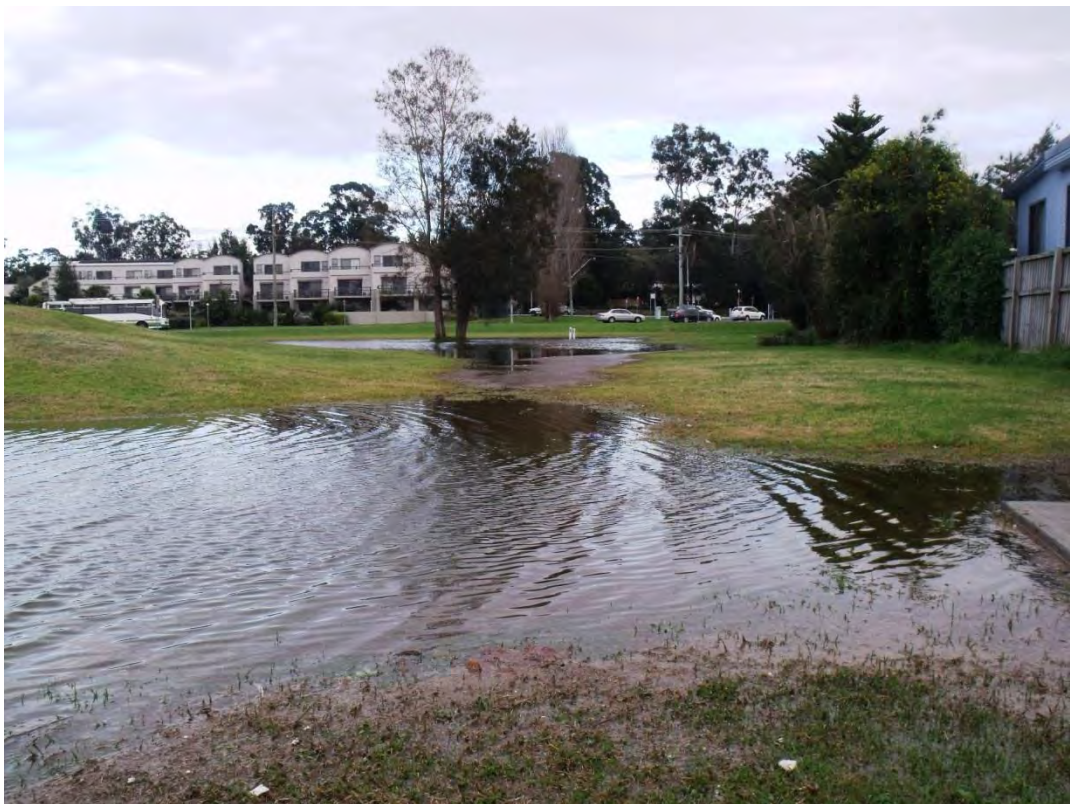
**Figure 8-28: Backshore Inundation at Corrigans Beach, 6 June 2012 (Mr Dick Crompton)**

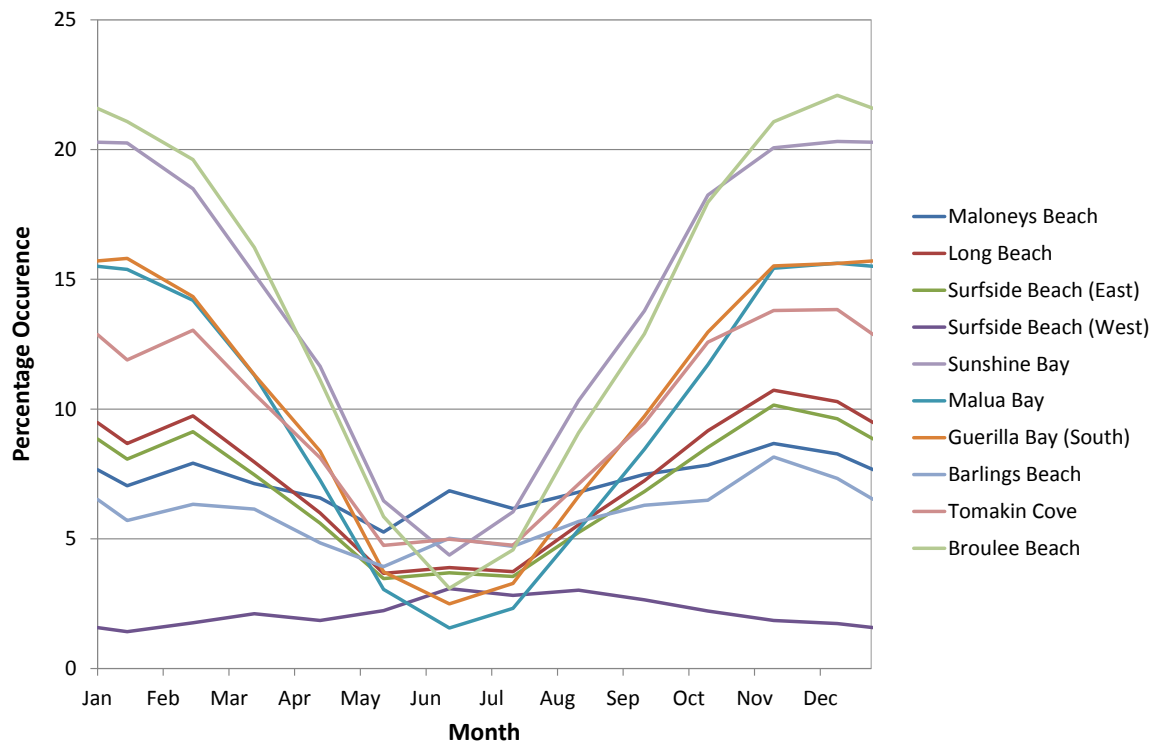
**Figure 9-1: BoM Moruya Heads Pilot Station Daily Average Wind - Occurrence of Winds for Dune Building – Dry Sand**

Based on daily average wind data from the BoM meteorological station at Moruya Heads, consideration of the median grain size and the orientation of each beach, the monthly percent occurrence of dune building winds at each beach is presented in Figure 9-1 (dry sand) and Figure 9-2 (wet sand). Natural dune building can occur when the winds are close to perpendicular to the shoreline, directed onshore and exceed the threshold of motion. It can be seen that, in general, the potential for dune building is lowest in May, June, July and August. Broulee Beach has the highest overall dune building potential and Surfside Beach (West) has the least.

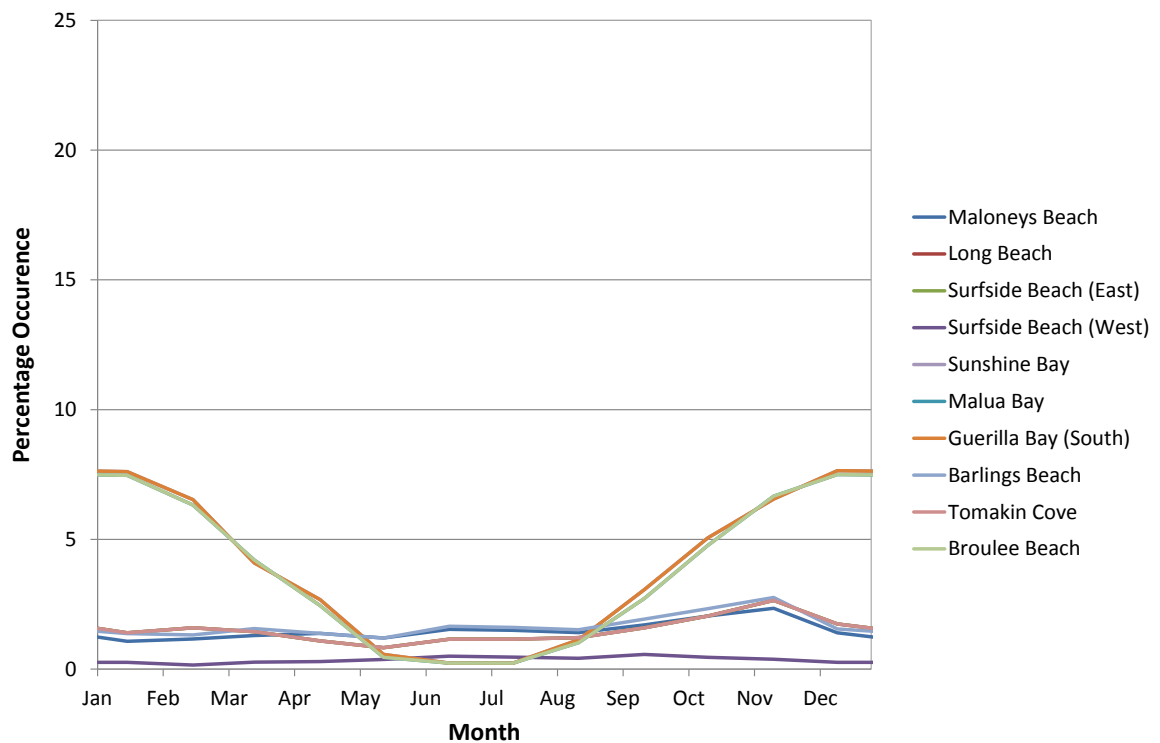
**Figure 9-2: BoM Moruya Heads Pilot Station Daily Average Winds - Occurrence of Winds for Dune Building – Wet Sand**

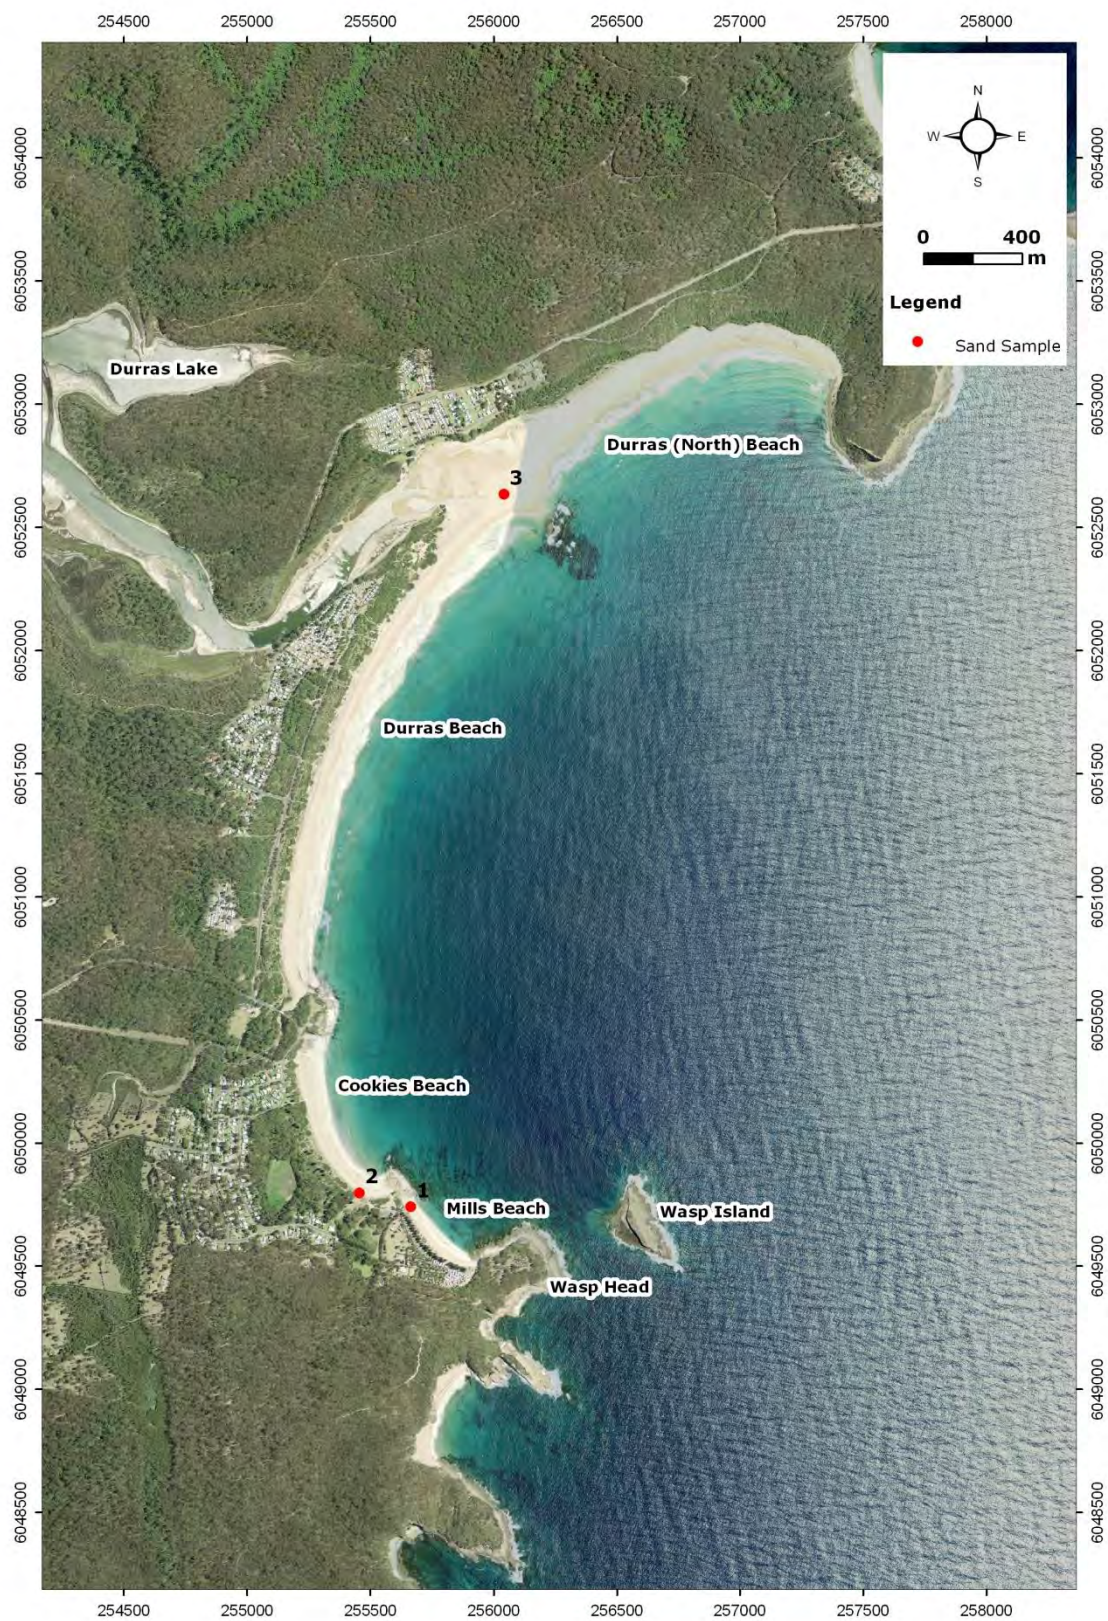
**Figure B-1: Durras and Cookies Beaches Site Details**

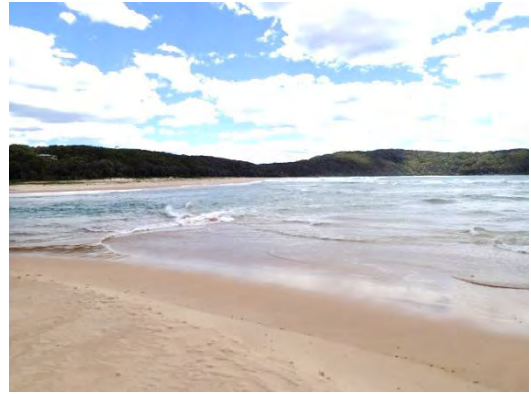
**b) Durras Lake entrance at northern end**

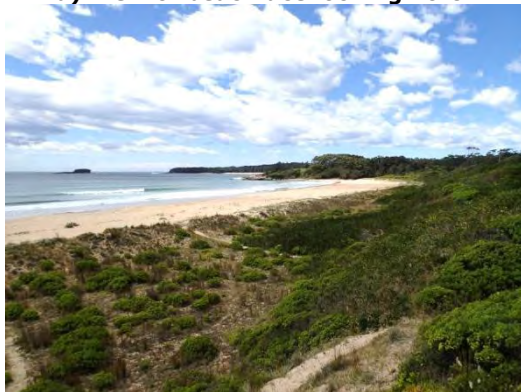
**c) Well vegetated dune looking south**

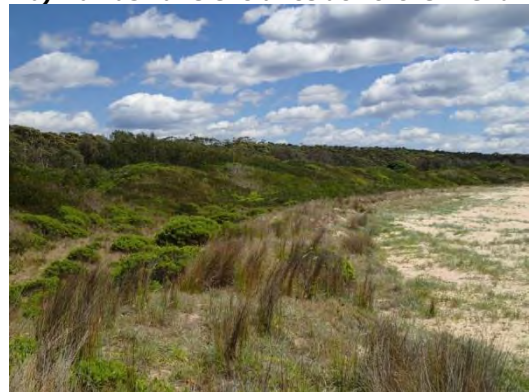
**d) Well vegetated dune looking north**

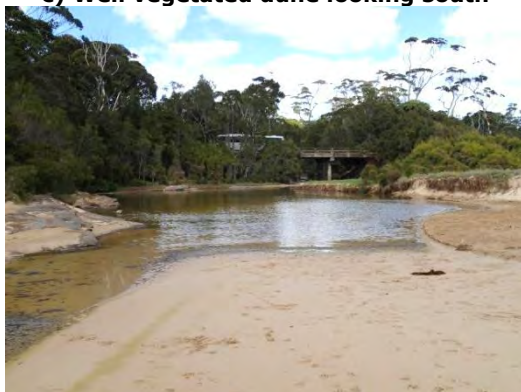
**e) Durras Creek entrance at southern end**
