## Eurobodalla Coastal Hazard Assessment

WRL Technical Report 2017/09  
October 2017

By I R Coghlan, J T Carley, A J Harrison, D Howe, A D Short,  
J E Ruprecht, F Flocard and P F Rahman

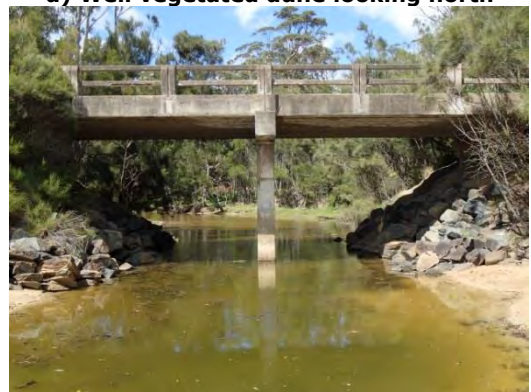
**f) Durras Road bridge at southern end**

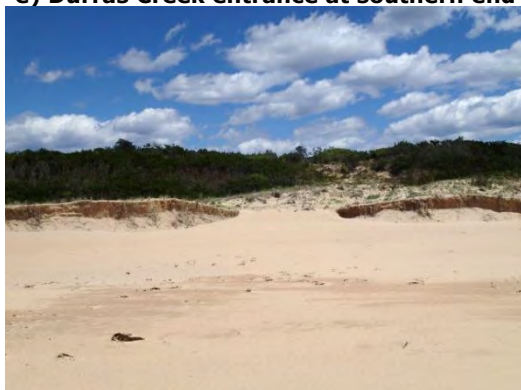
**g) Dune scarp at the centre of the beach**

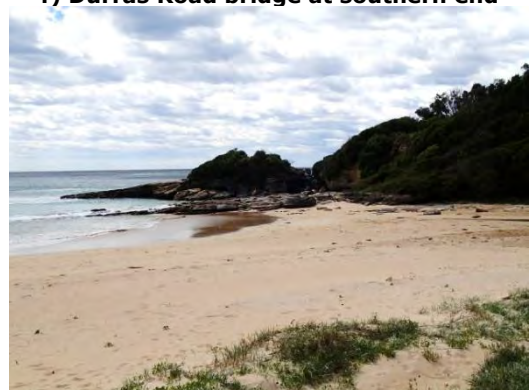
**h) Rock/reef at southern end**

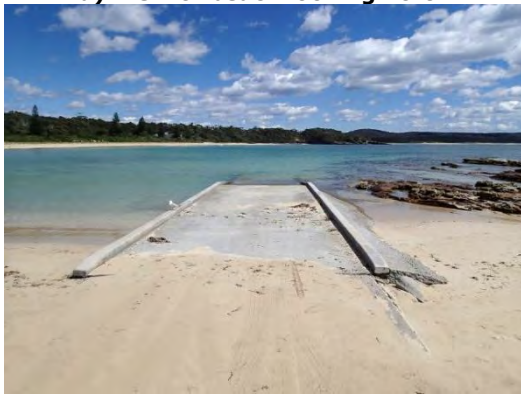
**c) Boat ramp at the southern end**

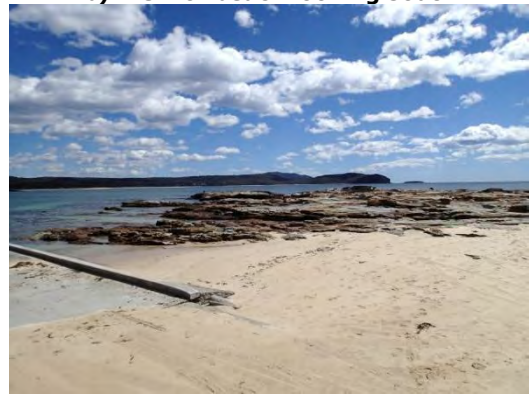
**d) Rock/reef at southern end**

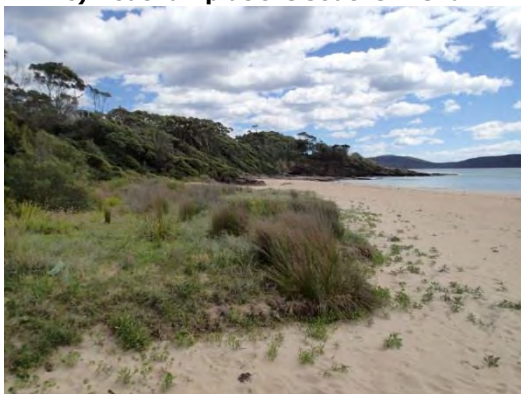
**e) Moderate dune vegetation**

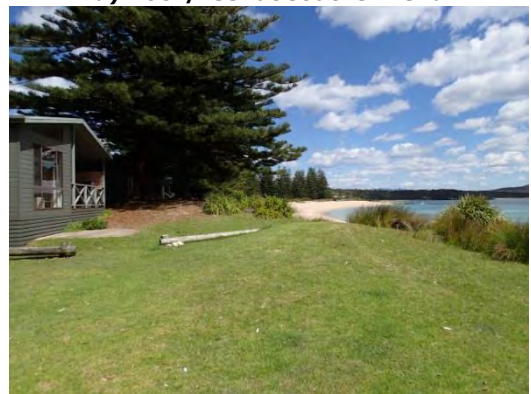
**f) Position of property relative to dune**

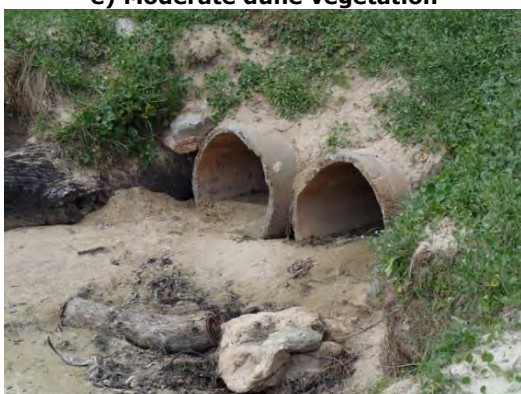
**g) Stormwater outlets at the southern end**

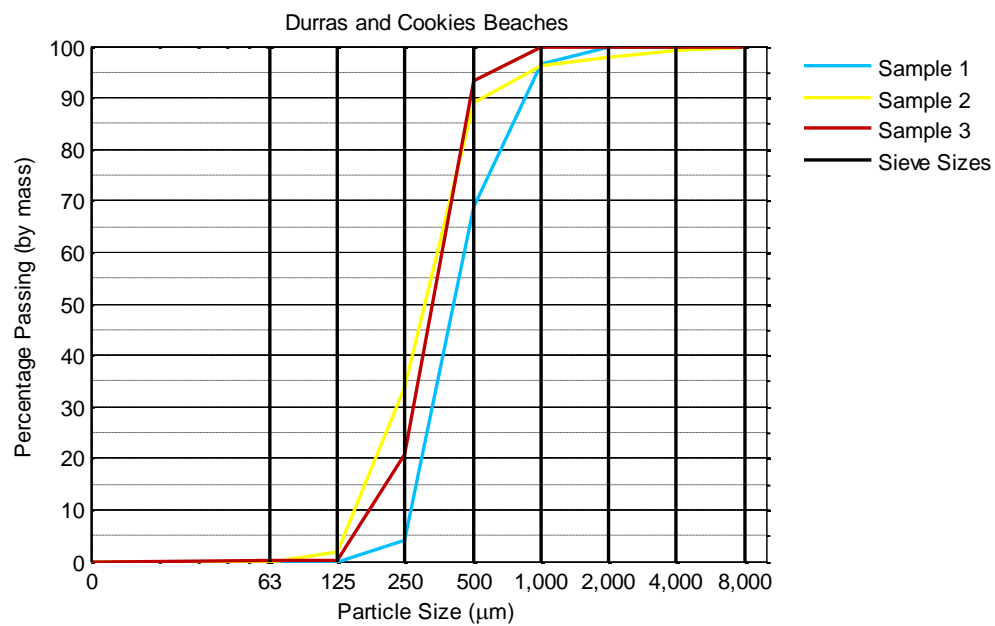
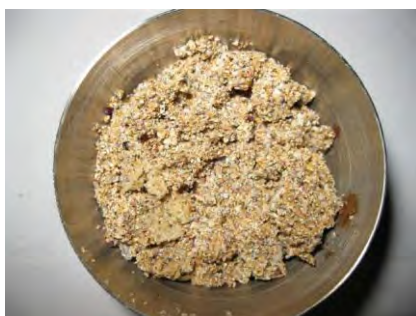
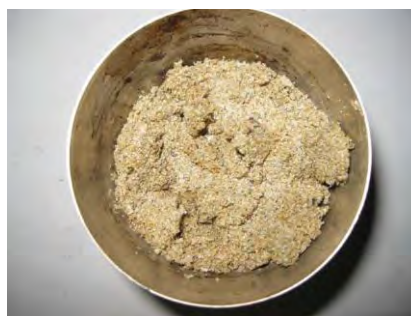
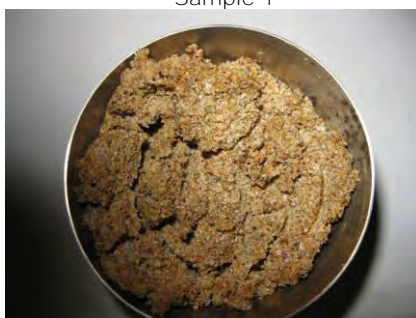
**Figure B-4: Durras and Cookies Beaches Sediment Samples**

Beach access is available from the northern and southern ends of the beach. The northern end provides pedestrian access to the beach from a small community of houses situated landward of Dilkera Street. Beach access at the southern end is via a designated pedestrian track and a concrete boat ramp, which is situated adjacent to the southern rocks and crosses the beach. A small picnic area and car park at the southern end are in close proximity to the beach and lie at low elevations. A summary of sand sample analysis is shown in Figure B-4

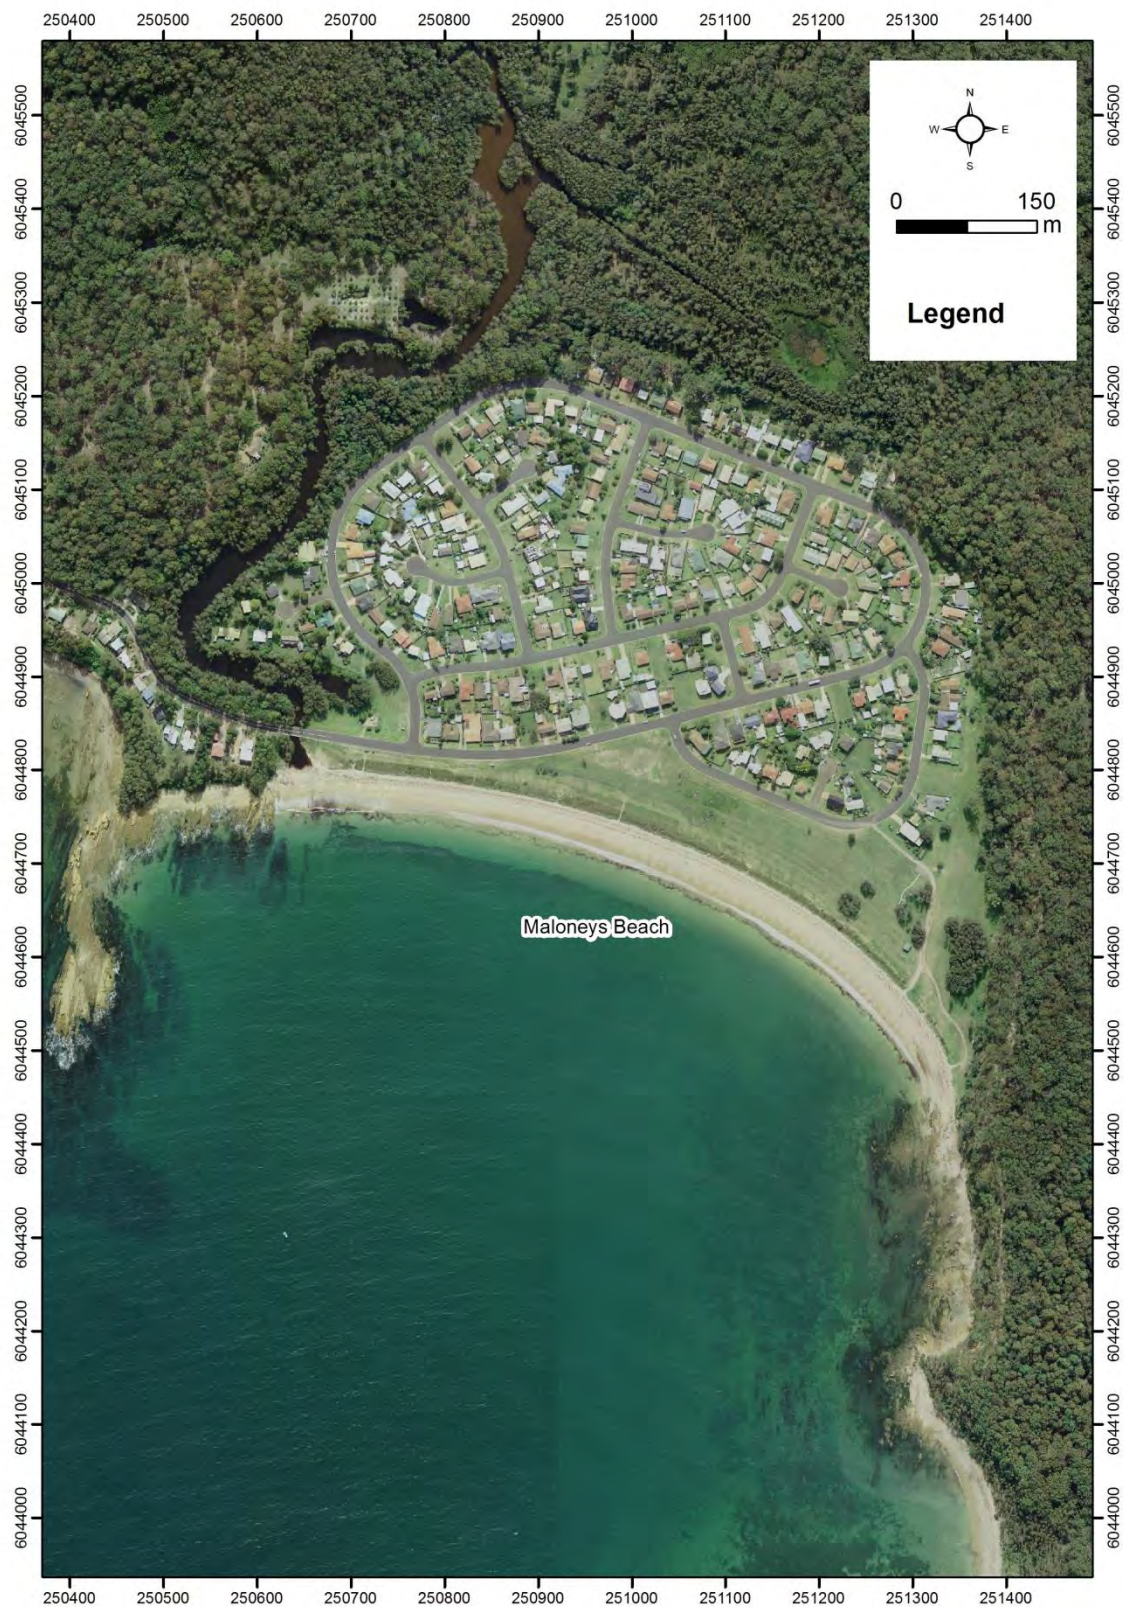
**Figure B-5: Maloneys Beach Site Details**

Maloneys Beach is 810 m long with a low gradient facing south (Figure B-5). A well vegetated and relatively steep, stabilised dune exists with a crest level of approximately 6 m AHD for most of the beach, decreasing to 3 m AHD at the eastern and western ends (Figure B-6). There are several breaks in the dune to allow for public pedestrian beach access. At the time of the inspection (1 November 2011), a small scarp was noted at the western end of the beach with one of the public beach access points closed as a result. The entrance to Maloneys Creek exists at the western end of the beach but was not open at the time of the inspection. This creek entrance appears to be quite stable as it is controlled by a box culvert at the bridge and constrained by rock walls on its western side. This creek connects to a large freshwater wetland approximately 800 m upstream. It is understood that beach boat launching occurs from the eastern end of the beach. The beach is backed by a small urban settlement with a ground level of approximately 5.0 m AHD, although there are lower lying areas near the wetland (3.5 m AHD). Car parks exist at both ends of the beach. Reefs exist off the eastern and western ends of the beach providing some protection from wave attack. A summary of sand sample analysis is shown in Figure B-7.

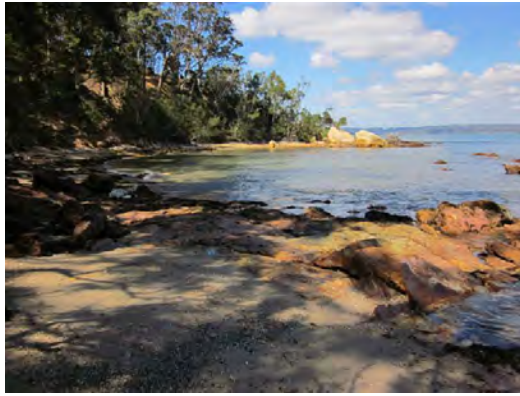
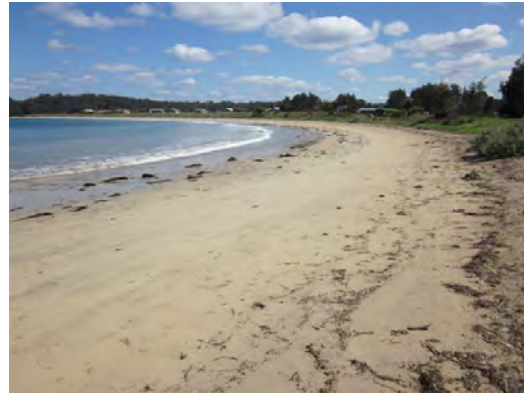
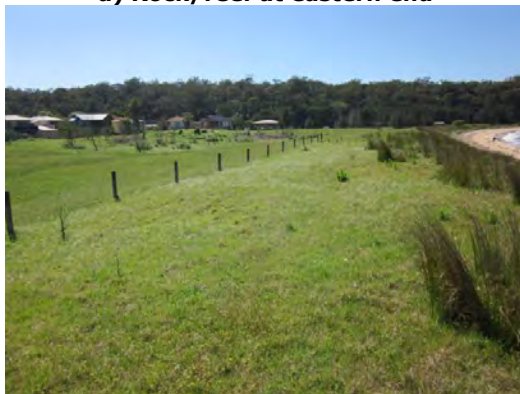
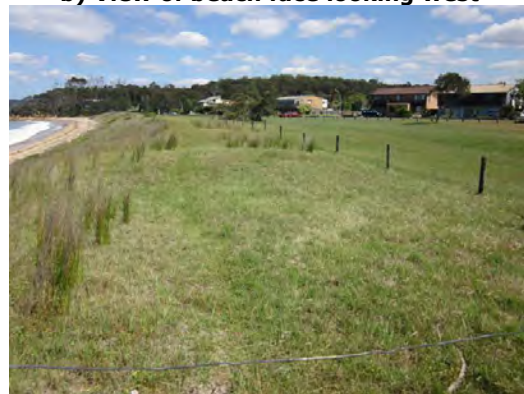
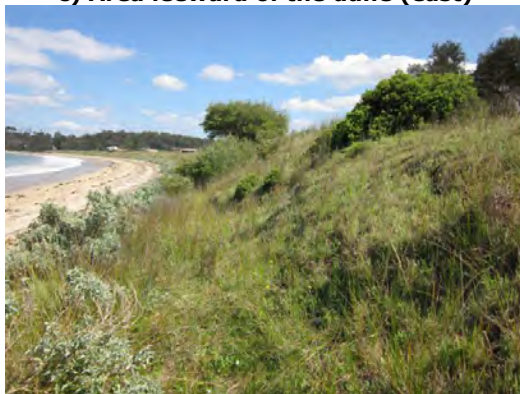
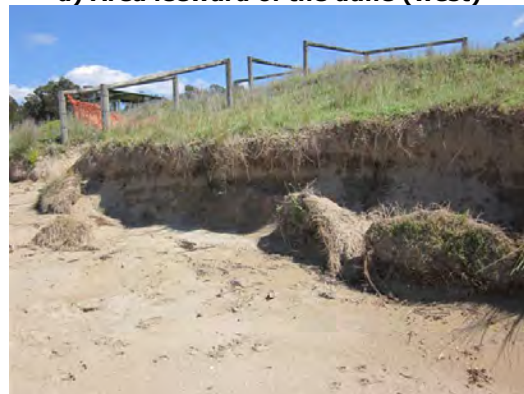
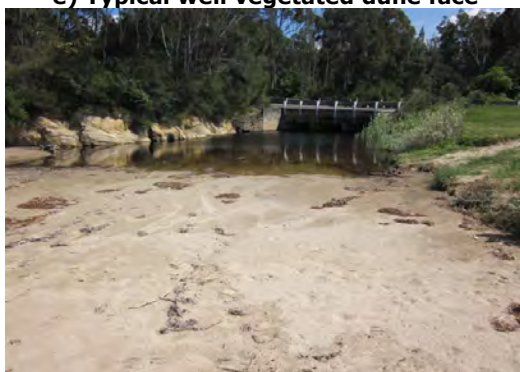
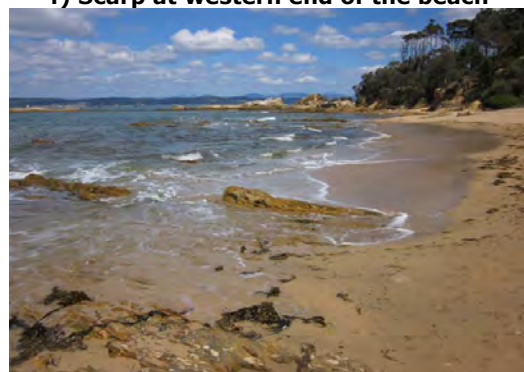
**Figure B-6: Maloneys Beach Site Inspection**

**a) Rock/reef at eastern end**

**b) View of beach face looking west**

**c) Area leeward of the dune (east)**

**d) Area leeward of the dune (west)**

**e) Typical well vegetated dune face**

**f) Scarp at western end of the beach**

**g) Maloneys Creek outlet**

**h) Rock/reef at western end**

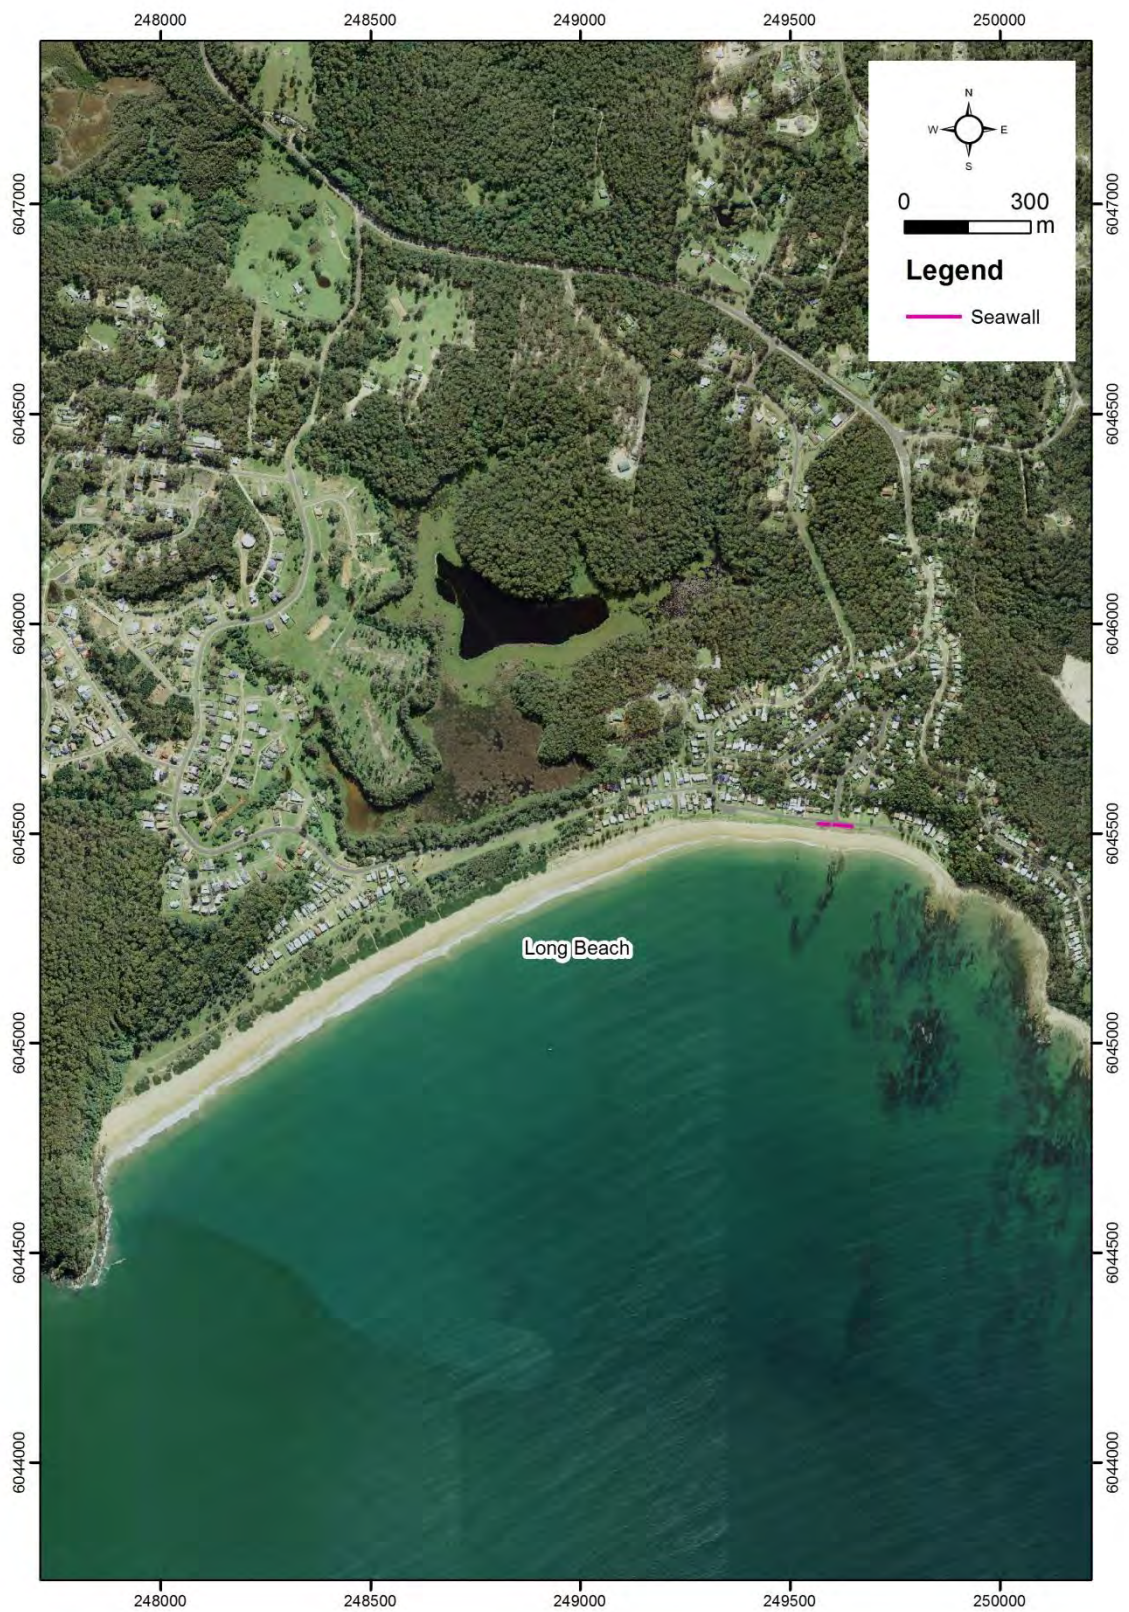
**Figure B-8: Long Beach Site Details**

The eastern third of Long Beach has private properties facing the beach on the northern side of Bay Road (Figure B-9). Two concrete stormwater outlets are located within this section. The foreshore either side of the westernmost stormwater outlet where Fauna Avenue intersects with Bay Road is protected by a rock revetment wall constructed during the 1980s (WMA, 2006). The condition of this wall is unknown (SMEC, 2010), however, WRL estimates that the primary armour is basalt with a typical size of 0.3 to 0.4 m. The wall is largely buried and has an irregular crest level of 3.0 to 3.5 m AHD. Since the structure is largely buried and construction details are unavailable, the alongshore extent of the seawall in Figure 2.7 is approximate only. The dune either side of this wall is poorly vegetated and relatively low, with a similar elevation as the wall. At the time of the inspection (31 October 2011), a small scarp was noted at the eastern end. The ground levels for most properties within the eastern third of Long Beach are above 3.5 m AHD, however, several properties have an elevation of 3.0 m AHD. Four wheel drive (4WD) beach access is available from the eastern end for boat launching. A car park also exists at the western end of this section.

Reed Swamp backs the central third of Long Beach and has an outlet at Sandy Place (100 m west of Long Beach Road). This creek entrance appears to be moderately stable as it is controlled by a box culvert. It is constrained by rock gabions upstream of the culvert, but there is no sidewall protection downstream. The dune height is approximately 5 m AHD except near the Reed Swamp outlet where it drops to approximately 3 m AHD. The back beach area is developed on the southern side of Sandy Place. Seaward of this development the dune is moderately vegetated, but to the west of the developed section, the dune is well vegetated.

The western third of the beach has a dune height of approximately 5 m AHD and is well vegetated (Figure B-10). There are several breaks in the dune to allow for public pedestrian beach access. The back beach area is relatively undeveloped except for a new sub-division on the southern side of Sandy Place. This development is well setback compared to those properties in the eastern and central thirds of the beach. A summary of sand sample analysis is shown in Figure B-11.

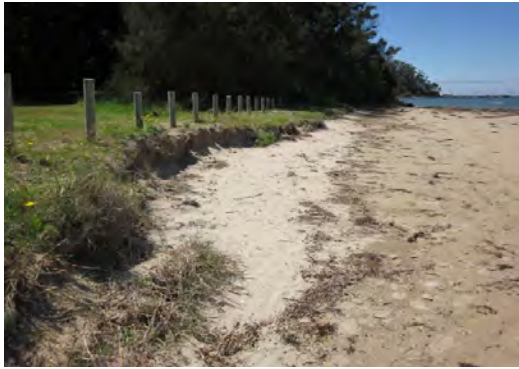
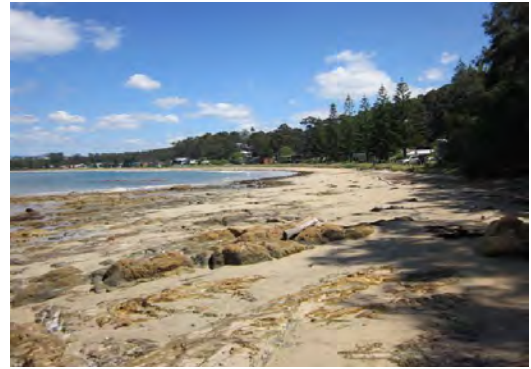
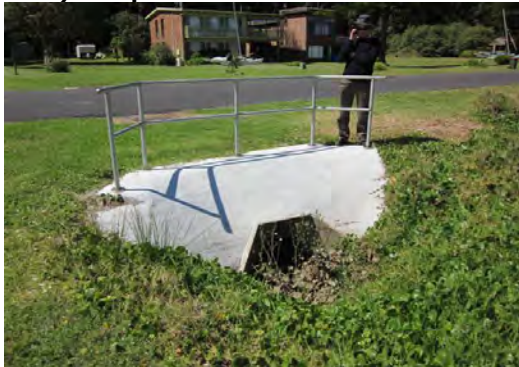
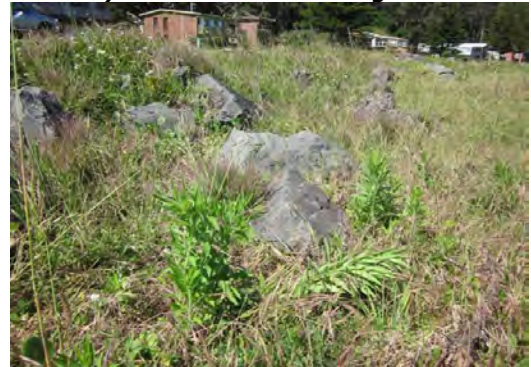
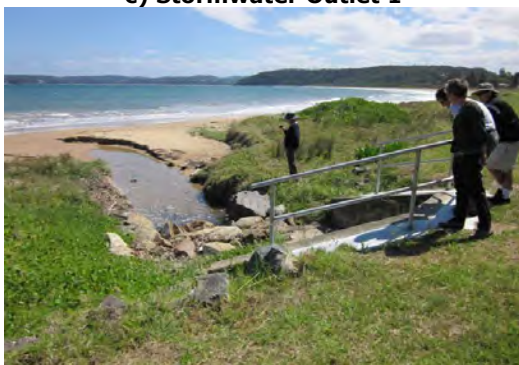
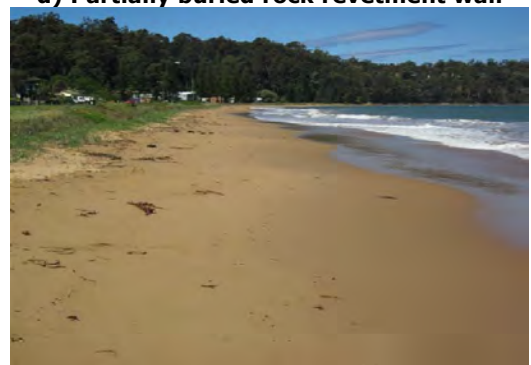
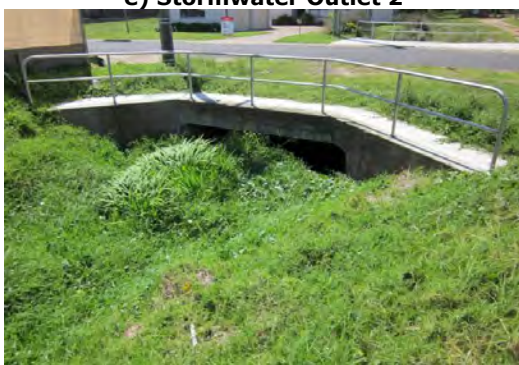
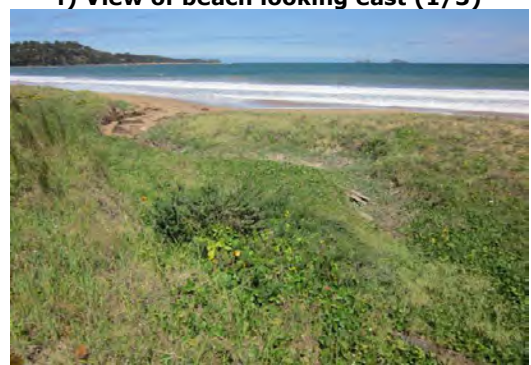
**Figure B-9: Long Beach Site Inspection (1 of 2)**

**a) Scarp at eastern end of the beach**

**b) View of beach looking west**

**c) Stormwater Outlet 1**

**d) Partially buried rock revetment wall**

**e) Stormwater Outlet 2**

**f) View of beach looking east (1/3)**

**g) Reed Swamp outlet**

**h) Erosion due to Reed Swamp outlet**

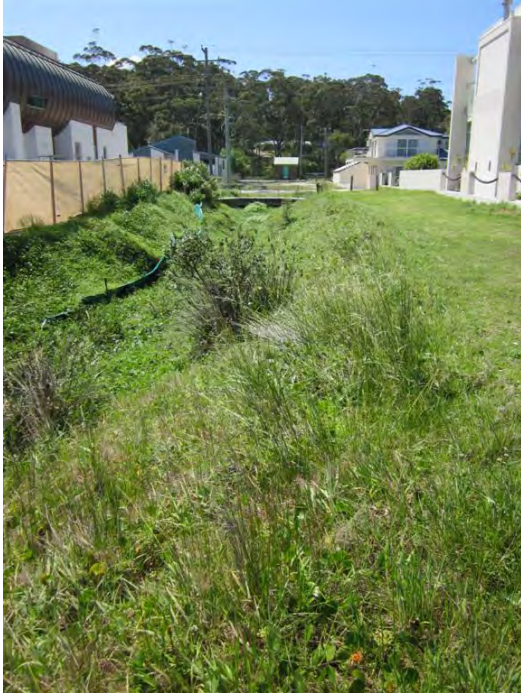
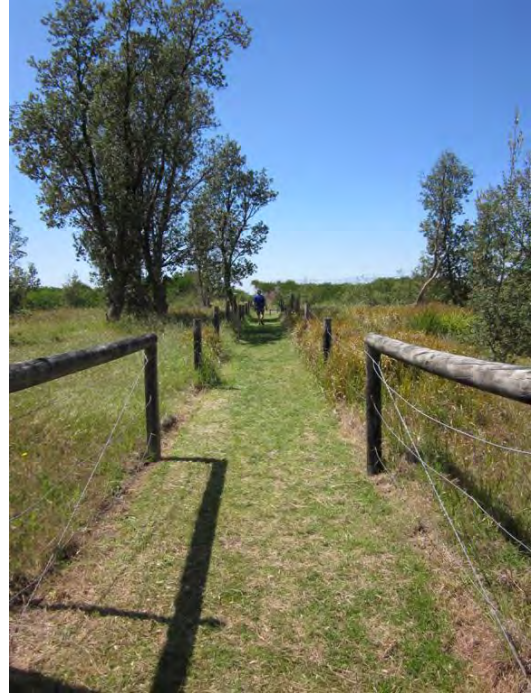
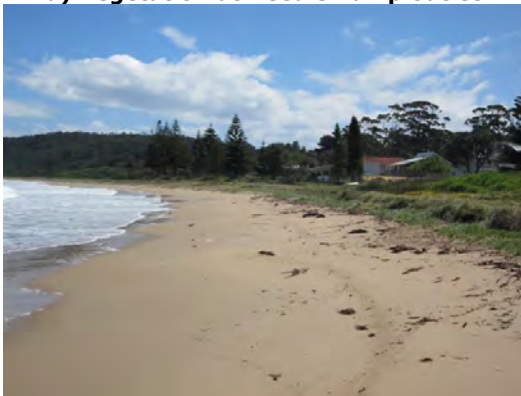
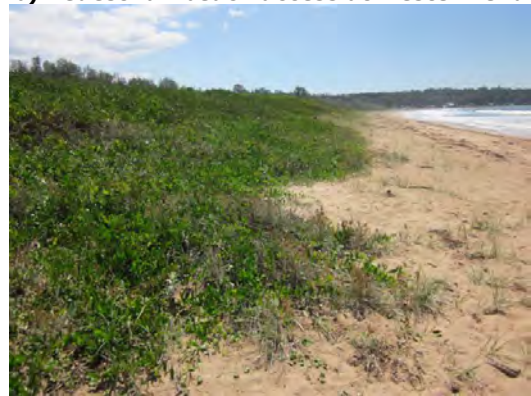
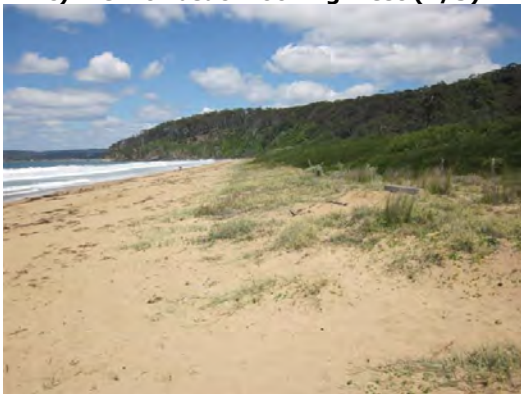
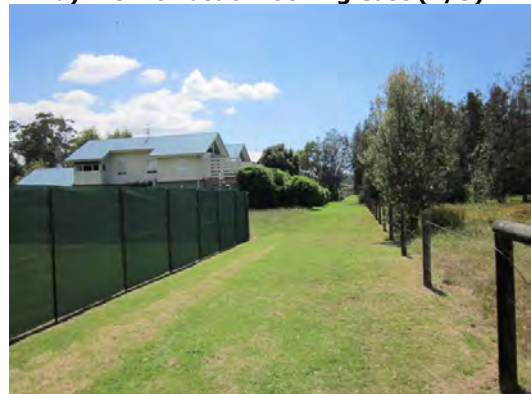
**Figure B-10: Long Beach Site Inspection (2 of 2)**

**a) Vegetation at Reed Swamp outlet**

**b) Pedestrian beach access at western end**

**c) View of beach looking west (1/3)**

**d) View of beach looking east (2/3)**

**e) View of beach looking west (2/3)**

**f) Setback development at western end**

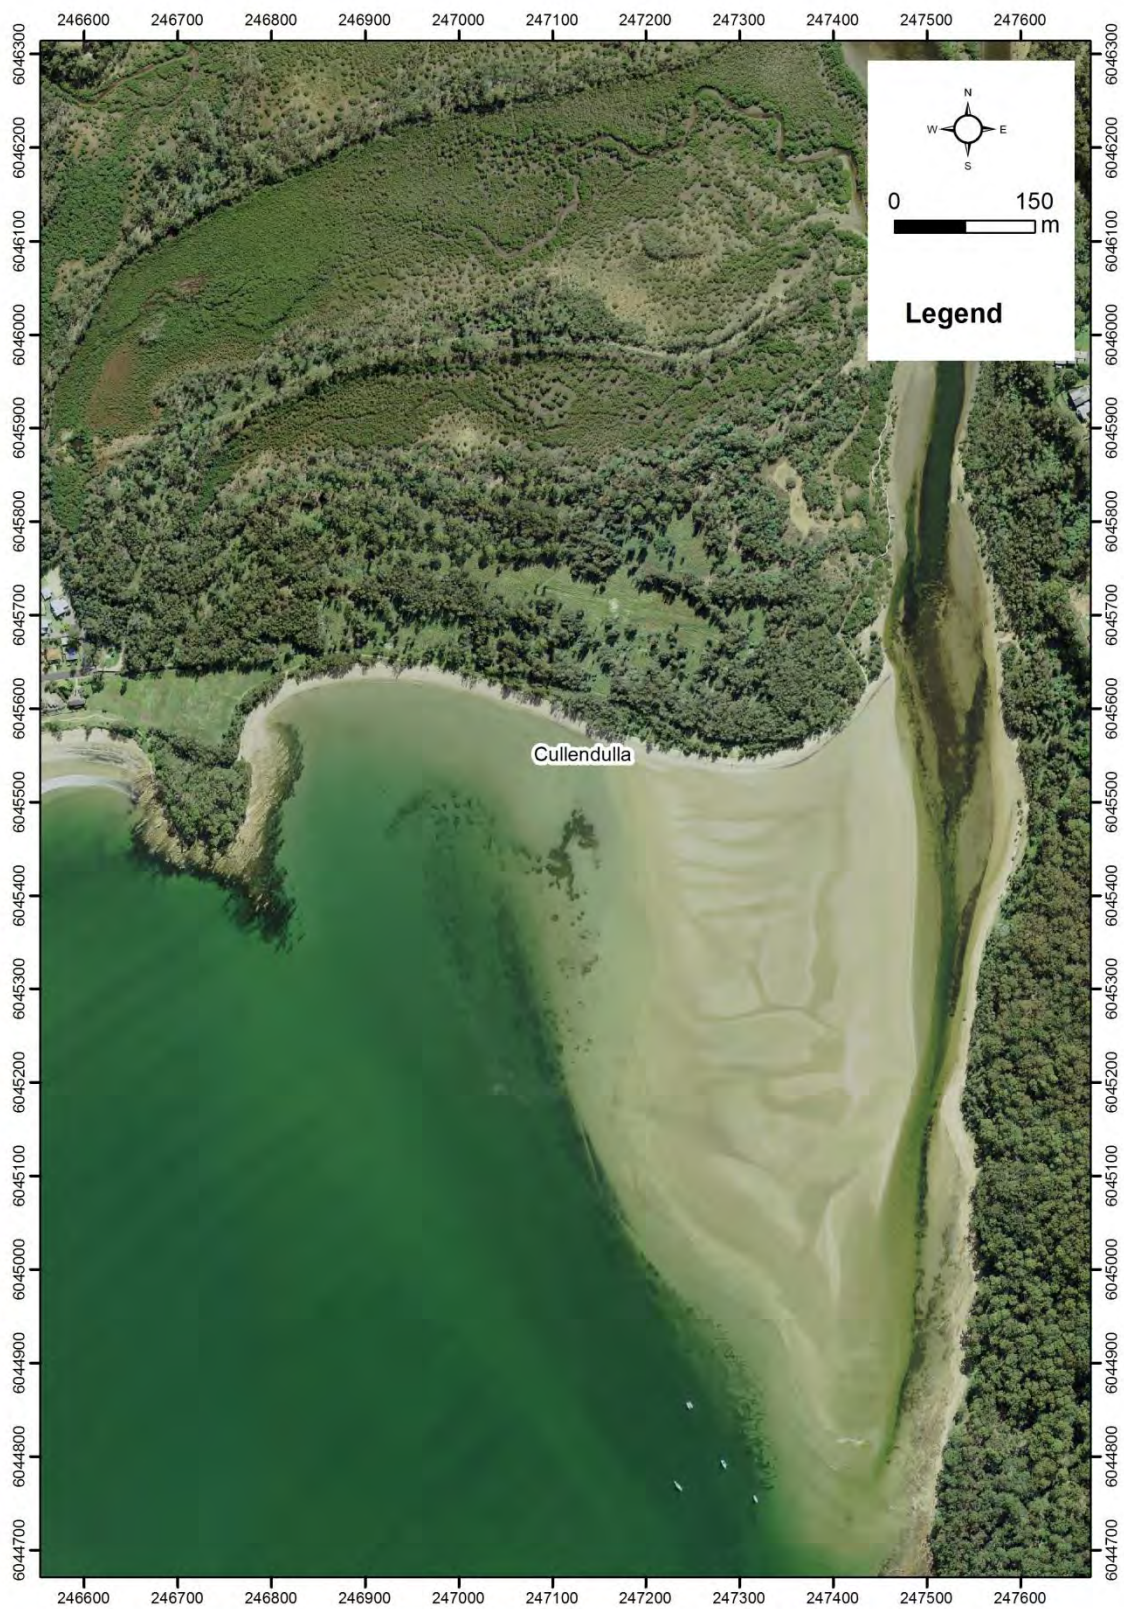
**Figure B-12: Cullendulla Beach Site Details**

Cullendulla Beach is a 660 m long beach with a low gradient facing south (Figure B-12). The beach is backed by a series of low beach ridges, then mangroves and inner beach ridges. The back beach area is well vegetated and has a relatively low elevation of between 1.5 and 2.0 m AHD. A scarp running along the length of the beach and vegetation loss due to recession were evident at the time of the site inspection (1 November 2011, Figure B-13). There is no residential development landward of this beach. However, an important sewer rising main, a telecommunications cable and a disused access track run along the back of the beach. The entrance to Cullendulla Creek does not have any artificial training structures, but is naturally constrained on its eastern side by rock shelves and cliffs. It was open at the time of the inspection. The creek connects to a large wetland upstream. A large ebb tide delta extends up to 1 km offshore at the eastern end of the beach. Square Head provides significant protection from swell wave attack for most of the beach. Reef also exists off the western end of the beach (Hawks Nest) providing some additional protection from wave attack. A summary of sand sample analysis is shown in Figure B-14.

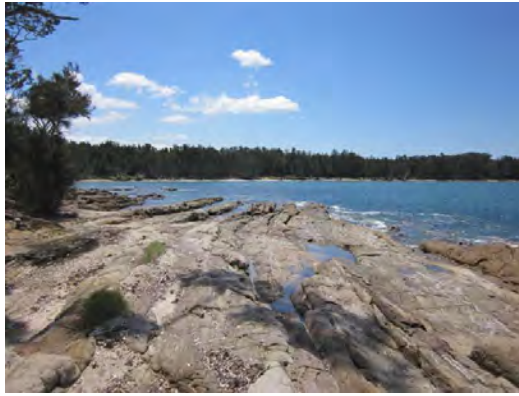
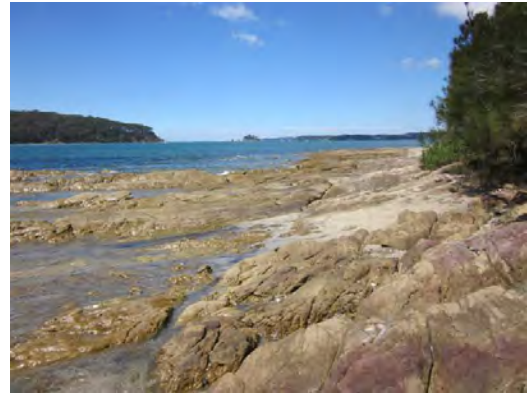
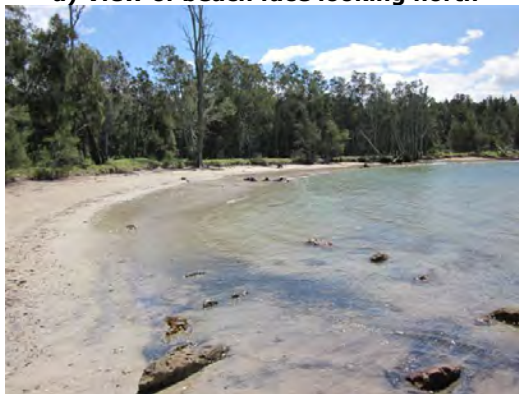
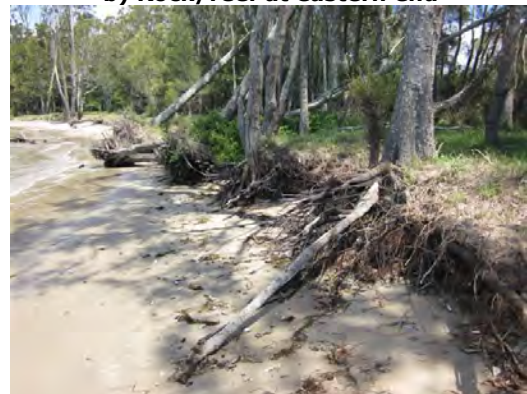
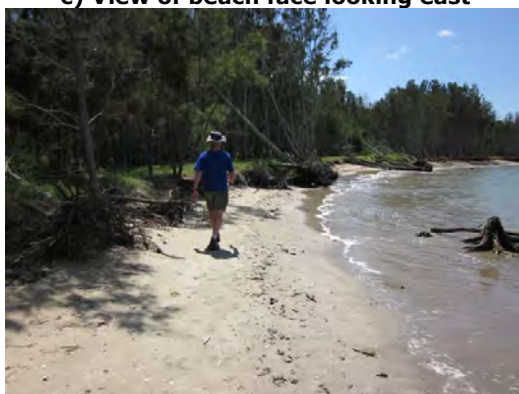
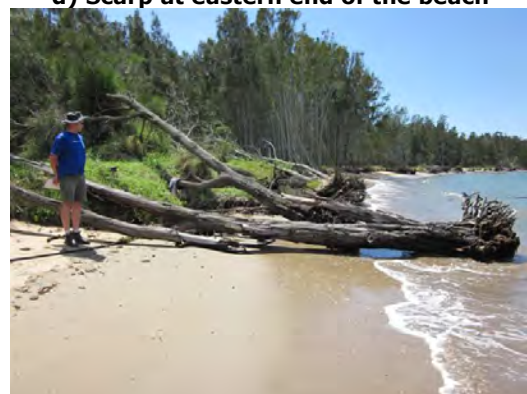
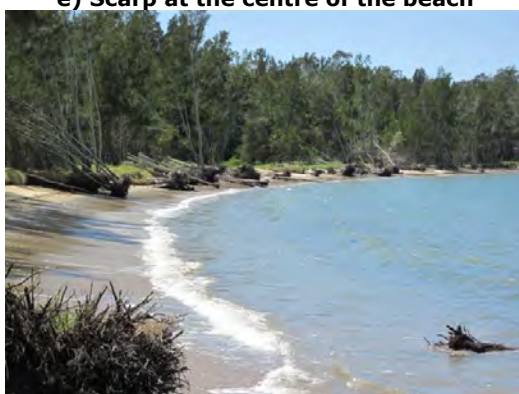
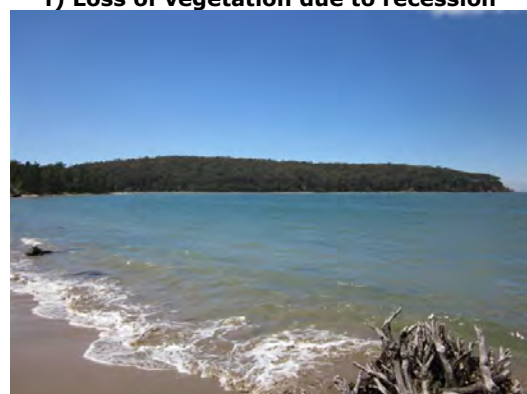
**Figure B-13: Cullendulla Beach Site Inspection**

**a) View of beach face looking north**

**b) Rock/reef at eastern end**

**c) View of beach face looking east**

**d) Scarp at eastern end of the beach**

**e) Scarp at the centre of the beach**

**f) Loss of vegetation due to recession**

**g) Evidence of recession along the beach**

**h) View of Square Head looking east**

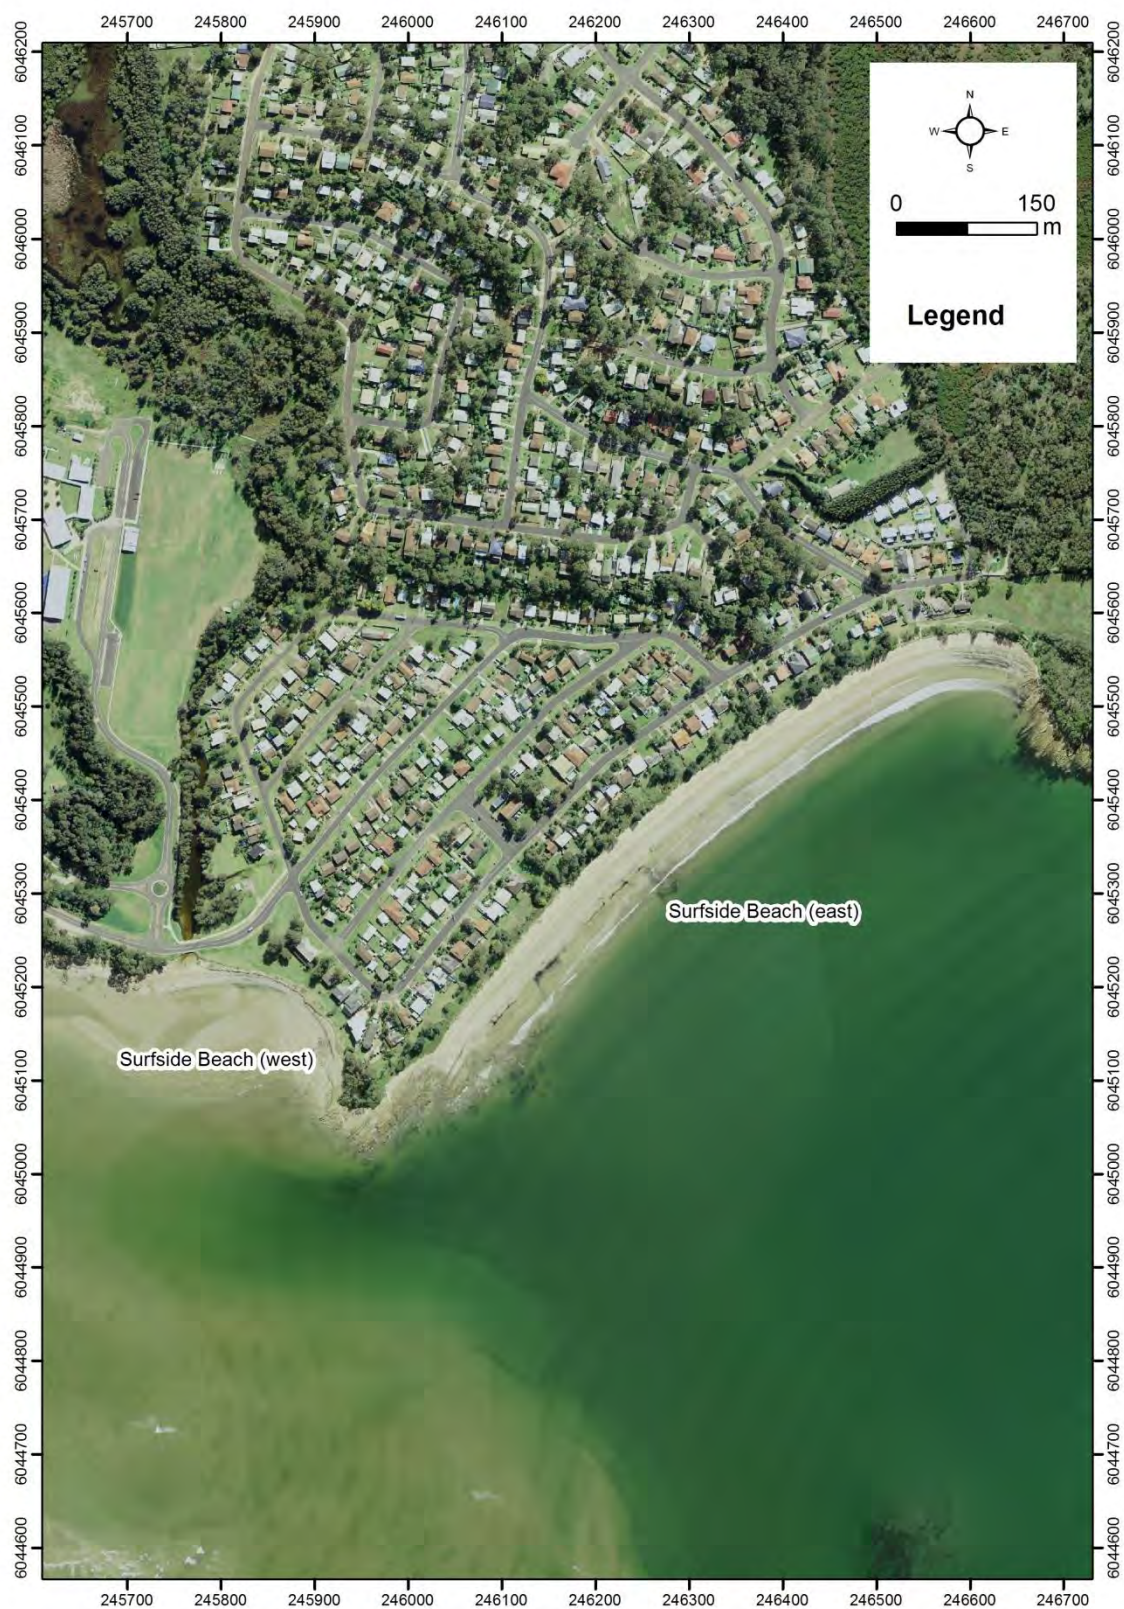
**Figure B-15: Surfside Beach (east and west) Site Details**

Surfside Beach is sub-divided into two different compartments for the purposes of this Coastal Hazard Assessment, Surfside Beach (East) and Surfside Beach (West) (Figure B-15).

Surfside Beach (East) is an 850 m long beach with a low gradient facing south-east (Figure B-16). The beach dune height is approximately 2.5 m AHD and is moderately well vegetated (although highly variable) along its length. The beach is backed by residential development (seaward of Myamba Parade) with a relatively low ground level of approximately 2.3 m AHD along its full length. Stormwater outlets exist at the northern (outlet damaged at the time of inspection, 31 October 2011) and southern ends of the beach and a sewage pumping station is also located behind the dune. There are several breaks in the dune to allow for public pedestrian beach access, and a car park also exists at the eastern end of the beach. Reefs exist off the northern and southern ends of the beach.

Surfside Beach (West) is a 270 m long beach with a low gradient facing south (Figure B-17). In other reports this same beach has also been referred to as McLeods Beach, Timbara Beach or Wharf Road (East). The beach dune crest is approximately 1.6 m AHD and is vegetated only with grass. The beach is backed by residential development (seaward of Myamba Parade) at the eastern end of the beach. The entrance to Surfside Creek exists at the western end of the beach but was not open at the time of inspection (31 October 2011). This creek extends 400 m from the opening where it joins a freshwater wetland. The creek entrance appears to be quite stable as it is controlled by a three pipe culvert under McLeod Street. The pipe culverts were half blocked due to sediment infilling from the beach. Reefs exist off the eastern and western ends of the beach providing some protection from wave attack. During the site inspection (31 October 2011), it was noted that waves approached the beach at an oblique angle producing a net longshore current westwards along the beach. A summary of sand sample analysis is shown in Figure B-18 and Figure B-19.

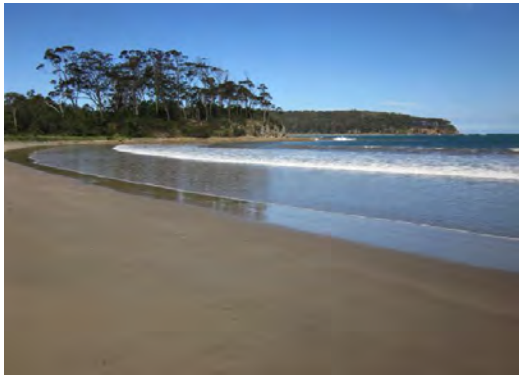
**a) Rock/reef at northern end**

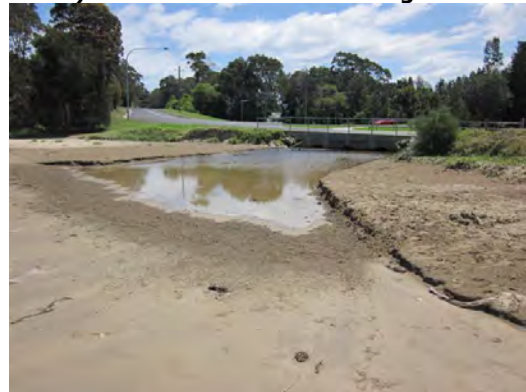
**f) Surfside Creek outlet**

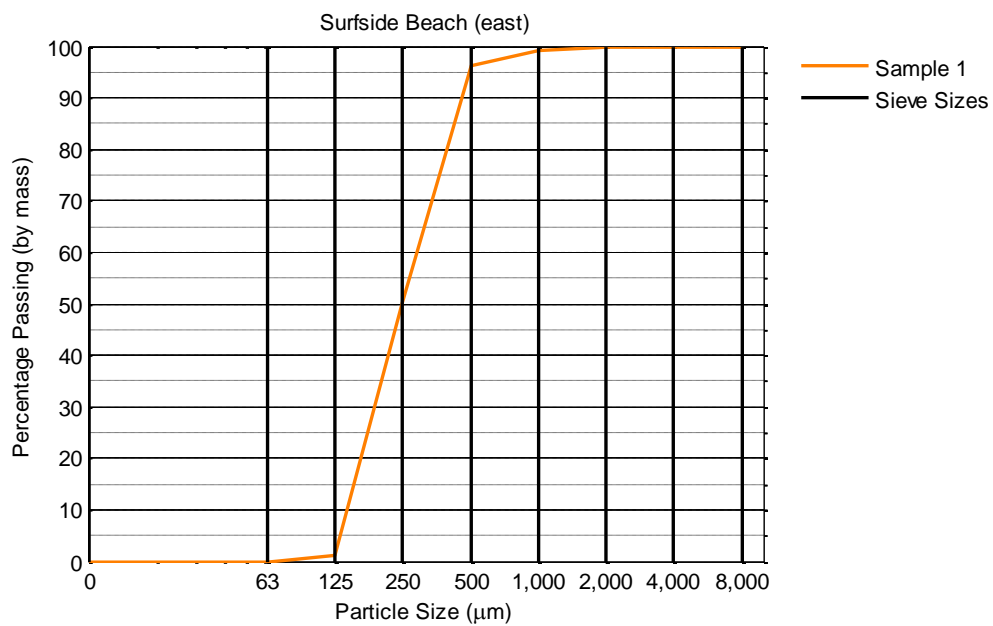
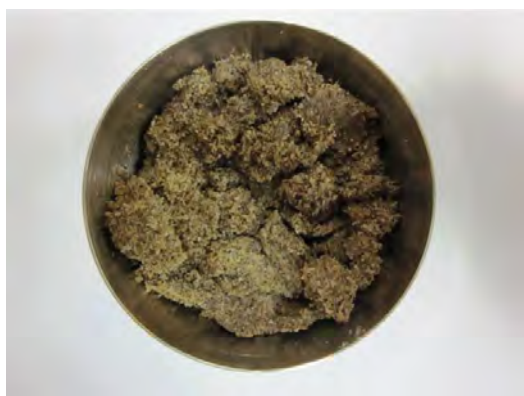
Sample 1

**Figure B-18: Surfside Beach (east) Sediment Sample**

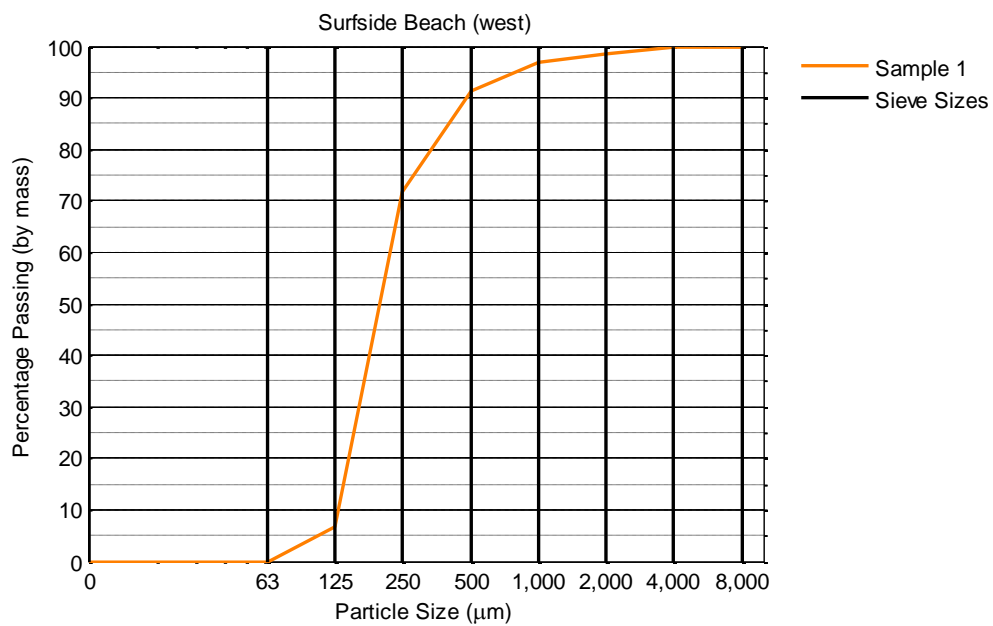
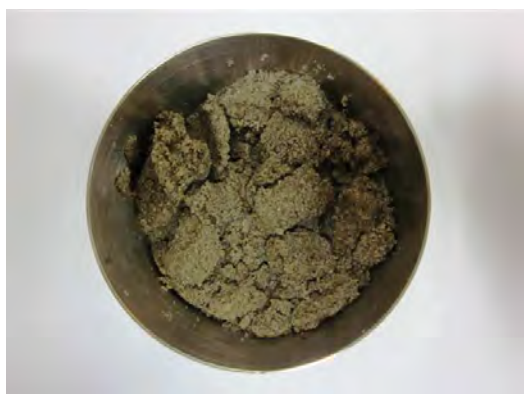
Sample 1

**Figure B-19: Surfside Beach (west) Sediment Sample**

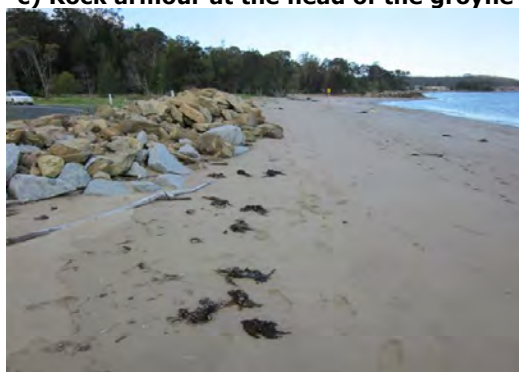
**e) Rock revetment wall**

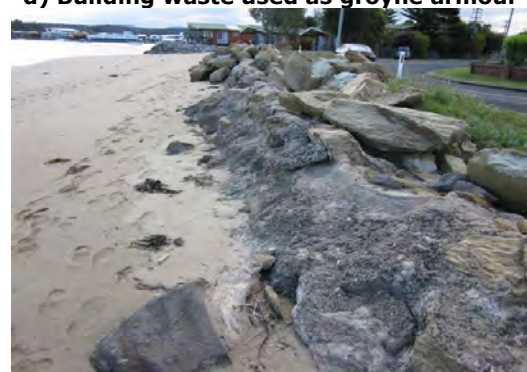
**f) Wall armour is grouted together**

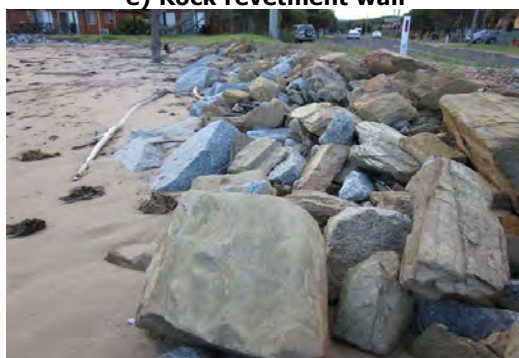
**g) Rock wall armour properties are mixed**

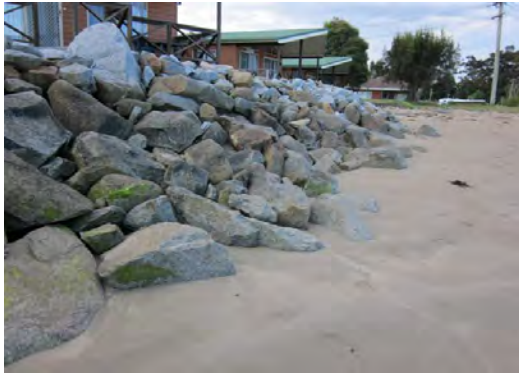
**a) Eastern end of rock revetment wall**

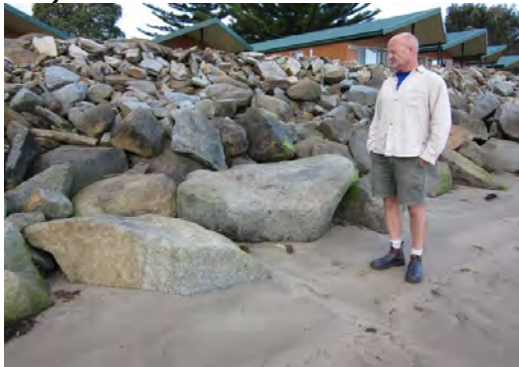
**c) Rock wall armour properties are mixed**

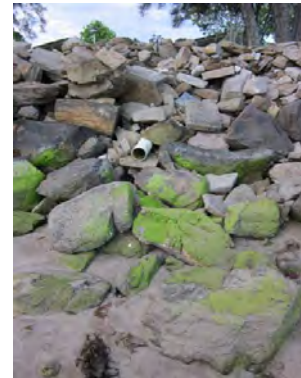
**d) Stormwater outlet from caravan park**

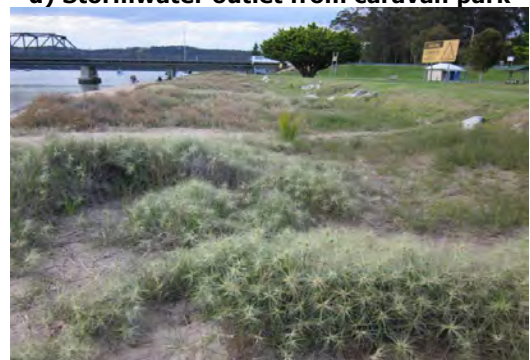
**f) Moderately vegetated dune face**

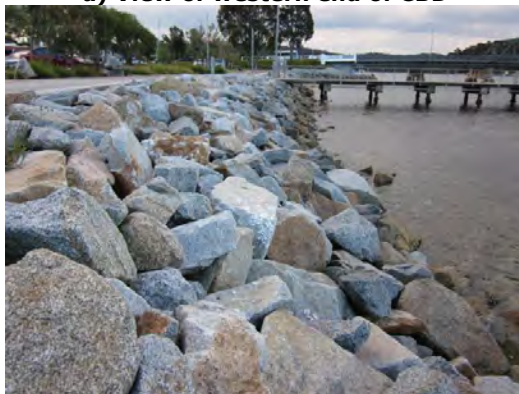
**c) View of revetment wall looking west 1**

Overall, the condition of the rock revetment wall around the CBD is considered to be reasonable. However, WRL recommends that ongoing monitoring of the condition of the wall be undertaken by ESC according to coastal engineering guidelines (USACE, 2006). At the western end of the CBD (up to the second wharf), the revetment is mainly composed of granite with an approximate size of 0.4 m. In this region, the armour appears to have recently been topped up. The structure slope in this region is relatively steep at approximately 1V:1.2H. There is a change in armour between the second wharf and the third wharf (Innes Boatshed), with at least two different types of rock (granite and another unknown material) used on the revetment. The granite has an approximate size of 0.3 m and the unknown rock type has a size of 0.9 m. The structure slope in this region is relatively flat at approximately 1V:2.0H. It should be noted that directly under the Innes Boatshed there is no rock revetment. Instead, the rock wall temporarily discontinues and is replaced by a vertical concrete besser block wall. Some pavers in the footpath were noted to be settling in this area, probably due to undermining or loss of fill through the wall. East of the third wharf (Innes Boatshed) the armour was mainly composed of granite with an approximate size of 0.4 m and a structure slope of 1V:2.0H. A geotextile filter was generally evident under the armour along the full length of the revetment.
