## Eurobodalla Coastal Hazard Assessment

WRL Technical Report 2017/09  
October 2017

By I R Coghlan, J T Carley, A J Harrison, D Howe, A D Short,  
J E Ruprecht, F Flocard and P F Rahman

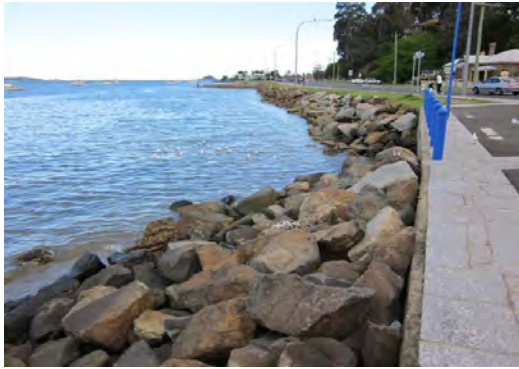
**a) Western end of rock revetment wall**

WRL understand that ESC is responsible for the maintenance of the revetment where Beach Road is located immediately in its lee (up to 50 m east of Herarde Street). The condition of the rock revetment wall under the responsibility of ESC is considered to be fair, however, one section requires immediate attention. Ongoing monitoring of the condition of the remainder of the wall should be undertaken by ESC. At the western end, the revetment is mainly composed of granite with an approximate size of 0.7 m, a geotextile underlayer and a relatively steep slope of approximately 1V:1.0H. Opposite **"The Old School House" (TOSH, 10 Beach Road)**, the revetment structure and its condition changes considerably; this region requires immediate attention from ESC. The rock type is unknown with an approximate size of 0.4 m and a structure slope of 1V:1.0H. No geotextile underlayer was visible. In this region, the crest of the revetment is below the level of Beach Road and fines are being lost through the wall over a distance of approximately 100 m. East of this section, the revetment rock changes back to granite with an approximate size of 0.7 m and a slope varying between approximately 1V:1.2H and 1V:1.6H. No geotextile underlayer was visible in this region.

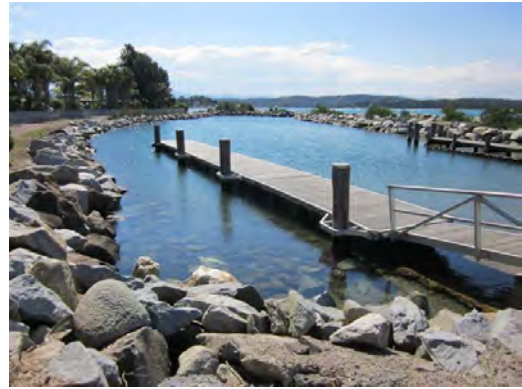
**b) Boat ramp**

While a review of the internal marina and the intertidal basin is beyond the scope of this study, it has significantly infilled with sediment. The outlet of Hanging Rock Creek is also within the marina. The Hanging Rock boat ramp is located towards the eastern end of the sub-section (Figure B-28). Extensive urban development is located landward of the marina and the boat ramp. Properties seaward of Beach Road and Tuna Street have variable degrees of protection from coastal processes. Again, this sub-section receives protection from offshore shoals which induce incident wave breaking.

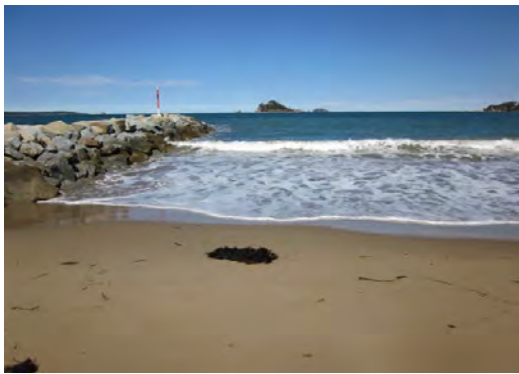
**a) Training wall at northern end of beach**

In addition to sand accumulation due to the presence of the training wall, sand dredged from the Clyde River (ebb tide) bar has repeatedly been placed at the northern and centre thirds of Corrigans Beach over many years. Buildings in the northernmost caravan park are set back further from the shoreline than those in the southern caravan park. The foreshore of the southern caravan park is protected by a rock revetment wall. The condition of this wall is unknown and was predominantly buried at the time of the inspection (1 November 2011). Since construction details are unavailable, the alongshore extent of the seawall in Figure B-29 is approximate only.

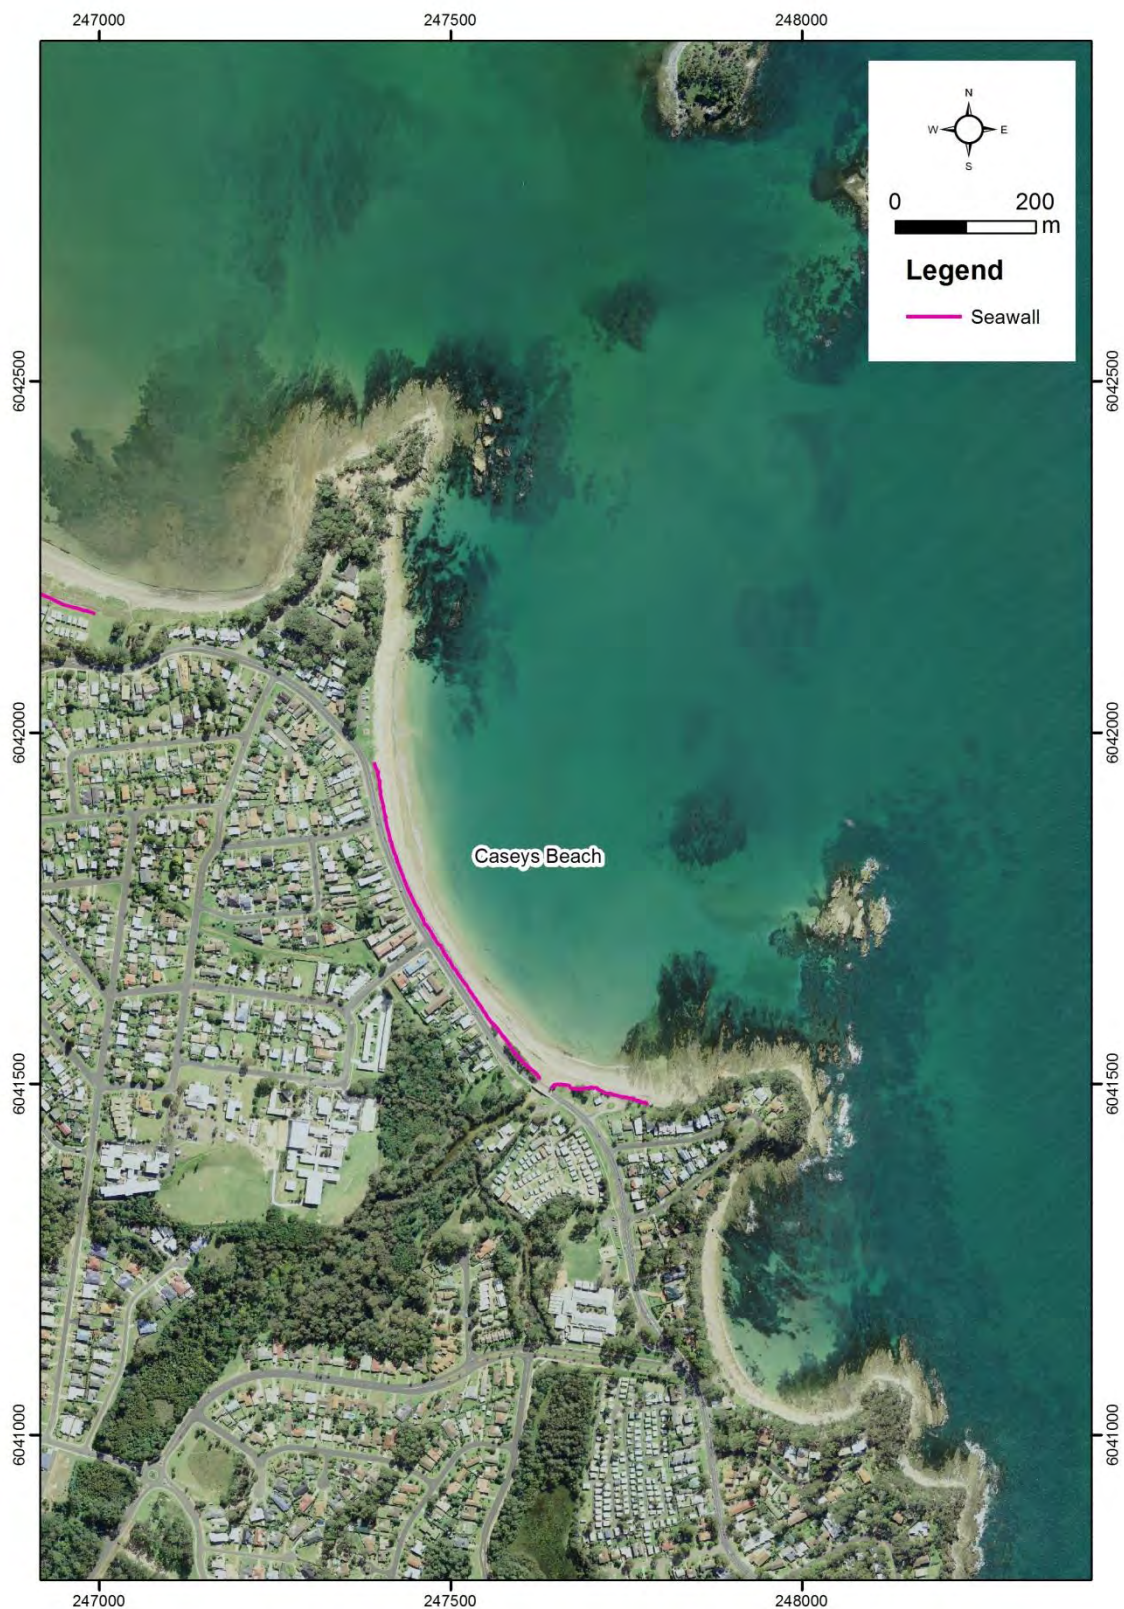
**Figure B-31: Caseys Beach Site Details**

Overall, the condition of the seawall along the northern part of Caseys Beach is considered to be poor and requires immediate action and ongoing monitoring by ESC. The reader is referred to **WRL's detailed condition assessment and design advice report for this seawall** (Blacka and Coghlan, 2016).

**Since WRL's original site inspection on 31 October 2011, WRL** also prepared a detailed condition assessment and design advice report for the seawall along the southern part of Caseys Beach which protects the sewage pumping station (Coghlan and Drummond, 2013). In April 2017, upgrade works on this seawall section were completed.

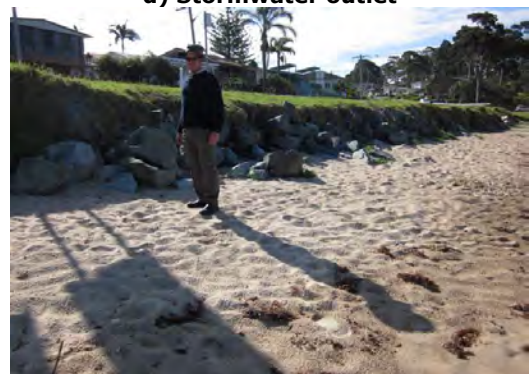
**f) Northern end of rock revetment wall**

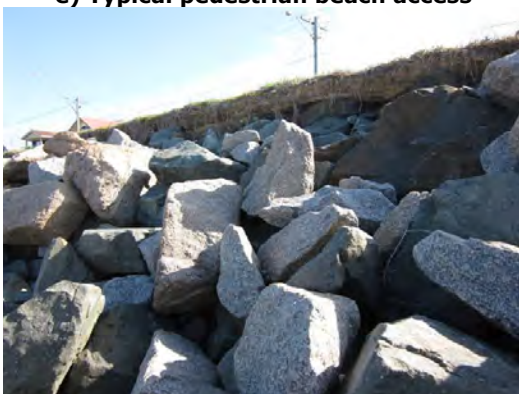
**g) Some slumping of armour at the crest**

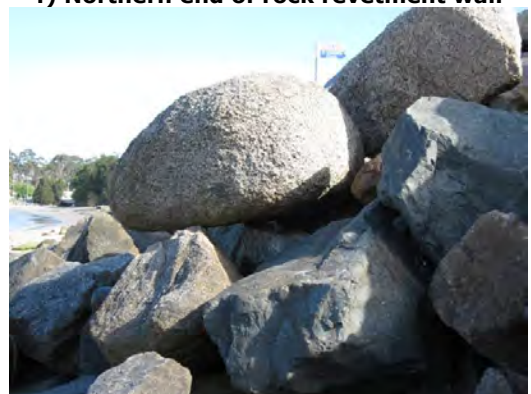
**h) Example of precariously positioned rock**

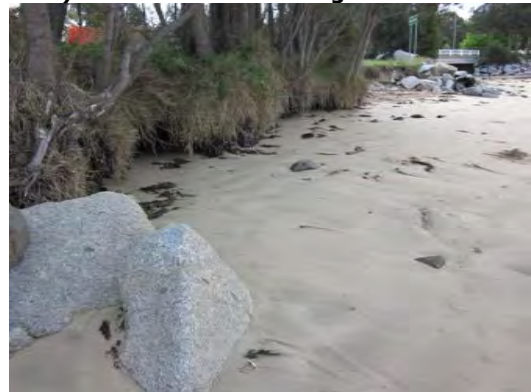
**d) Unprotected section of beach**

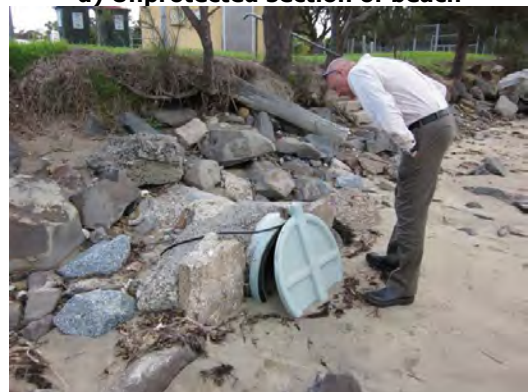
**f) Stormwater outlet (blocked floodgate)**

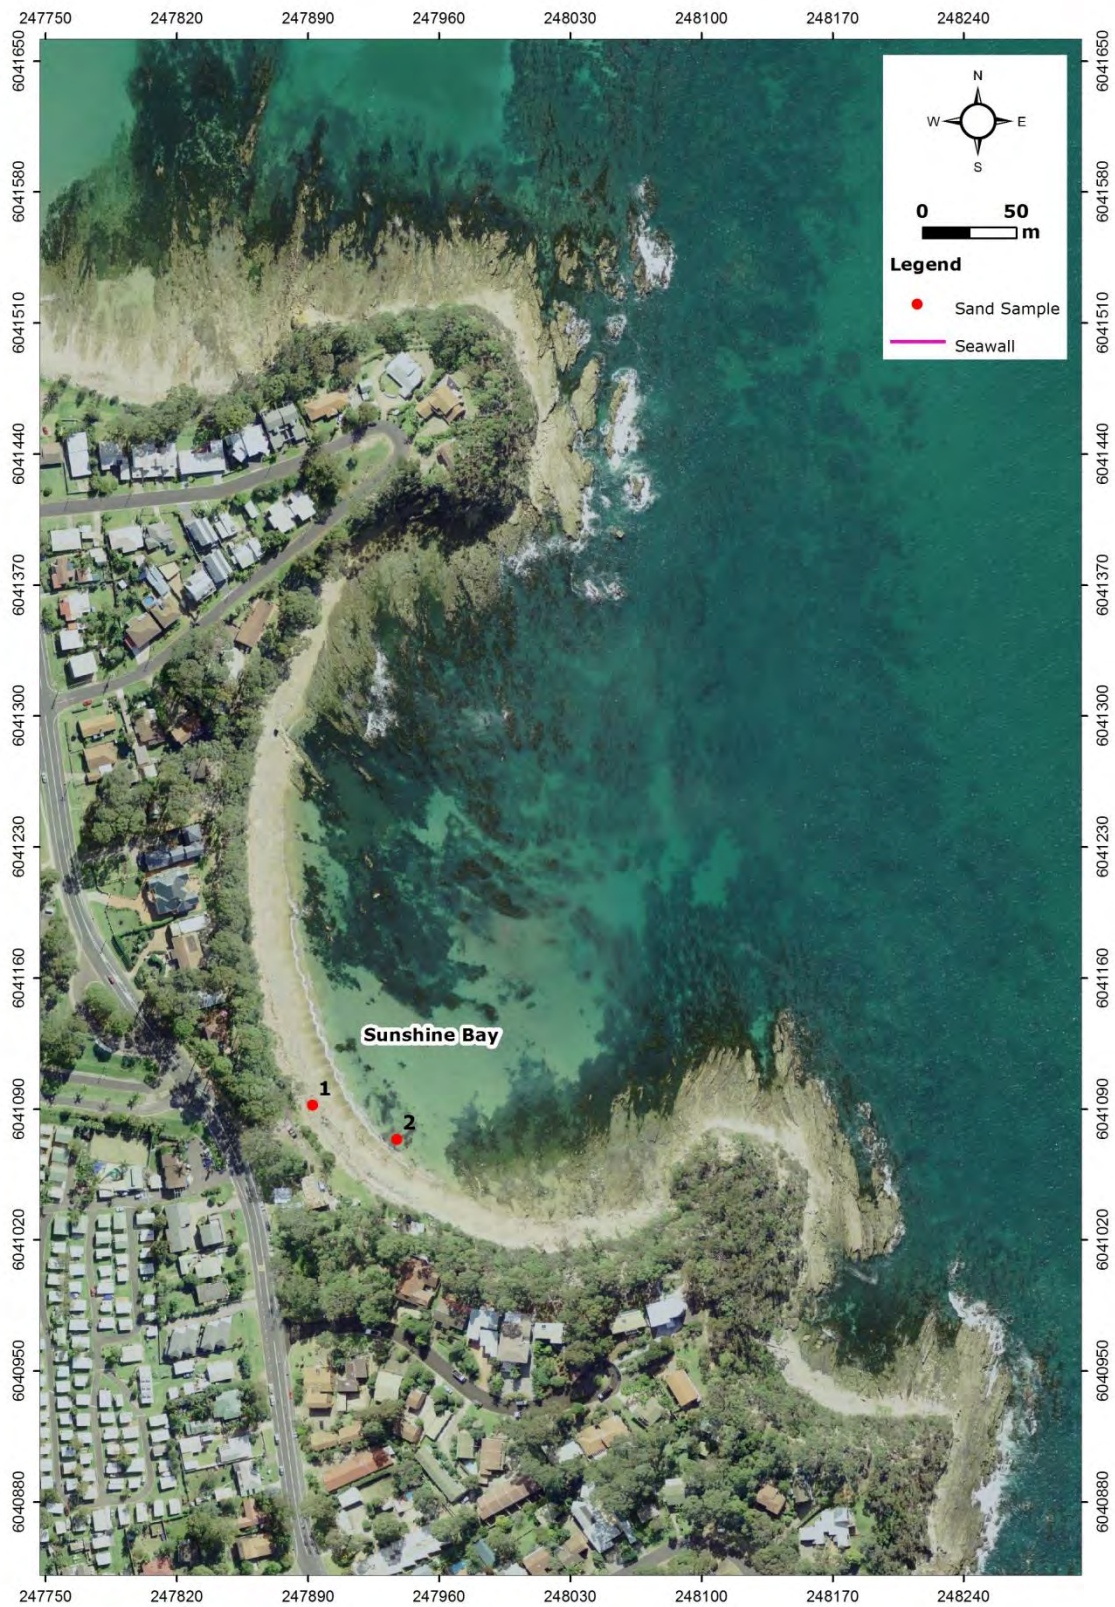
**Figure B-34: Sunshine Bay Site Details**

Sunshine Bay is a 520 m long beach with a low gradient, facing east to north-east (Figure B-34). The bay is semi-circular and is located between two well vegetated 20 m high headlands. The beach gradient reduces north to south with scarps noticeable along the foreshore. It is bordered and fronted by considerable rock and reef resulting in a low wave climate. There is no natural dune at Sunshine Bay (Figure B-35). A natural rock outcrop at the northern end of the beach had formed a small salient at the time of the site inspection (5 December 2012). Additional protection from wave attack is also provided by the Tollgate Islands to the south-south-east.

Beach Road runs just behind the beach with a small parking area towards the southern end, opposite a caravan park (Pleasurelea Tourist Resort). The car park is positioned landward of a low point in the beachface providing informal pedestrian access to the beach. Adjacent to the south side of the car park are several houses including a boatshed with a launching ramp and small wooden retaining wall. These structures are located at low elevations in close proximity to the beach. A summary of sand sample analysis is shown in Figure B-36.

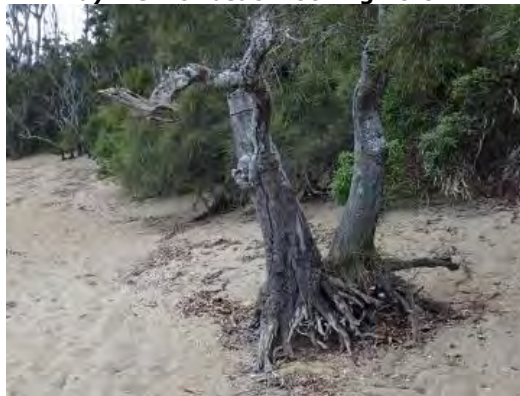
**c) Loss of vegetation**

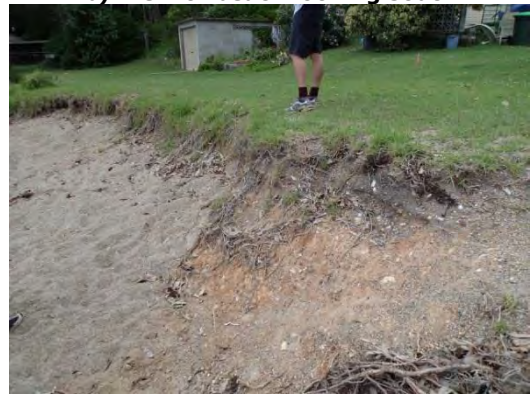
**d) Scarp at the southern end of the beach**

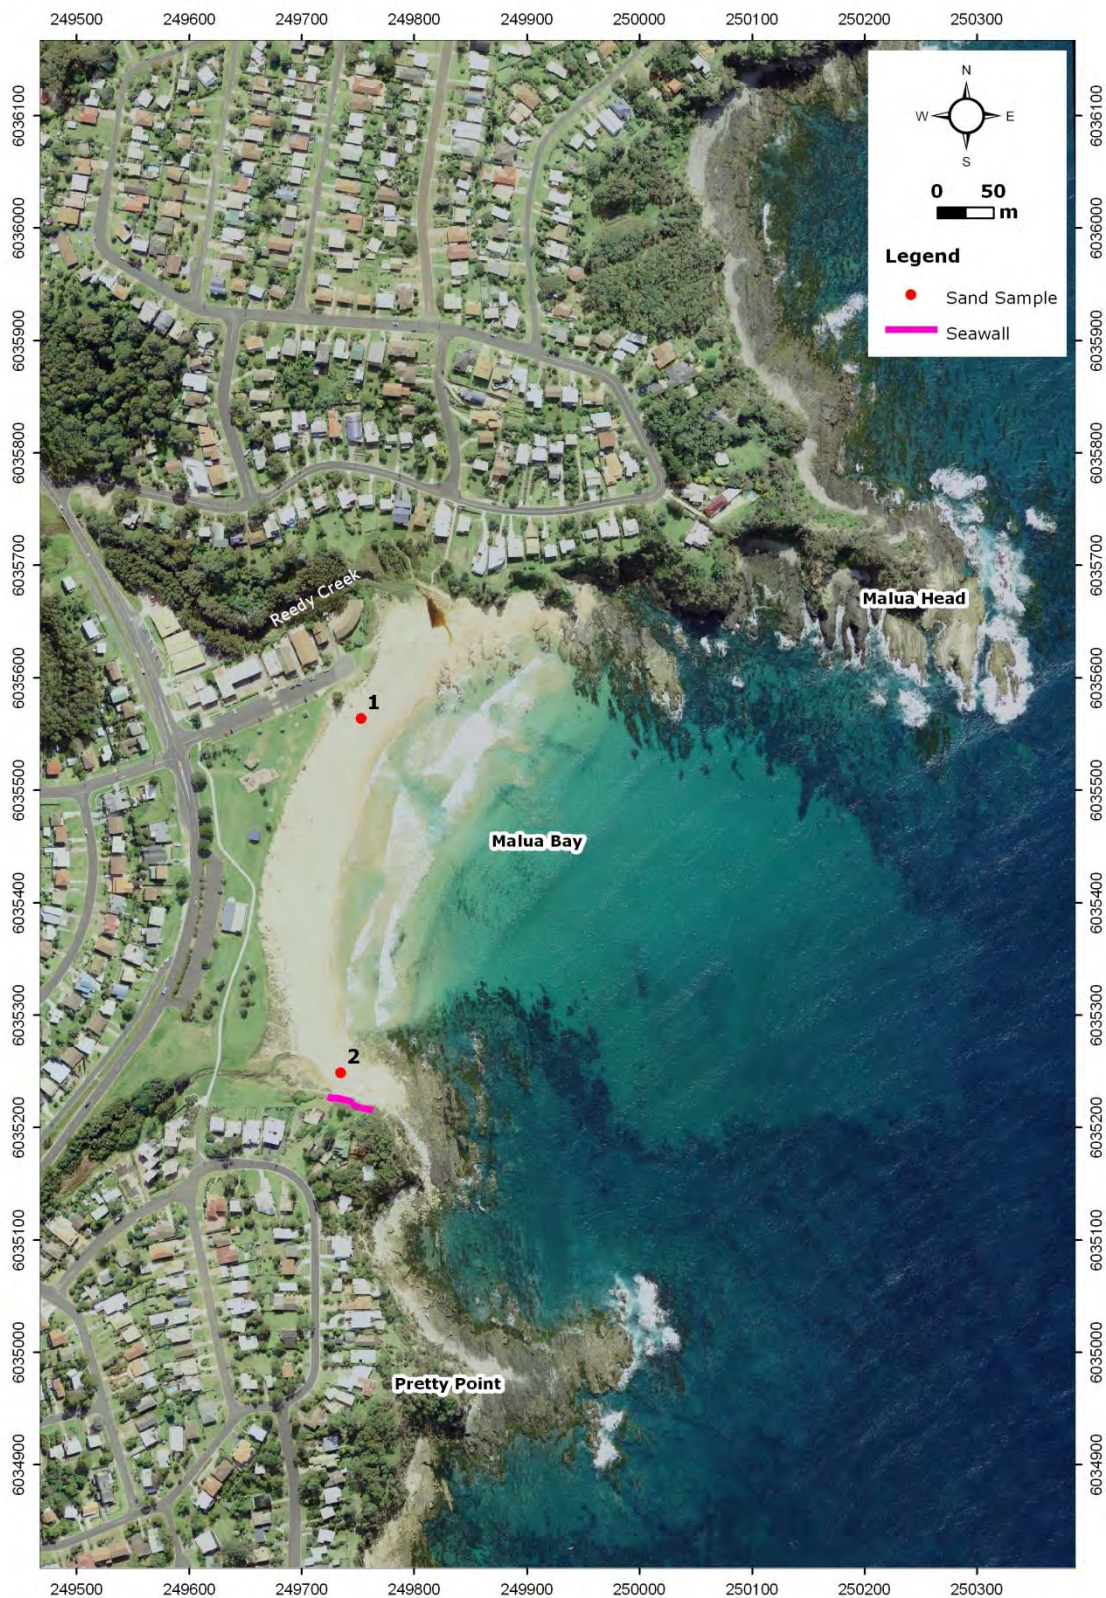
**Figure B-37: Malua Bay Site Details**

Malua Bay is a 510 m long beach with a low gradient, facing east (Figure B-37). It is bordered by Malua Head to the north and the base of Pretty Point to the south. Two creeks drain across the beach: Reedy Creek at the northern end and a small creek at the southern end (Figure B-38). Reedy Creek entrance is typically open and drains across a rock bed at the base of Malua Head, whereas, the creek mouth at the southern end is rarely open. These typical entrance conditions were observed at the time of the site inspection (5 December 2012). Both creeks are heavily vegetated along their banks and are controlled by culverts under George Bass Drive. Reedy Creek is controlled by three 3 m wide box culverts approximately 200 m landward of the beach and the southern creek is controlled by three 1.8 m concrete pipes approximately 100 m landward of the beach.

At the eastern end of Kuppa Avenue, an apartment block and a telecommunications pit are located at low elevations in close proximity to the beach. Some houses at the southern end of Malua Bay are also in close proximity to the beach.

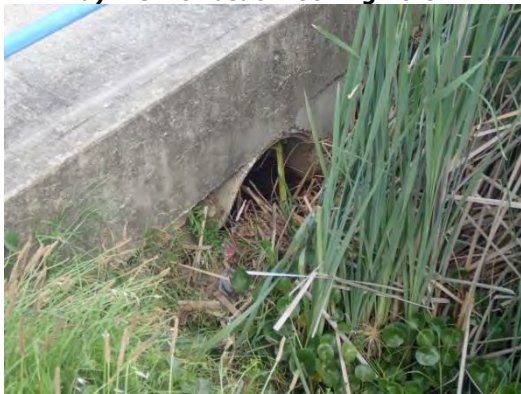
**c) Blocked stormwater pit at southern end**

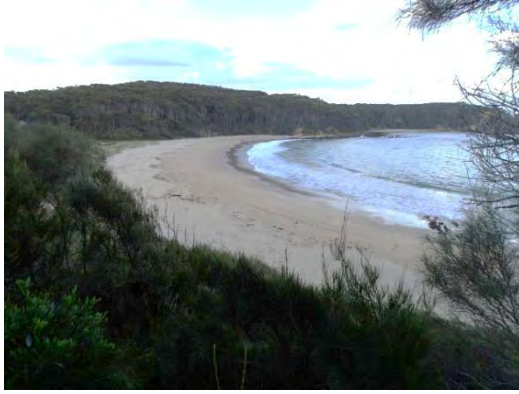
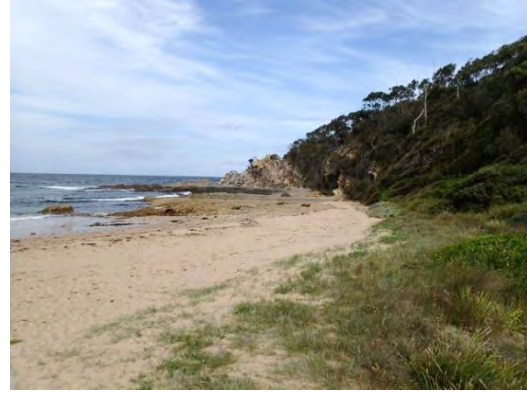
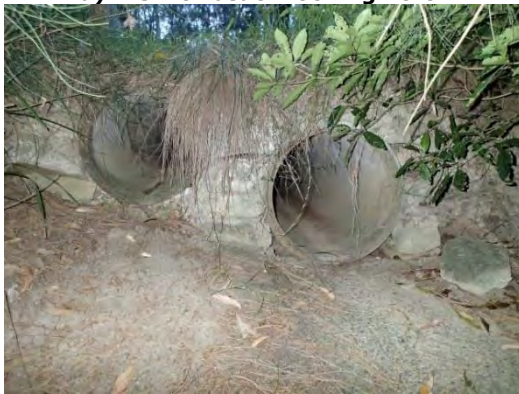
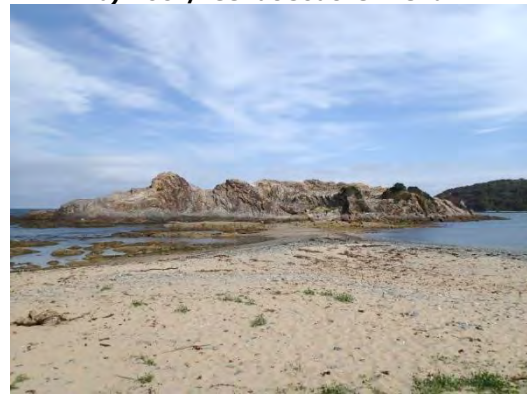
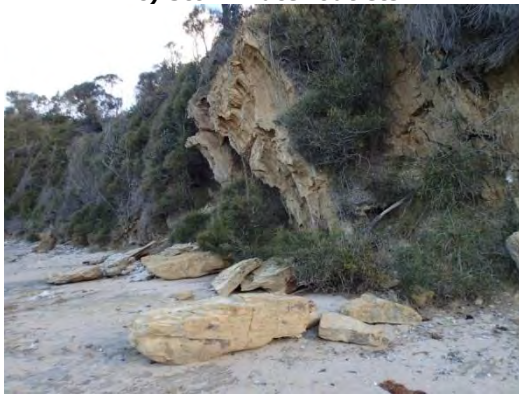
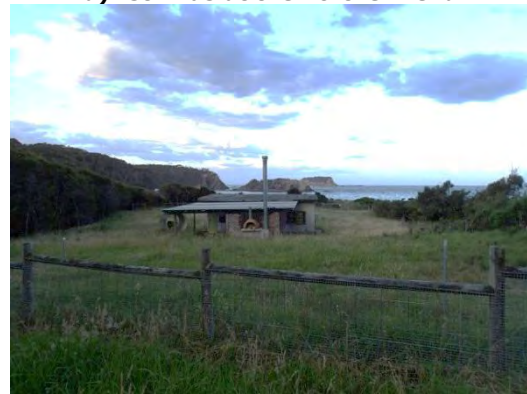
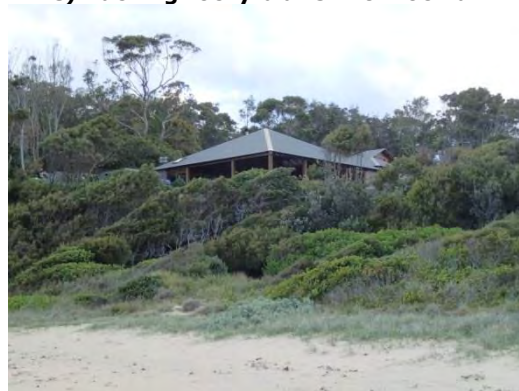
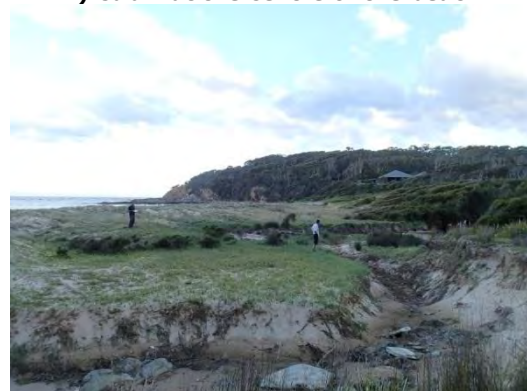
**Figure B-41: Guerilla Bay Site Inspection**

**a) View of beach looking north**

**b) Rock/reef at southern end**

**c) Stormwater outlets**

**d) Isthmus at the northern end**

**e) Backing rocky bluffs with rockfall**

**f) Cabin at the centre of the beach**

**g) House at the southern end**

**g) Scour of the banks of the creek**

A large, healthy dune is located landward of the beach. Guerilla Bay can be accessed via a small car park off Ocean Street. Houses at the northern and southern ends of the beach are located on rock cliffs. At the time of the site inspection, recent undercutting of the cliff was observed at the southern end. There are several properties with varying degrees of development located at low elevations in close proximity to the beach. A summary of sand sample analysis is shown in Figure B-42.

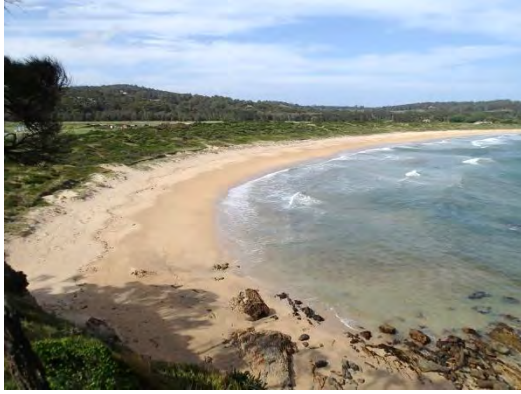
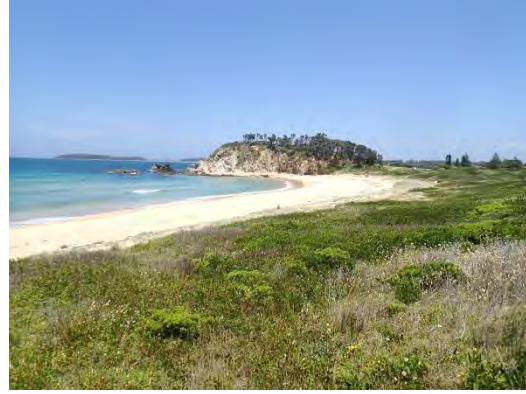
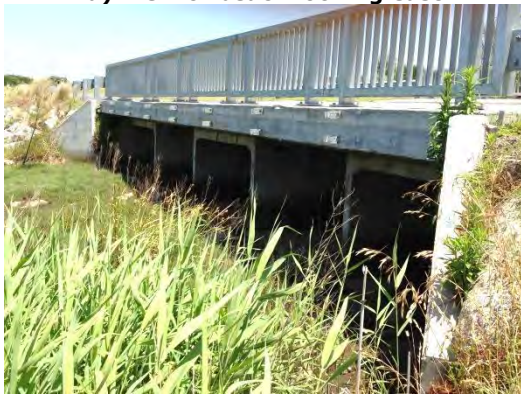
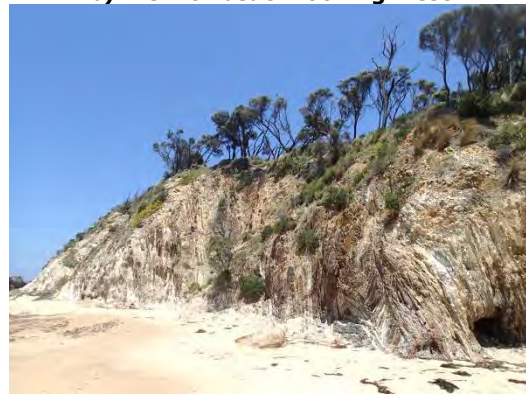
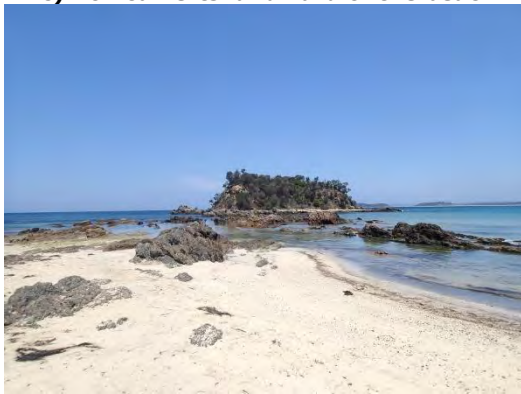
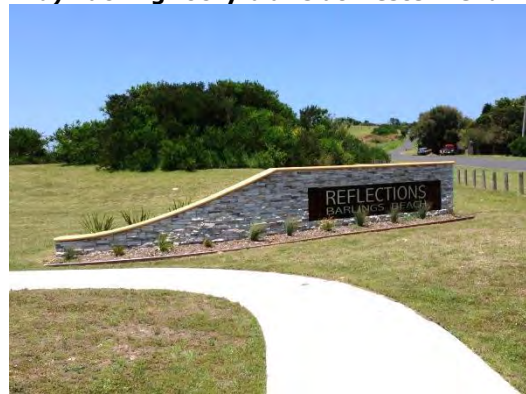
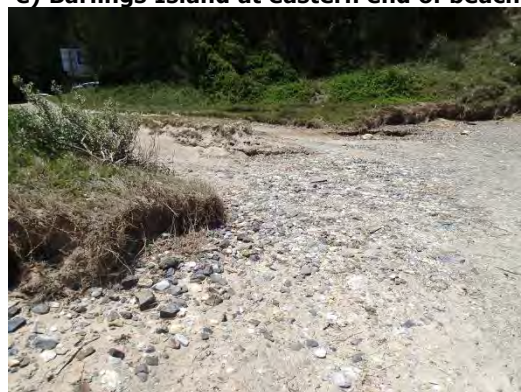
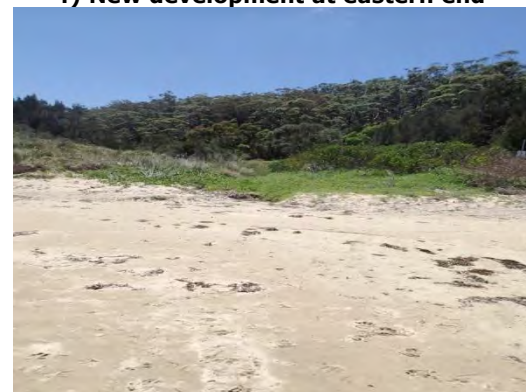
**Figure B-44: Barlings Beach Site Inspection**

**a) View of beach looking east**

**b) View of beach looking west**

**c) Box culverts landward of the beach**

**d) Backing rocky bluffs at western end**

**e) Barlings Island at eastern end of beach**

**f) New development at eastern end**

**g) 4WD beach access corridor**

**h) Creek entrance**

A large, well vegetated dune is located landward of the beach. Behind the eastern end of the beach is a caravan park with pedestrian access to the beach. Four-wheel drive beach access for boat launching is available along a dirt track at the eastern end too. At the western end of the beach, a new development is set back behind the foredune (at least 100 m from the beach), with the dune providing a natural buffer against erosion and inundation. Uncontrolled pedestrian access along the western end of the beach is available via the development and a small car park located off Sun Patch Parade. A summary of sand sample analysis is shown in Figure B-45.

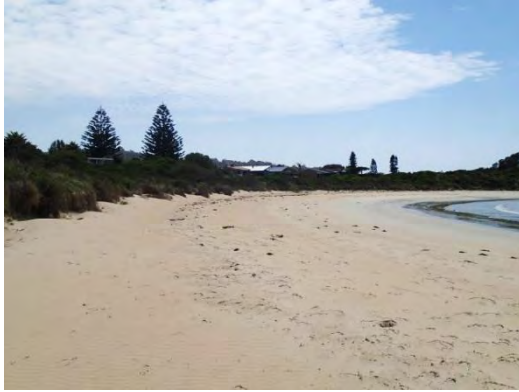
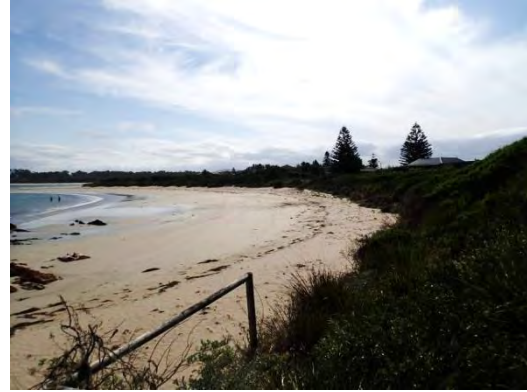
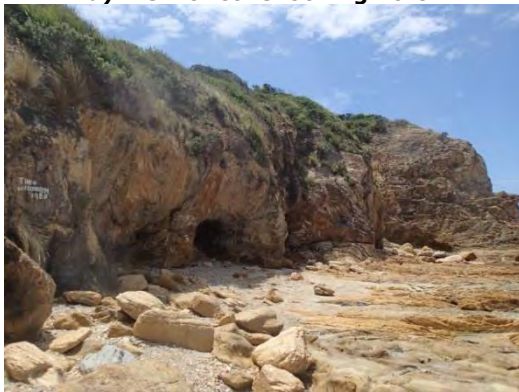
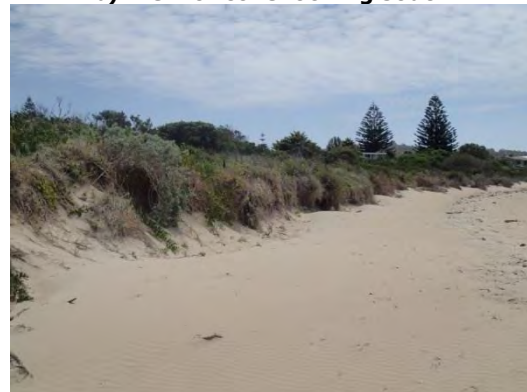
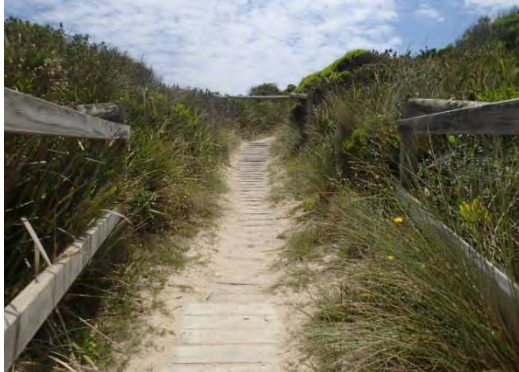
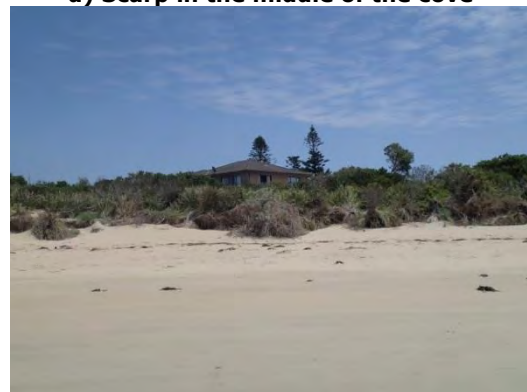
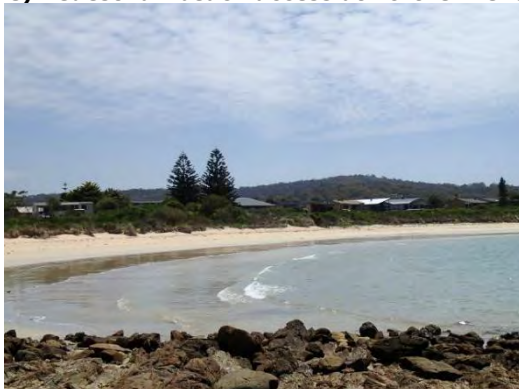
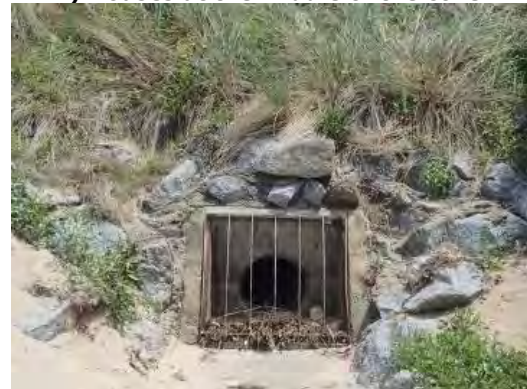
**Figure B-47: Tomakin Cove Site Inspection**

**a) View of cove looking north**

**b) View of cove looking south**

**c) Backing rocky bluffs at the northern end**

**d) Scarp in the middle of the cove**

**e) Pedestrian beach access at northern end**

**f) Houses at the middle of the cove**

**g) Houses at the southern end**

**h) Stormwater outlet**

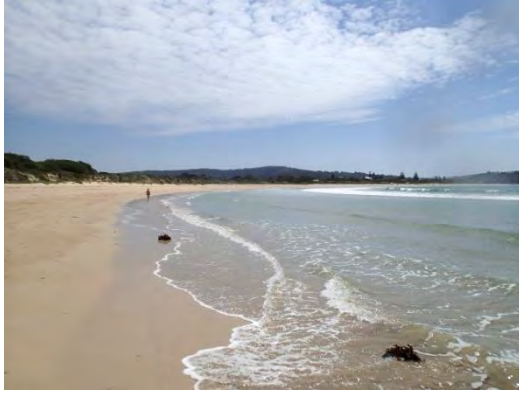
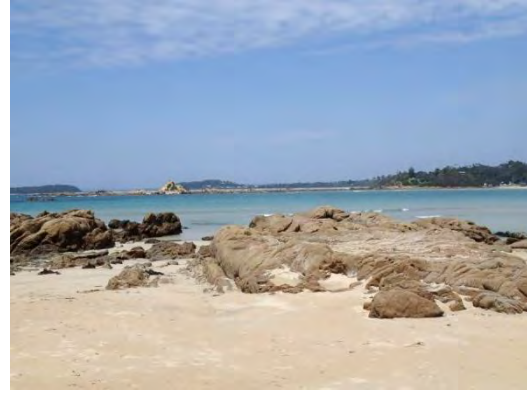
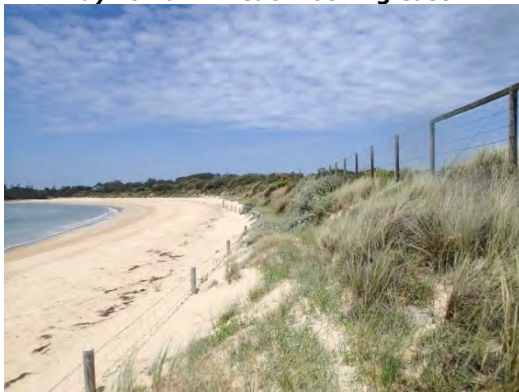
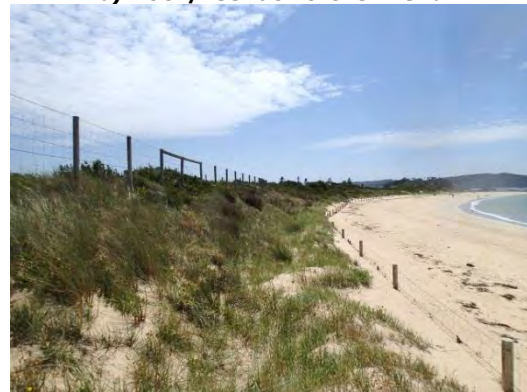
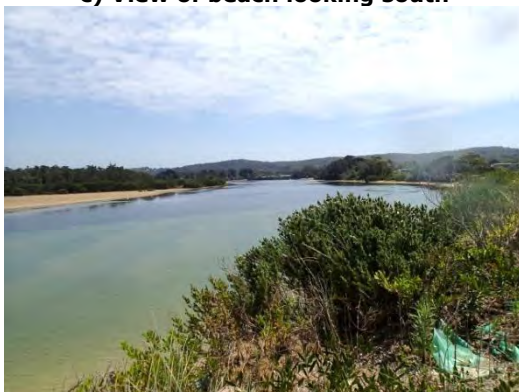
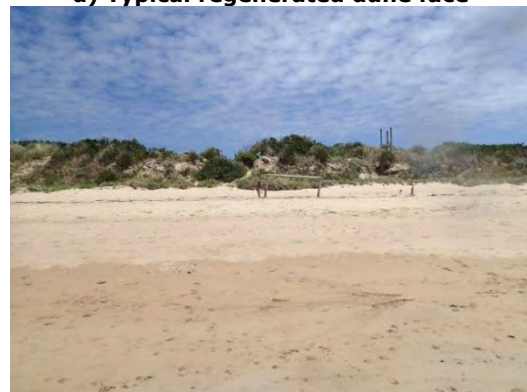
**a) Tomakin Beach looking east**

**b) Rock/reef at northern end**

**c) View of beach looking south**

**d) Typical regenerated dune face**

**e) View of Tomaga River from the centre**

**f) Scarp in the middle of the beach**

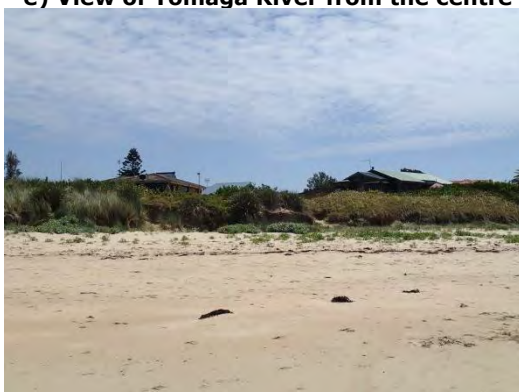
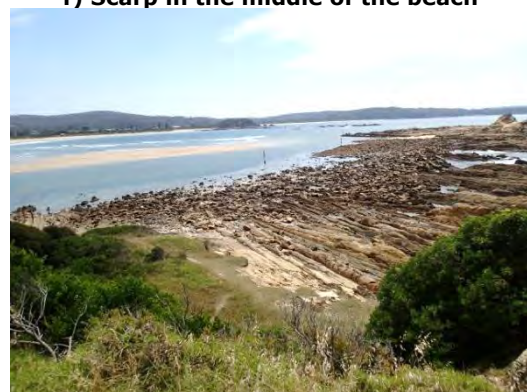
**Figure B-48: Tomakin Beach Site Inspection**

**g) Houses at northern end**

**h) Tomaga River entrance**

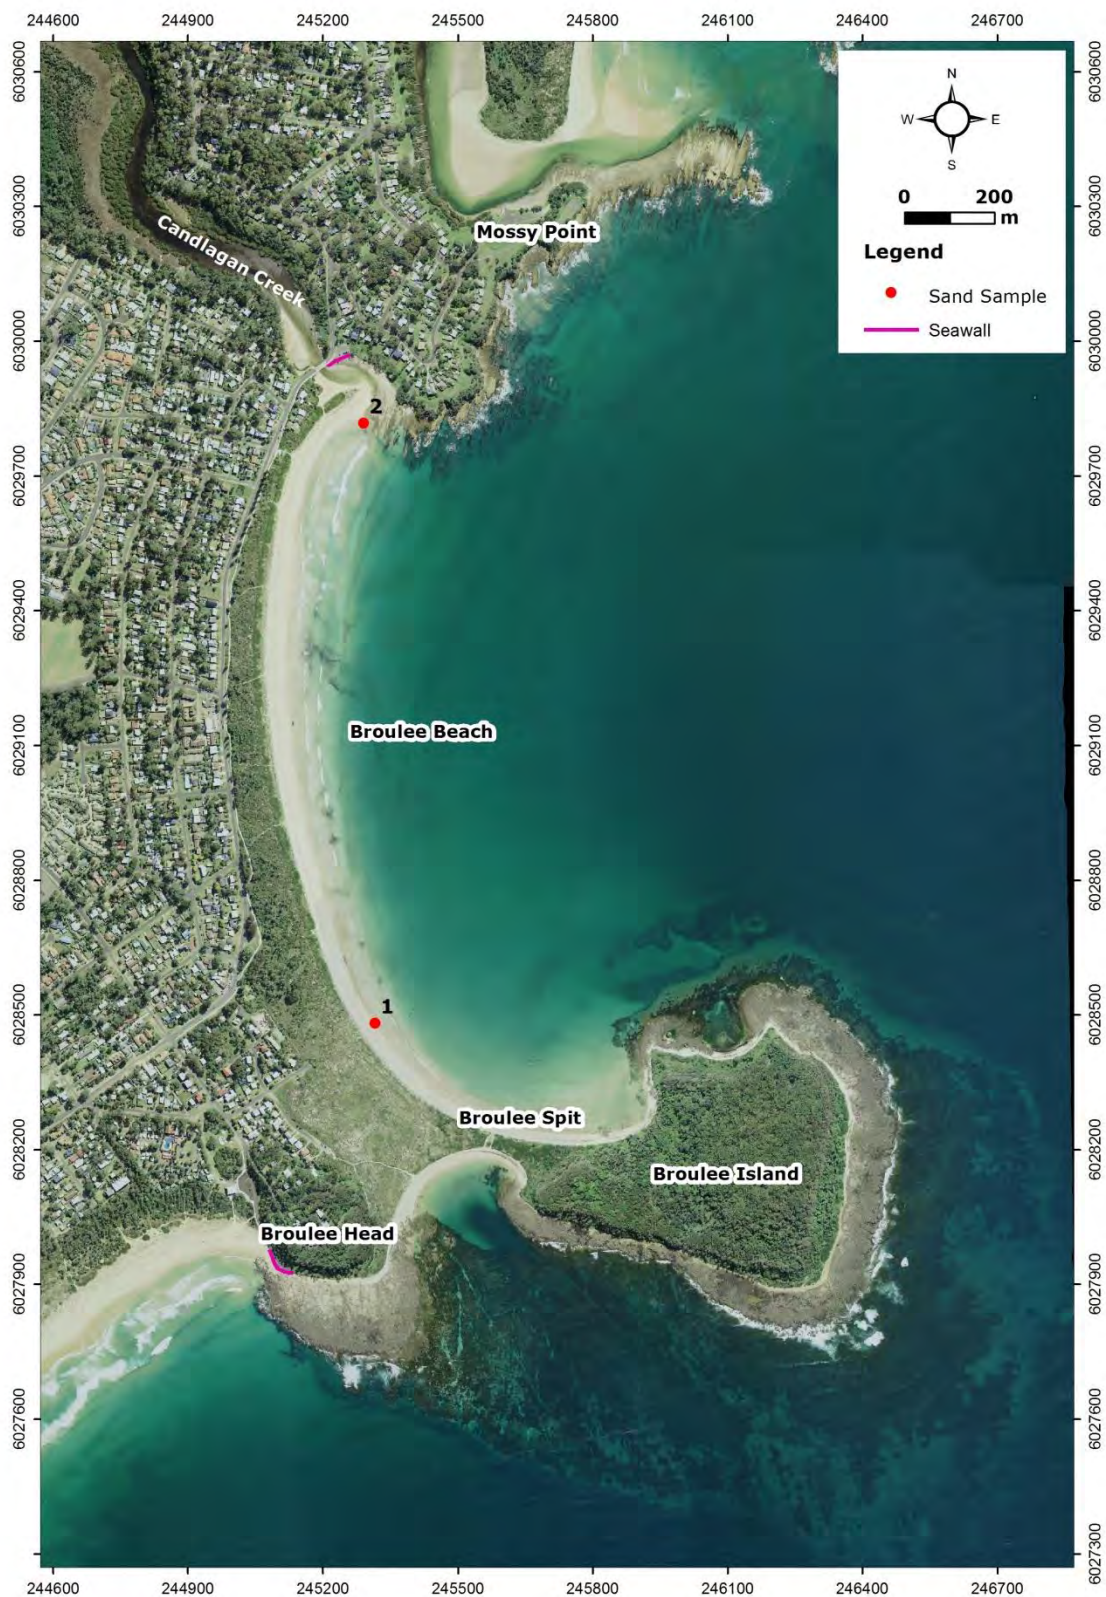
**Figure B-50: Broulee Beach Site Details**

Broulee Beach experiences a moderate wave climate with exposure generally reducing from north to south. Under typical conditions, the beach maintains an attached bar with a rip against the northern rocks (assisted by flow from Candlagan Creek) and several beach rips are usually present up to the middle of the beach, grading southwards to a low tide terrace along most of the southern half before finishing in a reflective beach in the southern corner. Low wave energy conditions at the southern end creates a wide, flat beach. On the southern side of Broulee Spit, the beach face has a high gradient.

A healthy, vegetated dune exists along the entire beach with several formal beach access points along Coronation Drive. This foredune provides a buffer between the beach and the road. Houses landward of Coronation Drive appear to be located well landward of the active beach. However, five houses at the northern end of the beach and on the southern side of Candlagan Creek are located in close proximity to the beach. These houses sit on the crest of the sand dune with limited sand stores and vegetation on the seaward side.

The southern end of the beach can be reached on foot from Bayside Street, Harbour Drive or a small headland car park at the end of Albert Street. The crest of the dune along the tombolo was approximately 3 m wide at the time of the site inspection (8 December 2012), although it is infrequently cut by large seas from the south (Appendix H). Houses at this end of Broulee Beach were set well back from the shoreline at the time of the site inspection. A sewage pumping station is also located on Bayside Street and is similarly set well back. A summary of sand sample analysis is shown in Figure B-52.

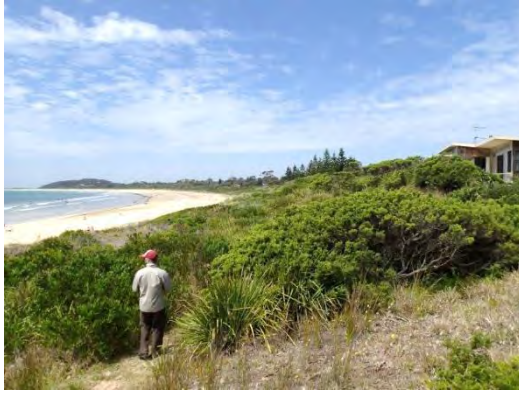
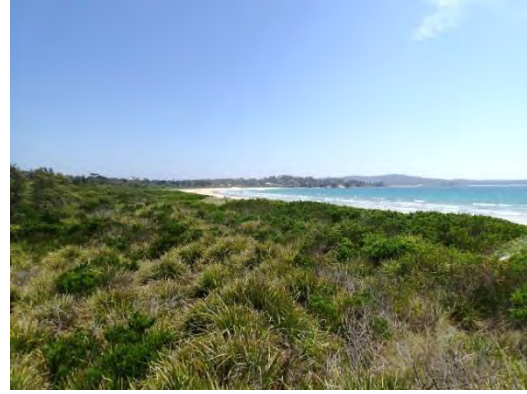
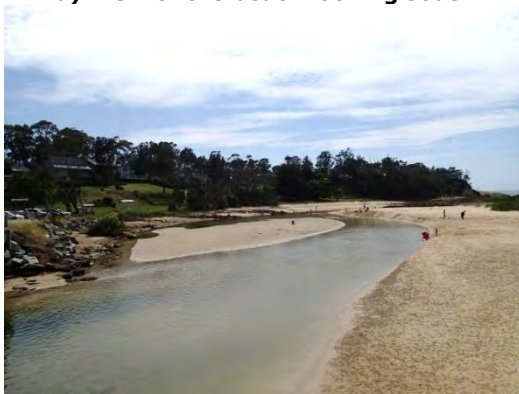
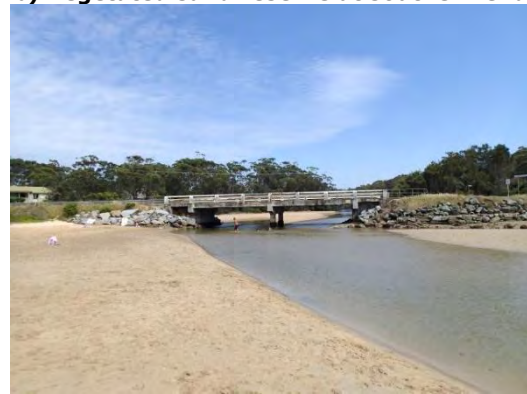
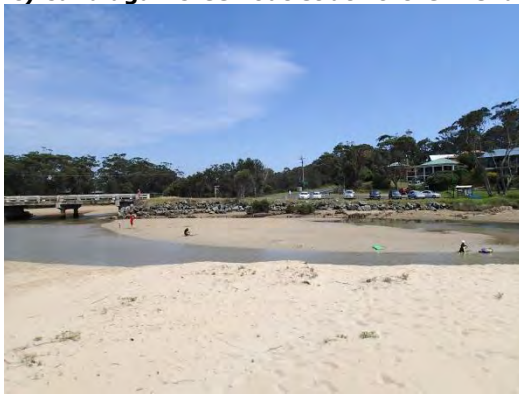
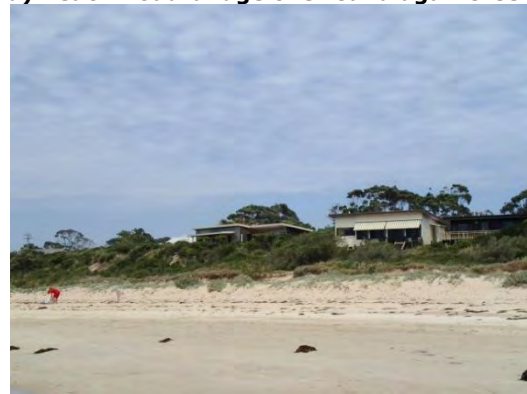
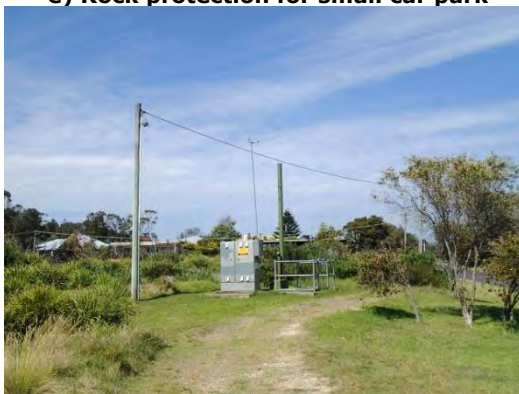
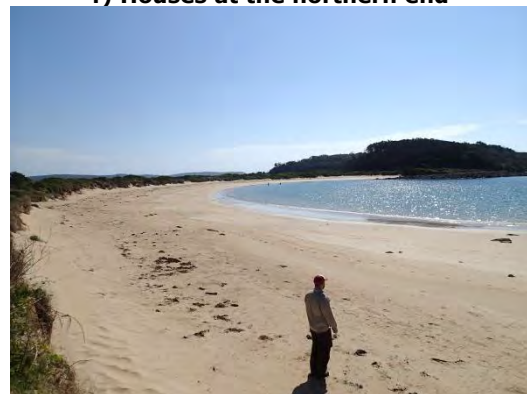
**Figure B-51: Broulee Beach Site Inspection**

**a) View of the beach looking south**

**b) Vegetated sand reserve at southern end**

**c) Candlagan Creek outlet at northern end**

**d) Beach Road bridge over Candlagan Creek**

**e) Rock protection for small car park**

**f) Houses at the northern end**

**g) Sewage pumping station**

**h) Broulee Tombolo and Island**

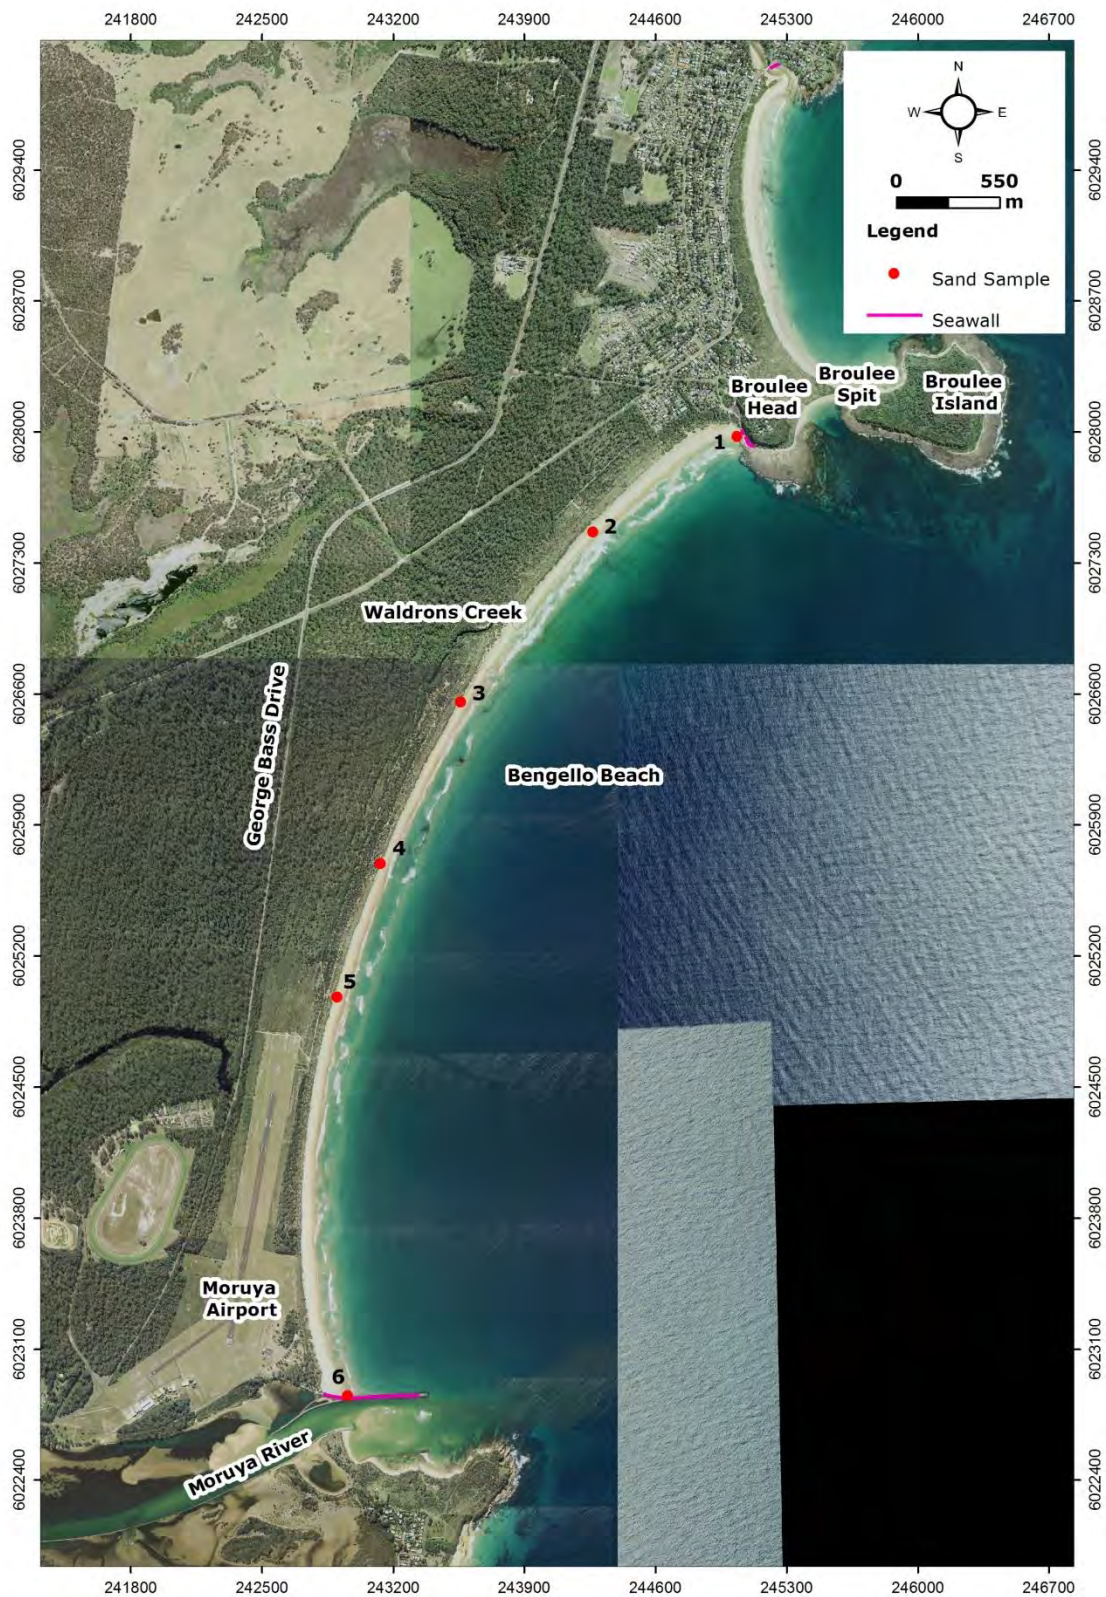
**Figure B-53: Bengello Beach Site Details**

The beach is accessible at the northern end where Broulee Surfers SLSC is located. There is a car park next to the SLSC and a second car park at the base of the headland near a small boat ramp and 0.8 m diameter stormwater outlet. The SLSC and caravan park (Big4 Broulee Beach Holiday Park) are located well landward of the dunes, whereas the car park at the base of the headland and the road (Heath Street) are located at low elevations in close proximity to the beach. A gated gravel road runs south behind the beach for 2 km providing vehicular access as far as Waldrons Creek which breaks out across the beach during floods. Large seas in 1975 resulted in the permanent closure of a section of this gravel road which ran the full length of the beach (Short, 2007). George Bass Drive now runs south behind the dunes and is located 1 to 2 km inland. George Bass Drive meets Bruce Cameron Drive which runs along the northern side of the Moruya River and terminates at Moruya Airport. There is also a car park at the southern end providing access to the beach. In addition to Moruya Airport, a caravan park (North Head Camp Ground) is also located landward of the southern end of Bengello Beach.

There are two coastal structures at either end of Bengello Beach. At the northern end of the beach, a small revetment protects the car park situated just off Heath Street. The revetment structure is composed of granite rock primary armour with an approximate size of 0.5 m, with no underlayer or secondary rock visible. The structure slope of the revetment wall is approximately 1.0V:1.5H. At the southern end of the beach, the northern training wall of the Moruya River interrupts littoral sand transport. The northern training wall has a pedestrian footpath along its entire length and has primary armour on both sides consisting of granite rock with an approximate size of 1.0 m, a geotextile underlayer and secondary rock armour. A summary of sand sample analysis is shown in Figure B-55.
