## Eurobodalla Coastal Hazard Assessment

WRL Technical Report 2017/09  
October 2017

By I R Coghlan, J T Carley, A J Harrison, D Howe, A D Short,  
J E Ruprecht, F Flocard and P F Rahman

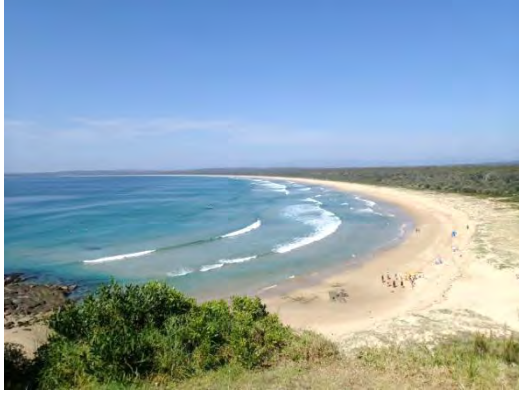
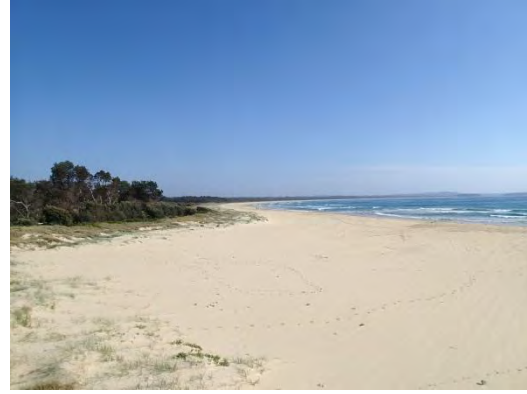
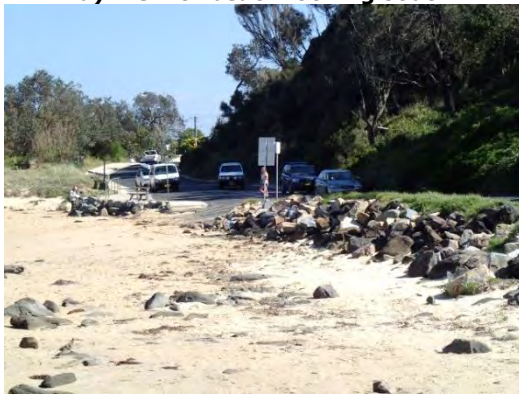
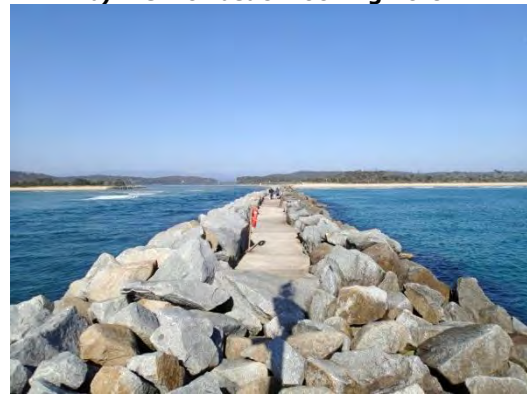
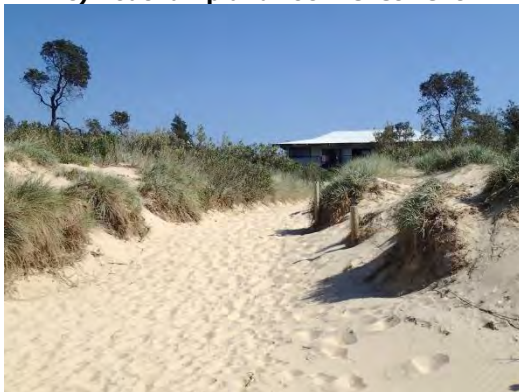
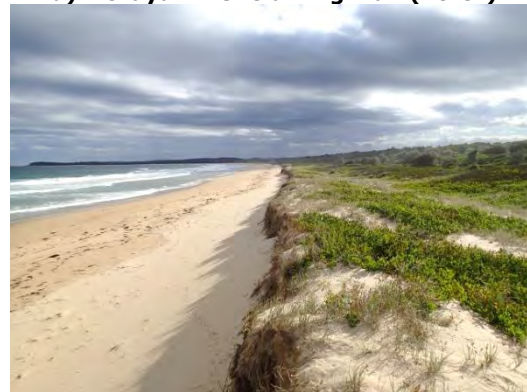
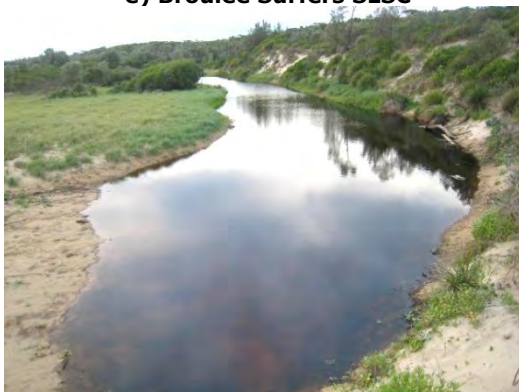
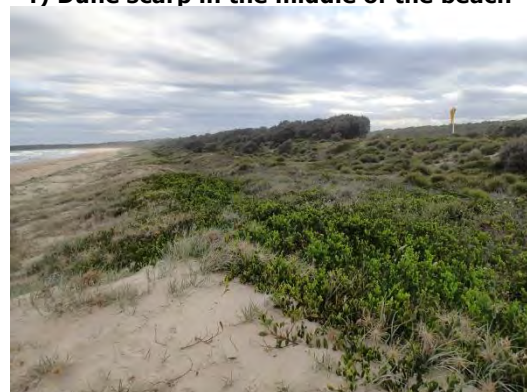
**Figure B-54: Bengello Beach site Inspection**

**a) View of beach looking south**

**b) View of beach looking north**

**c) Boat ramp and rock revetment**

**d) Moruya River training wall (north)**

**e) Broulee Surfers SLSC**

**f) Dune scarp in the middle of the beach**

**g) Waldrons Creek outlet**

**h) Northern end of Moruya Airport**

There are two coastal structures at either end of Bengello Beach. At the northern end of the beach, a small revetment protects the car park situated just off Heath Street. The revetment structure is composed of granite rock primary armour with an approximate size of 0.5 m, with no underlayer or secondary rock visible. The structure slope of the revetment wall is approximately 1.0V:1.5H. At the southern end of the beach, the northern training wall of the Moruya River interrupts littoral sand transport. The northern training wall has a pedestrian footpath along its entire length and has primary armour on both sides consisting of granite rock with an approximate size of 1.0 m, a geotextile underlayer and secondary rock armour. A summary of sand sample analysis is shown in Figure B-55.

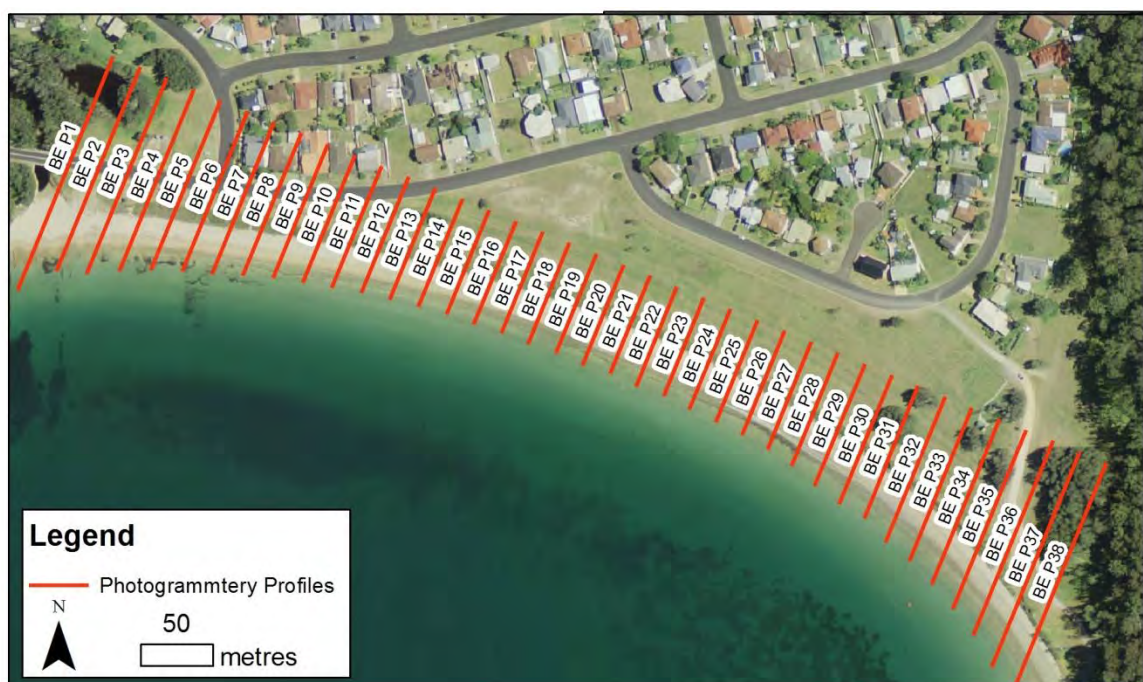
**Figure C-1: Maloneys Beach profile locations**

At each beach, the processed photogrammetry data has been provided at discrete profiles along the beach. Profile spacing varies between 20 m – 50 m, depending on the location. Figures C-1 to C-10 show the profile locations at each of the beaches where erosion modelling was undertaken. Each profile is identified by a block name (letter or number) and profile number (e.g. BEP19 – Block E, Profile 19).

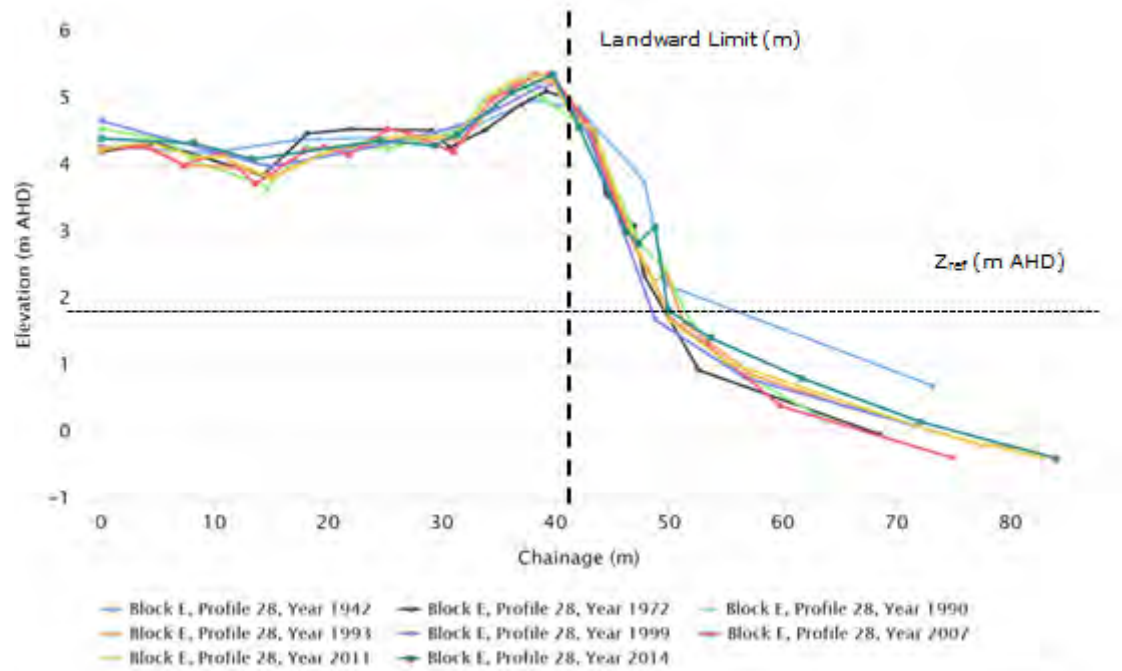
**Figure C-11: Example photogrammetry cross sections at Maloneys Beach East (Block E, Profile 28)**

Example photogrammetry cross sections for each beach section where erosion modelling was undertaken are shown in Figures C-11 to C-27.

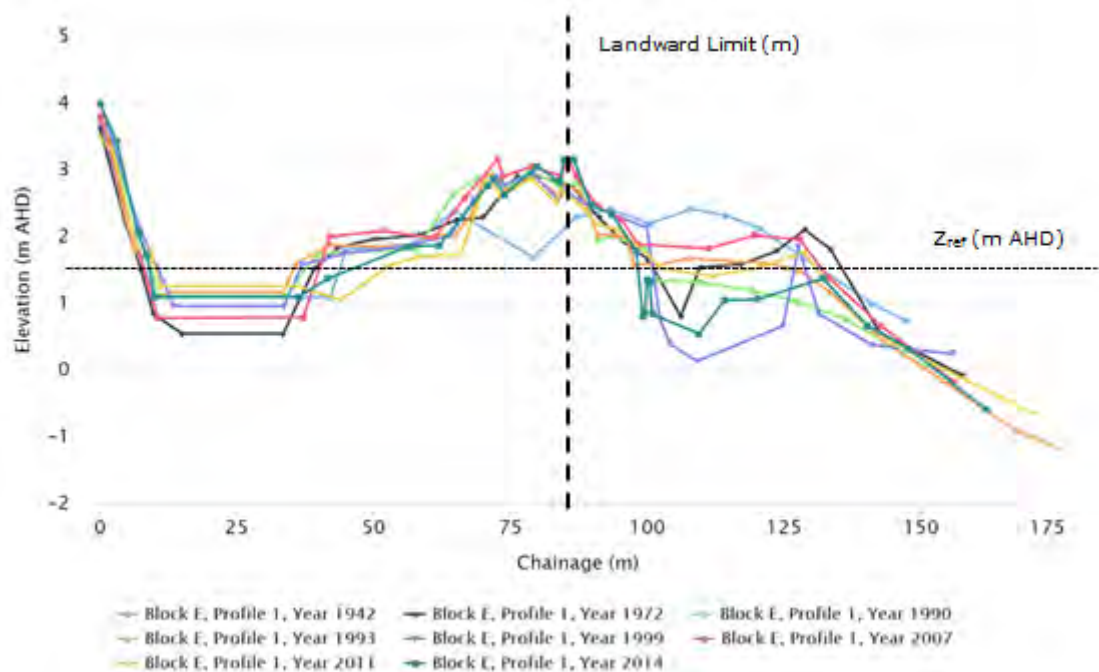
**Figure C-12: Example photogrammetry cross sections at Maloneys Beach West (Block E, Profile 1)**

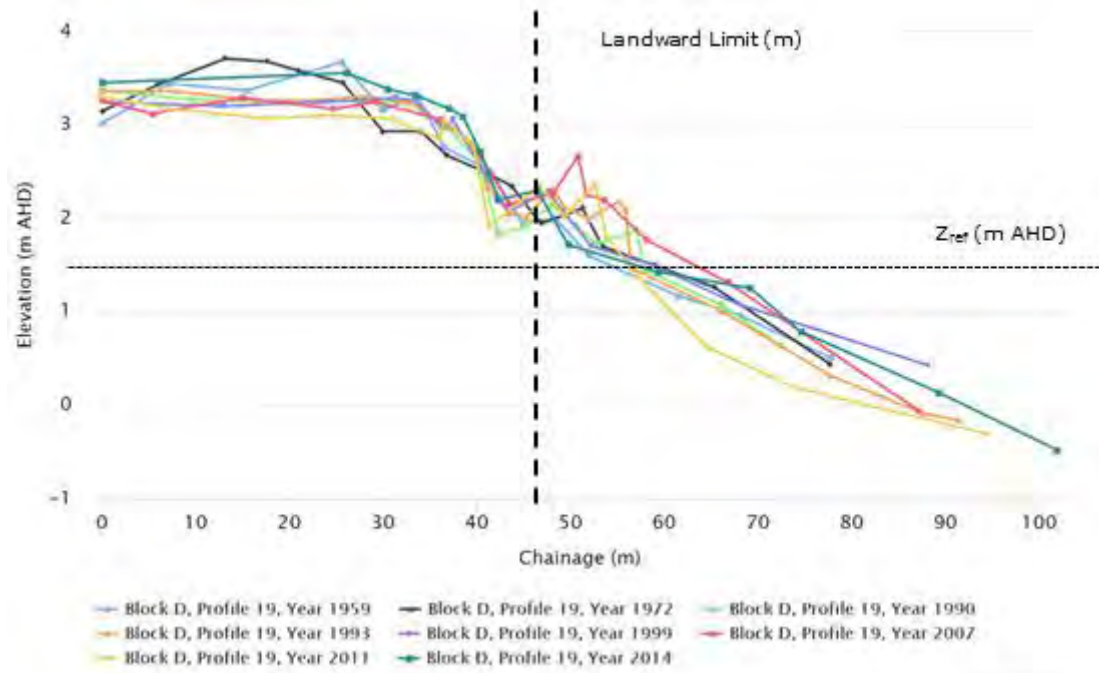
**Figure C-13: Example photogrammetry cross sections at Long Beach East (Block D, Profile 19)**

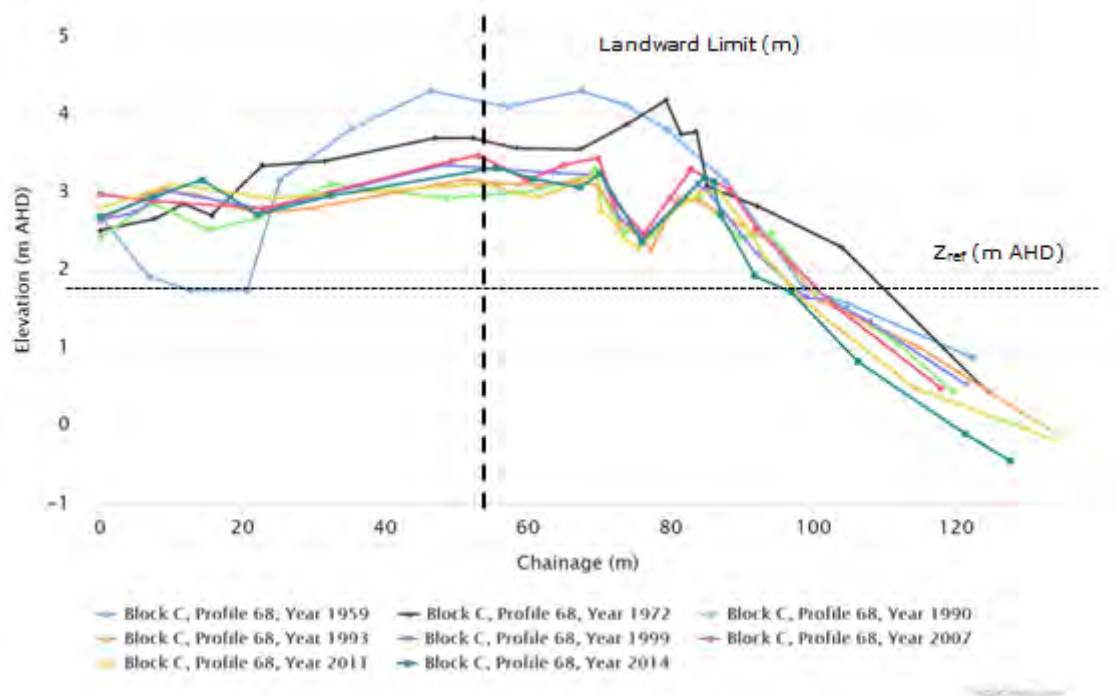
**Figure C-14: Example photogrammetry cross sections at Long Beach Central (Block C, Profile 68)**

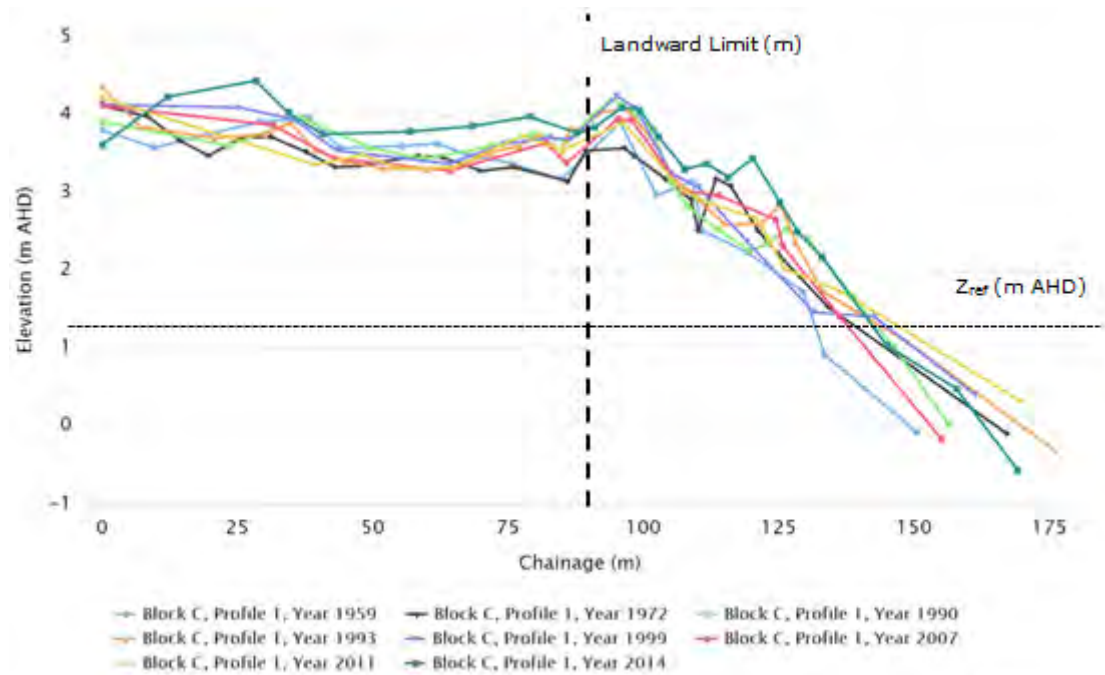
**Figure C-15: Example photogrammetry cross sections at Long Beach Central (Block C, Profile 1)**

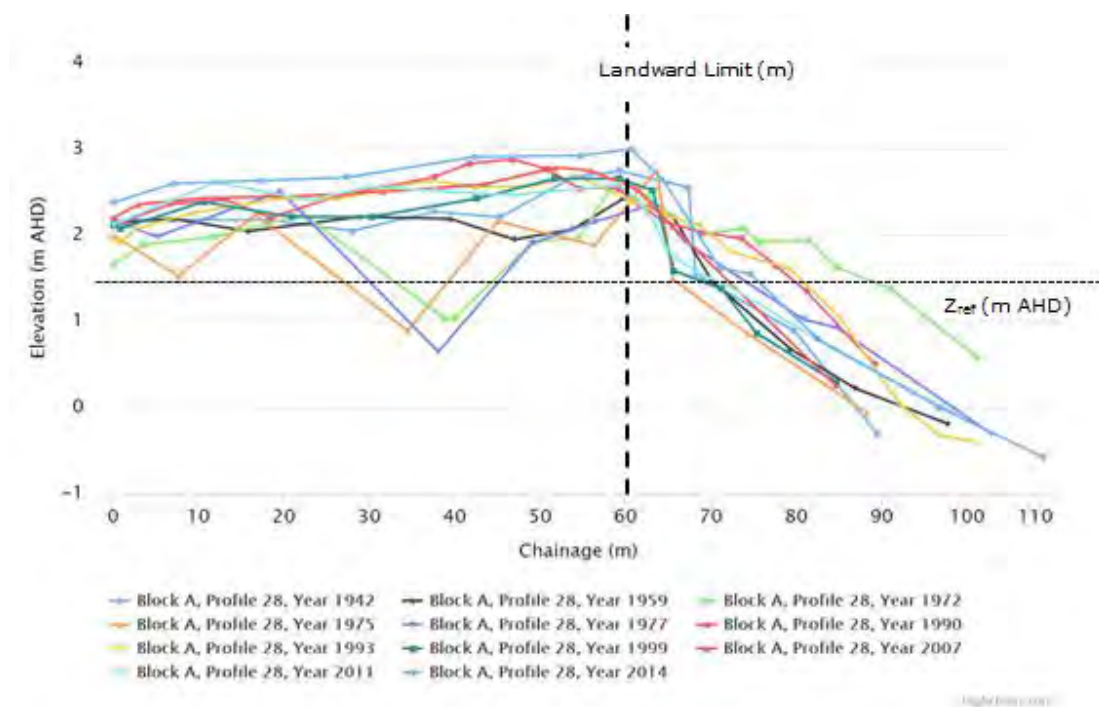
**Figure C-16: Example photogrammetry cross sections at Surfside Beach (east) North (Block A, Profile 28)**

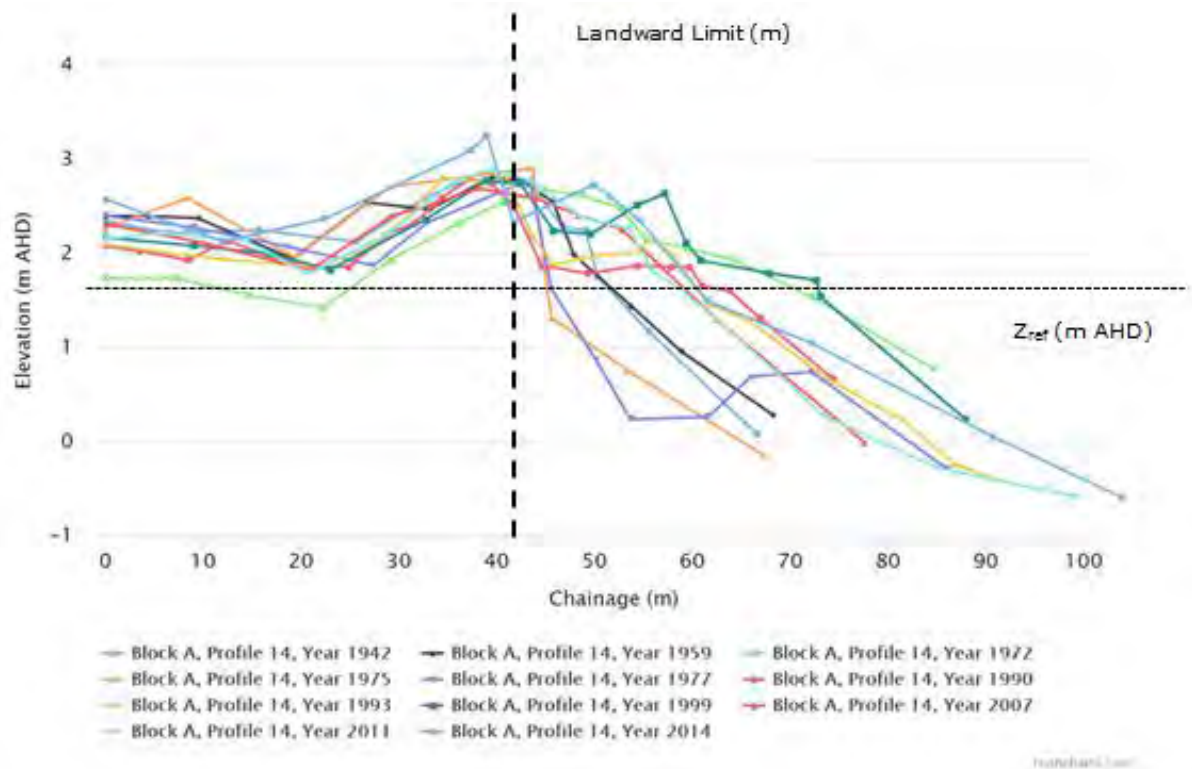
**Figure C-17: Example photogrammetry cross sections at Surfside Beach (east) South (Block A, Profile 14)**

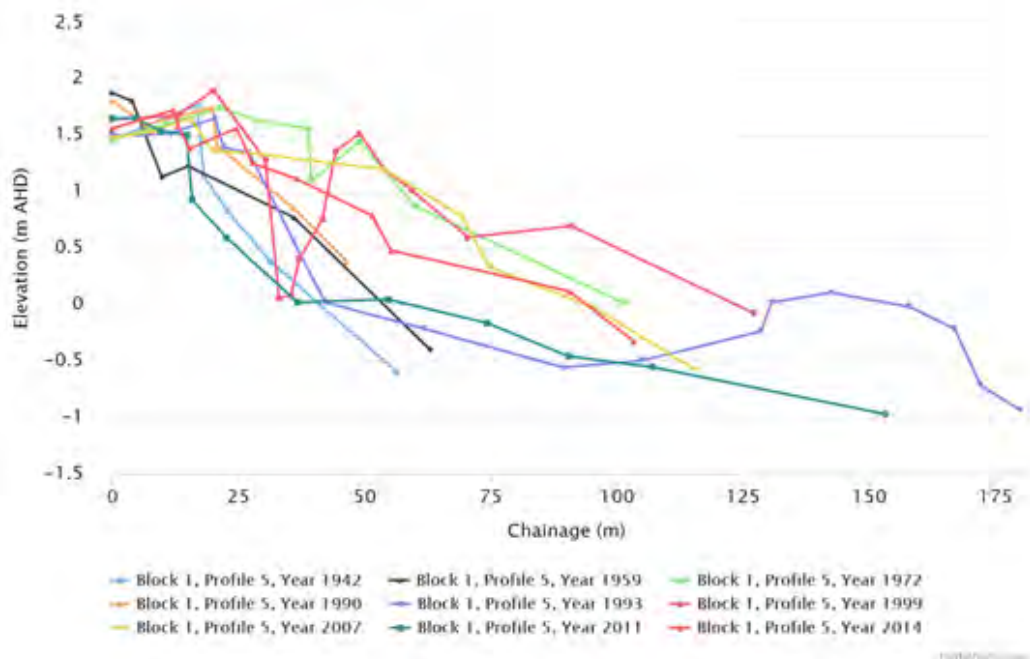
**Figure C-18: Example photogrammetry cross sections at Surfside Beach (west) (Block 1, Profile 5)**

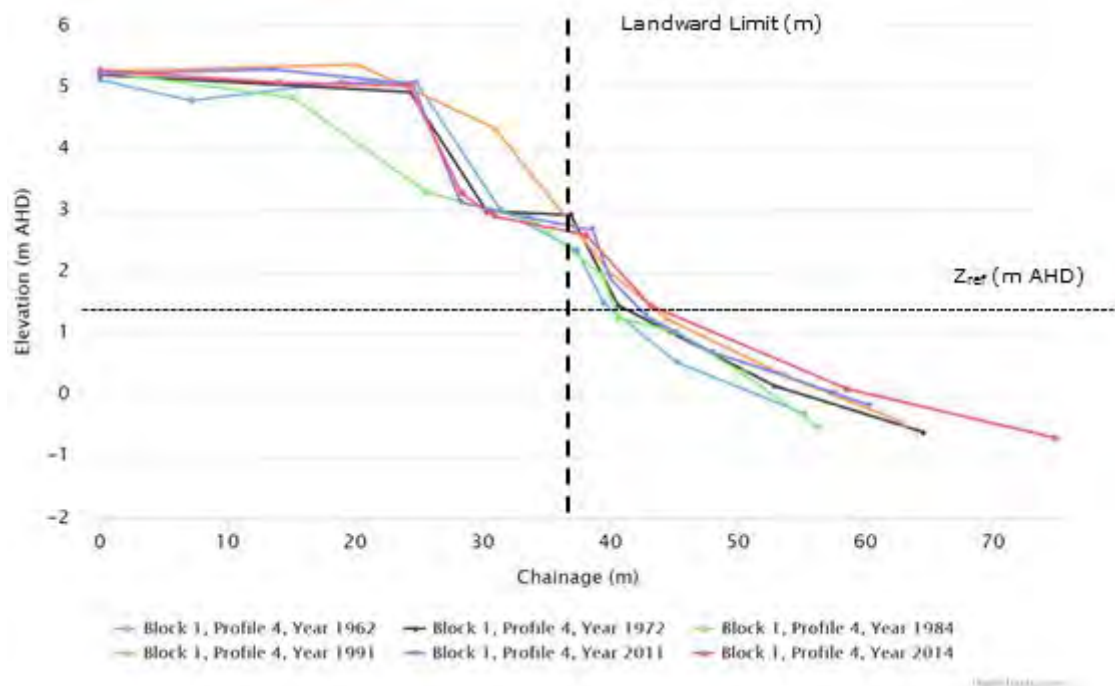
**Figure C-19: Example photogrammetry cross sections at Sunshine Bay (Block 1, Profile 4)**

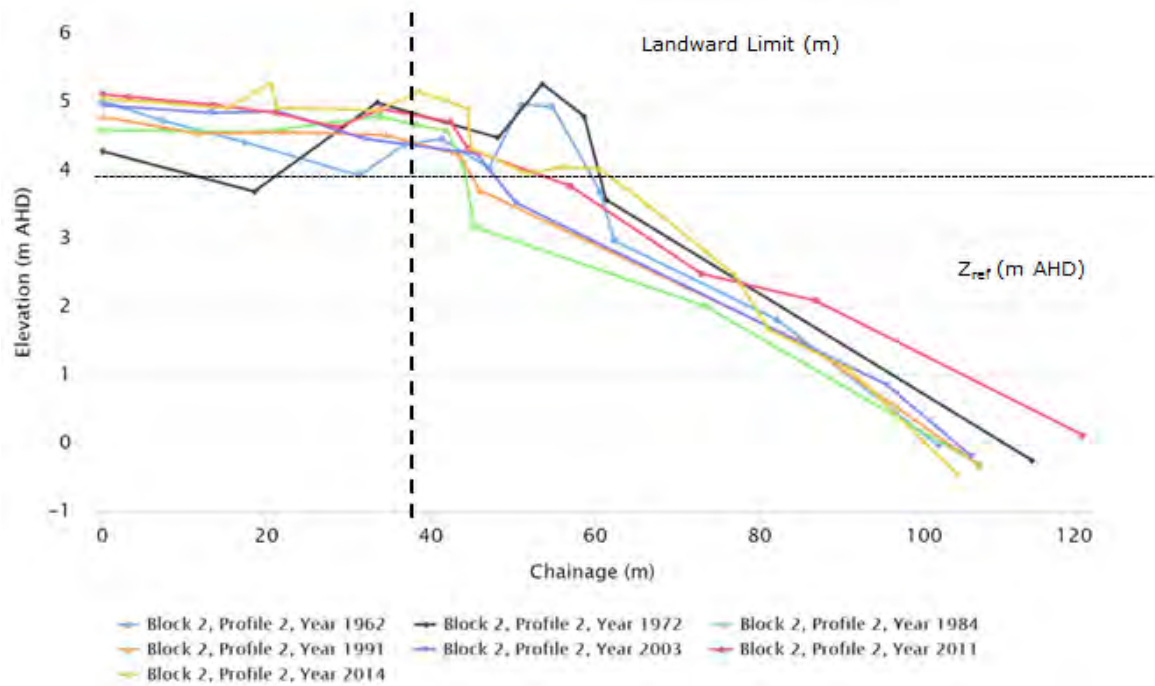
**Figure C-20: Example photogrammetry cross sections at Malua Bay (Block 2, Profile 2)**

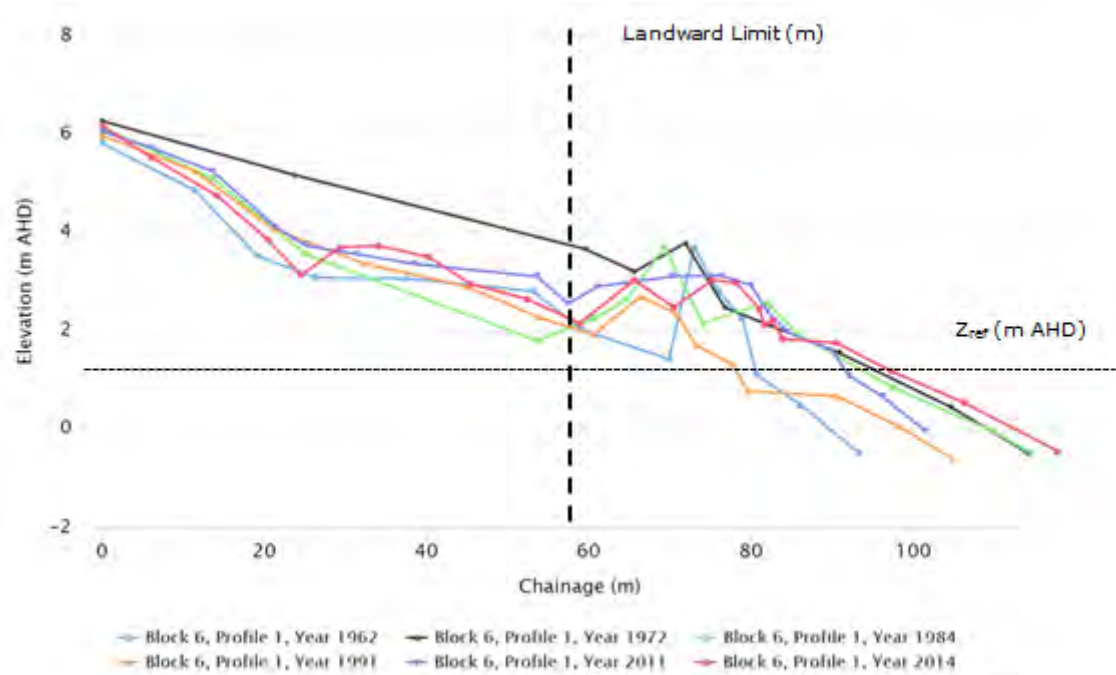
**Figure C-21: Example photogrammetry cross sections at Guerilla Bay (Block 6, Profile 1)**

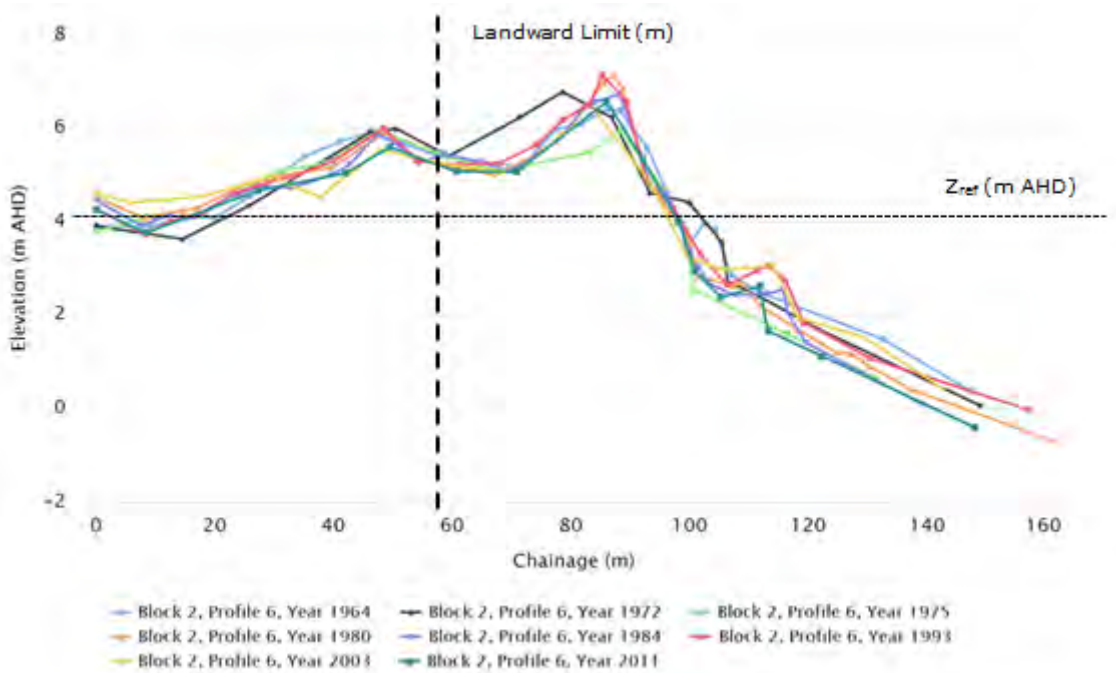
**Figure C-22: Example photogrammetry cross sections at Barlings Beach East (Block 2, Profile 6)**

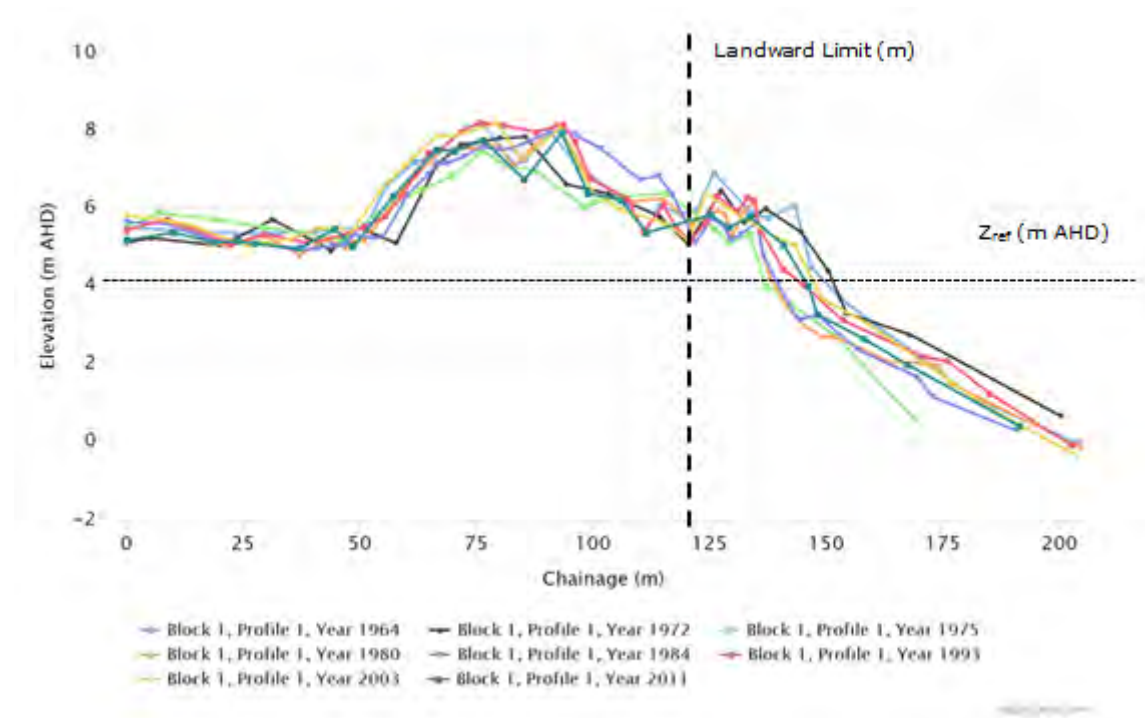
**Figure C-23: Example photogrammetry cross sections at Barlings Beach West (Block 1, Profile 1)**

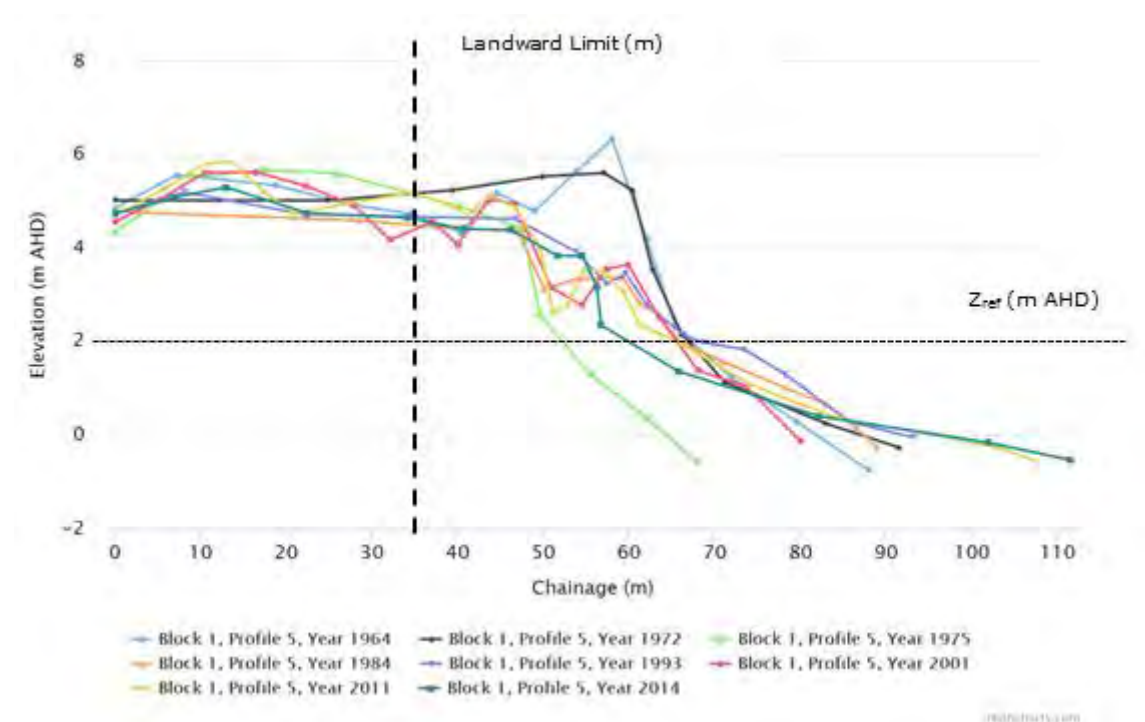
**Figure C-24: Example photogrammetry cross sections at Tomakin Cove (Block 1, Profile 5)**

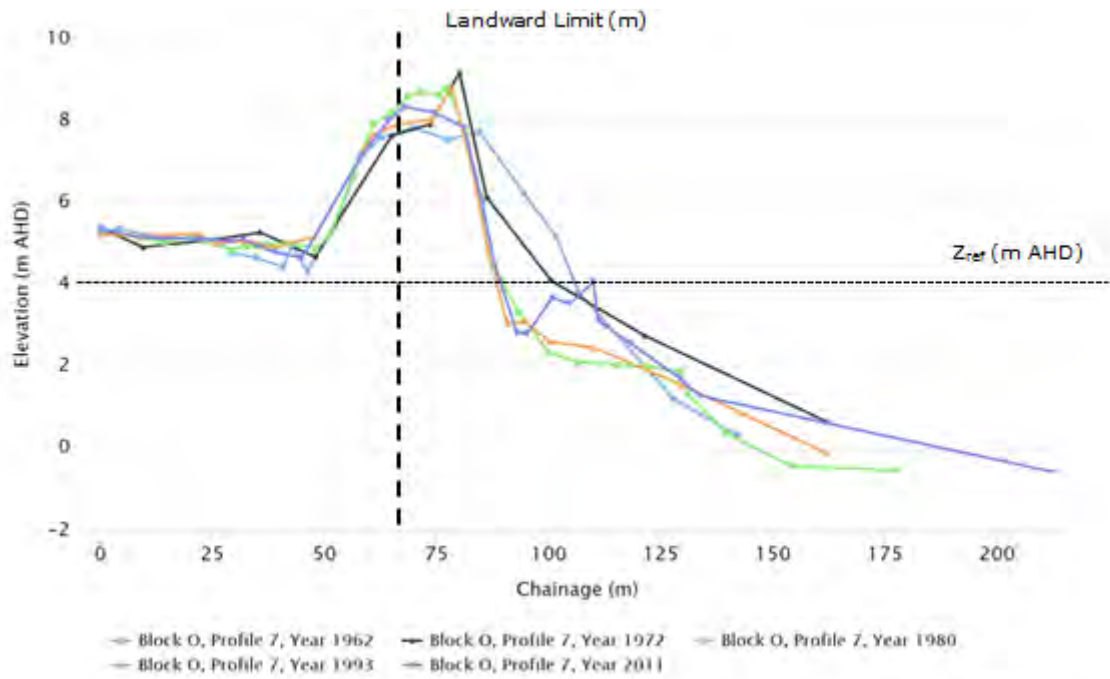
**Figure C-25: Example photogrammetry cross sections at Broulee Beach North (Block O, Profile 7)**

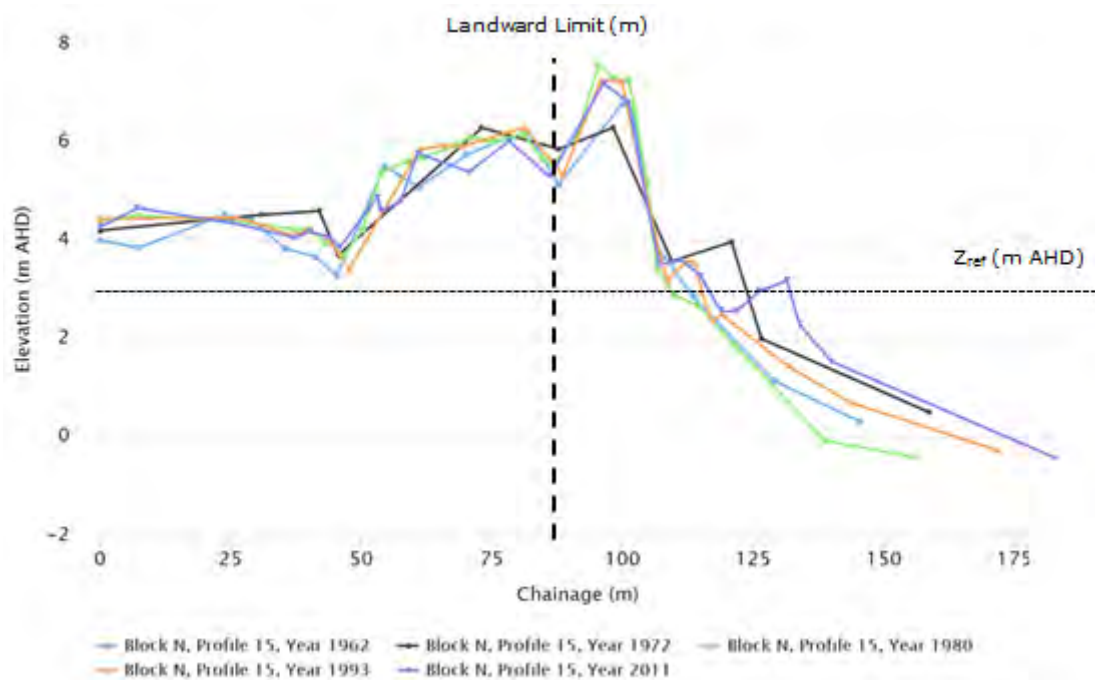
**Figure C-26: Example photogrammetry cross sections at Broulee Beach Central (Block N, Profile 15)**

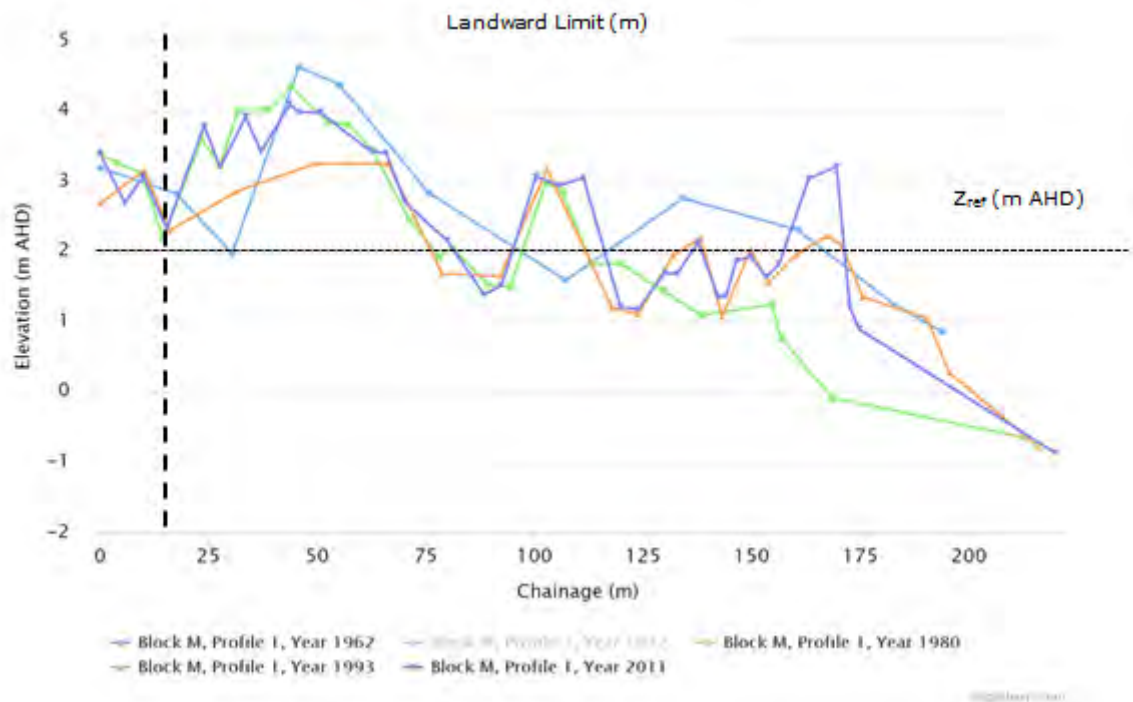
**Figure C-27: Example photogrammetry cross sections at Broulee Beach South (Block M, Profile 1)**

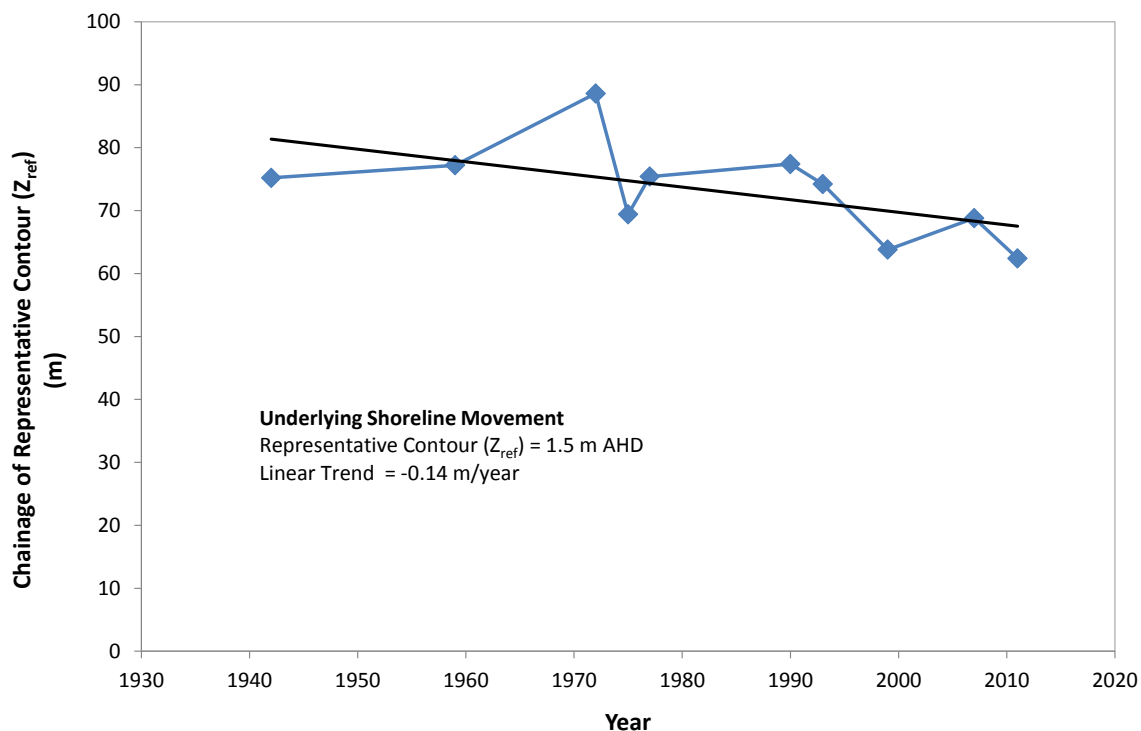
**Figure C-28: Example Underlying Shoreline Movement Analysis from Photogrammetry Data - Movement of Representative Contour, Surfside Beach (east), Block B, Profile 3**

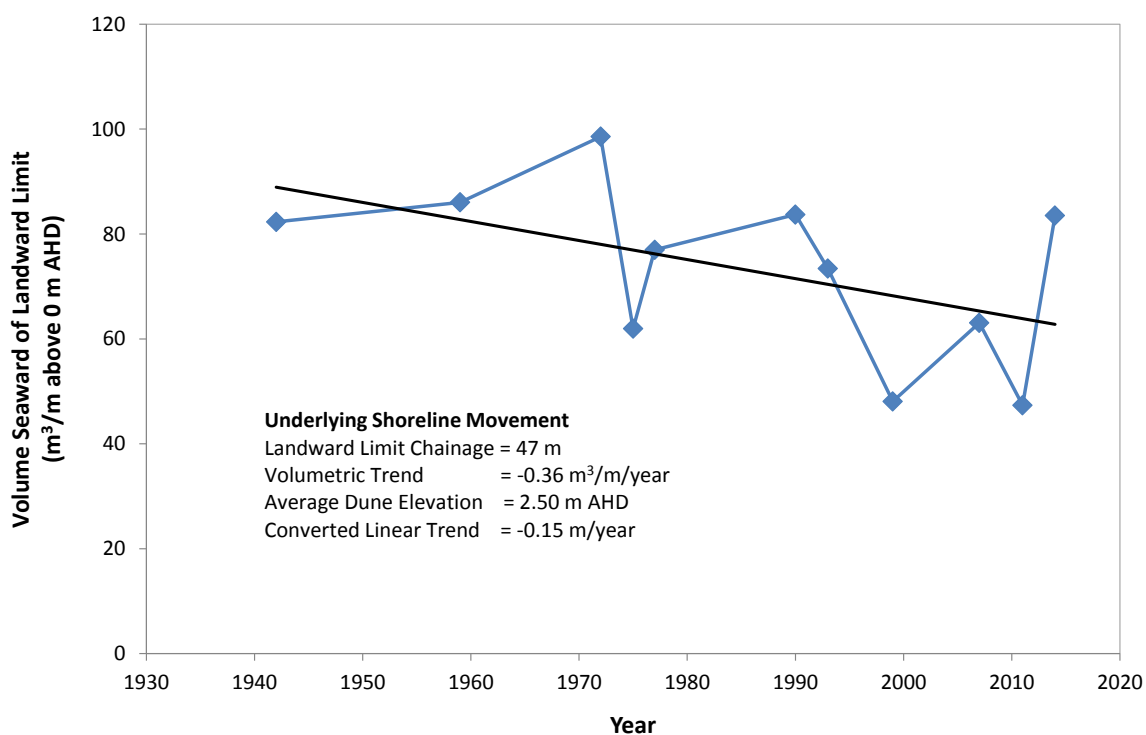
**Figure C-29: Example Underlying Shoreline Movement Analysis from Photogrammetry Data - Rate of Volumetric Change, Surfside Beach (east), Block B, Profile 3**

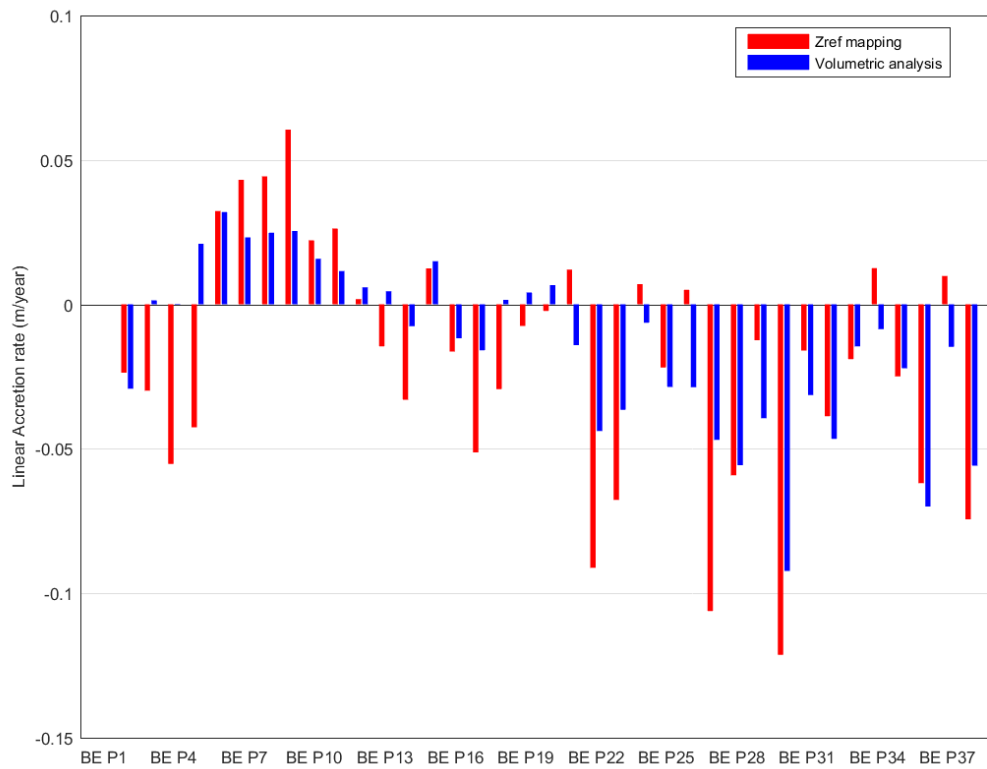
**Figure C-30: Maloneys Beach Underlying Movement**

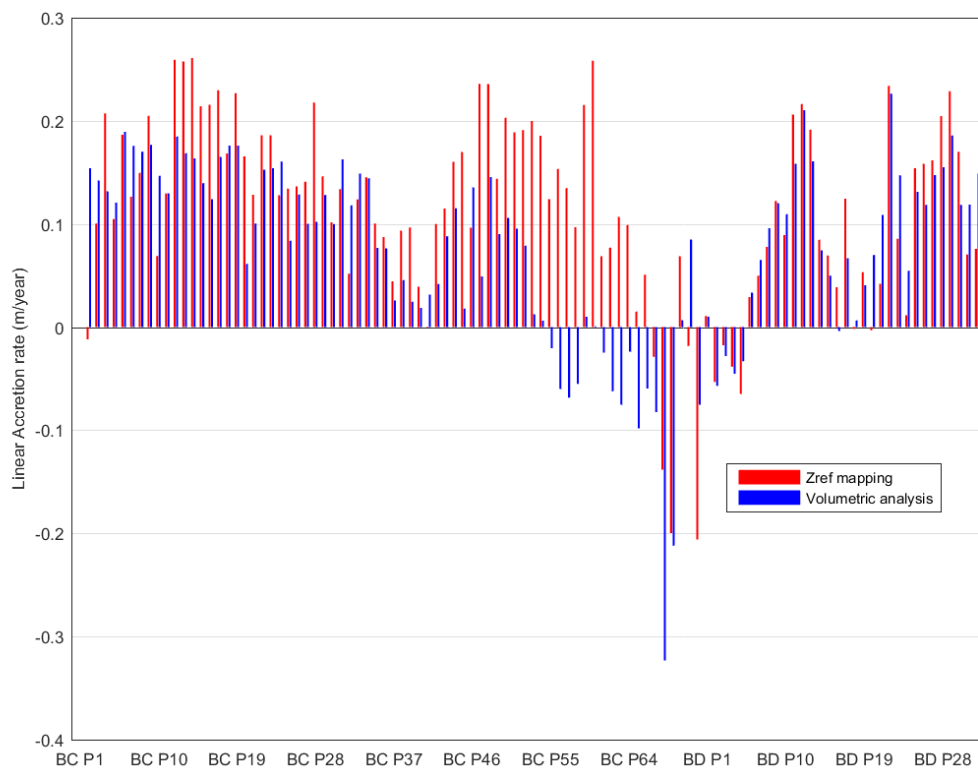
**Figure C-31: Long Beach Underlying Movement**

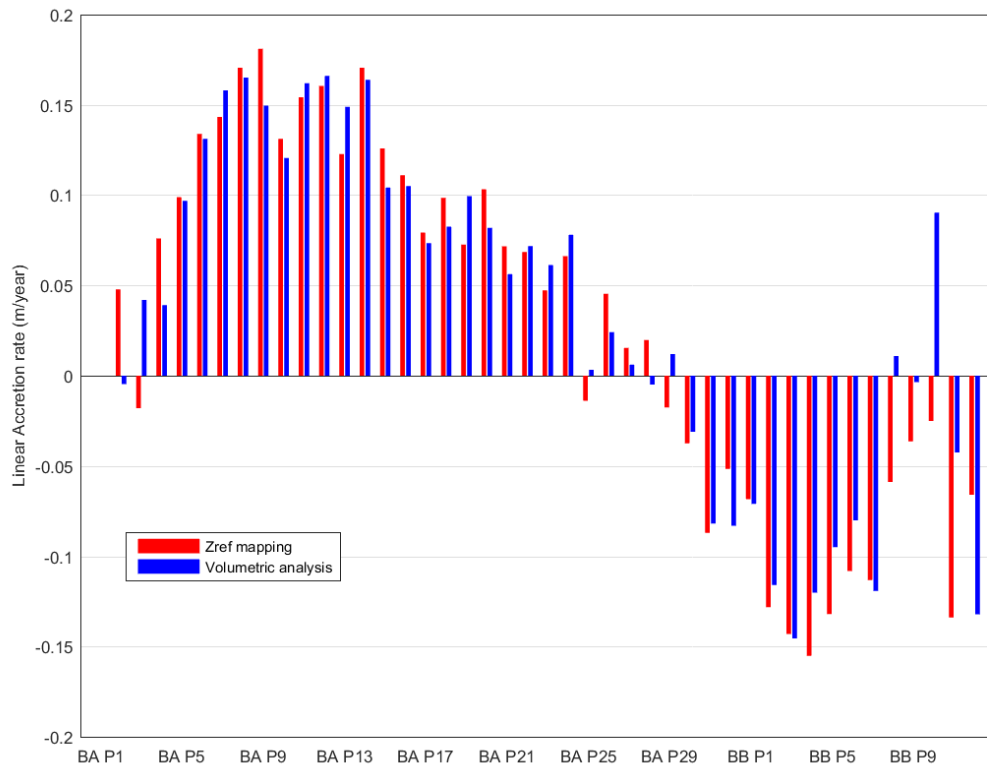
**Figure C-32: Surfside Beach (east) Underlying Movement**

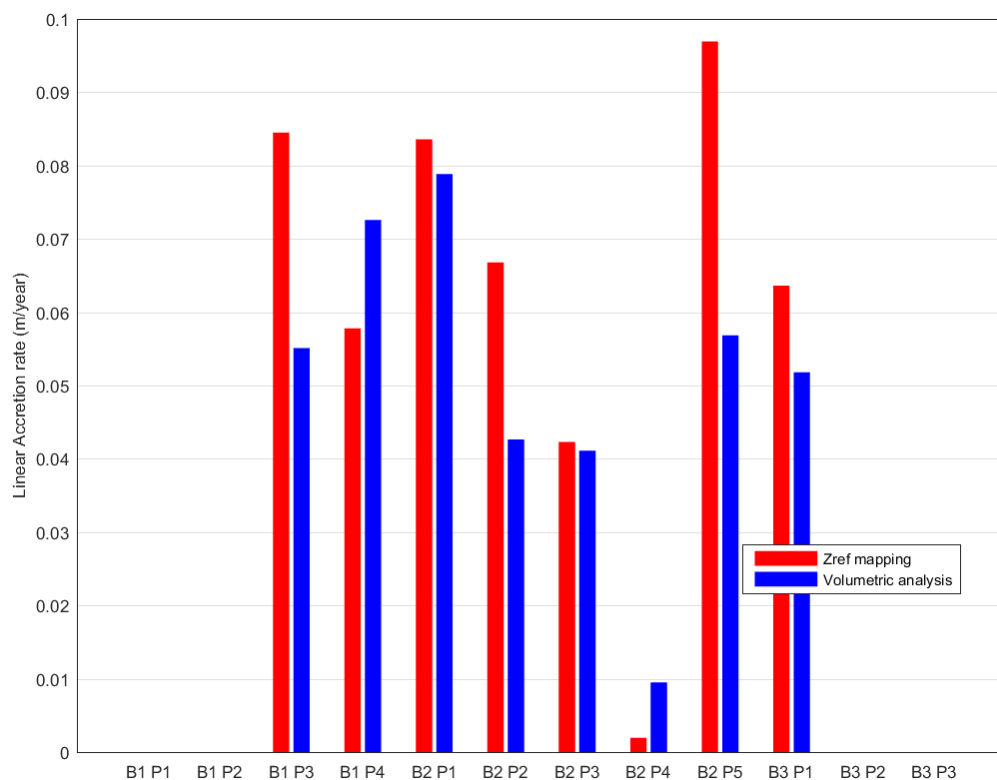
**Figure C-33: Sunshine Bay Underlying Movement**

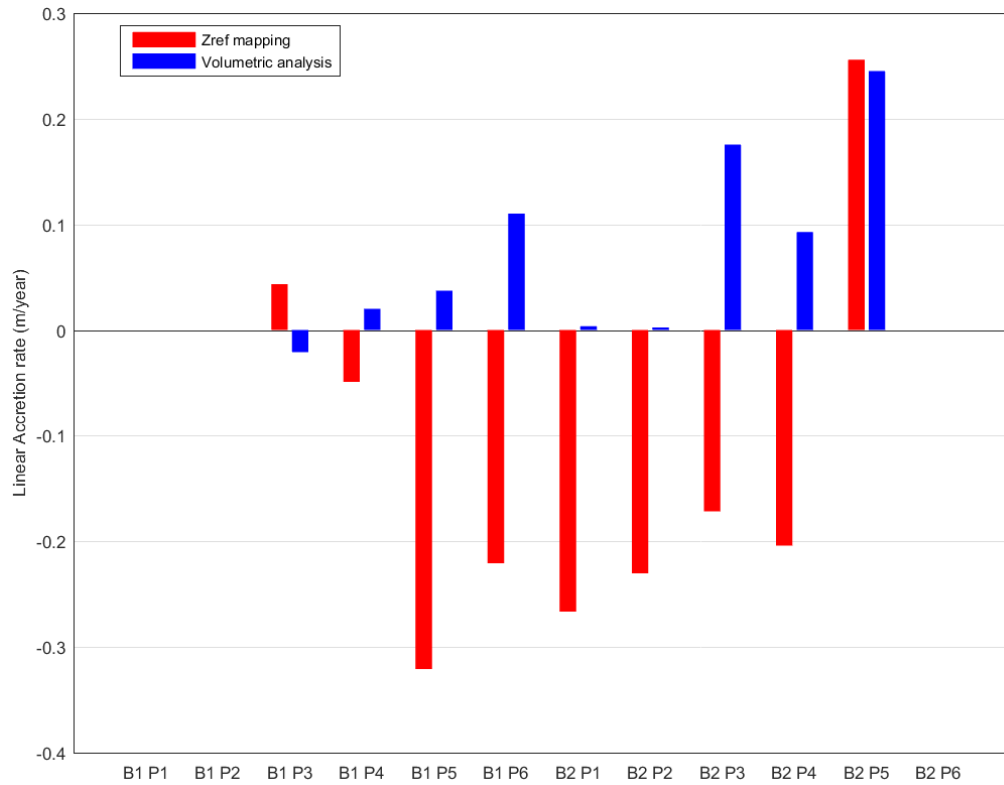
**Figure C-34: Malua Bay Underlying Movement**

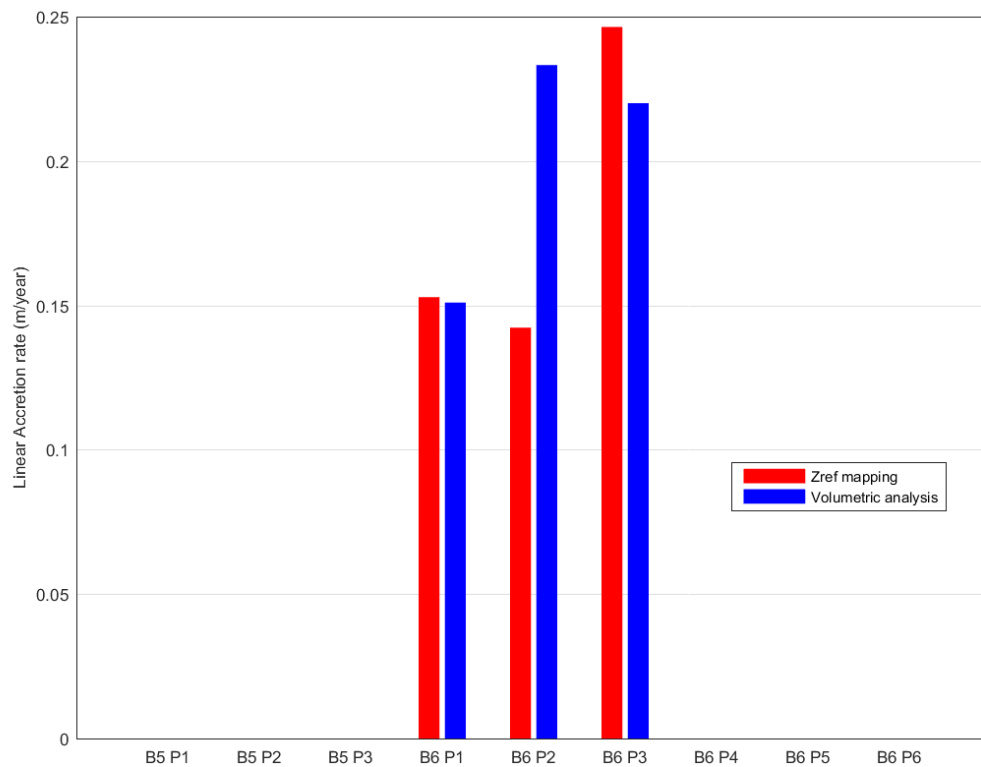
**Figure C-35: Guerilla Bay Underlying Movement**
