## Eurobodalla Coastal Hazard Assessment

WRL Technical Report 2017/09  
October 2017

By I R Coghlan, J T Carley, A J Harrison, D Howe, A D Short,  
J E Ruprecht, F Flocard and P F Rahman

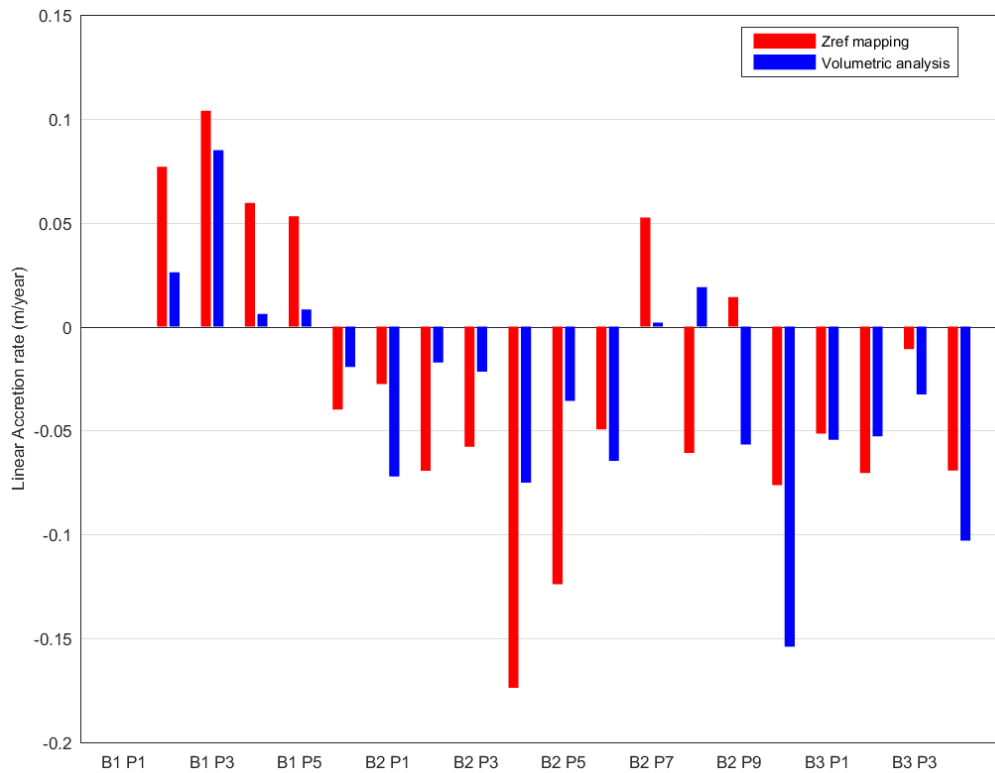
**Figure C-36: Barlings Beach Underlying Movement**

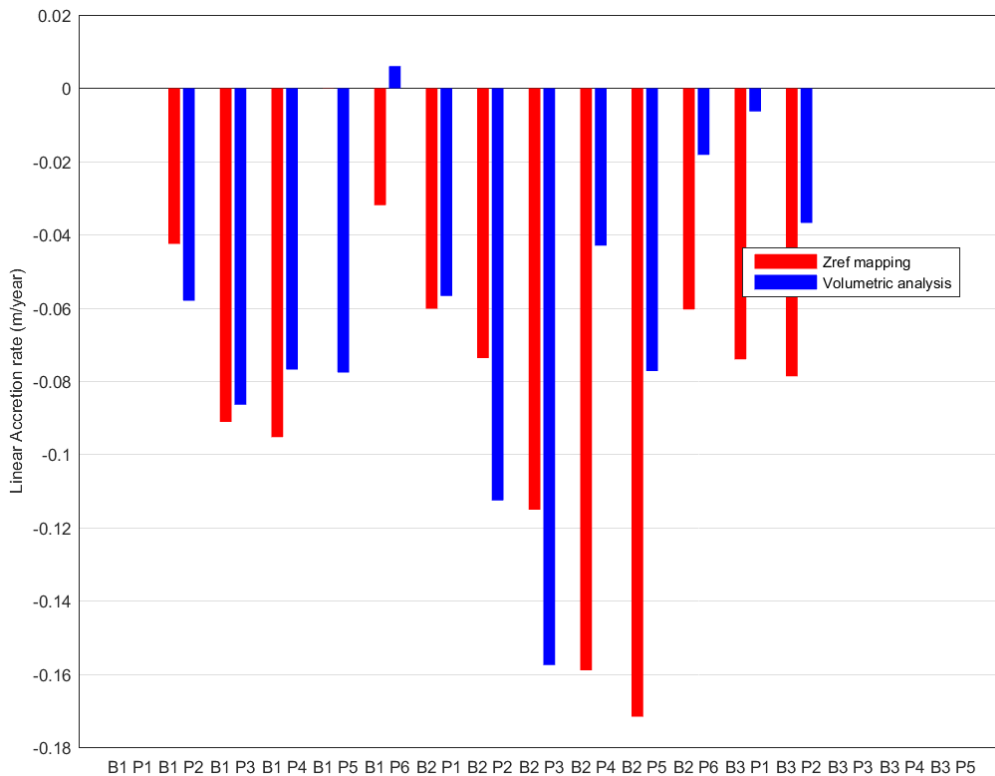
**Figure C-37: Tomakin Cove Underlying Movement**

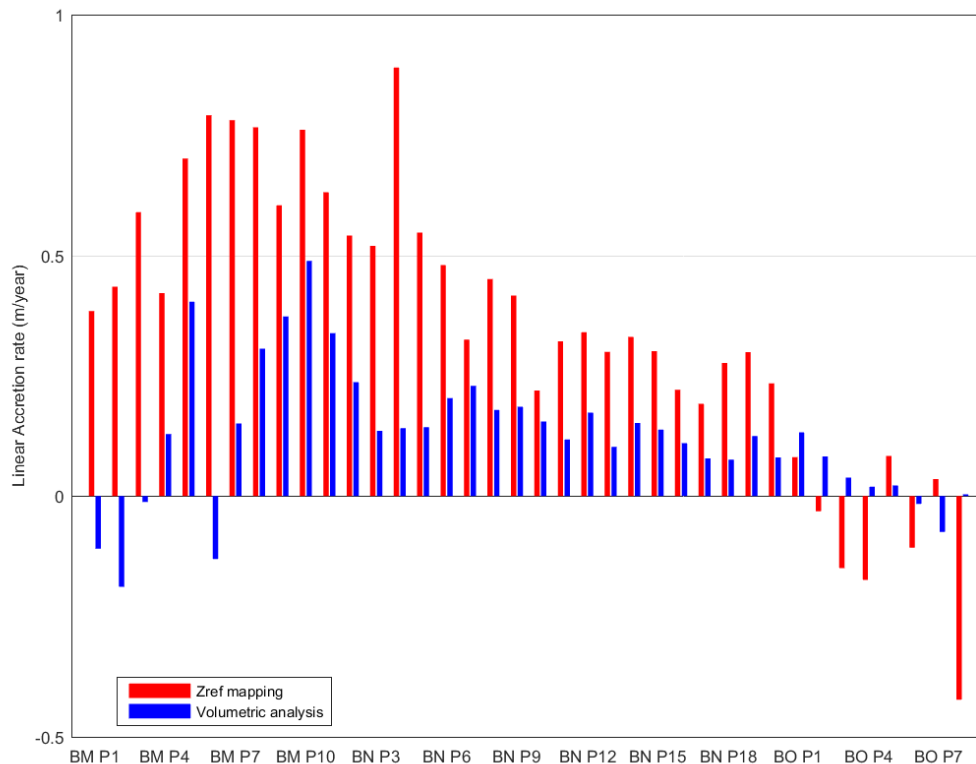
**Figure C-38: Broulee Beach Underlying Movement**

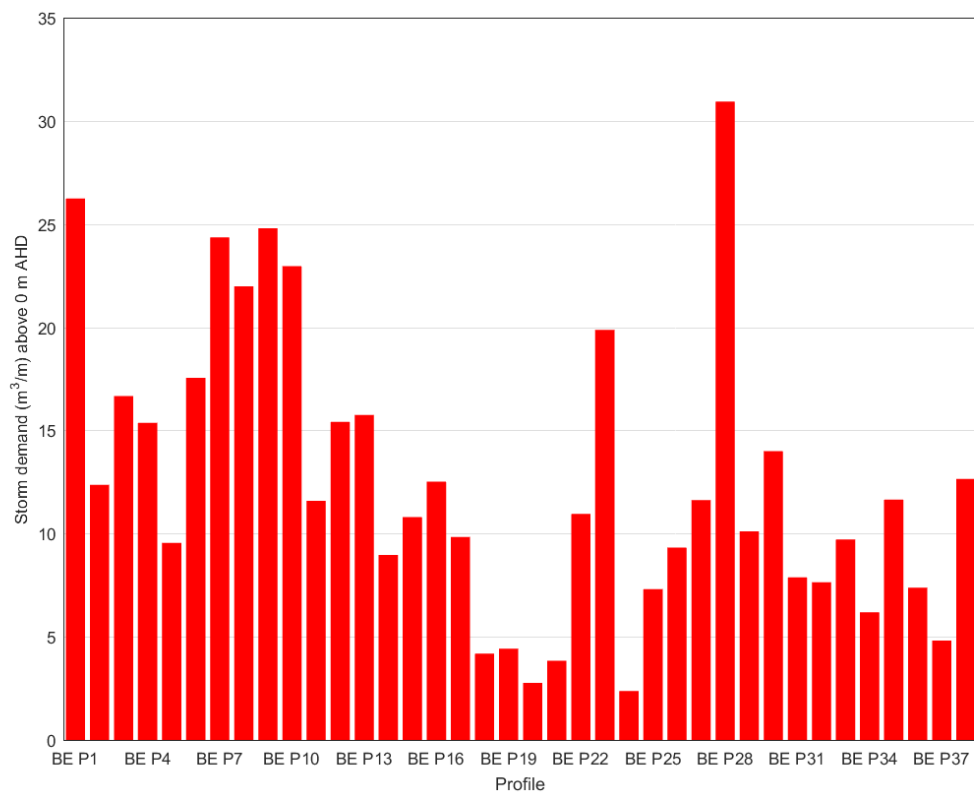
**Figure C-39: Maloney's Beach Maximum Storm Demand**

The maximum historical storm erosion is defined here as the maximum negative change in sub aerial beach volume between two consecutive photogrammetry years at each profile location. Similar to the volumetric analysis, profiles have been extrapolated to 0 m AHD (as necessary) at a slope of 1V:10H and volume was only calculated seaward of the landward limit described in Table C-3.

The results of the maximum historical storm erosion are provided in Figure C-39 to Figure C-47 and summarised in Table C-5. As per Section C.3.1, no results are provided at profiles backed by a rocky cliff or a creek mouth, nor are any results presented for Surfside Beach (west).

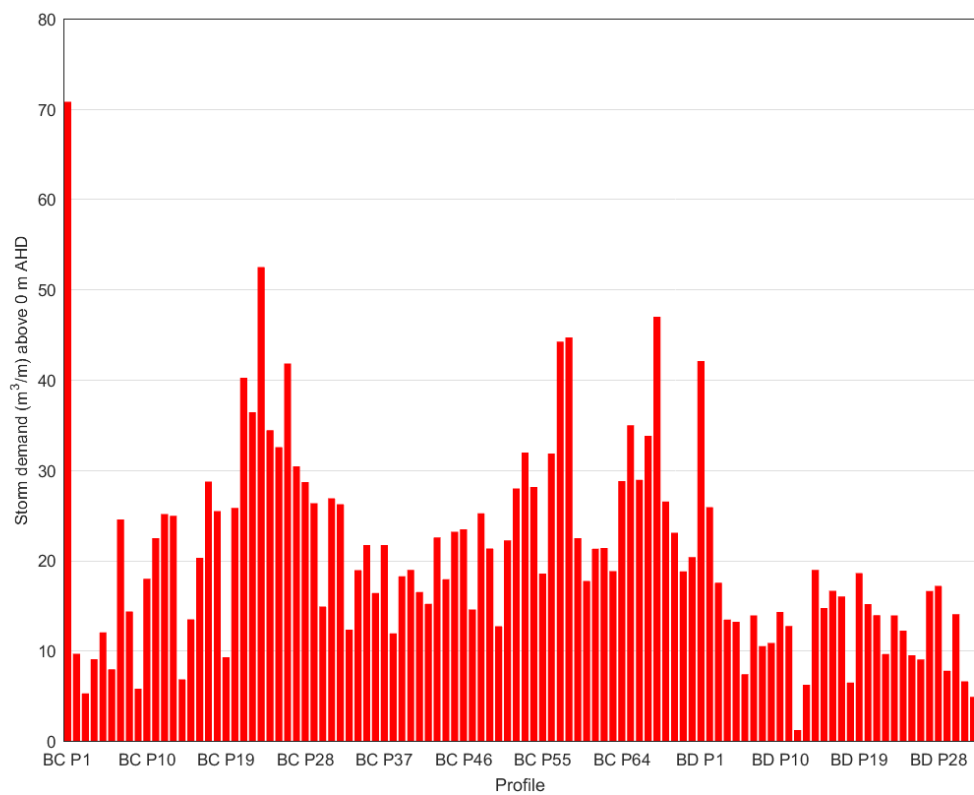
**Figure C-40: Long Beach Maximum Storm Demand**

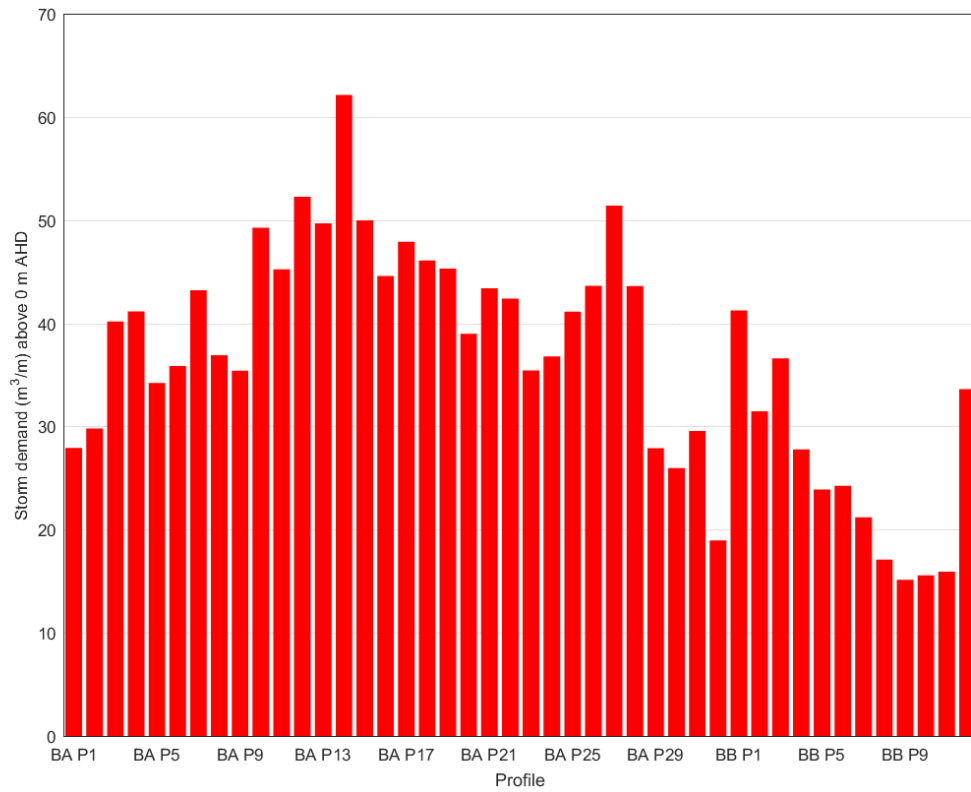
**Figure C-41: Surfside Beach (east) Maximum Storm Demand**

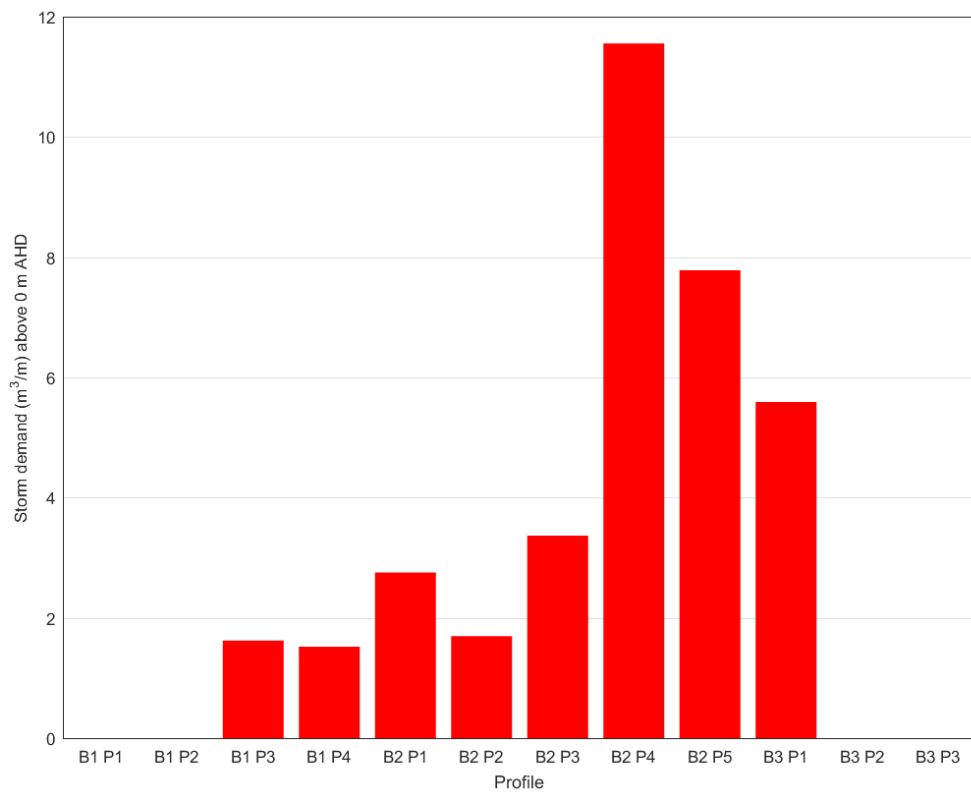
**Figure C-42: Sunshine Bay Maximum Storm Demand**

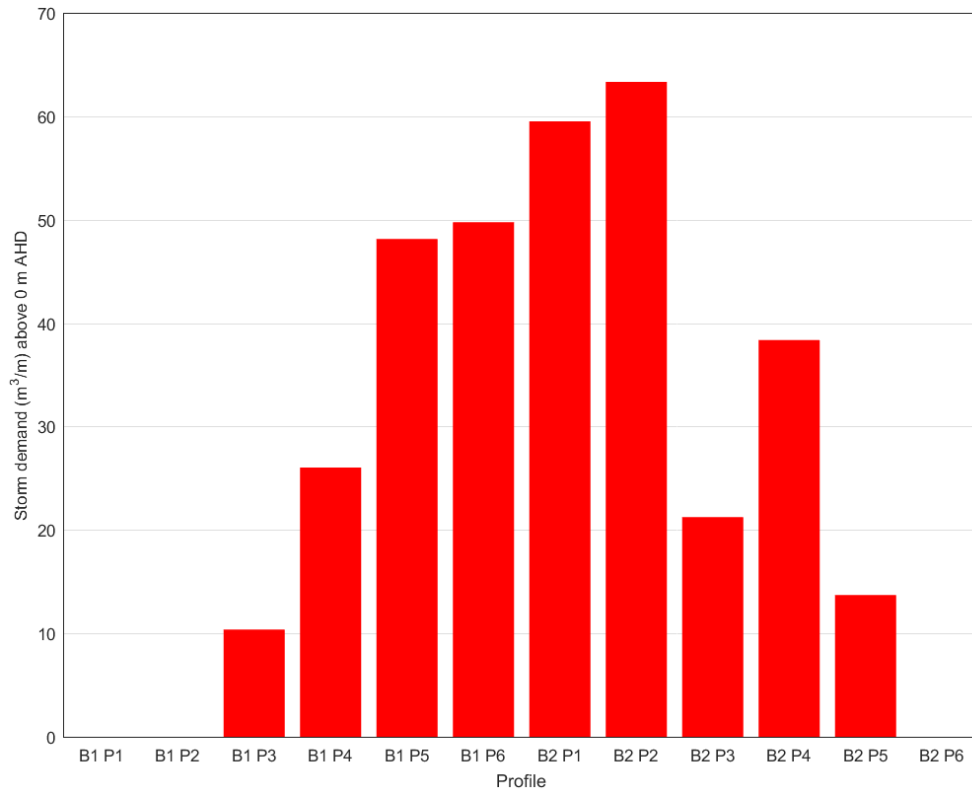
**Figure C-43: Malua Bay Maximum Storm Demand**

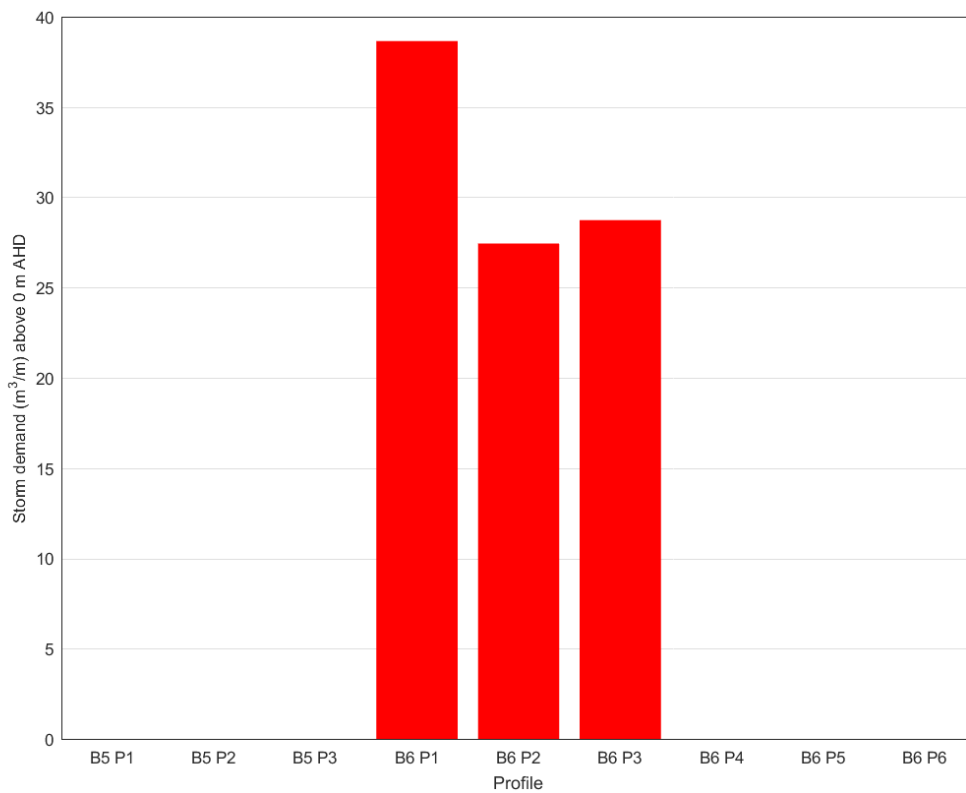
**Figure C-44: Guerilla Bay Maximum Storm Demand**

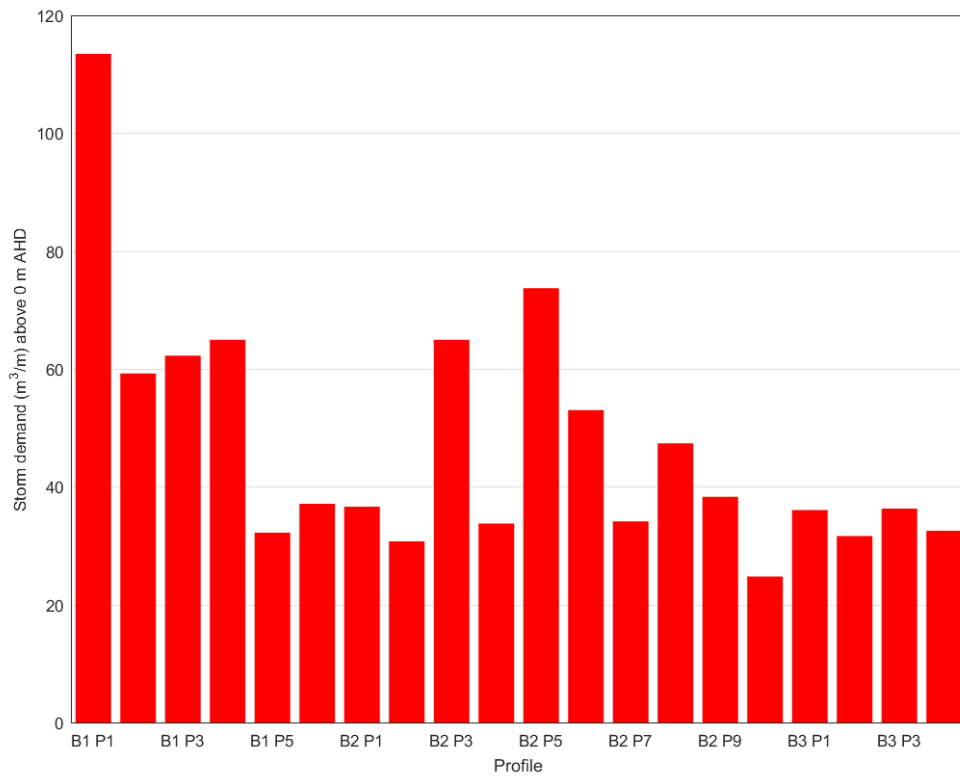
**Figure C-45: Barlings Beach Maximum Storm Demand**

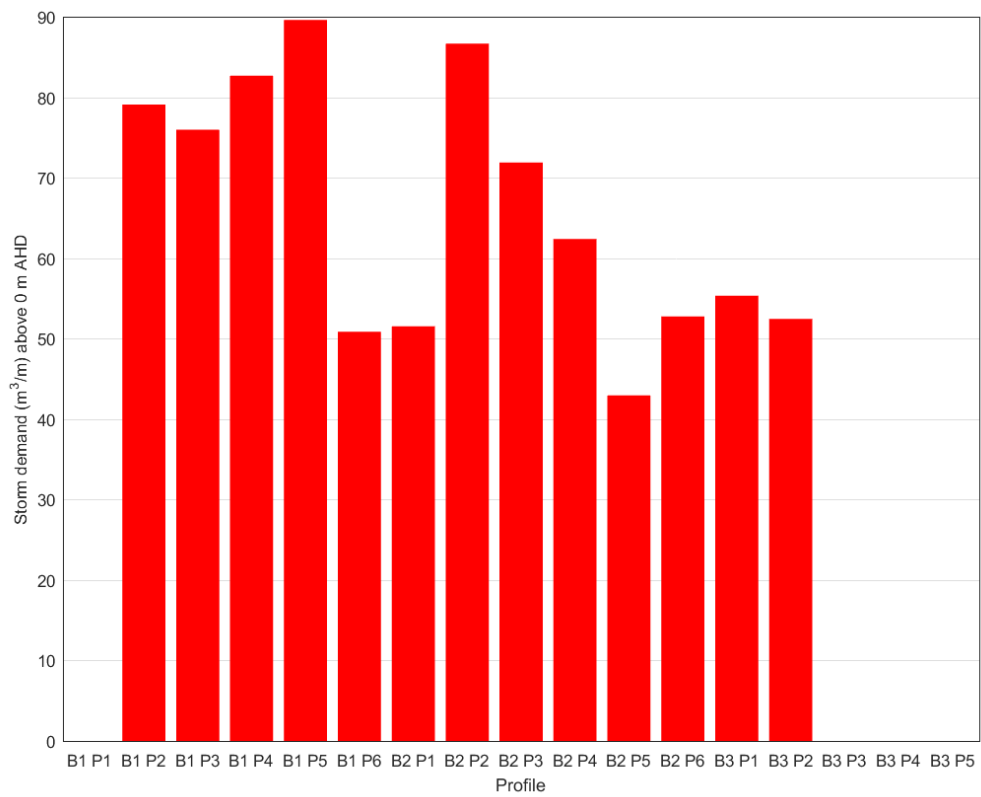
**Figure C-46: Tomakin Cove Maximum Storm Demand**

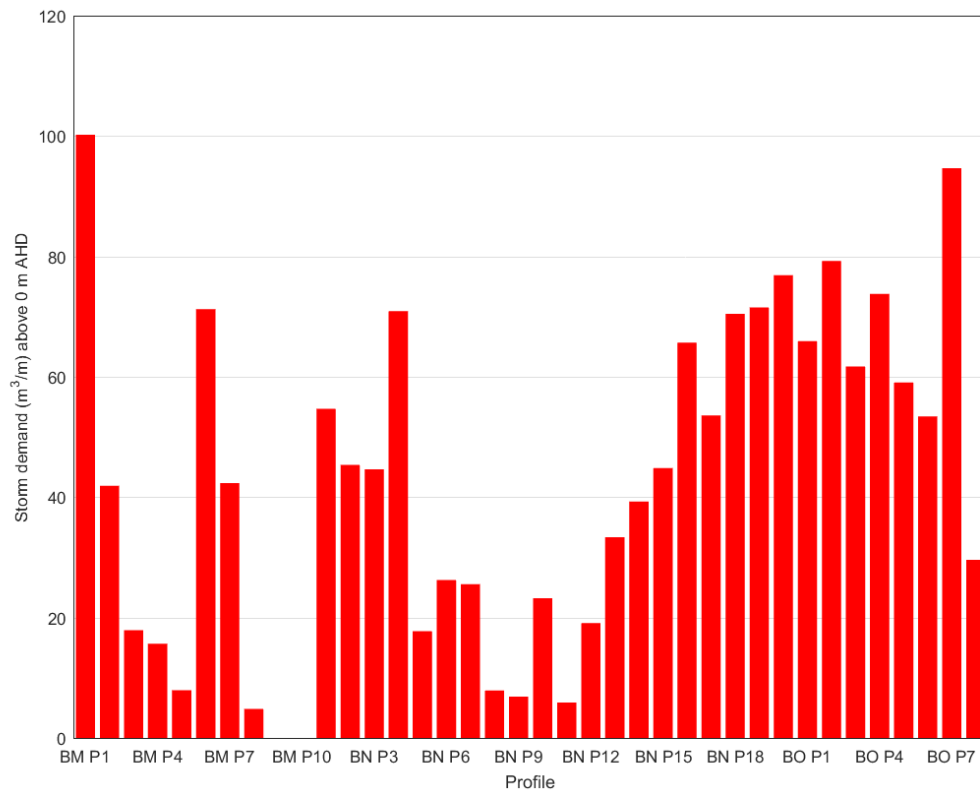
**Figure C-47: Broulee Beach Maximum Storm Demand**

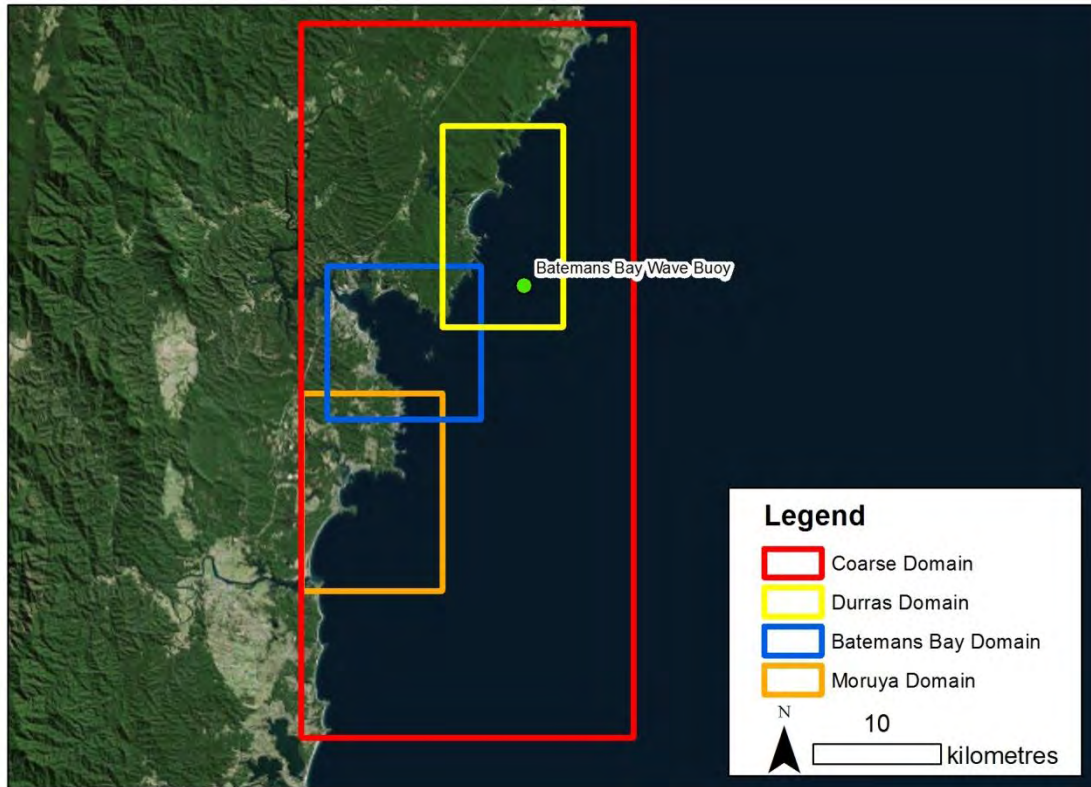
**Figure D-1: SWAN model domains**

4. Moruya Domain (Figure D-5) - this is a nested grid with a spatial resolution of 25 m, covering the southern extent of the study area. It is used to simulate wave propagation for beaches between (and including) Malua Bay and Bengello Beach.

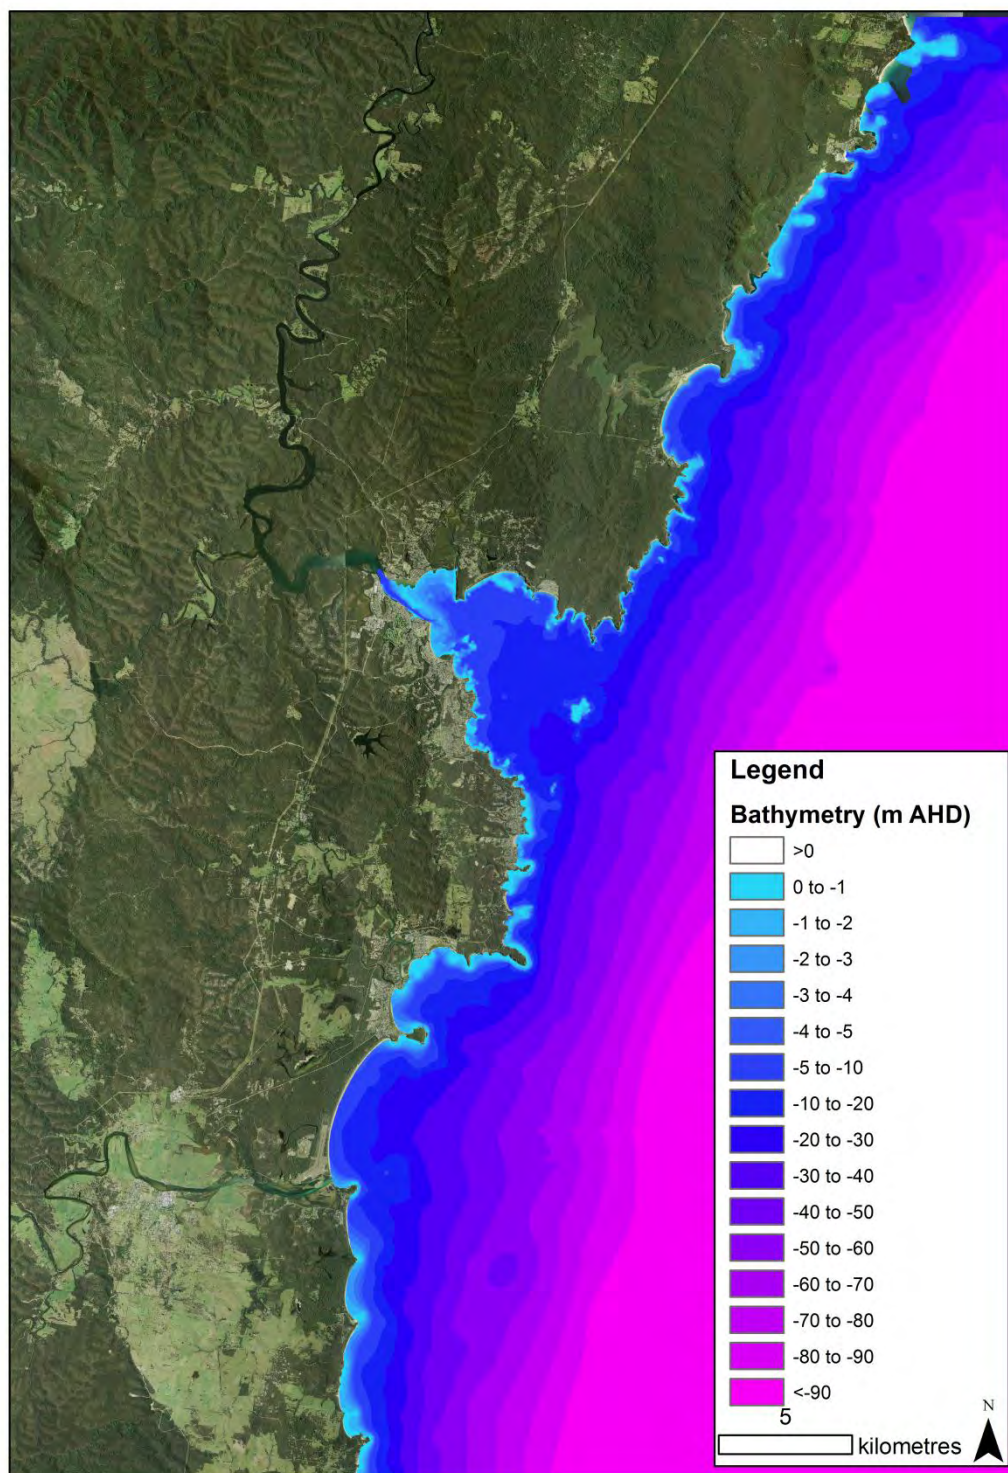
**Figure D-2: Eurobodalla Coarse model domain bathymetry**

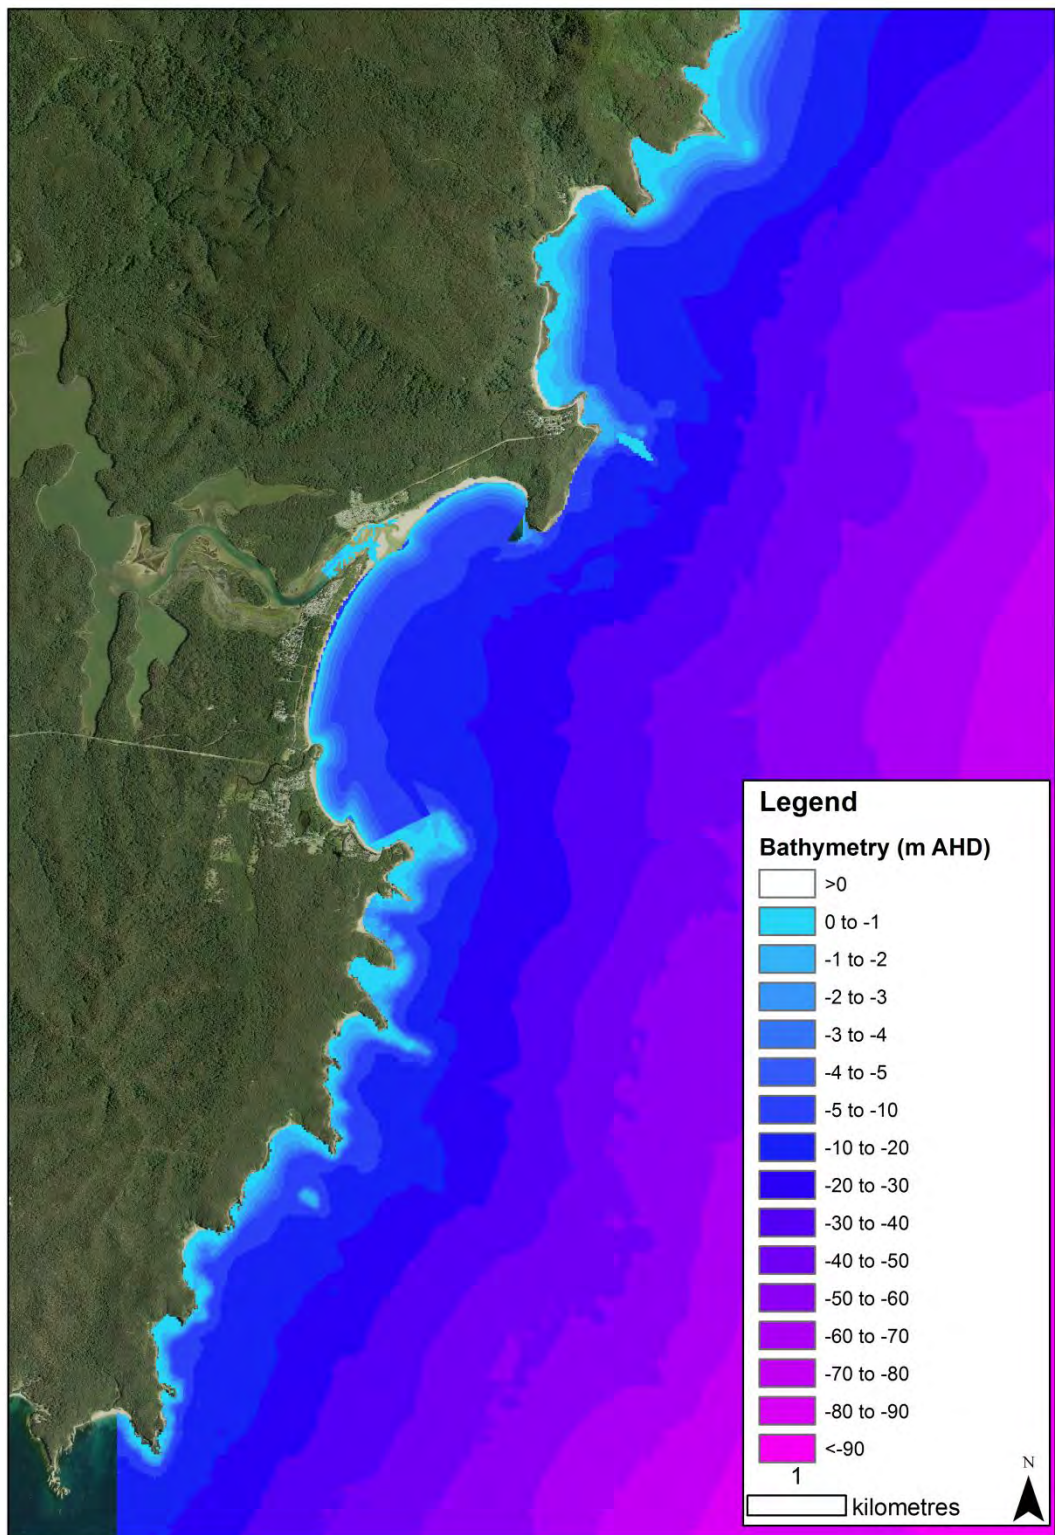
**Figure D-3: Durras model domain bathymetry**

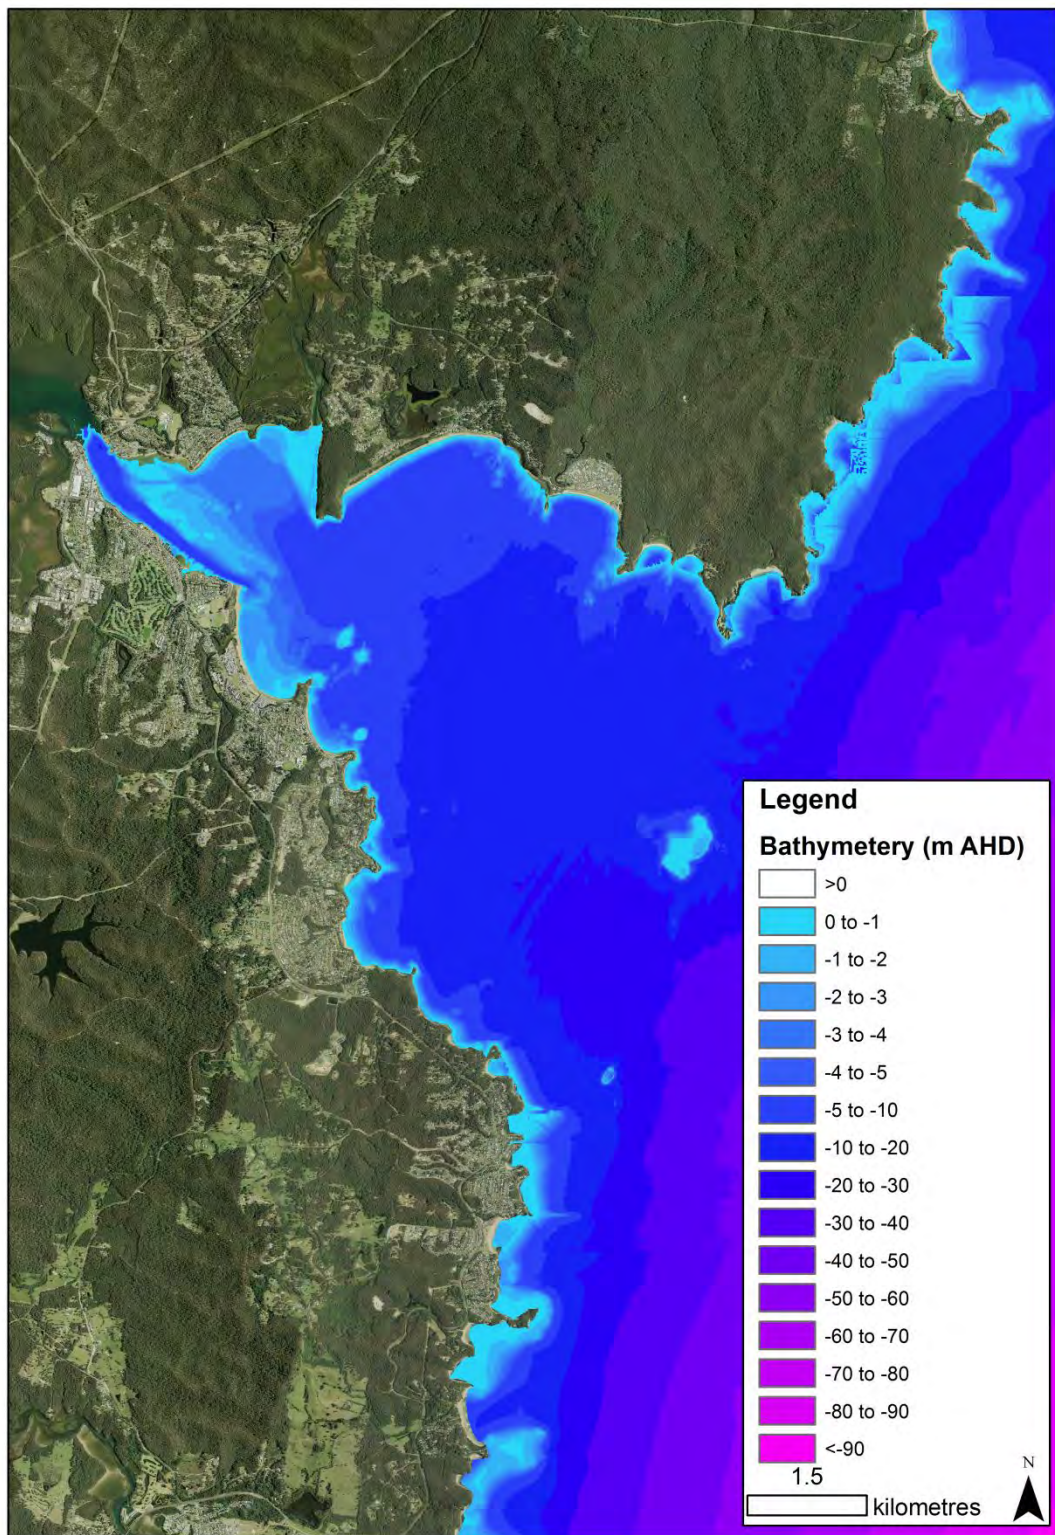
**Figure D-4: Batemans Bay model domain bathymetry**

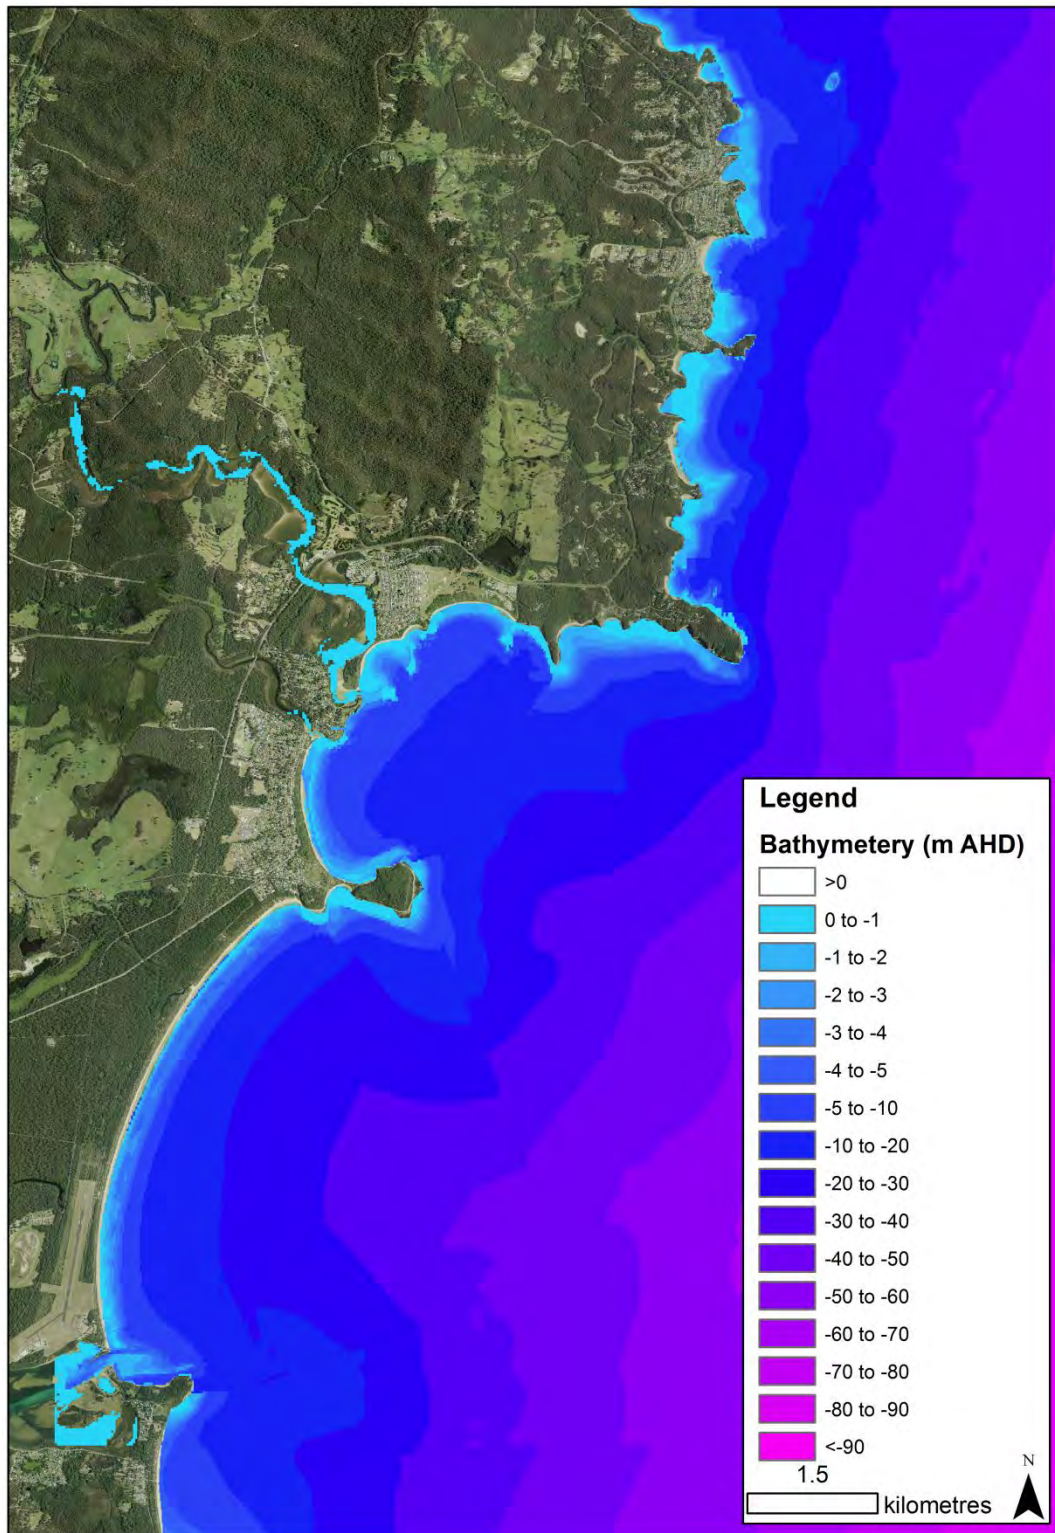
**Figure D-5: Moruya model domain bathymetry**

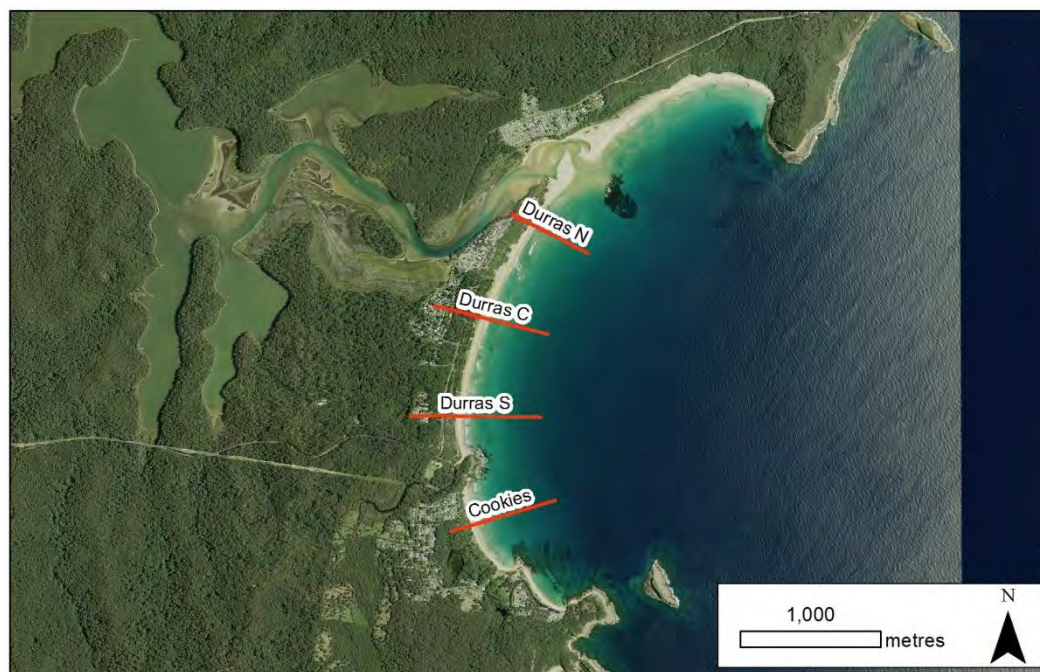
**Figure D-6: Output locations for the Durras region**

For each model simulation, spatial maps of wave height, period and direction have been generated for the four (4) model domains. More detailed information including significant wave height, mean and peak period and direction and depth have also been provided for 33 locations within the study area. These locations are shown in Figure D-6, Figure D-7 and Figure D-8.

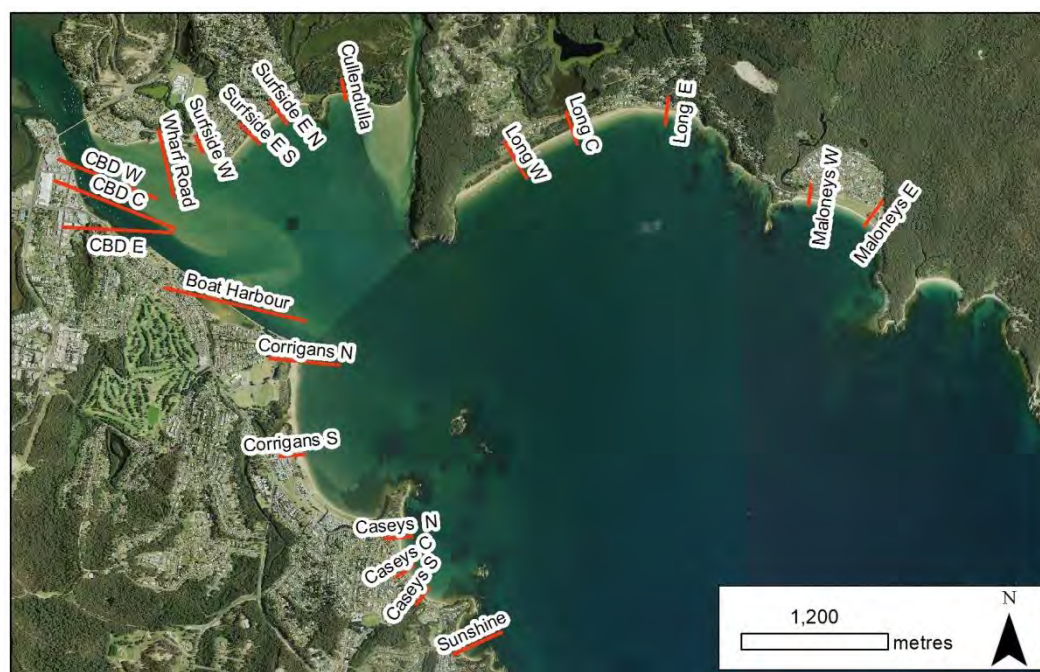
**Figure D-7: Output locations for the Batemans Bay region**

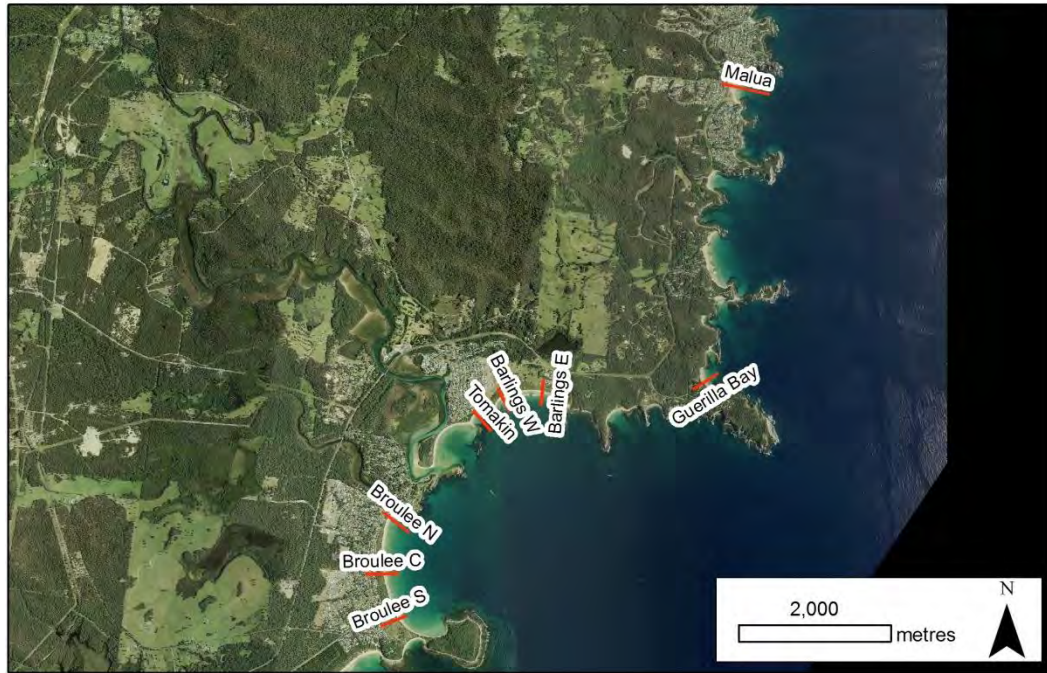
**Figure D-8: Output locations for the Moruya region**

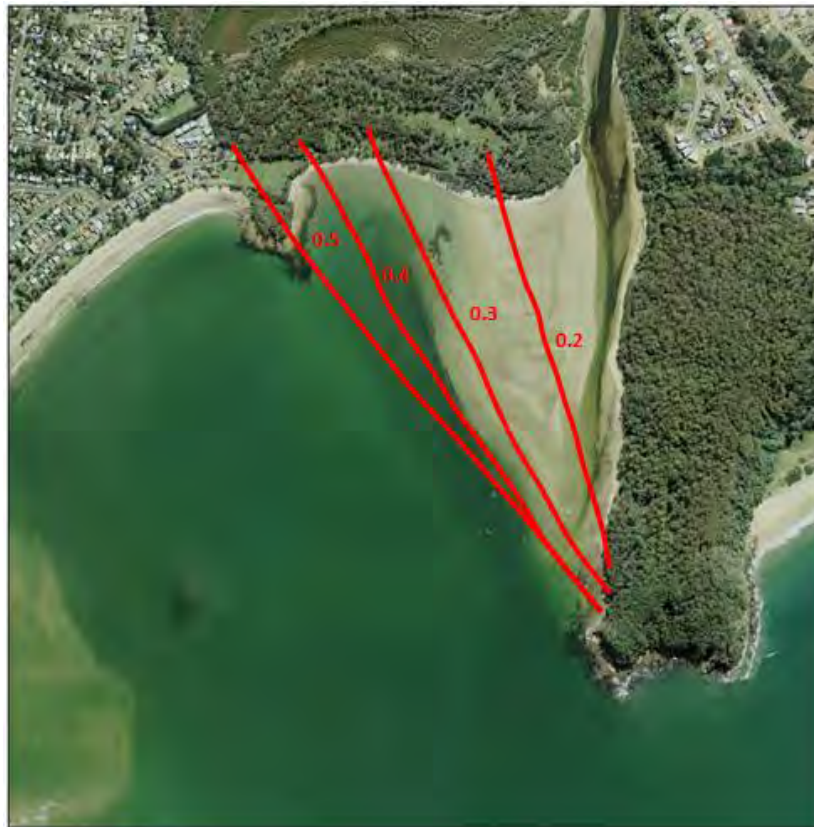
To estimate the diffracted wave height at Cullendulla, the irregular wave diffraction diagram for waves passing through a structure gap with  $B/L = 2.0$  (ratio of entrance width to local wavelength) and  $S_{MAX} = 75$  (directional spreading function; value appropriate for swell waves) published by Goda (2000) was overlain on the study area as shown in Figure D-9. A diffraction factor of 0.35 was used for design.

**Figure D-9: Irregular Wave Diffraction Coefficients at Cullendulla**

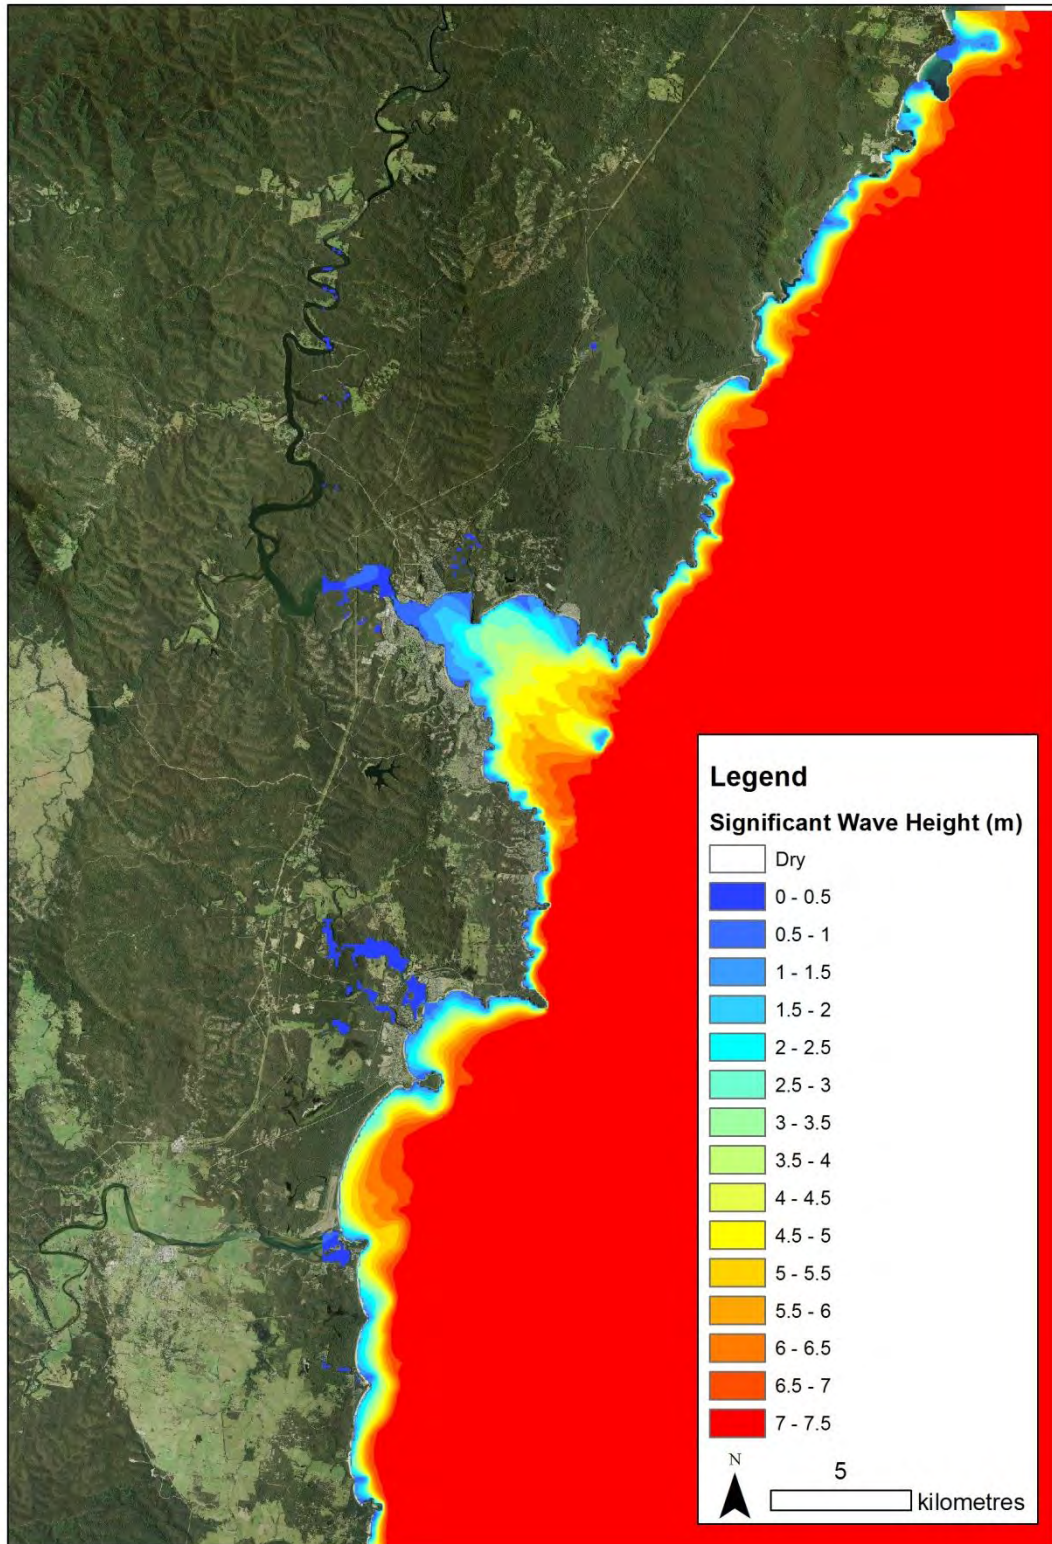
**Figure D-10: Example of 100 year ARI east south-east event for the Eurobodalla Coarse model domain**

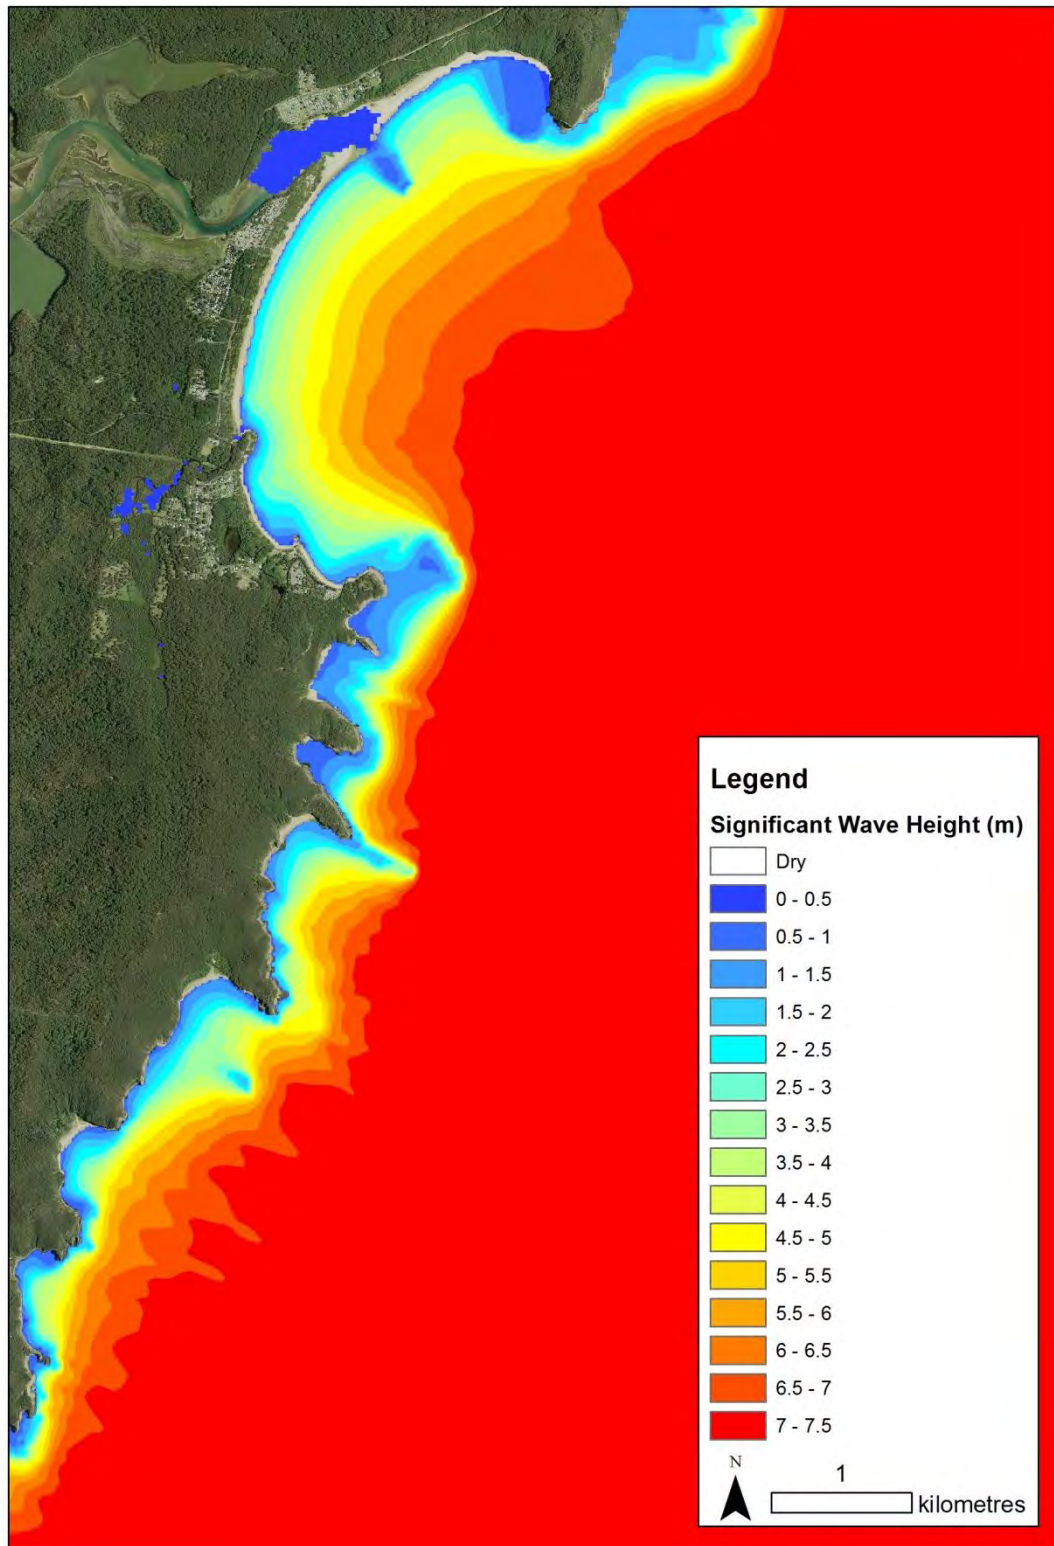
**Figure D-11: Example of 100 year ARI east south-east event for the Durras model domain**
