## Eurobodalla Coastal Hazard Assessment

WRL Technical Report 2017/09  
October 2017

By I R Coghlan, J T Carley, A J Harrison, D Howe, A D Short,  
J E Ruprecht, F Flocard and P F Rahman

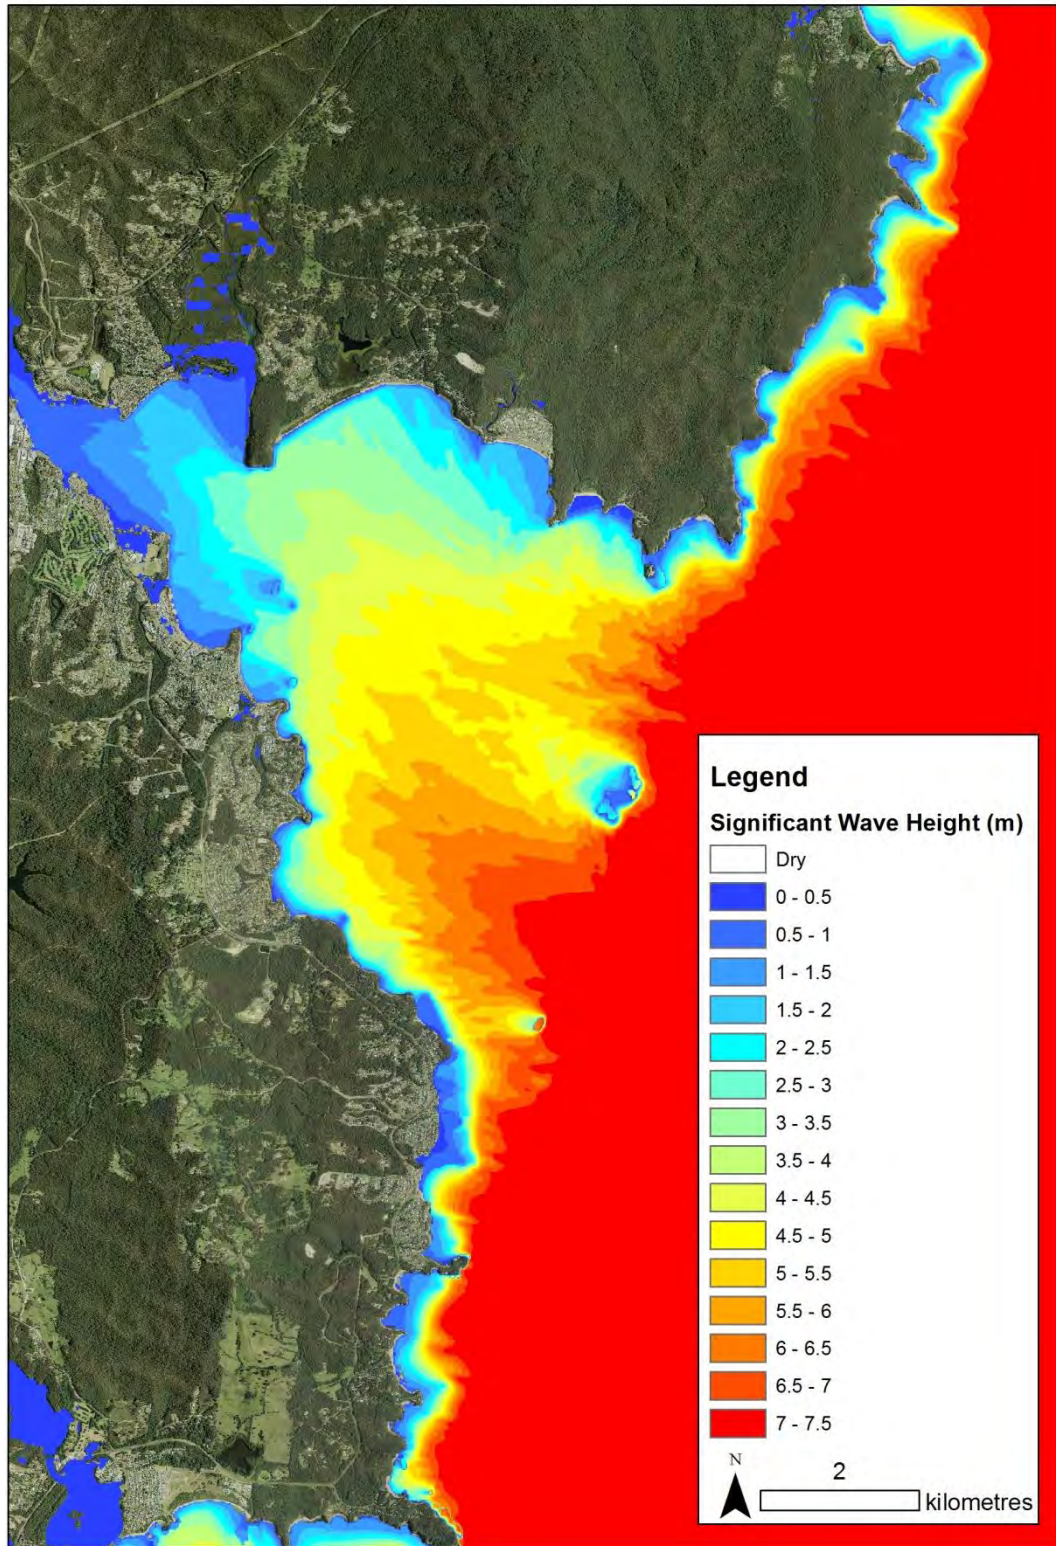
**Figure D-12: Example of 100 year ARI east south-east event for the Batemans Bay model domain**

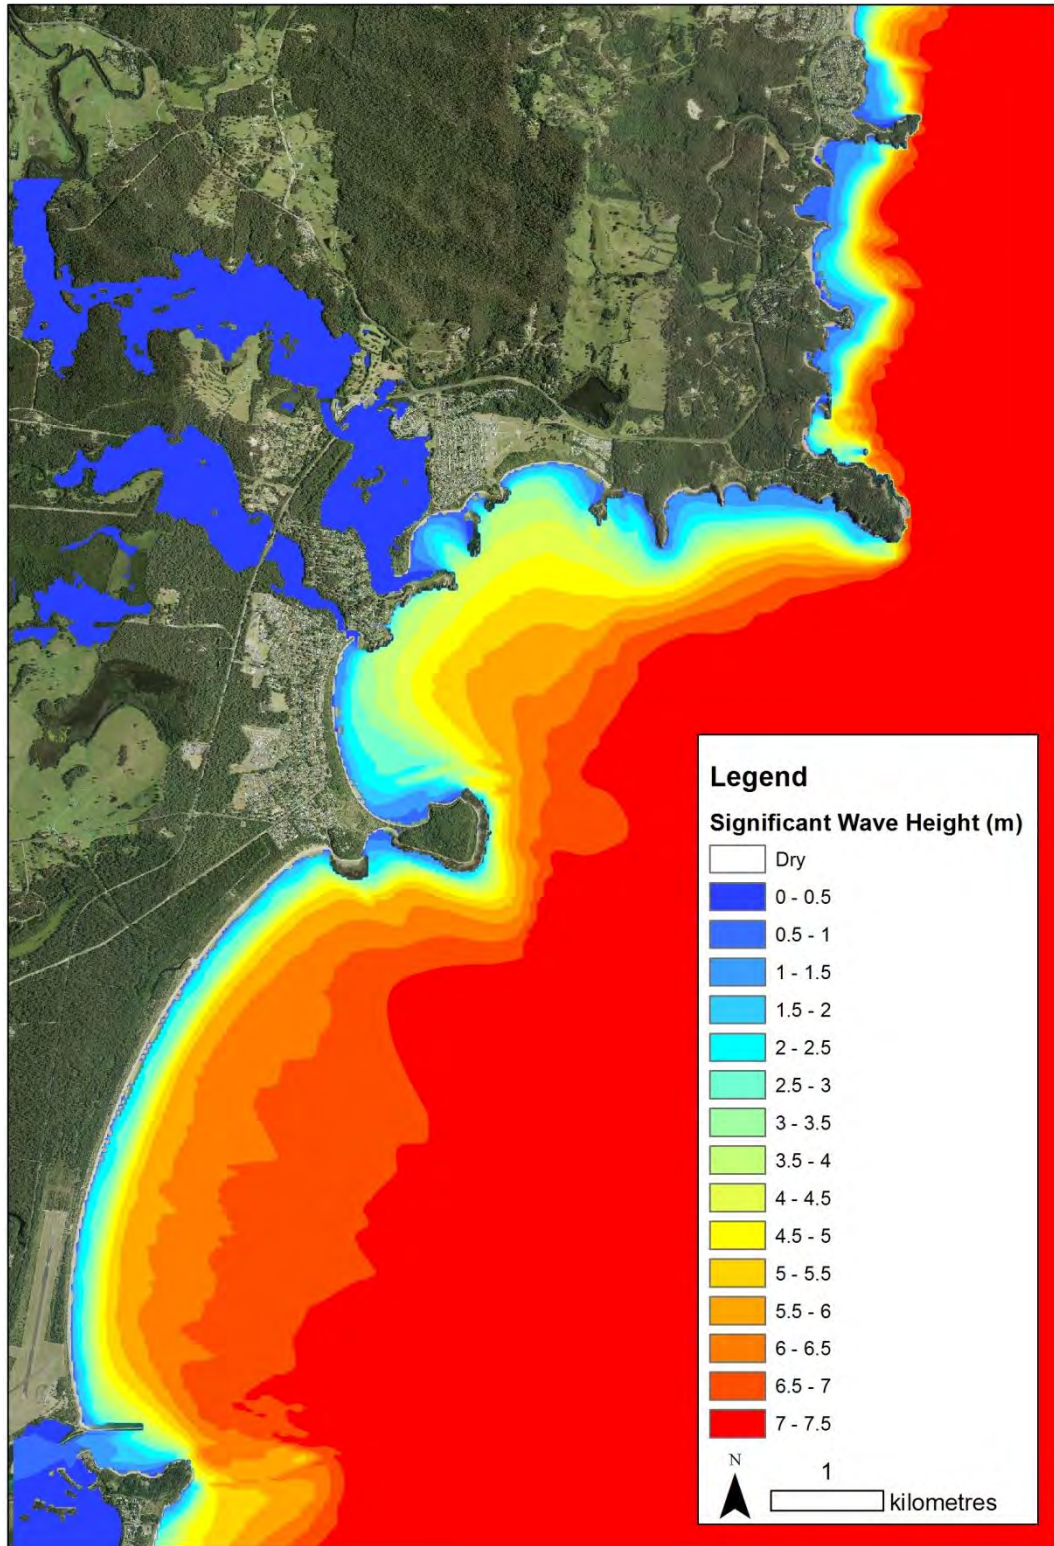
**Figure D-13: Example of 100 year ARI east south-east event for the Moruya model domain**

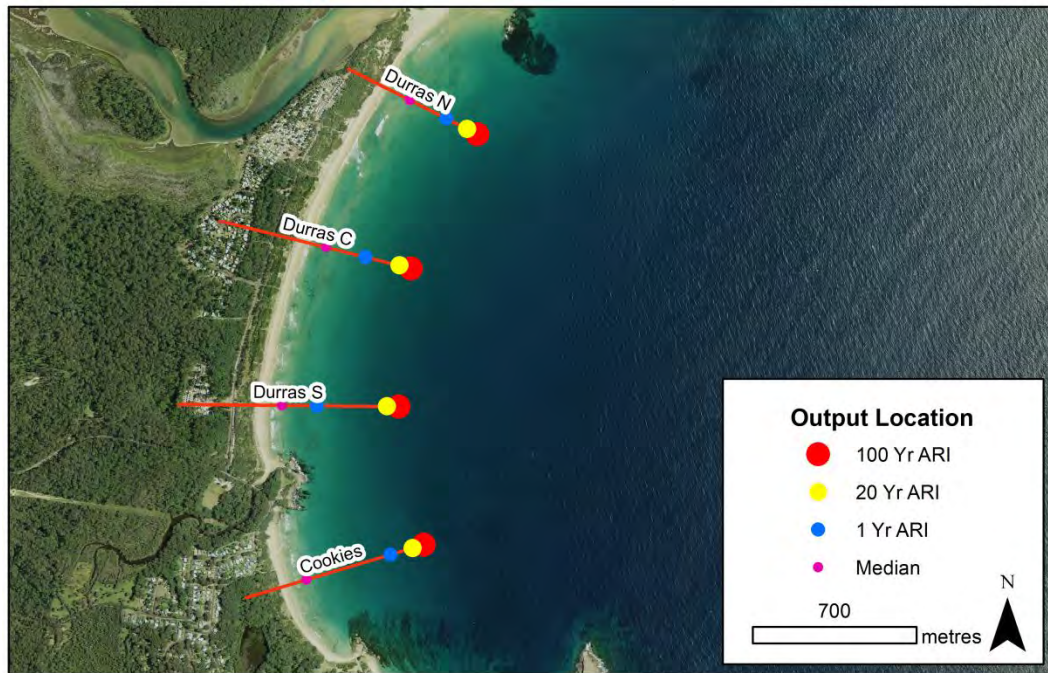
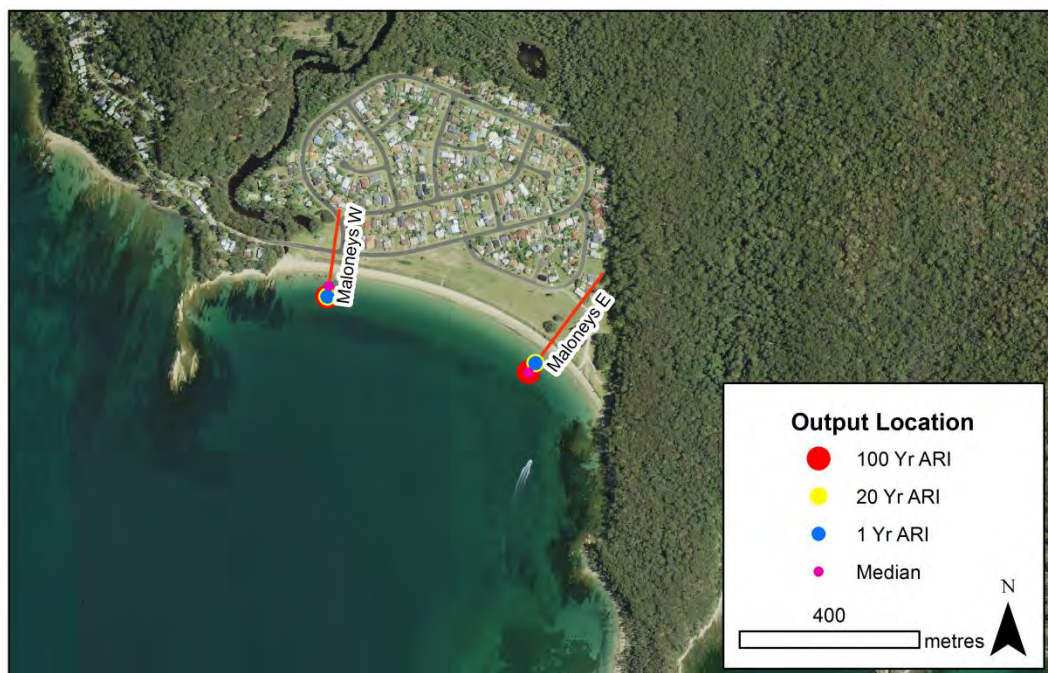
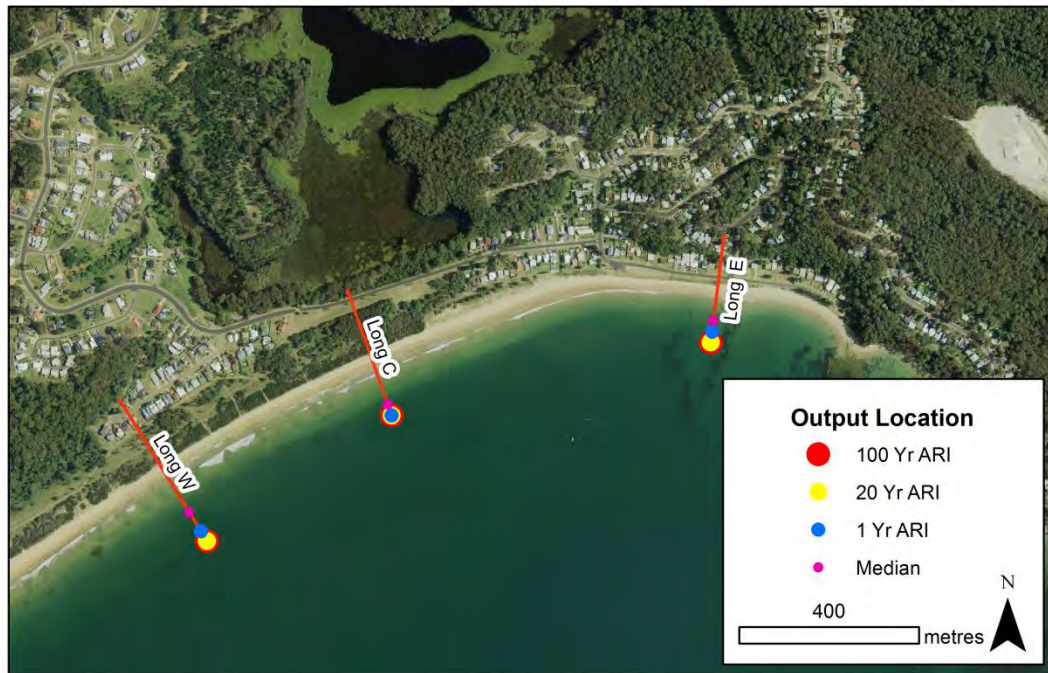
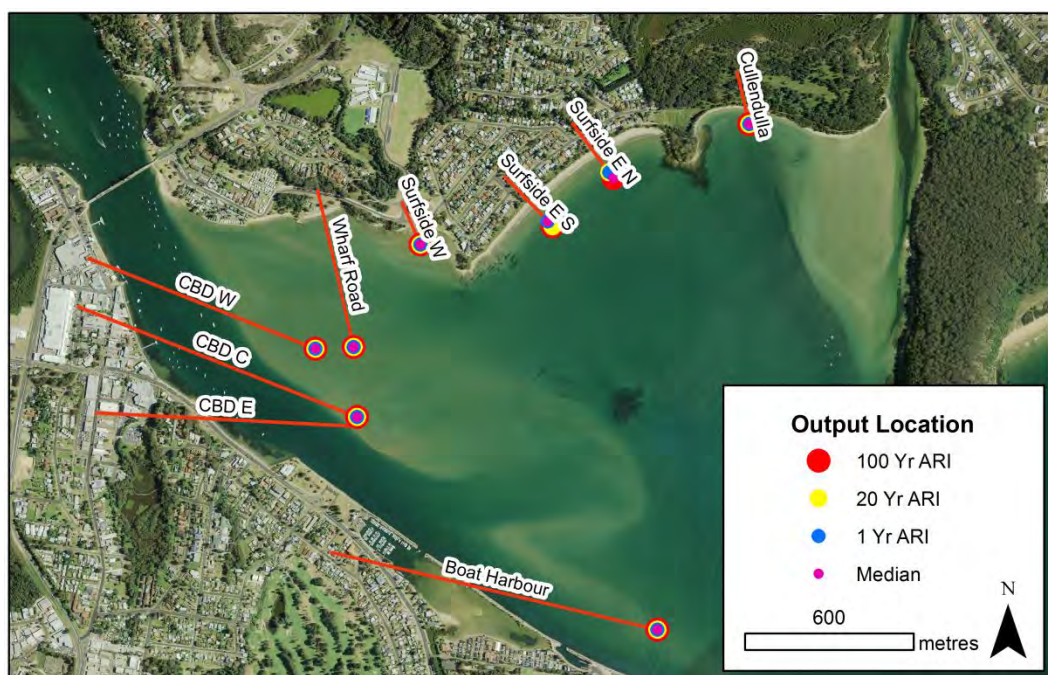
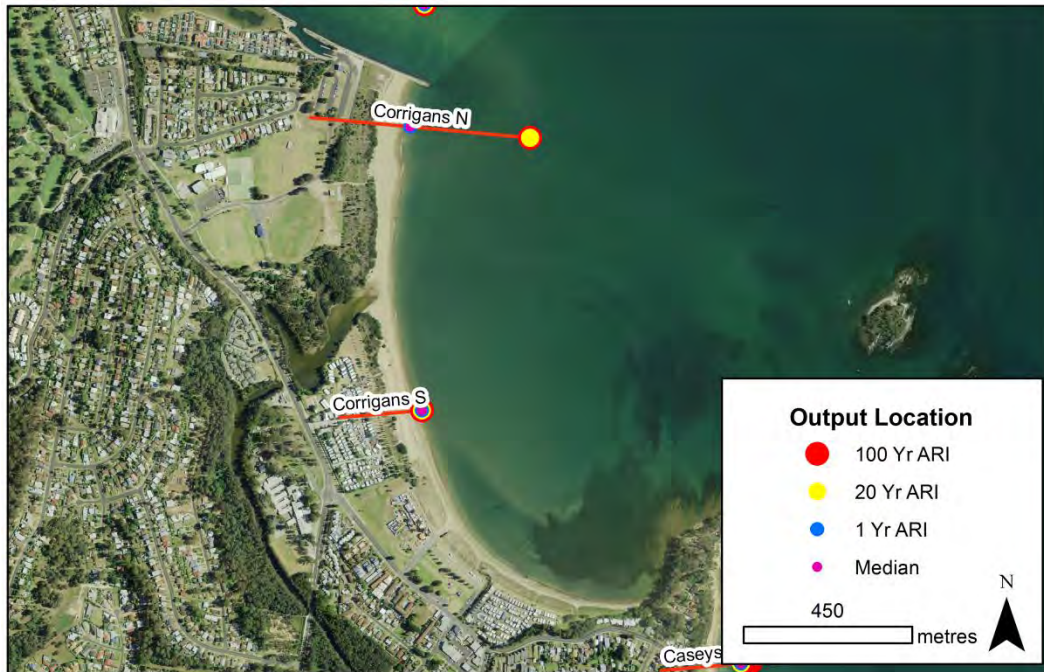
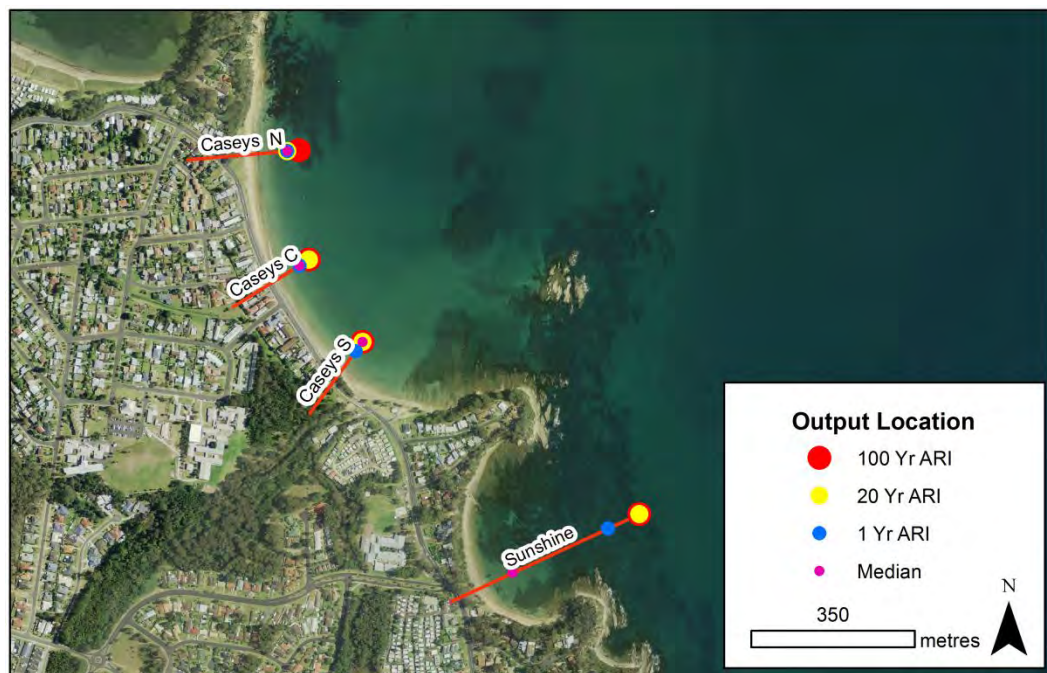
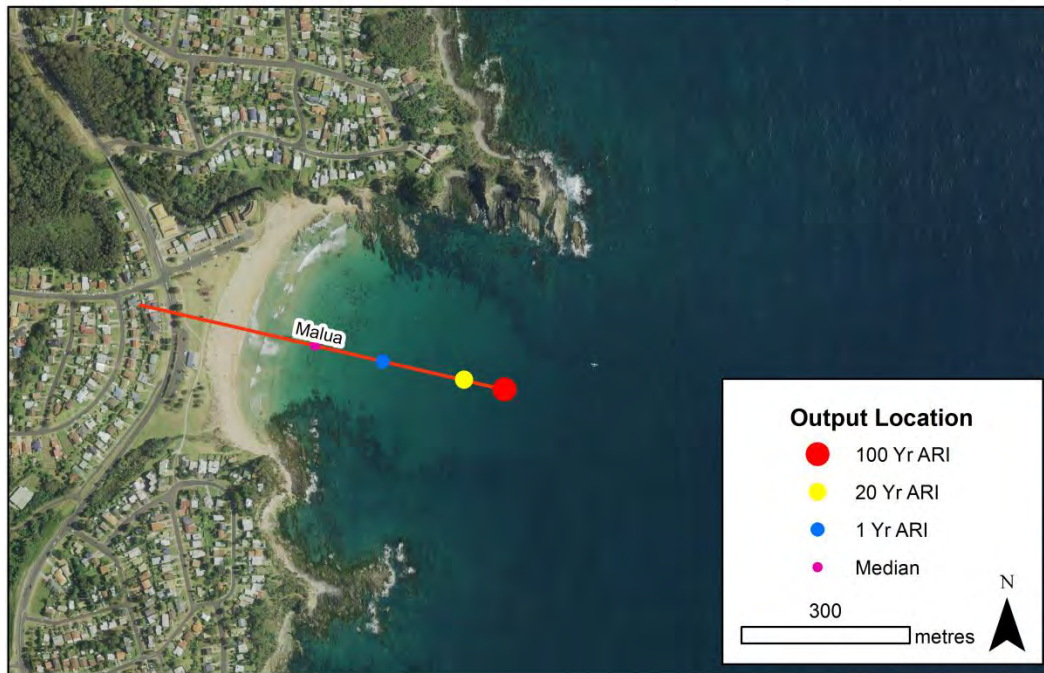
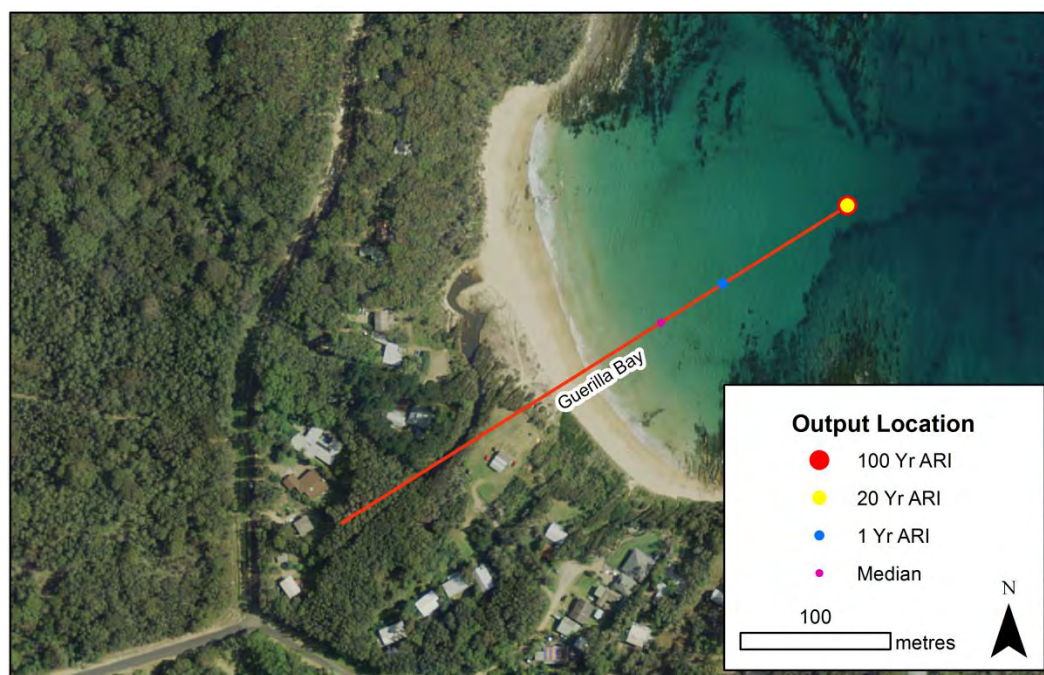
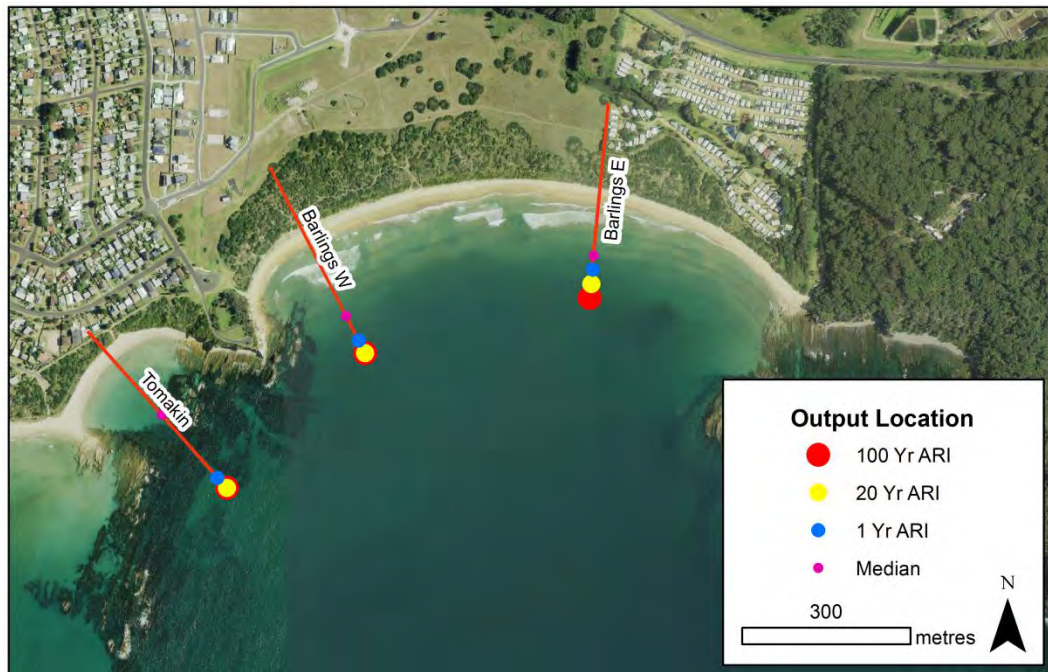
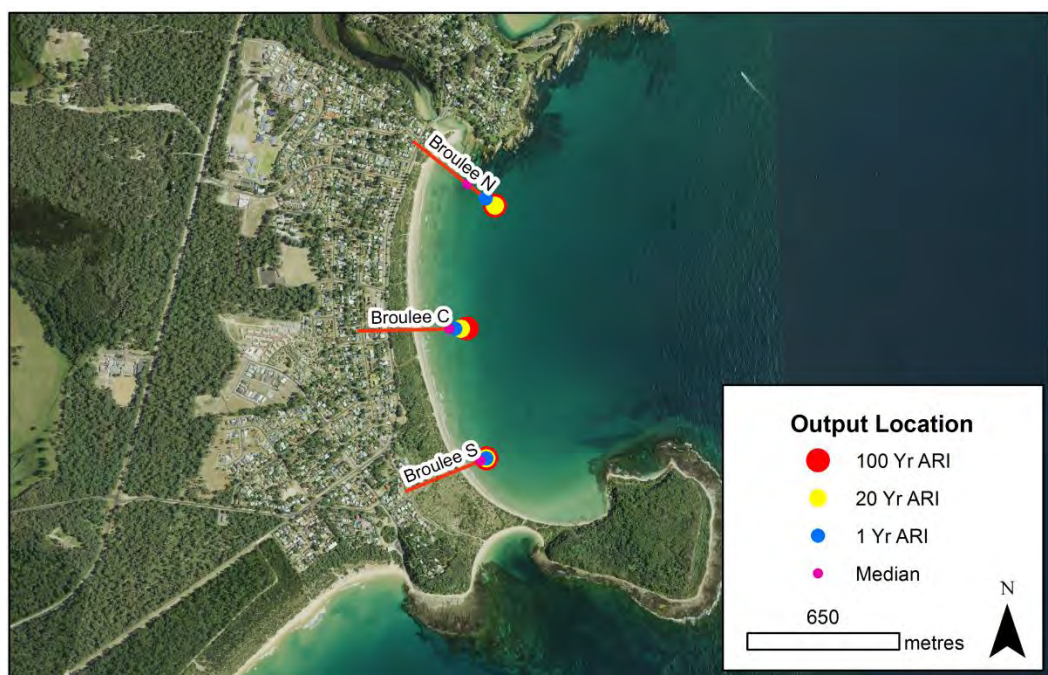
**Figure D-14: SWAN Output Locations: Durras Beach and Cookies Beach**

**Figure D-15: SWAN Output Locations: Maloneys Beach**

**Figure D-16: SWAN Output Locations: Long Beach**

**Figure D-17: SWAN Output Locations: Inner Batemans Bay Beaches**

**Figure D-18: SWAN Output Locations: Corrigans Beach**

**Figure D-19: SWAN Output Locations: Caseys Beach and Sunshine Bay**

**Figure D-20: SWAN Output Locations: Malua Bay**

**Figure D-21: SWAN Output Locations: Guerilla Bay**

**Figure D-22: SWAN Output Locations: Tomakin Cove and Barlings Beach**

**Figure D-23: SWAN Output Locations: Broulee Beach**

For each output location (coordinates in MGA Zone 56), wave conditions for each direction scenario were evaluated and maximum conditions (at outer breakpoint) are summarised in Table D-5. The median wave statistics originating from a south easterly (SE) direction are also included for comparison. Output locations are shown in Figure D-14 to Figure D-23.

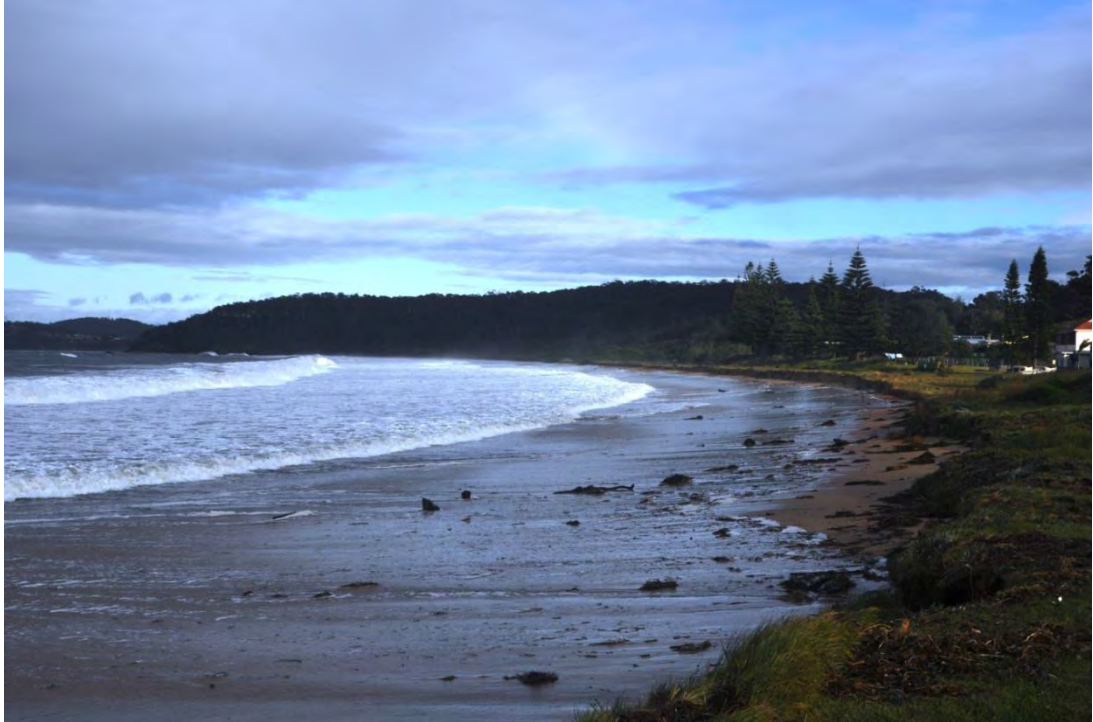
**Figure D-24: Nearshore Waves at Long Beach, 6 June 2012 (Mr Lindsay Usher)**

On 4-6 June 2012, a severe storm with offshore significant wave heights of 6 m (typical  $T_p = 13$  s, south-easterly wave direction, maximum water level 1.3 m AHD) had a large impact upon beaches within Batemans Bay. During this event, Mr Lindsay Usher of ESC photographed the nearshore wave conditions on 6 June 2012 at Long Beach (central section, Figure D-24) and Surfside Beach (east) (northern end, Figure D-25). Based on interpolation of existing SWAN results, WRL estimates that the significant wave heights at outer edge of the surf zone of these beaches at the peak of the storm to be 2.0 m and 1.3 m, respectively. These local wave heights are considered to have an approximate average recurrence interval of 5 years.

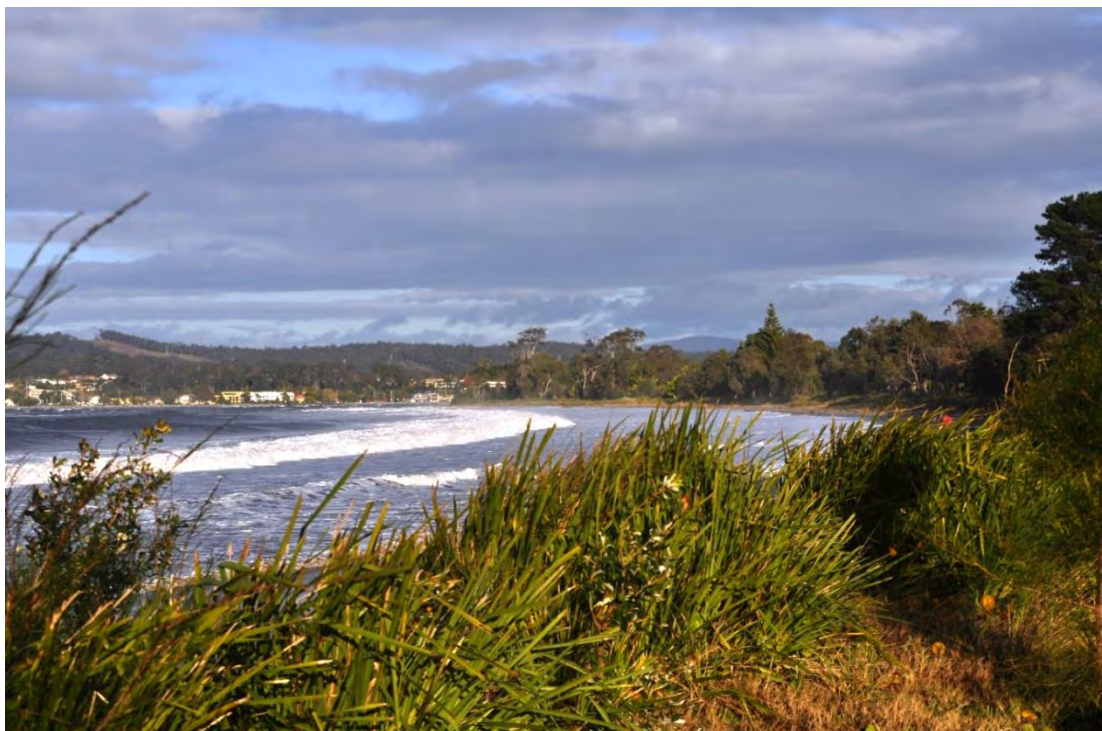
**Figure D-25: Nearshore Waves at Surfside Beach (East), 6 June 2012 (Mr Lindsay Usher)**

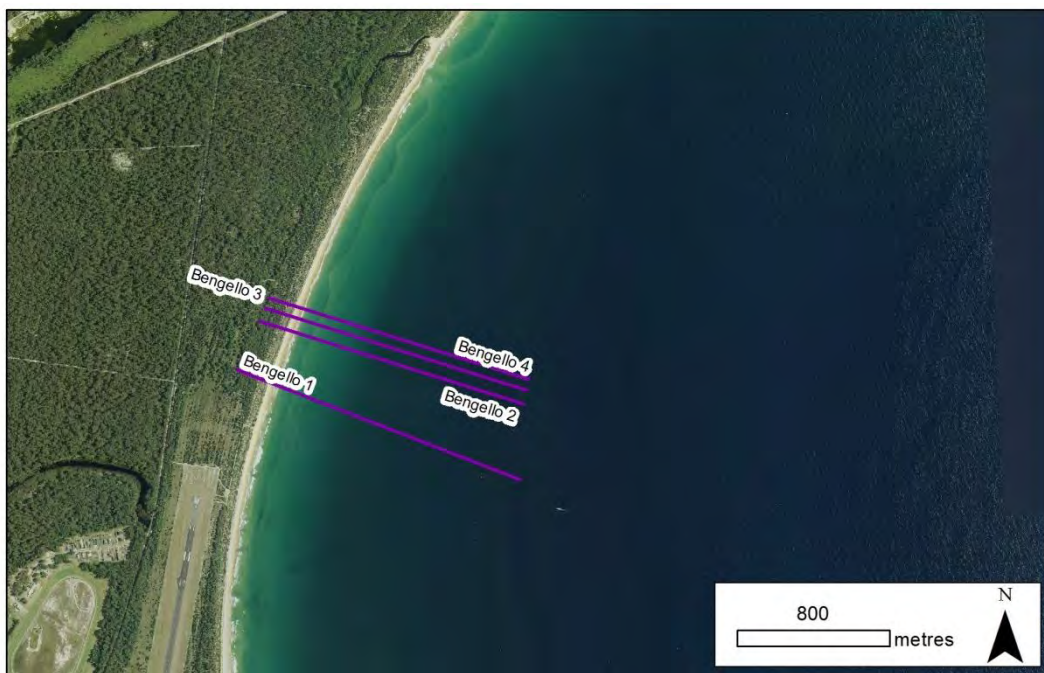
**Figure E-1: SBEACH erosion profiles Bengello Beach (calibration only)**

Through discussions with ESC and OEH, it was agreed that the SBEACH model would be calibrated at Bengello Beach, where reliable monitoring data exists. Bengello Beach has been monitored (approximately monthly) since 1972 with traditional survey techniques (Thom and Hall, 1991, McLean and Shen, 2006). The four profiles used for model calibration are shown in Figure E-1.

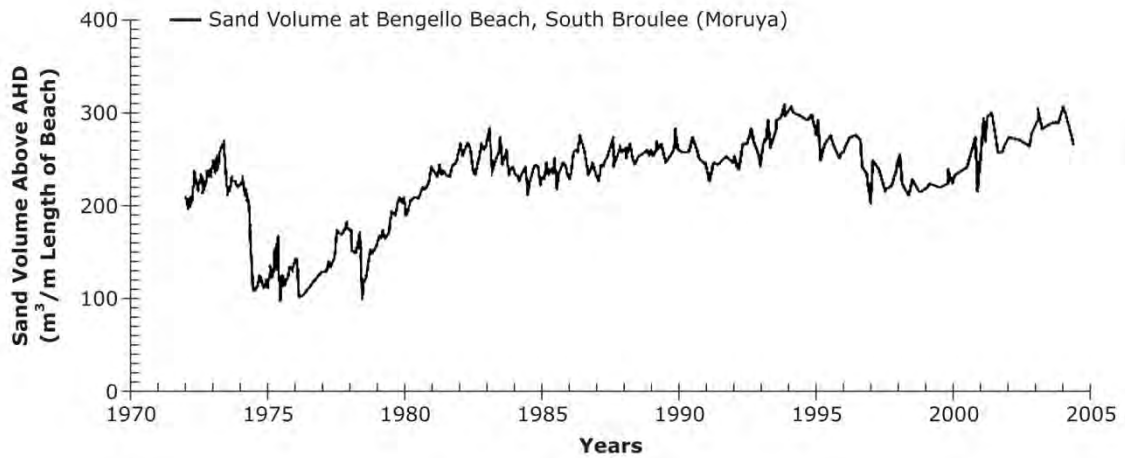
**Figure E-2: Timeseries of sand volume change at Bengello Beach (Source: McLean et al., 2010)**

In the last 45 years, the most erosive period occurred over three weeks during May – June 1974 (shown in Figure E-2). Measured profile data was recorded at four profiles before and after this storm period, with recorded erosion summarised in Table E-1. The maximum storm erosion over this period was 200 m<sup>3</sup>/m above -0.94 m AHD (estimated to be approximately 170 m<sup>3</sup>/m above 0 m AHD) and the average storm erosion across the four profiles was estimated at 95 m<sup>3</sup>/m

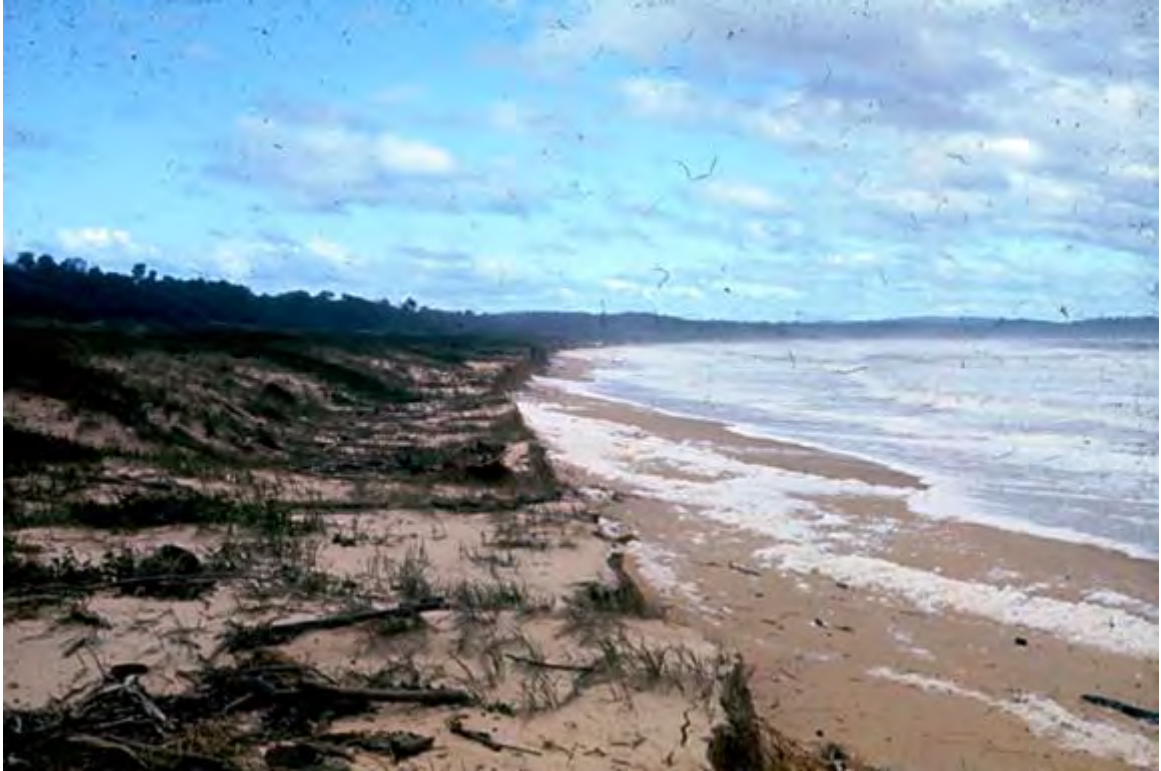
**Figure E-3: Bengello Beach (Profile 3 Looking North) 25 May 1974 - Further erosion occurred in early June 1974 after this photograph was taken (McLean et al., 2010)**

A photograph of Profile 3 during the May-June 1974 storm sequence is shown in Figure E-3. The final scarp for this storm sequence is now degraded and vegetated but still visible in a photograph of Profile 4 taken on 30 June 2007 (Figure E-4).

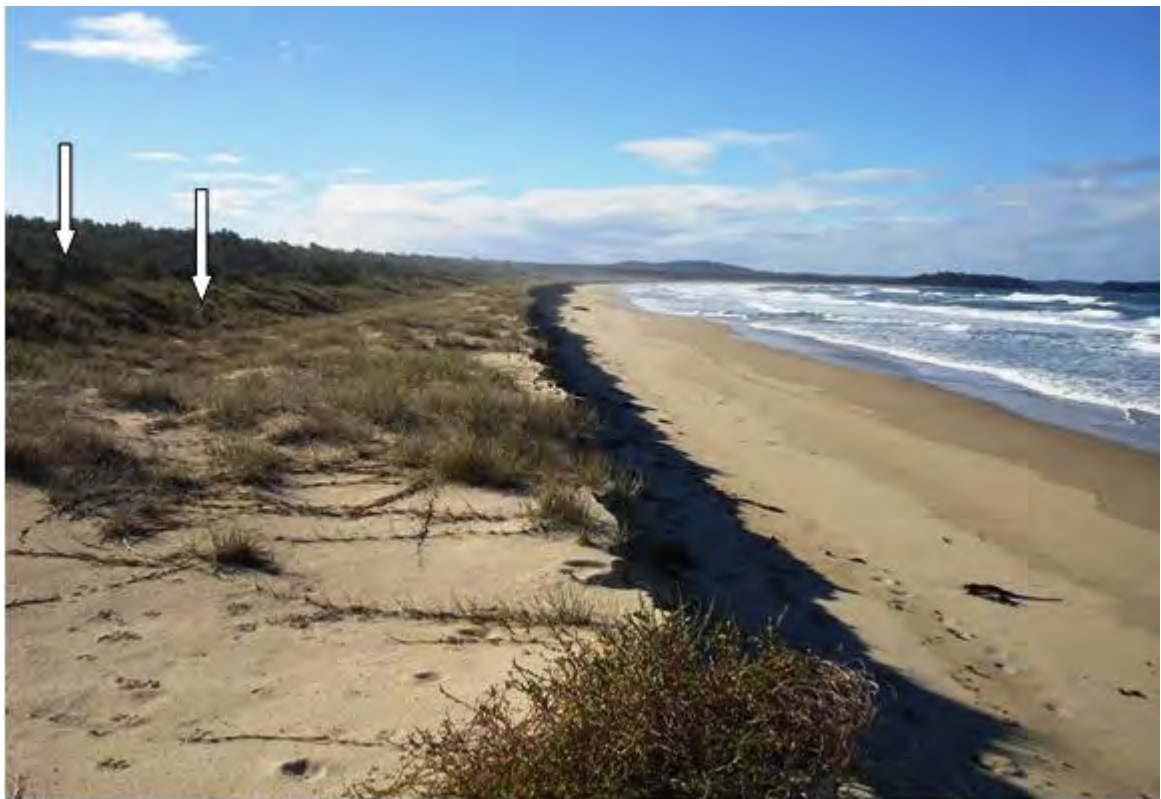
**Figure E-4: Bengello Beach (Profile 4 Looking North) 30 June 2007 after the "Pasha Bulker" Storm - left arrow indicates 1974-76 scarp, right indicates 1996-98 scarp (McLean et al., 2010)**

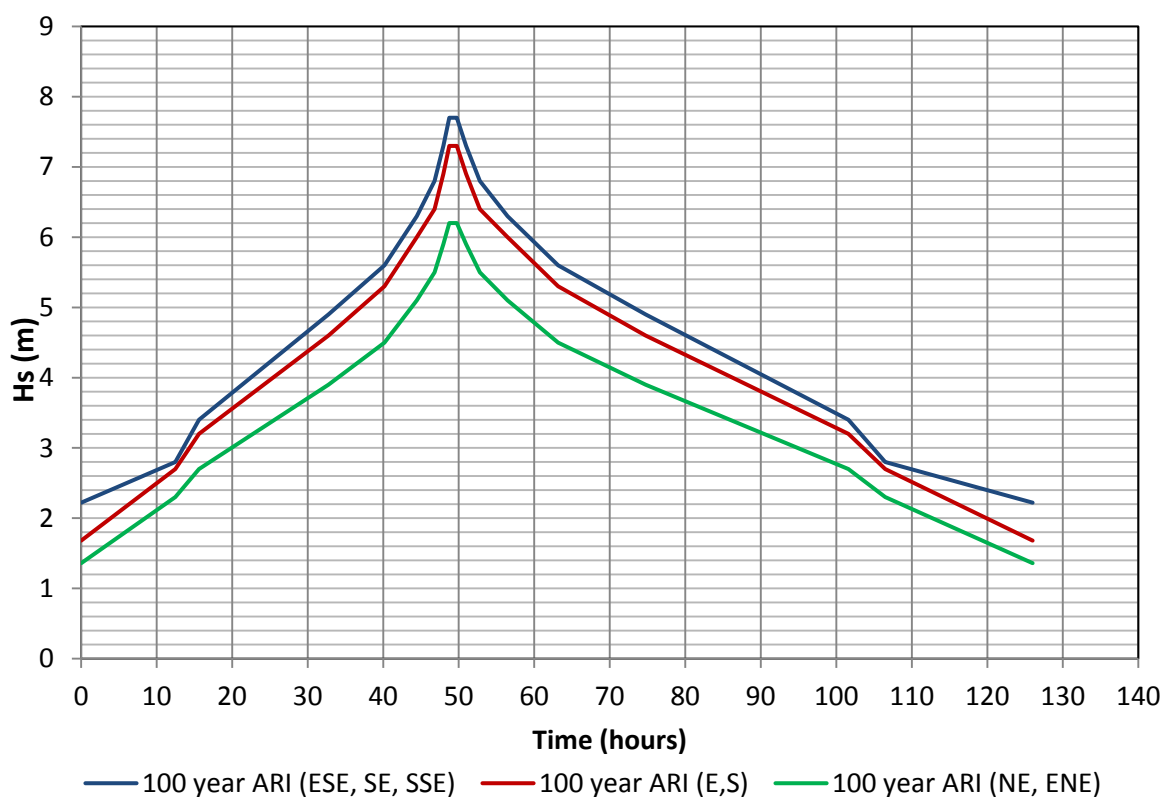
**Figure E-5: Offshore design wave conditions for Batemans Bay**

Shand et al. (2011) developed deepwater synthetic design storms, including a timeseries of significant wave height and peak spectral period, for a number of locations on the NSW coast, including Eden, south of Batemans Bay. In this study, the wave period and duration of the Eden offshore design storm has been adopted, however wave statistics from the Batemans Bay wave buoy have been used (generally 5% - 15% smaller than the wave climate at Eden). Note that the 100 year ARI offshore wave statistics vary with incident wave direction resulting in the development of three (3) offshore design storms for the 100 year ARI storm event (Figure E-5). The storm with the highest wave heights was applied for east-south-east, south-east and south-south-east directions. The storm with the lowest wave heights was utilised from the north-east and east-north-east directions. An intermediate storm was used for waves with incident directions of east and south.

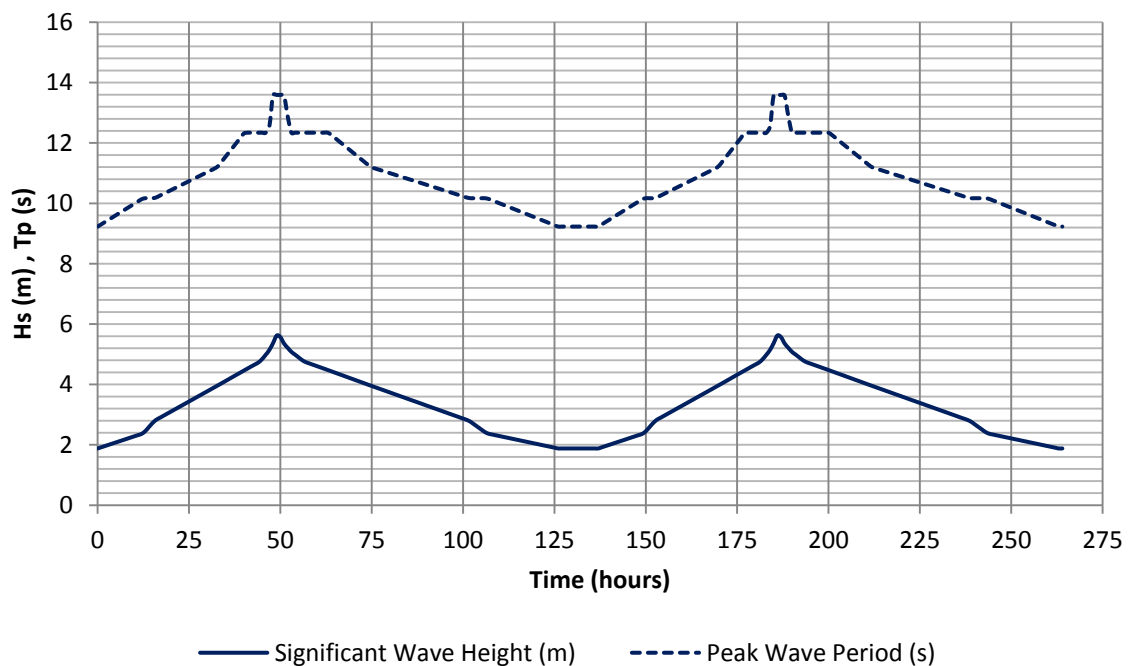
**Figure E-6: Example of nearshore synthetic design storm used at Bengello Profile 3**

The local wave heights resulting from the seven (7) offshore design storm directions were extracted from the SWAN model at each transect where waves were beginning to break (1% of waves were broken). Using the output of the SWAN model, a single nearshore synthetic design storm was developed for the most critical (design) wave direction for each transect, using the same duration as the offshore synthetic storm. An example of the nearshore transformation of the waves at Bengello Profile 3 is shown in Figure E-6. The nearshore synthetic design storm extracted from the SWAN wave model at each transect became the input to the SBEACH erosion model.

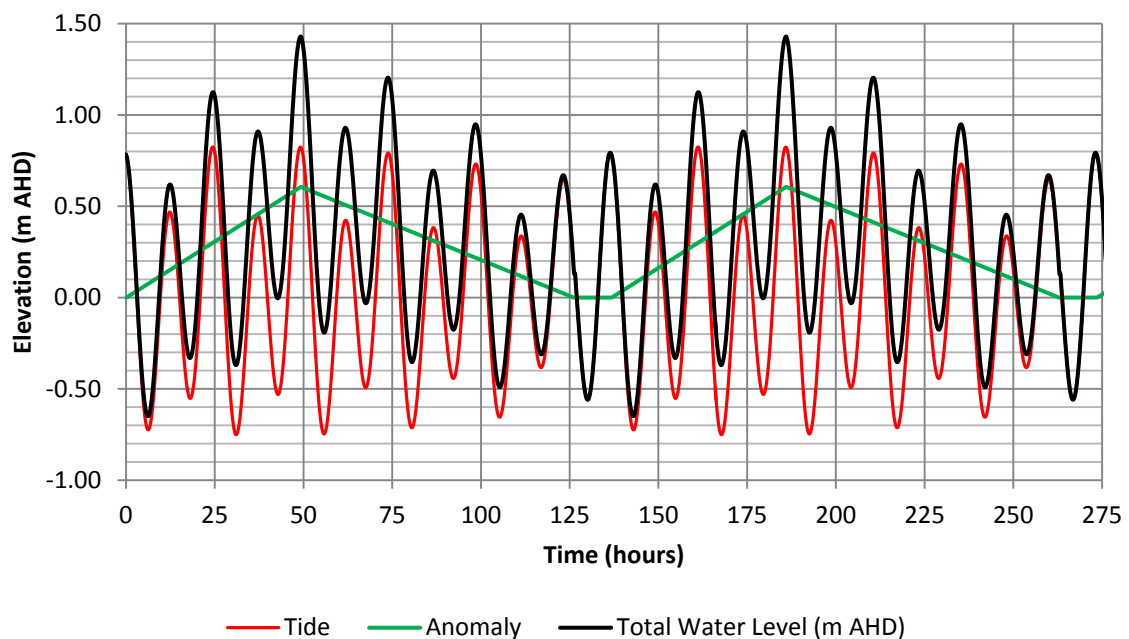
**Figure E-7: Water levels used for SBEACH modelling at locations outside of Batemans Bay**

For storm erosion modelling purposes, a spring tide timeseries was generated (based on tidal constituents for Princess Jetty) using harmonic analysis with a peak water level of 0.82 m AHD (between 14/06/2011 – 20/06/2011). Extreme values analysis has been undertaken at Batemans Bay and defined the 1% AEP (100 year ARI) water level offshore to be 1.43 m AHD. This level includes both tide and storm surge, implying a maximum storm surge of 0.51 m must be applied at the peak of the storm to meet the required water level. It would be overly conservative to apply the maximum storm surge over the entire modelling period, so to better model the storm, the surge is allowed to increase linearly from nil to the maximum level and back to nil over the course of the storm. The resulting water levels for locations outside of Batemans Bay are shown in Figure E-7.

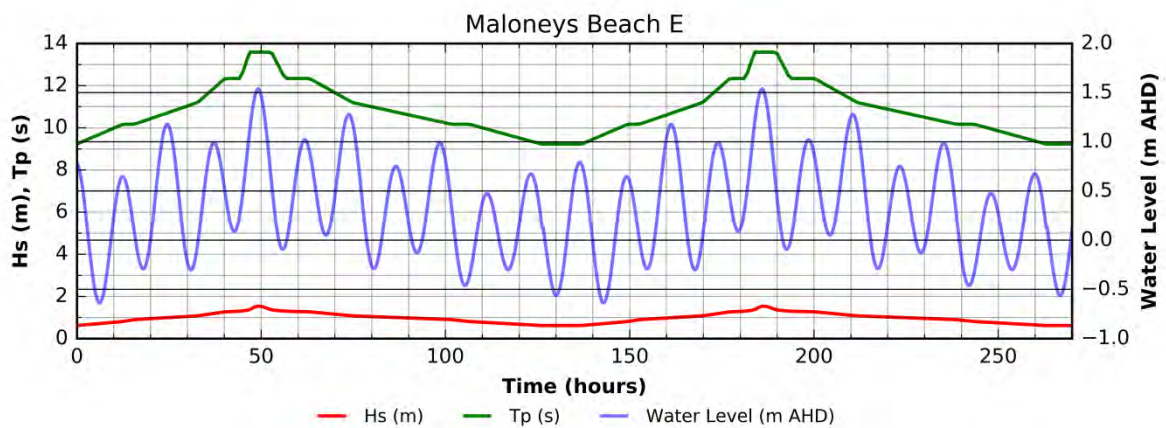
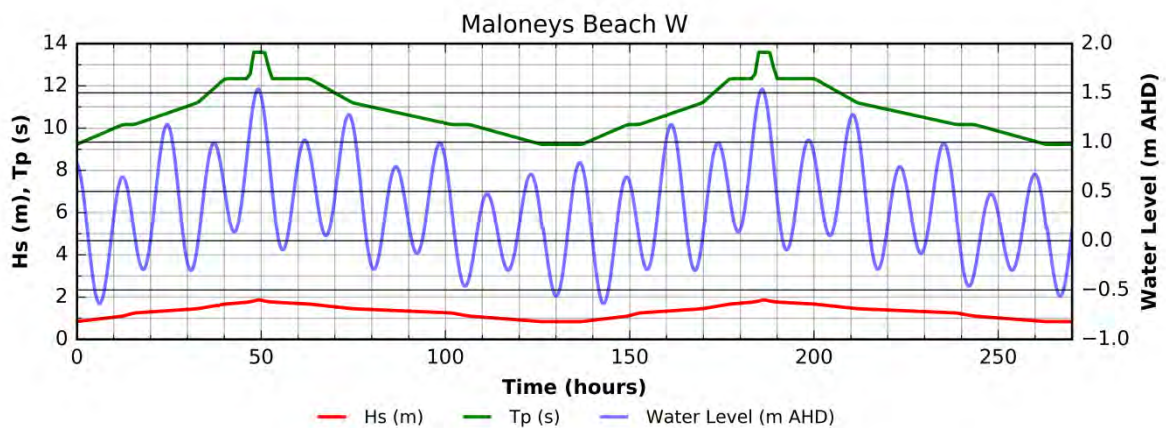
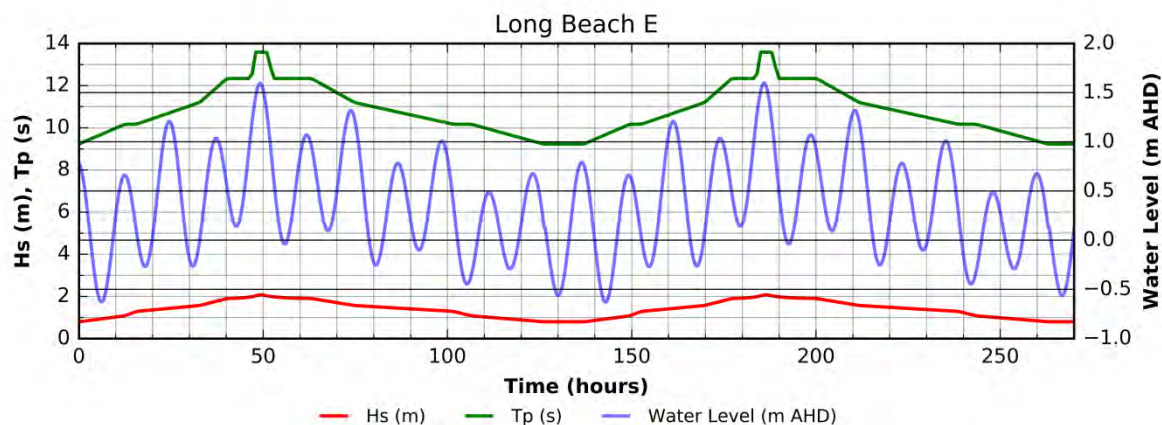
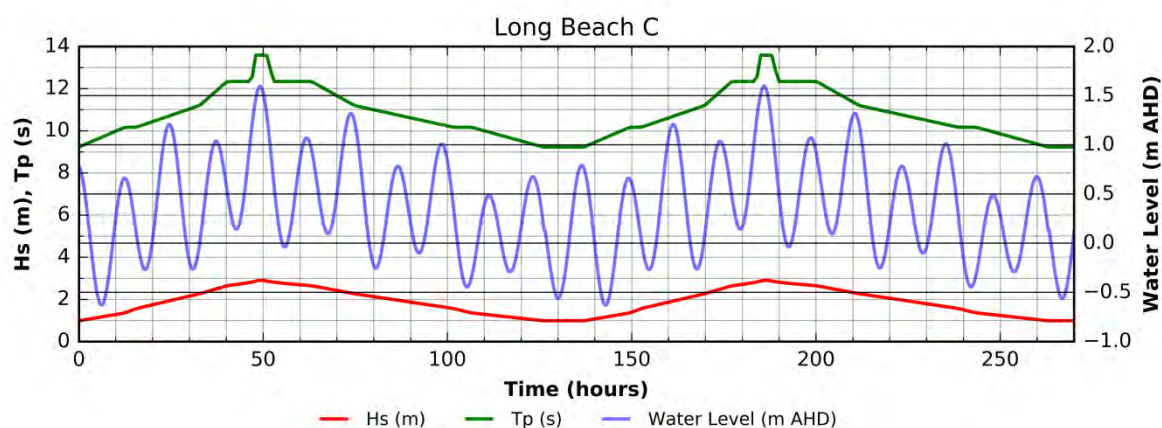
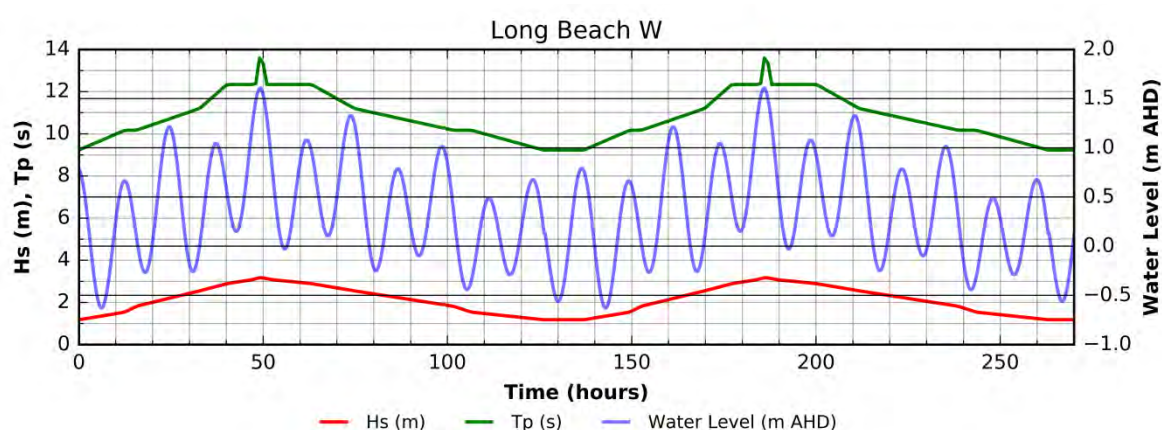
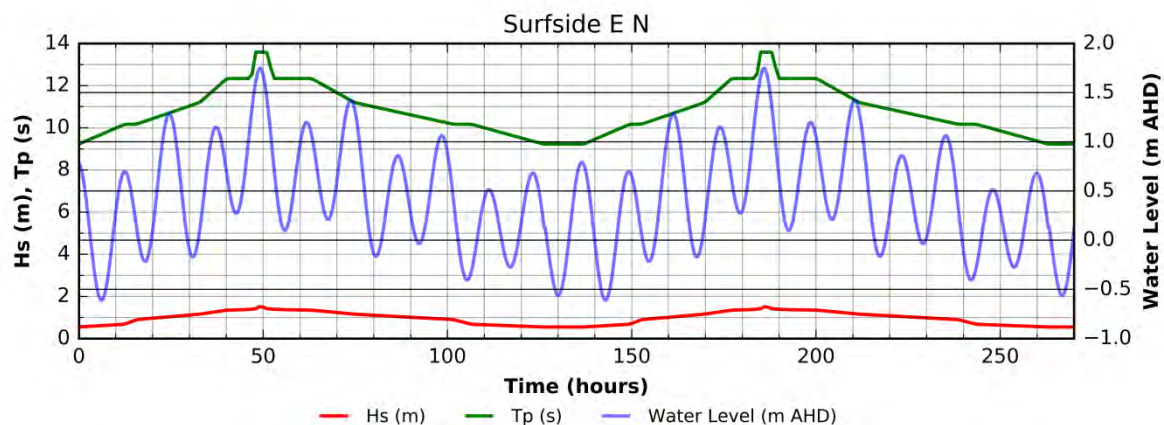
**Figure E-8: Wave Height, Water Level and Peak Period for Maloneys Beach East**

**Figure E-9: Wave Height, Water Level and Peak Period for Maloneys Beach West**

**Figure E-10: Wave Height, Water Level and Peak Period for Long Beach East**

**Figure E-11: Wave Height, Water Level and Peak Period for Long Beach Central**

**Figure E-12: Wave Height, Water Level and Peak Period for Long Beach West**

**Figure E-13: Wave Height, Water Level and Peak Period for Surfside Beach East North**

Figure E-8 to Figure E-22 show the local wave height, wave period and water level used for SBEACH modelling at each location.

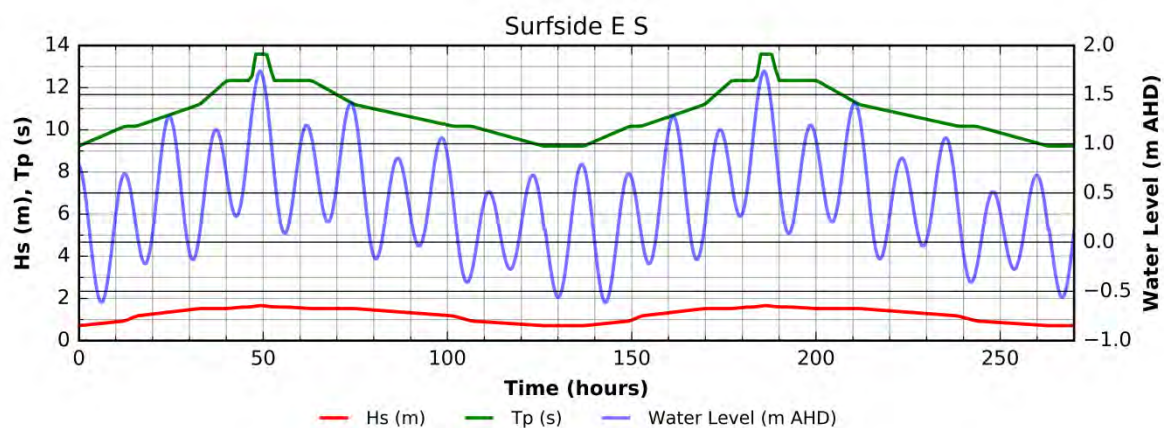
**Figure E-14: Wave Height, Water Level and Peak Period for Surfside Beach East South**
