## Eurobodalla Coastal Hazard Assessment

WRL Technical Report 2017/09  
October 2017

By I R Coghlan, J T Carley, A J Harrison, D Howe, A D Short,  
J E Ruprecht, F Flocard and P F Rahman

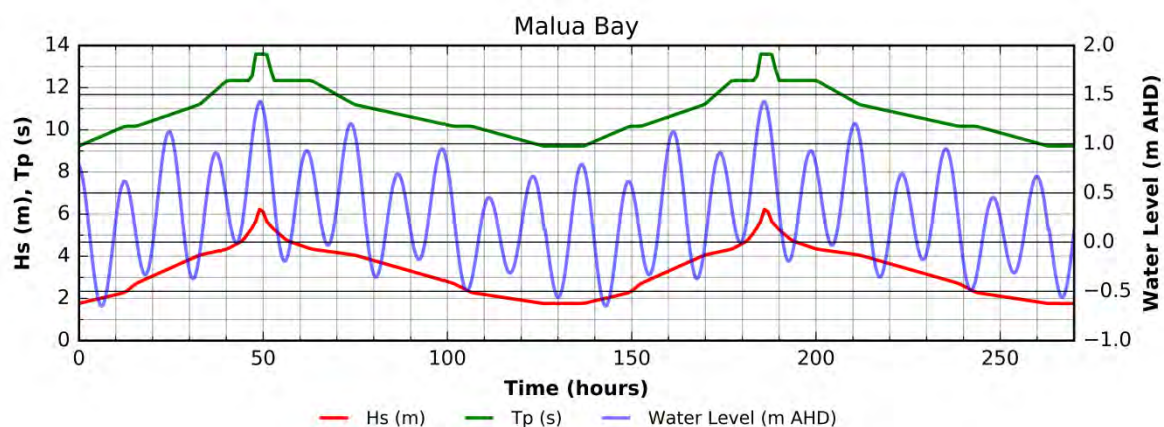
**Figure E-15: Wave Height, Water Level and Peak Period for Malua Bay**

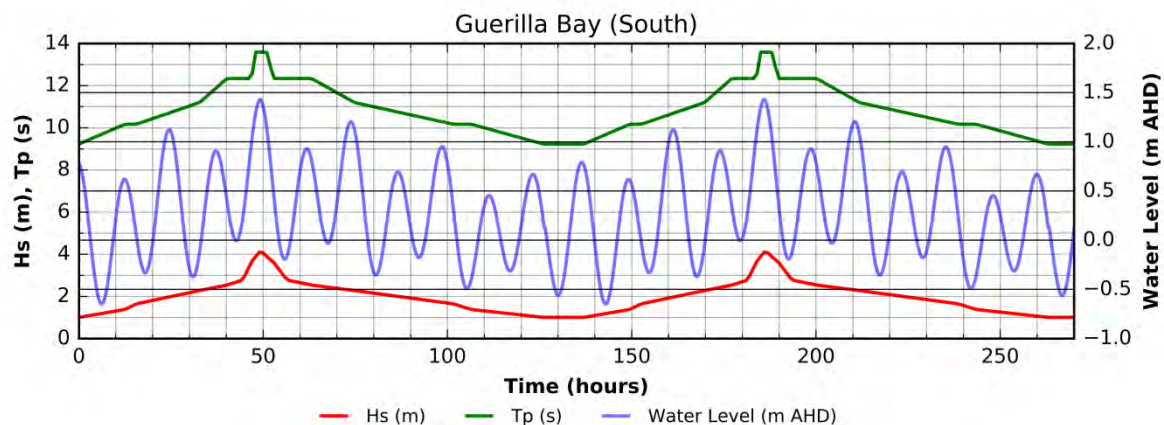
**Figure E-16: Wave Height, Water Level and Peak Period for Guerilla Bay (South)**

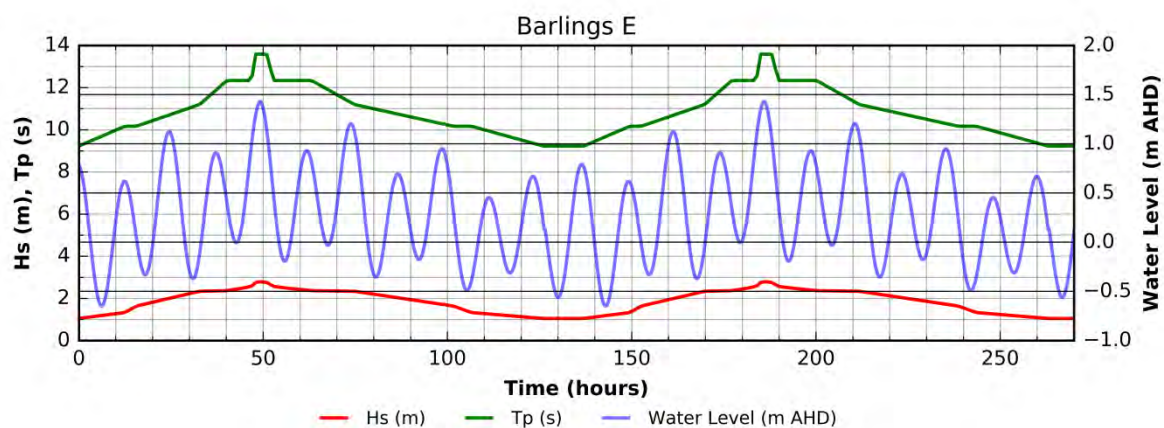
**Figure E-17: Wave Height, Water Level and Peak Period for Barlings Beach East**

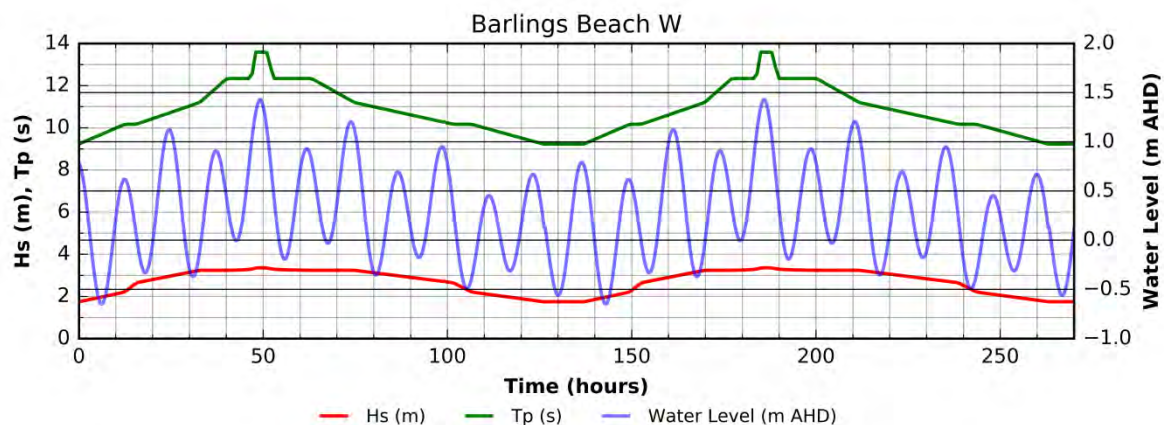
**Figure E-18: Wave Height, Water Level and Peak Period for Barlings Beach West**

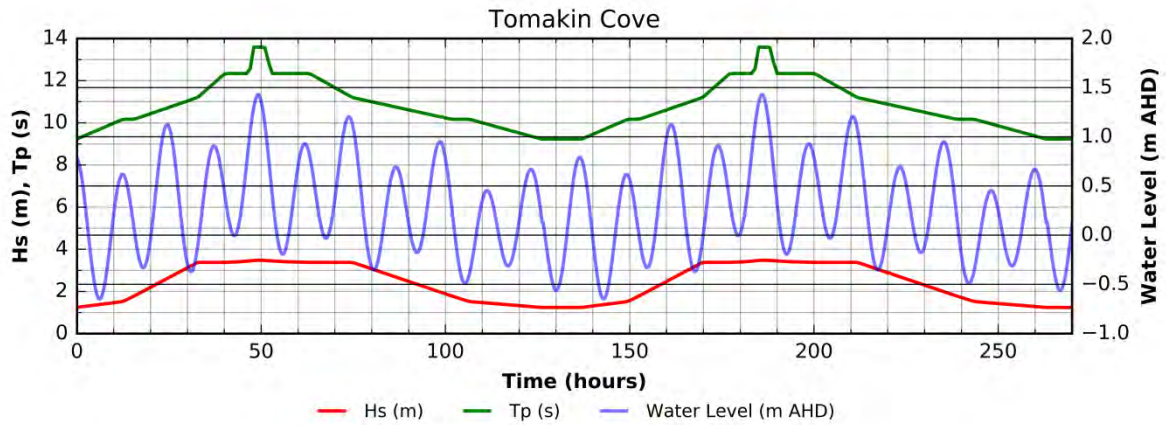
**Figure E-19: Wave Height, Water Level and Peak Period for Tomakin Cove**

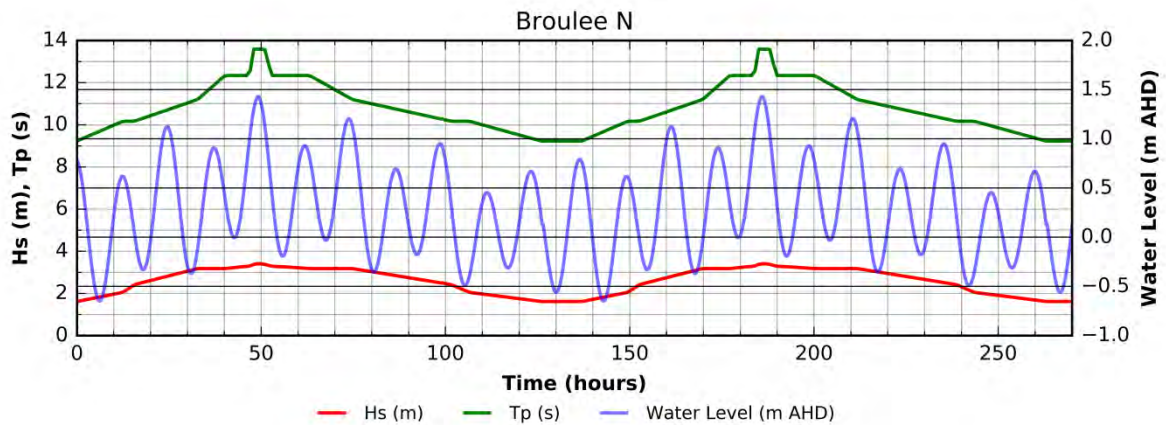
**Figure E-20: Wave Height, Water Level and Peak Period for Broulee Beach North**

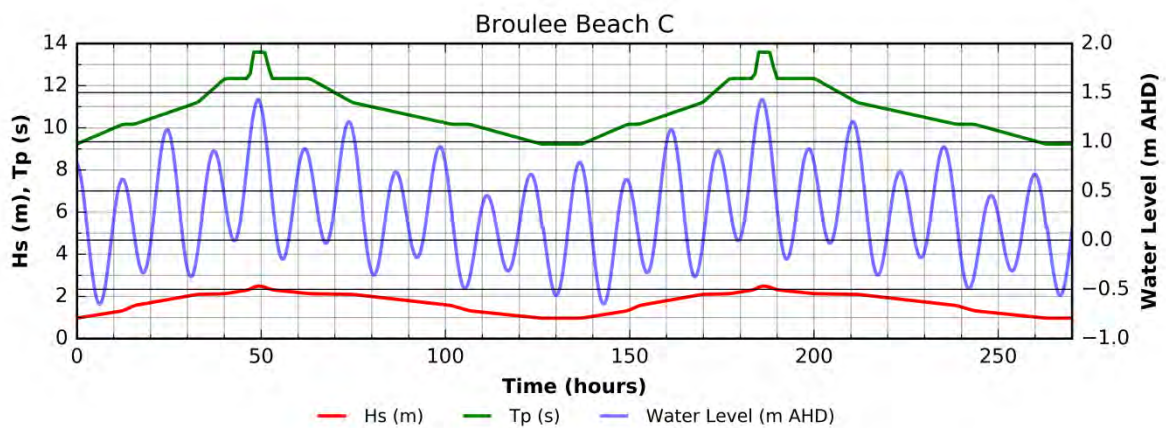
**Figure E-21: Wave Height, Water Level and Peak Period for Broulee Beach Central**

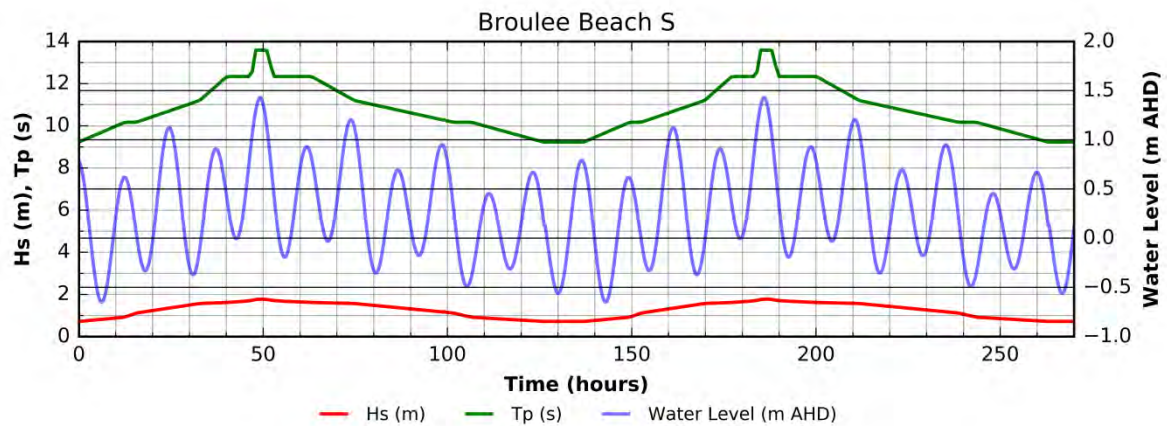
**Figure E-22: Wave Height, Water Level and Peak Period for Broulee Beach South**

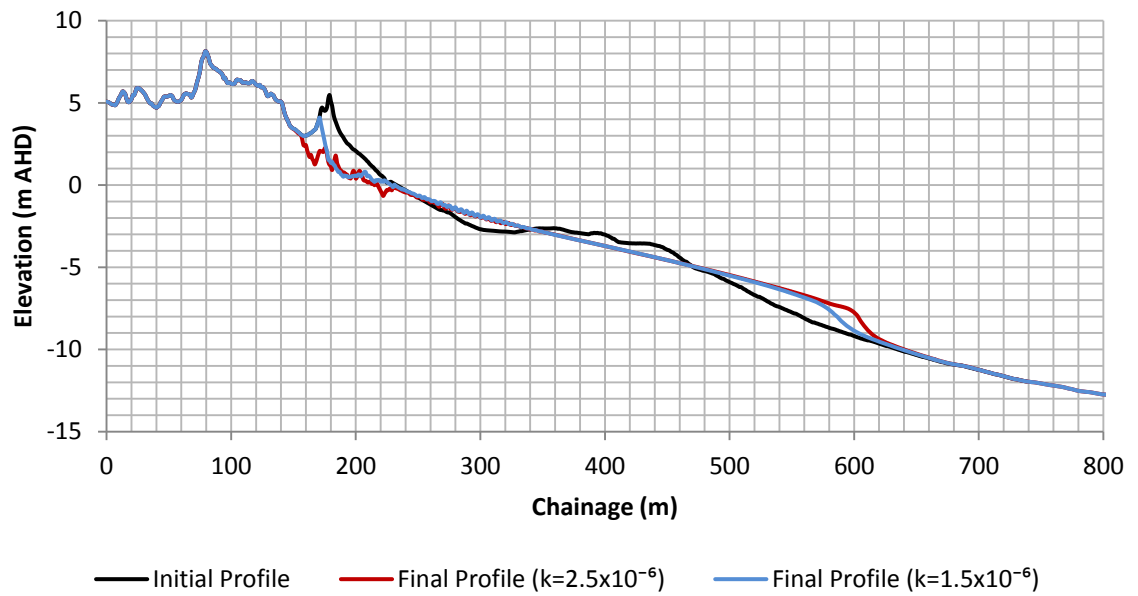
**Figure E-23: SBEACH results at Bengello Beach Profile 1**

The SBEACH model was calibrated under two separate conditions – aiming to achieve the maximum storm erosion observed at a single profile at Bengello Beach in 1974 (170 m<sup>3</sup>/m above 0 m AHD) and, over the four (4) modelled profiles, to achieve the average erosion observed across the whole beach over the same period (95 m<sup>3</sup>/m above 0 m AHD). These two target values were established because it is not known whether the maximum volume at Profile 2

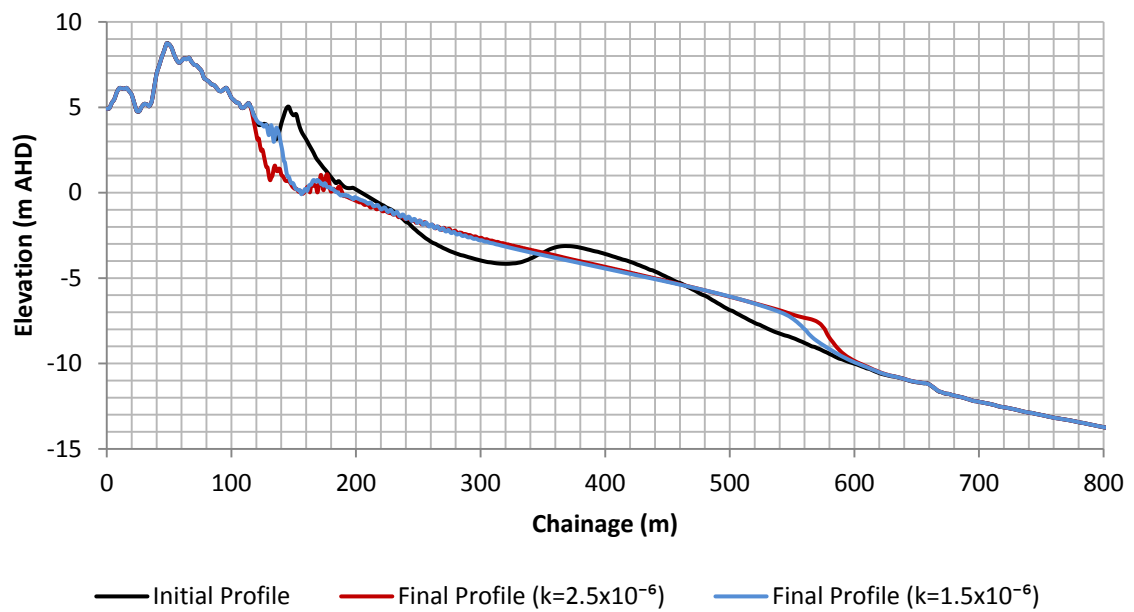
**Figure E-24: SBEACH results at Bengello Beach Profile 2**

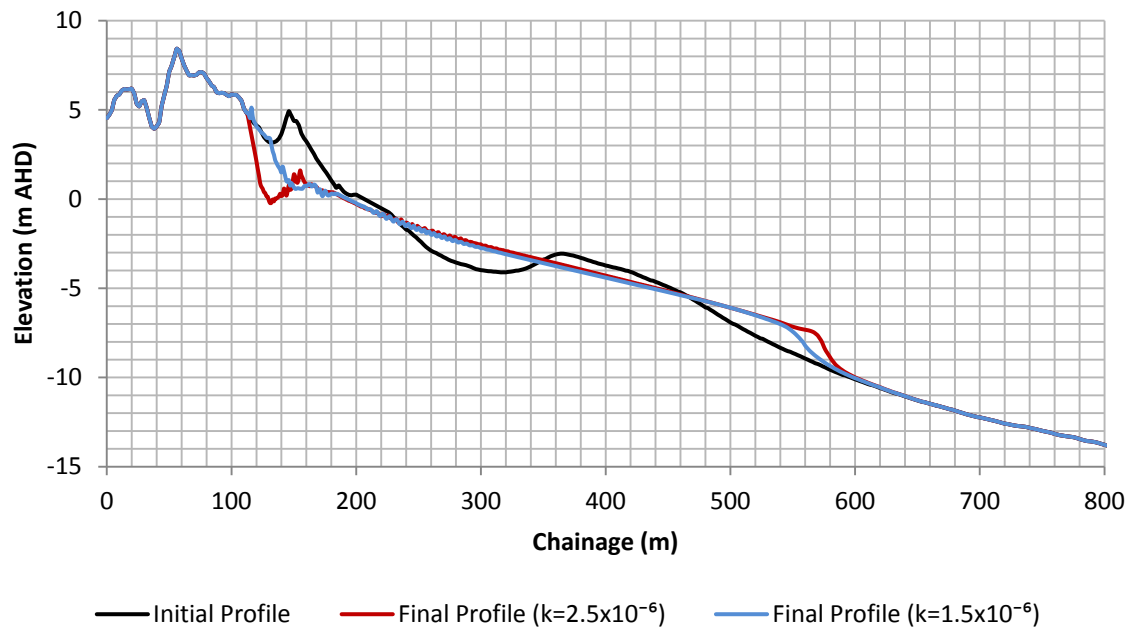
**Figure E-25: SBEACH results at Bengello Beach Profile 3**

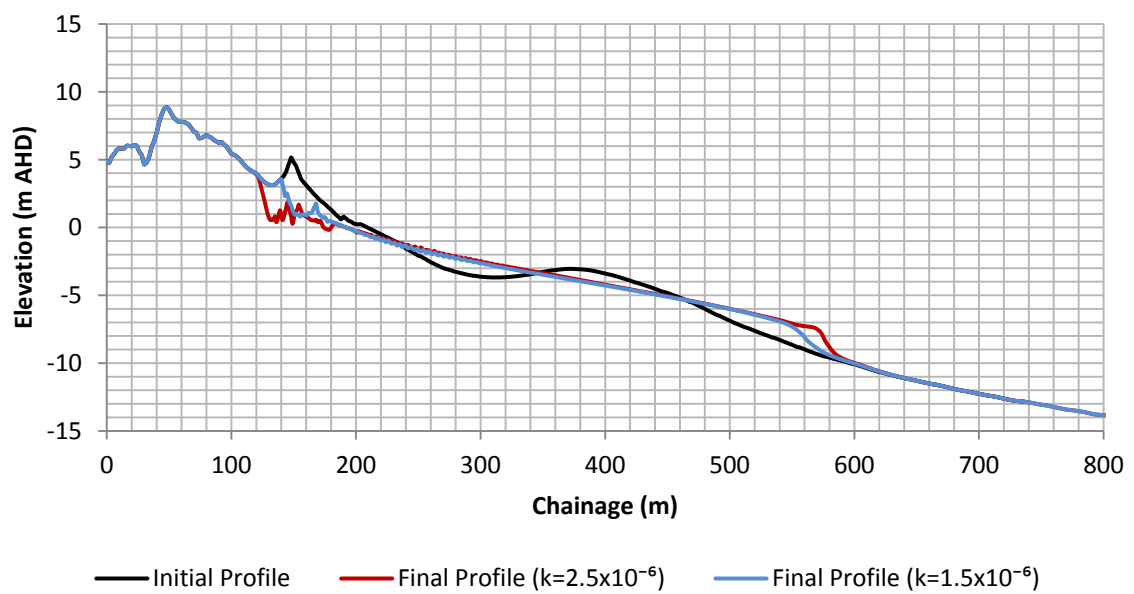
**Figure E-26: SBEACH results at Bengello Beach Profile 4**

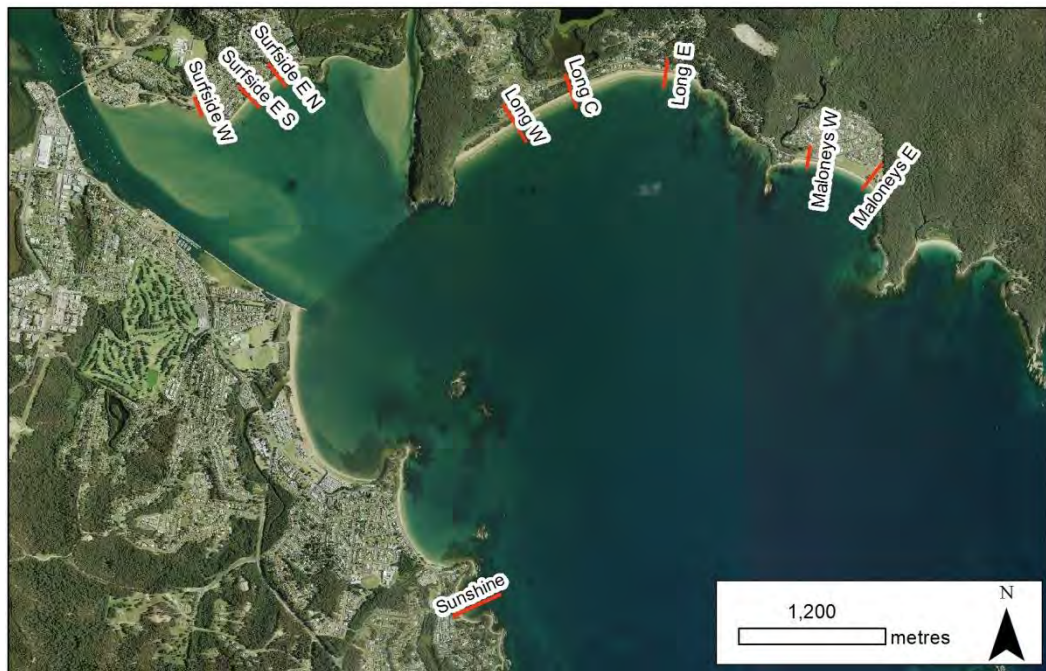
**Figure E-27: SBEACH erosion profile inner Batemans Bay**

SBEACH erosion modelling was undertaken at nine (9) beaches in the study area, as shown in Figure E-27 and Figure E-28. Where the beaches were long enough that the wave climate would vary significantly along the beach, multiple representative transects were used (15 total transects). WRL has previously collected and analysed sediment samples collected at each location to determine sediment size, and this is summarised in Table E-5. At Sunshine Bay, a distinct bimodal distribution of sediment size was observed and both grainsizes are provided. This type of sediment distribution is also observed at Caseys Beach (adjacent beach to the north) as discussed in NSW PWD (1987).

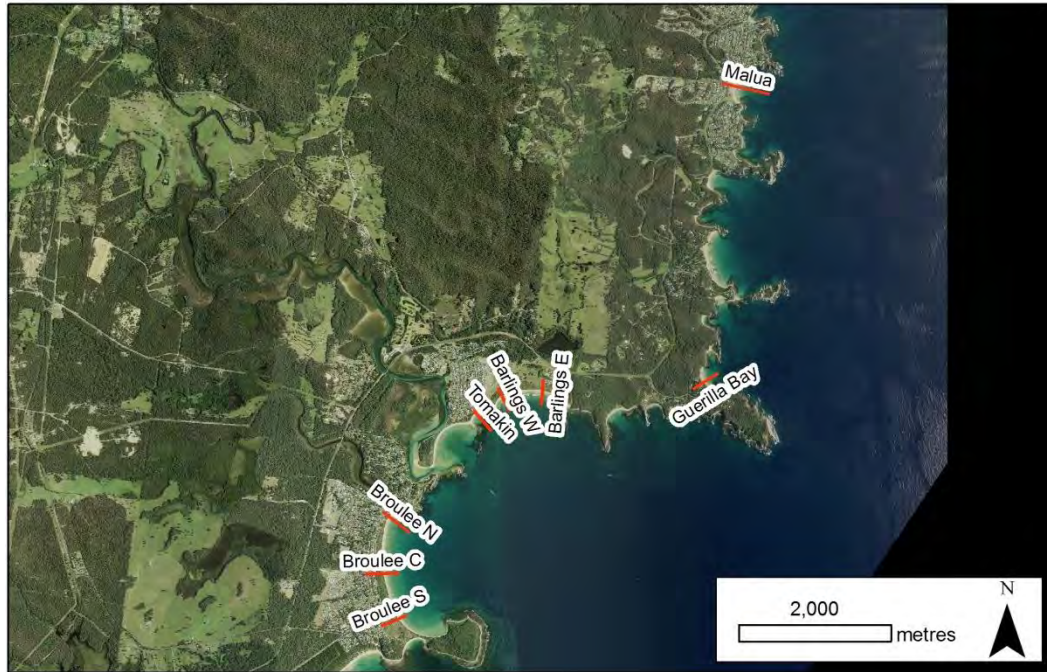
**Figure E-28: SBEACH erosion profiles southern area**

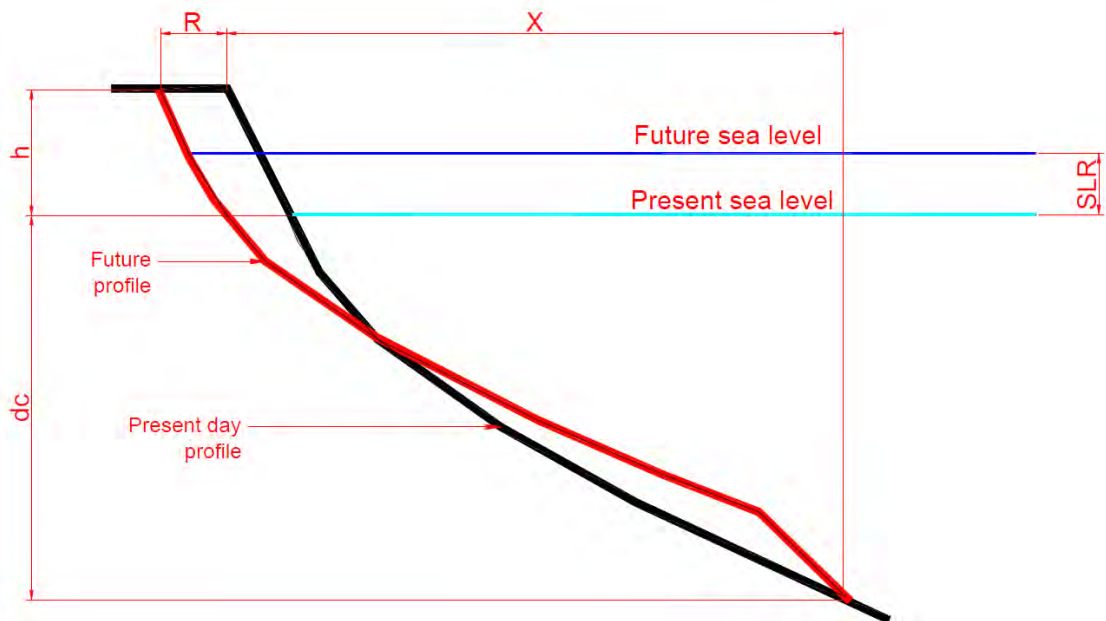
$$R = \frac{rX}{h+d_c} \quad (\text{F.1})$$

where R is horizontal recession (m)  
r is sea level rise (m)  
X is the horizontal distance between h and  $d_c$   
h is active dune/berm height (m)  
 $d_c$  is profile closure depth (m, expressed as a positive number)

**Figure F-1: Illustration of Bruun Rule**

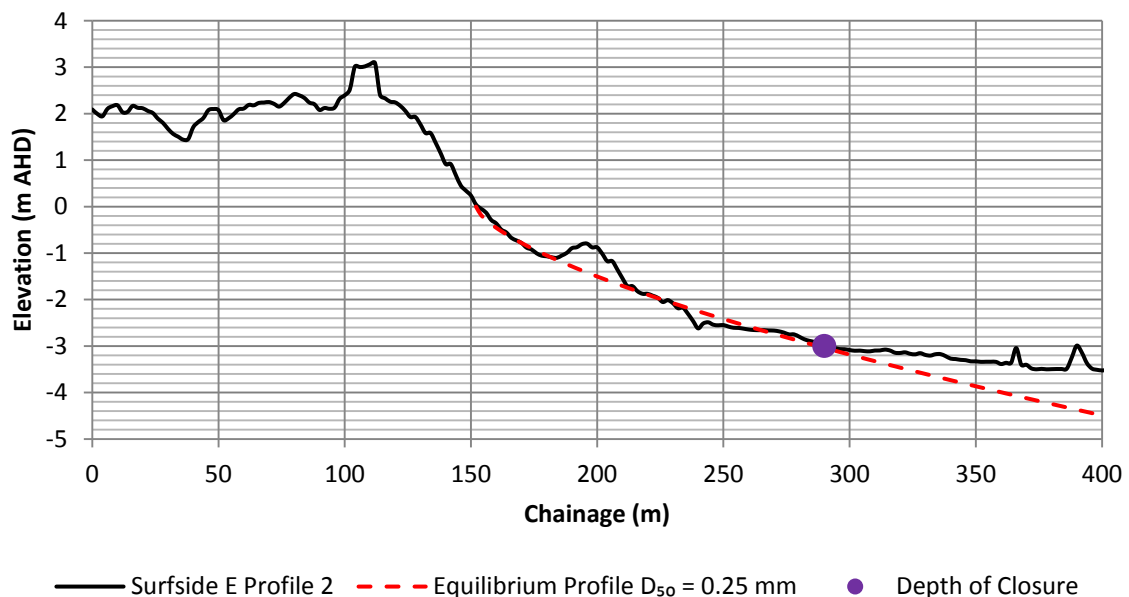
Since the sediment scale parameter,  $A$ , is dependent on the median grainsize, this equilibrium profile can be rapidly generated for each site. At the inner sections of Batemans Bay, the bathymetry is relatively flat and shallow and sediment movement is driven not only by wave forces, but through water movement from the Clyde River and Cullendulla Creek. Therefore, the outer depth of closure method of Hallermeier (1983) may not be appropriate at these locations. For this study, an alternate calculation of the depth of closure was to estimate the location where the observed profile begins to significantly deviate from the Dean equilibrium profile, as shown in Figure F-2. This methodology assumes that where the profile significantly deviates in shape and slope to the equilibrium profile, the sediment transport is no longer dominated by waves, and can therefore be considered the depth of closure for the purpose of using Bruun's rule. This approach to estimate depth of closure has previously been used within Batemans Bay (SMEC, 2010) and at other international locations (e.g. NASA, 2010). In the absence of repeat bathymetry surveys offshore of the Batemans Bay beaches, this alternative depth of closure estimate is considered instructive. However, it is acknowledged that the equilibrium concept assumes constant wave conditions and does not include the presence of bars. Furthermore, the point at which the observed profile deviates from the equilibrium profile may be influenced by the timing of the profile measurement with respect to erosion and accretion modes.

**Figure F-2: An example of estimating the depth of closure using the equilibrium profile at Surfside Beach (East) profile 2**

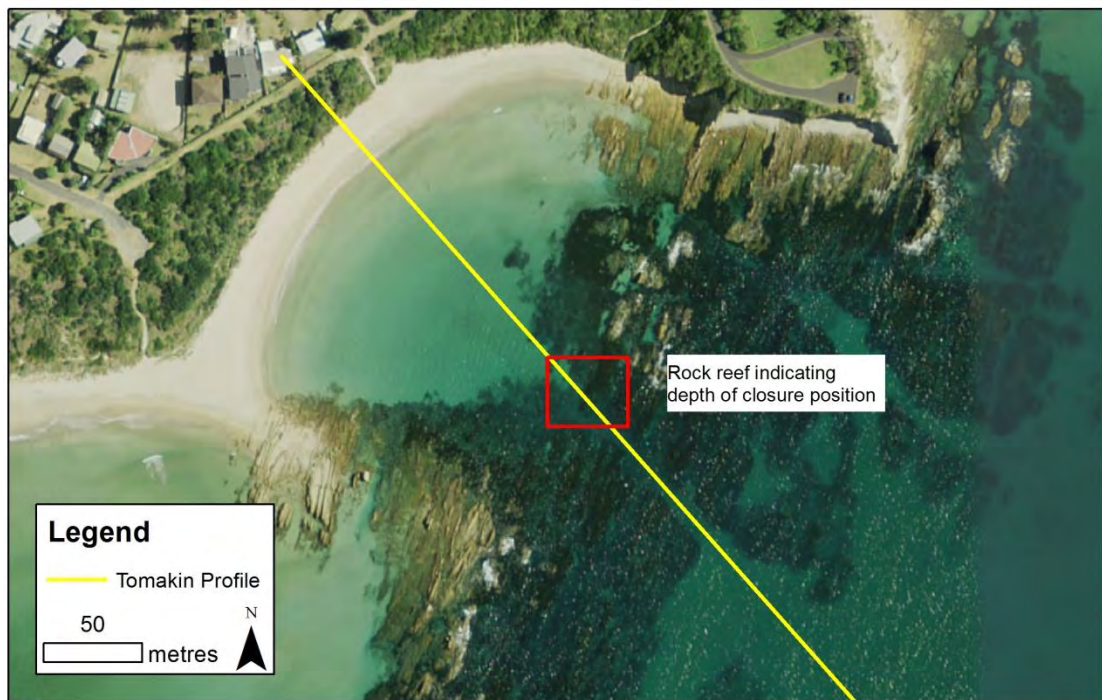
At a number of the beaches in this study, there are specific geological features and bathymetry that can be used to estimate the depth of closure. At these locations, there is an offshore reef which can be identified using aerial images, such as at Tomakin Cove in Figure F-3.

**Figure F-3: Using the rock reef to identify the position of the depth of closure at Tomakin Cove**

After identifying the location of the reef feature that indicates the position of the depth of closure, local bathymetric surveys were used to estimate the depth at this point. This methodology was used at all beaches which have an obvious reef feature and included Sunshine Bay, Malua Bay, Guerilla Bay and Tomakin Cove.

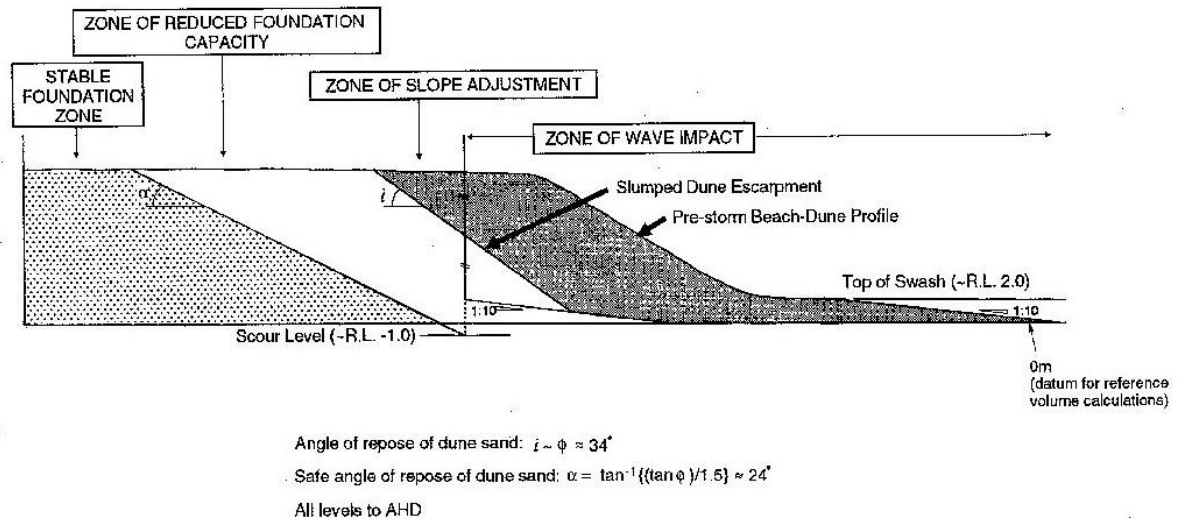
First pass, or “rule of thumb” erosion distance assessments are calculated by dividing the storm demand by the beach dune height. Nielsen et al. (1992) describes a more robust method, where a storm demand volume is converted to a horizontal distance by defining a zone of slope adjustment and a zone of reduced foundation capacity (Figure G-1).

**Figure G-1: Zone of slope adjustment (Nielsen et al, 1992)**

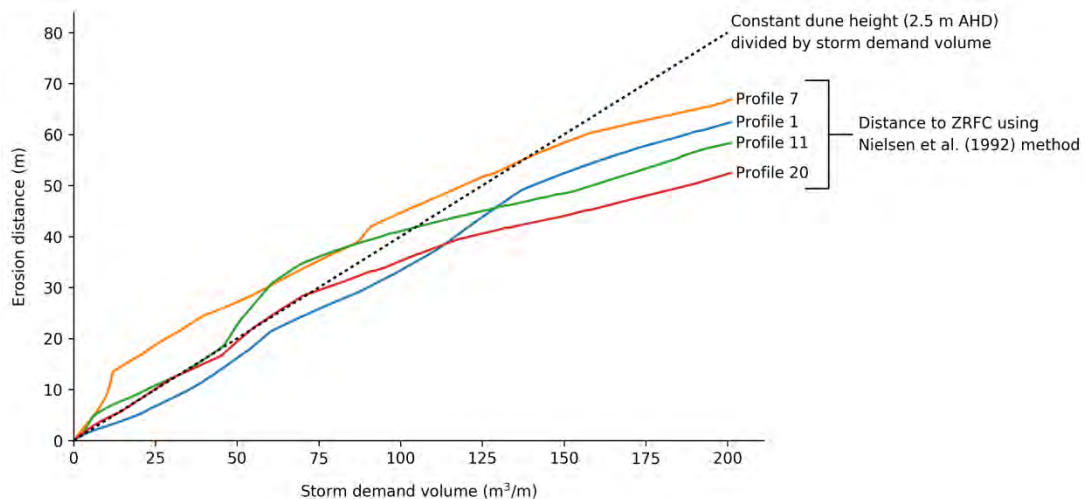
Typically, a constant dune height is adopted for each beach when using this method, but this approach is not ideal because beach profiles are often irregular, and vary alongshore. Measured cross sections of each beach’s dune system were used for this investigation (instead of a constant dune height), to accurately determine the relationship between storm demand volumes and erosion distances (Figure G-2). All calculations were undertaken volumetrically rather than using the simplified empirical equations in Nielsen et al., (1992) to define the ZWI, ZSA and ZRFC. That is, it was not necessary to define an average ground level to solve for each of these zones.

The only inputs were storm demand, swash elevation, scour level and the angle of repose.

**Figure G-2: Erosion distances for a range of storm demand volumes at Broulee Beach (block N)**

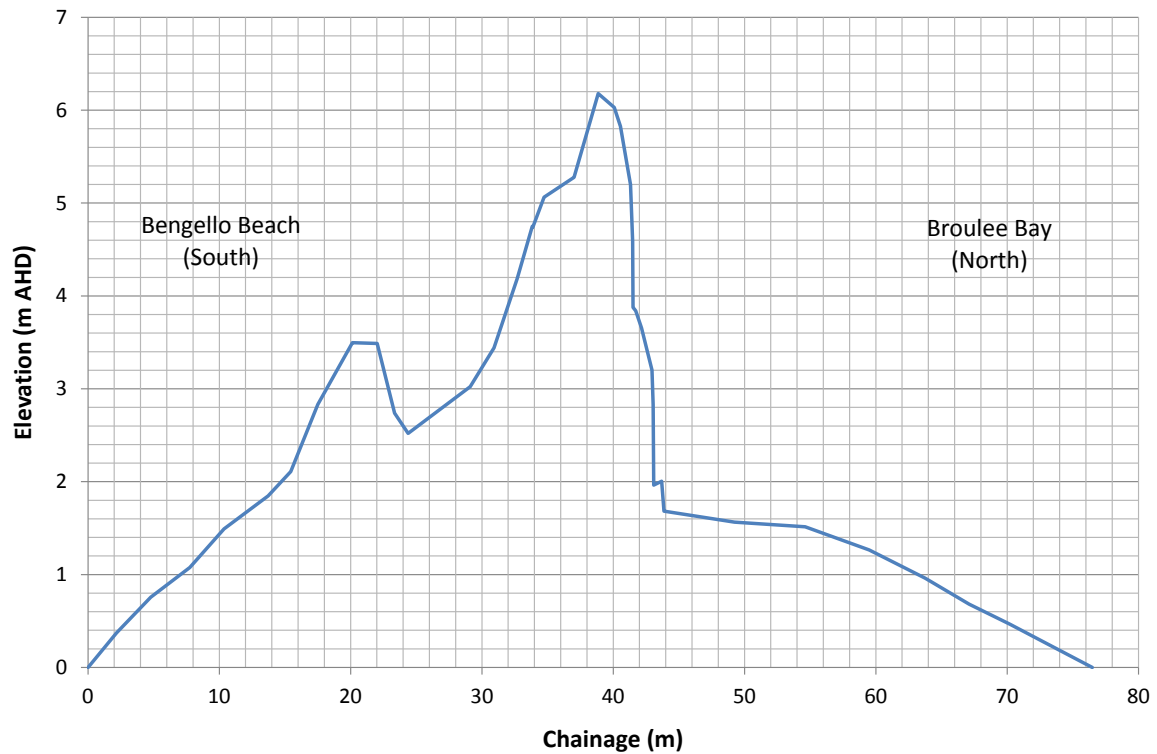
On 24 February 2017, WRL undertook a cross-sectional survey at the approximate narrowest point of the tombolo. Ground surface elevations were measured using a Trimble R10 RTK-GPS and offset using the NSW CorsNET network. The transect had a volume of 159 m<sup>3</sup>/m above 0 m AHD and is shown in Figure H-1.

**Figure H-1: WRL Survey of Broulee Island Tombolo (Facing West)- 28/02/2017**

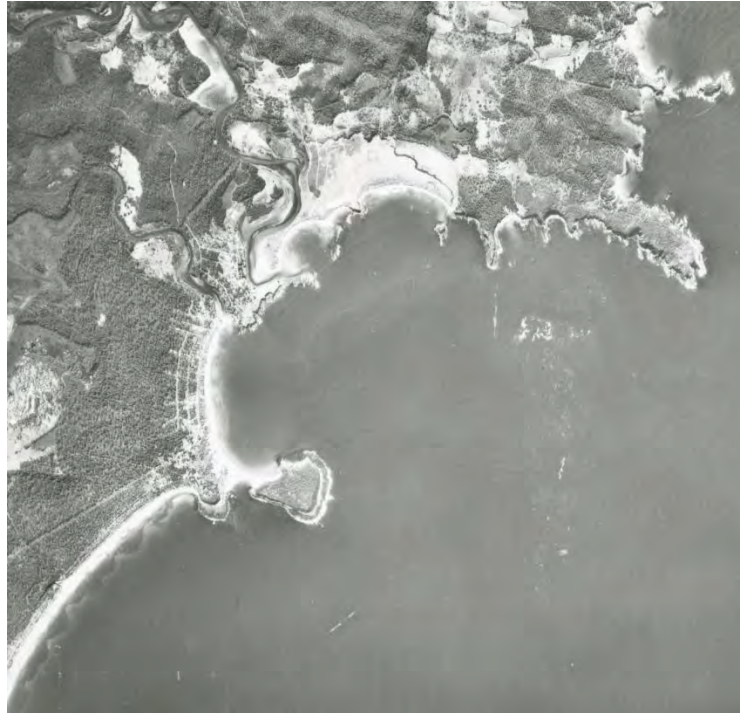
**Figure H-2:OEH Photogrammetry - Broulee Island 1/8/1961**

Date	Salient/Tombolo Condition	Vegetation Status	Reference
1/08/1961	Connected	No vegetation	OEH Aerial Photograph
??/03/1963	Connected	No vegetation	Oblique Photograph
??/02/1964	Connected	No vegetation	OEH Aerial Photograph
3/02/1965	Connected	?	Ballard (1982)
15/05/1966	Disconnected	N/A	Ballard (1982)
??/??/1967	Disconnected	N/A	Moruya & District Historical Society Observation
7/01/1969	Disconnected	N/A	OEH Aerial Photograph
9/05/1971	<b>Connecting</b>	?	Ballard (1982)
4/06/1972	Connected	No vegetation	OEH Aerial Photograph
??/06/1974	Disconnected	N/A	Ballard (1982)
10/09/1975	Disconnected	N/A	OEH Aerial Photograph
11/03/1977	Disconnected	N/A	OEH Aerial Photograph
28/07/1977	Disconnected	N/A	Ballard (1982)
26/11/1977	Disconnected	N/A	OEH Aerial Photograph
28/11/1977	Disconnected	N/A	OEH Aerial Photograph
??/12/1979	Disconnected	N/A	WRL Site Inspection
21/12/1980	<b>Connecting</b>	No vegetation	OEH Aerial Photograph

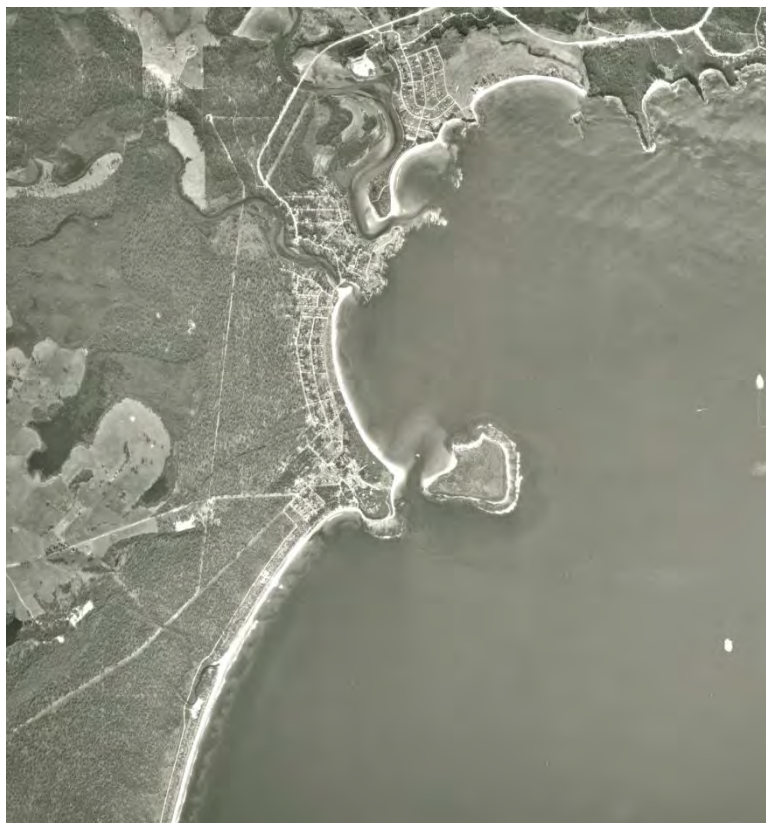
**Figure H-6: OEH Photogrammetry - Broulee Island 10/9/1975**

to confidently comment on the varying length of time that the island may be disconnected for, following a breach, but it is noted that, following the breach in May/June 1974, a tombolo did not reform until late 1980/ mid 1981; a six to seven (6-7) year duration. Note that WRL has made no attempt to estimate the varying volume of sand released into Broulee Bay when severing of the tombolo has occurred in the past.

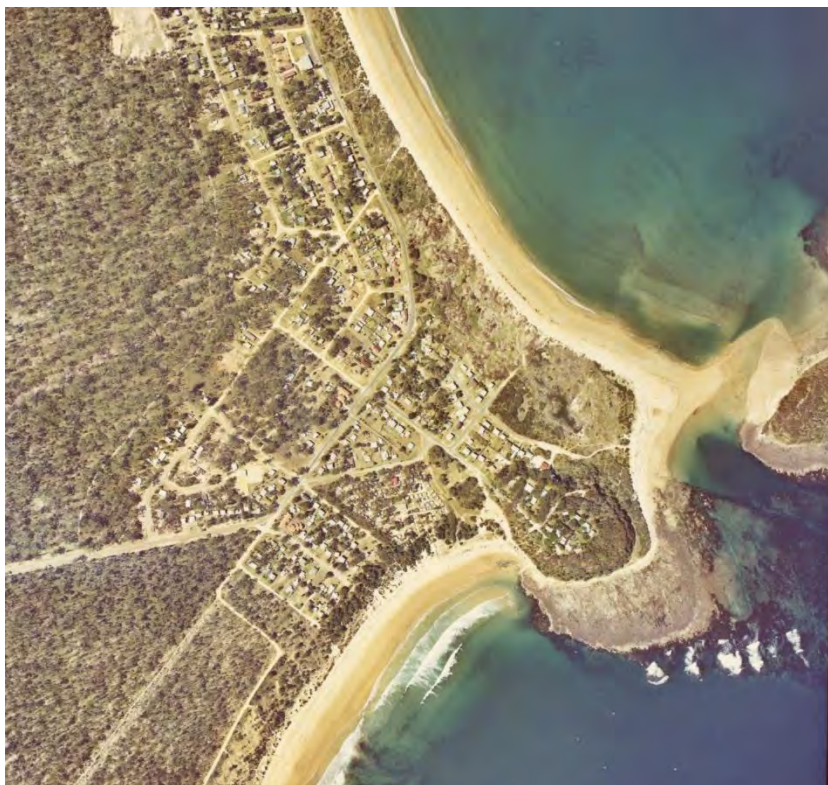
**Figure H-10: OEH Photogrammetry - Broulee Island 21/12/1980**

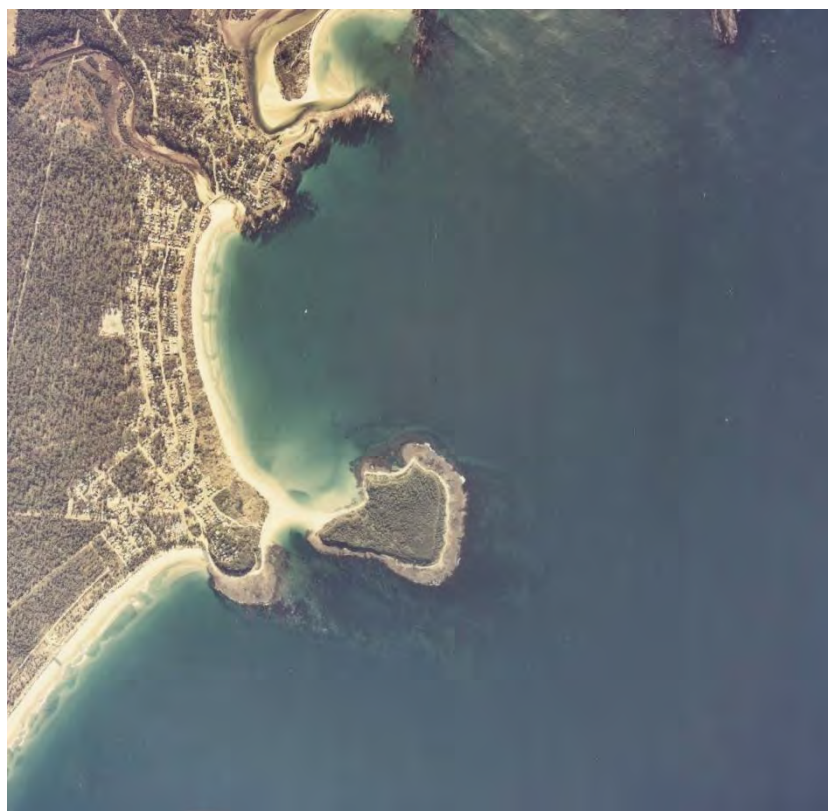
**Figure H-11: OEH Photogrammetry - Broulee Island 27/8/1981**

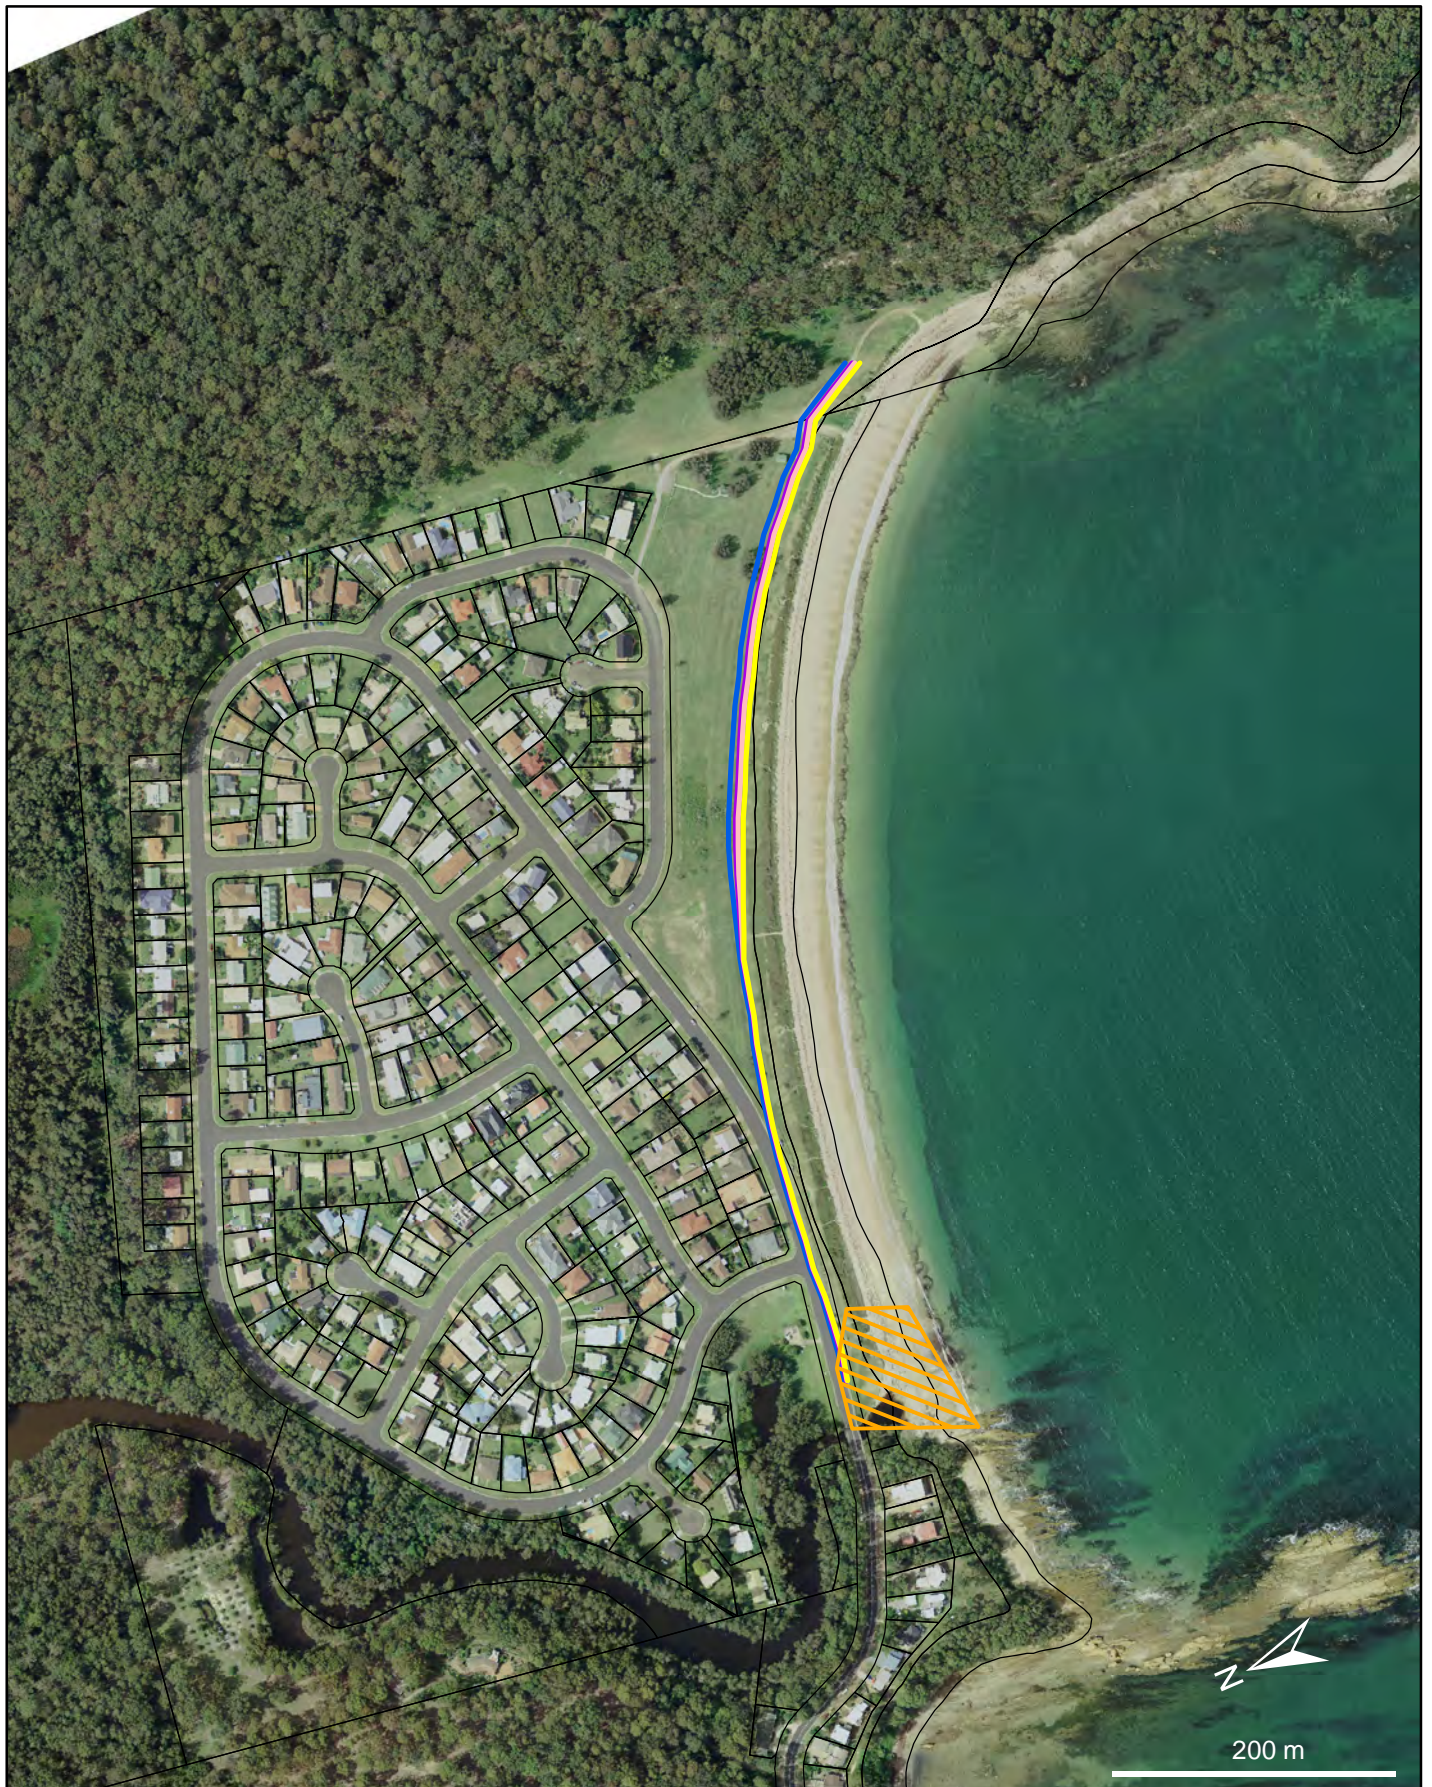
Note 1: Landward movement of the shoreline could be limited by the presence of bedrock.

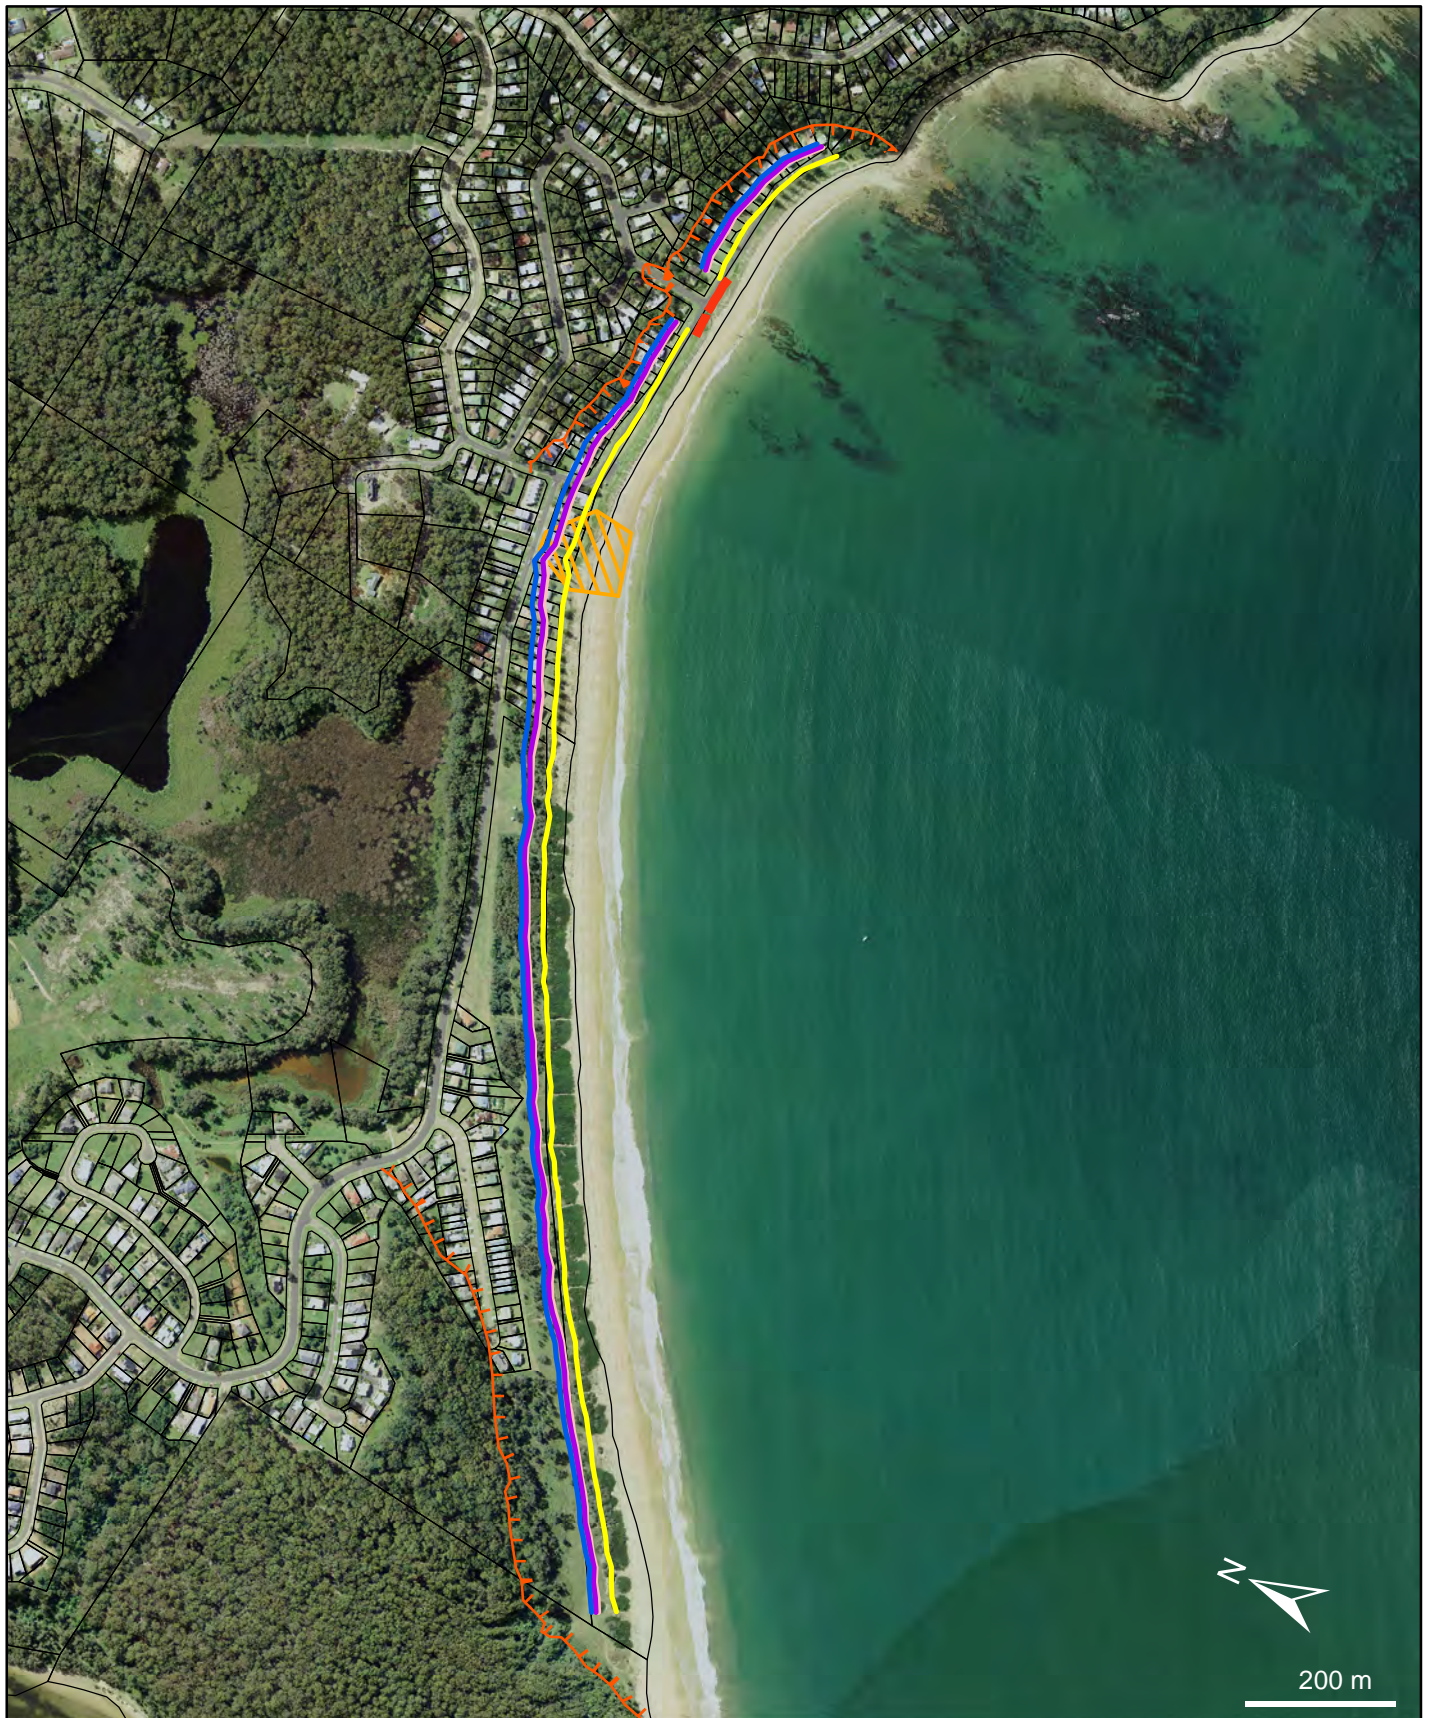
Figure I.1

Note 1: Landward movement of the shoreline could be limited by the presence of bedrock.
