## Eurobodalla Coastal Hazard Assessment

WRL Technical Report 2017/09  
October 2017

By I R Coghlan, J T Carley, A J Harrison, D Howe, A D Short,  
J E Ruprecht, F Flocard and P F Rahman

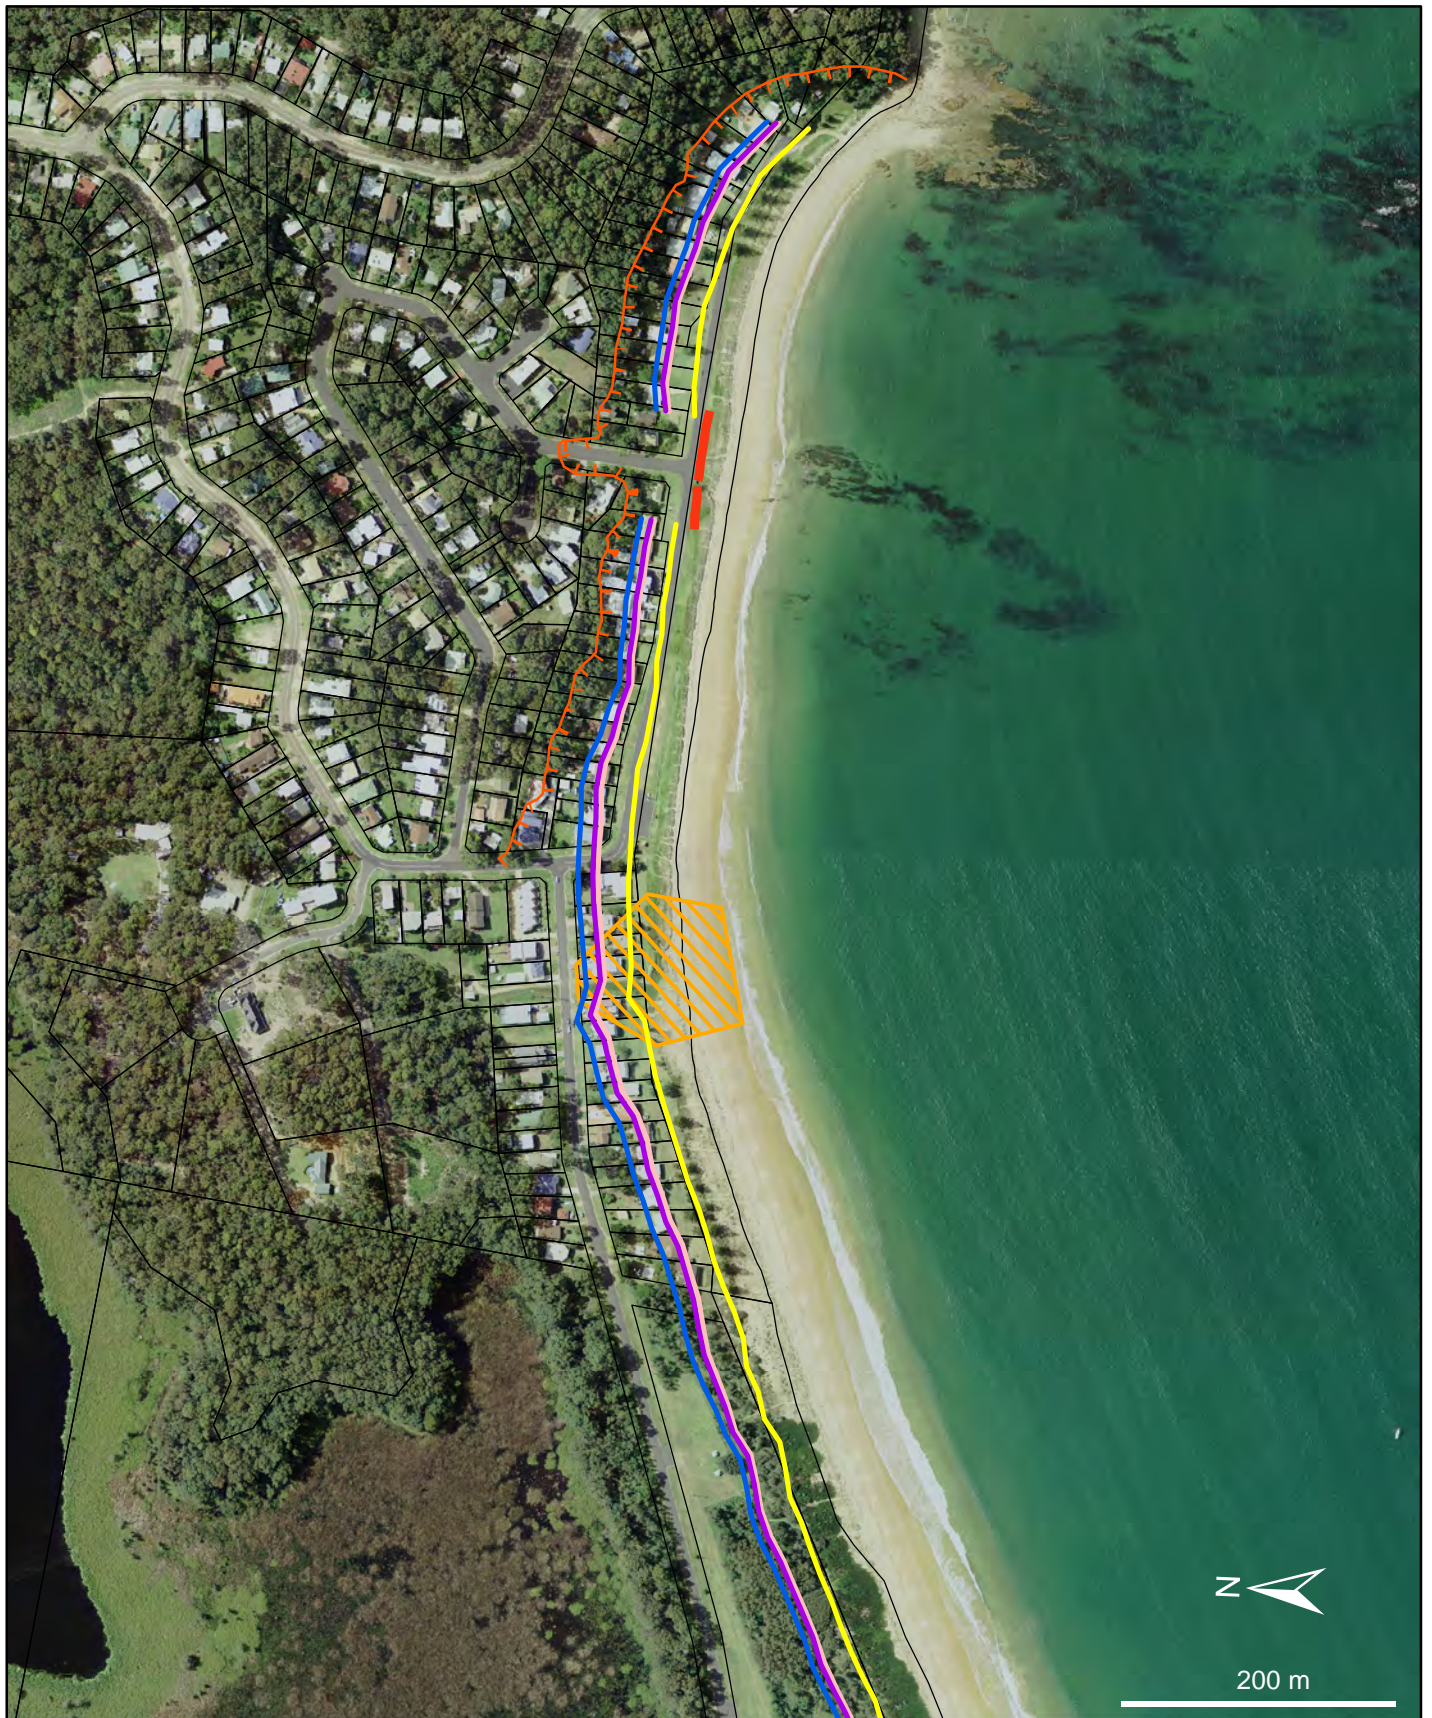
Figure I.2

Note 1: Landward movement of the shoreline could be limited by the presence of bedrock.

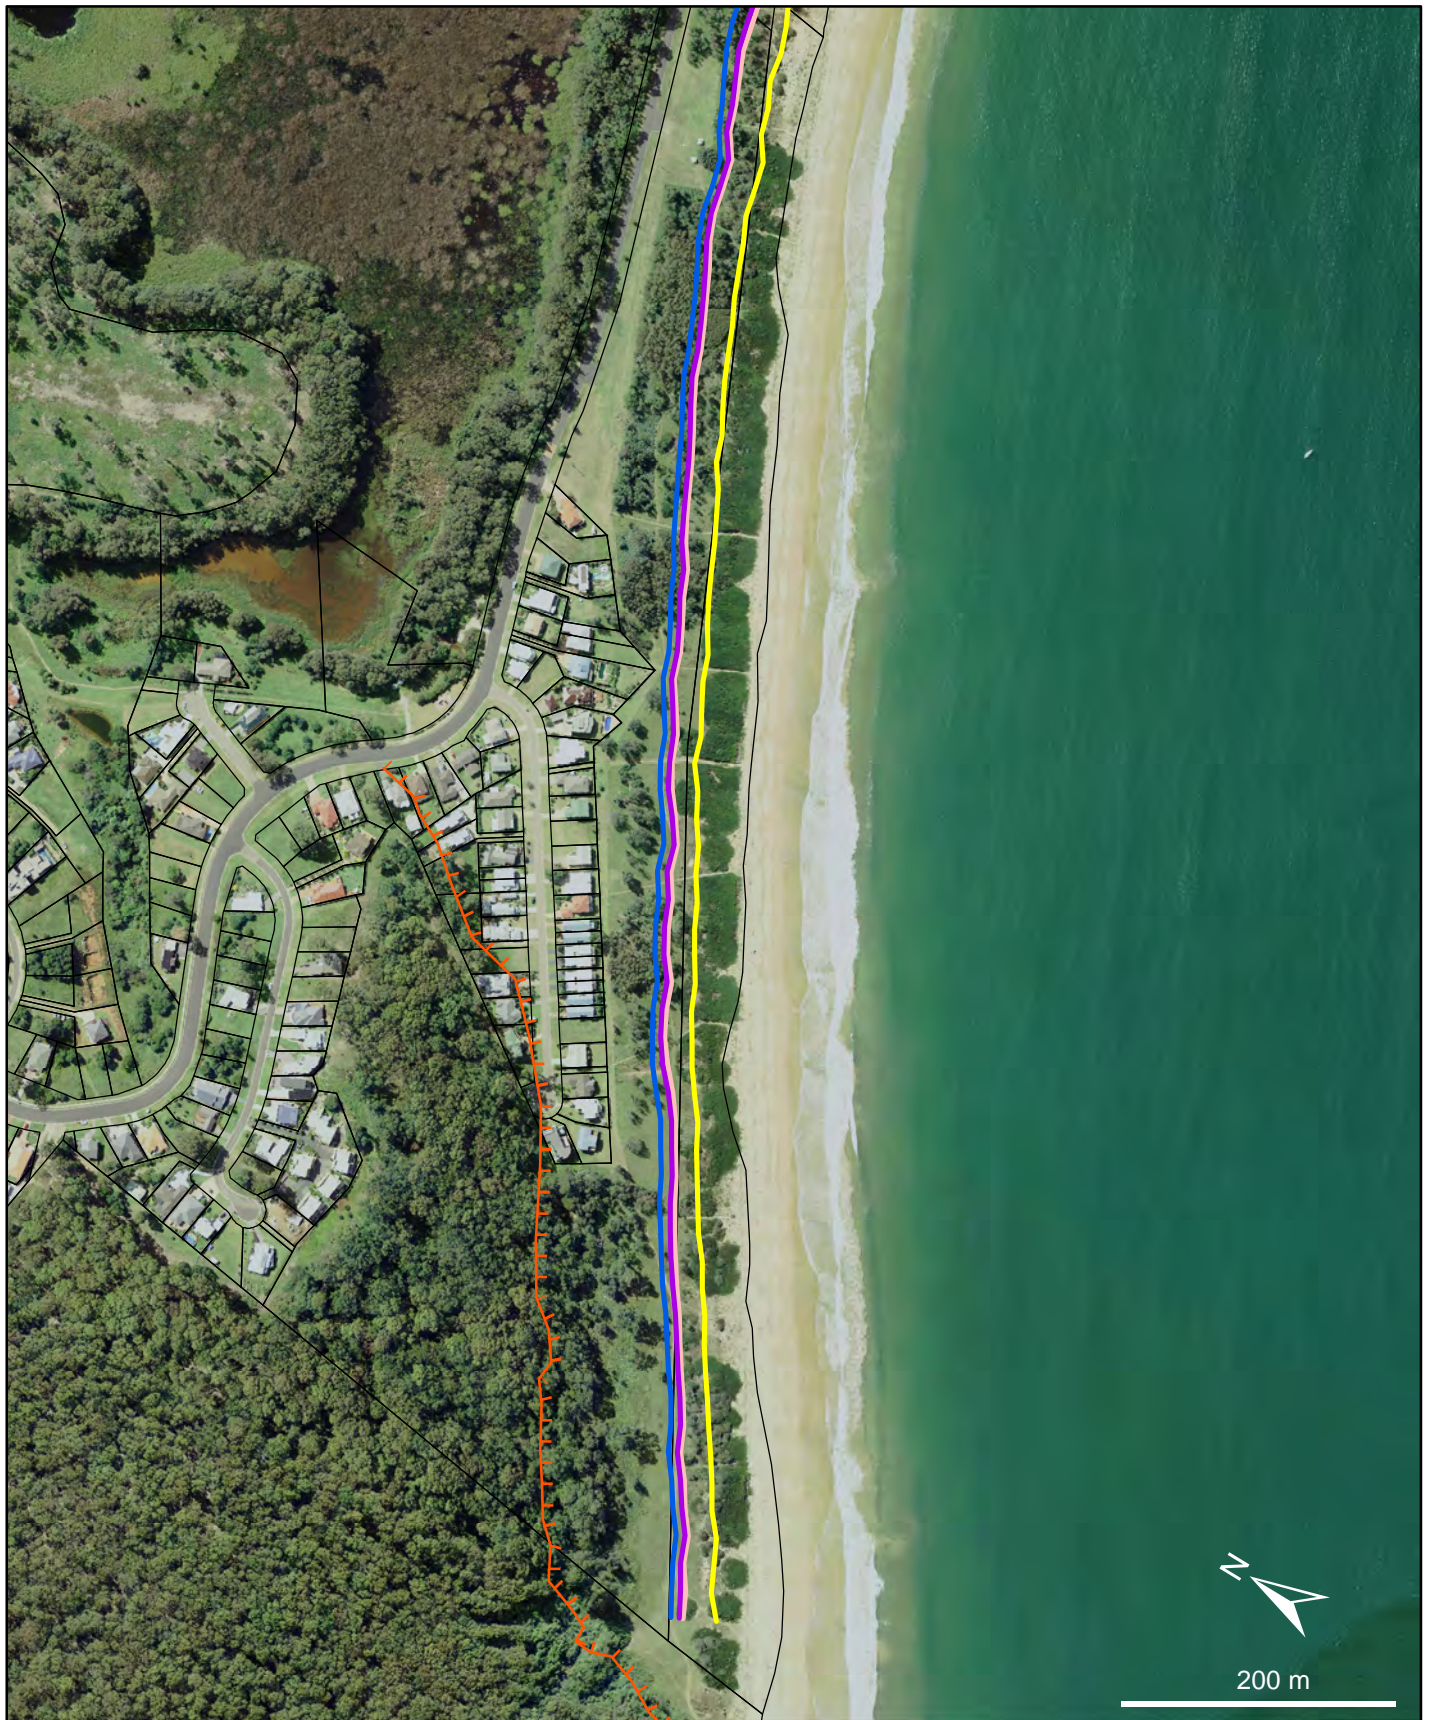
Figure I.3

Note 1: Landward movement of the shoreline could be limited by the presence of bedrock.

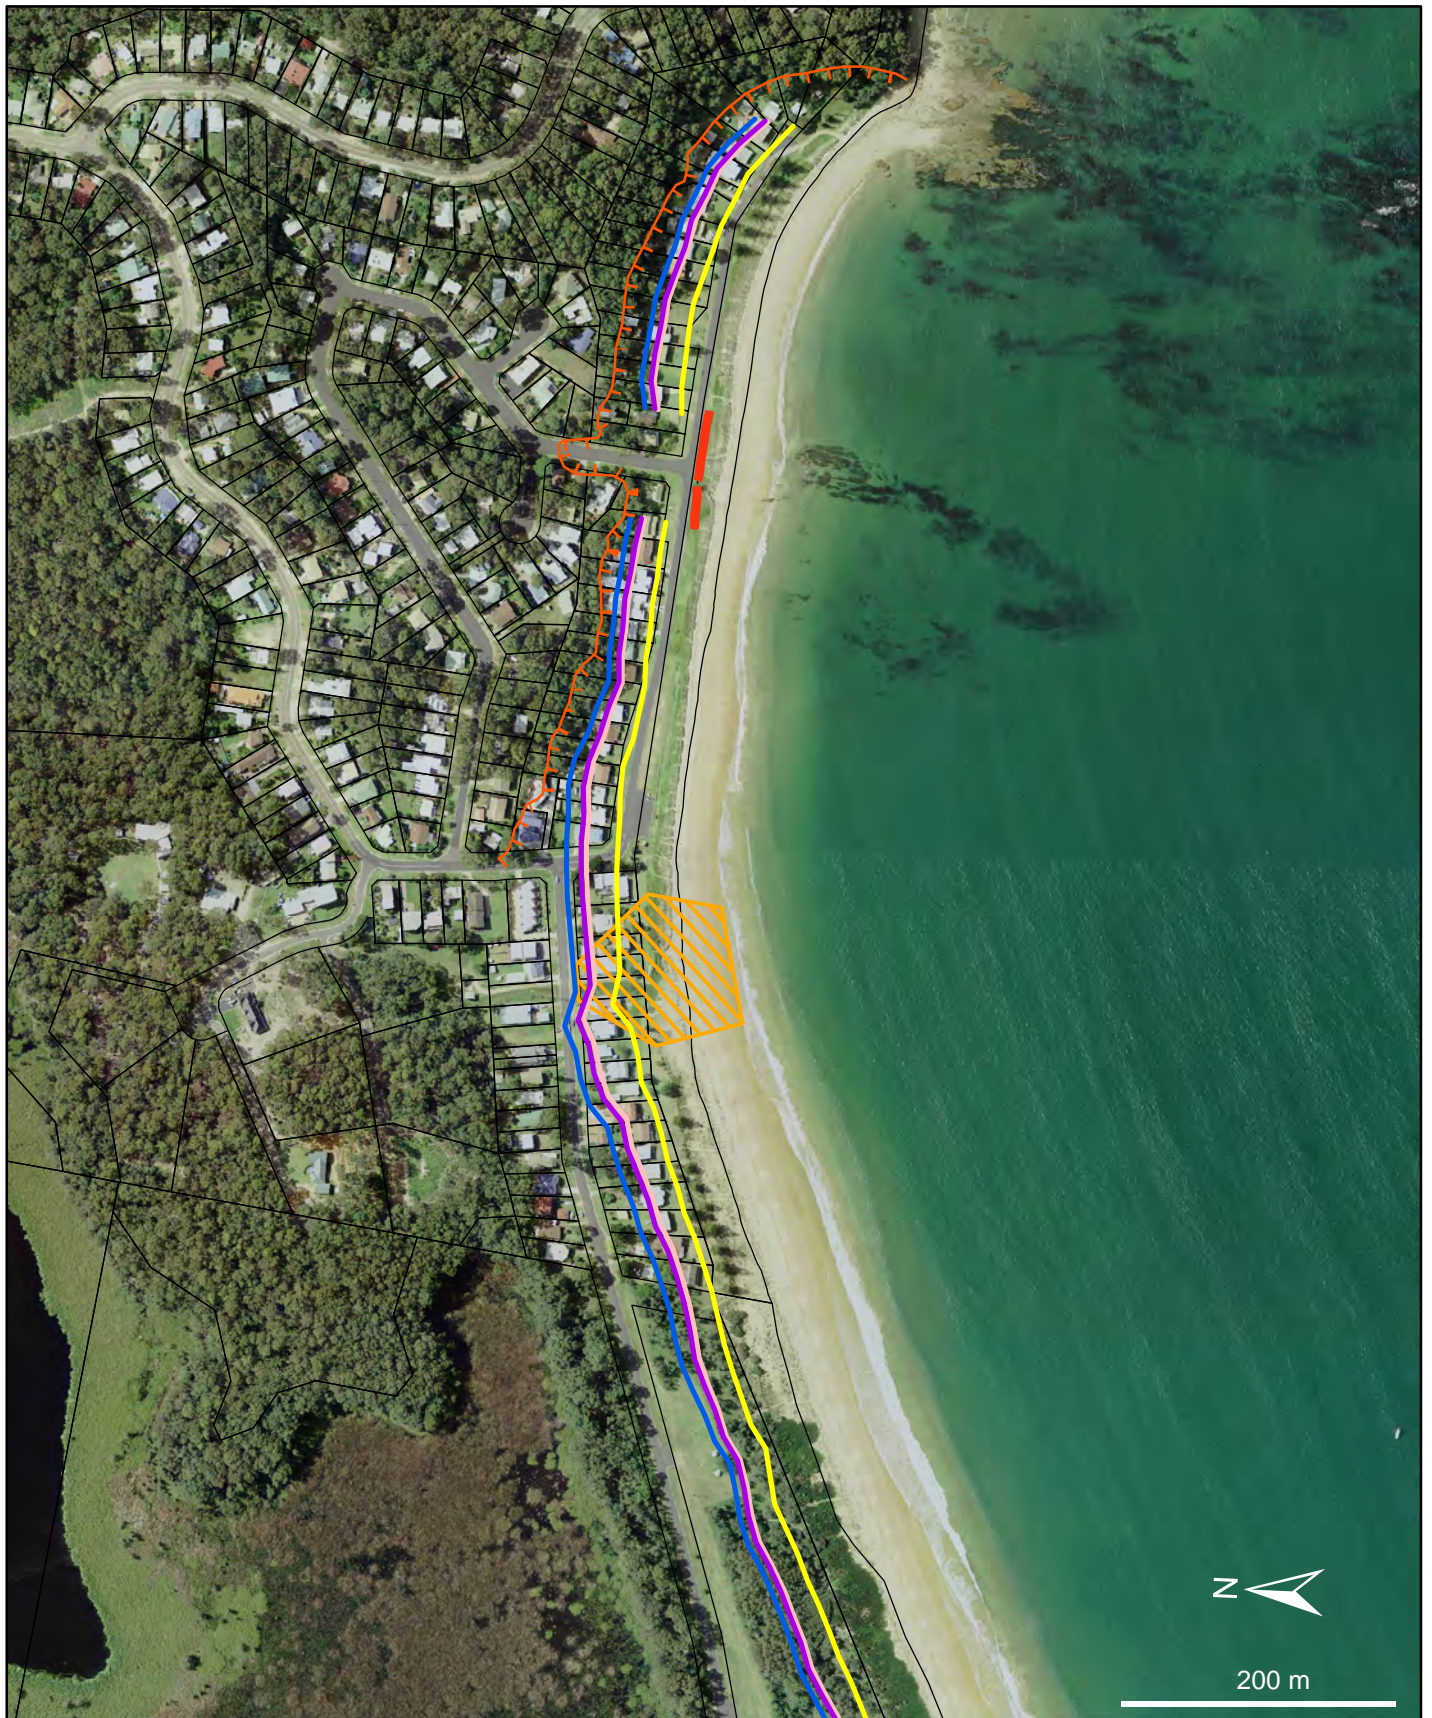
Figure I.5

Note 1: Landward movement of the shoreline could be limited by the presence of bedrock.

Note 2: The shoreline could potentially move landward of the hazard lines in the watercourse entrance instability region due to lowering of the beach profile from entrance scouring.

Note 3: Areas landward of the bedrock (non-erodible) line could be subject to coastal cliff or slope instability hazards which are beyond the scope of this study.

Note 4: The shape of hazard lines not located at the seawall is hypothetical only and requires further detailed assessment beyond the scope of this study.

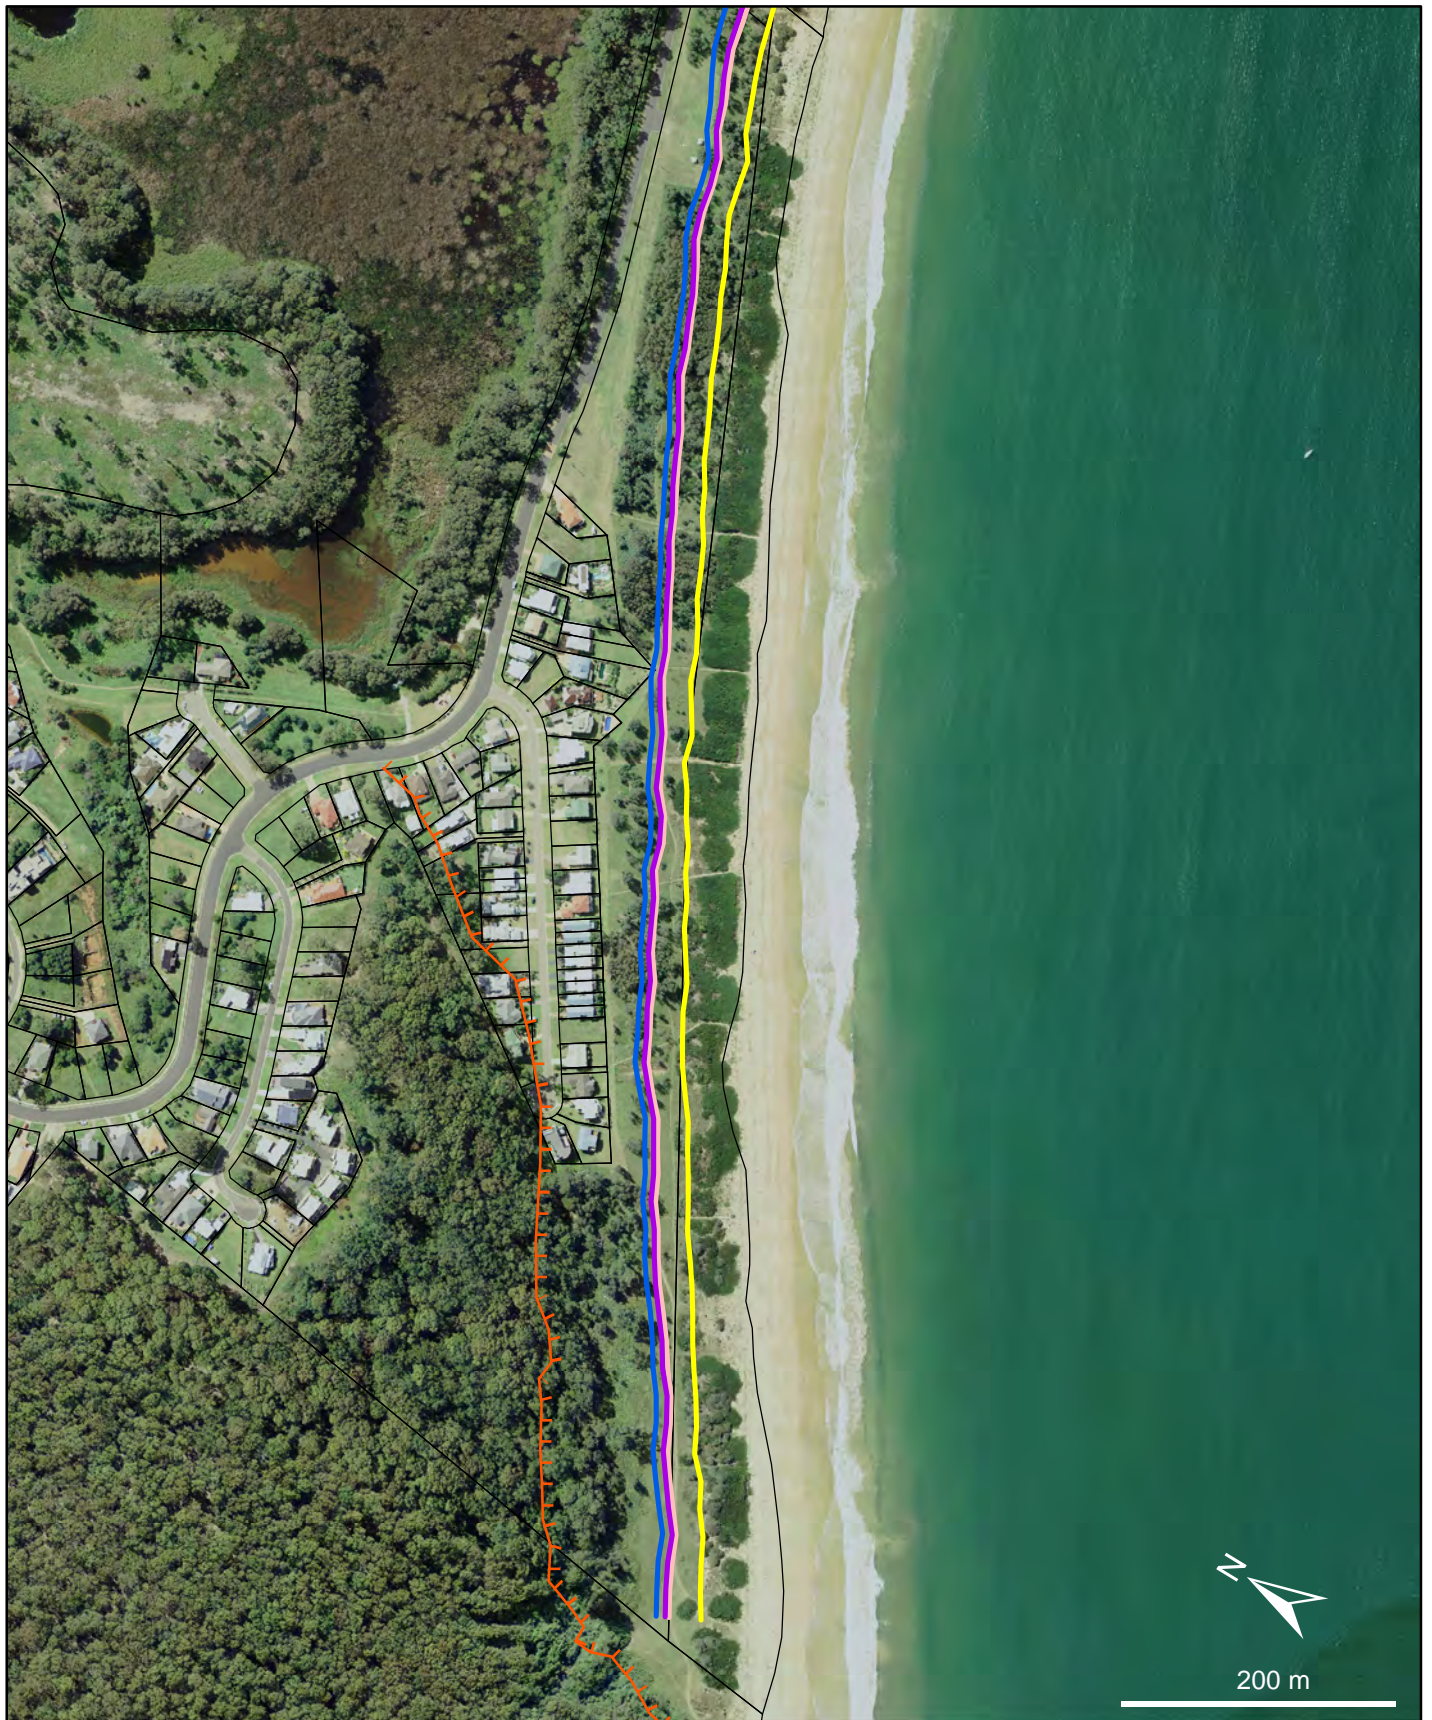
Figure I.6

Note 1: Landward movement of the shoreline could be limited by the presence of bedrock.

Note 2: The shoreline could potentially move landward of the hazard lines in the watercourse entrance instability region due to lowering of the beach profile from entrance scouring.

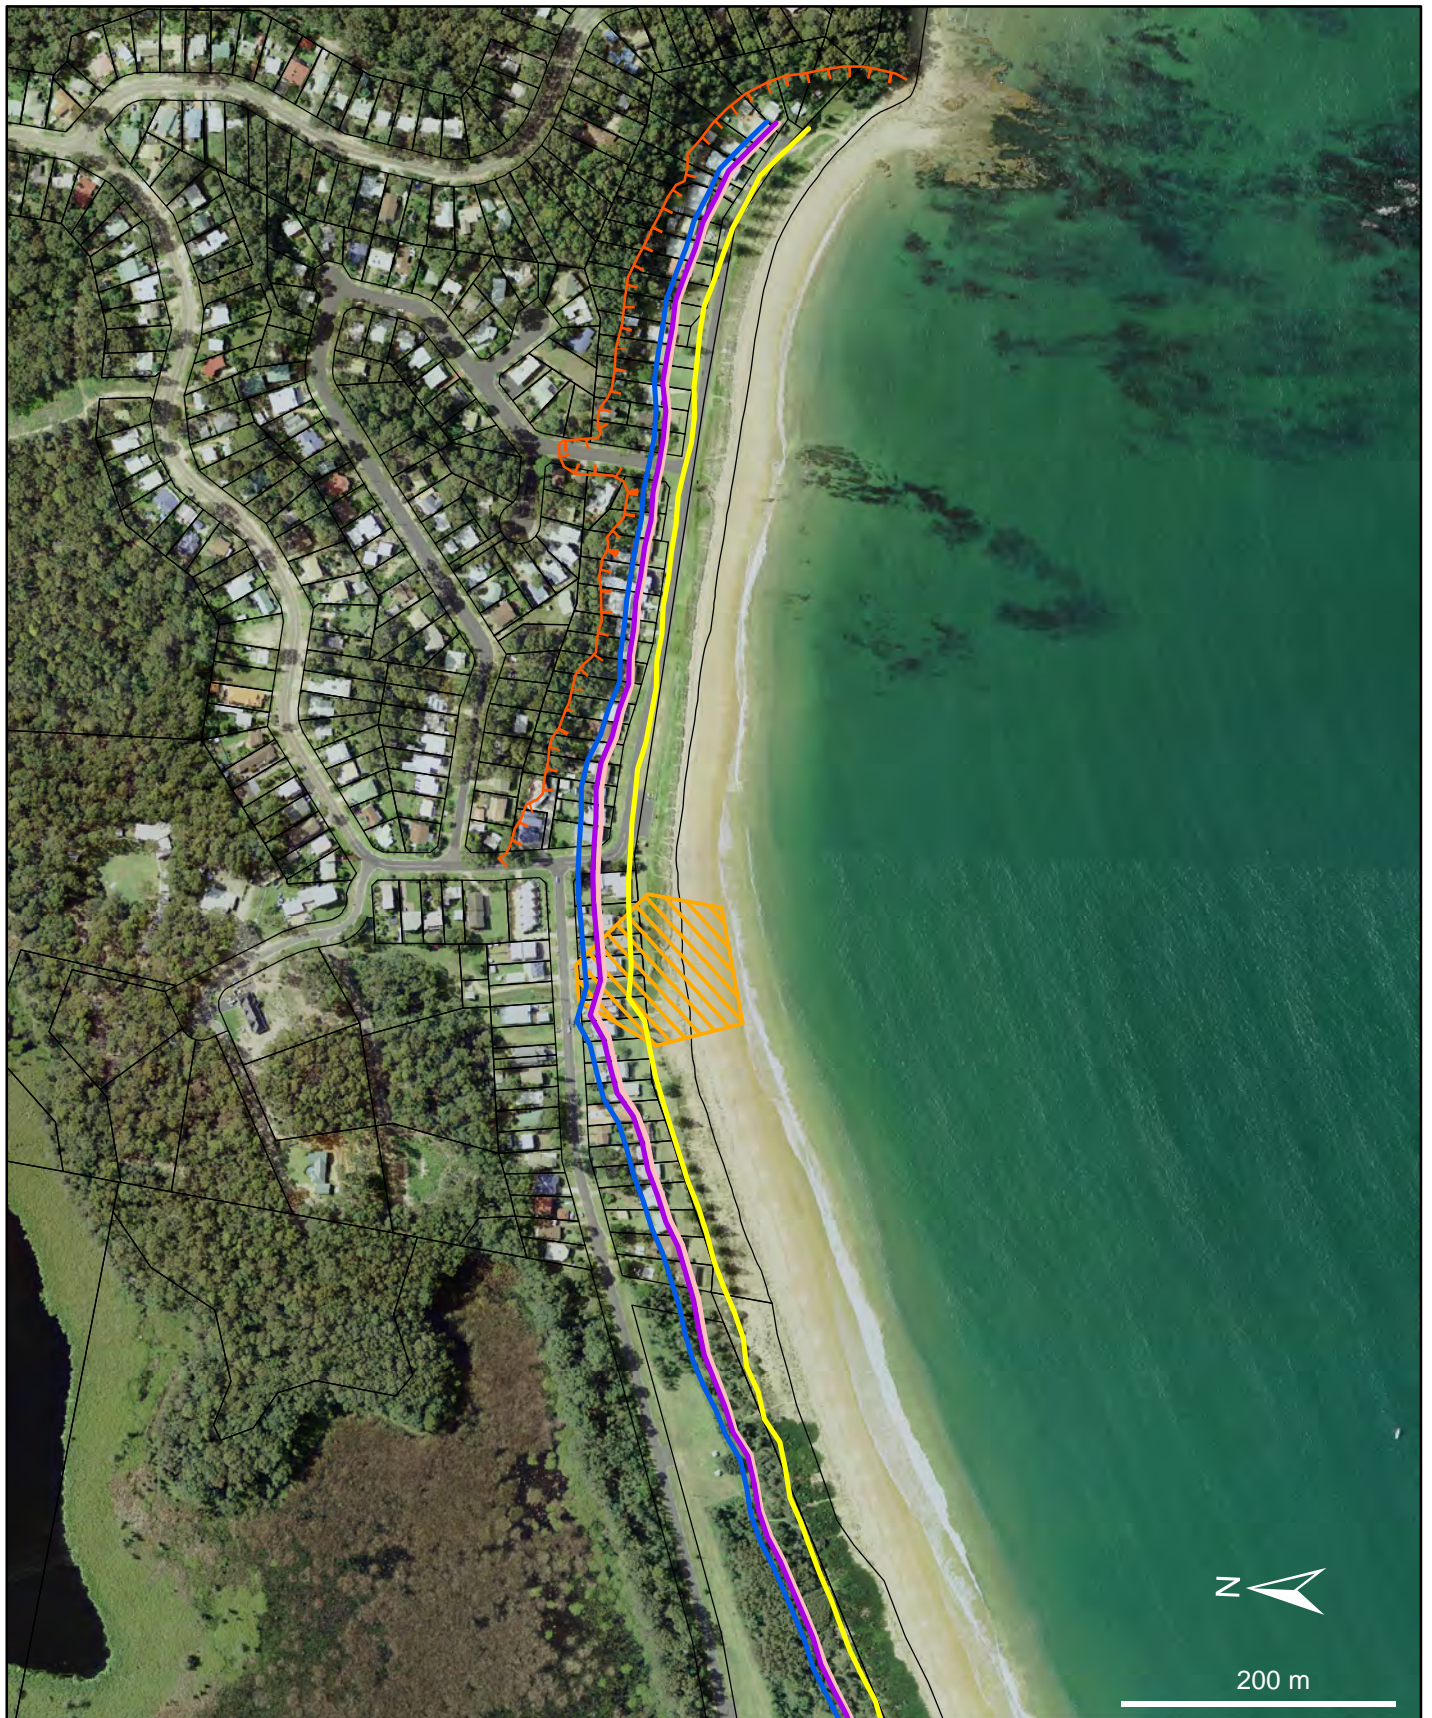
Figure I.7

Note 1: Landward movement of the shoreline could be limited by the presence of bedrock.

Note 2: The shoreline could potentially move landward of the hazard lines in the watercourse entrance instability region due to lowering of the beach profile from entrance scouring.

Note 3: Areas landward of the bedrock (non-erodible) line could be subject to coastal cliff or slope instability hazards which are beyond the scope of this study.

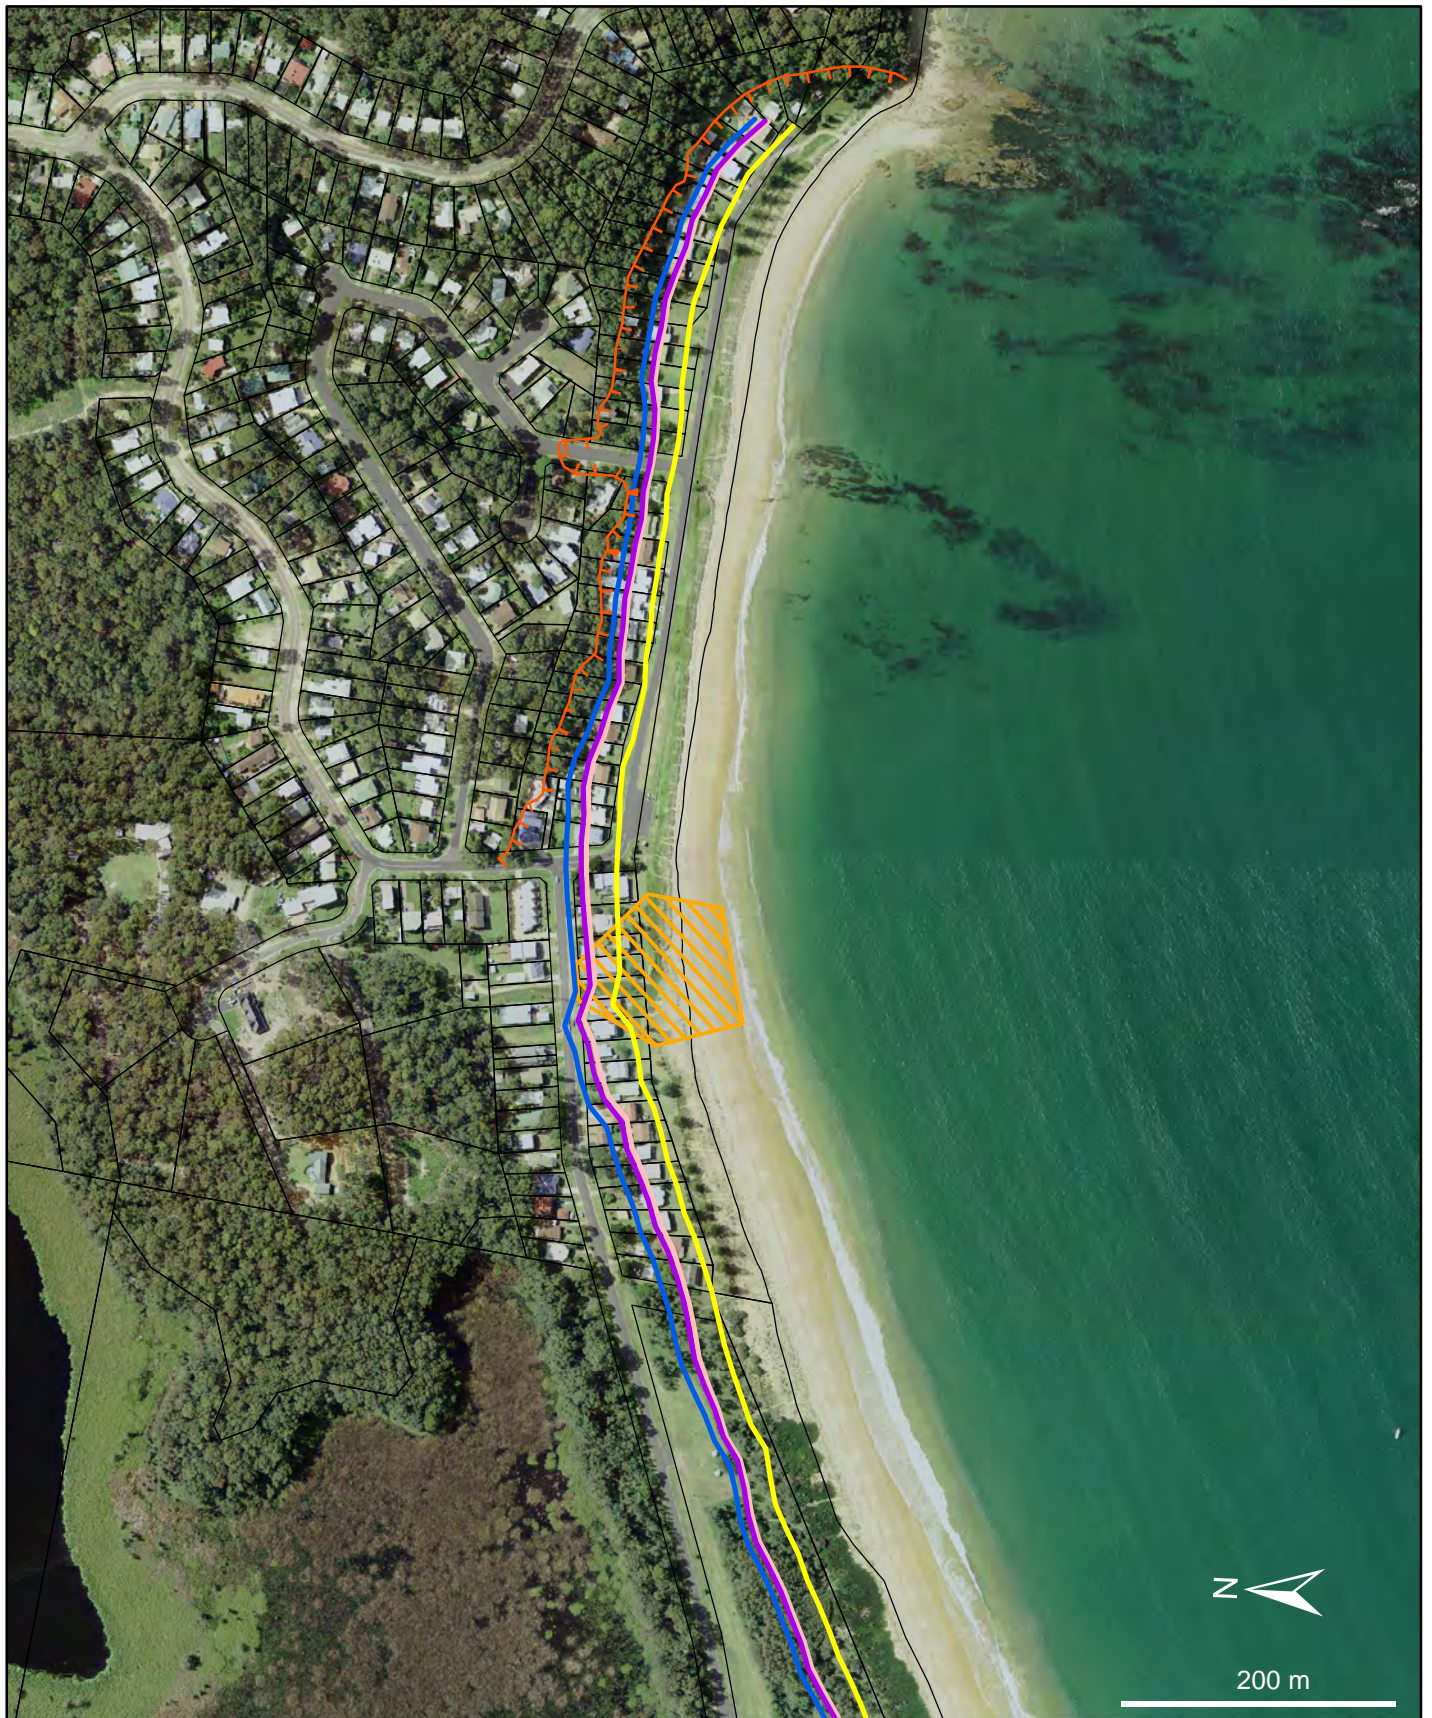
Figure I.8

Note 1: Landward movement of the shoreline could be limited by the presence of bedrock.

Note 2: The shoreline could potentially move landward of the hazard lines in the watercourse entrance instability region due to lowering of the beach profile from entrance scouring.

Note 3: Areas landward of the bedrock (non-erodible) line could be subject to coastal cliff or slope instability hazards which are beyond the scope of this study.

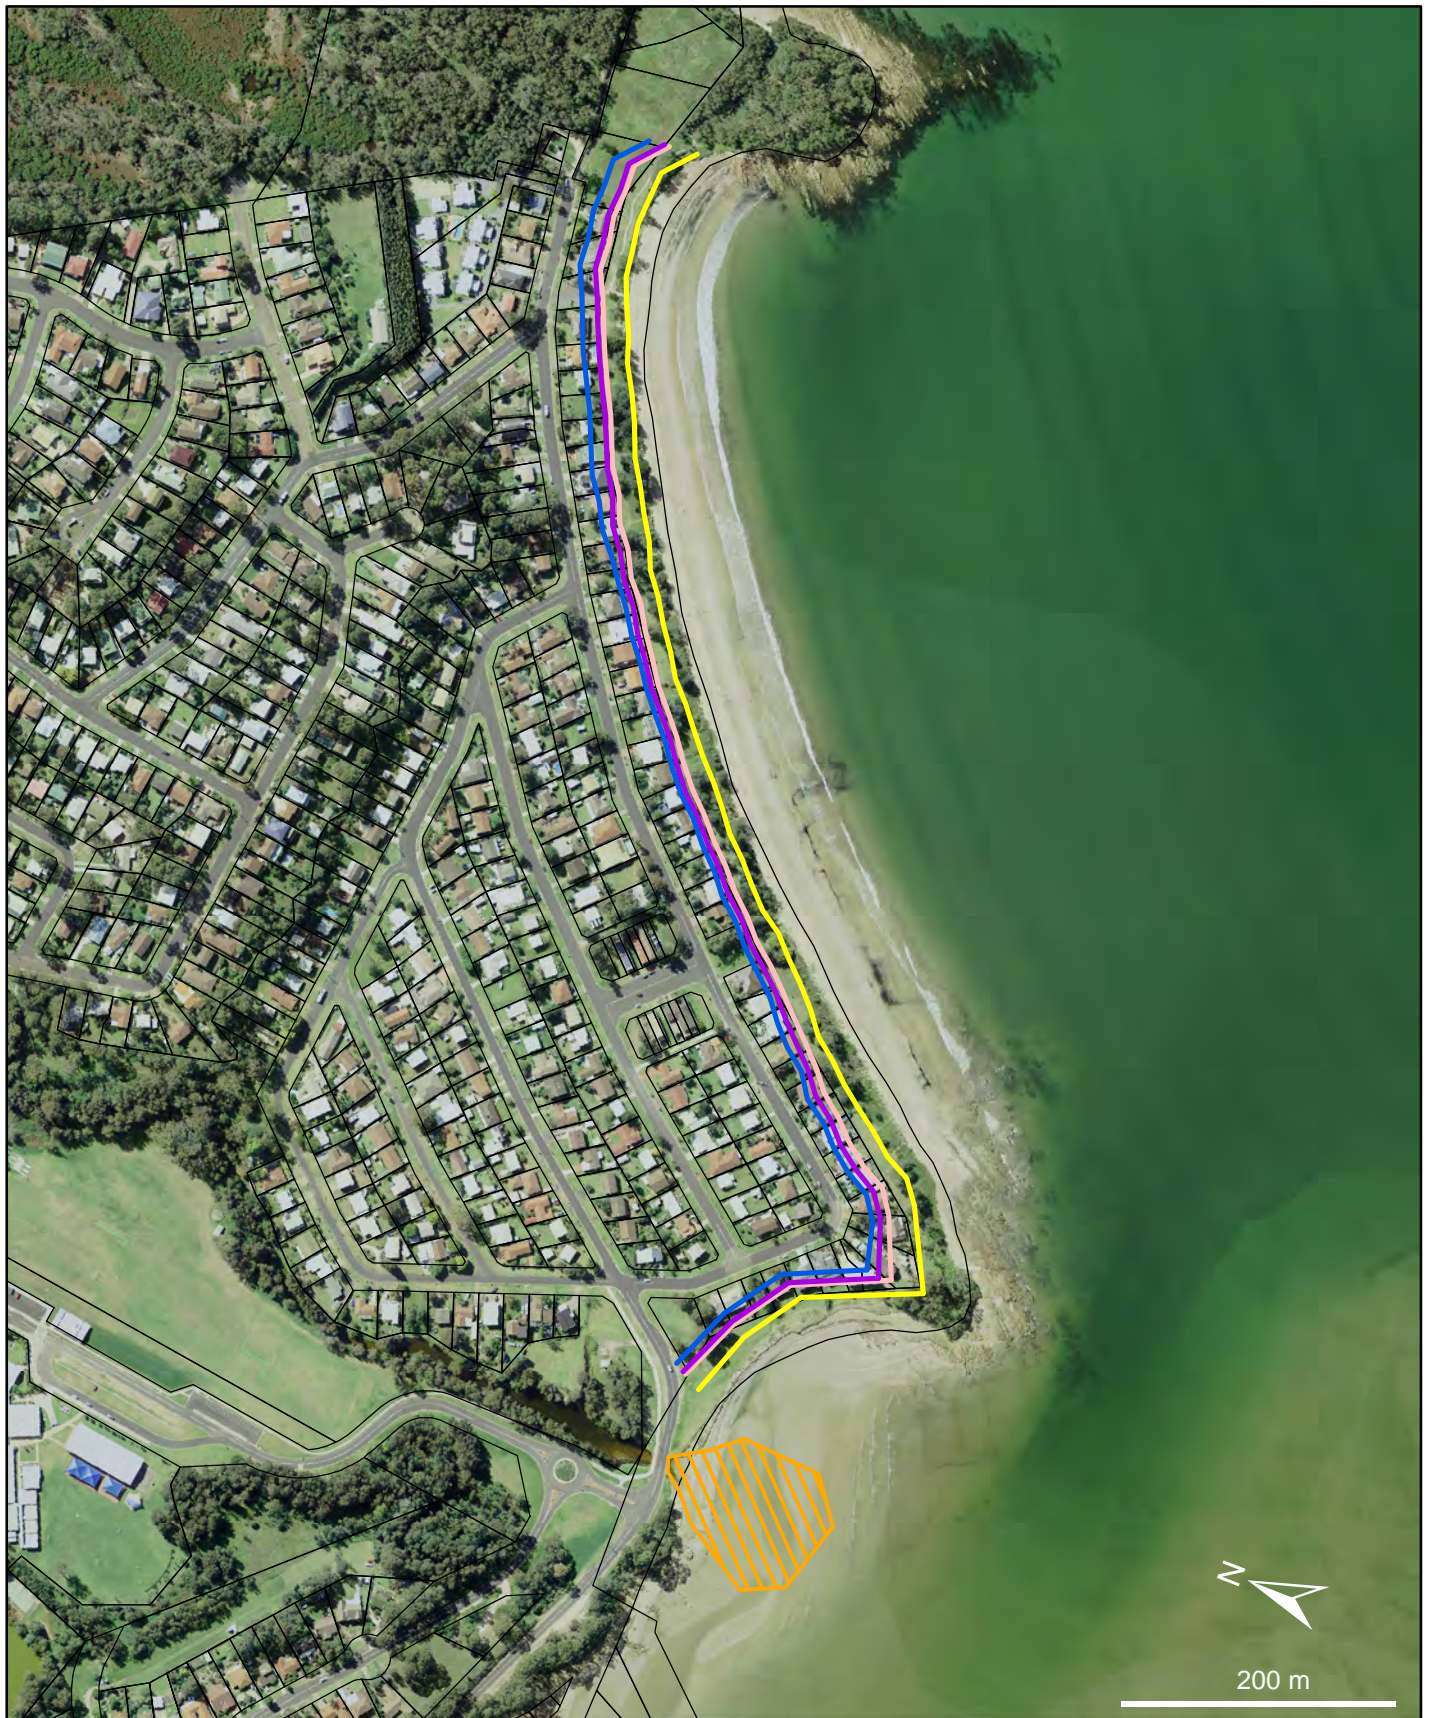
Figure I.9

Note 1: Landward movement of the shoreline could be limited by the presence of bedrock.

Note 2: The shoreline could potentially move landward of the hazard lines in the watercourse entrance instability region due to lowering of the beach profile from entrance scouring.

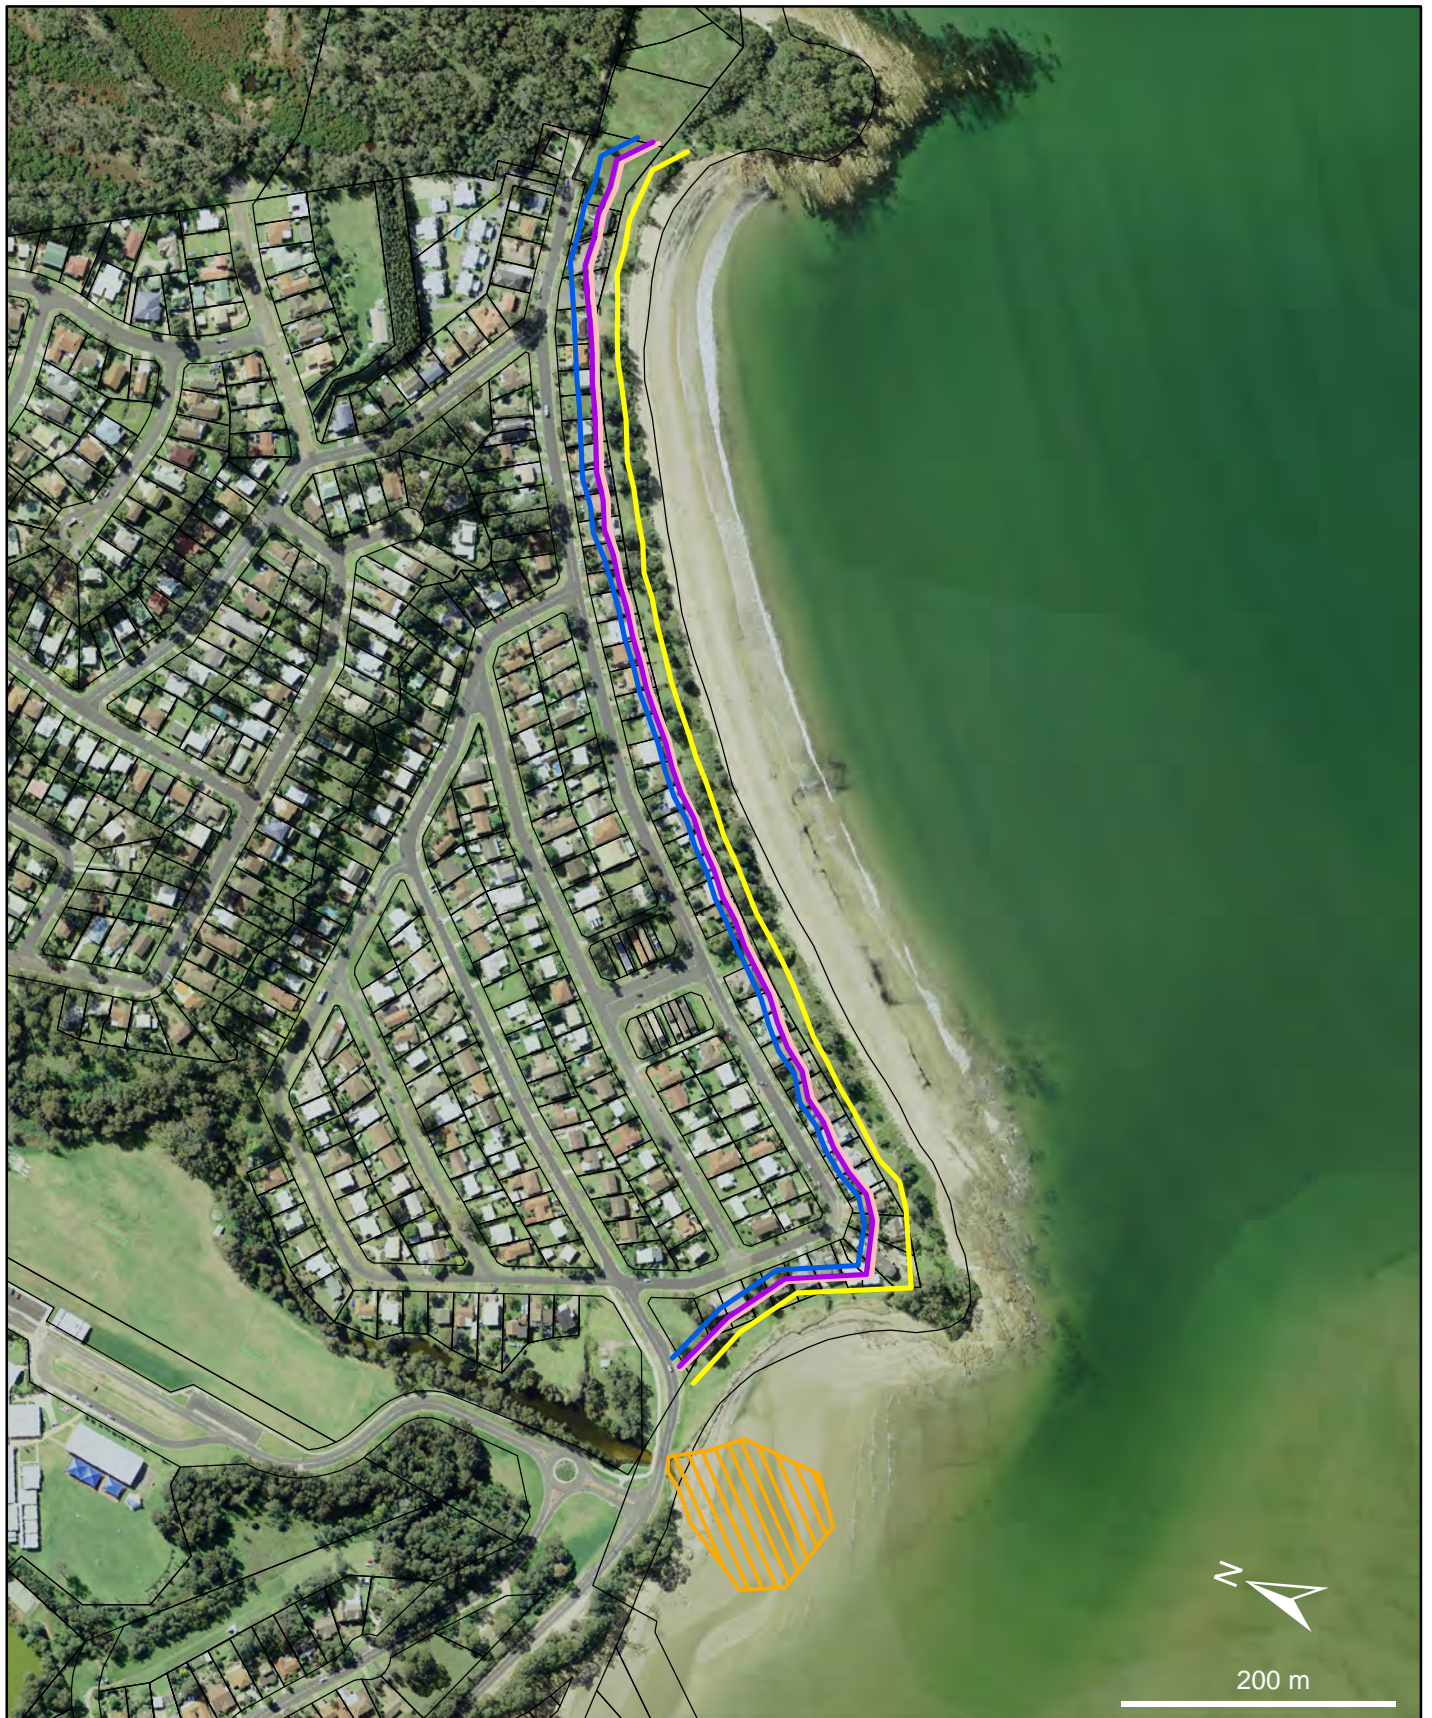
Figure I.10

Surfside Beach  
5% encounter probability  
Probabilistic erosion/recession hazard lines

Note 1: Landward movement of the shoreline could be limited by the presence of bedrock.

Note 2: The shoreline could potentially move landward of the hazard lines in the watercourse entrance instability region due to lowering of the beach profile from entrance scouring.

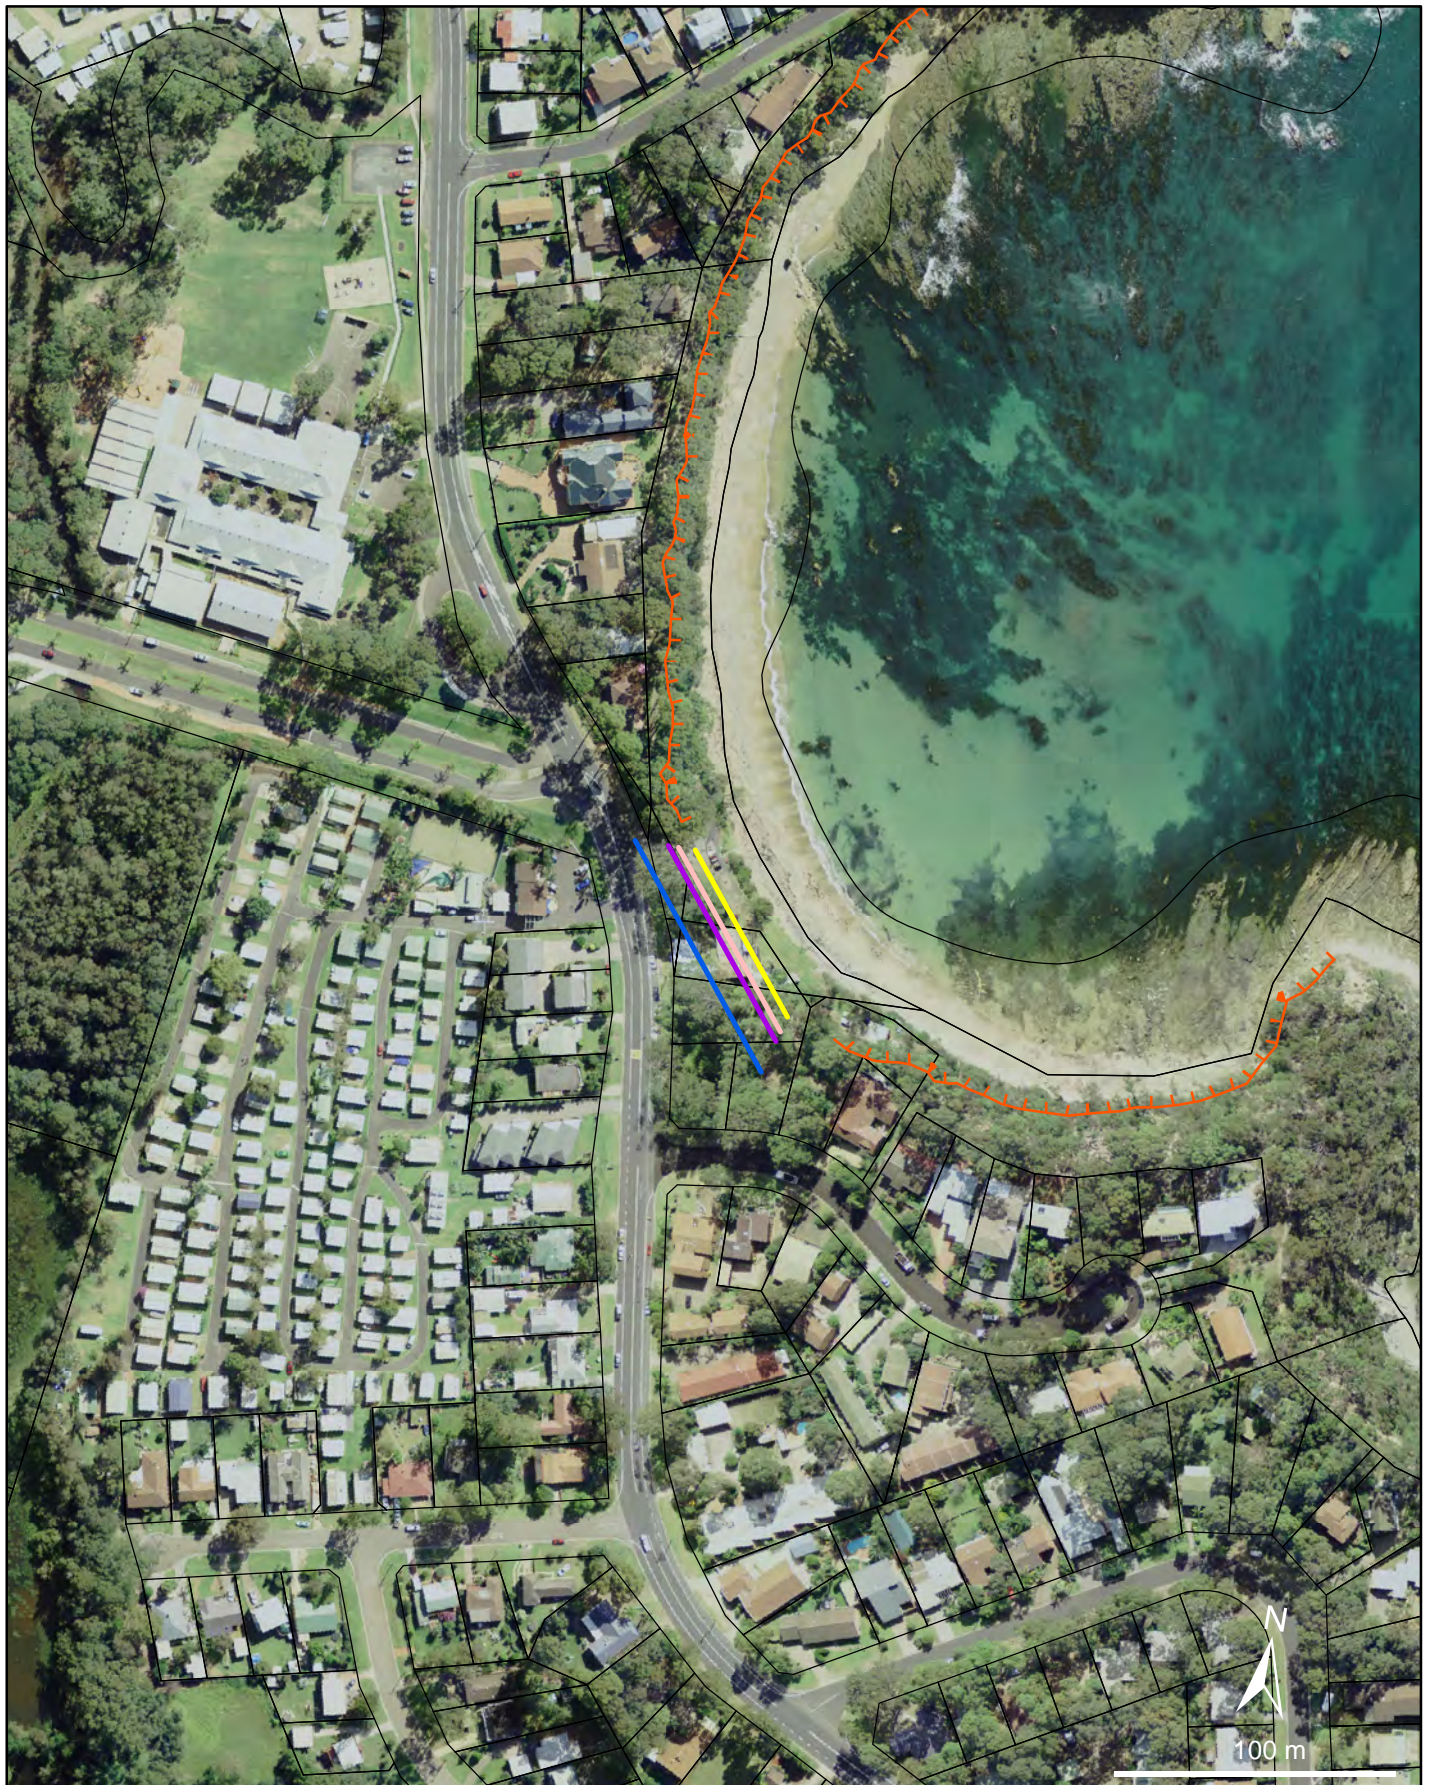
Figure I.11

Surfside Beach  
1% encounter probability  
Probabilistic erosion/recession hazard lines

Note 1: Landward movement of the shoreline could be limited by the presence of bedrock.

Note 2: Areas landward of the bedrock (non-erodible) line could be subject to coastal cliff or slope instability hazards which are beyond the scope of this study.
