## Eurobodalla Coastal Hazard Assessment

WRL Technical Report 2017/09  
October 2017

By I R Coghlan, J T Carley, A J Harrison, D Howe, A D Short,  
J E Ruprecht, F Flocard and P F Rahman

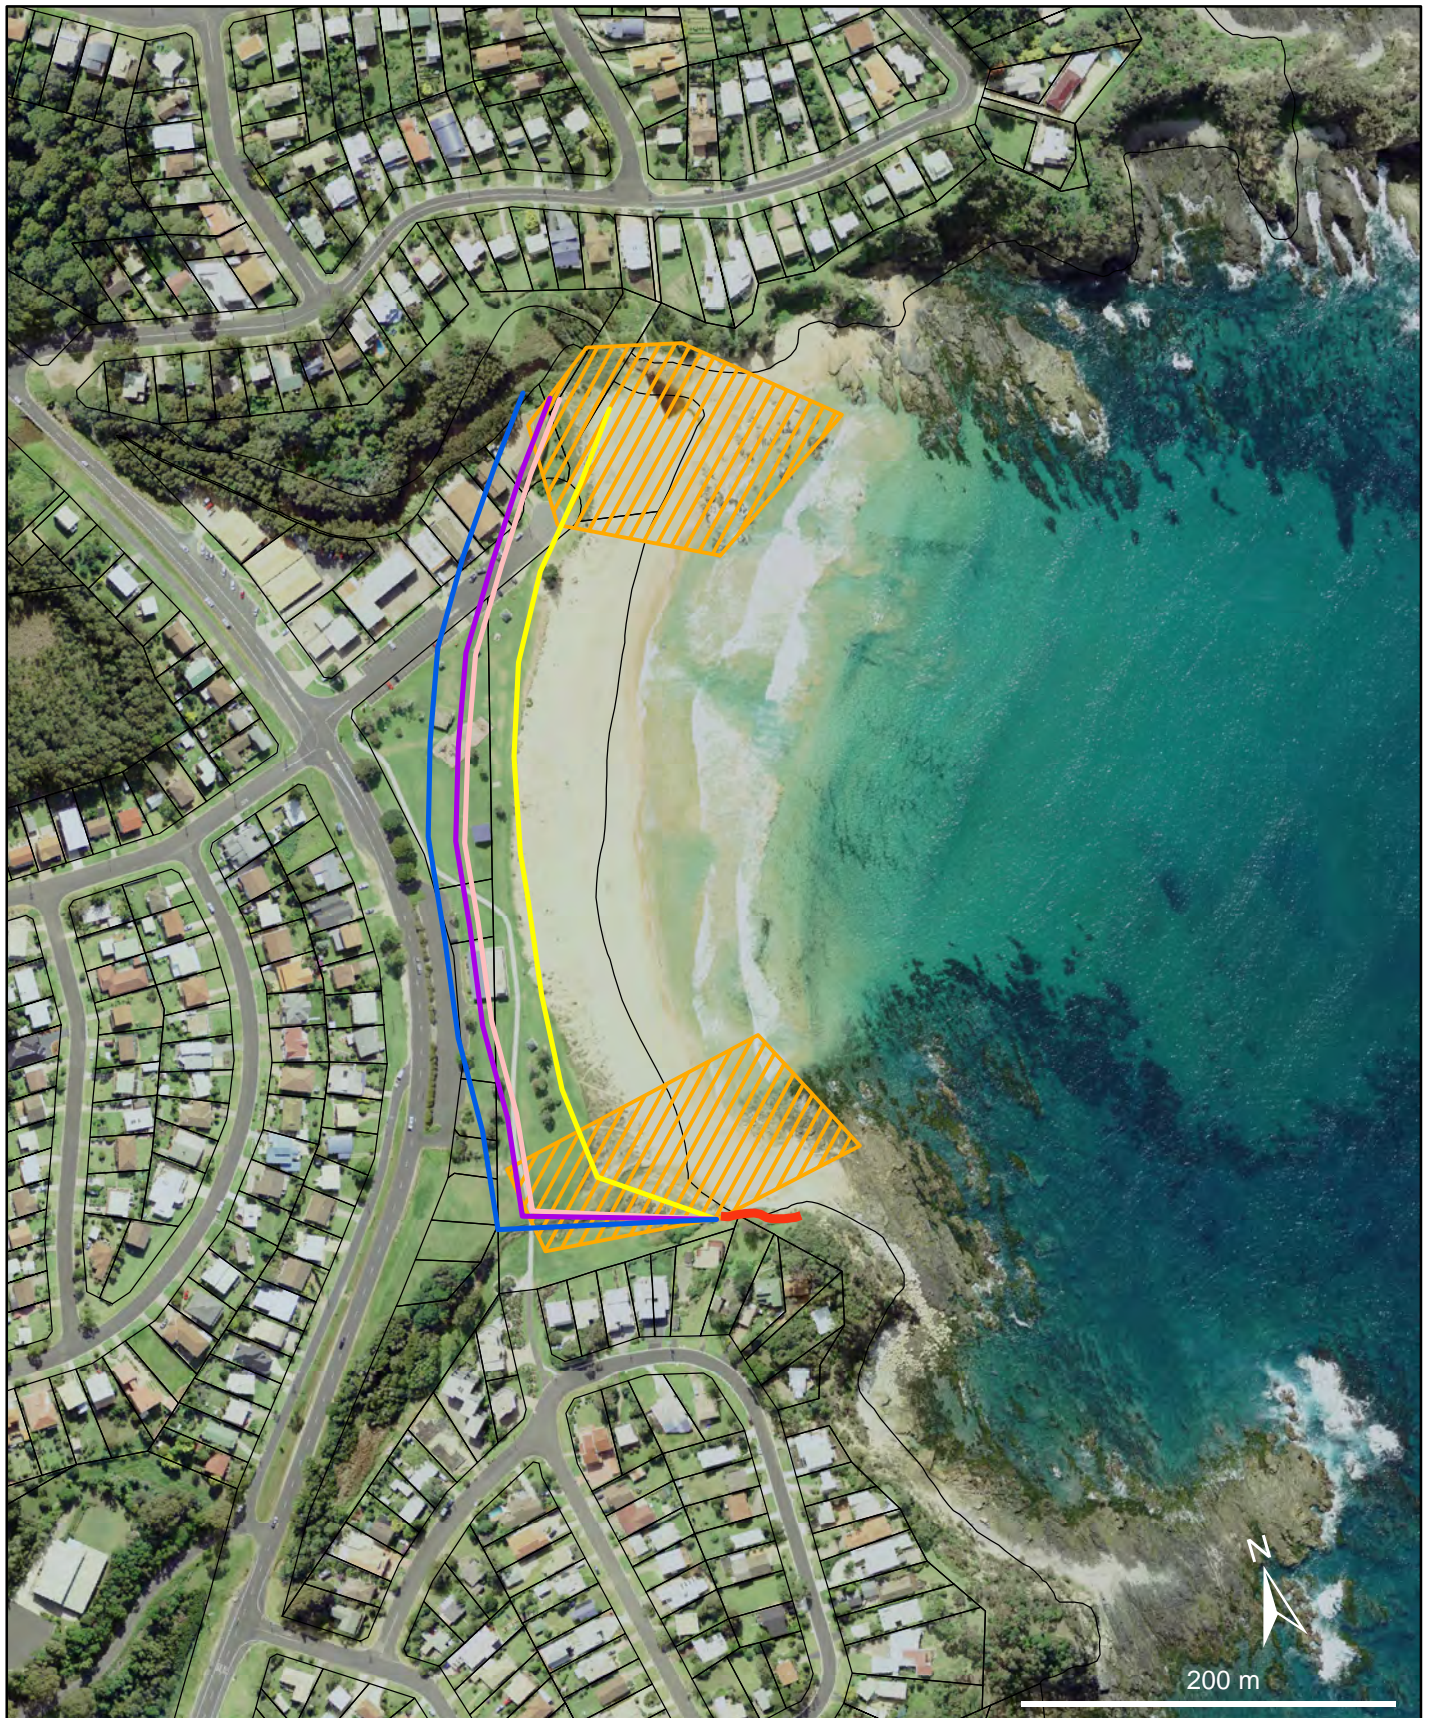
Figure I.12

Note 1: Landward movement of the shoreline could be limited by the presence of bedrock.

Note 2: The shoreline could potentially move landward of the hazard lines in the watercourse entrance instability region due to lowering of the beach profile from entrance scouring.

Note 3: The shape of hazard lines not located at the seawall is hypothetical only and requires further detailed assessment beyond the scope of this study.

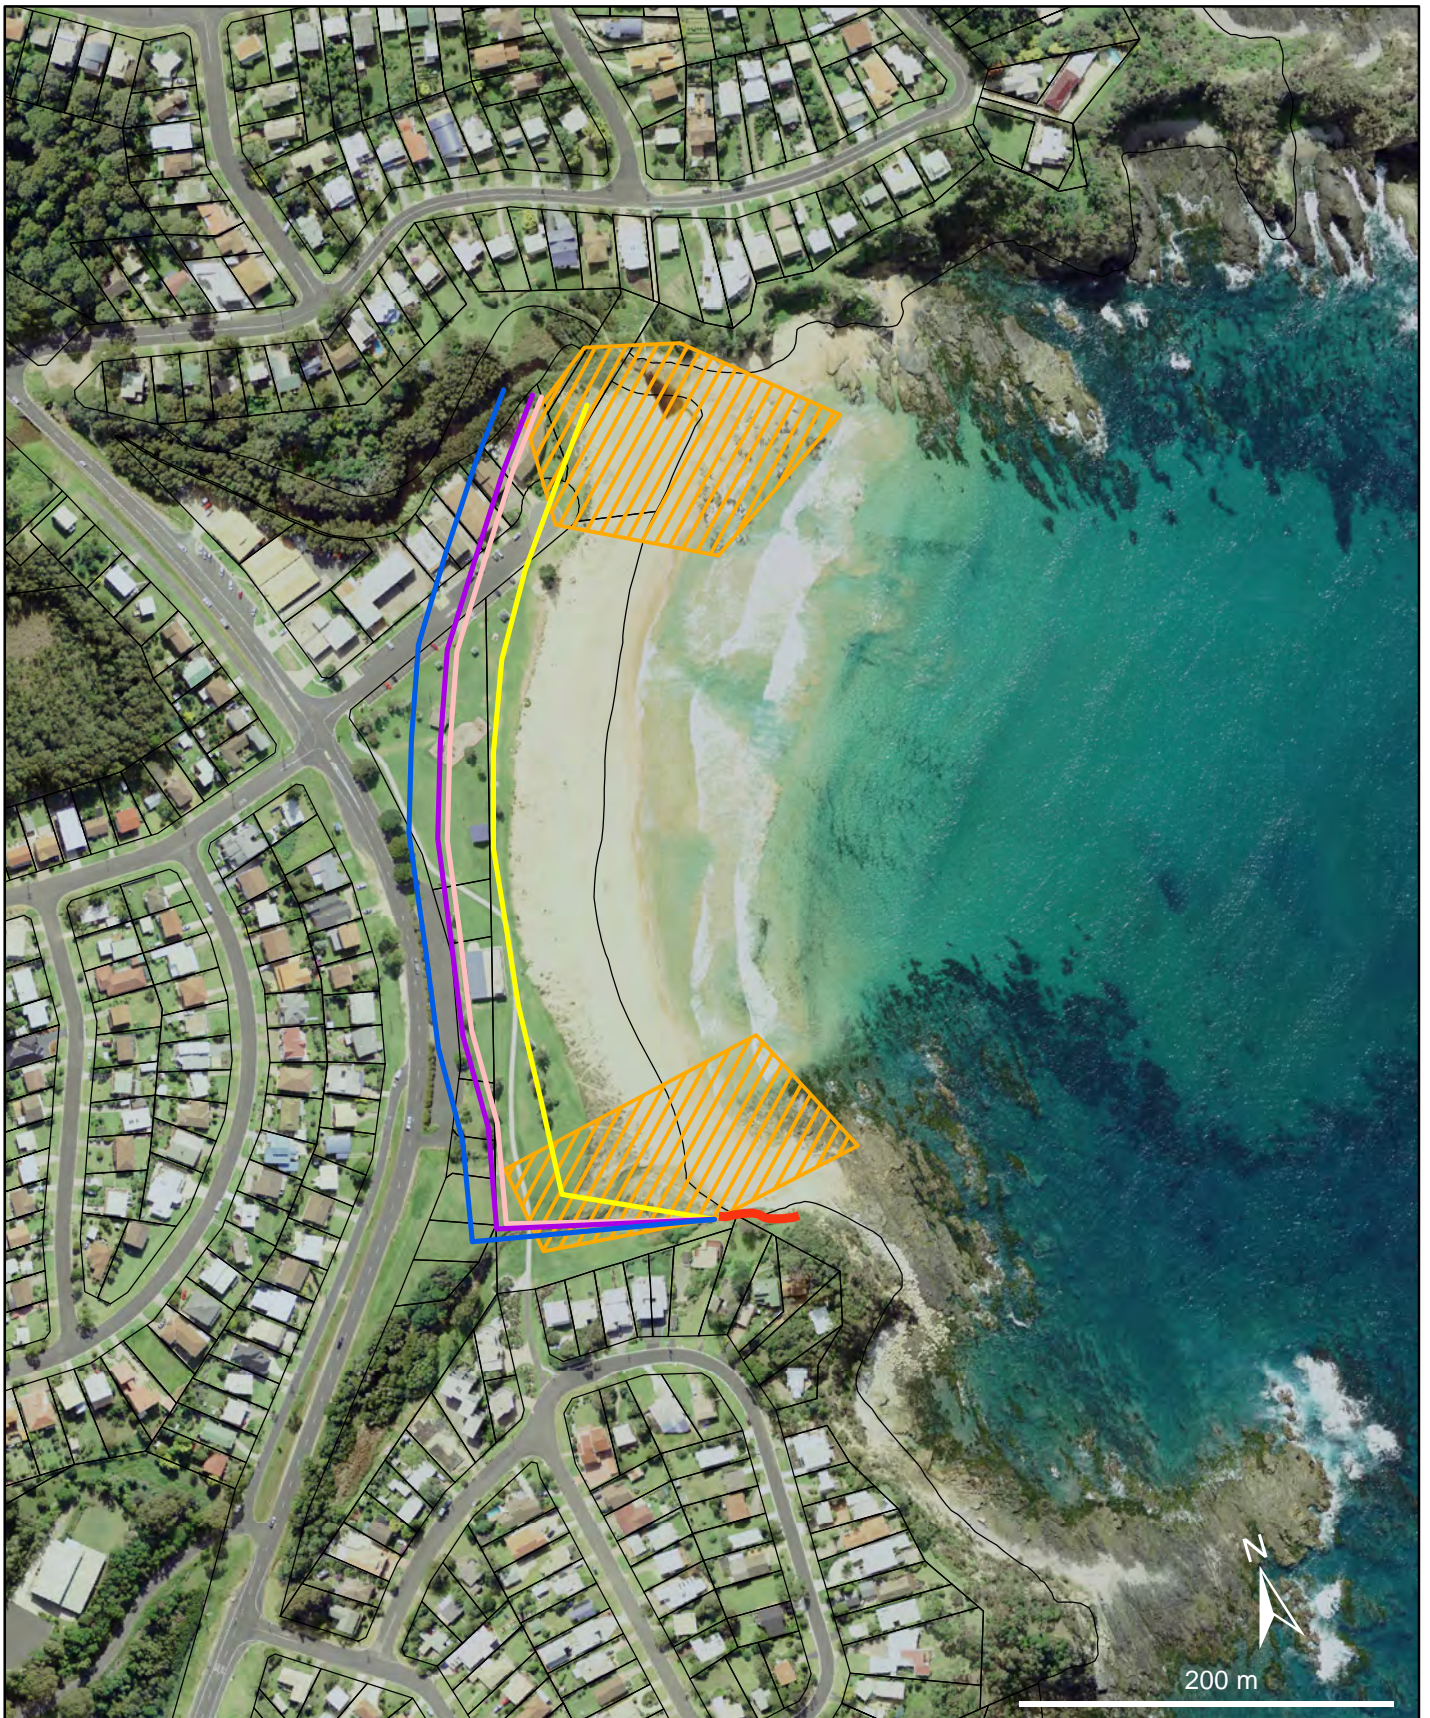
Figure I.13

Note 1: Landward movement of the shoreline could be limited by the presence of bedrock.

Note 2: The shoreline could potentially move landward of the hazard lines in the watercourse entrance instability region due to lowering of the beach profile from entrance scouring.

Note 3: The shape of hazard lines not located at the seawall is hypothetical only and requires further detailed assessment beyond the scope of this study.

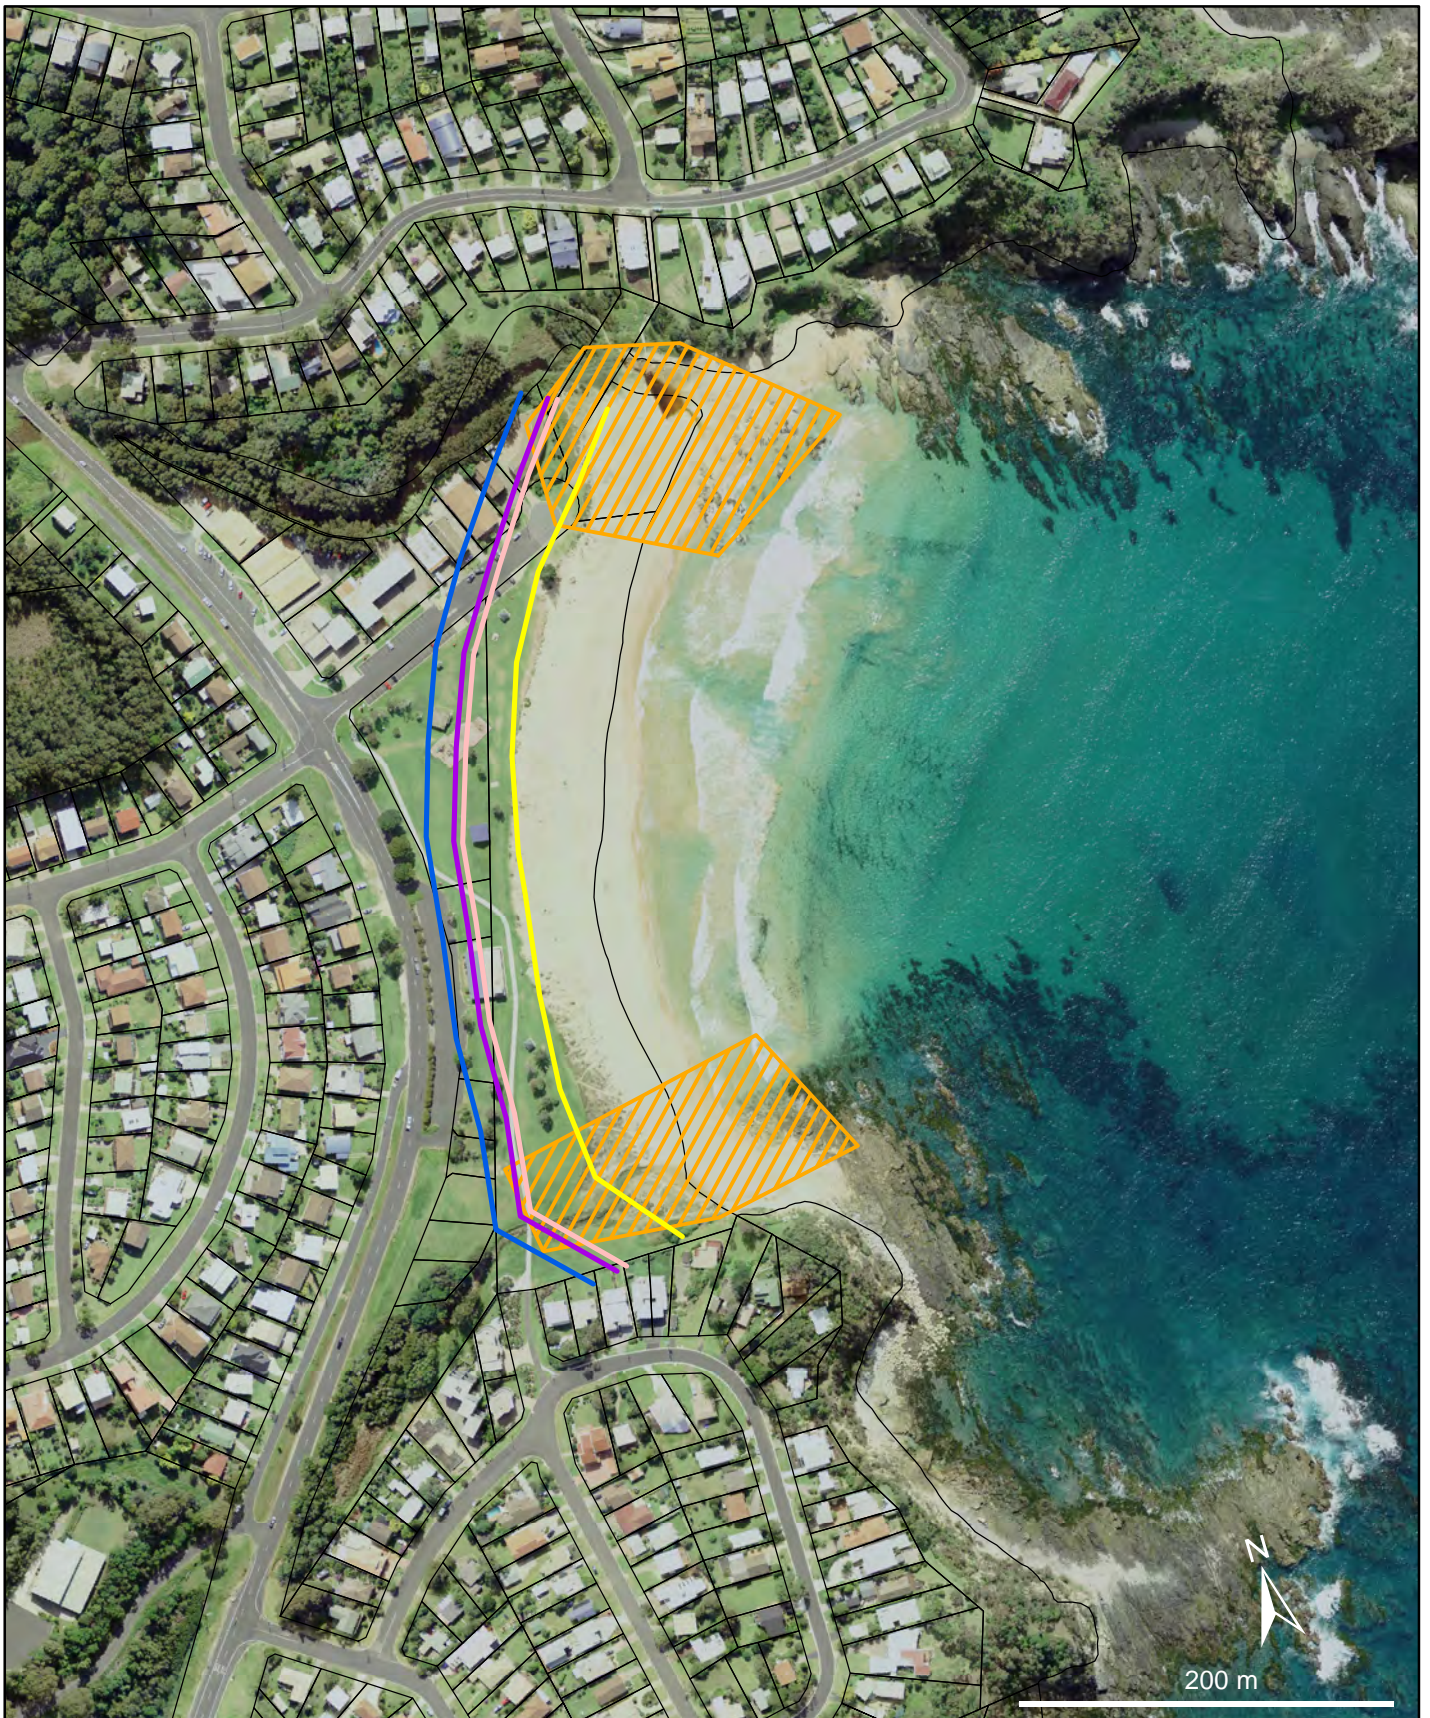
Figure I.14

Note 1: Landward movement of the shoreline could be limited by the presence of bedrock.

Note 2: The shoreline could potentially move landward of the hazard lines in the watercourse entrance instability region due to lowering of the beach profile from entrance scouring.

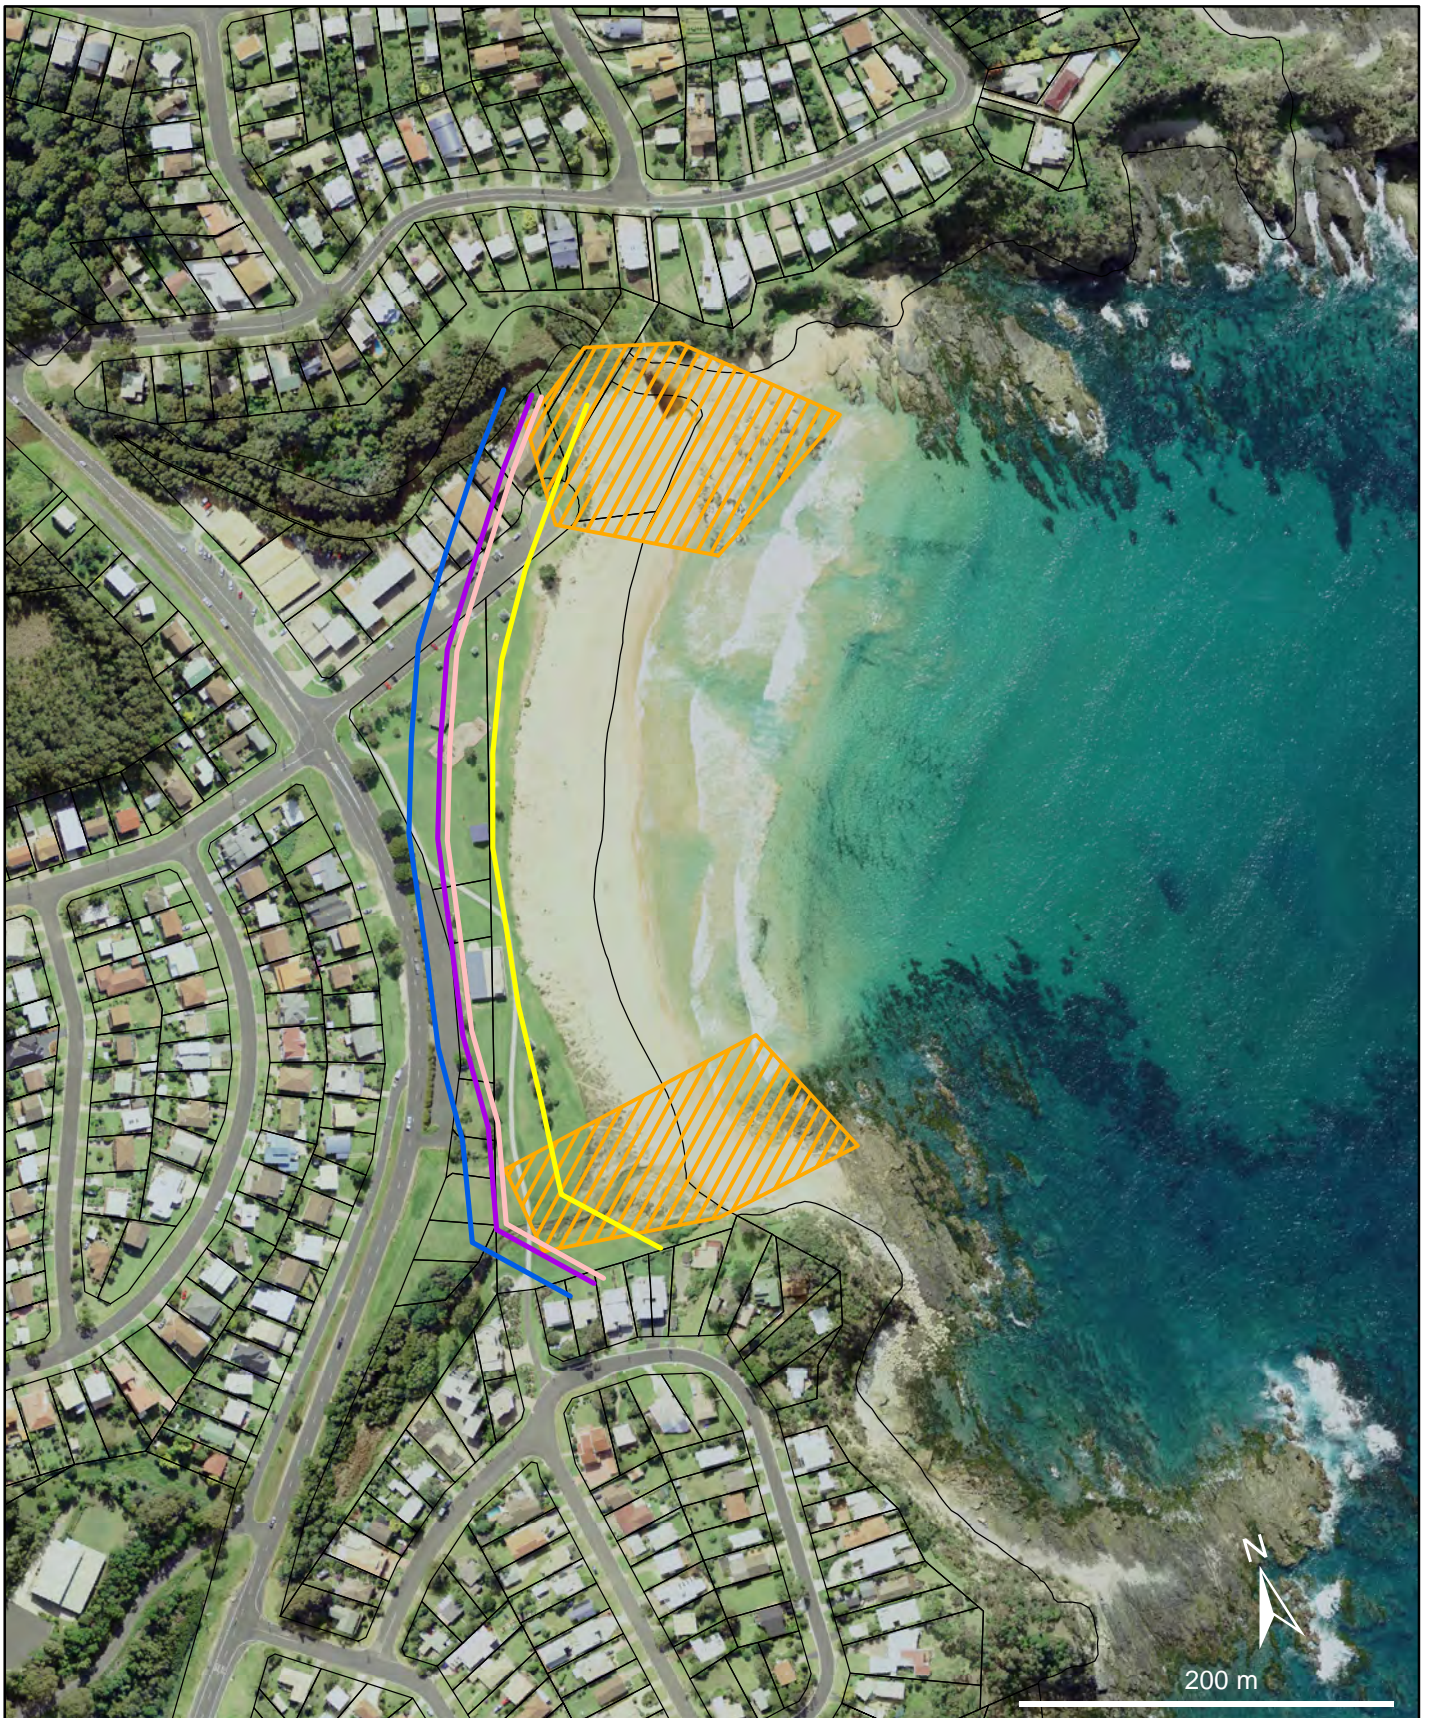
Figure I.15

Malua Bay no seawall  
5% encounter probability  
Probabilistic erosion/recession hazard lines

Note 1: Landward movement of the shoreline could be limited by the presence of bedrock.

Note 2: The shoreline could potentially move landward of the hazard lines in the watercourse entrance instability region due to lowering of the beach profile from entrance scouring.

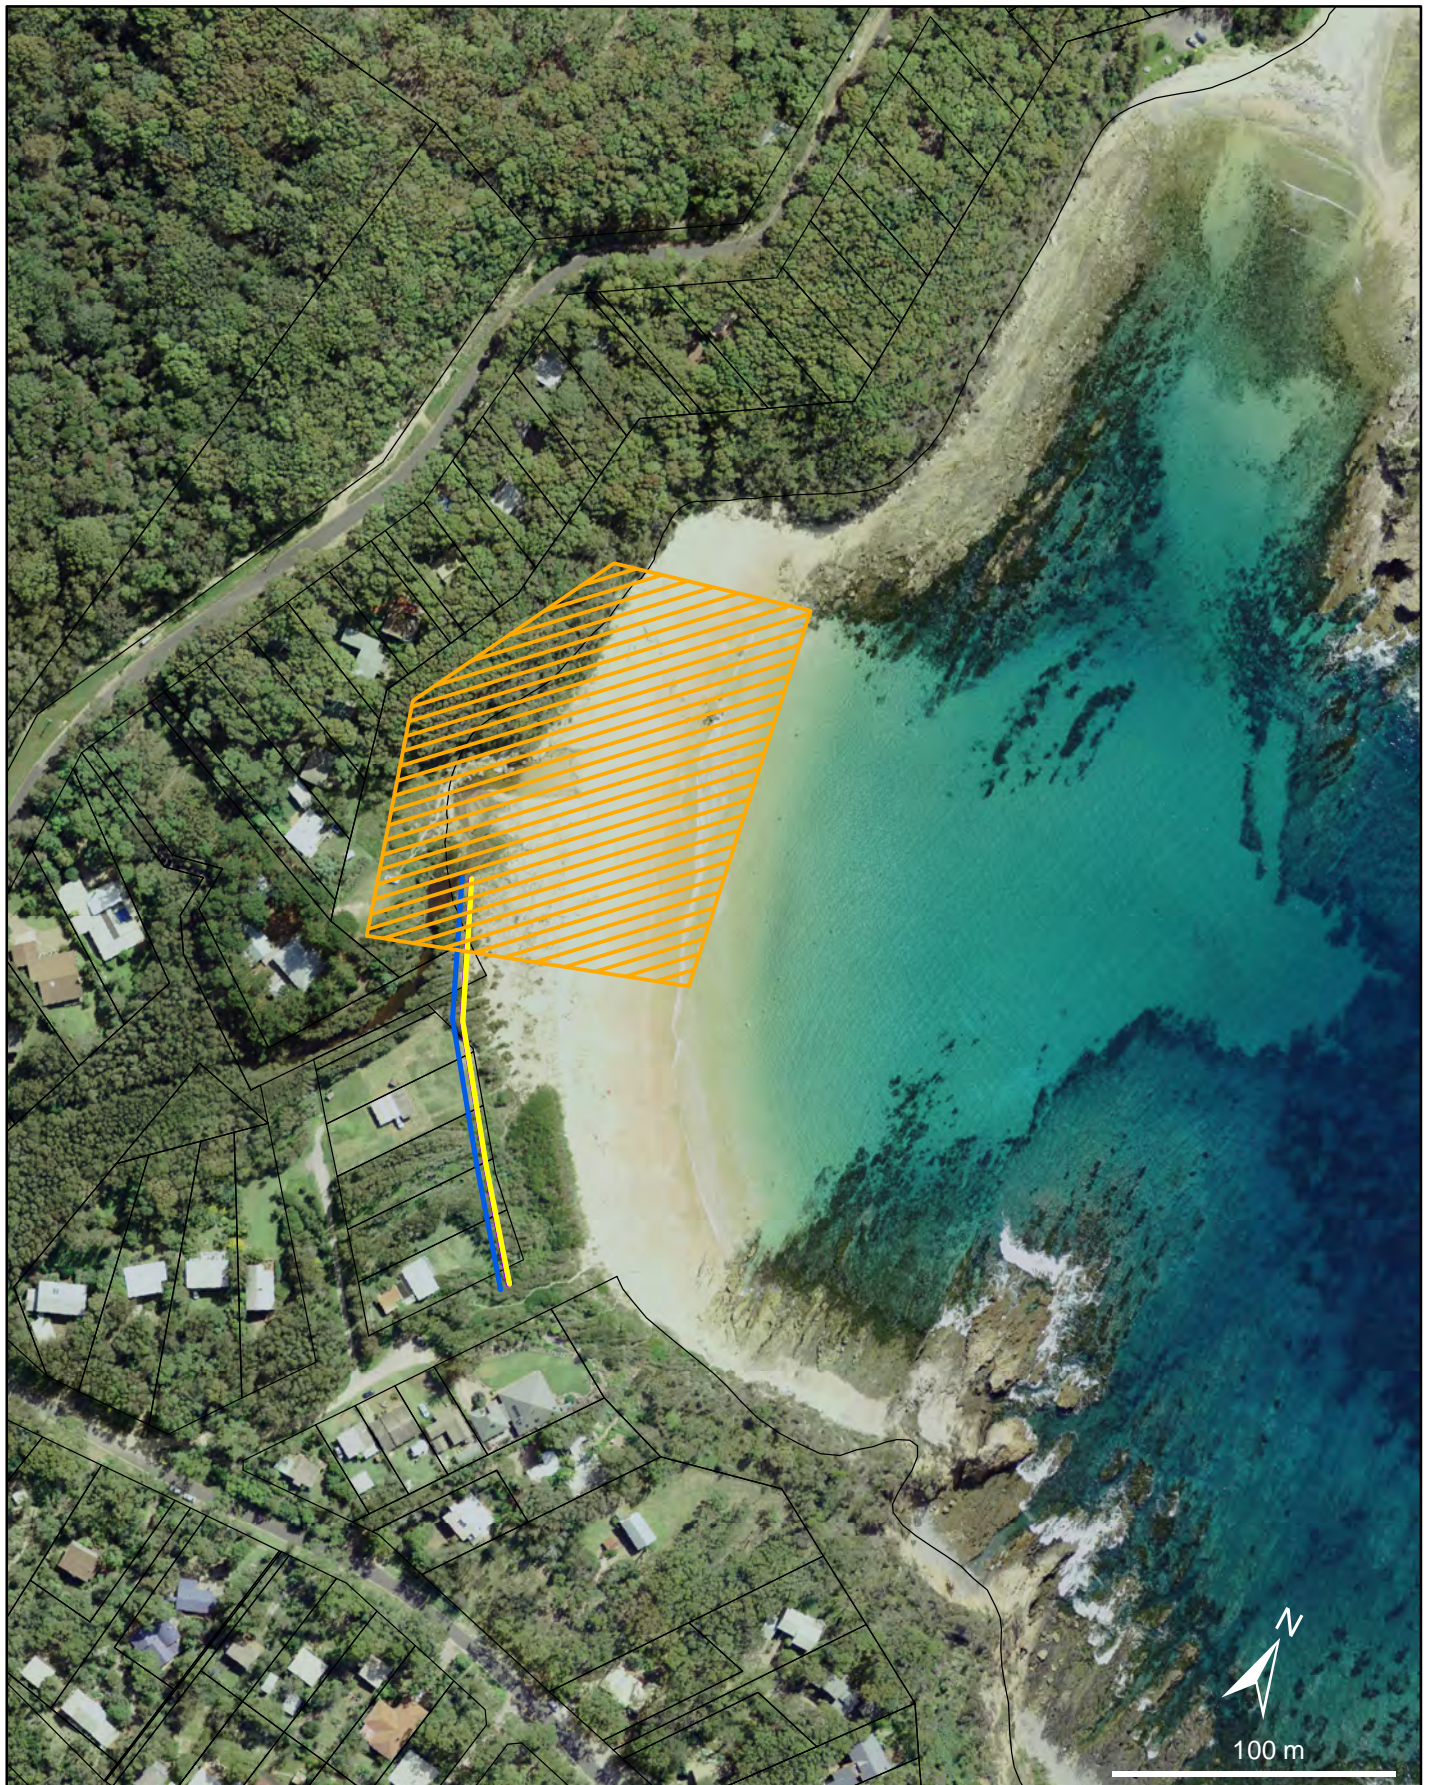
Figure I.16

Malua Bay no seawall  
1% encounter probability  
Probabilistic erosion/recession hazard lines

Note 1: Landward movement of the shoreline could be limited by the presence of bedrock.

Note 2: The shoreline could potentially move landward of the hazard lines in the watercourse entrance instability region due to lowering of the beach profile from entrance scouring.

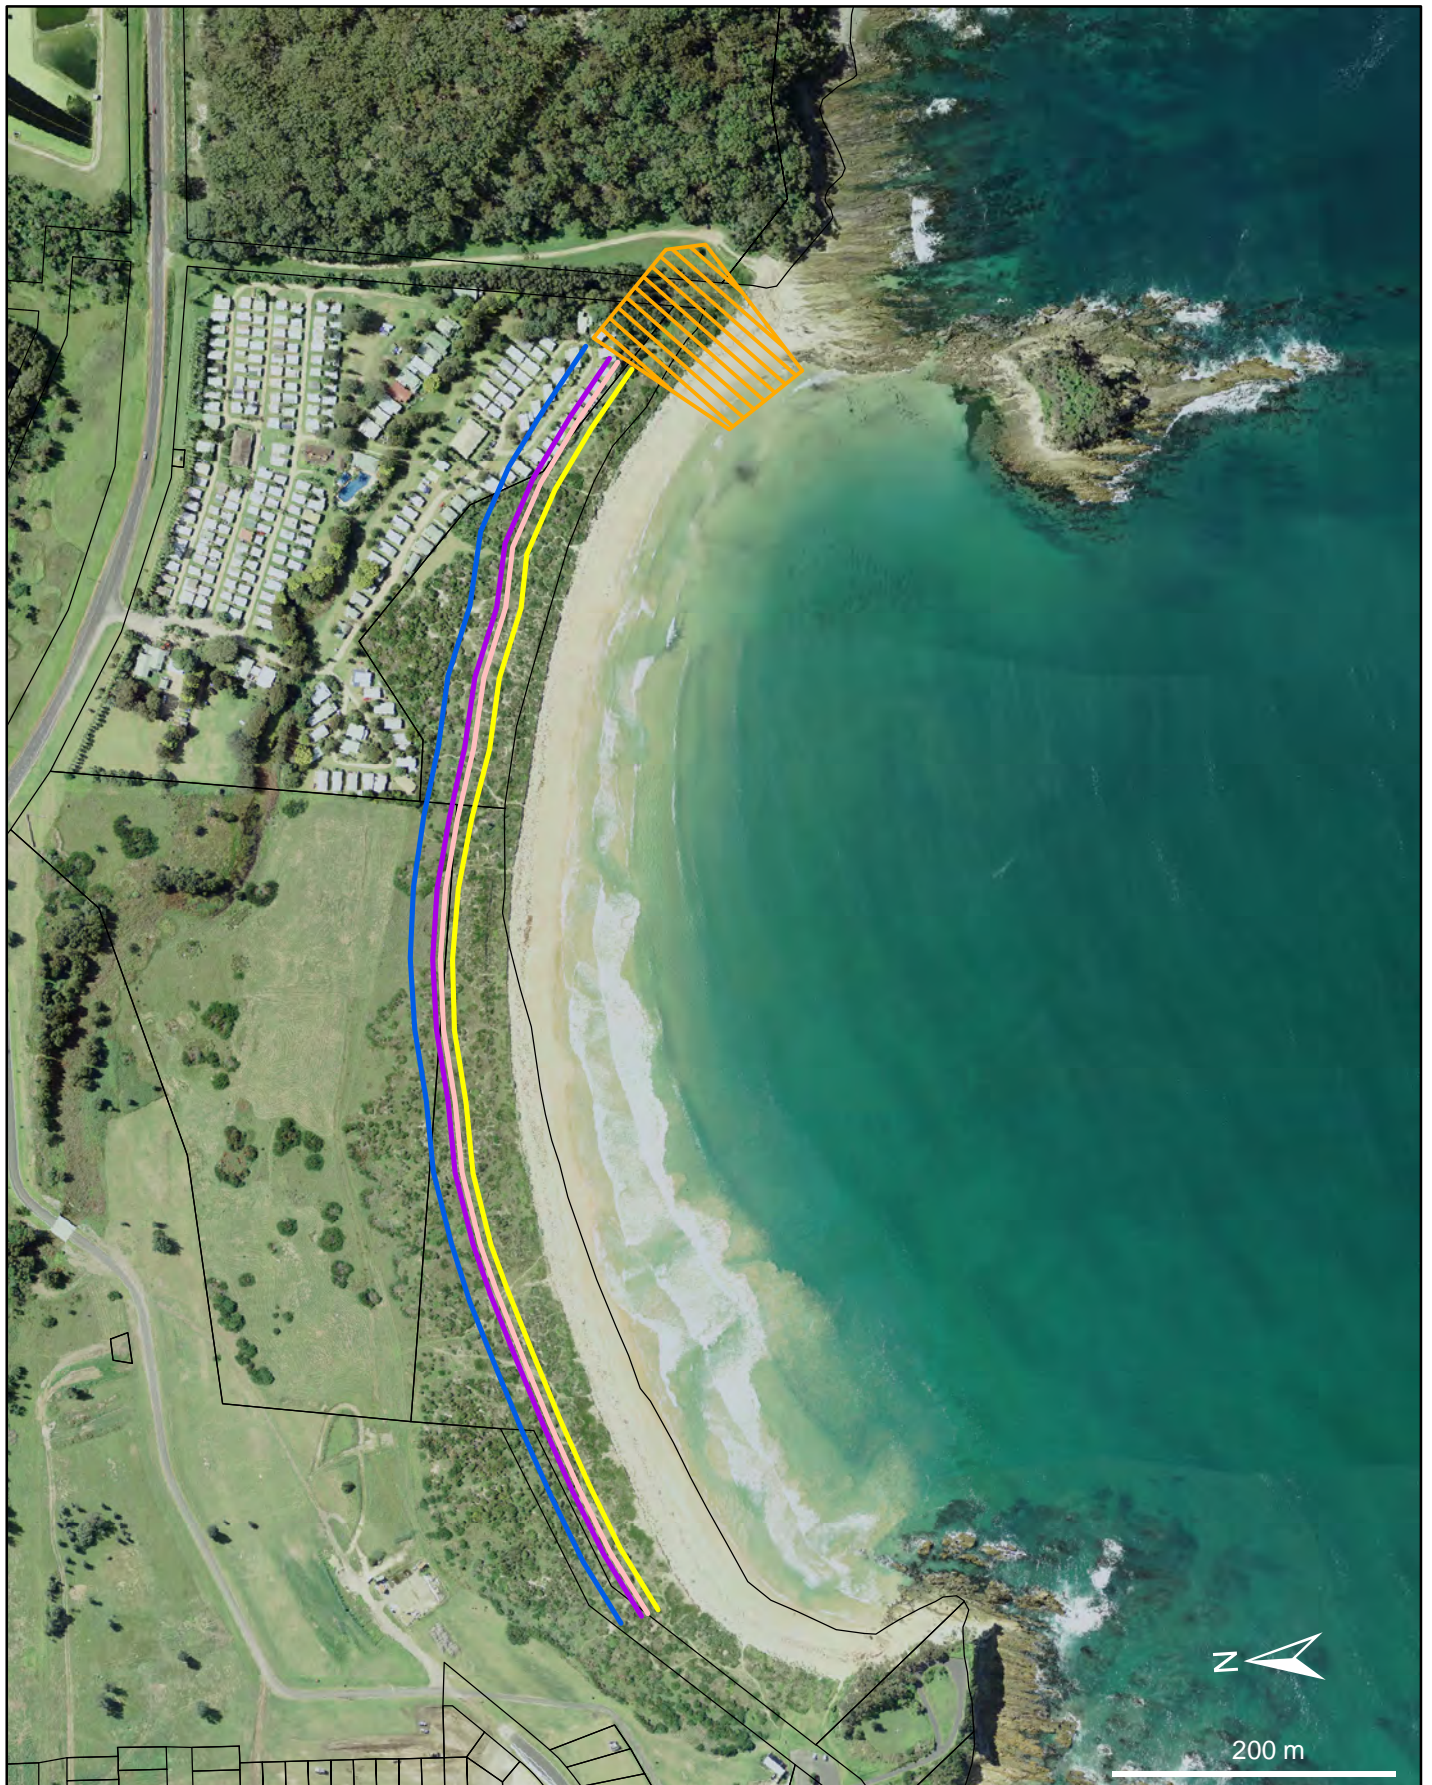
Figure I.17

Note 1: Landward movement of the shoreline could be limited by the presence of bedrock.

Note 2: The shoreline could potentially move landward of the hazard lines in the watercourse entrance instability region due to lowering of the beach profile from entrance scouring.

Note 3: Hazard lines do not extend to the western end of the beach as this is the limit of available photogrammetry.

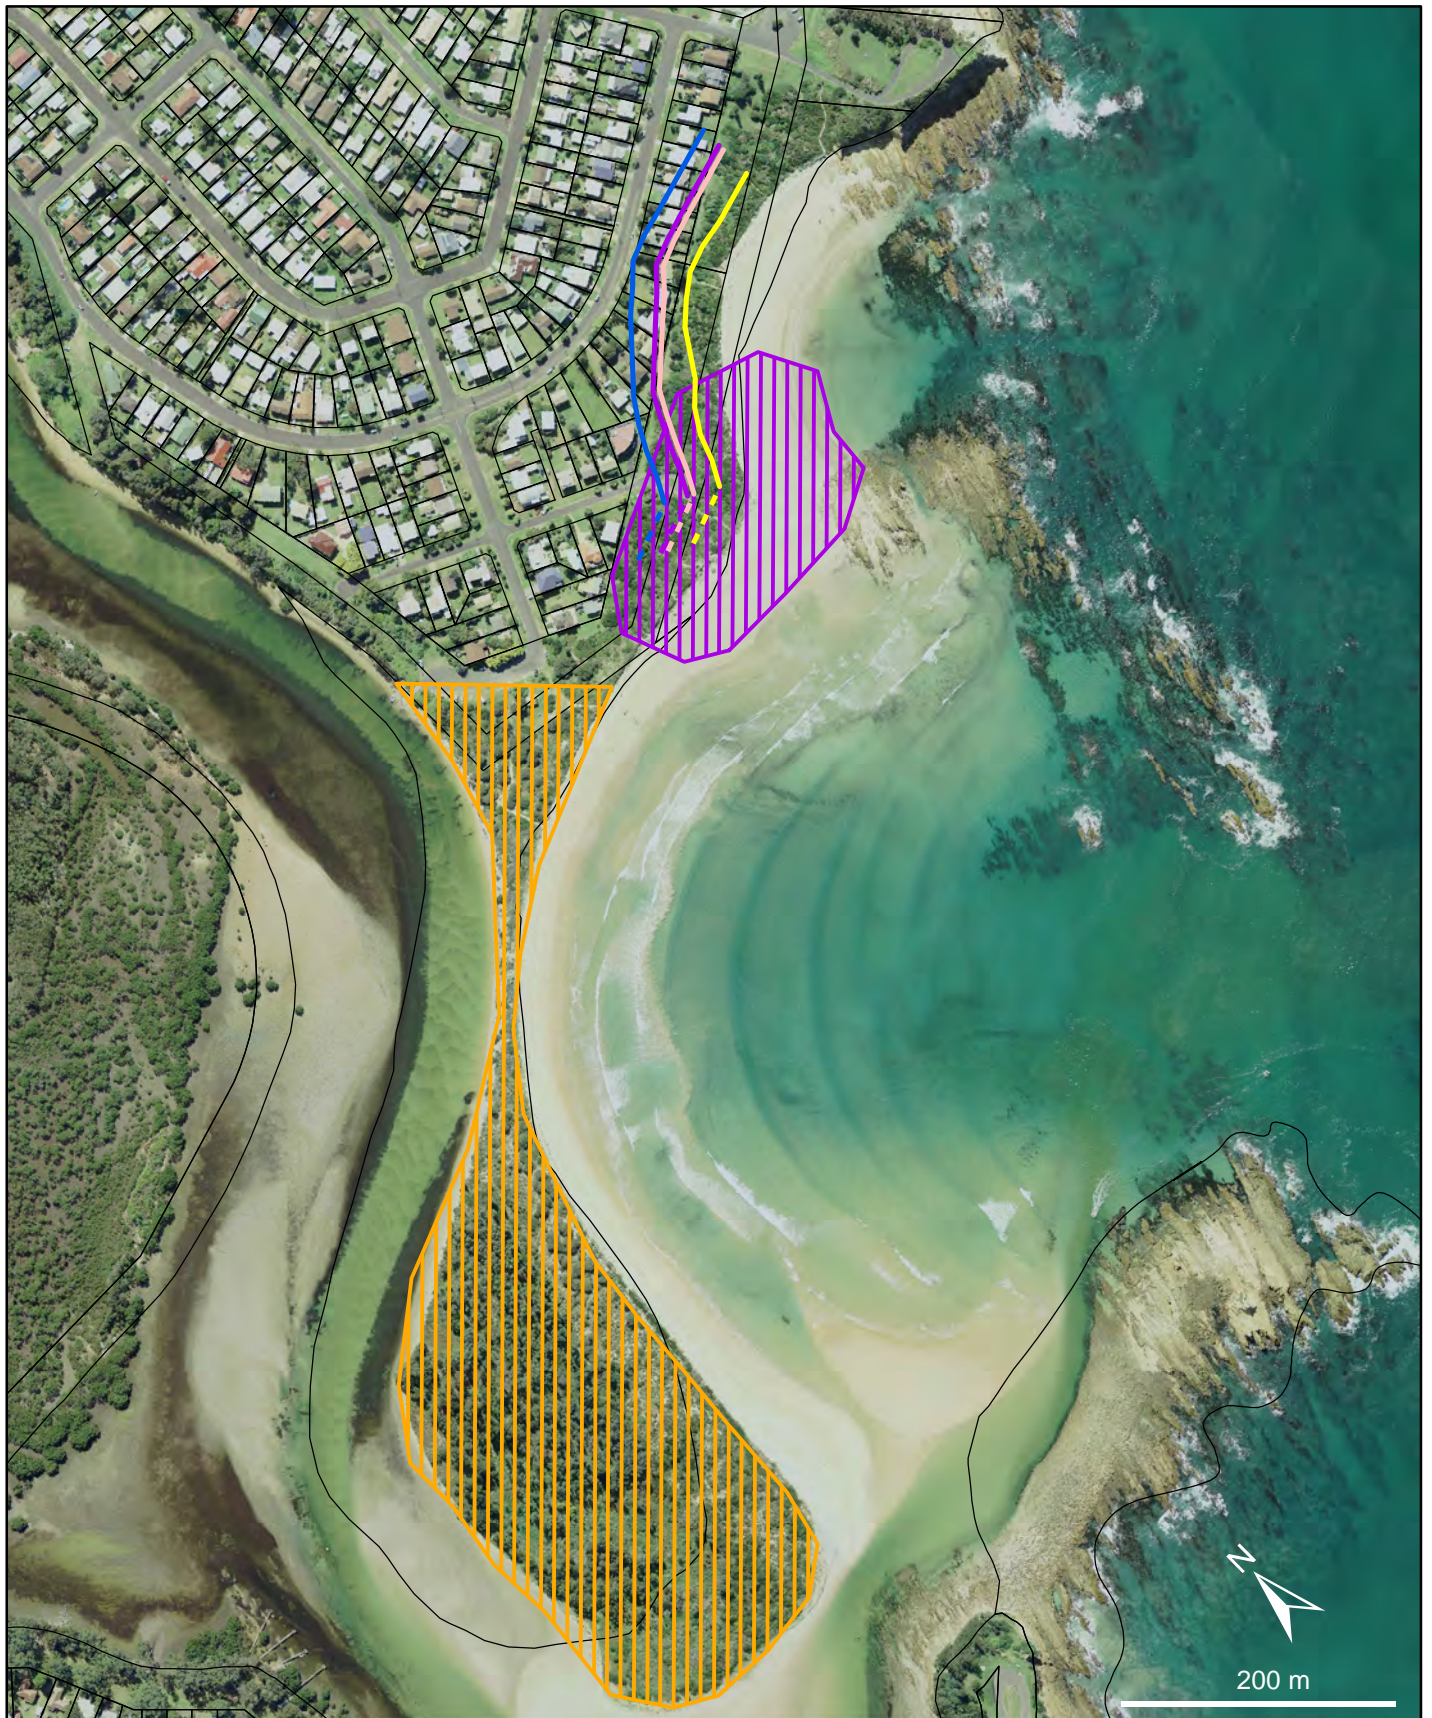
Figure I.18

Note 1: Landward movement of the shoreline could be limited by the presence of bedrock.

Note 2: The watercourse entrance instability region is potentially subject to breakthrough from the Tomaga River and modified sand transport processes.

Note 3: Potential for salient loss cannot be fully quantified with contemporary desktop engineering techniques. The shoreline could potentially move landward of the hazard lines in this region due to sea level rise or other coastal processes.

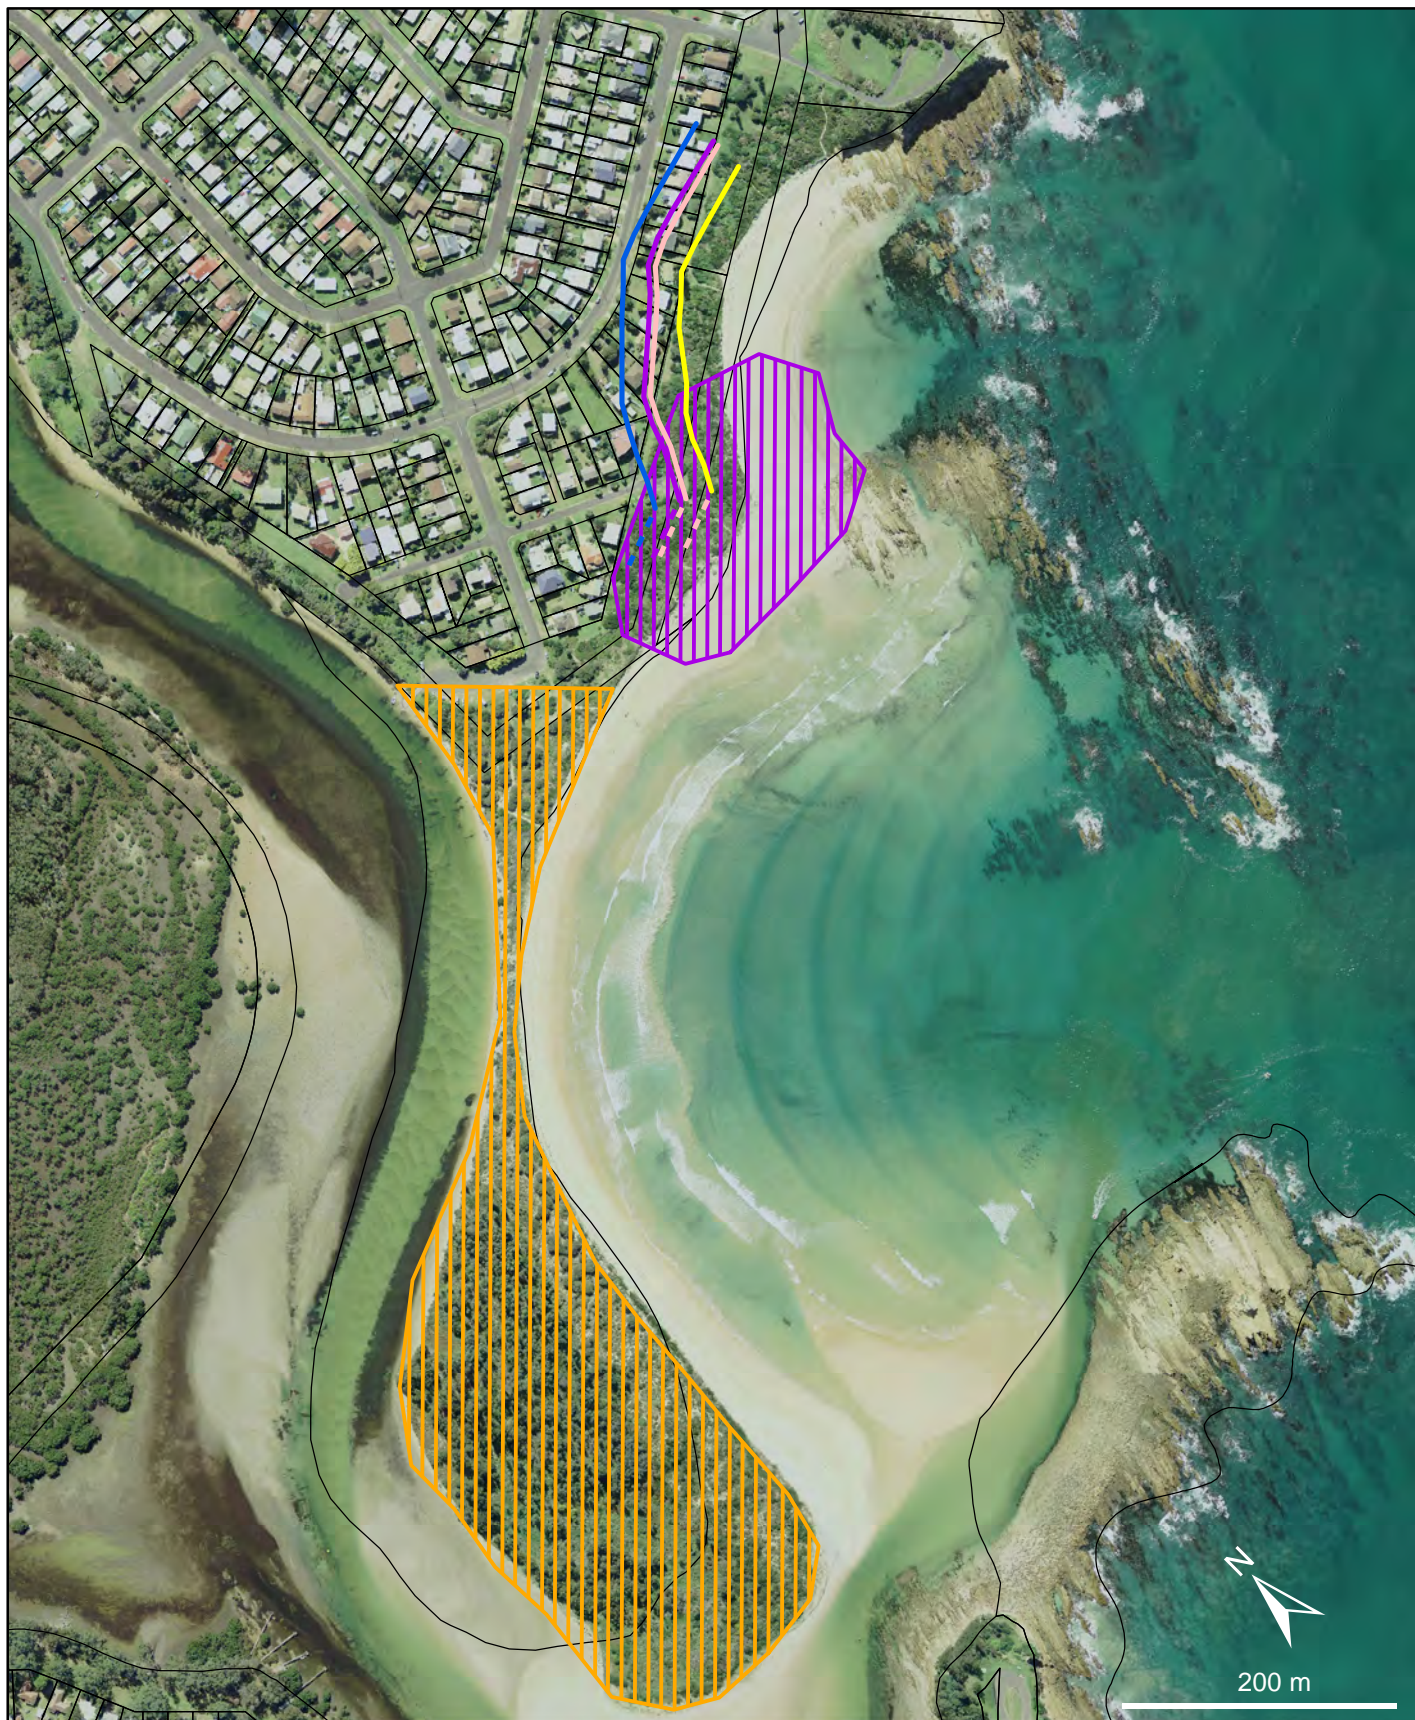
Figure I.19

Note 1: Landward movement of the shoreline could be limited by the presence of bedrock.

Note 2: The watercourse entrance instability region is potentially subject to breakthrough from the Tomaga River and modified sand transport processes.

Note 3: Potential for salient loss cannot be fully quantified with contemporary desktop engineering techniques. The shoreline could potentially move landward of the hazard lines in this region due to sea level rise or other coastal processes.

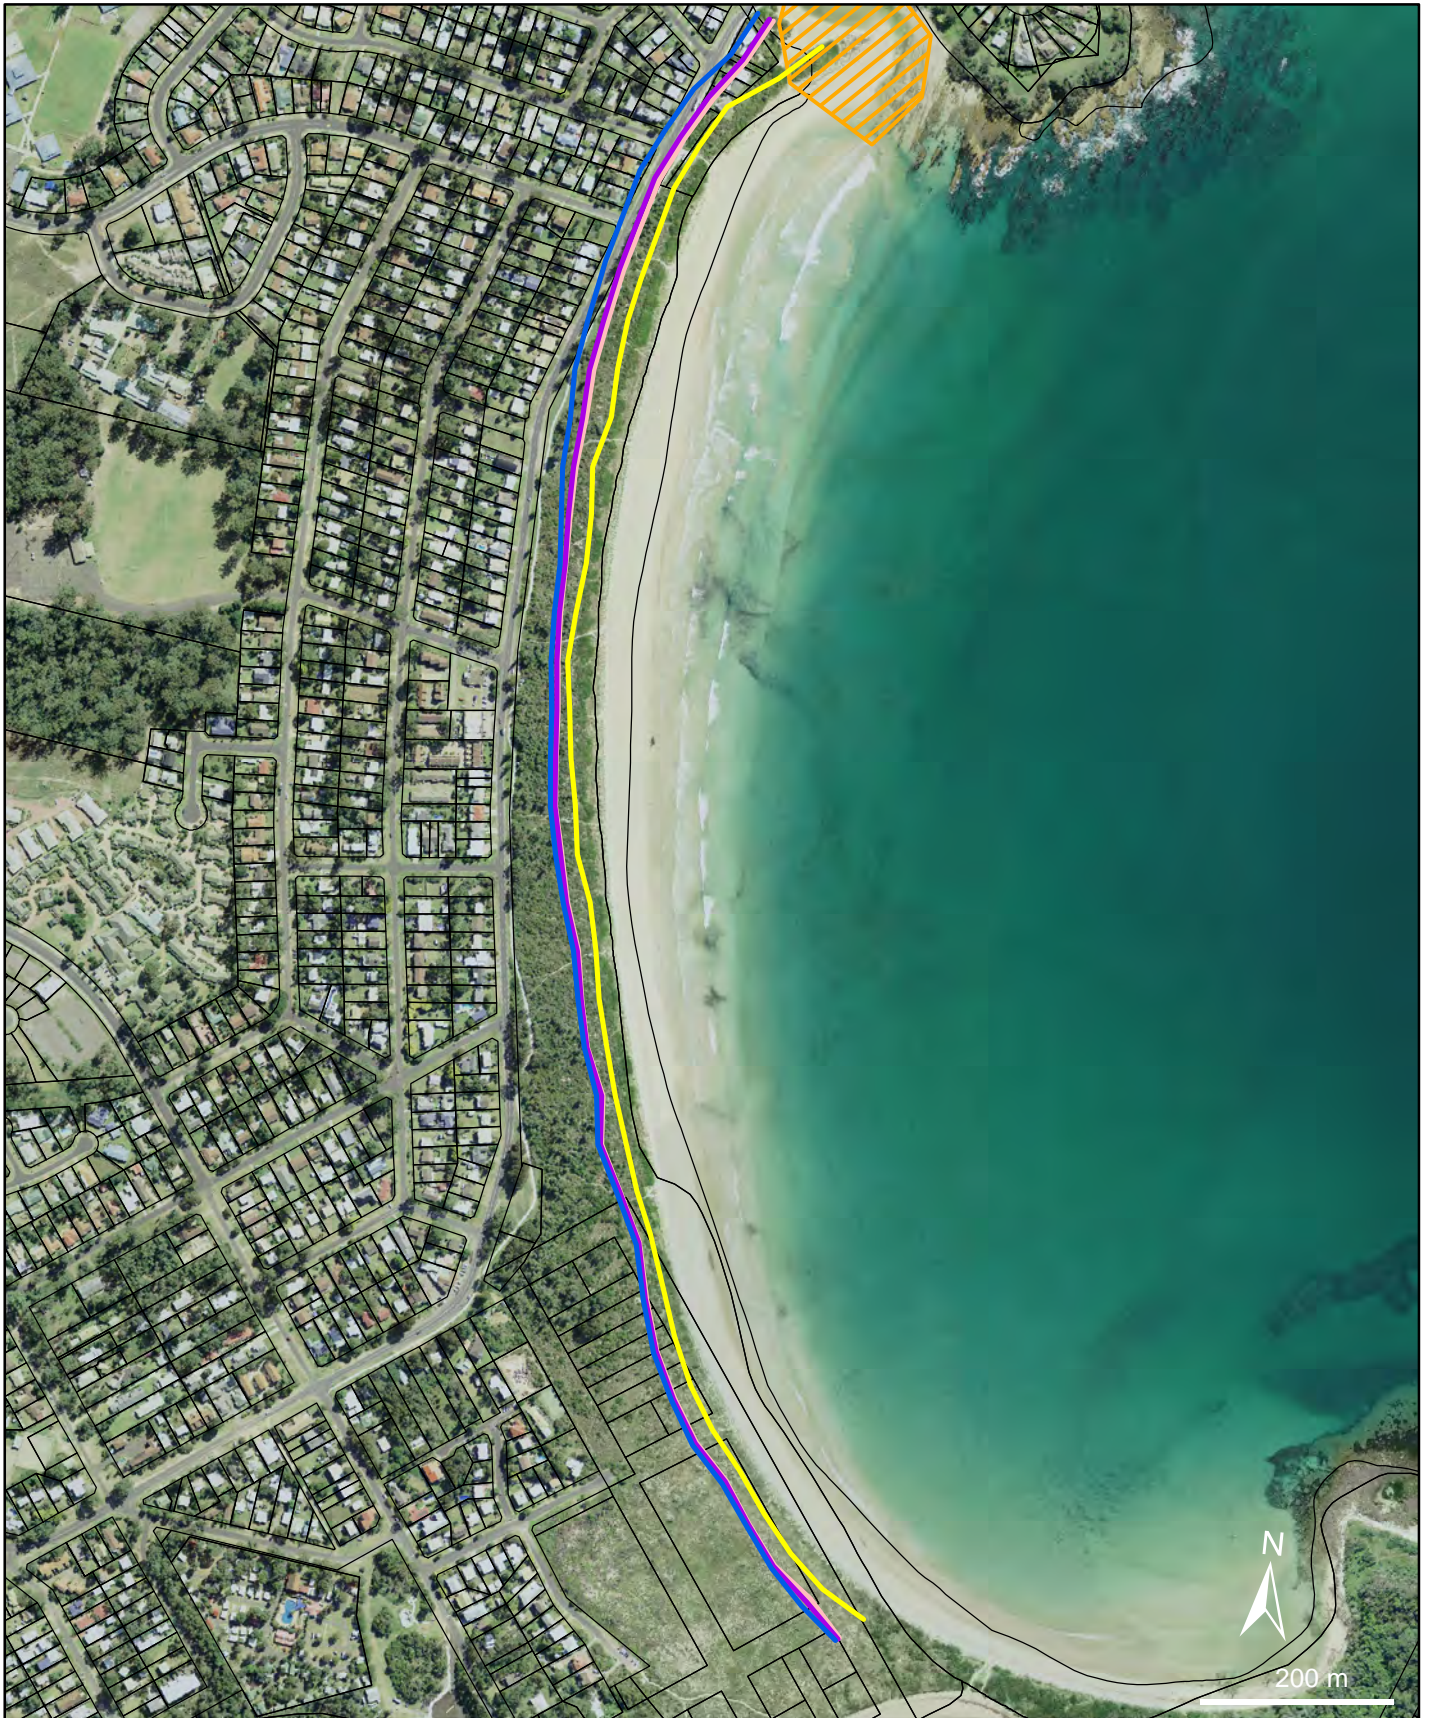
Note 1: Landward movement of the shoreline could be limited by the presence of bedrock.  
 Note 2: The shoreline could potentially move landward of the hazard lines in the watercourse entrance instability region due to lowering of the beach profile from entrance scouring.
