## Eurobodalla Coastal Hazard Assessment

WRL Technical Report 2017/09  
October 2017

By I R Coghlan, J T Carley, A J Harrison, D Howe, A D Short,  
J E Ruprecht, F Flocard and P F Rahman

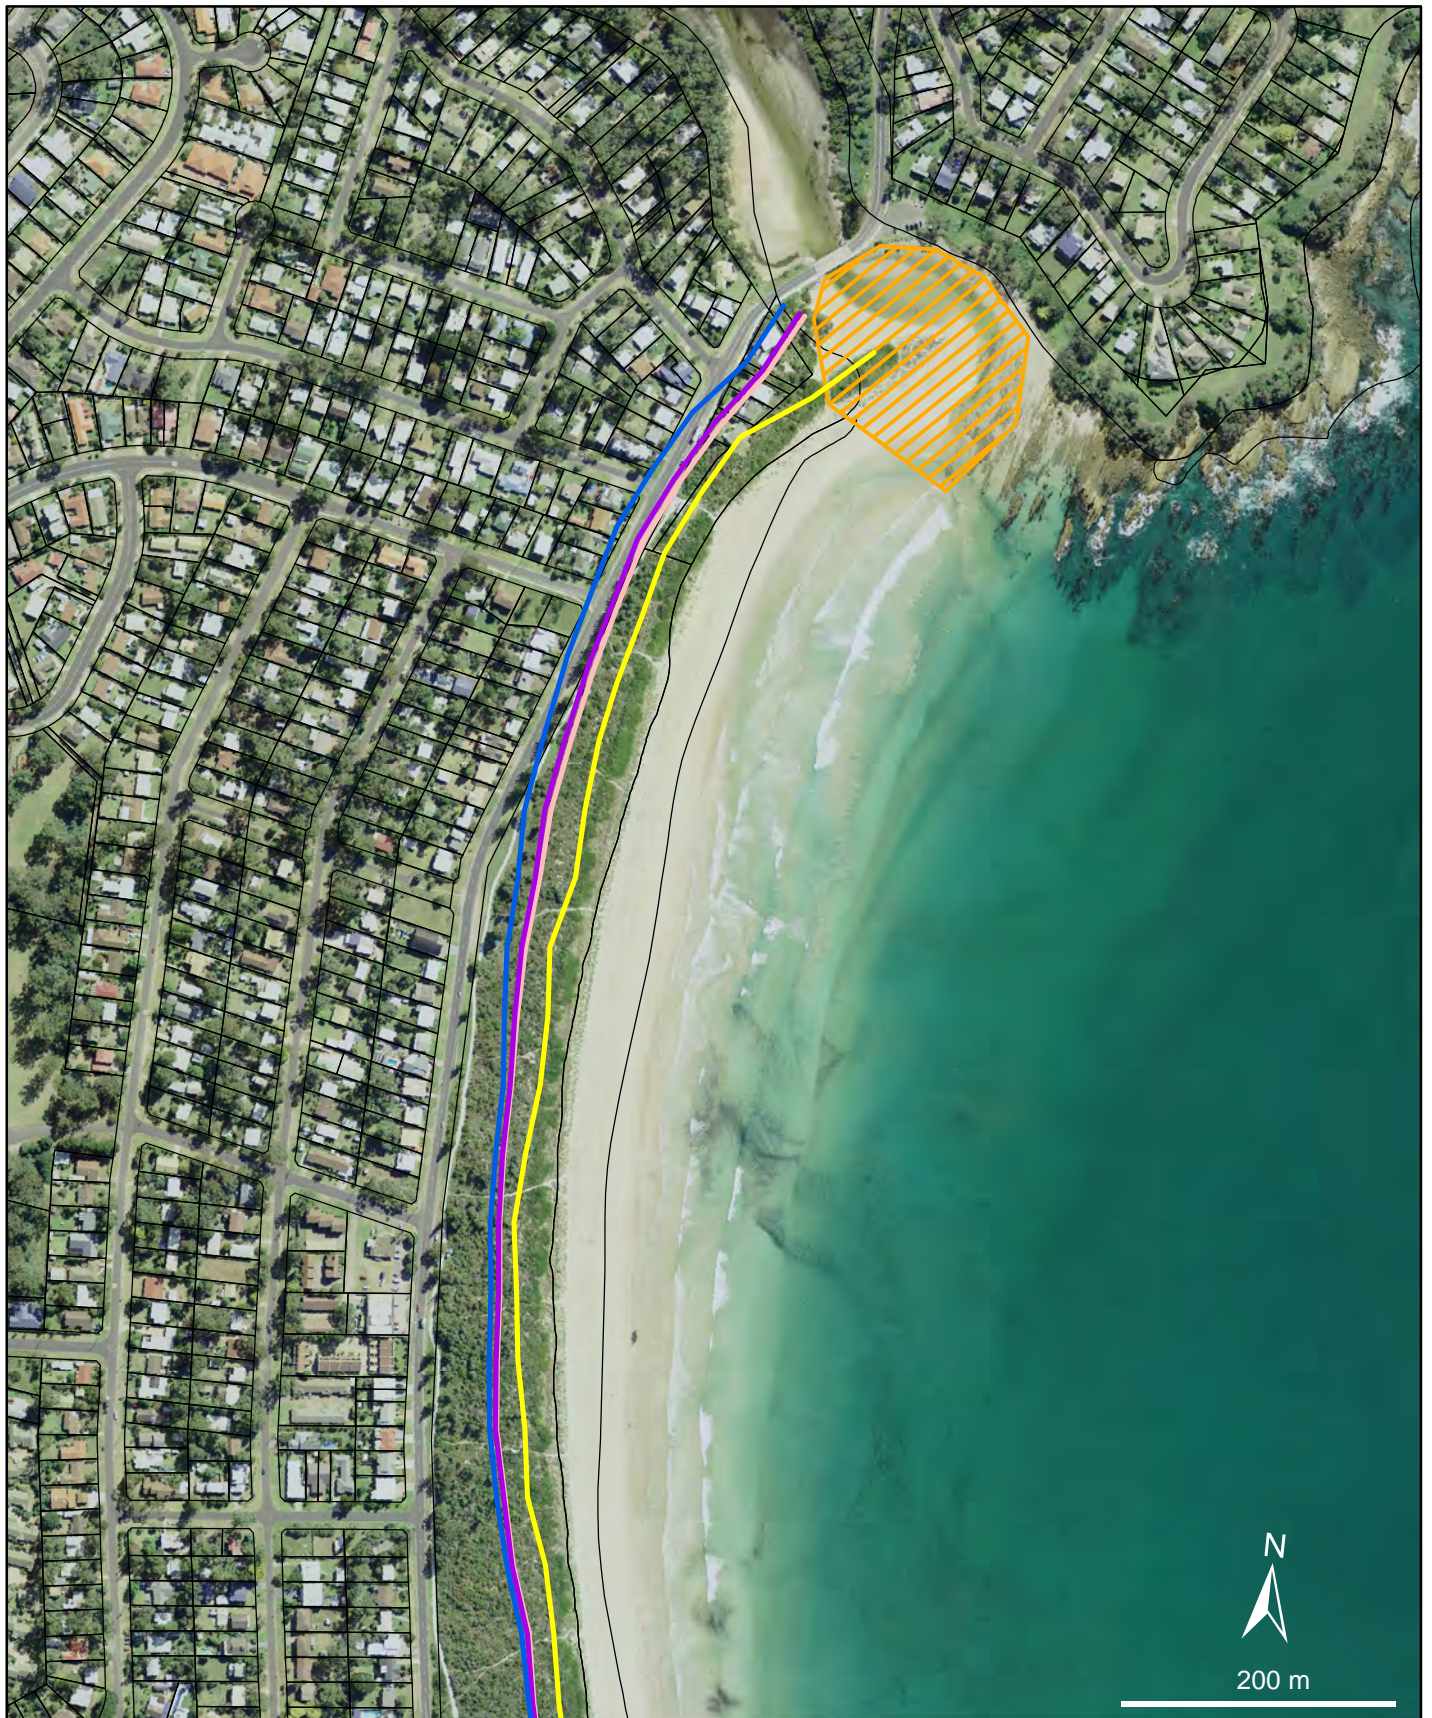
Figure I.21

Broulee Beach island attached  
 5% encounter probability  
 Probabilistic erosion/recession hazard lines

Note 1: Landward movement of the shoreline could be limited by the presence of bedrock.

Note 2: The shoreline could potentially move landward of the hazard lines in the watercourse entrance instability region due to lowering of the beach profile from entrance scouring.

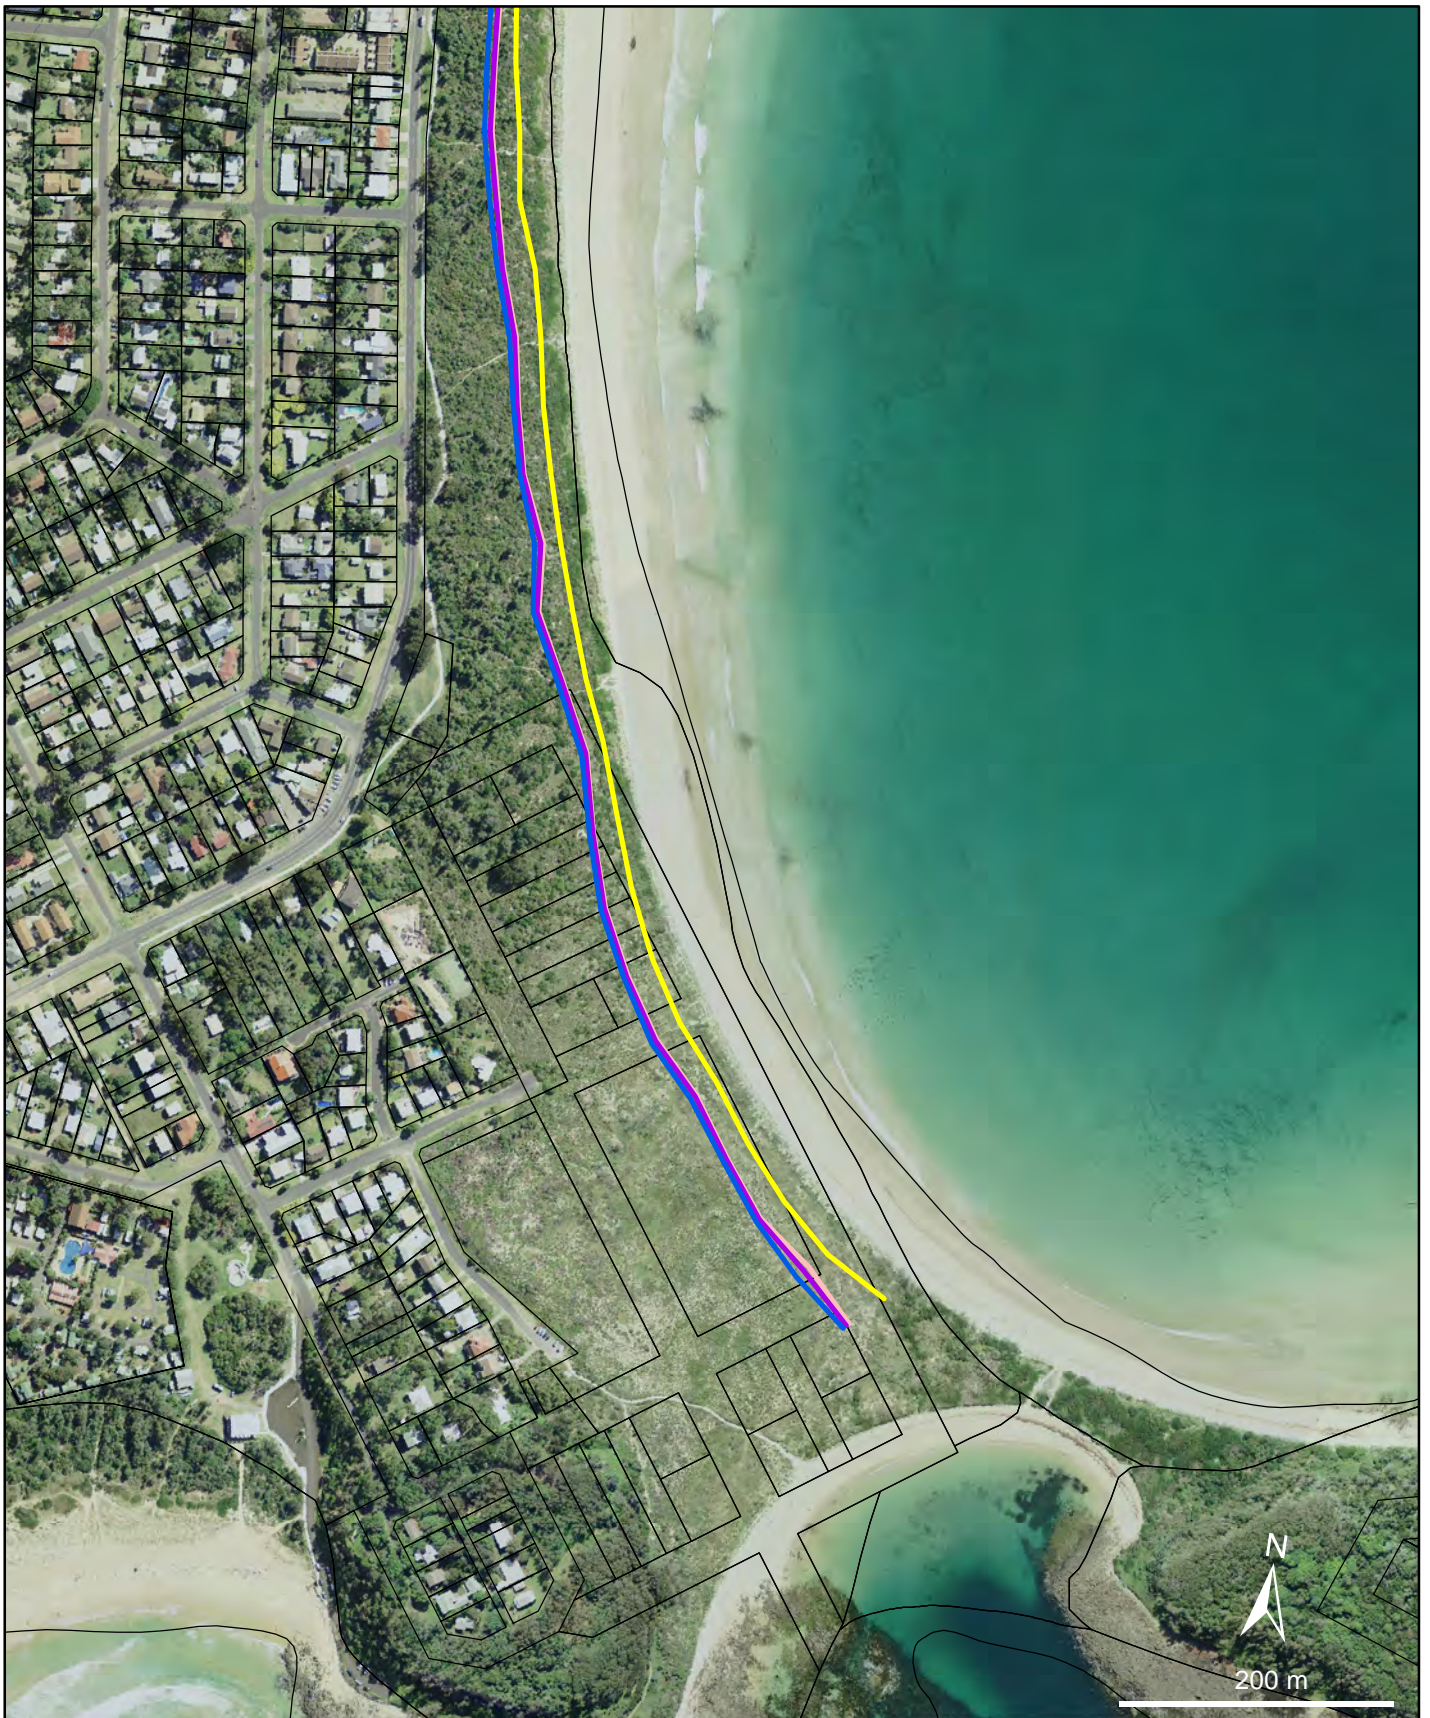
Figure I.22

Note 1: Landward movement of the shoreline could be limited by the presence of bedrock.

Note 2: The shoreline could potentially move landward of the hazard lines in the watercourse entrance instability region due to lowering of the beach profile from entrance scouring.

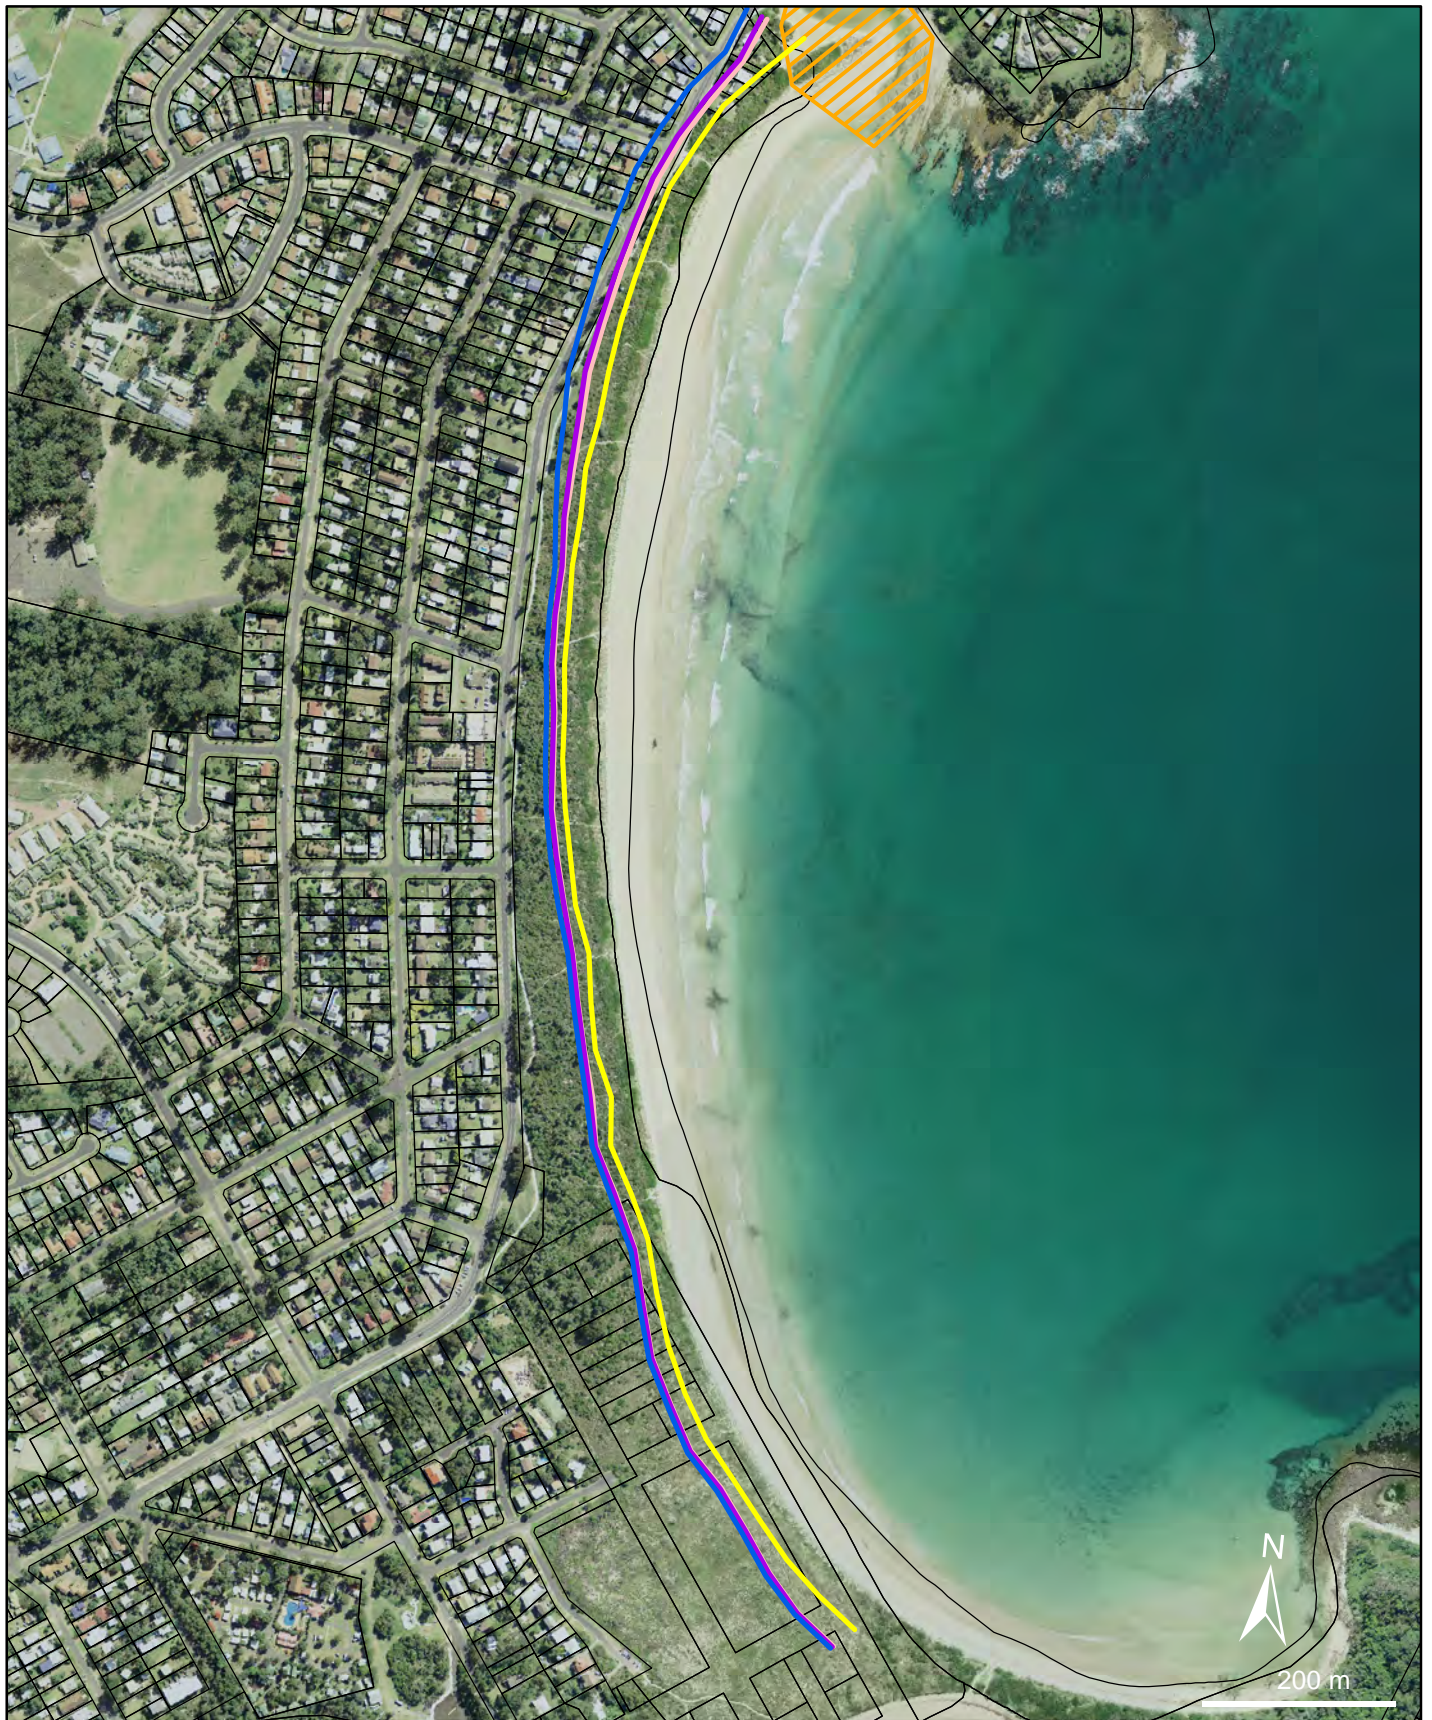
Figure I.23

Note 1: Landward movement of the shoreline could be limited by the presence of bedrock.

Note 2: The shoreline could potentially move landward of the hazard lines in the watercourse entrance instability region due to lowering of the beach profile from entrance scouring.

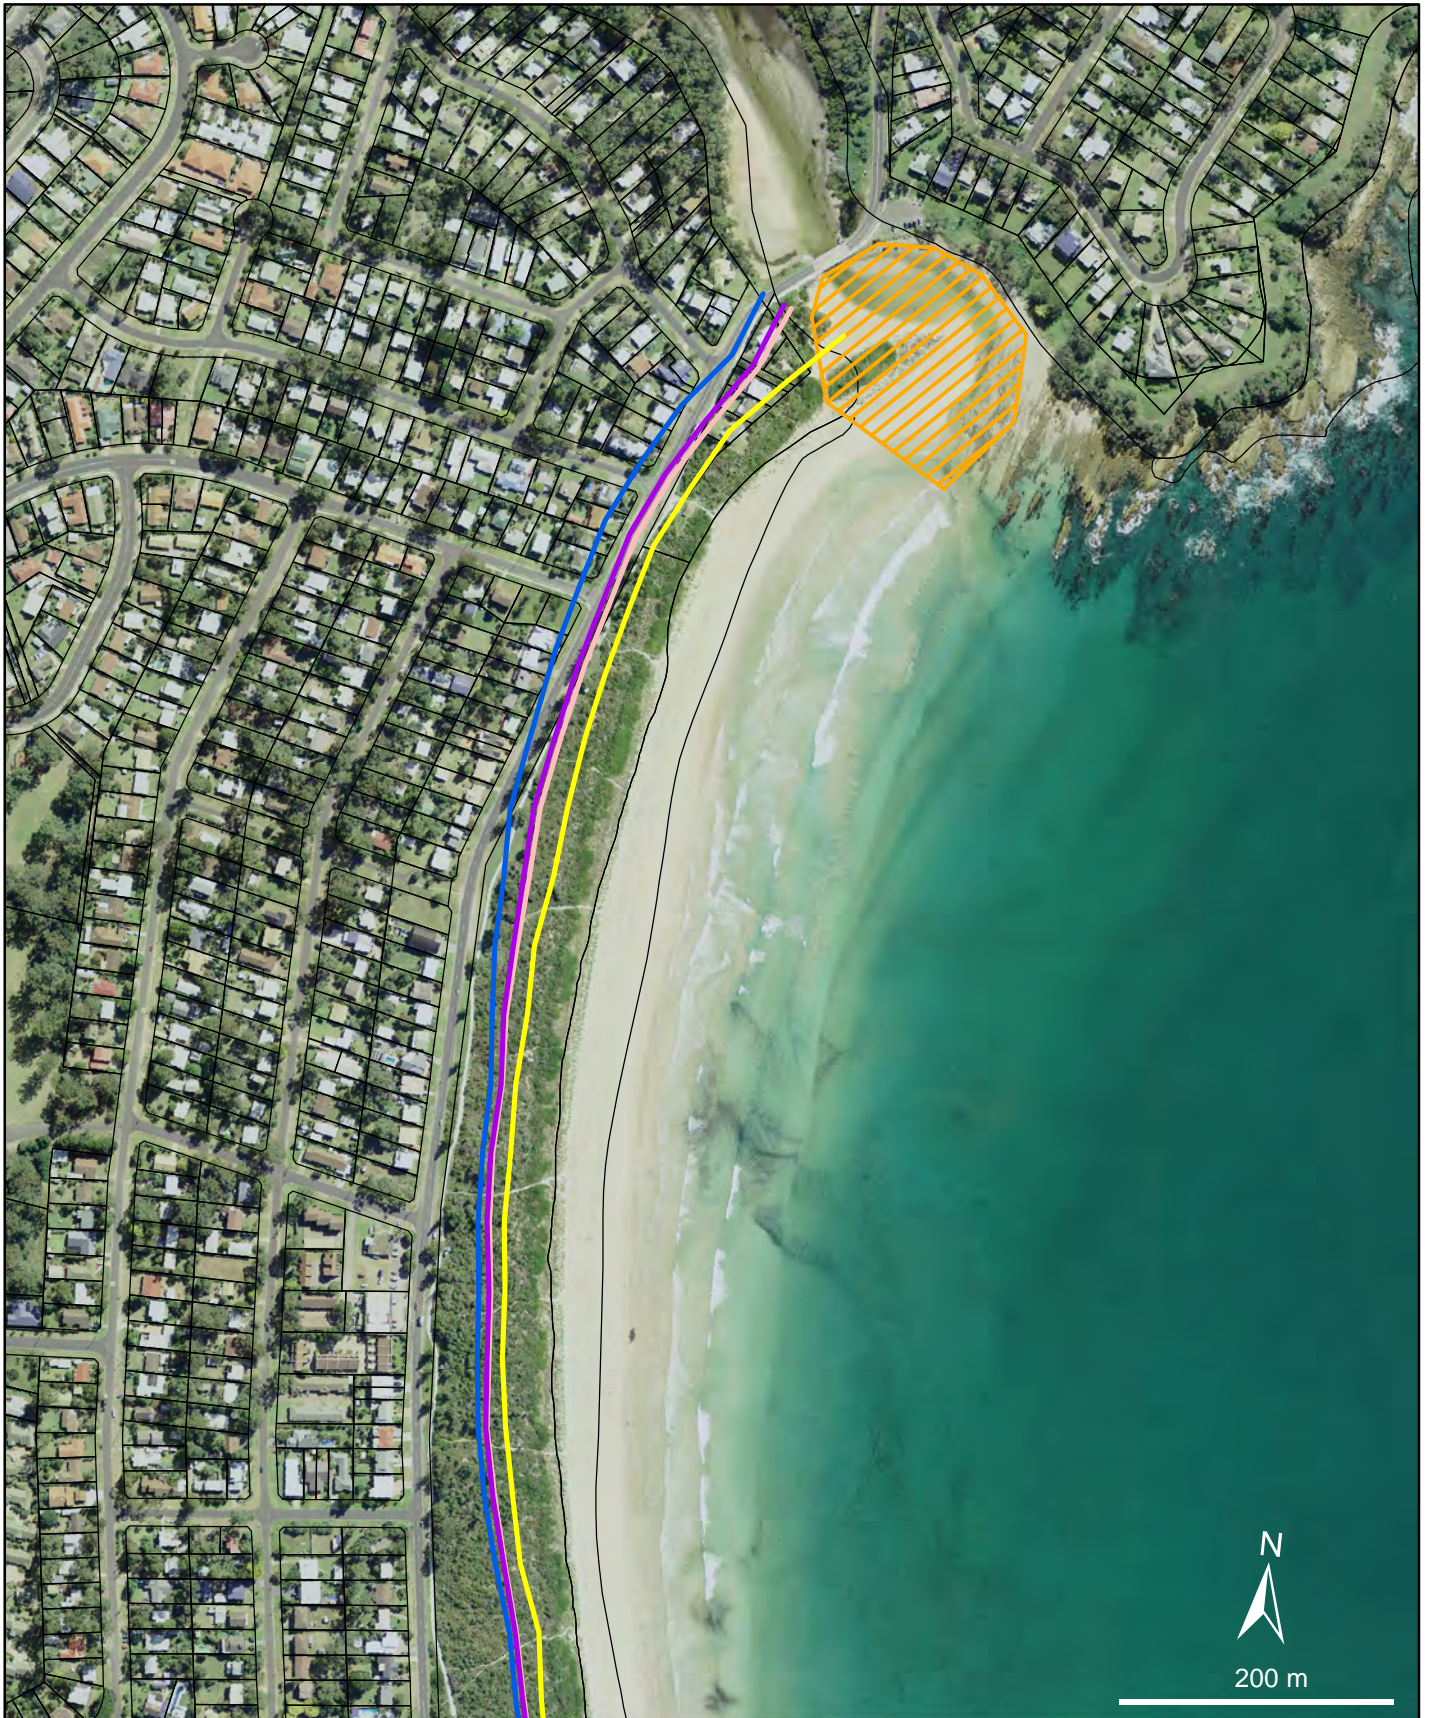
Figure I.24

Note 1: Landward movement of the shoreline could be limited by the presence of bedrock.

Note 2: The shoreline could potentially move landward of the hazard lines in the watercourse entrance instability region due to lowering of the beach profile from entrance scouring.

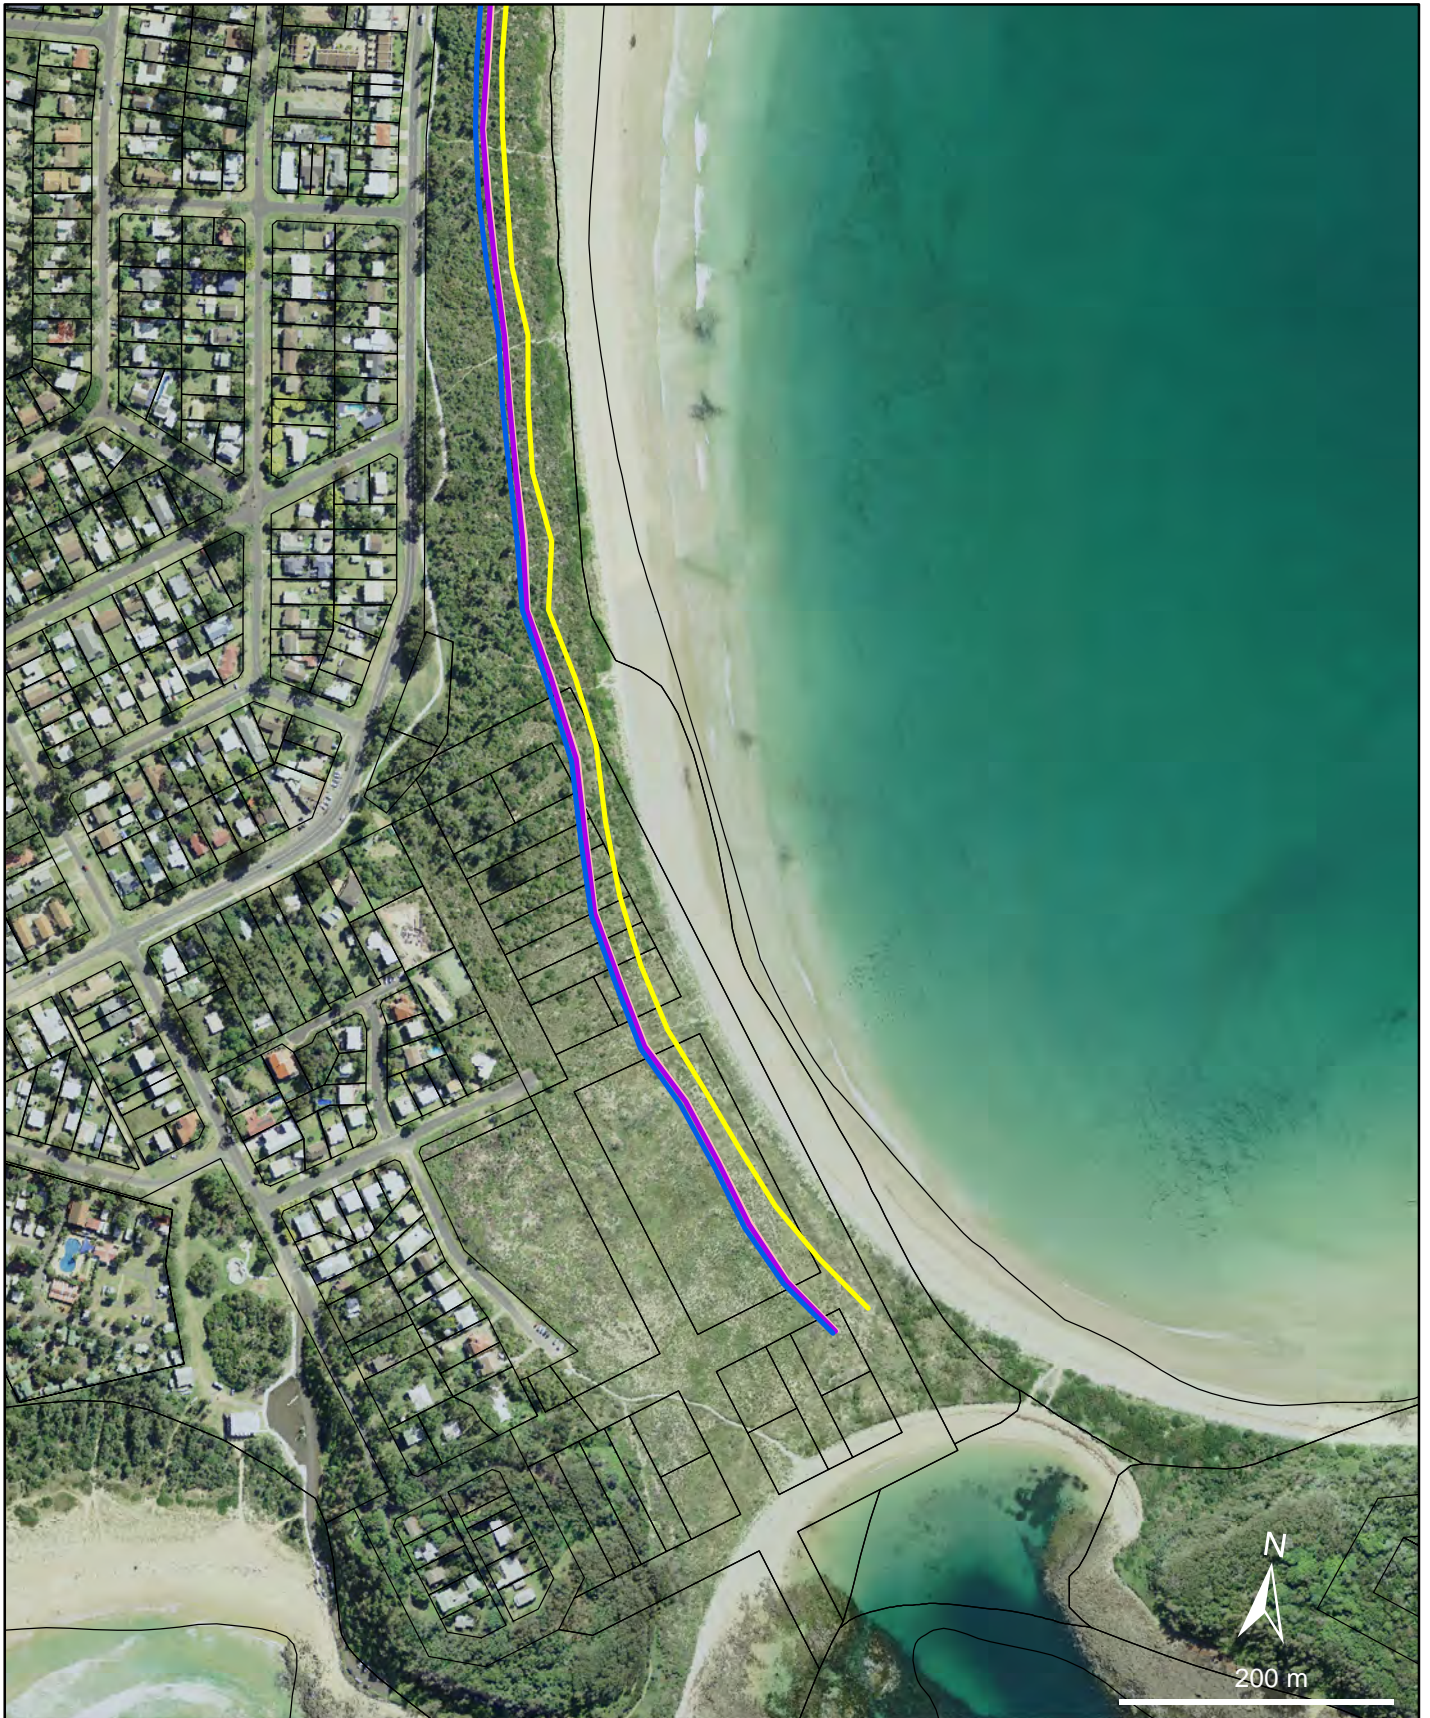
Figure I.25

Note 1: Landward movement of the shoreline could be limited by the presence of bedrock.

Note 2: The shoreline could potentially move landward of the hazard lines in the watercourse entrance instability region due to lowering of the beach profile from entrance scouring.

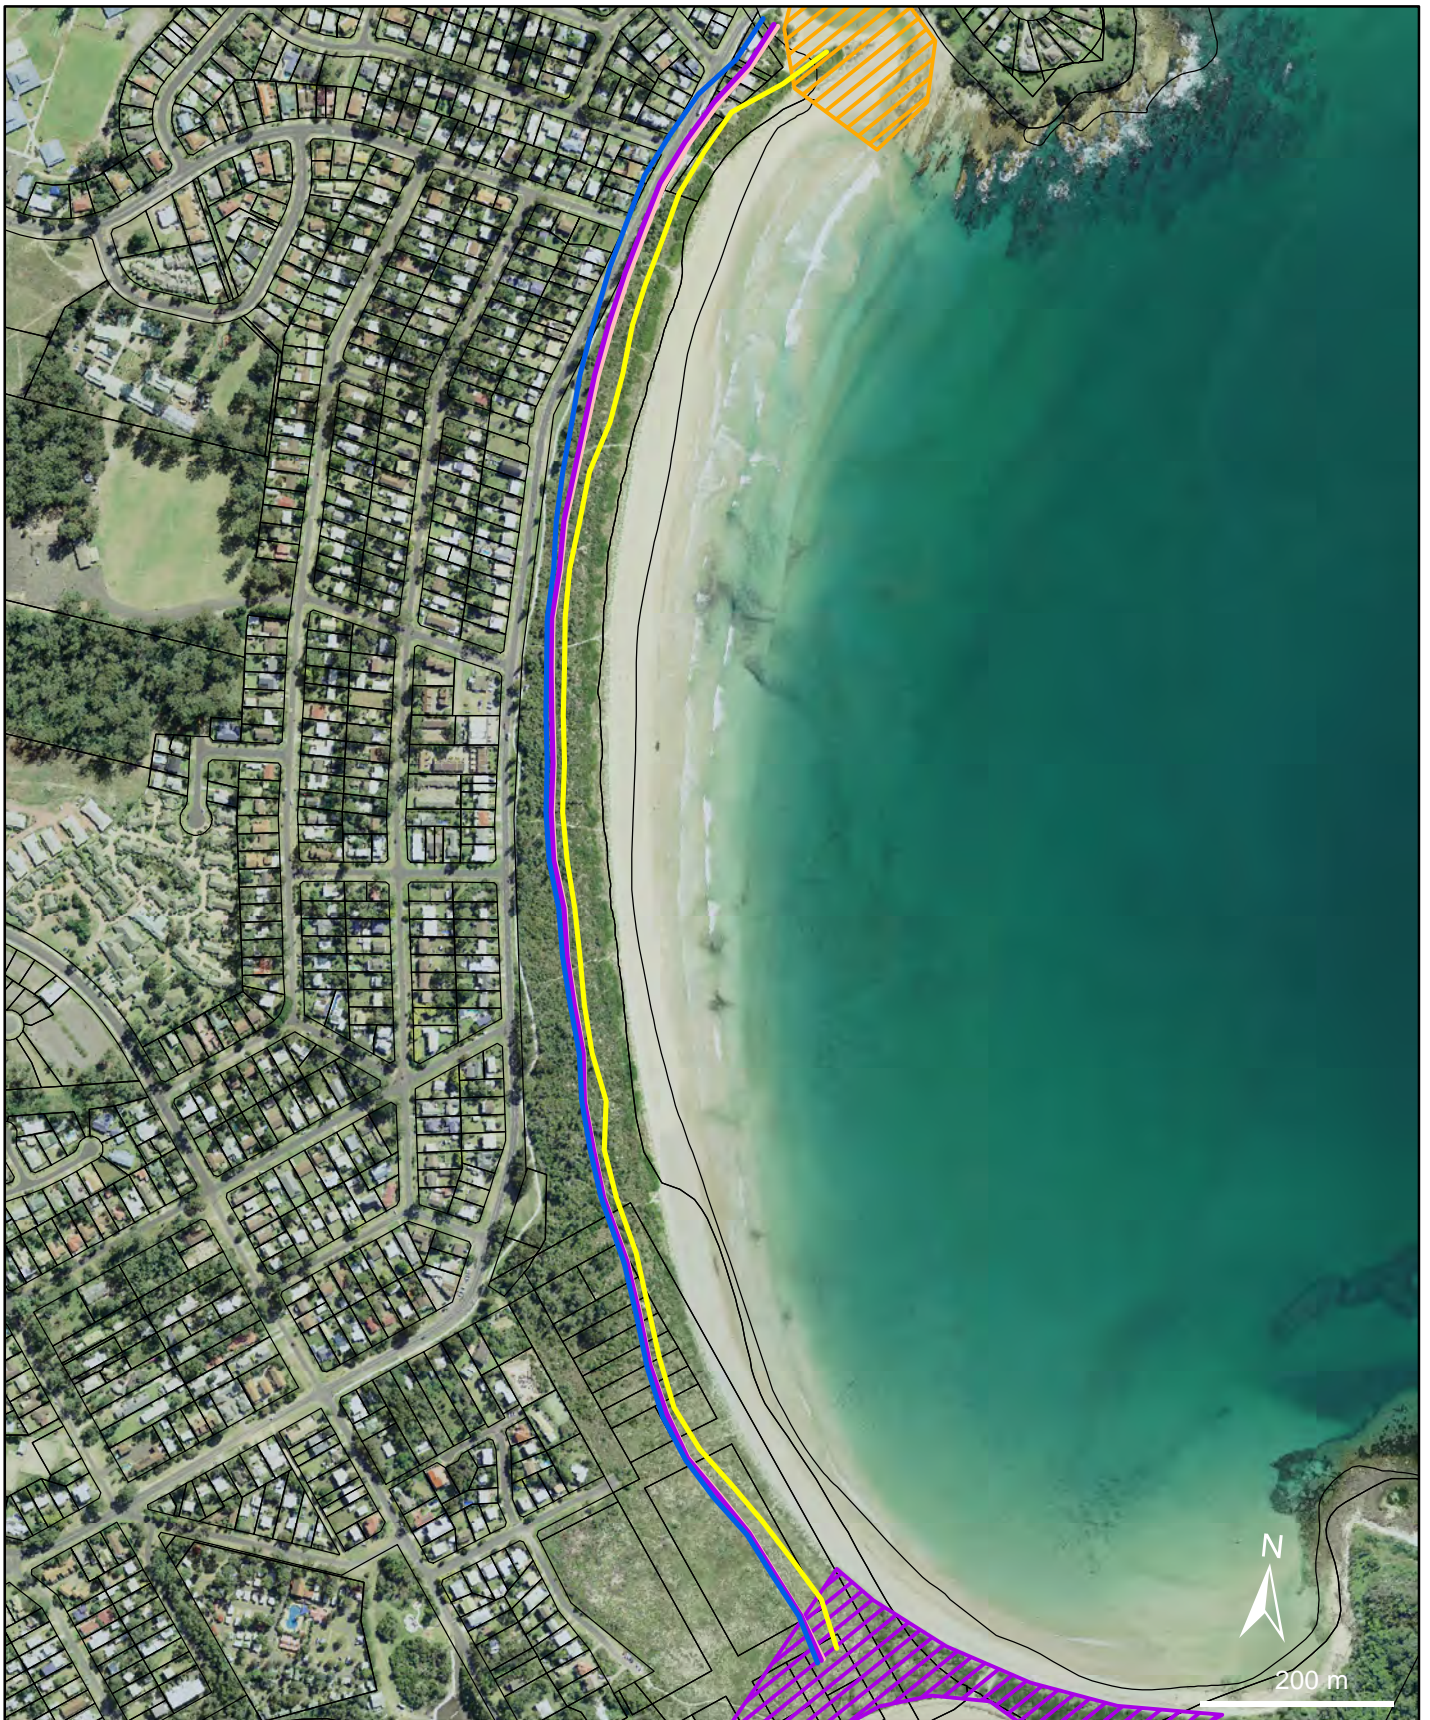
Figure I.26

Note 1: Landward movement of the shoreline could be limited by the presence of bedrock.

Note 2: The shoreline could potentially move landward of the hazard lines in the watercourse entrance instability region due to lowering of the beach profile from entrance scouring.

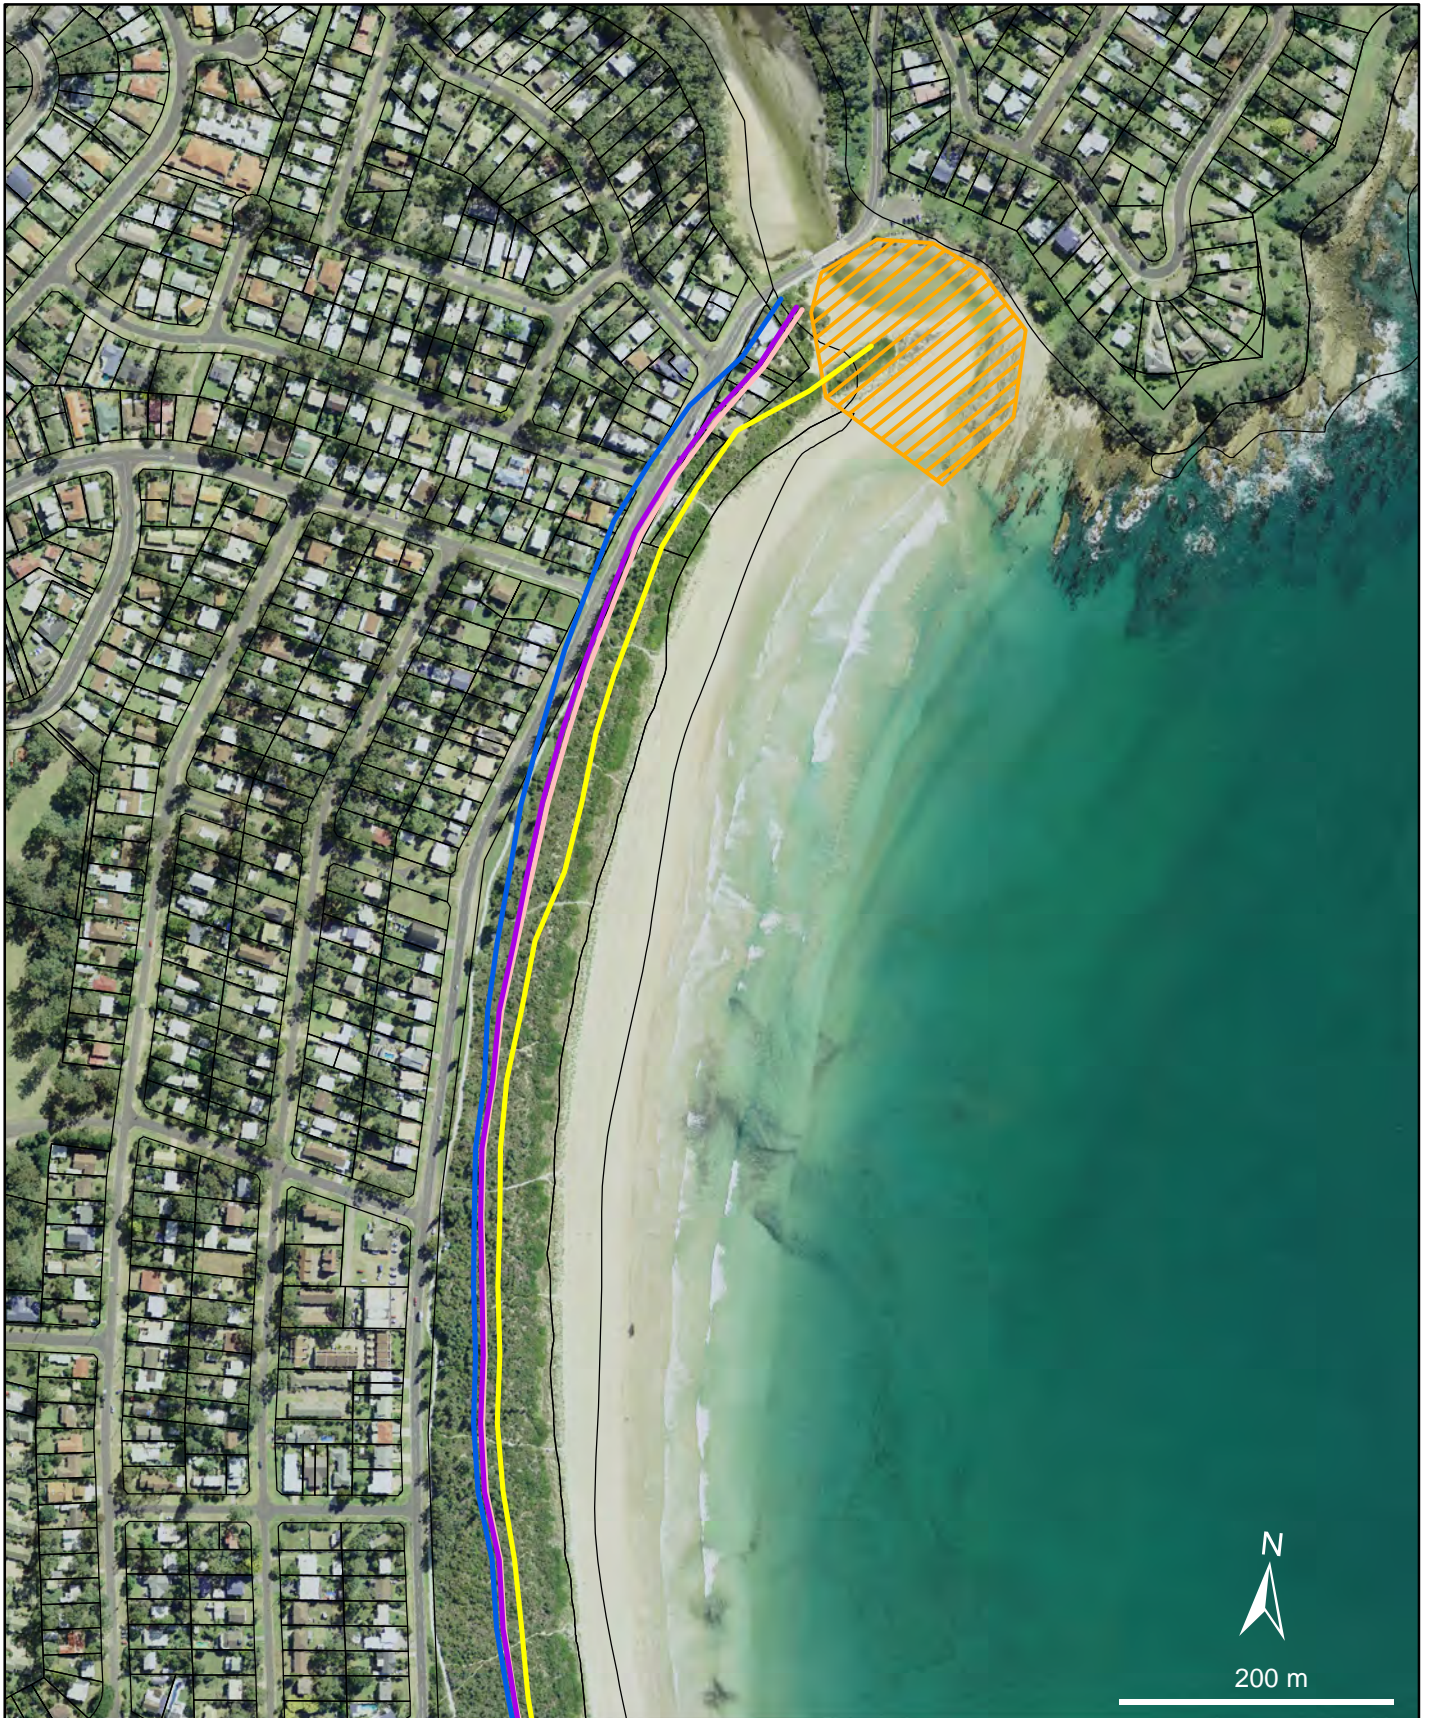
Figure I.27

Note 1: Landward movement of the shoreline could be limited by the presence of bedrock.

Note 2: The shoreline could potentially move landward of the hazard lines in the watercourse entrance instability region due to lowering of the beach profile from entrance scouring.

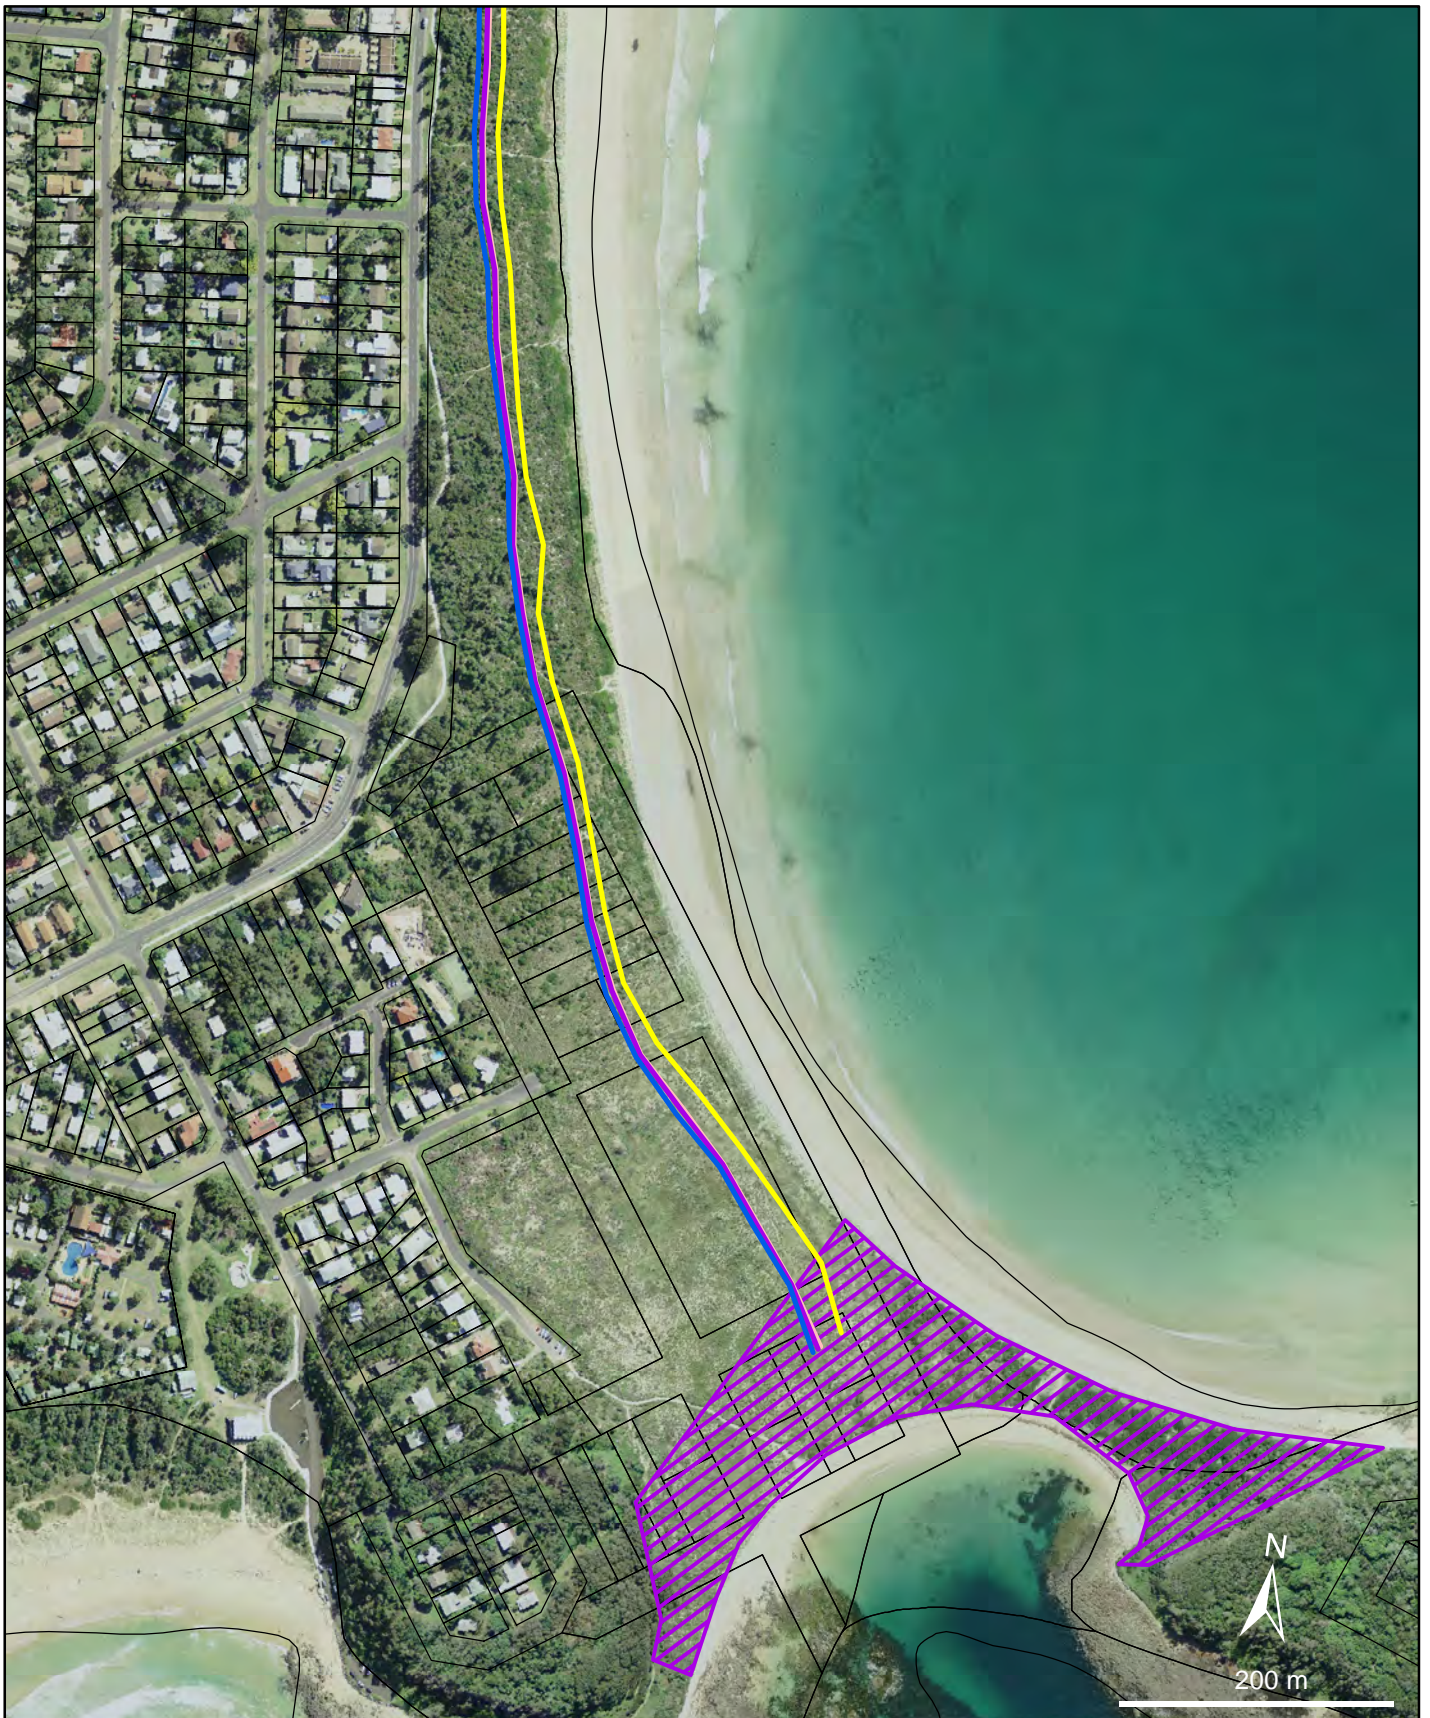
Figure I.28

Note 1: Landward movement of the shoreline could be limited by the presence of bedrock.

Note 2: The shoreline could potentially move landward of the hazard lines in the watercourse entrance instability region due to lowering of the beach profile from entrance scouring.

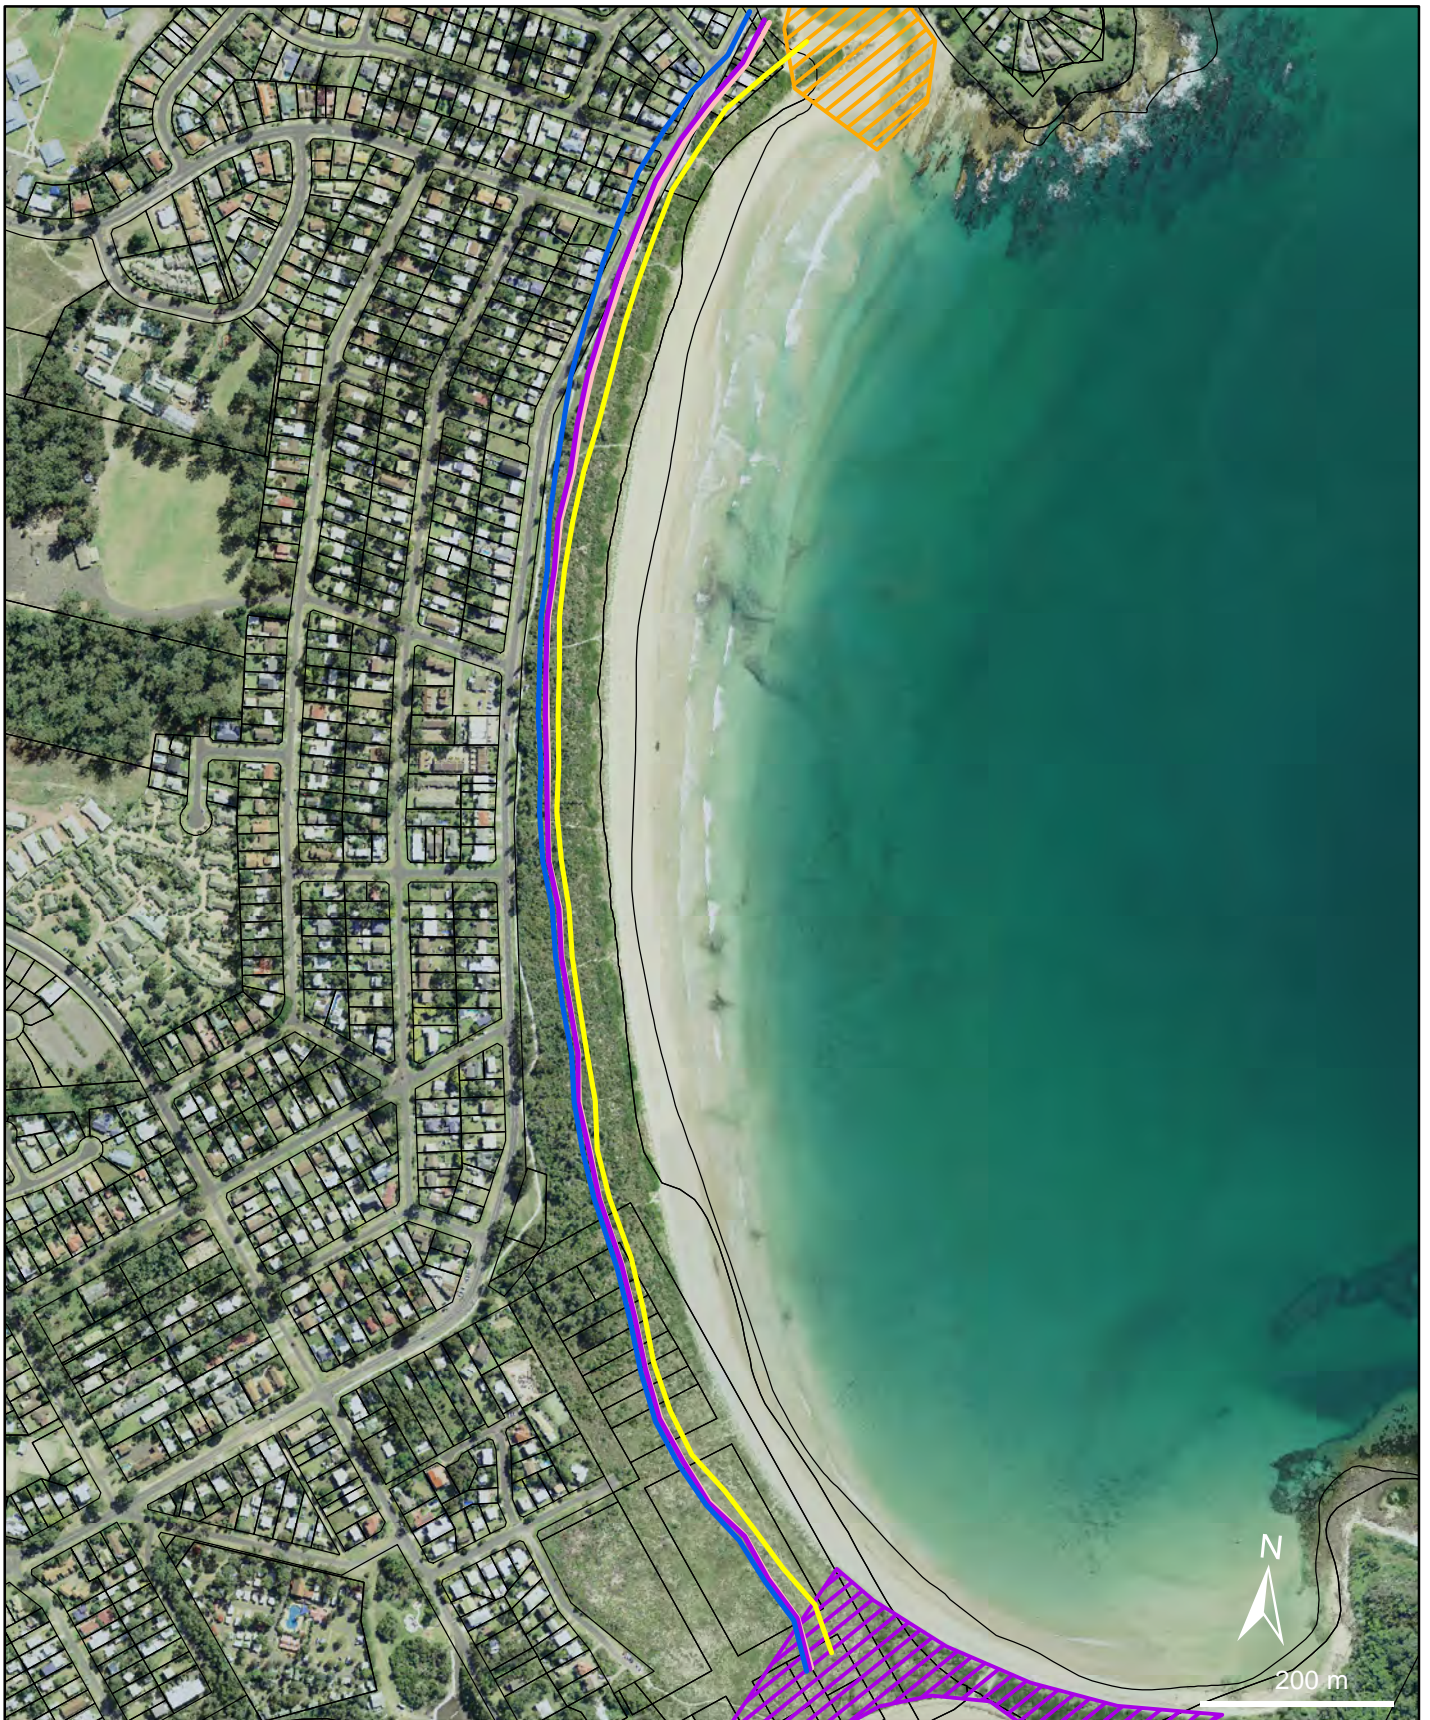
Figure I.29

Note 1: Landward movement of the shoreline could be limited by the presence of bedrock.

Note 2: The shoreline could potentially move landward of the hazard lines in the watercourse entrance instability region due to lowering of the beach profile from entrance scouring.
