## Eurobodalla Coastal Hazard Assessment

WRL Technical Report 2017/09  
October 2017

By I R Coghlan, J T Carley, A J Harrison, D Howe, A D Short,  
J E Ruprecht, F Flocard and P F Rahman

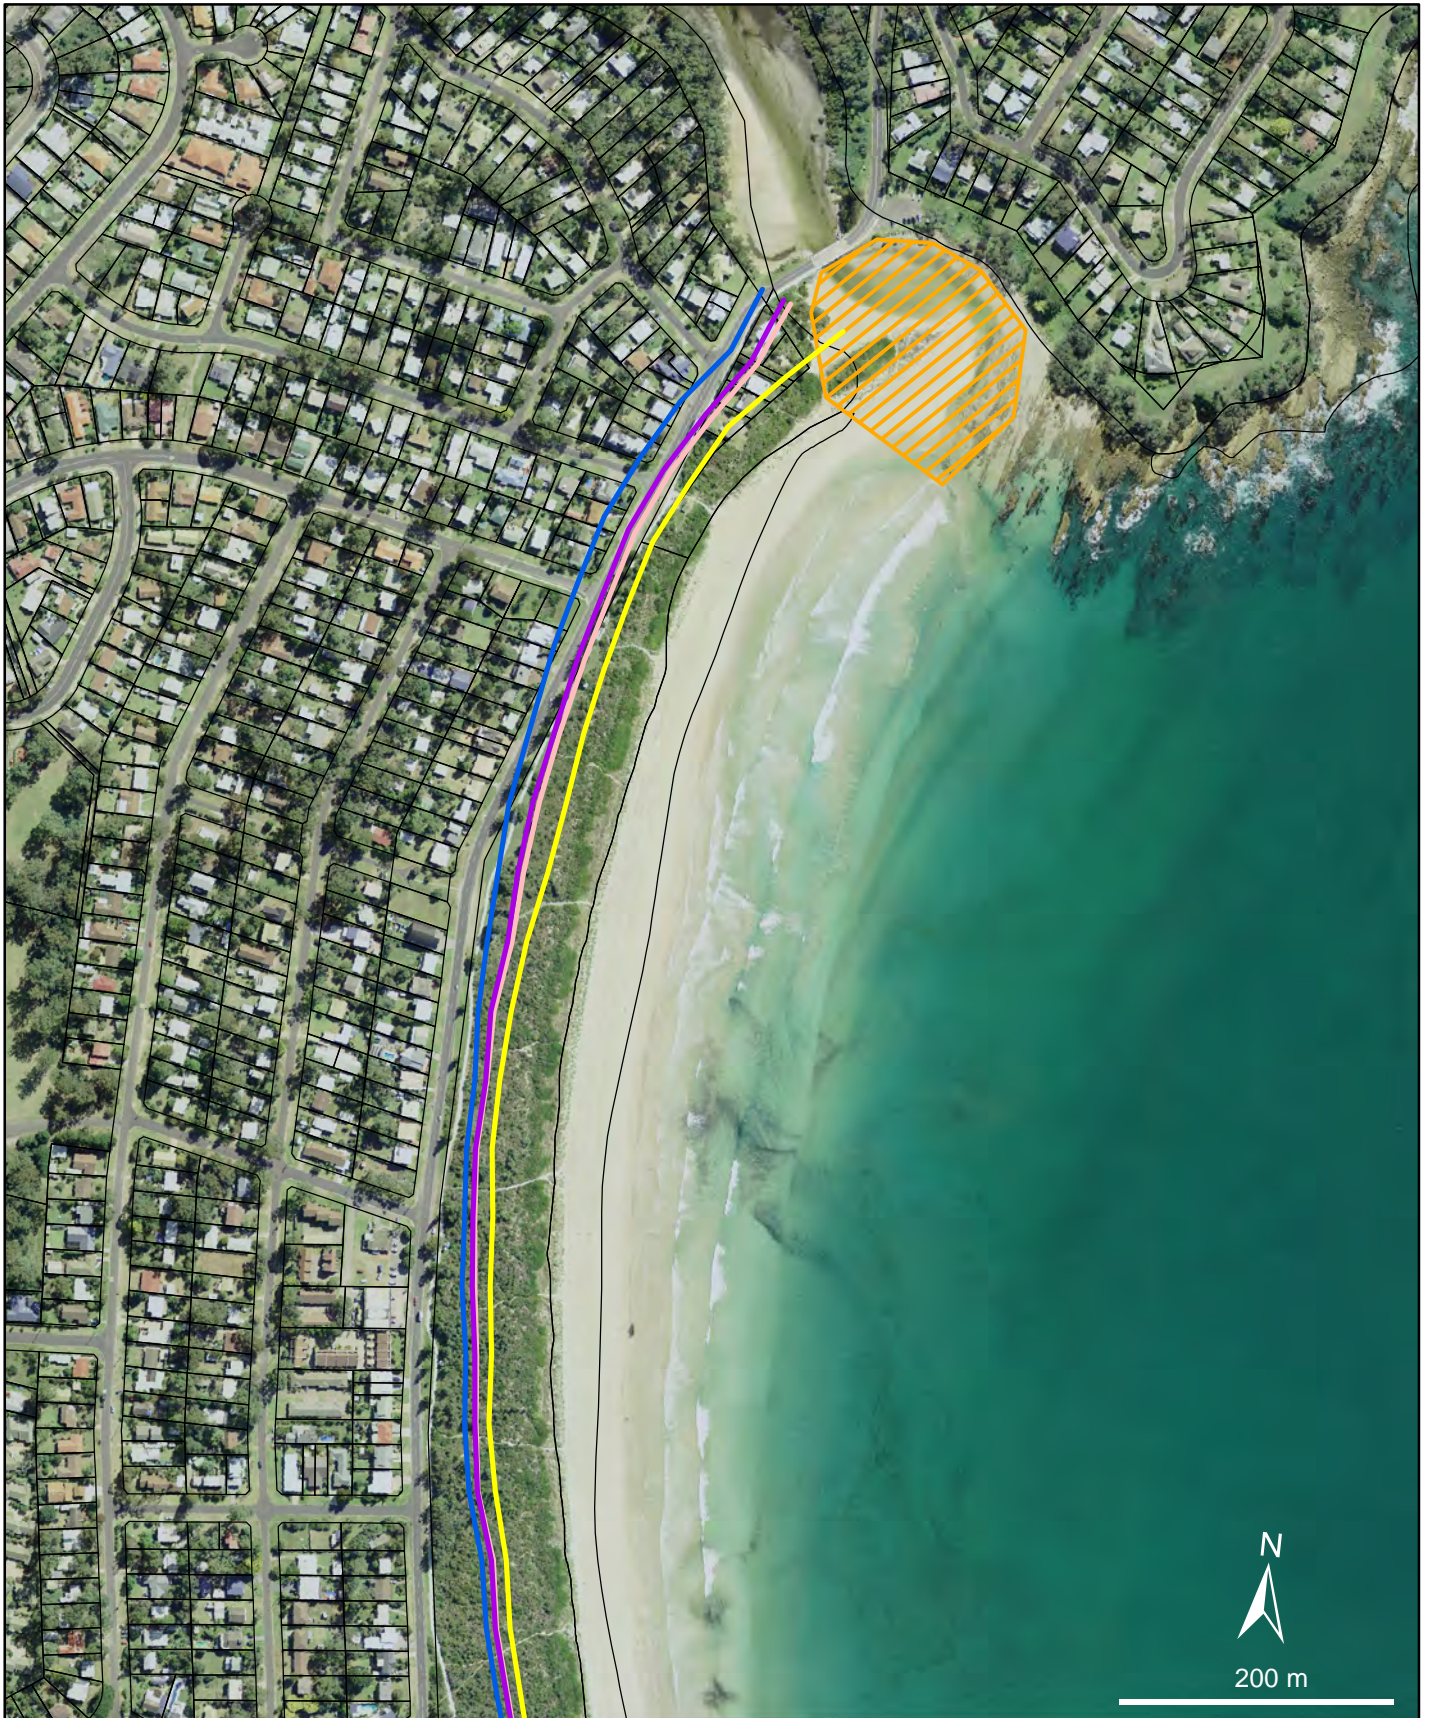
Figure I.30

Note 1: Landward movement of the shoreline could be limited by the presence of bedrock.

Note 2: The shoreline could potentially move landward of the hazard lines in the watercourse entrance instability region due to lowering of the beach profile from entrance scouring.

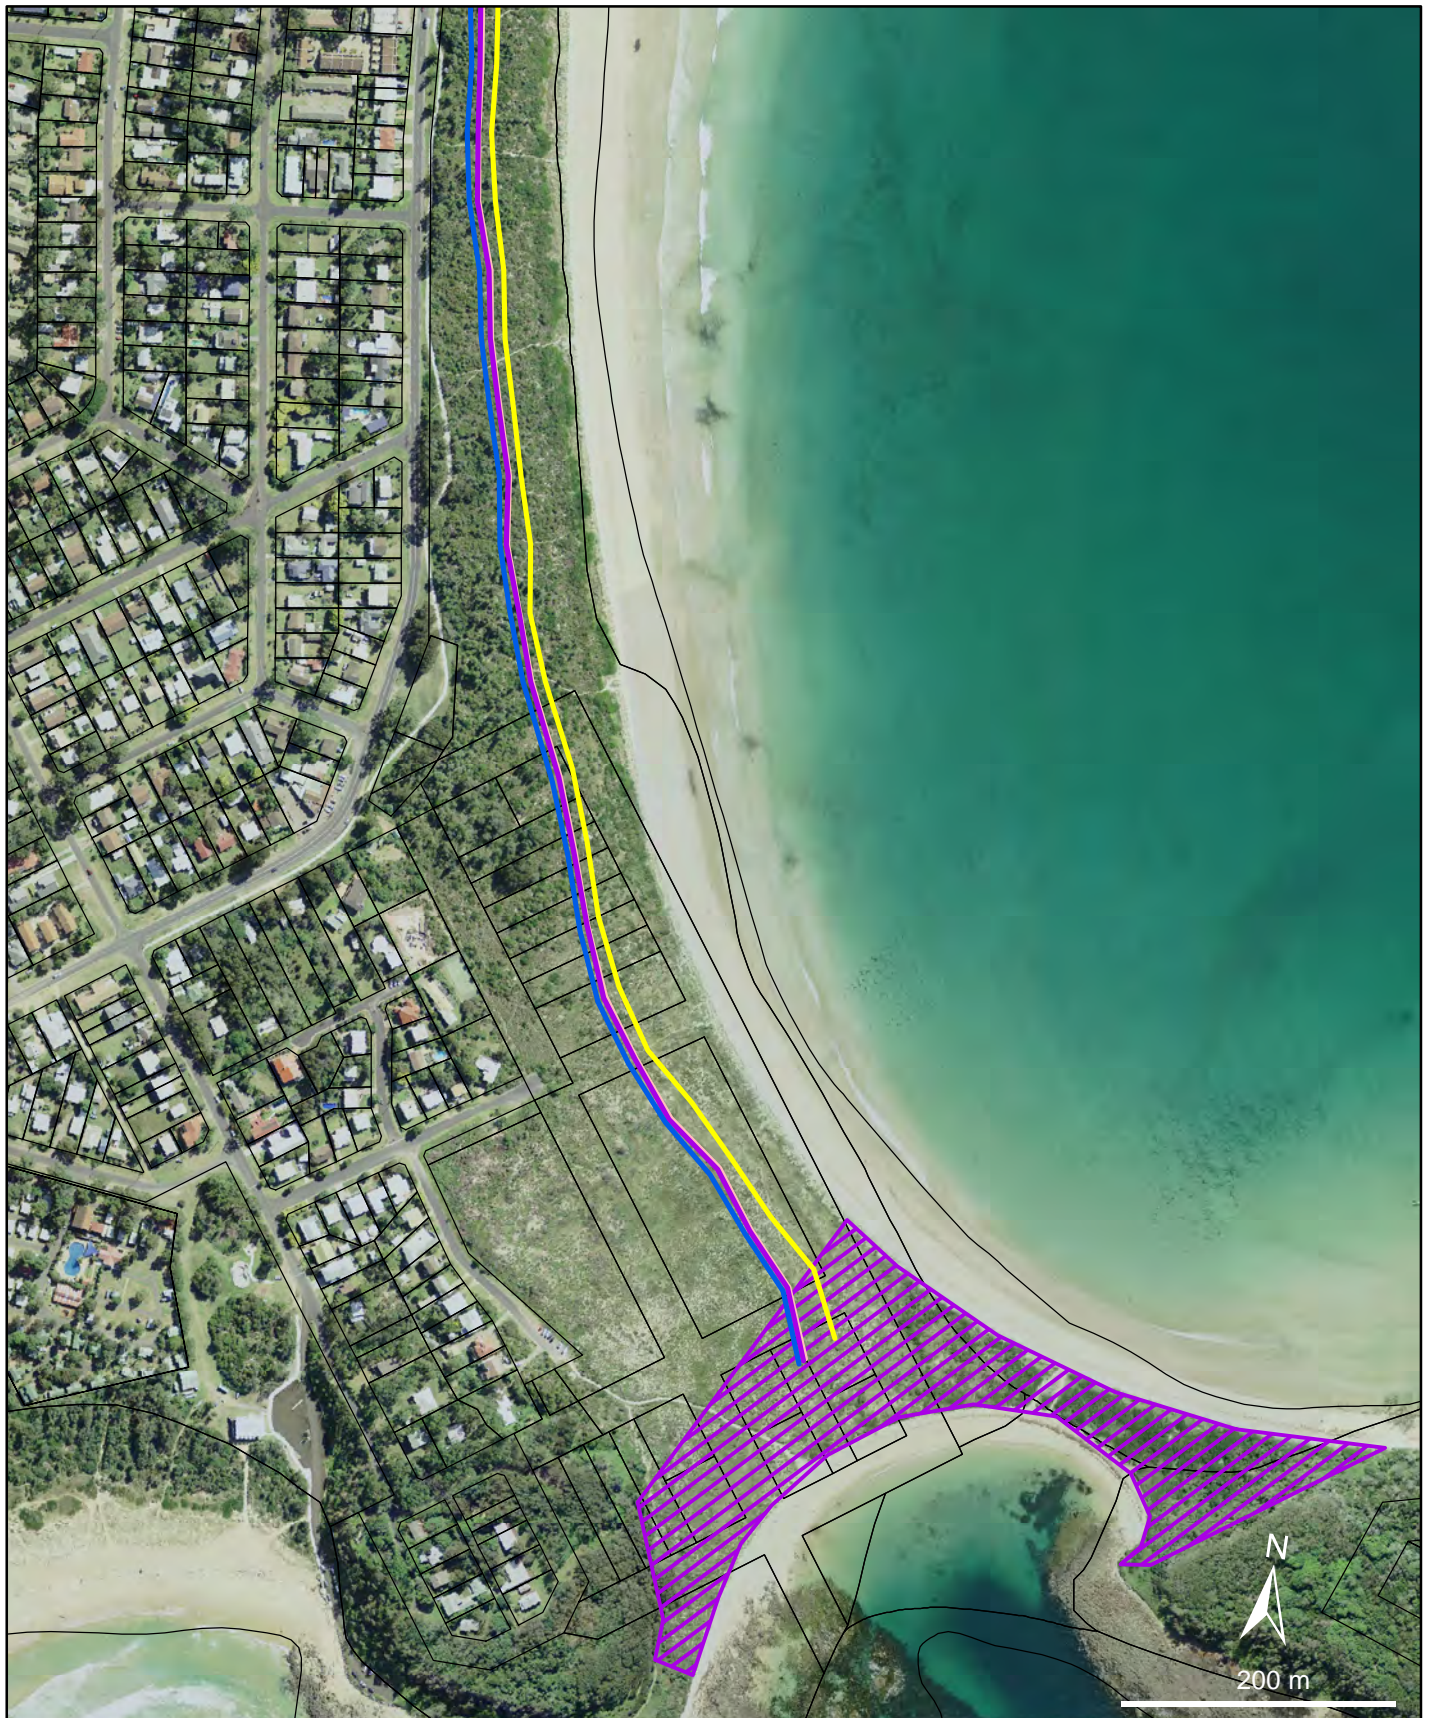
Figure I.31

Note 1: Landward movement of the shoreline could be limited by the presence of bedrock.

Note 2: The shoreline could potentially move landward of the hazard lines in the watercourse entrance instability region due to lowering of the beach profile from entrance scouring.

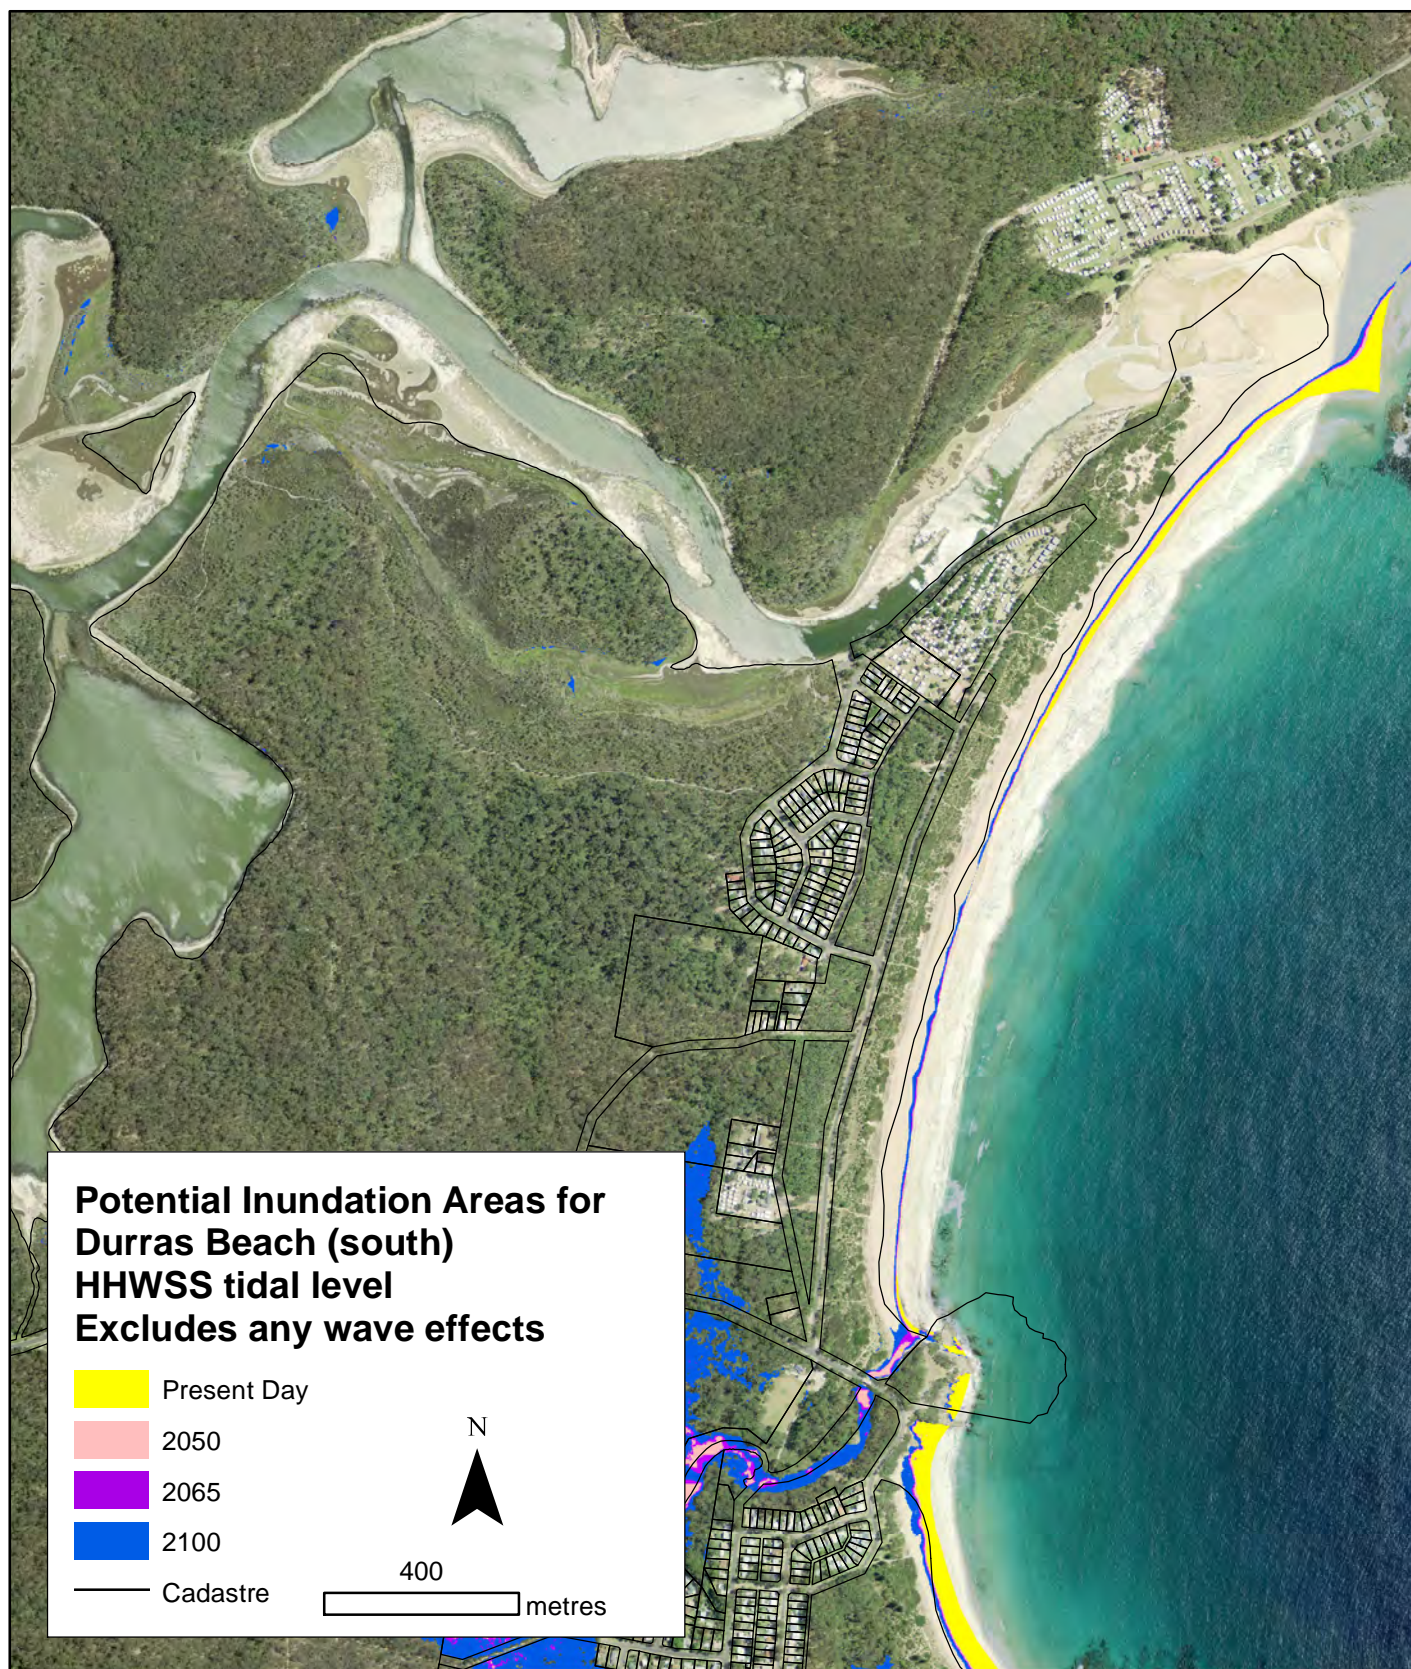
Inundation areas are mapped based on the most recent year of LIDAR data available (2011). The mapping has been based on the ground elevation (the "all ground" LIDAR layer) and does not consider flow paths, flow velocities or loss of flow momentum. It does not include allowance for future landward recession of the beach face and assumes that the crest level of the seawall (if present) and the topography remain as they were from the 2011 LIDAR data. By 2050, 2065 or 2100 both of these assumptions may not be valid. Should the seawall/dune be allowed to fail then the landward extent of inundation may increase. WRL is not responsible for the accuracy of the LIDAR data. Local surveys by a registered surveyor are recommended to determine local inundation extents.

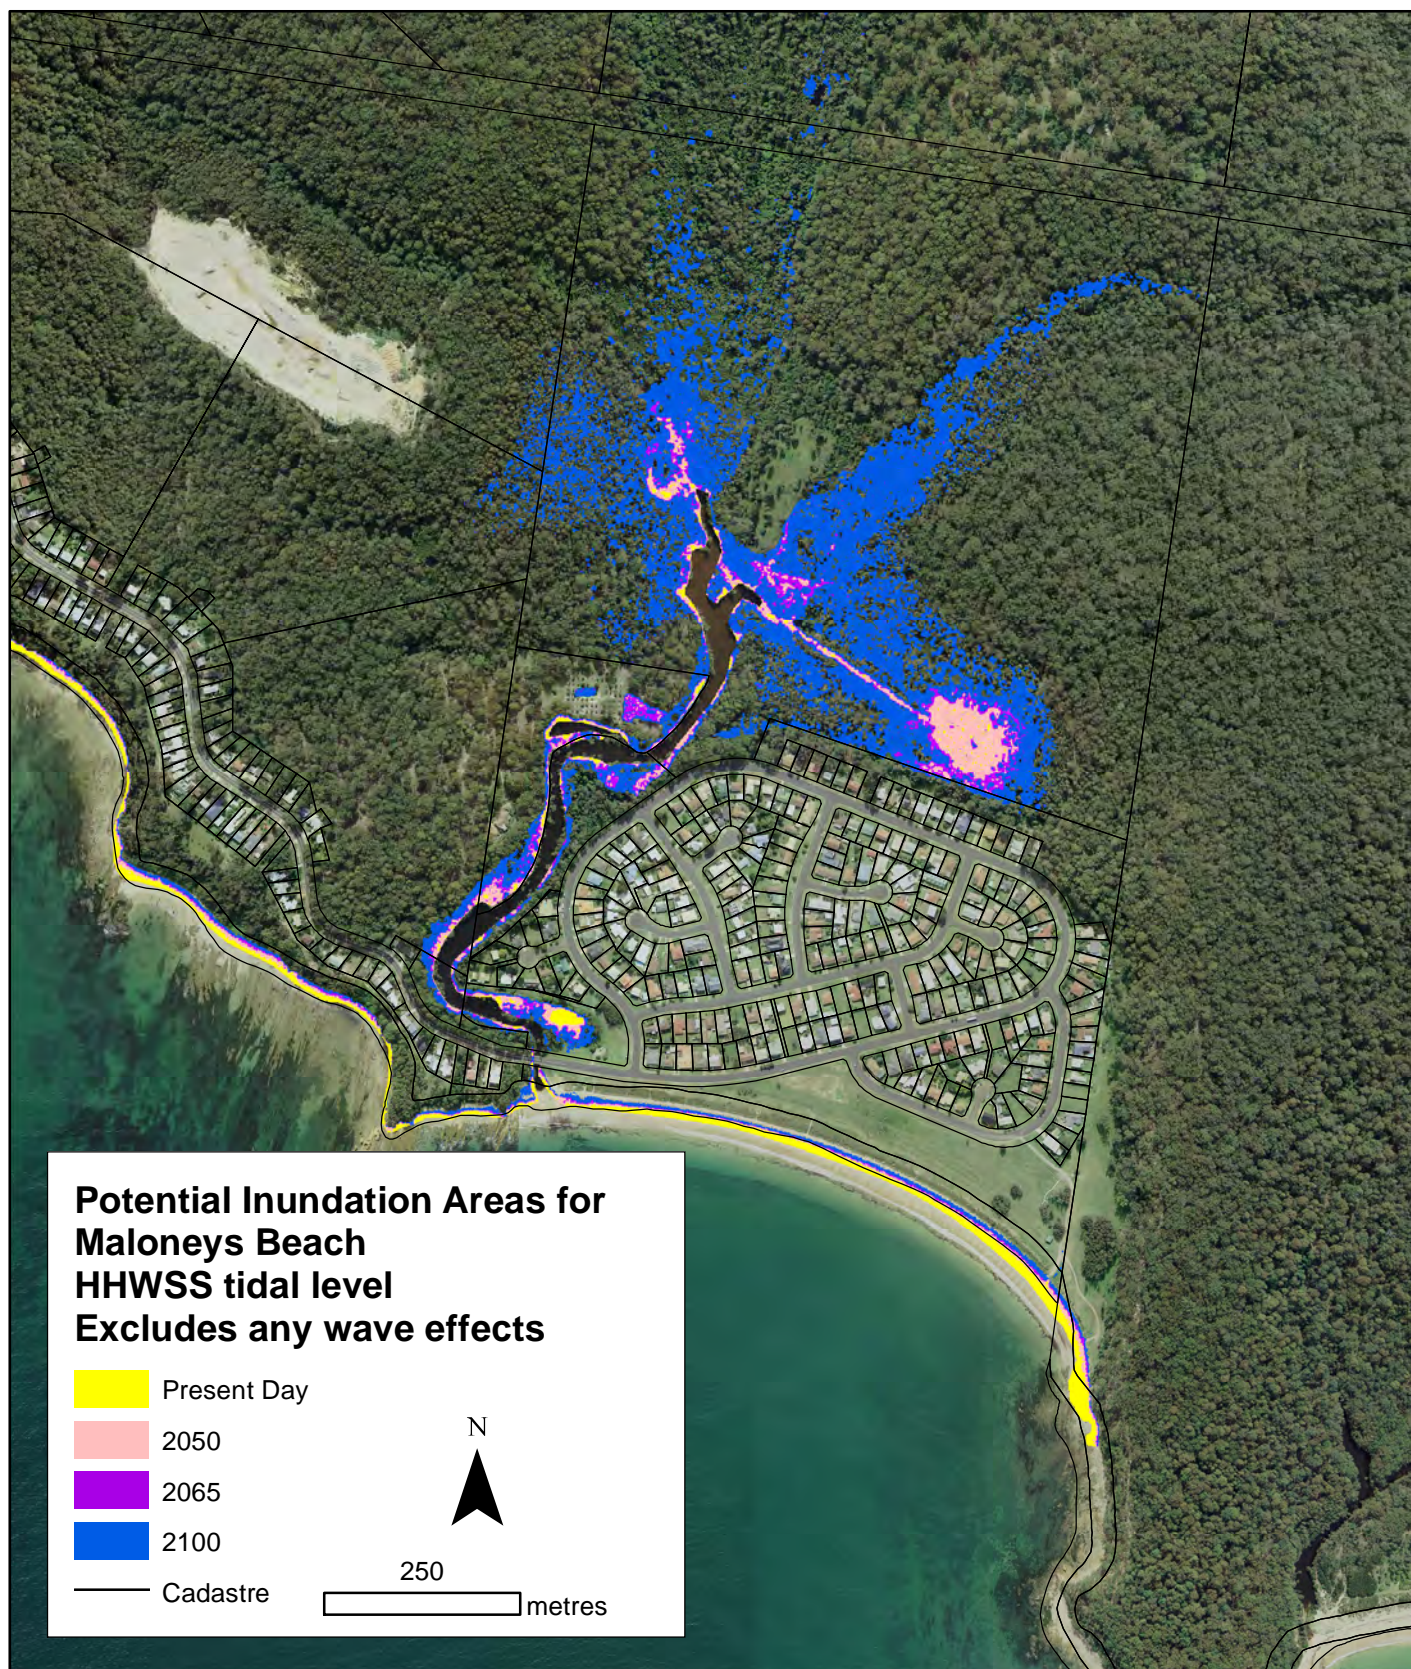
Inundation areas are mapped based on the most recent year of LIDAR data available (2005). The mapping has been based on the ground elevation (the "all ground" LIDAR layer) and does not consider flow paths, flow velocities or loss of flow momentum. It does not include allowance for future landward recession of the beach face and assumes that the crest level of the seawall (if present) and the topography remain as they were from the 2005 LIDAR data. By 2050, 2065 or 2100 both of these assumptions may not be valid. Should the seawall/dune be allowed to fail then the landward extent of inundation may increase. WRL is not responsible for the accuracy of the LIDAR data. Local surveys by a registered surveyor are recommended to determine local inundation extents.

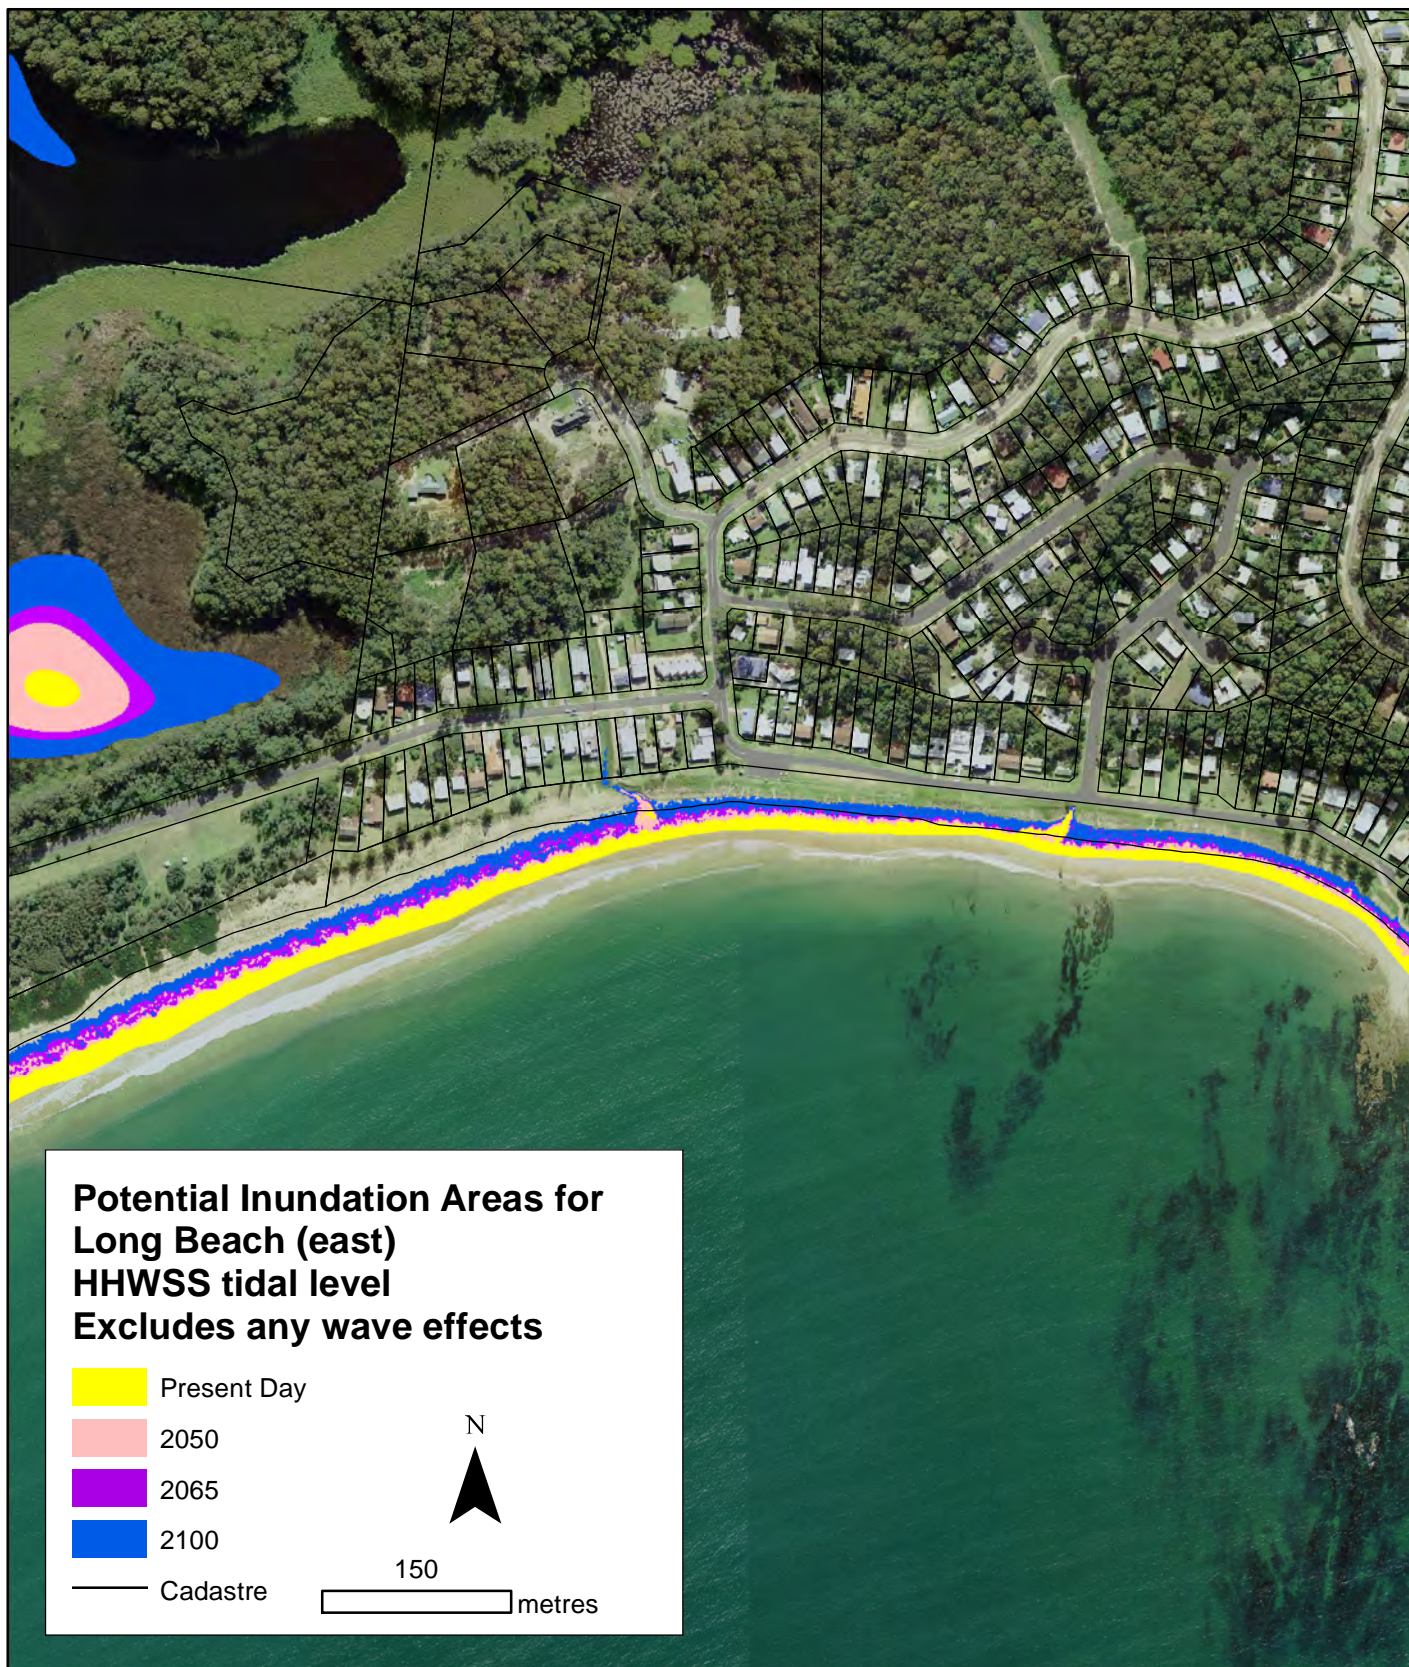
**Figure K.4**

Inundation areas are mapped based on the most recent year of LIDAR data available (2005). The mapping has been based on the ground elevation (the "all ground" LIDAR layer) and does not consider flow paths, flow velocities or loss of flow momentum. It does not include allowance for future landward recession of the beach face and assumes that the crest level of the seawall (if present) and the topography remain as they were from the 2005 LIDAR data. By 2050, 2065 or 2100 both of these assumptions may not be valid. Should the seawall/dune be allowed to fail then the landward extent of inundation may increase. WRL is not responsible for the accuracy of the LIDAR data. Local surveys by a registered surveyor are recommended to determine local inundation extents.

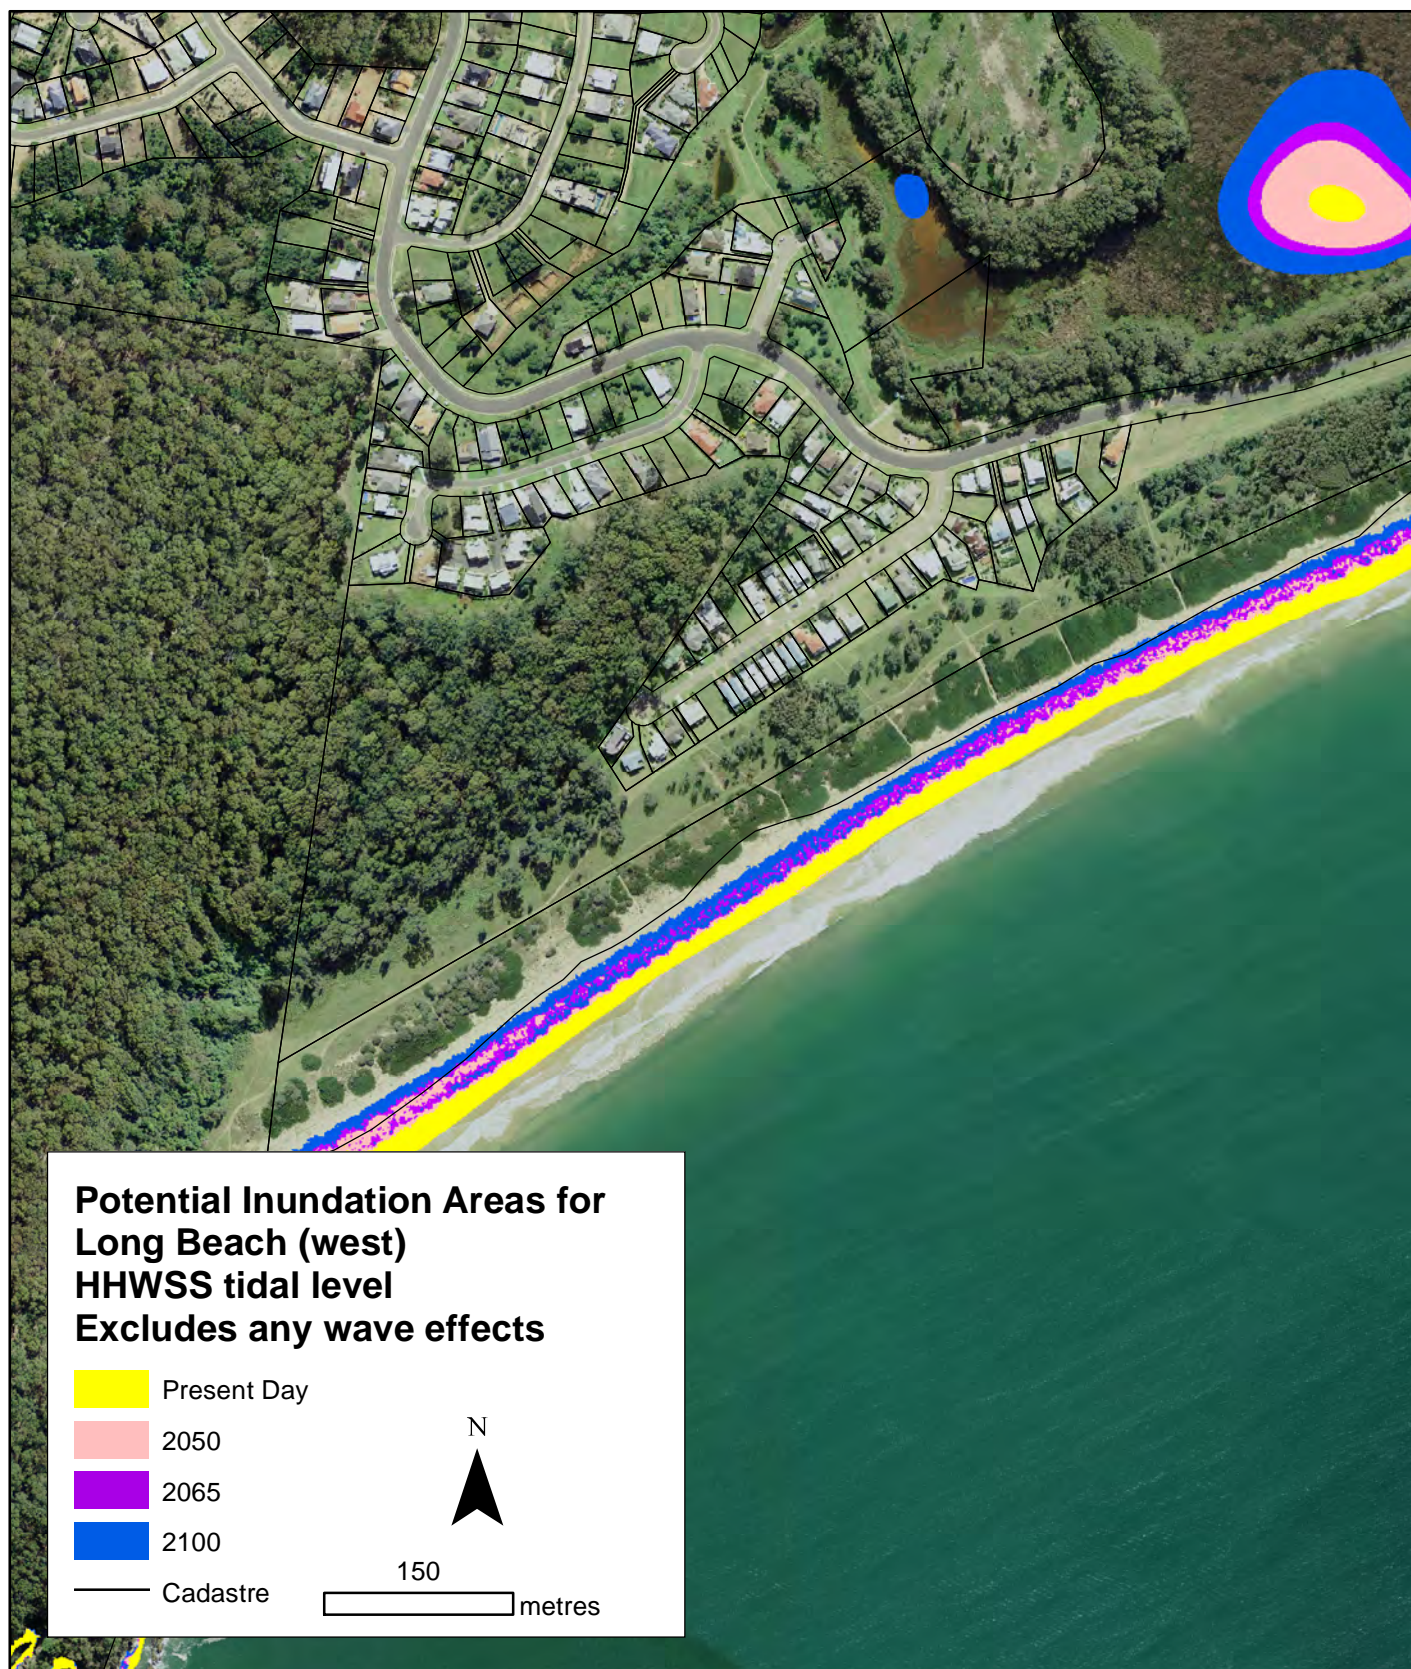
**Figure K.5**

Inundation areas are mapped based on the most recent year of LIDAR data available (2005). The mapping has been based on the ground elevation (the "all ground" LIDAR layer) and does not consider flow paths, flow velocities or loss of flow momentum. It does not include allowance for future landward recession of the beach face and assumes that the crest level of the seawall (if present) and the topography remain as they were from the 2005 LIDAR data. By 2050, 2065 or 2100 both of these assumptions may not be valid. Should the seawall/dune be allowed to fail then the landward extent of inundation may increase. WRL is not responsible for the accuracy of the LIDAR data. Local surveys by a registered surveyor are recommended to determine local inundation extents.

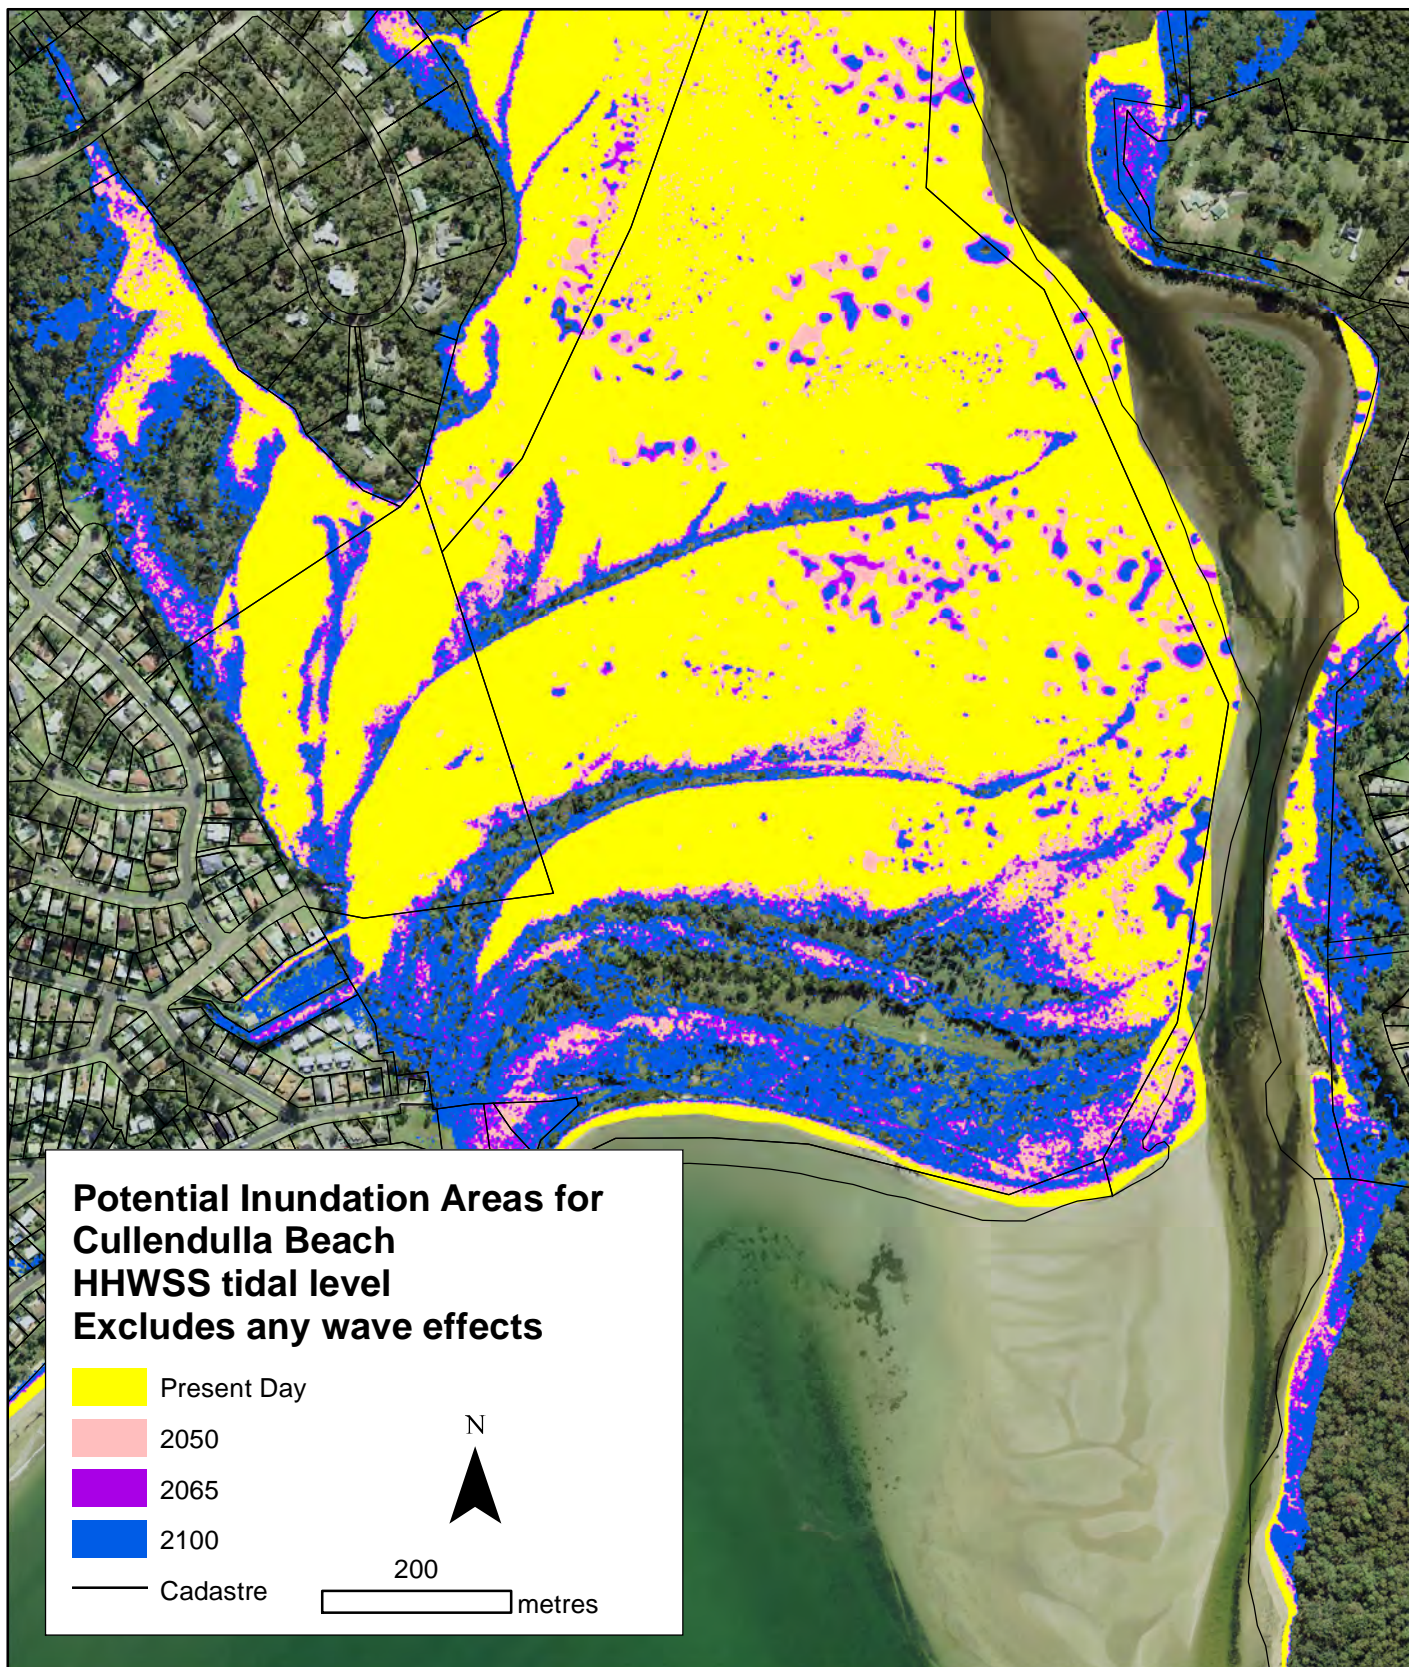
**Figure K.6**

Inundation areas are mapped based on the most recent year of LIDAR data available (2005). The mapping has been based on the ground elevation (the "all ground" LIDAR layer) and does not consider flow paths, flow velocities or loss of flow momentum. It does not include allowance for future landward recession of the beach face and assumes that the crest level of the seawall (if present) and the topography remain as they were from the 2005 LIDAR data. By 2050, 2065 or 2100 both of these assumptions may not be valid. Should the seawall/dune be allowed to fail then the landward extent of inundation may increase. WRL is not responsible for the accuracy of the LIDAR data. Local surveys by a registered surveyor are recommended to determine local inundation extents.

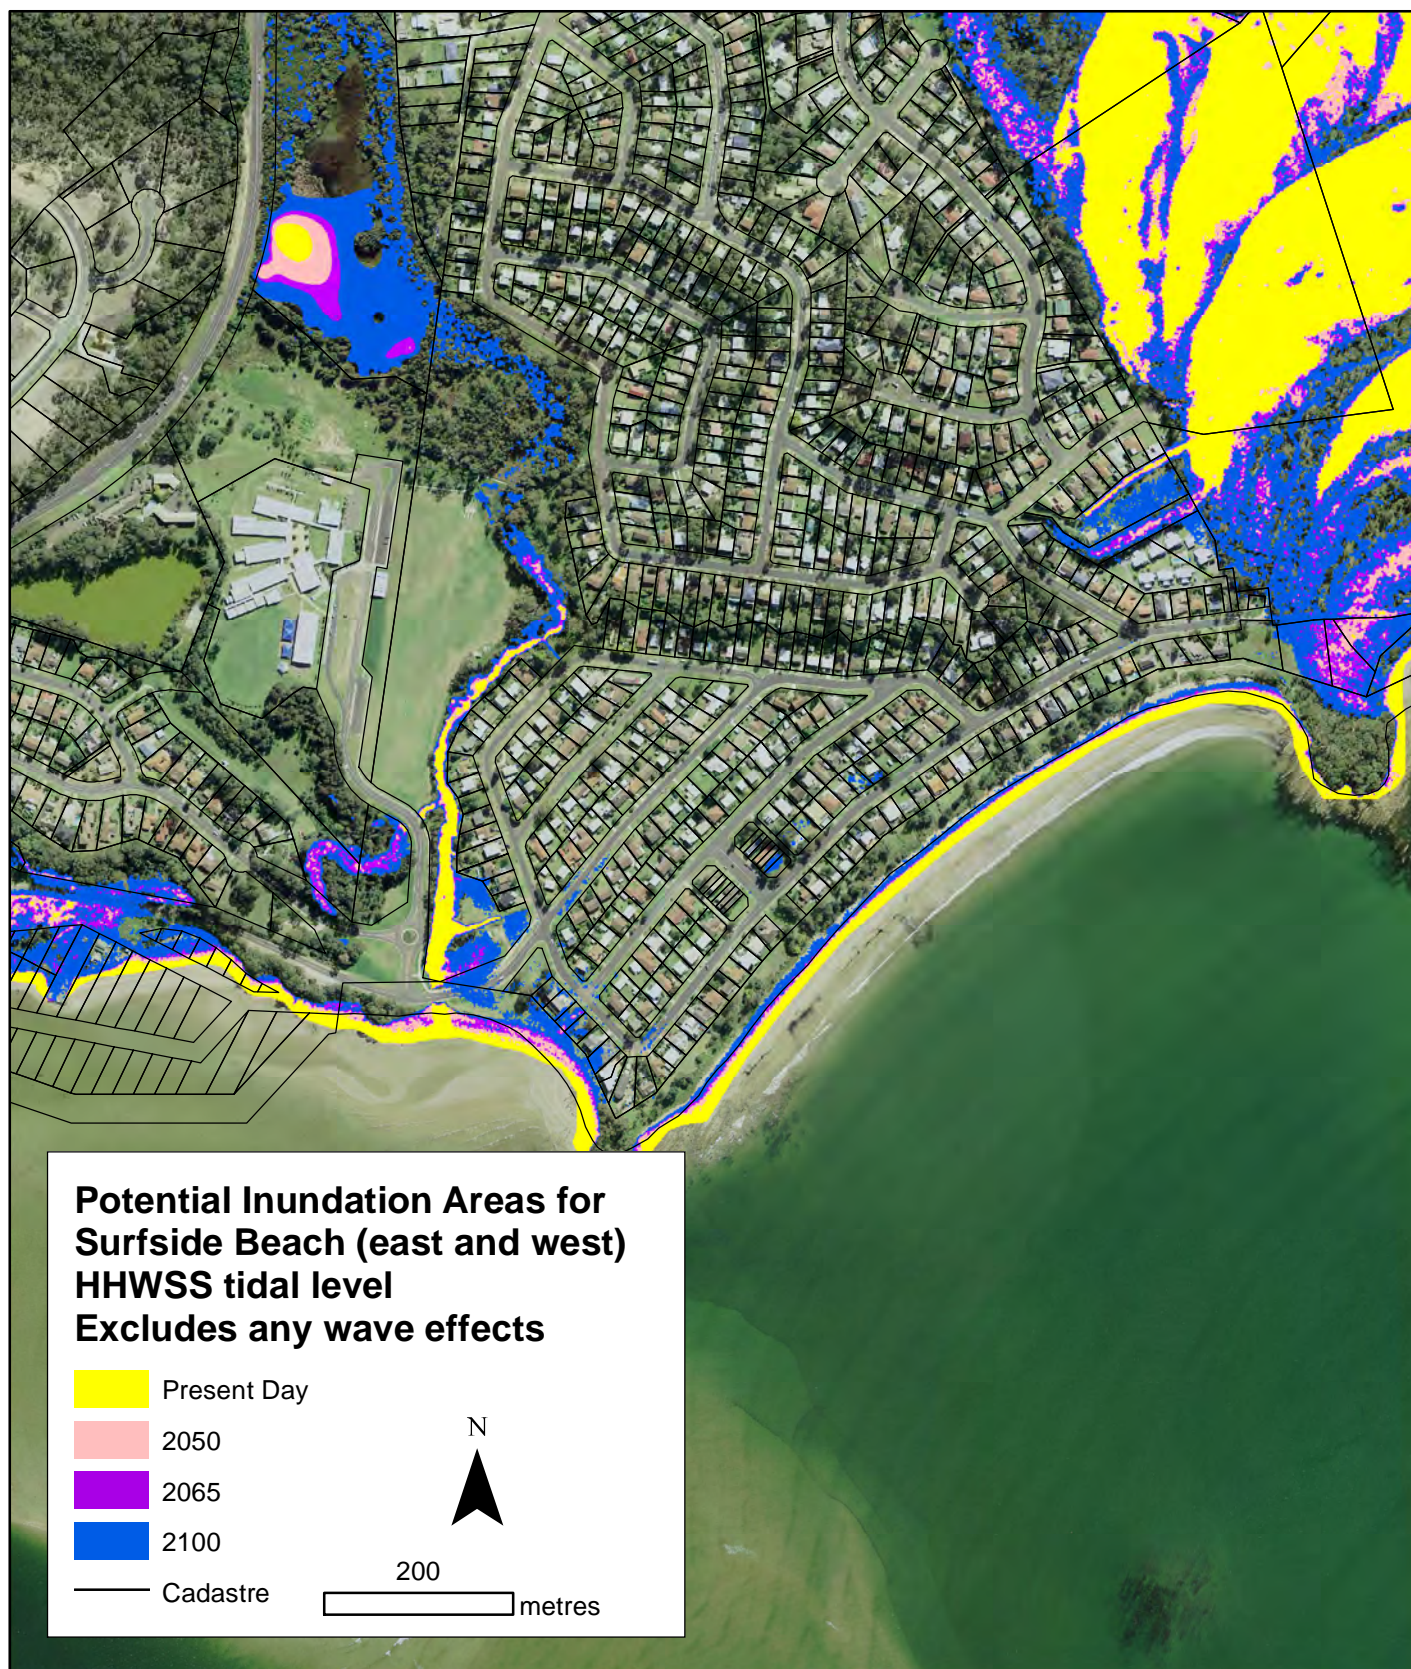
**Figure K.7**

Inundation areas are mapped based on the most recent year of LIDAR data available (2005). The mapping has been based on the ground elevation (the "all ground" LIDAR layer) and does not consider flow paths, flow velocities or loss of flow momentum. It does not include allowance for future landward recession of the beach face and assumes that the crest level of the seawall (if present) and the topography remain as they were from the 2005 LIDAR data. By 2050, 2065 or 2100 both of these assumptions may not be valid. Should the seawall/dune be allowed to fail then the landward extent of inundation may increase. WRL is not responsible for the accuracy of the LIDAR data. Local surveys by a registered surveyor are recommended to determine local inundation extents.

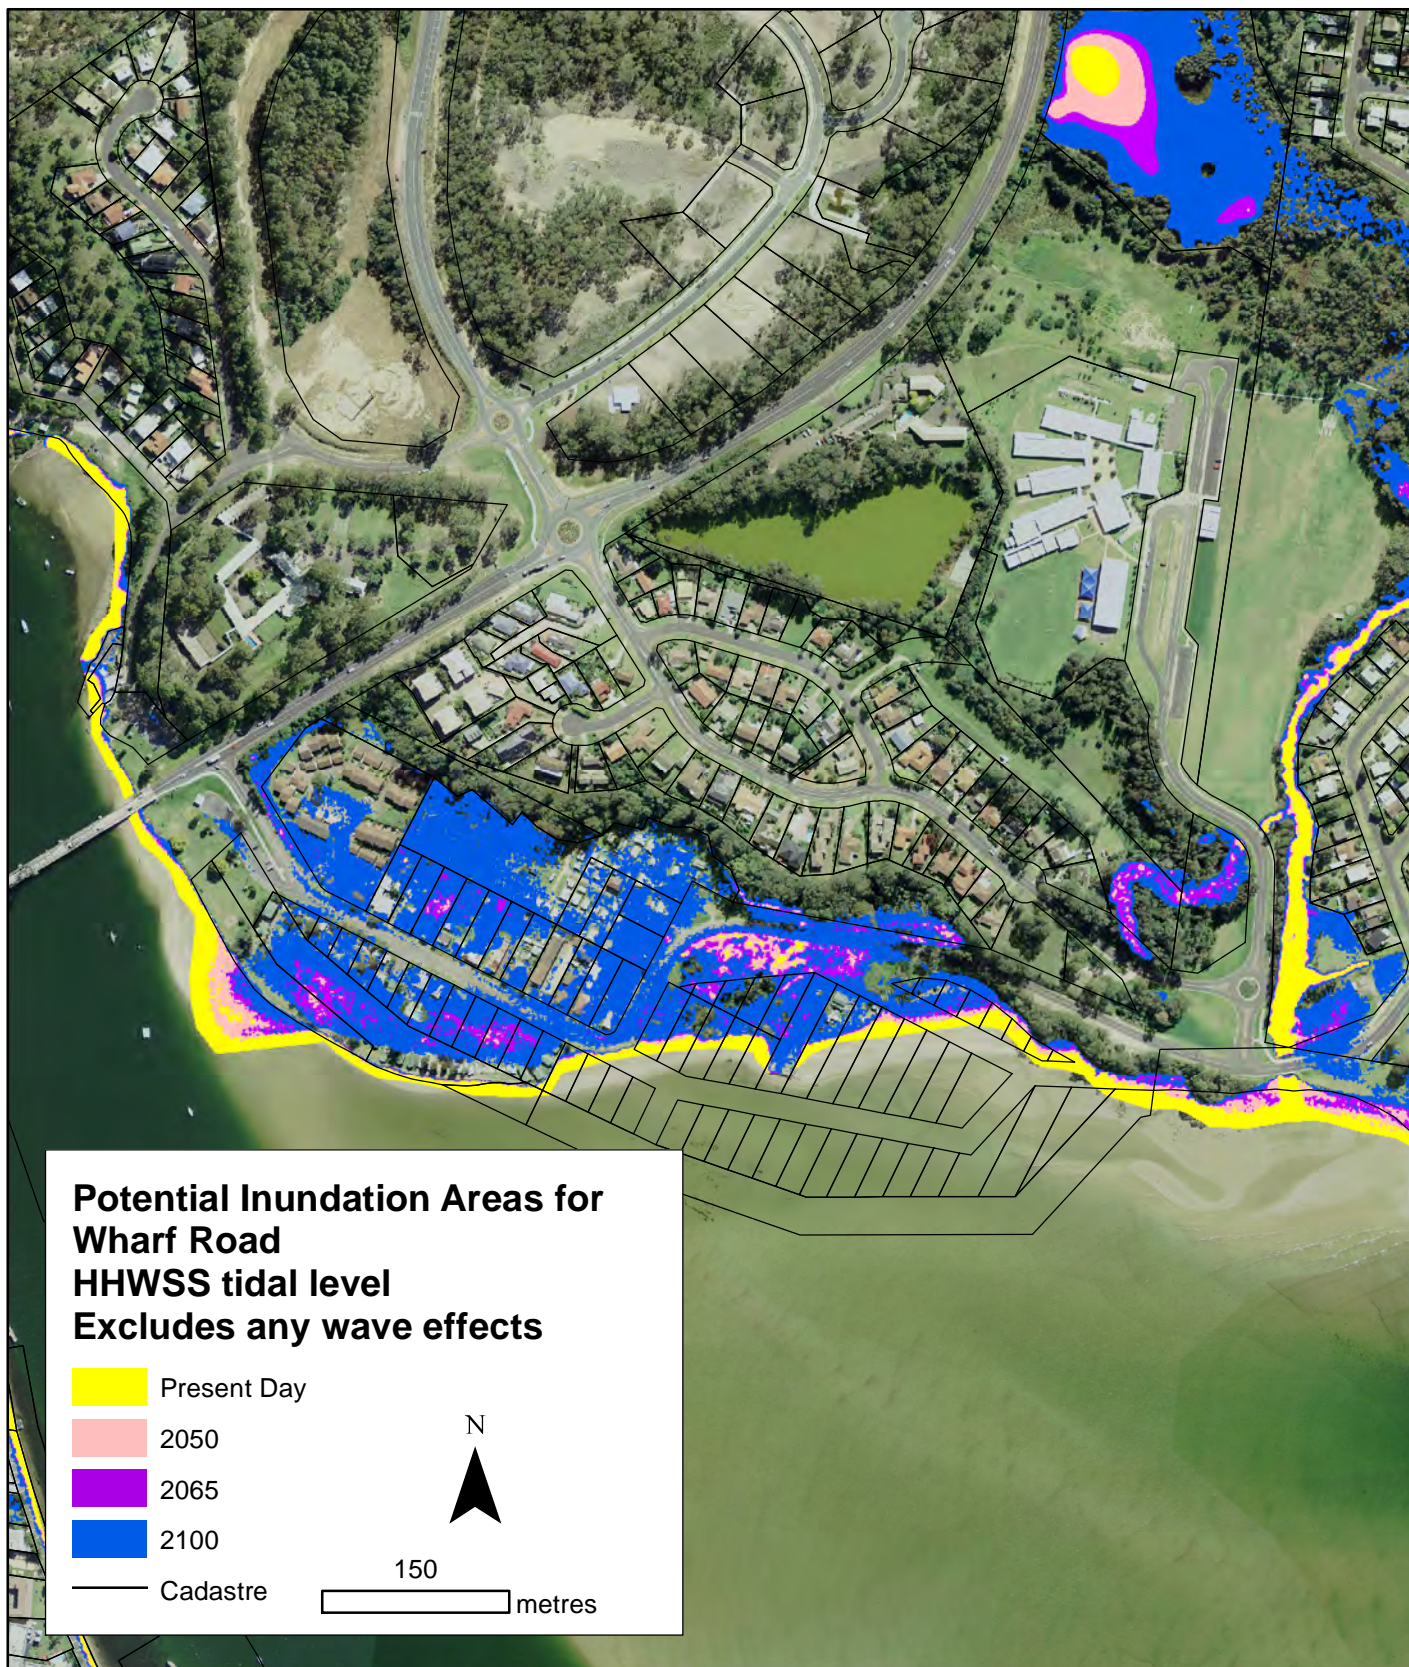
**Figure K.8**

Inundation areas are mapped based on the most recent year of LIDAR data available (2005). The mapping has been based on the ground elevation (the "all ground" LIDAR layer) and does not consider flow paths, flow velocities or loss of flow momentum. It does not include allowance for future landward recession of the beach face and assumes that the crest level of the seawall (if present) and the topography remain as they were from the 2005 LIDAR data. By 2050, 2065 or 2100 both of these assumptions may not be valid. Should the seawall/dune be allowed to fail then the landward extent of inundation may increase. WRL is not responsible for the accuracy of the LIDAR data. Local surveys by a registered surveyor are recommended to determine local inundation extents.
