## Eurobodalla Coastal Hazard Assessment

WRL Technical Report 2017/09  
October 2017

By I R Coghlan, J T Carley, A J Harrison, D Howe, A D Short,  
J E Ruprecht, F Flocard and P F Rahman

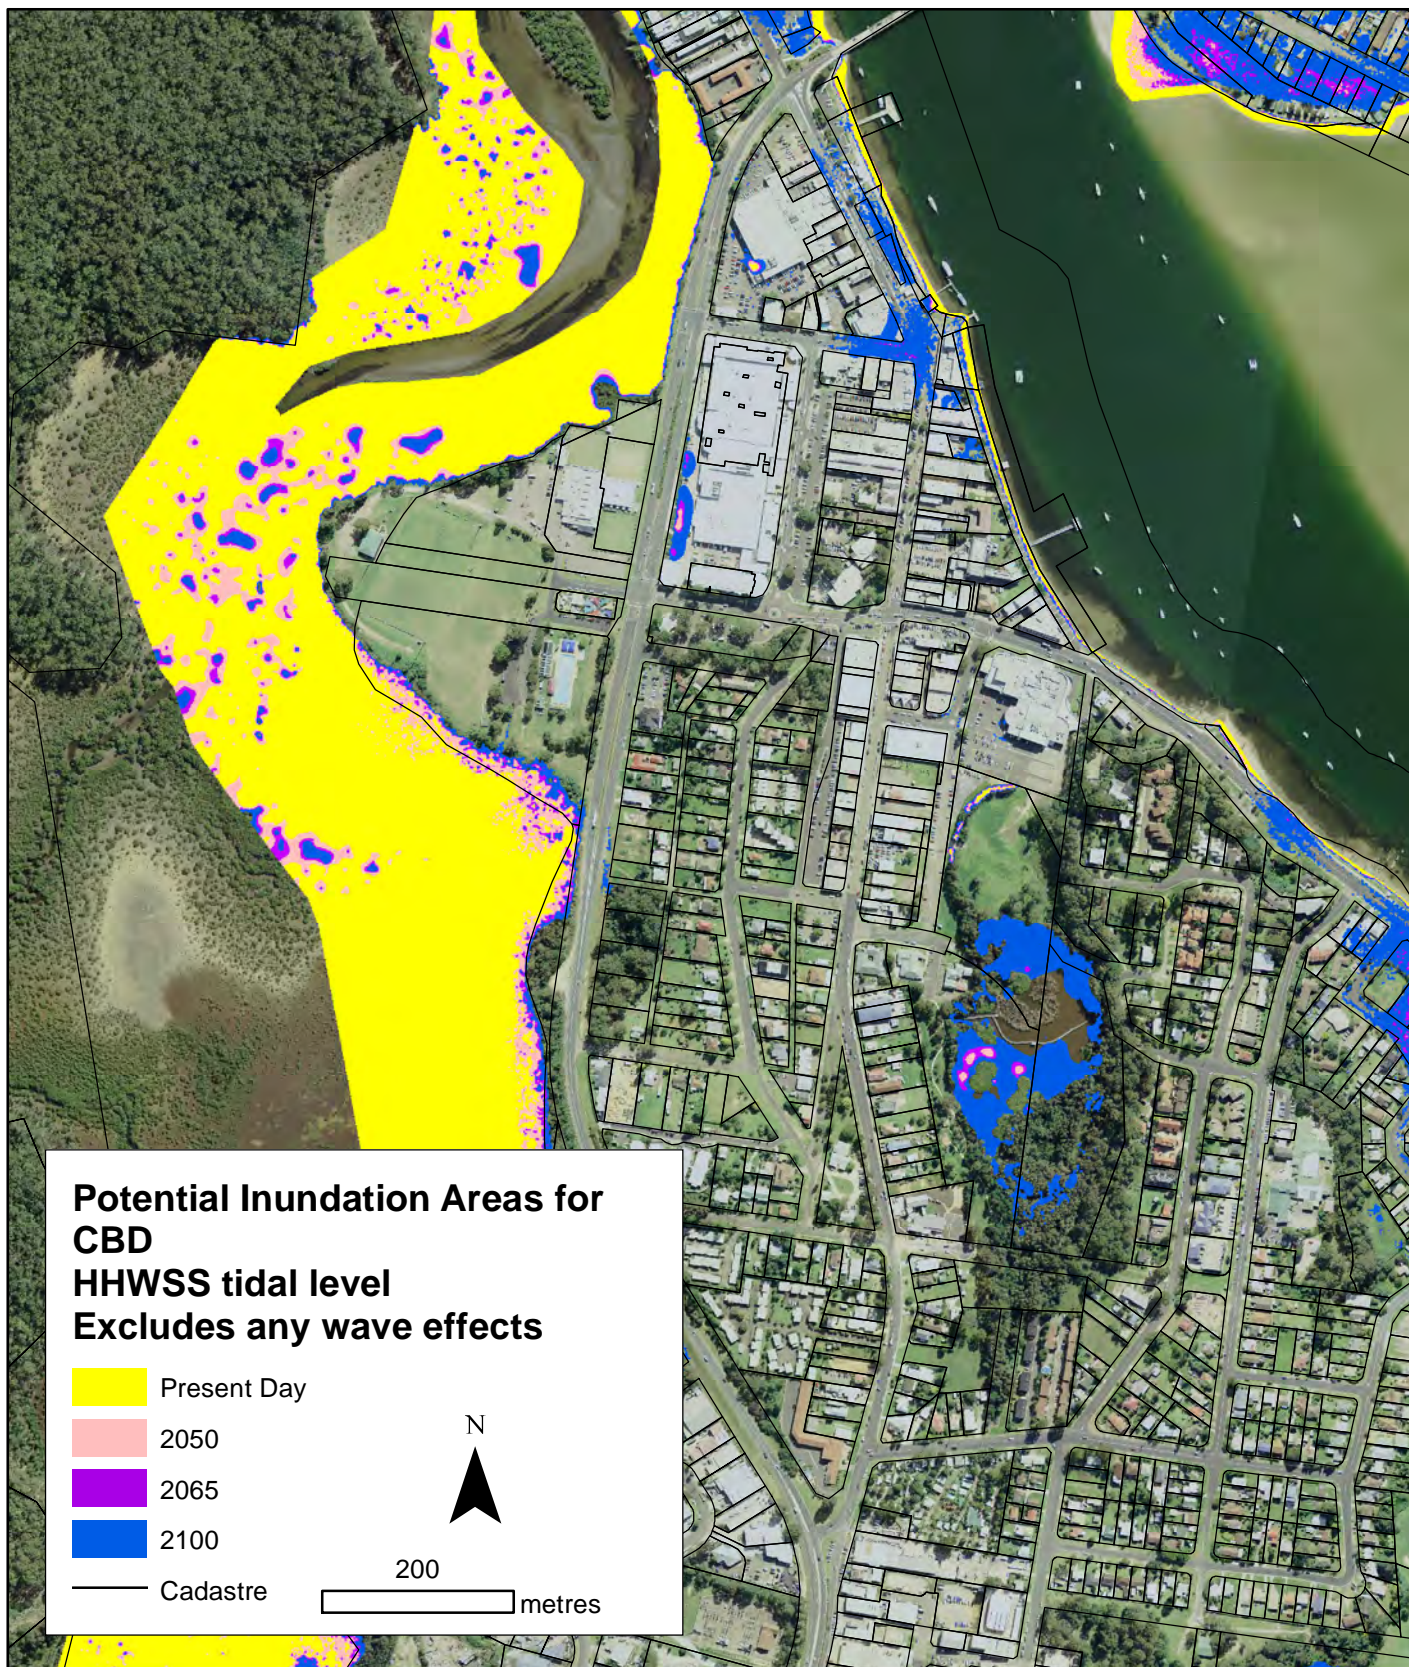
**Figure K.9**

Inundation areas are mapped based on the most recent year of LIDAR data available (2005). The mapping has been based on the ground elevation (the "all ground" LIDAR layer) and does not consider flow paths, flow velocities or loss of flow momentum. It does not include allowance for future landward recession of the beach face and assumes that the crest level of the seawall (if present) and the topography remain as they were from the 2005 LIDAR data. By 2050, 2065 or 2100 both of these assumptions may not be valid. Should the seawall/dune be allowed to fail then the landward extent of inundation may increase. WRL is not responsible for the accuracy of the LIDAR data. Local surveys by a registered surveyor are recommended to determine local inundation extents.

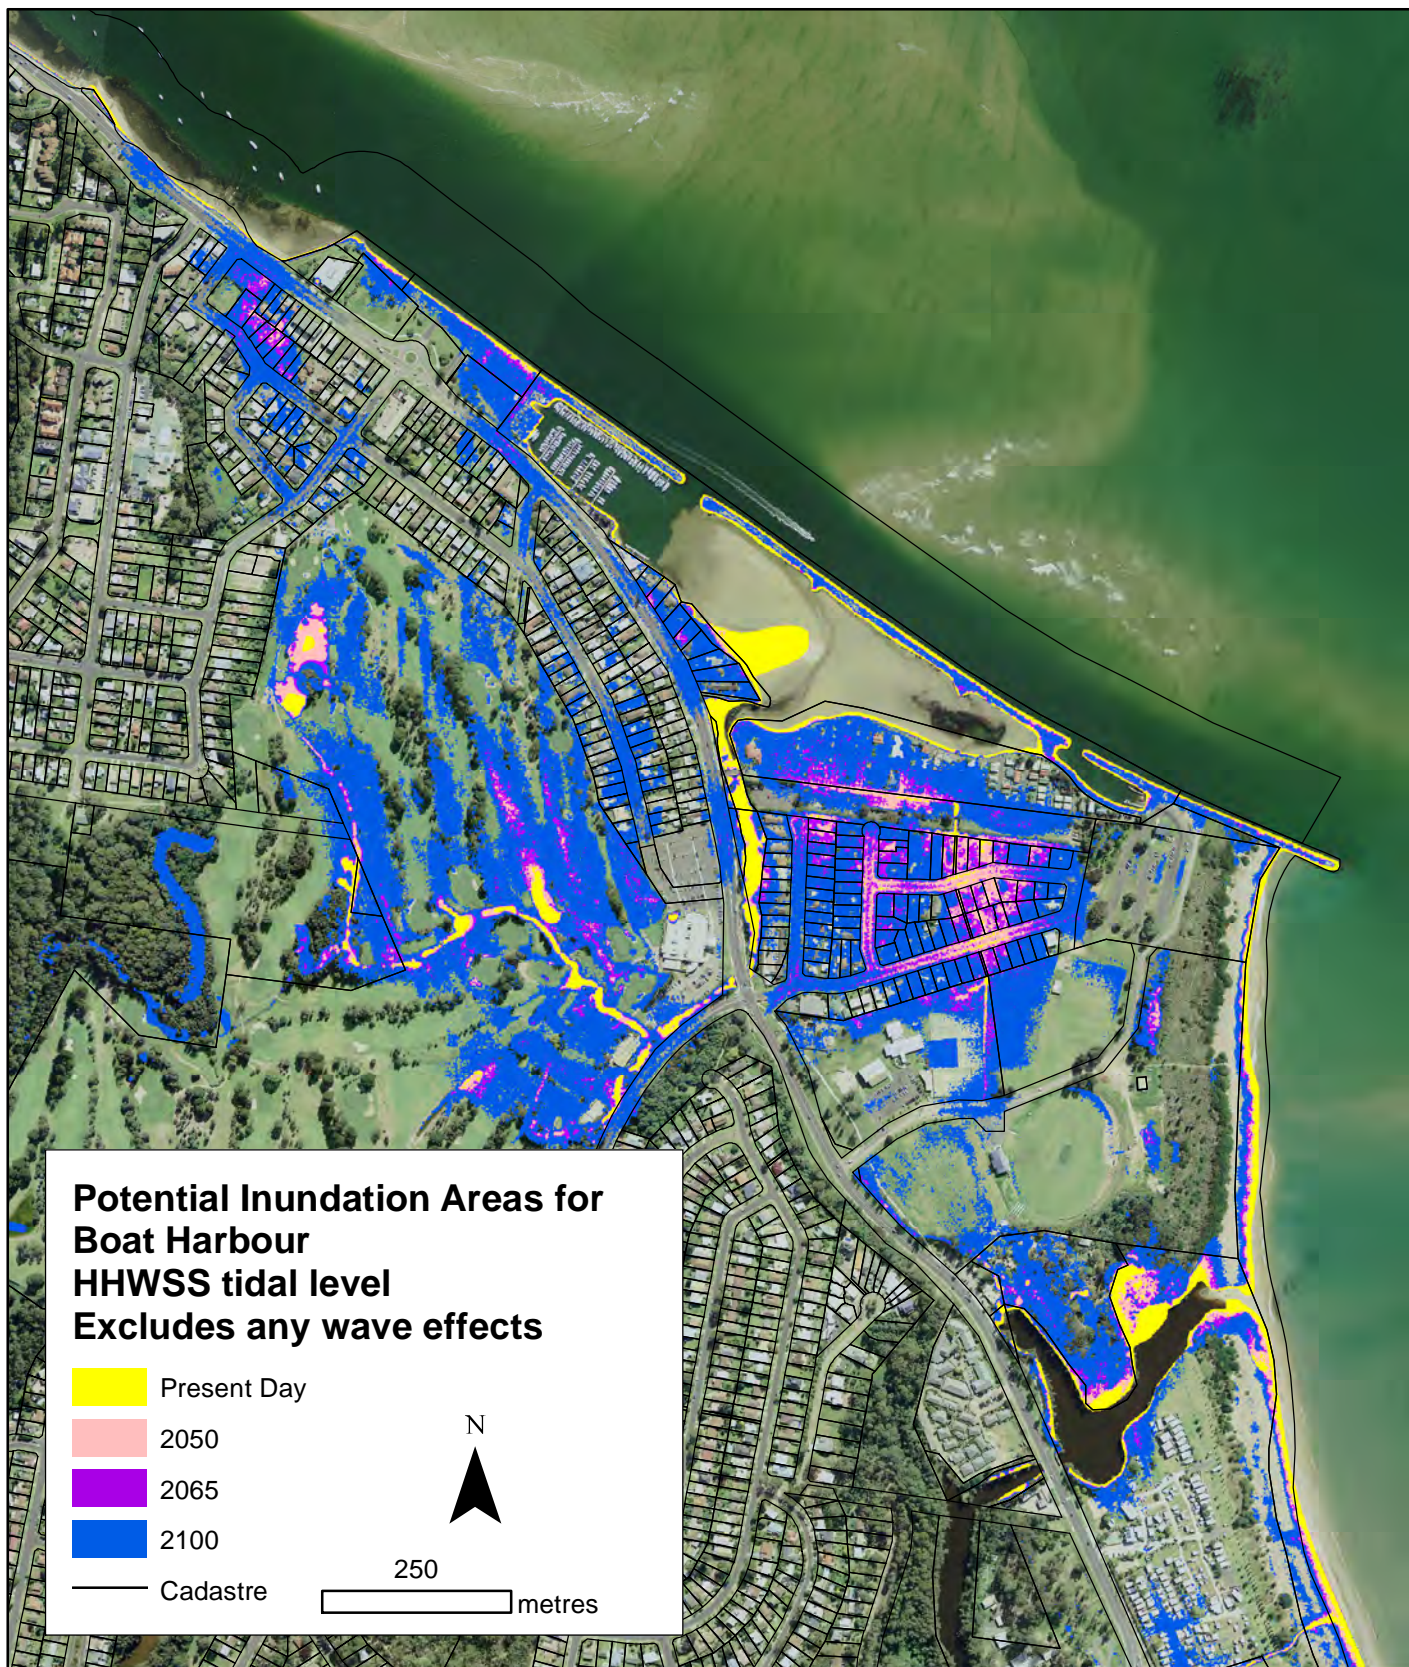
**Figure K.10**

Inundation areas are mapped based on the most recent year of LIDAR data available (2005). The mapping has been based on the ground elevation (the "all ground" LIDAR layer) and does not consider flow paths, flow velocities or loss of flow momentum. It does not include allowance for future landward recession of the beach face and assumes that the crest level of the seawall (if present) and the topography remain as they were from the 2005 LIDAR data. By 2050, 2065 or 2100 both of these assumptions may not be valid. Should the seawall/dune be allowed to fail then the landward extent of inundation may increase. WRL is not responsible for the accuracy of the LIDAR data. Local surveys by a registered surveyor are recommended to determine local inundation extents.

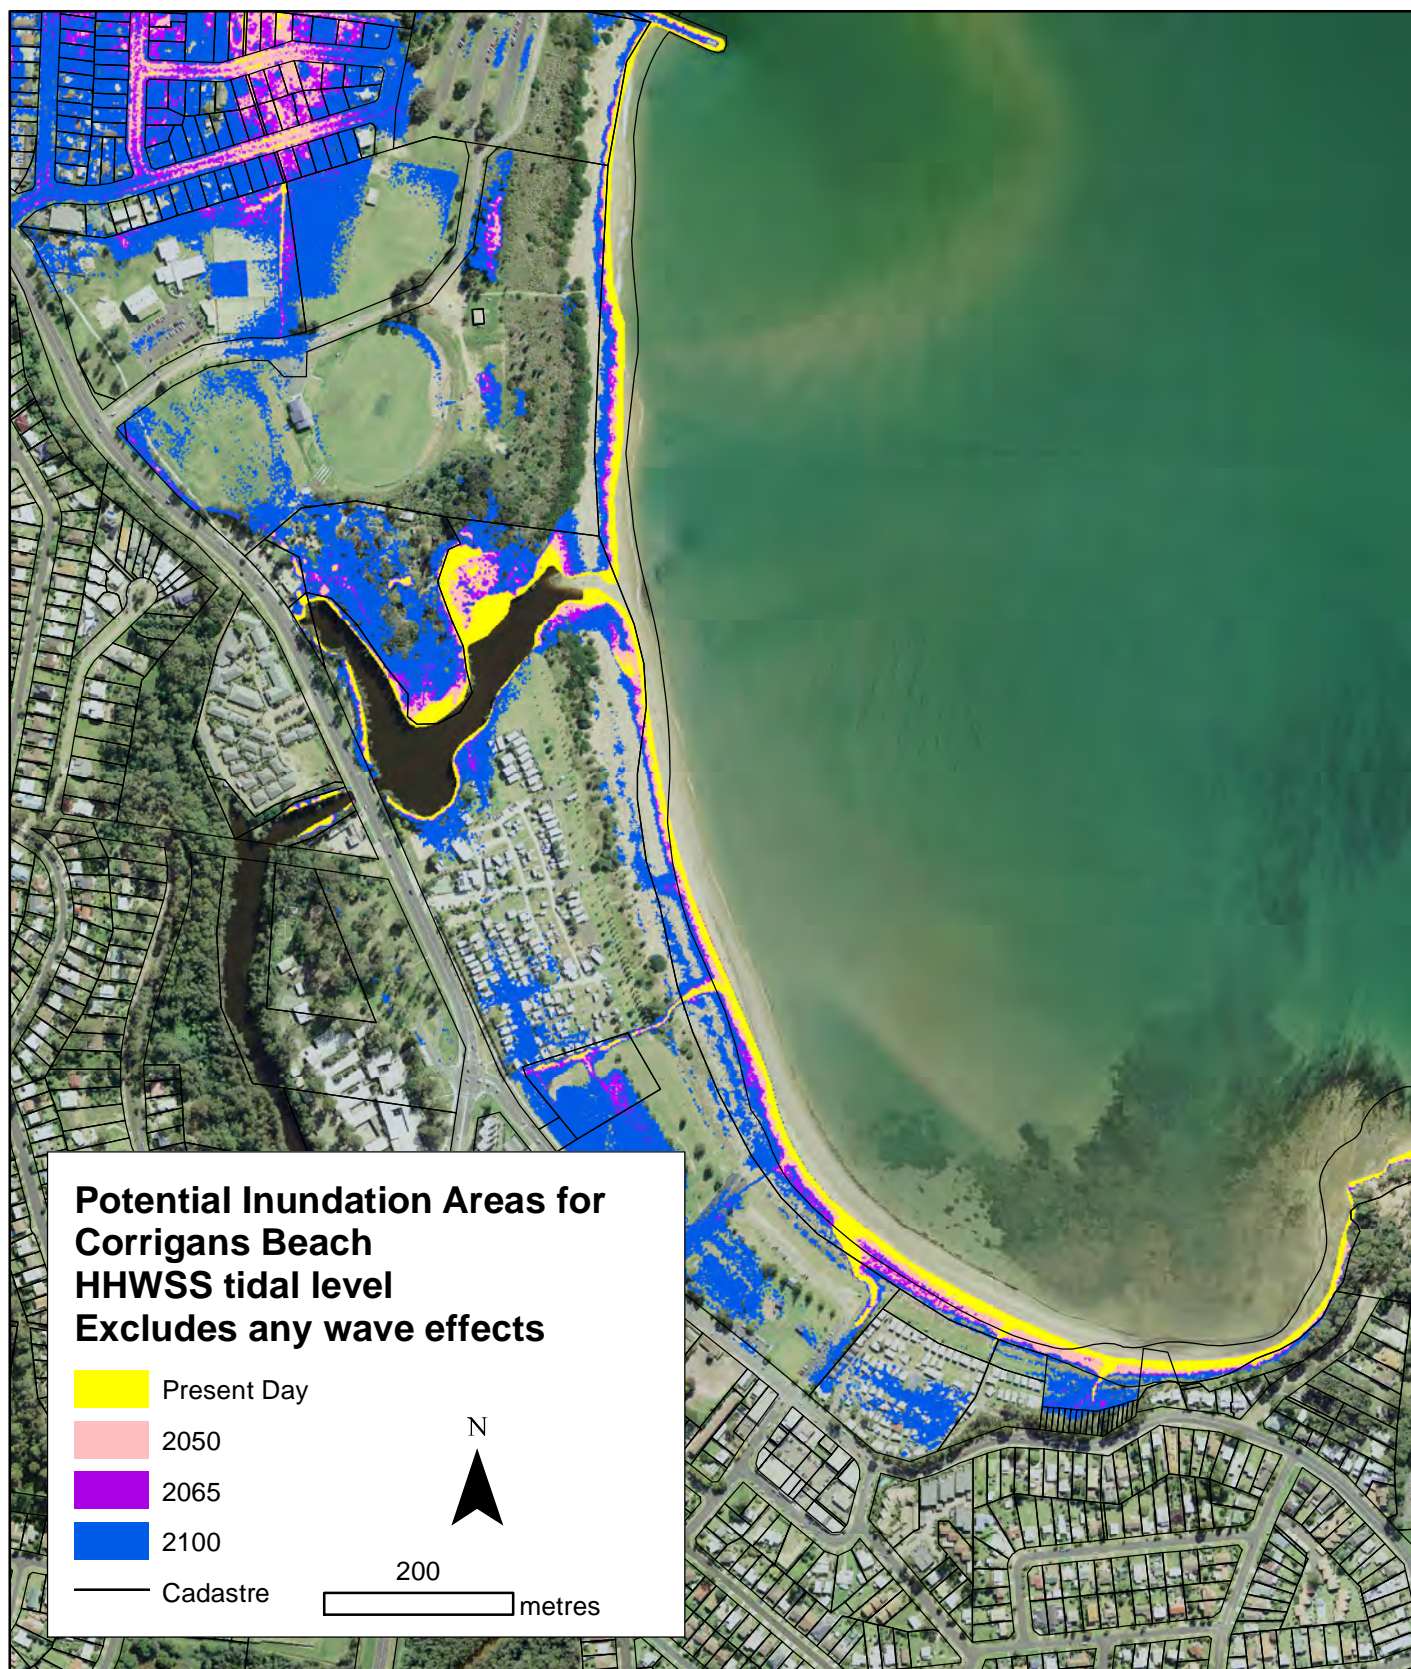
**Figure K.11**

Inundation areas are mapped based on the most recent year of LIDAR data available (2005). The mapping has been based on the ground elevation (the "all ground" LIDAR layer) and does not consider flow paths, flow velocities or loss of flow momentum. It does not include allowance for future landward recession of the beach face and assumes that the crest level of the seawall (if present) and the topography remain as they were from the 2005 LIDAR data. By 2050, 2065 or 2100 both of these assumptions may not be valid. Should the seawall/dune be allowed to fail then the landward extent of inundation may increase. WRL is not responsible for the accuracy of the LIDAR data. Local surveys by a registered surveyor are recommended to determine local inundation extents.

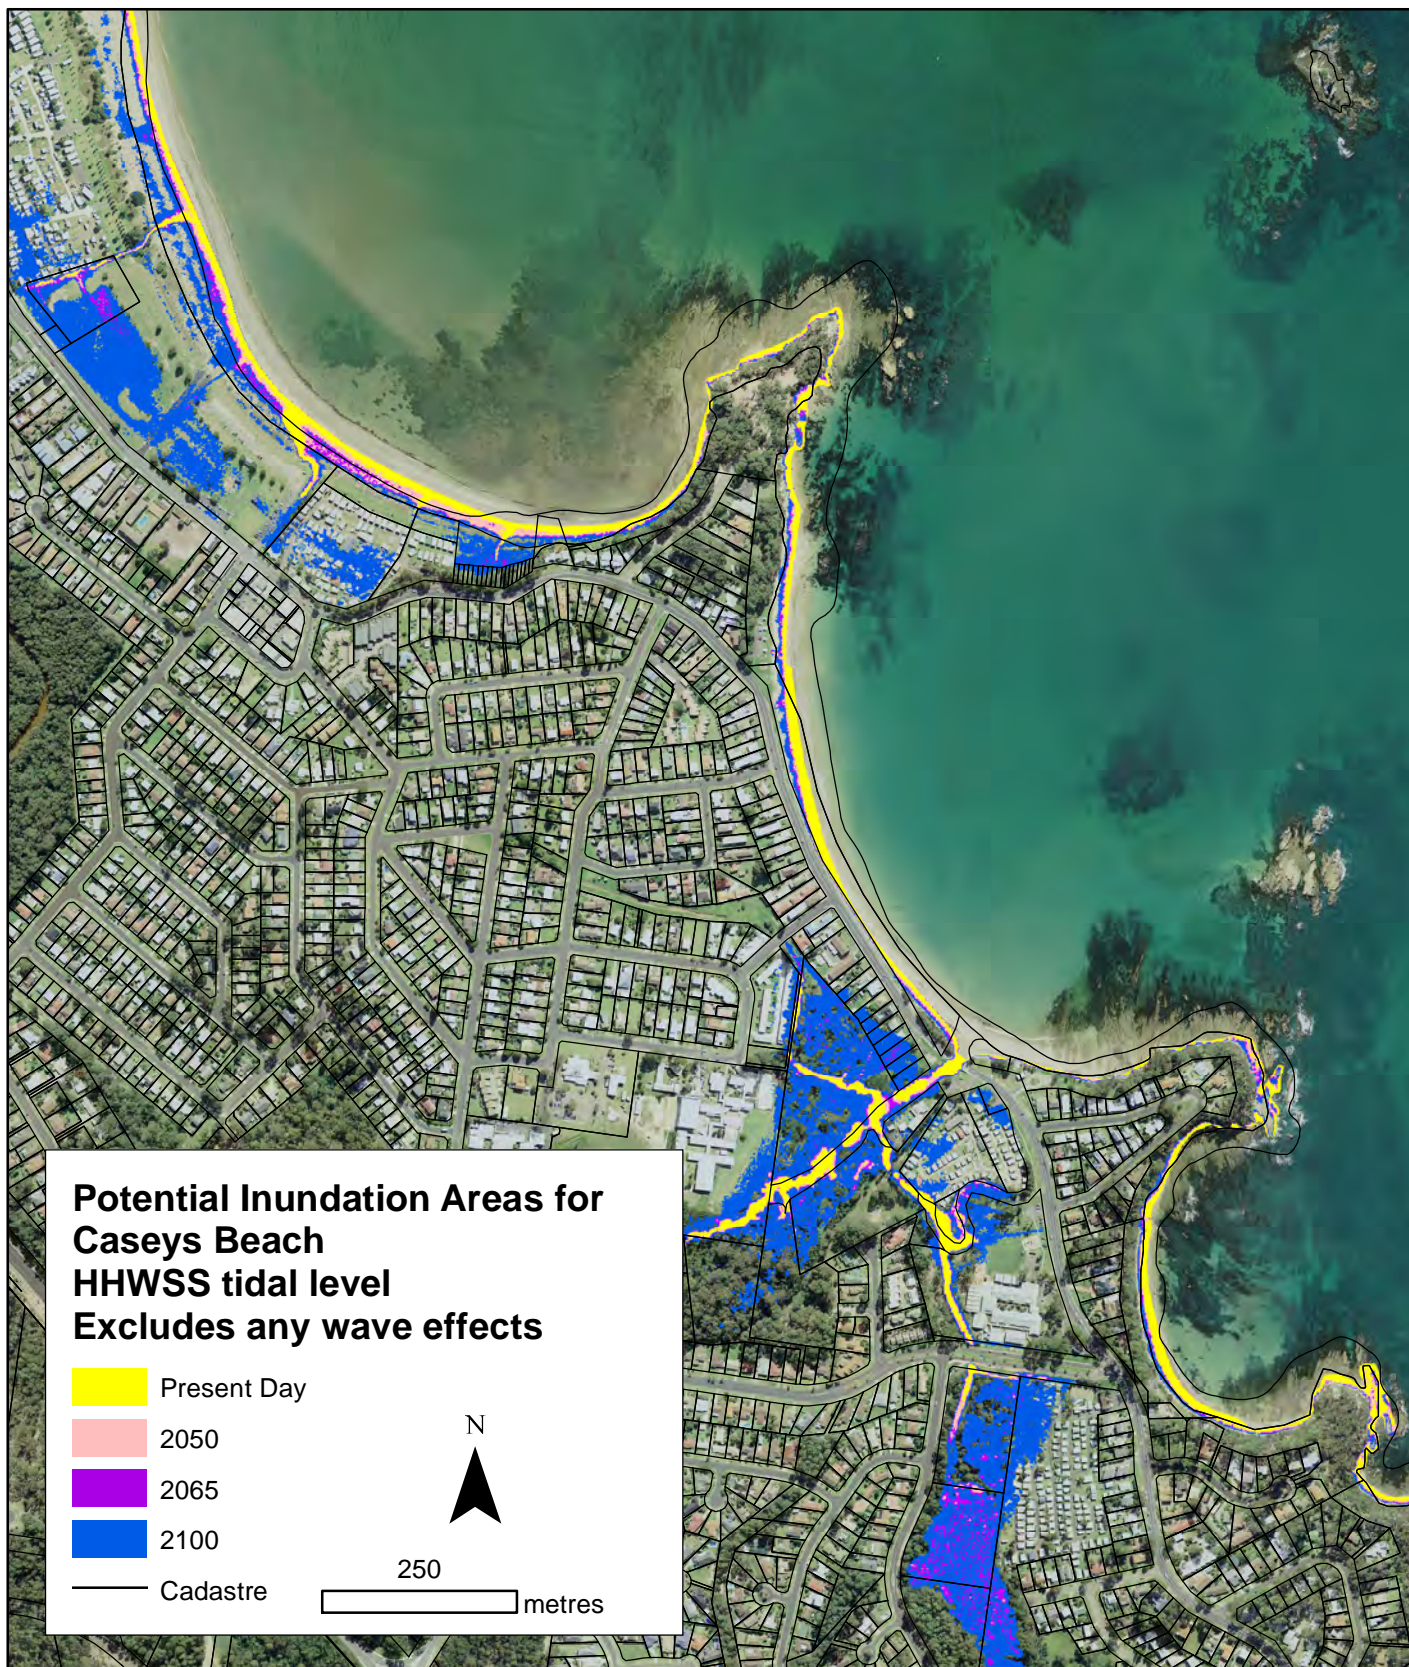
**Figure K.12**

Inundation areas are mapped based on the most recent year of LIDAR data available (2005). The mapping has been based on the ground elevation (the "all ground" LIDAR layer) and does not consider flow paths, flow velocities or loss of flow momentum. It does not include allowance for future landward recession of the beach face and assumes that the crest level of the seawall (if present) and the topography remain as they were from the 2005 LIDAR data. By 2050, 2065 or 2100 both of these assumptions may not be valid. Should the seawall/dune be allowed to fail then the landward extent of inundation may increase. WRL is not responsible for the accuracy of the LIDAR data. Local surveys by a registered surveyor are recommended to determine local inundation extents.

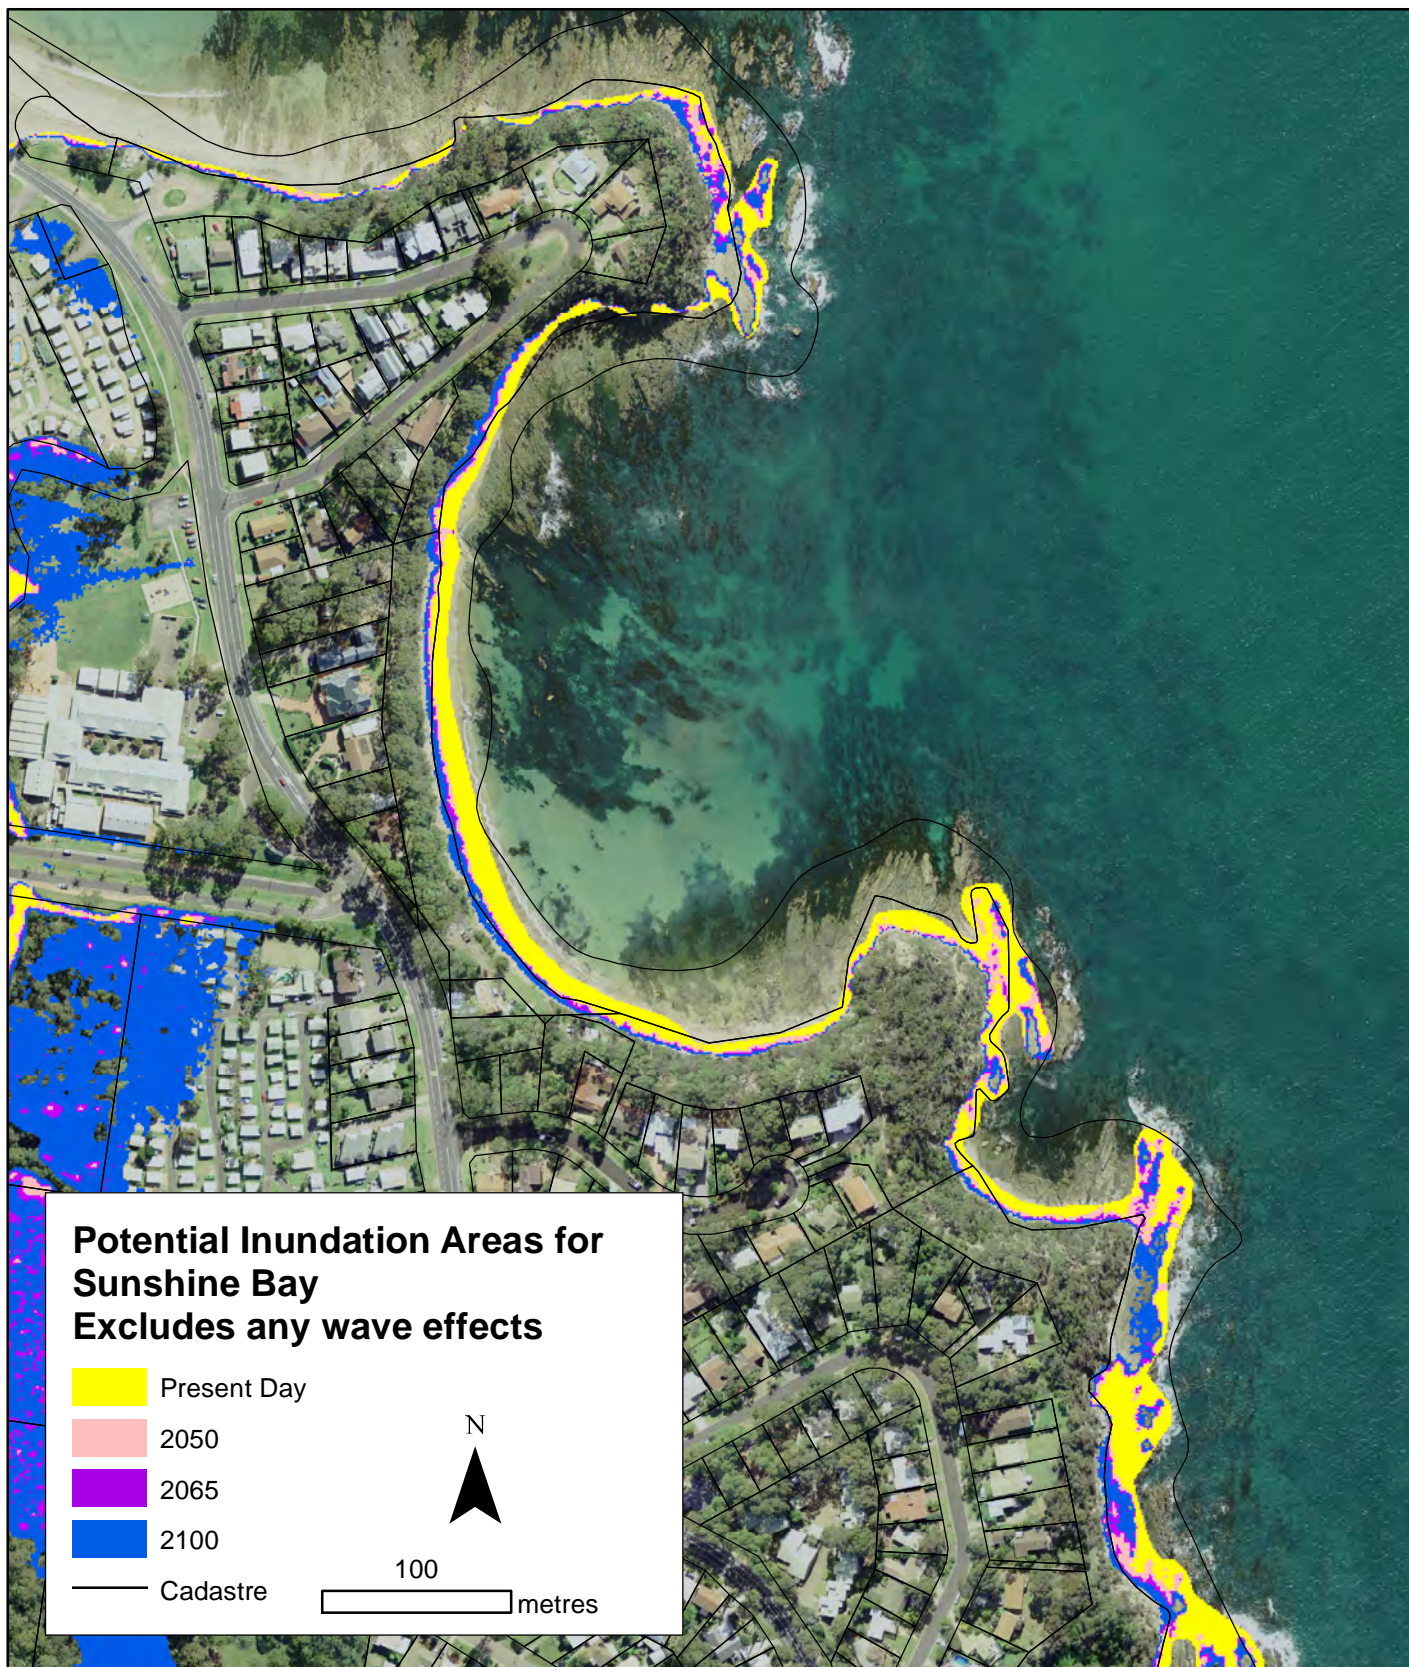
**Figure K.13**

Inundation areas are mapped based on the most recent year of LIDAR data available (2005). The mapping has been based on the ground elevation (the "all ground" LIDAR layer) and does not consider flow paths, flow velocities or loss of flow momentum. It does not include allowance for future landward recession of the beach face and assumes that the crest level of the seawall (if present) and the topography remain as they were from the 2005 LIDAR data. By 2050, 2065 or 2100 both of these assumptions may not be valid. Should the seawall/dune be allowed to fail then the landward extent of inundation may increase. WRL is not responsible for the accuracy of the LIDAR data. Local surveys by a registered surveyor are recommended to determine local inundation extents.

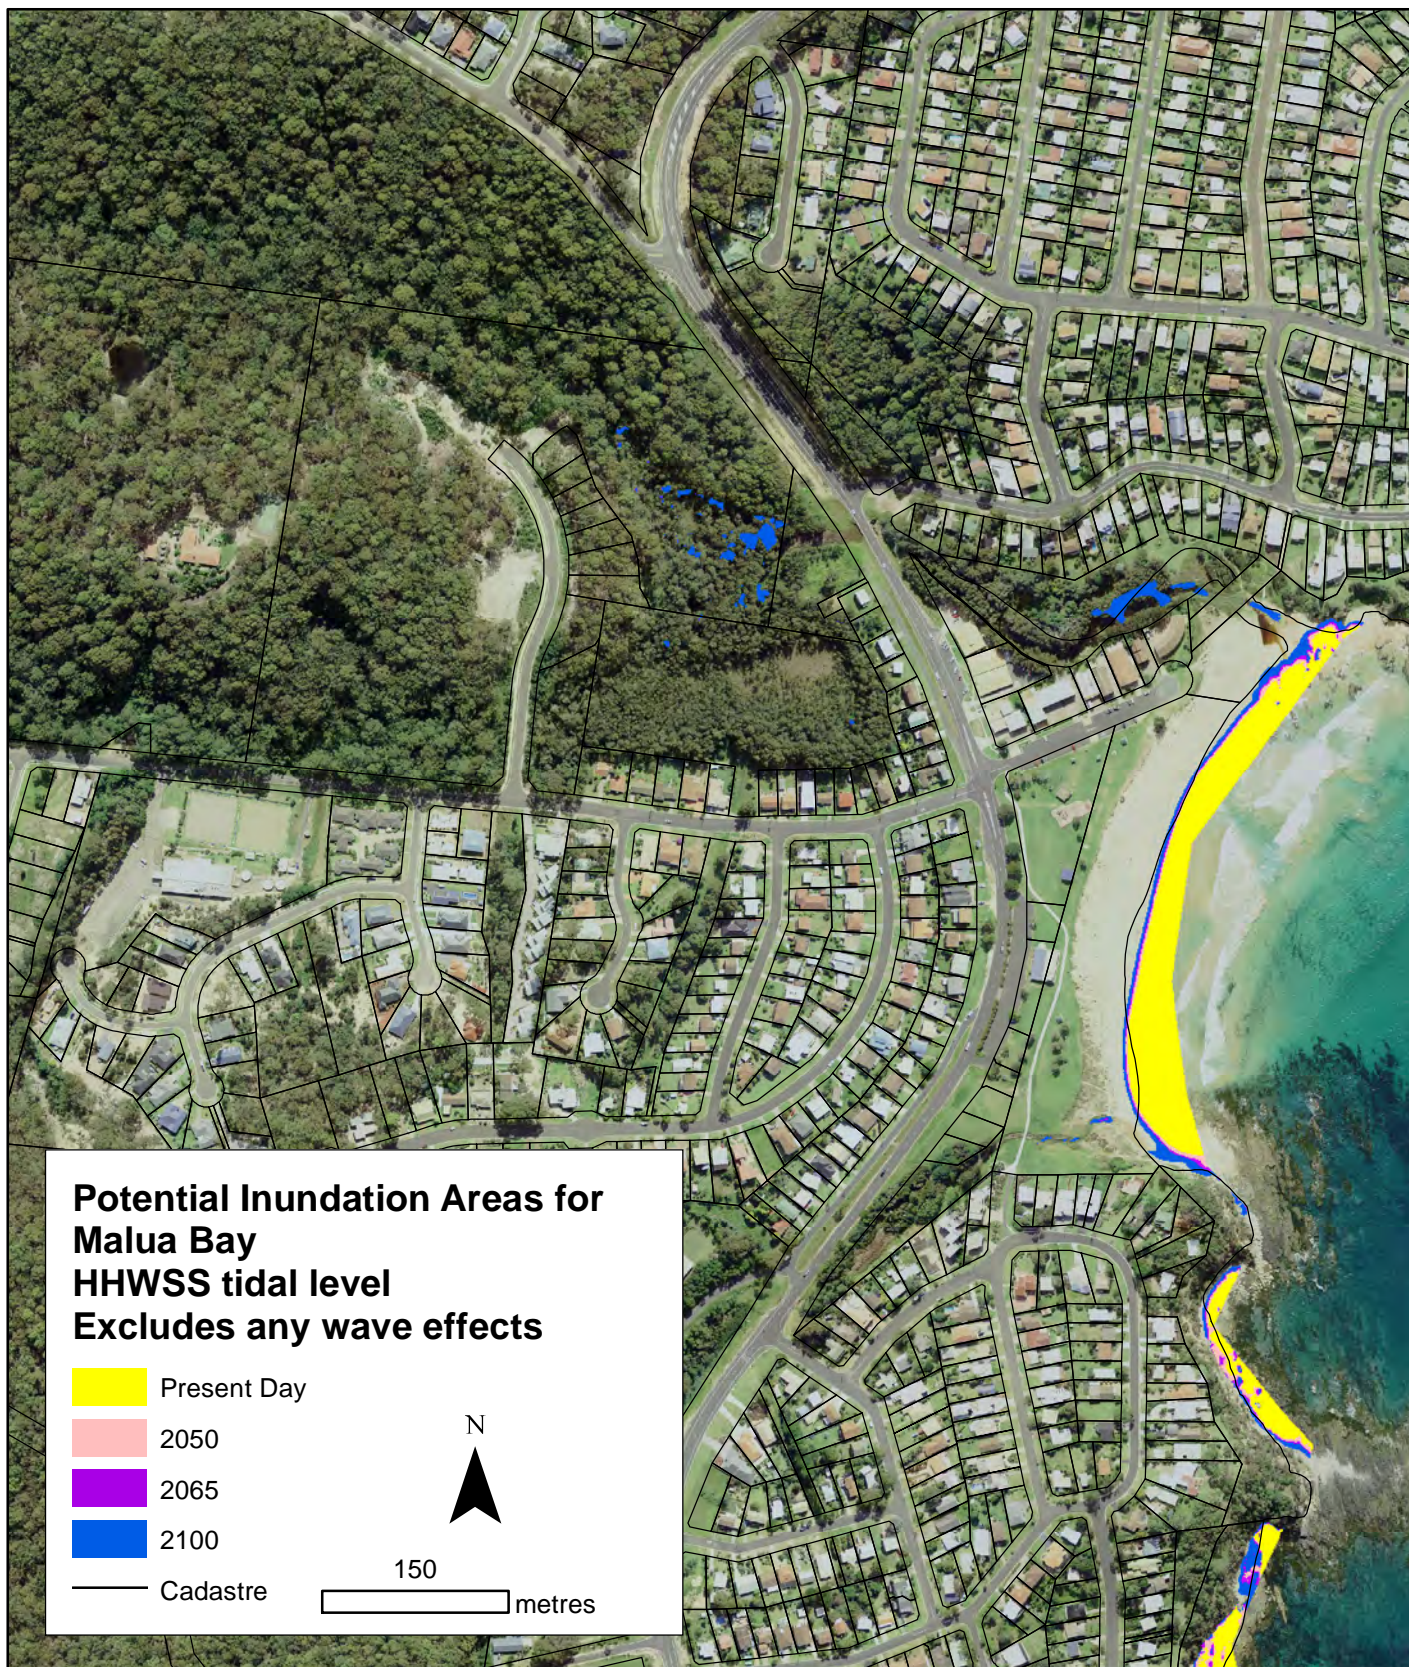
**Figure K.14**

Inundation areas are mapped based on the most recent year of LIDAR data available (2005). The mapping has been based on the ground elevation (the "all ground" LIDAR layer) and does not consider flow paths, flow velocities or loss of flow momentum. It does not include allowance for future landward recession of the beach face and assumes that the crest level of the seawall (if present) and the topography remain as they were from the 2005 LIDAR data. By 2050, 2065 or 2100 both of these assumptions may not be valid. Should the seawall/dune be allowed to fail then the landward extent of inundation may increase. WRL is not responsible for the accuracy of the LIDAR data. Local surveys by a registered surveyor are recommended to determine local inundation extents.

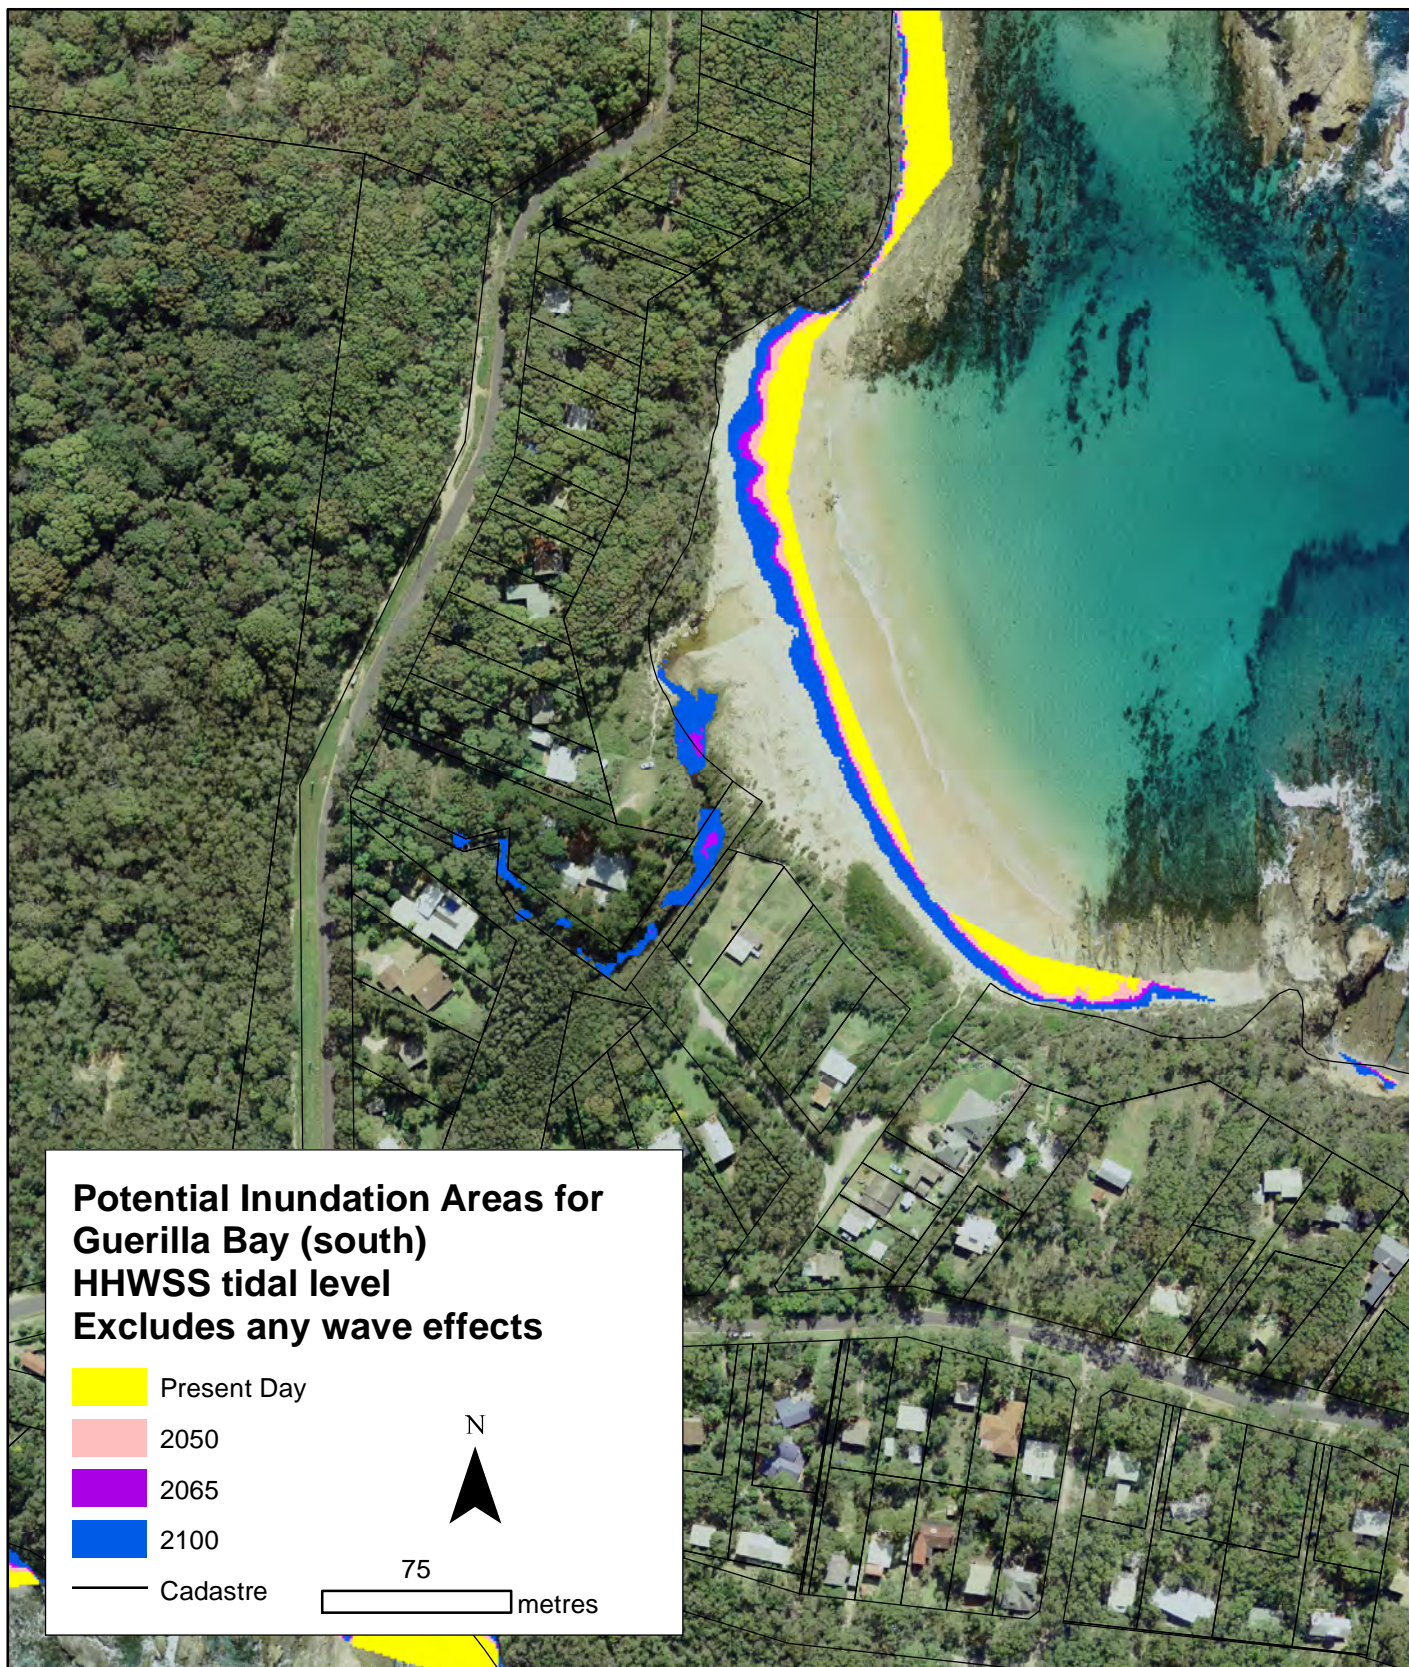
**Figure K.15**

Inundation areas are mapped based on the most recent year of LIDAR data available (2011). The mapping has been based on the ground elevation (the "all ground" LIDAR layer) and does not consider flow paths, flow velocities or loss of flow momentum. It does not include allowance for future landward recession of the beach face and assumes that the crest level of the seawall (if present) and the topography remain as they were from the 2011 LIDAR data. By 2050, 2065 or 2100 both of these assumptions may not be valid. Should the seawall/dune be allowed to fail then the landward extent of inundation may increase. WRL is not responsible for the accuracy of the LIDAR data. Local surveys by a registered surveyor are recommended to determine local inundation extents.

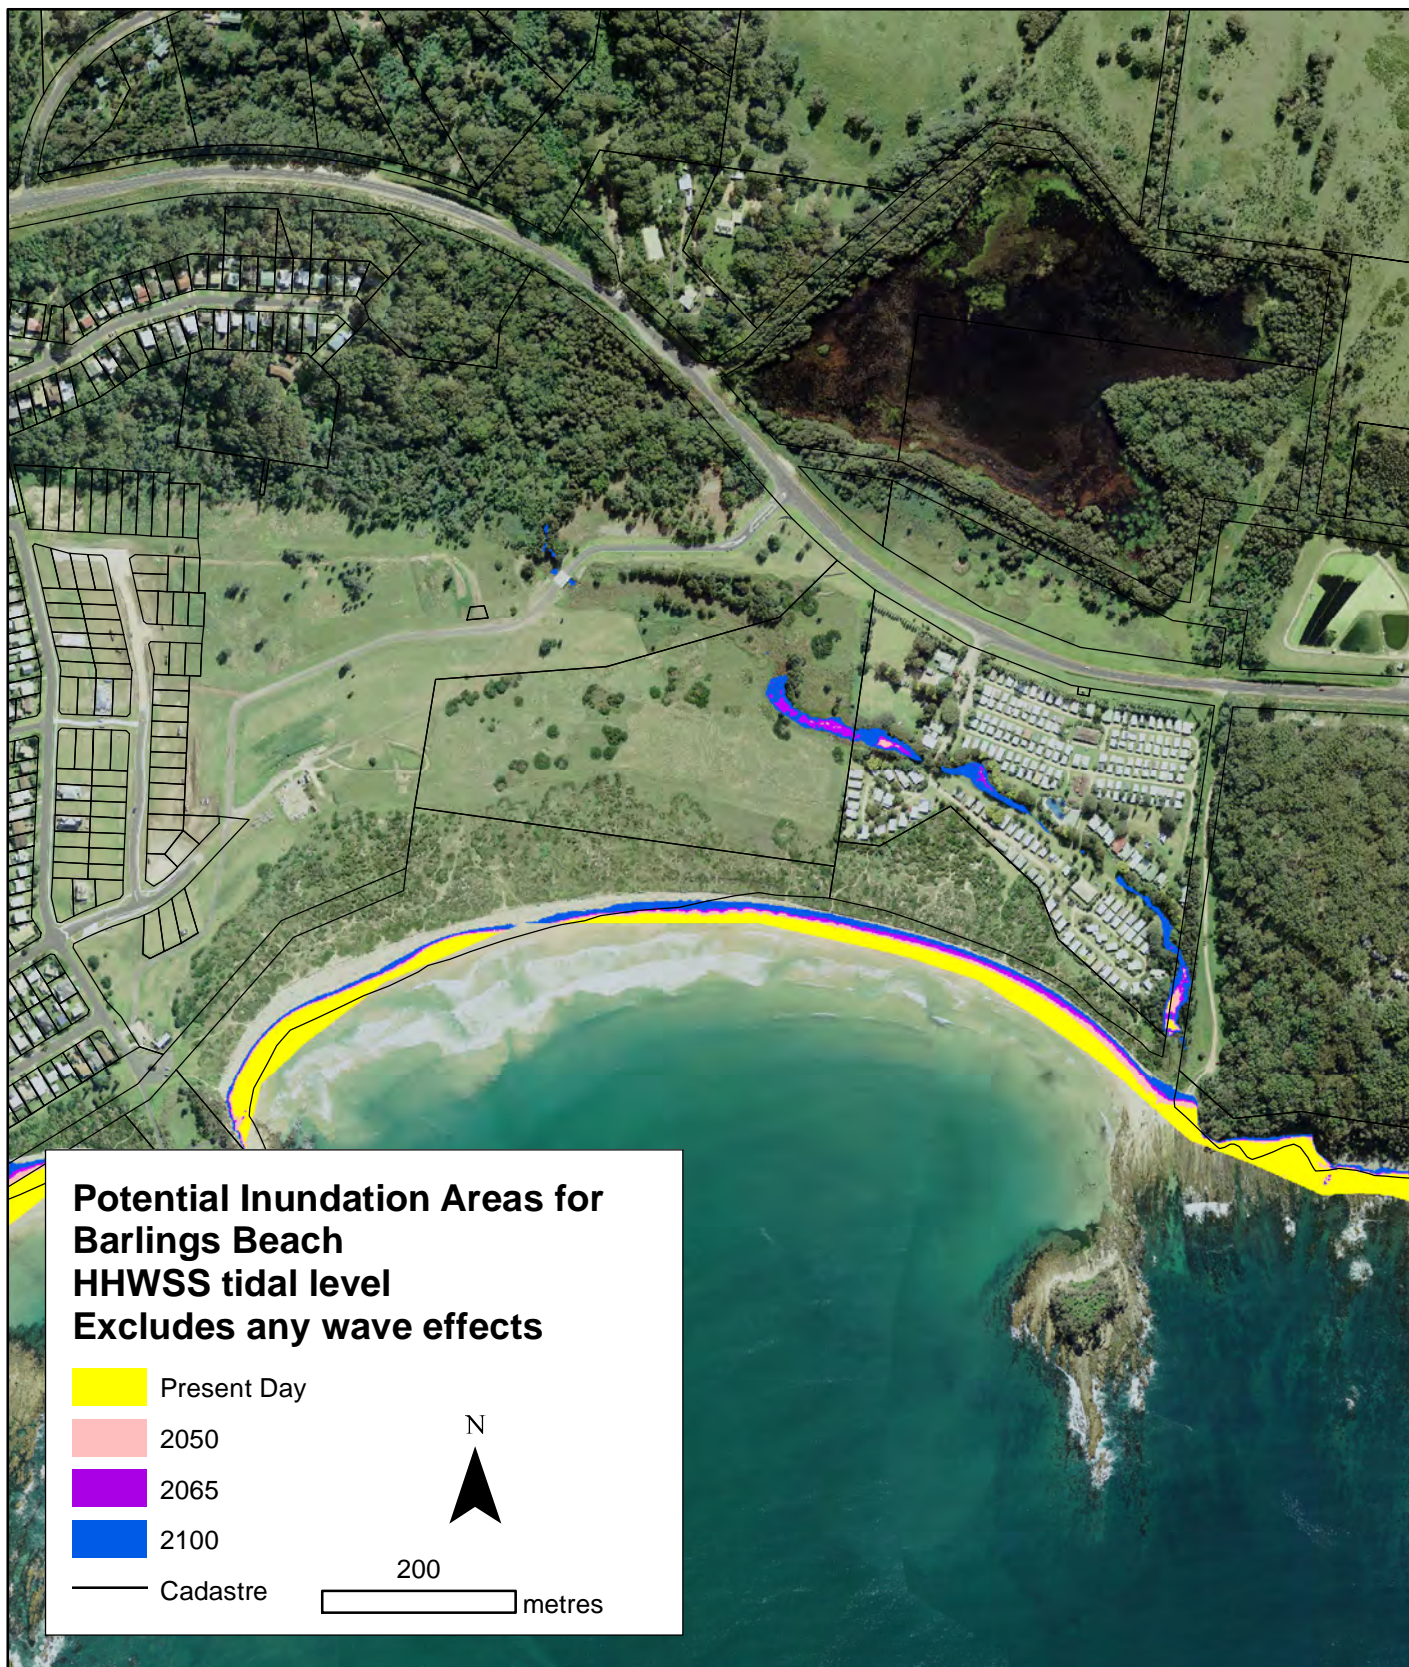
**Figure K.16**

Inundation areas are mapped based on the most recent year of LIDAR data available (2011). The mapping has been based on the ground elevation (the "all ground" LIDAR layer) and does not consider flow paths, flow velocities or loss of flow momentum. It does not include allowance for future landward recession of the beach face and assumes that the crest level of the seawall (if present) and the topography remain as they were from the 2011 LIDAR data. By 2050, 2065 or 2100 both of these assumptions may not be valid. Should the seawall/dune be allowed to fail then the landward extent of inundation may increase. WRL is not responsible for the accuracy of the LIDAR data. Local surveys by a registered surveyor are recommended to determine local inundation extents.

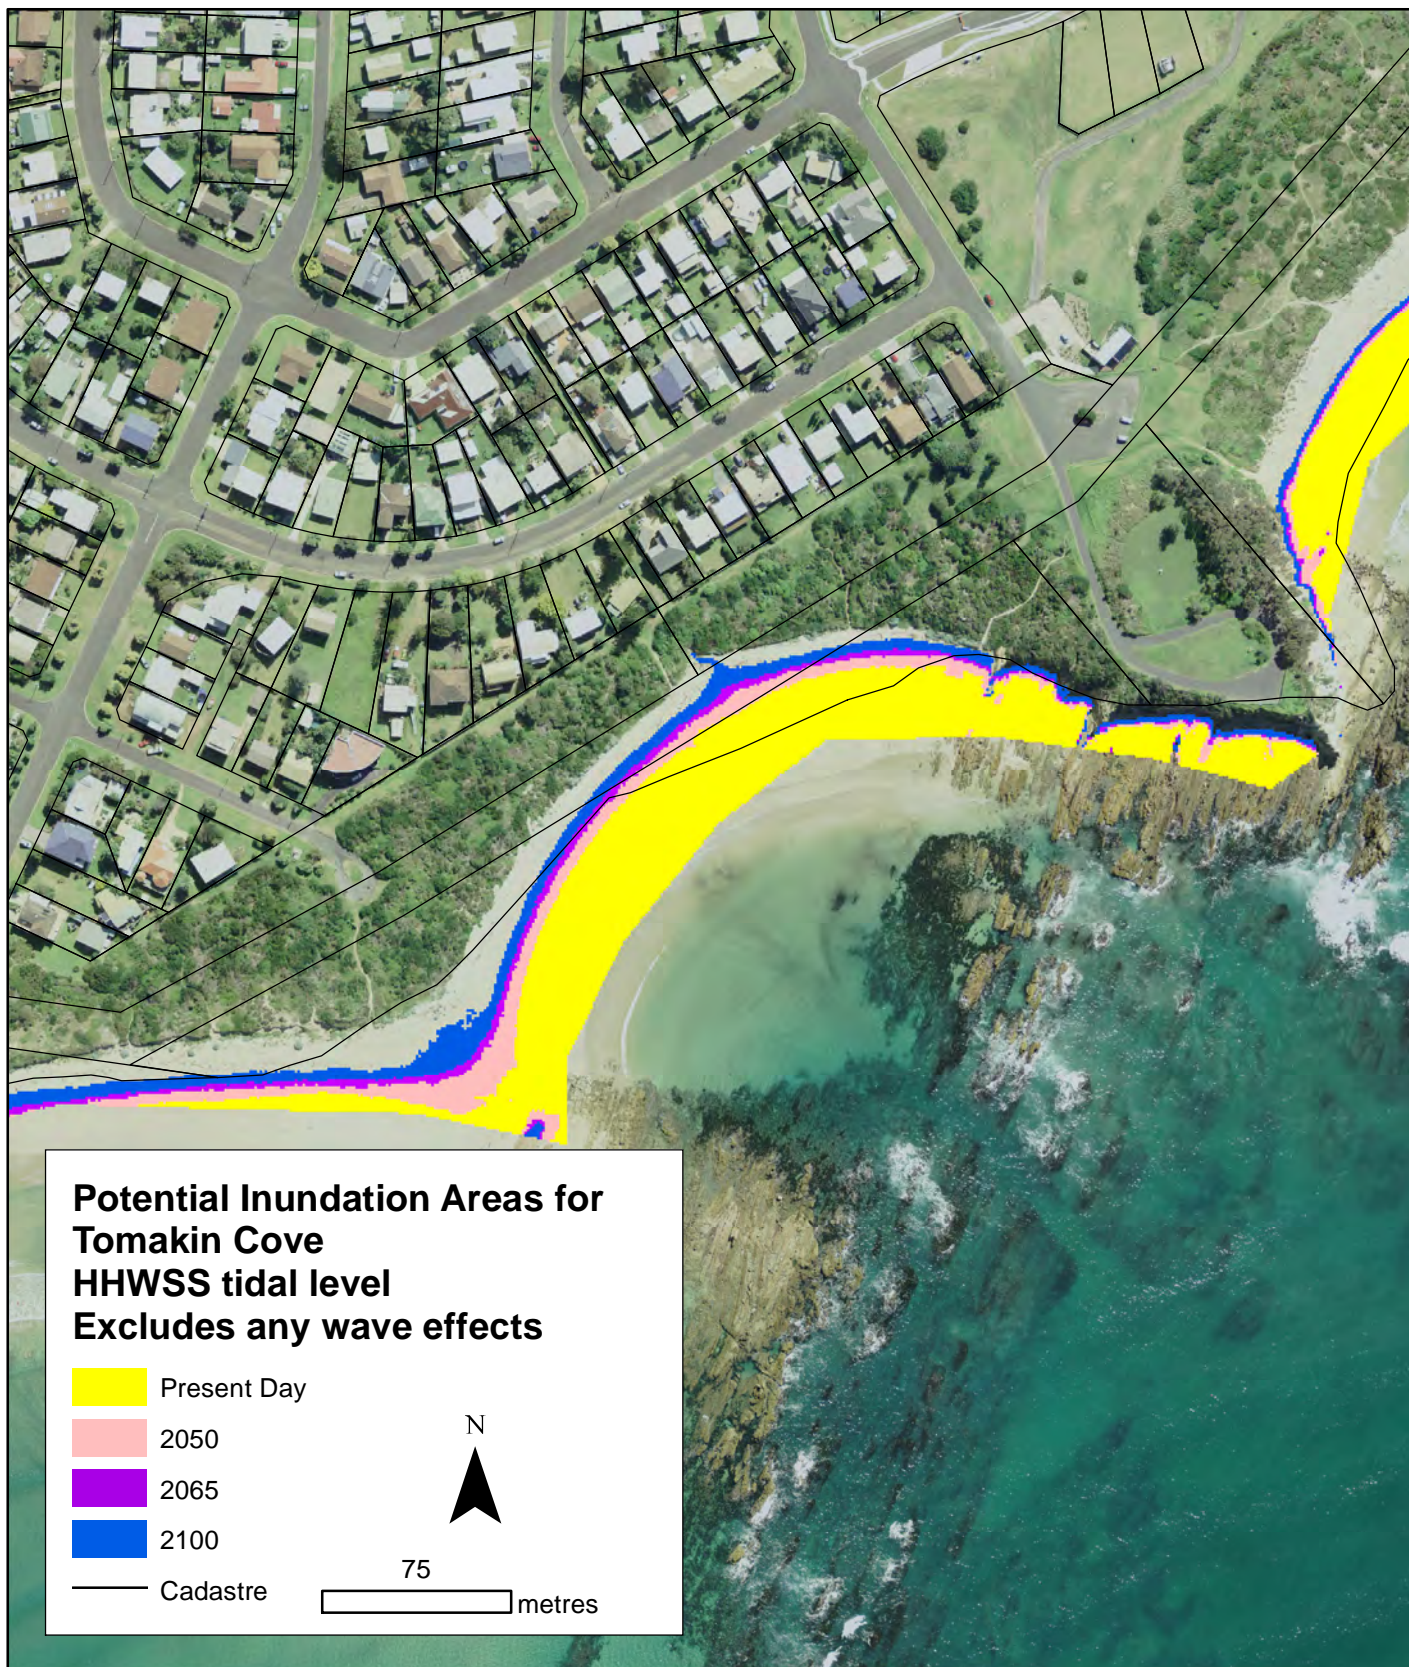
**Figure K.17**

Inundation areas are mapped based on the most recent year of LIDAR data available (2011). The mapping has been based on the ground elevation (the "all ground" LIDAR layer) and does not consider flow paths, flow velocities or loss of flow momentum. It does not include allowance for future landward recession of the beach face and assumes that the crest level of the seawall (if present) and the topography remain as they were from the 2011 LIDAR data. By 2050, 2065 or 2100 both of these assumptions may not be valid. Should the seawall/dune be allowed to fail then the landward extent of inundation may increase. WRL is not responsible for the accuracy of the LIDAR data. Local surveys by a registered surveyor are recommended to determine local inundation extents.
