## Eurobodalla Coastal Hazard Assessment

WRL Technical Report 2017/09  
October 2017

By I R Coghlan, J T Carley, A J Harrison, D Howe, A D Short,  
J E Ruprecht, F Flocard and P F Rahman

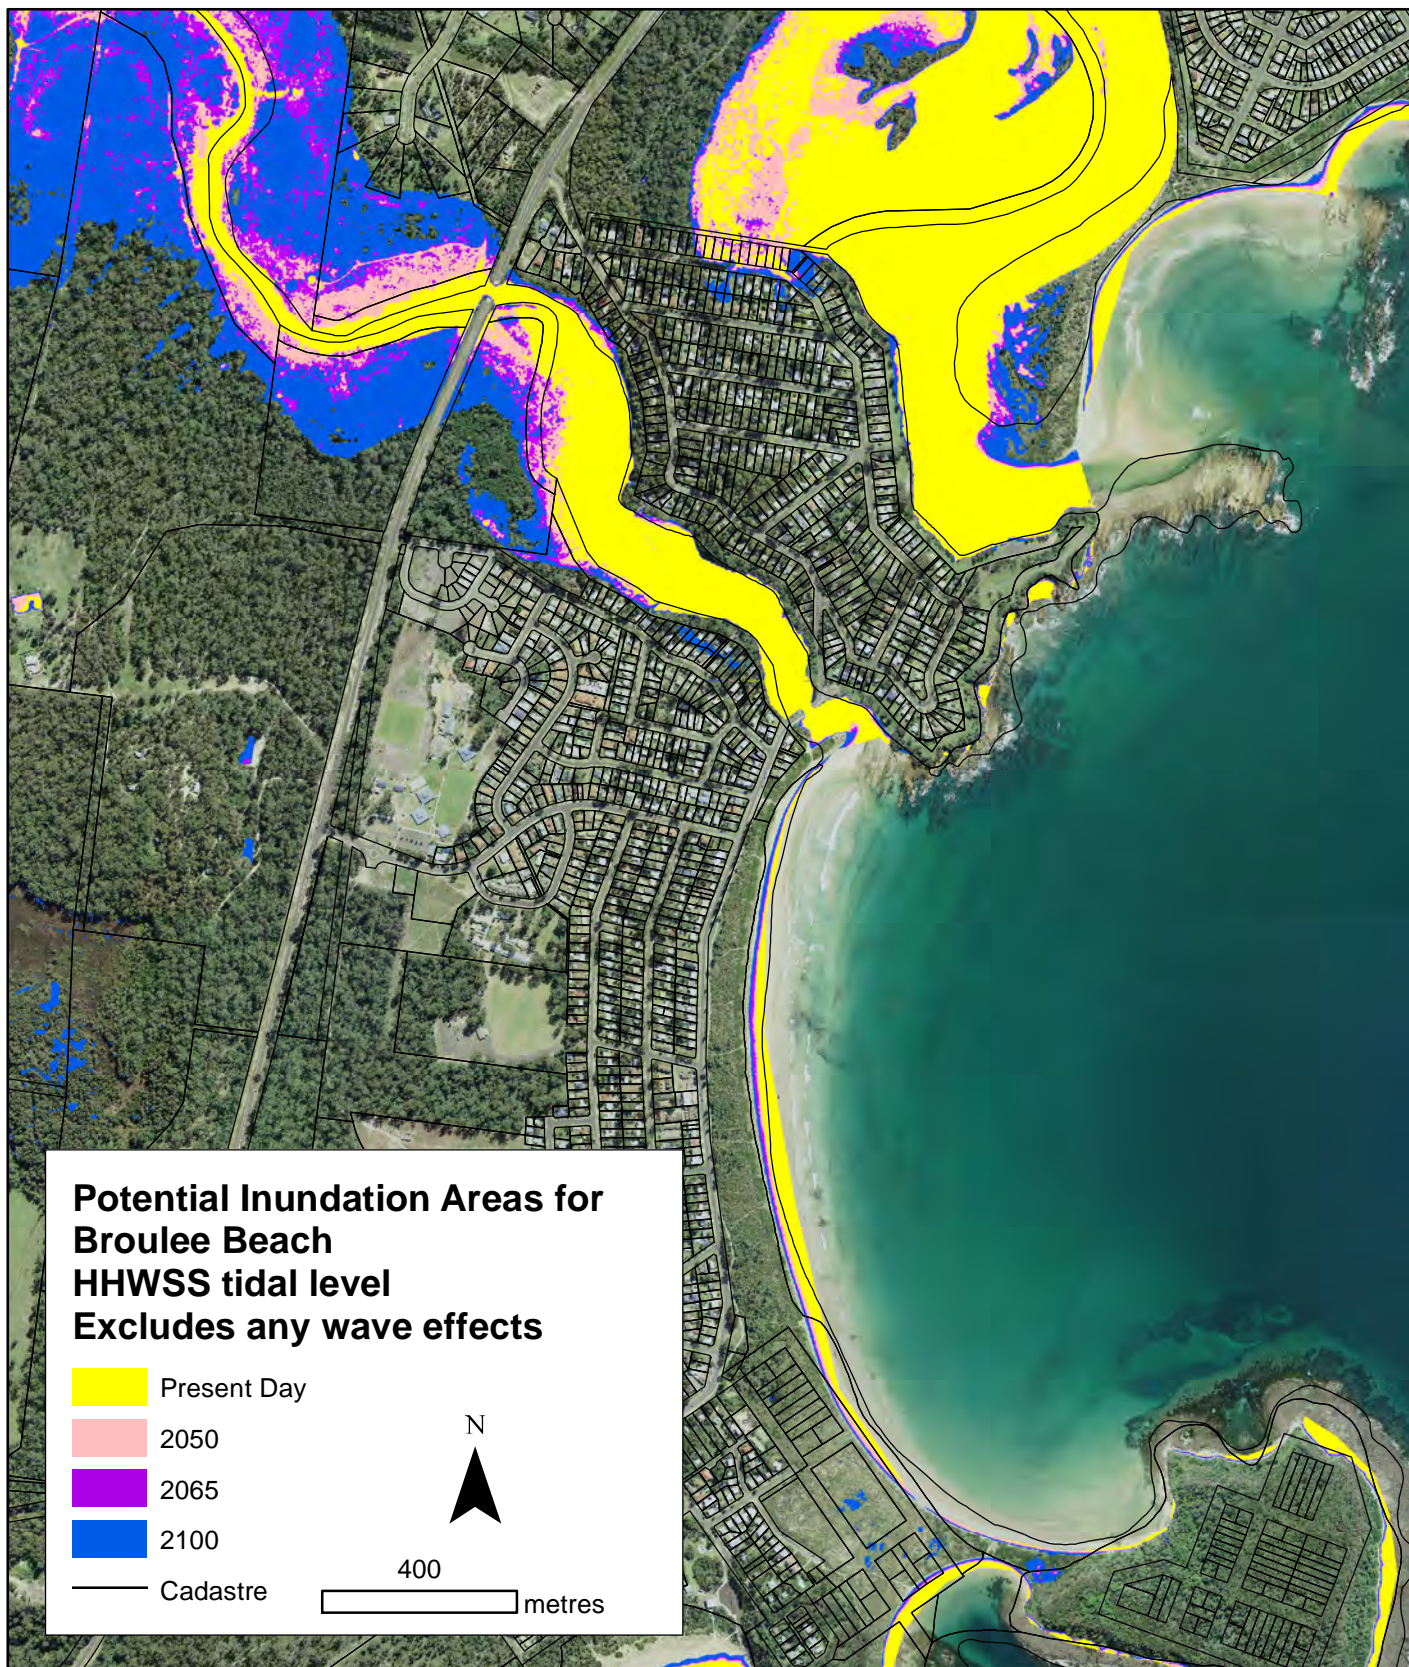
**Figure K.18**

Inundation areas are mapped based on the most recent year of LIDAR data available (2011). The mapping has been based on the ground elevation (the "all ground" LIDAR layer) and does not consider flow paths, flow velocities or loss of flow momentum. It does not include allowance for future landward recession of the beach face and assumes that the crest level of the seawall (if present) and the topography remain as they were from the 2011 LIDAR data. By 2050, 2065 or 2100 both of these assumptions may not be valid. Should the seawall/dune be allowed to fail then the landward extent of inundation may increase. WRL is not responsible for the accuracy of the LIDAR data. Local surveys by a registered surveyor are recommended to determine local inundation extents.

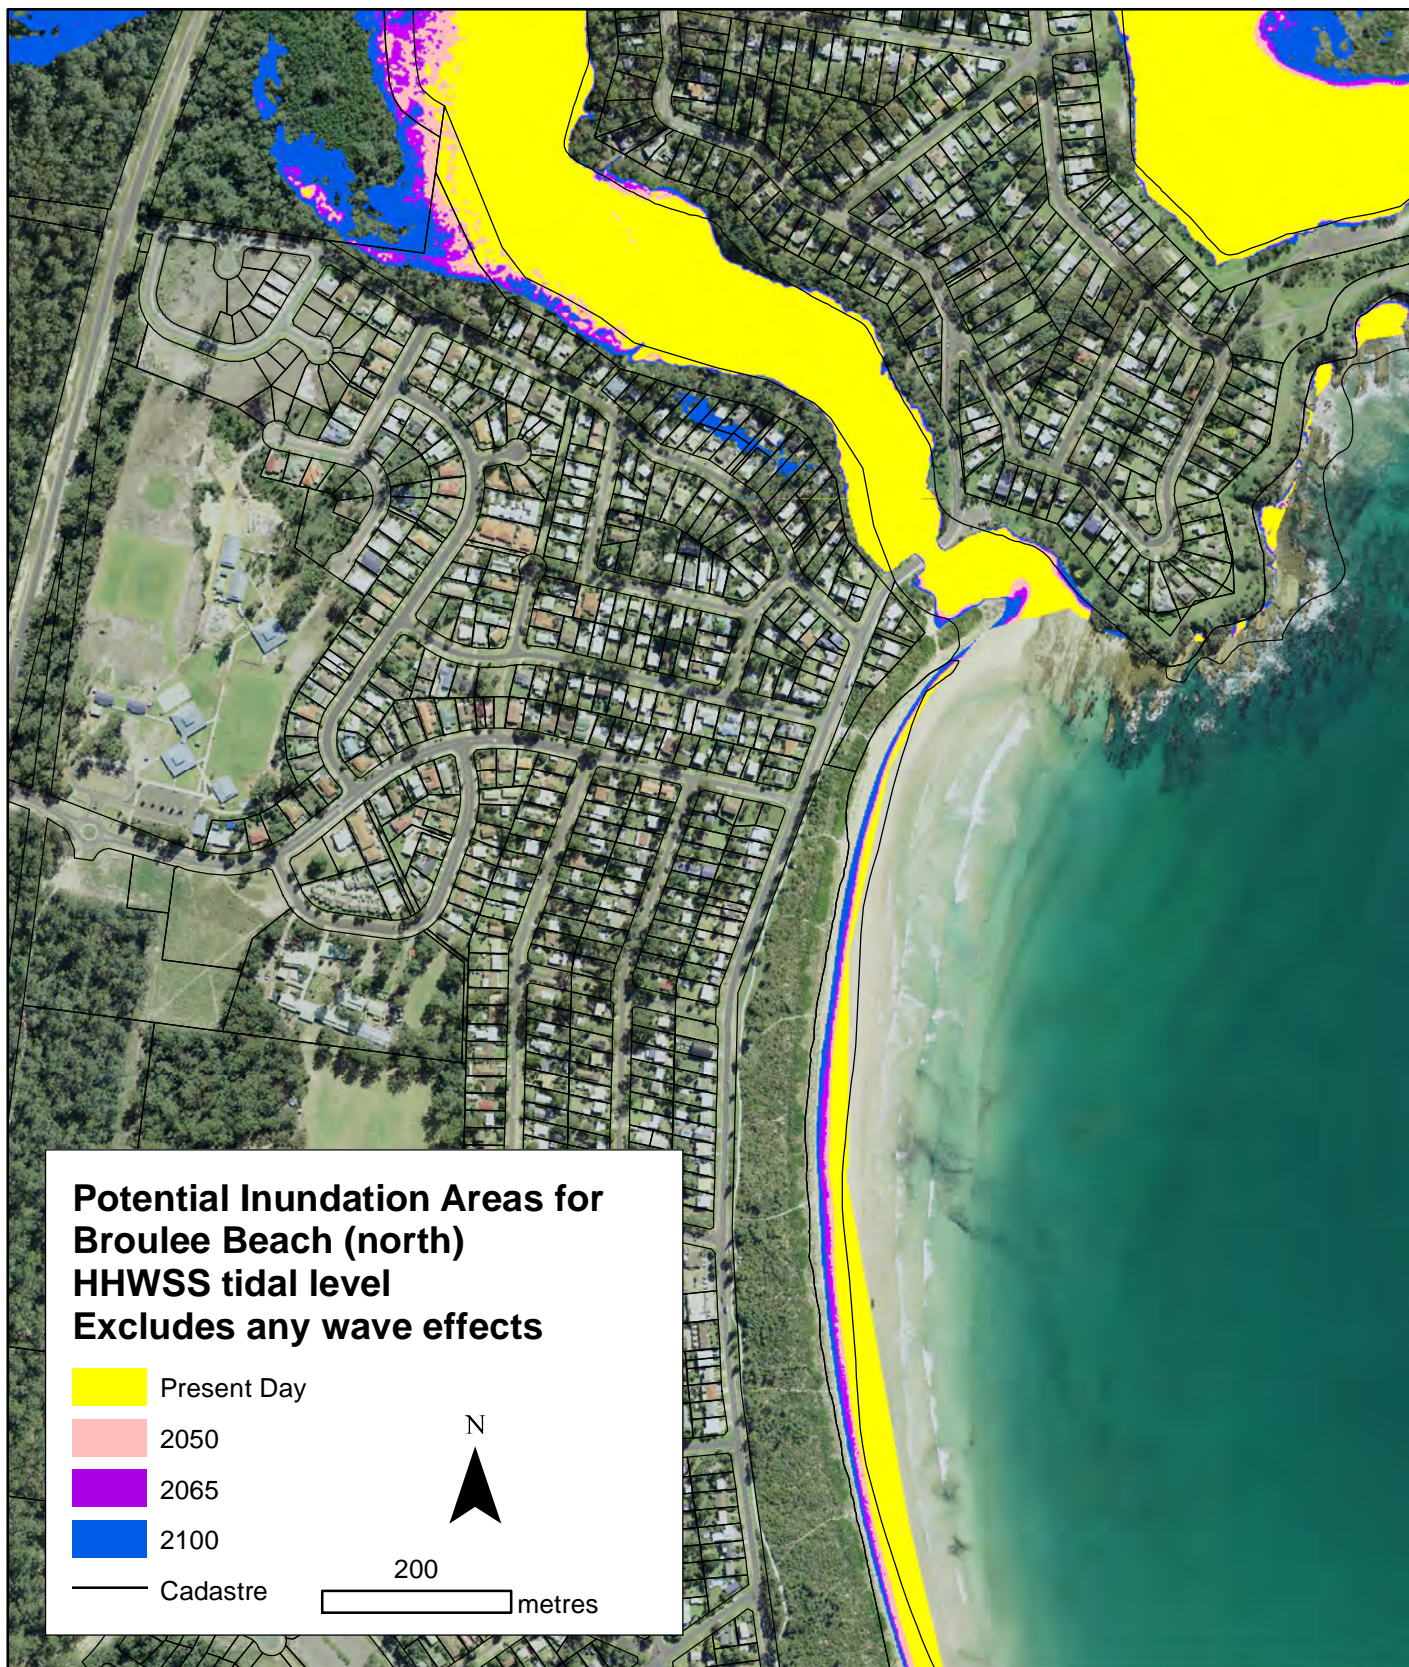
**Figure K.19**

Inundation areas are mapped based on the most recent year of LIDAR data available (2011). The mapping has been based on the ground elevation (the "all ground" LIDAR layer) and does not consider flow paths, flow velocities or loss of flow momentum. It does not include allowance for future landward recession of the beach face and assumes that the crest level of the seawall (if present) and the topography remain as they were from the 2011 LIDAR data. By 2050, 2065 or 2100 both of these assumptions may not be valid. Should the seawall/dune be allowed to fail then the landward extent of inundation may increase. WRL is not responsible for the accuracy of the LIDAR data. Local surveys by a registered surveyor are recommended to determine local inundation extents.

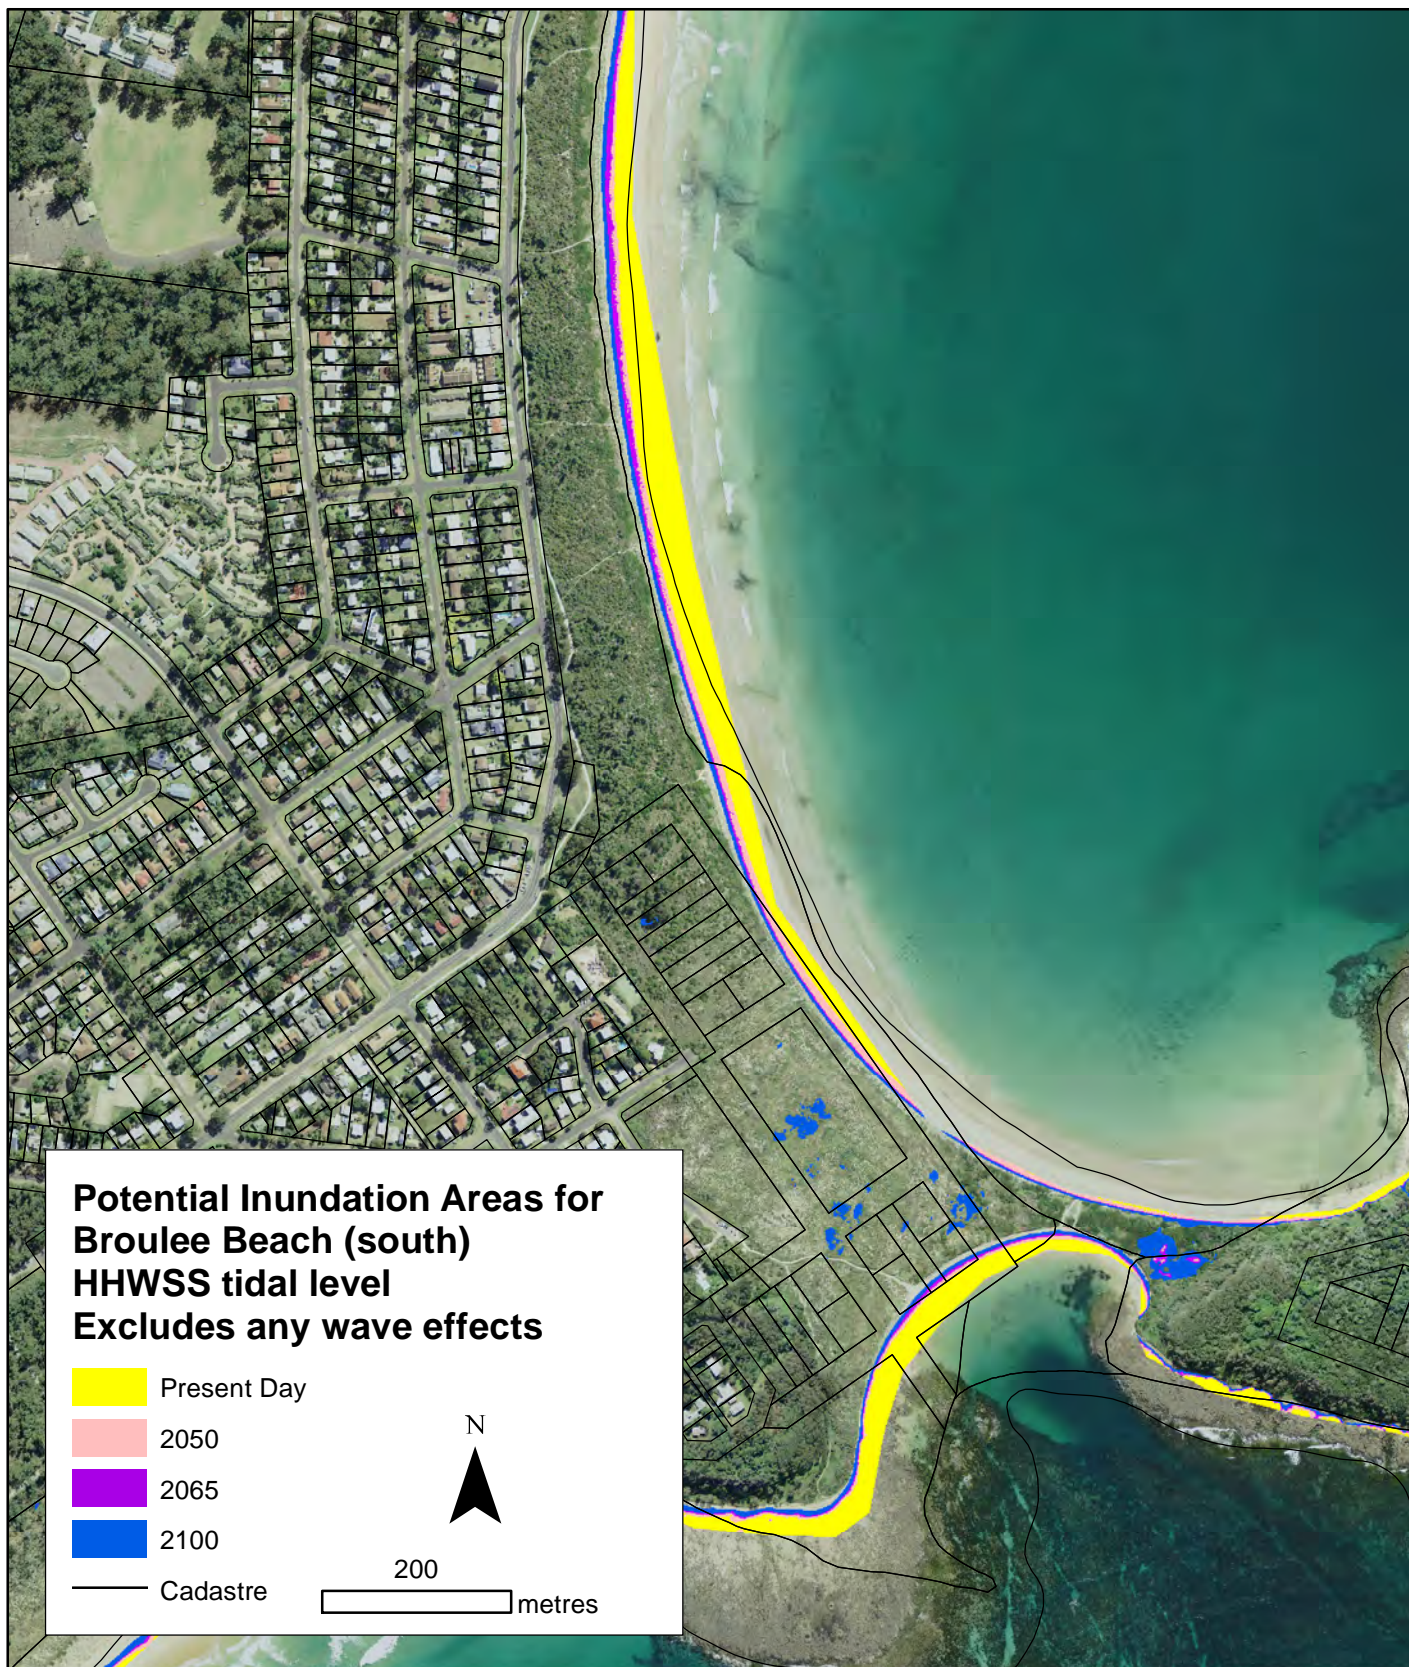
**Figure K.20**

Inundation areas are mapped based on the most recent year of LIDAR data available (2011). The mapping has been based on the ground elevation (the "all ground" LIDAR layer) and does not consider flow paths, flow velocities or loss of flow momentum. It does not include allowance for future landward recession of the beach face and assumes that the crest level of the seawall (if present) and the topography remain as they were from the 2011 LIDAR data. By 2050, 2065 or 2100 both of these assumptions may not be valid. Should the seawall/dune be allowed to fail then the landward extent of inundation may increase. WRL is not responsible for the accuracy of the LIDAR data. Local surveys by a registered surveyor are recommended to determine local inundation extents.

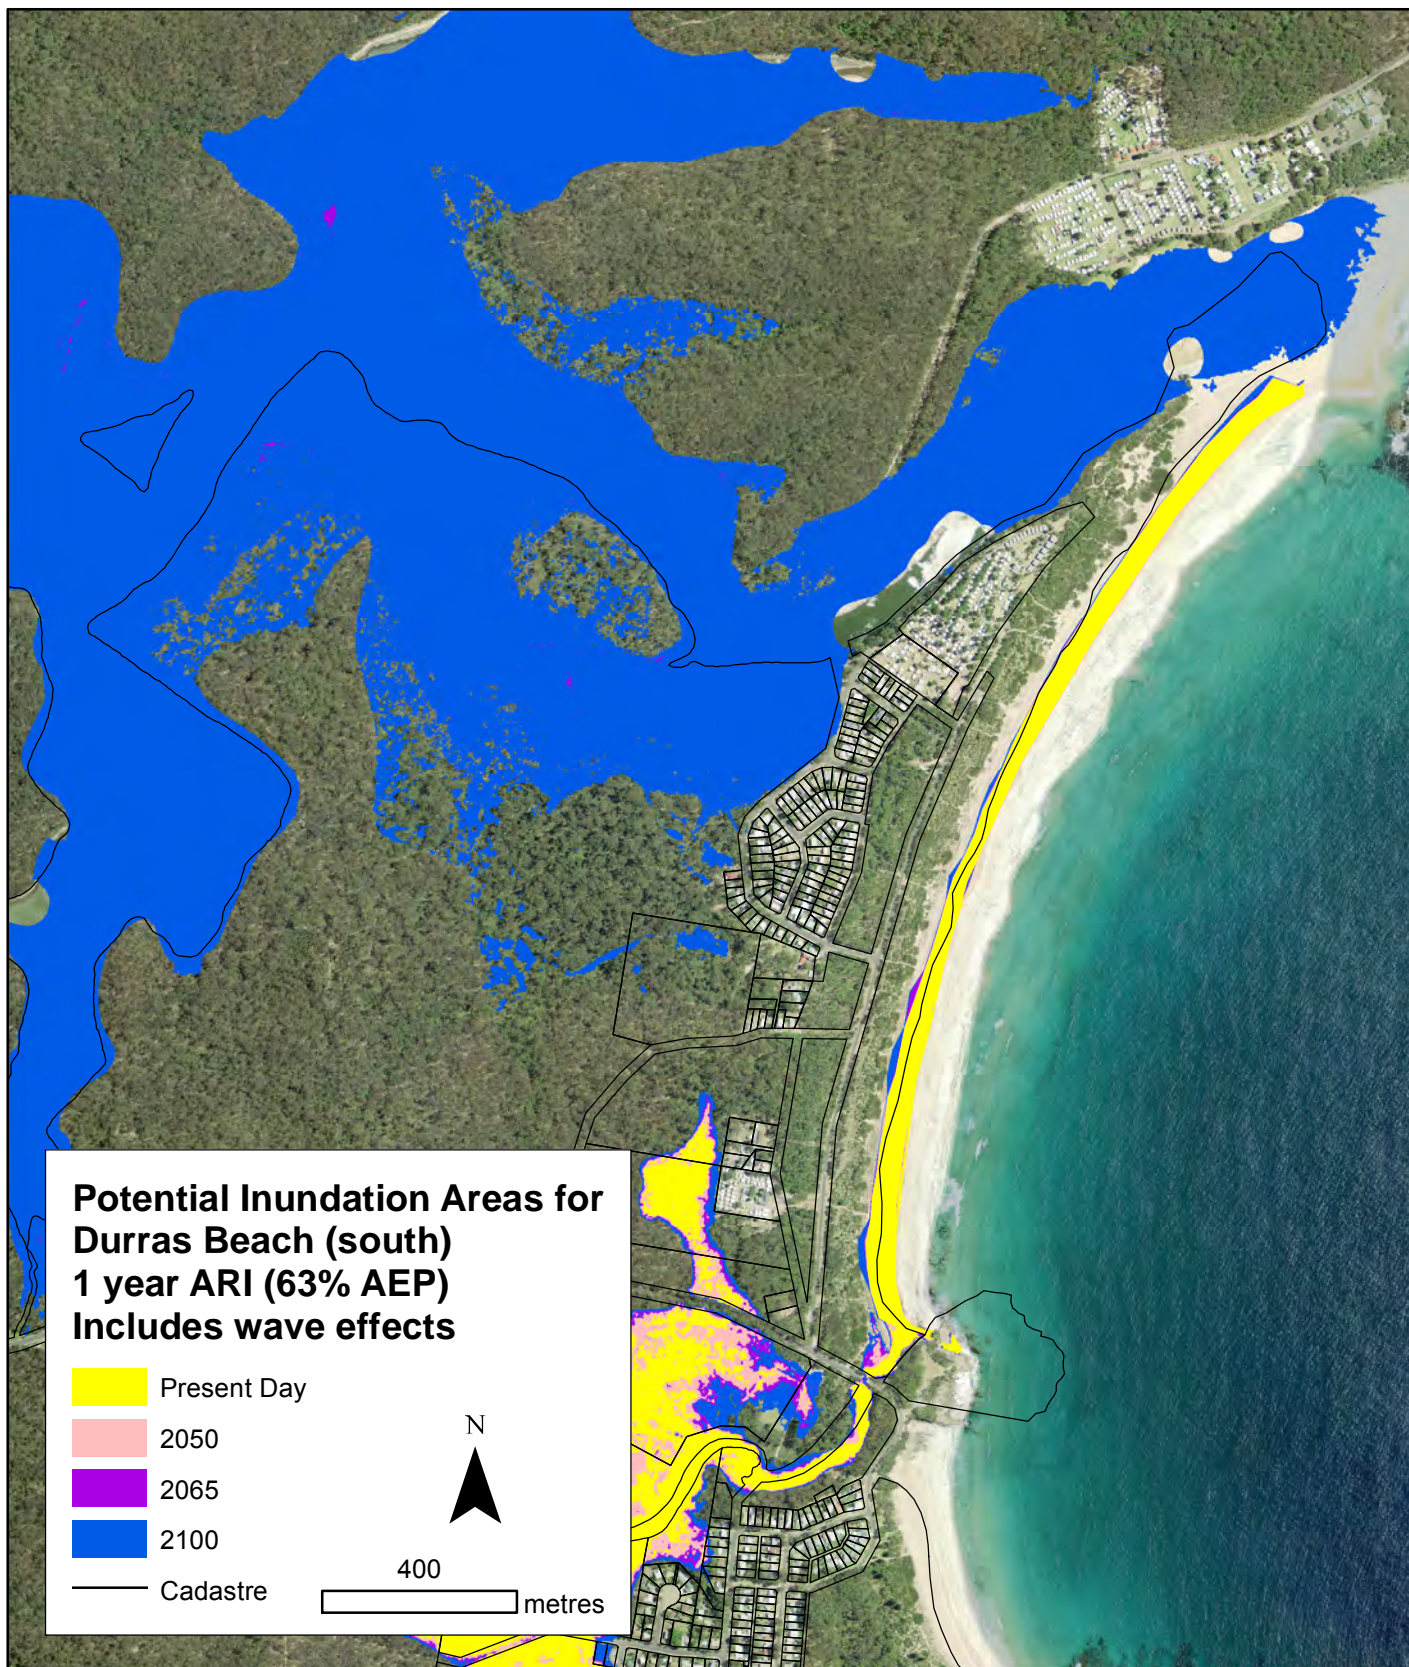
Inundation of the beachface and the area immediately landward of the dune crest is based on the most recent year of LIDAR data available (2011) and is in accordance with ESC's sea level rise policy and planning framework. It does not include allowance for future landward recession of the beach face and assumes that the crest level of the seawall (if present) and the topography remain as they were from the 2011 LIDAR data. By 2050, 2065 or 2100 both of these assumptions may not be valid. Should the seawall/dune be allowed to fail then the landward extent of inundation may increase. Inundation of low lying areas behind the beach is based on the most recent year of LIDAR data available (2011). The low lying inundation areas behind the beach are mapped based on the ground elevation (the "all ground" LIDAR layer) and do not consider flow paths, flow velocities, loss of flow momentum or wave propagation into creek areas. WRL is not responsible for the accuracy of the photogrammetry or LIDAR data. Local surveys by a registered surveyor are recommended to determine local inundation extents.

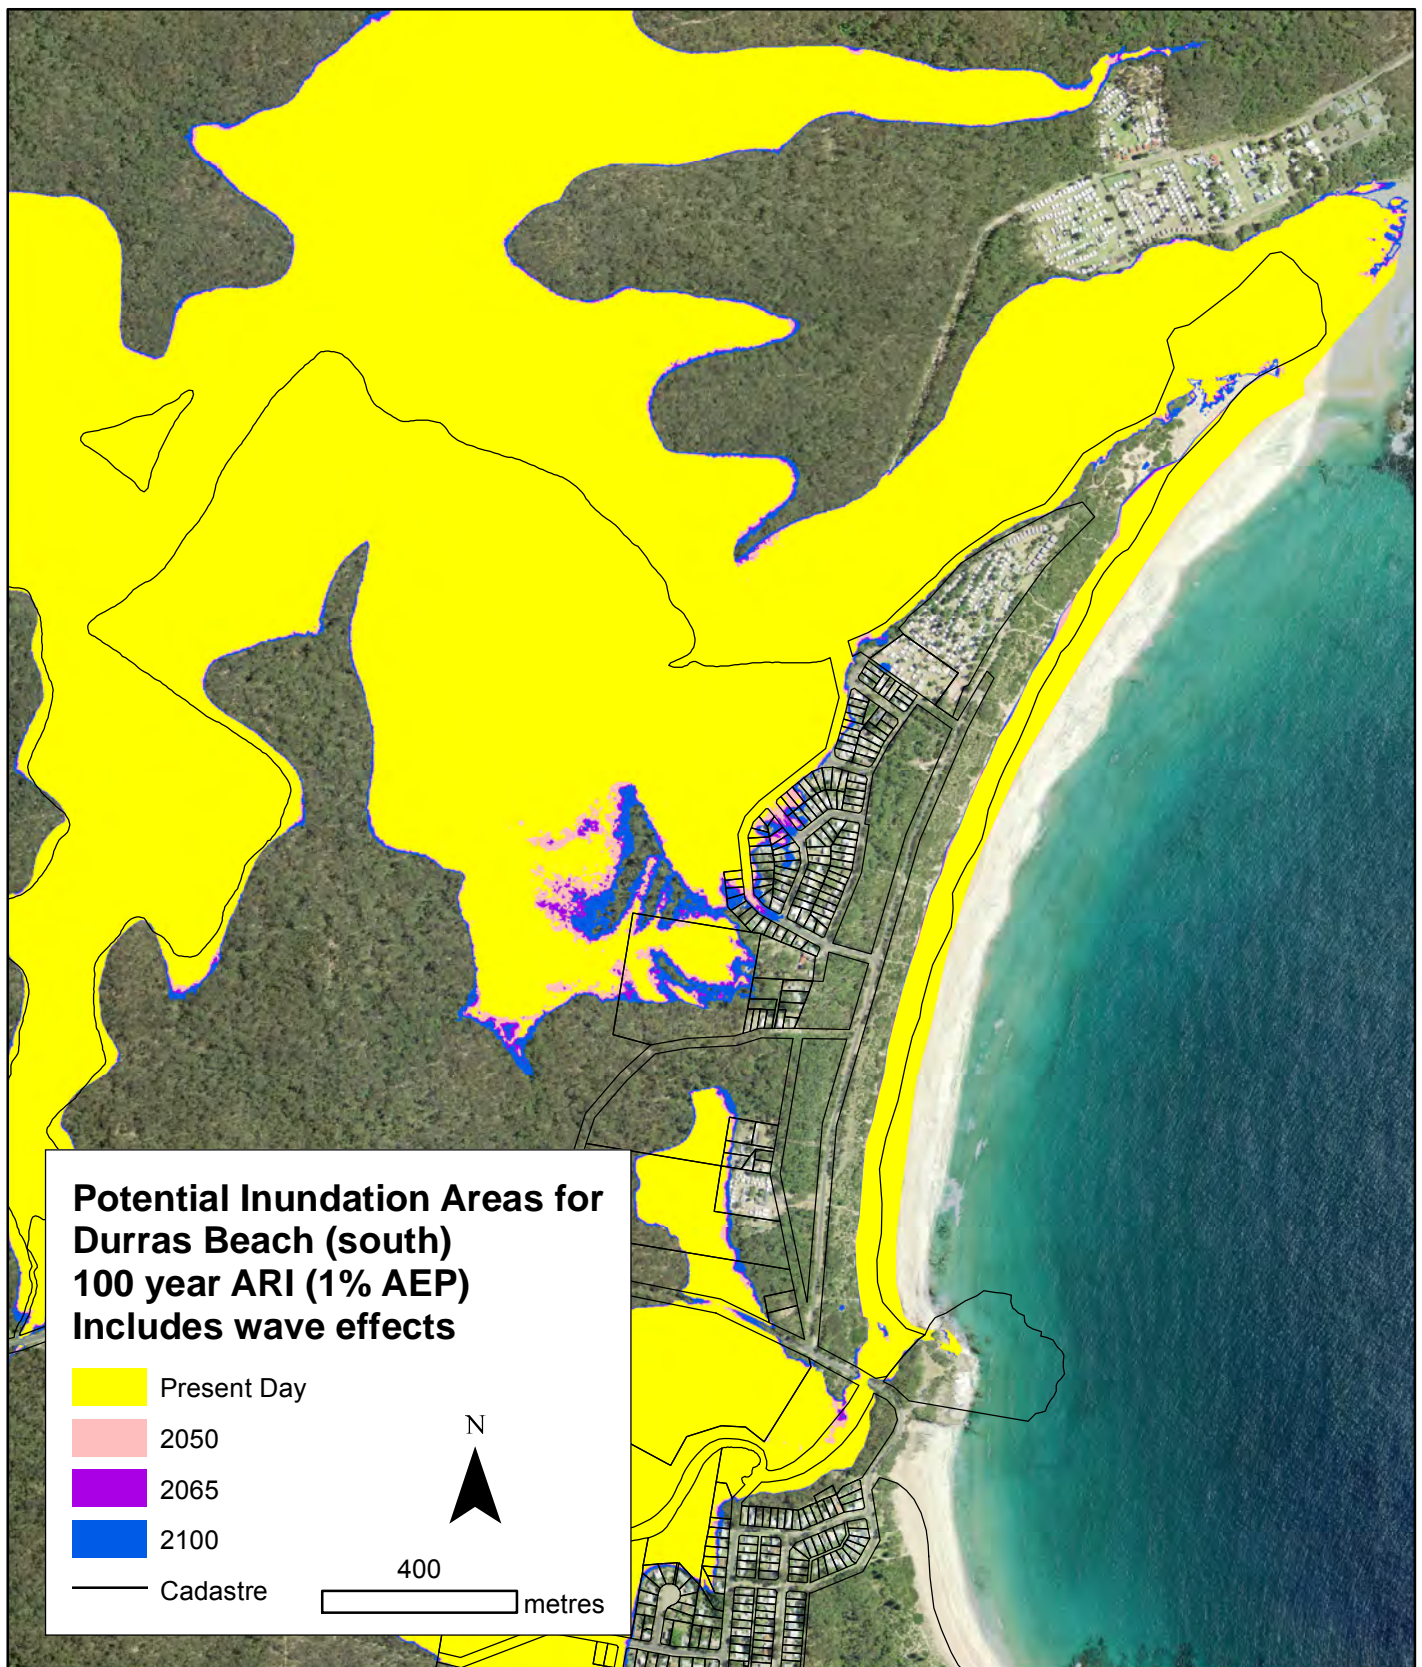
**Figure L.2**

Inundation of the beachface and the area immediately landward of the dune crest is based on the most recent year of LIDAR data available (2011) and is in accordance with ESC's sea level rise policy and planning framework. It does not include allowance for future landward recession of the beach face and assumes that the crest level of the seawall (if present) and the topography remain as they were from the 2011 LIDAR data. By 2050, 2065 or 2100 both of these assumptions may not be valid. Should the seawall/dune be allowed to fail then the landward extent of inundation may increase. Inundation of low lying areas behind the beach is based on the most recent year of LIDAR data available (2011). The low lying inundation areas behind the beach are mapped based on the ground elevation (the "all ground" LIDAR layer) and do not consider flow paths, flow velocities, loss of flow momentum or wave propagation into creek areas. WRL is not responsible for the accuracy of the photogrammetry or LIDAR data. Local surveys by a registered surveyor are recommended to determine local inundation extents.

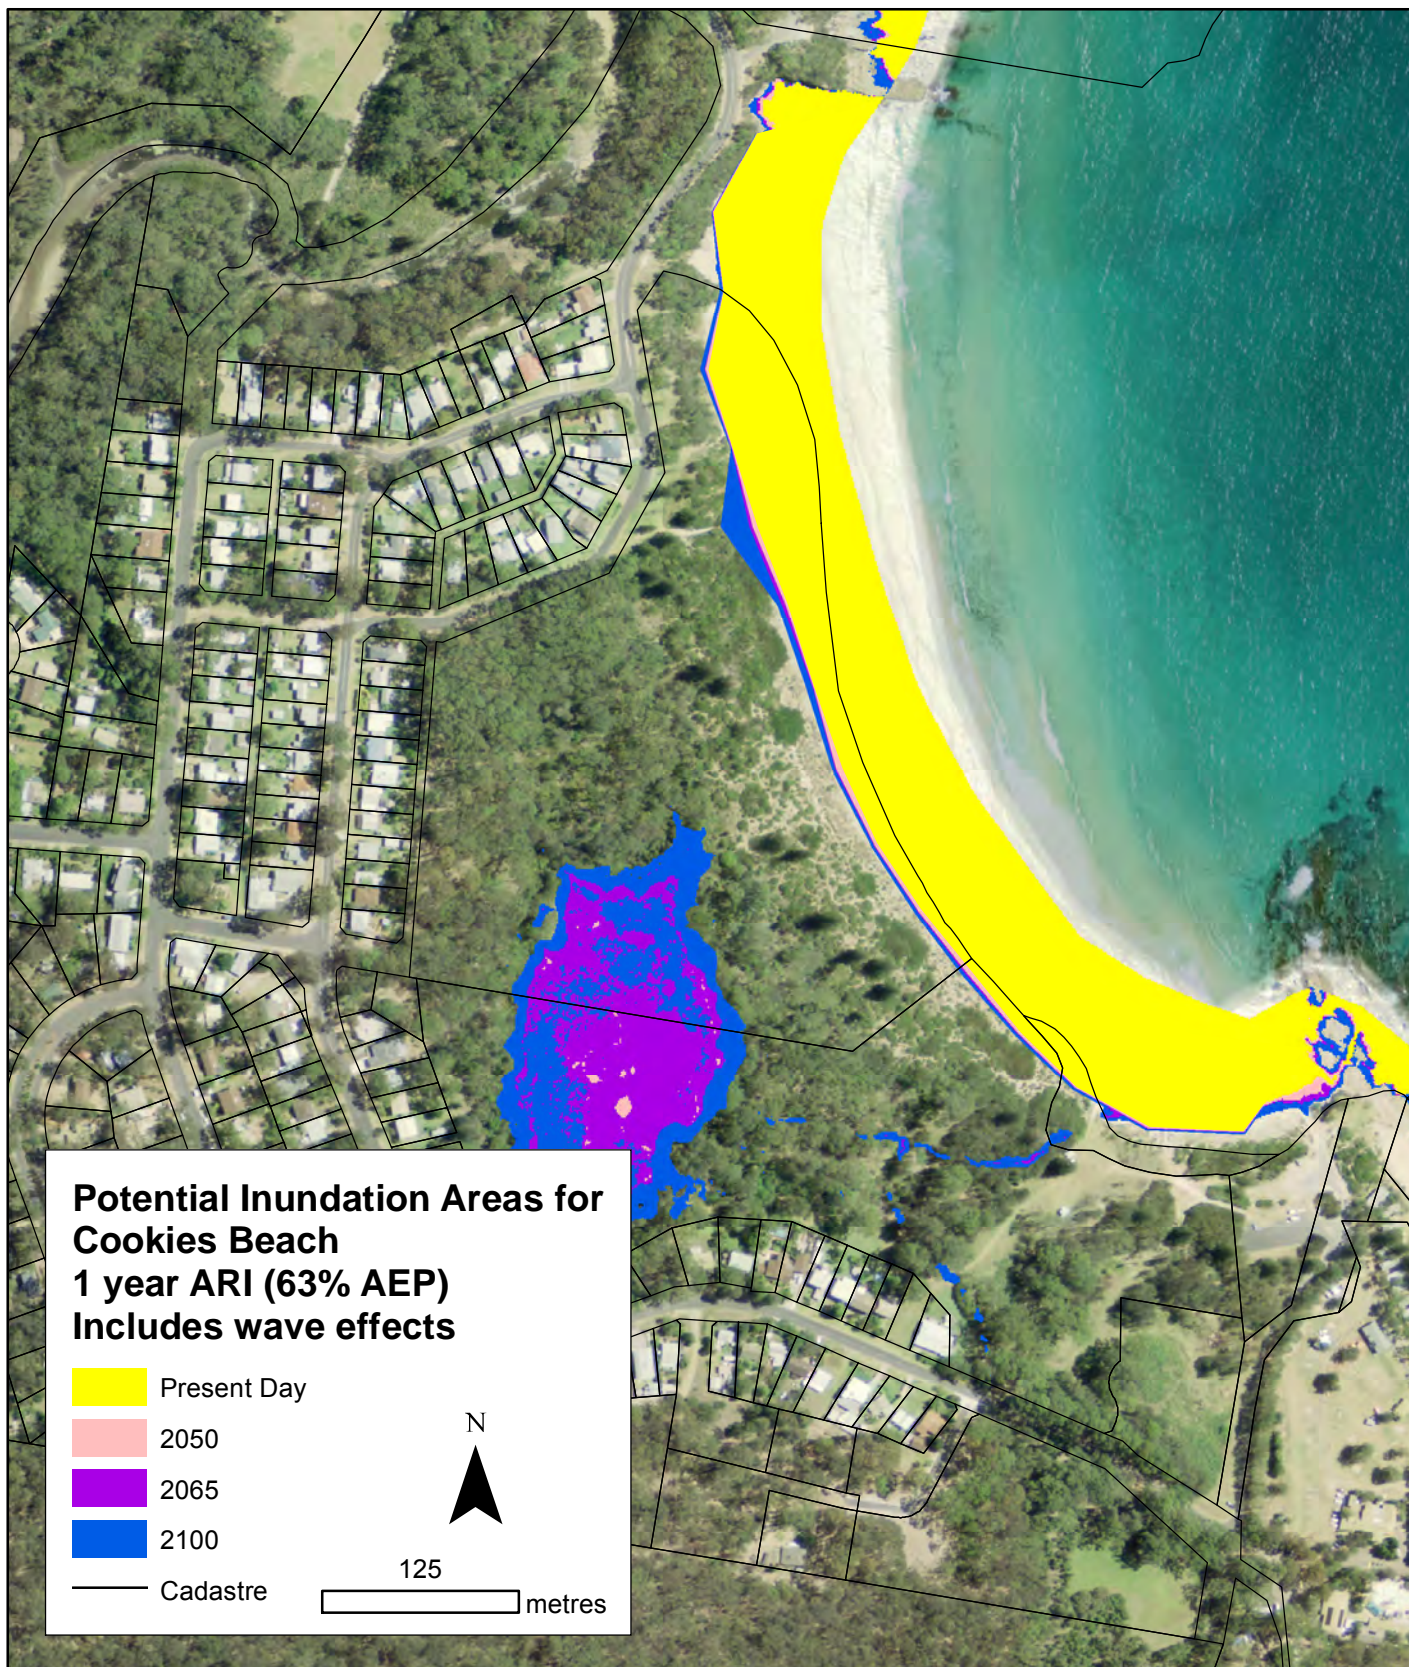
**Figure L.3**

Inundation of the beachface and the area immediately landward of the dune crest is based on the most recent year of LIDAR data available (2011) and is in accordance with ESC's sea level rise policy and planning framework. It does not include allowance for future landward recession of the beach face and assumes that the crest level of the seawall (if present) and the topography remain as they were from the 2011 LIDAR data. By 2050, 2065 or 2100 both of these assumptions may not be valid. Should the seawall/dune be allowed to fail then the landward extent of inundation may increase. Inundation of low lying areas behind the beach is based on the most recent year of LIDAR data available (2011). The low lying inundation areas behind the beach are mapped based on the ground elevation (the "all ground" LIDAR layer) and do not consider flow paths, flow velocities, loss of flow momentum or wave propagation into creek areas. WRL is not responsible for the accuracy of the photogrammetry or LIDAR data. Local surveys by a registered surveyor are recommended to determine local inundation extents.

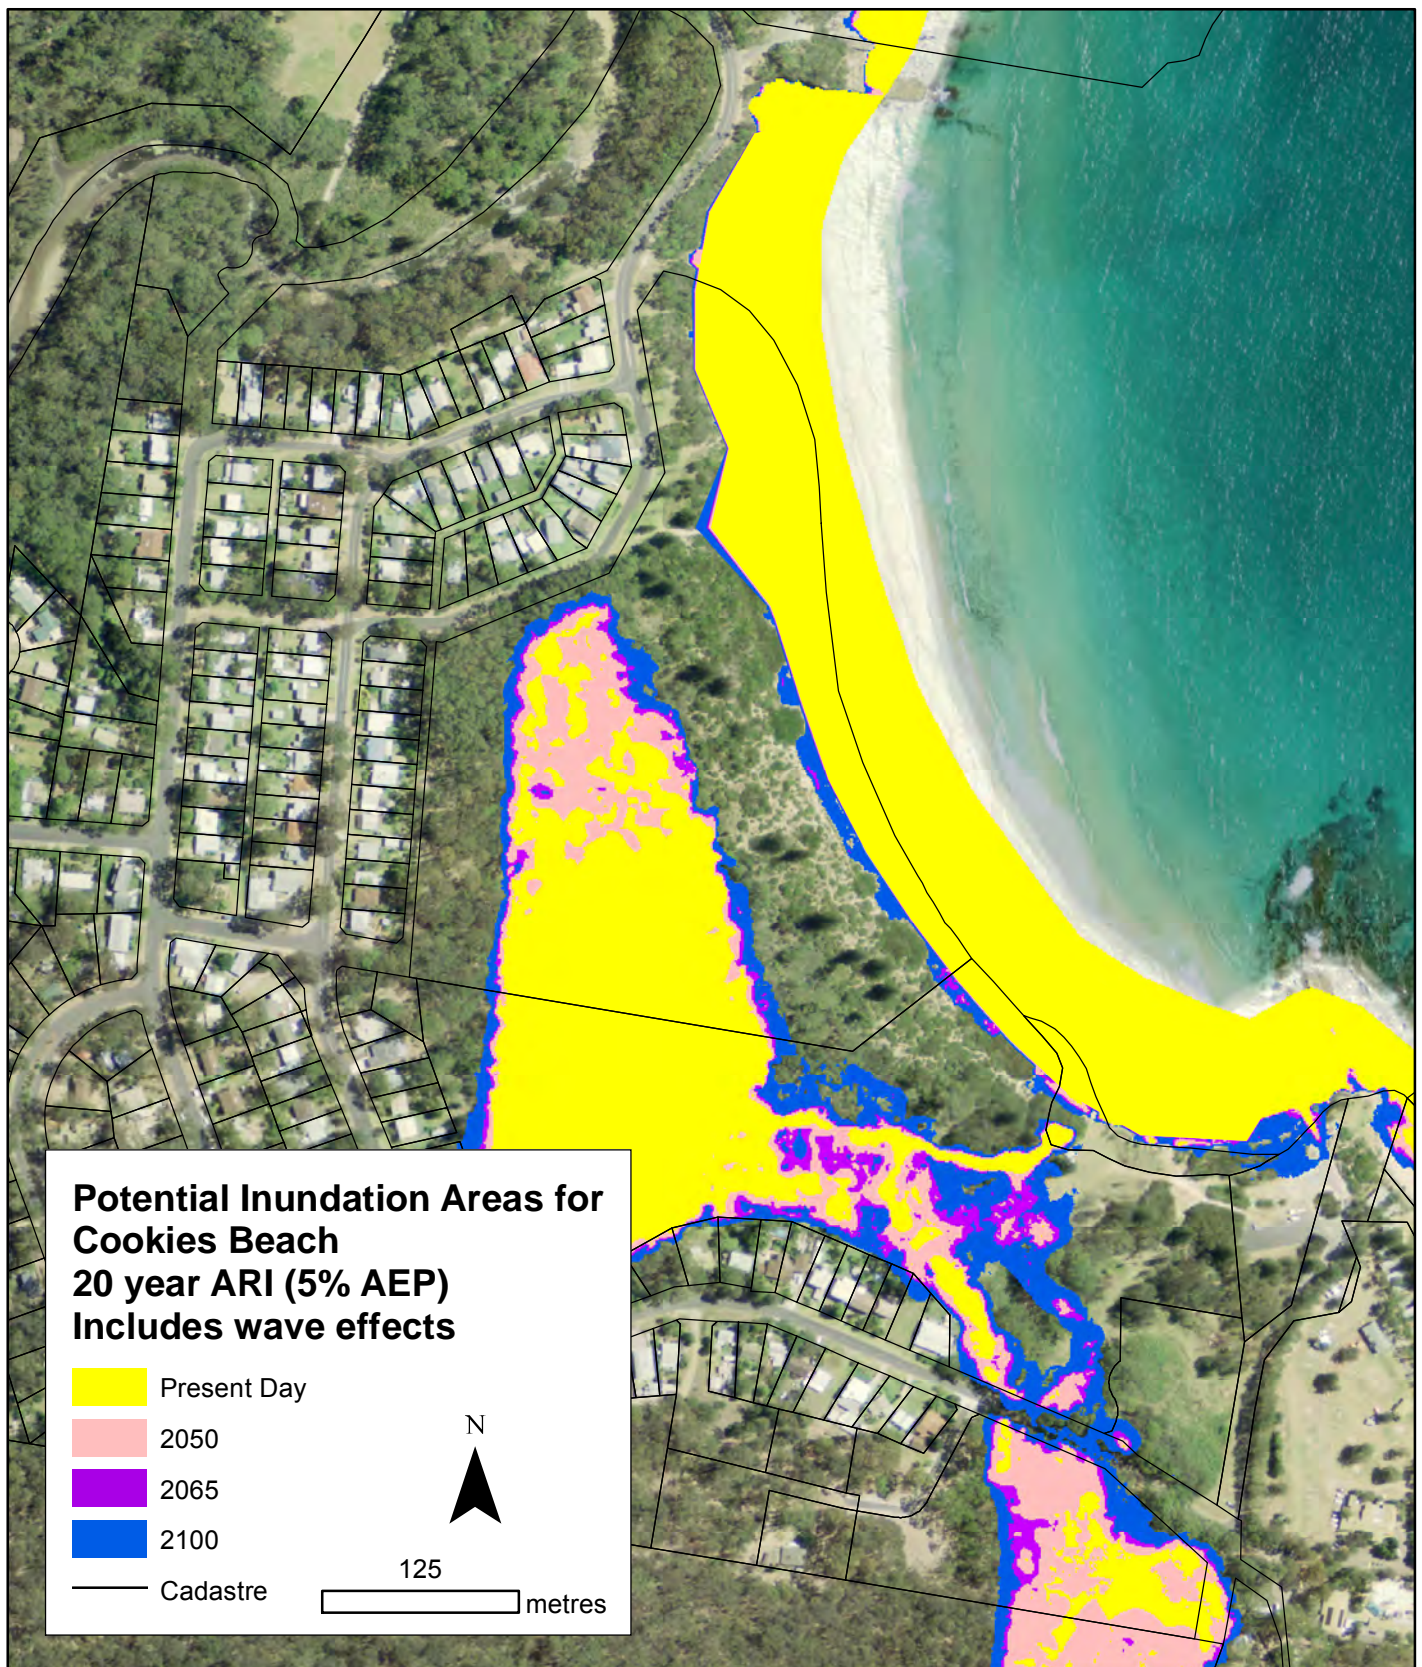
**Figure L.4**

Inundation of the beachface and the area immediately landward of the dune crest is based on the most recent year of LIDAR data available (2011) and is in accordance with ESC's sea level rise policy and planning framework. It does not include allowance for future landward recession of the beach face and assumes that the crest level of the seawall (if present) and the topography remain as they were from the 2011 LIDAR data. By 2050, 2065 or 2100 both of these assumptions may not be valid. Should the seawall/dune be allowed to fail then the landward extent of inundation may increase. Inundation of low lying areas behind the beach is based on the most recent year of LIDAR data available (2011). The low lying inundation areas behind the beach are mapped based on the ground elevation (the "all ground" LIDAR layer) and do not consider flow paths, flow velocities, loss of flow momentum or wave propagation into creek areas. WRL is not responsible for the accuracy of the photogrammetry or LIDAR data. Local surveys by a registered surveyor are recommended to determine local inundation extents.

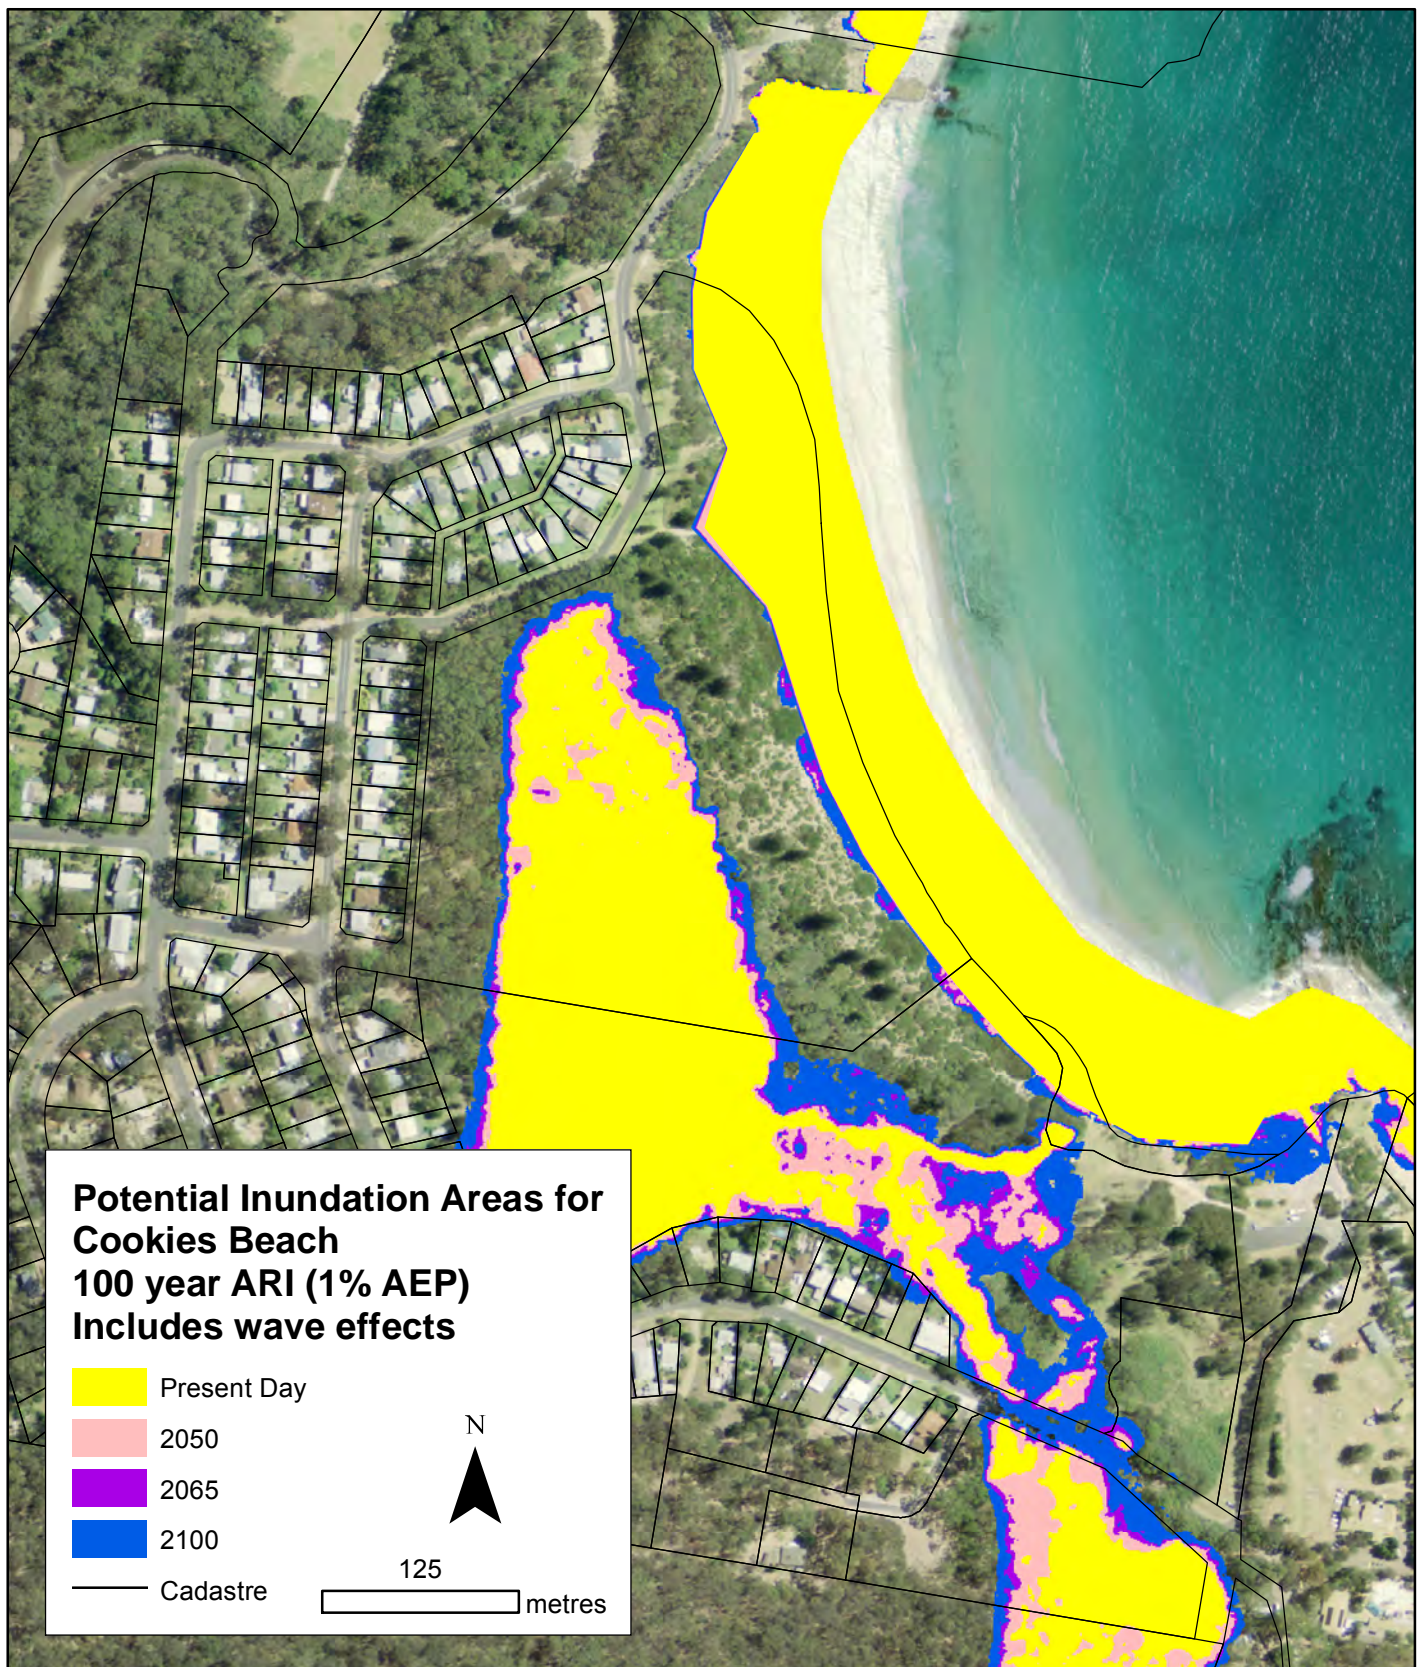
**Figure L.5**

Inundation of the beachface and the area immediately landward of the dune crest is based on the most recent year of LIDAR data available (2011) and is in accordance with ESC's sea level rise policy and planning framework. It does not include allowance for future landward recession of the beach face and assumes that the crest level of the seawall (if present) and the topography remain as they were from the 2011 LIDAR data. By 2050, 2065 or 2100 both of these assumptions may not be valid. Should the seawall/dune be allowed to fail then the landward extent of inundation may increase. Inundation of low lying areas behind the beach is based on the most recent year of LIDAR data available (2011). The low lying inundation areas behind the beach are mapped based on the ground elevation (the "all ground" LIDAR layer) and do not consider flow paths, flow velocities, loss of flow momentum or wave propagation into creek areas. WRL is not responsible for the accuracy of the photogrammetry or LIDAR data. Local surveys by a registered surveyor are recommended to determine local inundation extents.
