## Eurobodalla Coastal Hazard Assessment

WRL Technical Report 2017/09  
October 2017

By I R Coghlan, J T Carley, A J Harrison, D Howe, A D Short,  
J E Ruprecht, F Flocard and P F Rahman

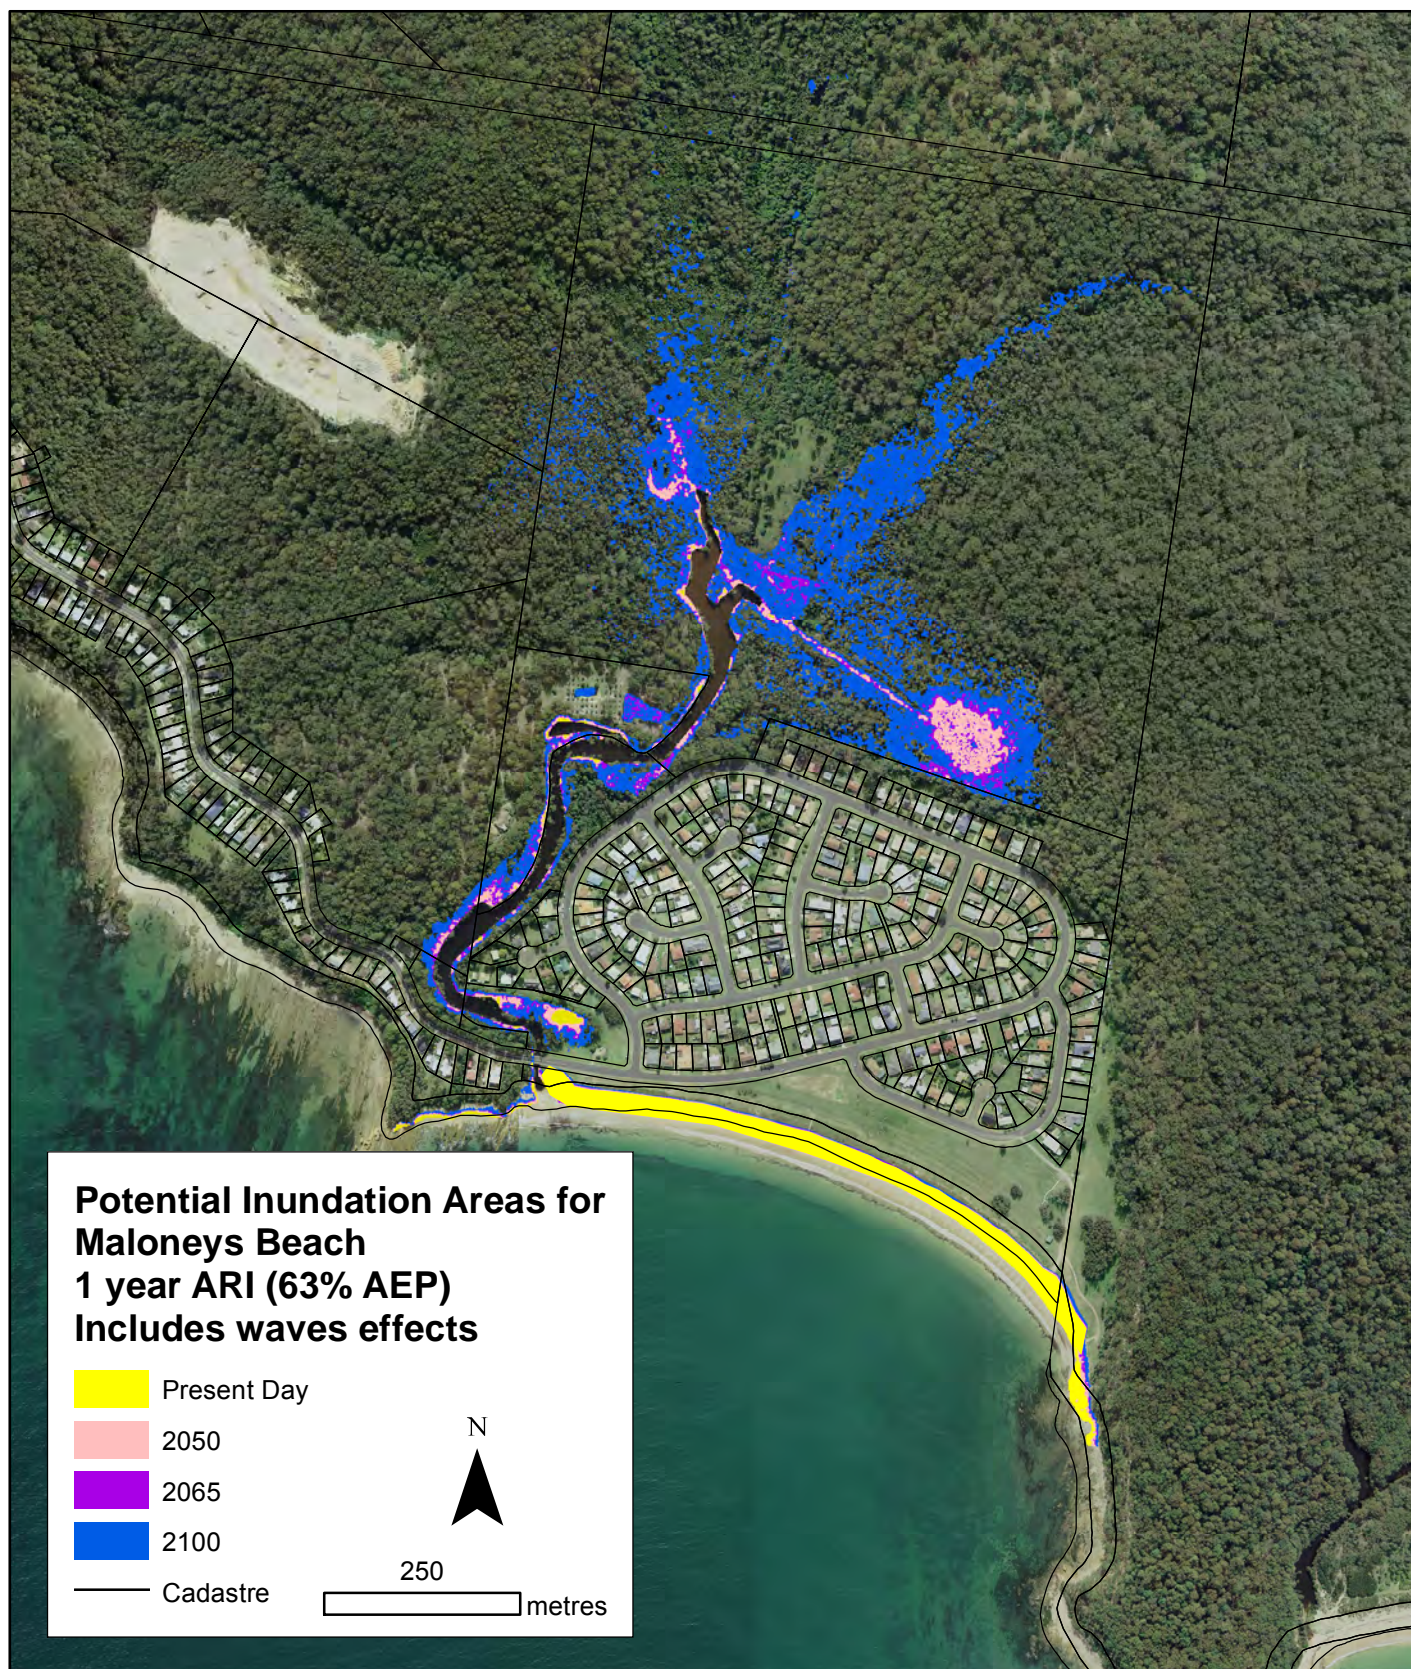
Inundation of the beachface and the area immediately landward of the dune crest is based on the most recent year of photogrammetry data available (2014) and is in accordance with ESC's sea level rise policy and planning framework. It does not include allowance for future landward recession of the beach face and assumes that the crest level of the seawall (if present) and the topography remain as they were from the 2014 photogrammetry data. By 2050, 2065 or 2100 both of these assumptions may not be valid. Should the seawall/dune be allowed to fail then the landward extent of inundation may increase. Inundation of low lying areas behind the beach is based on the most recent year of LIDAR data available (2005). The low lying inundation areas behind the beach are mapped based on the ground elevation (the "all ground" LIDAR layer) and do not consider flow paths, flow velocities, loss of flow momentum or wave propagation into creek areas. WRL is not responsible for the accuracy of the photogrammetry or LIDAR data. Local surveys by a registered surveyor are recommended to determine local inundation extents.

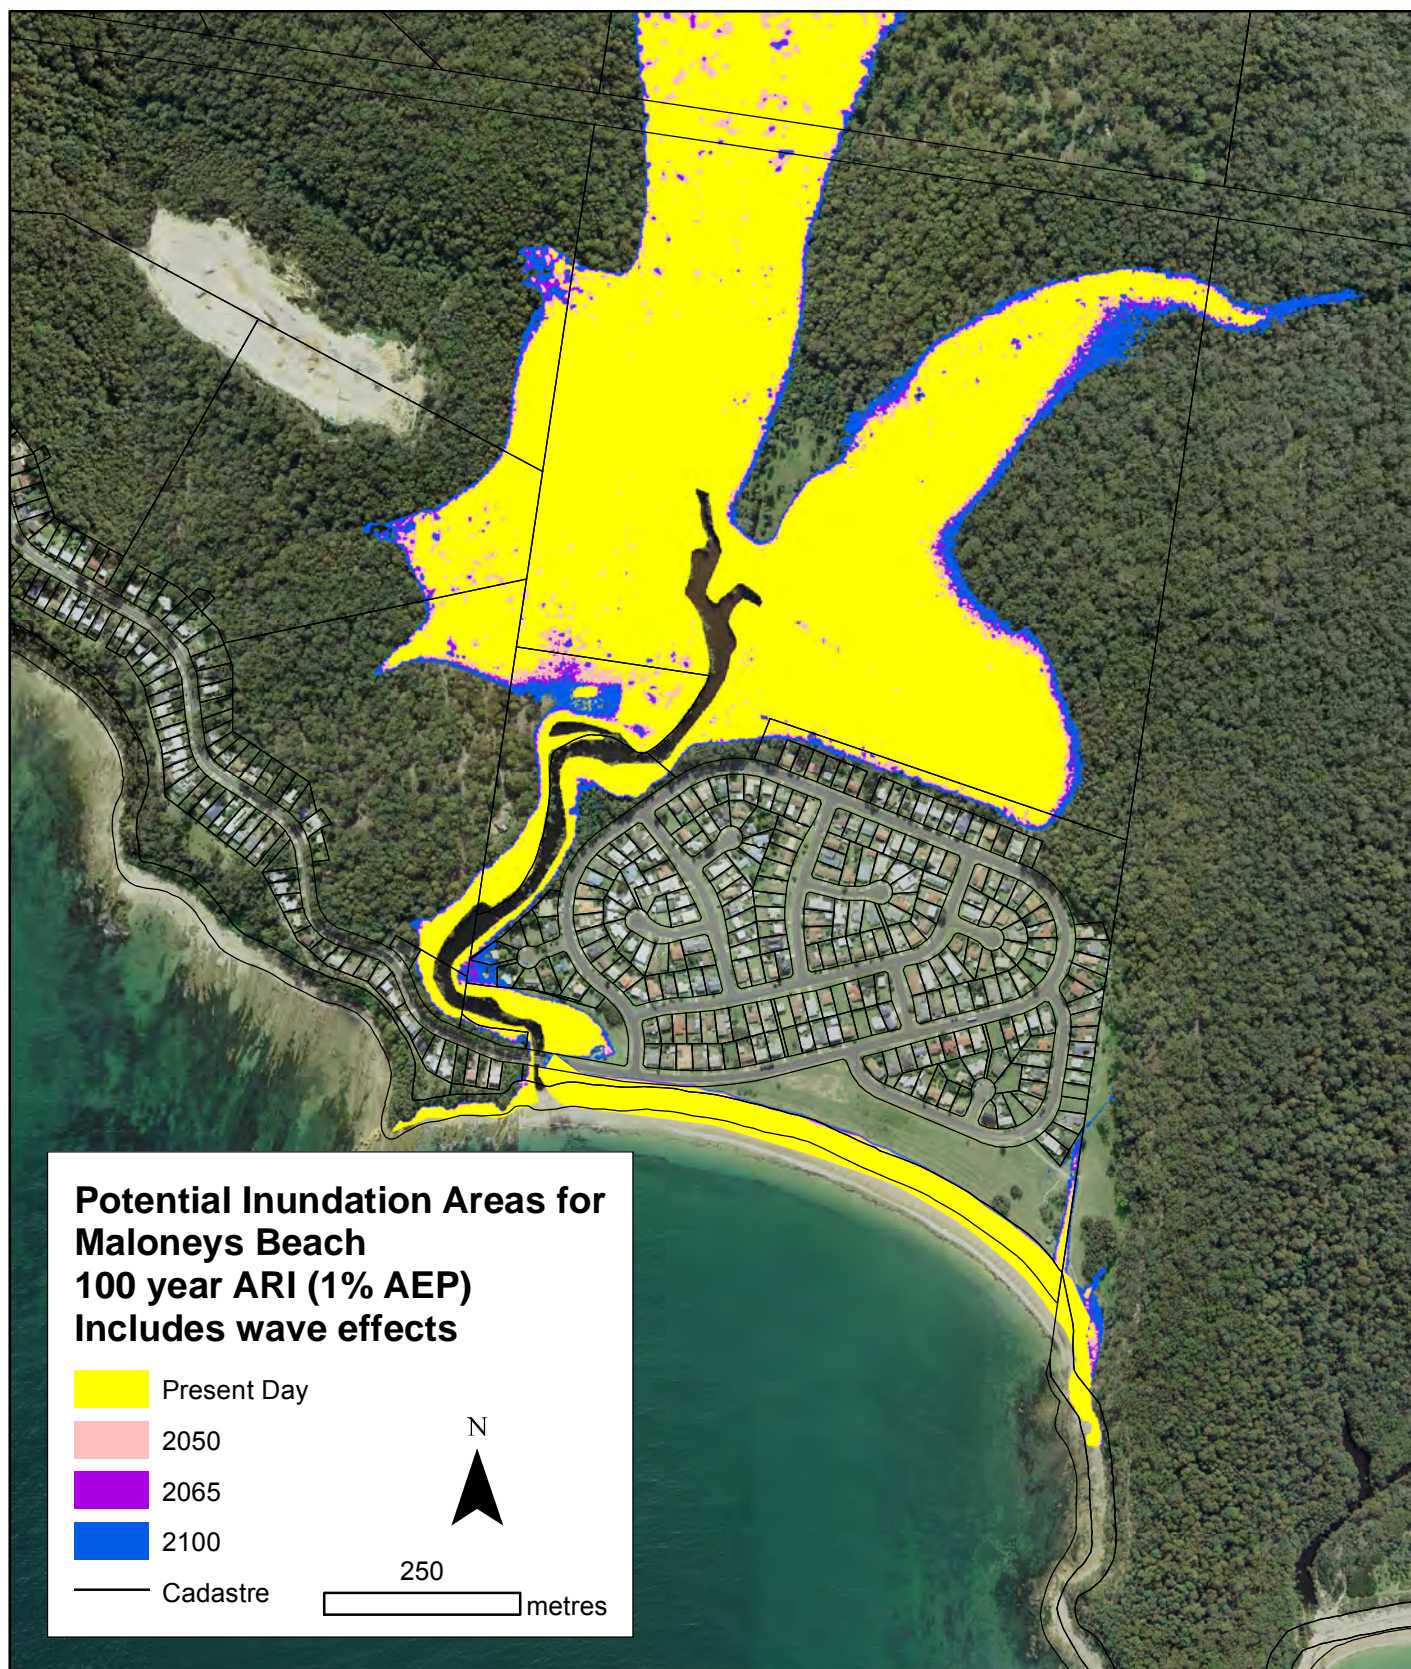
**Figure L.8**

Inundation of the beachface and the area immediately landward of the dune crest is based on the most recent year of photogrammetry data available (2014) and is in accordance with ESC's sea level rise policy and planning framework. It does not include allowance for future landward recession of the beach face and assumes that the crest level of the seawall (if present) and the topography remain as they were from the 2014 photogrammetry data. By 2050, 2065 or 2100 both of these assumptions may not be valid. Should the seawall/dune be allowed to fail then the landward extent of inundation may increase. Inundation of low lying areas behind the beach is based on the most recent year of LIDAR data available (2005). The low lying inundation areas behind the beach are mapped based on the ground elevation (the "all ground" LIDAR layer) and do not consider flow paths, flow velocities, loss of flow momentum or wave propagation into creek areas. WRL is not responsible for the accuracy of the photogrammetry or LIDAR data. Local surveys by a registered surveyor are recommended to determine local inundation extents.

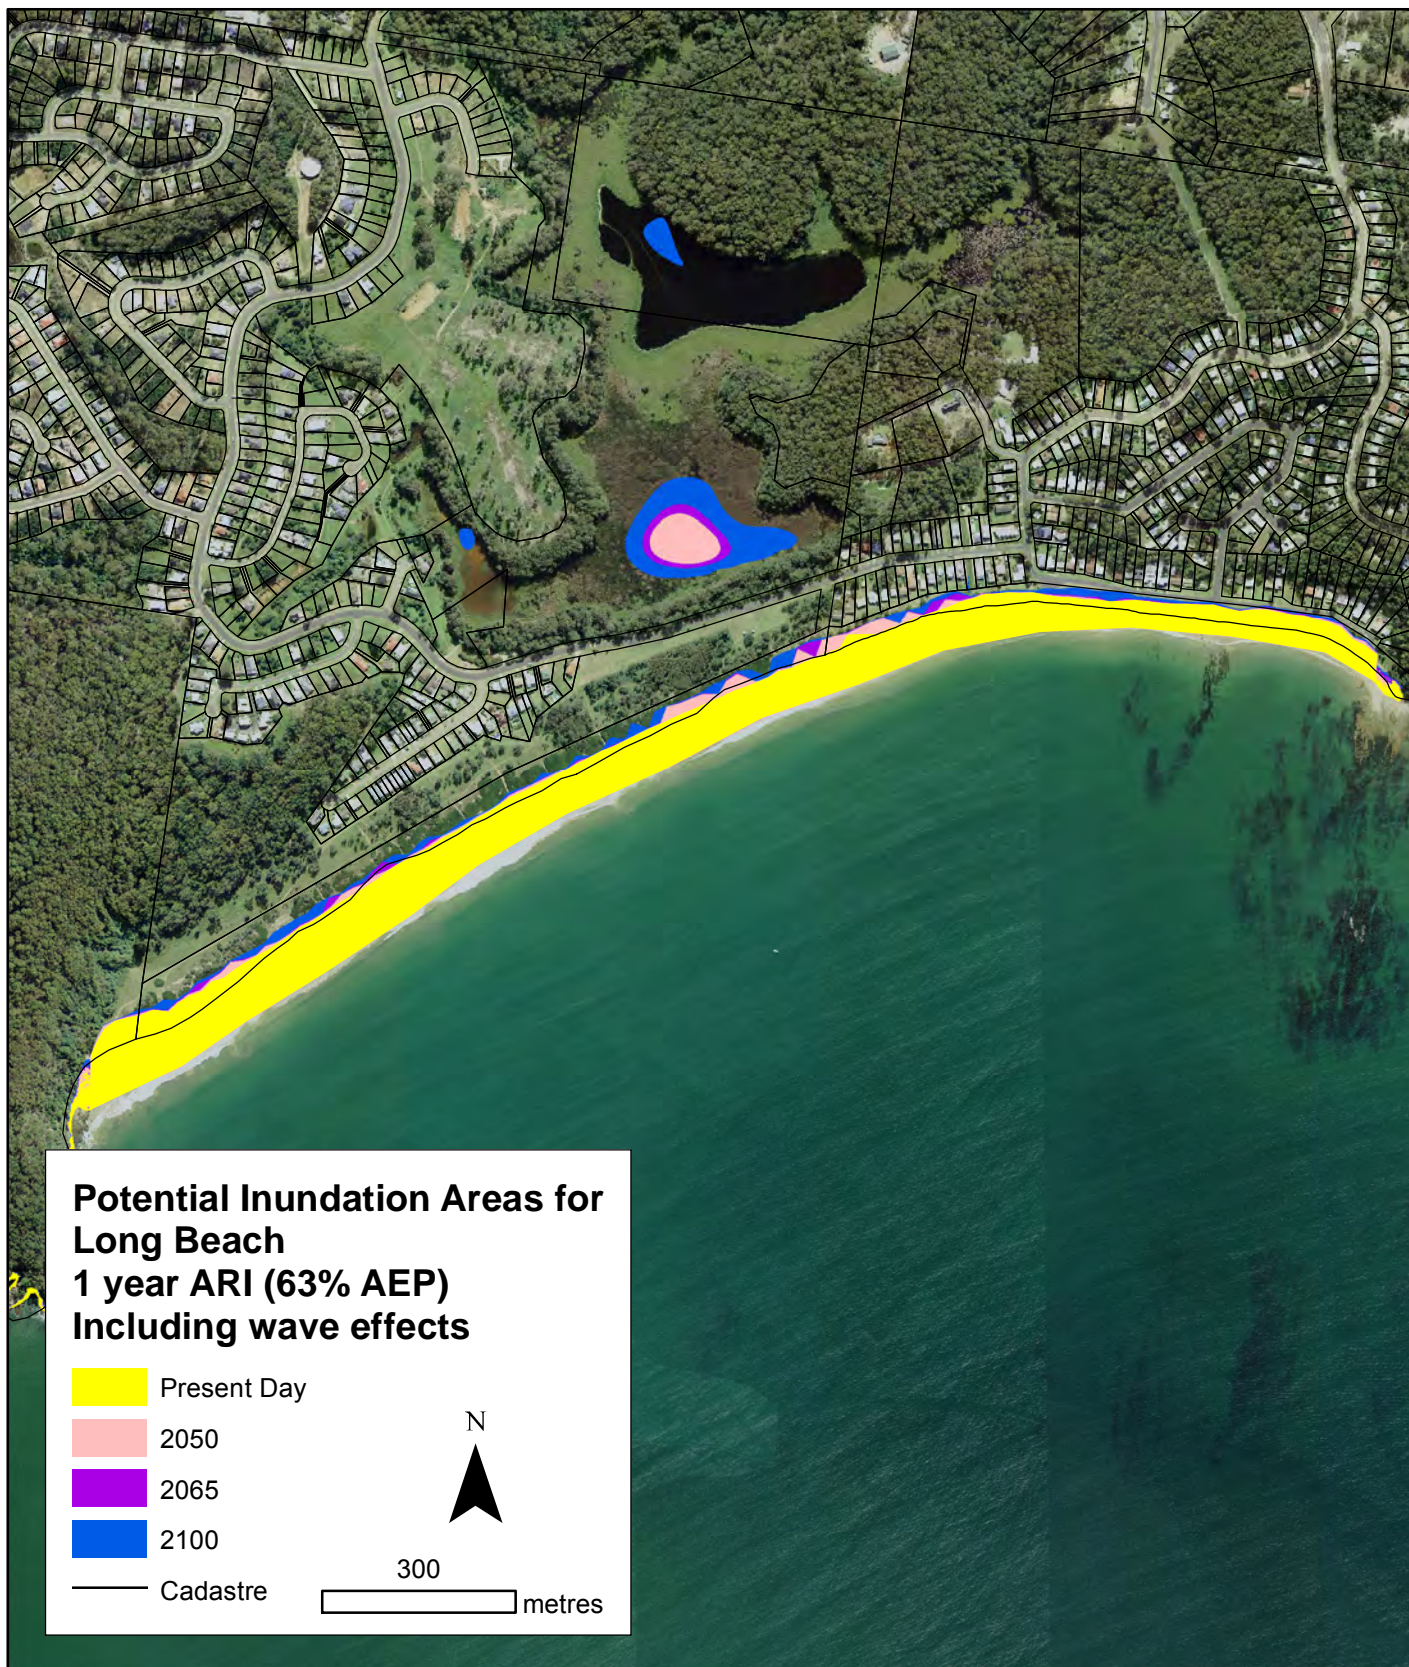
**Figure L.9**

Inundation of the beachface and the area immediately landward of the dune crest is based on the most recent year of photogrammetry data available (2014) and is in accordance with ESC's sea level rise policy and planning framework. It does not include allowance for future landward recession of the beach face and assumes that the crest level of the seawall (if present) and the topography remain as they were from the 2014 photogrammetry data. By 2050, 2065 or 2100 both of these assumptions may not be valid. Should the seawall/dune be allowed to fail then the landward extent of inundation may increase. Inundation of low lying areas behind the beach is based on the most recent year of LIDAR data available (2005). The low lying inundation areas behind the beach are mapped based on the ground elevation (the "all ground" LIDAR layer) and do not consider flow paths, flow velocities, loss of flow momentum or wave propagation into creek areas. WRL is not responsible for the accuracy of the photogrammetry or LIDAR data. Local surveys by a registered surveyor are recommended to determine local inundation extents.

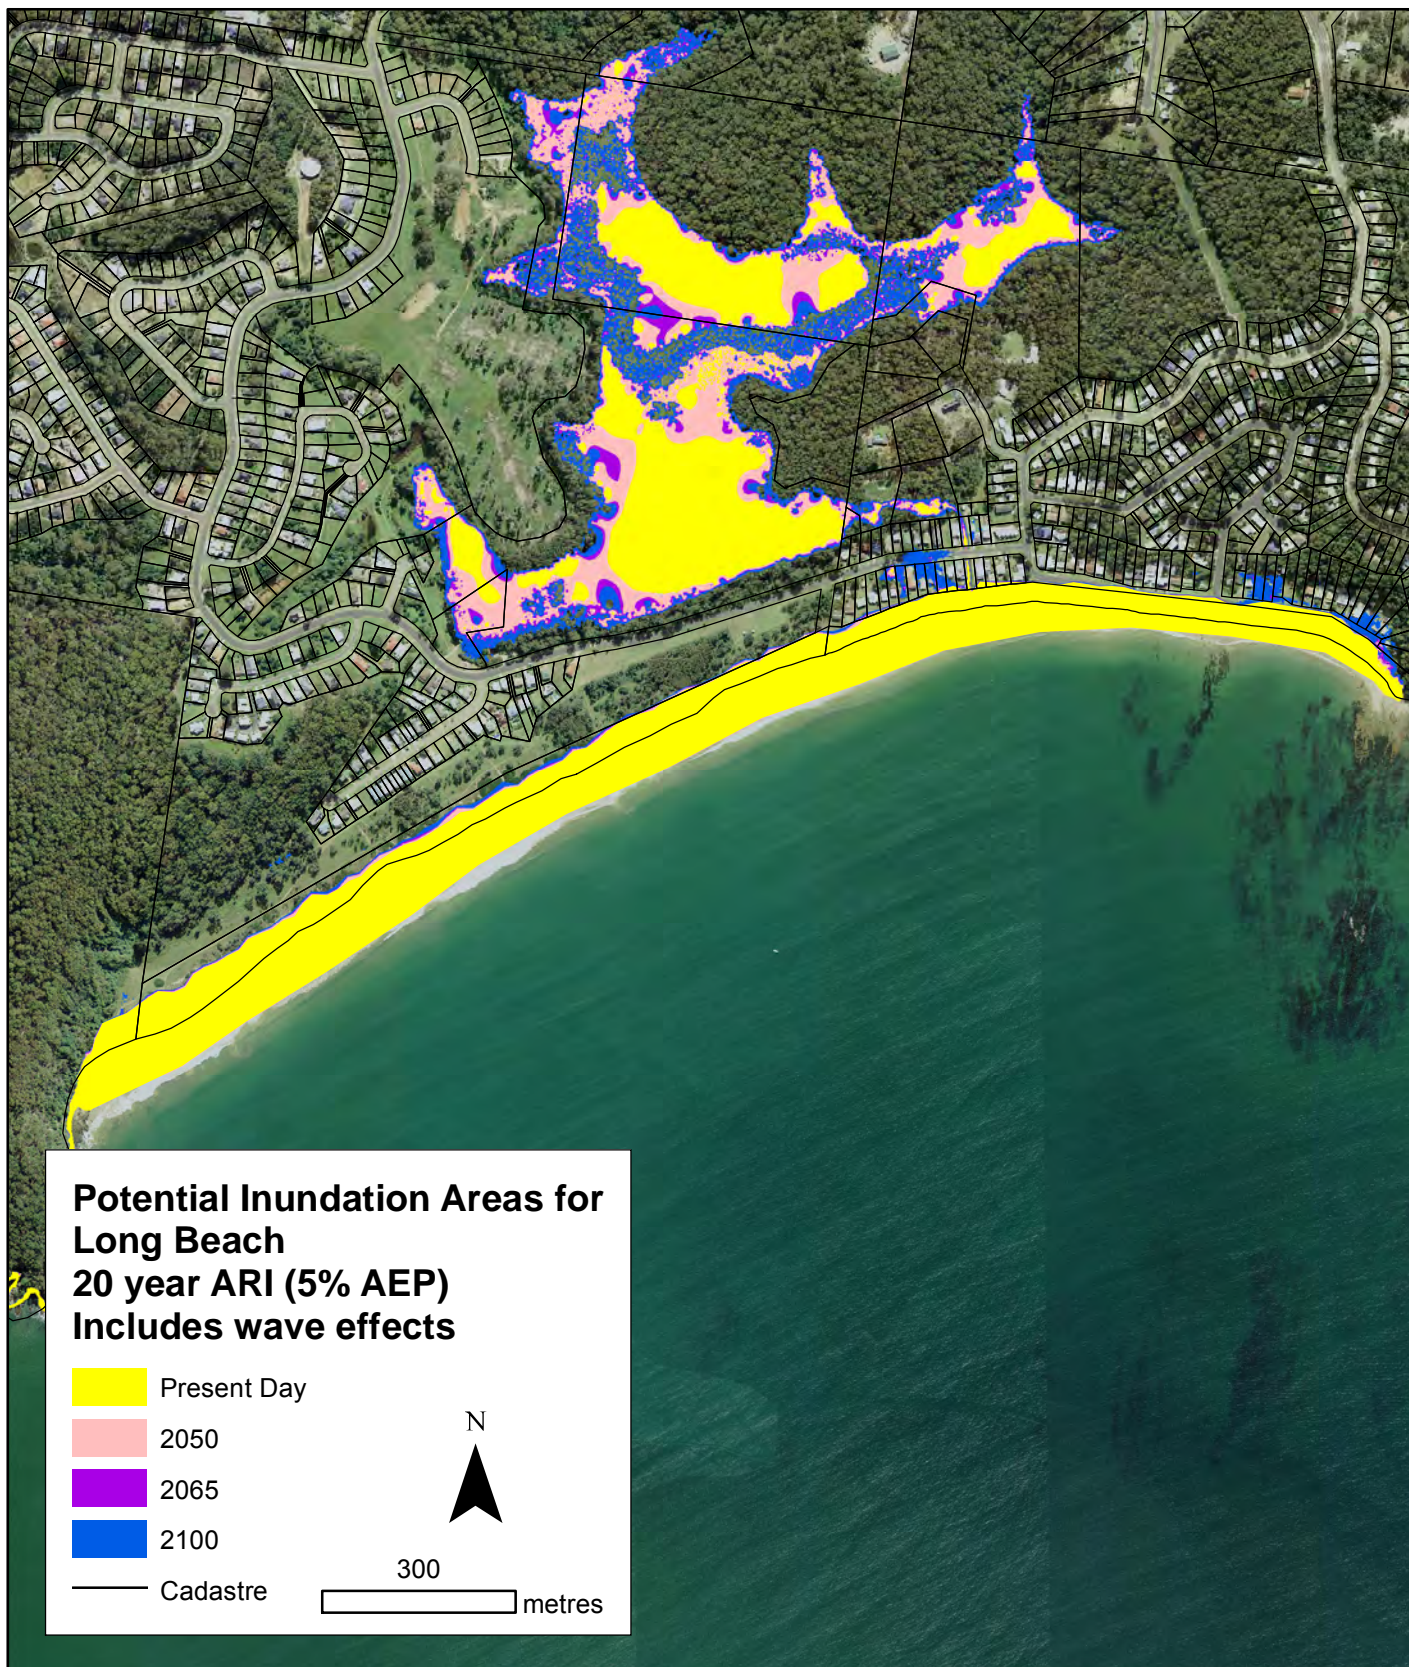
**Figure L.10**

Inundation of the beachface and the area immediately landward of the dune crest is based on the most recent year of photogrammetry data available (2014) and is in accordance with ESC's sea level rise policy and planning framework. It does not include allowance for future landward recession of the beach face and assumes that the crest level of the seawall (if present) and the topography remain as they were from the 2014 photogrammetry data. By 2050, 2065 or 2100 both of these assumptions may not be valid. Should the seawall/dune be allowed to fail then the landward extent of inundation may increase. Inundation of low lying areas behind the beach is based on the most recent year of LIDAR data available (2005). The low lying inundation areas behind the beach are mapped based on the ground elevation (the "all ground" LIDAR layer) and do not consider flow paths, flow velocities, loss of flow momentum or wave propagation into creek areas. WRL is not responsible for the accuracy of the photogrammetry or LIDAR data. Local surveys by a registered surveyor are recommended to determine local inundation extents.

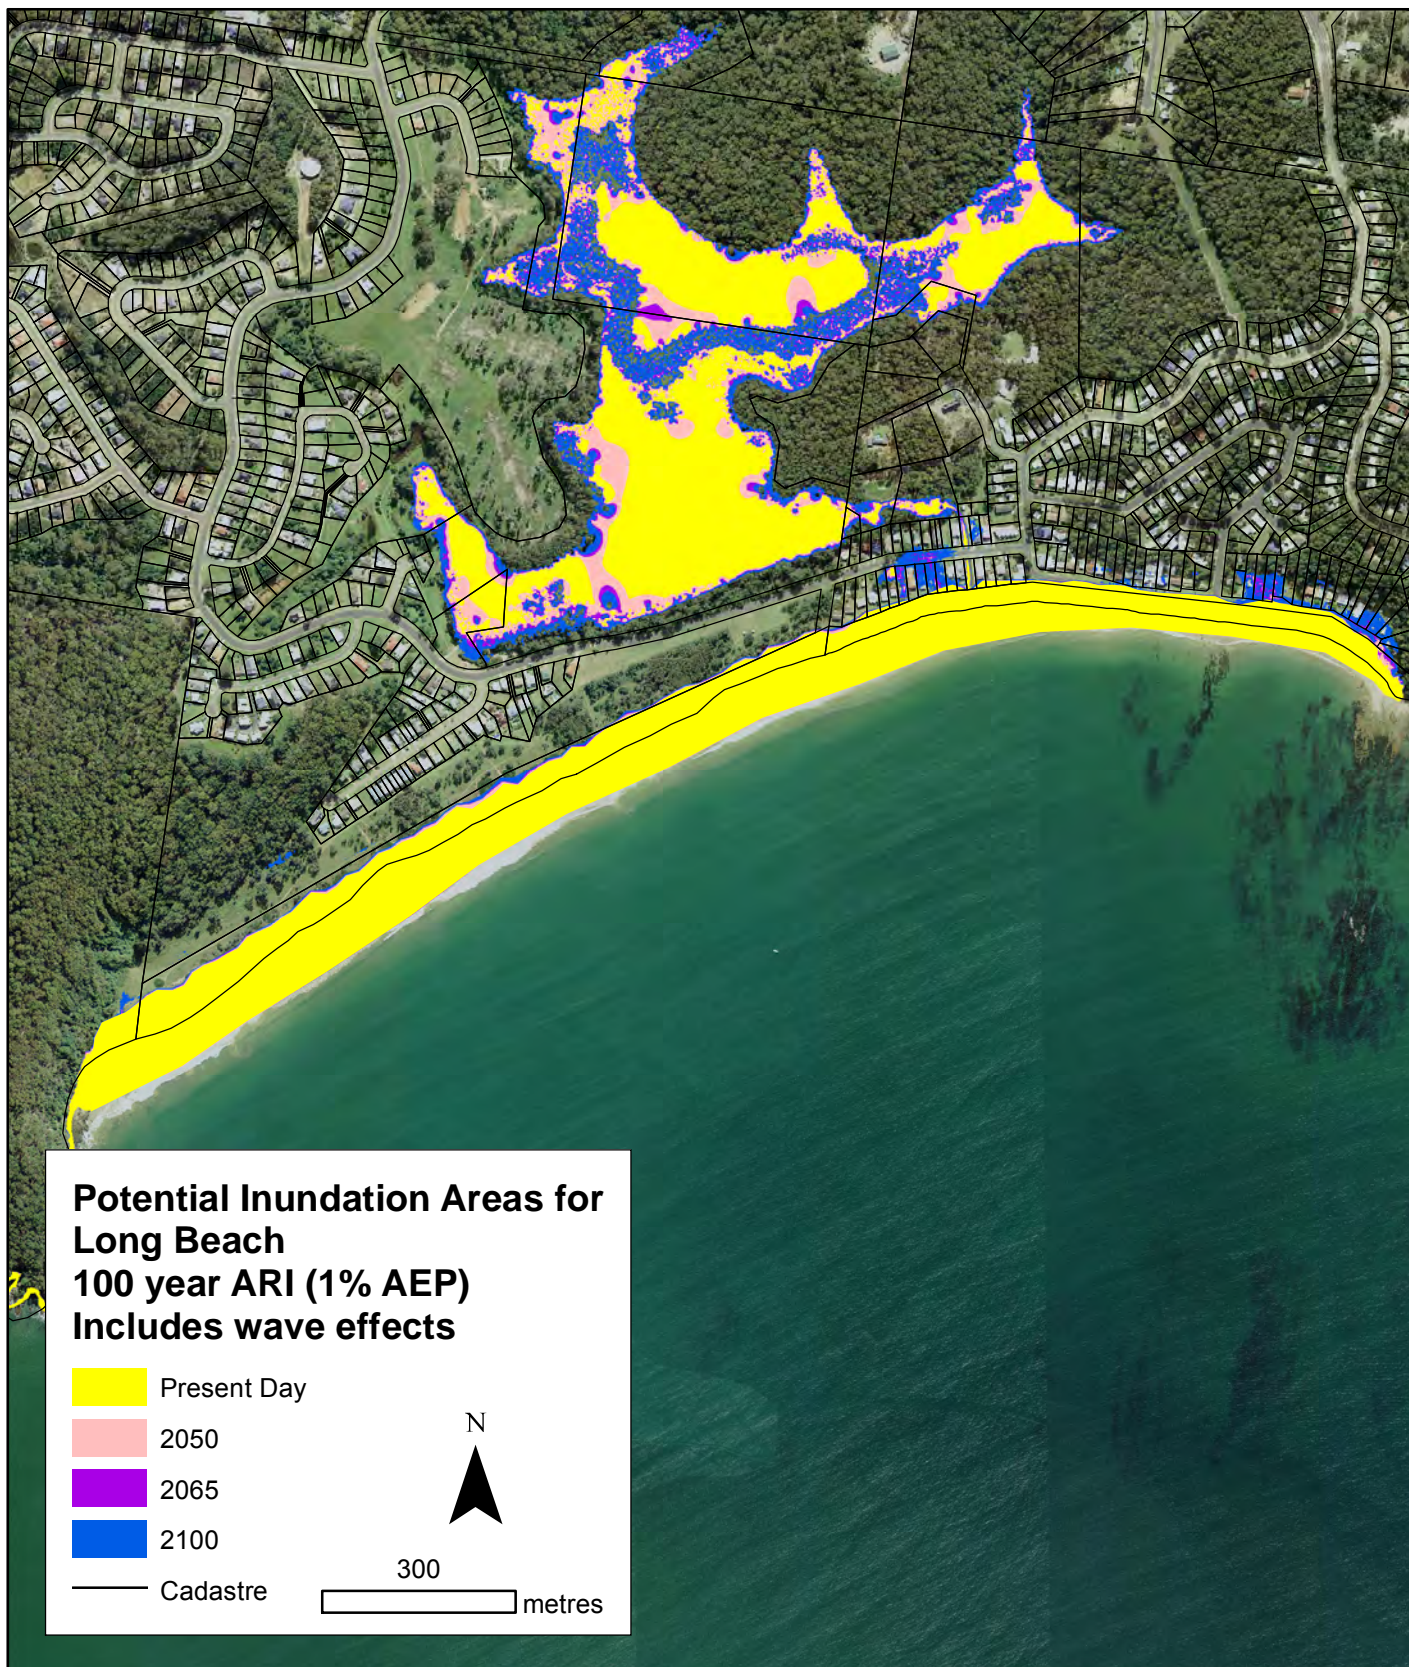
**Figure L.11**

Inundation of the beachface and the area immediately landward of the dune crest is based on the most recent year of photogrammetry data available (2014) and is in accordance with ESC's sea level rise policy and planning framework. It does not include allowance for future landward recession of the beach face and assumes that the crest level of the seawall (if present) and the topography remain as they were from the 2014 photogrammetry data. By 2050, 2065 or 2100 both of these assumptions may not be valid. Should the seawall/dune be allowed to fail then the landward extent of inundation may increase. Inundation of low lying areas behind the beach is based on the most recent year of LIDAR data available (2005). The low lying inundation areas behind the beach are mapped based on the ground elevation (the "all ground" LIDAR layer) and do not consider flow paths, flow velocities, loss of flow momentum or wave propagation into creek areas. WRL is not responsible for the accuracy of the photogrammetry or LIDAR data. Local surveys by a registered surveyor are recommended to determine local inundation extents.

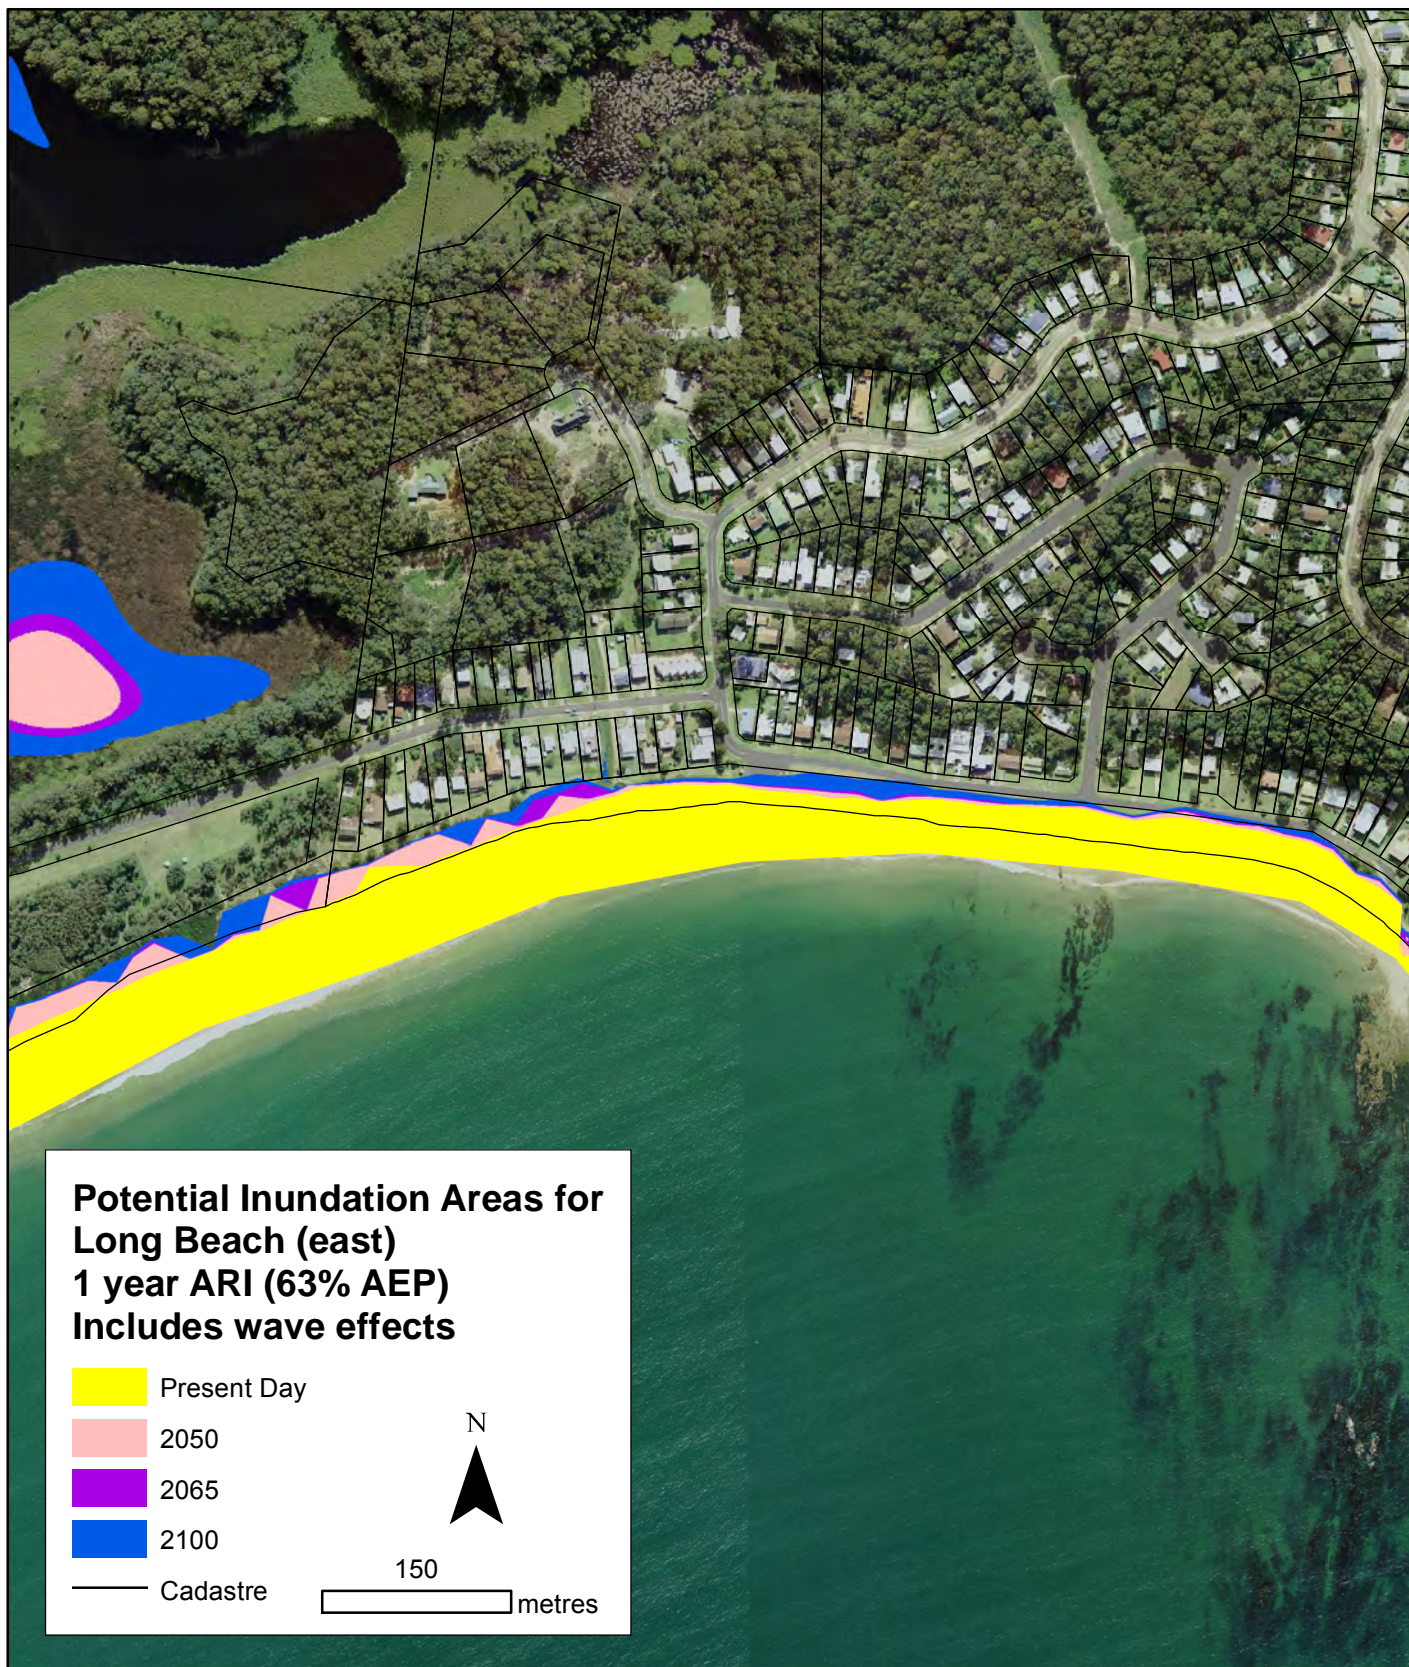
**Figure L.12**

Inundation of the beachface and the area immediately landward of the dune crest is based on the most recent year of photogrammetry data available (2014) and is in accordance with ESC's sea level rise policy and planning framework. It does not include allowance for future landward recession of the beach face and assumes that the crest level of the seawall (if present) and the topography remain as they were from the 2014 photogrammetry data. By 2050, 2065 or 2100 both of these assumptions may not be valid. Should the seawall/dune be allowed to fail then the landward extent of inundation may increase. Inundation of low lying areas behind the beach is based on the most recent year of LIDAR data available (2005). The low lying inundation areas behind the beach are mapped based on the ground elevation (the "all ground" LIDAR layer) and do not consider flow paths, flow velocities, loss of flow momentum or wave propagation into creek areas. WRL is not responsible for the accuracy of the photogrammetry or LIDAR data. Local surveys by a registered surveyor are recommended to determine local inundation extents.

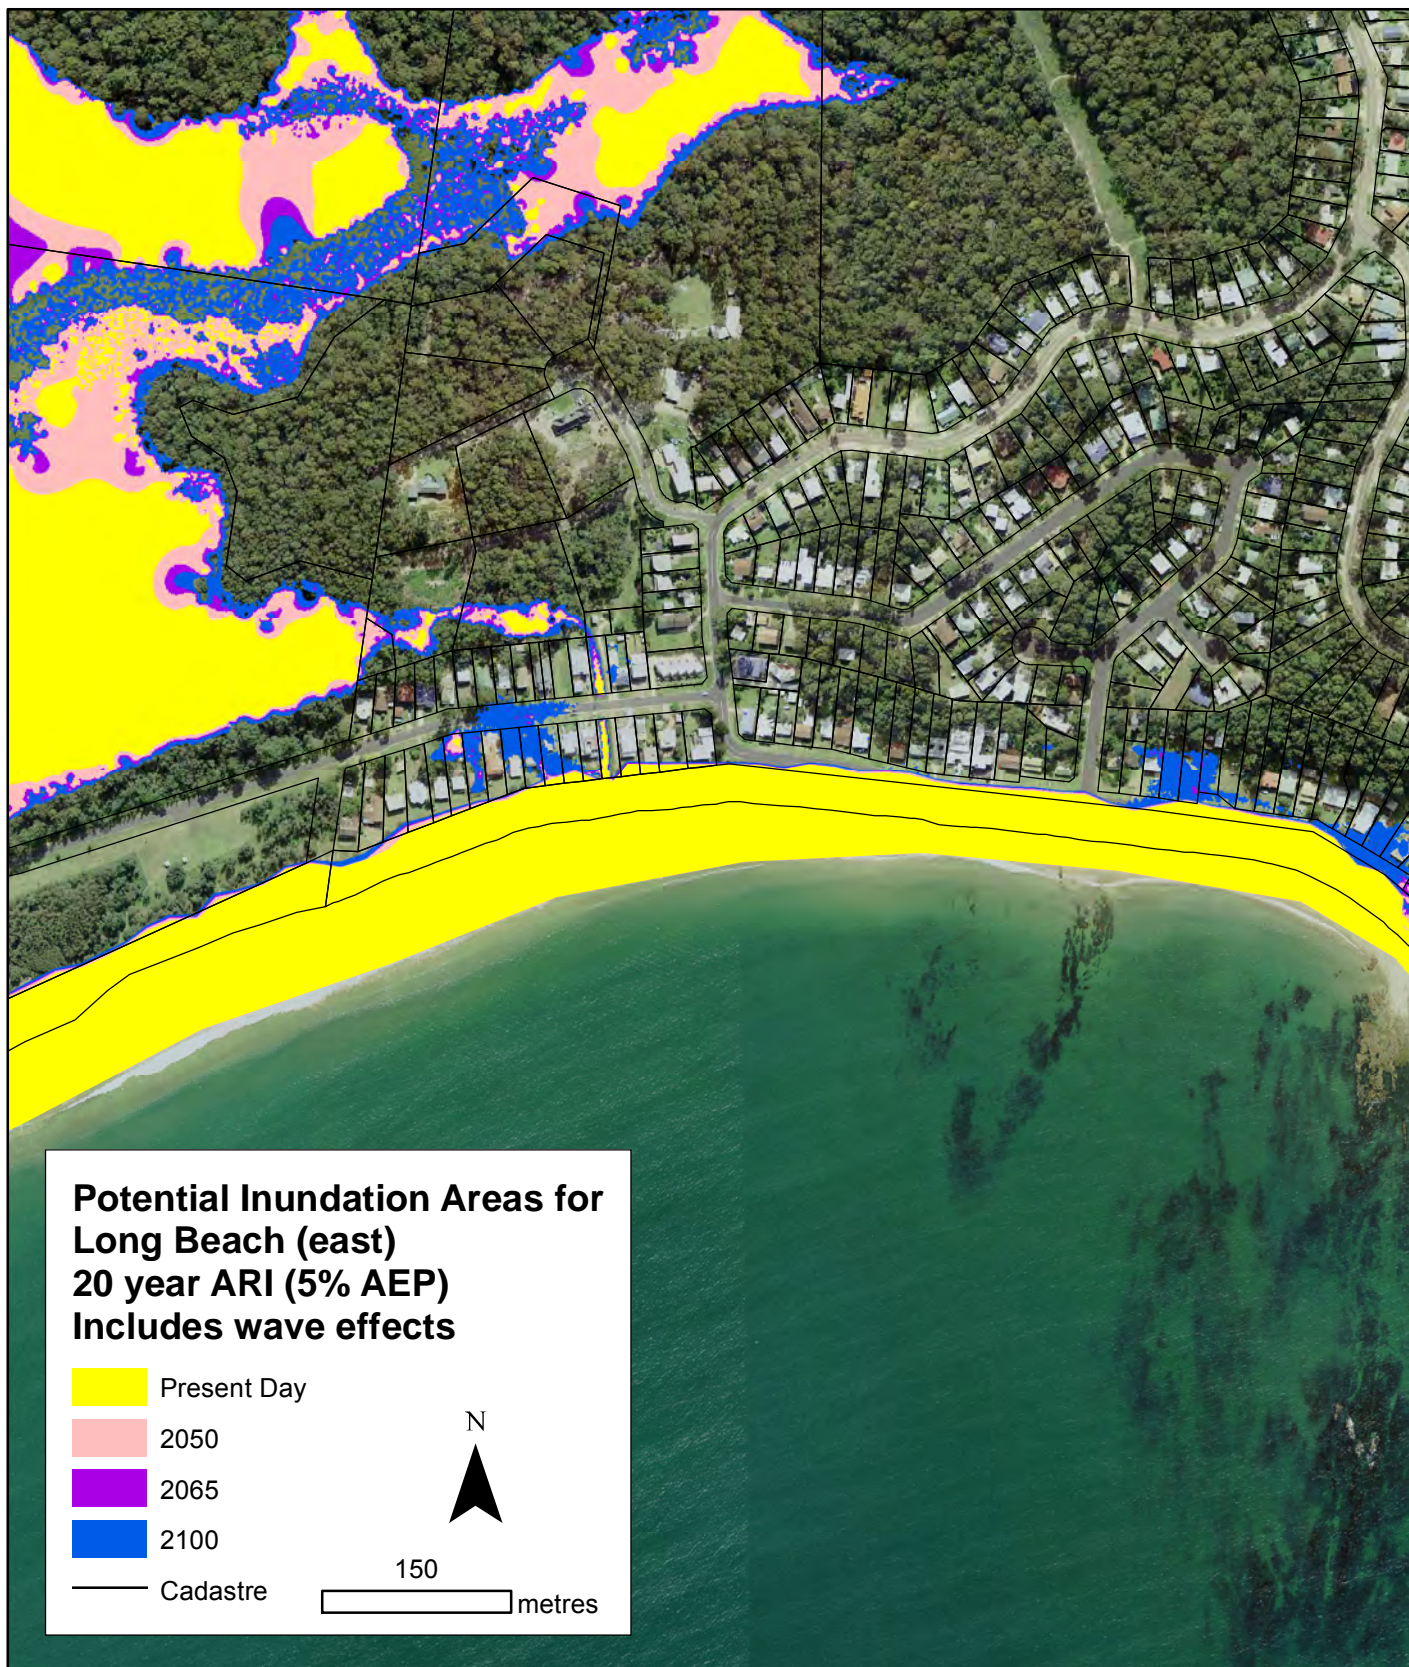
**Figure L.13**

Inundation of the beachface and the area immediately landward of the dune crest is based on the most recent year of photogrammetry data available (2014) and is in accordance with ESC's sea level rise policy and planning framework. It does not include allowance for future landward recession of the beach face and assumes that the crest level of the seawall (if present) and the topography remain as they were from the 2014 photogrammetry data. By 2050, 2065 or 2100 both of these assumptions may not be valid. Should the seawall/dune be allowed to fail then the landward extent of inundation may increase. Inundation of low lying areas behind the beach is based on the most recent year of LIDAR data available (2005). The low lying inundation areas behind the beach are mapped based on the ground elevation (the "all ground" LIDAR layer) and do not consider flow paths, flow velocities, loss of flow momentum or wave propagation into creek areas. WRL is not responsible for the accuracy of the photogrammetry or LIDAR data. Local surveys by a registered surveyor are recommended to determine local inundation extents.

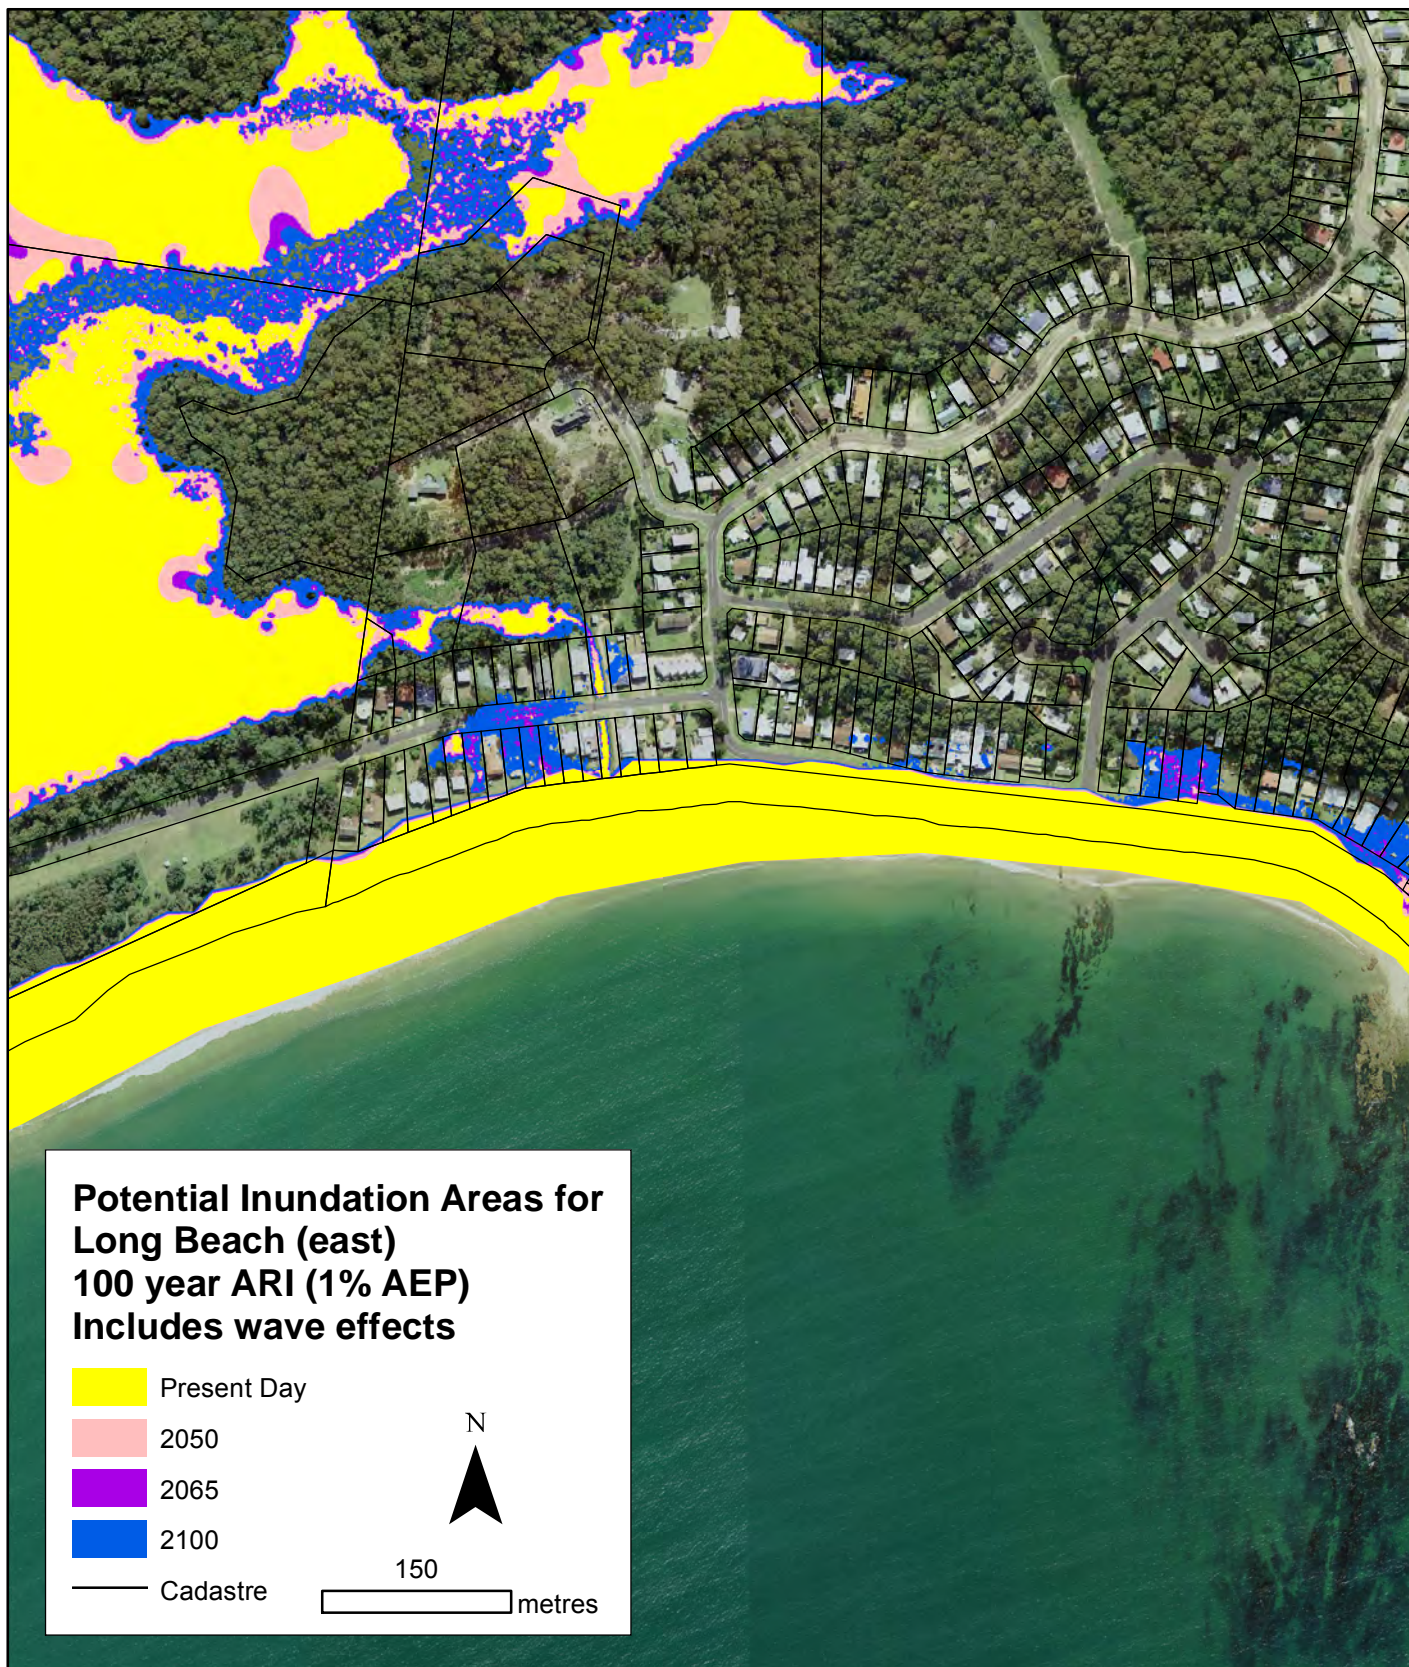
**Figure L.14**

Inundation of the beachface and the area immediately landward of the dune crest is based on the most recent year of photogrammetry data available (2014) and is in accordance with ESC's sea level rise policy and planning framework. It does not include allowance for future landward recession of the beach face and assumes that the crest level of the seawall (if present) and the topography remain as they were from the 2014 photogrammetry data. By 2050, 2065 or 2100 both of these assumptions may not be valid. Should the seawall/dune be allowed to fail then the landward extent of inundation may increase. Inundation of low lying areas behind the beach is based on the most recent year of LIDAR data available (2005). The low lying inundation areas behind the beach are mapped based on the ground elevation (the "all ground" LIDAR layer) and do not consider flow paths, flow velocities, loss of flow momentum or wave propagation into creek areas. WRL is not responsible for the accuracy of the photogrammetry or LIDAR data. Local surveys by a registered surveyor are recommended to determine local inundation extents.
