## Eurobodalla Coastal Hazard Assessment

WRL Technical Report 2017/09  
October 2017

By I R Coghlan, J T Carley, A J Harrison, D Howe, A D Short,  
J E Ruprecht, F Flocard and P F Rahman

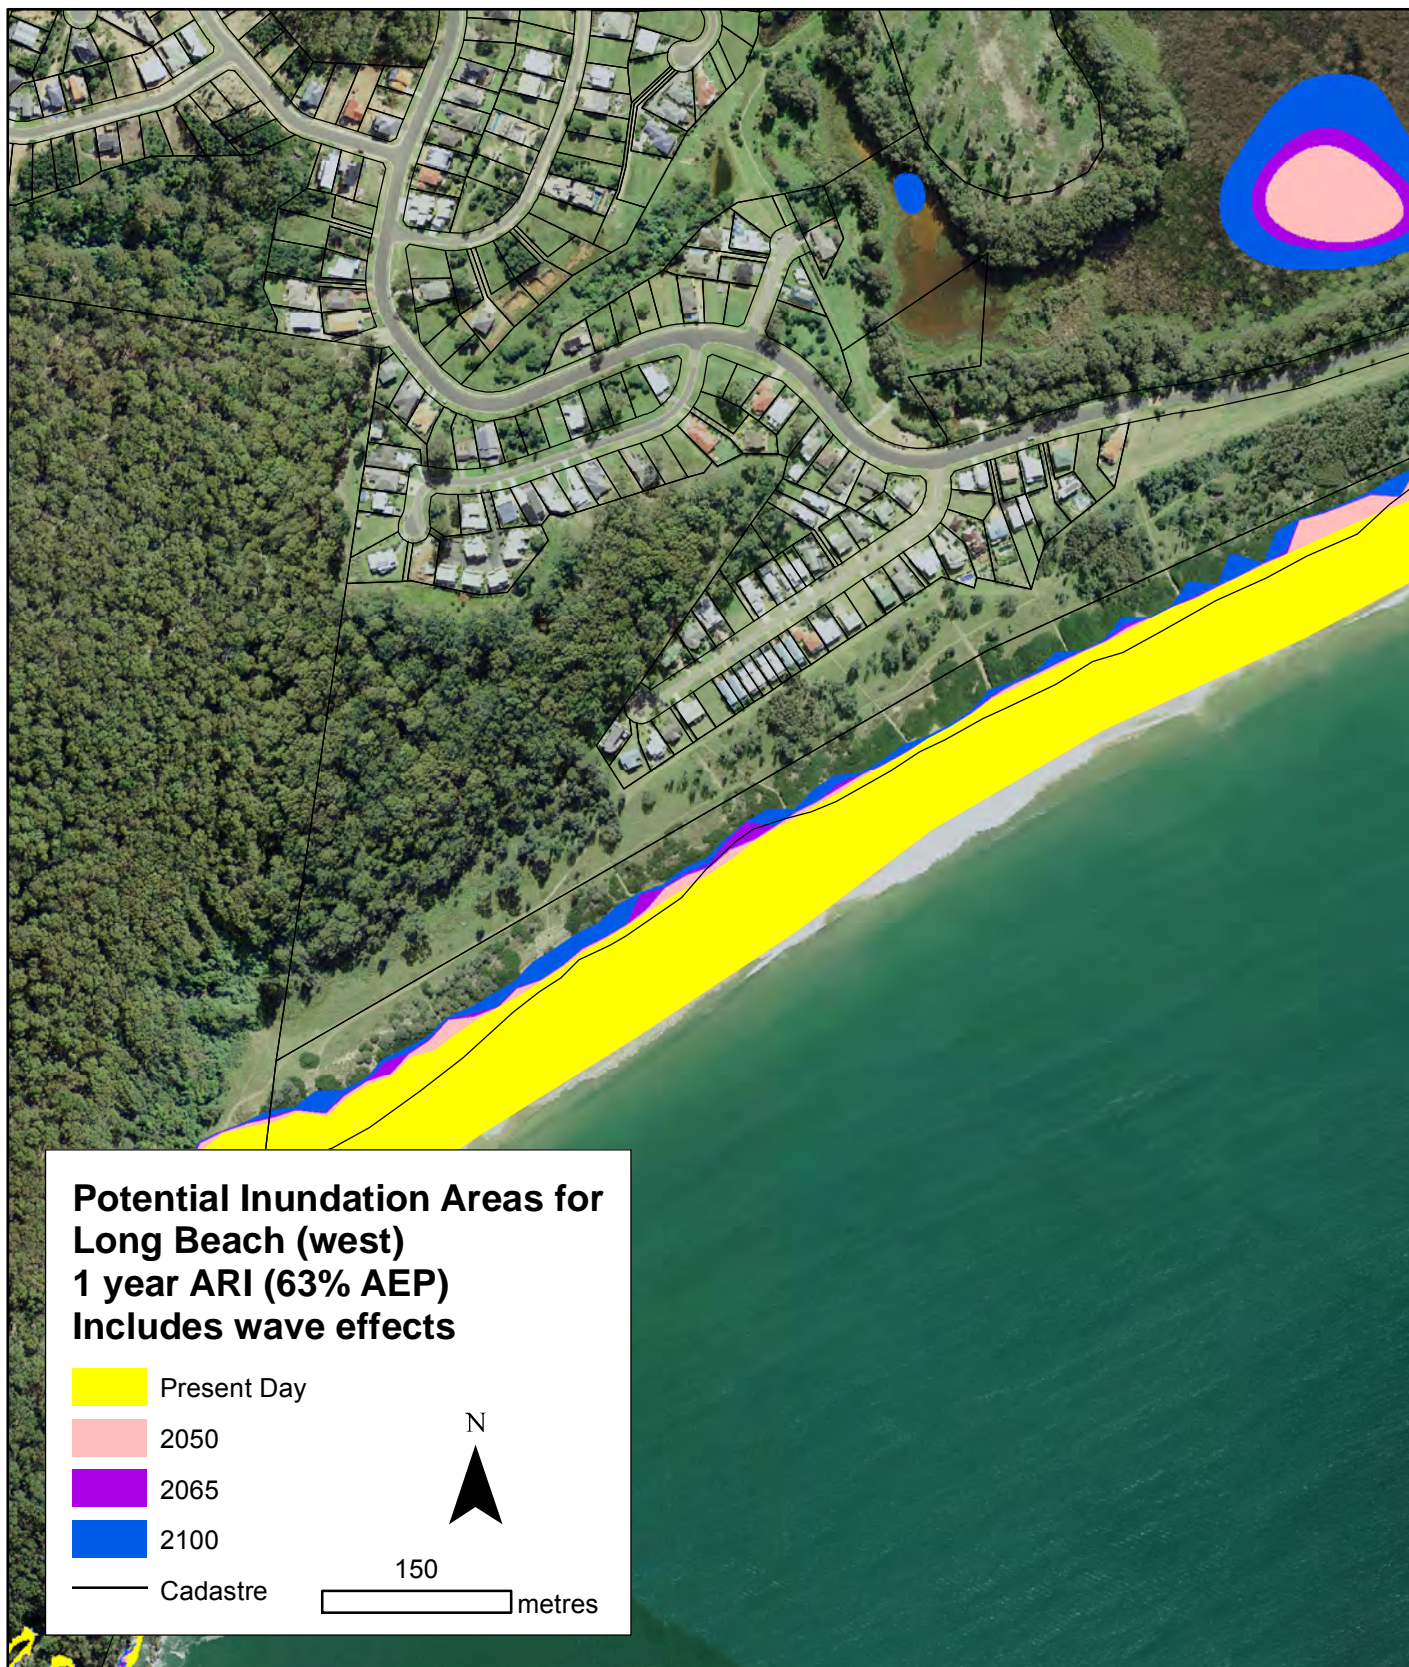
**Figure L.15**

Inundation of the beachface and the area immediately landward of the dune crest is based on the most recent year of photogrammetry data available (2014) and is in accordance with ESC's sea level rise policy and planning framework. It does not include allowance for future landward recession of the beach face and assumes that the crest level of the seawall (if present) and the topography remain as they were from the 2014 photogrammetry data. By 2050, 2065 or 2100 both of these assumptions may not be valid. Should the seawall/dune be allowed to fail then the landward extent of inundation may increase. Inundation of low lying areas behind the beach is based on the most recent year of LIDAR data available (2005). The low lying inundation areas behind the beach are mapped based on the ground elevation (the "all ground" LIDAR layer) and do not consider flow paths, flow velocities, loss of flow momentum or wave propagation into creek areas. WRL is not responsible for the accuracy of the photogrammetry or LIDAR data. Local surveys by a registered surveyor are recommended to determine local inundation extents.

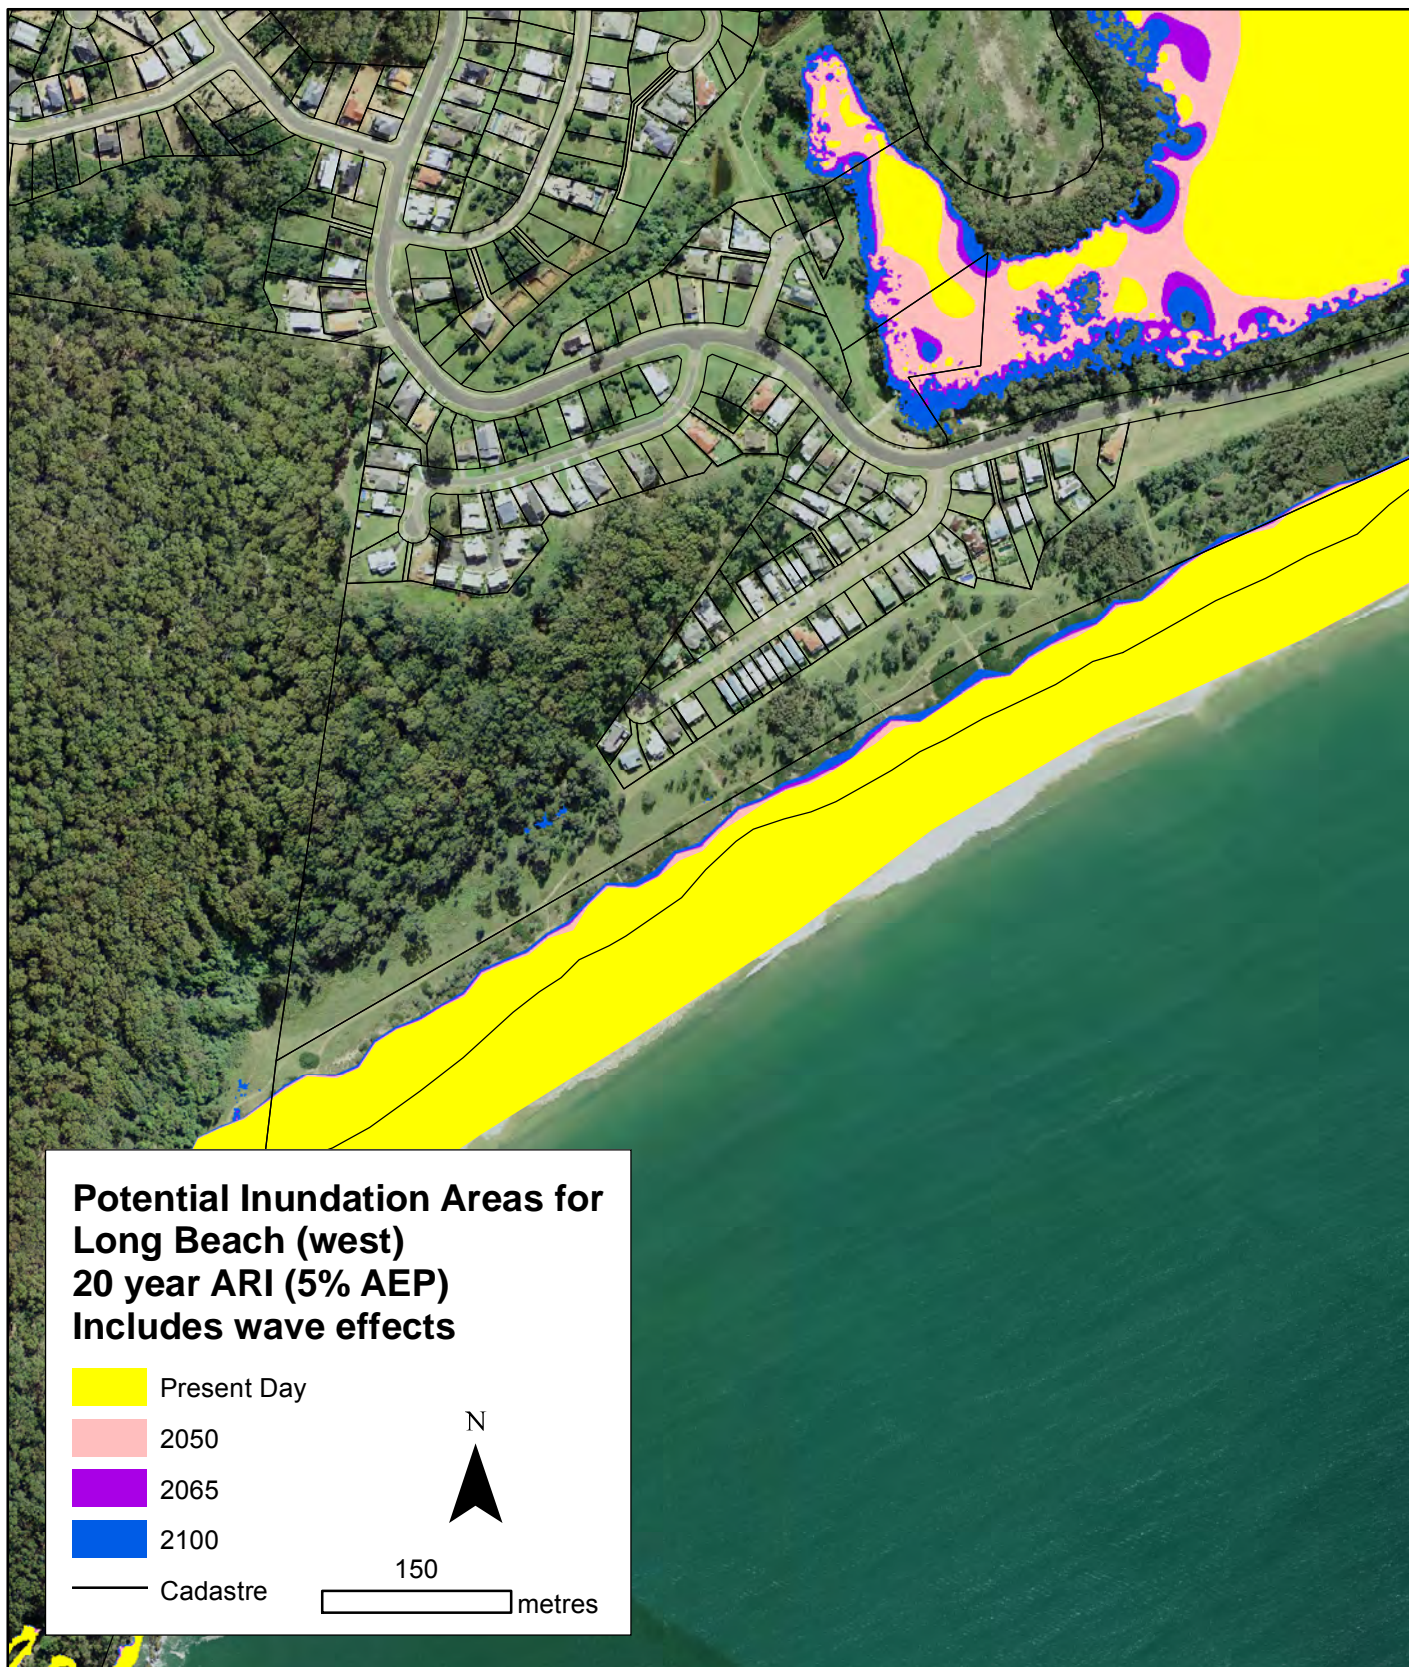
**Figure L.16**

Inundation of the beachface and the area immediately landward of the dune crest is based on the most recent year of photogrammetry data available (2014) and is in accordance with ESC's sea level rise policy and planning framework. It does not include allowance for future landward recession of the beach face and assumes that the crest level of the seawall (if present) and the topography remain as they were from the 2014 photogrammetry data. By 2050, 2065 or 2100 both of these assumptions may not be valid. Should the seawall/dune be allowed to fail then the landward extent of inundation may increase. Inundation of low lying areas behind the beach is based on the most recent year of LIDAR data available (2005). The low lying inundation areas behind the beach are mapped based on the ground elevation (the "all ground" LIDAR layer) and do not consider flow paths, flow velocities, loss of flow momentum or wave propagation into creek areas. WRL is not responsible for the accuracy of the photogrammetry or LIDAR data. Local surveys by a registered surveyor are recommended to determine local inundation extents.

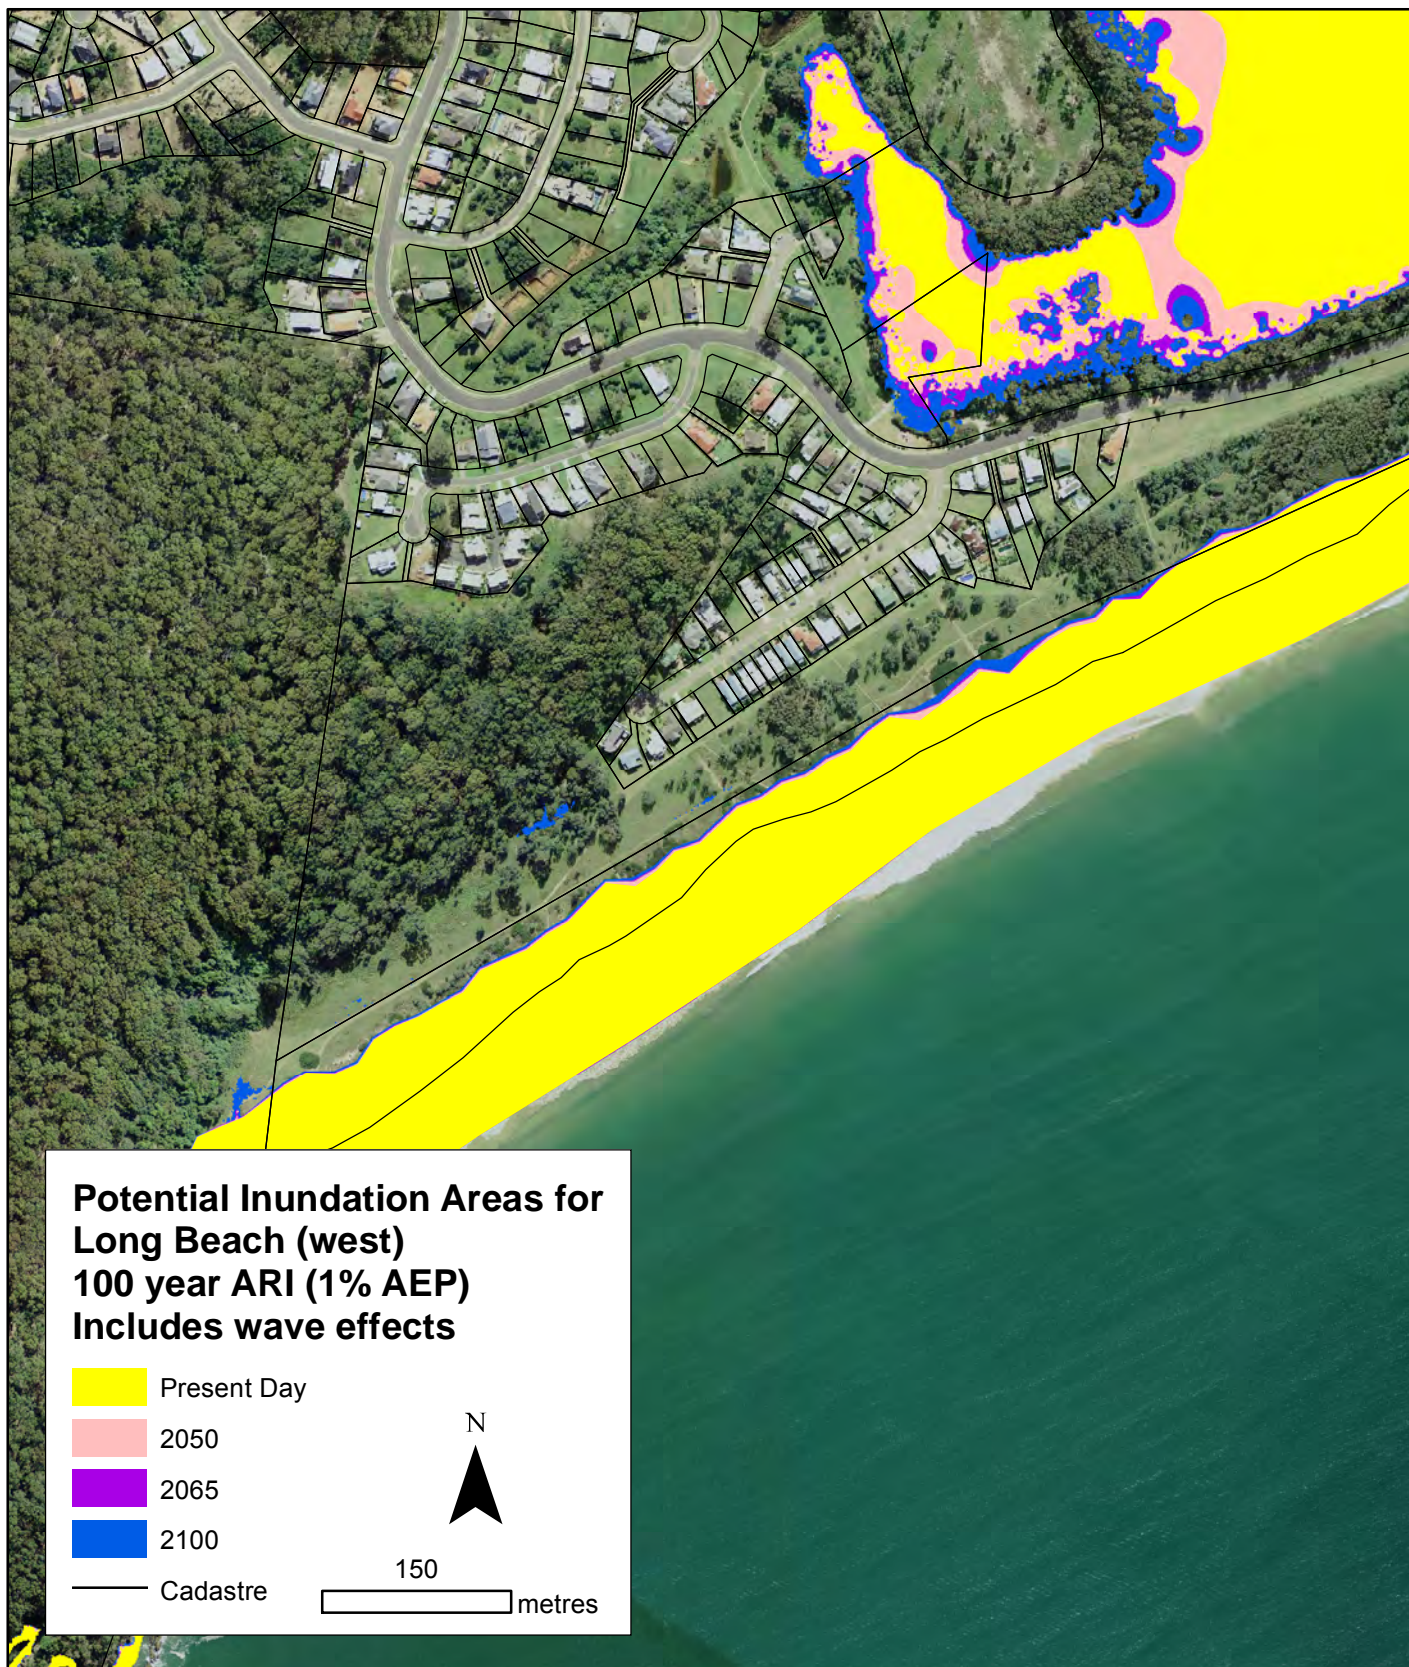
**Figure L.17**

Inundation of the beachface and the area immediately landward of the dune crest is based on the most recent year of photogrammetry data available (2014) and is in accordance with ESC's sea level rise policy and planning framework. It does not include allowance for future landward recession of the beach face and assumes that the crest level of the seawall (if present) and the topography remain as they were from the 2014 photogrammetry data. By 2050, 2065 or 2100 both of these assumptions may not be valid. Should the seawall/dune be allowed to fail then the landward extent of inundation may increase. Inundation of low lying areas behind the beach is based on the most recent year of LIDAR data available (2005). The low lying inundation areas behind the beach are mapped based on the ground elevation (the "all ground" LIDAR layer) and do not consider flow paths, flow velocities, loss of flow momentum or wave propagation into creek areas. WRL is not responsible for the accuracy of the photogrammetry or LIDAR data. Local surveys by a registered surveyor are recommended to determine local inundation extents.

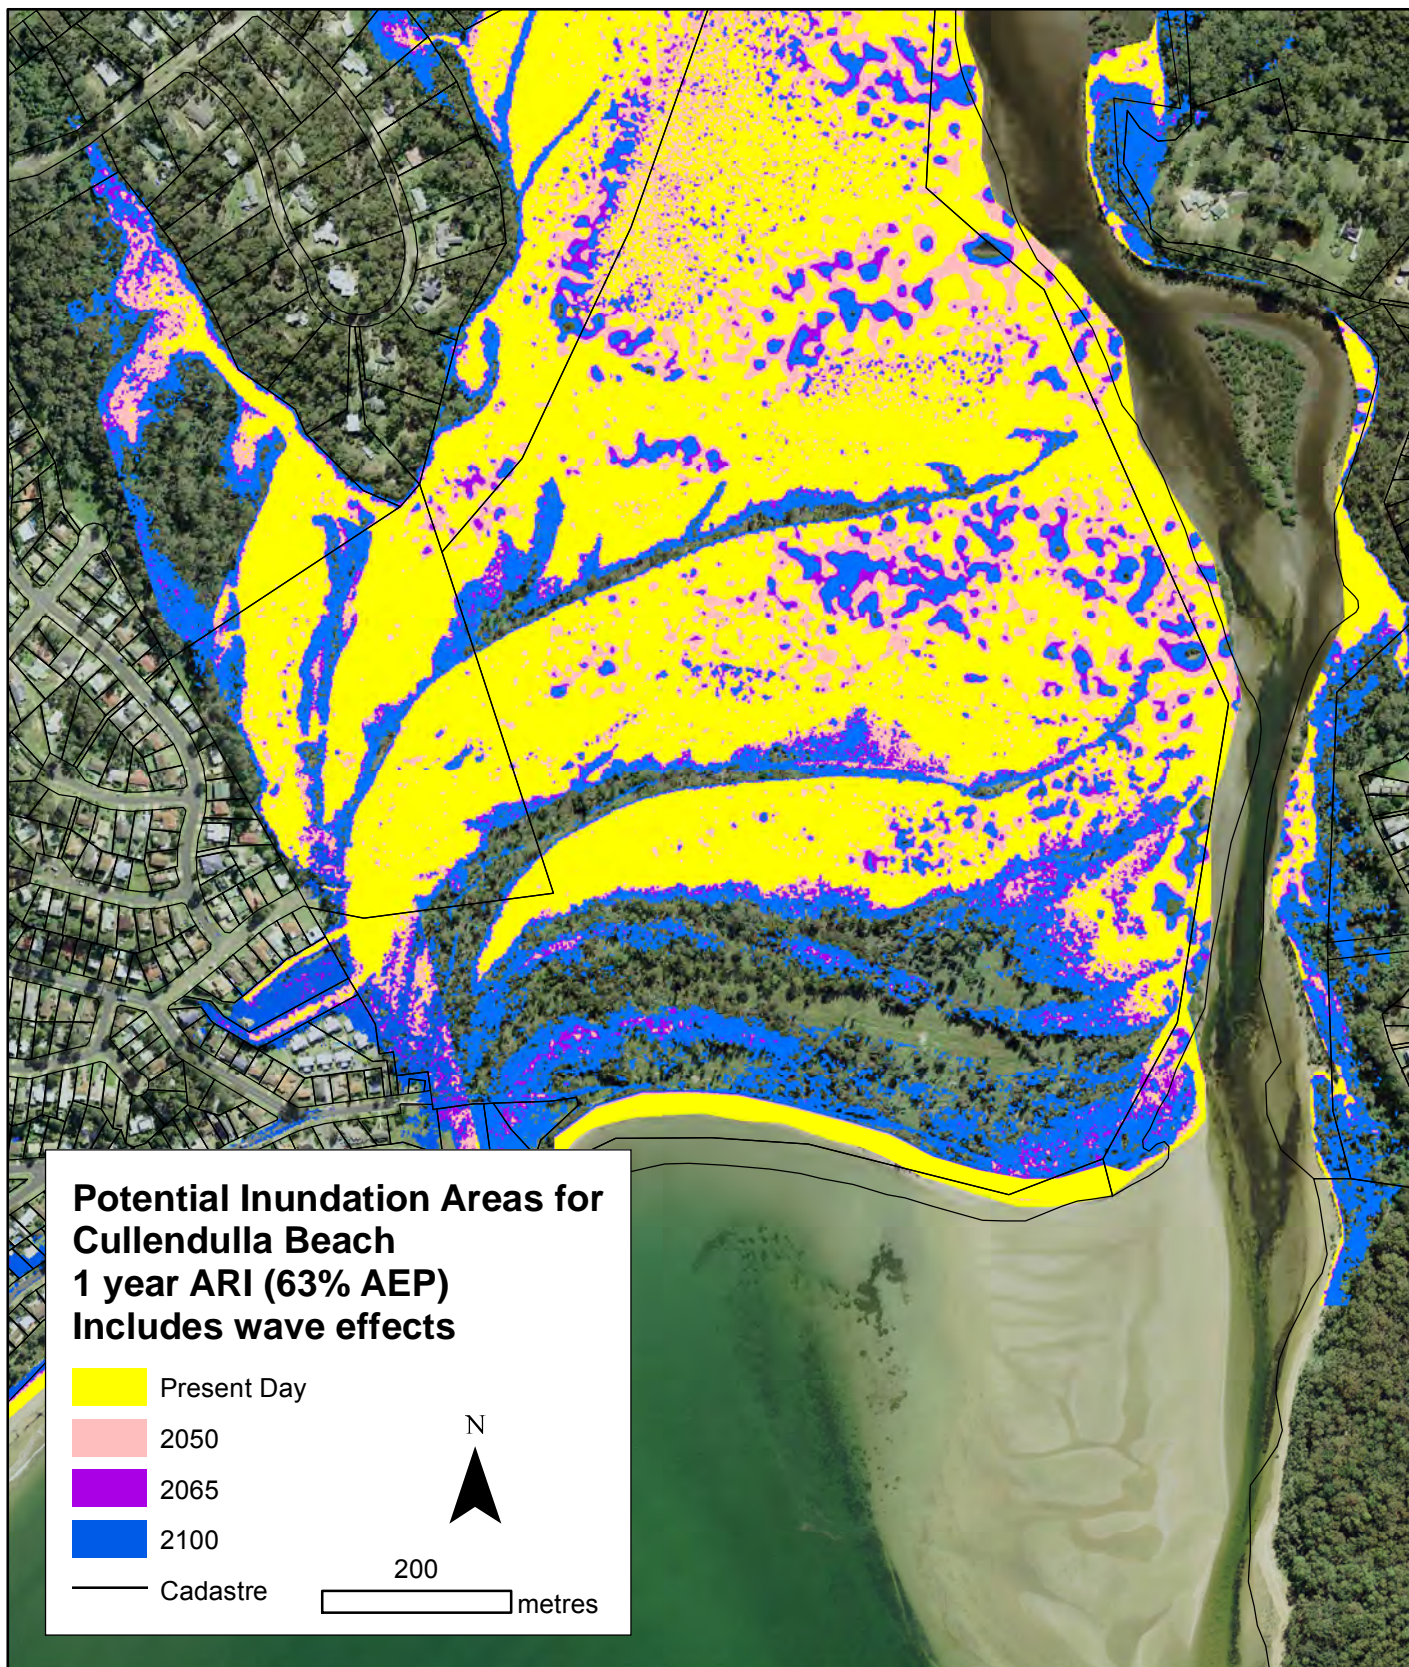
**Figure L.18**

Inundation of the beachface and the area immediately landward of the dune crest is based on the most recent year of LIDAR data available (2005) and is in accordance with ESC's sea level rise policy and planning framework. It does not include allowance for future landward recession of the beach face and assumes that the crest level of the seawall (if present) and the topography remain as they were from the 2005 LIDAR data. By 2050, 2065 or 2100 both of these assumptions may not be valid. Should the seawall/dune be allowed to fail then the landward extent of inundation may increase. Inundation of low lying areas behind the beach is based on the most recent year of LIDAR data available (2005). The low lying inundation areas behind the beach are mapped based on the ground elevation (the "all ground" LIDAR layer) and do not consider flow paths, flow velocities, loss of flow momentum or wave propagation into creek areas. WRL is not responsible for the accuracy of the photogrammetry or LIDAR data. Local surveys by a registered surveyor are recommended to determine local inundation extents.

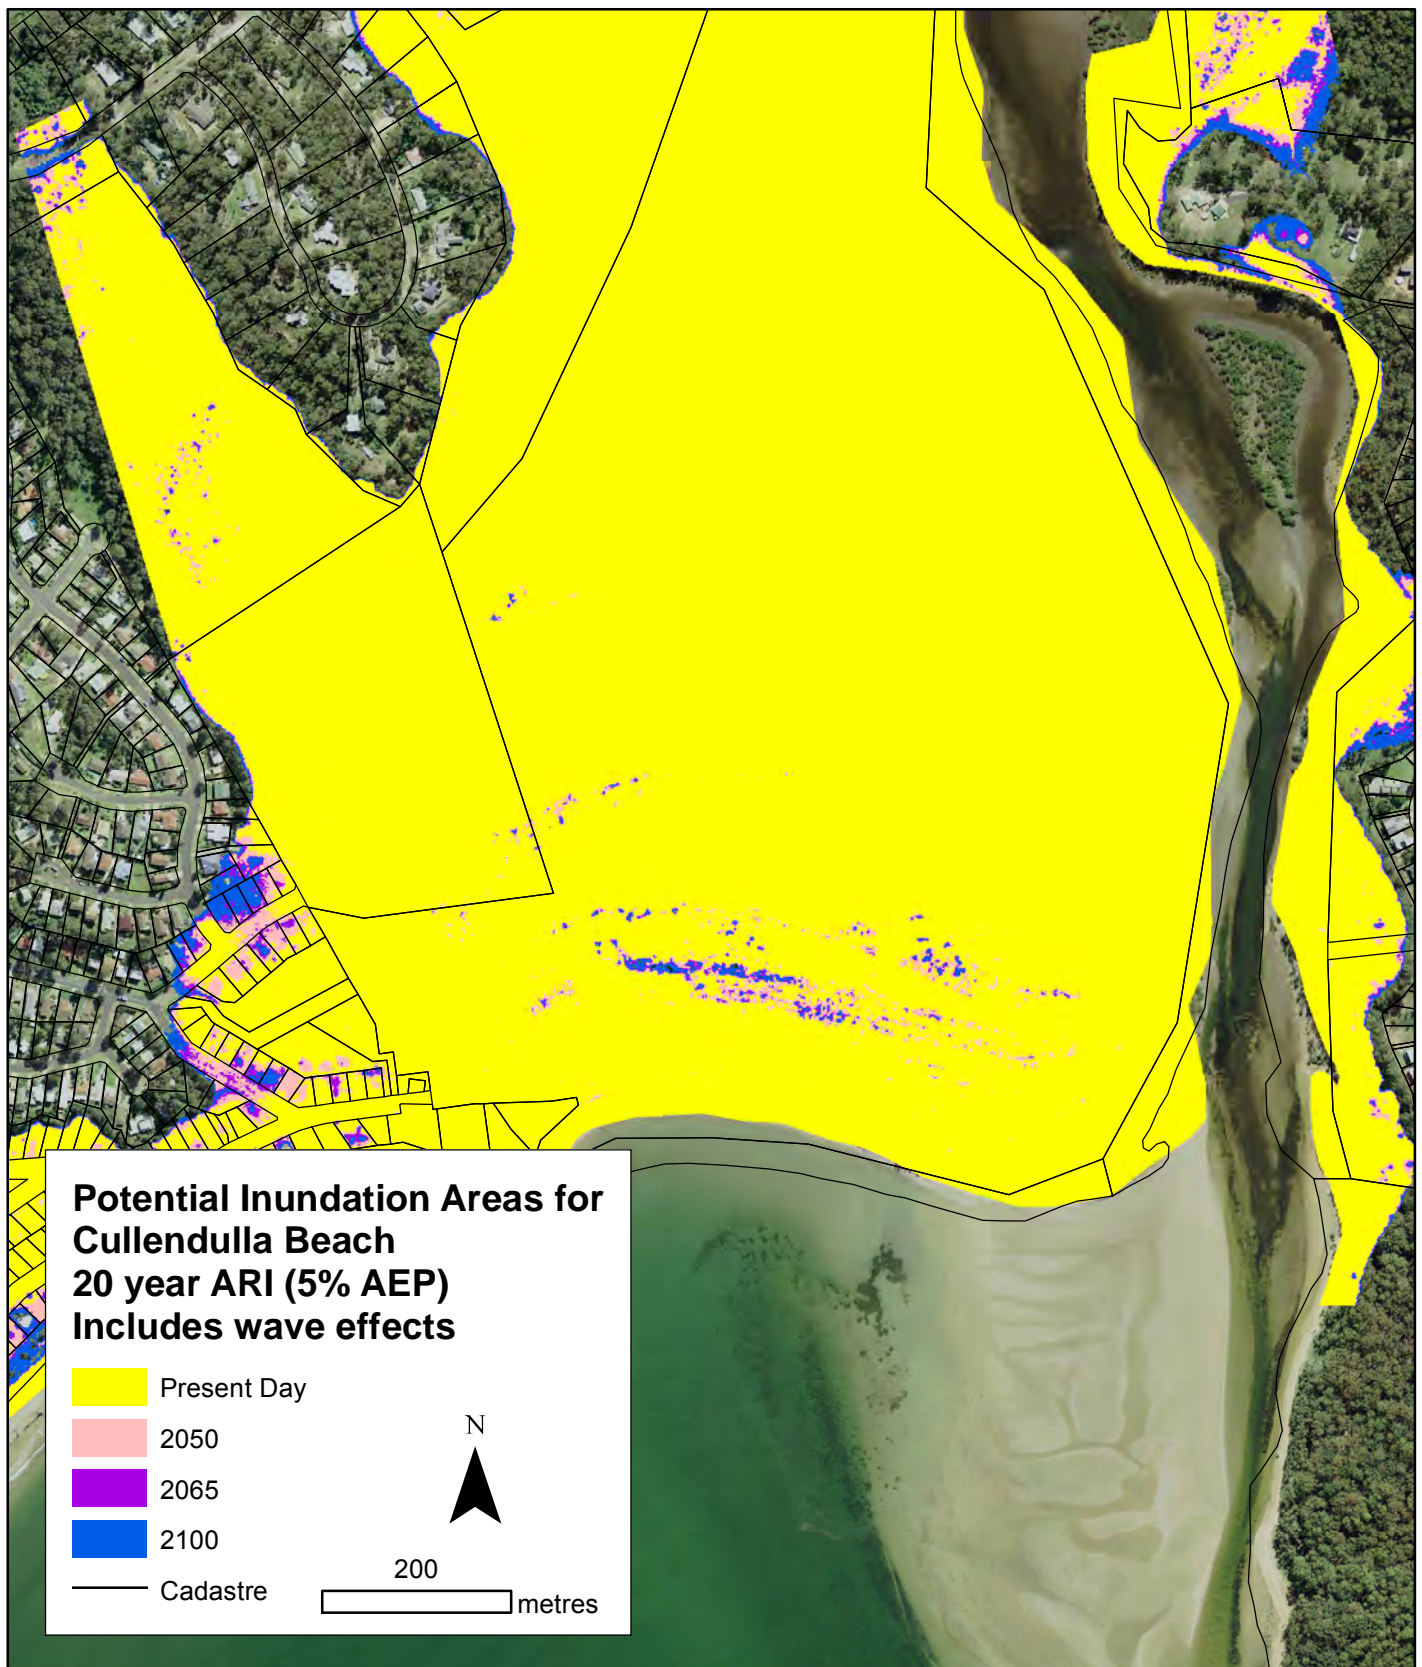
**Figure L.19**

Inundation of the beachface and the area immediately landward of the dune crest is based on the most recent year of LIDAR data available (2005) and is in accordance with ESC's sea level rise policy and planning framework. It does not include allowance for future landward recession of the beach face and assumes that the crest level of the seawall (if present) and the topography remain as they were from the 2005 LIDAR data. By 2050, 2065 or 2100 both of these assumptions may not be valid. Should the seawall/dune be allowed to fail then the landward extent of inundation may increase. Inundation of low lying areas behind the beach is based on the most recent year of LIDAR data available (2005). The low lying inundation areas behind the beach are mapped based on the ground elevation (the "all ground" LIDAR layer) and do not consider flow paths, flow velocities, loss of flow momentum or wave propagation into creek areas. WRL is not responsible for the accuracy of the photogrammetry or LIDAR data. Local surveys by a registered surveyor are recommended to determine local inundation extents.

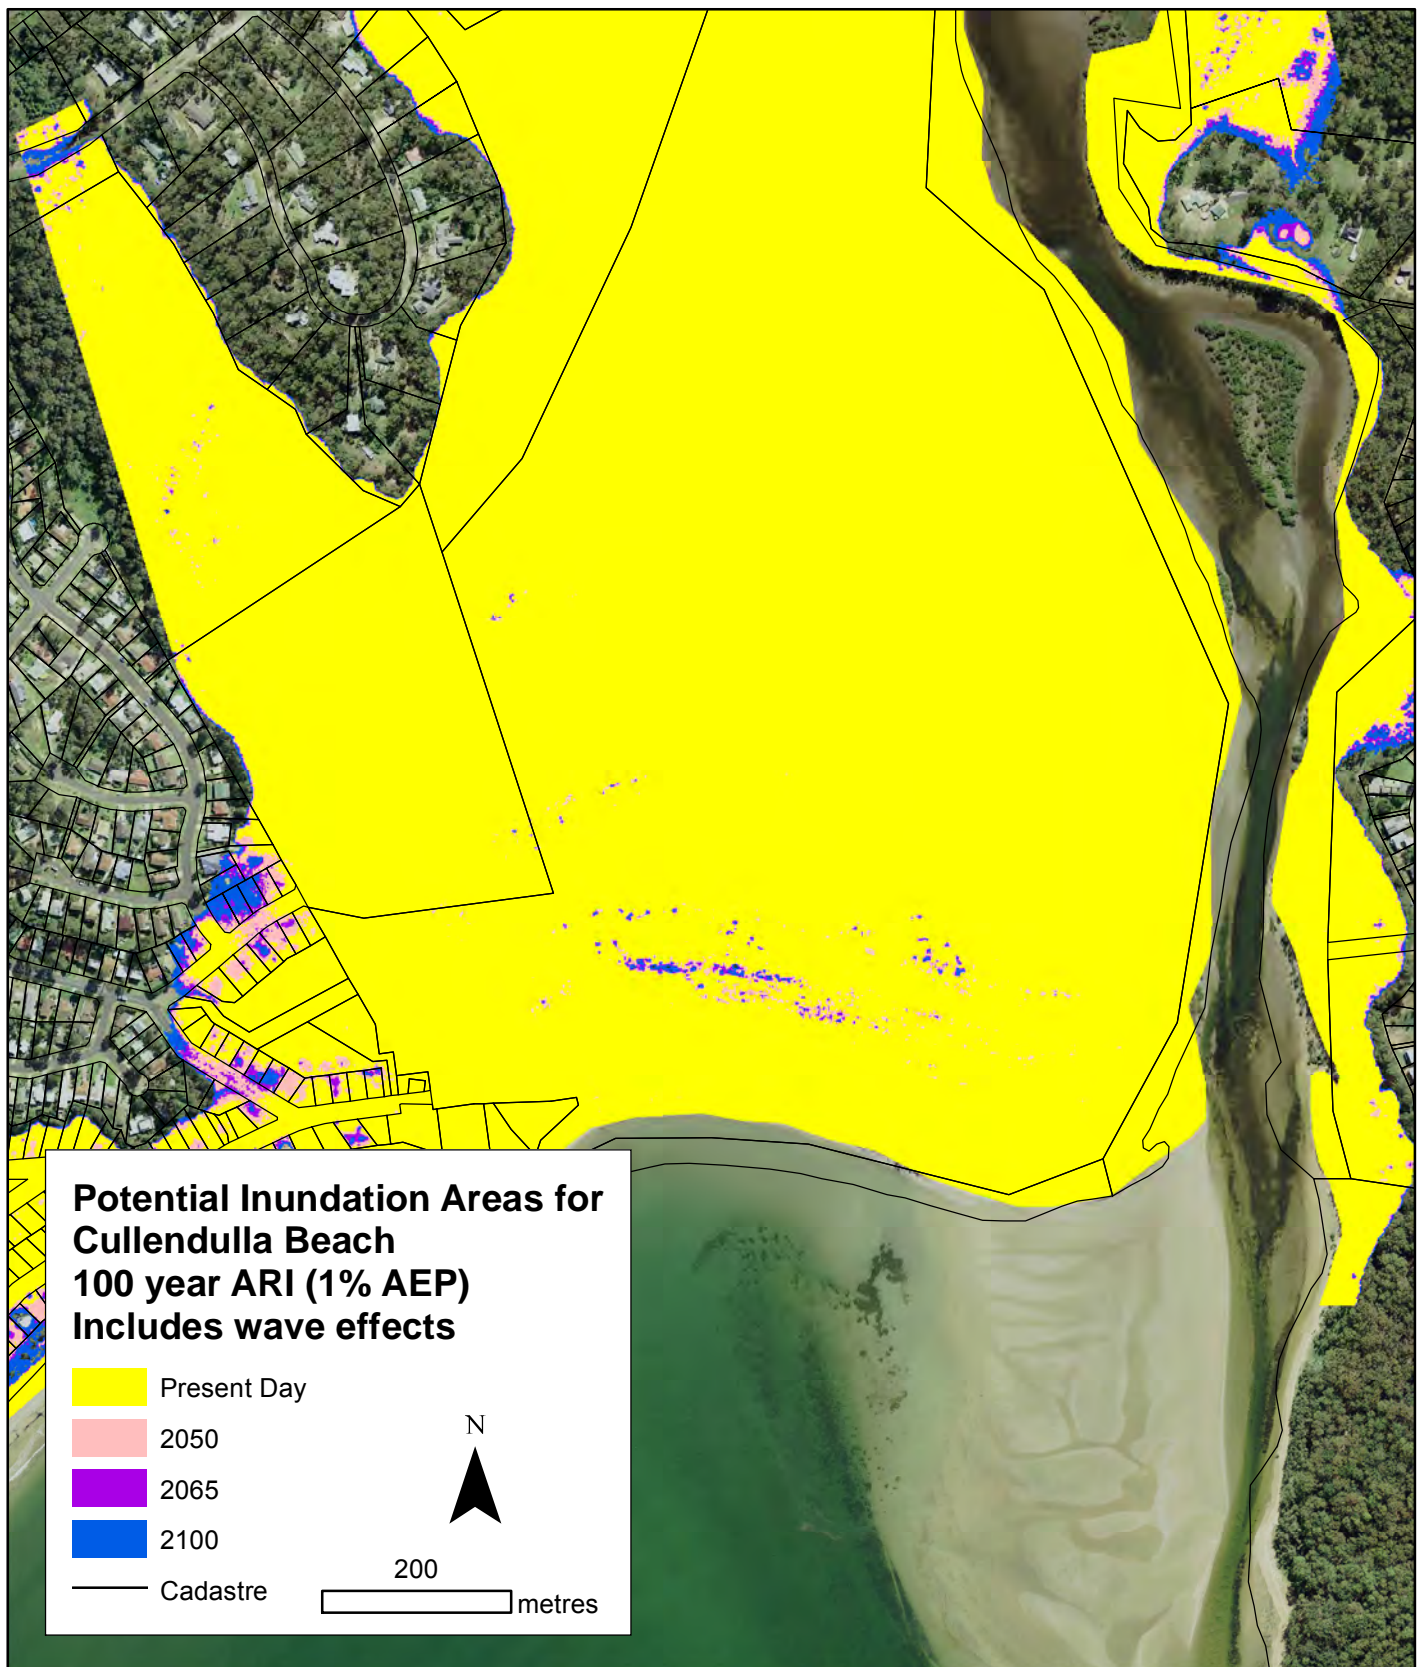
**Figure L.20**

Inundation of the beachface and the area immediately landward of the dune crest is based on the most recent year of LIDAR data available (2005) and is in accordance with ESC's sea level rise policy and planning framework. It does not include allowance for future landward recession of the beach face and assumes that the crest level of the seawall (if present) and the topography remain as they were from the 2005 LIDAR data. By 2050, 2065 or 2100 both of these assumptions may not be valid. Should the seawall/dune be allowed to fail then the landward extent of inundation may increase. Inundation of low lying areas behind the beach is based on the most recent year of LIDAR data available (2005). The low lying inundation areas behind the beach are mapped based on the ground elevation (the "all ground" LIDAR layer) and do not consider flow paths, flow velocities, loss of flow momentum or wave propagation into creek areas. WRL is not responsible for the accuracy of the photogrammetry or LIDAR data. Local surveys by a registered surveyor are recommended to determine local inundation extents.

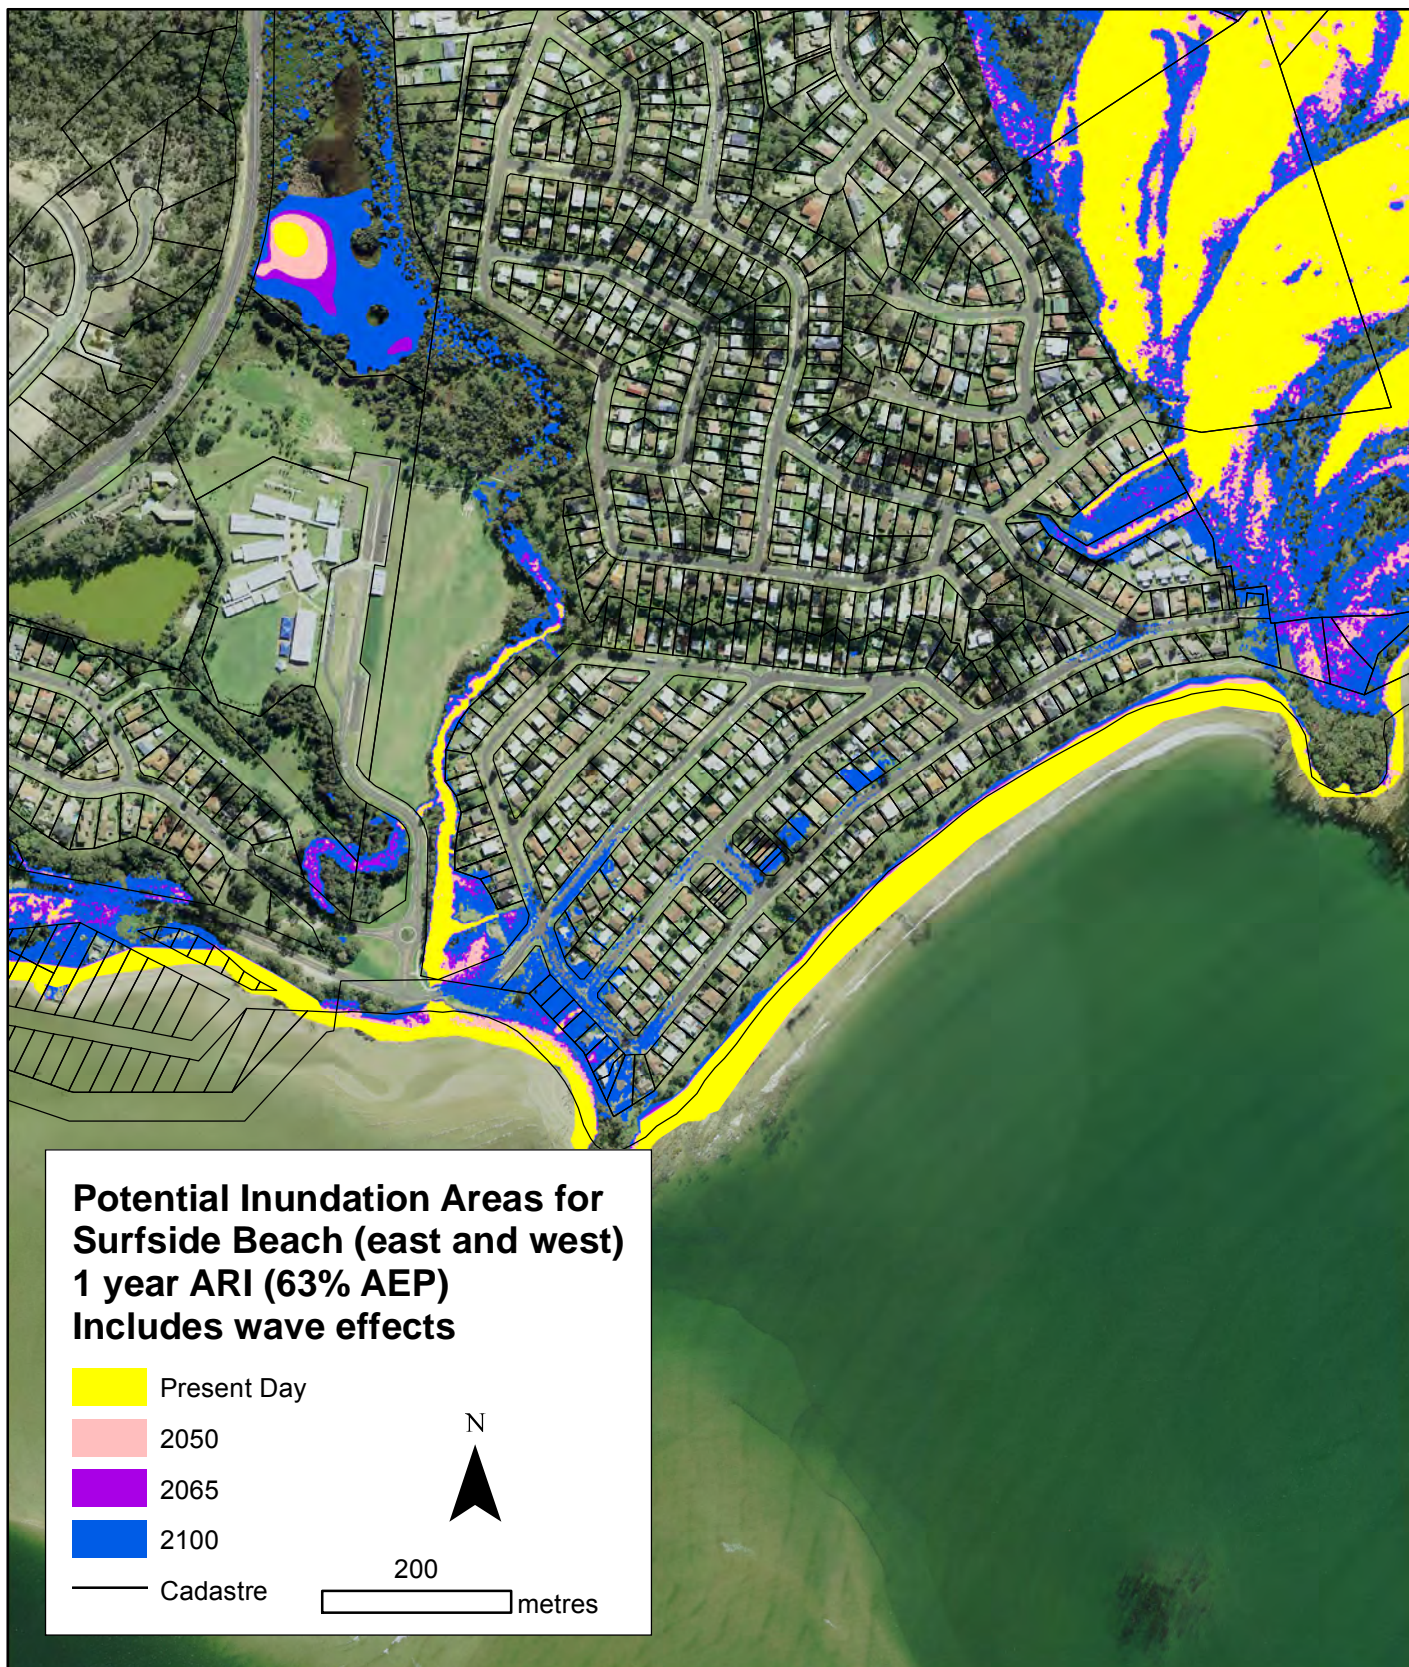
**Figure L.21**

Inundation of the beachface and the area immediately landward of the dune crest is based on the most recent year of photogrammetry data available (2014) and is in accordance with ESC's sea level rise policy and planning framework. It does not include allowance for future landward recession of the beach face and assumes that the crest level of the seawall (if present) and the topography remain as they were from the 2014 photogrammetry data. By 2050, 2065 or 2100 both of these assumptions may not be valid. Should the seawall/dune be allowed to fail then the landward extent of inundation may increase. Inundation of low lying areas behind the beach is based on the most recent year of LIDAR data available (2005). The low lying inundation areas behind the beach are mapped based on the ground elevation (the "all ground" LIDAR layer) and do not consider flow paths, flow velocities, loss of flow momentum or wave propagation into creek areas. WRL is not responsible for the accuracy of the photogrammetry or LIDAR data. Local surveys by a registered surveyor are recommended to determine local inundation extents.

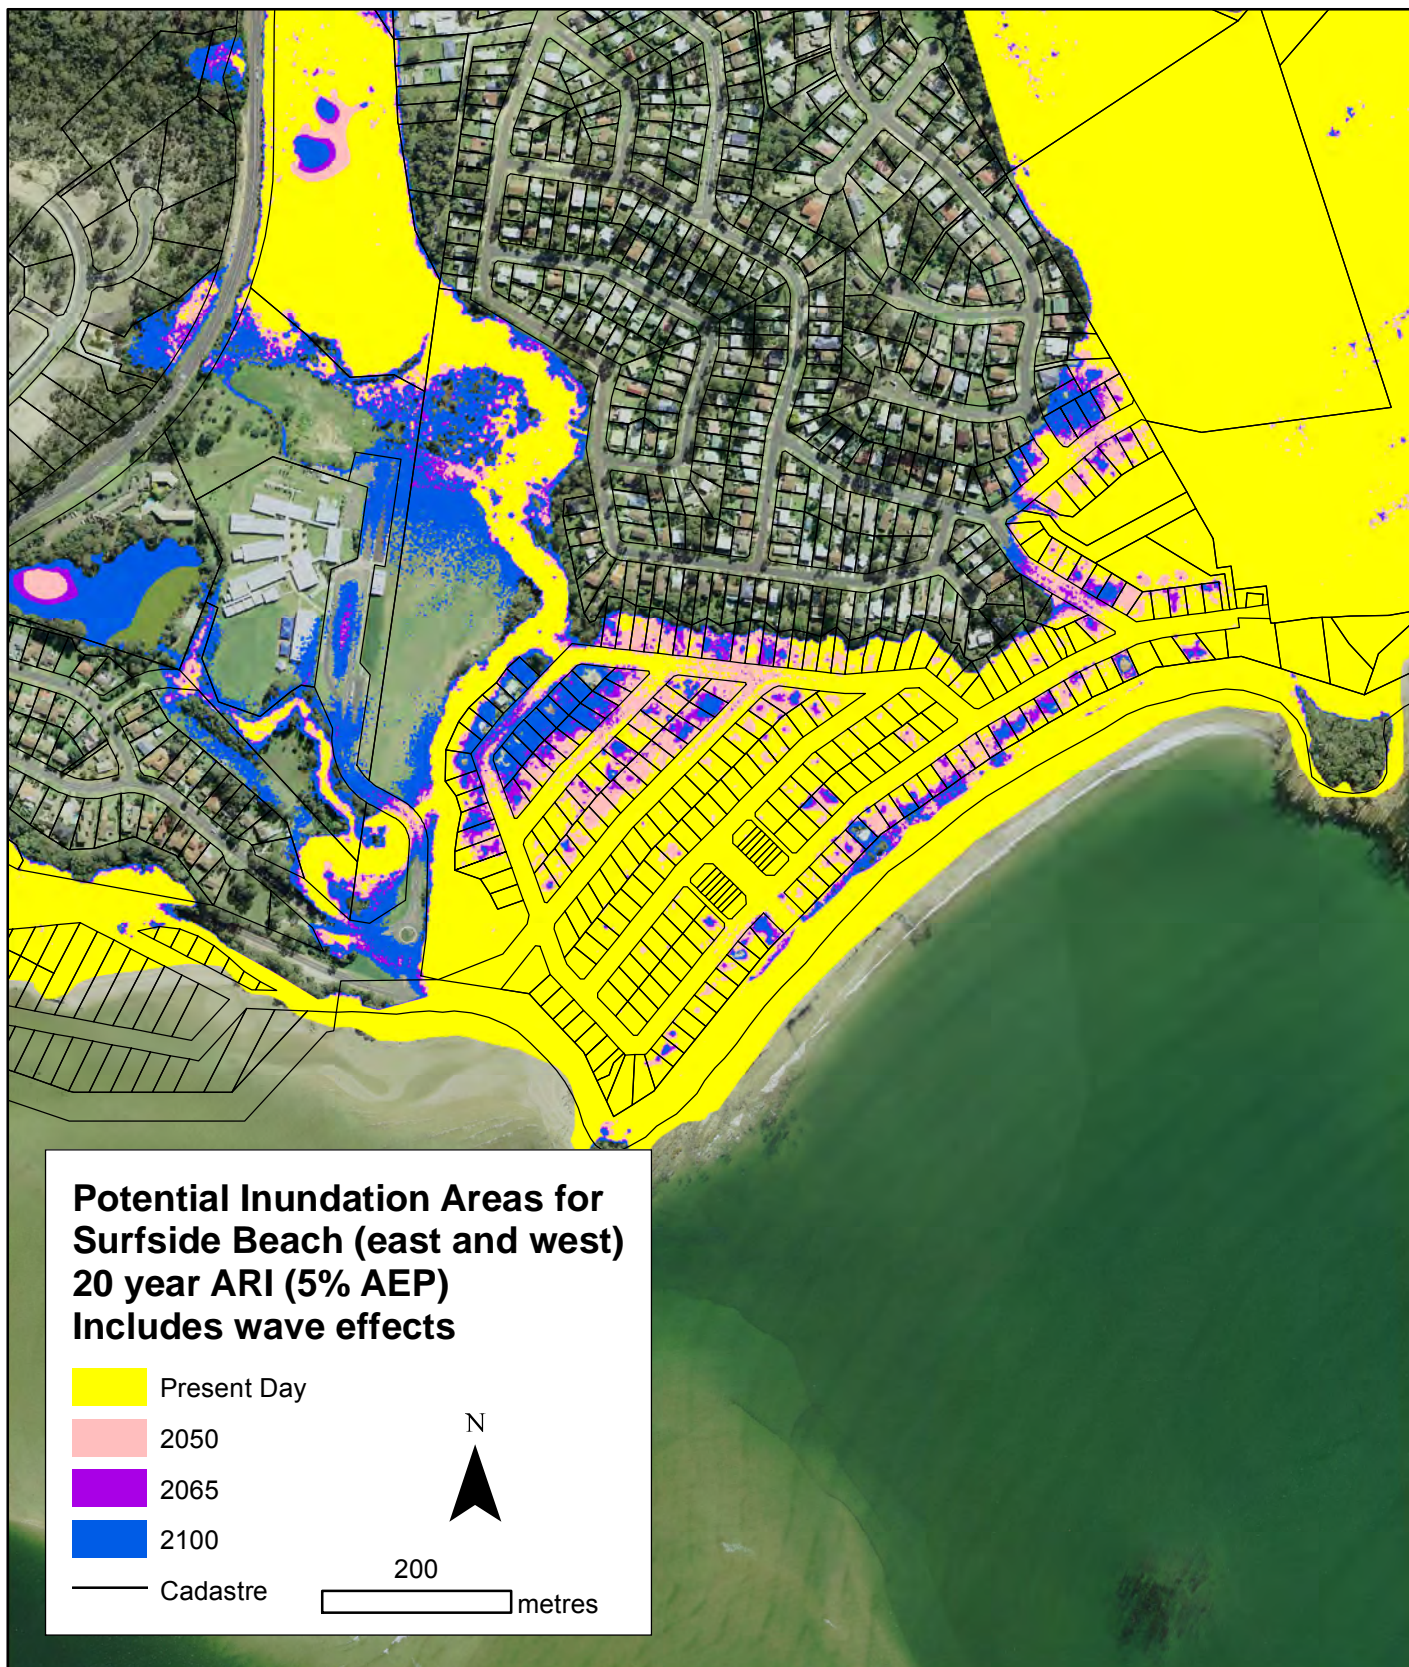
**Figure L.22**

Inundation of the beachface and the area immediately landward of the dune crest is based on the most recent year of photogrammetry data available (2014) and is in accordance with ESC's sea level rise policy and planning framework. It does not include allowance for future landward recession of the beach face and assumes that the crest level of the seawall (if present) and the topography remain as they were from the 2014 photogrammetry data. By 2050, 2065 or 2100 both of these assumptions may not be valid. Should the seawall/dune be allowed to fail then the landward extent of inundation may increase. Inundation of low lying areas behind the beach is based on the most recent year of LIDAR data available (2005). The low lying inundation areas behind the beach are mapped based on the ground elevation (the "all ground" LIDAR layer) and do not consider flow paths, flow velocities, loss of flow momentum or wave propagation into creek areas. WRL is not responsible for the accuracy of the photogrammetry or LIDAR data. Local surveys by a registered surveyor are recommended to determine local inundation extents.
