## Eurobodalla Coastal Hazard Assessment

WRL Technical Report 2017/09  
October 2017

By I R Coghlan, J T Carley, A J Harrison, D Howe, A D Short,  
J E Ruprecht, F Flocard and P F Rahman

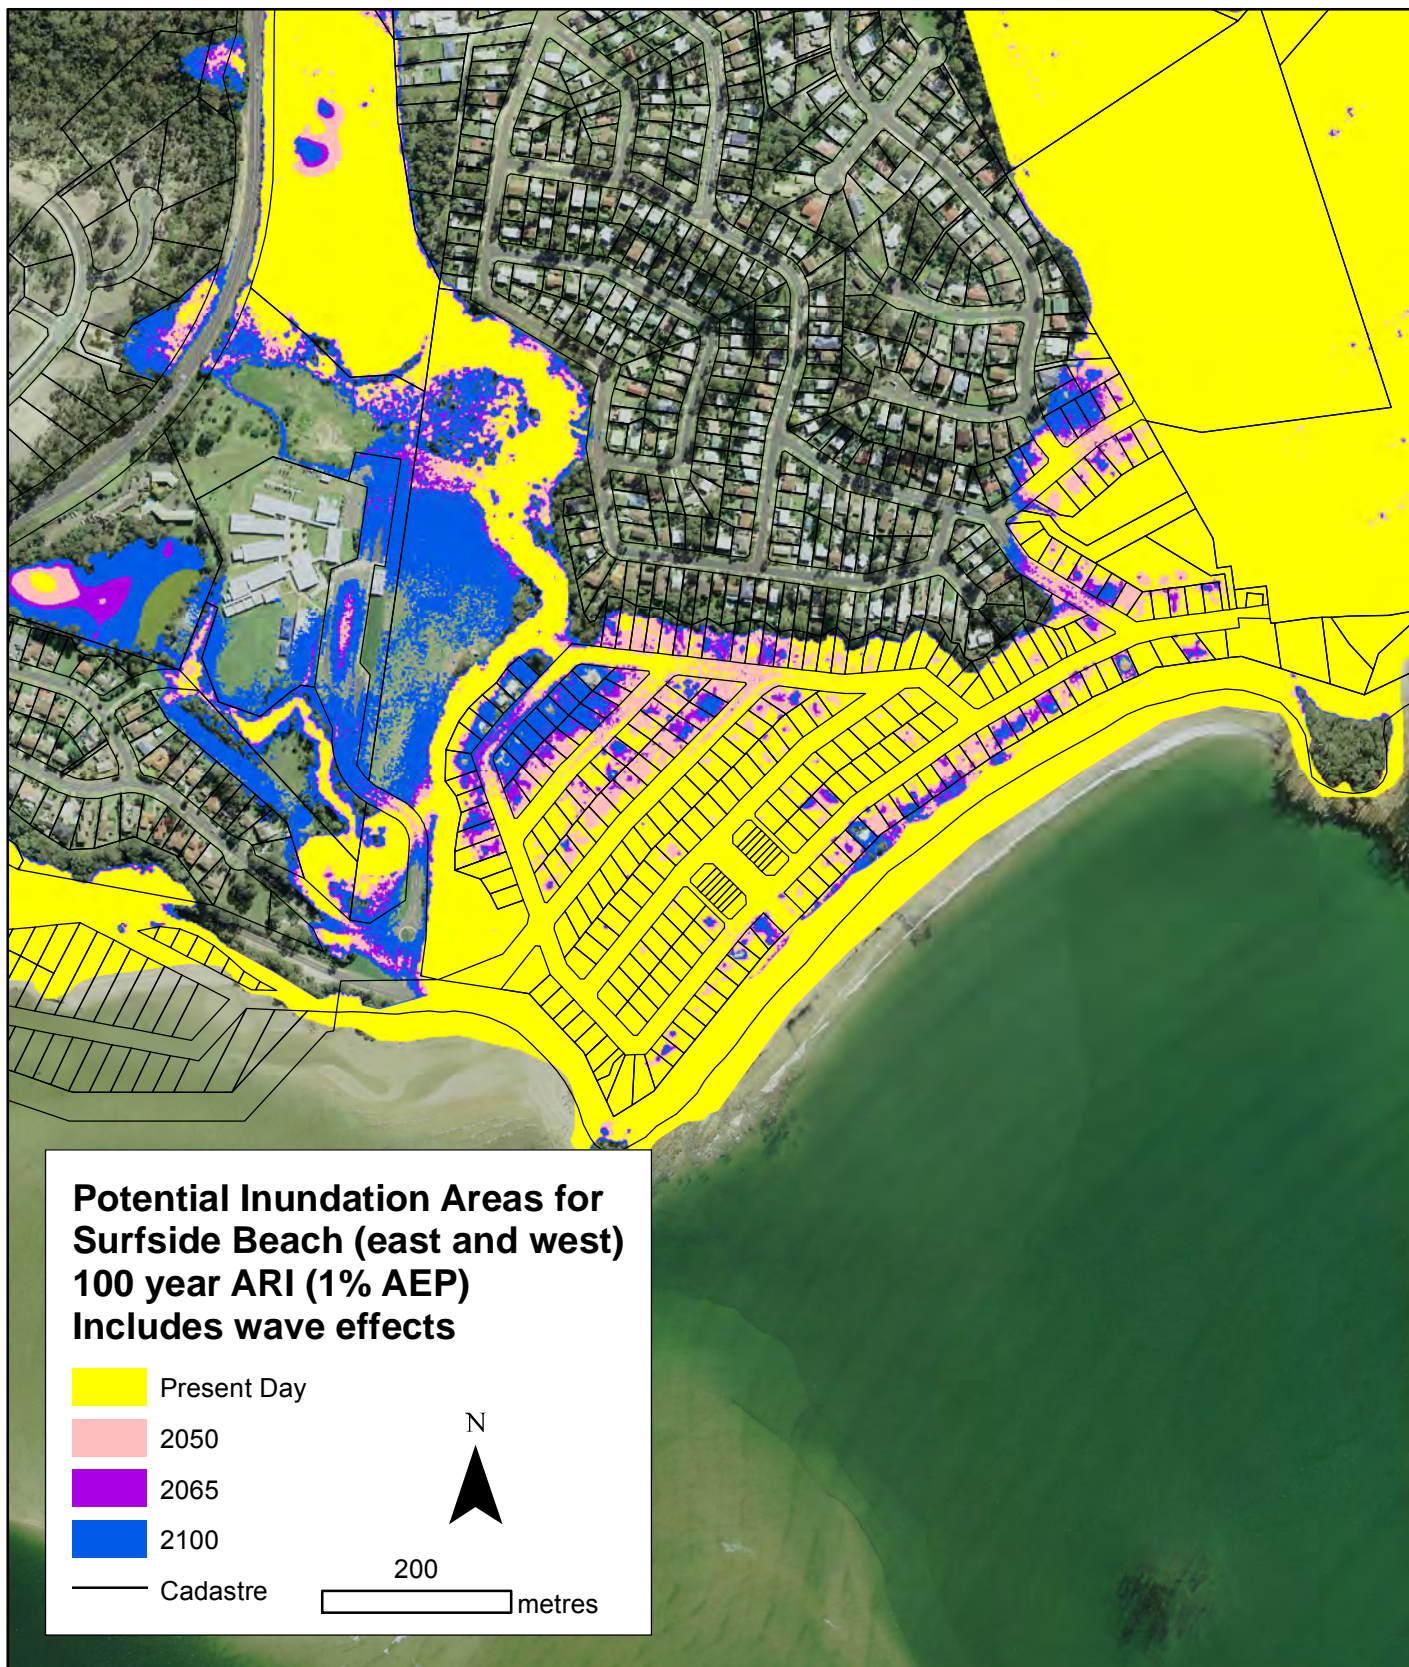
**Figure L.23**

Inundation of the beachface and the area immediately landward of the dune crest is based on the most recent year of photogrammetry data available (2014) and is in accordance with ESC's sea level rise policy and planning framework. It does not include allowance for future landward recession of the beach face and assumes that the crest level of the seawall (if present) and the topography remain as they were from the 2014 photogrammetry data. By 2050, 2065 or 2100 both of these assumptions may not be valid. Should the seawall/dune be allowed to fail then the landward extent of inundation may increase. Inundation of low lying areas behind the beach is based on the most recent year of LIDAR data available (2005). The low lying inundation areas behind the beach are mapped based on the ground elevation (the "all ground" LIDAR layer) and do not consider flow paths, flow velocities, loss of flow momentum or wave propagation into creek areas. WRL is not responsible for the accuracy of the photogrammetry or LIDAR data. Local surveys by a registered surveyor are recommended to determine local inundation extents.

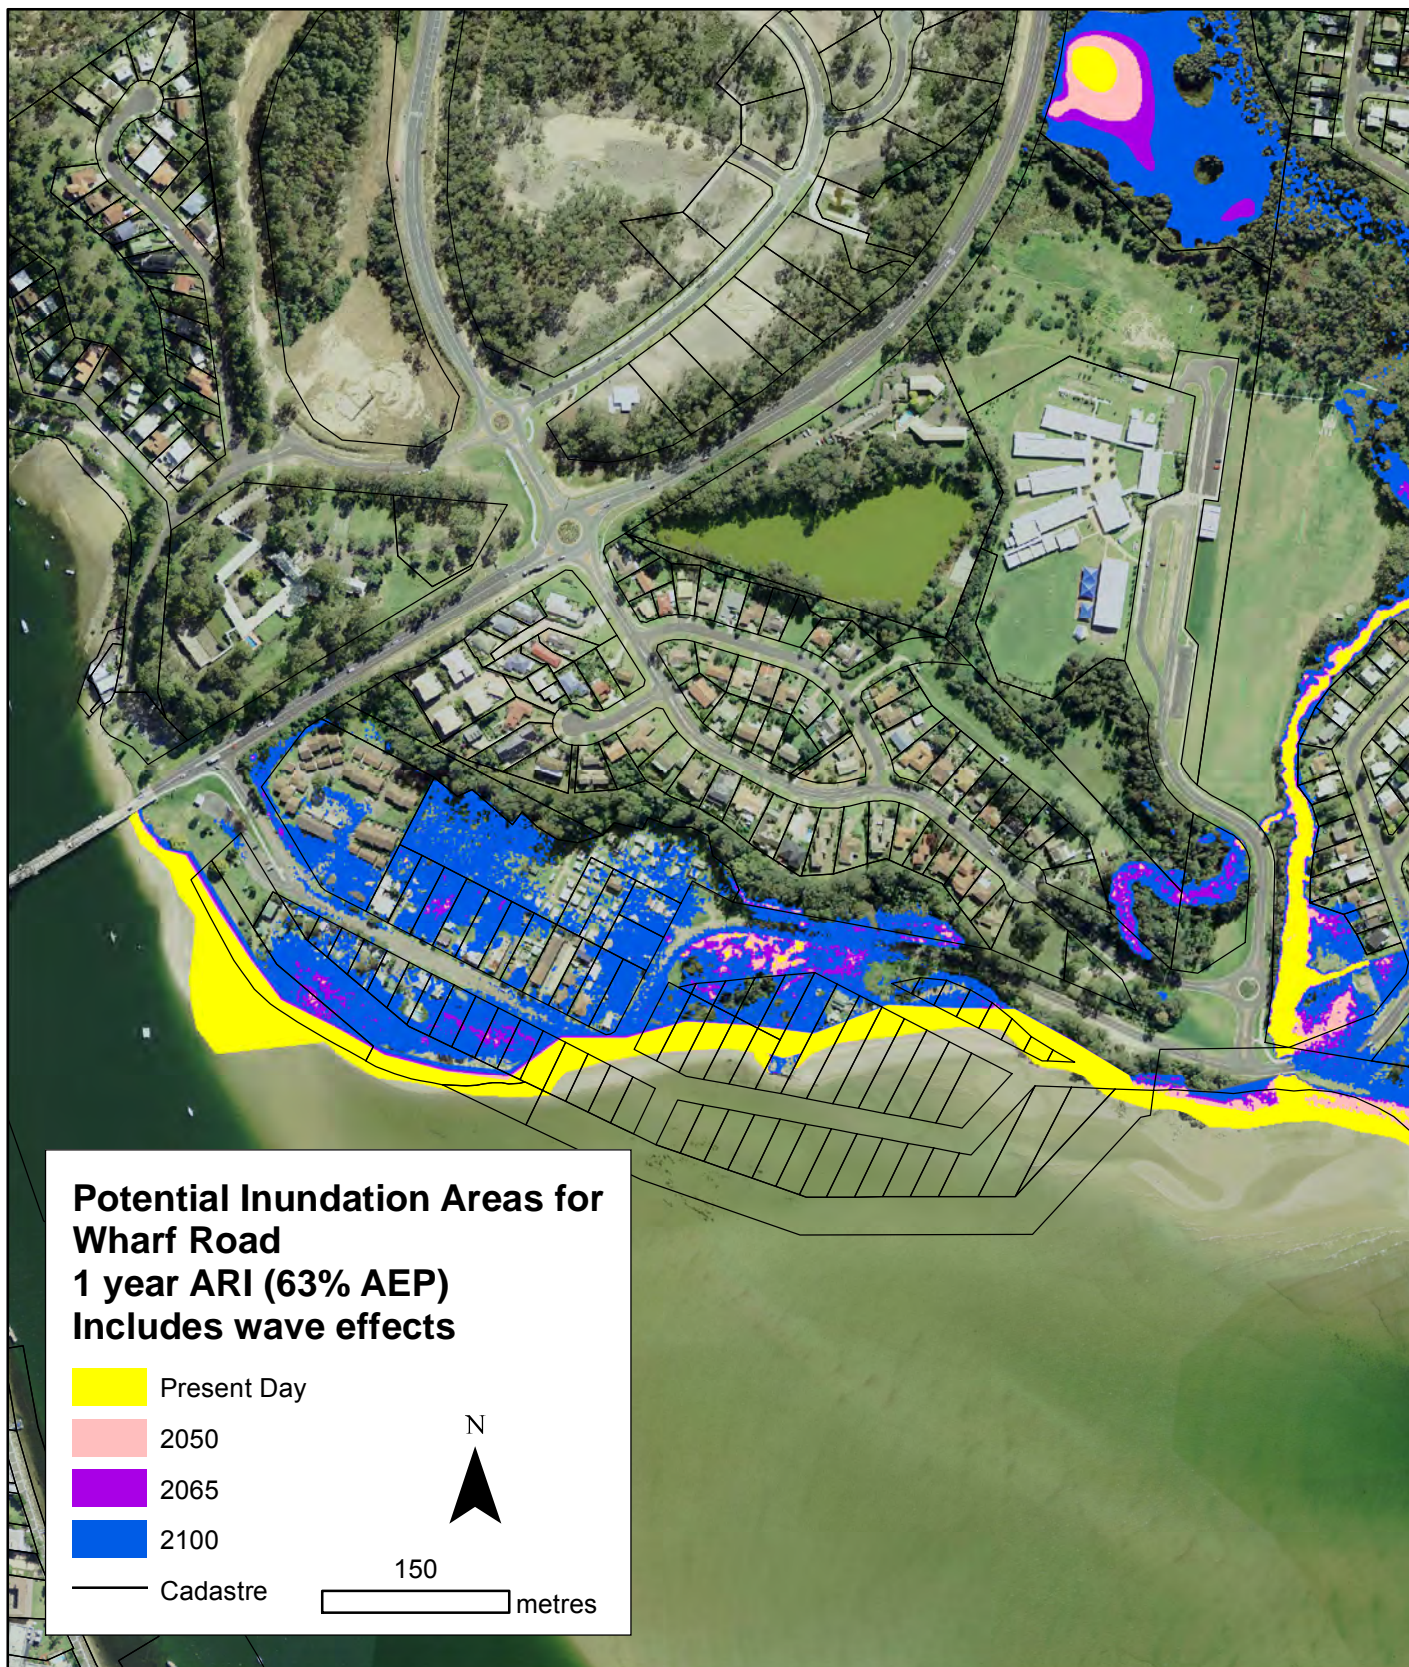
**Figure L.24**

Inundation of the beachface and the area immediately landward of the dune crest is based on the most recent year of LIDAR data available (2005) and is in accordance with ESC's sea level rise policy and planning framework. It does not include allowance for future landward recession of the beach face and assumes that the crest level of the seawall (if present) and the topography remain as they were from the 2005 LIDAR data. By 2050, 2065 or 2100 both of these assumptions may not be valid. Should the seawall/dune be allowed to fail then the landward extent of inundation may increase. Inundation of low lying areas behind the beach is based on the most recent year of LIDAR data available (2005). The low lying inundation areas behind the beach are mapped based on the ground elevation (the "all ground" LIDAR layer) and do not consider flow paths, flow velocities, loss of flow momentum or wave propagation into creek areas. WRL is not responsible for the accuracy of the photogrammetry or LIDAR data. Local surveys by a registered surveyor are recommended to determine local inundation extents.

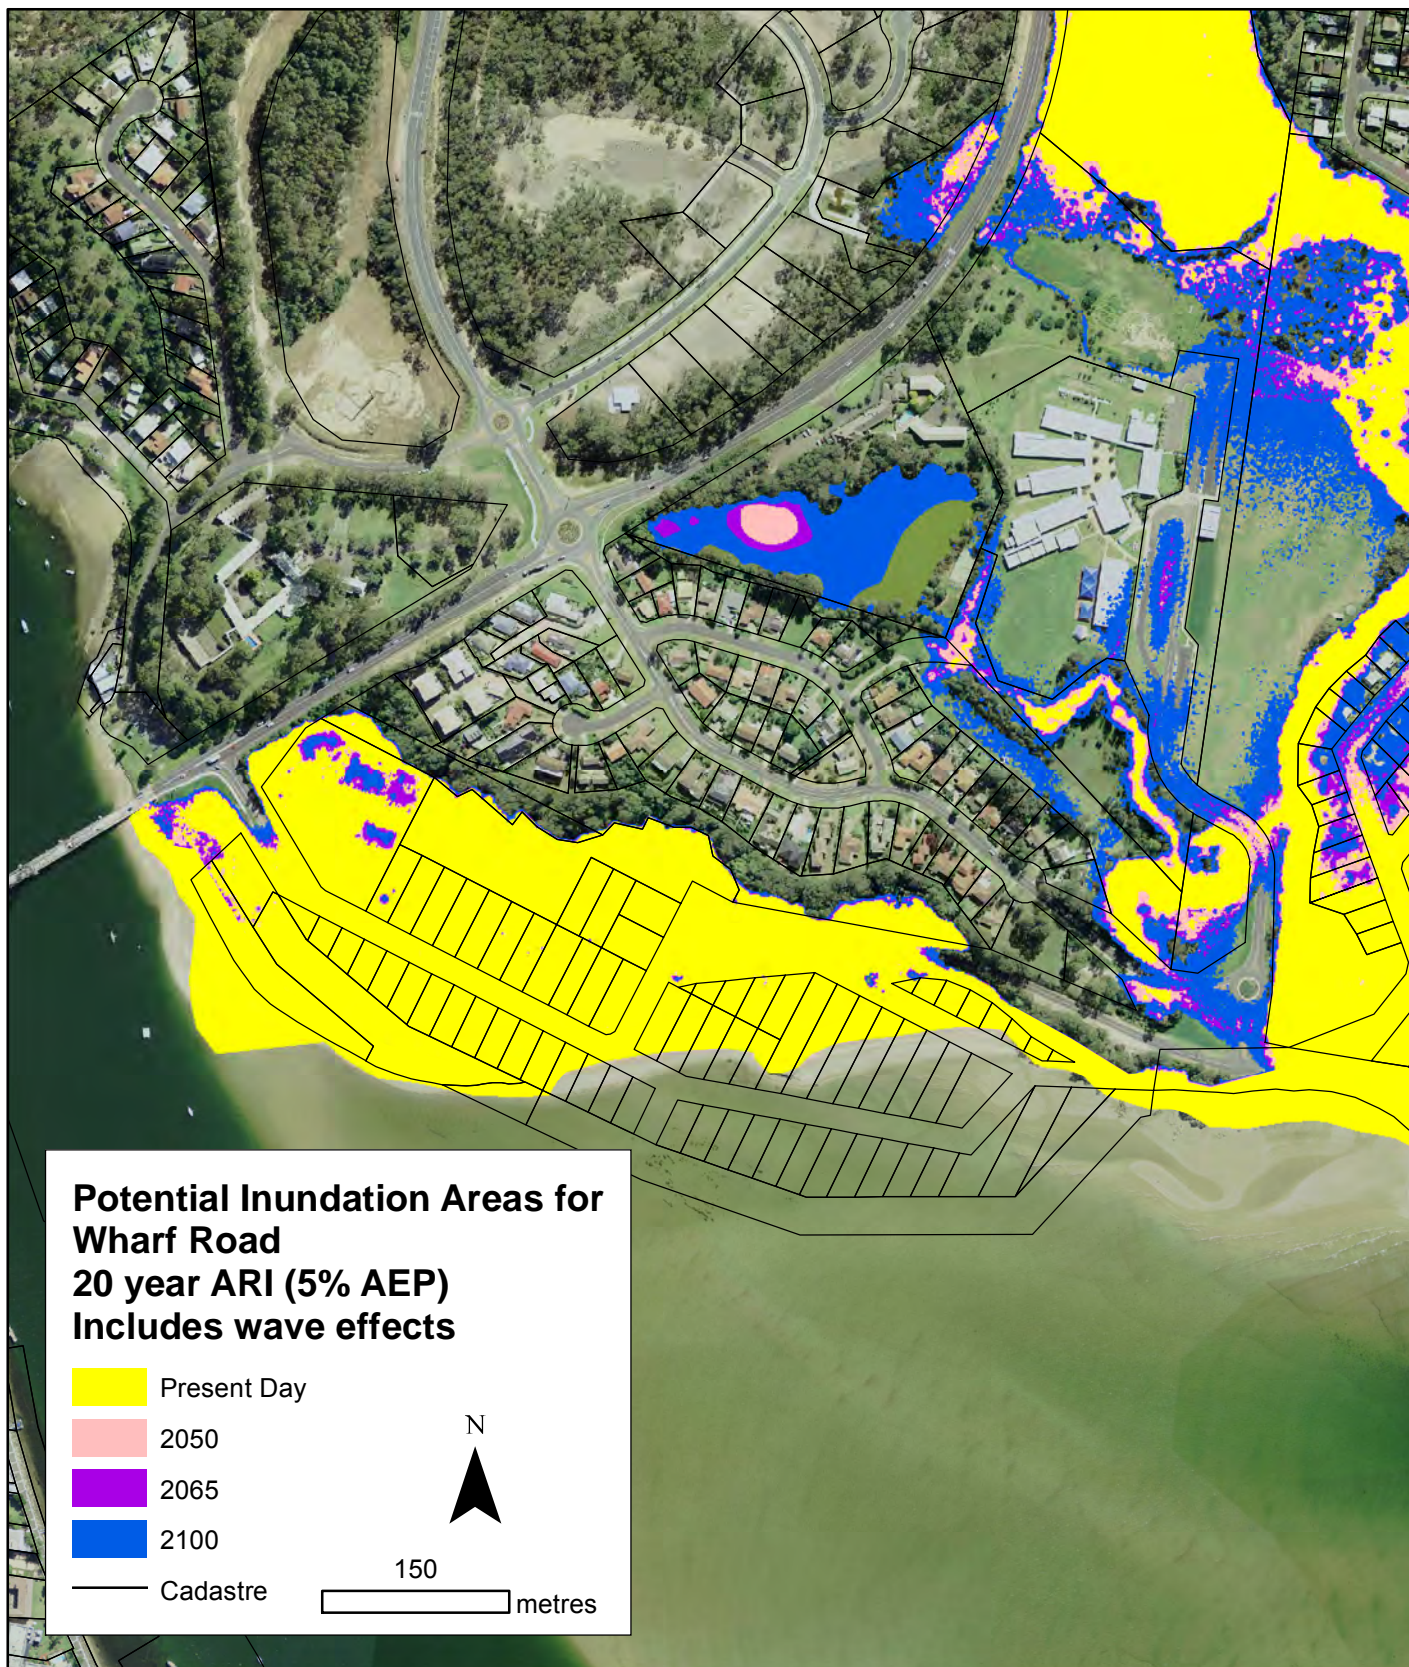
**Figure L.25**

Inundation of the beachface and the area immediately landward of the dune crest is based on the most recent year of LIDAR data available (2005) and is in accordance with ESC's sea level rise policy and planning framework. It does not include allowance for future landward recession of the beach face and assumes that the crest level of the seawall (if present) and the topography remain as they were from the 2005 LIDAR data. By 2050, 2065 or 2100 both of these assumptions may not be valid. Should the seawall/dune be allowed to fail then the landward extent of inundation may increase. Inundation of low lying areas behind the beach is based on the most recent year of LIDAR data available (2005). The low lying inundation areas behind the beach are mapped based on the ground elevation (the "all ground" LIDAR layer) and do not consider flow paths, flow velocities, loss of flow momentum or wave propagation into creek areas. WRL is not responsible for the accuracy of the photogrammetry or LIDAR data. Local surveys by a registered surveyor are recommended to determine local inundation extents.

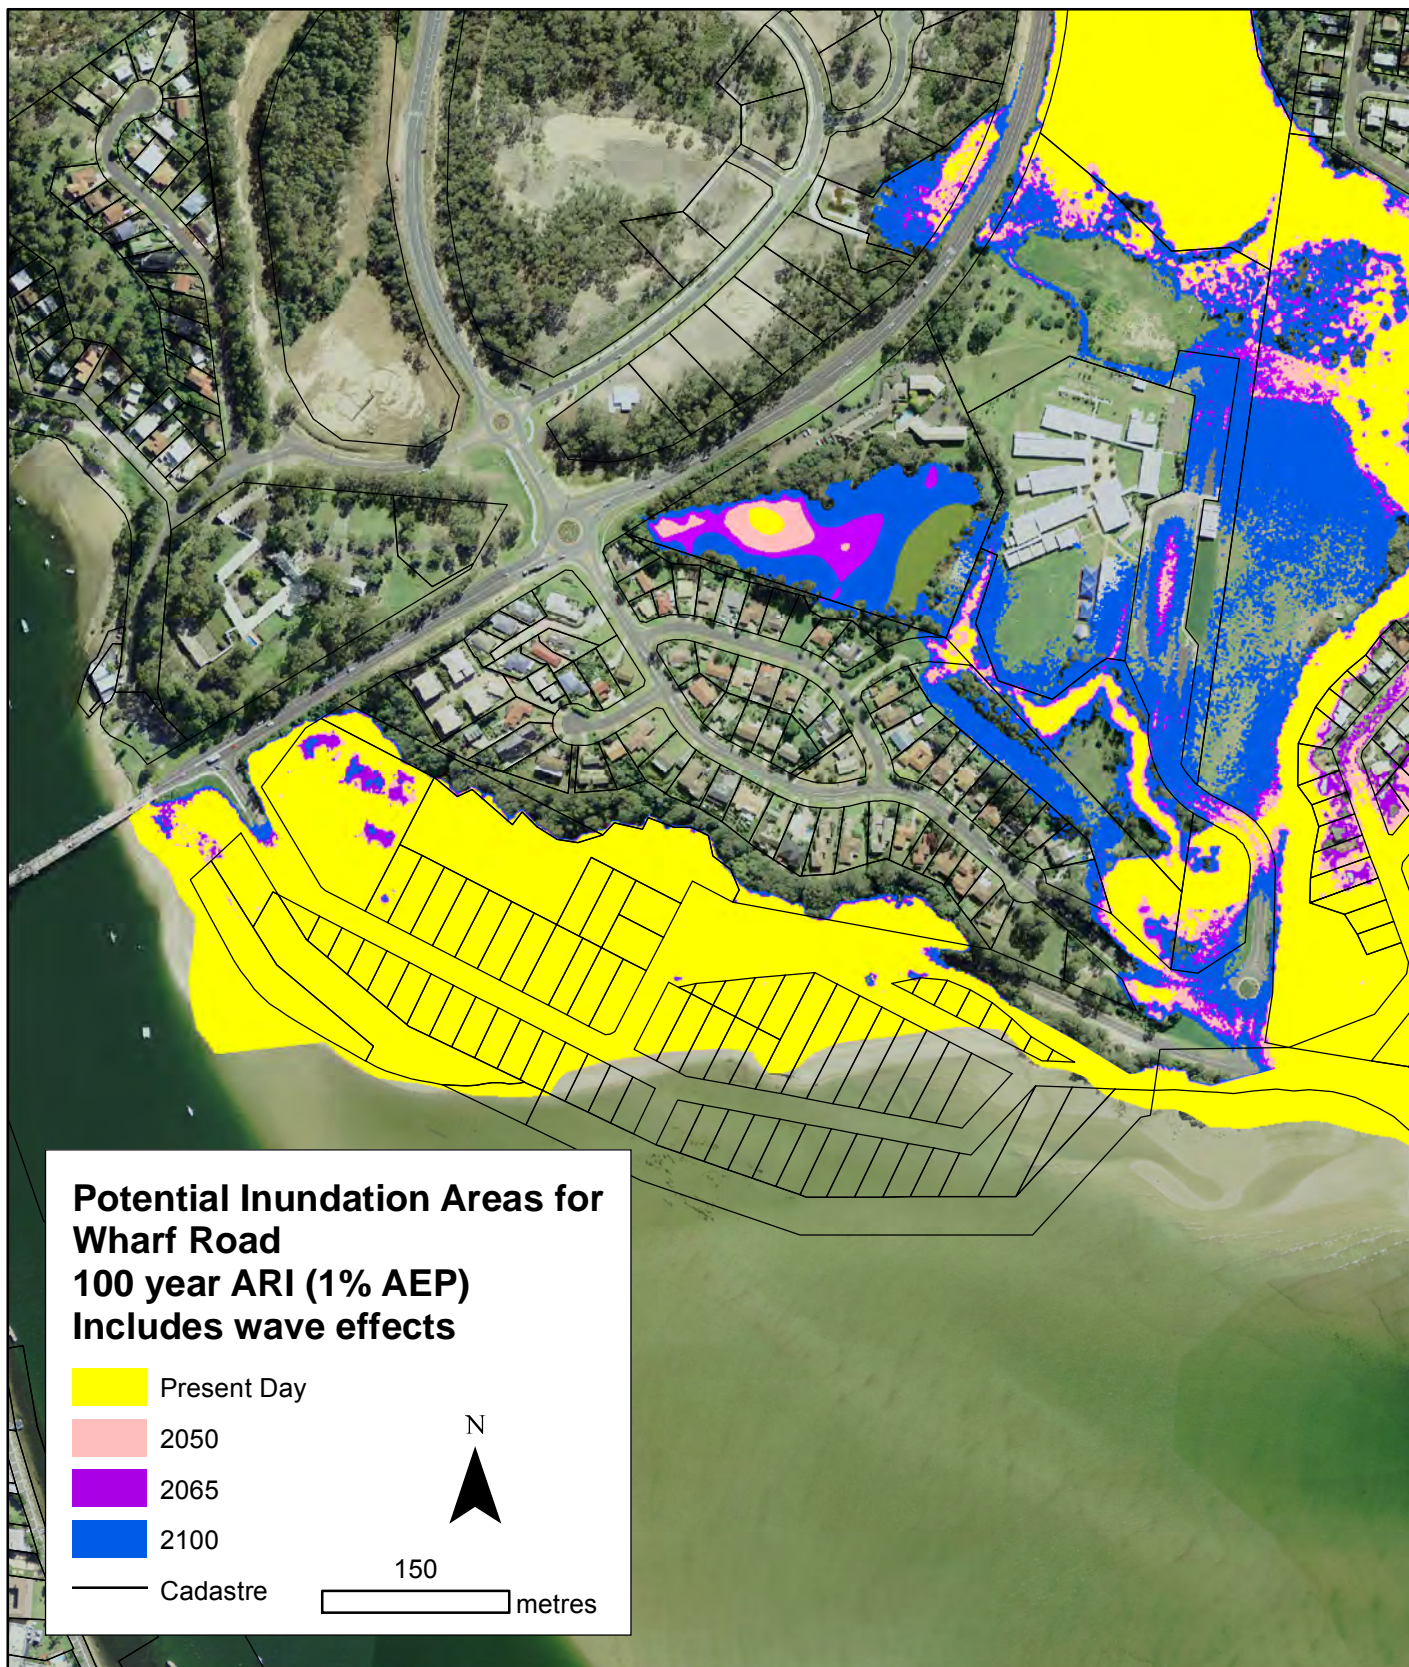
**Figure L.26**

Inundation of the beachface and the area immediately landward of the dune crest is based on the most recent year of LIDAR data available (2005) and is in accordance with ESC's sea level rise policy and planning framework. It does not include allowance for future landward recession of the beach face and assumes that the crest level of the seawall (if present) and the topography remain as they were from the 2005 LIDAR data. By 2050, 2065 or 2100 both of these assumptions may not be valid. Should the seawall/dune be allowed to fail then the landward extent of inundation may increase. Inundation of low lying areas behind the beach is based on the most recent year of LIDAR data available (2005). The low lying inundation areas behind the beach are mapped based on the ground elevation (the "all ground" LIDAR layer) and do not consider flow paths, flow velocities, loss of flow momentum or wave propagation into creek areas. WRL is not responsible for the accuracy of the photogrammetry or LIDAR data. Local surveys by a registered surveyor are recommended to determine local inundation extents.

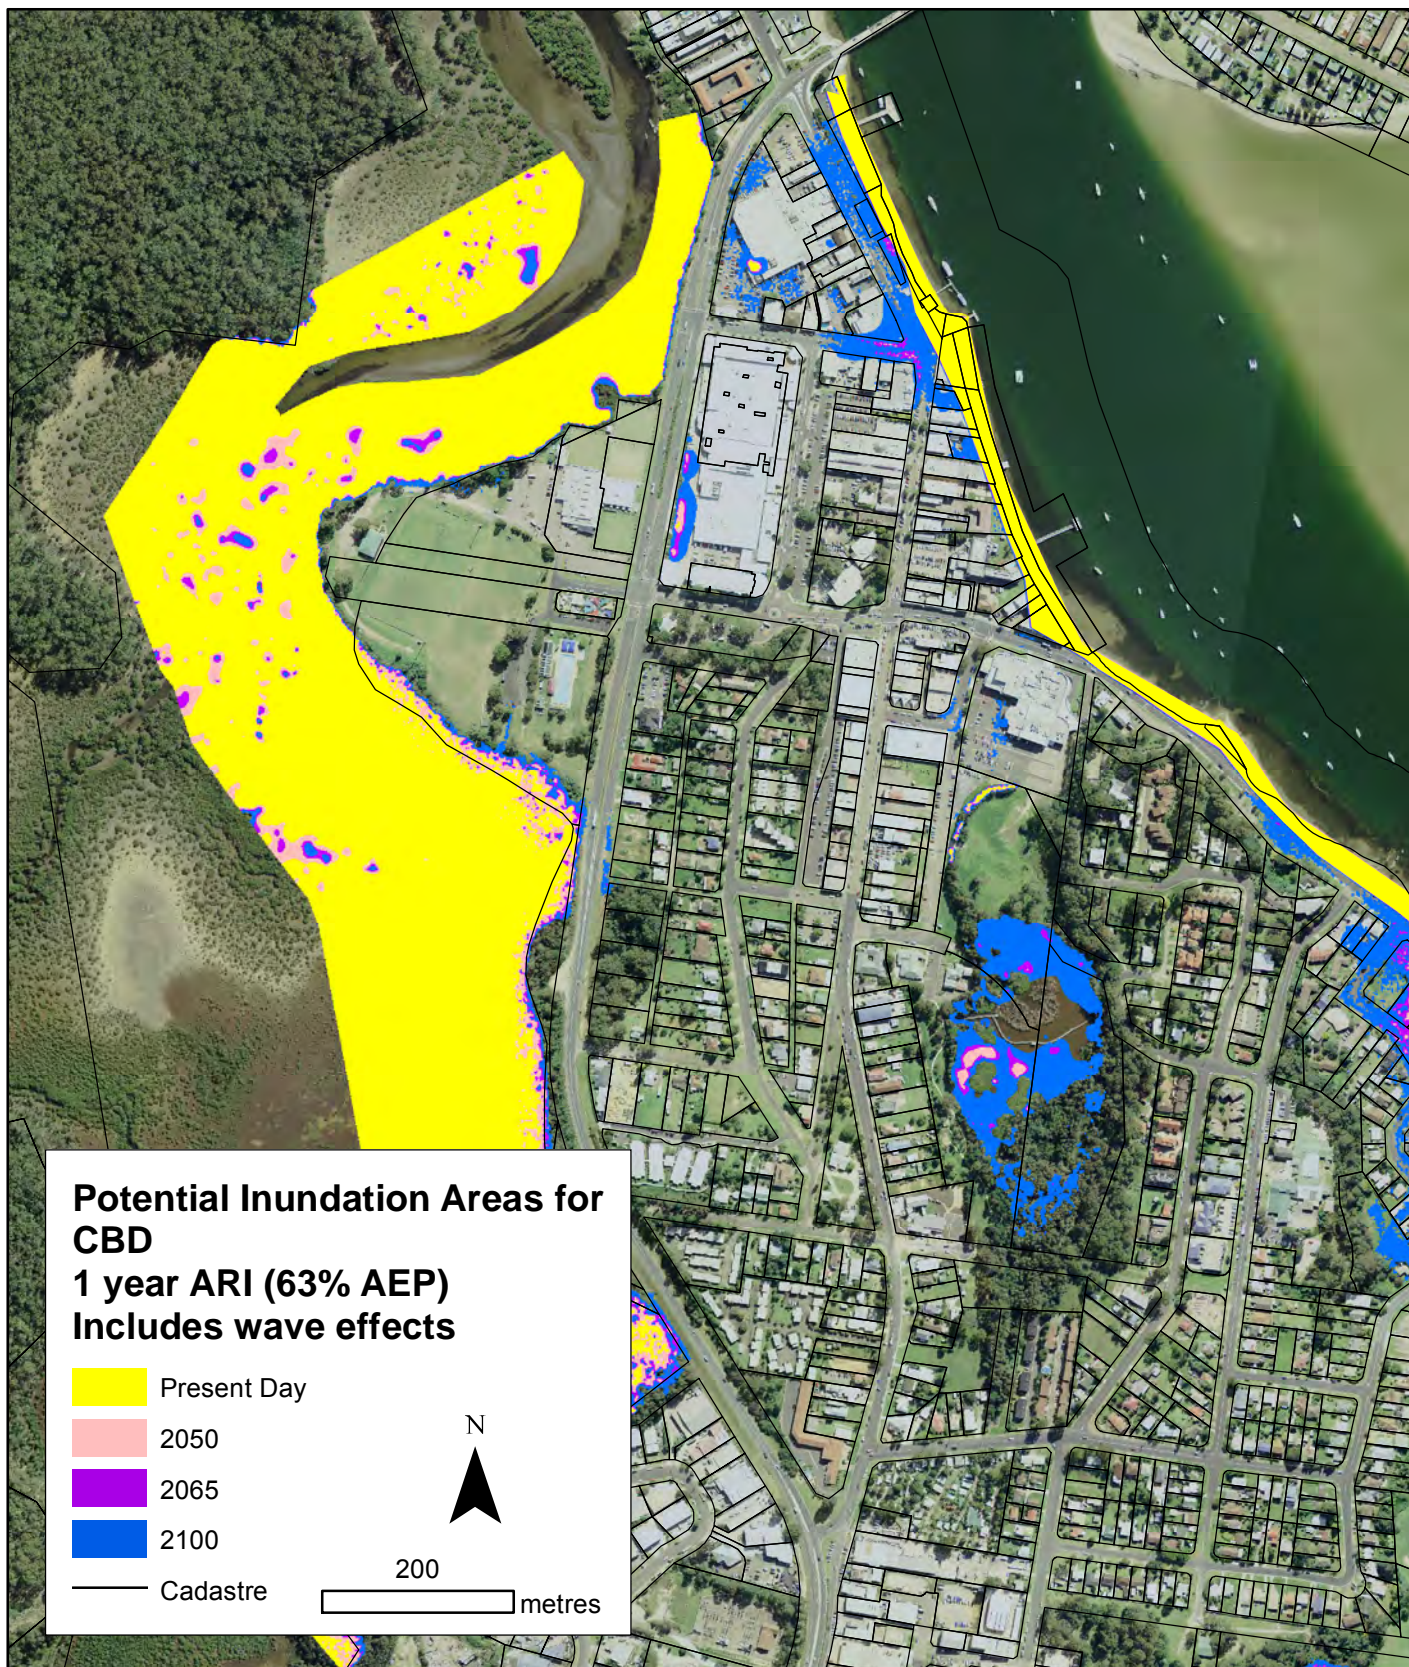
**Figure L.27**

Inundation of the beachface and the area immediately landward of the dune crest is based on the most recent year of LIDAR data available (2005) and is in accordance with ESC's sea level rise policy and planning framework. It does not include allowance for future landward recession of the beach face and assumes that the crest level of the seawall (if present) and the topography remain as they were from the 2005 LIDAR data. By 2050, 2065 or 2100 both of these assumptions may not be valid. Should the seawall/dune be allowed to fail then the landward extent of inundation may increase. Inundation of low lying areas behind the beach is based on the most recent year of LIDAR data available (2005). The low lying inundation areas behind the beach are mapped based on the ground elevation (the "all ground" LIDAR layer) and do not consider flow paths, flow velocities, loss of flow momentum or wave propagation into creek areas. WRL is not responsible for the accuracy of the photogrammetry or LIDAR data. Local surveys by a registered surveyor are recommended to determine local inundation extents.

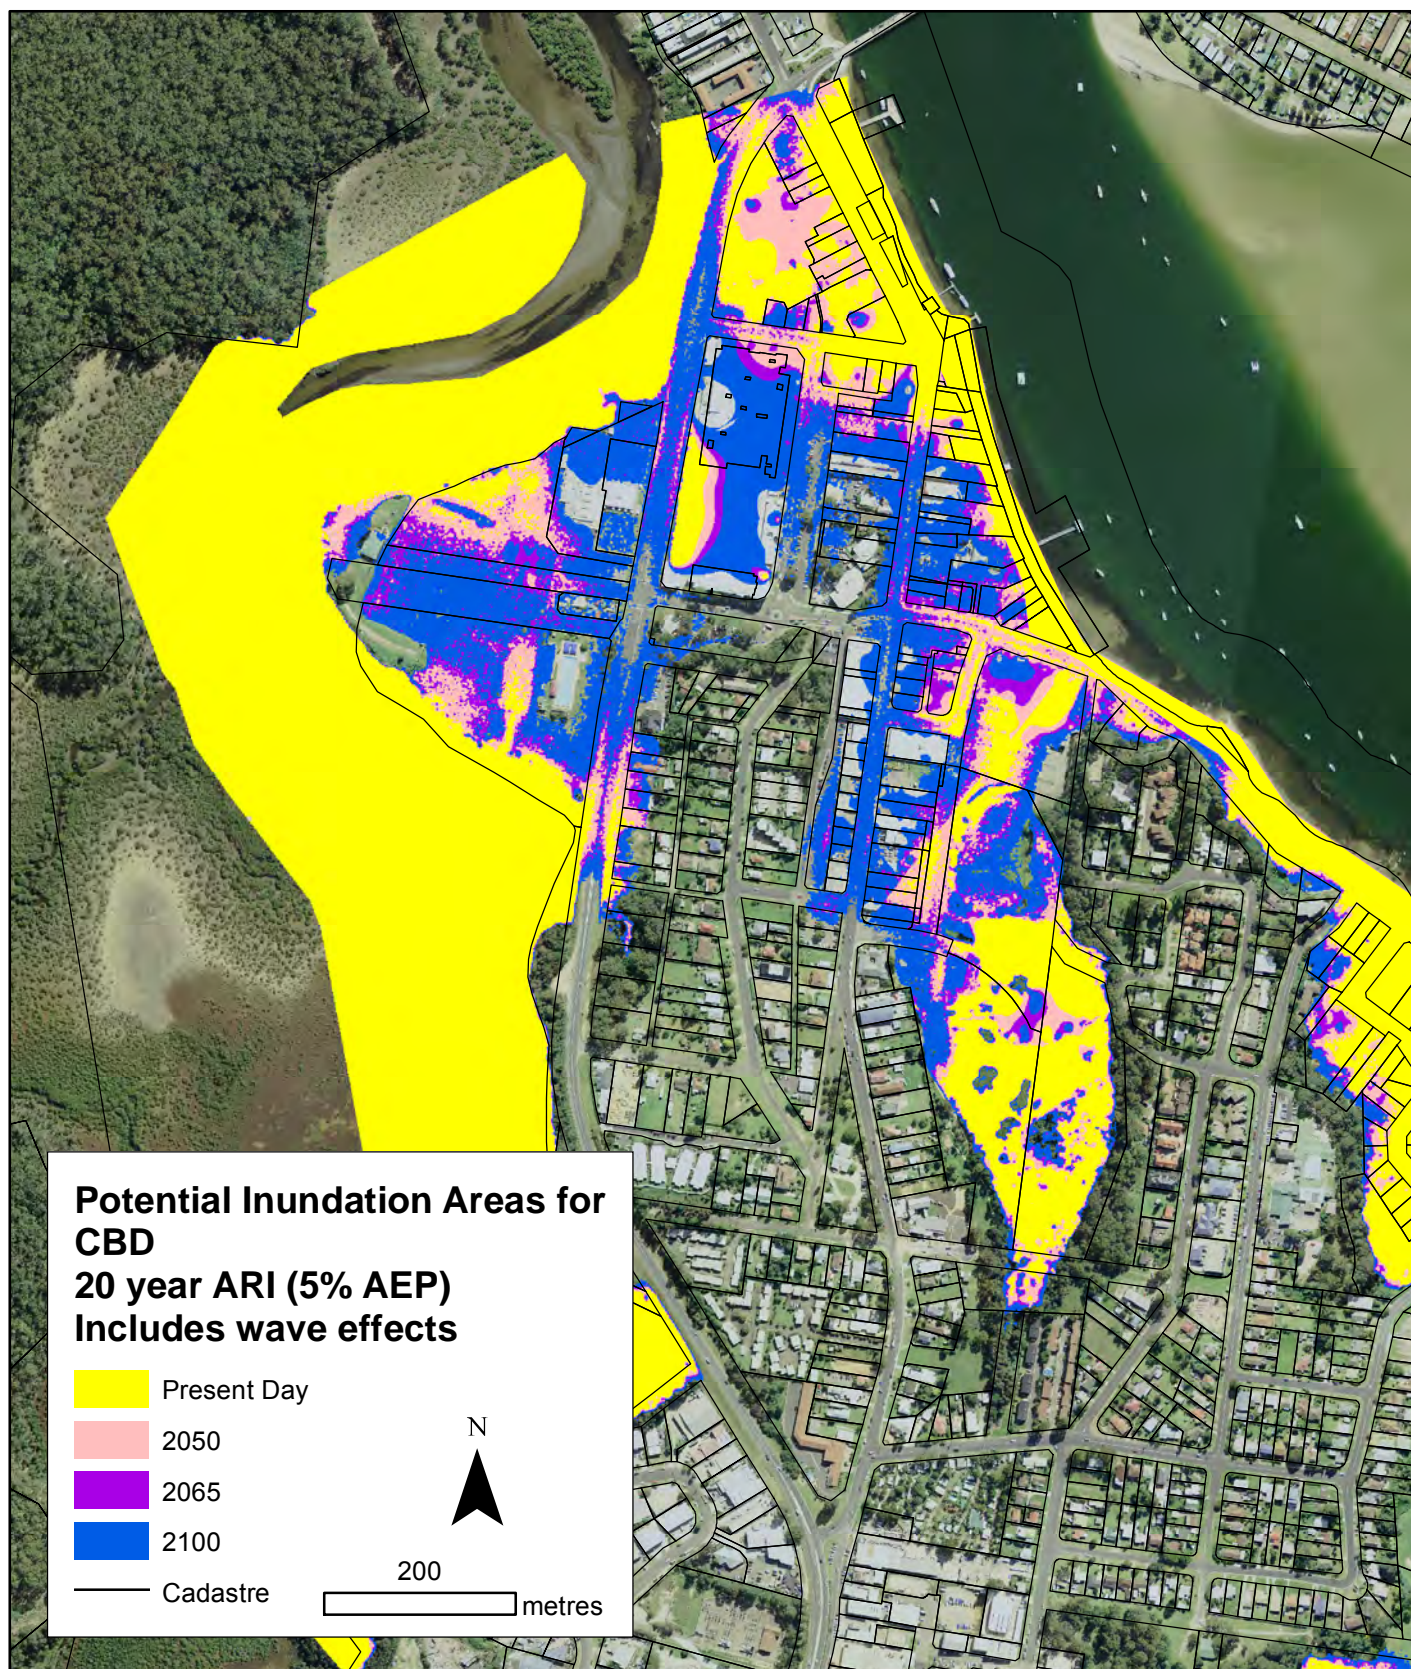
**Figure L.28**

Inundation of the beachface and the area immediately landward of the dune crest is based on the most recent year of LIDAR data available (2005) and is in accordance with ESC's sea level rise policy and planning framework. It does not include allowance for future landward recession of the beach face and assumes that the crest level of the seawall (if present) and the topography remain as they were from the 2005 LIDAR data. By 2050, 2065 or 2100 both of these assumptions may not be valid. Should the seawall/dune be allowed to fail then the landward extent of inundation may increase. Inundation of low lying areas behind the beach is based on the most recent year of LIDAR data available (2005). The low lying inundation areas behind the beach are mapped based on the ground elevation (the "all ground" LIDAR layer) and do not consider flow paths, flow velocities, loss of flow momentum or wave propagation into creek areas. WRL is not responsible for the accuracy of the photogrammetry or LIDAR data. Local surveys by a registered surveyor are recommended to determine local inundation extents.

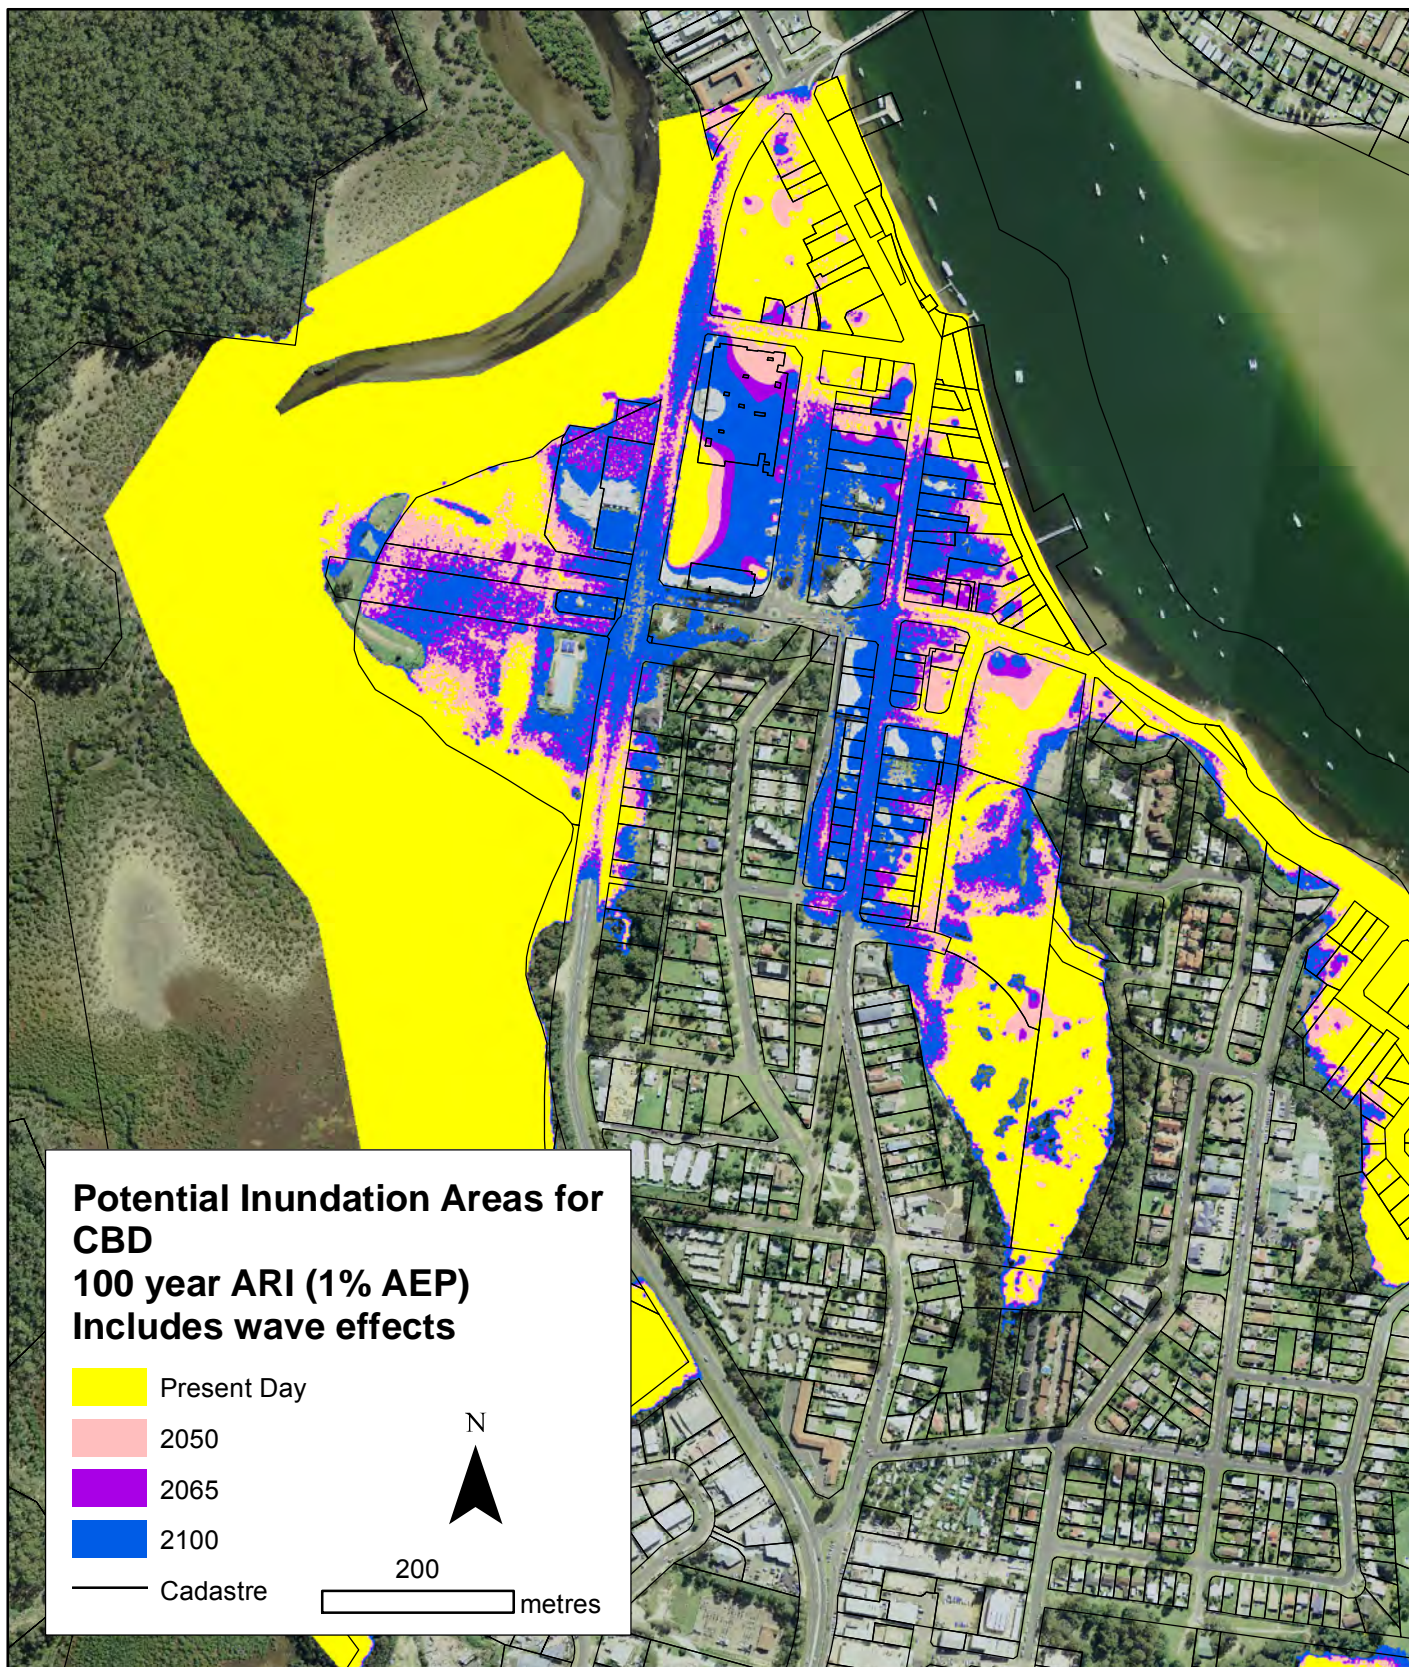
**Figure L.29**

Inundation of the beachface and the area immediately landward of the dune crest is based on the most recent year of LIDAR data available (2005) and is in accordance with ESC's sea level rise policy and planning framework. It does not include allowance for future landward recession of the beach face and assumes that the crest level of the seawall (if present) and the topography remain as they were from the 2005 LIDAR data. By 2050, 2065 or 2100 both of these assumptions may not be valid. Should the seawall/dune be allowed to fail then the landward extent of inundation may increase. Inundation of low lying areas behind the beach is based on the most recent year of LIDAR data available (2005). The low lying inundation areas behind the beach are mapped based on the ground elevation (the "all ground" LIDAR layer) and do not consider flow paths, flow velocities, loss of flow momentum or wave propagation into creek areas. WRL is not responsible for the accuracy of the photogrammetry or LIDAR data. Local surveys by a registered surveyor are recommended to determine local inundation extents.

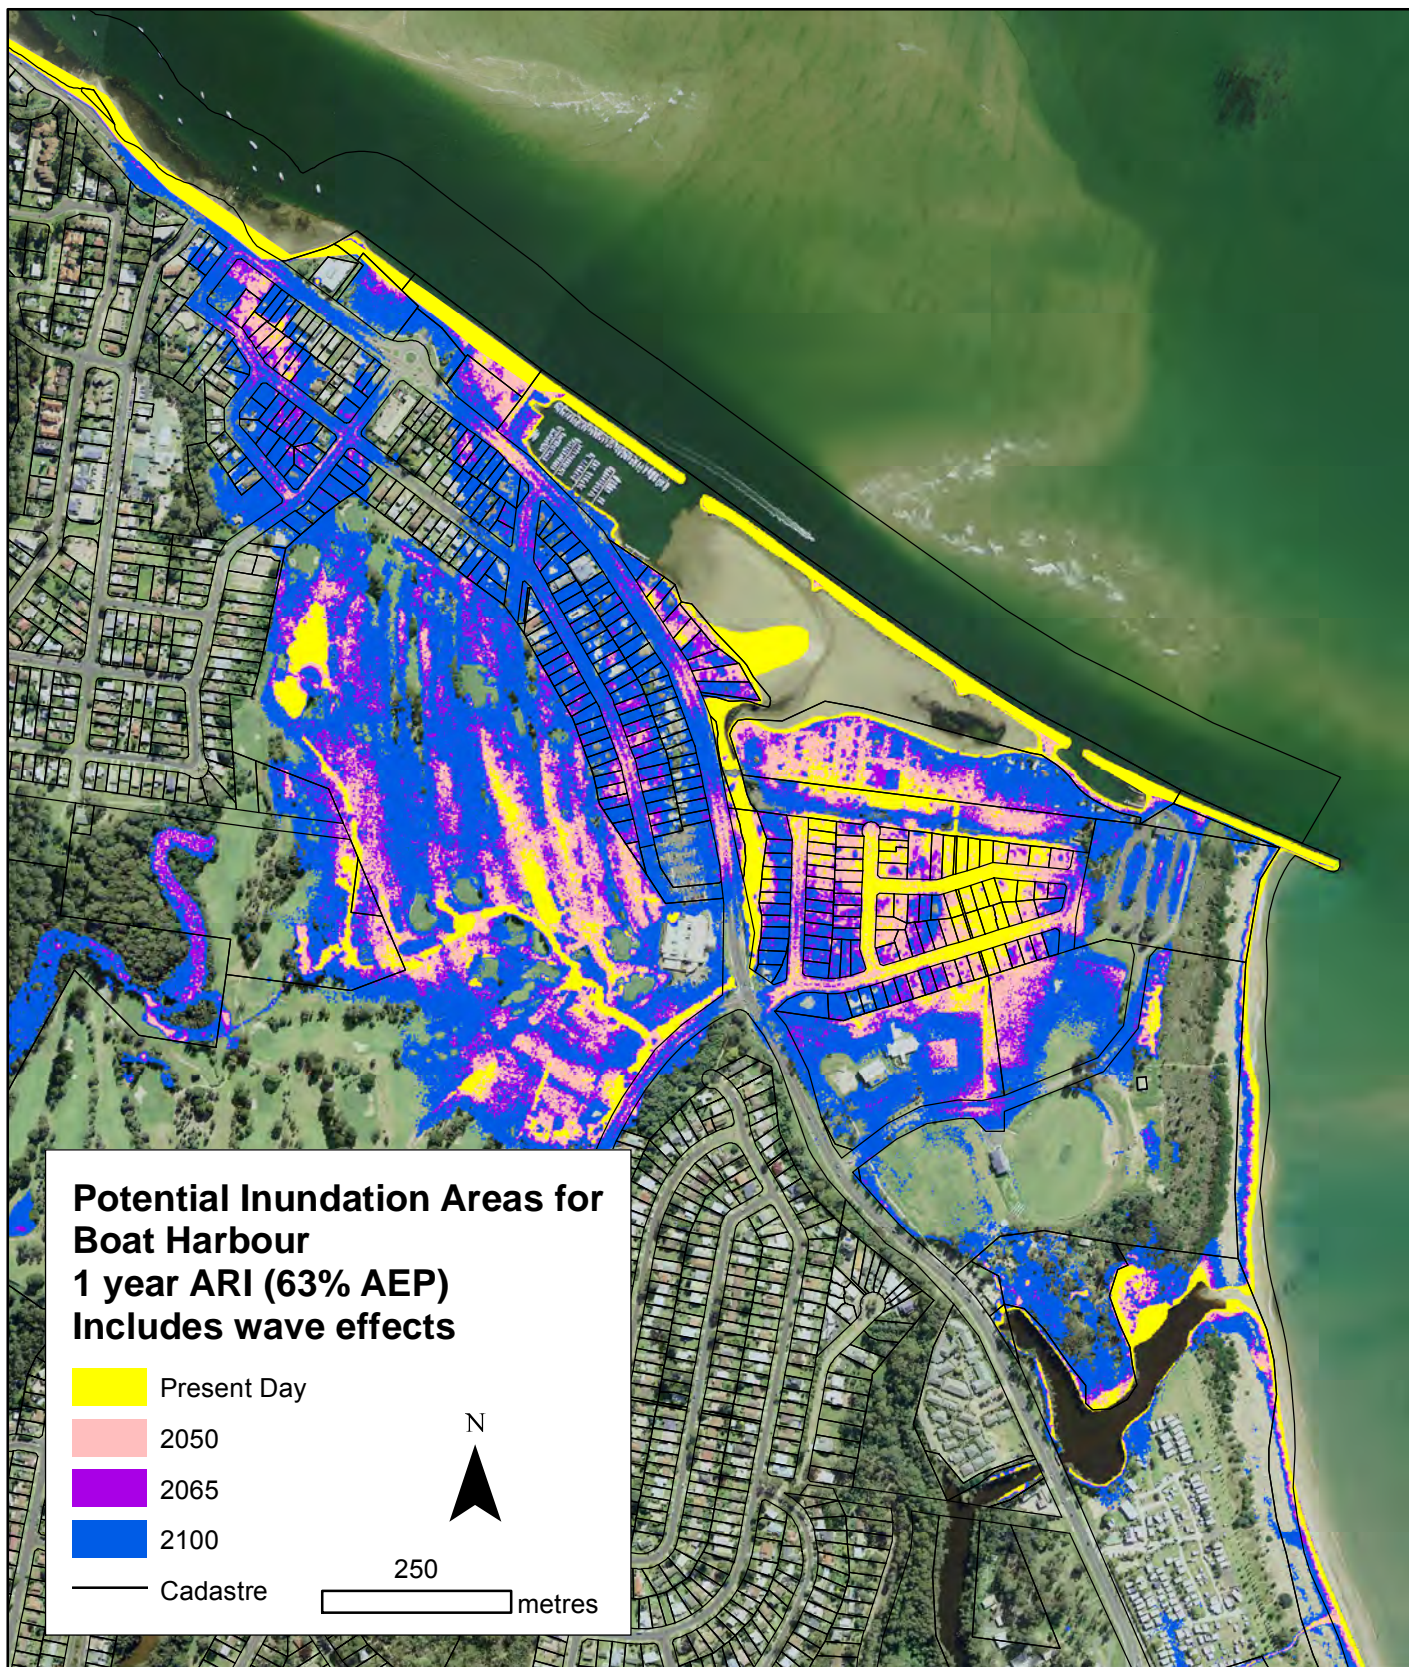
**Figure L.30**

Inundation of the beachface and the area immediately landward of the dune crest is based on the most recent year of LIDAR data available (2005) and is in accordance with ESC's sea level rise policy and planning framework. It does not include allowance for future landward recession of the beach face and assumes that the crest level of the seawall (if present) and the topography remain as they were from the 2005 LIDAR data. By 2050, 2065 or 2100 both of these assumptions may not be valid. Should the seawall/dune be allowed to fail then the landward extent of inundation may increase. Inundation of low lying areas behind the beach is based on the most recent year of LIDAR data available (2005). The low lying inundation areas behind the beach are mapped based on the ground elevation (the "all ground" LIDAR layer) and do not consider flow paths, flow velocities, loss of flow momentum or wave propagation into creek areas. WRL is not responsible for the accuracy of the photogrammetry or LIDAR data. Local surveys by a registered surveyor are recommended to determine local inundation extents.
