## Eurobodalla Coastal Hazard Assessment

WRL Technical Report 2017/09  
October 2017

By I R Coghlan, J T Carley, A J Harrison, D Howe, A D Short,  
J E Ruprecht, F Flocard and P F Rahman

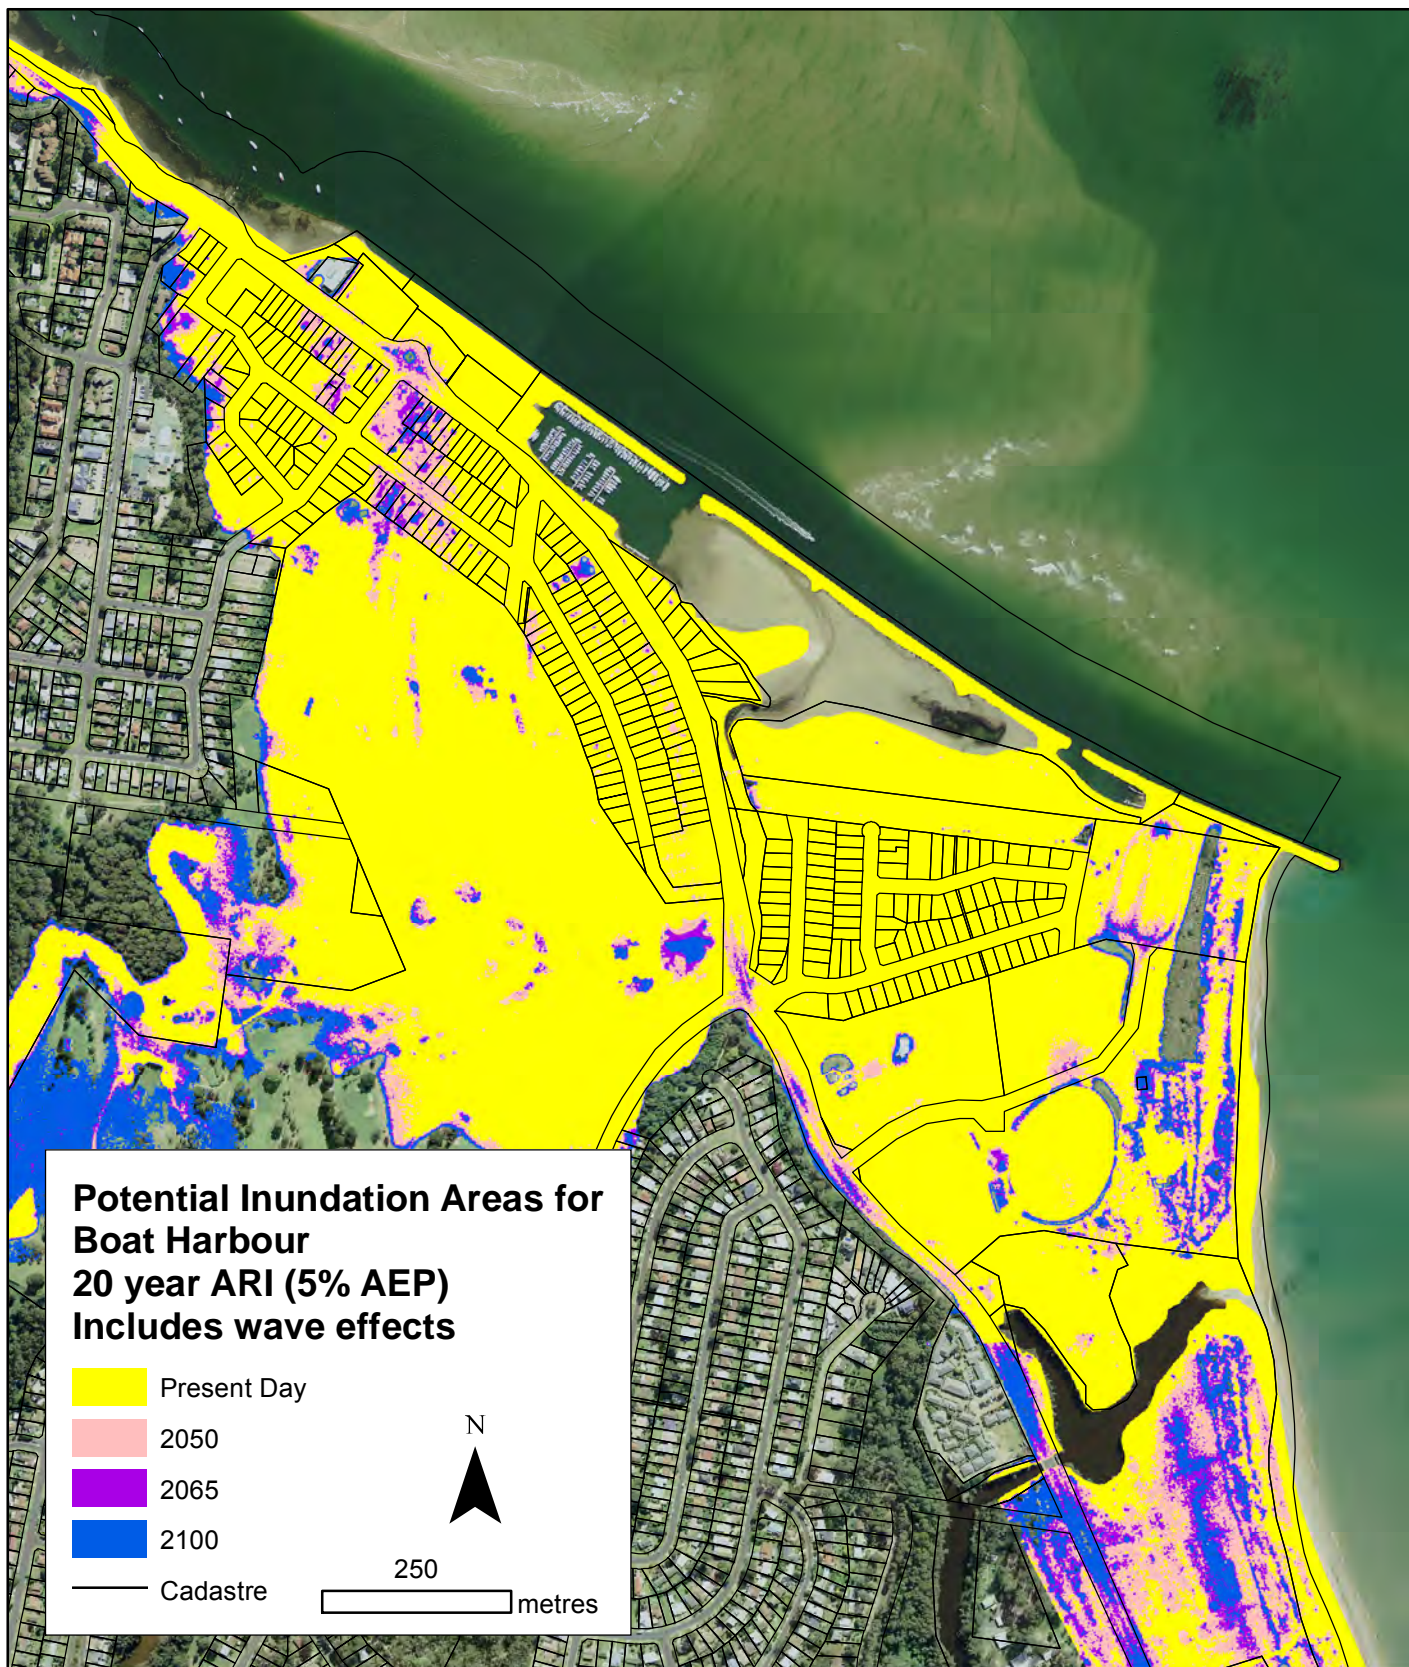
**Figure L.31**

Inundation of the beachface and the area immediately landward of the dune crest is based on the most recent year of LIDAR data available (2005) and is in accordance with ESC's sea level rise policy and planning framework. It does not include allowance for future landward recession of the beach face and assumes that the crest level of the seawall (if present) and the topography remain as they were from the 2005 LIDAR data. By 2050, 2065 or 2100 both of these assumptions may not be valid. Should the seawall/dune be allowed to fail then the landward extent of inundation may increase. Inundation of low lying areas behind the beach is based on the most recent year of LIDAR data available (2005). The low lying inundation areas behind the beach are mapped based on the ground elevation (the "all ground" LIDAR layer) and do not consider flow paths, flow velocities, loss of flow momentum or wave propagation into creek areas. WRL is not responsible for the accuracy of the photogrammetry or LIDAR data. Local surveys by a registered surveyor are recommended to determine local inundation extents.

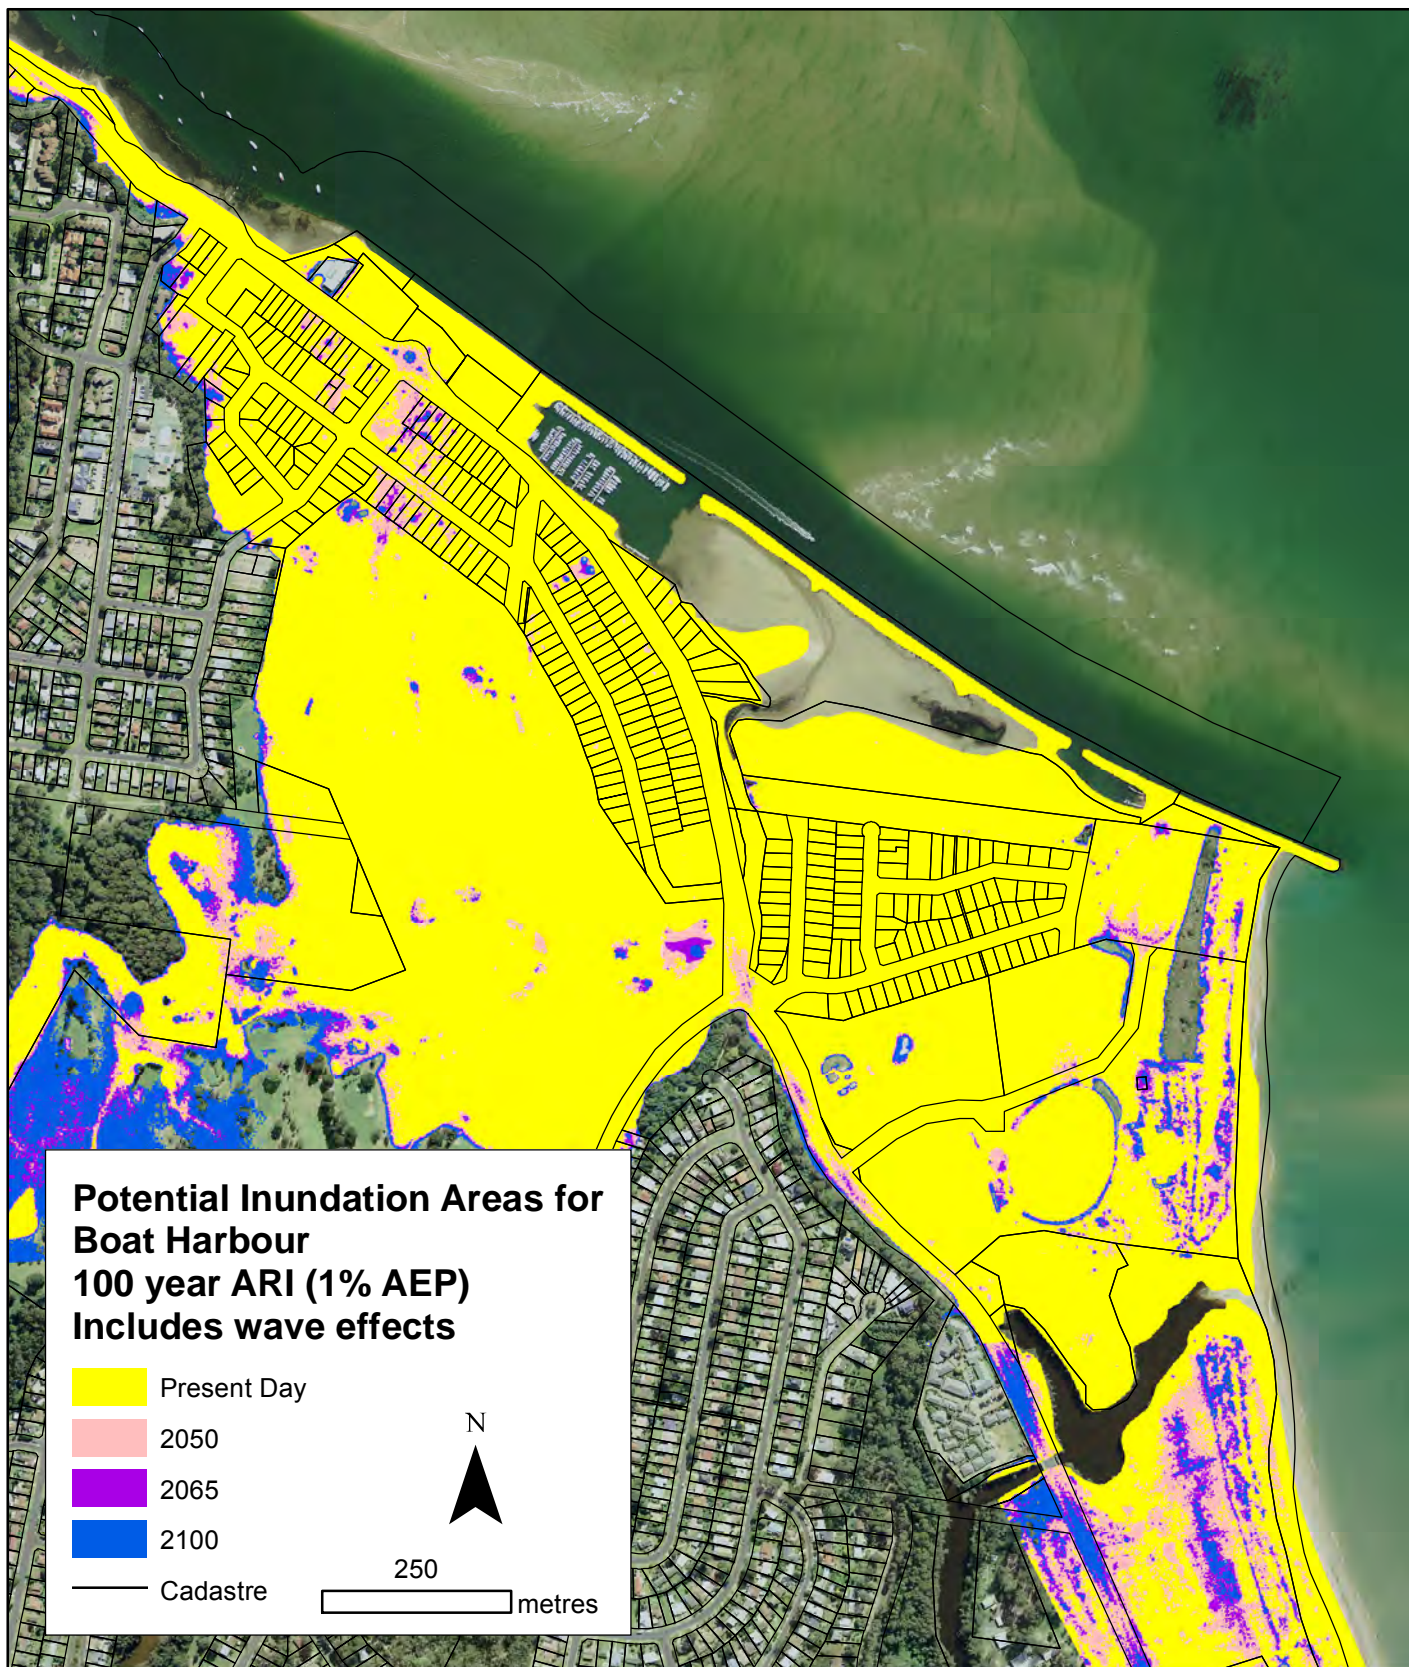
**Figure L.32**

Inundation of the beachface and the area immediately landward of the dune crest is based on the most recent year of LIDAR data available (2005) and is in accordance with ESC's sea level rise policy and planning framework. It does not include allowance for future landward recession of the beach face and assumes that the crest level of the seawall (if present) and the topography remain as they were from the 2005 LIDAR data. By 2050, 2065 or 2100 both of these assumptions may not be valid. Should the seawall/dune be allowed to fail then the landward extent of inundation may increase. Inundation of low lying areas behind the beach is based on the most recent year of LIDAR data available (2005). The low lying inundation areas behind the beach are mapped based on the ground elevation (the "all ground" LIDAR layer) and do not consider flow paths, flow velocities, loss of flow momentum or wave propagation into creek areas. WRL is not responsible for the accuracy of the photogrammetry or LIDAR data. Local surveys by a registered surveyor are recommended to determine local inundation extents.

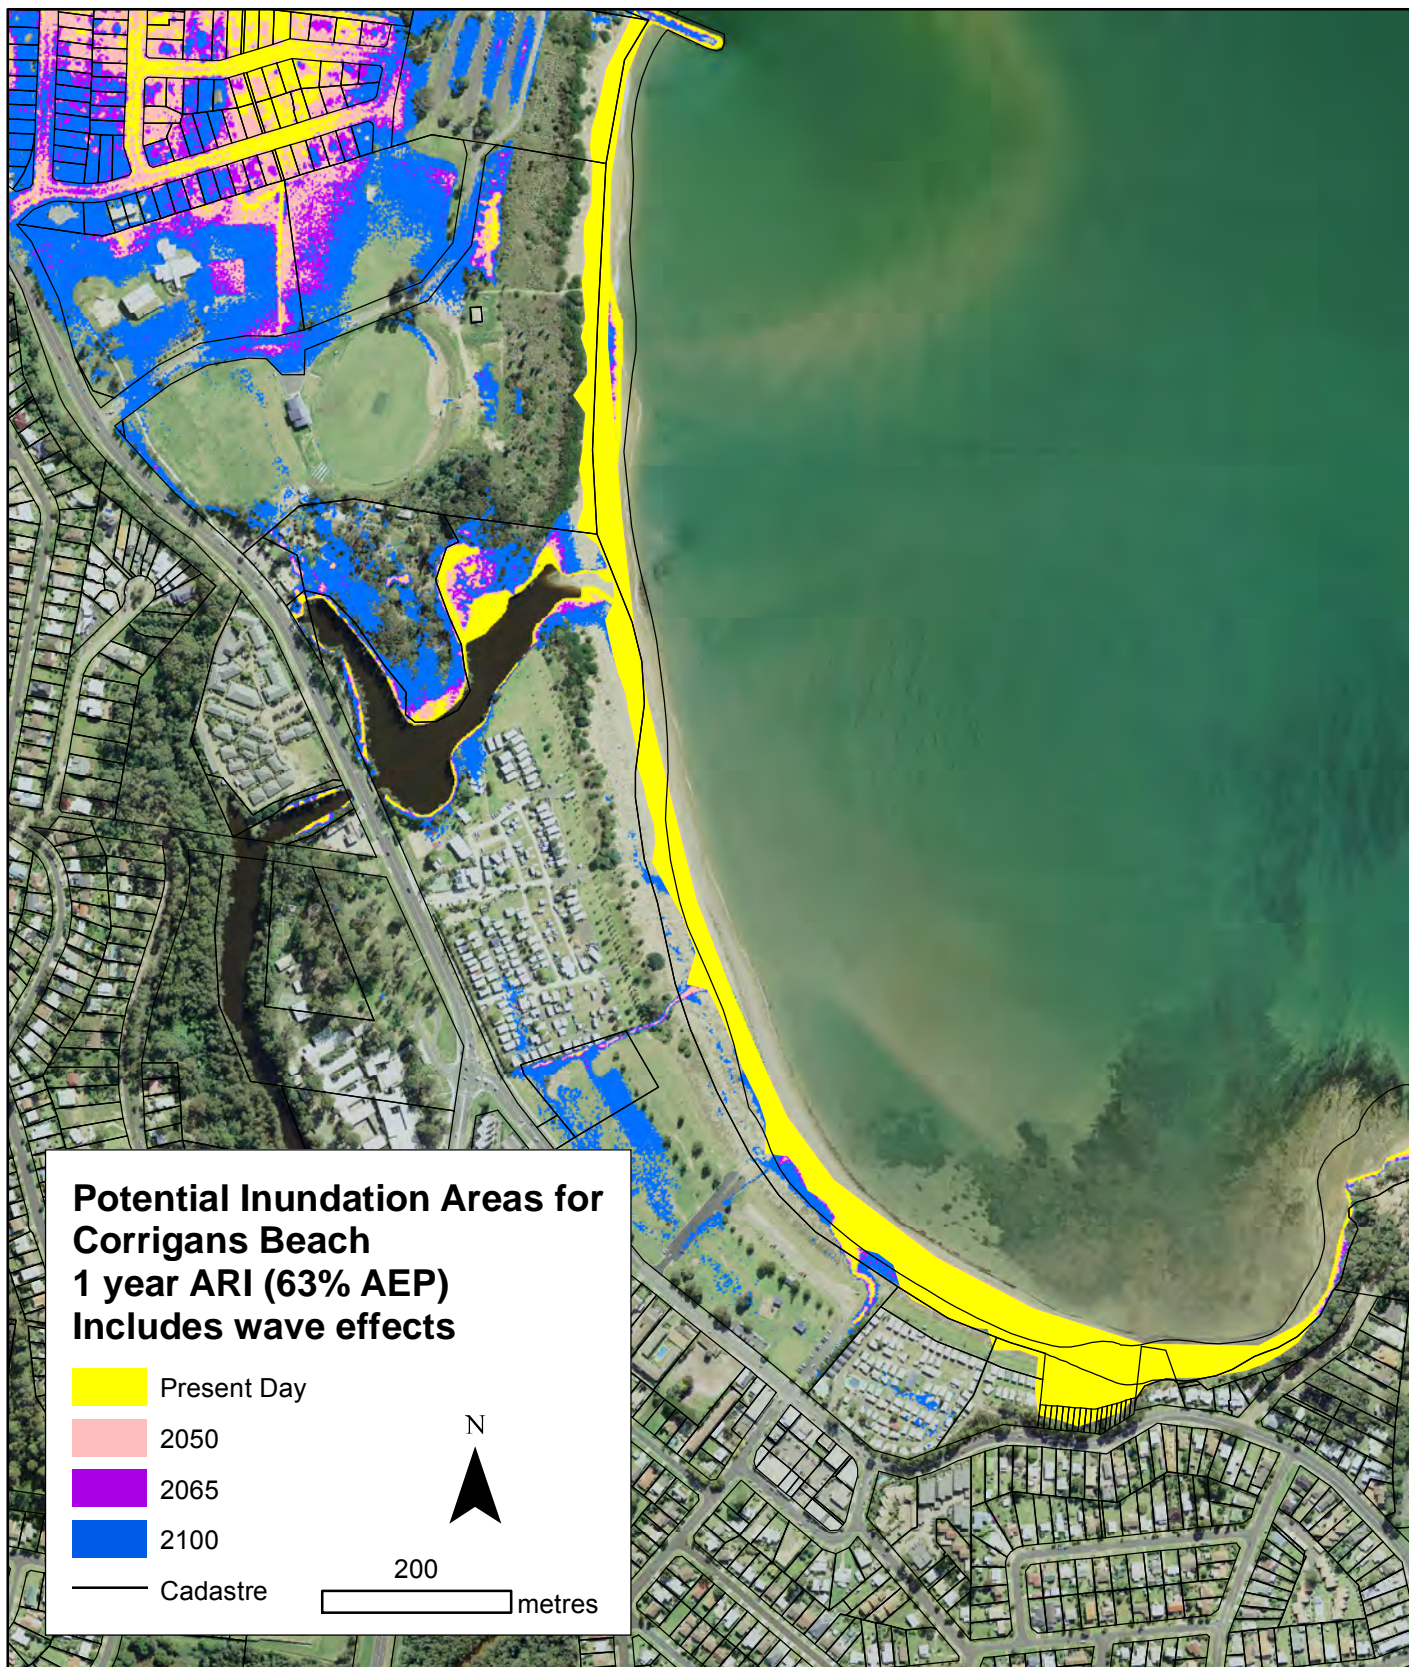
**Figure L.33**

Inundation of the beachface and the area immediately landward of the dune crest is based on the most recent year of photogrammetry data available (2014) and is in accordance with ESC's sea level rise policy and planning framework. It does not include allowance for future landward recession of the beach face and assumes that the crest level of the seawall (if present) and the topography remain as they were from the 2014 photogrammetry data. By 2050, 2065 or 2100 both of these assumptions may not be valid. Should the seawall/dune be allowed to fail then the landward extent of inundation may increase. Inundation of low lying areas behind the beach is based on the most recent year of LIDAR data available (2005). The low lying inundation areas behind the beach are mapped based on the ground elevation (the "all ground" LIDAR layer) and do not consider flow paths, flow velocities, loss of flow momentum or wave propagation into creek areas. WRL is not responsible for the accuracy of the photogrammetry or LIDAR data. Local surveys by a registered surveyor are recommended to determine local inundation extents.

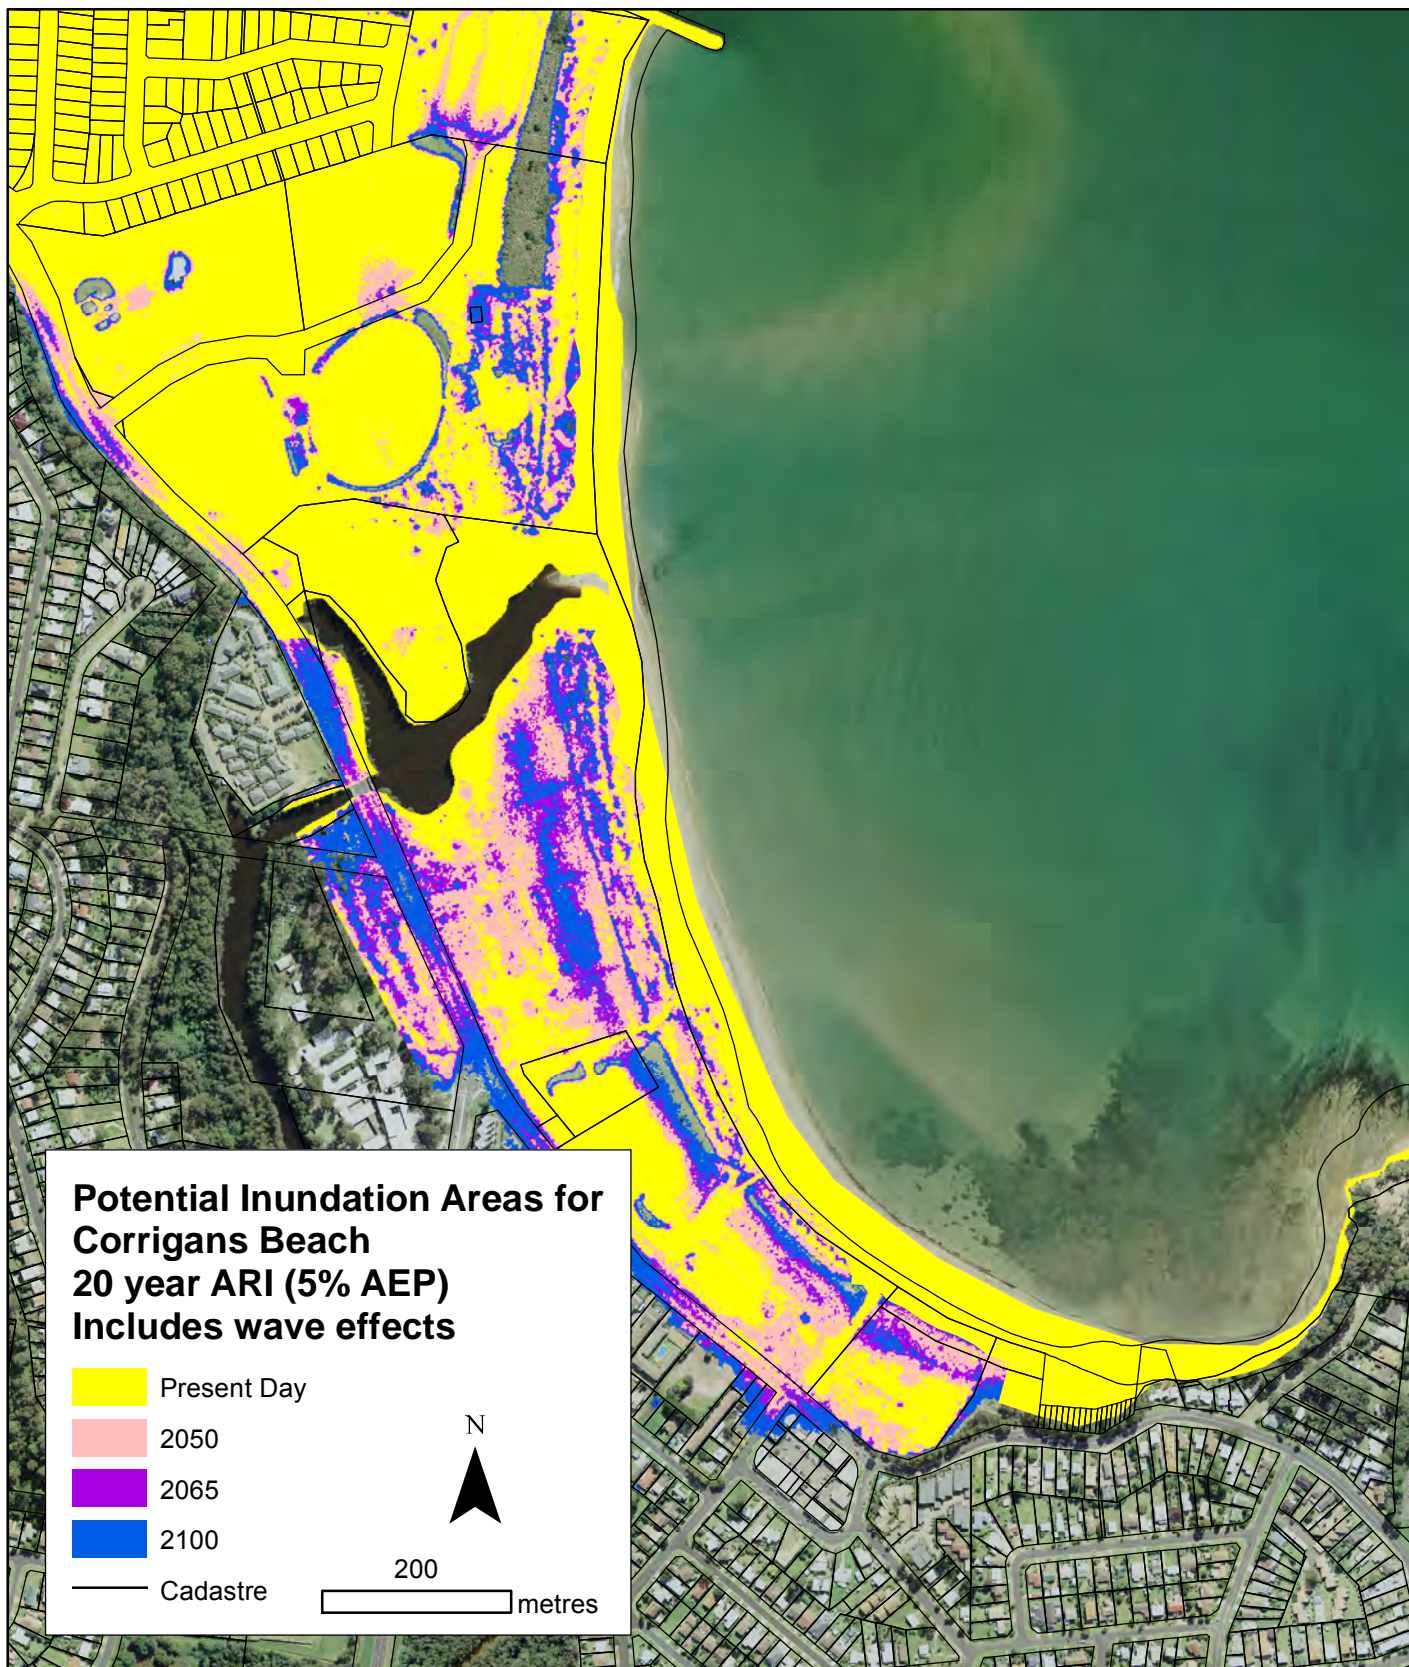
**Figure L.34**

Inundation of the beachface and the area immediately landward of the dune crest is based on the most recent year of photogrammetry data available (2014) and is in accordance with ESC's sea level rise policy and planning framework. It does not include allowance for future landward recession of the beach face and assumes that the crest level of the seawall (if present) and the topography remain as they were from the 2014 photogrammetry data. By 2050, 2065 or 2100 both of these assumptions may not be valid. Should the seawall/dune be allowed to fail then the landward extent of inundation may increase. Inundation of low lying areas behind the beach is based on the most recent year of LIDAR data available (2005). The low lying inundation areas behind the beach are mapped based on the ground elevation (the "all ground" LIDAR layer) and do not consider flow paths, flow velocities, loss of flow momentum or wave propagation into creek areas. WRL is not responsible for the accuracy of the photogrammetry or LIDAR data. Local surveys by a registered surveyor are recommended to determine local inundation extents.

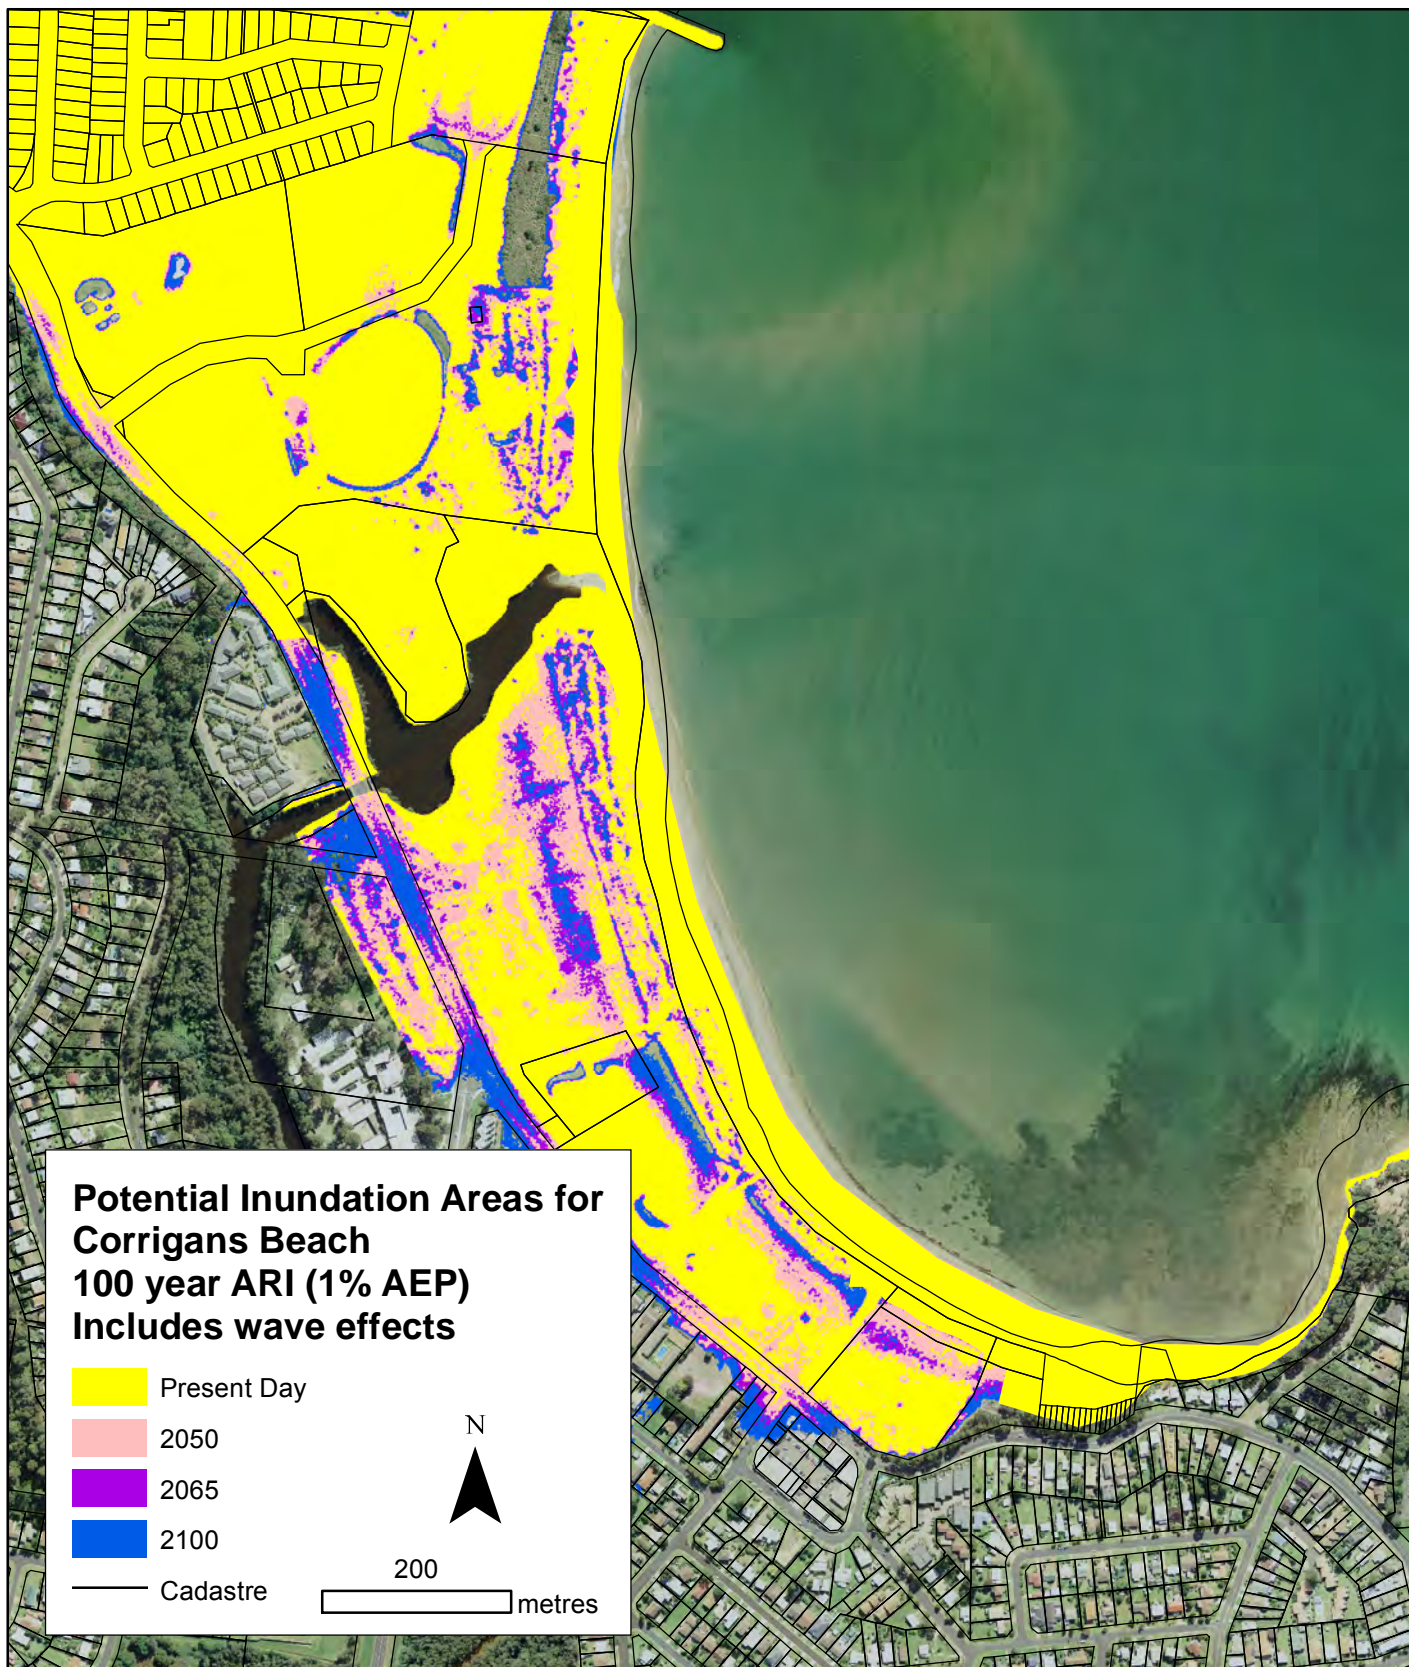
**Figure L.35**

Inundation of the beachface and the area immediately landward of the dune crest is based on the most recent year of photogrammetry data available (2014) and is in accordance with ESC's sea level rise policy and planning framework. It does not include allowance for future landward recession of the beach face and assumes that the crest level of the seawall (if present) and the topography remain as they were from the 2014 photogrammetry data. By 2050, 2065 or 2100 both of these assumptions may not be valid. Should the seawall/dune be allowed to fail then the landward extent of inundation may increase. Inundation of low lying areas behind the beach is based on the most recent year of LIDAR data available (2005). The low lying inundation areas behind the beach are mapped based on the ground elevation (the "all ground" LIDAR layer) and do not consider flow paths, flow velocities, loss of flow momentum or wave propagation into creek areas. WRL is not responsible for the accuracy of the photogrammetry or LIDAR data. Local surveys by a registered surveyor are recommended to determine local inundation extents.

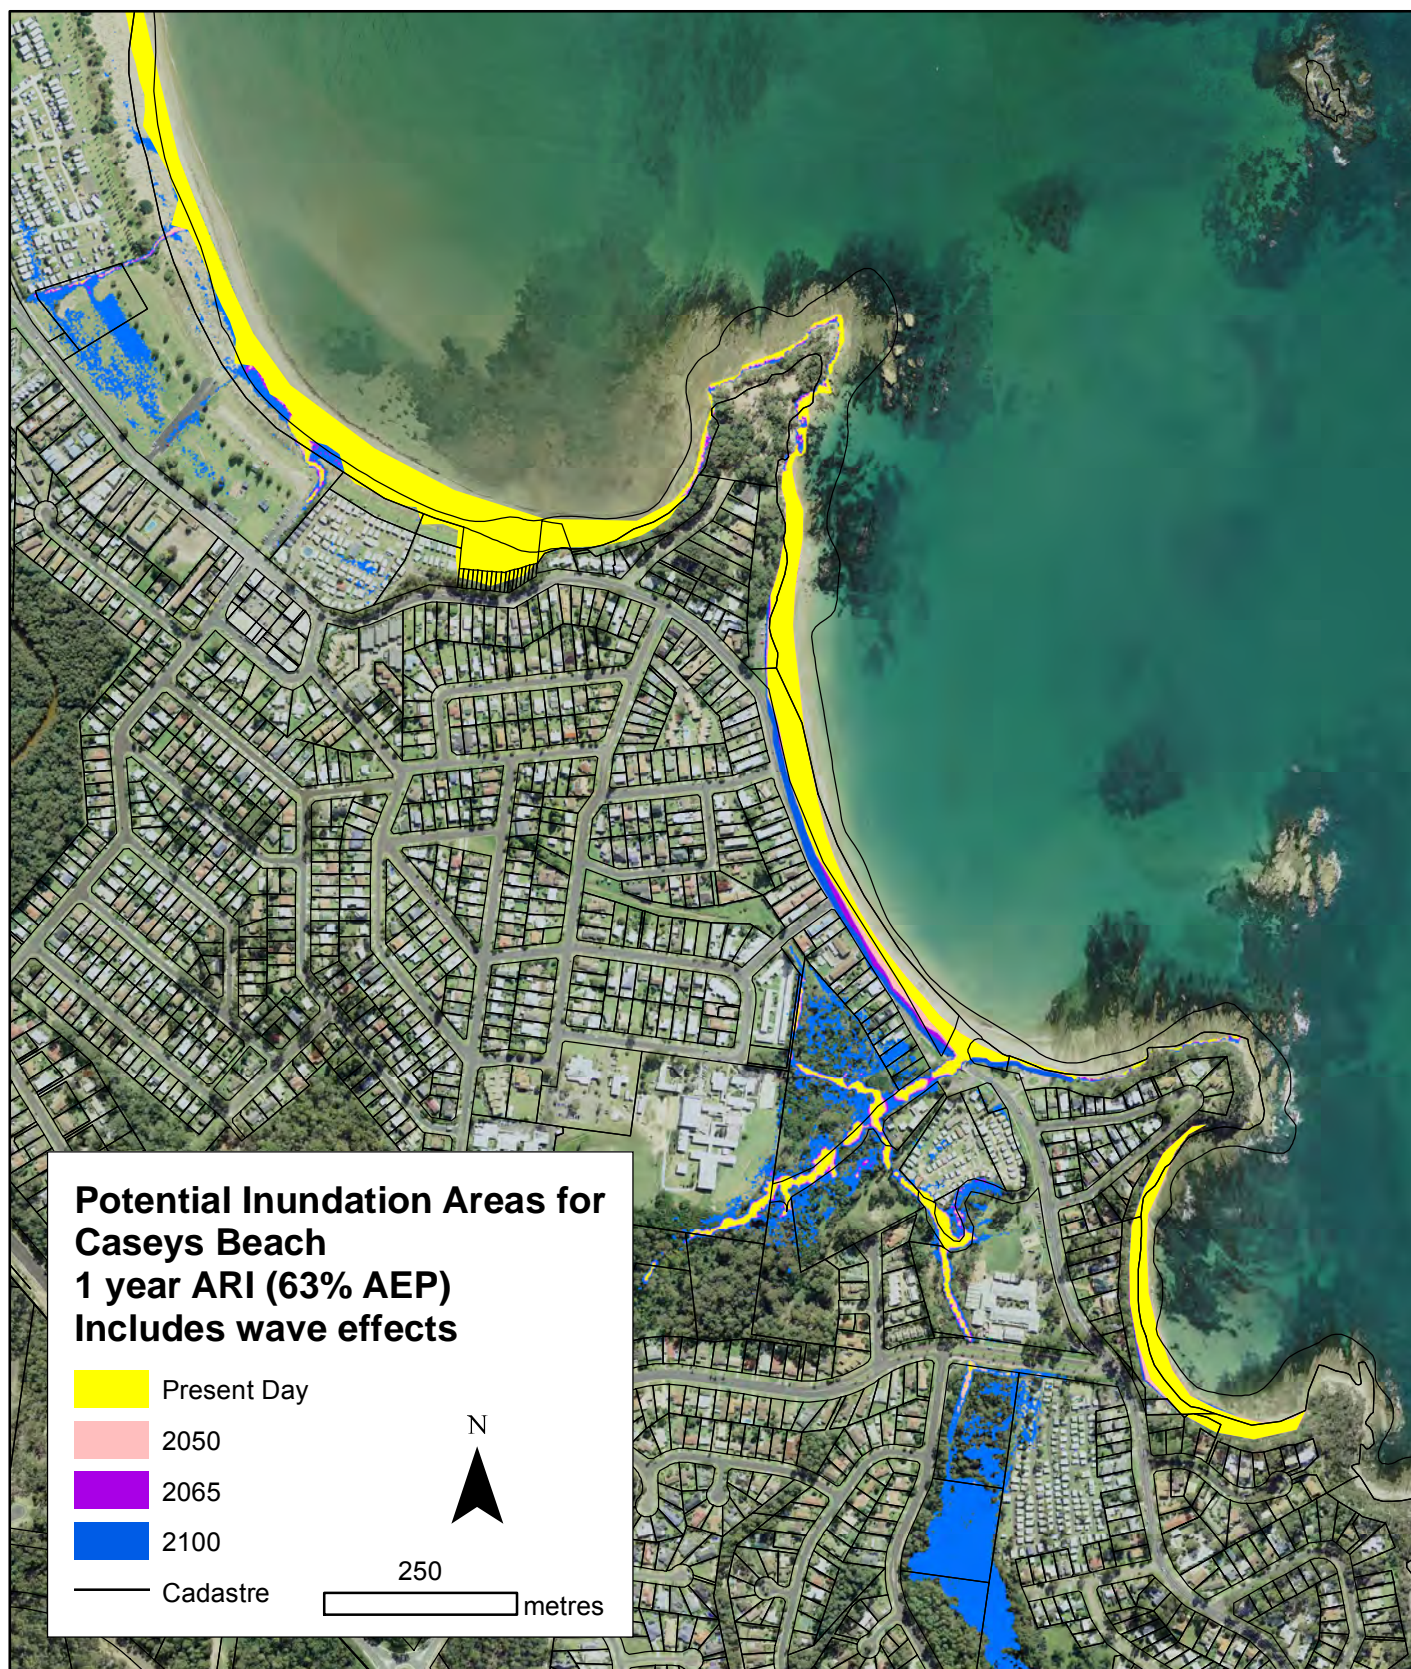
**Figure L.36**

Inundation of the beachface and the area immediately landward of the dune crest is based on the most recent year of LIDAR data available (2005) and is in accordance with ESC's sea level rise policy and planning framework. It does not include allowance for future landward recession of the beach face and assumes that the crest level of the seawall (if present) and the topography remain as they were from the 2005 LIDAR data. By 2050, 2065 or 2100 both of these assumptions may not be valid. Should the seawall/dune be allowed to fail then the landward extent of inundation may increase. Inundation of low lying areas behind the beach is based on the most recent year of LIDAR data available (2005). The low lying inundation areas behind the beach are mapped based on the ground elevation (the "all ground" LIDAR layer) and do not consider flow paths, flow velocities, loss of flow momentum or wave propagation into creek areas. WRL is not responsible for the accuracy of the photogrammetry or LIDAR data. Local surveys by a registered surveyor are recommended to determine local inundation extents.

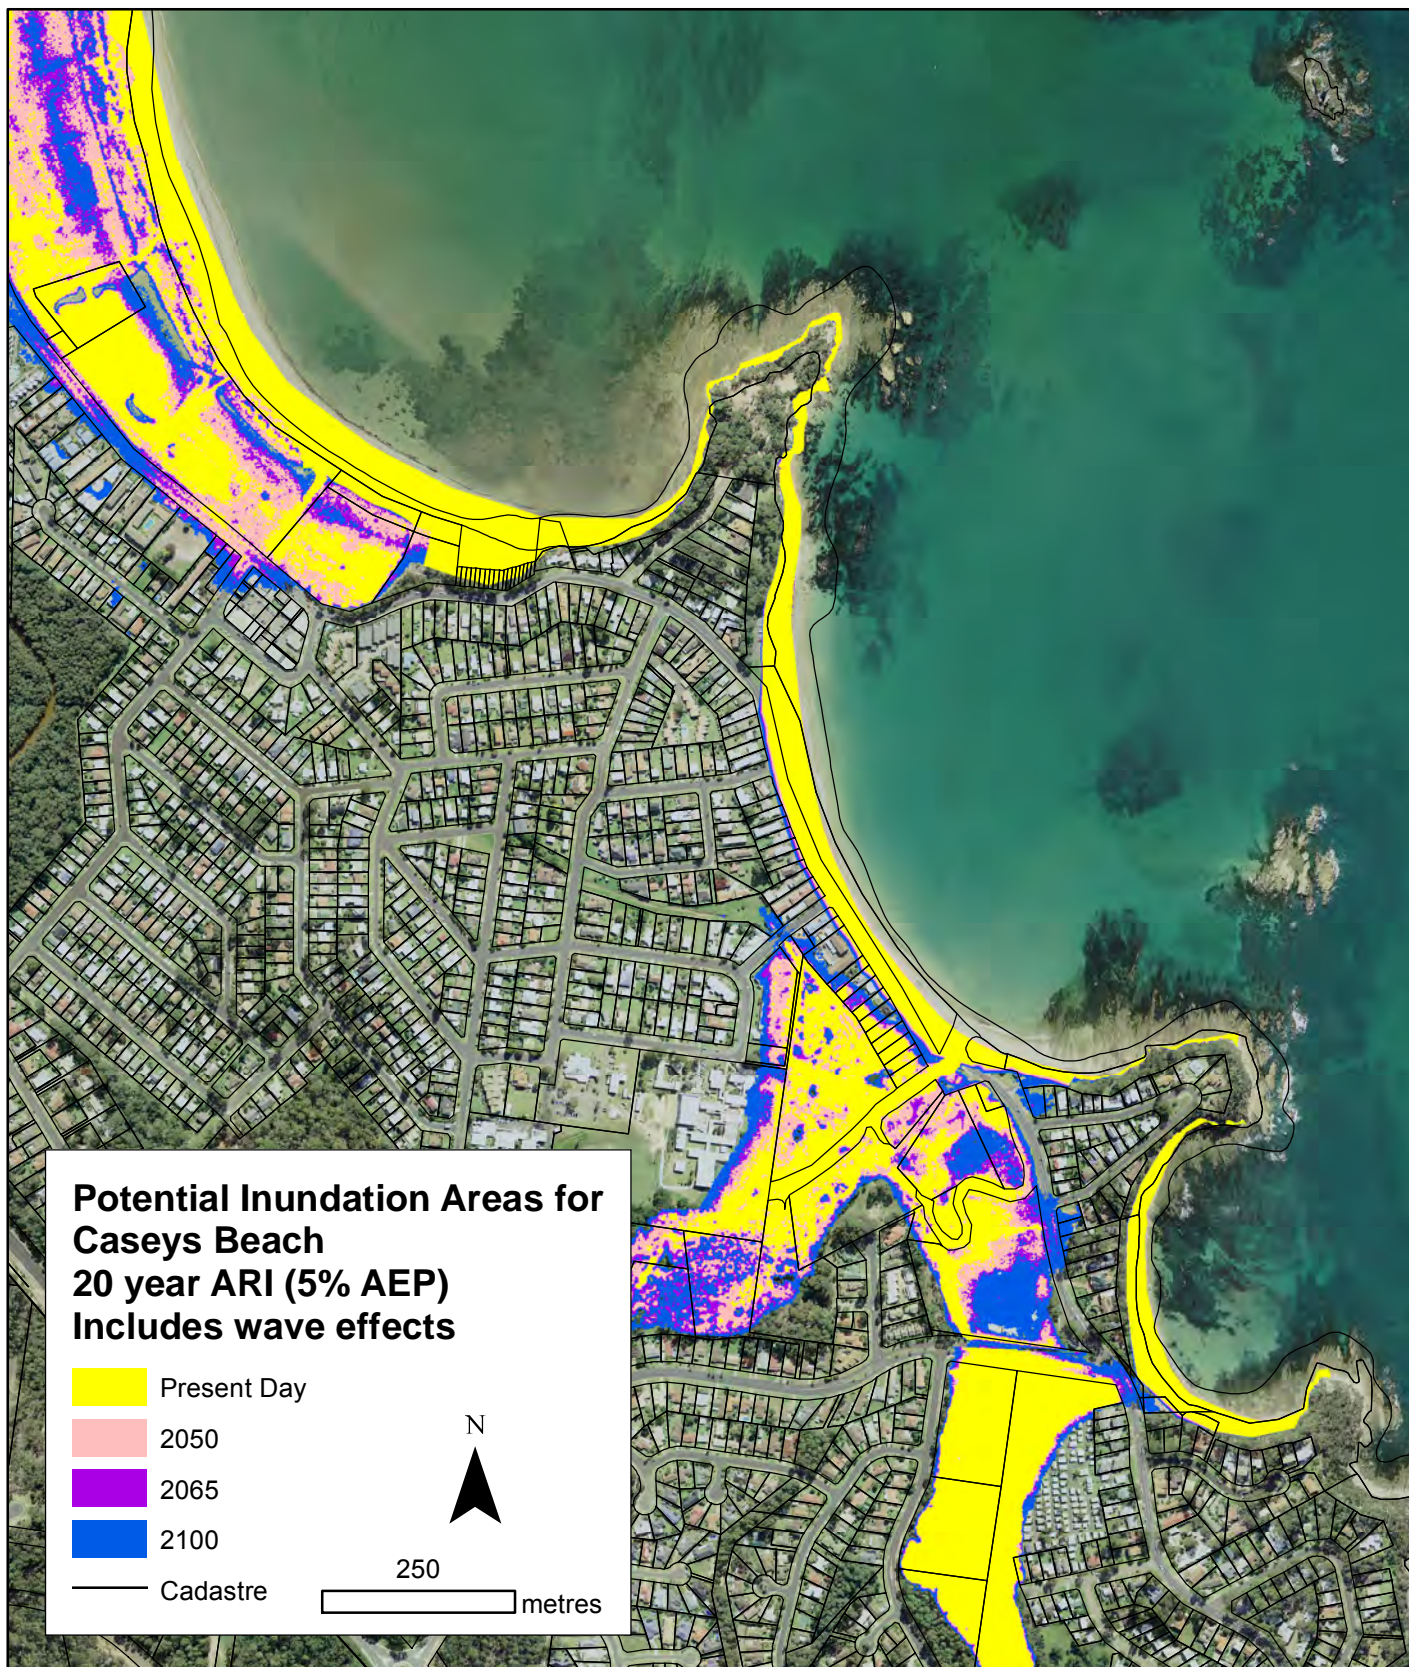
**Figure L.37**

Inundation of the beachface and the area immediately landward of the dune crest is based on the most recent year of LIDAR data available (2005) and is in accordance with ESC's sea level rise policy and planning framework. It does not include allowance for future landward recession of the beach face and assumes that the crest level of the seawall (if present) and the topography remain as they were from the 2005 LIDAR data. By 2050, 2065 or 2100 both of these assumptions may not be valid. Should the seawall/dune be allowed to fail then the landward extent of inundation may increase. Inundation of low lying areas behind the beach is based on the most recent year of LIDAR data available (2005). The low lying inundation areas behind the beach are mapped based on the ground elevation (the "all ground" LIDAR layer) and do not consider flow paths, flow velocities, loss of flow momentum or wave propagation into creek areas. WRL is not responsible for the accuracy of the photogrammetry or LIDAR data. Local surveys by a registered surveyor are recommended to determine local inundation extents.

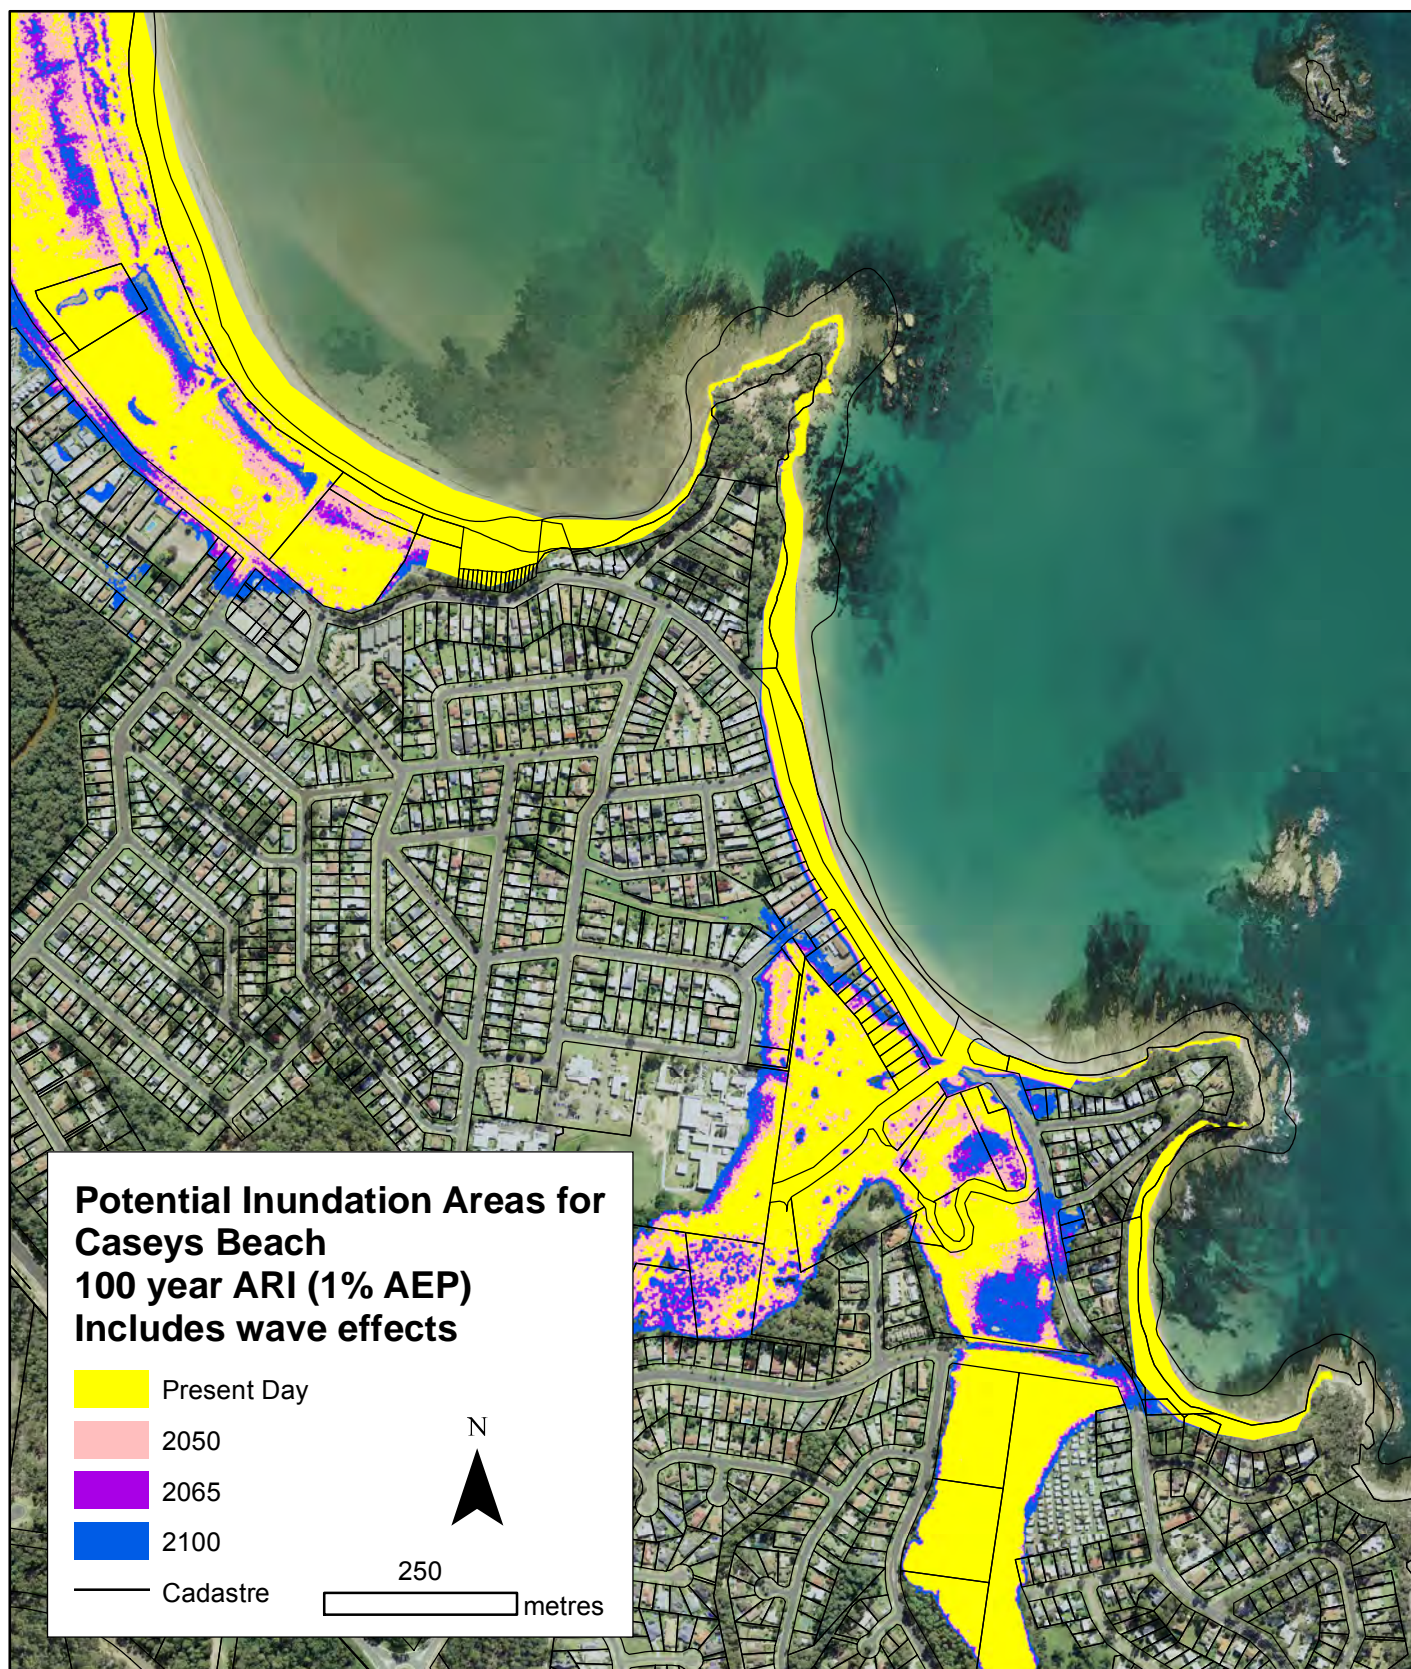
**Figure L.38**

Inundation of the beachface and the area immediately landward of the dune crest is based on the most recent year of LIDAR data available (2005) and is in accordance with ESC's sea level rise policy and planning framework. It does not include allowance for future landward recession of the beach face and assumes that the crest level of the seawall (if present) and the topography remain as they were from the 2005 LIDAR data. By 2050, 2065 or 2100 both of these assumptions may not be valid. Should the seawall/dune be allowed to fail then the landward extent of inundation may increase. Inundation of low lying areas behind the beach is based on the most recent year of LIDAR data available (2005). The low lying inundation areas behind the beach are mapped based on the ground elevation (the "all ground" LIDAR layer) and do not consider flow paths, flow velocities, loss of flow momentum or wave propagation into creek areas. WRL is not responsible for the accuracy of the photogrammetry or LIDAR data. Local surveys by a registered surveyor are recommended to determine local inundation extents.
