## Eurobodalla Coastal Hazard Assessment

WRL Technical Report 2017/09  
October 2017

By I R Coghlan, J T Carley, A J Harrison, D Howe, A D Short,  
J E Ruprecht, F Flocard and P F Rahman

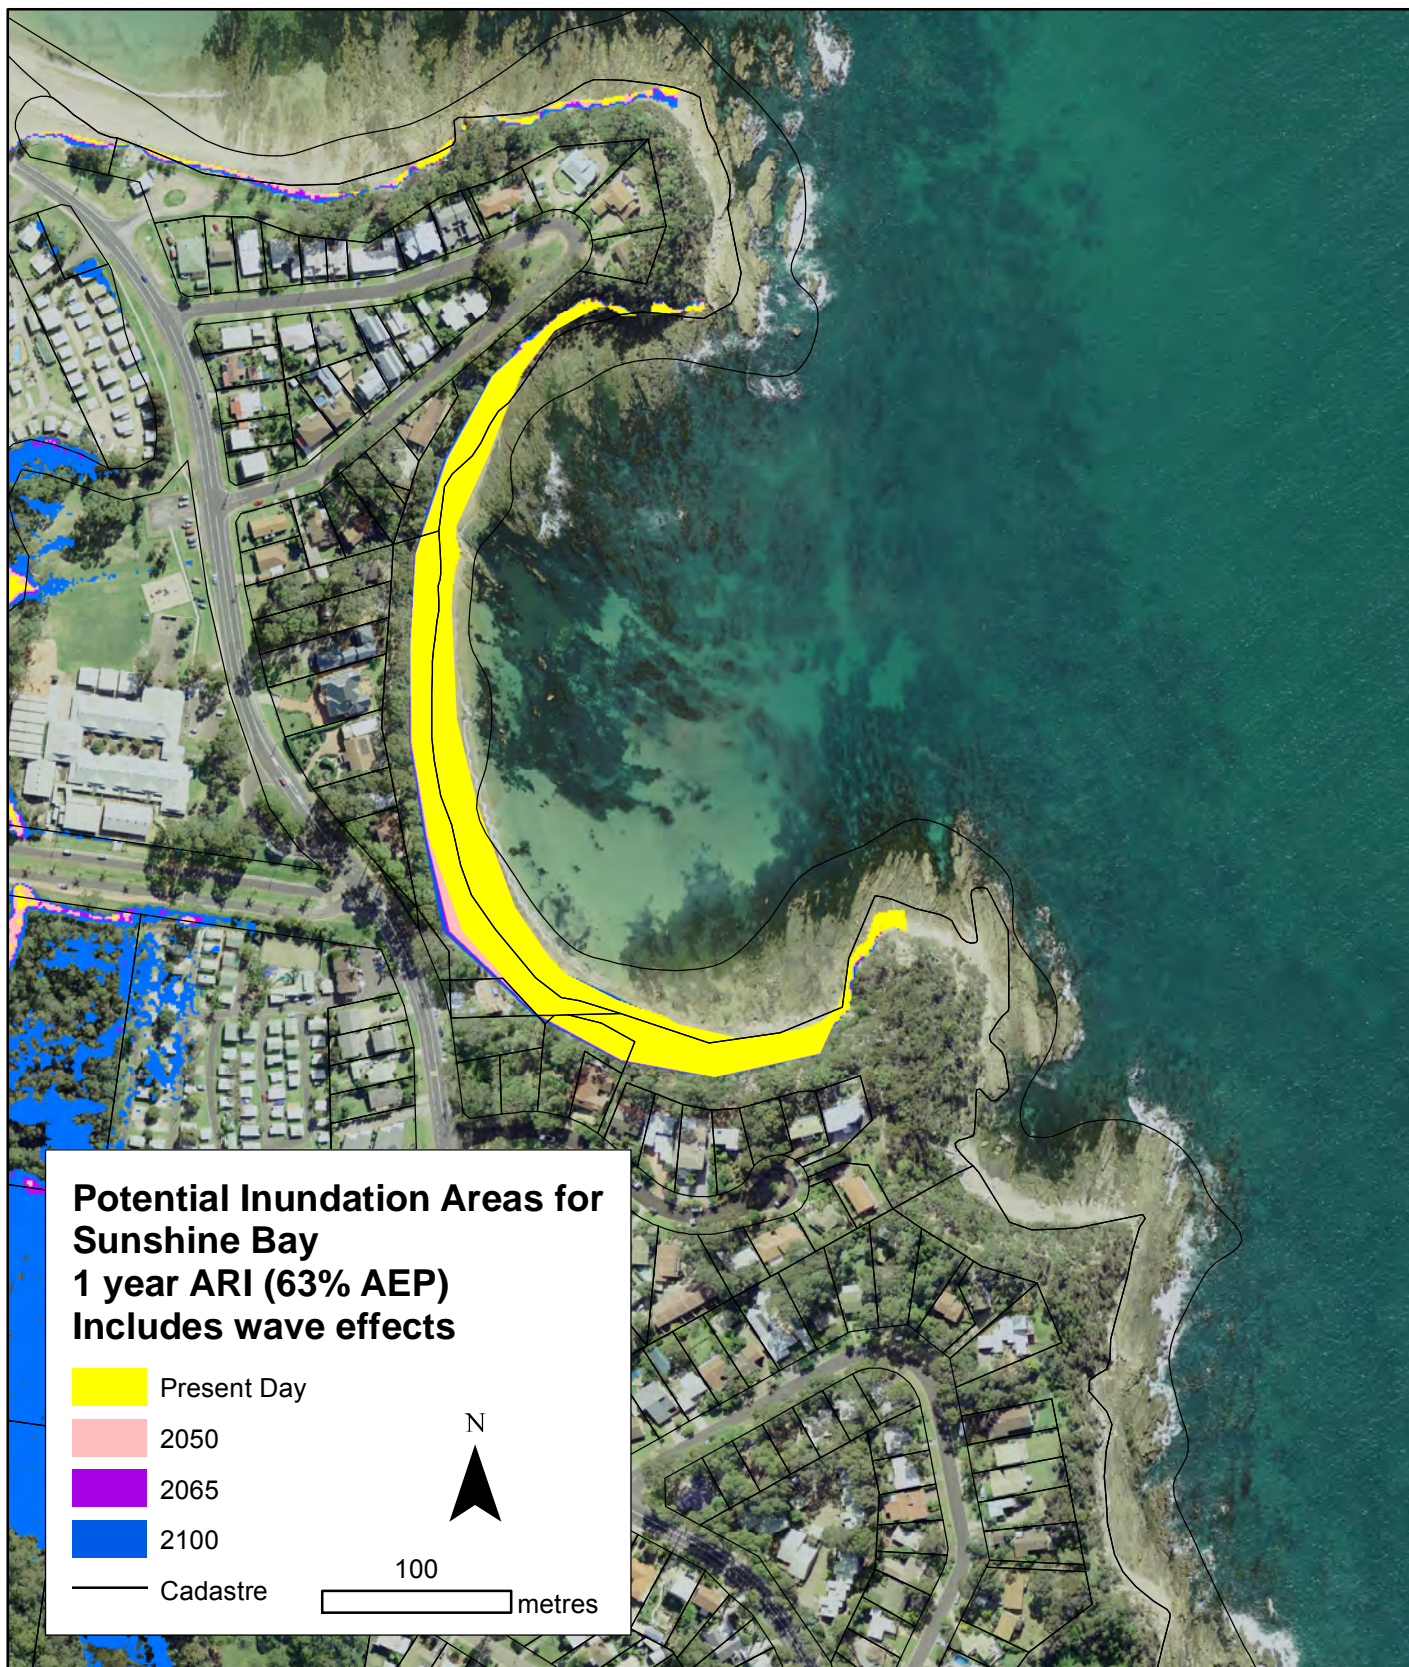
**Figure L.39**

Inundation of the beachface and the area immediately landward of the dune crest is based on the most recent year of photogrammetry data available (2014) and is in accordance with ESC's sea level rise policy and planning framework. It does not include allowance for future landward recession of the beach face and assumes that the crest level of the seawall (if present) and the topography remain as they were from the 2014 photogrammetry data. By 2050, 2065 or 2100 both of these assumptions may not be valid. Should the seawall/dune be allowed to fail then the landward extent of inundation may increase. Inundation of low lying areas behind the beach is based on the most recent year of LIDAR data available (2005). The low lying inundation areas behind the beach are mapped based on the ground elevation (the "all ground" LIDAR layer) and do not consider flow paths, flow velocities, loss of flow momentum or wave propagation into creek areas. WRL is not responsible for the accuracy of the photogrammetry or LIDAR data. Local surveys by a registered surveyor are recommended to determine local inundation extents.

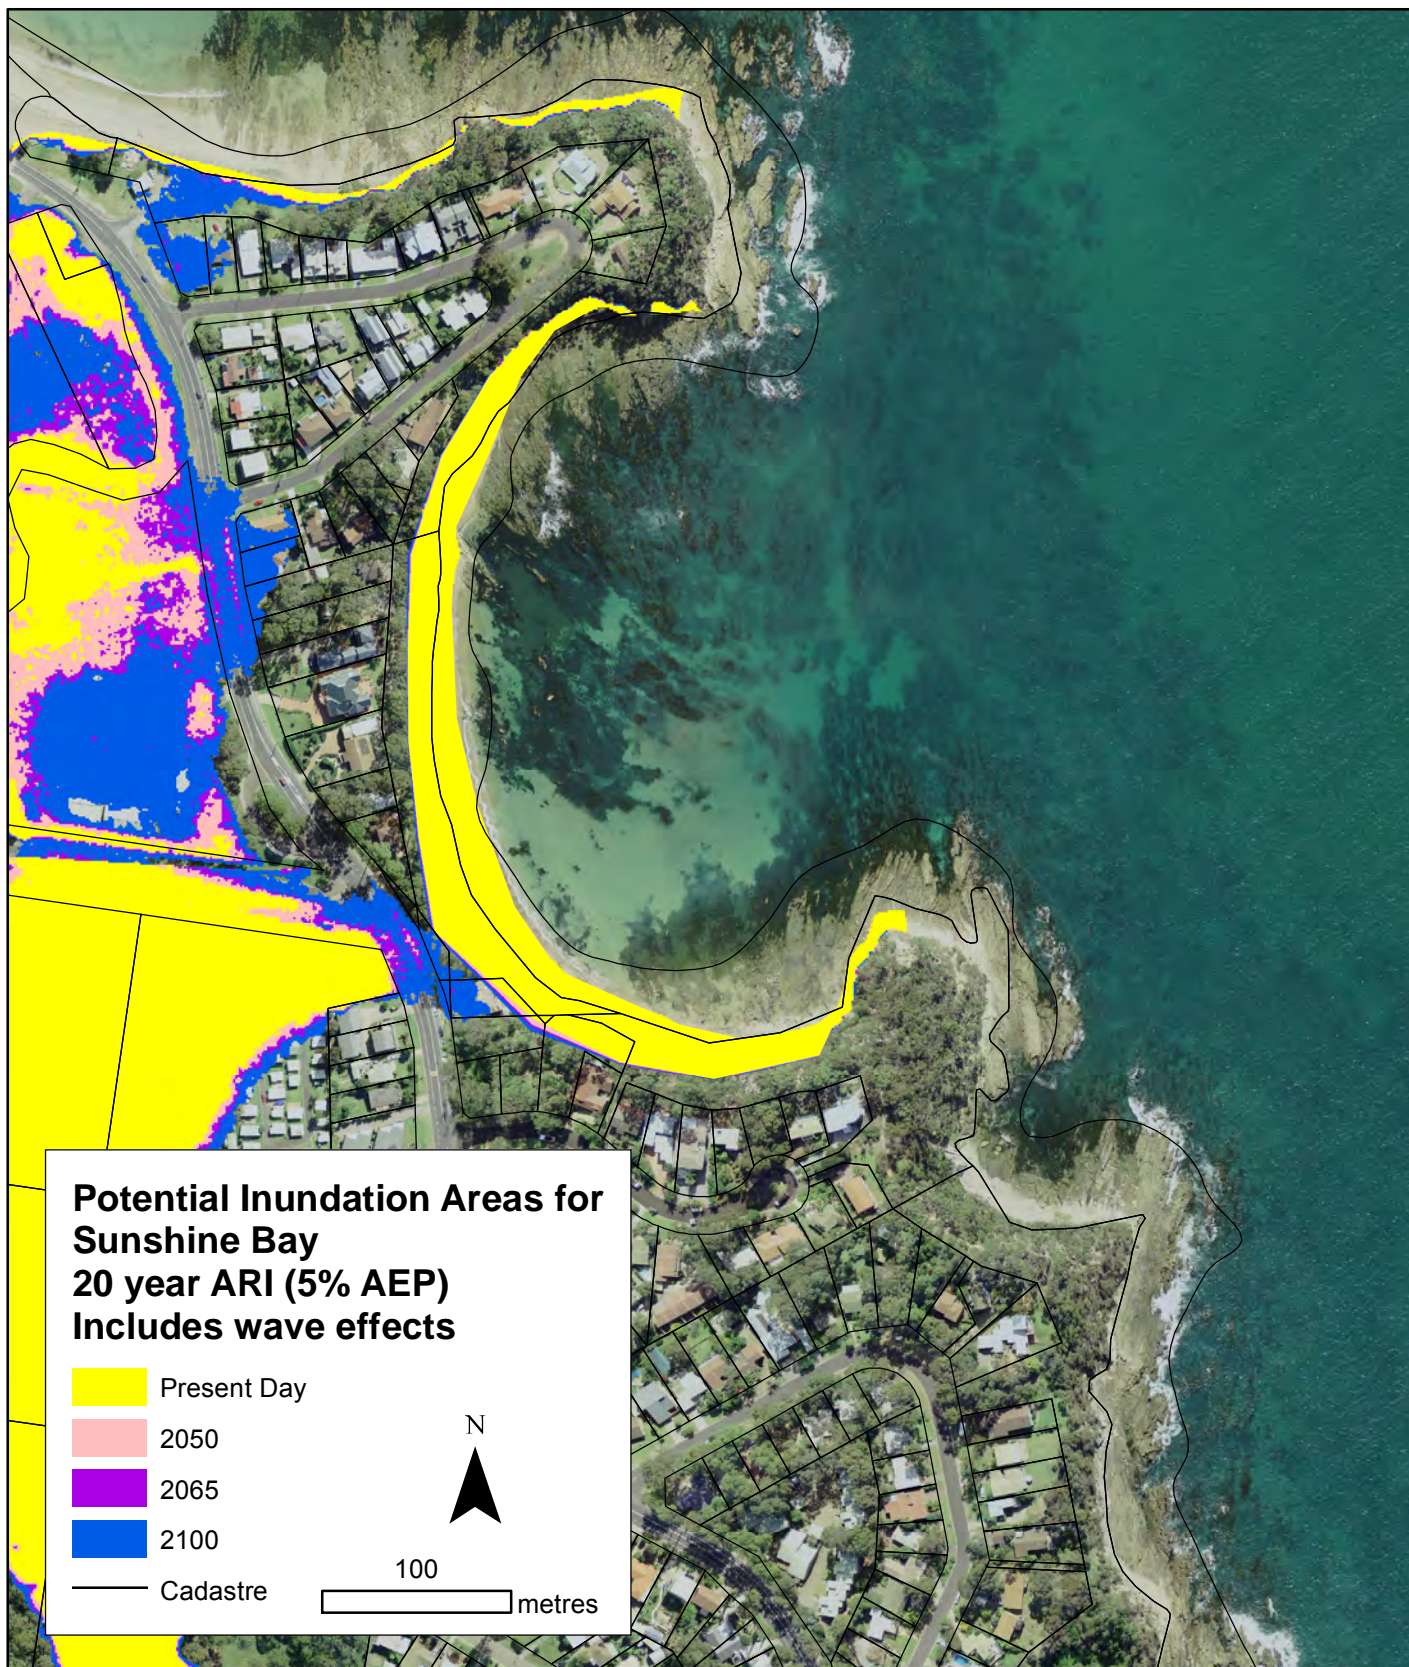
**Figure L.40**

Inundation of the beachface and the area immediately landward of the dune crest is based on the most recent year of photogrammetry data available (2014) and is in accordance with ESC's sea level rise policy and planning framework. It does not include allowance for future landward recession of the beach face and assumes that the crest level of the seawall (if present) and the topography remain as they were from the 2014 photogrammetry data. By 2050, 2065 or 2100 both of these assumptions may not be valid. Should the seawall/dune be allowed to fail then the landward extent of inundation may increase. Inundation of low lying areas behind the beach is based on the most recent year of LIDAR data available (2005). The low lying inundation areas behind the beach are mapped based on the ground elevation (the "all ground" LIDAR layer) and do not consider flow paths, flow velocities, loss of flow momentum or wave propagation into creek areas. WRL is not responsible for the accuracy of the photogrammetry or LIDAR data. Local surveys by a registered surveyor are recommended to determine local inundation extents.

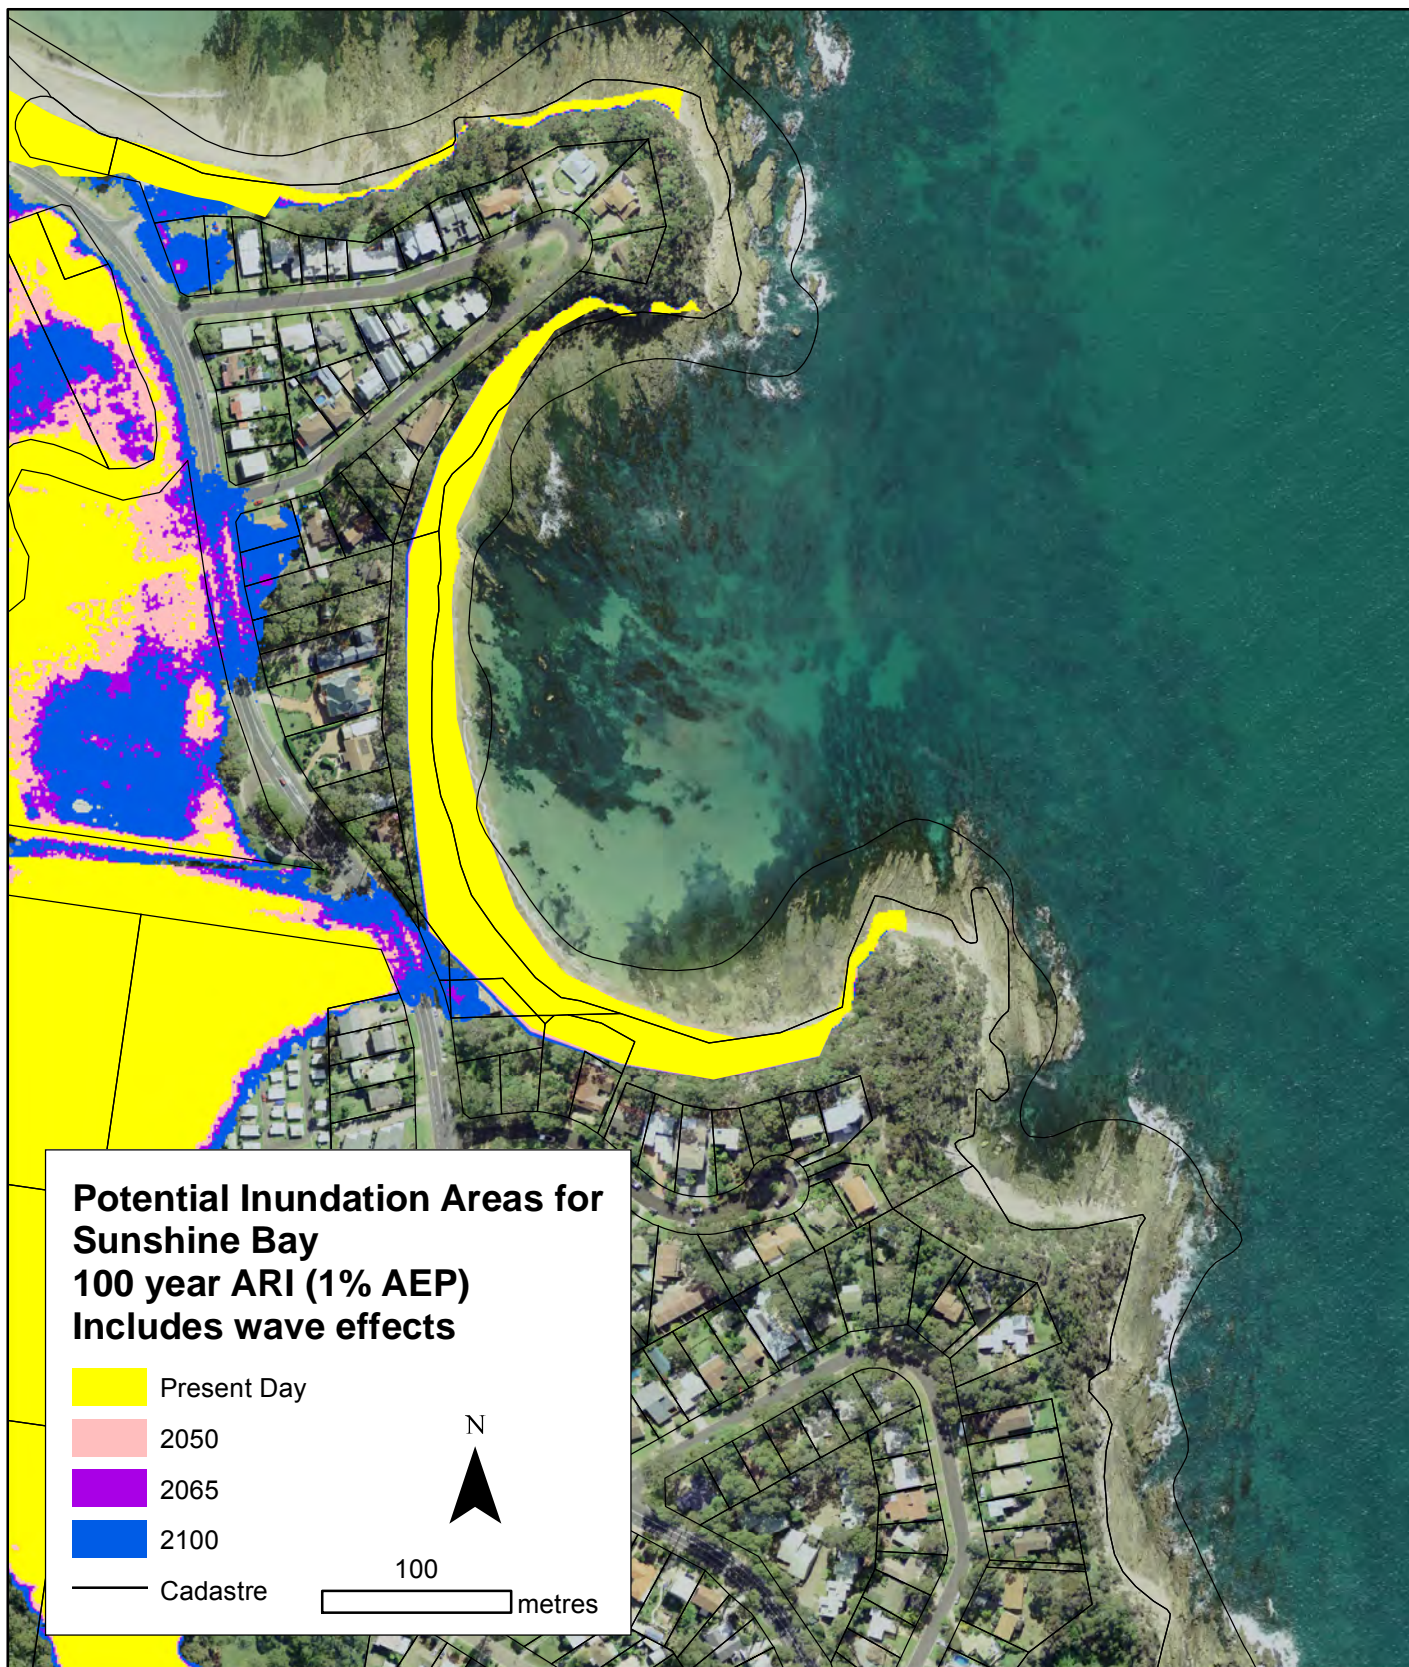
**Figure L.41**

Inundation of the beachface and the area immediately landward of the dune crest is based on the most recent year of photogrammetry data available (2014) and is in accordance with ESC's sea level rise policy and planning framework. It does not include allowance for future landward recession of the beach face and assumes that the crest level of the seawall (if present) and the topography remain as they were from the 2014 photogrammetry data. By 2050, 2065 or 2100 both of these assumptions may not be valid. Should the seawall/dune be allowed to fail then the landward extent of inundation may increase. Inundation of low lying areas behind the beach is based on the most recent year of LIDAR data available (2005). The low lying inundation areas behind the beach are mapped based on the ground elevation (the "all ground" LIDAR layer) and do not consider flow paths, flow velocities, loss of flow momentum or wave propagation into creek areas. WRL is not responsible for the accuracy of the photogrammetry or LIDAR data. Local surveys by a registered surveyor are recommended to determine local inundation extents.

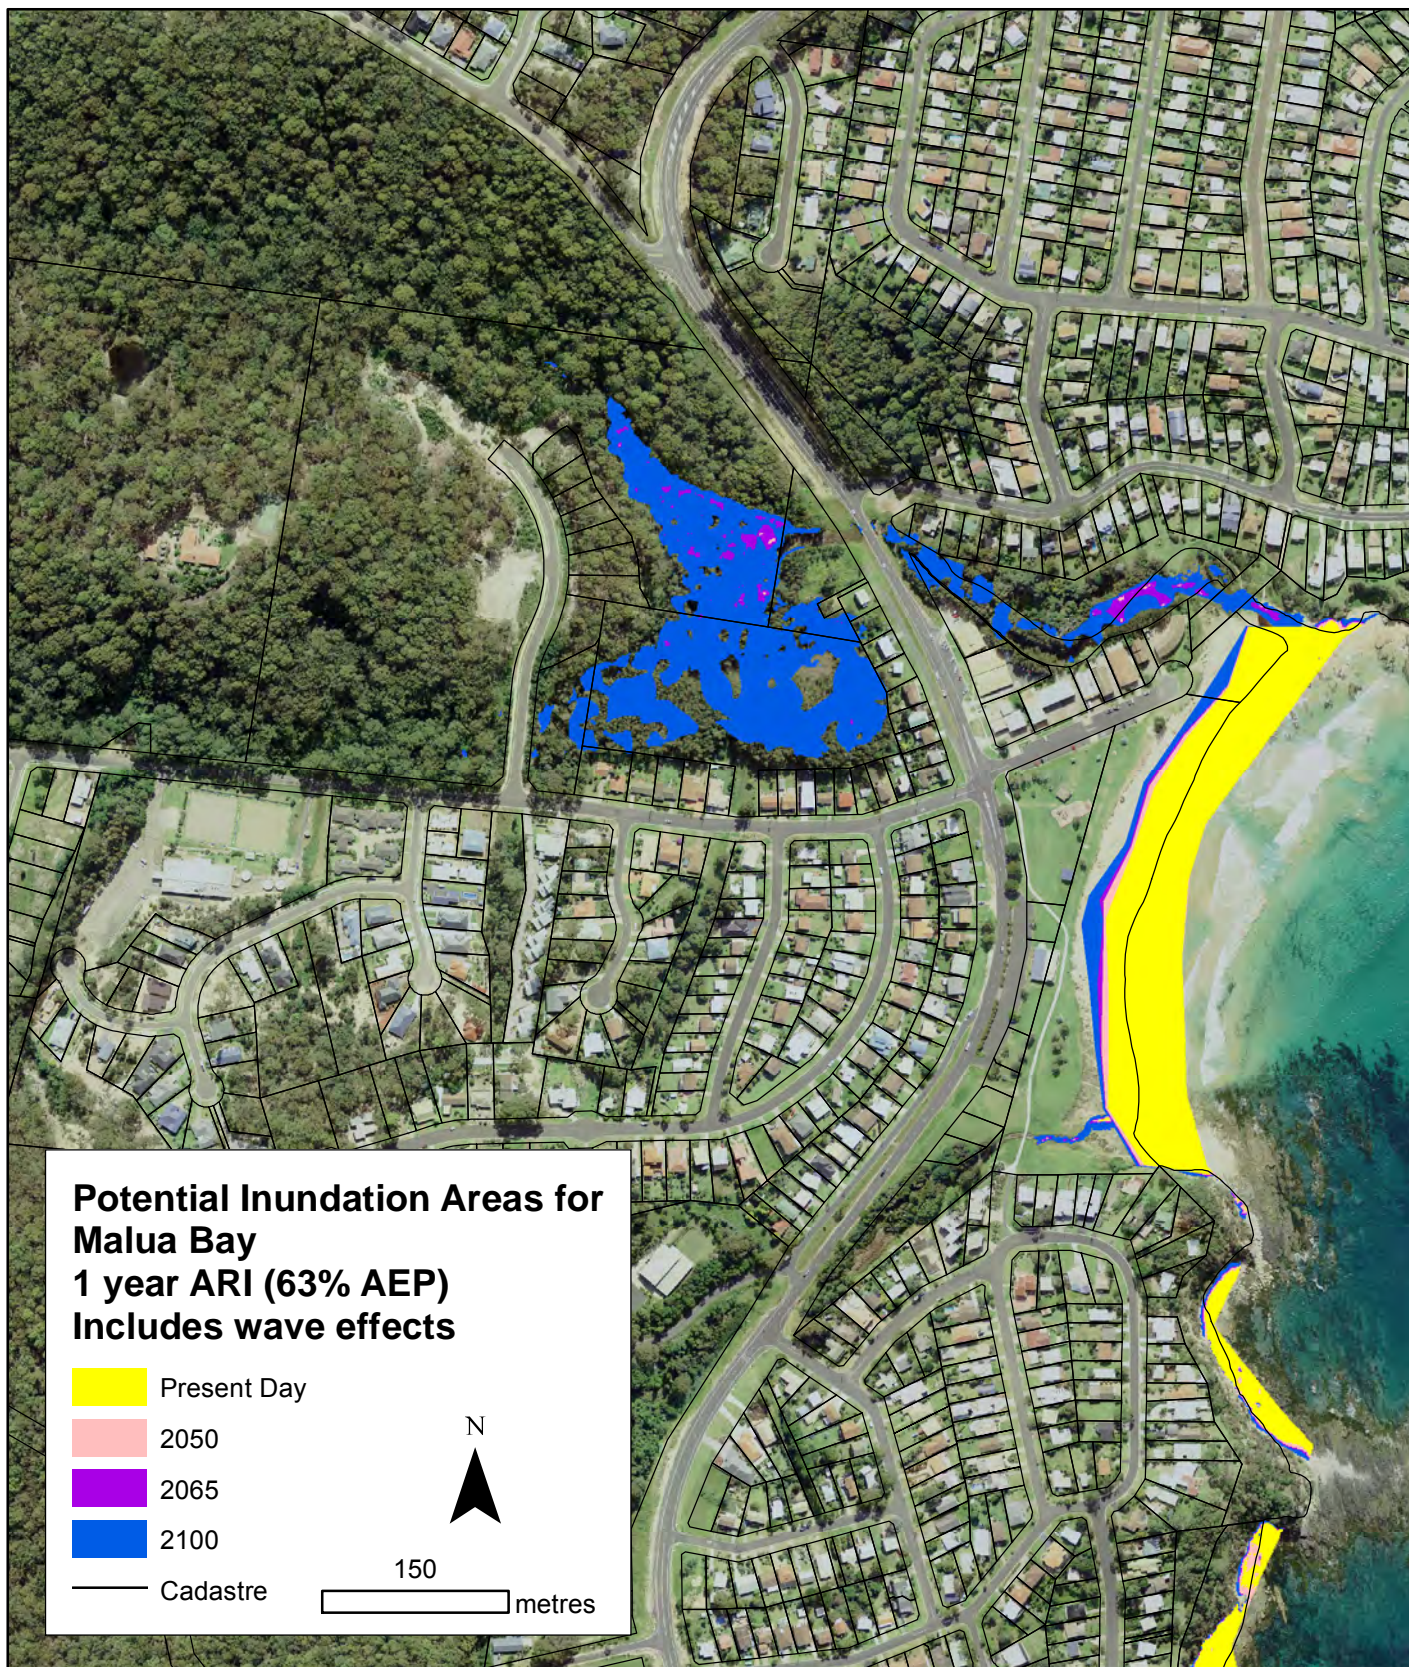
**Figure L.42**

Inundation of the beachface and the area immediately landward of the dune crest is based on the most recent year of photogrammetry data available (2014) and is in accordance with ESC's sea level rise policy and planning framework. It does not include allowance for future landward recession of the beach face and assumes that the crest level of the seawall (if present) and the topography remain as they were from the 2014 photogrammetry data. By 2050, 2065 or 2100 both of these assumptions may not be valid. Should the seawall/dune be allowed to fail then the landward extent of inundation may increase. Inundation of low lying areas behind the beach is based on the most recent year of LIDAR data available (2011). The low lying inundation areas behind the beach are mapped based on the ground elevation (the "all ground" LIDAR layer) and do not consider flow paths, flow velocities, loss of flow momentum or wave propagation into creek areas. WRL is not responsible for the accuracy of the photogrammetry or LIDAR data. Local surveys by a registered surveyor are recommended to determine local inundation extents.

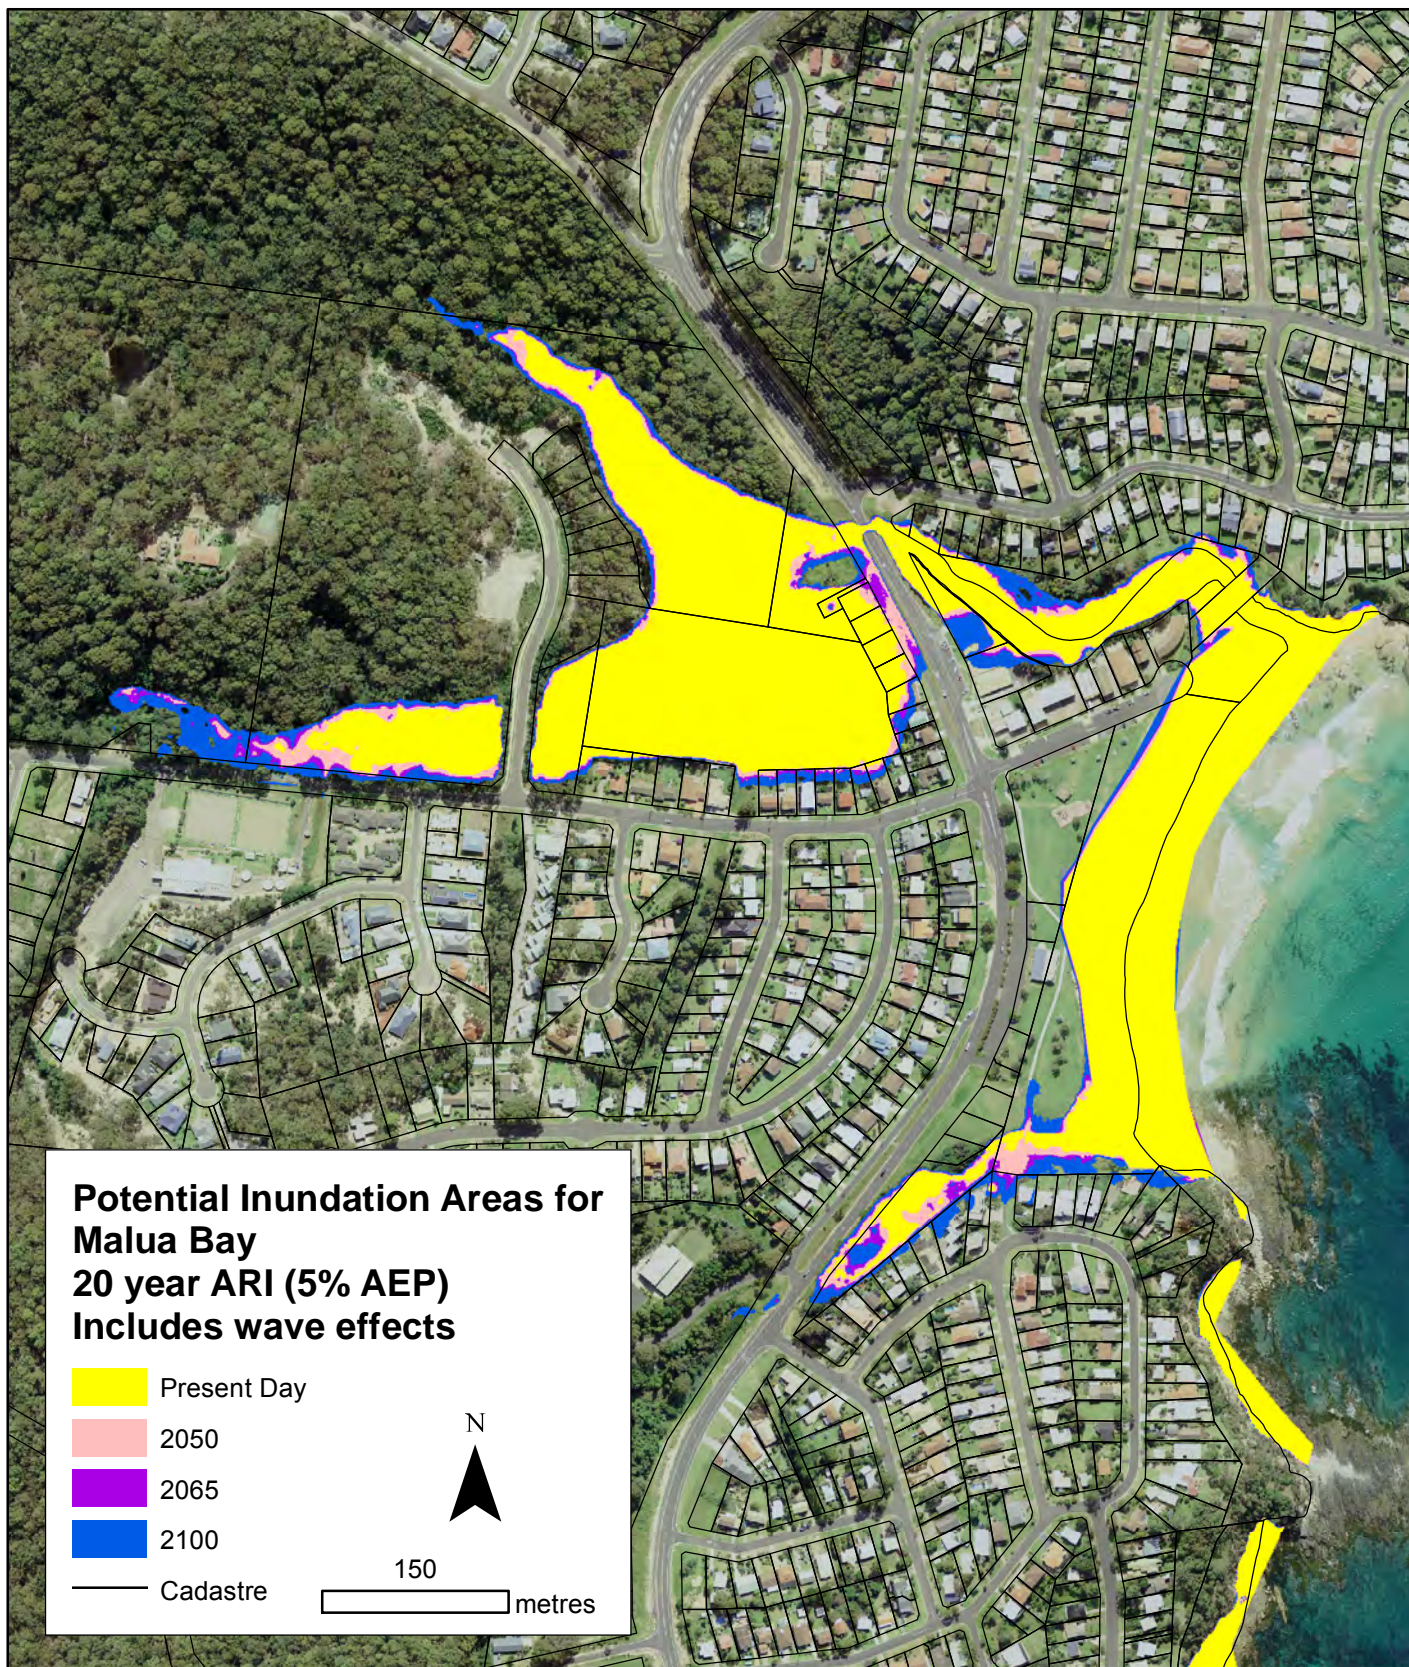
**Figure L.43**

Inundation of the beachface and the area immediately landward of the dune crest is based on the most recent year of photogrammetry data available (2014) and is in accordance with ESC's sea level rise policy and planning framework. It does not include allowance for future landward recession of the beach face and assumes that the crest level of the seawall (if present) and the topography remain as they were from the 2014 photogrammetry data. By 2050, 2065 or 2100 both of these assumptions may not be valid. Should the seawall/dune be allowed to fail then the landward extent of inundation may increase. Inundation of low lying areas behind the beach is based on the most recent year of LIDAR data available (2011). The low lying inundation areas behind the beach are mapped based on the ground elevation (the "all ground" LIDAR layer) and do not consider flow paths, flow velocities, loss of flow momentum or wave propagation into creek areas. WRL is not responsible for the accuracy of the photogrammetry or LIDAR data. Local surveys by a registered surveyor are recommended to determine local inundation extents.

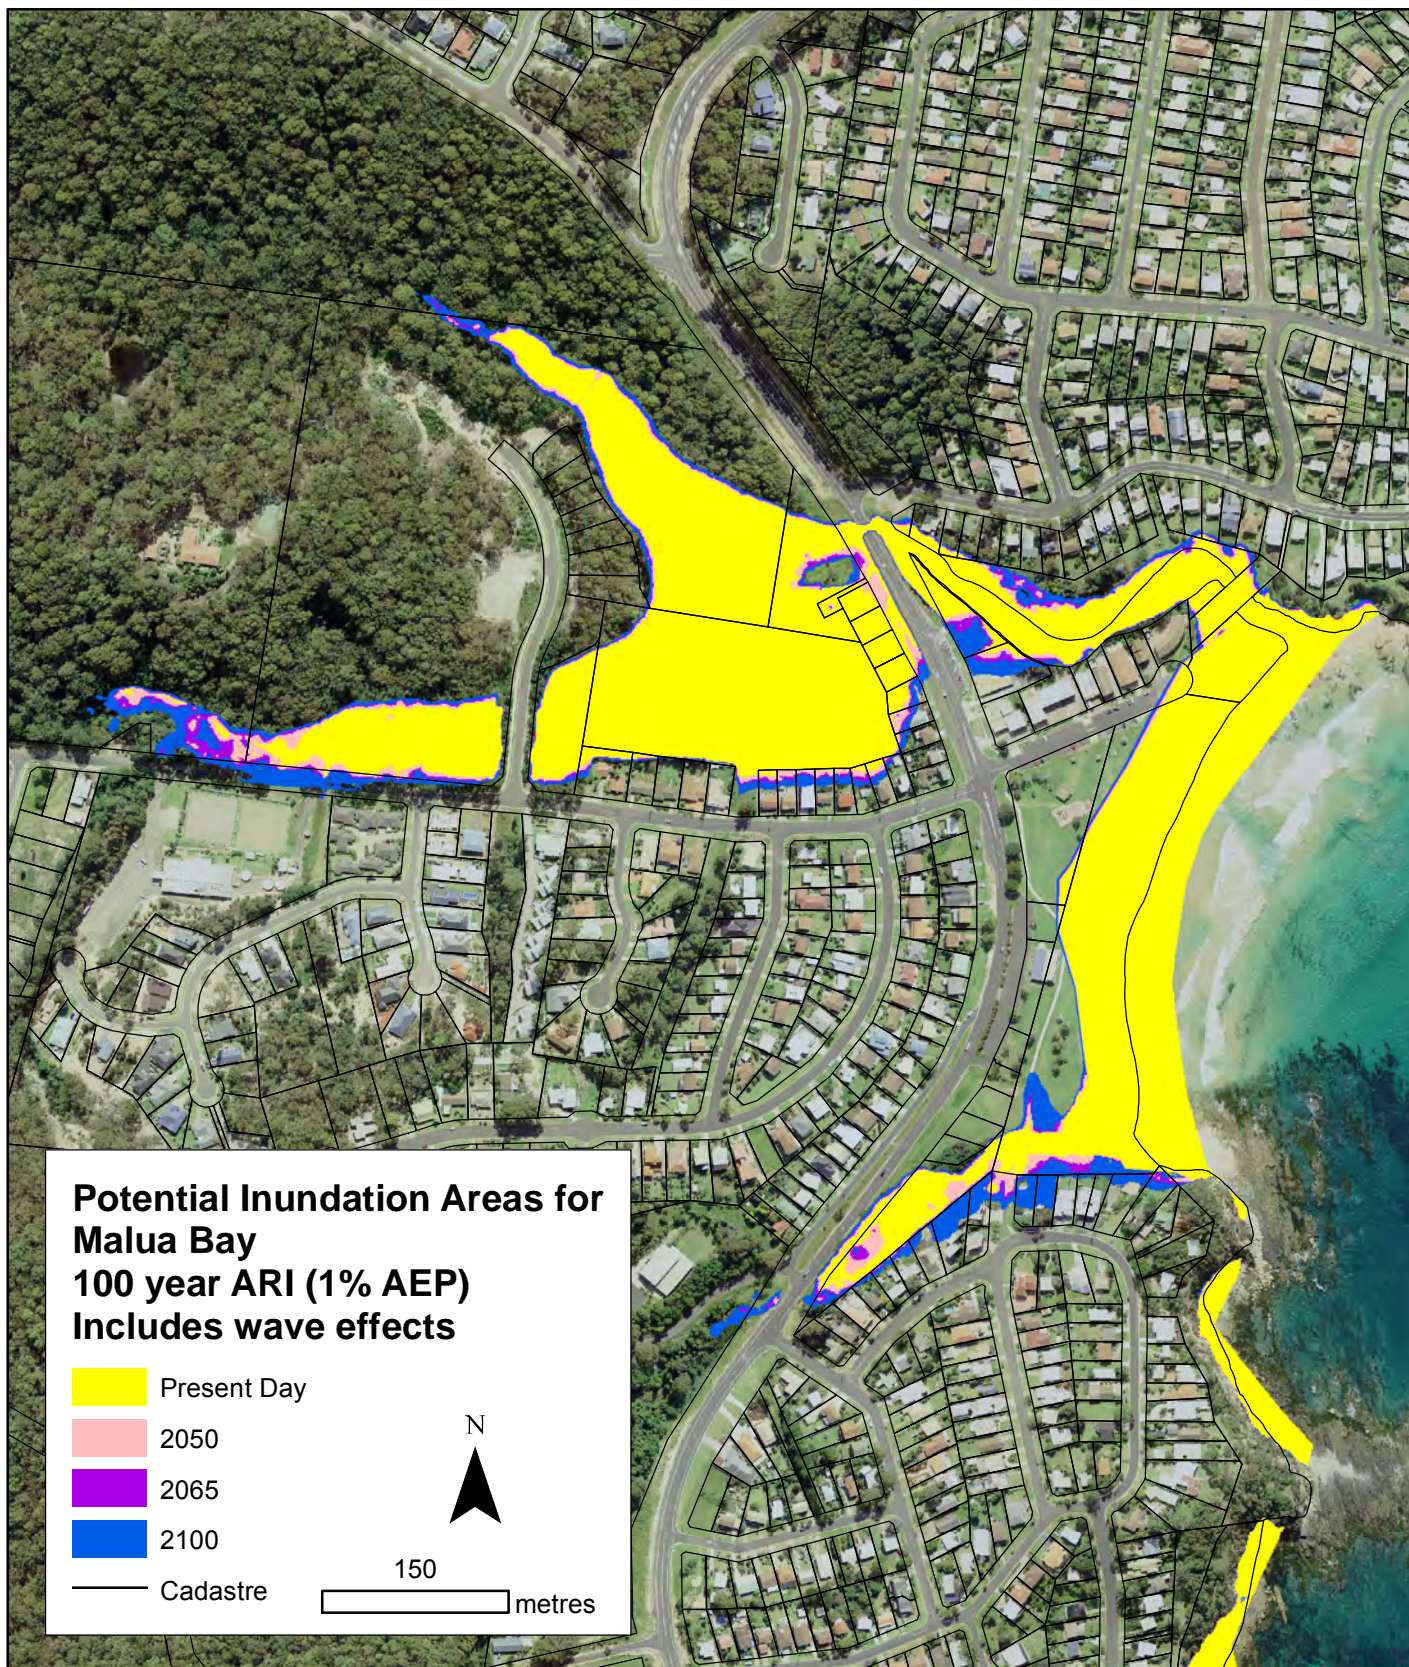
**Figure L.44**

Inundation of the beachface and the area immediately landward of the dune crest is based on the most recent year of photogrammetry data available (2014) and is in accordance with ESC's sea level rise policy and planning framework. It does not include allowance for future landward recession of the beach face and assumes that the crest level of the seawall (if present) and the topography remain as they were from the 2014 photogrammetry data. By 2050, 2065 or 2100 both of these assumptions may not be valid. Should the seawall/dune be allowed to fail then the landward extent of inundation may increase. Inundation of low lying areas behind the beach is based on the most recent year of LIDAR data available (2011). The low lying inundation areas behind the beach are mapped based on the ground elevation (the "all ground" LIDAR layer) and do not consider flow paths, flow velocities, loss of flow momentum or wave propagation into creek areas. WRL is not responsible for the accuracy of the photogrammetry or LIDAR data. Local surveys by a registered surveyor are recommended to determine local inundation extents.

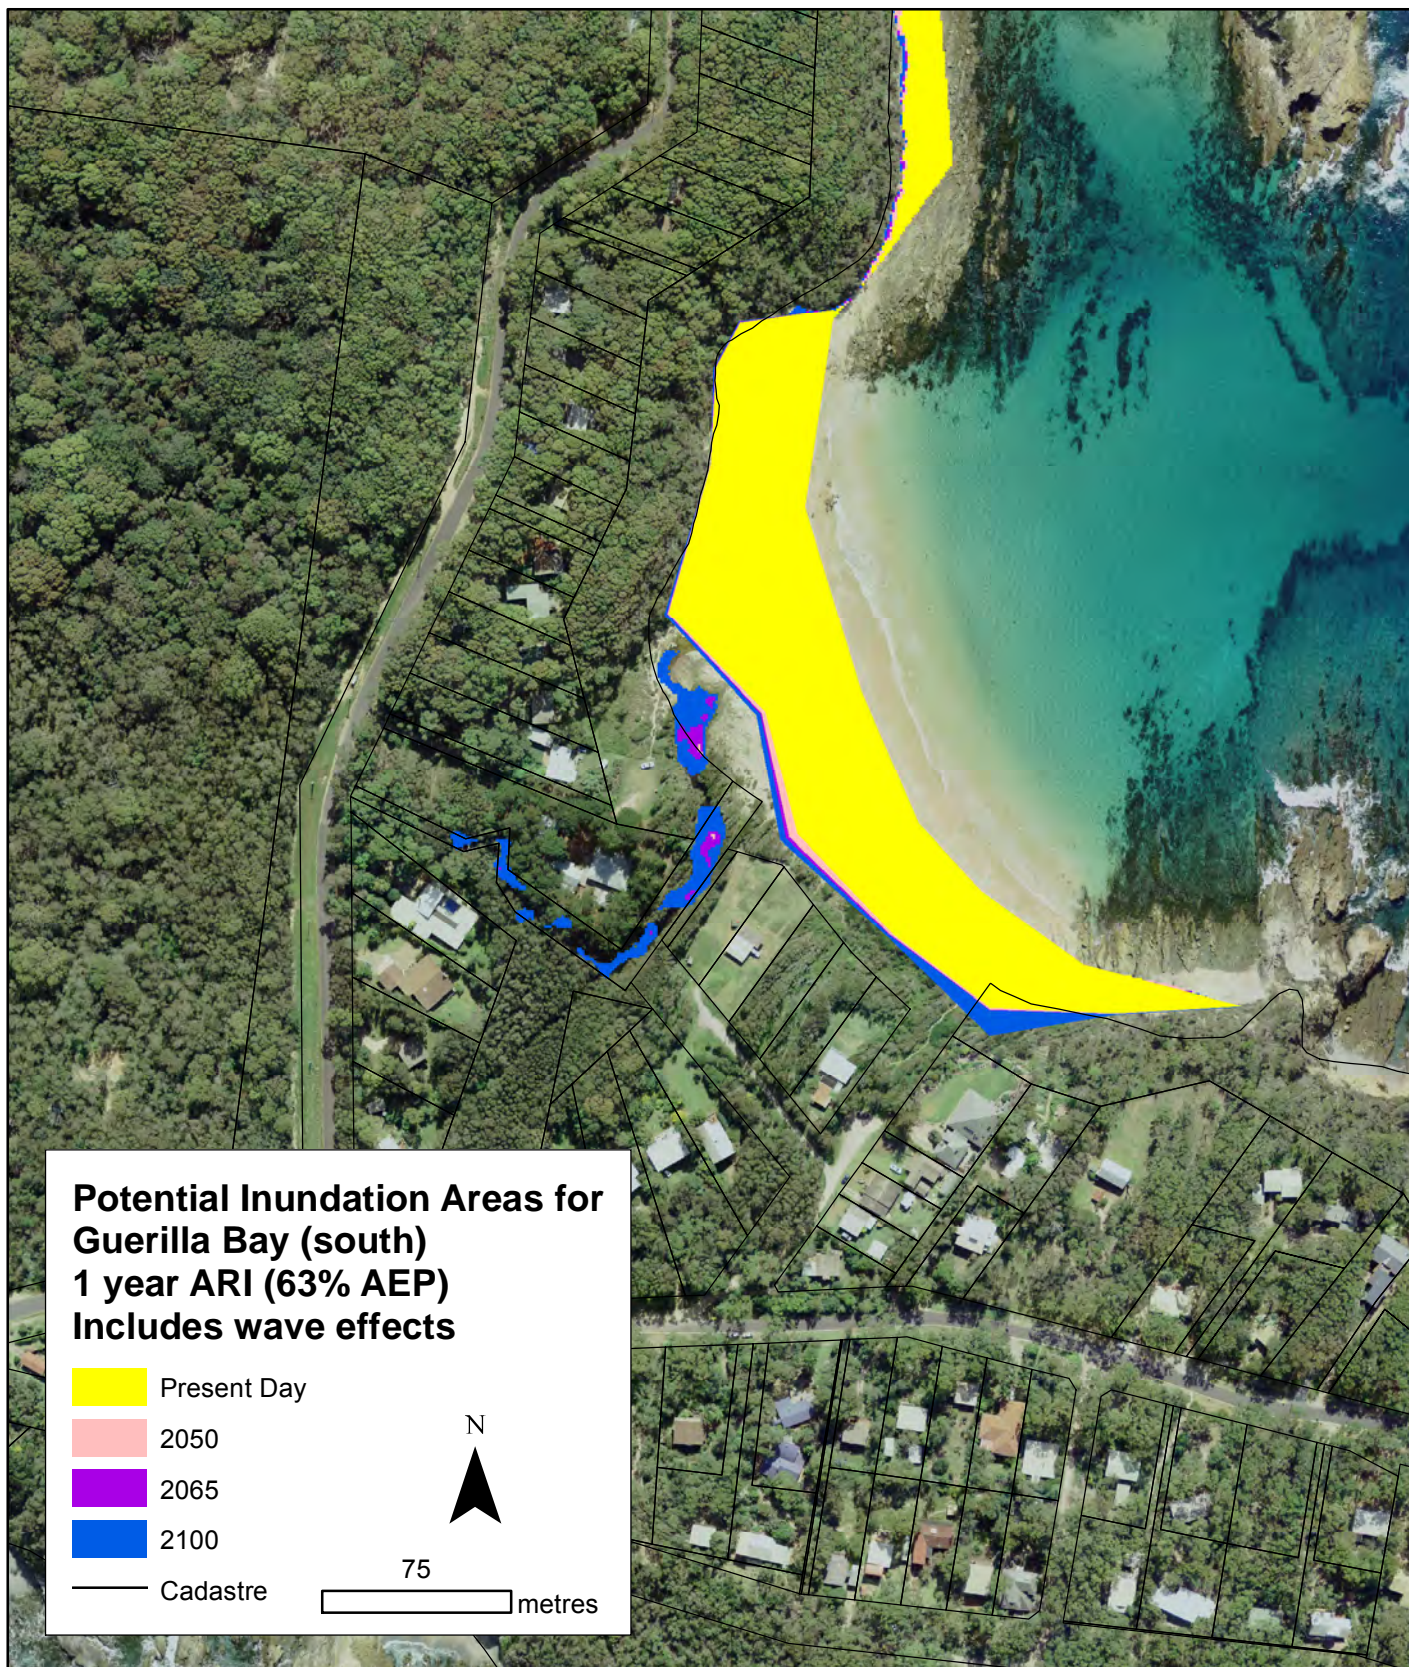
**Figure L.45**

Inundation of the beachface and the area immediately landward of the dune crest is based on the most recent year of photogrammetry data available (2014) and is in accordance with ESC's sea level rise policy and planning framework. It does not include allowance for future landward recession of the beach face and assumes that the crest level of the seawall (if present) and the topography remain as they were from the 2014 photogrammetry data. By 2050, 2065 or 2100 both of these assumptions may not be valid. Should the seawall/dune be allowed to fail then the landward extent of inundation may increase. Inundation of low lying areas behind the beach is based on the most recent year of LIDAR data available (2011). The low lying inundation areas behind the beach are mapped based on the ground elevation (the "all ground" LIDAR layer) and do not consider flow paths, flow velocities, loss of flow momentum or wave propagation into creek areas. WRL is not responsible for the accuracy of the photogrammetry or LIDAR data. Local surveys by a registered surveyor are recommended to determine local inundation extents.

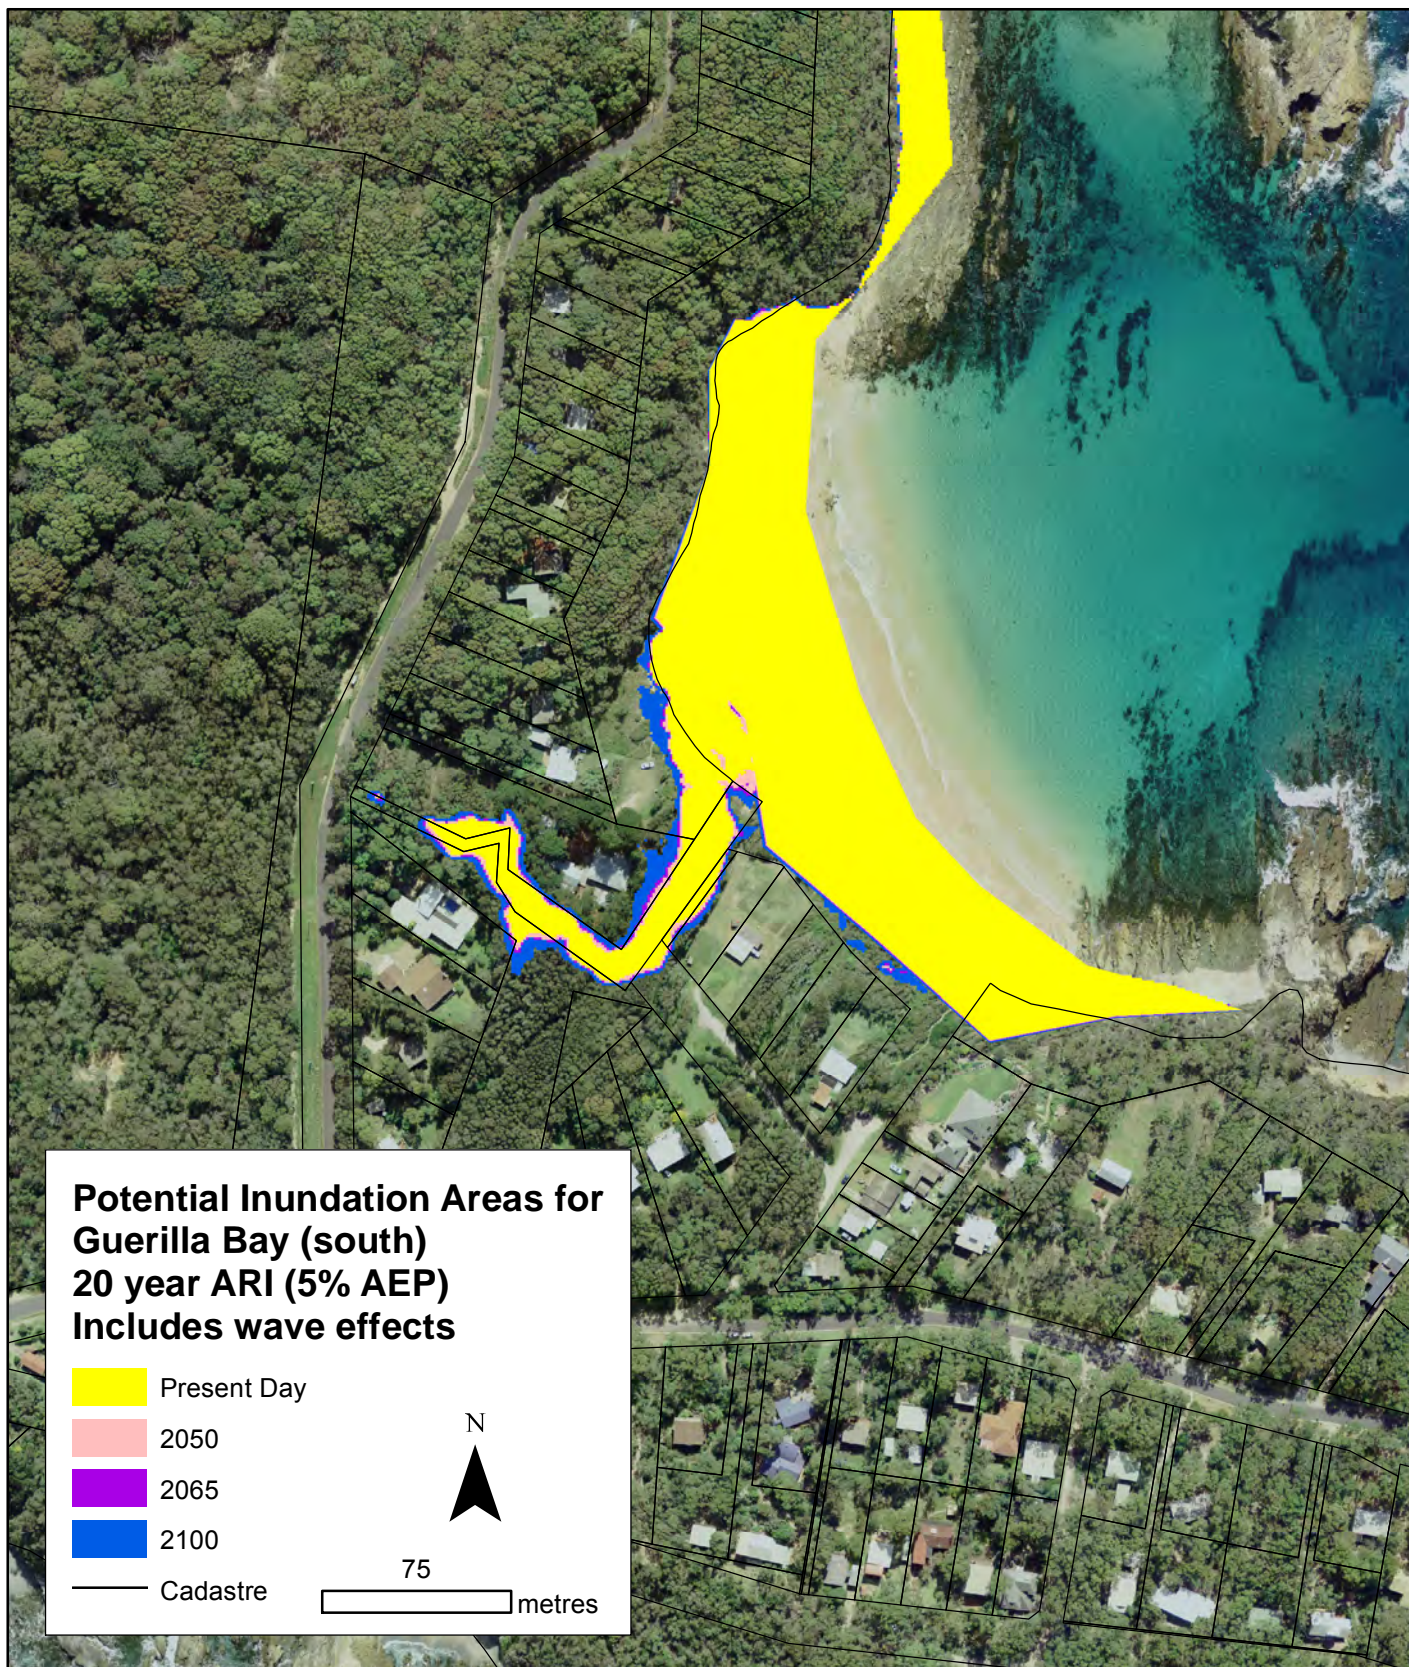
**Figure L.46**

Inundation of the beachface and the area immediately landward of the dune crest is based on the most recent year of photogrammetry data available (2014) and is in accordance with ESC's sea level rise policy and planning framework. It does not include allowance for future landward recession of the beach face and assumes that the crest level of the seawall (if present) and the topography remain as they were from the 2014 photogrammetry data. By 2050, 2065 or 2100 both of these assumptions may not be valid. Should the seawall/dune be allowed to fail then the landward extent of inundation may increase. Inundation of low lying areas behind the beach is based on the most recent year of LIDAR data available (2011). The low lying inundation areas behind the beach are mapped based on the ground elevation (the "all ground" LIDAR layer) and do not consider flow paths, flow velocities, loss of flow momentum or wave propagation into creek areas. WRL is not responsible for the accuracy of the photogrammetry or LIDAR data. Local surveys by a registered surveyor are recommended to determine local inundation extents.
