## Eurobodalla Coastal Hazard Assessment

WRL Technical Report 2017/09  
October 2017

By I R Coghlan, J T Carley, A J Harrison, D Howe, A D Short,  
J E Ruprecht, F Flocard and P F Rahman

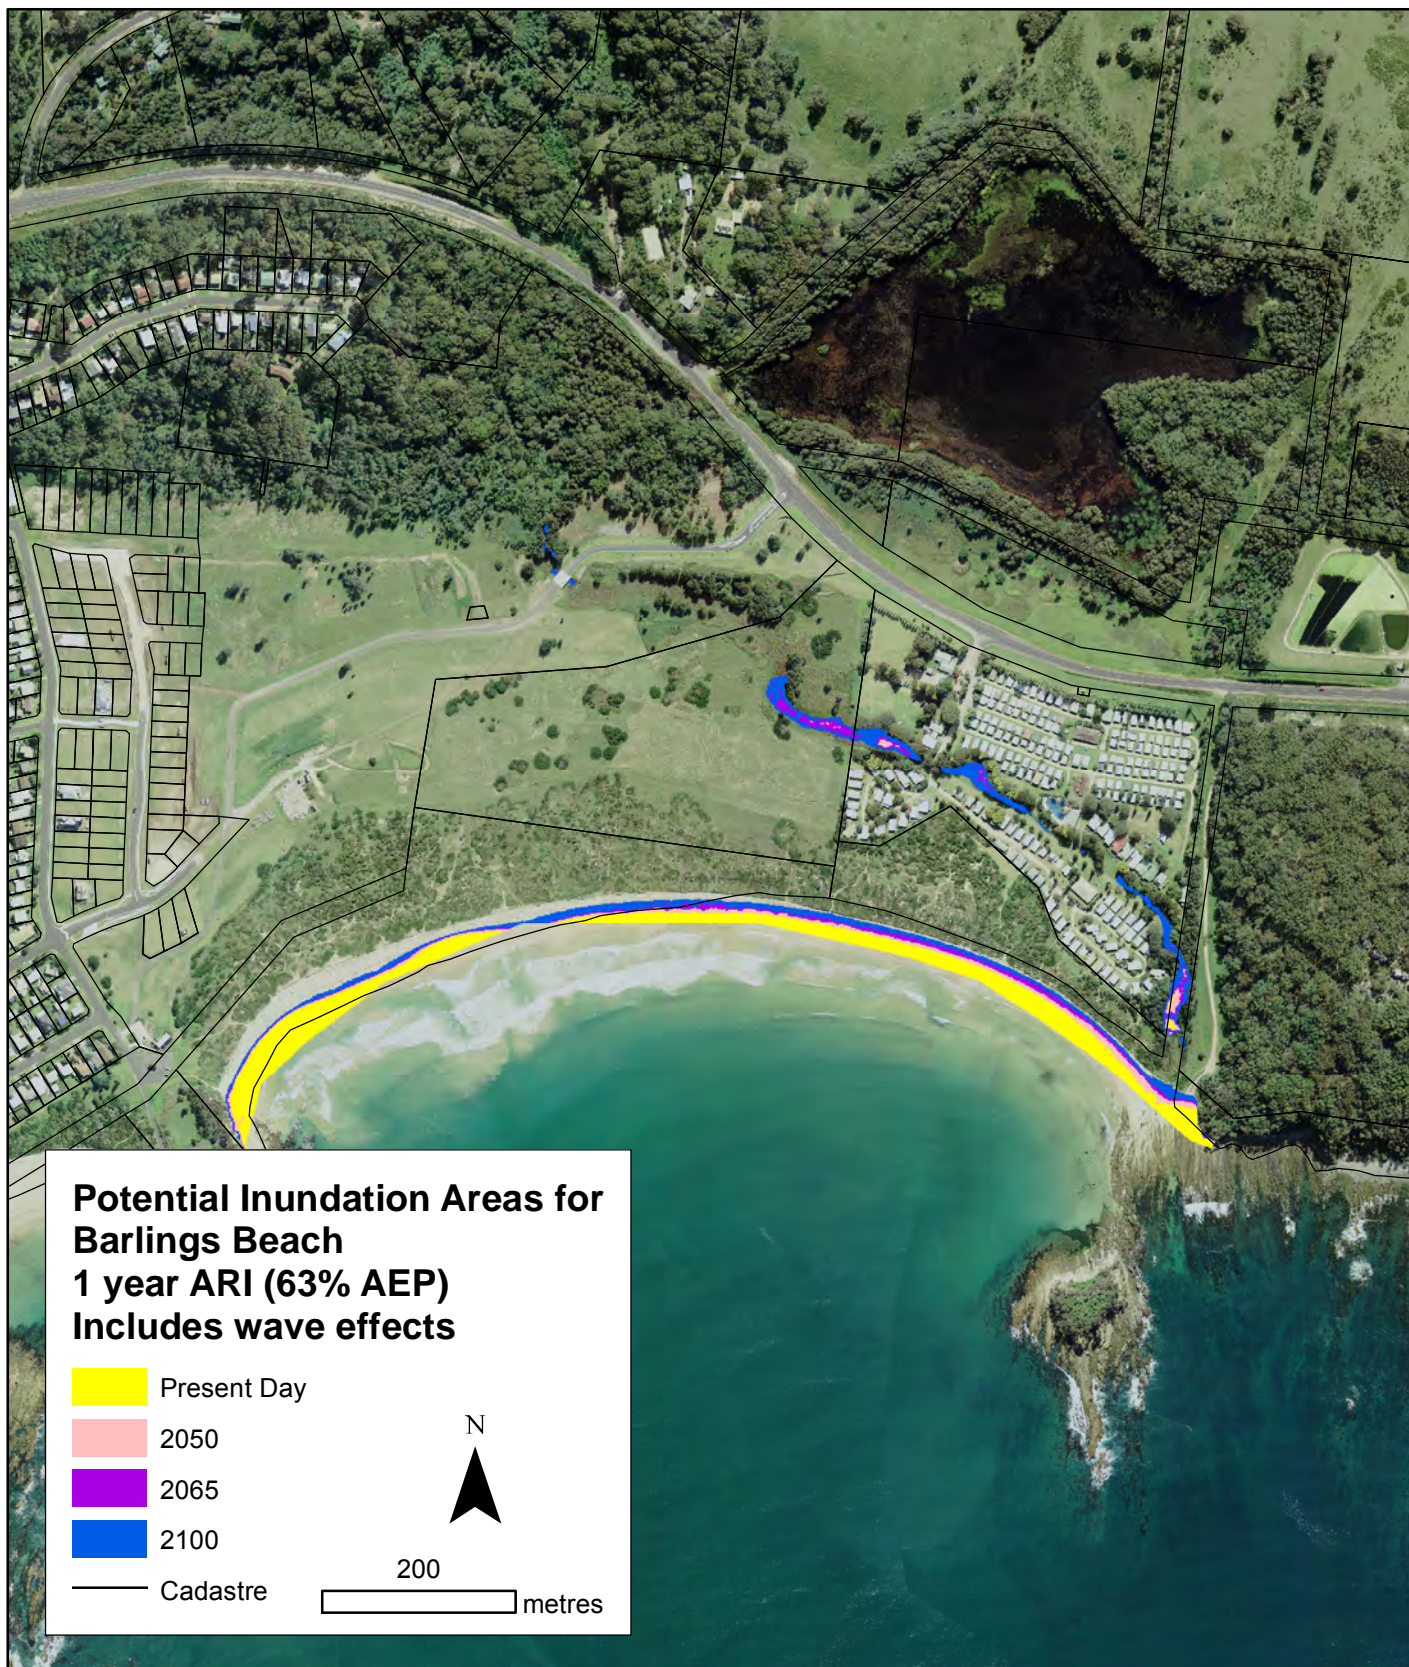
**Figure L.48**

Inundation of the beachface and the area immediately landward of the dune crest is based on the most recent year of photogrammetry data available (2014) and is in accordance with ESC's sea level rise policy and planning framework. It does not include allowance for future landward recession of the beach face and assumes that the crest level of the seawall (if present) and the topography remain as they were from the 2014 photogrammetry data. By 2050, 2065 or 2100 both of these assumptions may not be valid. Should the seawall/dune be allowed to fail then the landward extent of inundation may increase. Inundation of low lying areas behind the beach is based on the most recent year of LIDAR data available (2011). The low lying inundation areas behind the beach are mapped based on the ground elevation (the "all ground" LIDAR layer) and do not consider flow paths, flow velocities, loss of flow momentum or wave propagation into creek areas. WRL is not responsible for the accuracy of the photogrammetry or LIDAR data. Local surveys by a registered surveyor are recommended to determine local inundation extents.

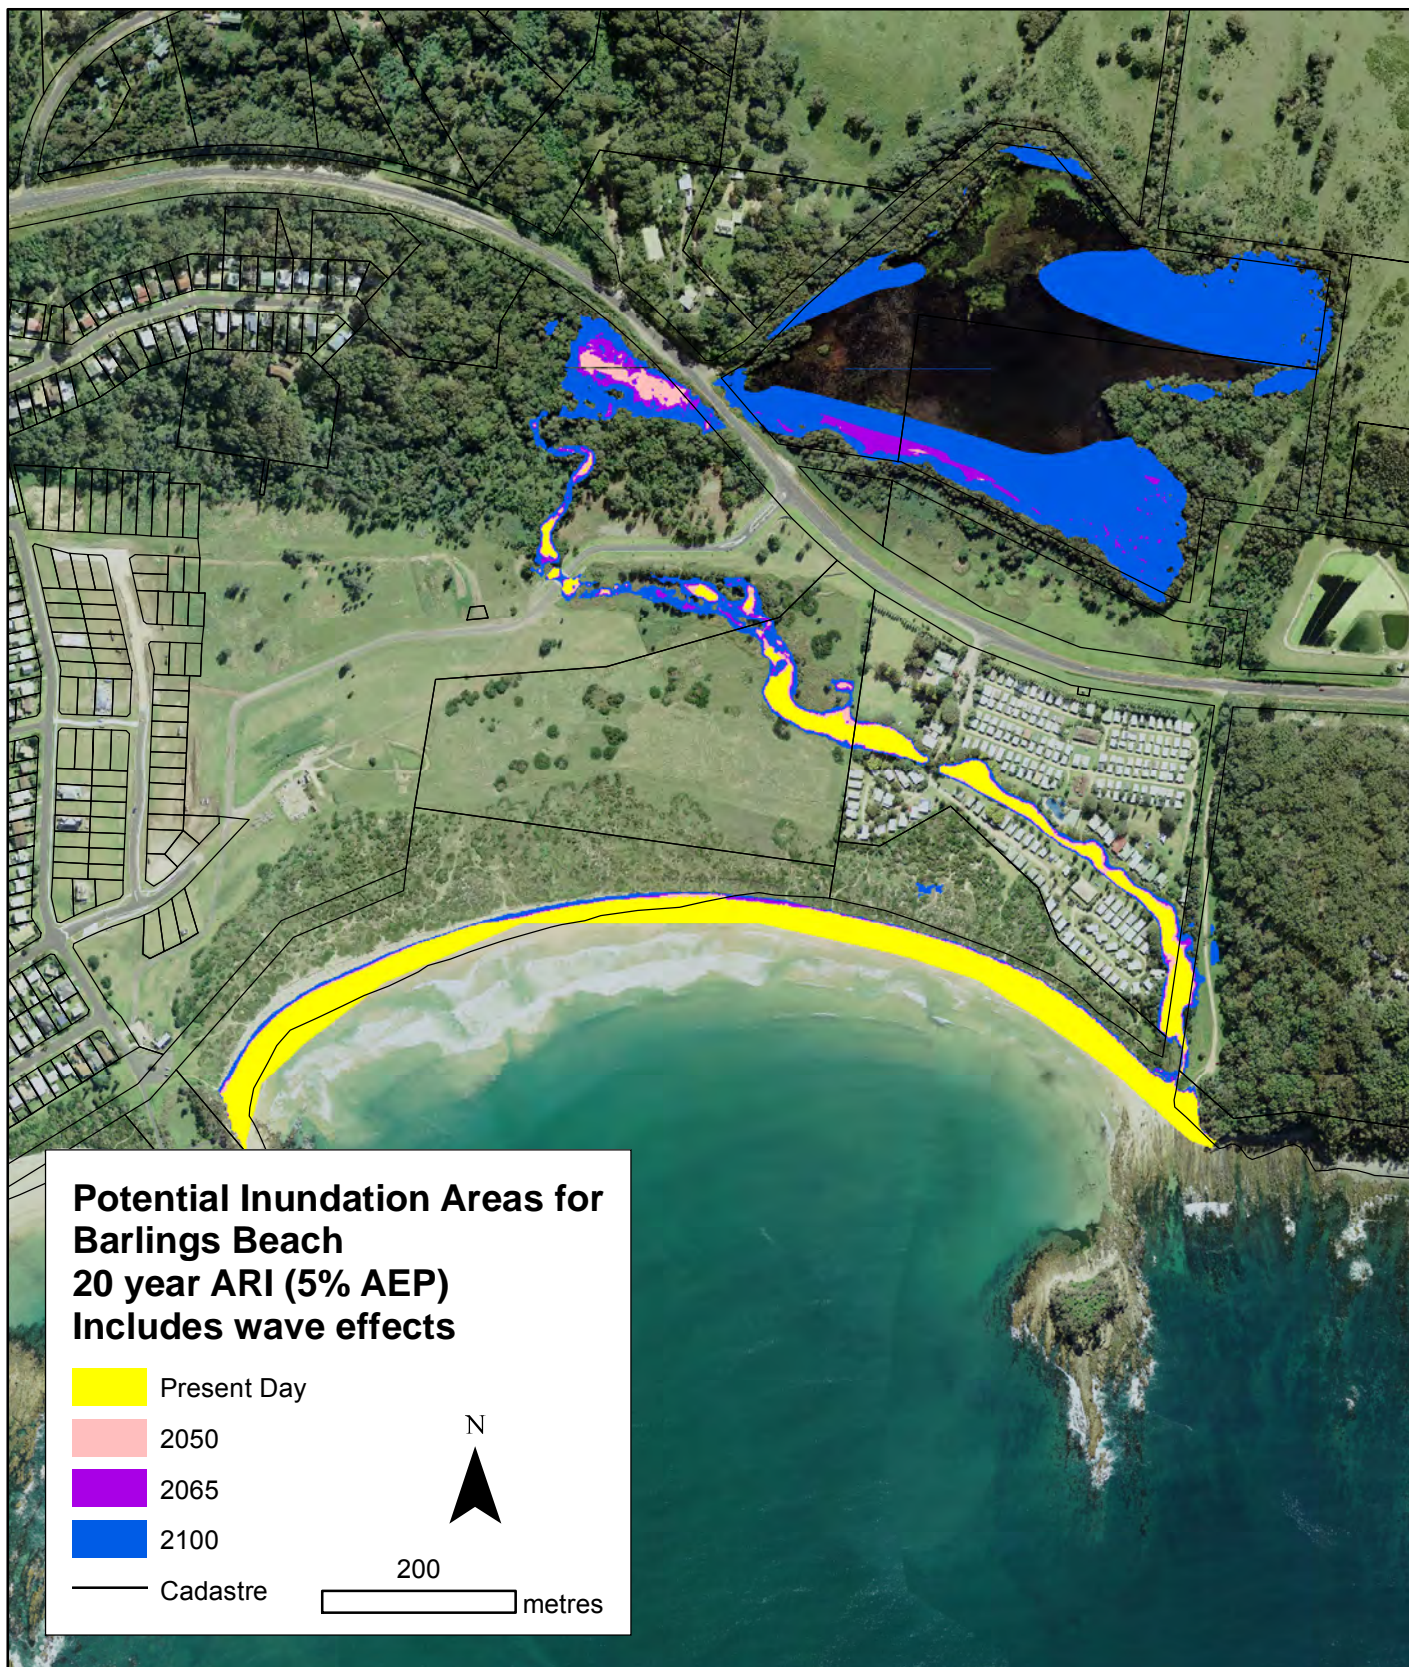
**Figure L.49**

Inundation of the beachface and the area immediately landward of the dune crest is based on the most recent year of photogrammetry data available (2011) and is in accordance with ESC's sea level rise policy and planning framework. It does not include allowance for future landward recession of the beach face and assumes that the crest level of the seawall (if present) and the topography remain as they were from the 2011 photogrammetry data. By 2050, 2065 or 2100 both of these assumptions may not be valid. Should the seawall/dune be allowed to fail then the landward extent of inundation may increase. Inundation of low lying areas behind the beach is based on the most recent year of LIDAR data available (2011). The low lying inundation areas behind the beach are mapped based on the ground elevation (the "all ground" LIDAR layer) and do not consider flow paths, flow velocities, loss of flow momentum or wave propagation into creek areas. WRL is not responsible for the accuracy of the photogrammetry or LIDAR data. Local surveys by a registered surveyor are recommended to determine local inundation extents.

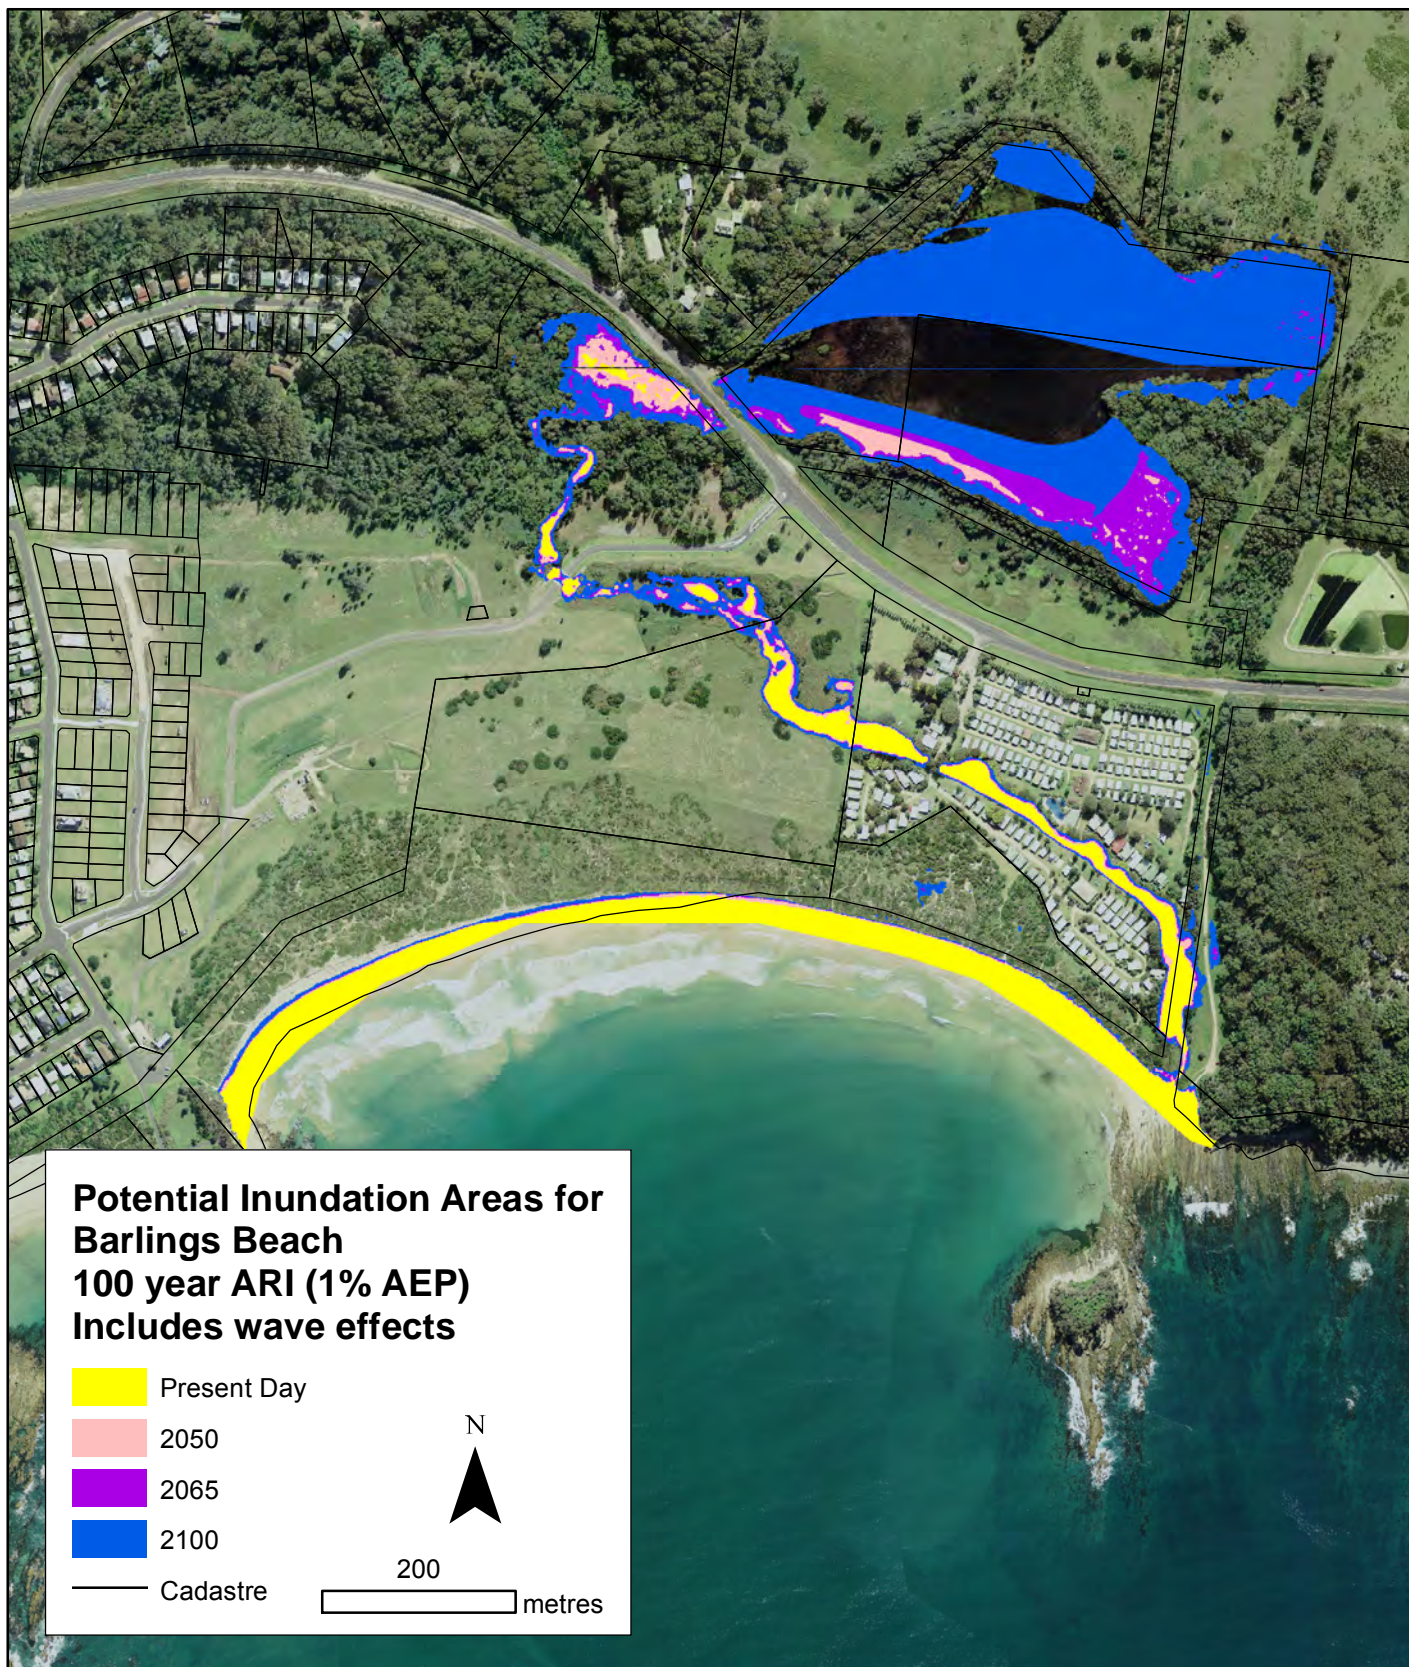
**Figure L.50**

Inundation of the beachface and the area immediately landward of the dune crest is based on the most recent year of photogrammetry data available (2011) and is in accordance with ESC's sea level rise policy and planning framework. It does not include allowance for future landward recession of the beach face and assumes that the crest level of the seawall (if present) and the topography remain as they were from the 2011 photogrammetry data. By 2050, 2065 or 2100 both of these assumptions may not be valid. Should the seawall/dune be allowed to fail then the landward extent of inundation may increase. Inundation of low lying areas behind the beach is based on the most recent year of LIDAR data available (2011). The low lying inundation areas behind the beach are mapped based on the ground elevation (the "all ground" LIDAR layer) and do not consider flow paths, flow velocities, loss of flow momentum or wave propagation into creek areas. WRL is not responsible for the accuracy of the photogrammetry or LIDAR data. Local surveys by a registered surveyor are recommended to determine local inundation extents.

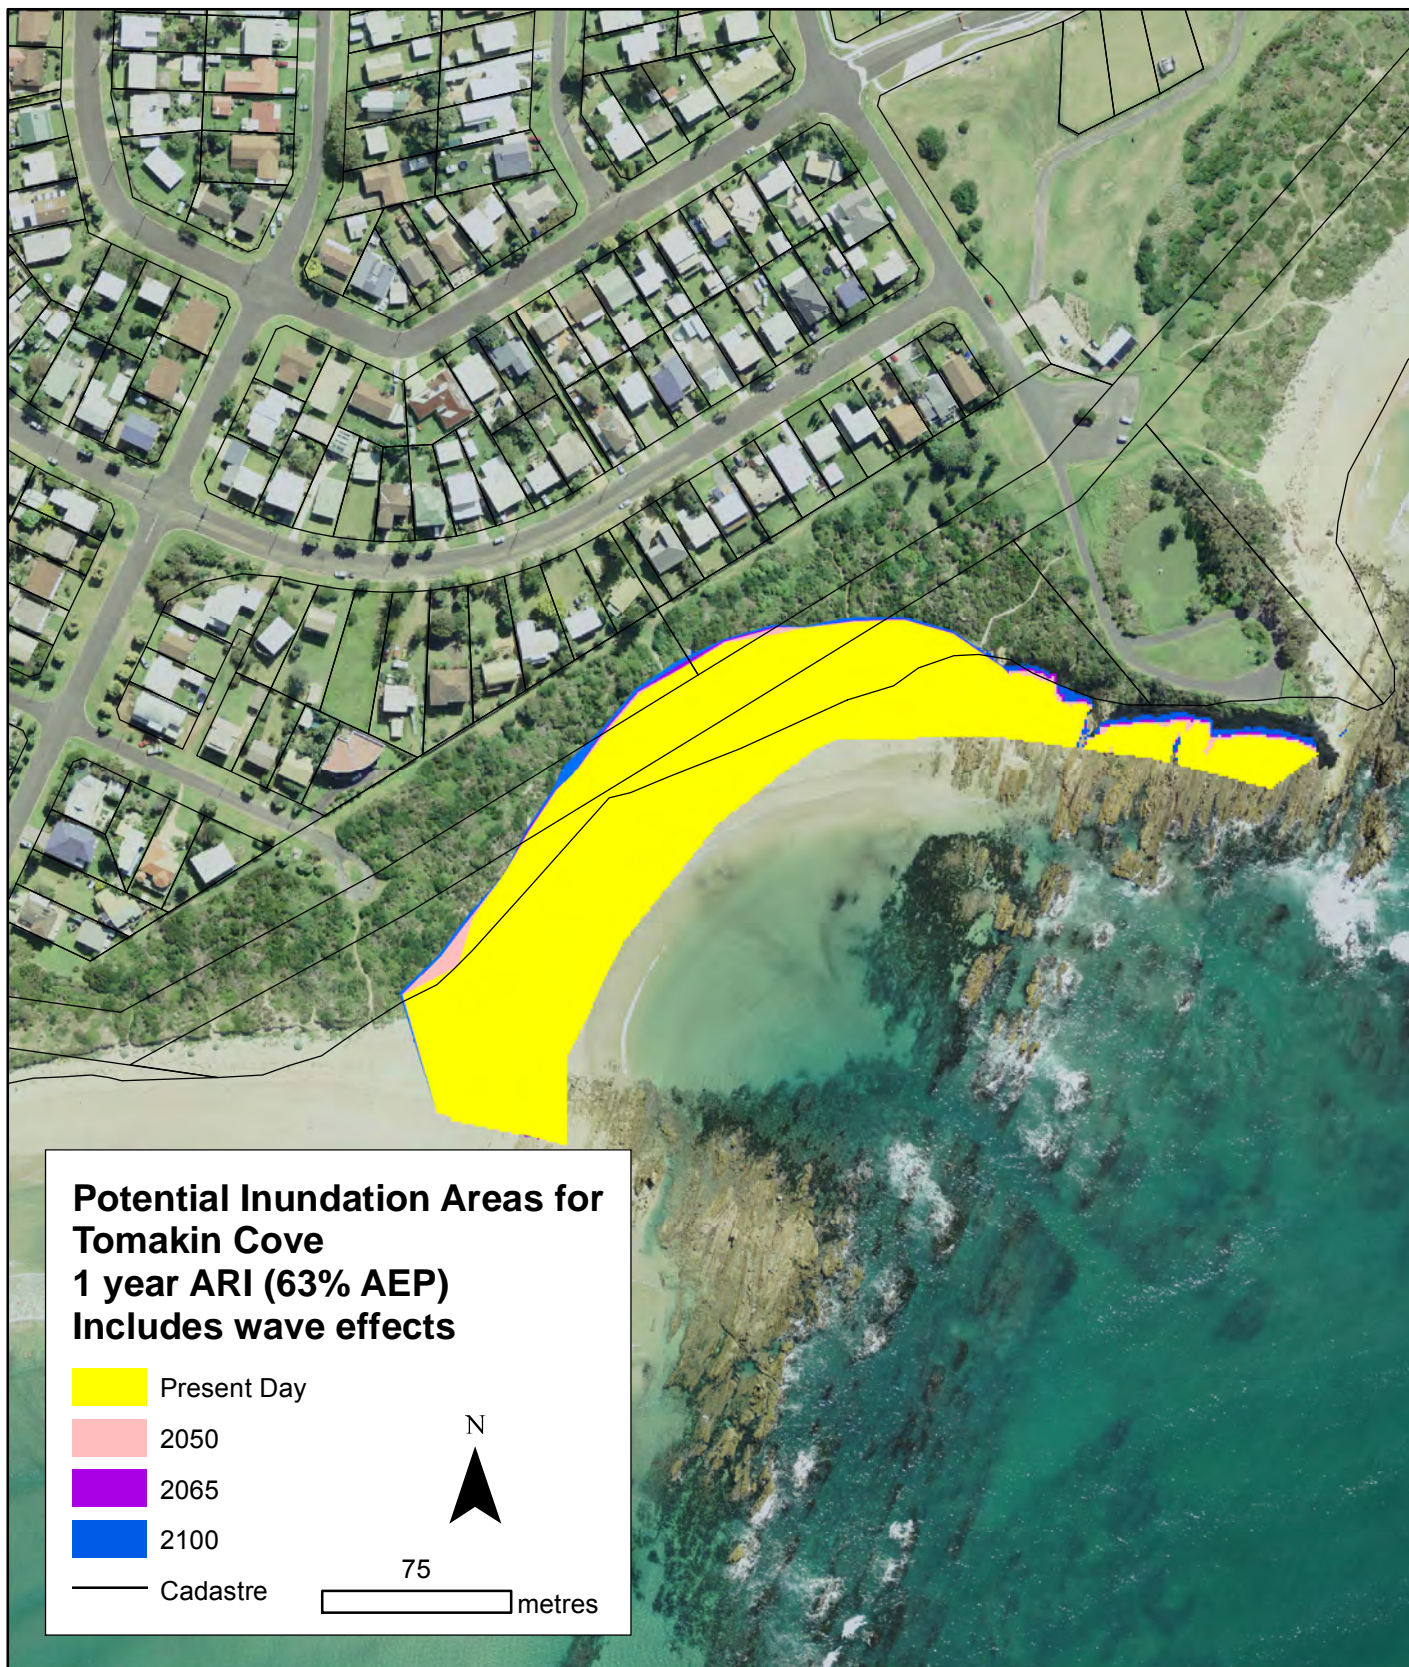
**Figure L.51**

Inundation of the beachface and the area immediately landward of the dune crest is based on the most recent year of photogrammetry data available (2011) and is in accordance with ESC's sea level rise policy and planning framework. It does not include allowance for future landward recession of the beach face and assumes that the crest level of the seawall (if present) and the topography remain as they were from the 2011 photogrammetry data. By 2050, 2065 or 2100 both of these assumptions may not be valid. Should the seawall/dune be allowed to fail then the landward extent of inundation may increase. Inundation of low lying areas behind the beach is based on the most recent year of LIDAR data available (2011). The low lying inundation areas behind the beach are mapped based on the ground elevation (the "all ground" LIDAR layer) and do not consider flow paths, flow velocities, loss of flow momentum or wave propagation into creek areas. WRL is not responsible for the accuracy of the photogrammetry or LIDAR data. Local surveys by a registered surveyor are recommended to determine local inundation extents.

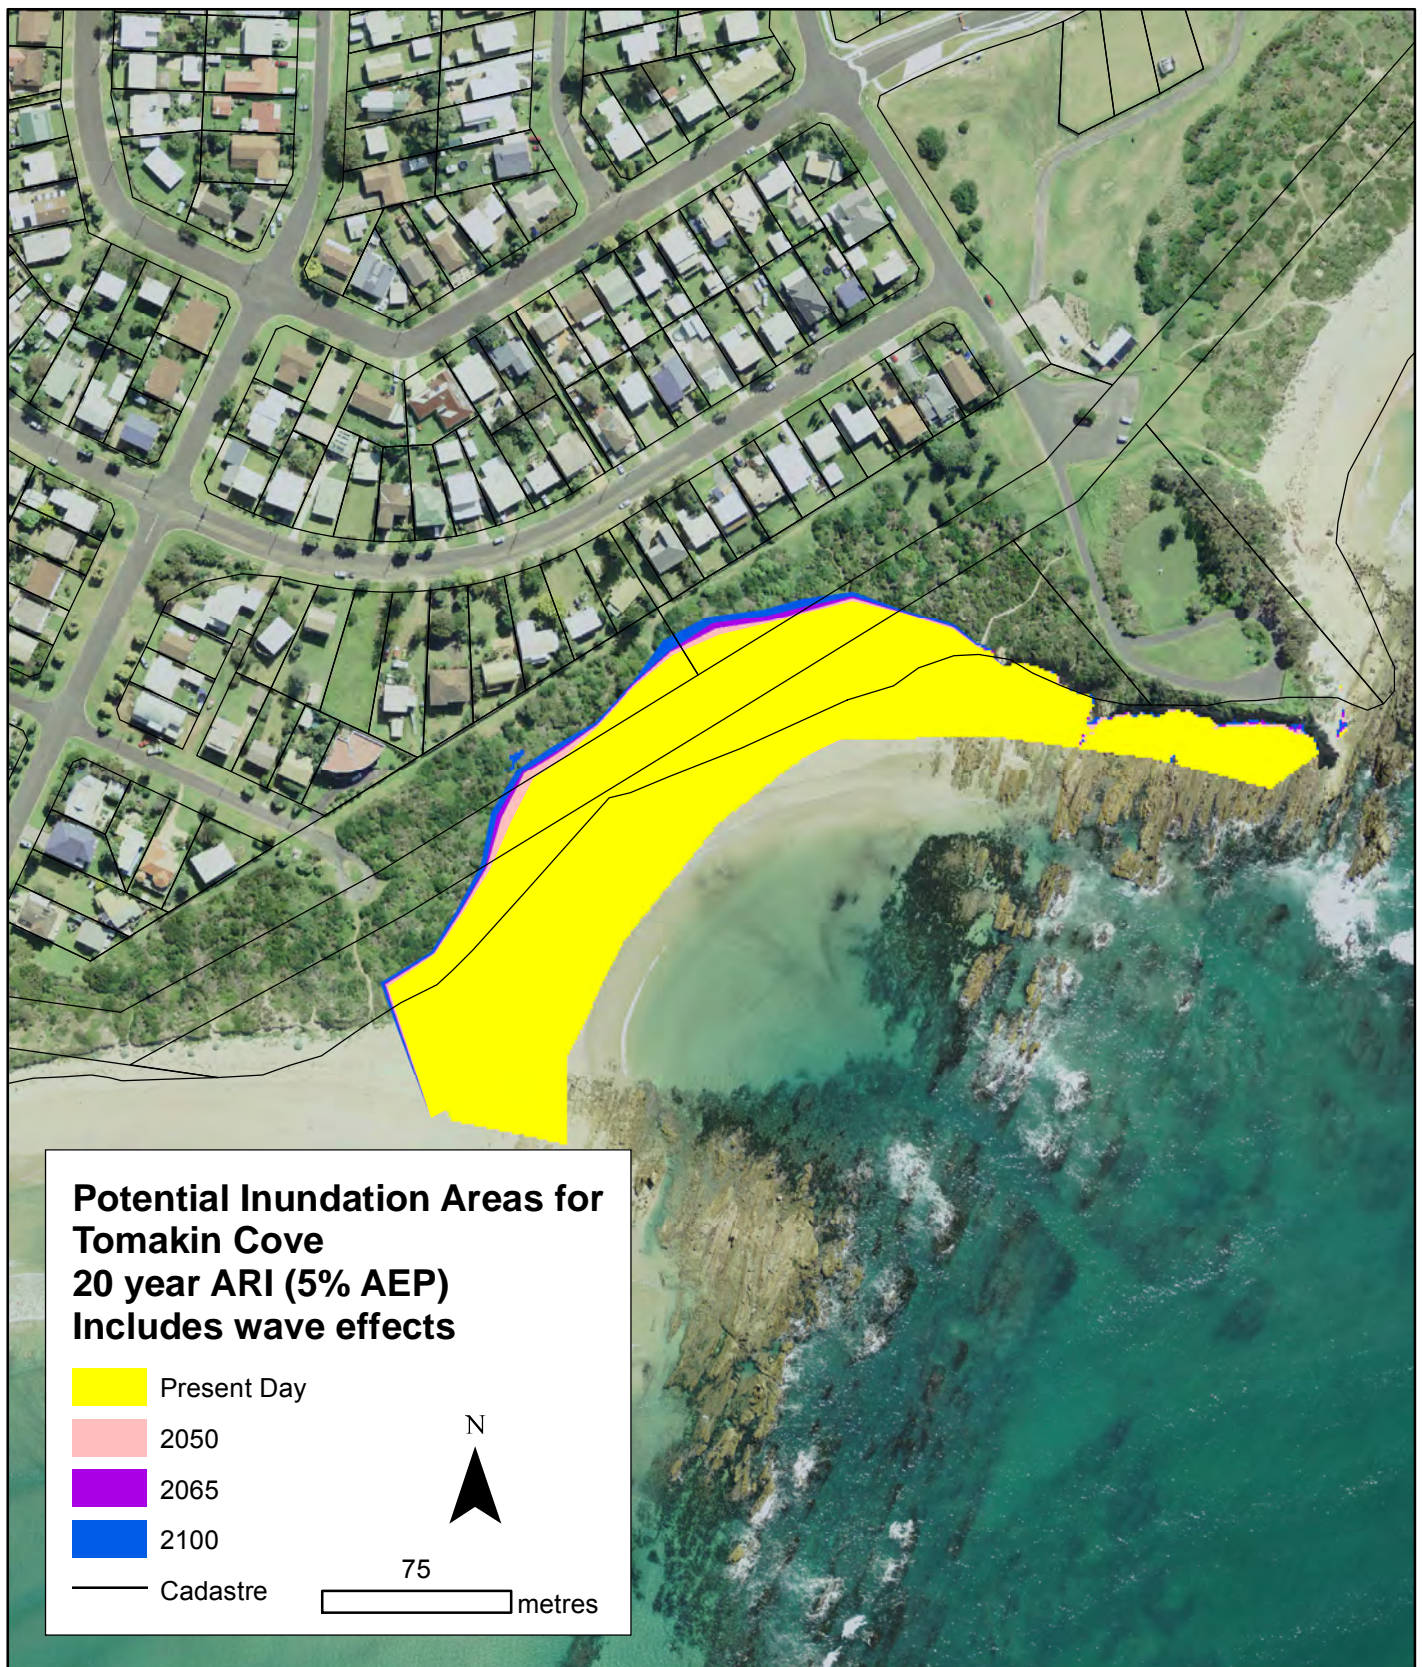
**Figure L.52**

Inundation of the beachface and the area immediately landward of the dune crest is based on the most recent year of photogrammetry data available (2014) and is in accordance with ESC's sea level rise policy and planning framework. It does not include allowance for future landward recession of the beach face and assumes that the crest level of the seawall (if present) and the topography remain as they were from the 2014 photogrammetry data. By 2050, 2065 or 2100 both of these assumptions may not be valid. Should the seawall/dune be allowed to fail then the landward extent of inundation may increase. Inundation of low lying areas behind the beach is based on the most recent year of LIDAR data available (2011). The low lying inundation areas behind the beach are mapped based on the ground elevation (the "all ground" LIDAR layer) and do not consider flow paths, flow velocities, loss of flow momentum or wave propagation into creek areas. WRL is not responsible for the accuracy of the photogrammetry or LIDAR data. Local surveys by a registered surveyor are recommended to determine local inundation extents.

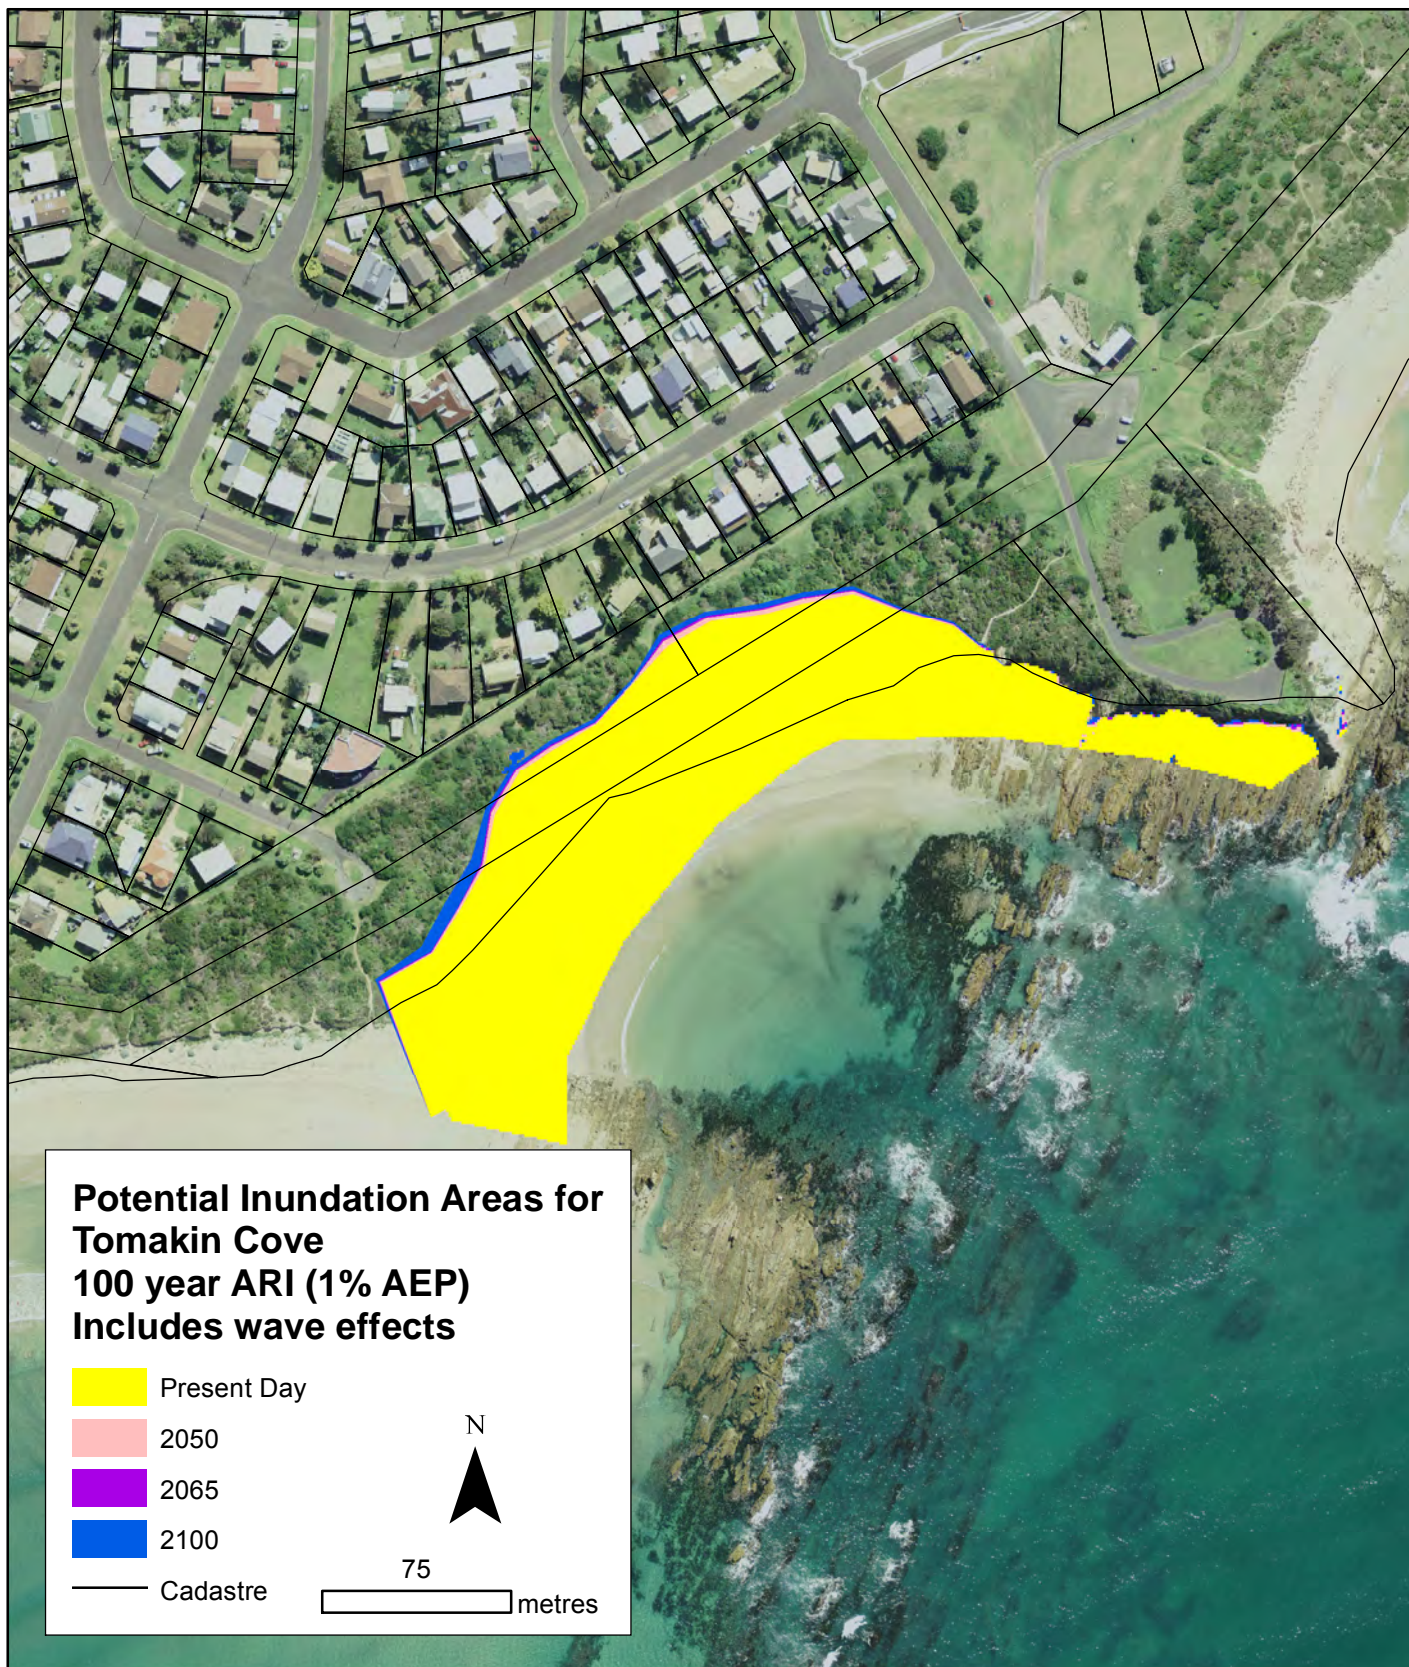
**Figure L.53**

Inundation of the beachface and the area immediately landward of the dune crest is based on the most recent year of photogrammetry data available (2014) and is in accordance with ESC's sea level rise policy and planning framework. It does not include allowance for future landward recession of the beach face and assumes that the crest level of the seawall (if present) and the topography remain as they were from the 2014 photogrammetry data. By 2050, 2065 or 2100 both of these assumptions may not be valid. Should the seawall/dune be allowed to fail then the landward extent of inundation may increase. Inundation of low lying areas behind the beach is based on the most recent year of LIDAR data available (2011). The low lying inundation areas behind the beach are mapped based on the ground elevation (the "all ground" LIDAR layer) and do not consider flow paths, flow velocities, loss of flow momentum or wave propagation into creek areas. WRL is not responsible for the accuracy of the photogrammetry or LIDAR data. Local surveys by a registered surveyor are recommended to determine local inundation extents.

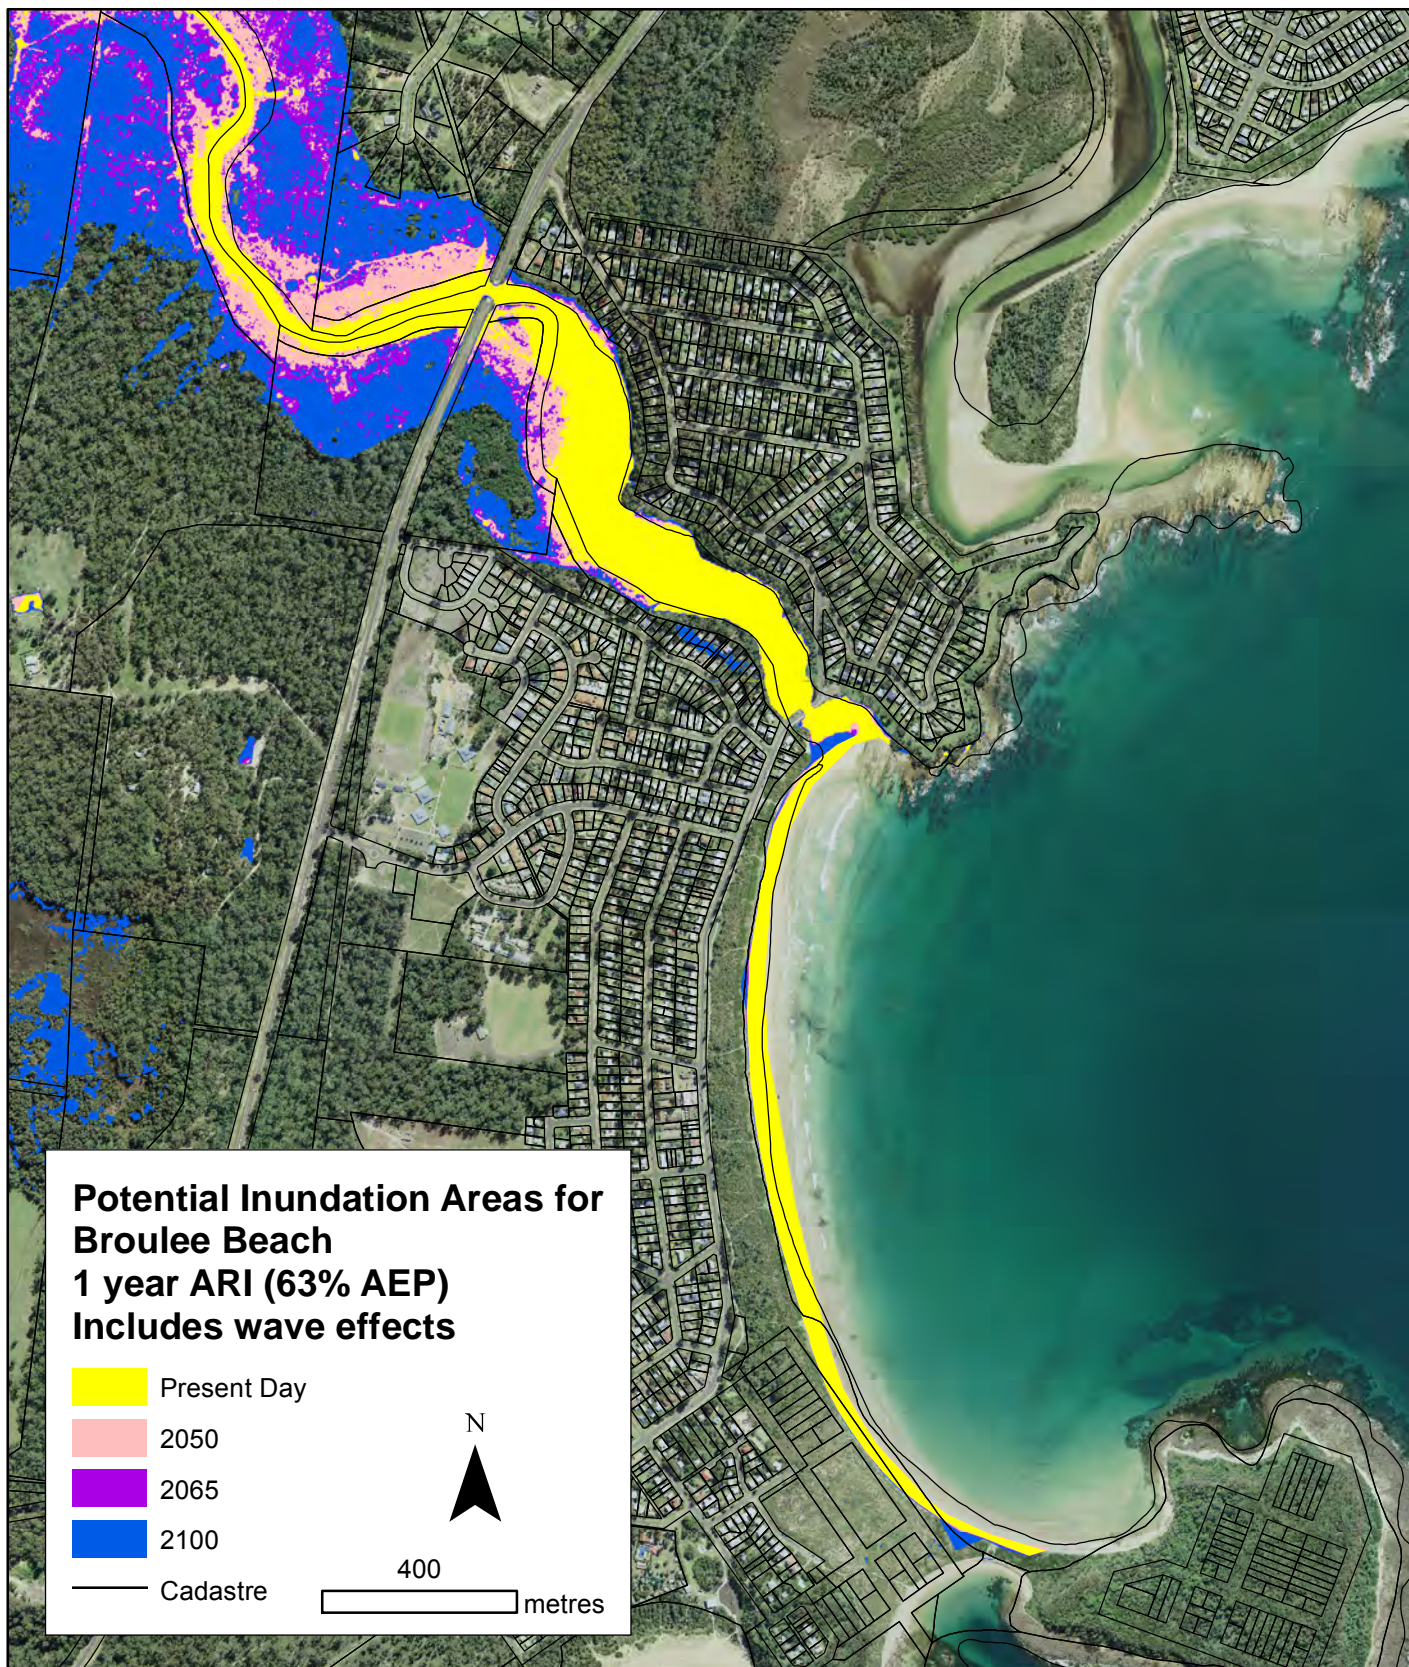
**Figure L.54**

Inundation of the beachface and the area immediately landward of the dune crest is based on the most recent year of photogrammetry data available (2014) and is in accordance with ESC's sea level rise policy and planning framework. It does not include allowance for future landward recession of the beach face and assumes that the crest level of the seawall (if present) and the topography remain as they were from the 2014 photogrammetry data. By 2050, 2065 or 2100 both of these assumptions may not be valid. Should the seawall/dune be allowed to fail then the landward extent of inundation may increase. Inundation of low lying areas behind the beach is based on the most recent year of LIDAR data available (2011). The low lying inundation areas behind the beach are mapped based on the ground elevation (the "all ground" LIDAR layer) and do not consider flow paths, flow velocities, loss of flow momentum or wave propagation into creek areas. WRL is not responsible for the accuracy of the photogrammetry or LIDAR data. Local surveys by a registered surveyor are recommended to determine local inundation extents.

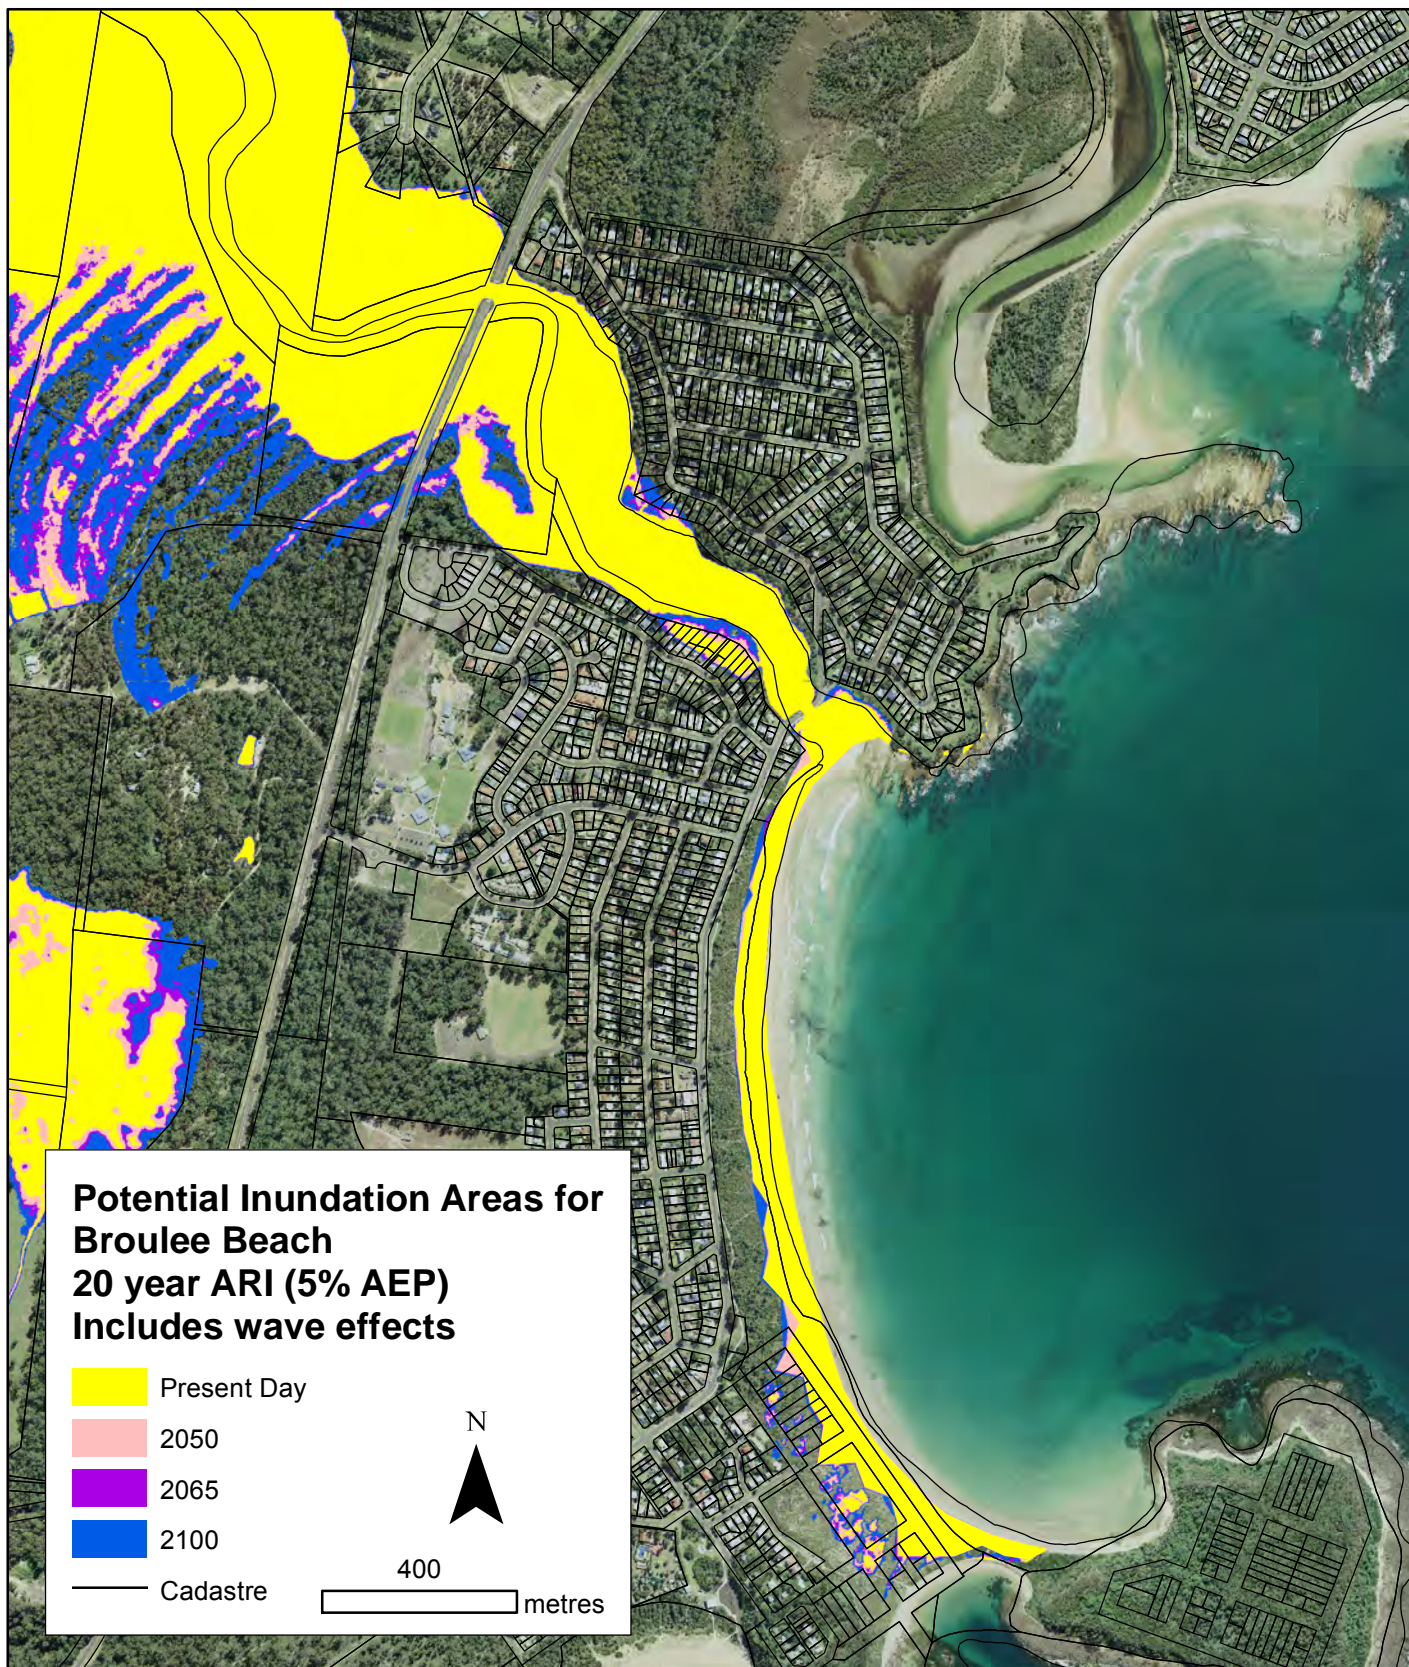
**Figure L.55**

Inundation of the beachface and the area immediately landward of the dune crest is based on the most recent year of photogrammetry data available (2011) and is in accordance with ESC's sea level rise policy and planning framework. It does not include allowance for future landward recession of the beach face and assumes that the crest level of the seawall (if present) and the topography remain as they were from the 2011 photogrammetry data. By 2050, 2065 or 2100 both of these assumptions may not be valid. Should the seawall/dune be allowed to fail then the landward extent of inundation may increase. Inundation of low lying areas behind the beach is based on the most recent year of LIDAR data available (2011). The low lying inundation areas behind the beach are mapped based on the ground elevation (the "all ground" LIDAR layer) and do not consider flow paths, flow velocities, loss of flow momentum or wave propagation into creek areas. WRL is not responsible for the accuracy of the photogrammetry or LIDAR data. Local surveys by a registered surveyor are recommended to determine local inundation extents. Inundation is only considered from Broulee Beach, no additional inundation from Bengello Beach has been incorporated.
