## Eurobodalla Coastal Hazard Assessment

WRL Technical Report 2017/09  
October 2017

By I R Coghlan, J T Carley, A J Harrison, D Howe, A D Short,  
J E Ruprecht, F Flocard and P F Rahman

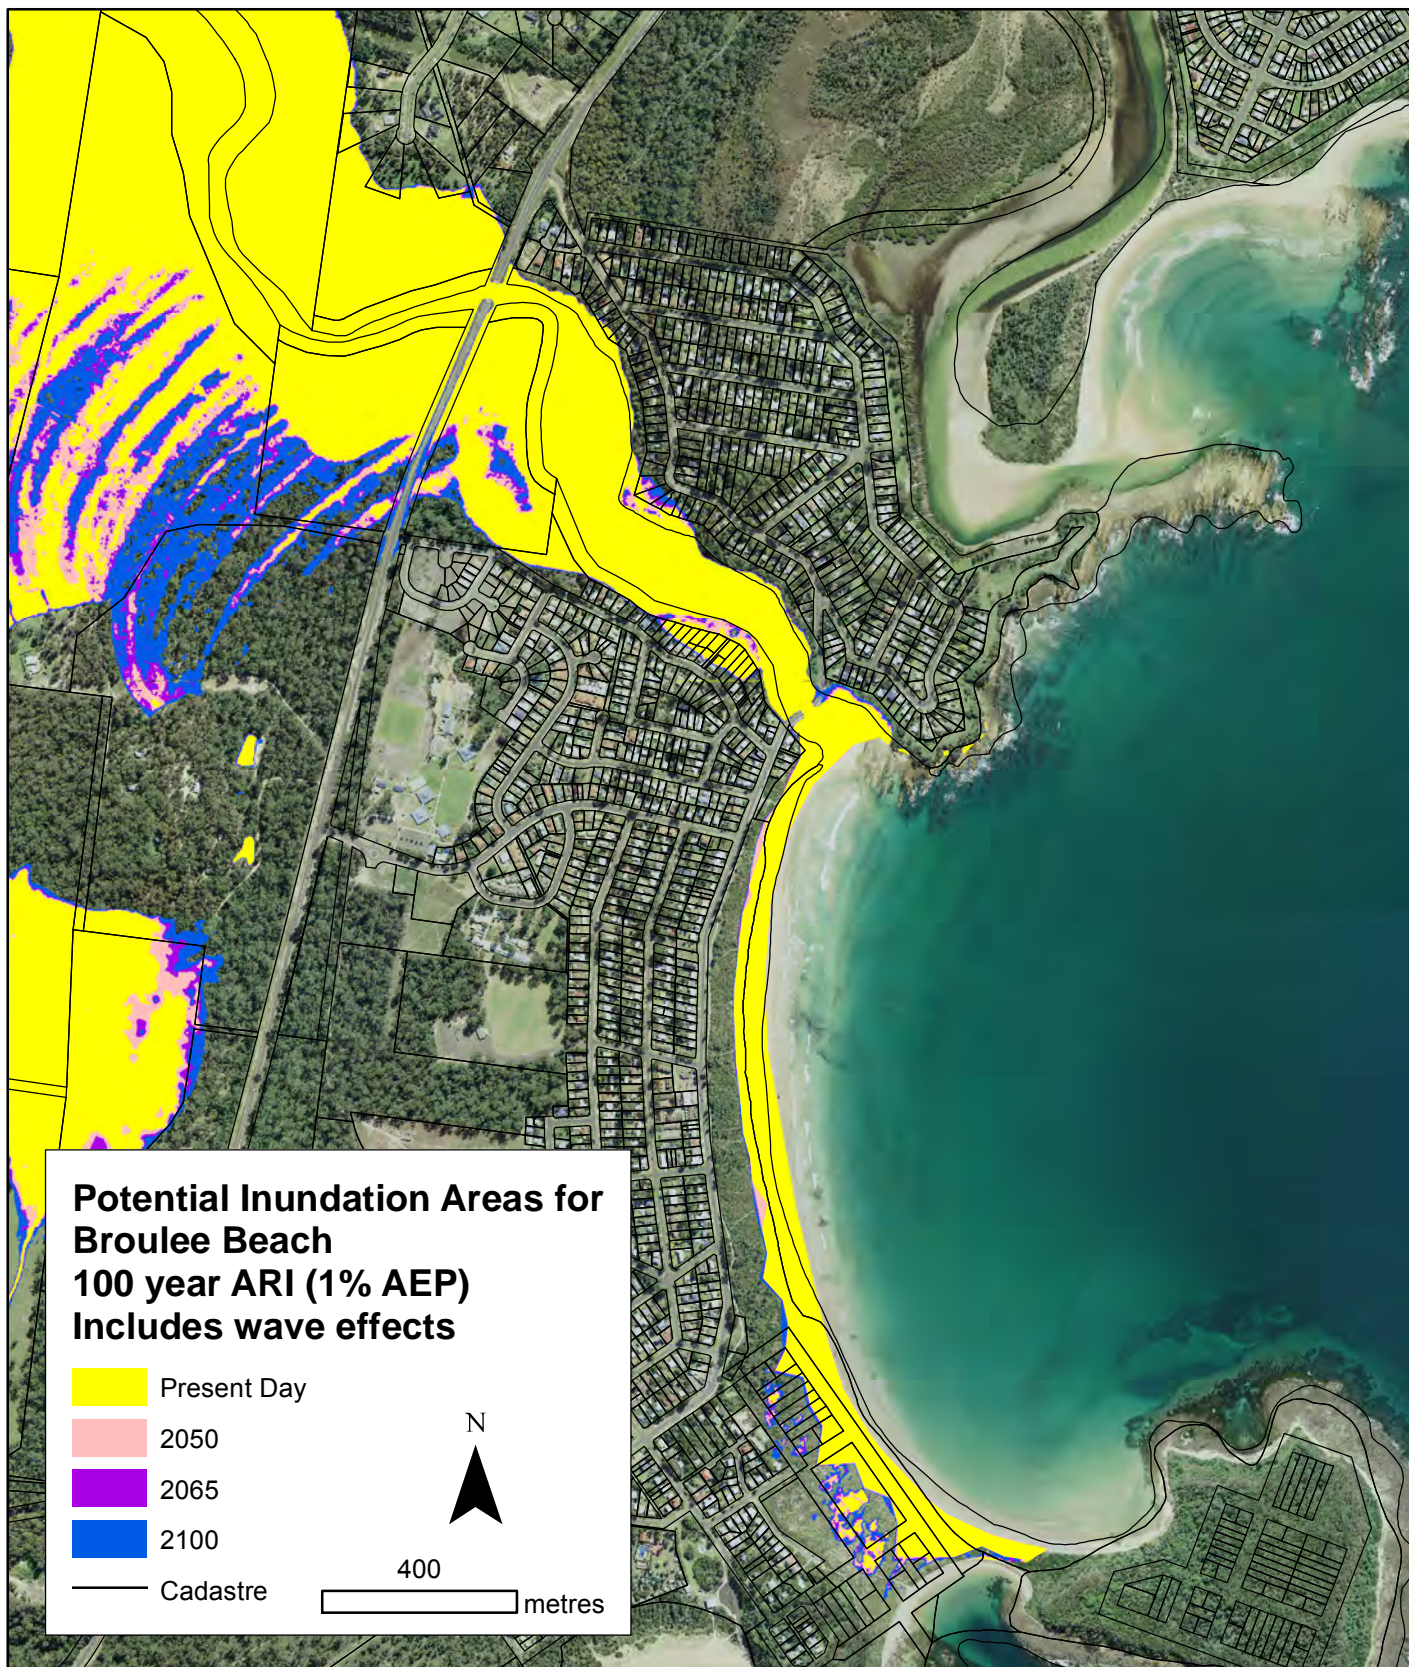
**Figure L.56**

Inundation of the beachface and the area immediately landward of the dune crest is based on the most recent year of photogrammetry data available (2011) and is in accordance with ESC's sea level rise policy and planning framework. It does not include allowance for future landward recession of the beach face and assumes that the crest level of the seawall (if present) and the topography remain as they were from the 2011 photogrammetry data. By 2050, 2065 or 2100 both of these assumptions may not be valid. Should the seawall/dune be allowed to fail then the landward extent of inundation may increase. Inundation of low lying areas behind the beach is based on the most recent year of LIDAR data available (2011). The low lying inundation areas behind the beach are mapped based on the ground elevation (the "all ground" LIDAR layer) and do not consider flow paths, flow velocities, loss of flow momentum or wave propagation into creek areas. WRL is not responsible for the accuracy of the photogrammetry or LIDAR data. Local surveys by a registered surveyor are recommended to determine local inundation extents. Inundation is only considered from Broulee Beach, no additional inundation from Bengello Beach has been incorporated.

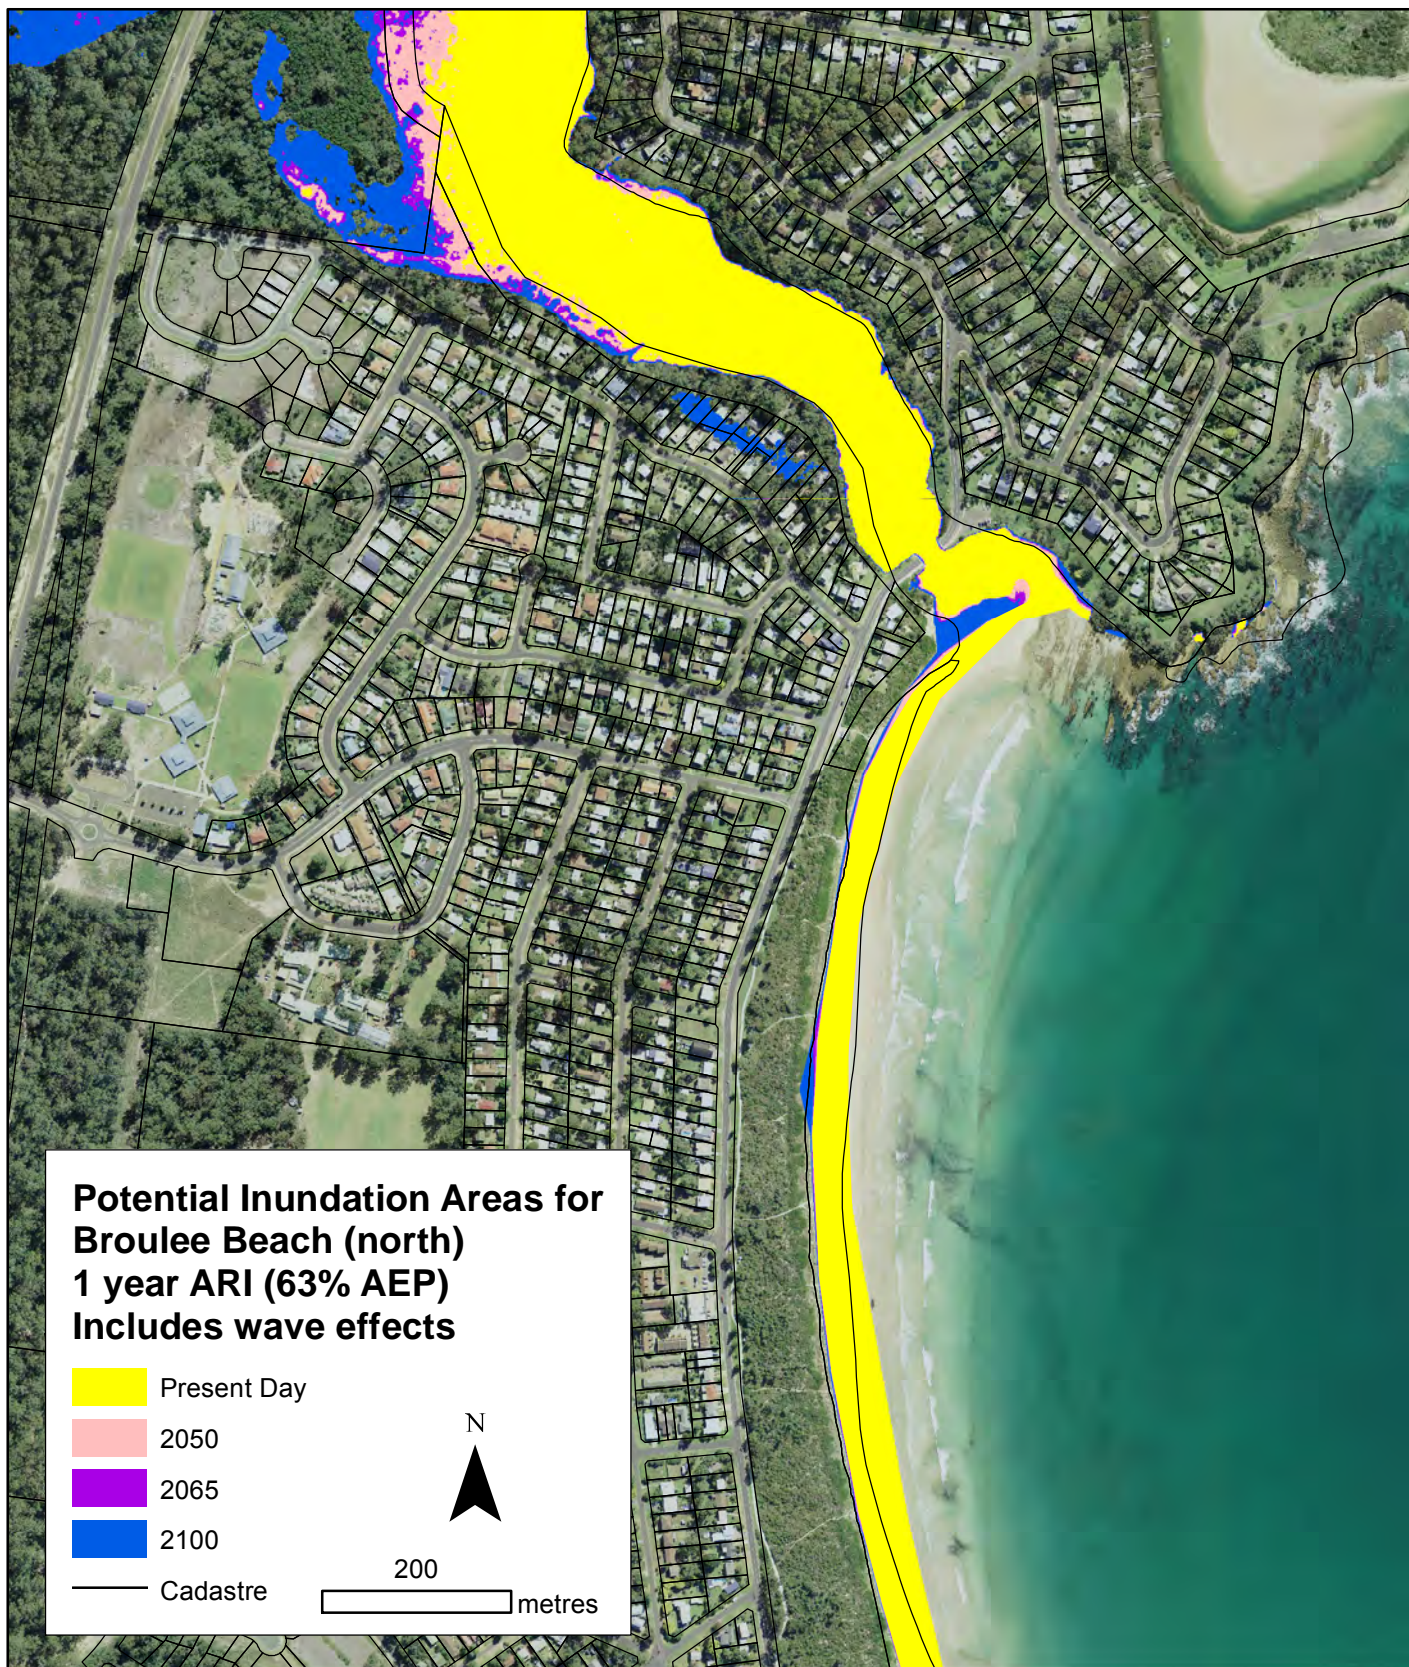
**Figure L.57**

Inundation of the beachface and the area immediately landward of the dune crest is based on the most recent year of photogrammetry data available (2011) and is in accordance with ESC's sea level rise policy and planning framework. It does not include allowance for future landward recession of the beach face and assumes that the crest level of the seawall (if present) and the topography remain as they were from the 2011 photogrammetry data. By 2050, 2065 or 2100 both of these assumptions may not be valid. Should the seawall/dune be allowed to fail then the landward extent of inundation may increase. Inundation of low lying areas behind the beach is based on the most recent year of LIDAR data available (2011). The low lying inundation areas behind the beach are mapped based on the ground elevation (the "all ground" LIDAR layer) and do not consider flow paths, flow velocities, loss of flow momentum or wave propagation into creek areas. WRL is not responsible for the accuracy of the photogrammetry or LIDAR data. Local surveys by a registered surveyor are recommended to determine local inundation extents. Inundation is only considered from Broulee Beach, no additional inundation from Bengello Beach has been incorporated.

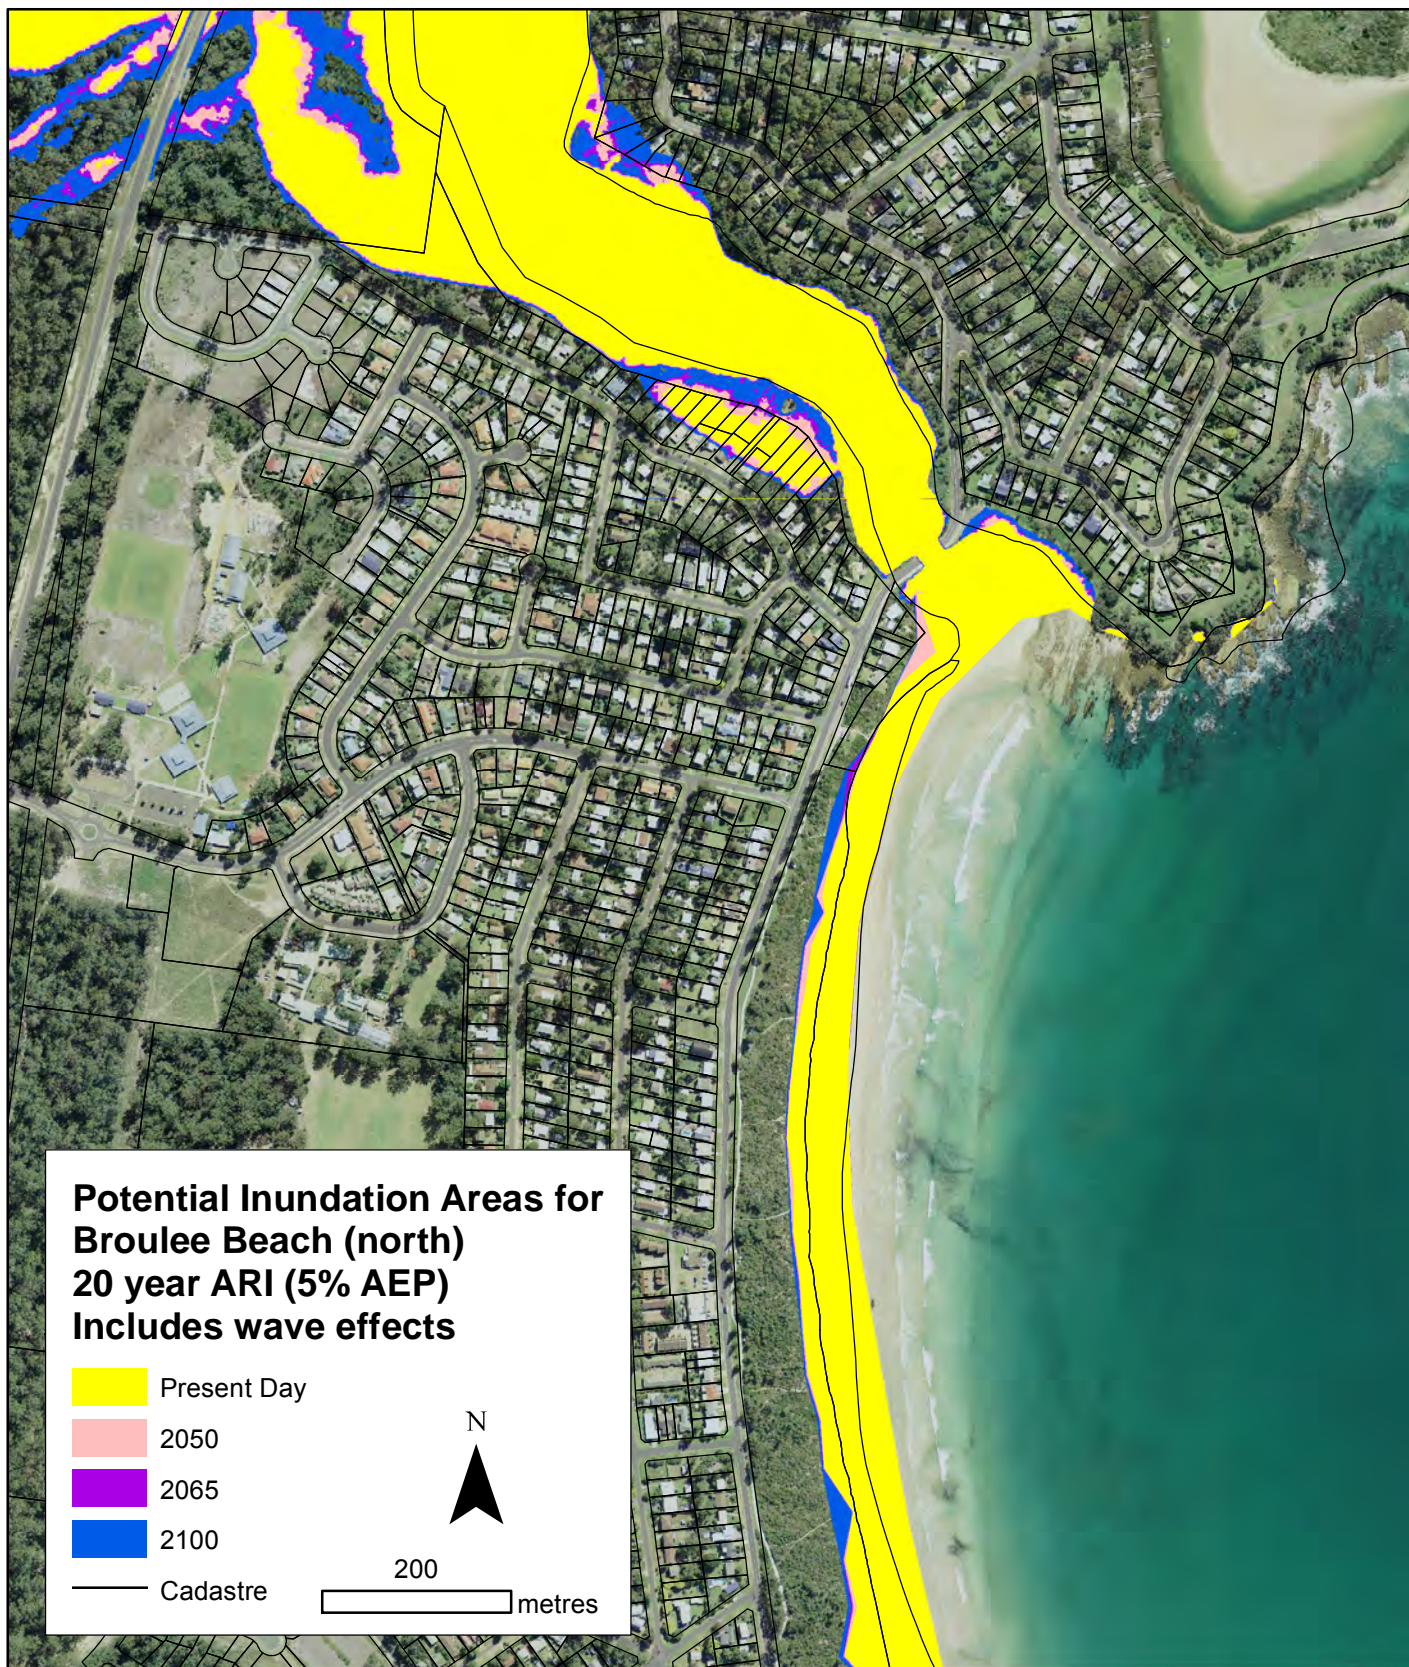
**Figure L.58**

Inundation of the beachface and the area immediately landward of the dune crest is based on the most recent year of photogrammetry data available (2011) and is in accordance with ESC's sea level rise policy and planning framework. It does not include allowance for future landward recession of the beach face and assumes that the crest level of the seawall (if present) and the topography remain as they were from the 2011 photogrammetry data. By 2050, 2065 or 2100 both of these assumptions may not be valid. Should the seawall/dune be allowed to fail then the landward extent of inundation may increase. Inundation of low lying areas behind the beach is based on the most recent year of LIDAR data available (2011). The low lying inundation areas behind the beach are mapped based on the ground elevation (the "all ground" LIDAR layer) and do not consider flow paths, flow velocities, loss of flow momentum or wave propagation into creek areas. WRL is not responsible for the accuracy of the photogrammetry or LIDAR data. Local surveys by a registered surveyor are recommended to determine local inundation extents. Inundation is only considered from Barlings Bay, no additional inundation from Bengello has been incorporated.

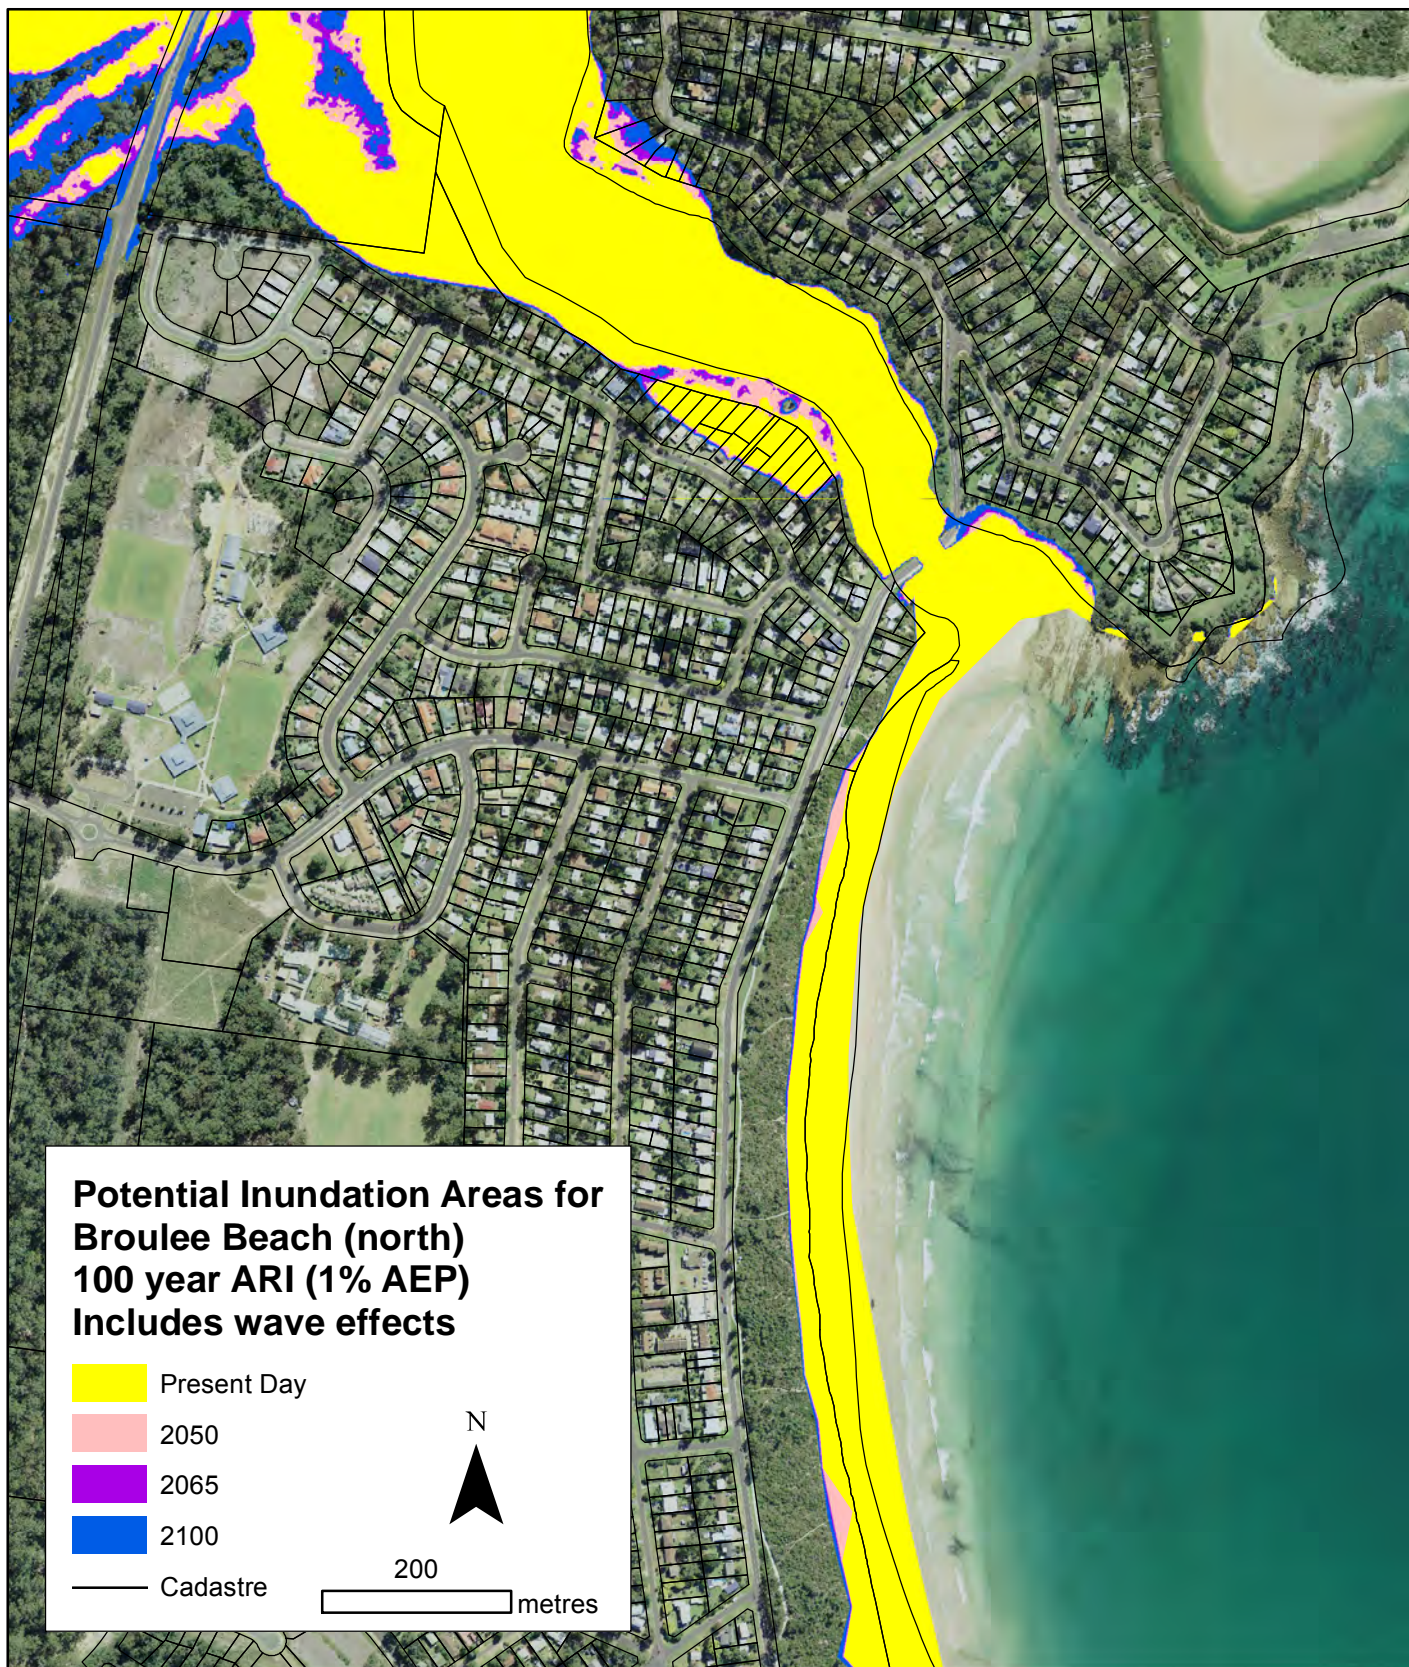
**Figure L.59**

Inundation of the beachface and the area immediately landward of the dune crest is based on the most recent year of photogrammetry data available (2011) and is in accordance with ESC's sea level rise policy and planning framework. It does not include allowance for future landward recession of the beach face and assumes that the crest level of the seawall (if present) and the topography remain as they were from the 2011 photogrammetry data. By 2050, 2065 or 2100 both of these assumptions may not be valid. Should the seawall/dune be allowed to fail then the landward extent of inundation may increase. Inundation of low lying areas behind the beach is based on the most recent year of LIDAR data available (2011). The low lying inundation areas behind the beach are mapped based on the ground elevation (the "all ground" LIDAR layer) and do not consider flow paths, flow velocities, loss of flow momentum or wave propagation into creek areas. WRL is not responsible for the accuracy of the photogrammetry or LIDAR data. Local surveys by a registered surveyor are recommended to determine local inundation extents. Inundation is only considered from Broulee Beach, no additional inundation from Bengello Beach has been incorporated.

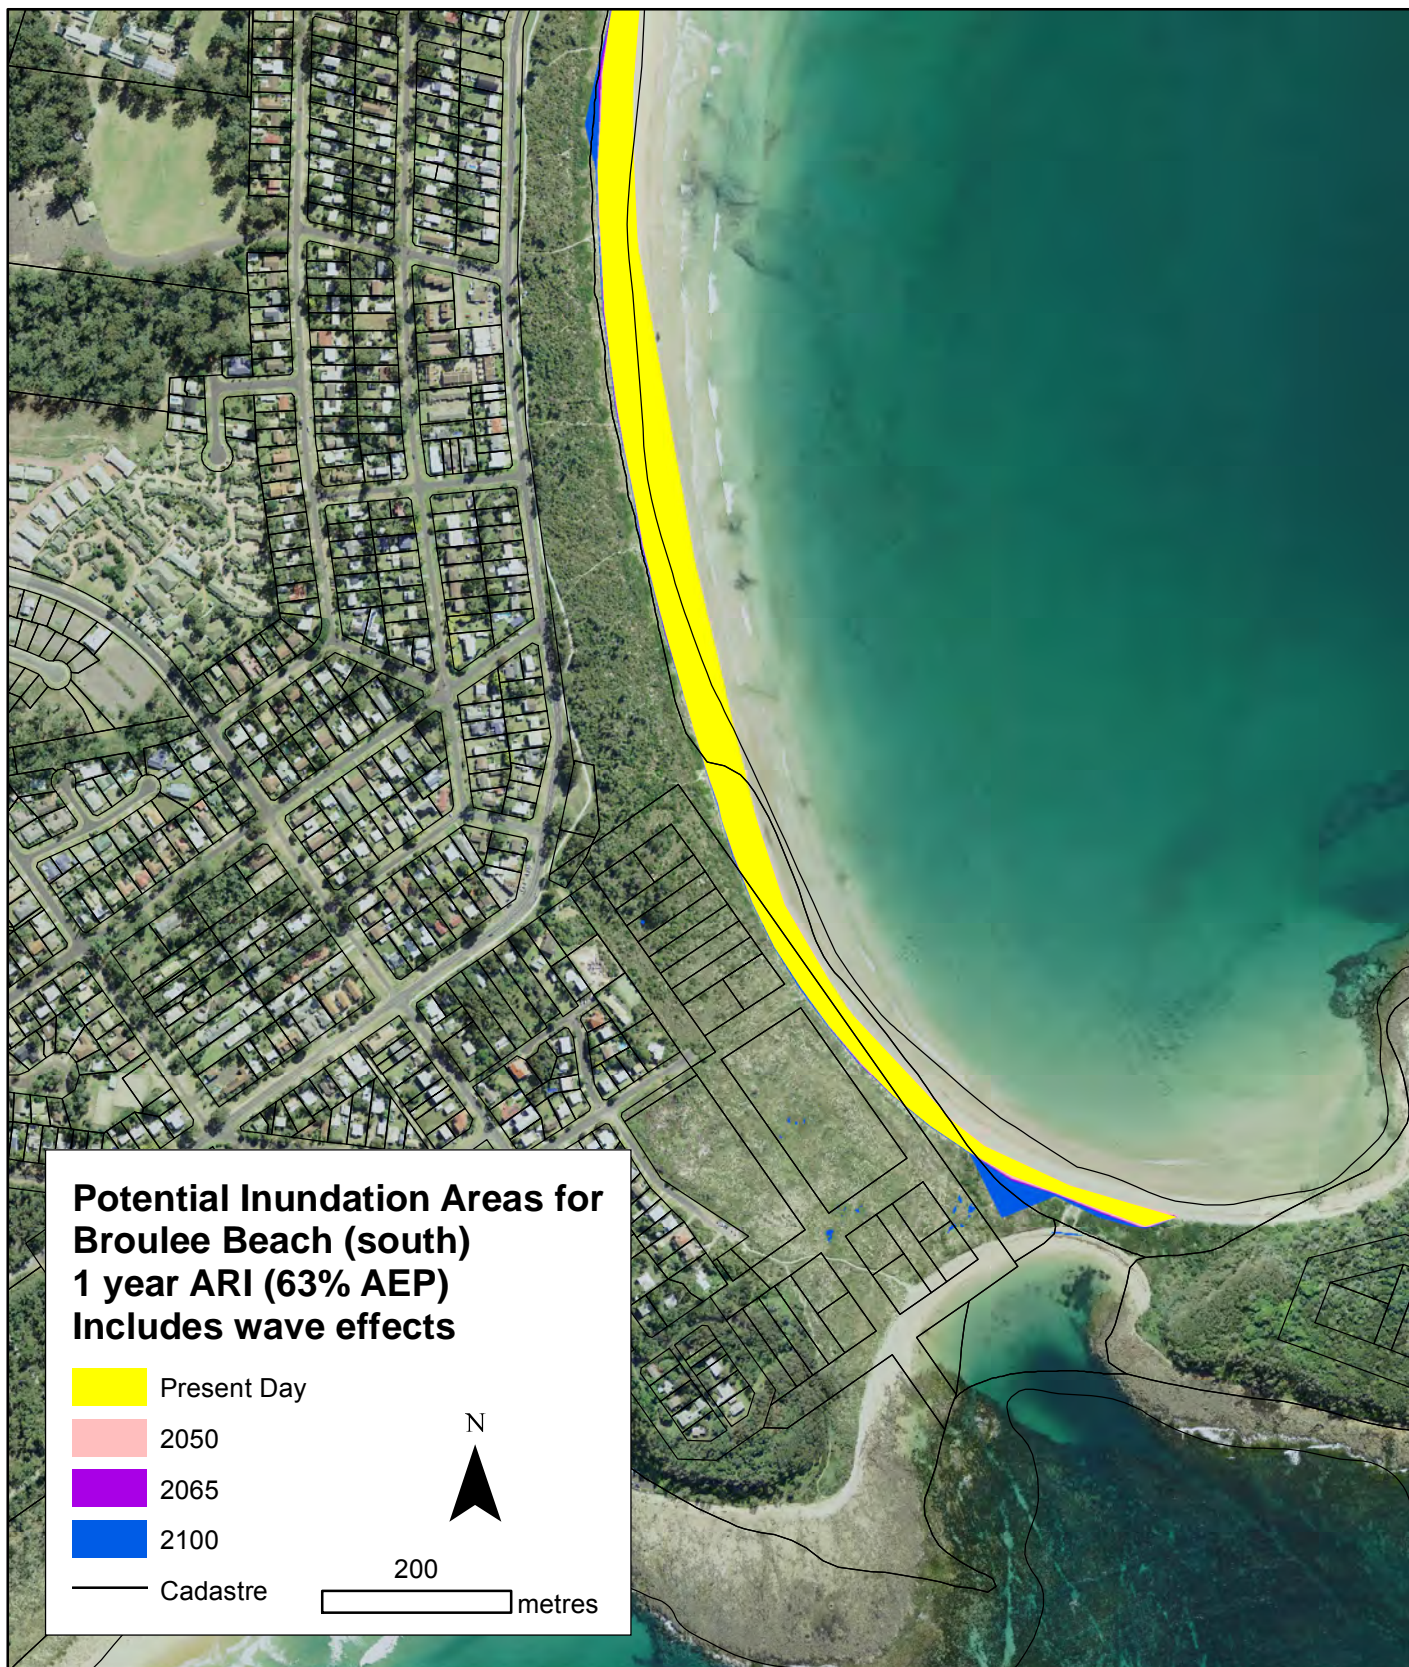
**Figure L.60**

Inundation of the beachface and the area immediately landward of the dune crest is based on the most recent year of photogrammetry data available (2011) and is in accordance with ESC's sea level rise policy and planning framework. It does not include allowance for future landward recession of the beach face and assumes that the crest level of the seawall (if present) and the topography remain as they were from the 2011 photogrammetry data. By 2050, 2065 or 2100 both of these assumptions may not be valid. Should the seawall/dune be allowed to fail then the landward extent of inundation may increase. Inundation of low lying areas behind the beach is based on the most recent year of LIDAR data available (2011). The low lying inundation areas behind the beach are mapped based on the ground elevation (the "all ground" LIDAR layer) and do not consider flow paths, flow velocities, loss of flow momentum or wave propagation into creek areas. WRL is not responsible for the accuracy of the photogrammetry or LIDAR data. Local surveys by a registered surveyor are recommended to determine local inundation extents. Inundation is only considered from Broulee Beach, no additional inundation from Bengello Beach has been incorporated.

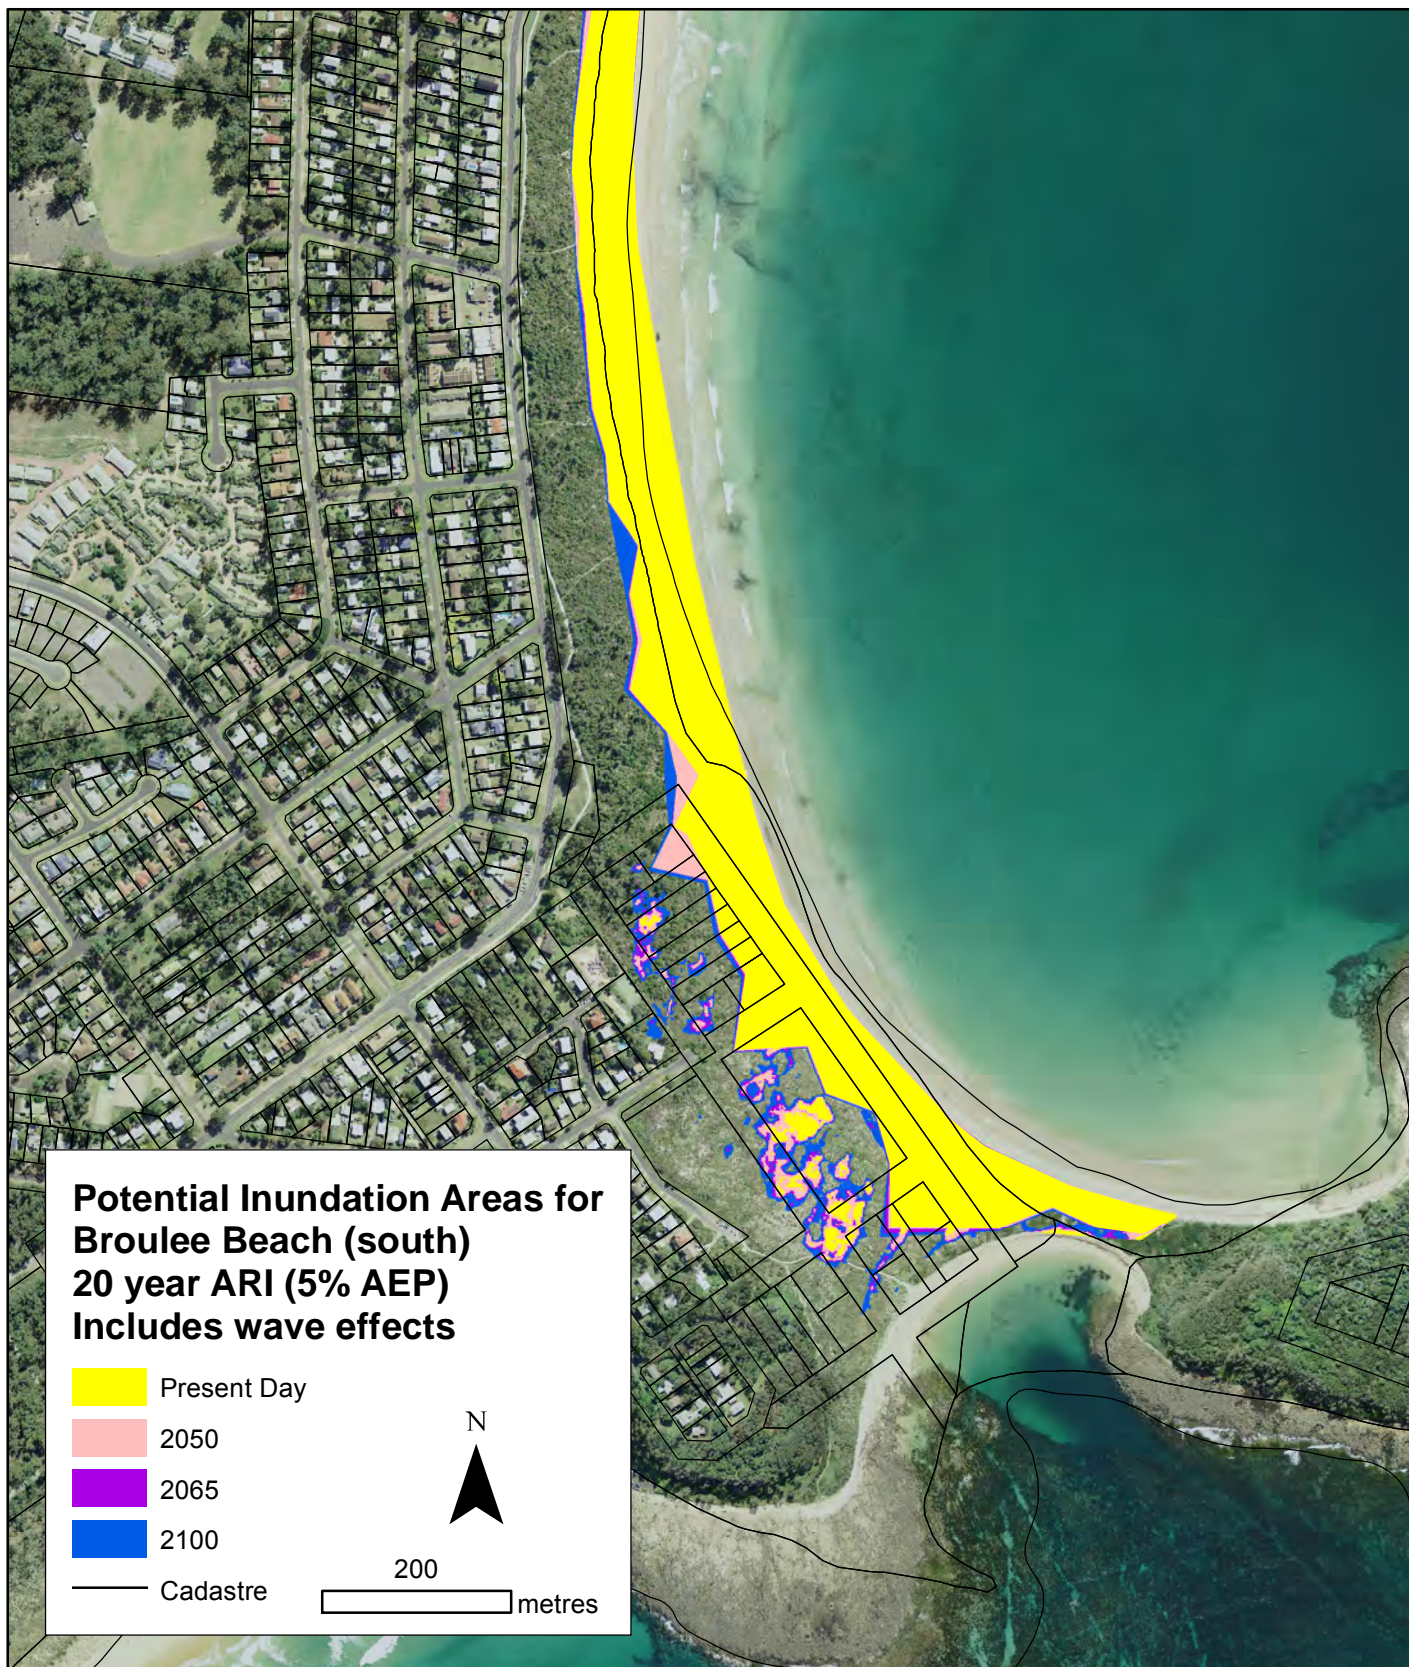
**Figure L.61**

Inundation of the beachface and the area immediately landward of the dune crest is based on the most recent year of photogrammetry data available (2011) and is in accordance with ESC's sea level rise policy and planning framework. It does not include allowance for future landward recession of the beach face and assumes that the crest level of the seawall (if present) and the topography remain as they were from the 2011 photogrammetry data. By 2050, 2065 or 2100 both of these assumptions may not be valid. Should the seawall/dune be allowed to fail then the landward extent of inundation may increase. Inundation of low lying areas behind the beach is based on the most recent year of LIDAR data available (2011). The low lying inundation areas behind the beach are mapped based on the ground elevation (the "all ground" LIDAR layer) and do not consider flow paths, flow velocities, loss of flow momentum or wave propagation into creek areas. WRL is not responsible for the accuracy of the photogrammetry or LIDAR data. Local surveys by a registered surveyor are recommended to determine local inundation extents. Inundation is only considered from Broulee Beach, no additional inundation from Bengello Beach has been incorporated.

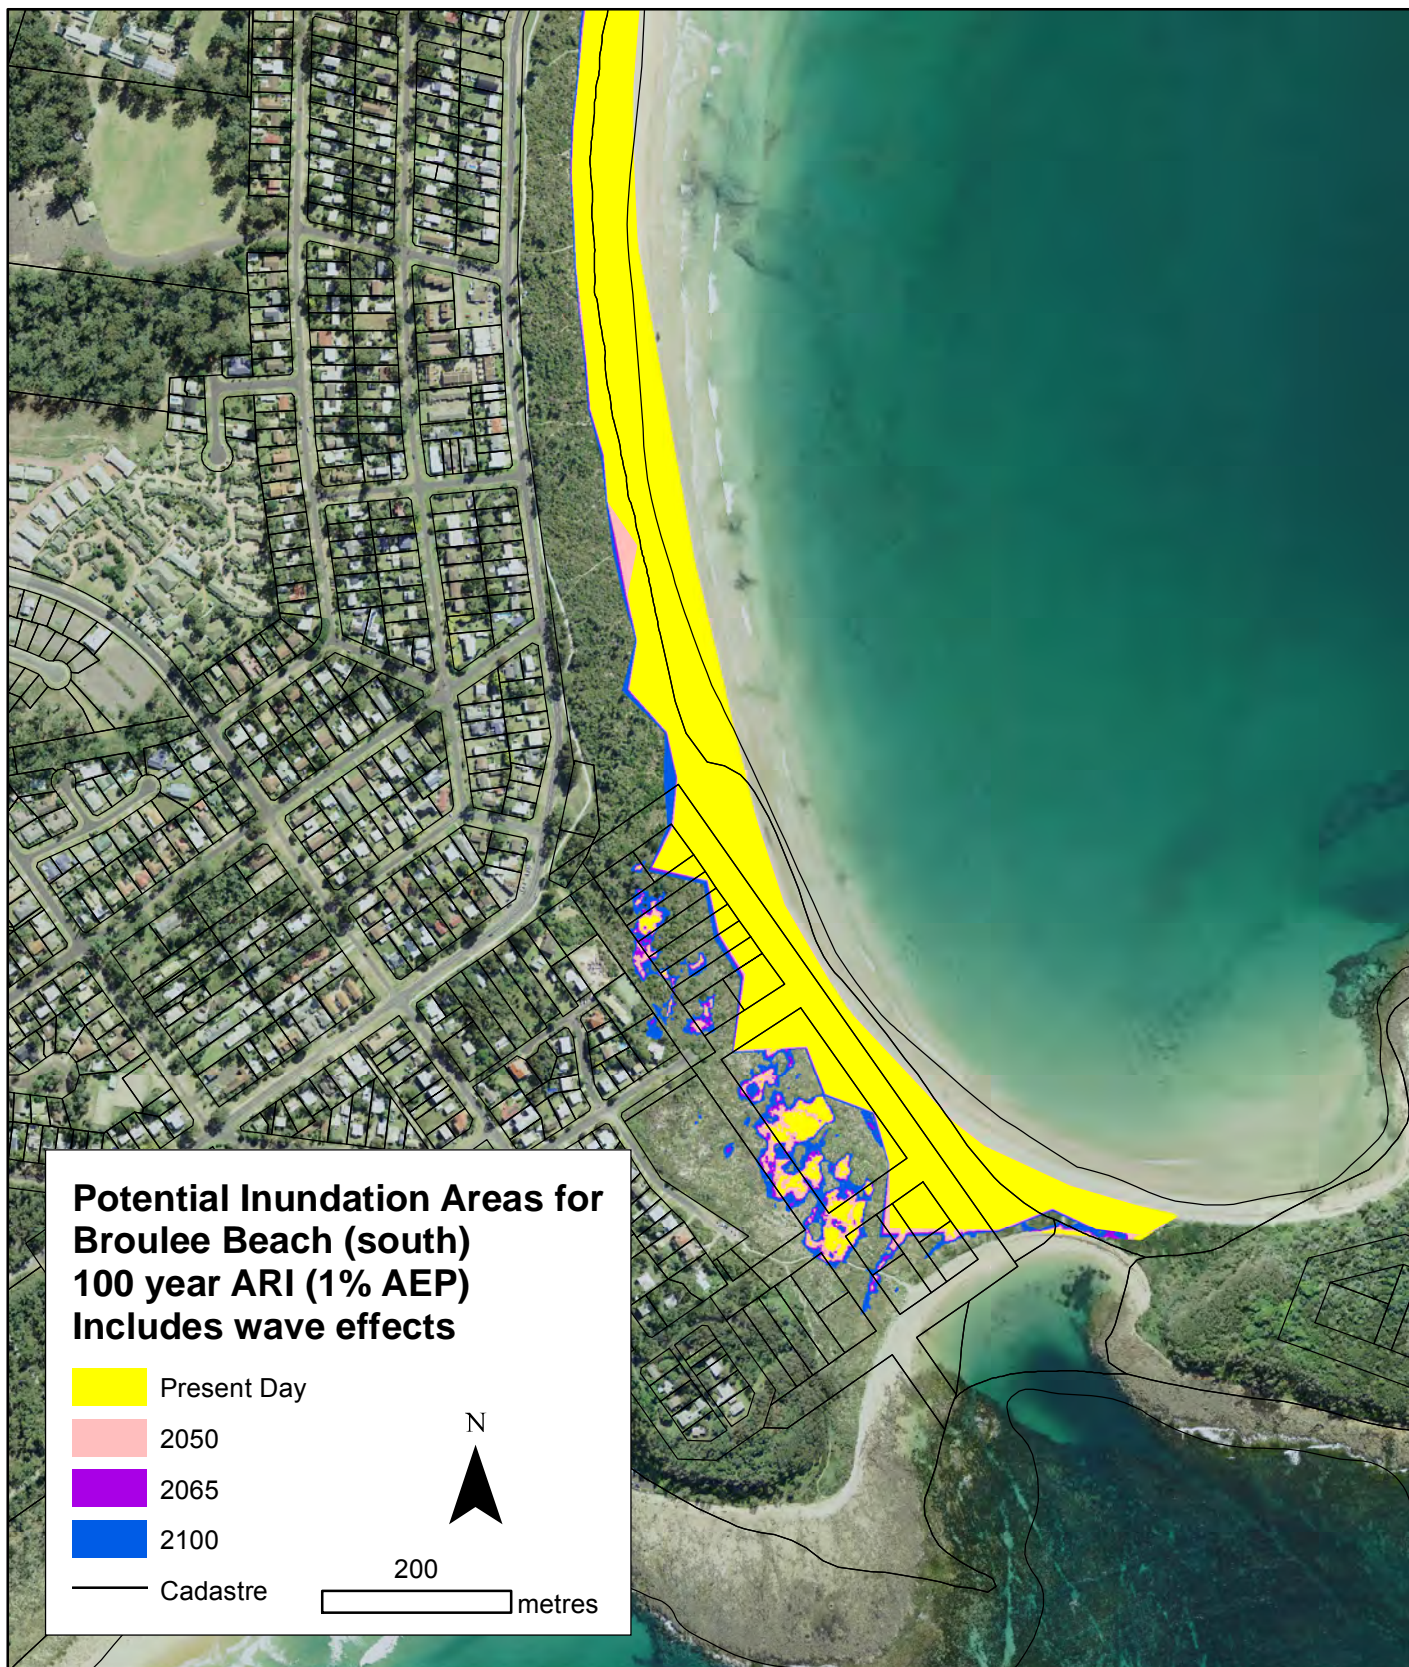
**Figure L.62**

Inundation of the beachface and the area immediately landward of the dune crest is based on the most recent year of photogrammetry data available (2011) and is in accordance with ESC's sea level rise policy and planning framework. It does not include allowance for future landward recession of the beach face and assumes that the crest level of the seawall (if present) and the topography remain as they were from the 2011 photogrammetry data. By 2050, 2065 or 2100 both of these assumptions may not be valid. Should the seawall/dune be allowed to fail then the landward extent of inundation may increase. Inundation of low lying areas behind the beach is based on the most recent year of LIDAR data available (2011). The low lying inundation areas behind the beach are mapped based on the ground elevation (the "all ground" LIDAR layer) and do not consider flow paths, flow velocities, loss of flow momentum or wave propagation into creek areas. WRL is not responsible for the accuracy of the photogrammetry or LIDAR data. Local surveys by a registered surveyor are recommended to determine local inundation extents. Inundation is only considered from Broulee Beach, no additional inundation from Bengello Beach has been incorporated.

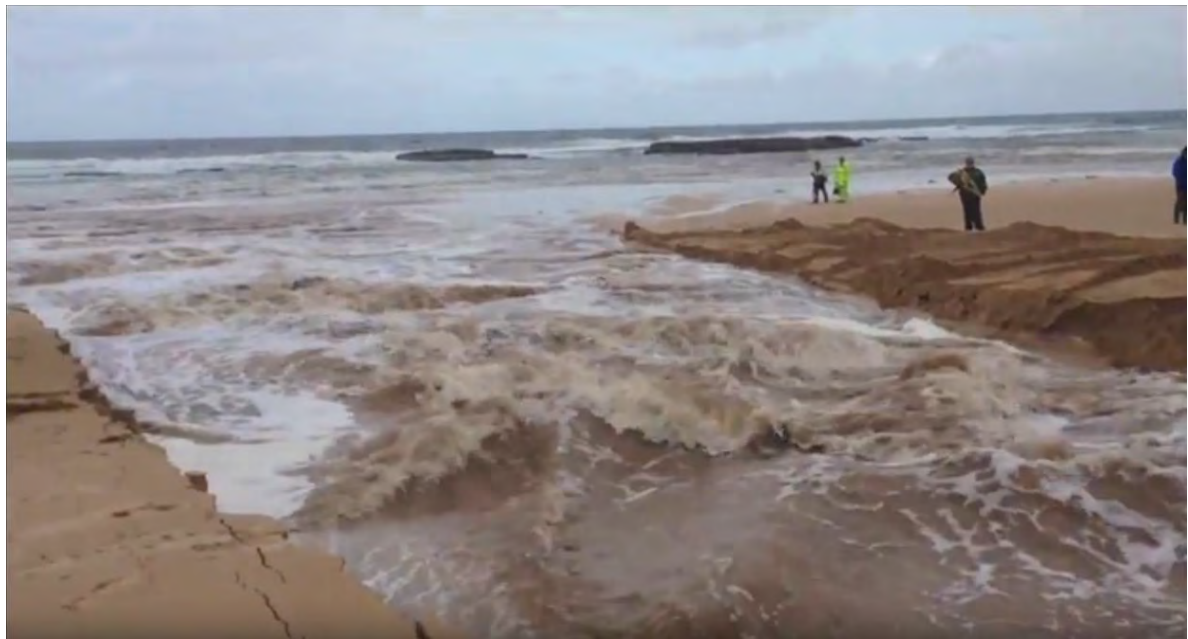
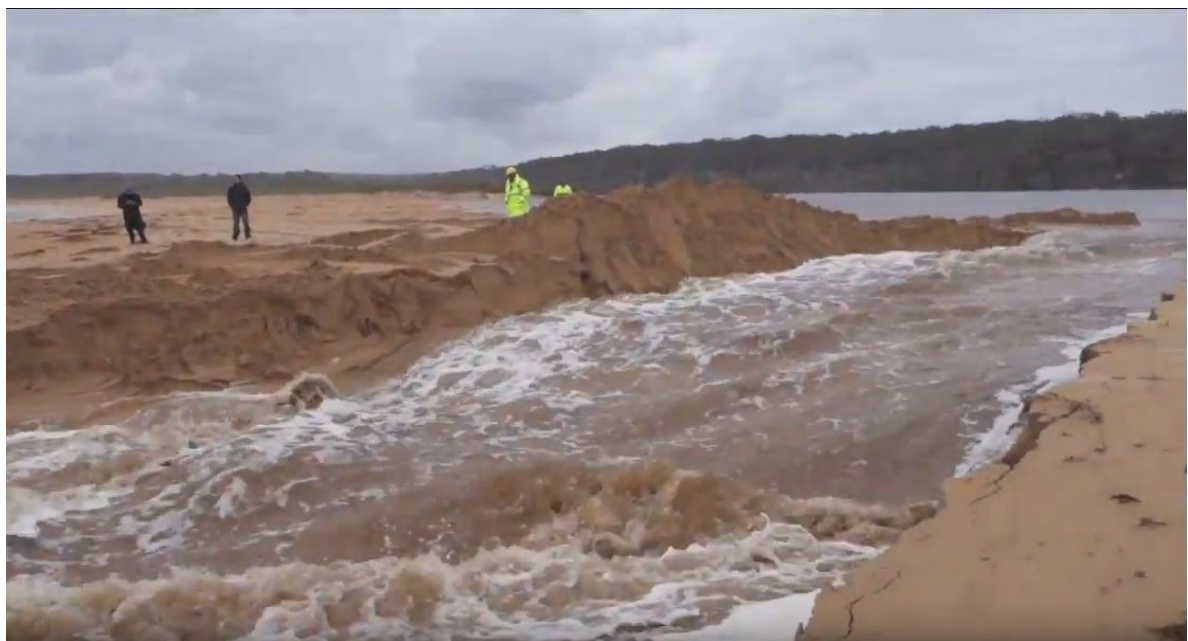
**Figure M-1: Durras Lake Entrance Shortly After Mechanical Opening 26 August 2014  
(Source: Durras Lake North Holiday Park, 2014)**

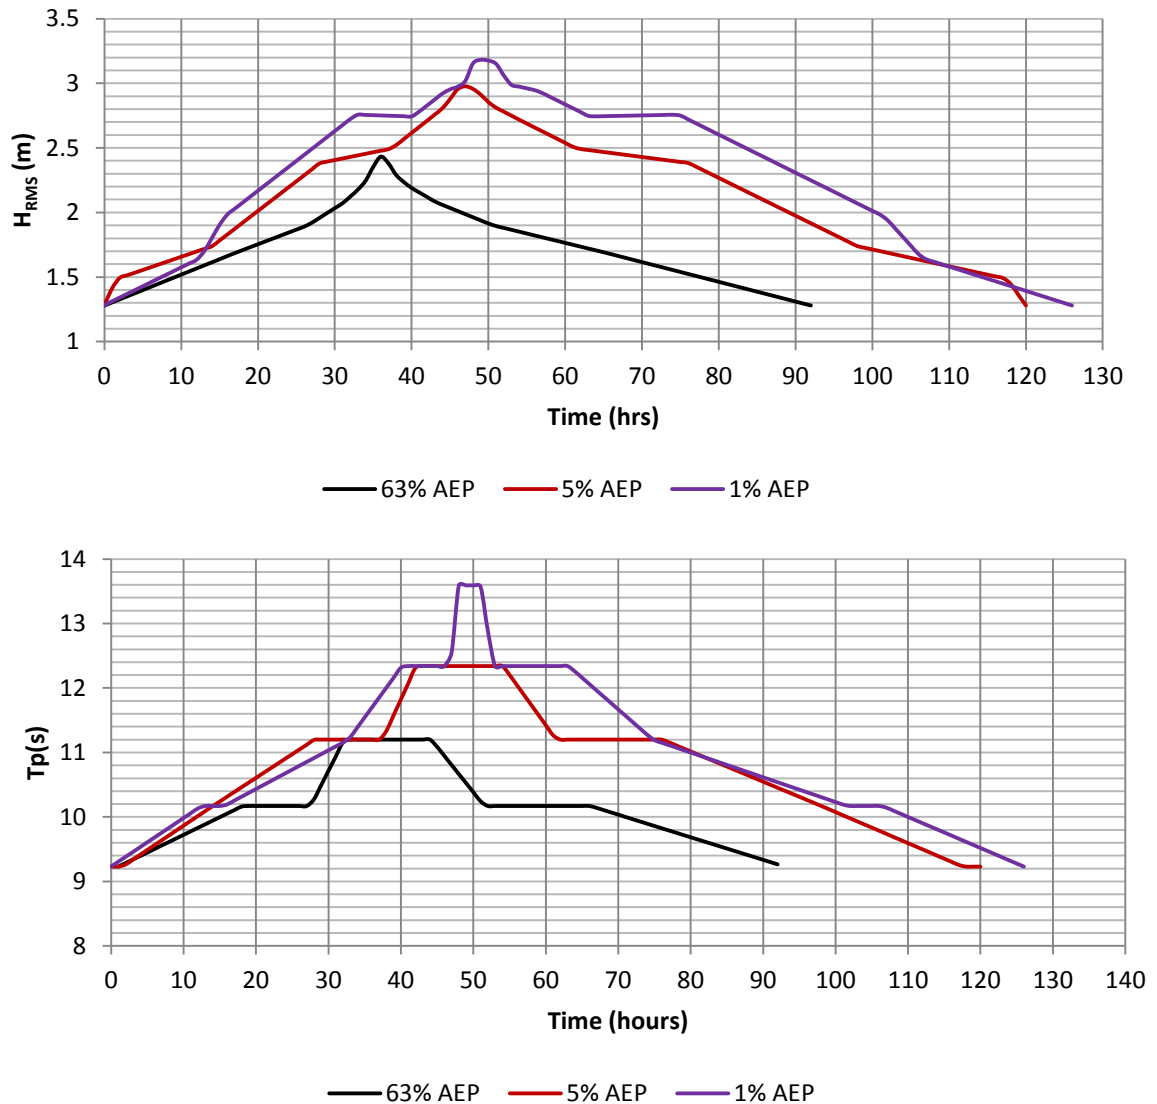
wave climate at Eden). The synthetic 1%, 5% and 63% AEP storm ( $H_{RMS}$  and  $T_p$ ) timeseries is shown in Figure M-2. To investigate the wave setup expect to occur at Durras Beach, the root mean square wave height  $H_{RMS}$  (m) corresponding to the significant wave heights extracted from the SWAN model was first calculated according to CIRIA (2007) in Equation M.1.

**Figure M-2: Synthetic Design Storms ( $H_{RMS}$  and  $T_p$ ) used for Durras Lake Tailwater levels**

Breaking waves cause an elevated water level in the surf zone due to the radiation stress of the breaking waves being balanced by a gradient in the water surface. The storm waves shown in Figure M-2 were applied as a boundary condition to the Dally, Dean and Dalrymple (1984) two-dimensional surf zone model (implemented using the numerical modelling software SBEACH). From this model, total water levels, including wave setup, were extracted at 15 minute time intervals to define the design tailwater conditions discussed in the following sub-section.

Elevated design peak water level conditions (excluding wave runup) are summarised in Table M-2. Constructed synthetic water level time series are provided in Figure M-6, Figure M-5 and Figure M-4 for the 63%, 5% and 1% AEP (1, 20 and 100 year ARI) storm events respectively. The length of the provided timeseries corresponds directly with the length of the appropriate coastal storm event, as per Figure M-2.

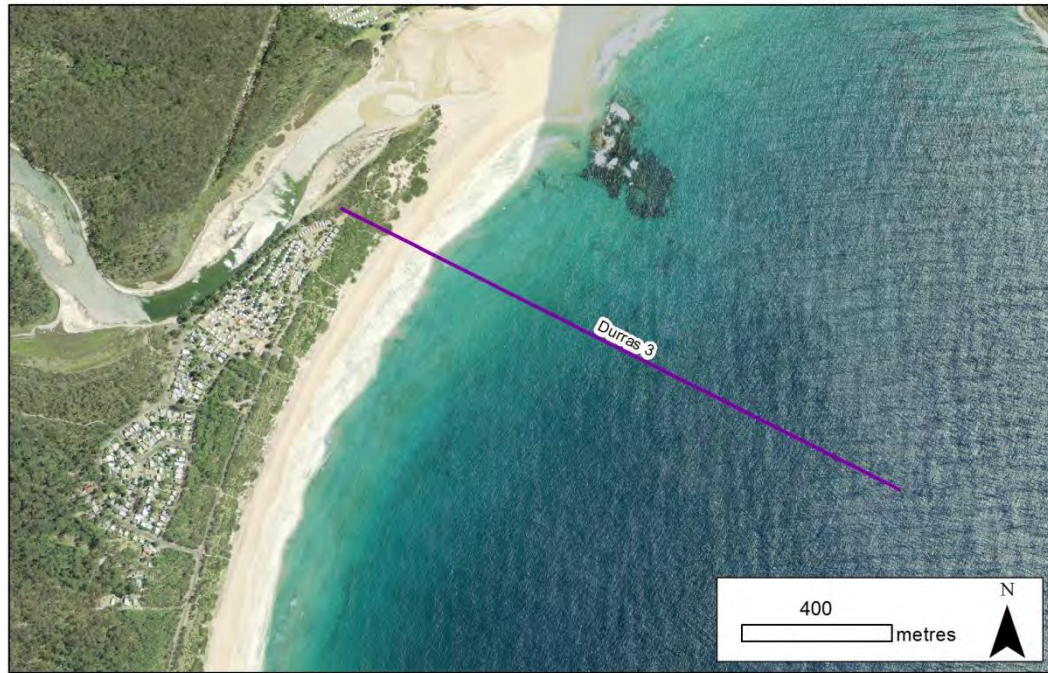
The Durras Lake tailwater modelling has been based on a profile immediately south of the lake entrance (shown in Figure M-3). Topographic information was extracted of the subaerial portion of the profile from the 2011 LIDAR. As no recent near shore bathymetric data was available for Durras Beach, an Dean Equilibrium Profile (Dean, 1977) was assumed based on a grain size of 0.37 mm, as per the methodology in Section 8.3.2.

**Figure M-3: Location of tailwater conditions analysis for Durras Lake**
