## Eurobodalla Coastal Hazard Assessment

WRL Technical Report 2017/09  
October 2017

By I R Coghlan, J T Carley, A J Harrison, D Howe, A D Short,  
J E Ruprecht, F Flocard and P F Rahman

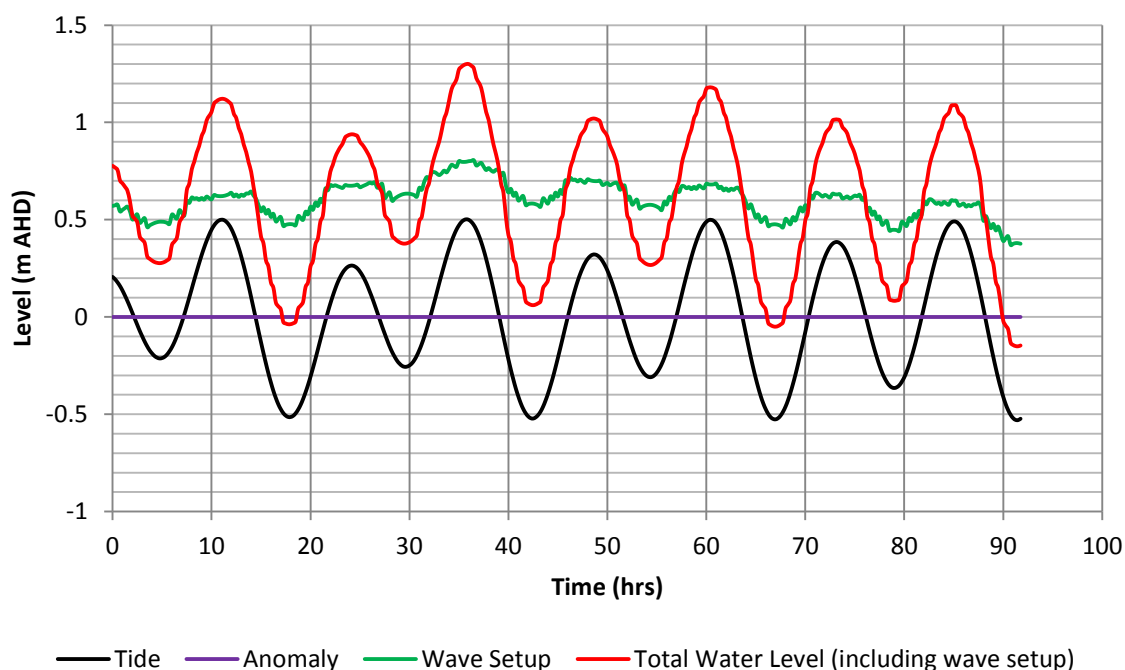
**Figure M-4: Durras Lake tailwater conditions: 63% AEP**

Elevated design peak water level conditions (excluding wave runup) are summarised in Table M-2. Constructed synthetic water level time series are provided in Figure M-6, Figure M-5 and Figure M-4 for the 63%, 5% and 1% AEP (1, 20 and 100 year ARI) storm events respectively. The length of the provided timeseries corresponds directly with the length of the appropriate coastal storm event, as per Figure M-2.

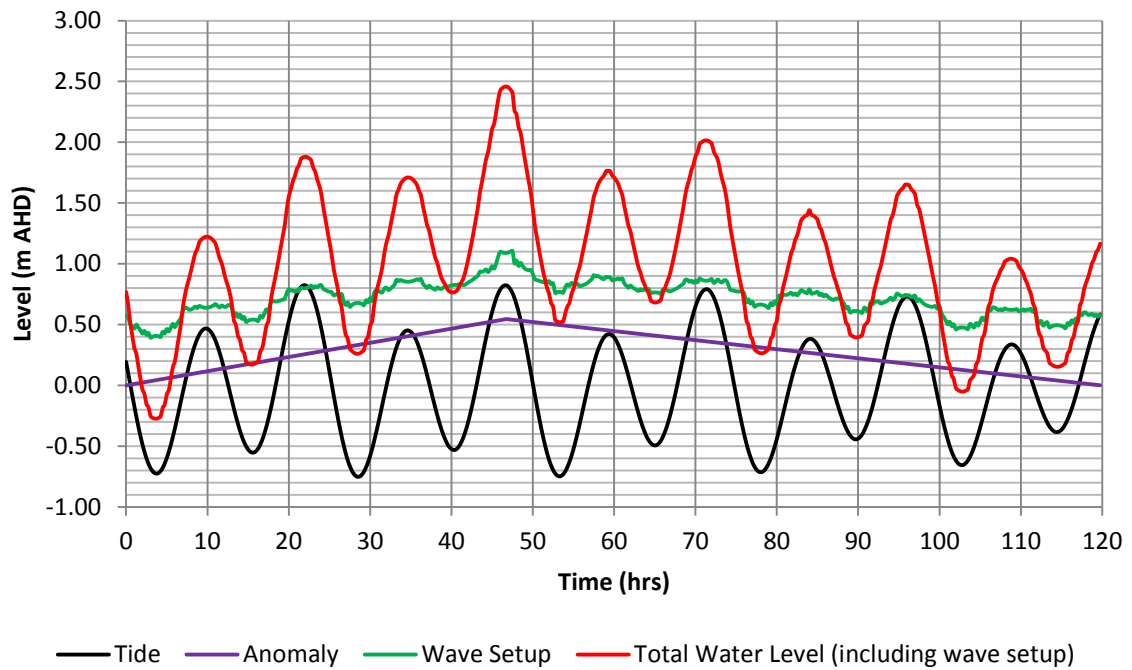
**Figure M-5: Durras Lake tailwater conditions: 5% AEP**

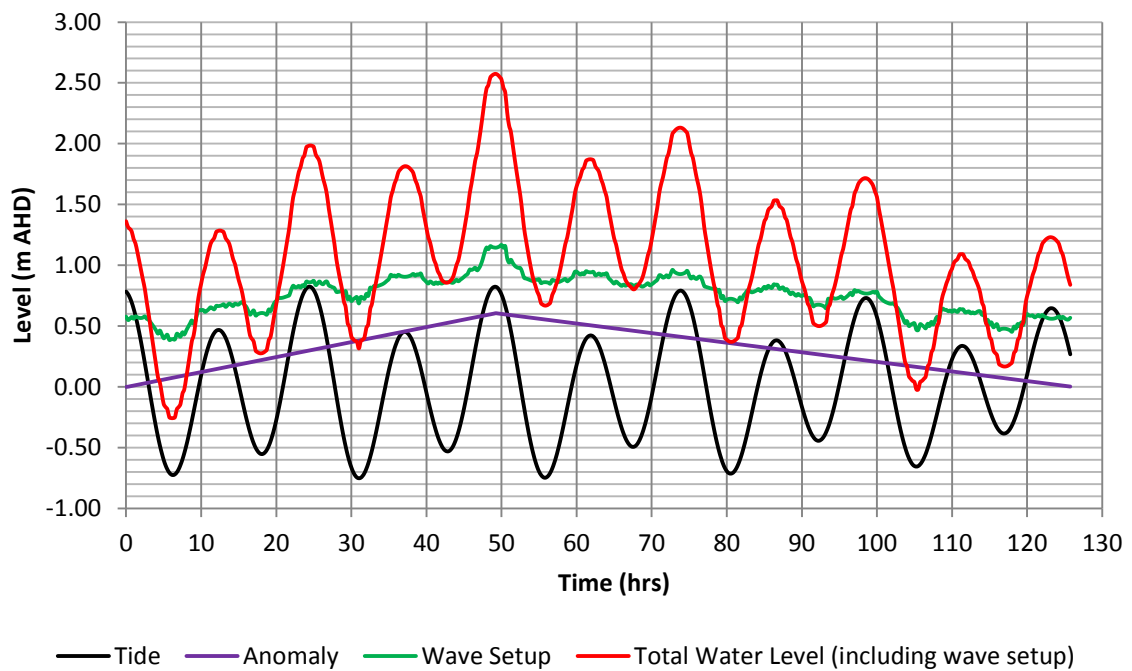
**Figure M-6: Durras Lake tailwater conditions: 1% AEP**
